CONSERVATION SURVEY

MAX-LIEBLING-HOUSE

29, IDELSON STREET, TEL AVIV

Tel Aviv/Berlin, 2016/17

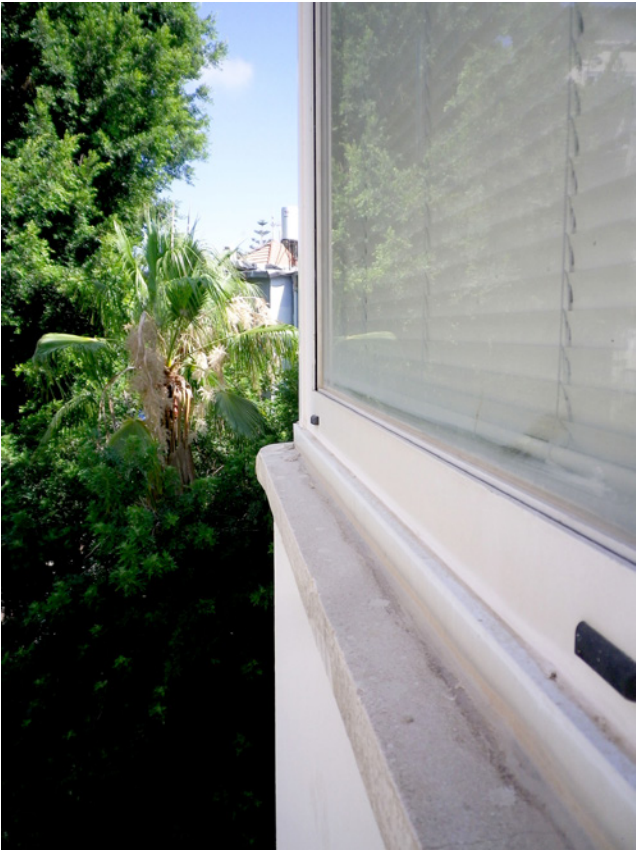
Fig. 88 Northern balcony (type B.3), subsequently enclosed with windows, 2015

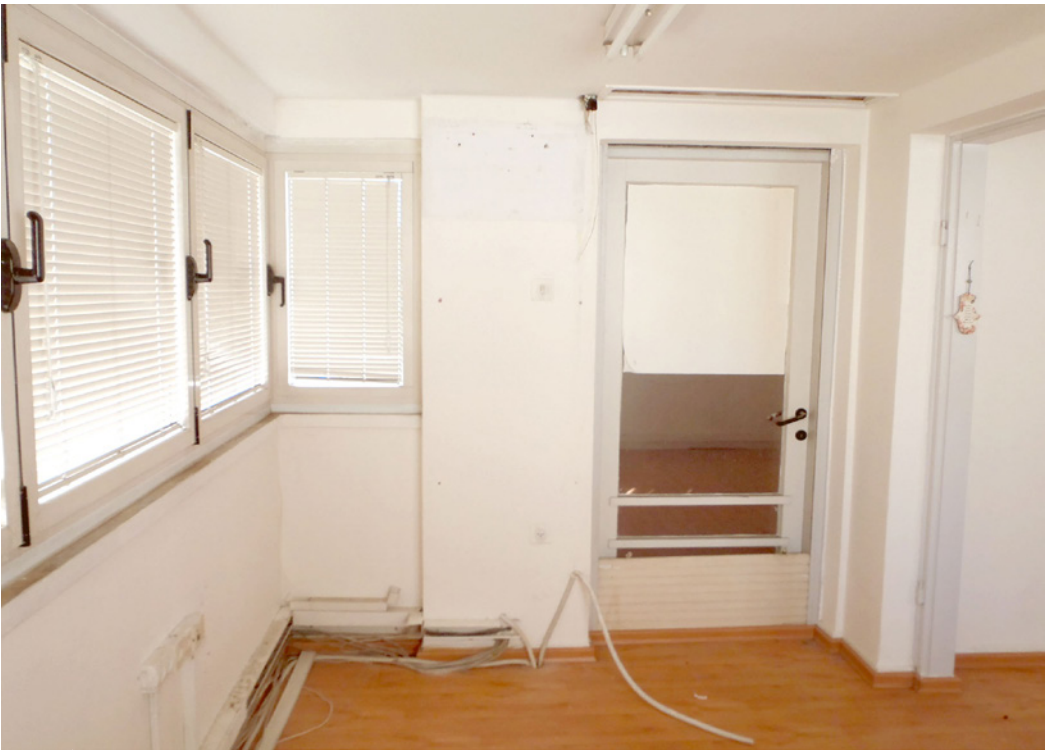
Fig. 89 Northern balcony used as a room. Remains of a presumably original wooden roller shutter at the former balcony door, 2015

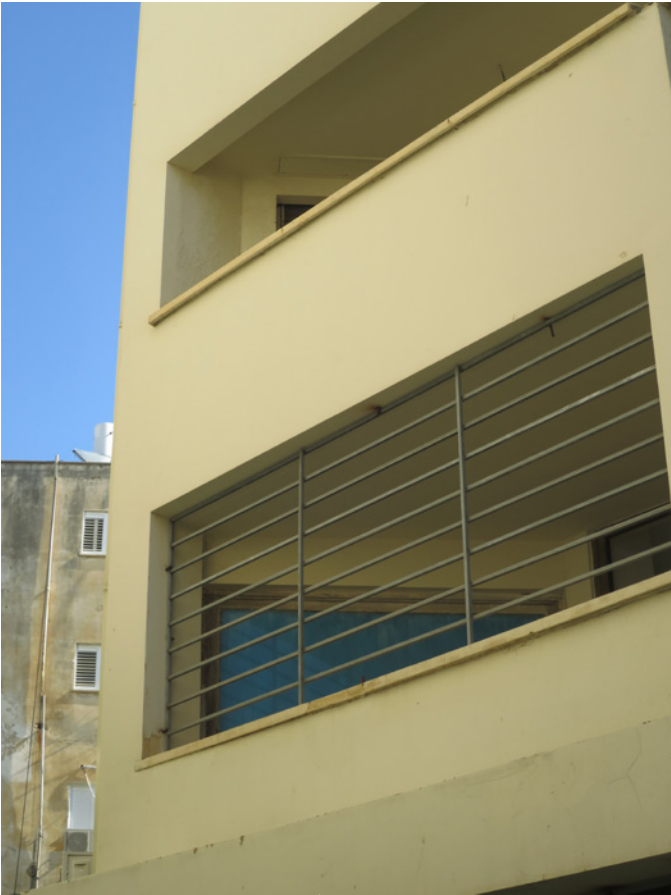
Fig. 90 Western balconies (type B.4), the ground floor balcony 00.U has only 1.46m headroom, 2015

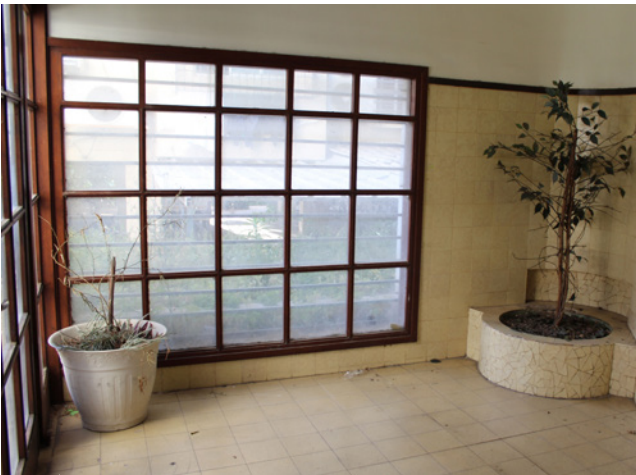
Fig. 94 Entrance hall with an original fountain reused as a planter, 2015

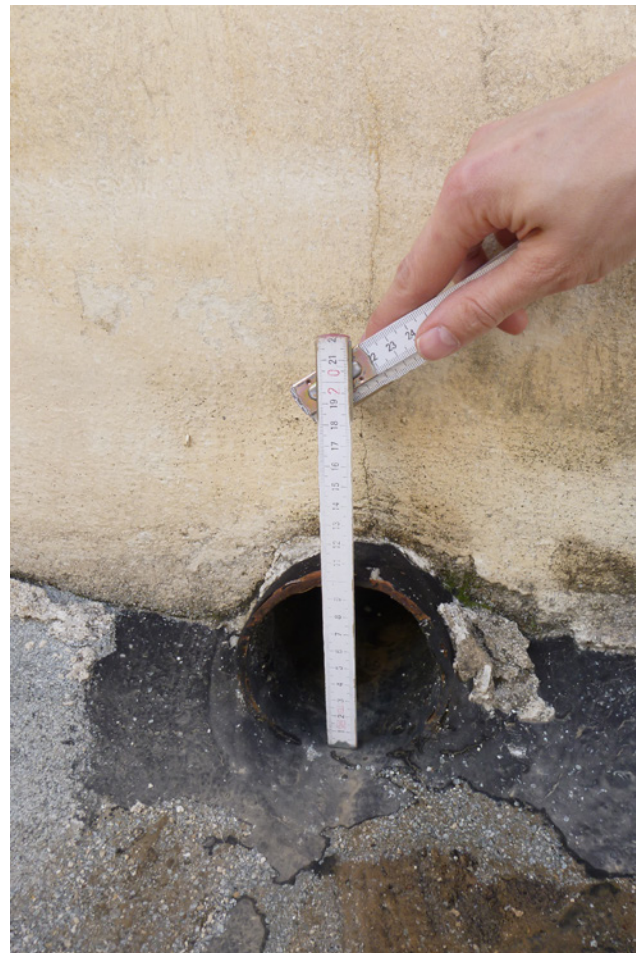
Fig. 103 Roof drainage, 2015

The roof itself is surfaced with bituminous sheeting. The southern half is drained through an inlet connected to a downpipe that, on the stories below, is to be found in the northeast corner of the south balcony. The northern half of the roof is drained via two spouts that penetrate the base of the parapet in the north and west. The rainwater from each of these enters an exposed downpipe that is mounted on the respective facade. It is worth noting that the two separate halves of the roof surface are connected via a pipe at the base of the parapets at the southwest corner of the stair penthouse. This acts as an emergency overflow for water to flow from the southern to the northern half, where it can be discharged through the spout on the west side. The roofs of the stair penthouse and the storage room are also connected. These surfaces are drained through a hole in the low parapet of the storage room. On its north side, a large area of render has become discolored black owing to the lack of a spout that projects adequately from the wall.

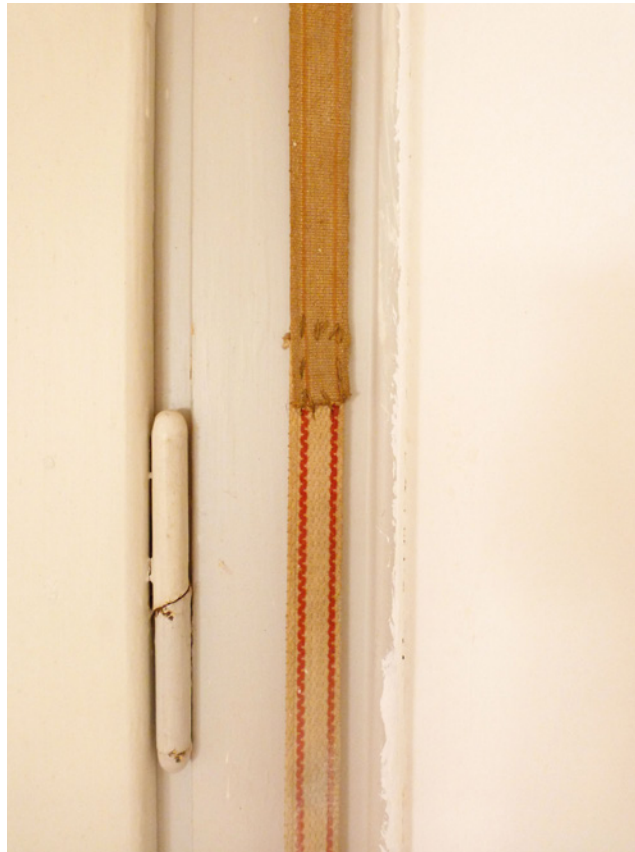
Fig. 106 Repaired roller shutter belt, upper part probably original, 2015

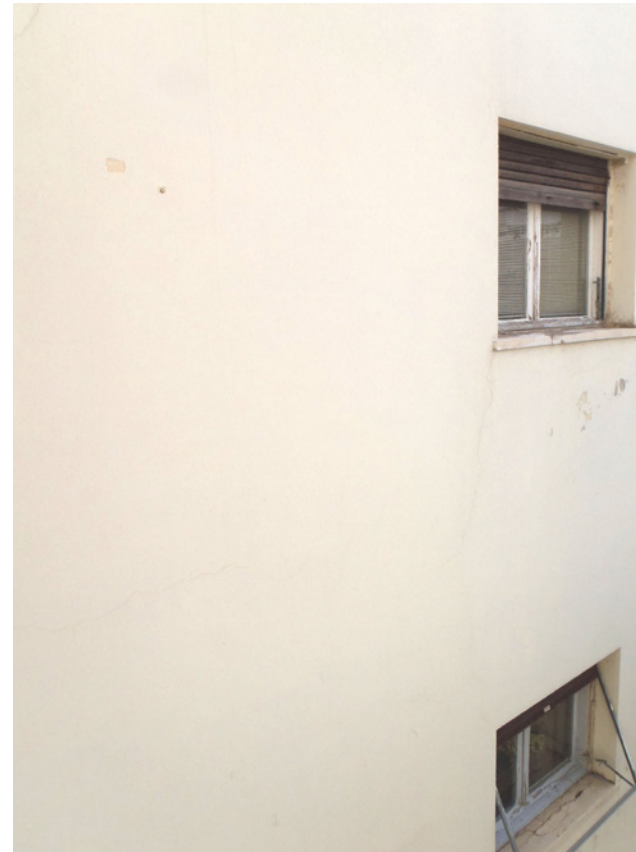
Fig. 108 Windows, roller shutters not original, east facade, 2015

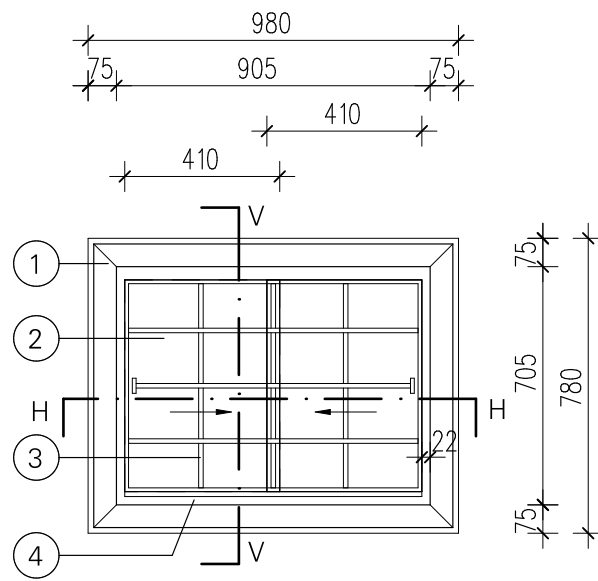
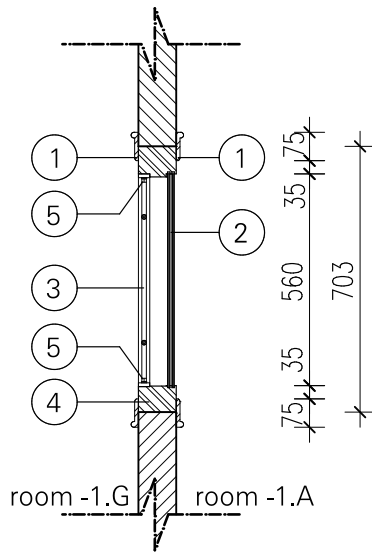
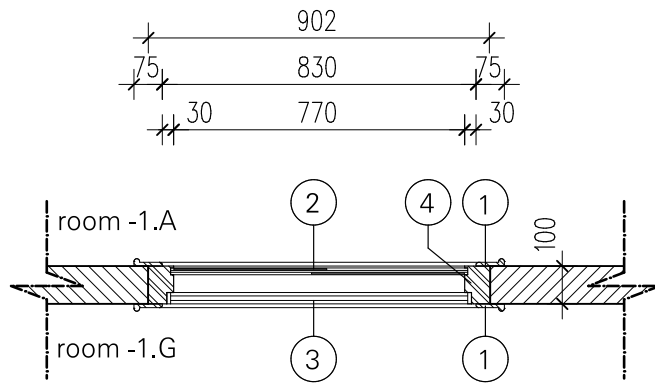
W.2.9

- ① Casing with half-round edge trim
- ② Sliding window, original, 2 opening panes, clear glass
- ③ Window grille, square section bar, steel, painted not original
- ④ Block frame window, wood
- ⑤ Fastenings for former original grille

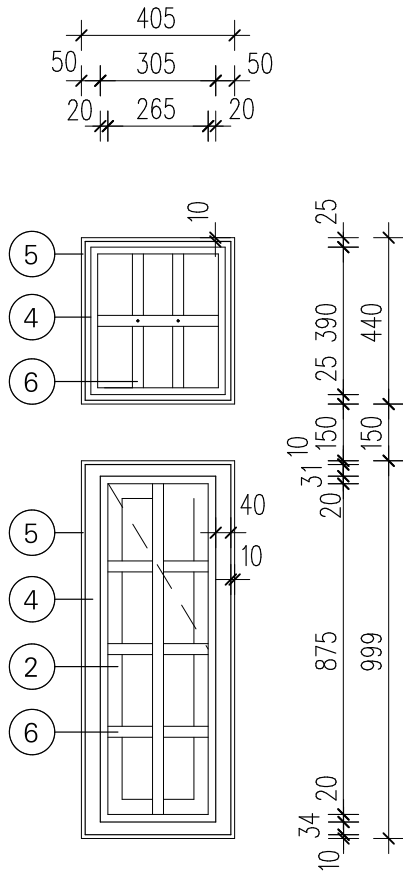
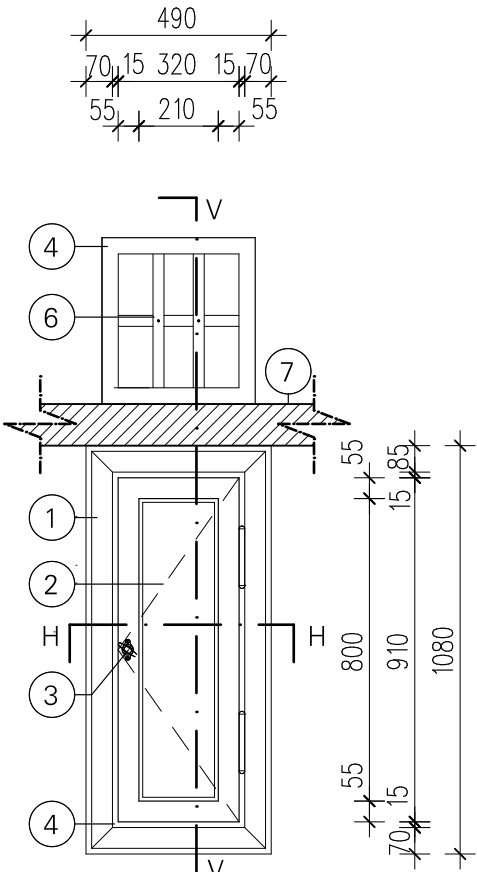
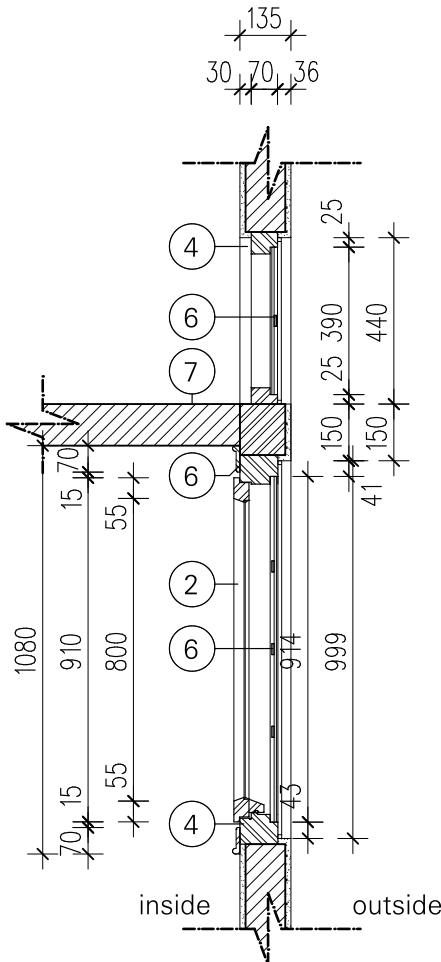
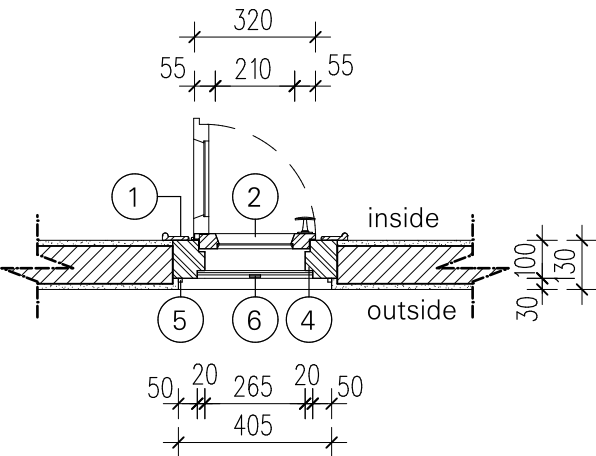
W.3.1

- ① Casing with half-round edge trim
- ② Side-hung casement, textured glass
- ③ Oval knob (original) brass, surface finish nickel silver (stamped "NICKSIL" on shaft of handle), presumably manufactured by the German producer Wehag, espagnolette bolt
- ④ Ventilation opening of the storage space in the ceiling void block frame window without sash, wood, painted
- ⑤ Edge trim 10x10 mm
- ⑥ Window grille, flat steel, probably originally attached to steel lugs in the window frame
- ⑦ Intermediate ceiling, probably reinforced concrete

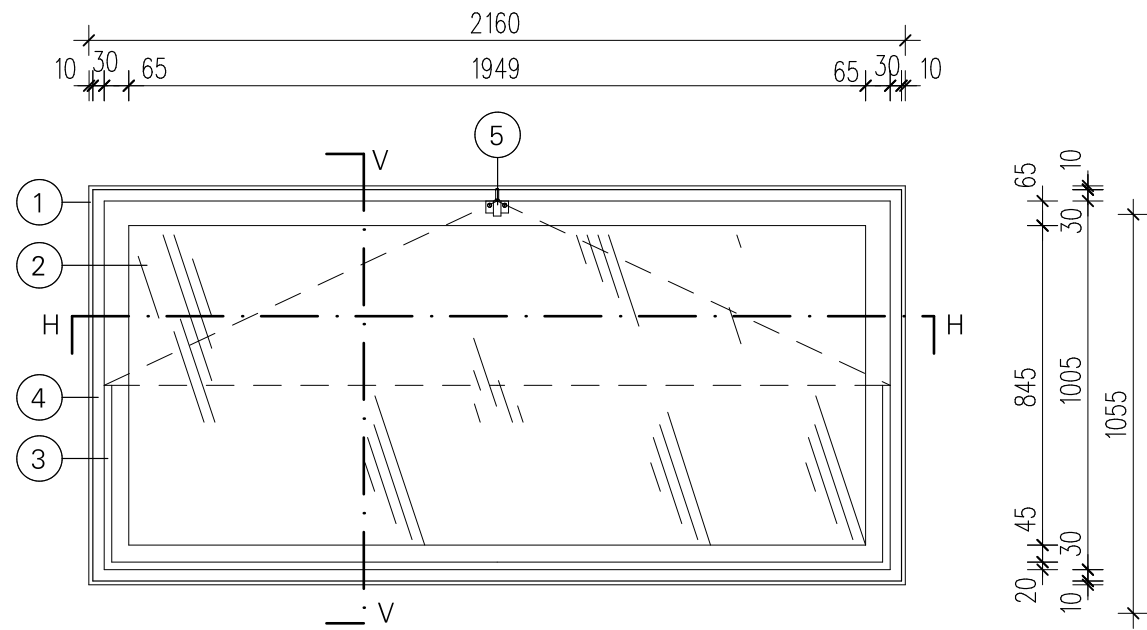
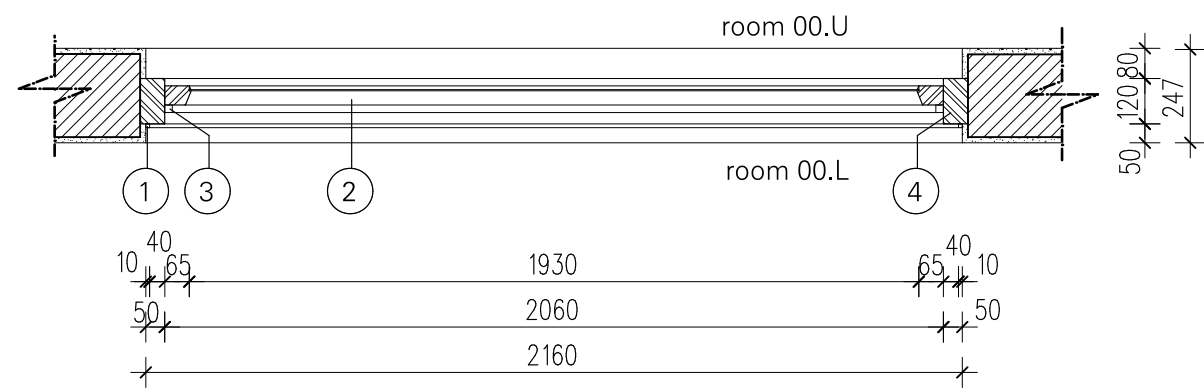
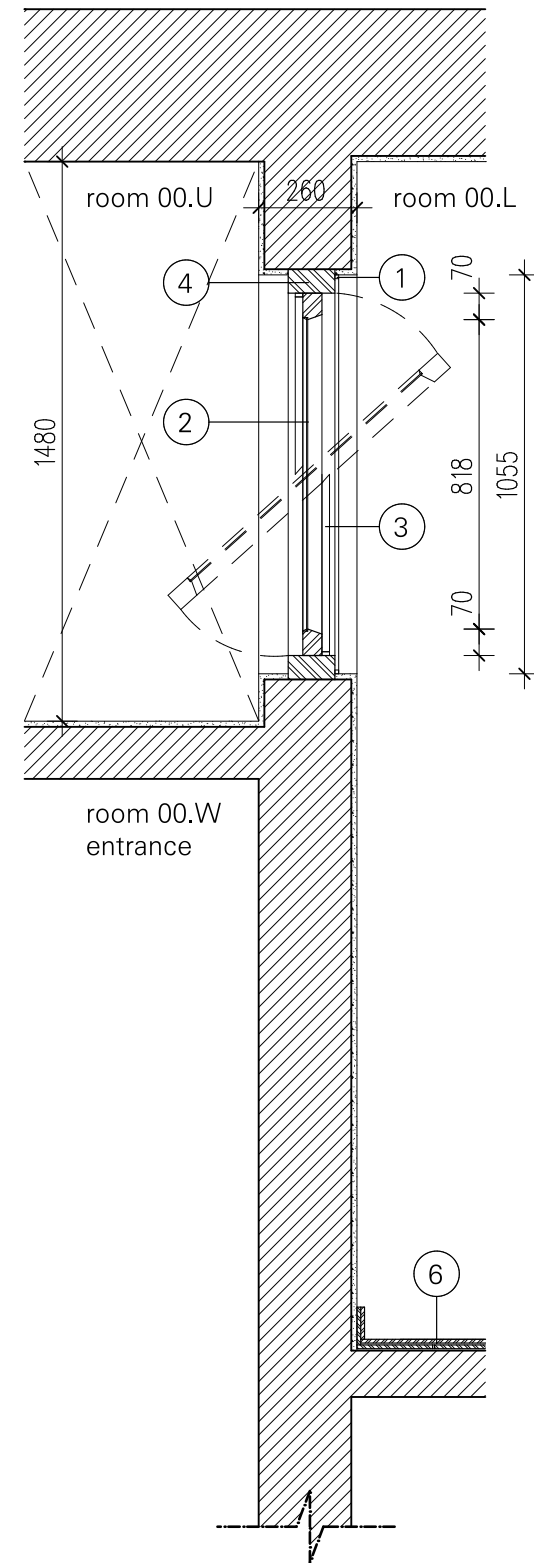
- ① Edge trim, square section 10 x 10 mm
- ② Pivoting sash
- ③ Rebate strip to arrest sash in the open position, 20 x 20 mm
- ④ Block frame window, wood
- ⑤ Snap closure with loop for attaching a pull cord or equivalent
- ⑥ Flooring: new ceramic floor tiles laid on top of the original floor covering and baseboard. Original floor covering of terrazzo floor tiles, yellowish beige, 20 x 20 x 1 cm and base tiles 20 x 10 x 1 cm

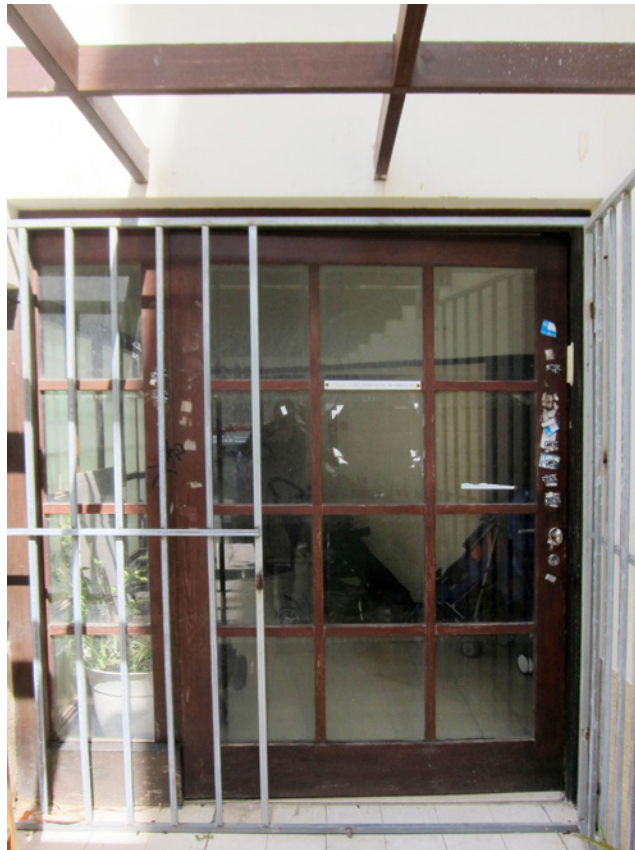
Fig. 112 Original main entrance door, 2015

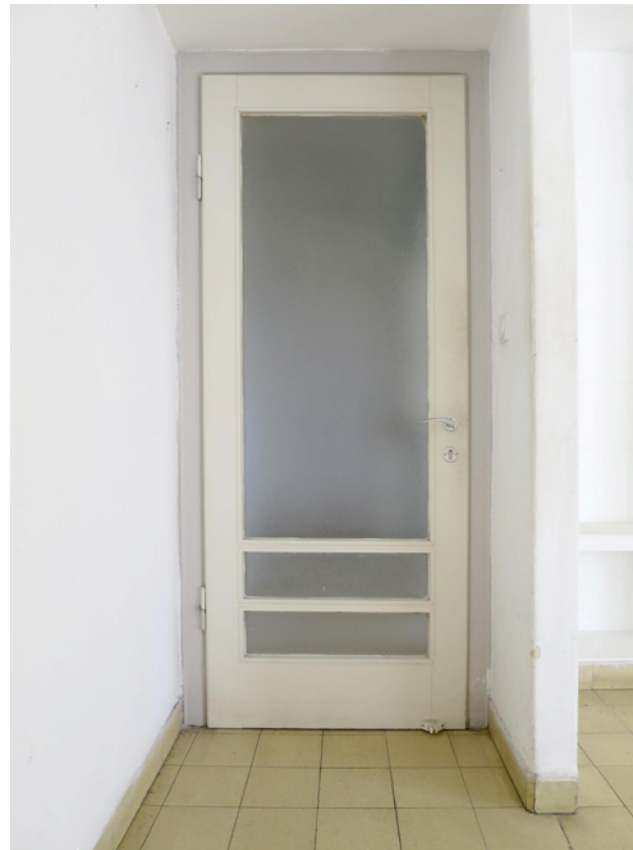
Fig. 114 Original interior door, room 02.A (third floor), 2015

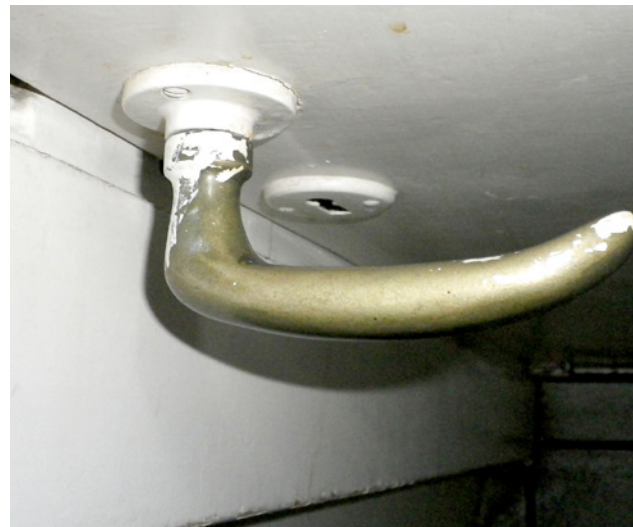
Fig. 115 Original door handle, second floor, 2015

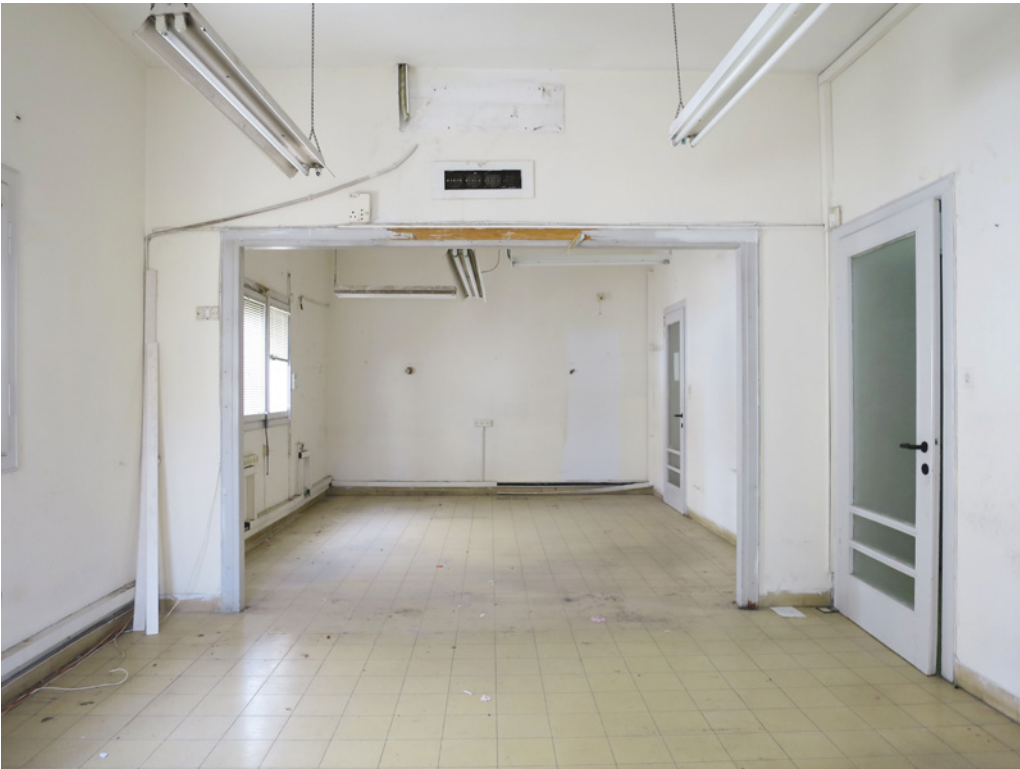
Fig. 116 Wall opening formerly closed by a folding door, third floor, 2015

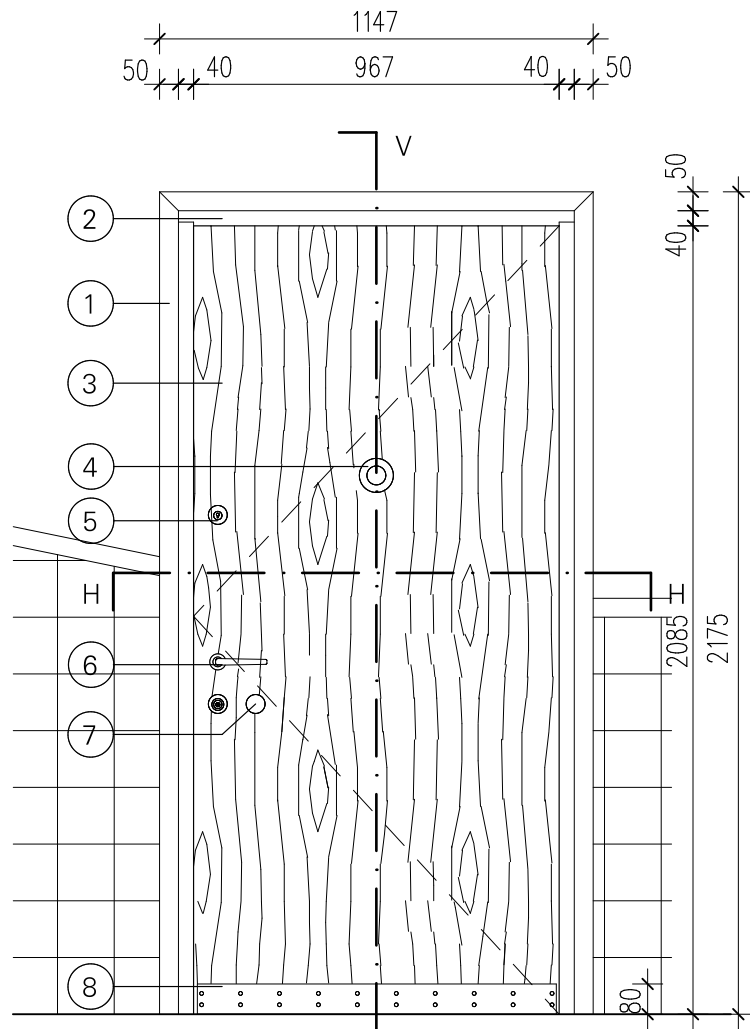
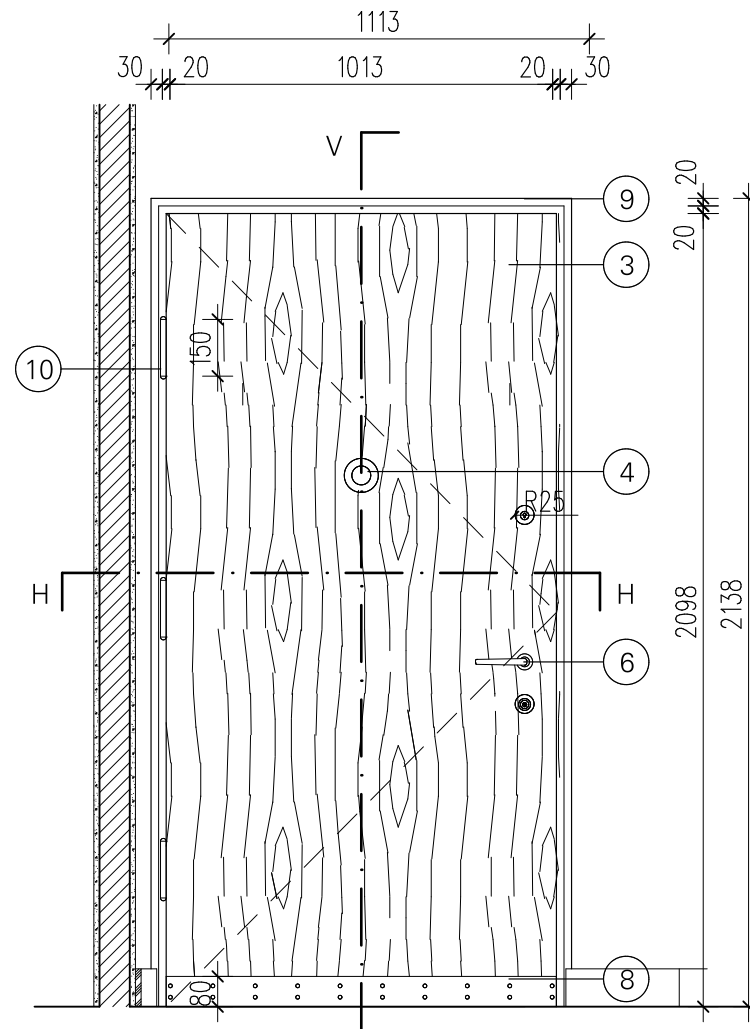
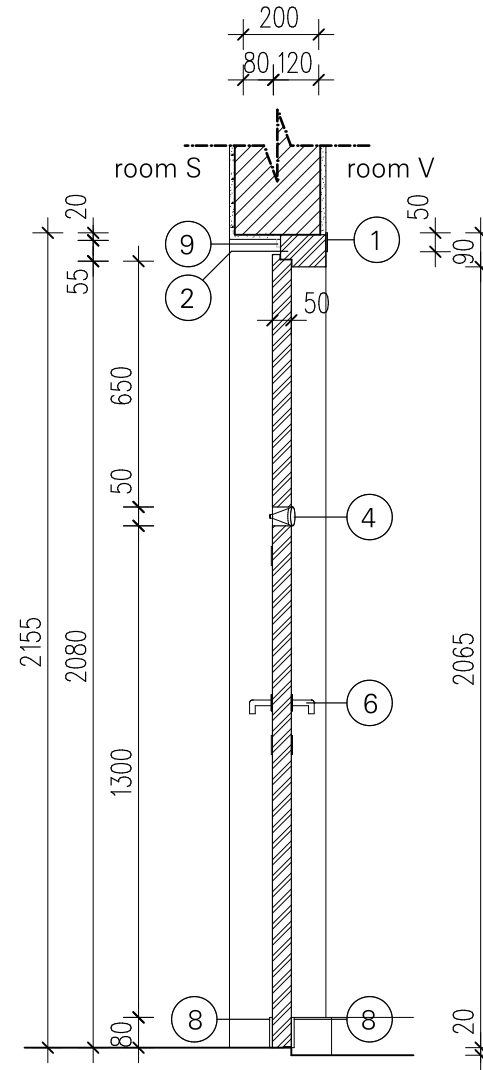
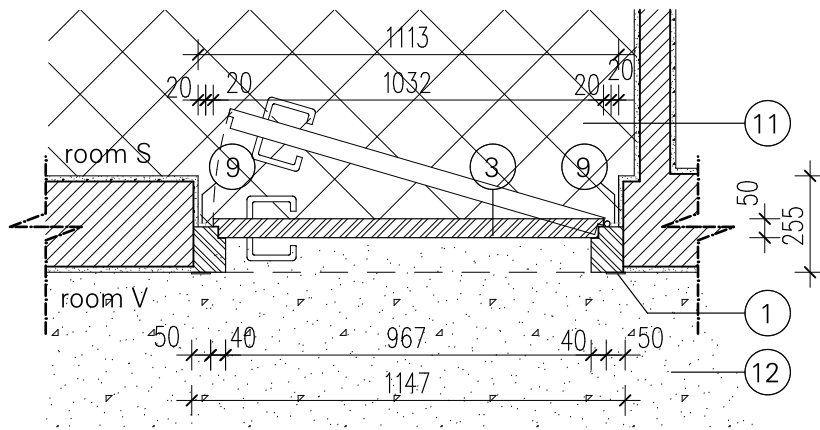
D.1.2

- ① Exterior casing, oak dark-varnished, mitred at corners
- ② Butt frame, oak, dark-varnished, inswing
- ③ Solid door leaf, oak, dark-varnished, rabbeted
- ④ Peephole, presumably nickel silver, outer diameter 75 mm, visible screw fixing on the interior, movable lens mounted on swivel bearing
- ⑤ Upper deadlock, cylinder, not original
- ⑥ Door handle, plastic, not original
- ⑦ Escutcheon, original, presumably nickel silver, screw-fixed subsequently next to actual keyhole, outer dia. 45 mm
- ⑧ Kick plate, original, probably zinc sheet, fixed with round head screws across full width of door leaf, H = 80 mm
- ⑨ Interior lining, oak, dark-varnished
- ⑩ Mortise hinge, original, probably steel or brass, with barrel ring
- ⑪ Apartment floor, terrazzo floor tiles, 20 x 20 cm, yellowish, straight-lay (grid), original
- ⑫ Staircase floor, cast terrazzo, yellowish, original

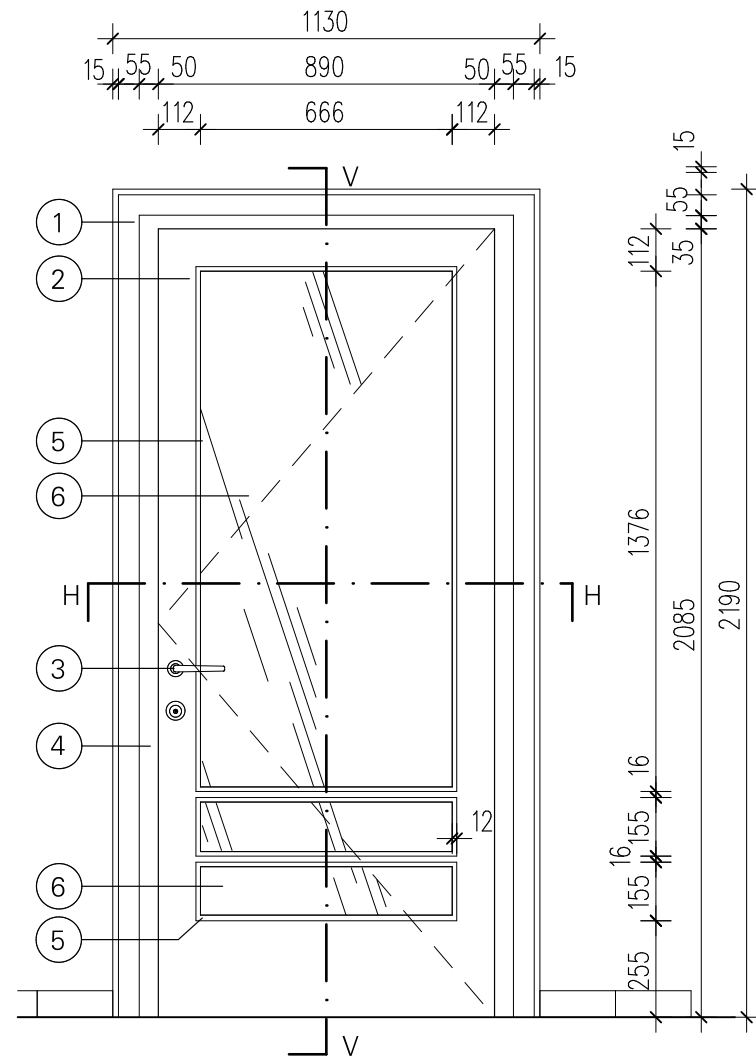
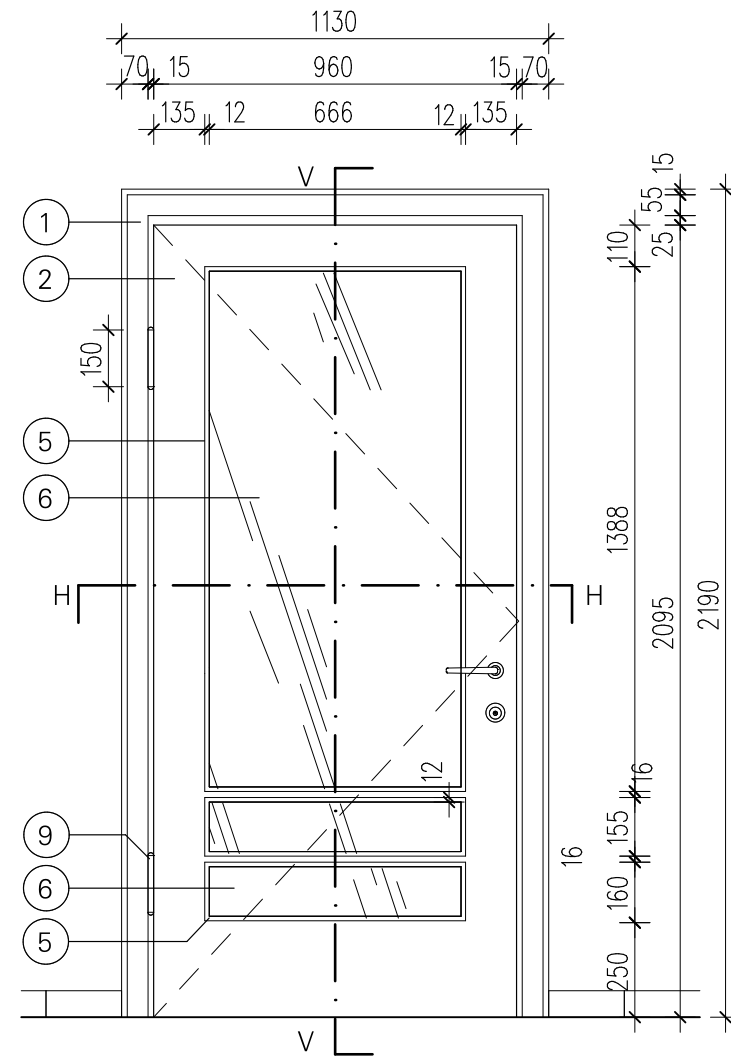
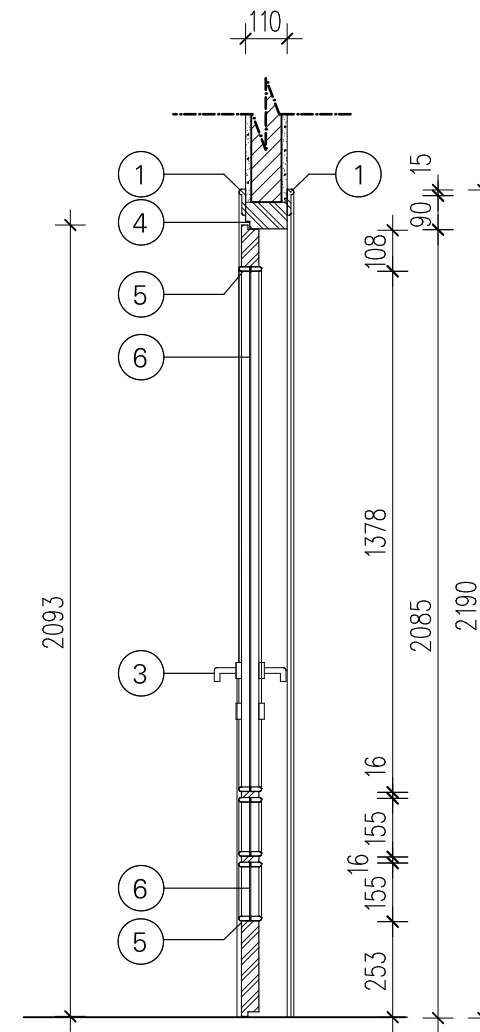
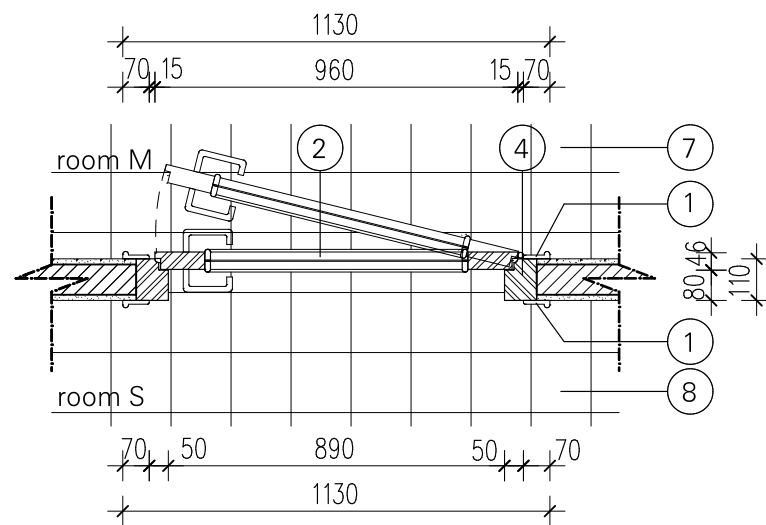
D.1.3

- ① Casing with half-round edge trim, wood (white spruce) painted gray
- ② Frame door with 3 glass panes, wood (white spruce), painted white
- ③ Door handle with round rose and round escutcheon, plastic, not original
- ④ Butt frame door, wood, painted white
- ⑤ Glazing bar, wood painted white, W = 12 mm
- ⑥ Obscure glass pane, textured glass, original
- ⑦ Apartment floor, terrazzo floor tiles, 20 x 20 cm, yellowish, straight-lay (grid), original
- ⑧ Guide rail for roller shutters, U-channel, galvanized steel
- ⑨ Rising butt hinge, presumably steel, painted white/grey, original

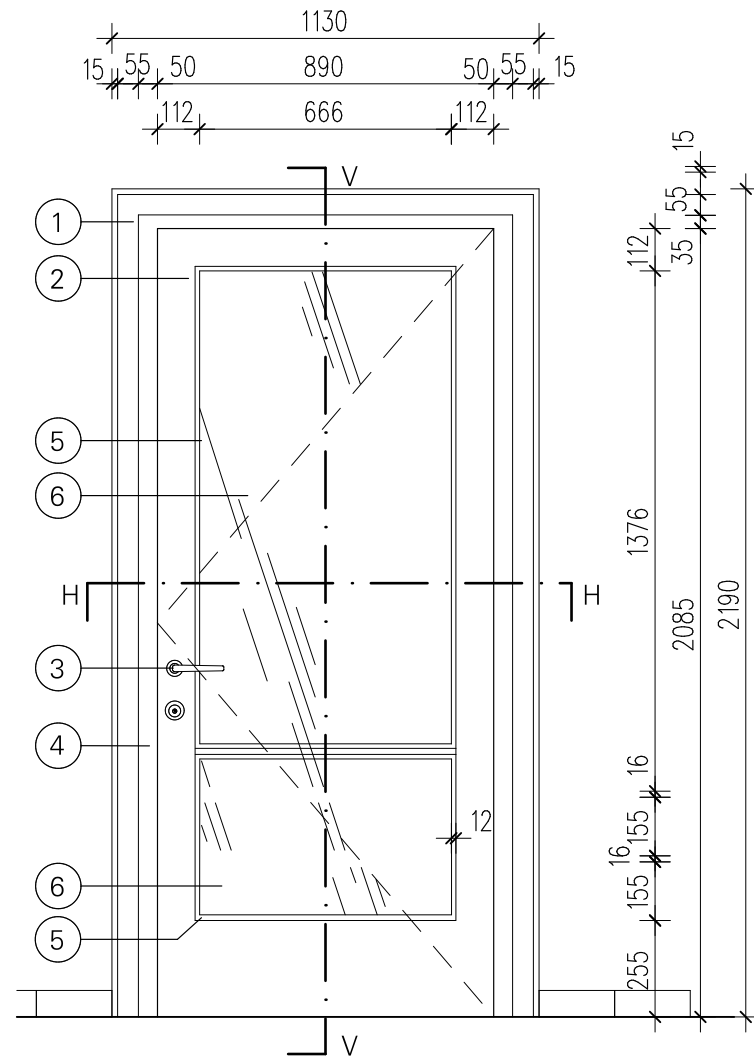
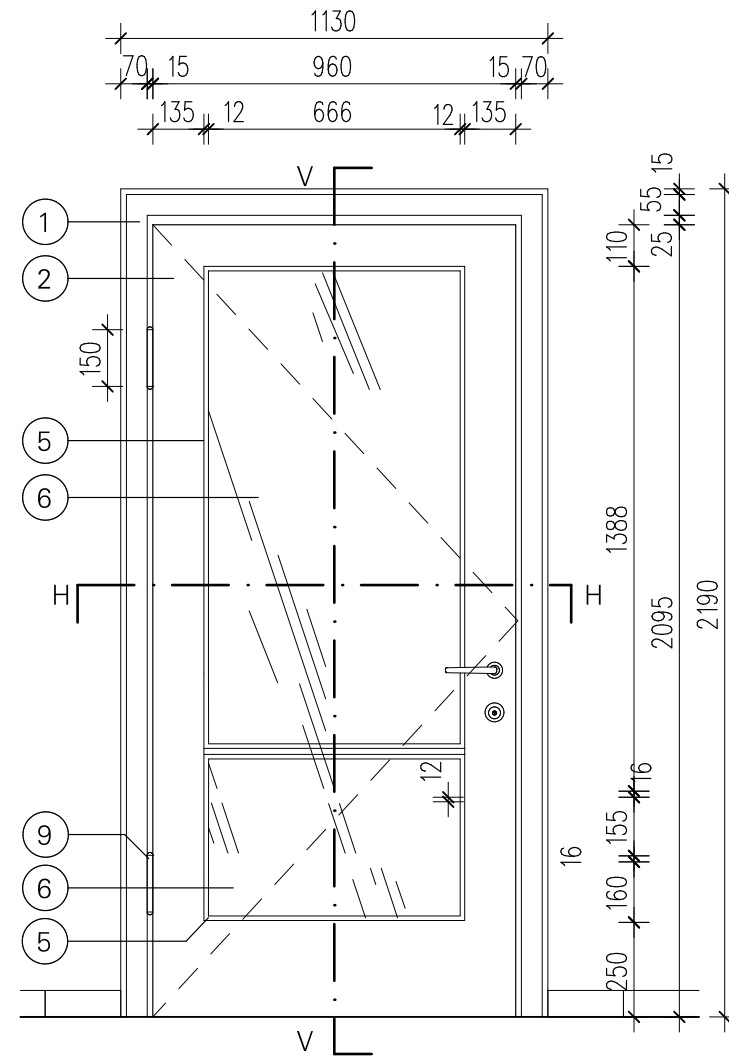
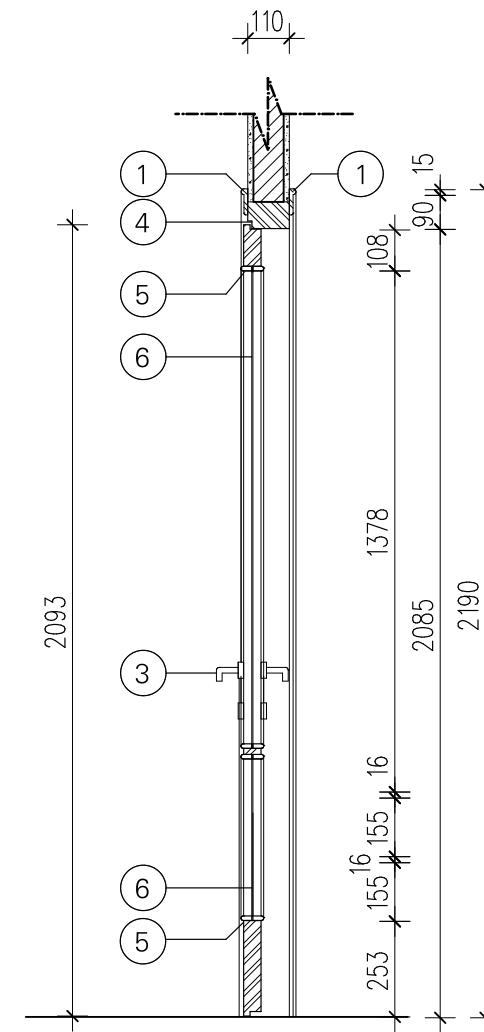
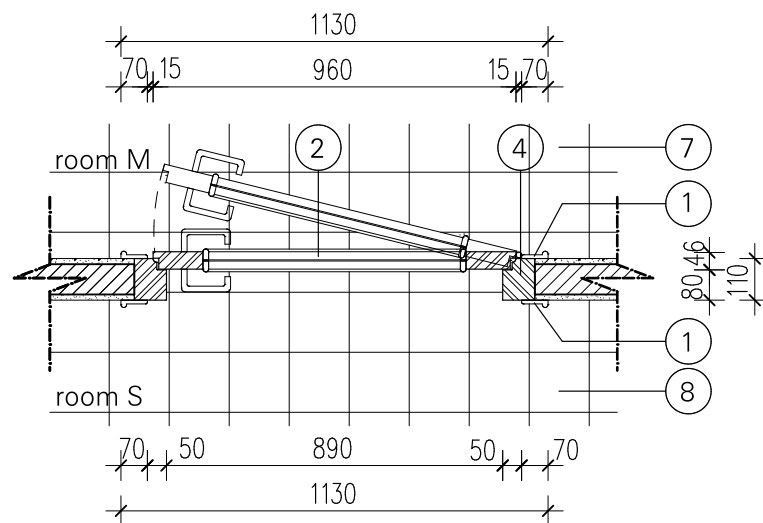
D.1.4

- ① Casing with half-round edge trim, wood (white spruce) painted gray
- ② Frame door with 2 glass panes, wood (white spruce), painted white
- ③ Door handle with round rose and round escutcheon, plastic, not original
- ④ Butt frame door, wood, painted white
- ⑤ Glazing bar, wood painted white, W = 12 mm
- ⑥ Obscure glass pane, textured glass, original
- ⑦ Apartment floor, terrazzo floor tiles, 20 x 20 cm, yellowish, straight-lay (grid), original
- ⑧ Guide rail for roller shutters, U-channel, galvanized steel
- ⑨ Rising butt hinge, steel, painted white/grey, original

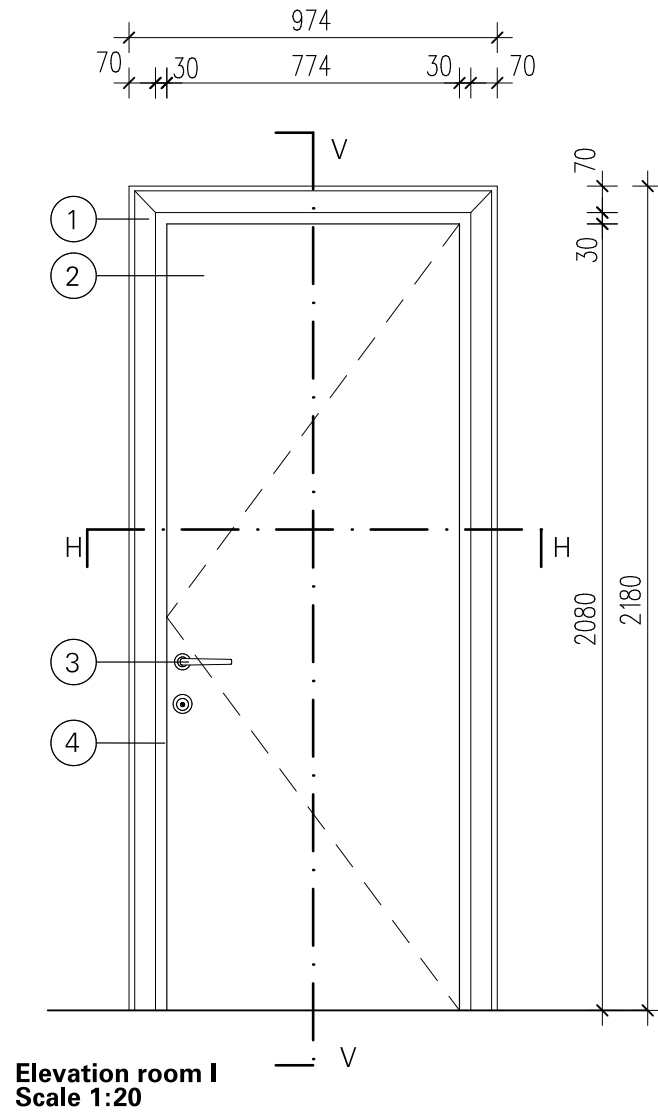
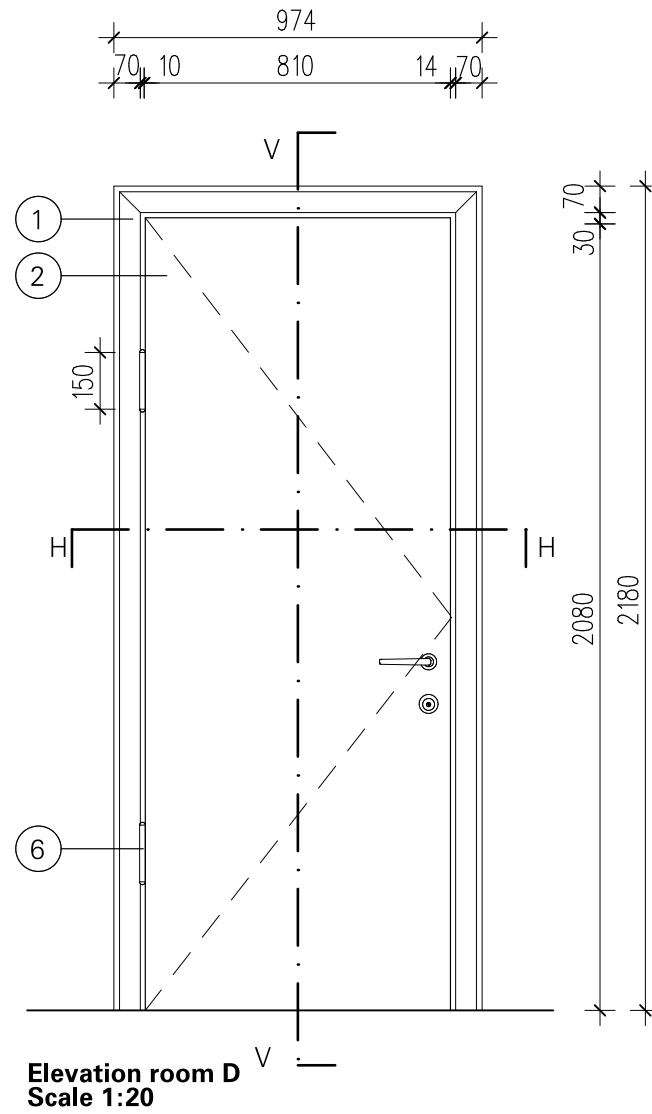
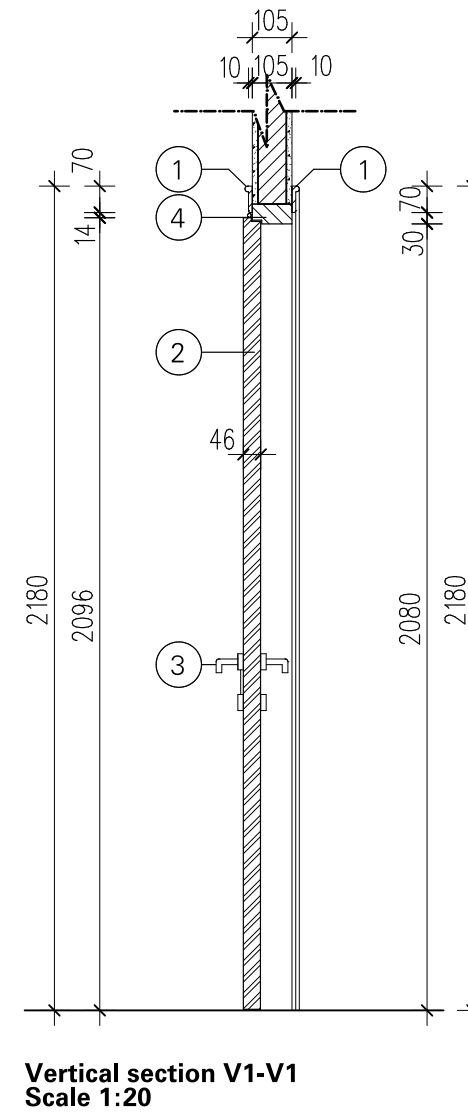
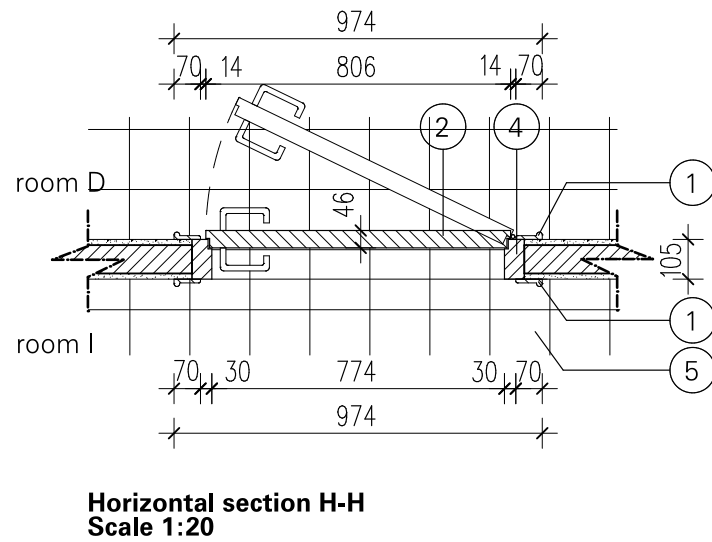
D.1.5

- ① Casing with half-round edge trim, wood (white spruce) painted gray
- ② Solid door leaf, wood (white spruce), painted gray, original
- ③ Door handle with round rose and round escutcheon, light metal alloy, not original
- ④ Butt frame door, wood, painted white
- ⑤ Apartment floor, terrazzo floor tiles, 20 x 20 cm yellowish, straight-lay (grid), original
- ⑥ Rising butt hinge, steel, painted white/grey, original
