CONSERVATION SURVEY

MAX-LIEBLING-HOUSE

29, IDELSON STREET, TEL AVIV

Tel Aviv/Berlin, 2016/17

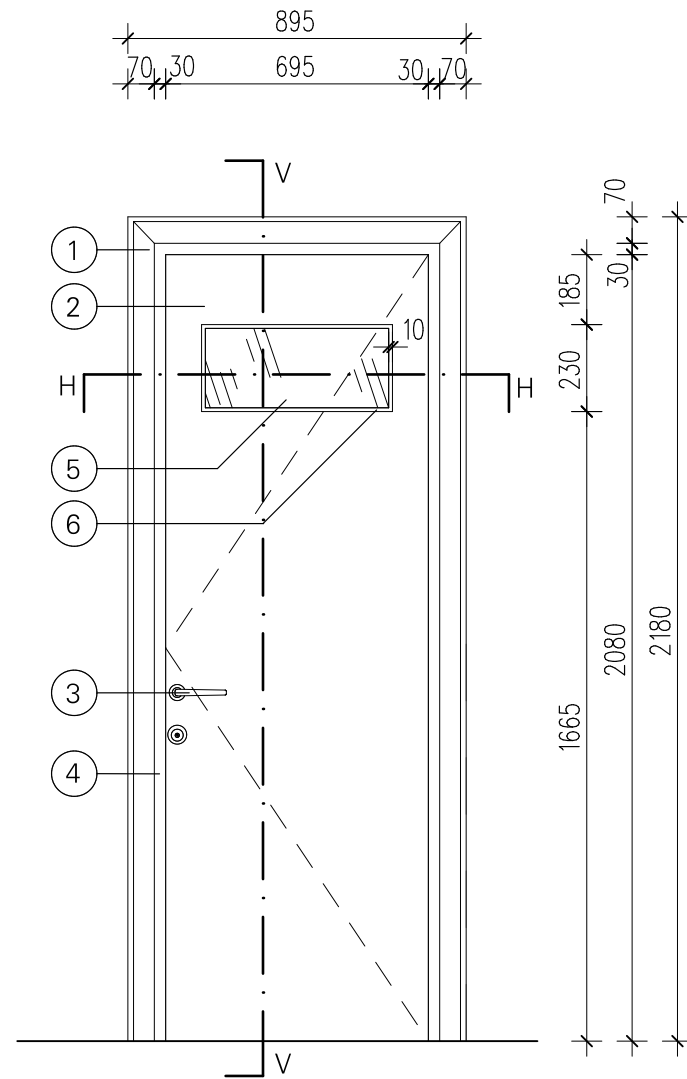
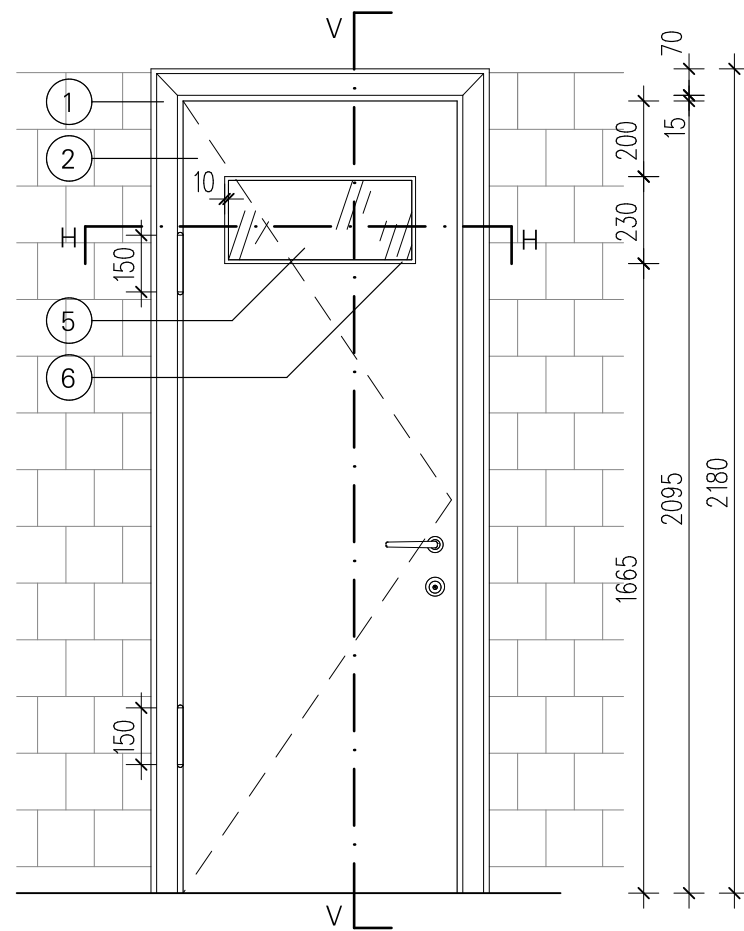
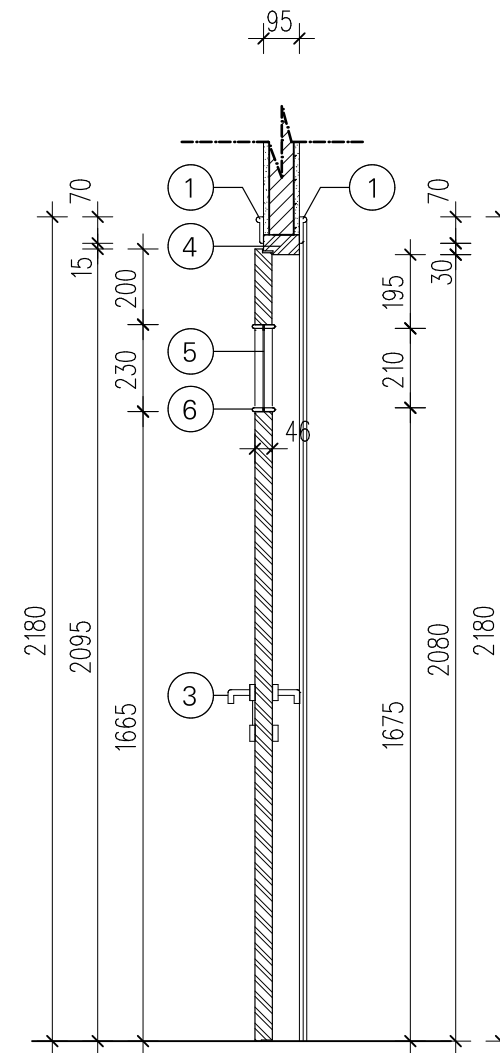
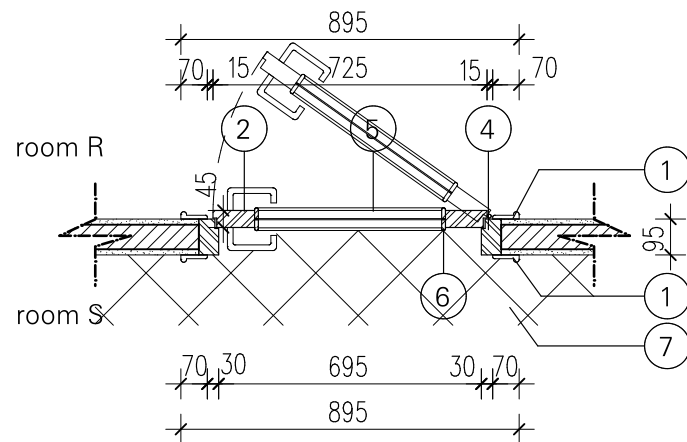
D.1.6

- ① Casing with half-round edge trim, wood (white spruce) painted gray
- ② Solid door leaf, wood (white spruce), painted white, with glass pane 50 x 20 cm, original
- ③ Door handle with round rose and round escutcheon, original, nickel silver, presumably manufactured by Wehag
- ④ Butt frame door, wood, painted white
- ⑤ Glazing bar, wood painted white, W = 12 mm
- ⑥ Obscure glass pane, textured glass, original
- ⑦ Apartment floor, terrazzo floor tiles, 20 x 20 cm, yellowish, straight-lay (grid), original

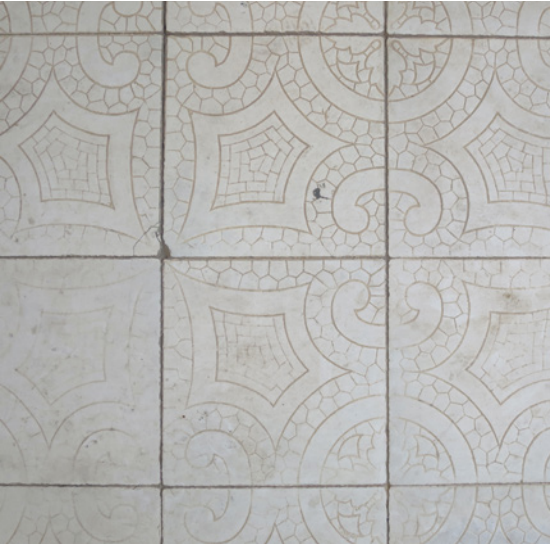
Fig. 118 Original ornamental cement tiles on the exterior entrance floor, 2016

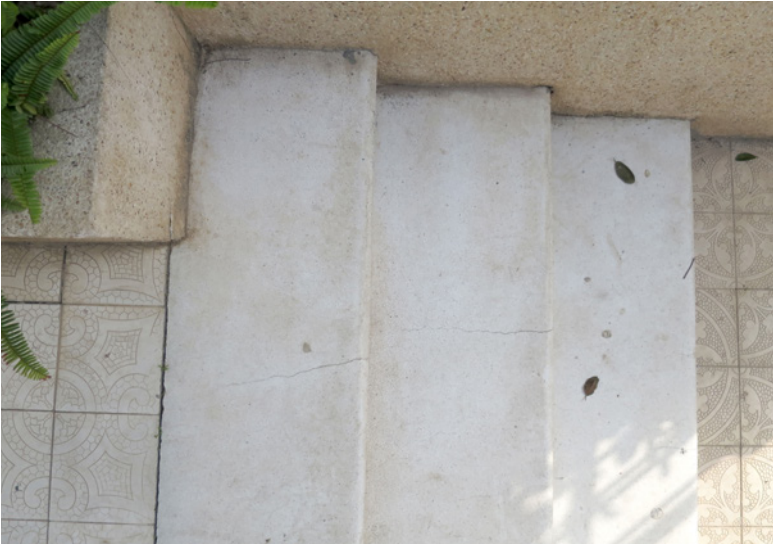
Fig. 119 White terrazzo steps on the entrance path. On the right side: cement replacement tiles; on the left side: original tiles, 2016

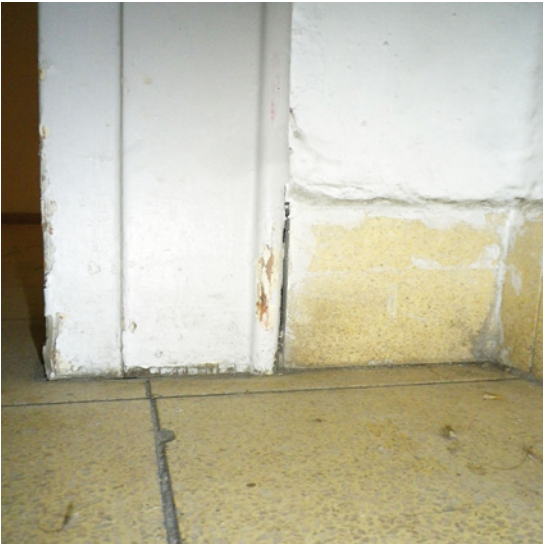
Fig. 120 Original tiles on the floor, connection between base tile and door frame, 2015

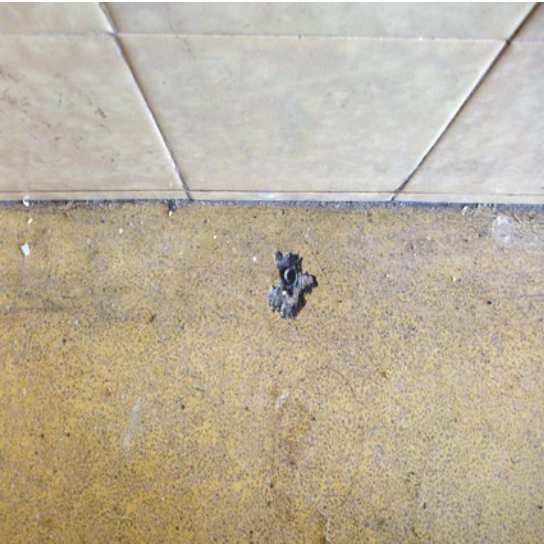
Fig. 121 Original terrazzo floor in the staircase, metal fixing for a carpet, 2015

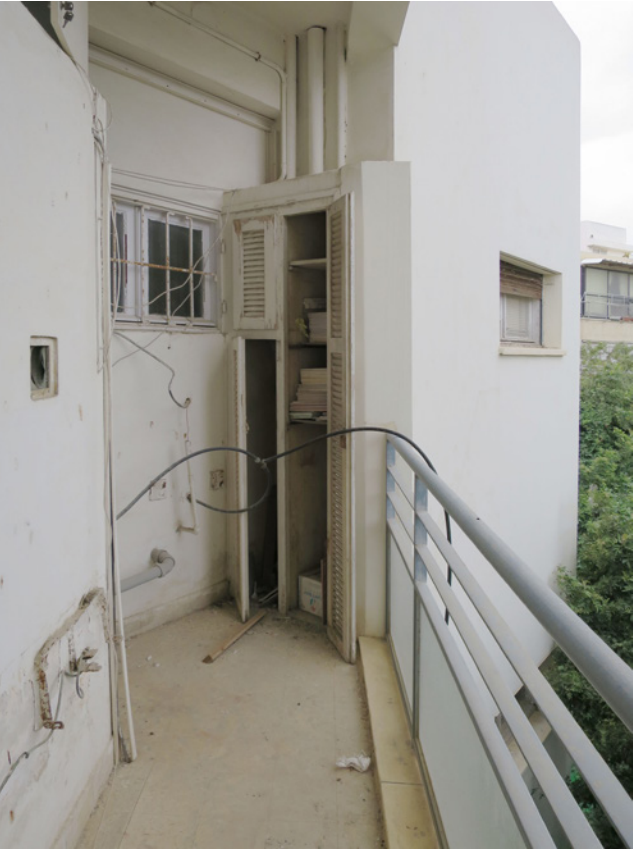
Fig. 126 Built-in cabinet on the balcony 01.K partly used for laundry reached from the bathroom 01.P through a hatch (type S.1), 2015

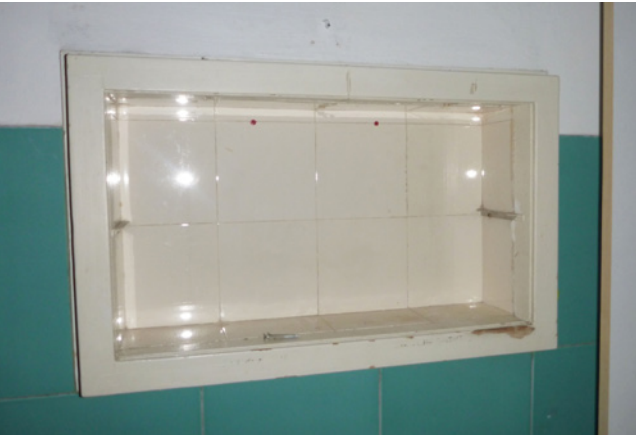
Fig. 127 Small bathroom cabinet, originally with sliding glass panels (type S.2), 2015

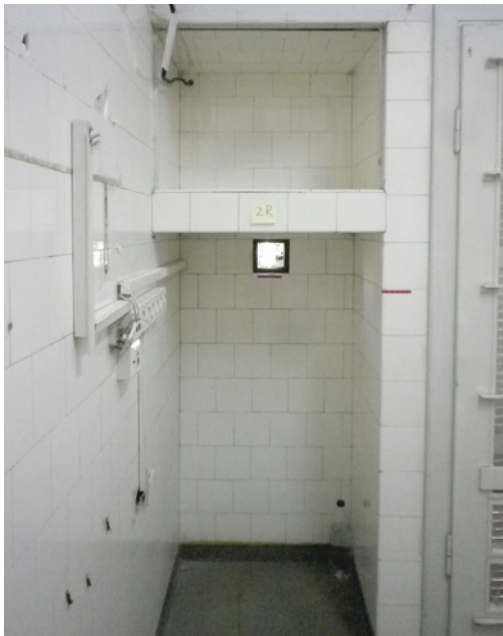
Fig. 130 Cabinet recess in kitchen 02.R (type S.4), 2015

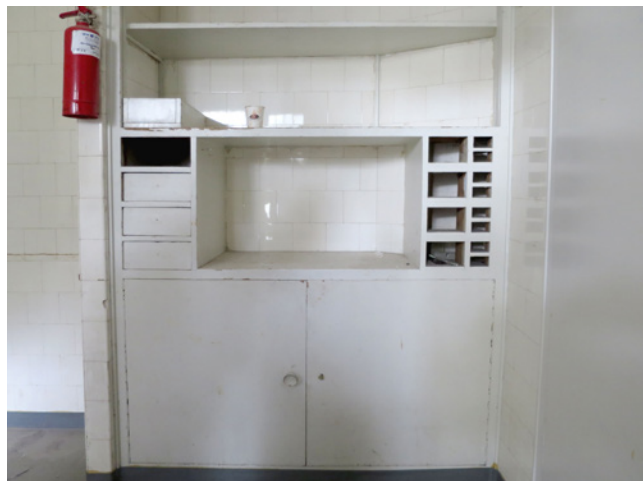
Fig. 132 Built-in kitchen cabinet in room 02.R (type S.5), 2015

this, the left-hand recess is empty of furniture, but on the right there is a cabinet unit consisting of three drawers and two compartments with double doors. Below this cabinet, the right-hand recess has a solid plinth, which is lined and faced along the front with white wall tiles. The kitchen in Room 02.R was probably installed along much the same lines, but the countertop area along its southern wall no longer exists. Some parts of the cabinet in the western wall recess are likewise missing. The recess is divided into two volumes by a tiled wall. The left-hand part probably contained a simple shelving unit with removable shelves. The only remains of this are the wall-mounted channels on the sides of the recess, which supported the shelves. The right-hand part of the wall recess is occupied by a kitchen sideboard, which consists of a floor cabinet with doors, a counter flanked on both sides by drawers, and shelving above, designed with sliding doors. The two hinged doors of the base cabinet and one original knob still exist, but above that the storage scoops (probably made of glass or ceramics) are all missing, as are the sliding doors, which presumably consisted (as in Kitchen 02.G) of corrugated glass.

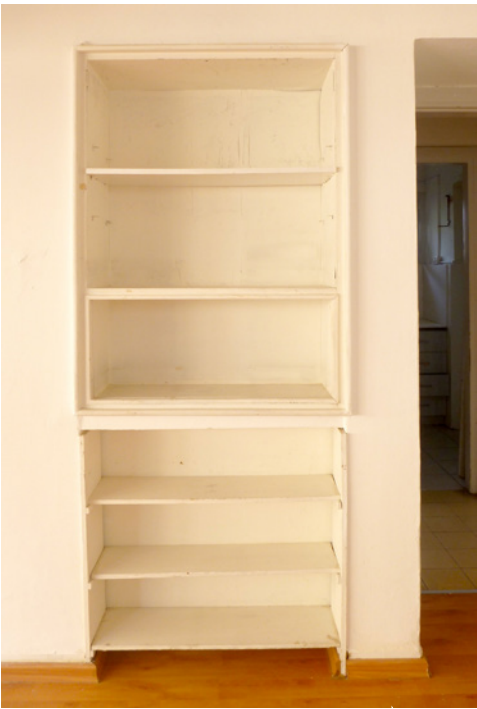
Fig. 138 Original built-in cabinet in room 02.N, new shelves added in the lower part (type S.9), 2015

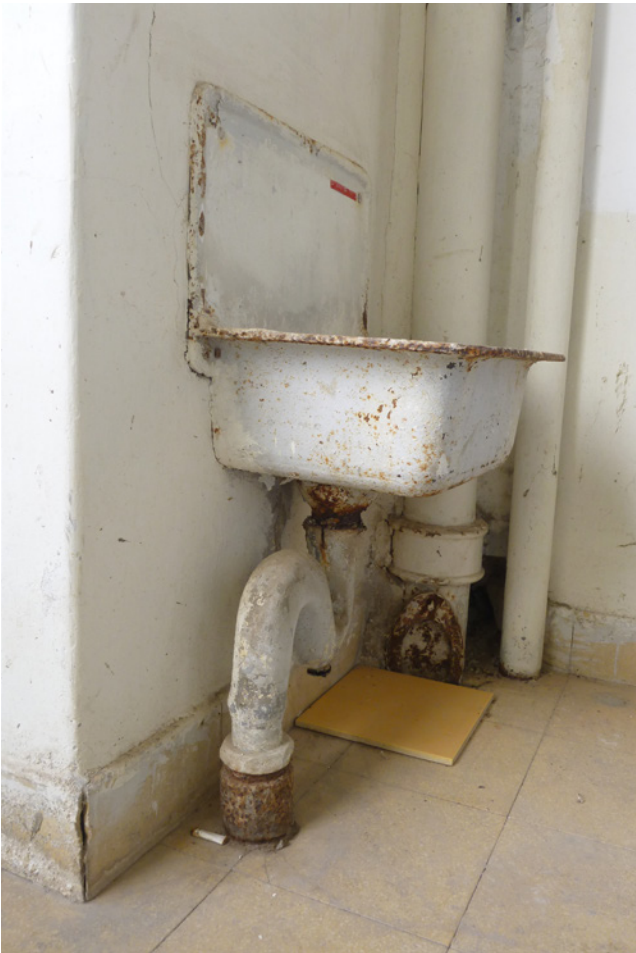
Fig. 140 Original sink on the balcony 02.K, 2015

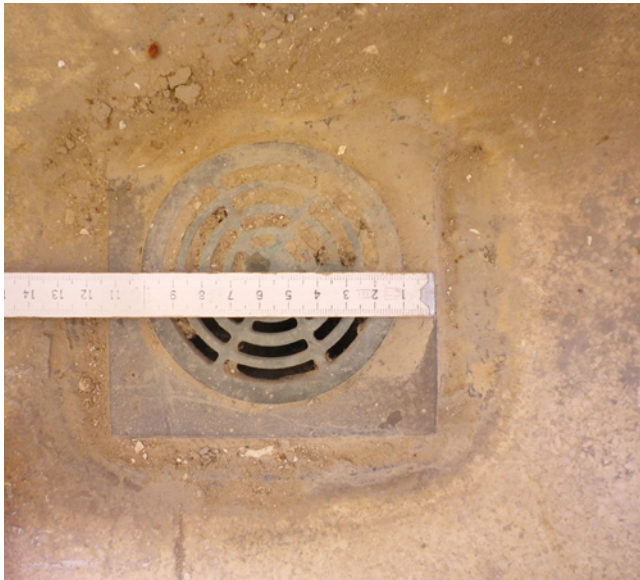
Fig. 143 Grating for a drainage inlet on the balcony 02.J, 2015

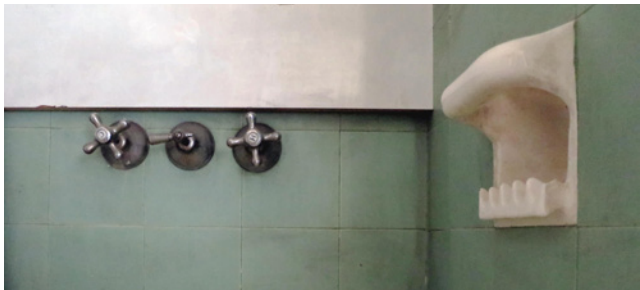
Fig. 142 Sanitary fixtures in the shower, room 01.E, original ceramic soap dish and shower valve, 2015

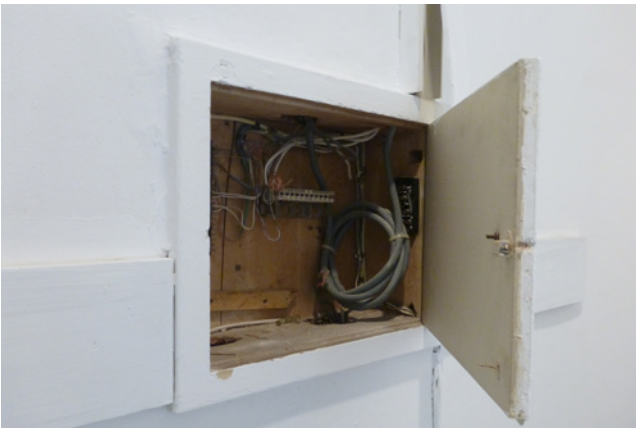
Fig. 141 Built-in electrical installations (maybe former fuse box), room 01.S, dating unclear, 2015

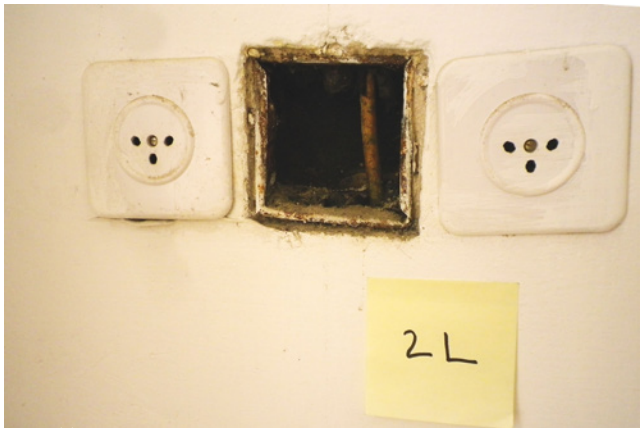
Fig. 144 Original sockets and electrical installations, 2015

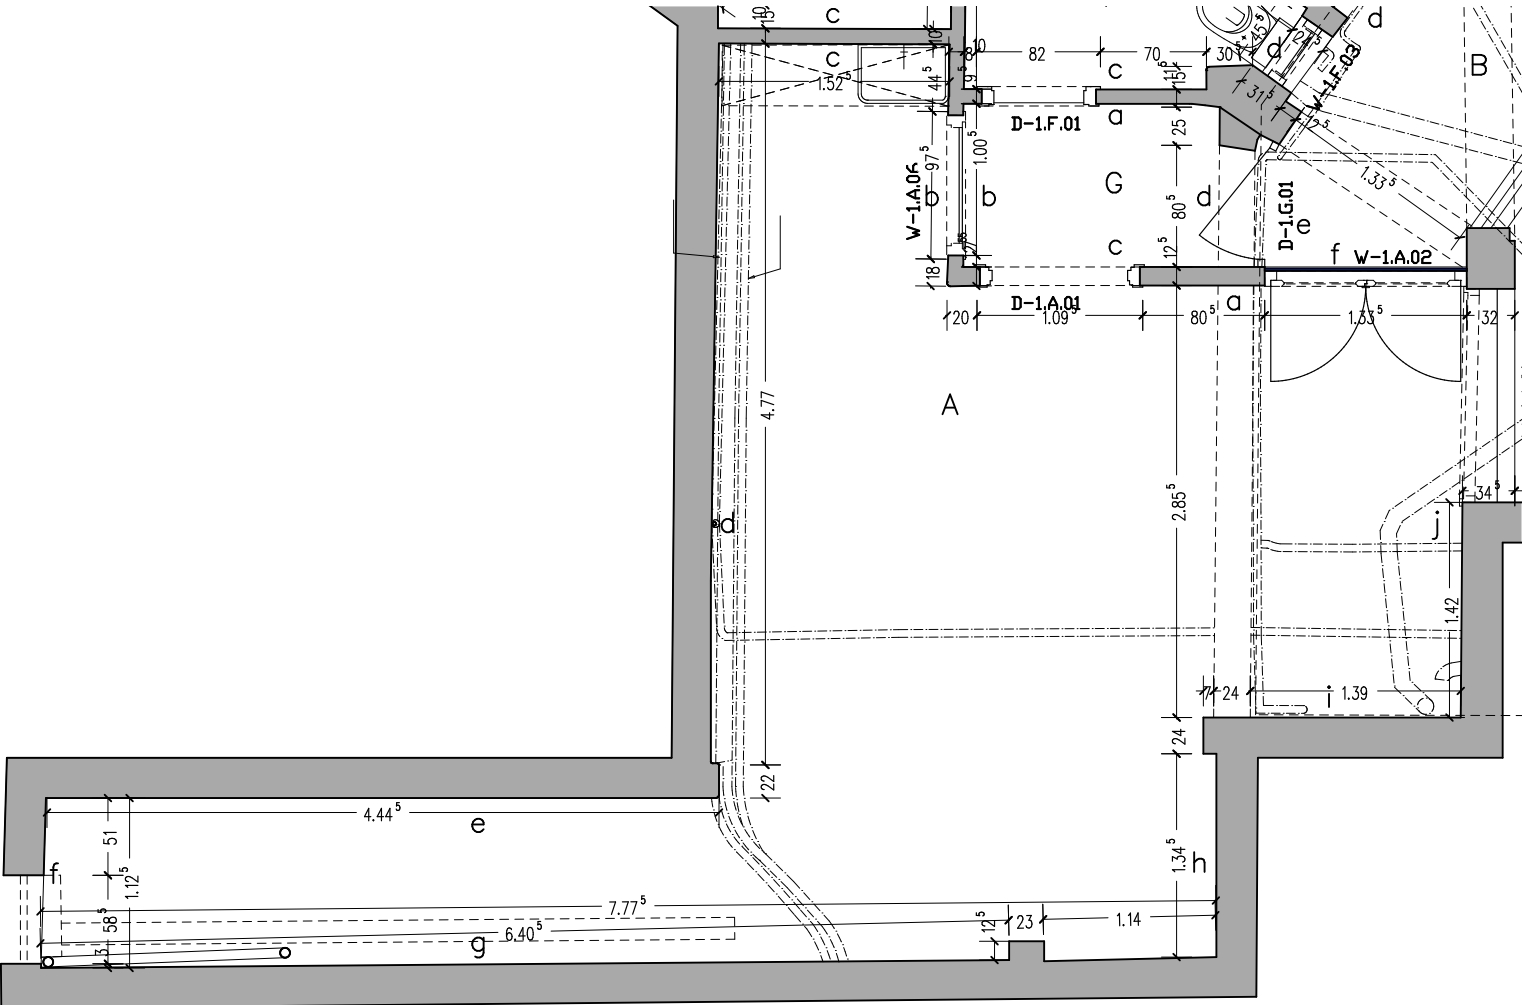
Basement, floor plan 1:50, room -1.A

DATE		FLOOR		FUNCTION	ROOM
04/30/2015		Basement		Utility room	-1.A
ELEMENT	TYPE	DESCRIPTION	CONDITION, NOTES	DATING	ORIGINAL MATERIALS AND COLORS
FLOOR					
	F.2.1	Ceramic floor and base tiles, beige	Probably original terrazzo floor and base tiles beneath, condition unknown	1960s-1990s	(M4)
WALLS AND BUILT-IN ELEMENTS					
a		Painted concrete wall, flush-mounted socket and light switches	Paint renewed, moisture damage; socket and light switch to the right of the door original	1937	M6
W-1.A.02	W.2.9	Double-sash casement window; metal grille formerly mounted outside	One sash missing, glass of the other sash broken; window opening boarded up with a zinc sheet from the outside	1937	M13, (probably C.1.6); grille: M23
D-1.A.01	D.2.1	Door opening	Door leaf missing, frame original	1937	M13, (probably C.1.6)
b		Painted concrete wall and original wall tiling with soap dish above the sink	Subsequently painted white	1937	M6; tiles: M9

W-1.A.03	W.2.8	Double-sash sliding window, glass leaves; grille of round iron bars on the side of -1.G		1937	M13, (probably C.1.6); grille: M23
c		Painted concrete wall and wall tiling	Subsequently painted white; plaster cracked and damaged	1937	M6, tiles: M9
c		Original ceramic sink on a metal bracket; faucets	Surface damage to the sink, original faucets extant but turning handles missing; paint on the bracket and pipes probably original	1937	Sink: white; bracket and pipes: M23, (turquoise); faucets: M21 or M25
c		Built-in cupboard above the sink, formerly provided with sliding glass panels	Probably original, sliding panels and shelf missing; color not verifiable	1937	M13, (probably C.1.6), turquoise
d		Painted concrete wall and original wall tiling; sanitary installation pipes; flush-mounted socket	Paint renewed	Wall and socket 1937	M6
e		Painted concrete wall	Paint renewed	1937	M6
f		Painted concrete wall; wall opening for the house connection line; metal grille	Wall opening probably original	1937	M6; grille: M23

g		Painted concrete wall	Paint renewed	1937	M6
h		Painted concrete wall	Paint renewed	1937	M6
i		Painted concrete wall	Paint renewed	1937	M6
j		Painted concrete wall	Paint renewed	1937	M6
W-1.A.01	W.2.9	Double-sash casement window; walled up	Frame partly damaged; 1 sash missing	1937	M13, (probably C.1.6)
CEILING					
		Concrete ceiling; waste water pipes; fluorescent lighting; remains of an original lighting fixture	Partly corroded reinforcement visible; several areas of moisture damage; waste water pipes probably original	1937	Concrete, white

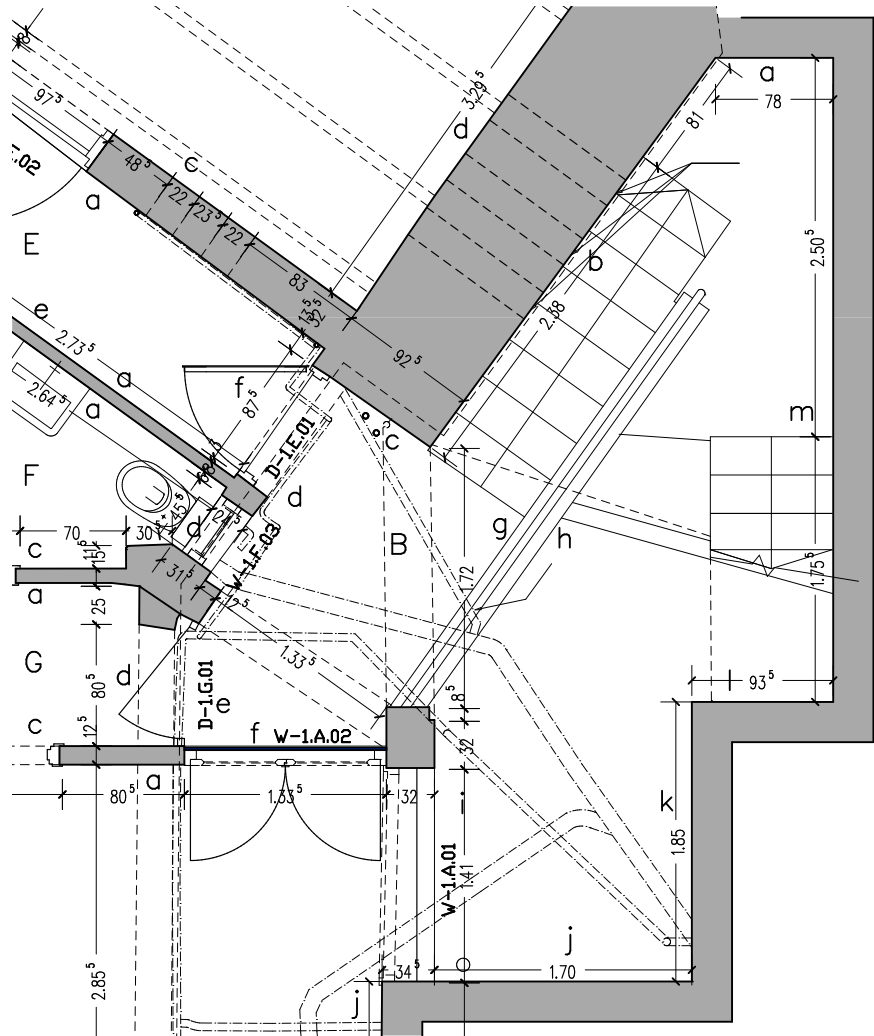
Basement, floor plan 1:50, room -1.B

DATE		FLOOR		FUNCTION	ROOM
04/30/2015		Basement		Entrance	-1.B
ELEMENT	TYPE	DESCRIPTION	CONDITION, NOTES	DATING	ORIGINAL MATERIALS AND COLORS
FLOOR					
	F.2.1	Ceramic floor and base tiles, beige; floor drainage inlet		1990s	
WALLS AND BUILT-IN ELEMENTS					
a		Rendered exterior shaft wall of the exterior staircase with a planter	Renewed render, moisture damage	Wall 1937; plaster 1990s	M7
b		Rendered exterior wall; three round wall openings for the ventilation of the air raid shelter, wire mesh covering	Renewed render, openings probably subsequent	Wall 1937; plaster 1990s	M7
c		Rendered exterior wall	Renewed render	Wall 1937; plaster 1990s	M7
d		Rendered exterior wall	Renewed render	Wall 1937; plaster 1990s	M7
D-1.E.01	D.2.3	External solid door	Replaced	1990s	
W-1.F.03	W.3.1	Single-sash casement window; vertical iron bars and wire mesh on the outside	Paint partly peeling off	1937	M13, (probably C.1.6); grille: M23

e		Rendered exterior wall	Renewed render	Wall 1937; plaster 1990s	M7
D-1.G.01	D.2.3	External door	Replaced; door leaf damaged, door is open		
f		Rendered exterior wall	Renewed render	Wall 1937; plaster 1990s	M7
W-1.A.02	W.2.9	Double-sash casement window; metal grille formerly mounted outside	Window opening subsequently boarded up with a zinc sheet from the outside	1937; zinc sheet later	M13, (probably C.1.6)
g		Shaft wall of the exterior staircase, steel railing with galvanized woven wire mesh	New	1960s-1990s	M7
h		Steel railing with galvanized woven wire mesh	New	1990s	
i		Inaccessible		1990s	M7
W-1.A.01	W.2.9	Double-sash casement window; walled up	Frame partly damaged; 1 sash is missing	1937; walling later	M13, (probably C.1.6)
j		Inaccessible		1990s	M7
k		Inaccessible		1990s	M7
l		Shaft wall of the exterior staircase	New	1990s	M7
m		Shaft wall of the exterior staircase	New	1990s	M7
CEILING					
		Rendered exterior ceiling construction	Renewed render	Ceiling 1937; plaster 1990s	Concrete, cream white

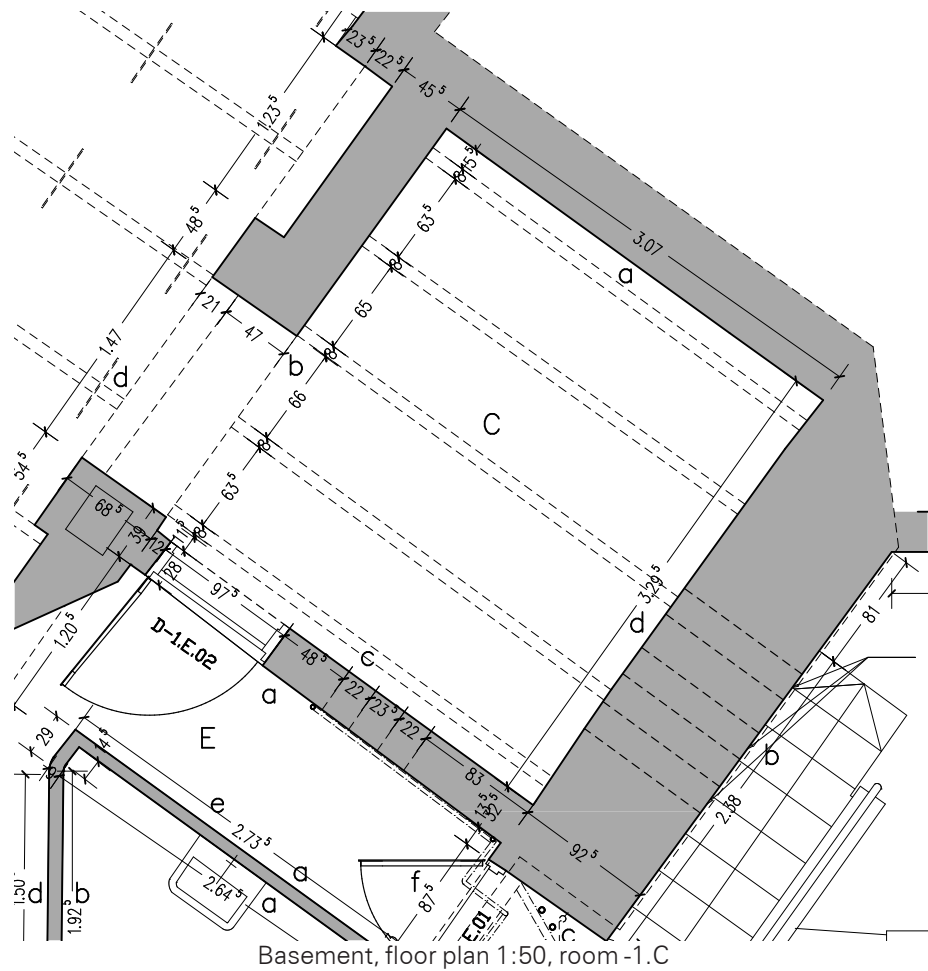
DATE		FLOOR		FUNCTION	ROOM
04/30/2015		Basement		Protection room	-1.C
ELEMENT	TYPE	DESCRIPTION	CONDITION, NOTES	DATING	ORIGINAL MATERIALS AND COLORS
FLOOR					
	F.2.1	Ceramic floor and base tiles, beige		Probably 2008	
WALLS AND BUILT-IN ELEMENTS					
a		Concrete wall strengthening the original construction		Wall 1937; supplementary wall 2008	
b		Concrete wall strengthening the original construction		Wall 1937; supplementary wall 2008	
c		Concrete wall strengthening the original construction, two round ventilation openings		Wall 1937; supplementary wall 2008	
D-1.E.02	D.2.3	Solid protective door	New	2008	
d		Concrete wall strengthening the original construction		Wall 1937; supplementary wall 2008	
CEILING					
		Concrete ceiling of the air raid shelter construction strengthened with painted I-beams		Ceiling 1937; supplementary beams 2008	Concrete

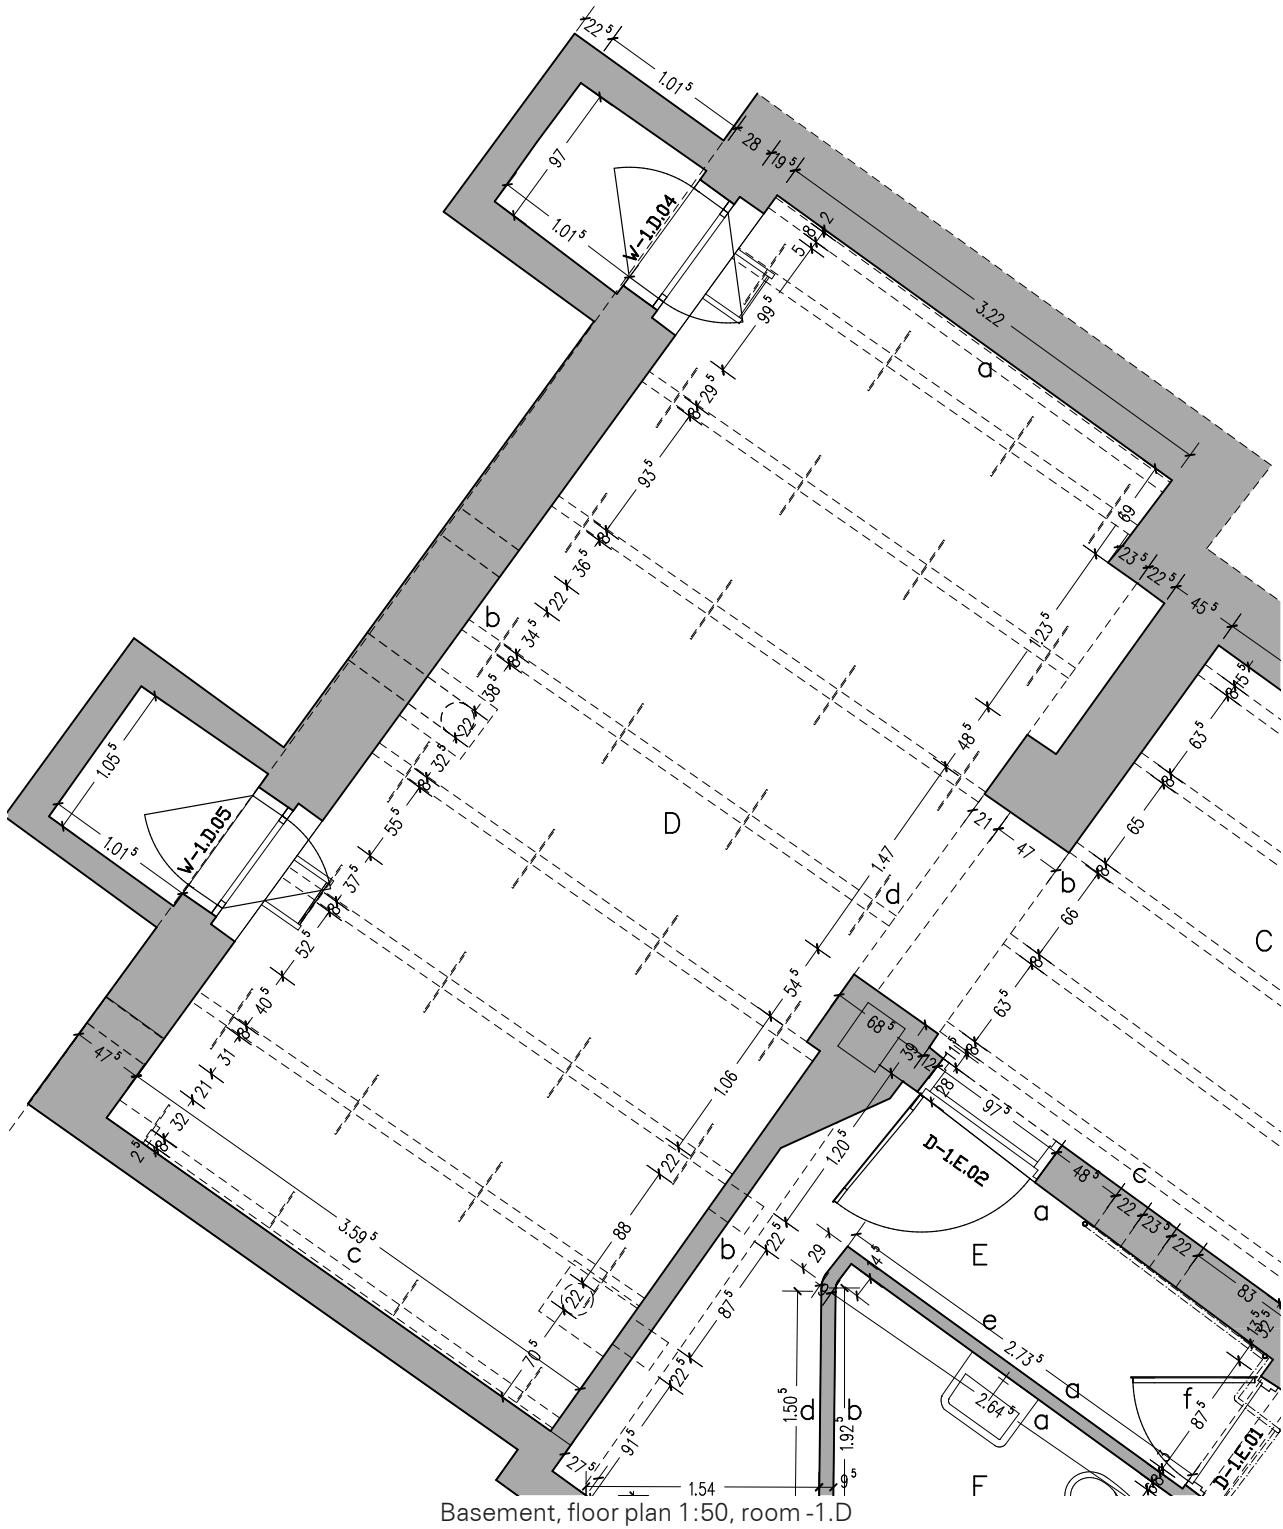
DATE		FLOOR		FUNCTION	ROOM
04/30/2015		Basement		Protection room	-1.D
ELEMENT	TYPE	DESCRIPTION	CONDITION, NOTES	DATING	ORIGINAL MATERIALS AND COLORS
FLOOR					
	F.2.1	Ceramic floor and base tiles, beige		2008	
WALLS AND BUILT-IN ELEMENTS					
a		Concrete wall strengthening the original construction; wall-mounted fluorescent lighting		Wall 1937; supplementary wall 2008	
b		Concrete wall strengthening the original construction; two round ventilation openings covered by a metal sheet; ventilation unit		Wall 1937; supplementary wall 2008	
W-1.D.04		Window with an exterior window shaft, emergency exit of the air raid shelter	New	2008	
W-1.D.05		Window with an exterior window shaft, emergency exit of the protection room	New	2008	
c		Concrete wall strengthening the original construction; wall-mounted fluorescent lighting and air-conditioning unit		Wall 1937; supplementary wall and technical installations 2008

d		Concrete wall; round ventilation opening covered by a metal sheet; ventilation unit		Wall 1937; supplementary wall and technical installations 2008	
CEILING					
		Concrete ceiling of the air-raid shelter construction reinforced by I-beams and steel plates painted pale gray	Supplementary beams new	Ceiling 1937; supplementary beams 2008	Concrete

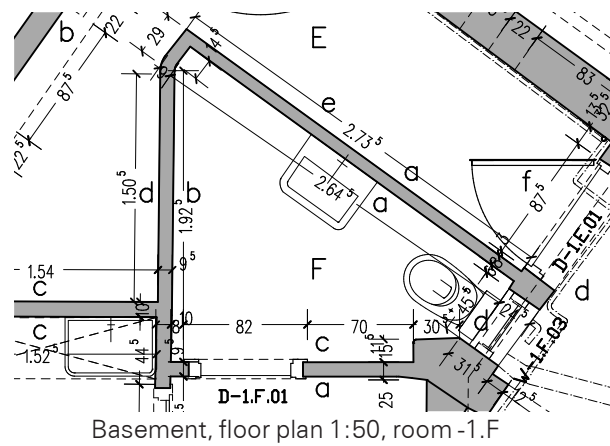
DATE		FLOOR		FUNCTION	ROOM
04/30/2015		Basement		WC	-1.F
ELEMENT	TYPE	DESCRIPTION	CONDITION, NOTES	DATING	ORIGINAL MATERIALS AND COLORS
FLOOR					
	F.2.1	Ceramic floor and base tiles, gray	Probably original terrazzo floor and base tiles beneath, condition unknown	1960s-1990s	(M4)
WALLS AND BUILT-IN ELEMENTS					
a		Concrete wall, wall tiling made of terrazzo tiles on walls a and b up to approx. 60cm; original wall-mounted ceramic sink with trap and two faucets, one line of beige terrazzo tiles above the sink	Paint renewed, partly peeling off; remains of former mounts; sink: scratched surface; one faucet missing, turning handle of the other one is missing, probably not original	1937; faucets later	M6; wall tiling: M4
b		Concrete wall; wall tiling made of terrazzo tiles on walls a and b, height approx. 60cm from finished floor level	Paint partly peeling off, remains of former mounts	1937	M6
c		Concrete wall	Paint renewed	1937	M6

D-1.F.01	D.2.1	Door opening	Door leaf missing, frame original	1937	M13, (probably C.1.6)
d		Concrete wall	Paint renewed	1937	M6
W-1.F.03	W.3.1	Single-sash casement window; vertical iron bars and wire mesh on the outside	Original glass and handles; iron elements corroded	1937	M13; grille: M23; glass: M20
CEILING					
		Concrete ceiling	Paint renewed	1937	Concrete/white

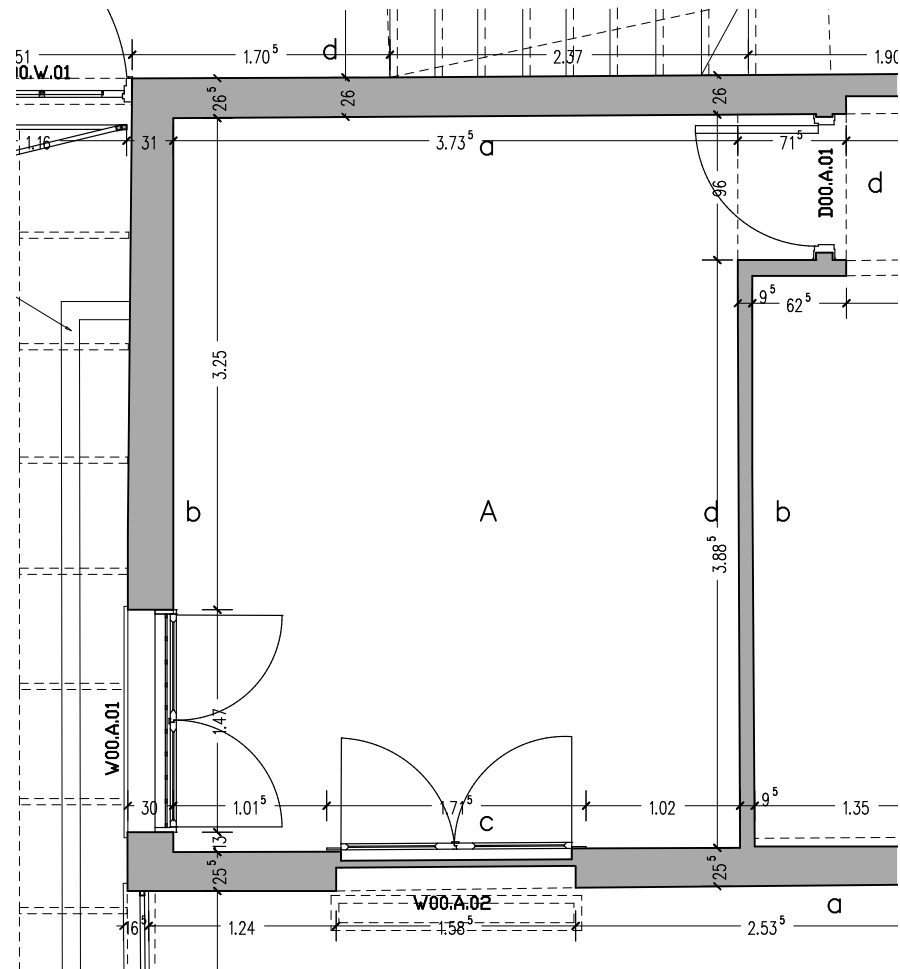
Ground floor plan 1:50, room 00.A

DATE		FLOOR		FUNCTION	ROOM
04/30/2015		Ground Floor		Room	00.A
ELEMENT	TYPE	DESCRIPTION	CONDITION, NOTES	DATING	ORIGINAL MATERIALS AND COLORS
FLOOR					
	F.2.1	Laminate flooring, gray, with plastic baseboard, black	Original terrazzo floor and base tiles beneath, condition unknown	1990s or later	(M4)
WALLS AND BUILT-IN ELEMENTS					
a		Presumably concrete wall; open wiring	Surface renewed	Wall and plaster 1937	M7, (probably C.1.1)
b		Plastered exterior wall; open wiring	Surface renewed	Wall and plaster 1937	M7, (probably C.1.1)
W00.A.01	W.2.1	Double-sash casement window	Paint renewed, paint partly peeling off; original handles; roller shutter belt missing	1937	M13, (probably C.1.6); glass: M20; handles: M21
c		Plastered exterior wall; open wiring	Surface renewed	Wall and plaster 1937; wiring 1960s-1990s	M7, (probably C.1.1)
W00.A.02	W.1.1	Double-leaf balcony door; three panes of clear glass	Paint renewed; original handles	1937	M13, (probably C.1.6); handles: M21

d		Plastered interior wall; wall-mounted air-conditioning unit and open wiring	Surface renewed	Wall and plaster 1937; technical installations 1960s-1990s	M7, (probably C.1.1)
D00.A.01	D.1.3	Single-leaf door with a wooden frame; three panes of textured glass	Paint renewed, handles partly original	1937	M13, (probably C.1.6); glass: M19; handles: M21
CEILING					
		Suspended grid ceiling with integrated louvered luminaire	Original beam-and-block ceiling above	1937; suspended ceiling 1990s	Concrete, plaster

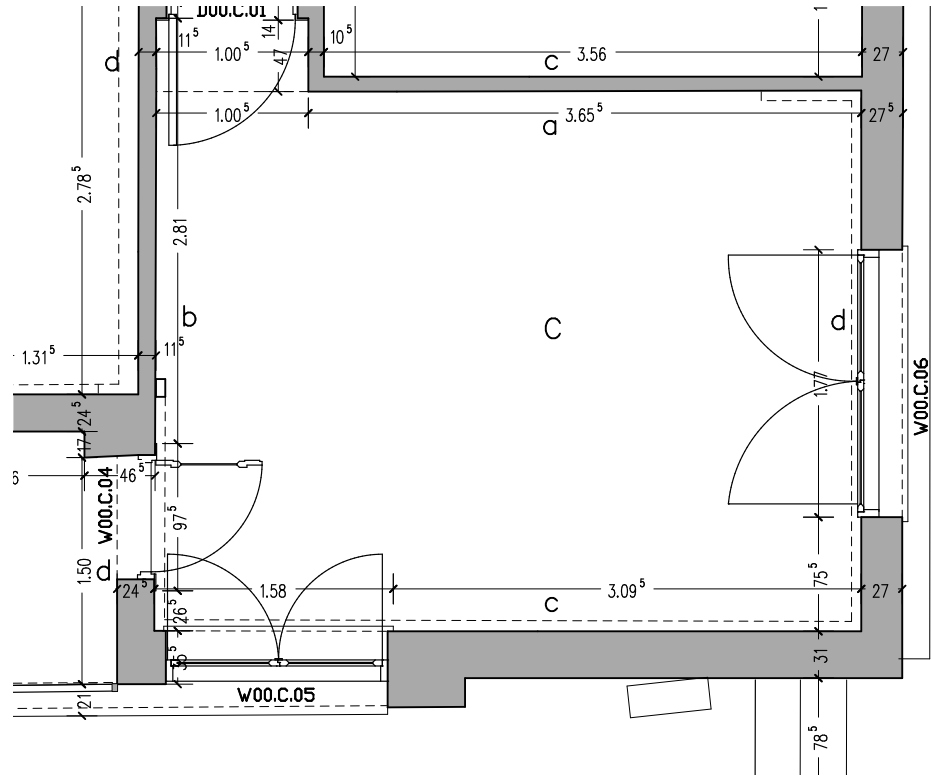
DATE		FLOOR		FUNCTION	ROOM
04/30/2015		Ground Floor		Room	00.C
ELEMENT	TYPE	DESCRIPTION	CONDITION, NOTES	DATING	ORIGINAL MATERIALS AND COLORS
FLOOR					
	F.2.1	Laminate flooring, gray, with plastic baseboard, black	Original terrazzo floor and base tiles beneath, condition unknown	1990s or later	(M4)
WALLS AND BUILT-IN ELEMENTS					
a		Plastered interior wall; wall-mounted air-conditioning unit and open wiring	Surface renewed	Wall and plaster 1937; wiring 1960s-1990s	M7, (probably C.1.1)
D00.C.01	D.1.5	Single-leaf solid door	Paint and handles renewed	1937; handles 1960s-1970s	M13, (probably C.1.6)
b		Interior, partly exterior wall, plastered; open wiring	Surface renewed	Wall and plaster 1937; wiring 1960s-1990s	M7, (probably C.1.1)
W00.C.04	W.1.2	Single-leaf balcony door; three panes of clear glass; grille mounted on the inside	Grille probably original; original handles painted white; paint renewed	1937	M13, (probably C.1.6); glass: M20; handles: M21; grille: M23

c		Exterior wall; window recess; open wiring and wall-mounted air-conditioning unit	Surface renewed	Wall and plaster 1937; wiring 1960s-1990s	M7, (probably C.1.1)
W00.C.06	W.2.1	Double-sash casement window; terrazzo window sill on the inside	Paint renewed, paint partly peeling off; handles and sill original	1937	M13, (probably C.1.6); glass: M20; handles: M21; sill: M3
d		Plastered interior wall; open wiring	Surface renewed	Wall and plaster 1937; wiring 1960s-1990s	M7, (probably C.1.1)
W00.C.06	D.2.2	Double-sash casement window	Paint renewed, partly peeling of the paint; original handles	1937	M13, (probably C.1.6); glass: M20; handles: M21
CEILING					
		Beam-and-block ceiling, plaster; suspended louvered luminaire	Surface renewed	1937; luminaires 1990s	Concrete, plaster

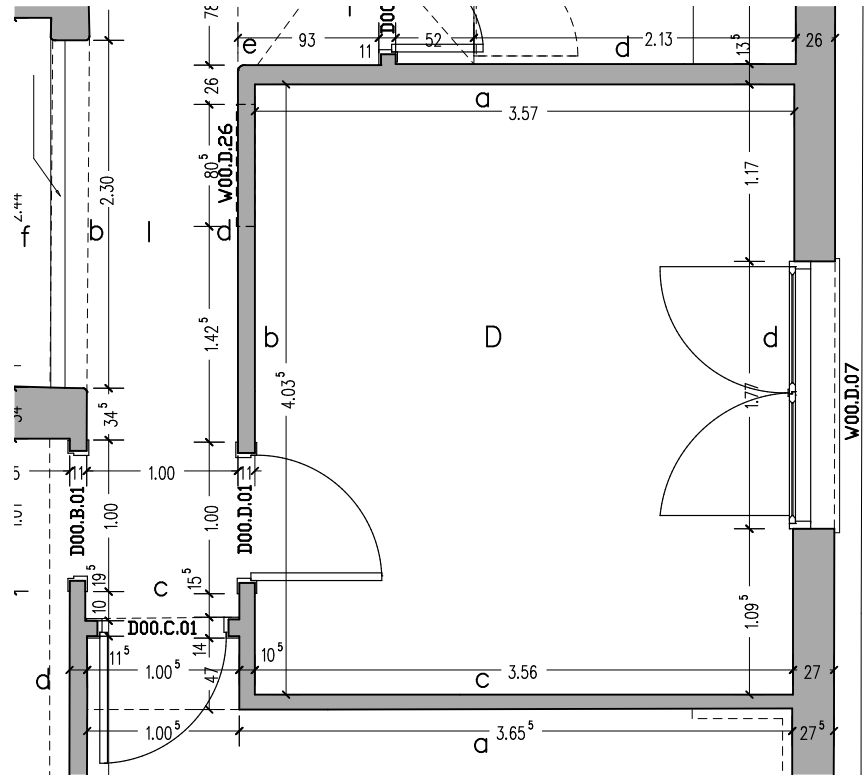
Ground floor plan 1:50, room 00.D

DATE		FLOOR		FUNCTION	ROOM
04/30/2015		Ground Floor		Room	00.D
ELEMENT	TYPE	DESCRIPTION	CONDITION, NOTES	DATING	ORIGINAL MATERIALS AND COLORS
FLOOR					
	F.2.1	Laminate flooring, gray, with plastic baseboard, black	Original terrazzo floor and base tiles beneath, condition unknown	1990s	(M4)
WALLS AND BUILT-IN ELEMENTS					
a		Plastered interior wall; open wiring	Surface renewed	Wall and plaster 1937; wiring 1960s-1990s	M7, (probably C.1.1)
b		Plastered interior wall	Surface renewed	Wall and plaster 1937	M7, (probably C.1.1)
W00.D.26	W.2.6	Double-sash interior sliding window	Paint renewed	1937	M13, (probably C.1.6); glass: M20
D00.D.01	D.1.5	Single-leaf solid door	Paint and handles renewed	1937; handles 1960s-1970s	M13, (probably C.1.6)
c		Plastered interior wall; wall-mounted air-conditioning unit	Surface renewed	Wall and plaster 1937; wiring 1960s-1990s	M7, (probably C.1.1)
d		Plastered interior wall; open wiring	Surface renewed	Wall and plaster 1937; wiring 1960 s-1990s	M7, (probably C.1.1)

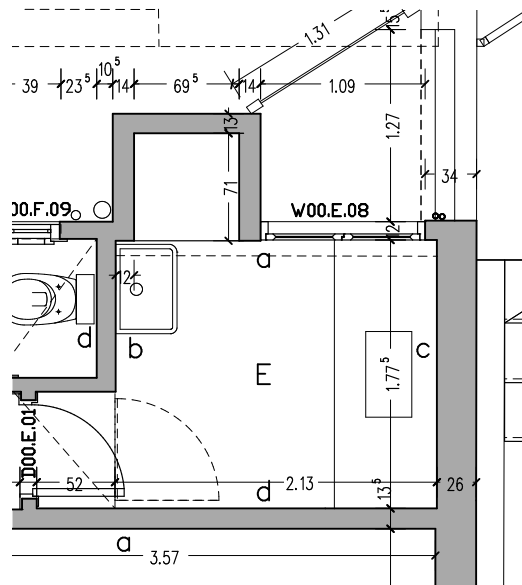
DATE		FLOOR		FUNCTION	ROOM
04/30/2015		Ground Floor		Former bathroom	00.E
ELEMENT	TYPE	DESCRIPTION	CONDITION, NOTES	DATING	ORIGINAL MATERIALS AND COLORS
FLOOR					
	F.2.1	Laminate flooring, gray, with plastic baseboard, black	Original terrazzo floor and base tiles beneath, condition unknown	1990s or later	(M4)
WALLS AND BUILT-IN ELEMENTS					
a		Plastered exterior wall; alcove on the left (former shower) with gypsum board shelves inserted; wall tiling on the right	Paint and tiles renewed	Wall and plaster 1937; tiles and shelves 1990s or later	M7, (probably C.1.1)
W00.E.09	D.2.3	Double-sash window (no laundry hatch door below it, in contrast to 01.E and 02.E) with an exterior grille plus wire mesh	Paint renewed	1937	M13, (probably C.1.6); glass: M19; handles: M21; steel: M23
b		Plastered interior wall	Surface renewed	Wall and plaster 1937	M7, (probably C.1.1)
Storage space	S.11	Single-leaf solid hatch with a knob leading to a storage space in the ceiling void	Paint renewed	1937	M13, (probably C.1.6); knob: M22

D00.E.01	D.1.6	Single-leaf solid door with a small glass pane	Paint renewed; handles painted	1937	M13, (probably C.1.6); glass: M19; handles: M21
c		Plastered interior wall with remains of an original radiator recess and a wall tiling (cf. 02.E); radiator and heating pipes wall-mounted air-conditioning unit, open wiring and telecom/IT devices	Original wall tiling and radiator subsequently painted; new tiling of the original wall tiling on the left side	Wall, plaster, tiles, radiator 1937; technical installations 1960s-1990s or later	M7, (probably C.1.1); tiles: M10?
d		Plastered interior wall with a built-in kitchen consisting of a sink unit, a wall unit and a wall tiling; surface-mounted telecom/IT device	Surface renewed; built-in kitchen, wall tiling, electrical installations new	Wall and plaster 1937; technical installations 1960s-1990s or later	M7, (probably C.1.1)
CEILING					
		Beam-and-block ceiling, plaster; suspended lowered luminaire	Surface renewed	1937; luminaires 1990s	Concrete, plaster

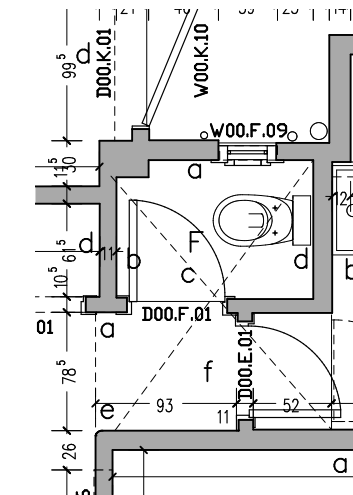
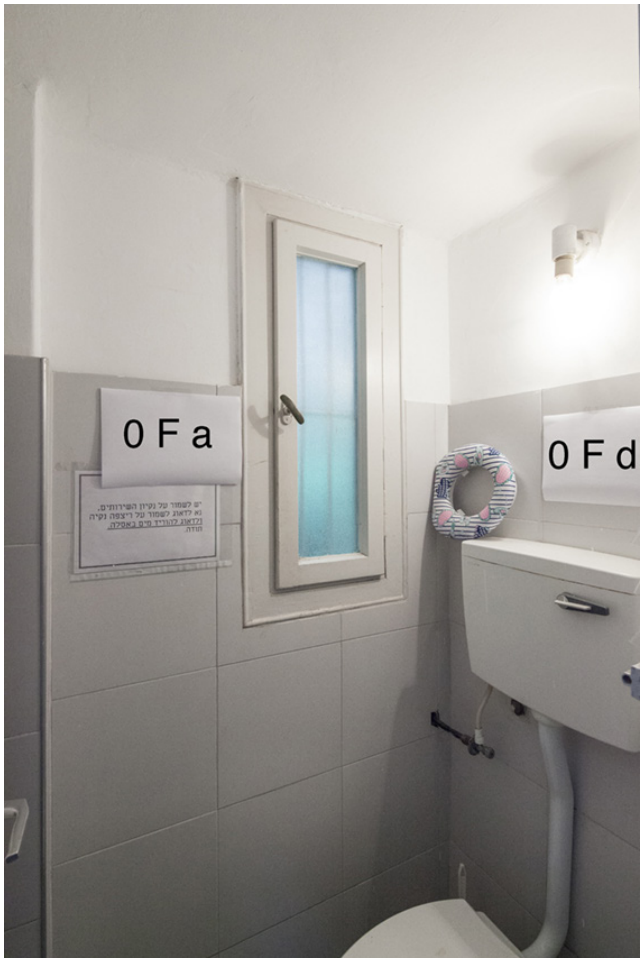
Ground floor plan 1:50, room 00.F

DATE		FLOOR		FUNCTION	ROOM
04/30/2015		Ground Floor		WC	00.F
ELEMENT	TYPE	DESCRIPTION	CONDITION, NOTES	DATING	ORIGINAL MATERIALS AND COLORS
FLOOR					
	F.2.1	Laminate flooring, gray, with plastic baseboard, black	Original terrazzo floor and base tiles beneath, condition unknown	1990s or later	(M4)
WALLS AND BUILT-IN ELEMENTS					
a		Plastered interior wall; wall tiling up to approx. 1.65m; open wiring	Surface renewed	Wall and plaster 1937; wiring 1960s-1990s	M7, (probably C.1.1)
b		Plastered interior wall; wall tiling up to approx. 1.65m	Surface renewed	Wall and plaster 1937	M7, (probably C.1.1)
W00.D.25	W.2.6	Double-sash interior sliding window	Paint renewed	1937	M13, (probably C.1.6); glass: M20
D00.D.01	D.1.5	Single-leaf solid door	Paint and handles renewed	1937; handles 1960s-1970s	M13, (probably C.1.6);
c		Plastered interior wall; wall tiling up to approx. 1.65m; wall-mounted air-conditioning unit	Surface renewed	Wall and plaster 1937; wiring 1960s-1990s	M7, (probably C.1.1)

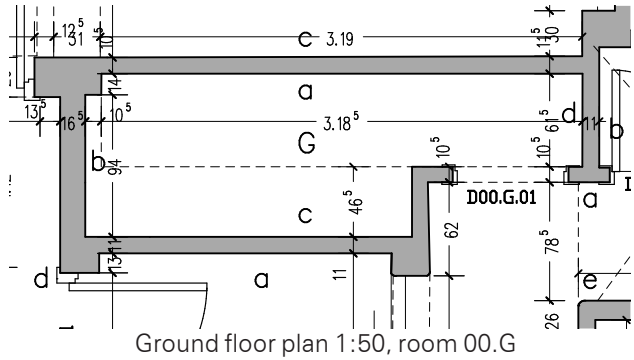
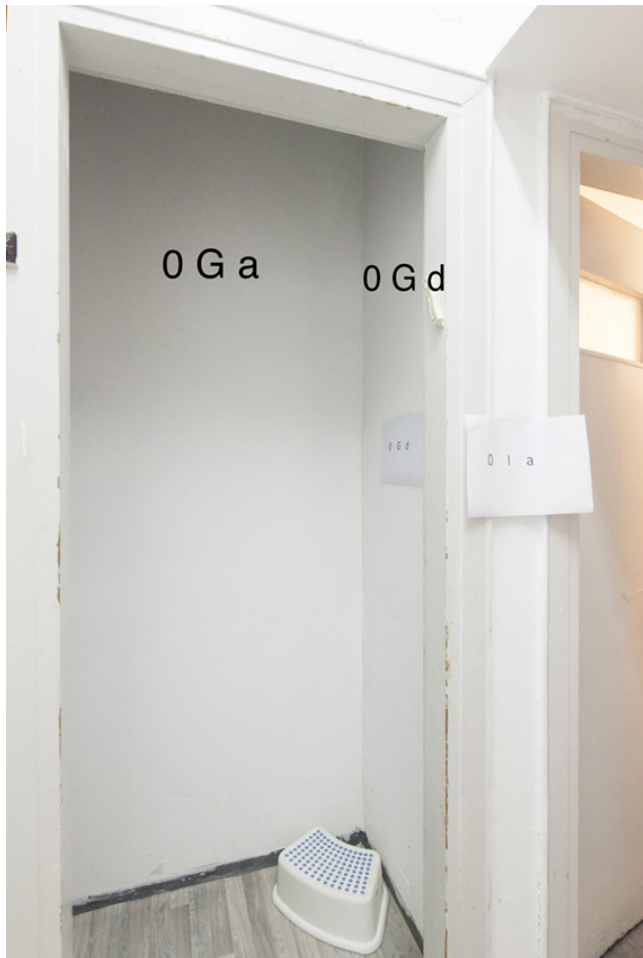
Room 00.G; _MG_3551.jpg; photo: Aviad Bar Ness, 2015

DATE		FLOOR		FUNCTION	ROOM
04/30/2015		Ground Floor		Room	00.G
ELEMENT	TYPE	DESCRIPTION	CONDITION, NOTES	DATING	ORIGINAL MATERIALS AND COLORS
FLOOR					
	F.2.1	Laminate flooring, gray, with plastic baseboard, black	Original terrazzo floor and base tiles beneath, condition unknown	1990s	(M4)
WALLS AND BUILT-IN ELEMENTS					
a		Plastered interior wall	Surface renewed	Wall and plaster 1937	M7, (probably C.1.1)
b		Plastered interior wall, recess with wall tiling	Surface renewed, wall tiling new	Wall and plaster 1937; tiles 1990s or later	M7, (probably C.1.1)
c		Plastered interior wall, recess with wall tiling; wall-mounted louvered luminaire	Surface renewed, wall tiling new	Wall and plaster 1937; tiles and technical installations 1960s-1990s or later	M7, (probably C.1.1)
D00.G.01	D.2.1	Door opening with original frame	Paint renewed; leaf missing	1937	M13, (probably C.1.6)
d		Plastered interior wall	Surface renewed	Wall and plaster 1937	M7, (probably C.1.1)
