CONSERVATION SURVEY

MAX-LIEBLING-HOUSE

29, IDELSON STREET, TEL AVIV

Tel Aviv/Berlin, 2016/17

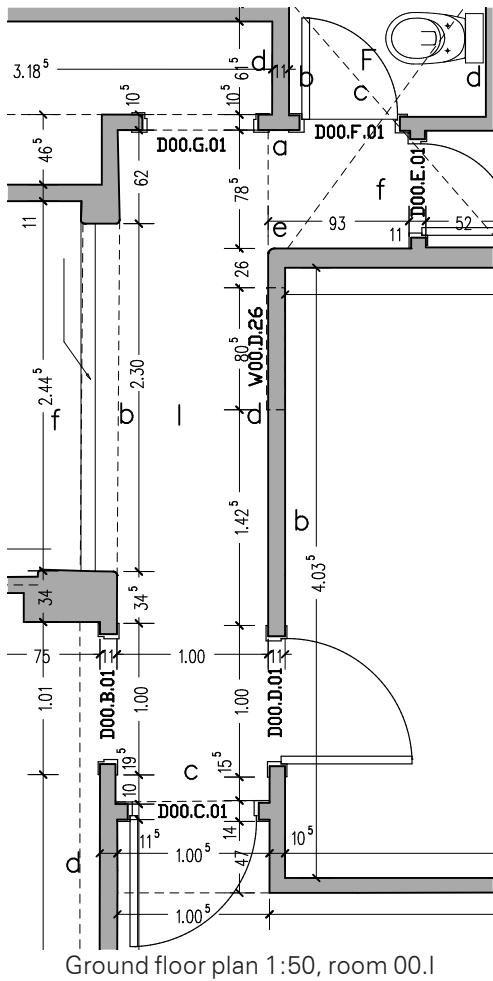
DATE		FLOOR		FUNCTION	ROOM
04/30/2015		Ground Floor		Corridor	00.I
ELEMENT	TYPE	DESCRIPTION	CONDITION, NOTES	DATING	ORIGINAL MATERIALS AND COLORS
FLOOR					
	F.2.1	Laminate flooring; beige terrazzo base tiles, in some parts black plastic baseboard added	Original terrazzo floor and base tiles beneath, condition unknown	1990s or later, base tiles 1937	M4
WALLS AND BUILT-IN ELEMENTS					
a		Plastered interior wall	Surface renewed	Wall and plaster 1937	M7, (probably C.1.1)
D00.F.01	D.1.6	Single-leaf solid door with a small glass pane	Paint renewed; original handles painted	1937	M13, (probably C.1.6); glass: M19; handles: M21
D00.G.01	D.2.1	Door opening with original frame	Paint renewed; door leaf missing	1937	M13, (probably C.1.6)
b		Plastered interior wall that stops short of the ceiling, adjoining room 00.H, running between two concrete columns; wall-mounted electrical distribution box	Surface renewed; wall possibly inserted subsequently; electrical installation renewed	1937, (wall adjoining room H 1937), technical installation 1960s-1990s	M7, (probably C.1.1)

D00.B.01	D.2.1	Door opening with original frame	Door leaf missing, paint renewed	1937	M13, (probably C.1.6)
c		Plastered interior wall, open wiring	Surface renewed	Wall and plaster 1937	M7, (probably C.1.1)
D00.C.01	D.1.5	Single-leaf solid door	Paint and handles renewed	1937; handles 1960s-1970s	M13, (probably C.1.6)
d		Plastered interior wall	Surface renewed	Wall and plaster 1937	M7, (probably C.1.1)
D00.D.01	D.1.5	Single-leaf solid door	Paint and handles renewed	1937; handles 1960s-1970s	M13, (probably C.1.6)
W00.D.26	W.2.6	Double-sash interior sliding window	Paint renewed	1937	M13, (probably C.1.6); glass: M20
e		Plastered interior wall	Surface renewed	Wall and plaster 1937	M7, (probably C.1.1)
f		Plastered interior wall	Surface renewed	Wall and plaster 1937	M7, (probably C.1.1)
D00.E.01	D.1.6	Single-leaf solid door with a small glass pane	Paint renewed; handles painted	1937	M13, (probably C.1.6); glass: M19; handles: M21

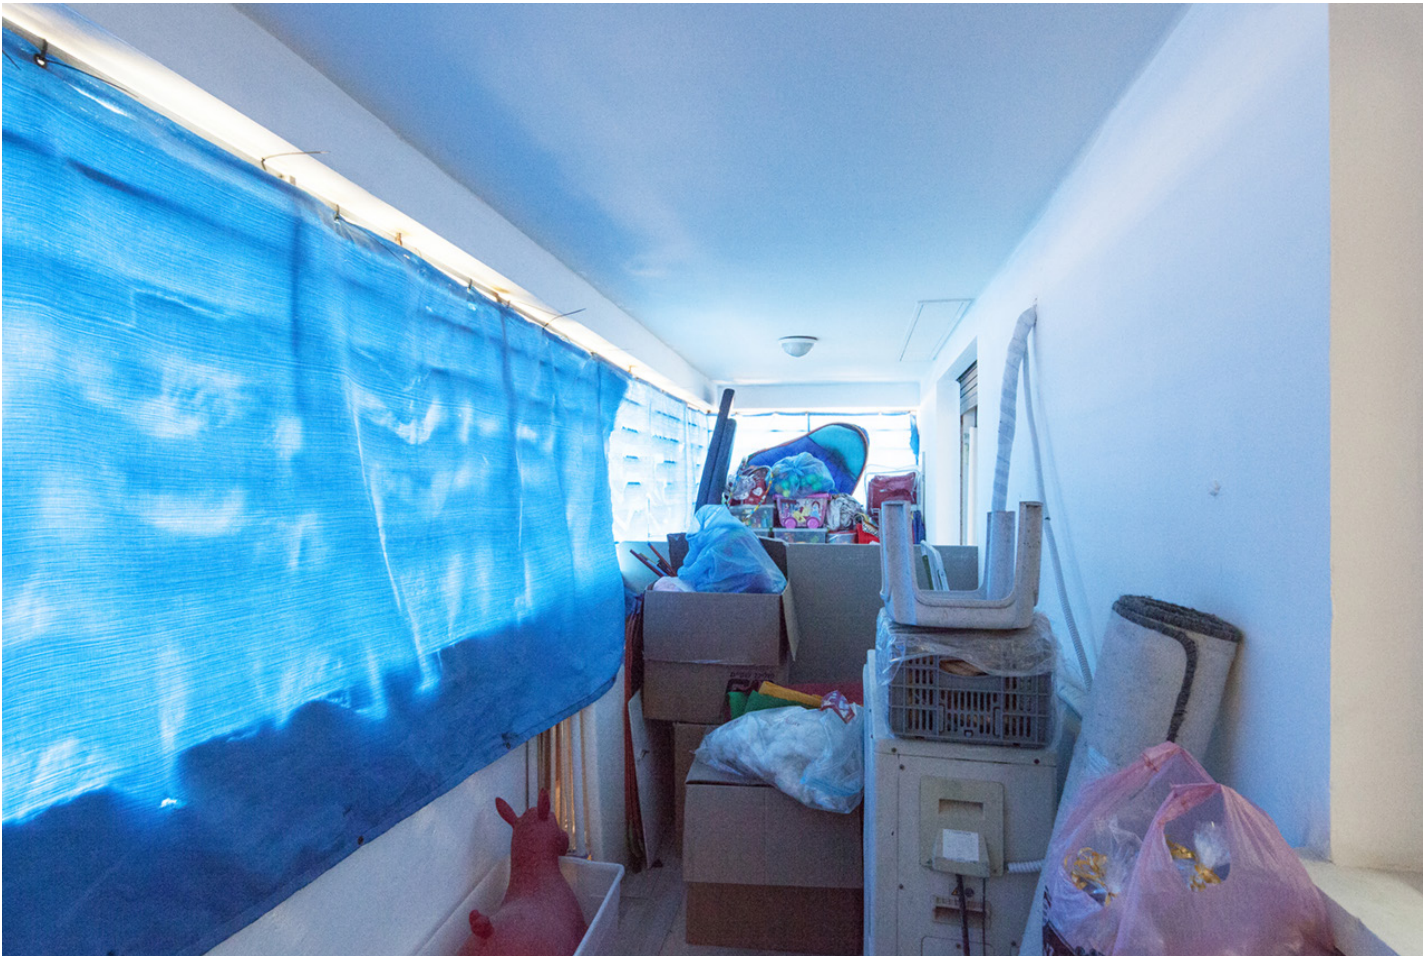
Room 00.J; _MG_3556.jpg; photo: Aviad Bar Ness, 2015

DATE		FLOOR		FUNCTION	ROOM
04/30/2015		Ground Floor		Balcony (B.1)	00.J
ELEMENT	TYPE	DESCRIPTION	CONDITION, NOTES	DATING	ORIGINAL MATERIALS AND COLORS
FLOOR					
	F.2.1	Laminate flooring, gray, with plastic baseboard, black	Original terrazzo floor and base tiles beneath, condition unknown	1990s or later	(M4)
WALLS AND BUILT-IN ELEMENTS					
a		Rendered exterior wall, cased wall-mounted drainpipe, located in the corner with wall d	Paint renewed	Wall and plaster 1937; paint 1990s	M7, (probably C.1.4)
W00.B.03	W.2.1	Double-sash casement window; window sill painted white	Paint renewed, partly peeling off; original handles	1937	M13, (probably C.1.6); glass: M20; handles: M21
W00.A.02	W.1.1	Double-leaf balcony door; three panes of clear glass	Paint renewed, partly peeling off; original handles	1937	M13, (probably C.1.6); handles: M21
b		Rendered exterior parapet; terrazzo coping with a water drip; round steel column mounted on the coping in the corner of the balcony with a sleeve socket at the base; galvanized steel grille (divided by a vertical bar into two parts with six horizontal bars each) mounted between the parapet and the upper fascia	Paint and terrazzo coping renewed broadly similar to the original materials; paint peeling off, cracks in the plaster at the connection to the coping; column probably original	Wall, plaster and column 1937; paint, coping and grille 1990s	Railing: M7, (probably C.1.4); column: M23 (original color white)

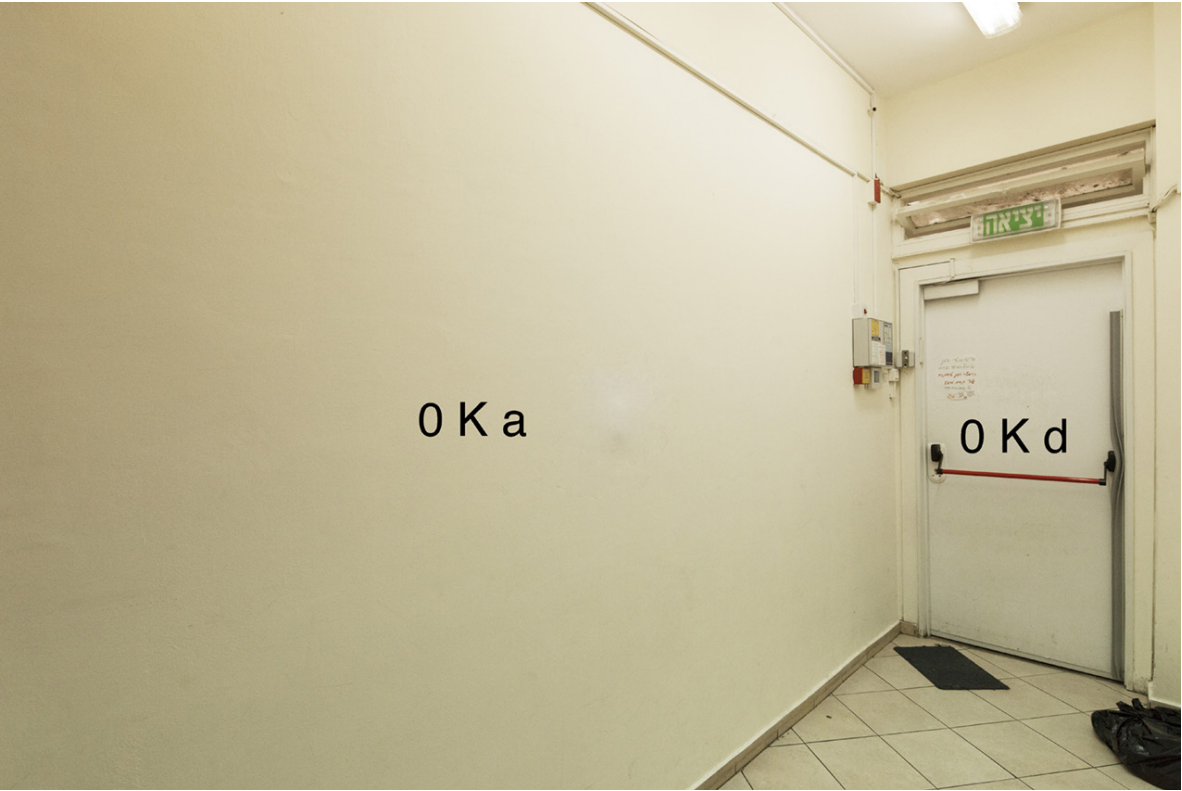
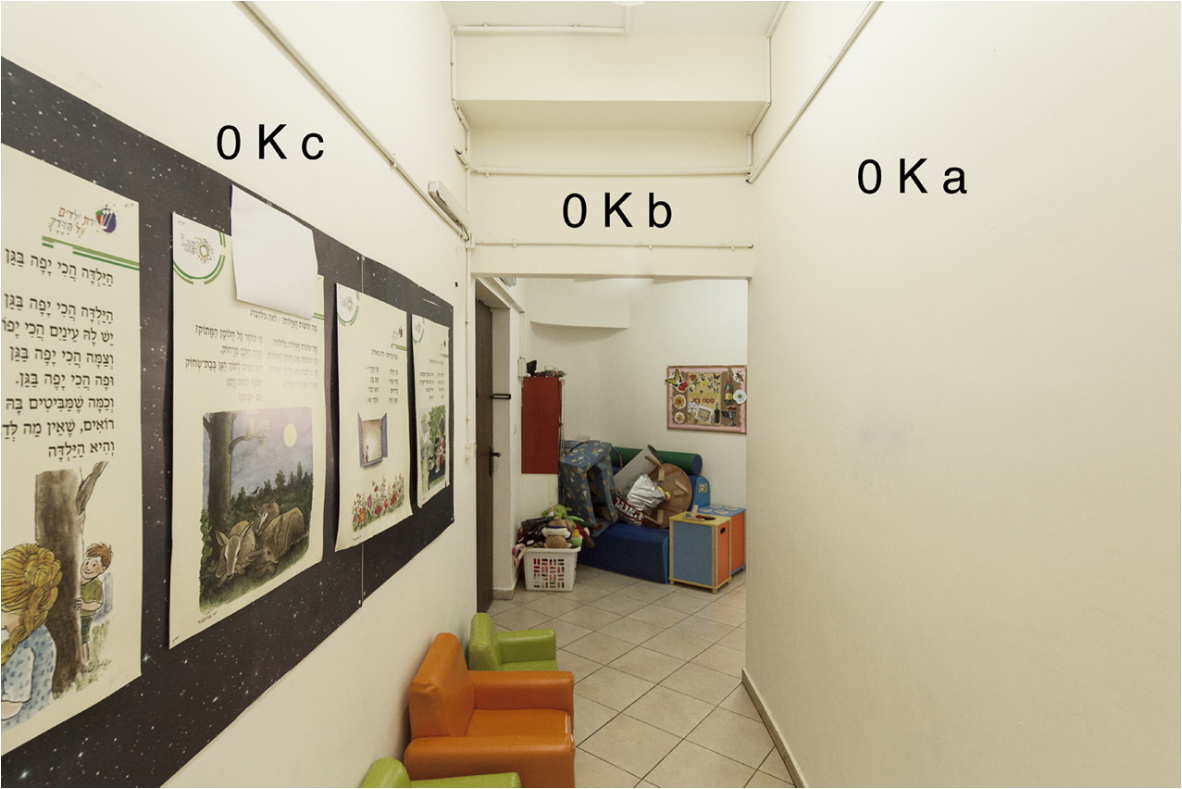
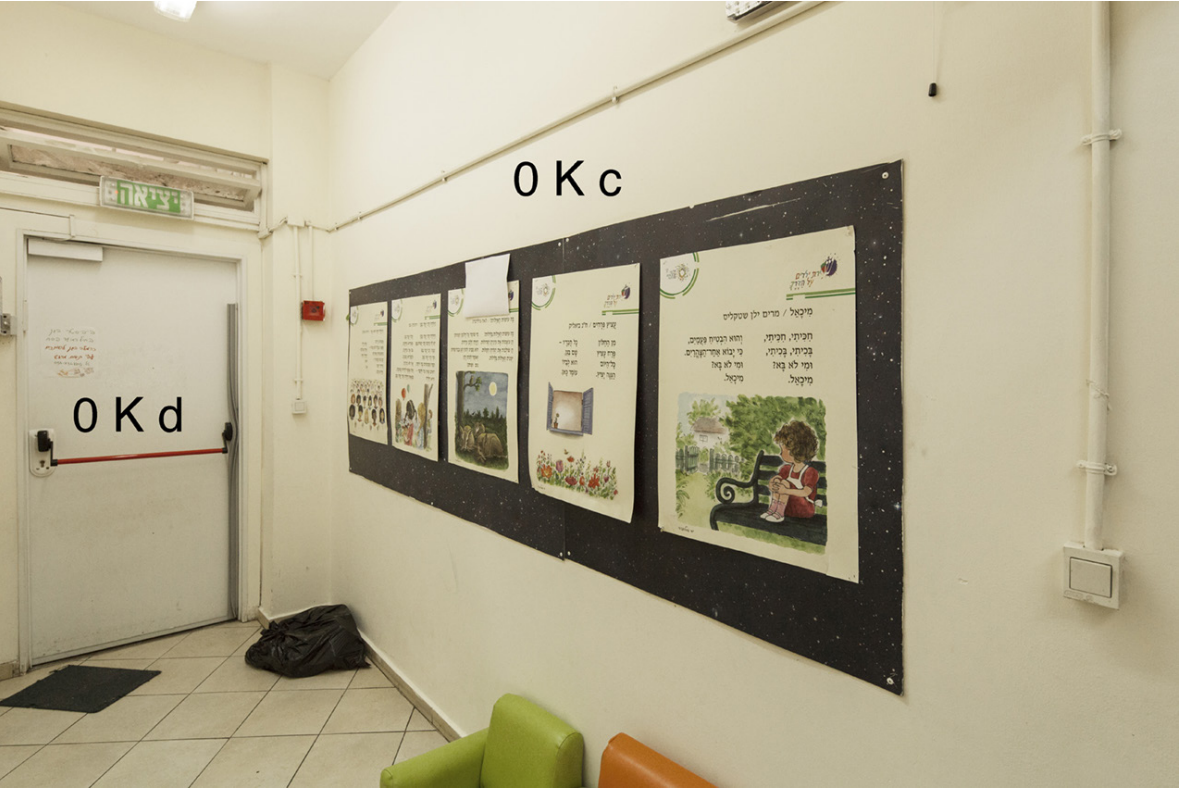
Room 00.K; _MG_3607.jpg; photo: Aviad Bar Ness, 2015

DATE		FLOOR		FUNCTION	ROOM
04/30/2015		Ground Floor		Corridor	00.K
ELEMENT	TYPE	DESCRIPTION	CONDITION, NOTES	DATING	ORIGINAL MATERIALS AND COLORS
FLOOR					
	F.2.1	Ceramic floor and base tiles, beige	Original terrazzo floor and base tiles beneath, condition unknown	1990s or later	(M4)
WALLS AND BUILT-IN ELEMENTS					
a		Plastered interior wall; open wiring and wall-mounted distribution box	Surface renewed	Wall and plaster 1937; technical installations 1990s	M7, (probably C.1.1)
b		Plastered interior wall, wall-mounted fluorescent lighting, open wiring	Surface renewed	Wall and plaster 1937; wiring 1960s-1990s	M7, (probably C.1.1)
c		Plastered interior wall, open wiring	Surface renewed	Wall and plaster 1937; wiring 1960s-1990s	M7, (probably C.1.1)
d		Plastered interior wall, wall-mounted emergency exit lighting	Surface renewed; emergency light new	Wall and plaster 1937; technical installations 1960s-1990s or later	M7, (probably C.1.1)

D00.K.01	W.2.3	Single-leaf exterior emergency exit door with a push bar	Replaced	1990s or later	
W00.K.10	W.3.2	Horizontal pivot window	Paint renewed	1937	M13, (probably C.1.6); glass: M20; handles; M21?
CEILING					
		Beam-and-block ceiling, plaster; fluorescent lighting	Surface renewed	1937; luminaires 1990s	Concrete, plaster

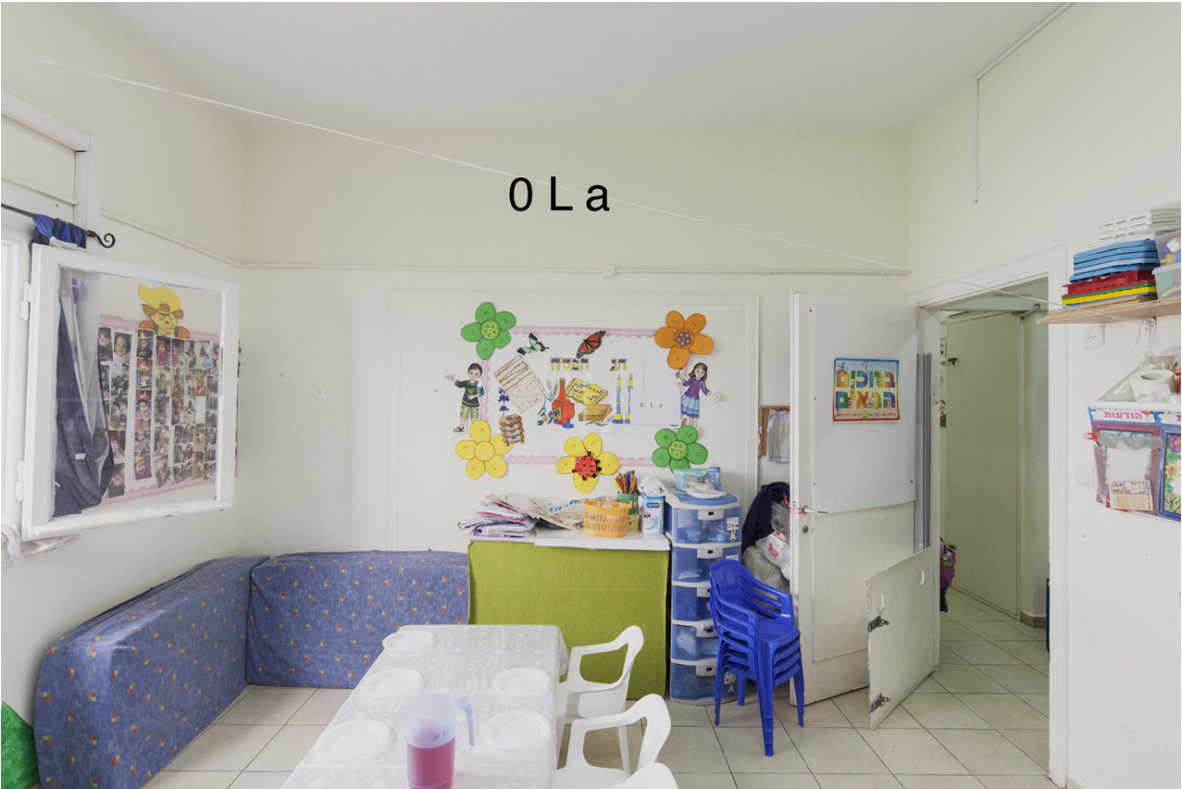
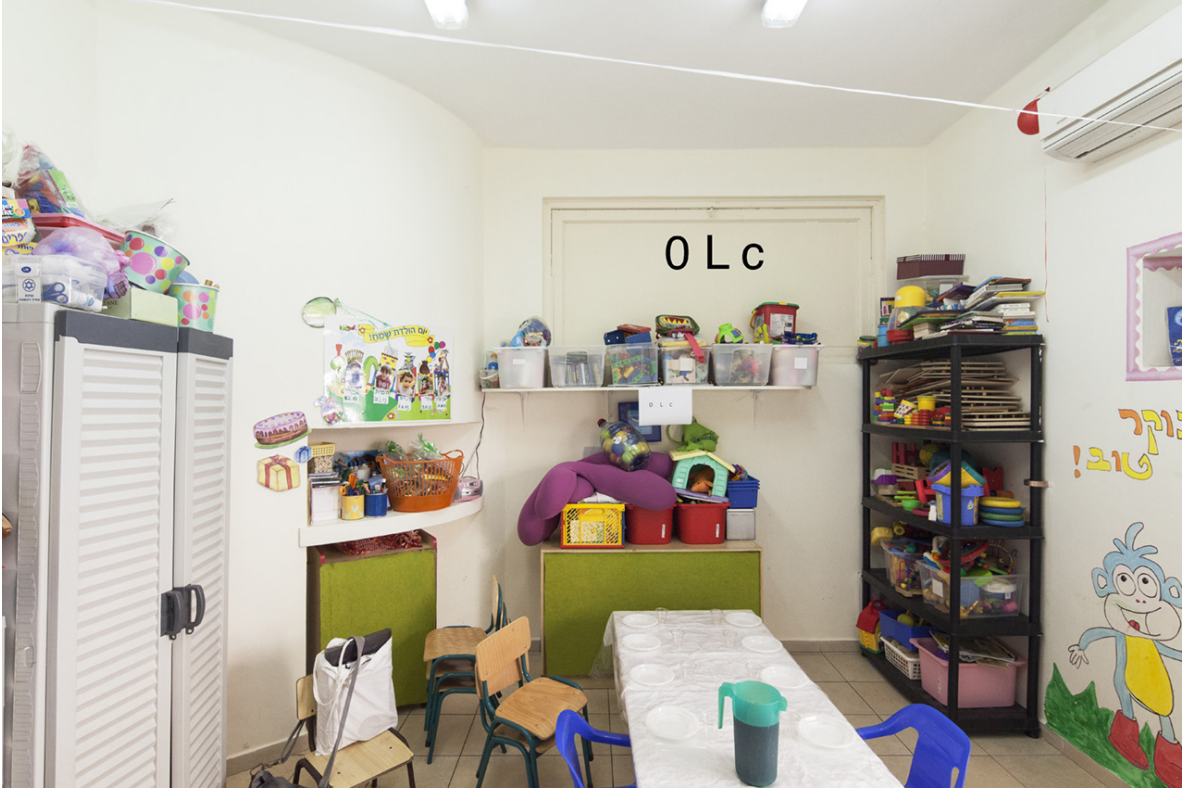
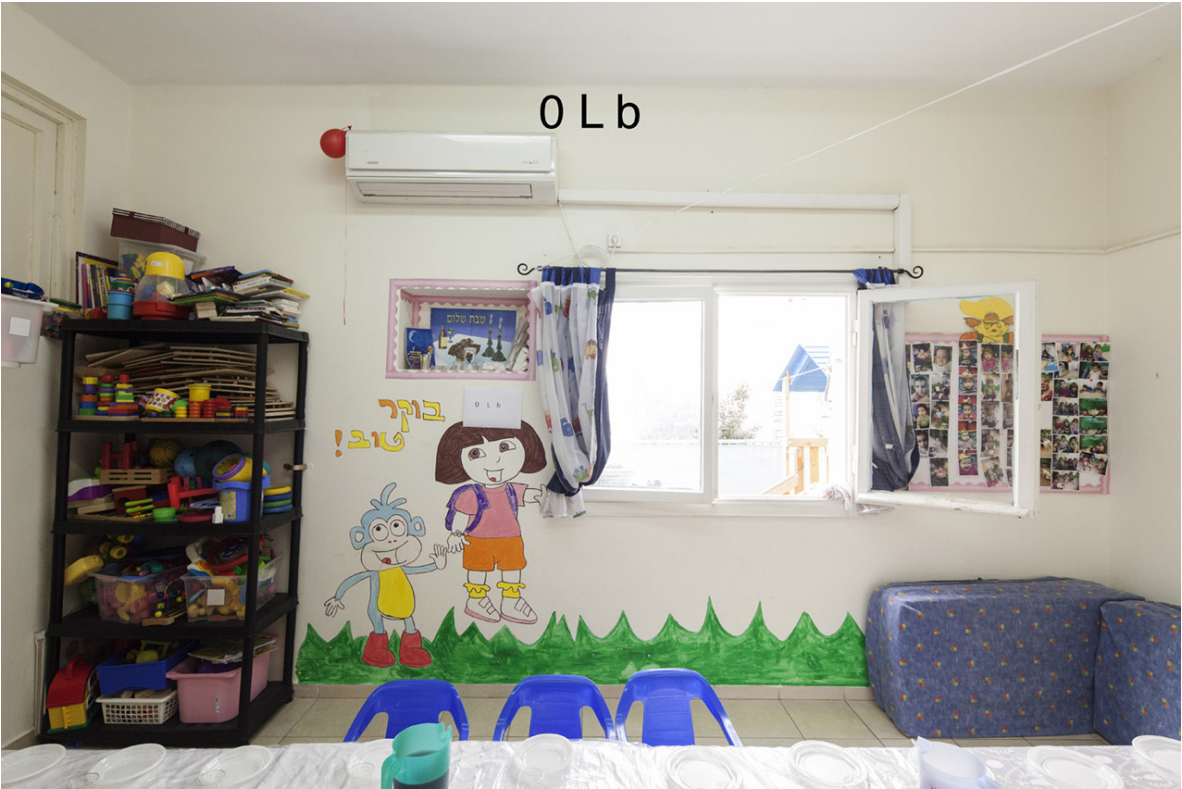
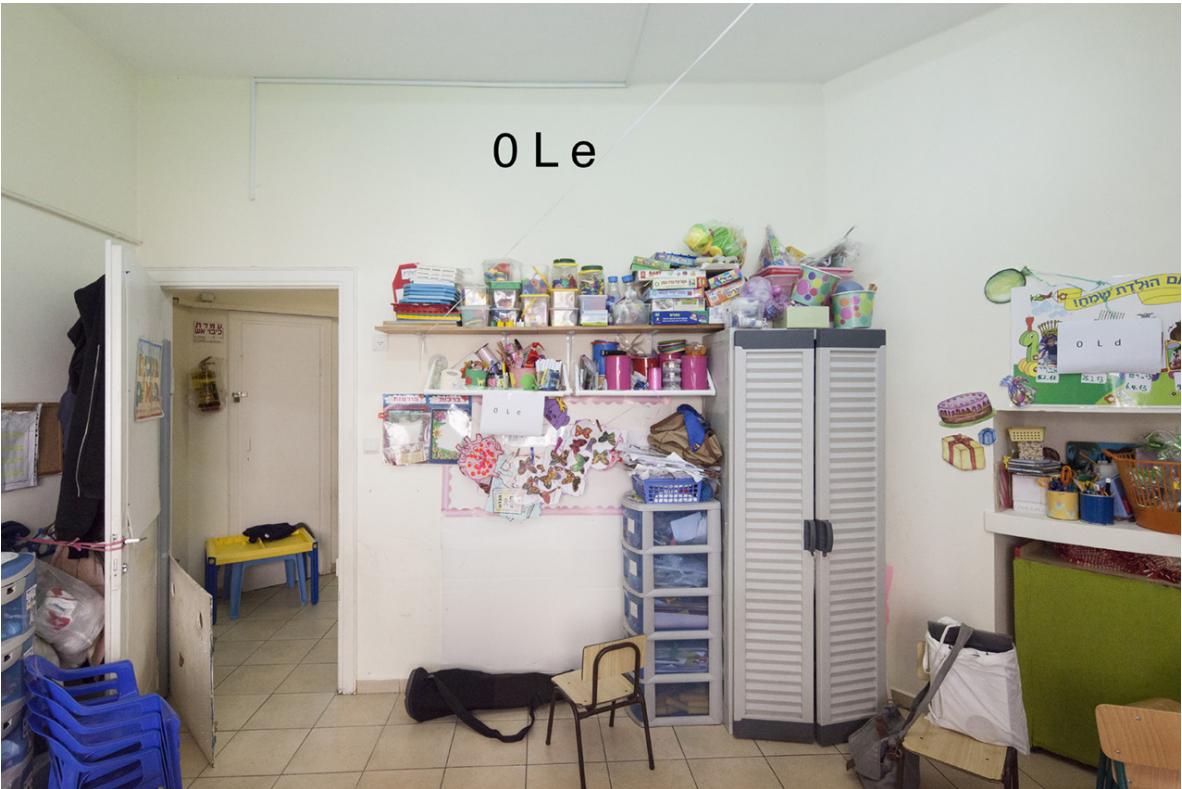
Room 00.L; _MG_3566.jpg; photo: Aviad Bar Ness, 2015

DATE		FLOOR		FUNCTION	ROOM
04/30/2015		Ground Floor		Former parlor	00.L
ELEMENT	TYPE	DESCRIPTION	CONDITION, NOTES	DATING	ORIGINAL MATERIALS AND COLORS
FLOOR					
	F.2.1	Ceramic floor and base tiles, beige	Original terrazzo floor and base tiles beneath, condition unknown	1990s or later	(M4)
WALLS AND BUILT-IN ELEMENTS					
a		Plastered interior wall; open wiring	Surface renewed	Wall and plaster 1937	M7, (probably C.1.1)
D00.L.02	D.2.1	Door opening with original frame, probably for a two-leaf door; doorway now boarded up with dry-wall	Door leaves missing, paint renewed	1937; drywall construction 1990s	M13, (probably C.1.6)
b		Plastered exterior wall; small recess on the left; open wiring and air-conditioning unit	Surface renewed	Wall and plaster 1937; technical installations 1990s	M7, (probably C.1.1)
W00.L.23	W.2.1	Double-sash casement window	Paint renewed, original handles painted white	1937	M13, (probably C.1.6); glass: M20; handles: M21

c		Plastered interior wall, upper part adjoining balcony 00.U	Surface renewed	Wall and plaster 1937	M7, (probably C.1.1)
W00.L.24	W.3.6	Pivot window; originally glazed, now filled with a panel	Interior paint renewed, exterior paint peeling off; original glass replaced with a panel	1937; panel later	M13, (probably C.1.6)
d		Rounded interior wall, plastered; open wiring; former radiator wall recess contains a built-in shelf	Surface renewed; wall recess cf. 01.L, 02.L	Wall and plaster 1937	M7, (probably C.1.1)
e		Plastered interior wall; flush-mounted socket and light switch, open wiring	Surface renewed	Wall and plaster 1937; socket and light switch and wiring 1990s	M7, (probably C.1.1)
D00.L.01	D.1.3	Single-leaf door in a wooden frame; three panes of textured glass, covered with plywood on both sides	Paint and handles renewed; plywood added subsequently	1937; handles and panel 1960s-1990s	M13, (probably C.1.6)

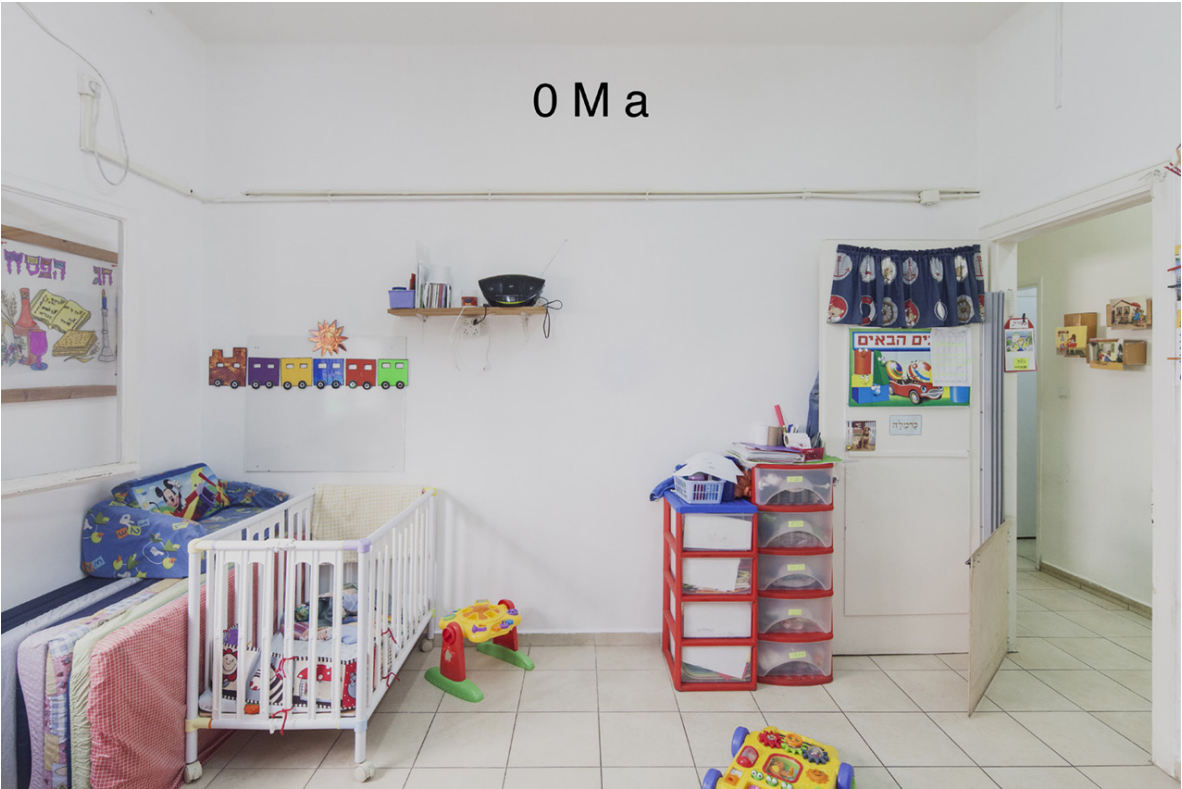
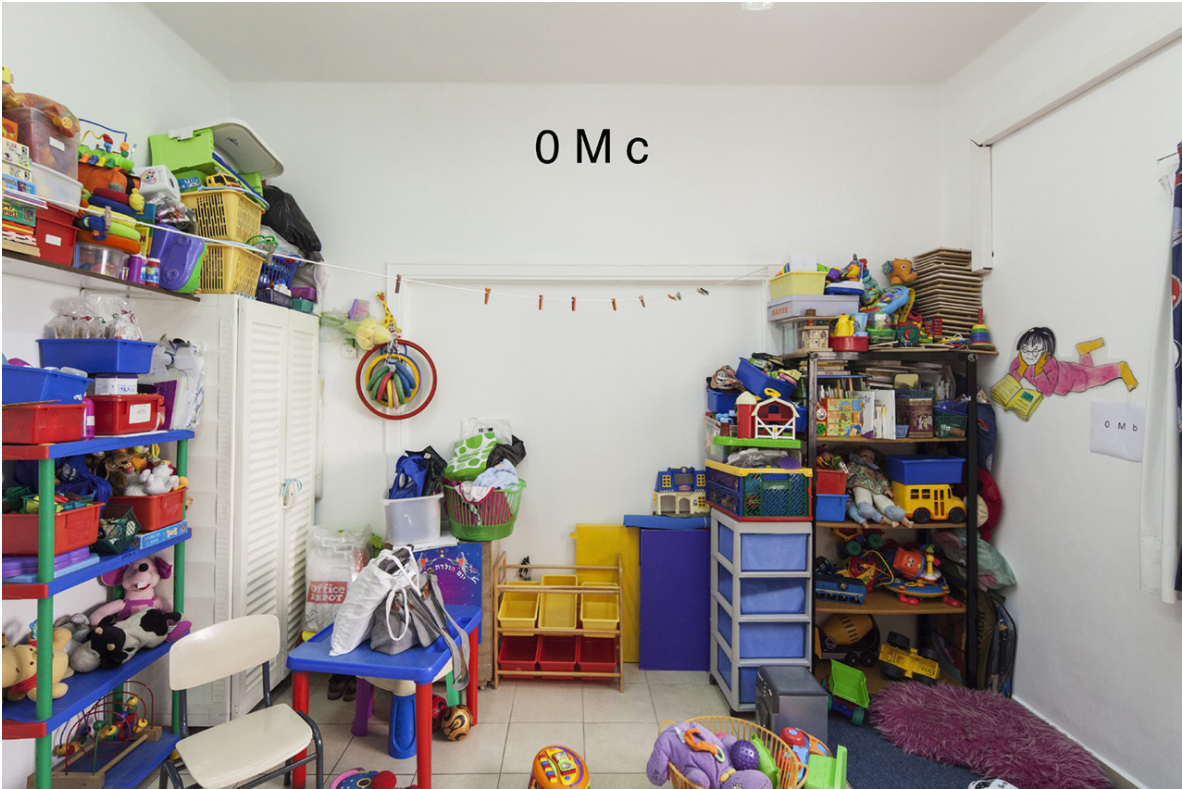
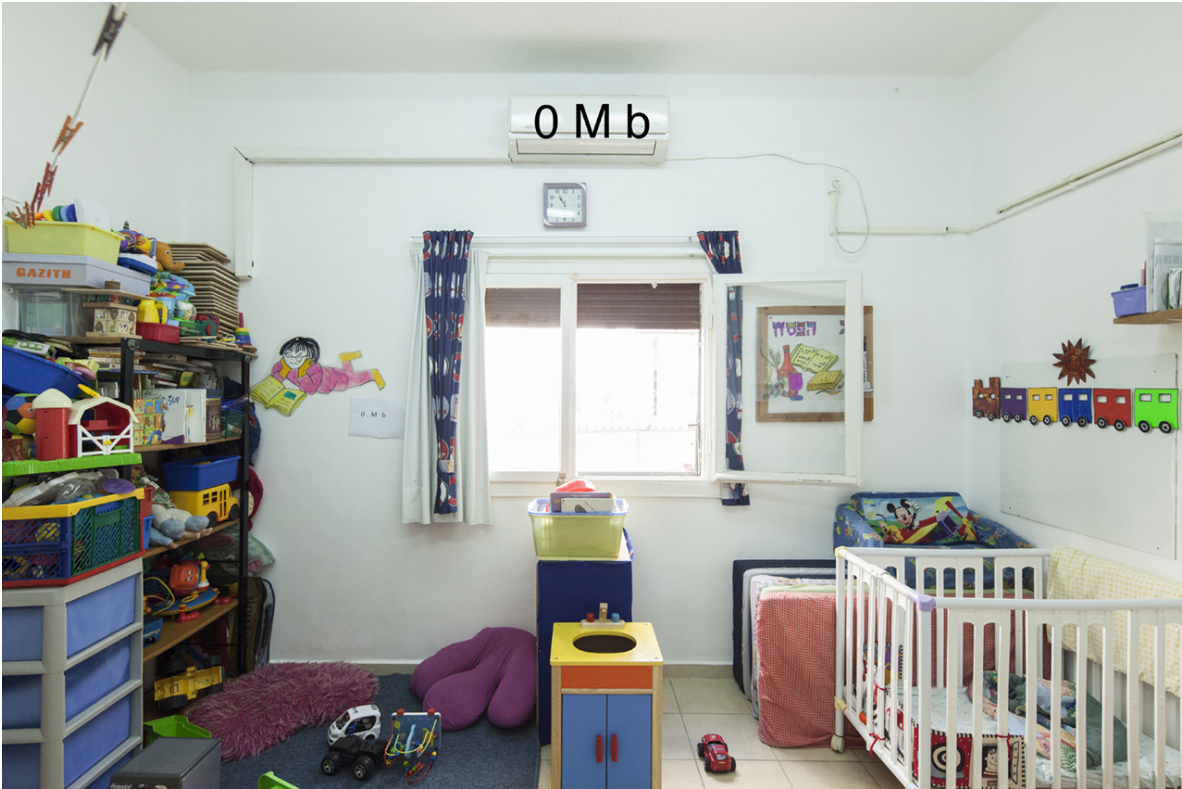
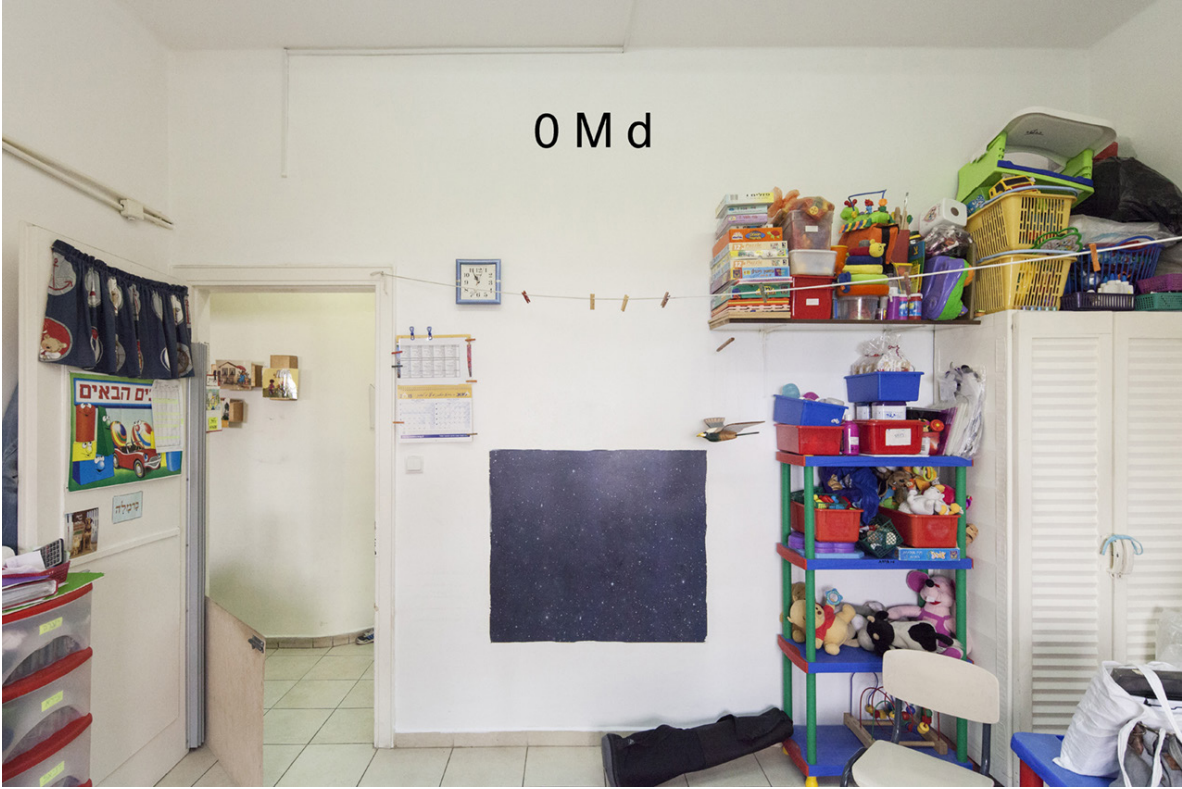
Room 00.M; _MG_3574.jpg; photo: Aviad Bar Ness, 2015

DATE		FLOOR		FUNCTION	ROOM
04/30/2015		Ground Floor		Room	00.M
ELEMENT	TYPE	DESCRIPTION	CONDITION, NOTES	DATING	ORIGINAL MATERIALS AND COLORS
FLOOR					
	F.2.1	Ceramic floor and base tiles, beige	Original terrazzo floor and base tiles beneath, condition unknown	1990s or later	(M4)
WALLS AND BUILT-IN ELEMENTS					
a		Plastered interior wall; open wiring	Surface renewed	Wall and plaster 1937; wiring 1960s-1990s	M7, (probably C.1.1)
b		Plastered exterior wall; wall-mounted air-conditioning unit and open wiring	Surface renewed	Wall and plaster 1937; technical installations 1990s	M7, (probably C.1.1)
W00.M.22	W.2.1	Double-sash casement window	Paint renewed; original handles painted white	1937	M13, (probably C.1.6); glass: M20; handles: M21
c		Plastered interior wall; recess with a doorway boarded up with drywall	Surface renewed; door opening subsequently boarded up	Wall and plaster 1937; drywall construction 1990s	M7, (probably C.1.1)

D00.L.02	D.2.1	Door opening with original frame; doorway boarded up	Originally probably two door leaves, missing; paint renewed	1937	M13, (probably C.1.6)
d		Plastered interior wall; open wiring	Surface renewed	Wall and plaster 1937; wiring 1990s	M7, (probably C.1.1)
D00.M.01	D.1.3	Single-leaf door with a wooden frame; three panes of textured glass; covered with plywood on both sides	Paint and handles renewed, plywood sheet added subsequently	1937; handles and panel 1960s-1990s	M13, (probably C.1.6)
CEILING					
		Beam-and-block ceiling, plaster; fluorescent lighting	Surface renewed	1937; luminaires 1990s	Concrete, plaster

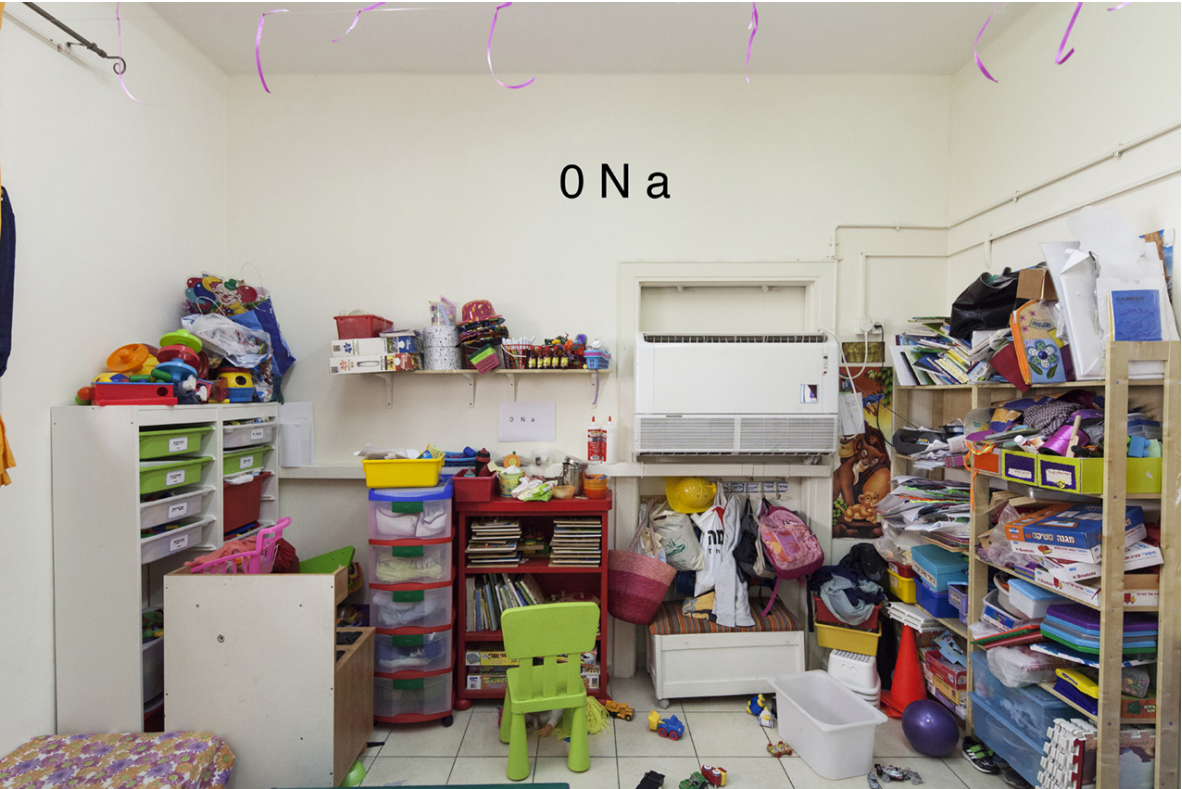
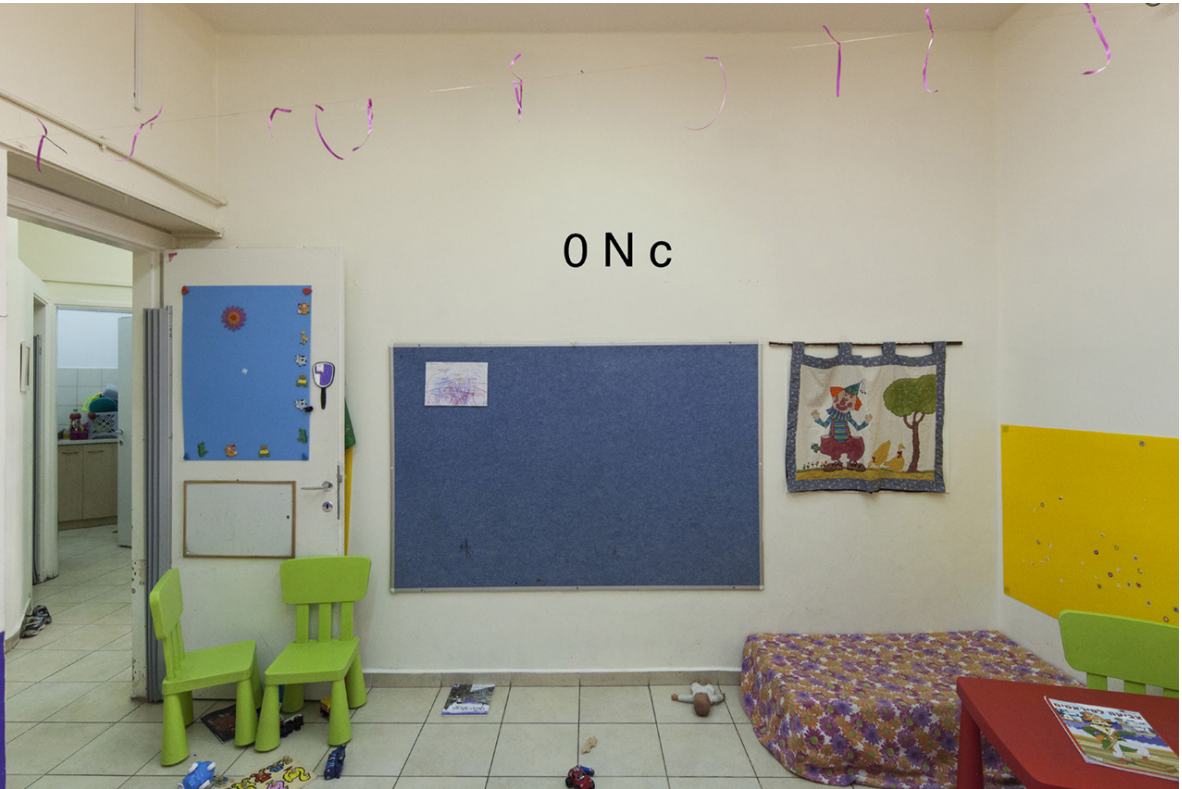
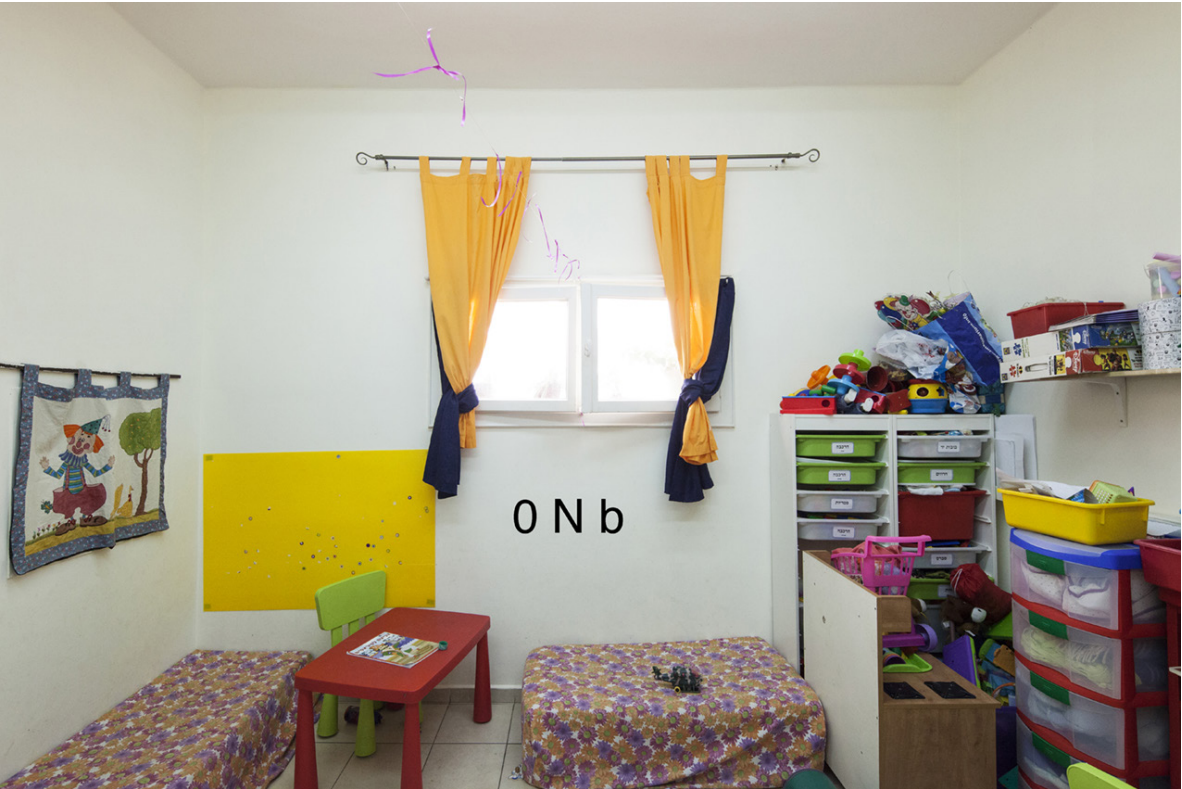
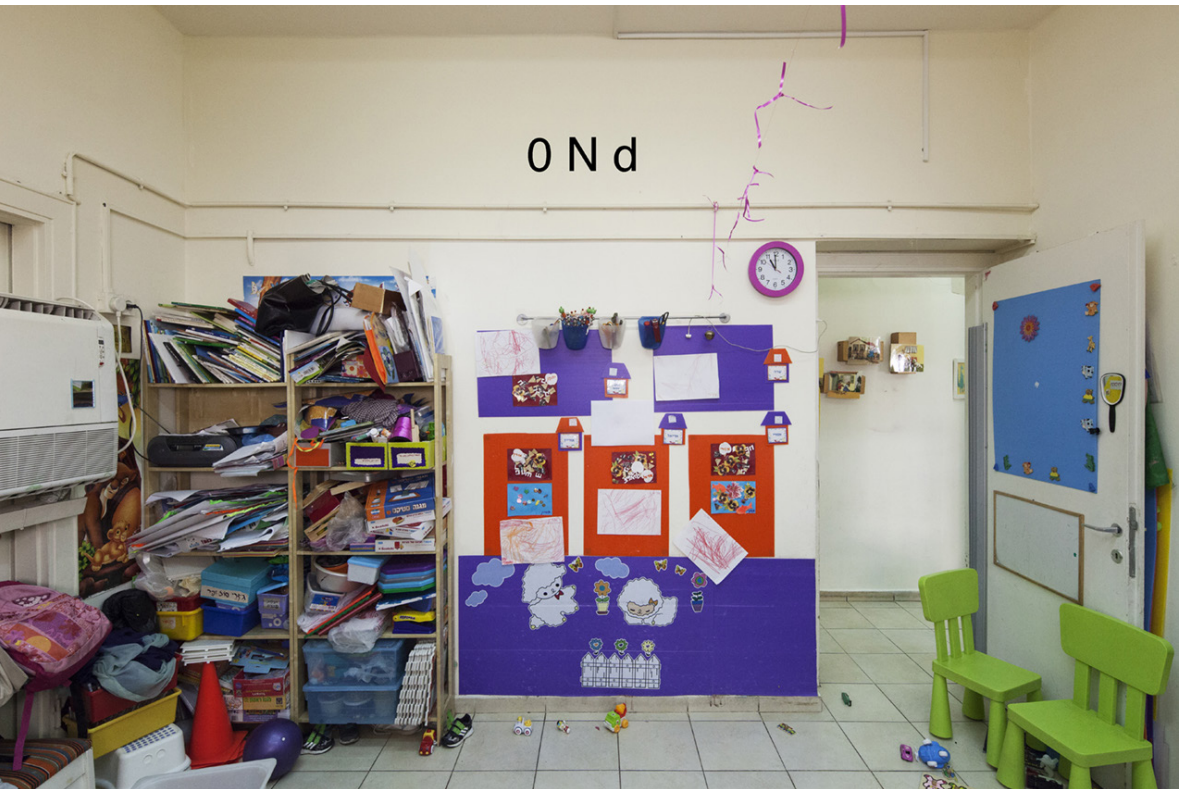
Room 00.N; _MG_3586.jpg; photo: Aviad Bar Ness, 2015

DATE		FLOOR		FUNCTION	ROOM
04/30/2015		Ground Floor		Room	00.N
ELEMENT	TYPE	DESCRIPTION	CONDITION, NOTES	DATING	ORIGINAL MATERIALS AND COLORS
FLOOR					
	F.2.1	Ceramic floor and base tiles, beige	Original terrazzo floor and base tiles beneath, condition unknown	1990s or later	(M4)
WALLS AND BUILT-IN ELEMENTS					
a		Plastered interior wall; recess with a doorway boarded up with drywall; wall-mounted air-conditioning unit and open wiring	Surface renewed; doorway boarded up subsequently	Wall and plaster 1937; drywall construction and technical installations 1990s or later	M7, (probably C.1.1)
W00.N.19	W.2.1	Door opening of a former balcony door (type W.1.2); doorway blocked up	Original frame, leaves missing, paint renewed	1937	M13, (probably C.1.6)
b		Plastered exterior wall	Surface renewed	Wall and plaster 1937	M7, (probably C.1.1)
W00.N.21	W.2.5	Double-sash casement window	Paint renewed, original handles painted white	1937	M13, (probably C.1.6); glass: M20; handles: M21

c		Plastered interior wall	Surface renewed	Wall and plaster 1937	M7, (probably C.1.1)
d		Plastered interior wall; open wiring	Surface renewed	Wall and plaster 1937	M7, (probably C.1.1)
D00.N.01	D.1.5	Single-leaf solid door	Paint and handles renewed	1937; handles probably 1990s	M13, (probably C.1.6)
CEILING					
		Beam-and-block ceiling, plaster; fluorescent lighting	Surface renewed	1937; luminaires 1990s	Concrete, plaster

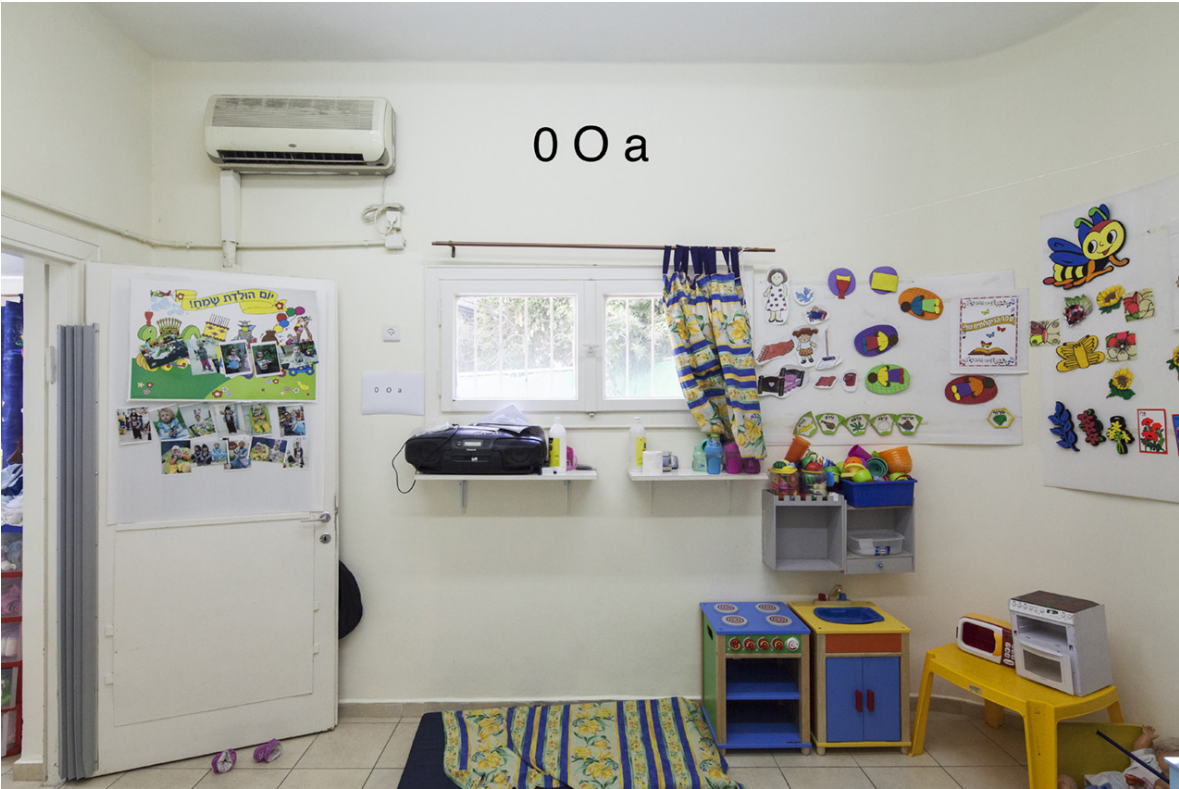
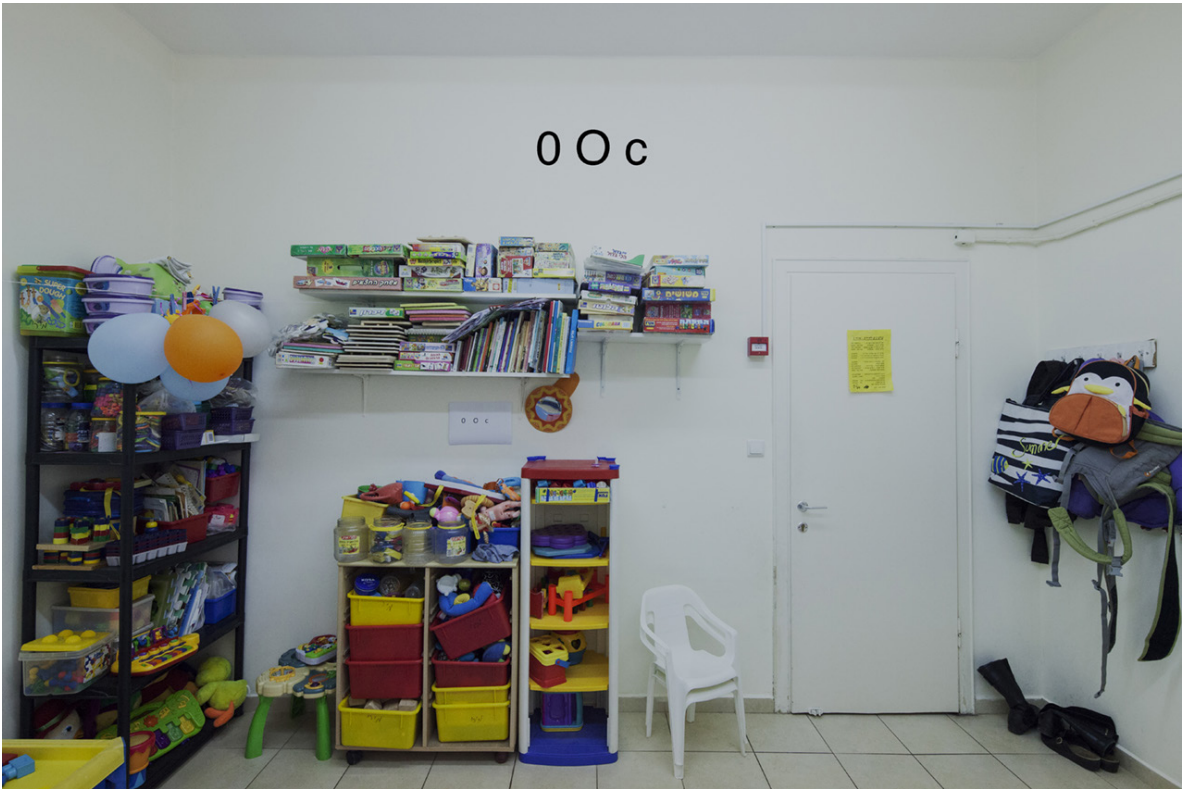
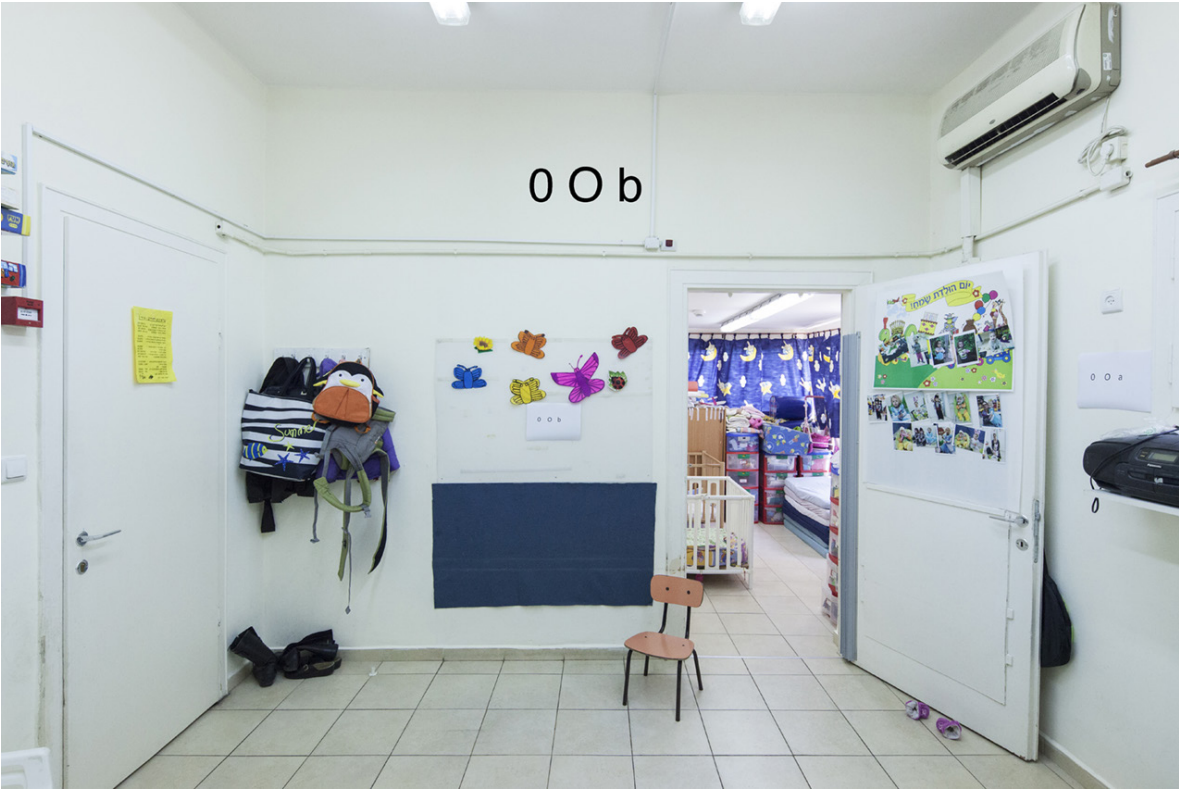
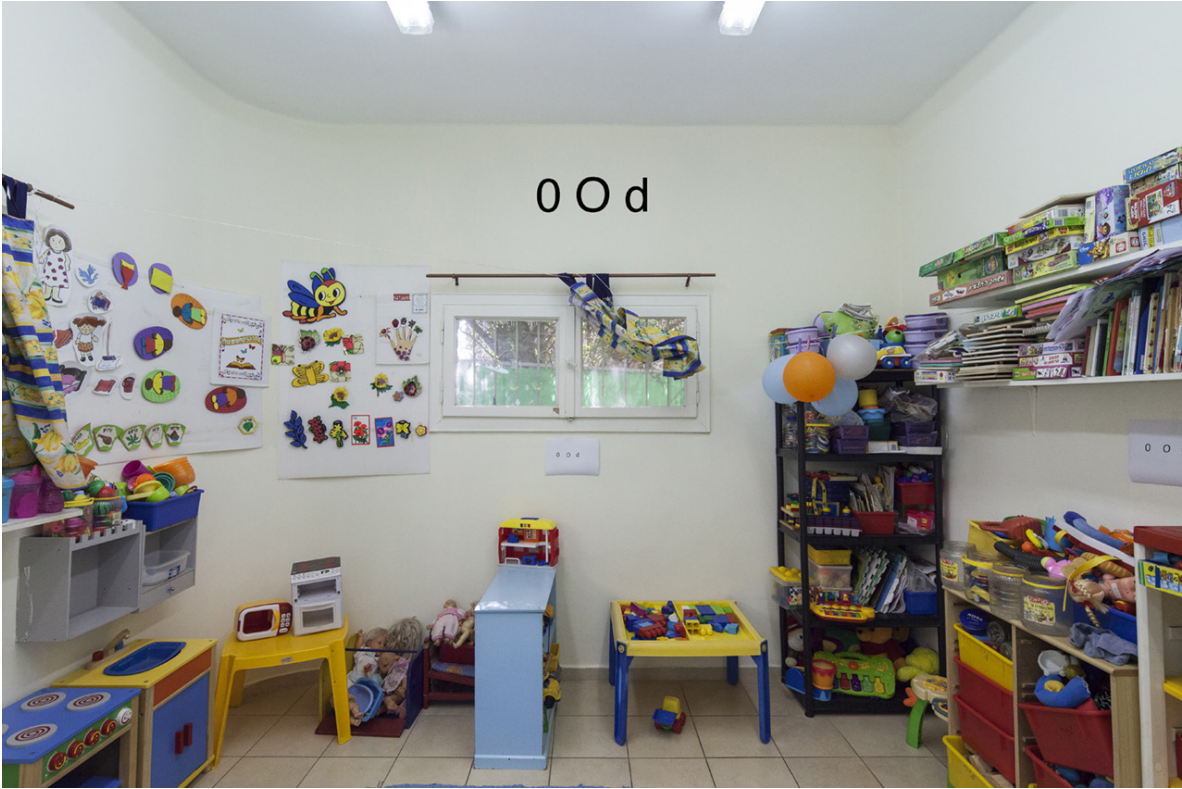
Room 00.O; _MG_3581.jpg; photo: Aviad Bar Ness, 2015

DATE		FLOOR		FUNCTION	ROOM
04/30/2015		Ground Floor		Room	00.O
ELEMENT	TYPE	DESCRIPTION	CONDITION, NOTES	DATING	ORIGINAL MATERIALS AND COLORS
FLOOR					
	F.2.1	Ceramic floor and base tiles, beige	Original terrazzo floor and base tiles beneath, condition unknown	1990s or later	(M4)
WALLS AND BUILT-IN ELEMENTS					
a		Plastered exterior wall with a rounded corner on the left side; wall-mounted air-conditioning unit and open wiring, cable bushing	Surface renewed	Wall and plaster 1937; electrical installations 1990s or later	M7, (probably C.1.1)
W00.O.17	W.2.5	Double-sash casement window; original handles; exterior metal grille (10 vertical bars)	Paint renewed, handles painted white	1937	M13, (probably C.1.6); glass: M20; handles: M21; grille: M23
b		Plastered exterior wall, open wiring	Surface renewed	Wall and plaster 1937	M7, (probably C.1.1)
W00.O.18	W.1.2	Single-leaf balcony door with a wooden frame; three glass panes, covered with plywood on both sides	Handles and paint renewed; plywood sheets added subsequently; no roller shutter	1937; handles and panel probably 1990s	M13, (probably C.1.6); glass: (M20); grille: M23
