CONSERVATION SURVEY

MAX-LIEBLING-HOUSE

29, IDELSON STREET, TEL AVIV

Tel Aviv/Berlin, 2016/17

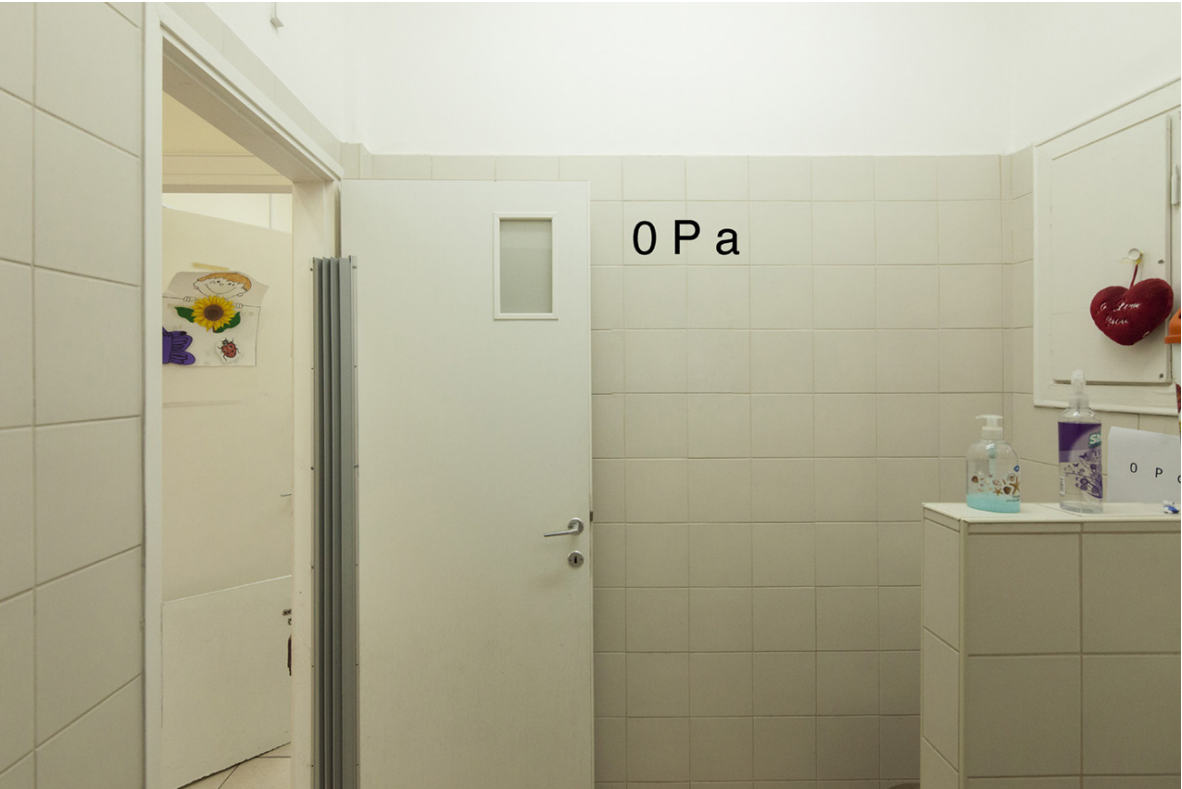
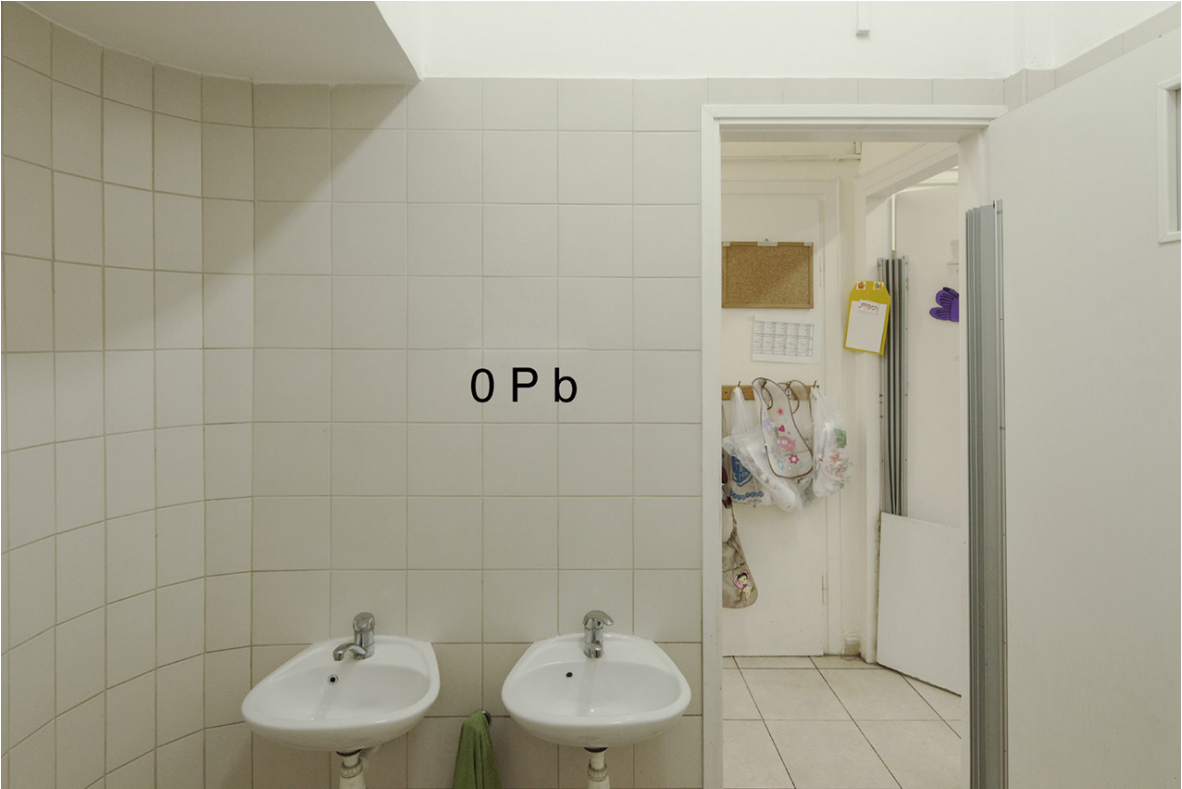
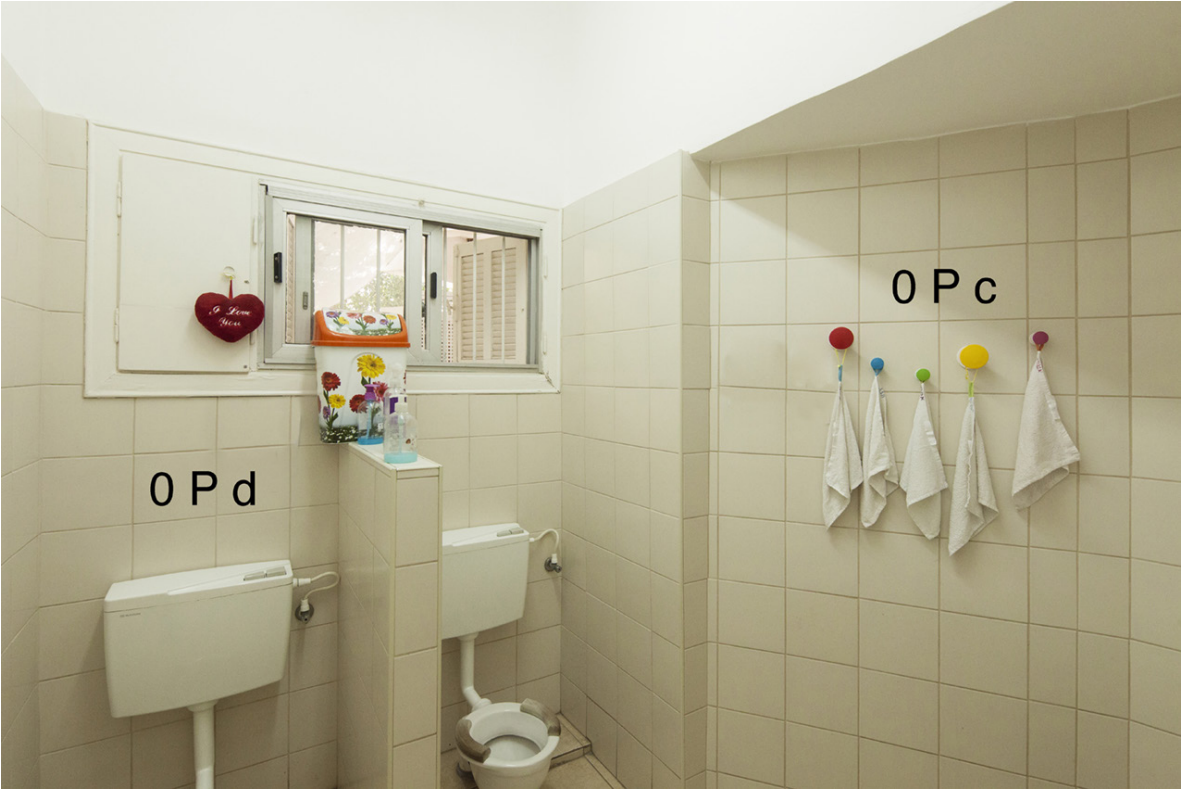
Room 00.P; _MG_3597.jpg; photo: Aviad Bar Ness, 2015

DATE		FLOOR		FUNCTION	ROOM
04/30/2015		Ground Floor		Bathroom	00.P
ELEMENT	TYPE	DESCRIPTION	CONDITION, NOTES	DATING	ORIGINAL MATERIALS AND COLORS
FLOOR					
	F.2.1	Ceramic floor and base tiles, beige	Original terrazzo floor and base tiles beneath, condition unknown	1990s or later	(M4)
WALLS AND BUILT-IN ELEMENTS					
a		Plastered interior wall, wall tiling up to approx. 2.10m	Surface renewed; wall tiling new	Wall and plaster 1937; tiling 1990s or later	M7, (probably C.1.1)
b		Plastered interior wall, wall tiling up to approx. 2.10m; two wall-mounted ceramic sinks	Surface renewed; wall tiling and sinks new	Wall and plaster 1937; tiling and sinks 1990s or later	M7, (probably C.1.1)
D00.P01	W.2.3	Single-leaf door with a wooden frame; one pane of textured glass		1990s or later	
c		Plastered interior wall with a rounded alcove (former shower), wall tiling up to approx. 2.10m	Surface renewed	Wall and plaster 1937	M7, (probably C.1.1)

d		Plastered interior wall, wall tiling up to approx. 2.10m; two toilets with wall-mounted cisterns, child-size; tiled half-height partition between the toilets	Surface renewed; wall tiling, toilets and partition new	Wall and plaster 1937; sanitary equipment 1990s or later	M7, (probably C.1.1)
W00.P.15	W.4.4	Double-sash aluminum sliding window built in an original window frame; original wooden laundry hatch on the left side; wooden exterior shutters with slats; exterior metal grille (7 vertical bars)	Sliding window renewed; original type W.2.4, window leaves missing; paint of frame and hatch renewed, hatch knob and grille original, painted white	1937; aluminum window 1990s or later	M13, (probably C.1.6); grille: M23
CEILING					
		Beam-and-block ceiling, plaster; fluorescent lighting	Surface renewed	1937; luminaires 1990s	Concrete, plaster

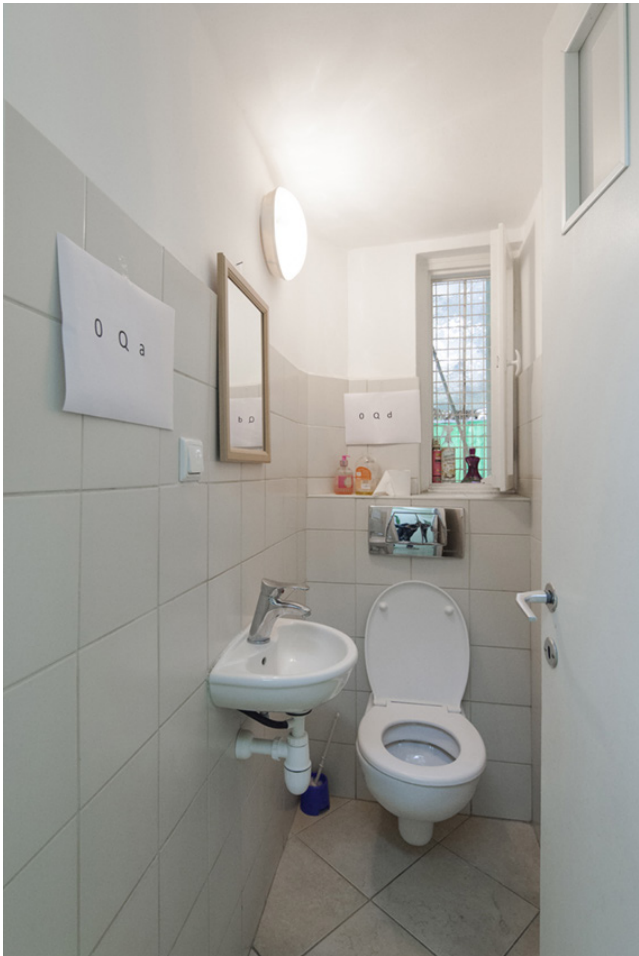
Room 00.Q; _MG_3599.jpg; photo: Aviad Bar Ness, 2015

DATE		FLOOR		FUNCTION	ROOM
04/30/2015		Ground Floor		WC	00.Q
ELEMENT	TYPE	DESCRIPTION	CONDITION, NOTES	DATING	ORIGINAL MATERIALS AND COLORS
FLOOR					
	F.2.1	Ceramic floor and base tiles, beige	Original terrazzo floor and base tiles beneath, condition unknown	1990s or later	(M4)
WALLS AND BUILT-IN ELEMENTS					
a		Plastered interior wall, wall tiling up to approx. 1.80m; wall-mounted ceramic sink; wall-mounted circular luminaire	Surface renewed; wall tiling and sink new	Wall and plaster 1937; tiles, sink and luminaire 1990s or later	M7, (probably C.1.1)
b		Plastered interior wall, wall tiling up to approx. 1.80m	Surface renewed; wall tiling new	Wall and plaster 1937; tiles 1990s or later	M7, (probably C.1.1)
D00.Q.01	W.2.3	Single-leaf door with a wooden frame; one pane of textured glass		1990s or later	M13, (probably C.1.6)
c		Plastered interior wall, wall tiling up to approx. 1.80m	Surface renewed; wall tiling new	Wall and plaster 1937; tiles 1990s or later	M7, (probably C.1.1)

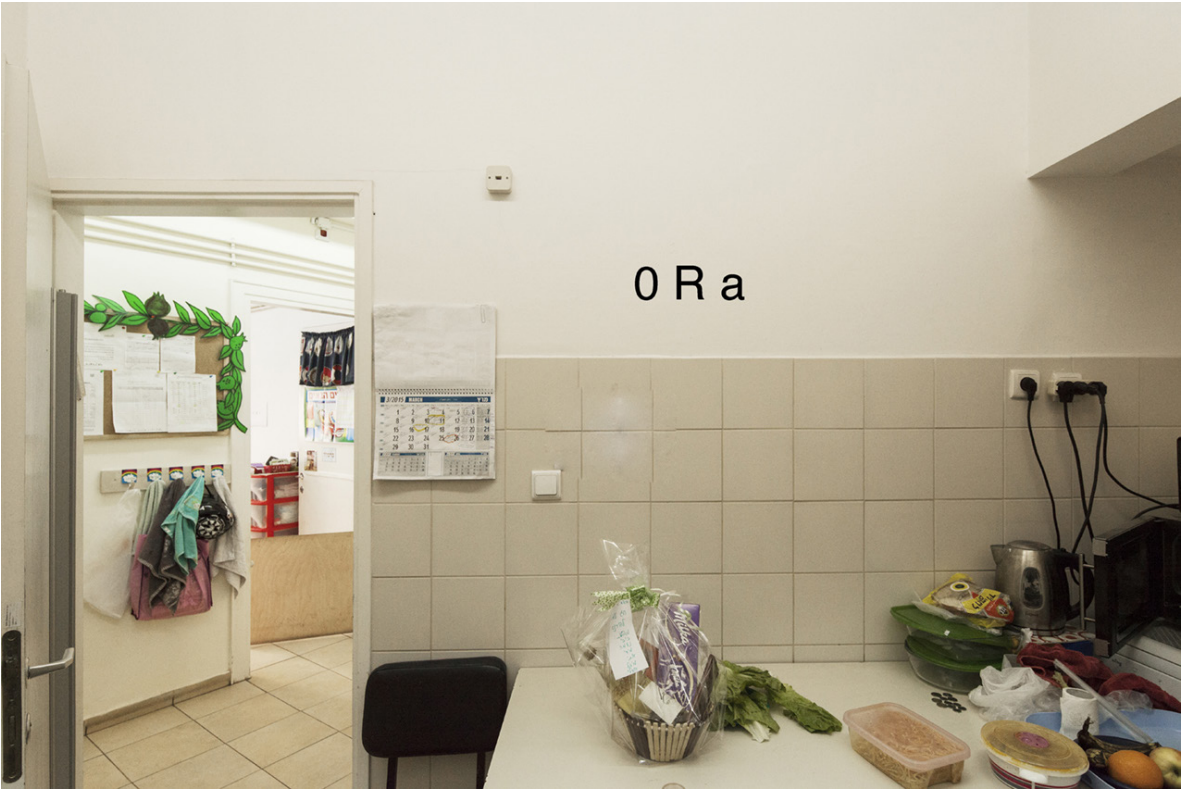
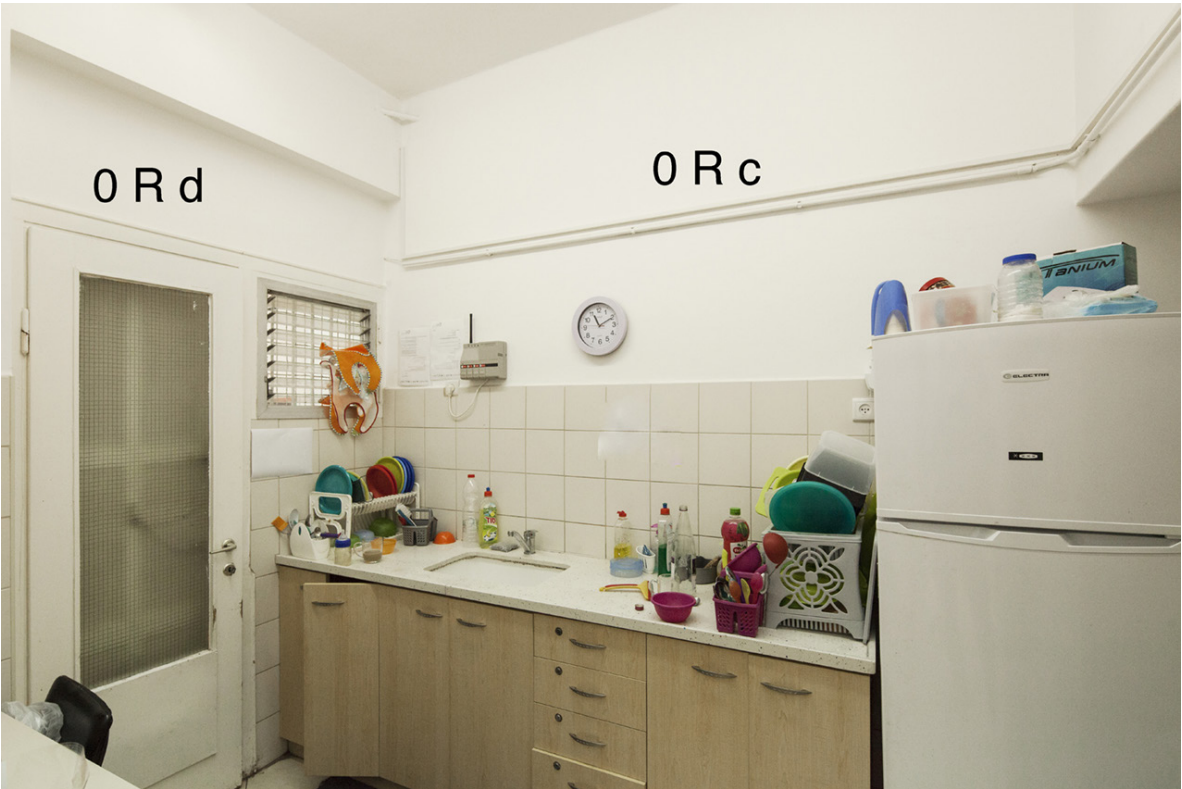
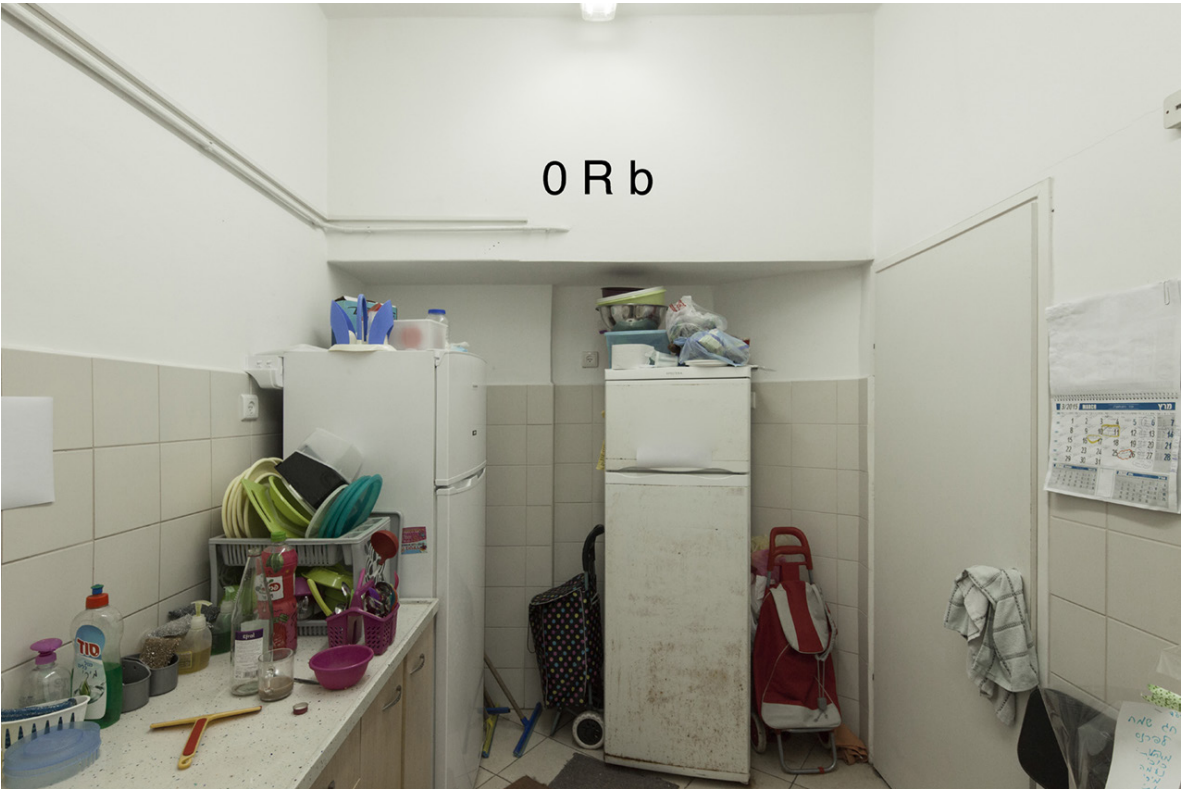
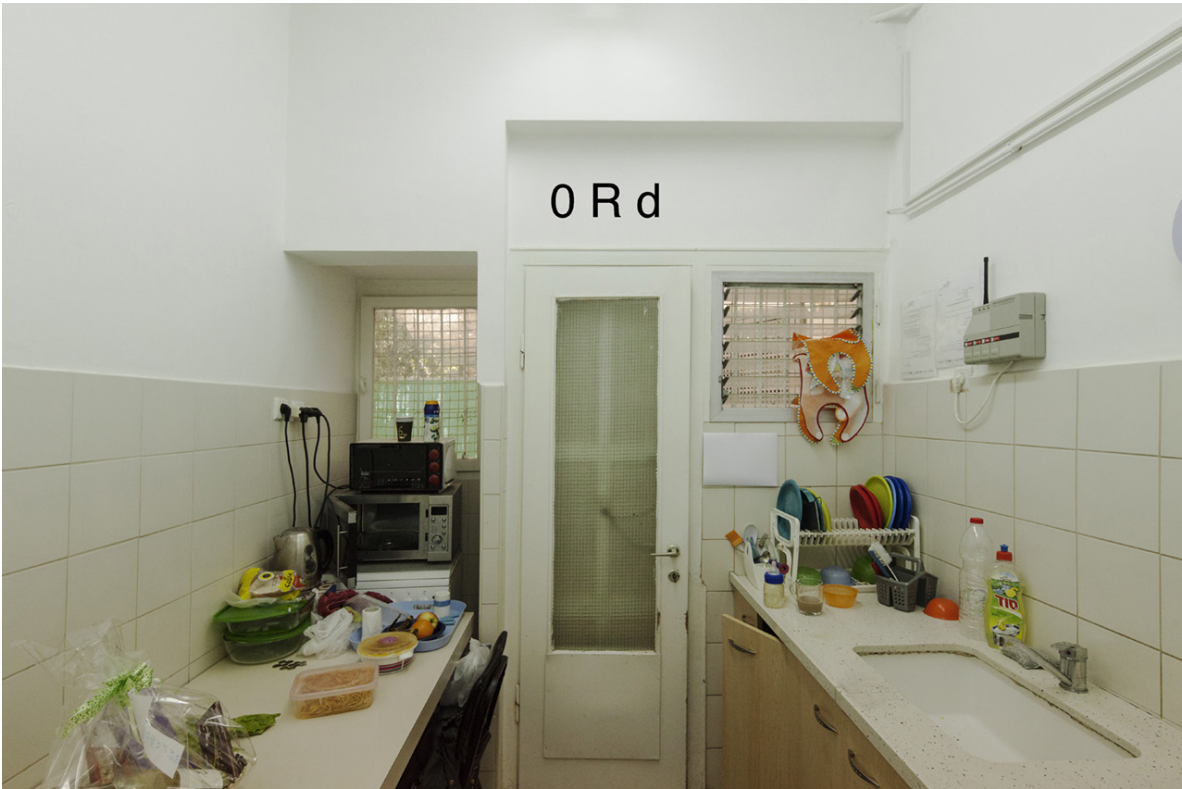
Room 00.R; _MG_3601.jpg; photo: Aviad Bar Ness, 2015

DATE		FLOOR		FUNCTION	ROOM
04/30/2015		Ground Floor		Kitchen	00.R
ELEMENT	TYPE	DESCRIPTION	CONDITION, NOTES	DATING	ORIGINAL MATERIALS AND COLORS
FLOOR					
	F.2.1	Ceramic floor and base tiles, beige	Original terrazzo floor and base tiles beneath, condition unknown	1990s or later	(M4)
WALLS AND BUILT-IN ELEMENTS					
a		Plastered interior wall, wall tiling up to approx. 1.60m; flush-mounted sockets and light switch	Surface renewed; wall tiling renewed, original wall-tiling beneath	Wall and plaster 1937; tiling and installations 1990s or later	M7, (probably C.1.1)
D00.R.01	W.2.3	Single-leaf solid door with a wooden frame		1990s or later	M13, (probably C.1.6)
b		Plastered interior wall, partly oblique recess for original built-in kitchen furniture, wall tiling up to approx. 1.60m; exposed water pipes	Surface renewed; wall tiling renewed, original wall-tiling beneath (cf. 02.R)	Wall and plaster 1937; water lines later; tiling 1990s or later	M7, (probably C.1.1)

c		Plastered interior wall with a sink unit and wall tiling up to approx. 1.60m, open wiring	Surface renewed; wall tiling renewed, original wall-tiling beneath; tiled sink unit and installations new	Wall and plaster 1937; tiling, sink unit and installations 1990s or later	M7, (probably C.1.1)
d		Plastered exterior wall with an alcove on the left side, wall tiling up to approx. 1.60m	Surface renewed; wall tiling renewed, original wall-tiling beneath	Wall and plaster 1937; tiling 1990s or later	M7, (probably C.1.1)
W00.R.11	W.4.1	Double-sash aluminum ventilation window with glazed horizontal slats fitted in an original window opening (W.3.4); exterior metal grille (5 vertical bars) and woven wire mesh	New window in an original opening, grille and wire mesh probably original	opening and grille 1937; window 1990s	grille: M23
W00.R.12	W.1.3	Single-leaf balcony door; three panes of wire glass, lower part covered with a plywood sheet, exterior grille (one vertical and two horizontal flat bars); wooden exterior shutters with slats	Paint and handles renewed; plywood sheet added subsequently	1937	M13, (probably C.1.6); glass: M17; grille: M23

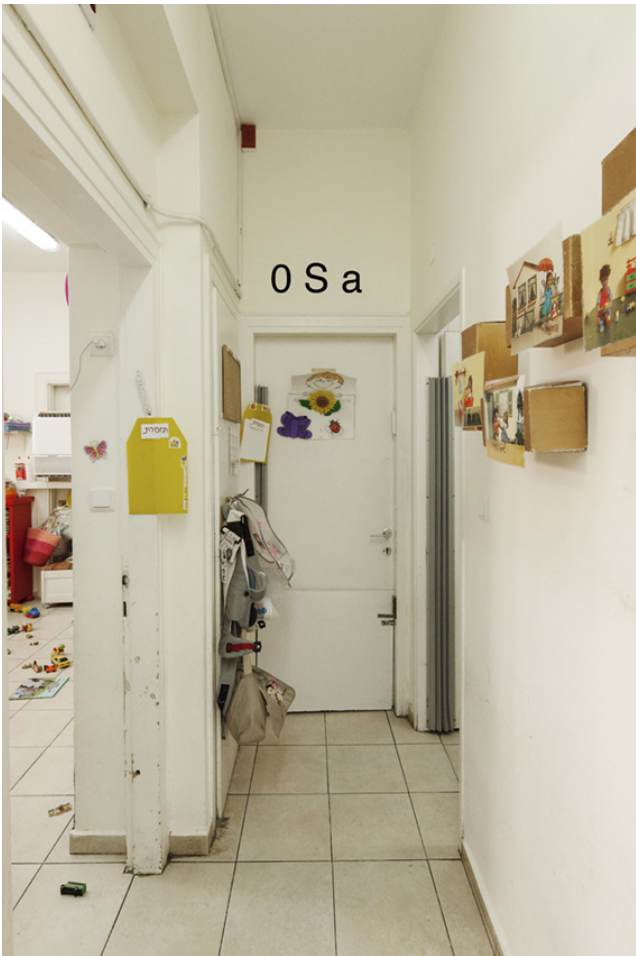
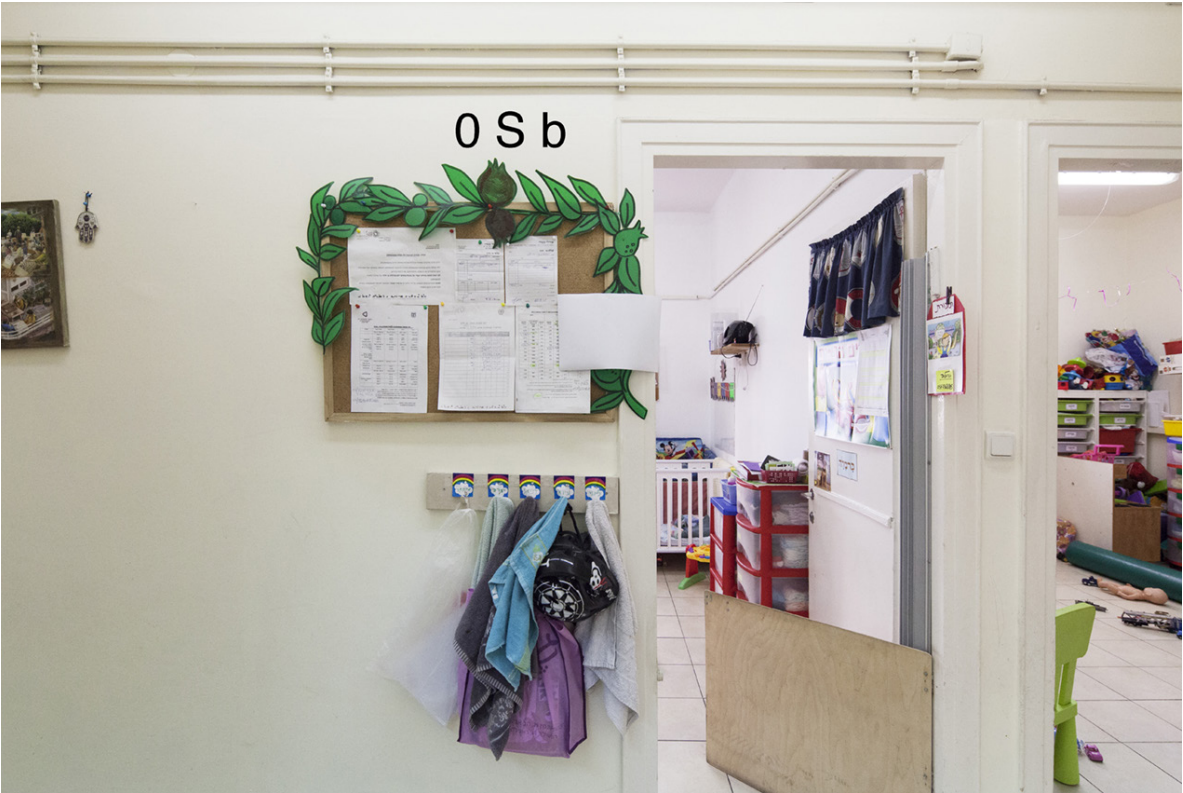
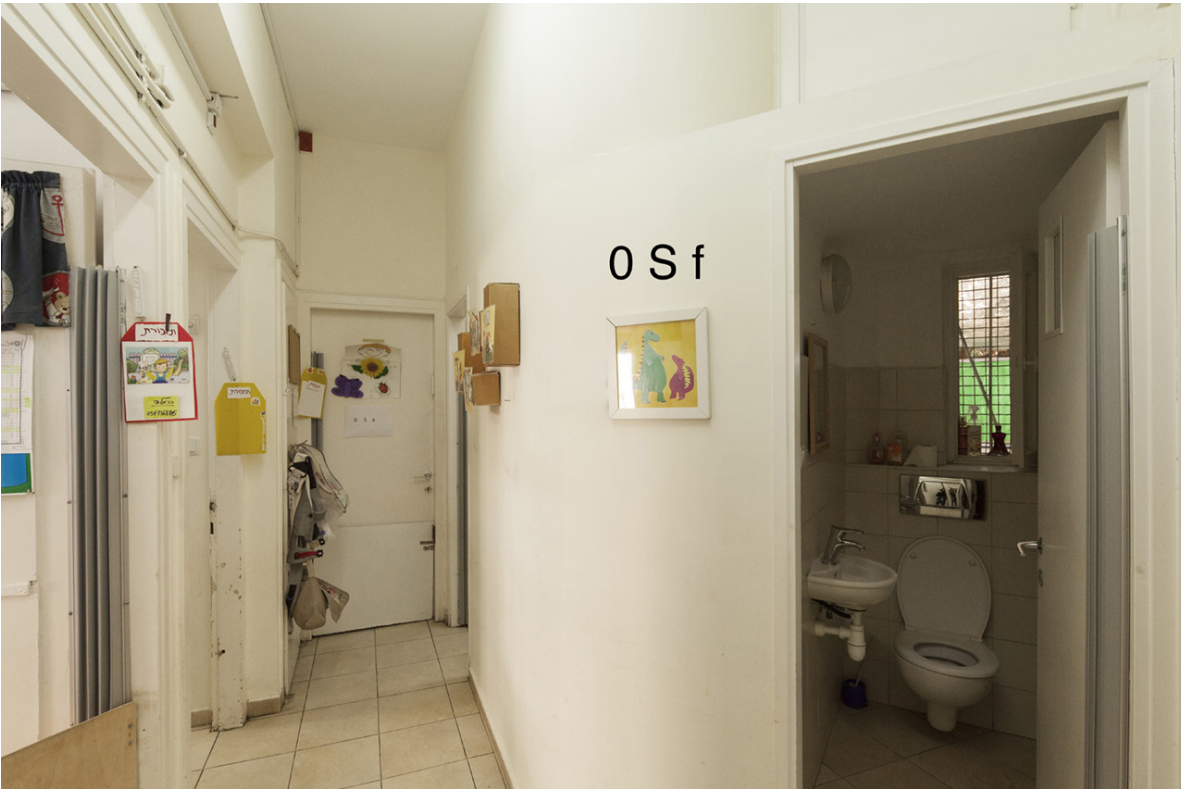
Room 00.S; _MG_3610.jpg; photo: Aviad Bar Ness, 2015

DATE		FLOOR		FUNCTION	ROOM
04/30/2015		Ground Floor		Corridor	00.S
ELEMENT	TYPE	DESCRIPTION	CONDITION, NOTES	DATING	ORIGINAL MATERIALS AND COLORS
FLOOR					
	F.2.1	Ceramic floor and base tiles, beige	Original terrazzo floor and base tiles beneath, condition unknown	1990s or later	(M4)
WALLS AND BUILT-IN ELEMENTS					
a		Plastered interior wall	Surface renewed	1937	M7, (probably C.1.1)
D00.N.01	D.1.5	Single-leaf solid door	Paint and handles renewed	1937; handles probably 1990s	M13, (probably C.1.6)
b		Plastered interior wall; thickness of block wall is less than that of adjoining concrete columns and beam; open wiring	Surface renewed	Wall and plaster 1937	M7, (probably C.1.1)
Closet	S.10	Single-leaf closet adjacent to room 00.N, shelves	Paint renewed	1937	Wood: M13, (probably C.1.6)
D00.N.01	D.1.5	Single-leaf solid door	Paint and handles renewed	1937; handles probably 1990s	M13, (probably C.1.6)
D00.M.01	D.1.3	Single-leaf door with a wooden frame; three panes of textured glass; covered with plywood on both sides	Paint and handles renewed, plywood sheet added subsequently	1937; handles and panel probably 1990s	M13, (probably C.1.6)

DATE		FLOOR		FUNCTION	ROOM
04/30/2015		Ground Floor		Corridor	00.S
ELEMENT	TYPE	DESCRIPTION	CONDITION, NOTES	DATING	ORIGINAL MATERIALS AND COLORS
h		Interior wall, lower part with door opening probably drywall construction; upper part with a rounded corner to wall i, plastered solid construction	Lower construction new, upper part original	Wall and plaster 1937; drywall construction 1990s or later	M7, (probably C.1.1)
Storage space	S.11	Single-leaf solid hatch cover of a storage space in the ceiling void	Paint renewed, knob missing	1937	M13, (probably C.1.6)
D00.Q.01	W.2.3	Single-leaf door with a wooden frame; one pane of textured glass		1990s or later	M13, (probably C.1.6)
i		Plastered interior wall, rounded corner to wall h; open wiring	Surface renewed	Wall and plaster 1937	M7, (probably C.1.1)
D00.P01	W.2.3	Single-leaf door with a wooden frame; one pane of textured glass		1990s or later	M13, (probably C.1.6)

CEILING					
		Beam-and-block ceiling, plaster; fluorescent lighting	Surface renewed	1937; luminaires 1990s	Concrete, plaster

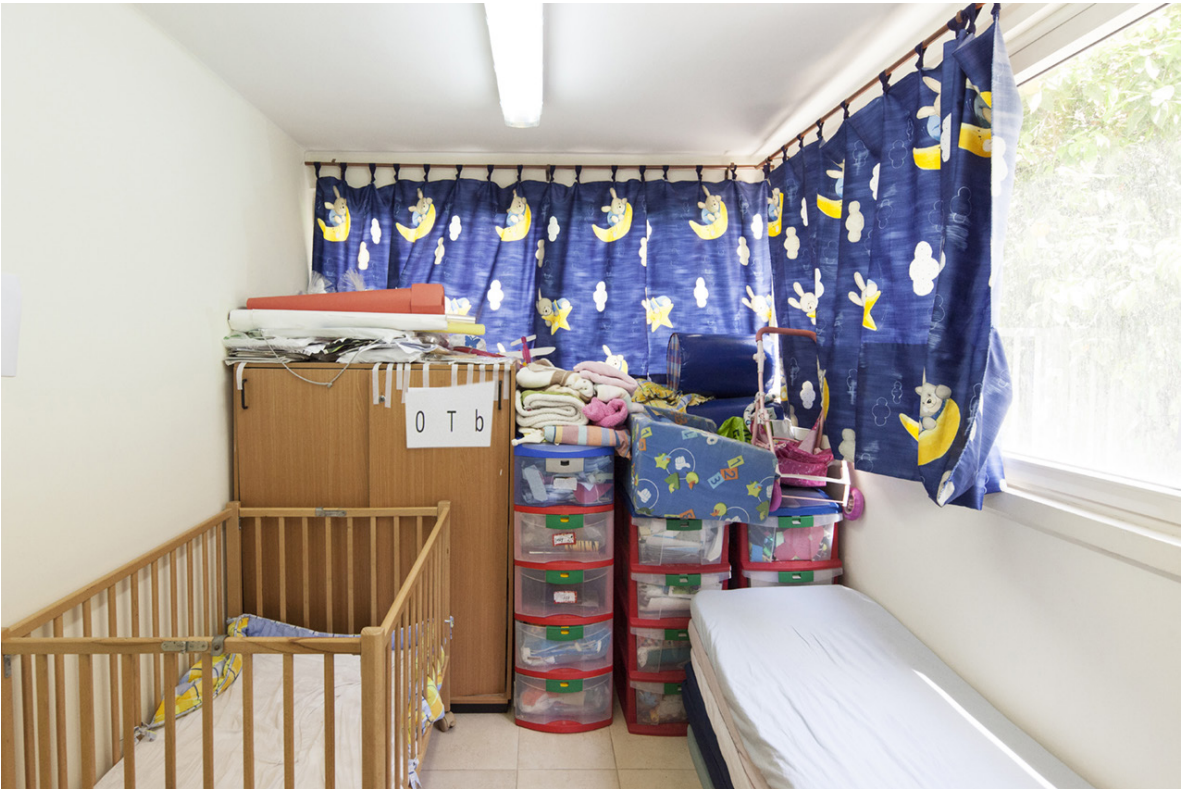
Room 00.T; _MG_3593.jpg; photo: Aviad Bar Ness, 2015

DATE		FLOOR		FUNCTION	ROOM
04/30/2015		Ground Floor		Balcony (B.3)	00.T
ELEMENT	TYPE	DESCRIPTION	CONDITION, NOTES	DATING	ORIGINAL MATERIALS AND COLORS
FLOOR					
	F.2.1	Ceramic floor and base tiles, beige	Original terrazzo floor and base tiles beneath, condition unknown	1990s or later	(M4)
WALLS AND BUILT-IN ELEMENTS					
a		Rendered exterior parapet with a terrazzo coping; glazing fitted between the parapet and the upper fascia	Surface renewed; original coping painted white; glazing new	Wall and plaster 1937; windows 1990s	Railing: M7, (probably C.1.1); coping: M6
b		Rendered exterior parapet with a terrazzo coping; glazing fitted between the parapet and the upper fascia	Surface renewed; original coping painted white; glazing new	Wall and plaster 1937; windows 1990s	Railing: M7, (probably C.1.1); coping: M6
W00.T.20	W.4.2	Balcony glazing, consisting of 7 single-leaf aluminum windows	new	1990s	
c		Rendered exterior wall; recess with a blocked-up doorway, plastic air-conditioning grille	Surface renewed	Wall and plaster 1937; drywall construction and technical installations 1990s or later	M7, (probably C.1.1)

W00.N.19	W.2.1	Door opening of a former balcony door (type W.1.2) boarded up with drywall	Leaves and frame missing	1937	
d		Rendered exterior parapet with a terrazzo coping; glazing fitted between the parapet and the upper fascia	Surface renewed; original coping painted white; glazing new	Wall and plaster 1937; windows 1990s	Railing: M7, (probably C.1.1); coping: M6
W00.O.18	W.1.2	Single-leaf balcony door with a wooden frame; three panes of textured glass, covered with plywood on both sides	Handles and paint renewed; plywood sheets added subsequently; no shutter	1937; handles and panel probably 1990s	M13, (probably C.1.6); glass: M20; grille: M23
CEILING					
		Plastered dropped ceiling; hatches with removable wooden covers to access the shutter boxes above balcony doors W00.T.19 and W00.T.20; fluorescent lighting	Plaster, paint of the wooden covers renewed	1937; luminaire 1990s	Concrete, plaster; covers: M13, (probably C.1.6)

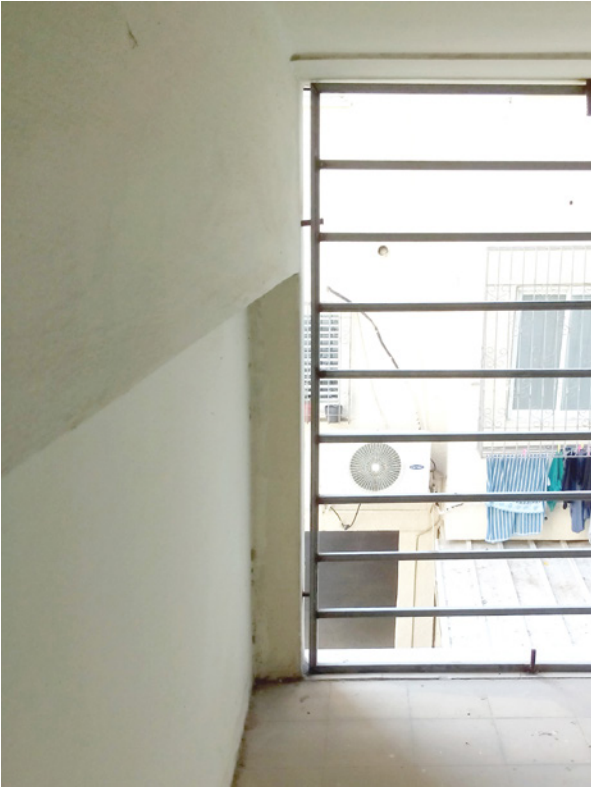
Room 00.U; 2015-07-03 MLE_002 MLH-TRr.jpg; photo: Brenne Architekten, 2015

DATE		FLOOR		FUNCTION	ROOM
04/30/2015		Ground Floor		Balcony (B.4)	00.U
ELEMENT	TYPE	DESCRIPTION	CONDITION, NOTES	DATING	ORIGINAL MATERIALS AND COLORS
FLOOR					
	F.1.1	Original terrazzo floor tiles	Remains of paint	1937	M4
WALLS AND BUILT-IN ELEMENTS					
a		Rendered exterior wall	Render renewed	Wall and render 1937	M7, (probably C.1.4)
W00.L.24	W.3.6	Pivot window; originally glazed, now filled with a panel	Interior paint renewed, exterior paint peeling off	1937; panel later	M13, (probably C.1.6)
b		Galvanized steel grille (three vertical compartments with ten horizontal bars each) mounted between the balcony floor and the fascia above	New	1960s-1990s	
c		Rendered exterior wall, recess	Render renewed	Wall and render 1937	M7, (probably C.1.4)
d		Rendered exterior wall	Render renewed	Wall and render 1937	M7, (probably C.1.4)
W00.V.25	W.1.2	Three-part window with a wooden frame, one horizontal and one vertical sash bar; upper part: two sliding sashes; lower part: two panes of fixed glazing	Exterior paint partly peeling off	1937	Wood: M11; glass: M18 (sliding sashes), M16 (fixed glazing)

CEILING					
		Rendered exterior ceiling	Render renewed	Ceiling 1937; render 1990s	Concrete, render

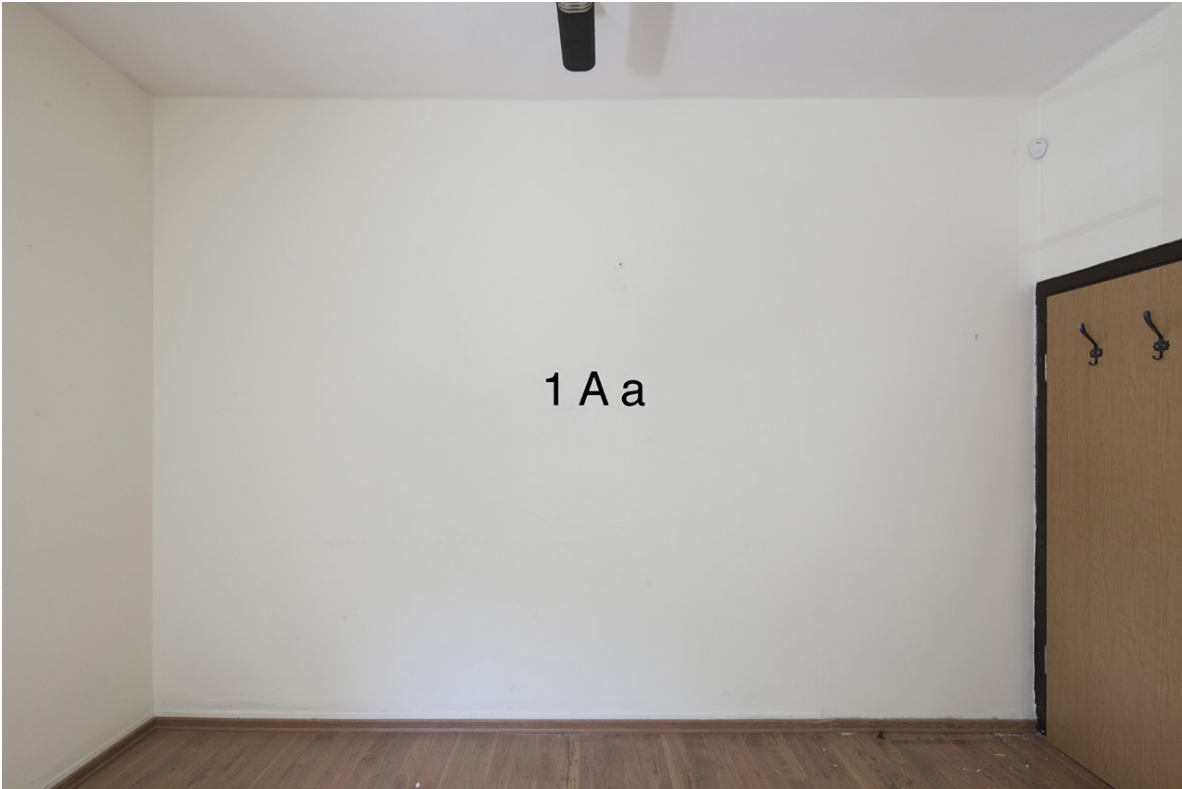
Room 01.A; _MG_3268.jpg; photo: Aviad Bar Ness, 2015

DATE		FLOOR		FUNCTION	ROOM
04/30/2015		2nd Floor		Room	01.A
ELEMENT	TYPE	DESCRIPTION	CONDITION, NOTES	DATING	ORIGINAL MATERIALS AND COLORS
FLOOR					
	F.2.1	Wood block parquet and wooden baseboard	Original terrazzo floor and base tiles beneath, condition unknown	1990s	(M4)
WALLS AND BUILT-IN ELEMENTS					
a		Interior wall, presumably concrete	Surface renewed	Wall and plaster 1937	M7, (C.1.1)
b		Exterior wall; open wiring	Surface renewed	Wall and plaster 1937; wiring 1960s-1990s	M7, (C.1.1)
W01.A.01	W.2.1	Double-sash casement window	Paint renewed, partly peeling off; handles replaced; no roller shutter belt	1937; handles 1960s-1970s	Wood: M13, (C.1.6); glass: M20
c		Plastered exterior wall; recess with wooden shelving; core hole in the upper part of the wall; open wiring	Surface renewed; built-in cupboard new	Wall and plaster 1937; wiring 1960s-1990s	M7, (C.1.1)
W01.A.02	W.1.1	Double-leaf balcony door with a wooden frame; three panes of clear glass	Paint renewed and handles replaced; space in between door and shutter filled with insulating wool, roller shutter belt not original	1937; insulation probably 1990s	Wood: M13, (C.1.6); glass: M20

d		Plastered interior wall; wall-mounted air-conditioning unit and open wiring	Surface renewed	Wall and plaster 1937; wiring 1960s-1990s	M7, (C.1.1)
D01.A.01	D.2.2	Single-leaf solid door with a wooden frame	Frame and original, paint renewed	1937; leaf 1960s-1990s	Wood: M13, (C.1.6)
CEILING					
		Beam-and-block ceiling, plaster; suspended lowered luminaire	Surface renewed	1937; light 1960s-1990s	Concrete, plaster, (C.1.1)

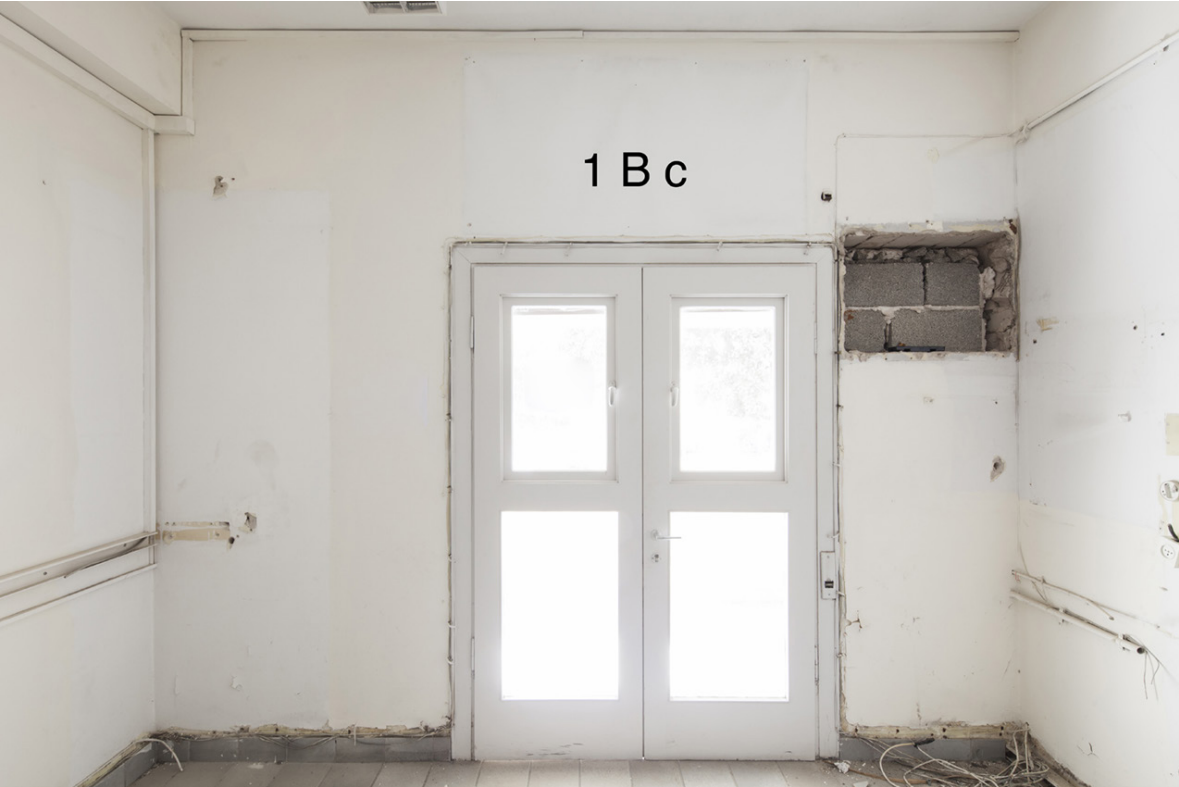
Room 01.B; _MG_3275.jpg; photo: Aviad Bar Ness, 2015

DATE		FLOOR		FUNCTION	ROOM
04/30/2015		2nd Floor		Room	01.B
ELEMENT	TYPE	DESCRIPTION	CONDITION, NOTES	DATING	ORIGINAL MATERIALS AND COLORS
FLOOR					
	F.2.1	Ceramic floor and base tiles, gray	Original terrazzo floor and base tiles beneath, condition unknown	1990s	(M4)
WALLS AND BUILT-IN ELEMENTS					
a		Plastered interior wall adjacent to the staircase, presumably concrete; open wiring; open space to the corridor room 01.H	Surface renewed; no remains of a dwarf wall with a radiator recess (cf. 00.B and 02.B)	Wall and plaster 1937; wiring 1960s-1990s	M7, (C.1.1)
b		Plastered interior wall; open wiring	Surface renewed	Wall and plaster 1937; wiring 1960s-1990s	M7, (C.1.1)
D01.A.01	D.2.2	Single-leaf solid door with a wooden frame	Frame and original, paint renewed	1937; leaf 1960s-1990s	Wood: M13, (C.1.6)
c		Plastered exterior wall; wall opening on the right side, approx. 70 x 50cm, walled up with light-weight concrete blocks flush with the facade; open wiring	Surface renewed, wall opening subsequently constructed	Wall and plaster 1937; wall opening and wiring 1960s-1990s	M7, (C.1.1)

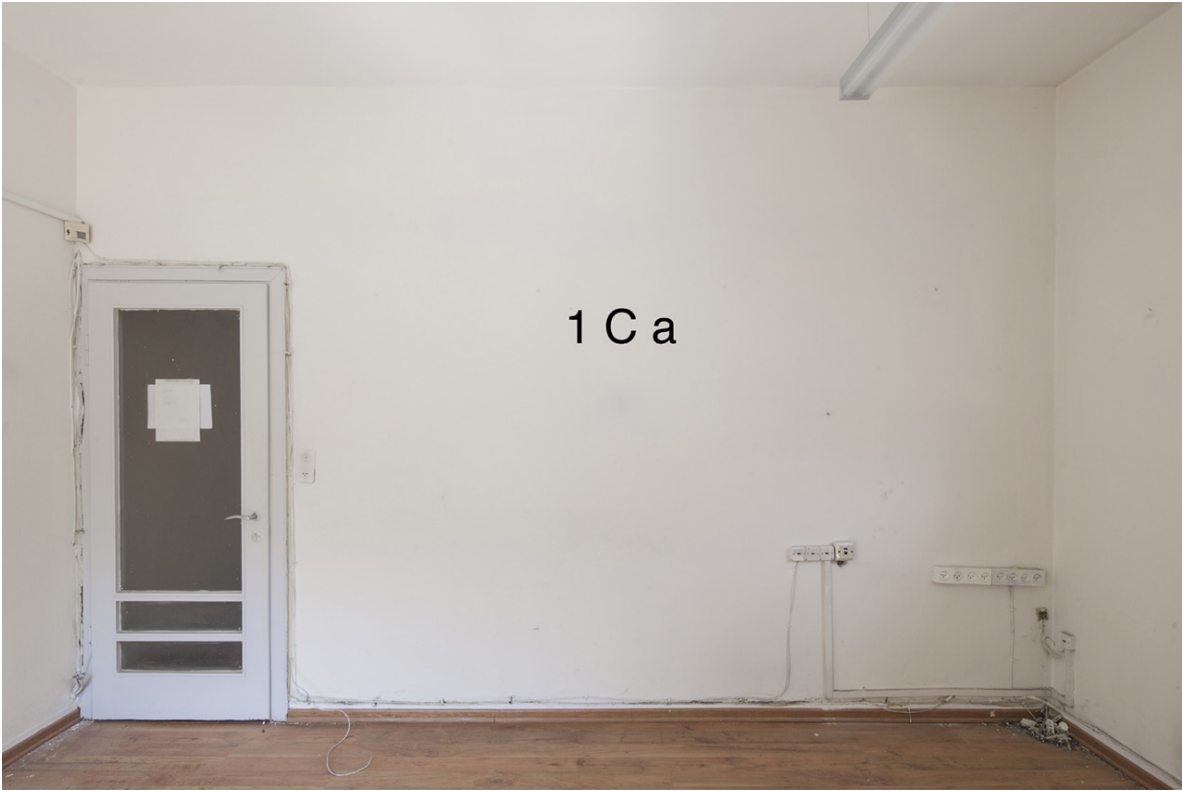
Room 01.C; _MG_3307.jpg; photo: Aviad Bar Ness, 2015

DATE		FLOOR		FUNCTION	ROOM
04/30/2015		2nd Floor		Room	01.C
ELEMENT	TYPE	DESCRIPTION	CONDITION, NOTES	DATING	ORIGINAL MATERIALS AND COLORS
FLOOR					
	F.2.1	Wood block parquet and wooden baseboard	Original terrazzo floor and base tiles beneath, condition unknown	1990s	(M4)
WALLS AND BUILT-IN ELEMENTS					
a		Plastered interior wall; open wiring; flush-mounted socket and light switch next to the door	Surface renewed	Wall, plaster, socket and light switch 1937; wiring 1960s-1990s	M7, (C.1.1); socket and light switch: M26
D01.C.01	D.1.3	Single-leaf door with a wooden frame; three panes of clear glass	Paint renewed and handles replaced	1937; handles 1960s-1970s	Wood: M13, (C.1.6); glass: M20
b		Interior, partly exterior wall, plastered; open wiring, cable bushing to the balcony	Surface renewed	Wall and plaster 1937; wiring 1960s-1990s	M7, (C.1.1)
c		Plastered exterior wall with a window alcove and terrazzo sill; flush-mounted socket; open wiring	Surface renewed	Wall, plaster and socket 1937; wiring 1990s	M7, (C.1.1); sill: M3; socket: M26

W01.C.04	W.2.1	Double-sash casement window; original terrazzo window sill	Paint renewed, peeling off on the outside; handles replaced; roller shutter belt not original	1937; handles 1960s-1970s	Wood: M13, (C.1.6); glass: M20; sill: M3
d		Plastered interior wall; open wiring	Surface renewed	Wall and plaster 1937; wiring 1960s-1990s	M7, (C.1.1)
W01.C.05	W.2.2	Double-sash casement window	Paint renewed and handles replaced, paint peeling off on the outside; no roller shutter belt	1937; handles 1960s-1970s	Wood: M13, (C.1.6); glass: M20;
CEILING					
		Beam-and-block ceiling, plaster; surface-mounted fluorescent light and suspended louvered luminaires	Surface renewed	1937; light 1960s-1990s	Concrete, plaster, (C.1.1)

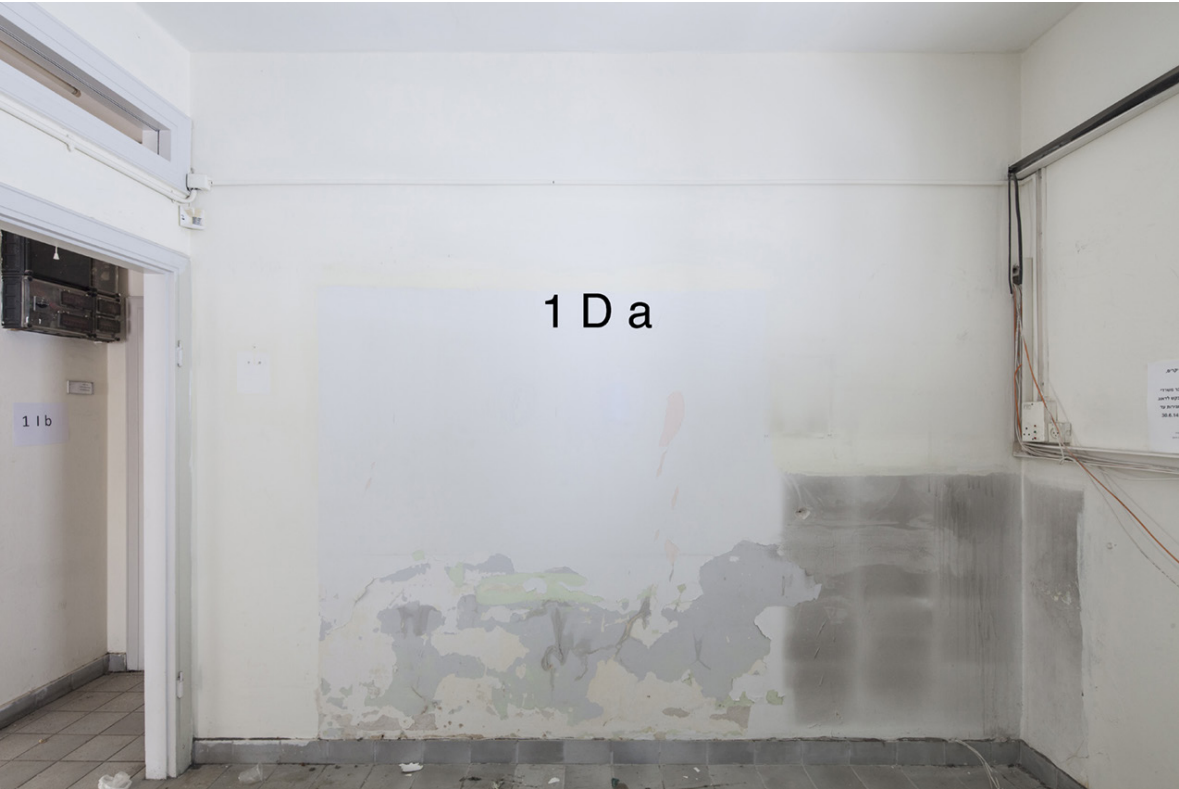
Room 01.D; _MG_3288.jpg; photo: Aviad Bar Ness, 2015

DATE		FLOOR		FUNCTION	ROOM
04/30/2015		2nd Floor		Room	01.D
ELEMENT	TYPE	DESCRIPTION	CONDITION, NOTES	DATING	ORIGINAL MATERIALS AND COLORS
FLOOR					
	F.2.1	Ceramic floor and base tiles, gray	Original terrazzo floor and base tiles beneath, condition unknown	1990s	(M4)
WALLS AND BUILT-IN ELEMENTS					
a		Plastered interior wall; open wiring	Surface renewed	Wall and plaster 1937; wiring 1960s-1990s	M7, (C.1.1)
b		Plastered interior wall; flush-mounted light switch next to the door; open wiring	Surface renewed	Wall and plaster and light switch 1937	M7, (C.1.1); light switch: M26
W01.D.26	W.2.7	Double-sash interior sliding window	Paint renewed	1937	Wood: M13, (C.1.6); glass: M20
D01.D.01	D.2.1	Door opening with original frame, leaf missing	Paint renewed	1937	Wood: M13, (C.1.6)
c		Plastered interior wall; open wiring	Surface renewed	Wall and plaster 1937; wiring 1960s-1990s	M7, (C.1.1)
d		Plastered interior wall; open wiring, flush-mounted socket	Surface renewed	Wall, plaster and socket 1937; wiring 1960s-1990s	M7, (C.1.1)

W01.D.06	W.2.2	Double-sash casement window	Paint renewed, partly peeling off on the outside; handles replaced; no roller shutter belt	1937; handles 1960s-1970s	Wood: M13, (C.1.6); glass: M20
CEILING					
		Beam-and-block ceiling, plaster; suspended louvered luminaire	Surface renewed	1937; light 1960s-1990s	Concrete, plaster, (C.1.1)

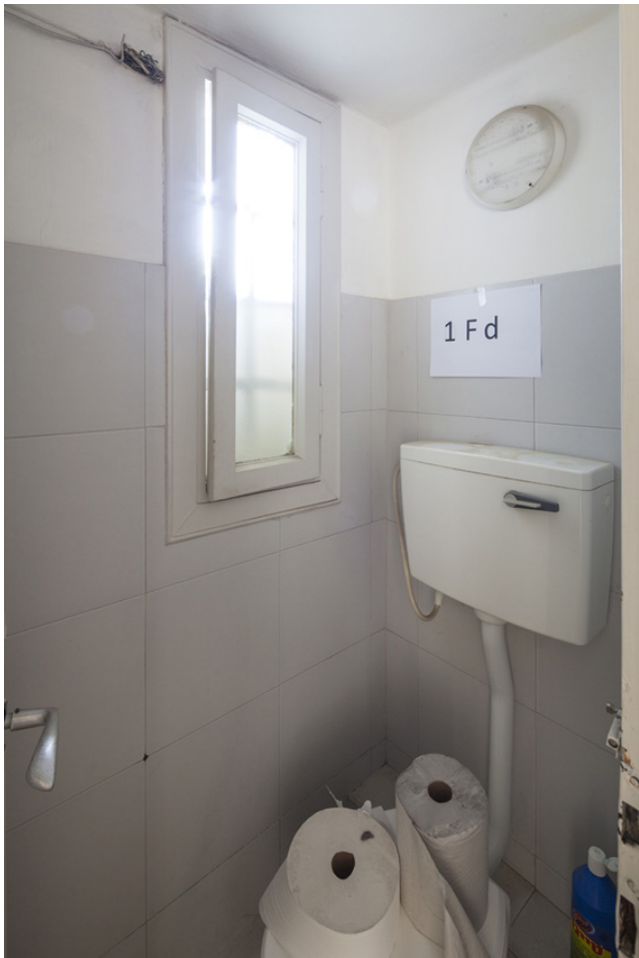
Room 01.F; _MG_3300.jpg; photo: Aviad Bar Ness, 2015

DATE		FLOOR		FUNCTION	ROOM
04/30/2015		2nd Floor		Room	01.F
ELEMENT	TYPE	DESCRIPTION	CONDITION, NOTES	DATING	ORIGINAL MATERIALS AND COLORS
FLOOR					
		Ceramic floor and base tiles, gray	Original terrazzo floor and base tiles probably not preserved	1990s	
WALLS AND BUILT-IN ELEMENTS					
a		Plastered exterior wall, wall tiling up to approx. 1.65m	Surface renewed; new wall tiling, probably original wall tiling beneath	Wall and plaster 1937; tiles probably 1990s or later	M7, (C.1.1)
W01.F.08	W.3.1	Single-sash window with a metal grille	Paint renewed; grille probably original; handle missing	1937	Wood: M13, (C.1.6); glass: M19; grille: M23
b		Exterior wall; wall tiling	Surface renewed; new wall tiling, probably original wall tiling beneath	Wall and plaster 1937; tiles probably 1990s or later	M7, (C.1.1)
c		Exterior wall; wall tiling	Surface renewed; new wall tiling, probably original wall tiling beneath	Wall and plaster 1937; tiles probably 1990s or later	M7, (C.1.1)

D01.F.01	D.1.6	Single-leaf solid door with a small glass pane	Paint renewed and handles replaced	1937; handles 1960s-1970s	Wood: M13, (C.1.6); glass: M19
d		Plastered interior wall; wall tiling; toilet with wall-mounted cistern; wall-mounted luminaire	Surface renewed; new wall tiling, probably original wall tiling beneath; WC renewed	Wall and plaster 1937; tiles and equipment probably 1990s or later	M7, (C.1.1)
CEILING					
		Beam-and-block ceiling, plaster	Surface renewed	1937	Concrete, plaster, (C.1.1)

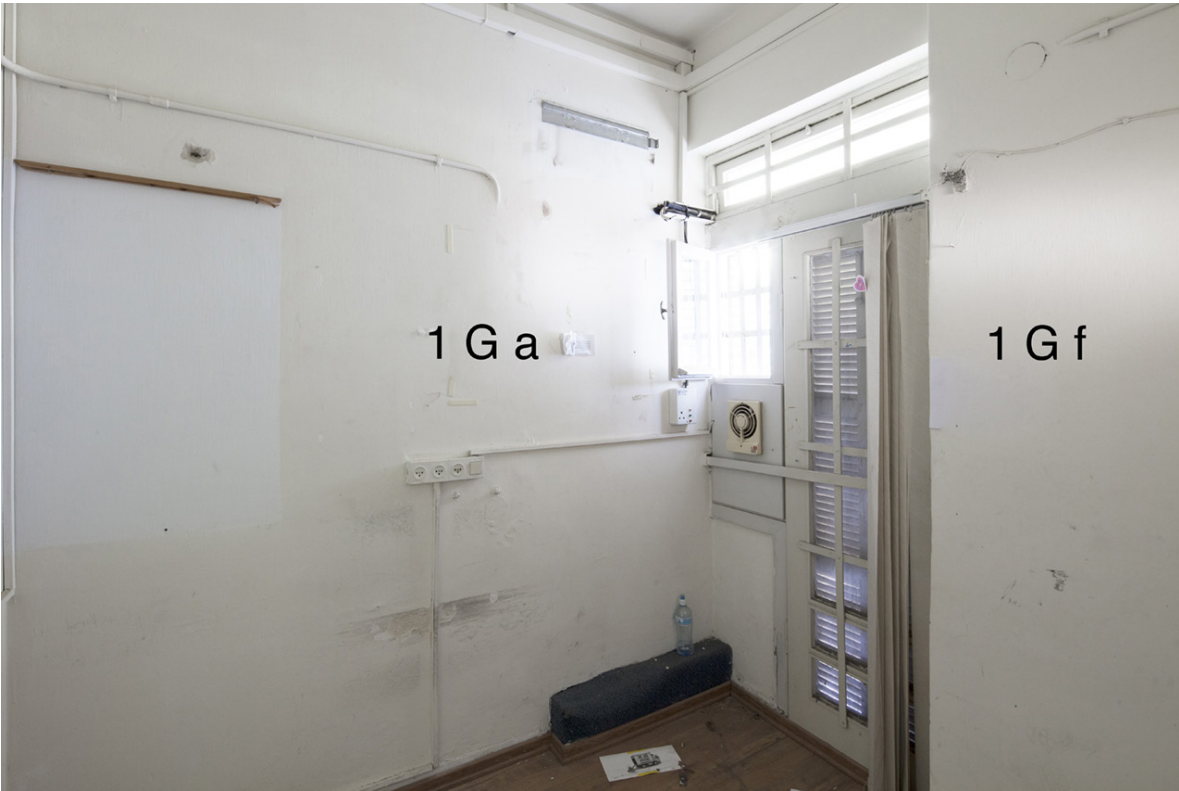
Room 01.G; _MG_3301.jpg; photo: Aviad Bar Ness, 2015

DATE		FLOOR		FUNCTION	ROOM
04/30/2015		2nd Floor		Kitchen	01.G
ELEMENT	TYPE	DESCRIPTION	CONDITION, NOTES	DATING	ORIGINAL MATERIALS AND COLORS
FLOOR					
	F.2.1	Wood block parquet and wooden baseboard	Original beige terrazzo floor and base tiles beneath	1990s	(M4)
WALLS AND BUILT-IN ELEMENTS					
a		Plastered interior wall, open wiring; remains of a water supply line (cf. 02.G) and a solid plinth on the right side	Surface renewed; solid plinth possibly part of a former kitchen equipment (cf. 02.G)	Wall and plaster 1937; wiring 1960s-1990s	M7, (C.1.1)
b		Plastered interior wall; open wiring	Surface renewed	Wall and plaster 1937; wiring 1960s-1990s	M7, (C.1.1)
c		Plastered interior wall; recess for a built-in shelf on the right side; open wiring; flush-mounted light switch	Surface renewed; some battens for supporting wooden shelves remain	Wall, plaster and light switch 1937; wiring 1960s-1990s	M7, (C.1.1); light switch: M26

D01.G.01	D.1.6	Single-leaf solid door with a small glass pane	Paint renewed; plastic handles, renewed	1937; handles 1960s-1970s	Wood: M13, (C.1.6); glass: M19
d		Partly exterior and interior wall, plastered	Surface renewed	Wall and plaster 1937	M7, (C.1.1)
W01.G.09	W.1.3	Single-leaf balcony door; three panes of clear glass; metal grille mounted on the inside; flat steel bolt crossing the door and the window W01.G.11; wooden exterior shutters with slats	Metal grille probably original; original handles painted white; paint renewed; horizontal bolt added subsequently	1937; bolt 1960s-1990s	Wood: M13, (C.1.6); glass: M20; handles: M21; grille: M23
W01.G.10	W.3.2	Ventilation window above the door, pivot sash	Paint renewed	1937	Wood: M13, (C.1.6); glass: M20
W01.G.11	W.3.3	Single-sash window combined with the hatch door to the exterior food cabinet; grille and wire mesh on the outside of the window; electric ventilator built into the hatch door; cable bushing; wooden exterior shutters with slats	Paint renewed; grille and mesh probably original; ventilator added subsequently	1937; technical installations 1960s-1990s	Wood: M13, (C.1.6); glass: M20; handles: M21; grille: M23
