CONSERVATION SURVEY

MAX-LIEBLING-HOUSE

29, IDELSON STREET, TEL AVIV

Tel Aviv/Berlin, 2016/17

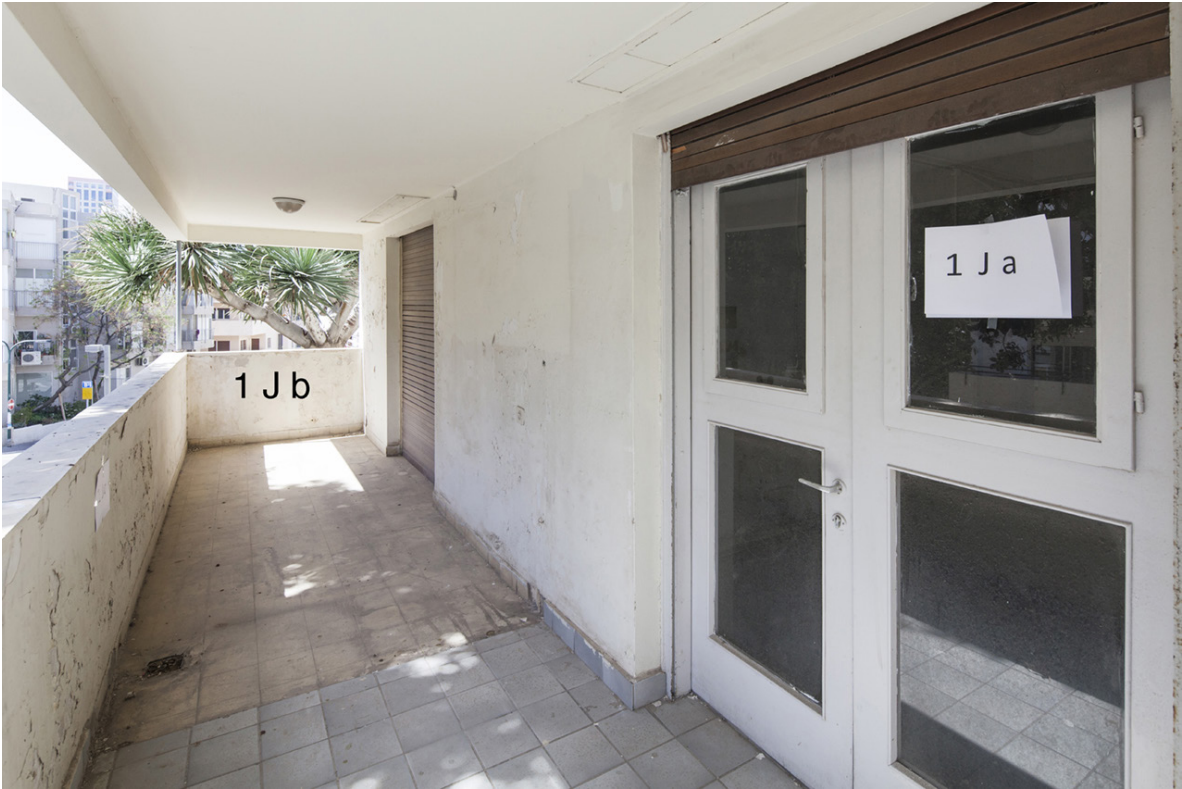
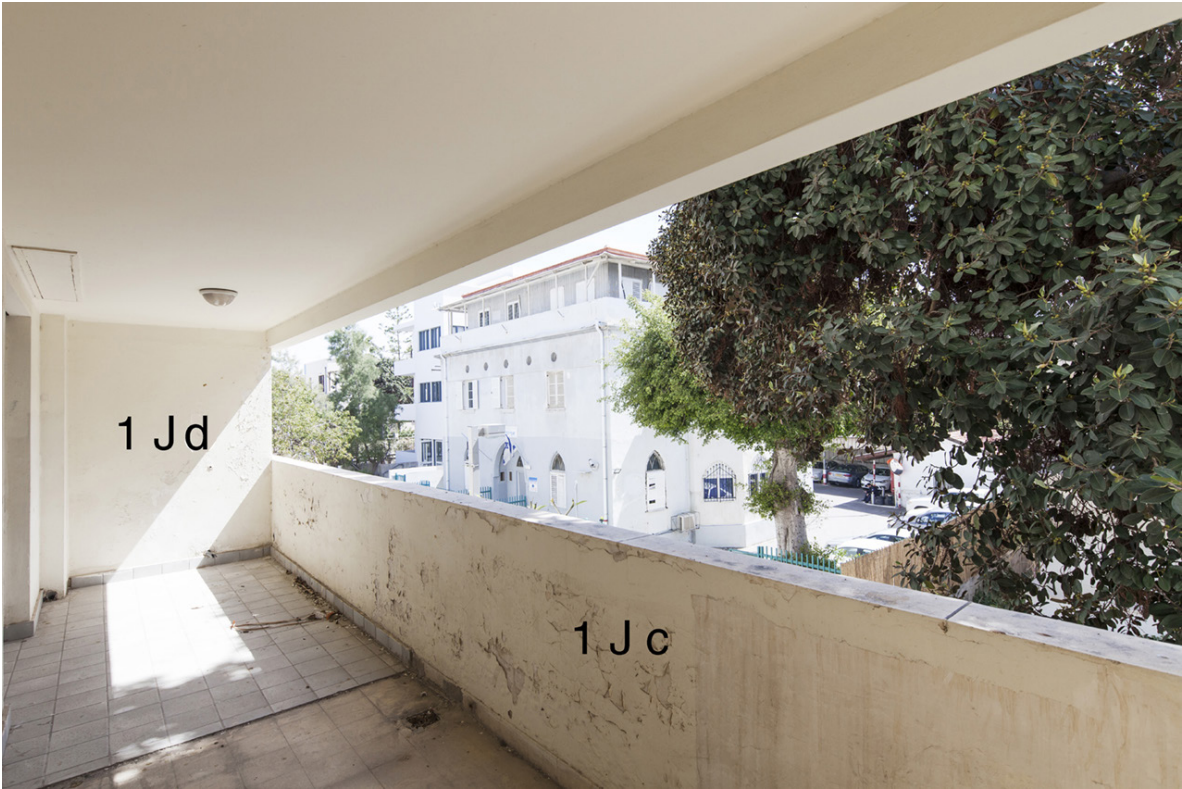
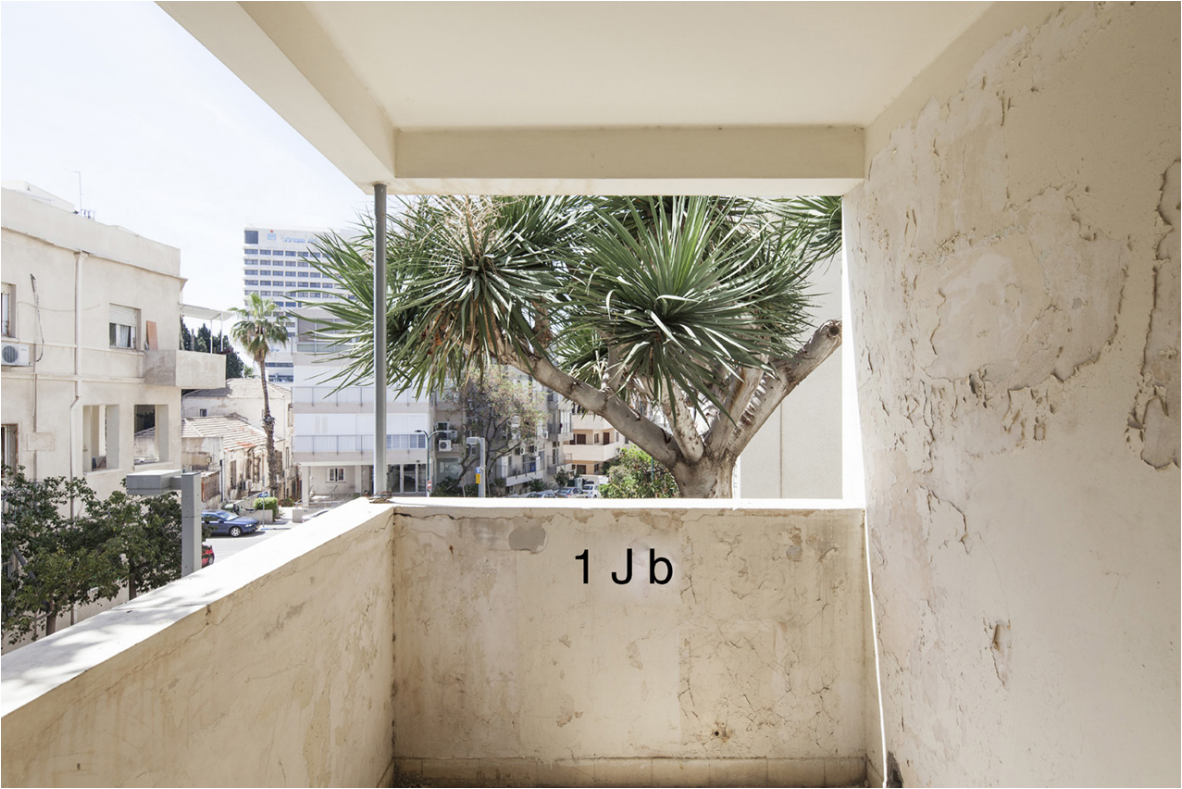
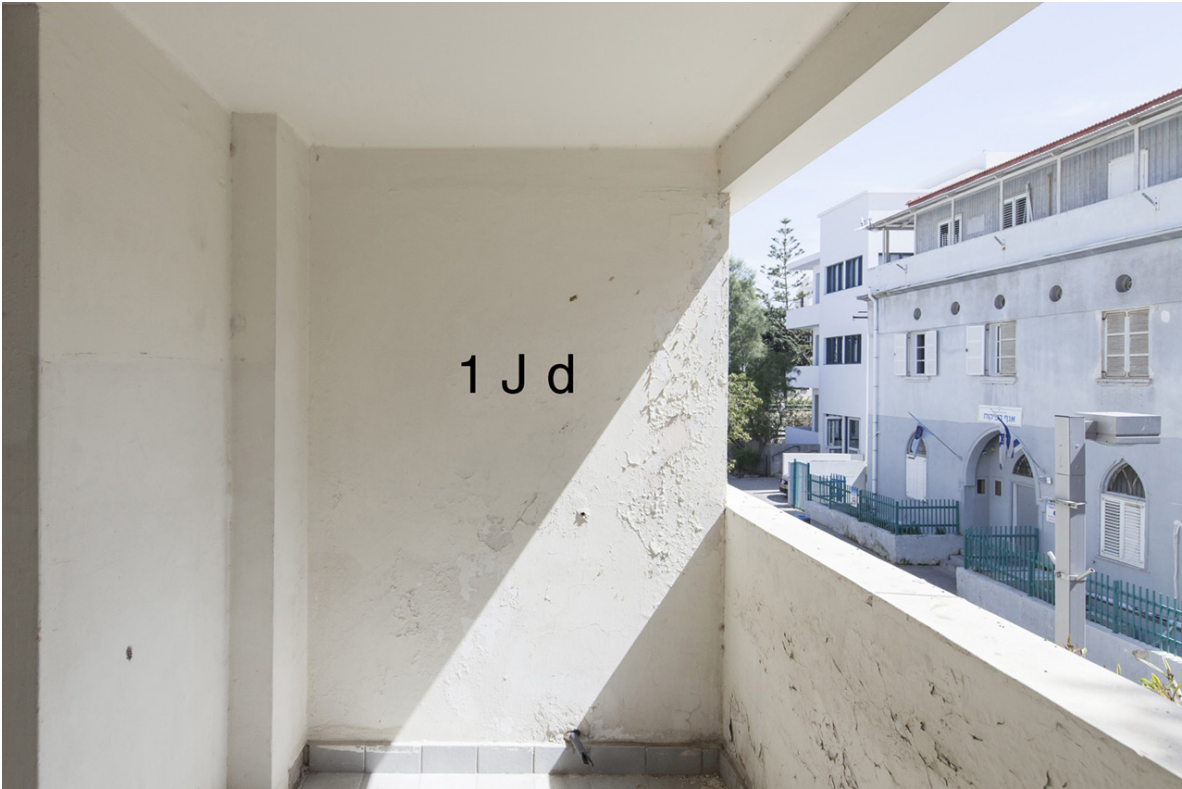
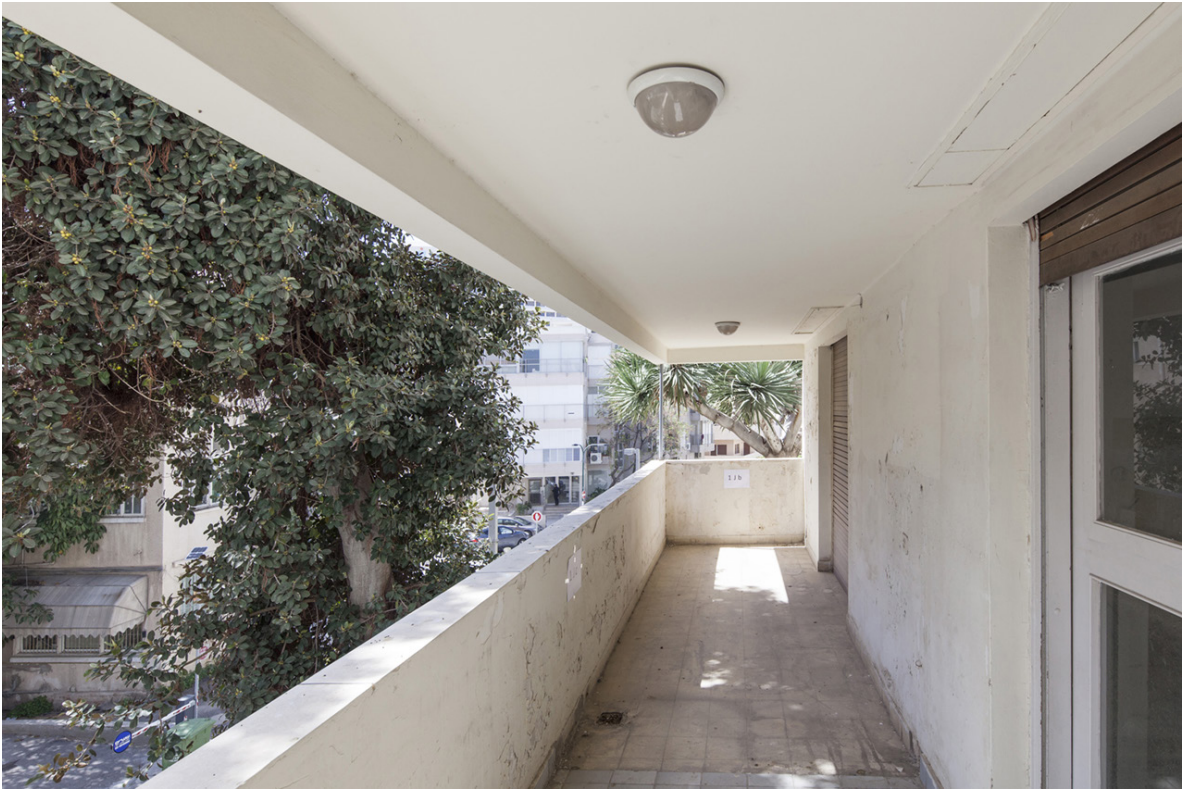
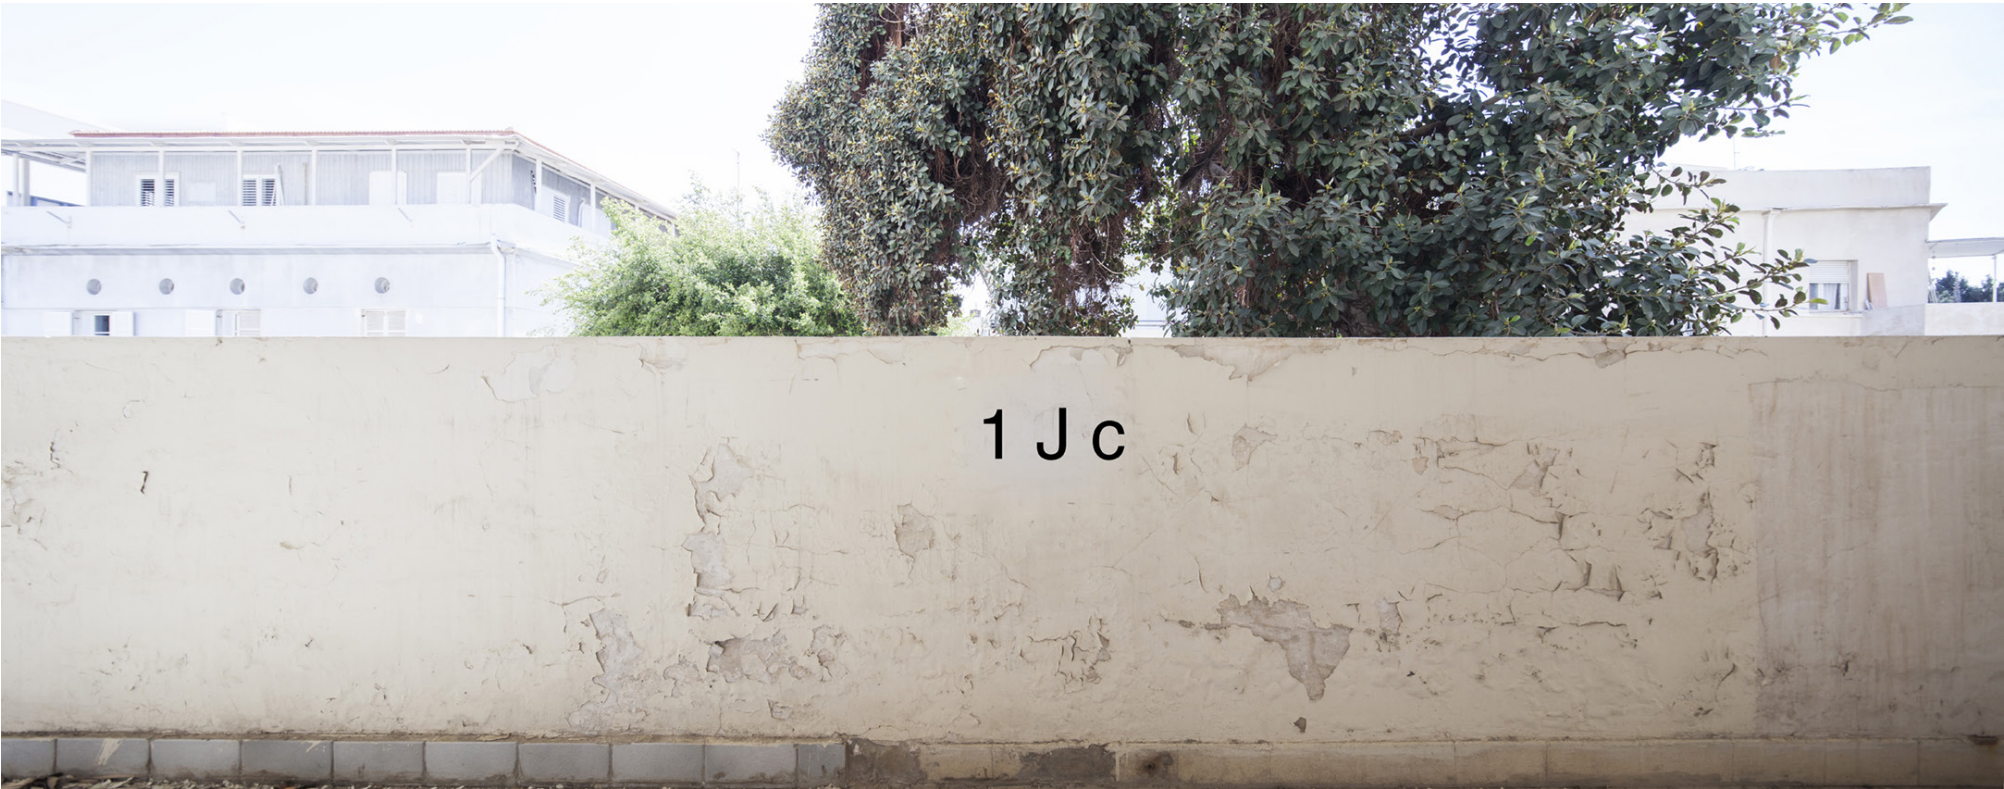
DATE		FLOOR		FUNCTION	ROOM
04/30/2015		2nd Floor		Balcony (B.1)	01.J
ELEMENT	TYPE	DESCRIPTION	CONDITION, NOTES	DATING	ORIGINAL MATERIALS AND COLORS
FLOOR					
	F.1.1; F.2.1	Partly terrazzo floor and and base tiles, partly covered with new ceramic tiling flooring and base tiles	Original beige terrazzo floor is preserved in the western part, original floor drain is filled with concrete	1937; 1990s	M4
WALLS AND BUILT-IN ELEMENTS					
a		Rendered exterior wall, cased wall-mounted drainpipe with a connecting pipe in the corner to wall d; flush-mounted light switch	Renewed render and paint; drain hole added subsequently	Wall, plaster, pipe and light switch 1937; paint 1990s	M7, (C.1.4); light switch: M26
W01.B.03	W.4.4	Double-leaf balcony door; two glass panel in each leaf; both upper panels can be opened independently	Frame original, door leaves renewed	1937; 1990s	Wood: M13, (C.1.6)
W01.A.02	W.1.1	Double-leaf balcony door; space in between door and shutter is filled with insulating wool	Paint renewed and handles replaced; space in between door and shutter filled with insulating wool, roller shutter belt not original	1937; insulation probably 1990s	Wood: M13, (C.1.6); glass: M20

b		Rendered exterior parapet; terrazzo coping with a water drip; round steel column mounted on the coping at the corner of the balcony, with a sleeve socket at its foot and its head	Paint and terrazzo coping renewed broadly similar to the original materials; paint peeling off, cracks in the render at the connection to the coping; column probably original	Wall, plaster and column 1937; paint and coping 1990s	Railing: M7, (C.1.4); column: M23 (original color probably white)
c		Rendered exterior parapet; terrazzo coping with a water drip	Paint and terrazzo coping renewed broadly similar to the original materials; paint peeling off, cracks in the render at the connection to the coping	Wall and plaster 1937; paint and coping 1990s	Railing: M7, (C.1.4)
d		Rendered exterior wall; cable bushing from the interior	Renewed render and paint; no remains of a balcony door (cf. 00.J and 02.J)	Wall and plaster 1937; paint and cable bushing 1990s	M7, (C.1.4)

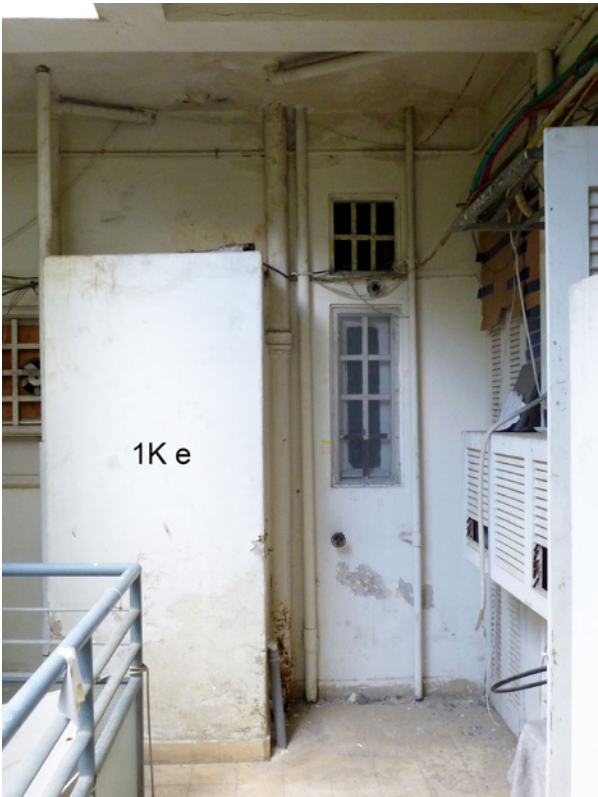
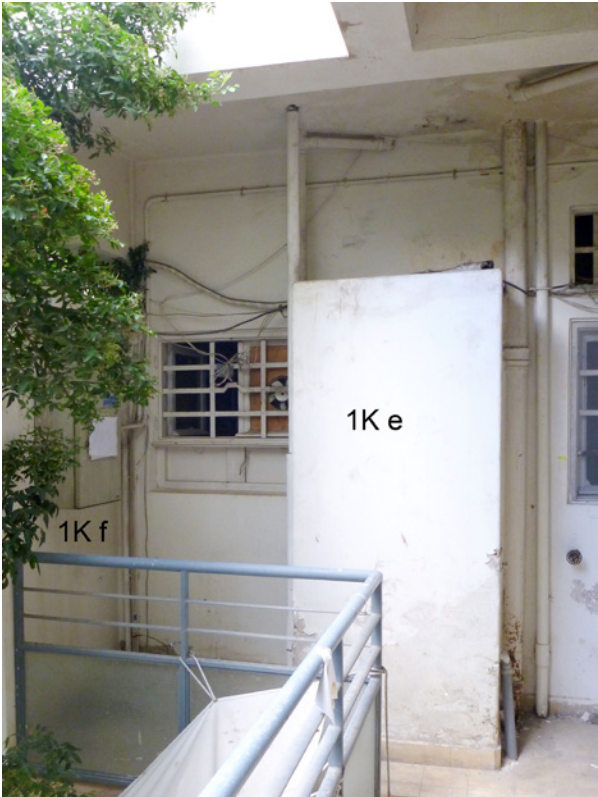
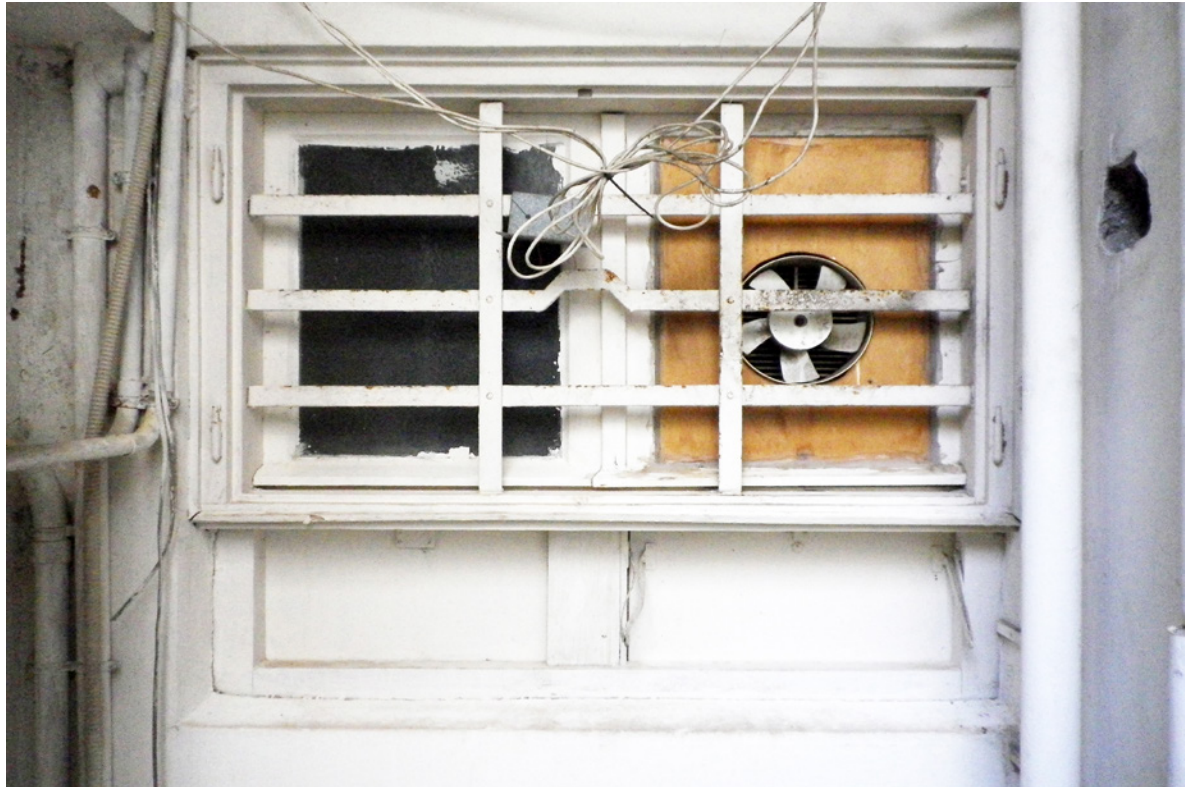
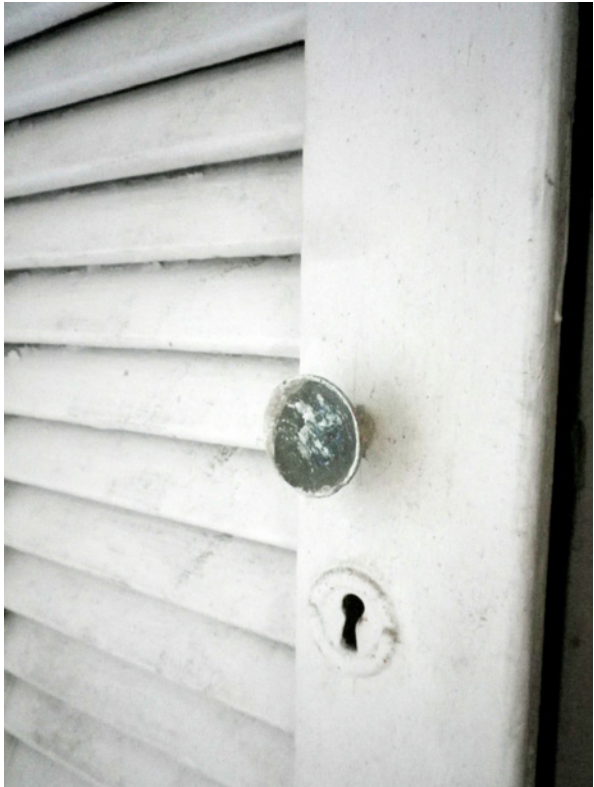
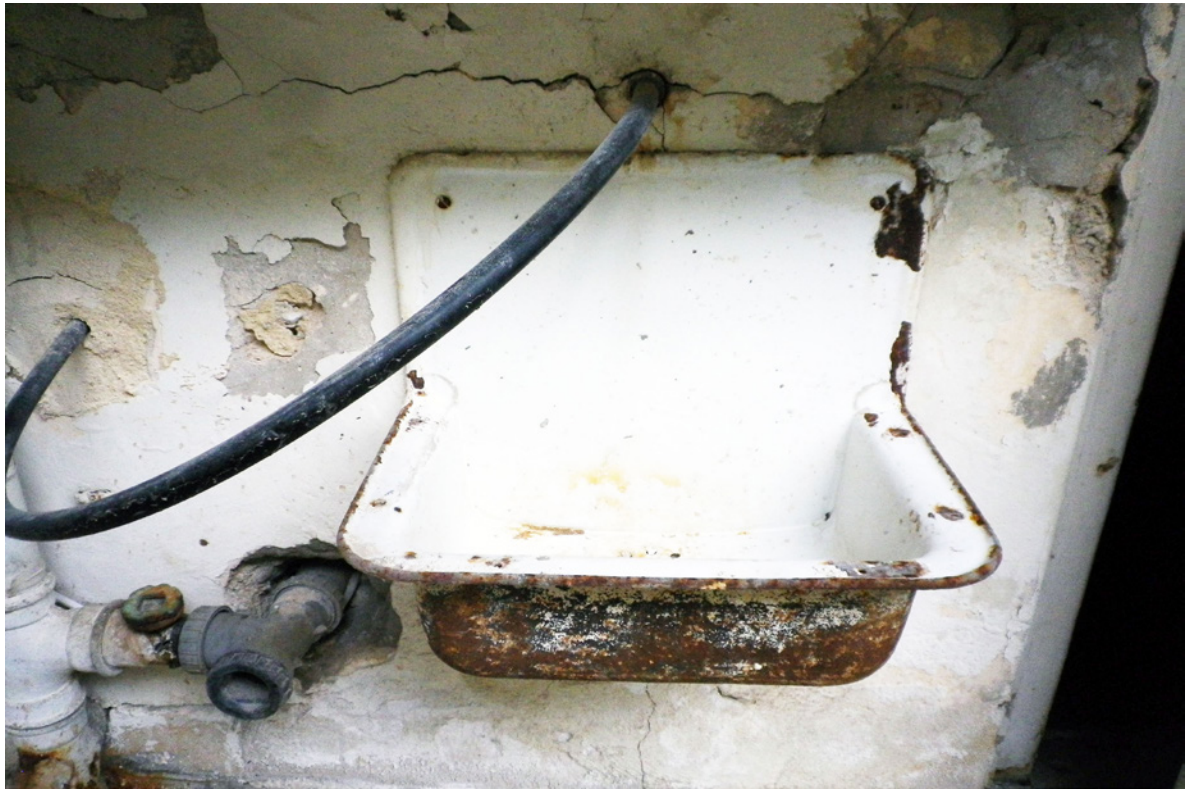
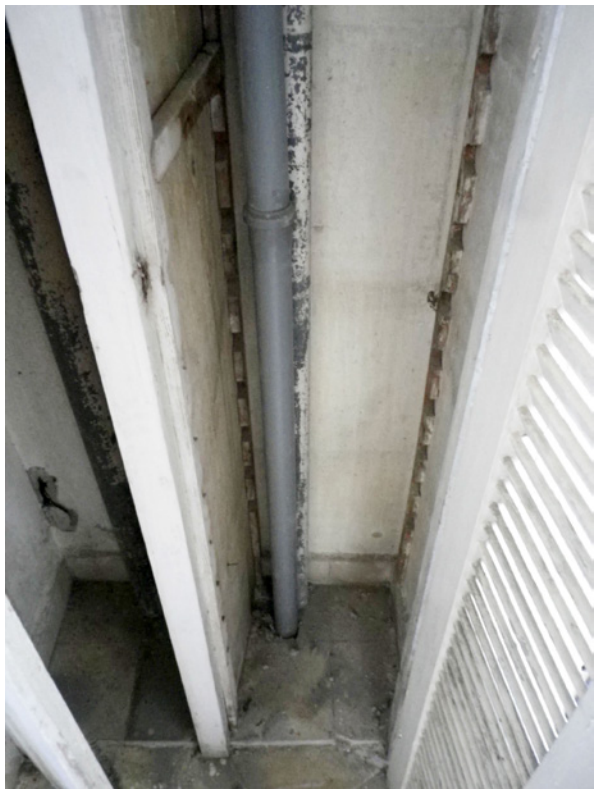
DATE		FLOOR		FUNCTION	ROOM
04/30/2015		2nd Floor		Balcony (B.2)	01.K
ELEMENT	TYPE	DESCRIPTION	CONDITION, NOTES	DATING	ORIGINAL MATERIALS AND COLORS
FLOOR					
	F.1.1	Terrazzo floor and base tiles; balcony curb of terrazzo blocks	Original flooring partly damaged, loose tiles, scratched surface, cracks, discolorations; curb blocks replaced	1937; balcony edge 1990s	M4
WALLS AND BUILT-IN ELEMENTS					
a		Rendered exterior wall with a laundry closet in a solid housing; cast-iron roof drainpipes running vertically through the closet	Paint renewed	1937	M7, (C.1.4); wood: M13, (C.1.6)
Laundry cupboard	S.1	Laundry closet with a hatch door in window W01.P.15 of the adjacent bathroom 01.P; double doors with wooden frames and slats	Paint renewed; internal arrangement original	1937	Wood: M13, (C.1.6)
b		Rendered exterior wall; cast-iron drainage and water pipes running vertically in front of the facade; wall-mounted steel rack for an air-conditioning unit and two core holes through the upper part of the wall; several open installations for water and electricity	Paint renewed; wall-mounted installations, core holes and wiring new	Wall, plaster, drainage and water pipes 1937; paint, technical installations and wiring 1960s-1990s	M7, (C.1.4)

DATE		FLOOR		FUNCTION	ROOM
04/30/2015		2nd Floor		Balcony (B.2)	01.K
ELEMENT	TYPE	DESCRIPTION	CONDITION, NOTES	DATING	ORIGINAL MATERIALS AND COLORS
d		Rendered exterior wall, projecting volume of the shower alcove (bathroom 01.E); small square wall opening of the ceiling storage space above W01.F08; drainage and water pipes running vertically in front of the facade; open wiring; white ceramic wall-mounted lighting fixture above W01.F08	Paint renewed; no remains of a laundry closet in front of the laundry hatch doors of W01.E.07	Wall and plaster of the wall projection, drainpipes and lighting fixture 1937; plaster, paint, technical installations and wiring 1960s-1990s	M7, (C.1.4)
W01.F08	W.3.1	Single-sash window with a metal grille	Paint renewed; grille probably original; handle missing	1937	Wood: M13, (C.1.6); glass: M19; steel: M23
W01.E.07	W.2.3	Double-sash window combined with two laundry hatch doors below and an exterior metal grille; plywood sheet with a built-in electric ventilator instead of a glass panel in the left sash of the window	Paint renewed; handles original, grille probably original; ventilator new	1937; ventilator 1960s-1990s	Wood: M13, (C.1.6); glass: M19; handles: M21; grille: M23

e		Solid side wall of the balcony consisting of a wall with a recess, a horizontal slit and fascia; open wiring and a wall-mounted distribution box	Paint renewed; distribution box new	1937; 1990s	M7, (C.1.4)
f/g		Railing, steel construction with wire glass panels and a round handrail	Renewed in keeping with the historical pattern; glass panels partly removed	1990s	Steel, probably powder-coated; wire glass
CEILING					
		Beam-and-block ceiling, plaster; drainpipes from balcony 02.K; open wiring	Paint renewed; pipes partly original; partial discoloration and traces of moisture	1937; 1990s	M7, (C.1.4)

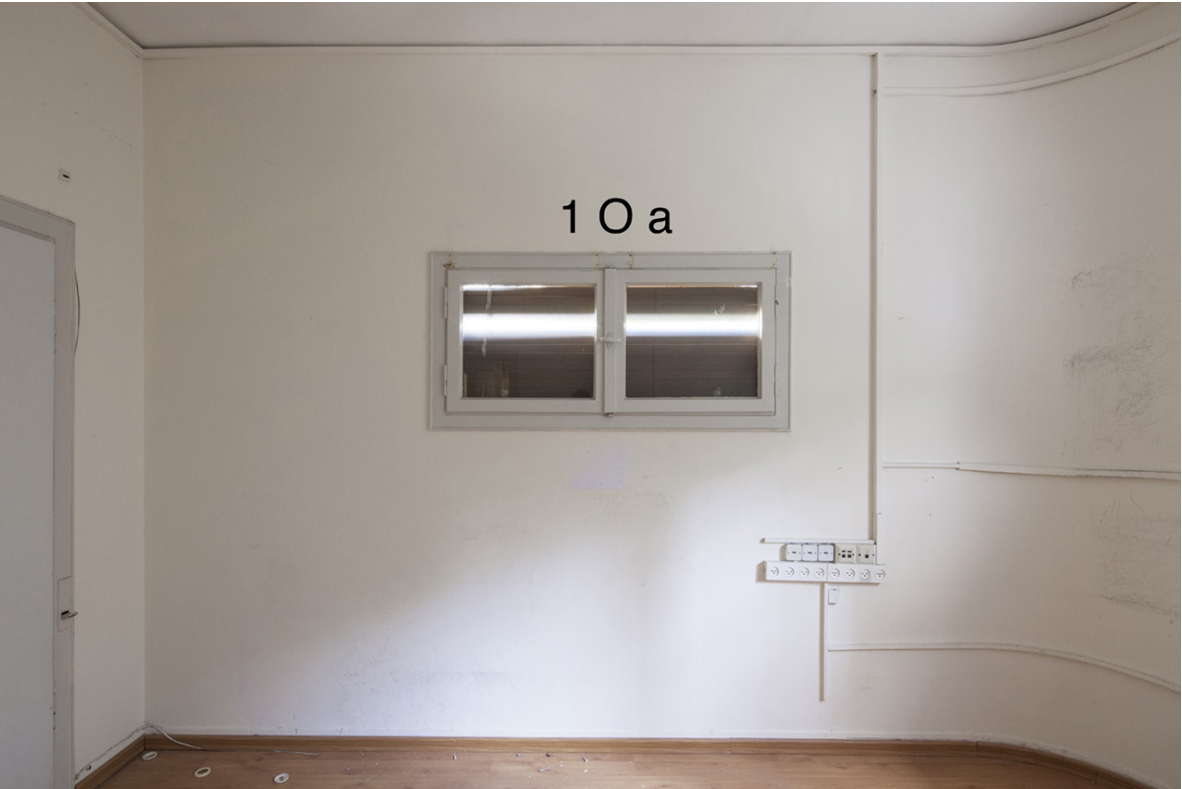
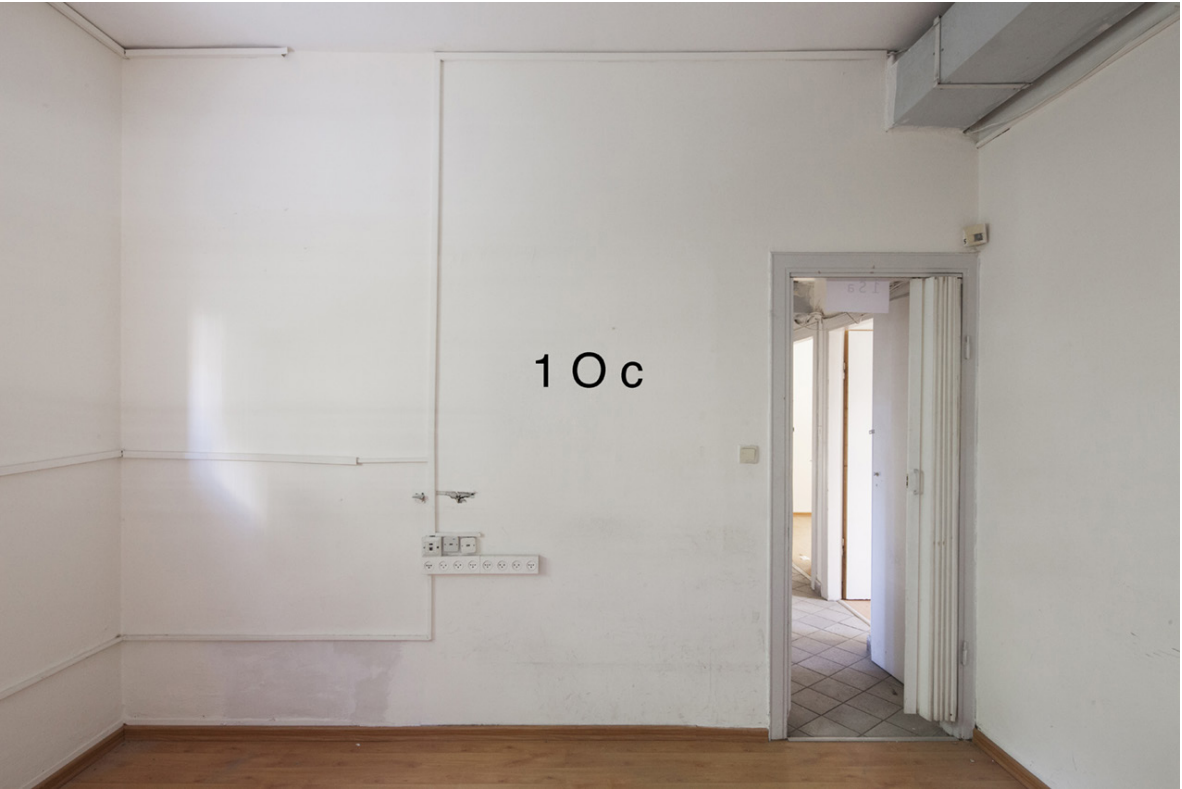
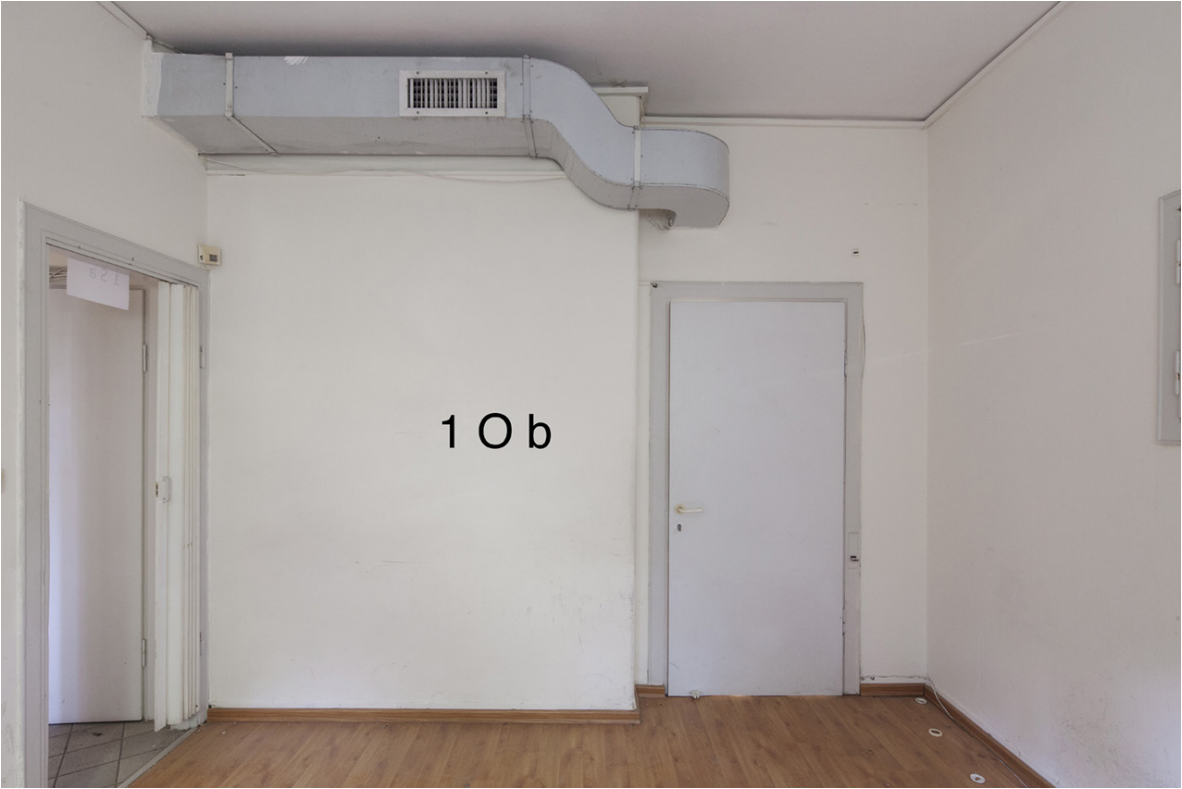
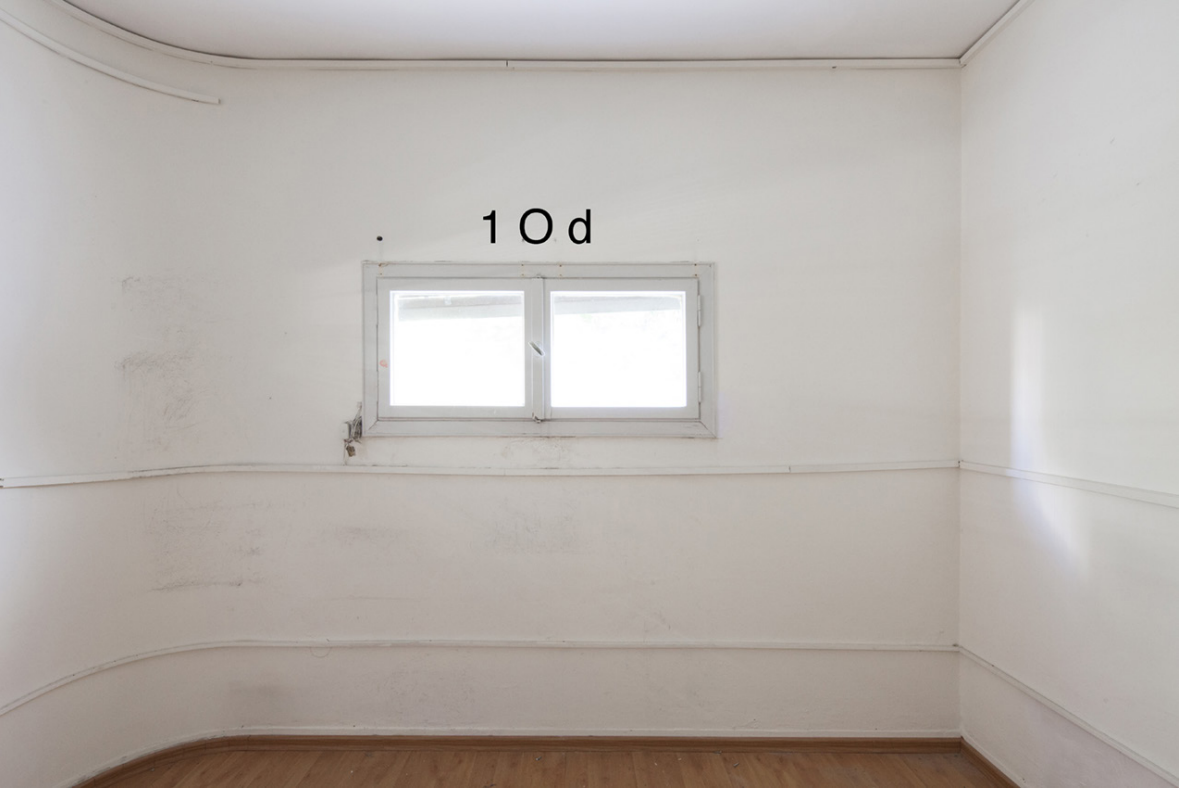
DATE		FLOOR		FUNCTION	ROOM
04/30/2015		2nd Floor		Room	01.O
ELEMENT	TYPE	DESCRIPTION	CONDITION, NOTES	DATING	ORIGINAL MATERIALS AND COLORS
FLOOR					
	F.2.1	Wood block parquet and wooden baseboard	Original terrazzo floor and base tiles beneath, condition unknown	1990s	(M4)
WALLS AND BUILT-IN ELEMENTS					
a		Plastered exterior wall with a rounded corner on the left side; open wiring	Surface renewed, shutter belt boxes subsequently removed	Wall and plaster 1937; wiring 1960s-1990s	M7, (C.1.1)
W01.O.17	W.2.5	Double-sash casement window	Paint renewed, original handles painted white; no roller shutter belt, shutter defective	1937	Wood: M13, (C.1.6); glass: M20; handles: M21
b		Plastered interior wall; open wiring and ventilation duct running from room 01.S to 01.T	Surface renewed	Wall and plaster 1937; technical installation 1960s-1990s	M7, (C.1.1)
W01.O.18	W.4.4	Single-leaf solid door with a wooden frame	Original door type probably W.1.2; no roller shutter belt	Frame 1937; door leaf 1990s	Wood: M13, (C.1.6)

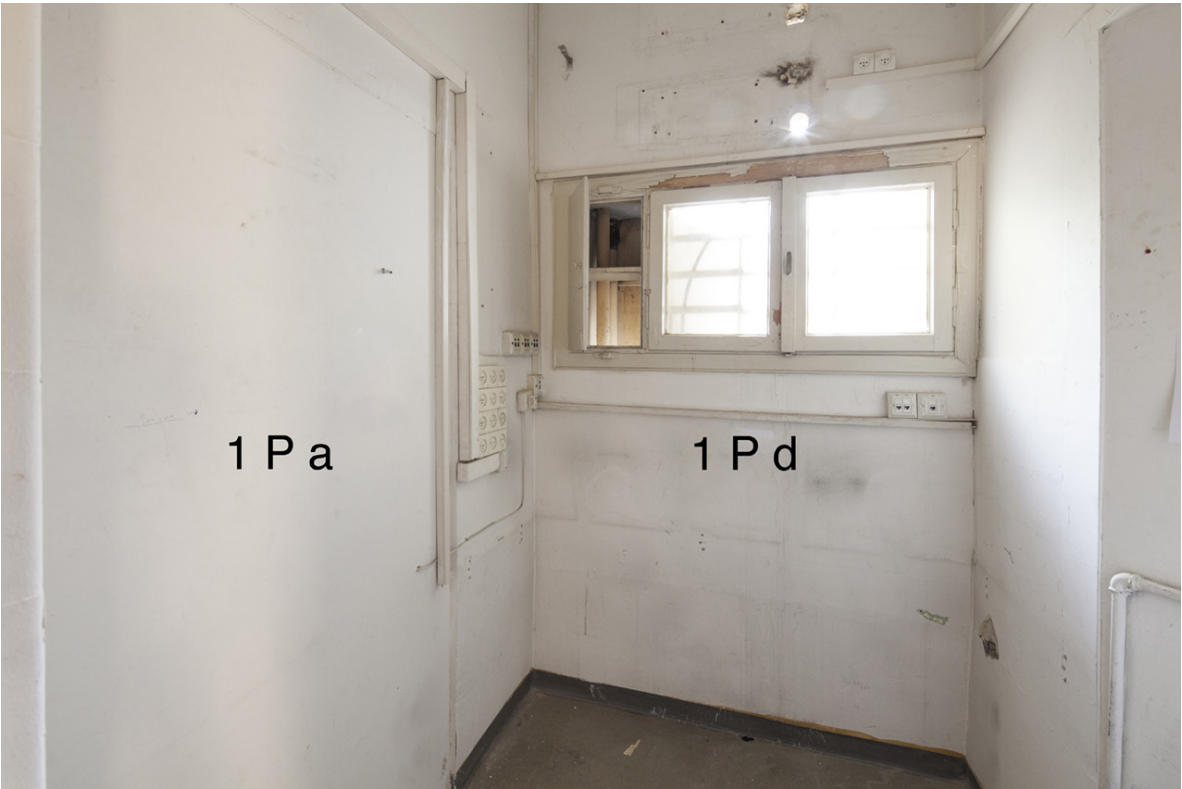
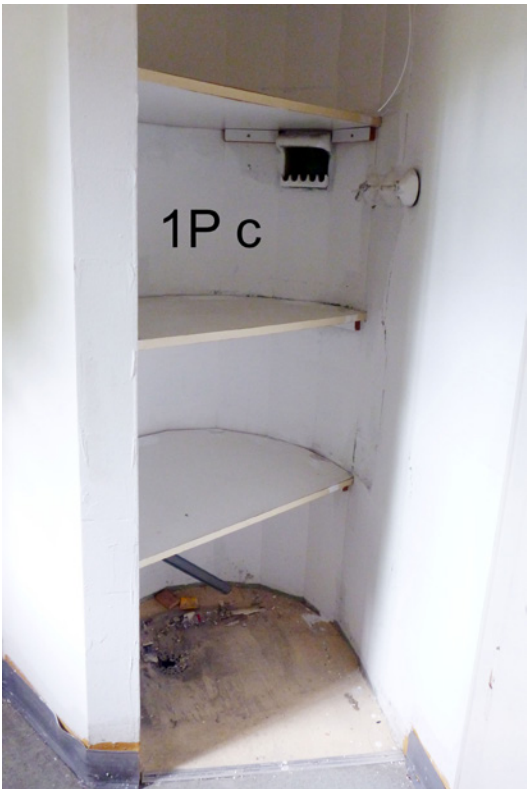
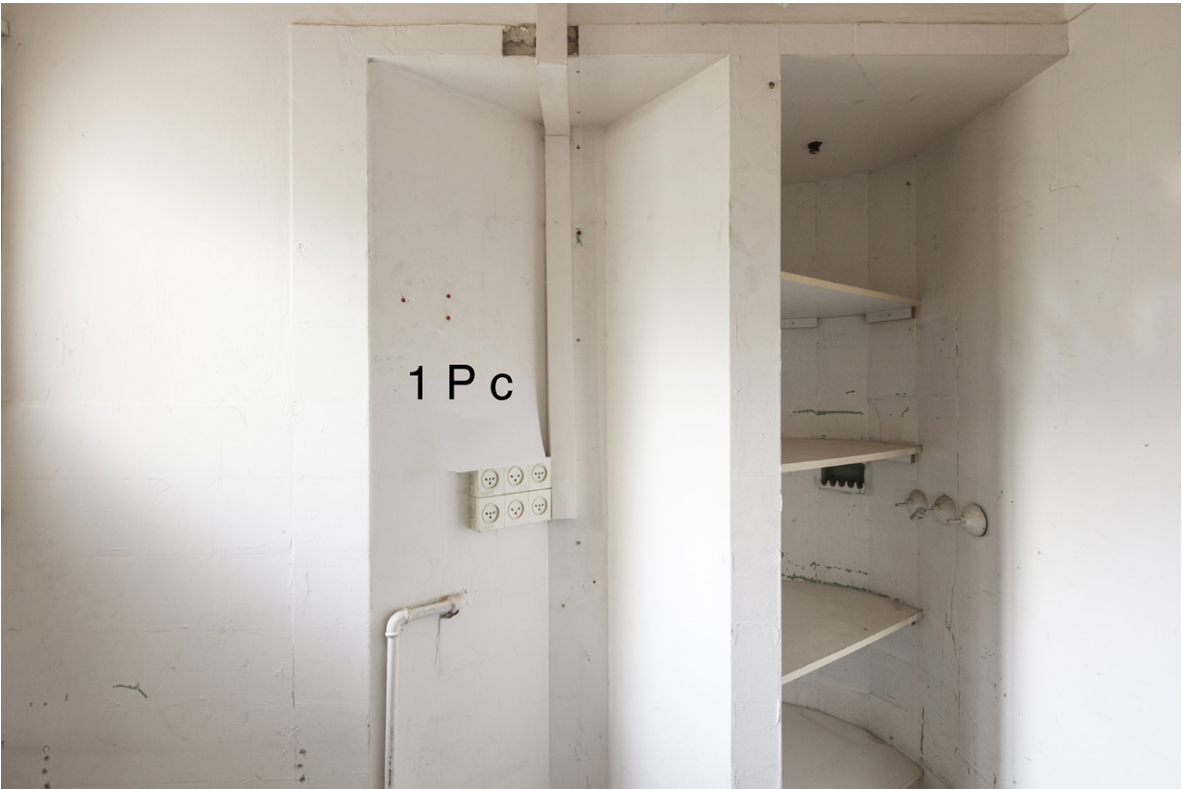
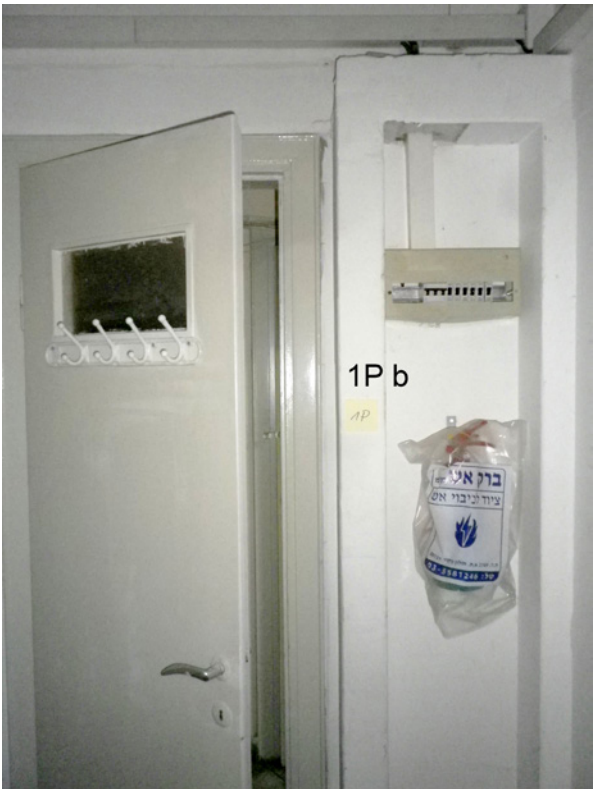
DATE		FLOOR		FUNCTION	ROOM
04/30/2015		2nd Floor		Room	01.P
ELEMENT	TYPE	DESCRIPTION	CONDITION, NOTES	DATING	ORIGINAL MATERIALS AND COLORS
FLOOR					
	F.2.1	PVC-flooring with black plastic baseboard; terrazzo flooring in the shower alcove laid to falls	Original terrazzo floor and base tiles beneath, condition unknown	1990s	(M4); M5
WALLS AND BUILT-IN ELEMENTS					
a		Plastered interior wall, wall tiling up to approx. 1.35m on the right and 2.25m on the left side; open wiring	Paint renewed; wall tiling original, subsequently painted	Wall, plaster and wall tiling 1937	M7, (C.1.1)
b		Interior wall with a radiator recess with remains of a heating line on its right and a shower alcove with remains of faucets and a soap dish on its left; wall tiling up to approx. 2.40m, upper part plastered; open wiring, fuse box mounted in the radiator recess	Paint renewed; wall tiling, soap dish and remains of the faucets in the shower original; everything subsequently painted	Wall, plaster and wall-tiling 1937	M7, (C.1.1)

D01.P01	D.1.6	Single-leaf solid door with a small glass pane	Paint renewed and handles replaced	1937; handles 1960s-1970s	Wood: M13, (C.1.6); glass: M19
c		Plastered interior wall with a rounded shower alcove and a trapezoidal WC alcove; wall tiling up to approx. 2.25m in the alcoves and up to 1.50m on the left side; shower alcove converted into an open closet with shelves; open wiring	Wall tiling original, partly damaged; surface subsequently painted	Wall, plaster and wall tiling 1937; shelves later	M7, (C.1.1)
d		Plastered interior wall, wall tiling up to the window frame; two core holes through the wall above the window; open wiring	Wall tiling original, partly damaged; surface subsequently painted	Wall, plaster and wall tiling 1937	M7, (C.1.1)
W01.P15	W.2.4	Double-sash window combined with a laundry hatch and an exterior metal grille	Paint renewed and partly peeling off; original handles	1937	Wood: M13, (C.1.6); handles: M21
