CONSERVATION SURVEY

MAX-LIEBLING-HOUSE

29, IDELSON STREET, TEL AVIV

Tel Aviv/Berlin, 2016/17

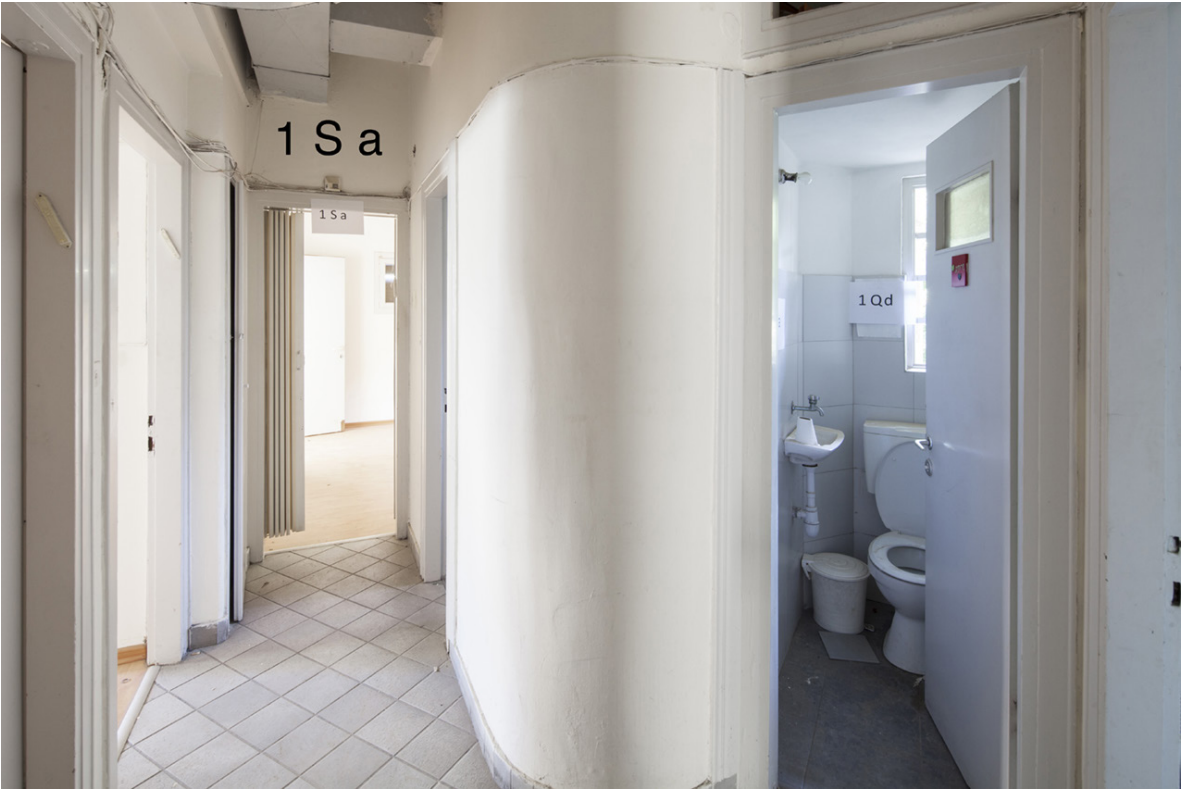
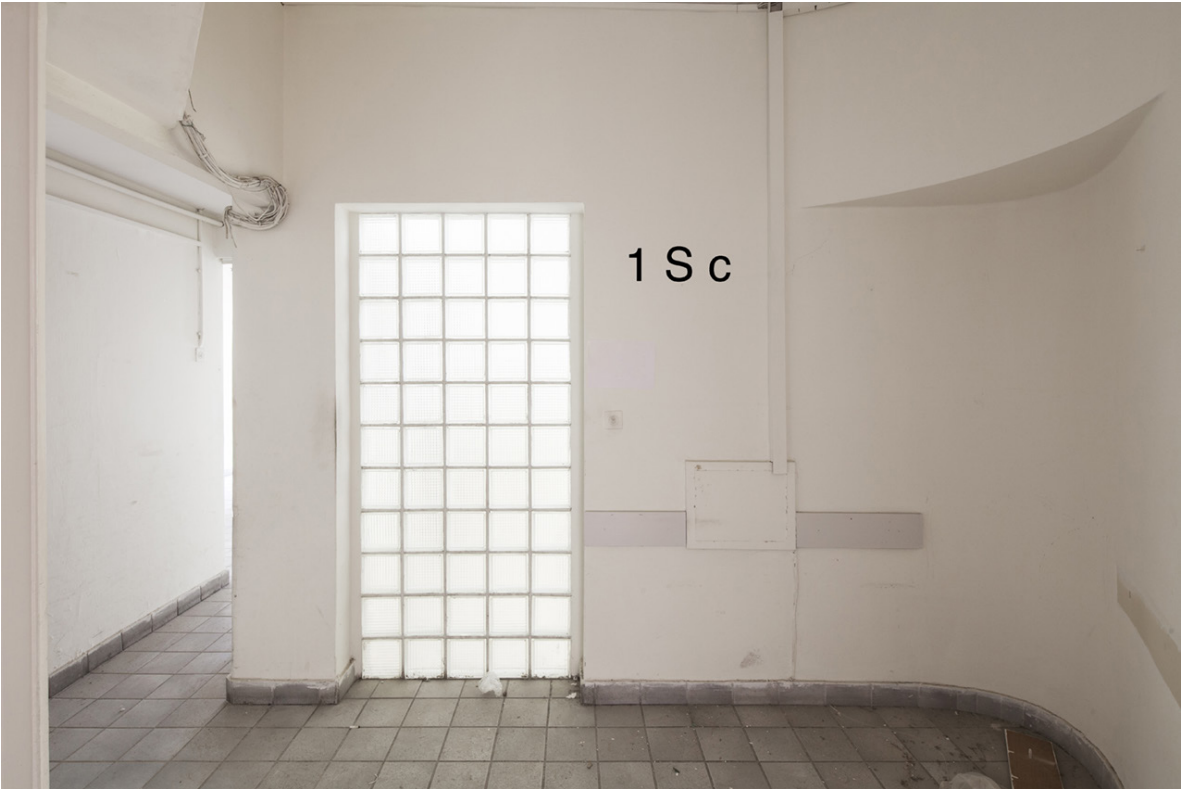
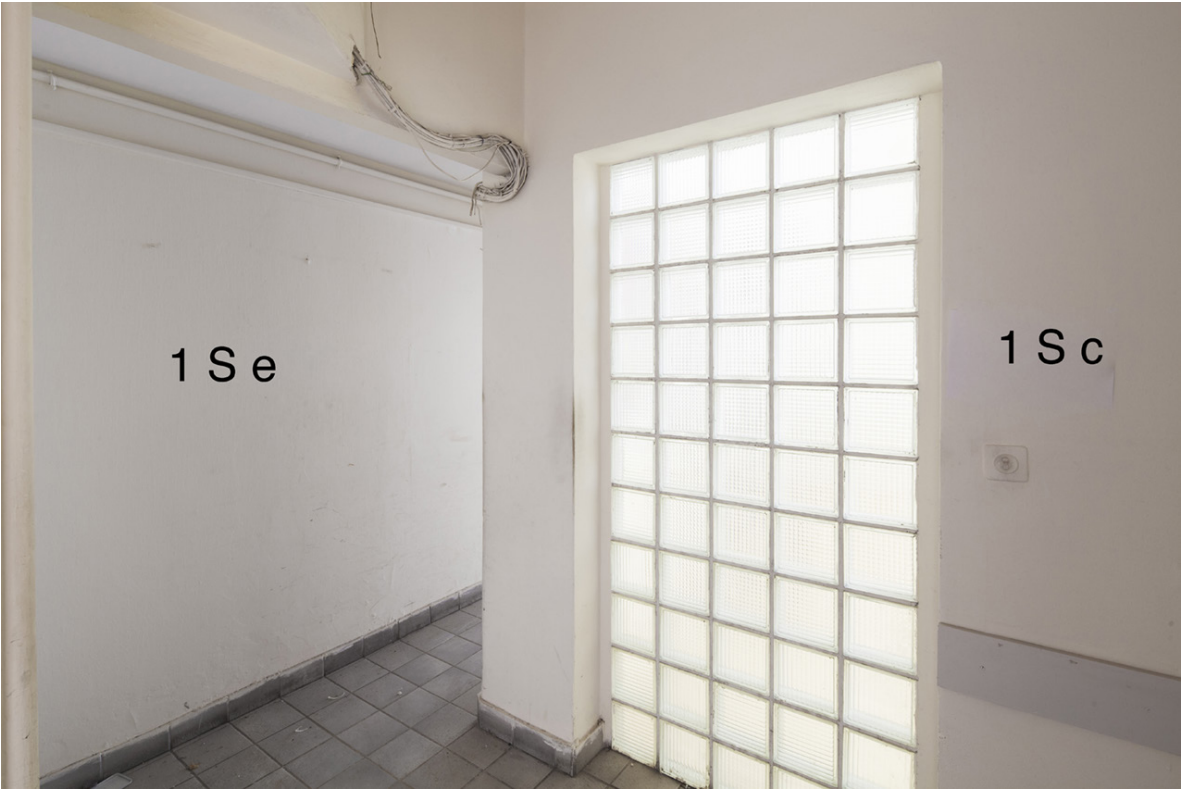
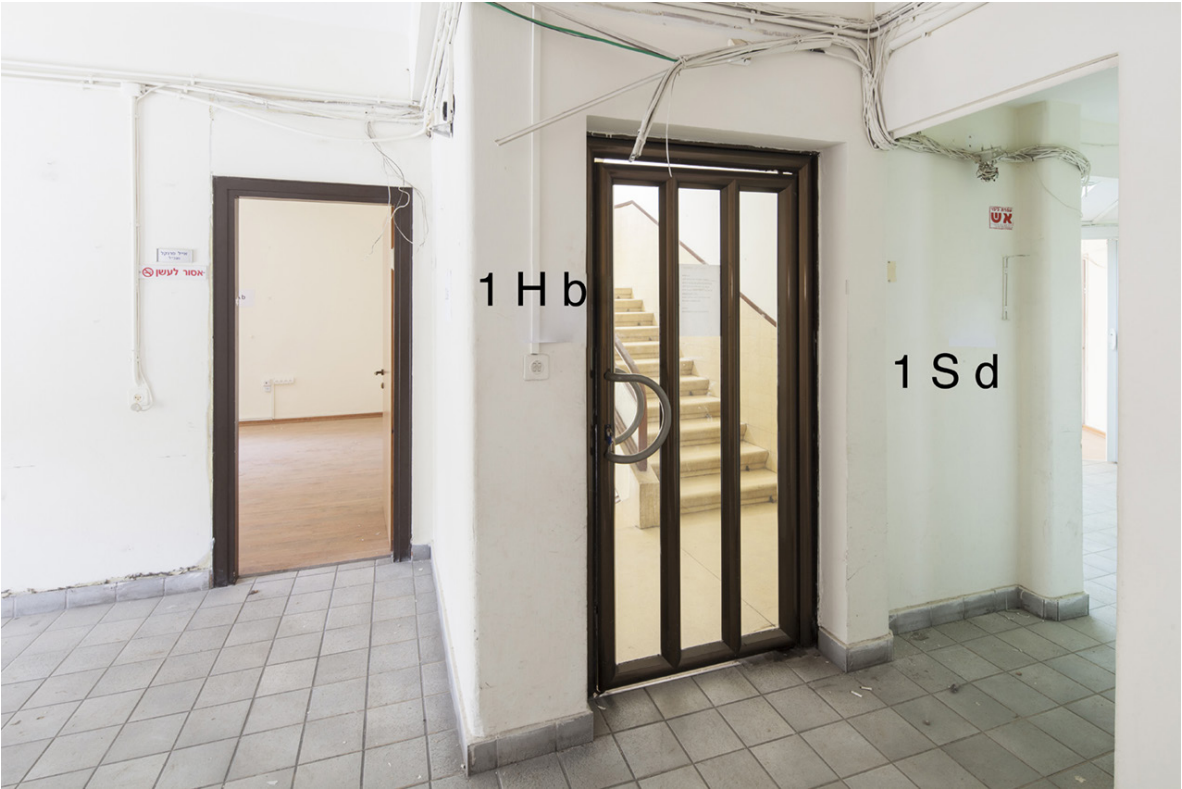
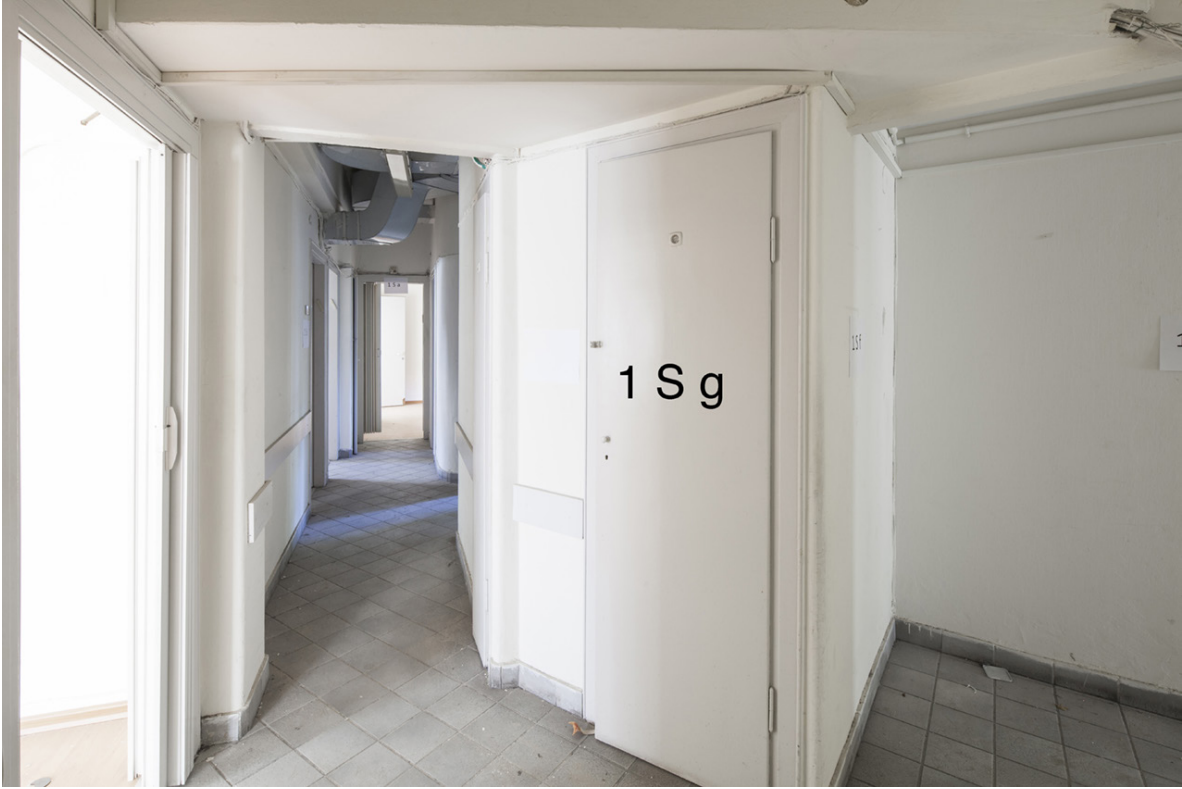
DATE		FLOOR		FUNCTION	ROOM
04/30/2015		2nd Floor		Corridor	01.S
ELEMENT	TYPE	DESCRIPTION	CONDITION, NOTES	DATING	ORIGINAL MATERIALS AND COLORS
FLOOR					
		Ceramic floor and base tiles, gray;	Original terrazzo floor and base tiles beneath, condition unknown	1990s	(M4)
WALLS AND BUILT-IN ELEMENTS					
a		Plastered interior wall, ventilation duct penetrating the wall above the door and continuing into Room 01.O	Surface renewed	Wall and plaster 1937; ventilation duct probably 1990s or later	M7, (C.1.1)
D01.O.01	D.2.2	Single-leaf door opening with wooden frame and plastic sliding folding door	Original door type probably D.1.4	Frame 1937; folding door 1960s-1990s	Wood: M13, (C.1.6)
b		Plastered interior wall; recess due to wall thickness being less than that of concrete columns and beam; wooden board to protect wall surface; flush-mounted light switch between D01.N.01 and D01.M.01; open wiring	Surface renewed; wall protection new	Wall, plaster and light switch 1937; wooden board and wiring 1960s-1990s	M7, (C.1.1); light switch: M26

Closet	S.10	Single-leaf closet adjacent to room 01.N, shelves	Paint renewed	1937	Wood: M13, (C.1.6)
D01.N.01	D.1.5	Single-leaf solid door with a vent opening and grille	Paint renewed and handles replaced; vent opening and grille added subsequently	1937; handles probably 1990s	Wood: M13, (C.1.6)
D01.M.01	D.1.5	Single-leaf solid door	Paint renewed and handles replaced	1937; handles 1960s-1970s	Wood: M13, (C.1.6)
D01.L.01	D.2.2	Single-leaf door opening with wooden frame and plastic sliding folding door	Original door type probably D.1.3	Frame 1937; folding door probably 1960s-1990s	Wood: M13, (C.1.6)
c		Plastered interior wall with a rounded corner to wall b; flush-mounted light switch; wooden board to protect wall surface; wall recess with wooden hatch for an electrical distribution box; open wiring	Surface renewed; wall protection, distribution box and glass bricks new; apartment entrance door presumably removed, original door type probably D.1.2	Wall, plaster and light switch 1937; wall protection, glass bricks, distribution box probably 1950s-1990s	M7, (C.1.1); light switch: M26

DATE		FLOOR		FUNCTION	ROOM
04/30/2015		2nd Floor		Corridor	01.S
ELEMENT	TYPE	DESCRIPTION	CONDITION, NOTES	DATING	ORIGINAL MATERIALS AND COLORS
D01.R.01	D.1.6	Single-leaf solid door with a small glass pane	Paint renewed and handles replaced	1937; handles probably 1990s	Wood: M13, (C.1.6); glass: M19
Storage space	S.11	Single-leaf solid hatch door of a storage space in the ceiling void	Paint renewed; knob original	1937	Wood: M13, (C.1.6); knob: probably M21
D01.Q.01	D.1.6	Single-leaf solid door with a small glass pane	Paint renewed and handles replaced	1937; handles 1960s-1970s	Wood: M13, (C.1.6); glass: M19
i		Plastered interior wall, rounded corner to wall h; open wiring	Surface renewed	Wall and plaster 1937	M7, (C.1.1)
D01.P.01	W.2.3	Single-leaf door with a wooden frame; one pane of textured glass		1990s or later	Wood/white
CEILING					
		Beam-and-block ceiling, plaster; suspended ventilation ducts partly covered by the dropped ceiling of gypsum board at walls c, d, e, f, g; suspended louvered luminaires	Paint of the solid ceiling renewed	1937; dropped ceiling, ventilation and lights 1960s-1990s	Concrete, plaster (C.1.1)

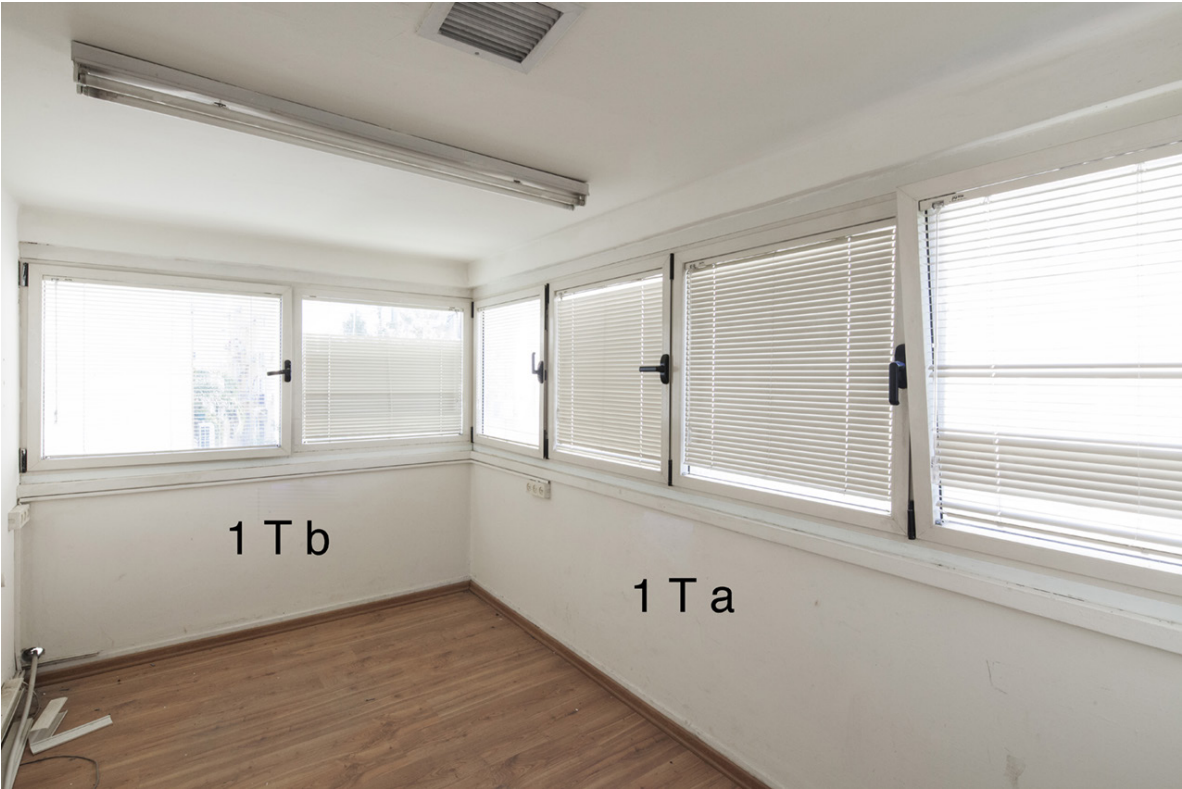
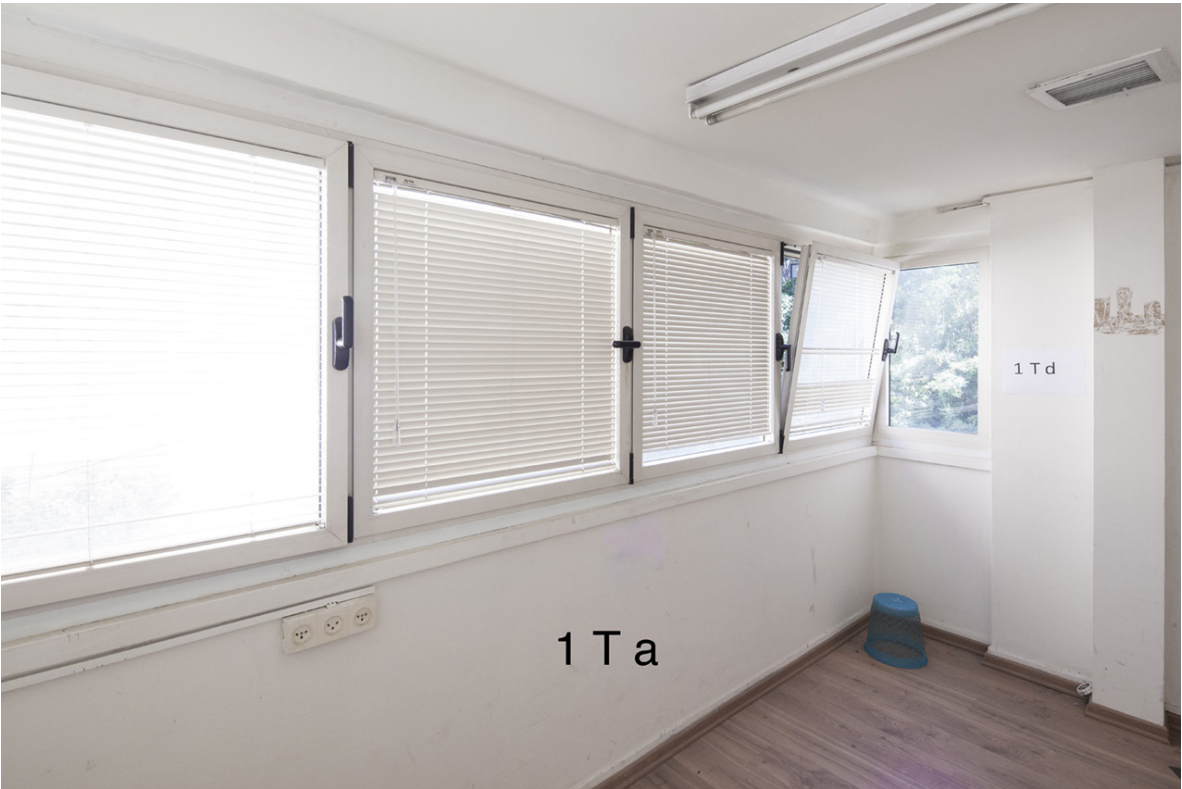
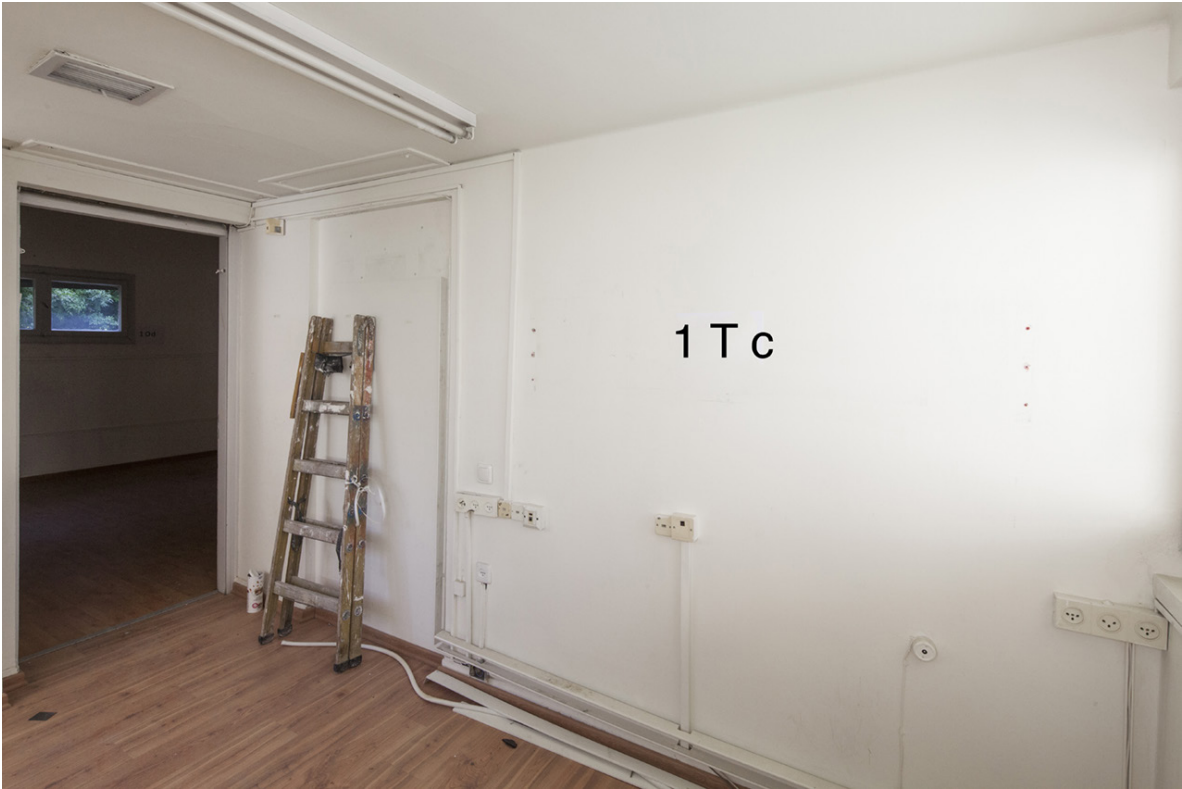
DATE		FLOOR		FUNCTION	ROOM
04/30/2015		2nd Floor		Balcony (B.3)	01.T
ELEMENT	TYPE	DESCRIPTION	CONDITION, NOTES	DATING	ORIGINAL MATERIALS AND COLORS
FLOOR					
	F.2.1	Wood block parquet and wooden baseboard	Original terrazzo floor and base tiles beneath, condition unknown	1990s or later	(M4)
WALLS AND BUILT-IN ELEMENTS					
a		Plastered exterior parapet with a terrazzo coping; glazing mounted between the balcony parapet and the upper fascia	Surface renewed; original coping painted white; glazing new	Wall, plaster and coping 1937; windows 1960s-1990s	Railing: M7, (C.1.1); coping: M6
b		Plastered exterior parapet with a terrazzo coping; glazing mounted between the balcony parapet and the upper fascia; cable bushing	Surface renewed; original coping painted white; glazing new	Wall, plaster and coping 1937; windows 1960s-1990s	Railing: M7, (C.1.1); coping: M6
W01.T.20	W.4.2	Balcony glazing, consisting of 7 single-sash aluminum windows adjoining one another	new	1960s-1990s

c		Plastered exterior wall; wall recess with a boarded-up door opening; open wiring	Surface renewed	Wall and plaster 1937; drywall construction and wiring 1990s	M7, (C.1.1)
W01.N.19	W.2.1	Doorway of a former balcony door (type W.1.2) boarded up with drywall construction	Leaves and frame missing	1960s-1990s	
d		Plastered exterior parapet with a terrazzo coping; plastic windows mounted between the balcony parapet and the upper fascia; cased wall-mounted drainpipe with a connecting pipe	Surface renewed; original coping painted white; windows new	Wall, plaster and coping 1937; windows 1960s-1990s	Railing: M7, (C.1.1); coping: M6
W01.O.18	W.4.4	Single-leaf solid door with a wooden frame	Original door type probably W.1.2	Frame 1937; door leaf 1990s	Wood: M13, (C.1.6)
CEILING					
		Plastered dropped ceiling; opening with removable wooden covers for the shutter boxes above the balcony doors W01.N.19 and W01.O.18; two vent openings in the suspended ceiling; surface-mounted fluorescent lighting	Paint of the original wooden covers renewed; vent openings made subsequently	Ceiling 1937; light 1960s-1990s	M7, (C.1.1); wood: M13, (C.1.6)

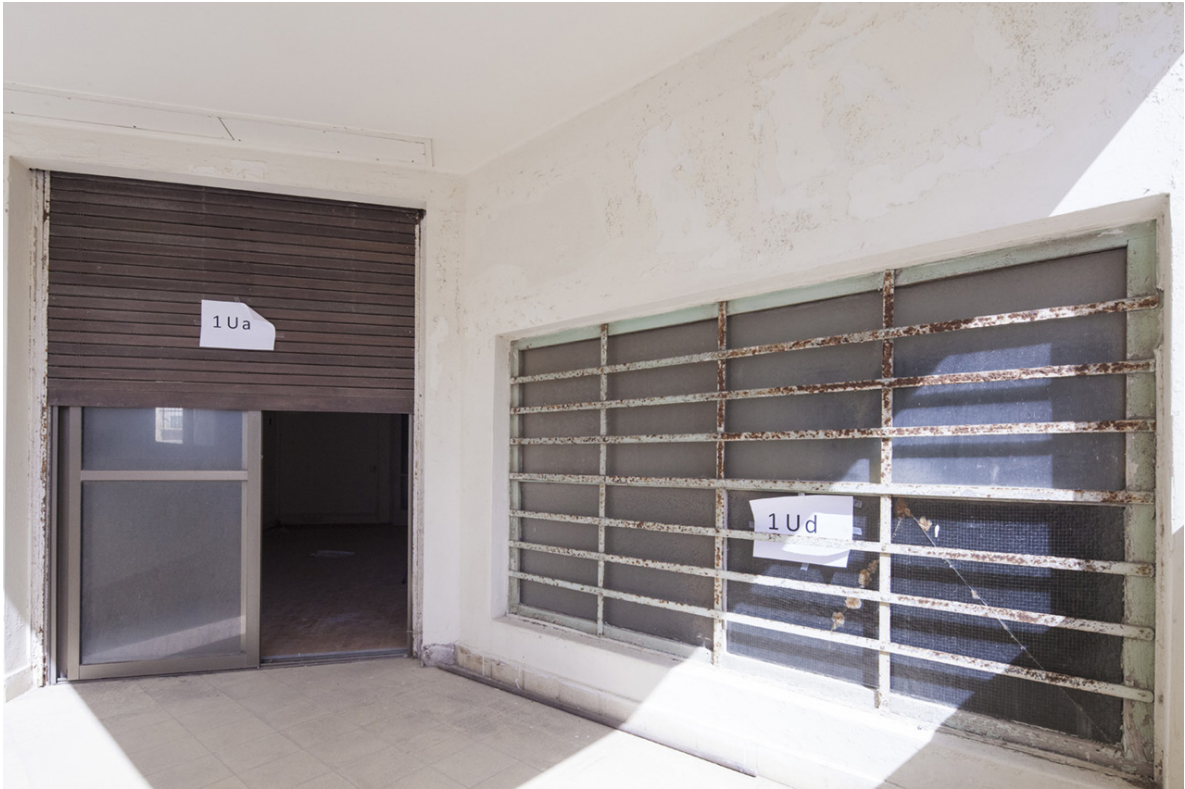
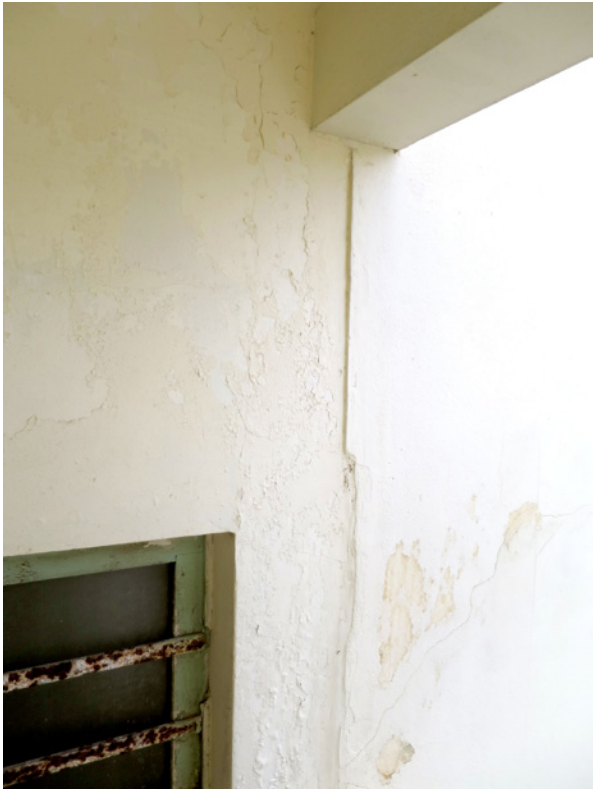
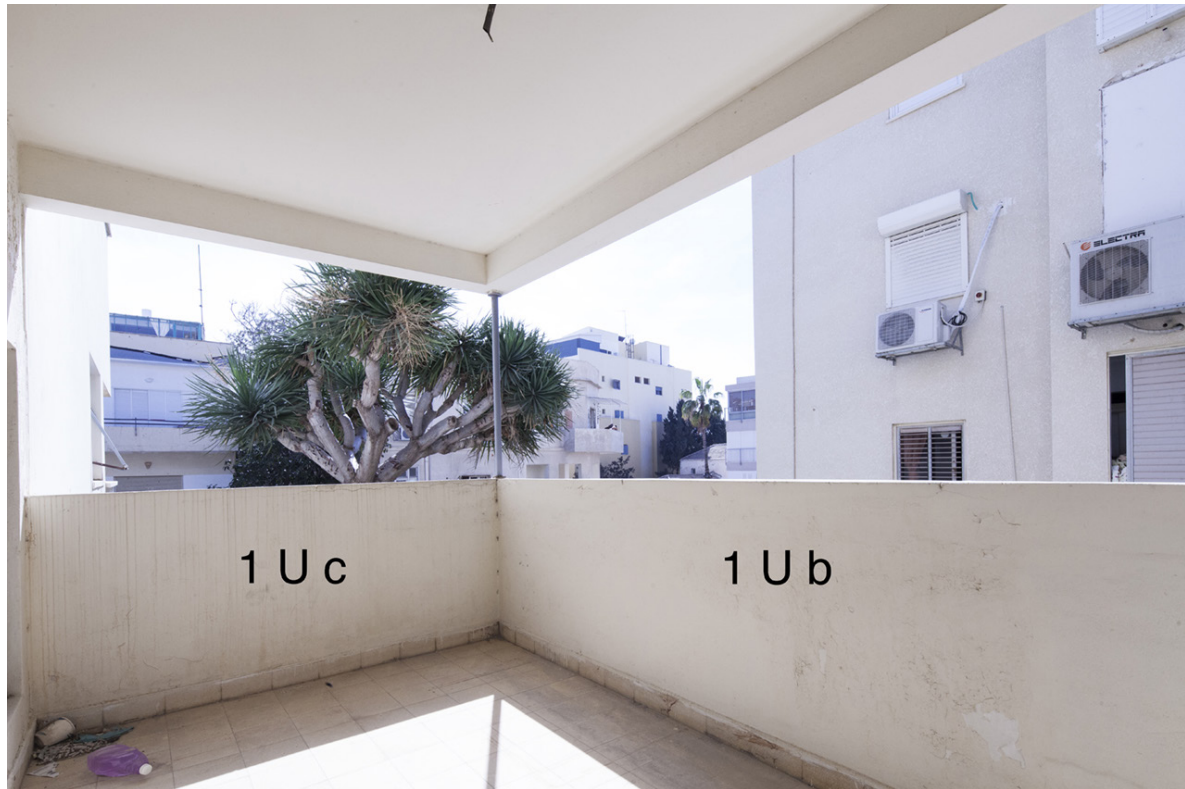
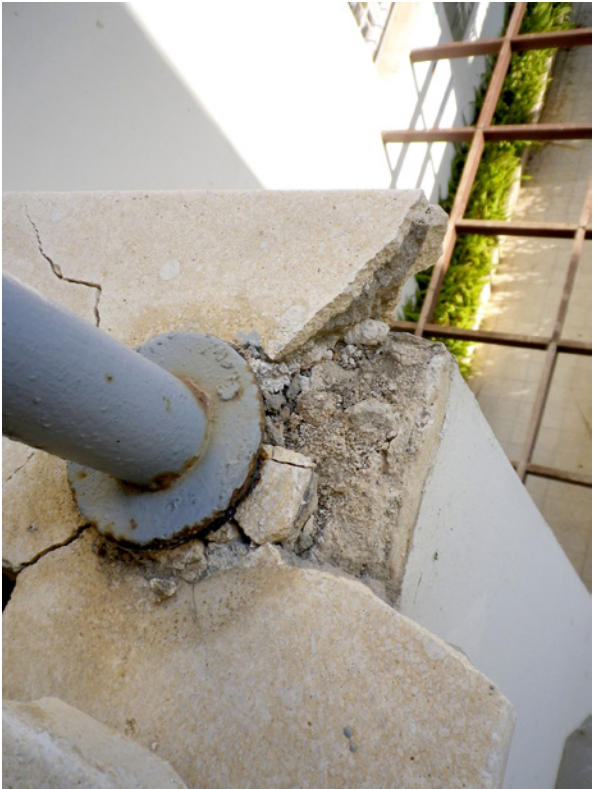
DATE		FLOOR		FUNCTION	ROOM
04/30/2015		2nd Floor		Balcony (B.4)	01.U
ELEMENT	TYPE	DESCRIPTION	CONDITION, NOTES	DATING	ORIGINAL MATERIALS AND COLORS
FLOOR					
	F.1.1	Terrazzo floor and base tiles	Partly scratched surface, cracks, few base tiles missing	1937	M4
WALLS AND BUILT-IN ELEMENTS					
a		Rendered exterior wall	Surface renewed	Wall and render 1937	M7, (C.1.4)
W01.L.24	W.4.4	Aluminum sliding door onto balcony with two glazed sliding panels; wooden frame of the original door preserved	Paint of the original frame renewed; no roller shutter belt; original door probably type W.1.1 (cf. 02.L)	Frame 1937; door probably 1990s	Wood: M13, (C.1.6)
b		Rendered exterior parapet; terrazzo coping with a water drip; round steel column mounted on the coping in the corner of the balcony, with a sleeve socket at its foot and its head	Paint and terrazzo coping renewed broadly similar to the original materials; paint peeling off, cracks in the render at the connection to the coping; column probably original	Wall, render and column 1937; paint and coping 1990s	Railing: M7, (C.1.4); column: M23 (original color white);

c		Rendered exterior parapet with a terrazzo coping	Paint and terrazzo coping renewed broadly similar to the original materials; paint peeling off, cracks in the render at the connection to the coping	Wall and render, 1937; paint and coping 1990s	Railing: M7, (C.1.4)
d		Rendered exterior wall	Surface renewed	Wall and render 1937	M7, (C.1.4)
W01.V.25	W.1.2	Three-part window with a wooden frame, one horizontal and one vertical sash bar; upper part: two sliding sashes; lower part: two panes of fixed glazing; grille (3 vertical and 7 horizontal steel bars)	Exterior paint peeling off; crack in the wire glass; grille partly corroded	1937	Wood: M13, (C.1.6); glass M18 (sliding sashes), M16 (fixed glazing); grille: M23
CEILING					
		Rendered dropped ceiling; hatch with removable wooden cover for the shutter box above the balcony door	Surface renewed; paint of the original wooden covers renewed	1937	Concrete and render, (C.1.1); wood: M13, (C.1.6)

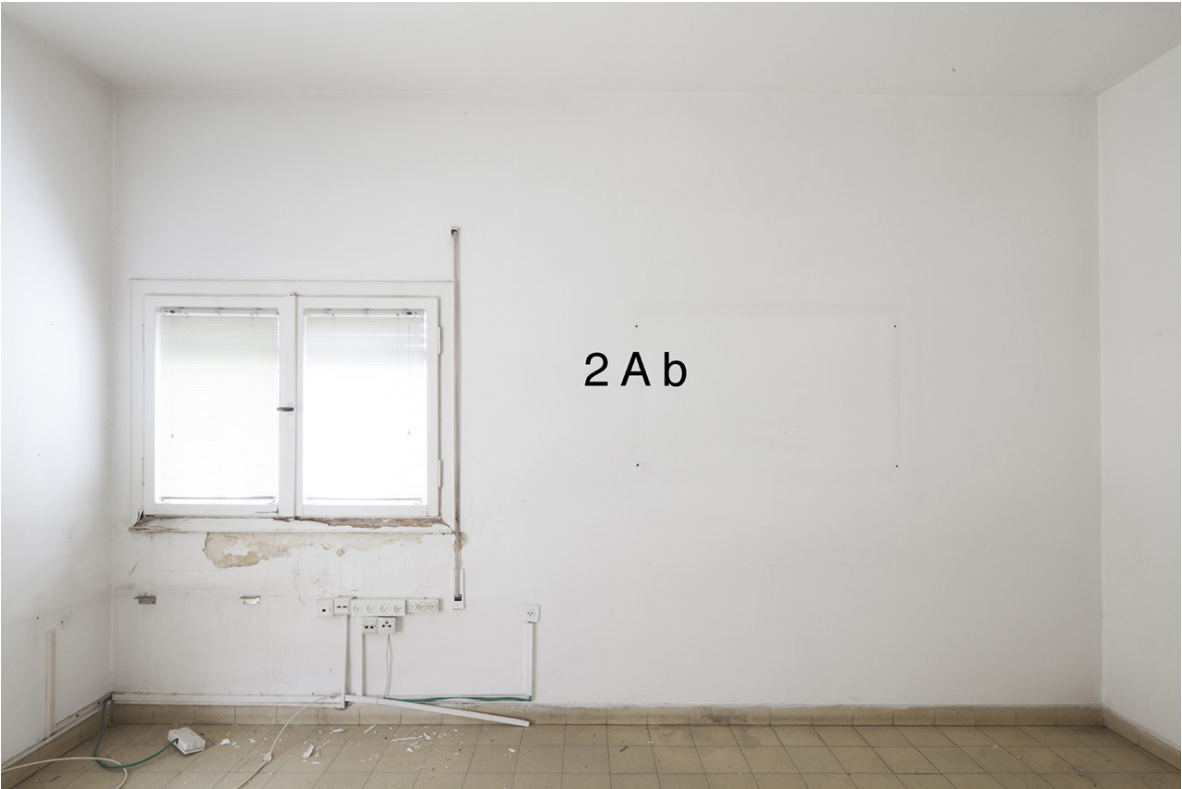
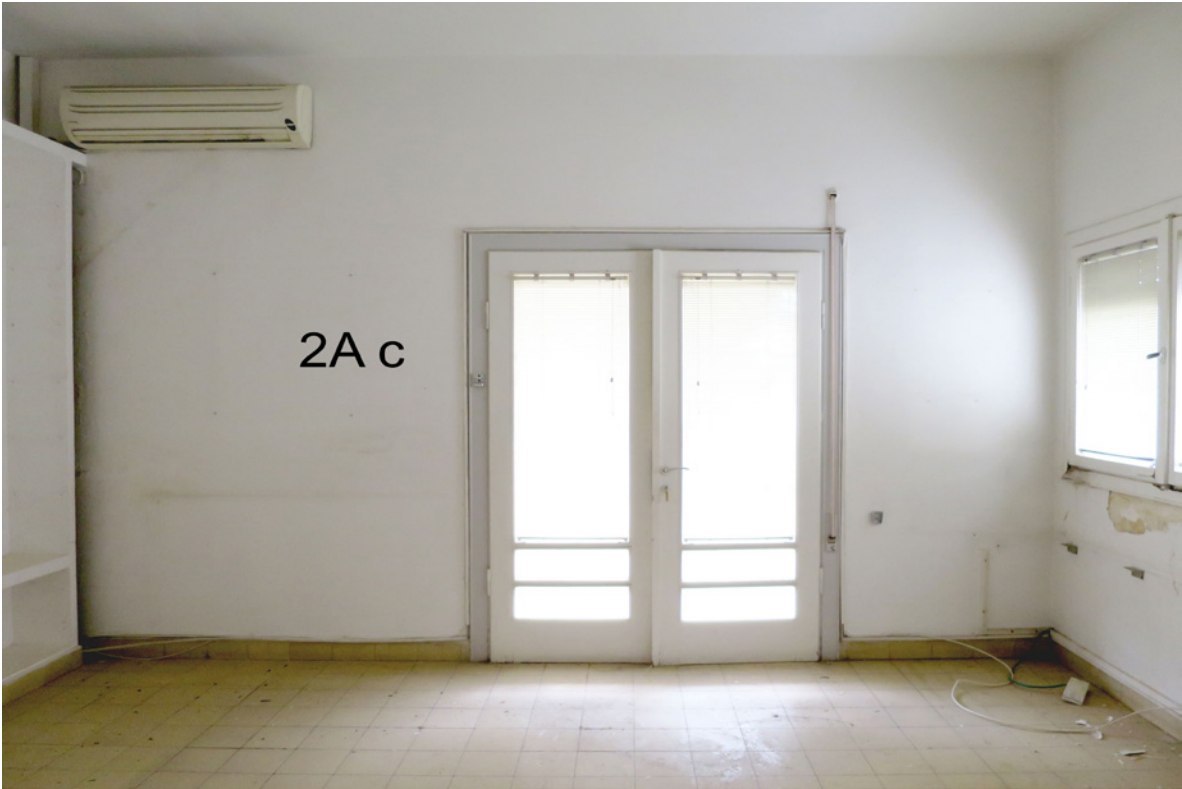
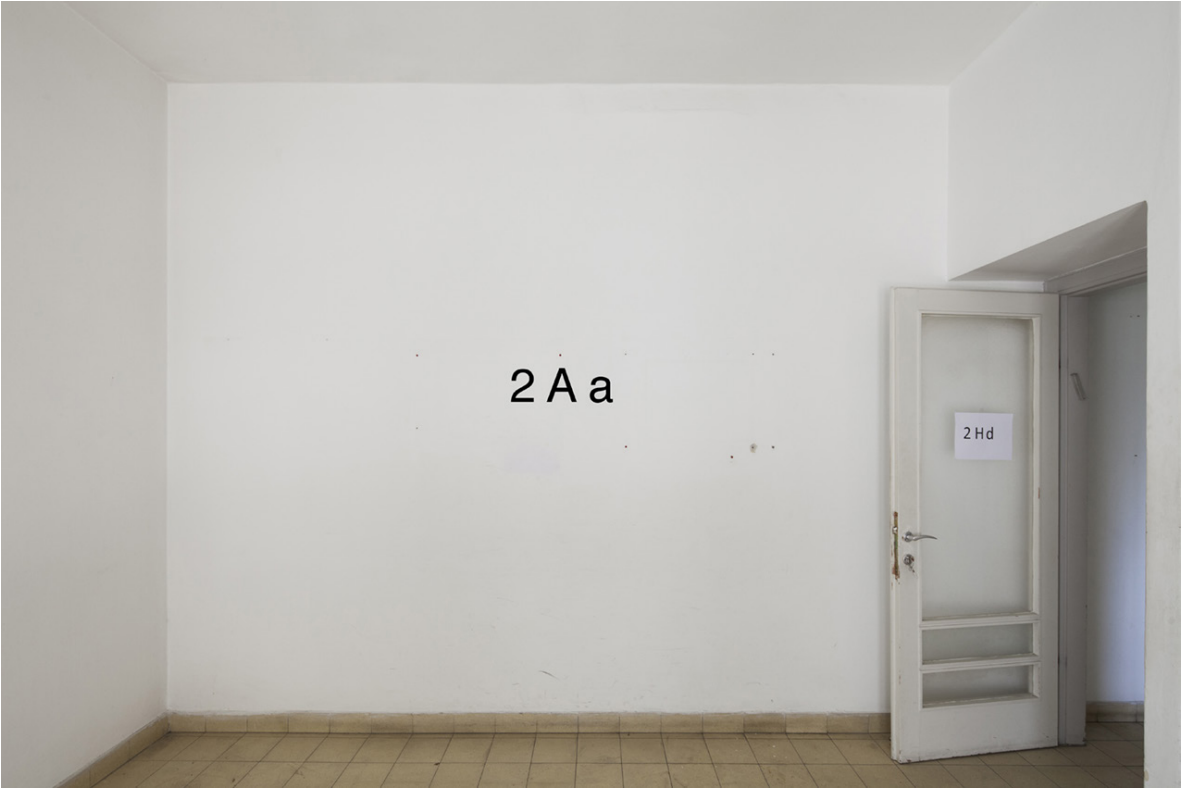
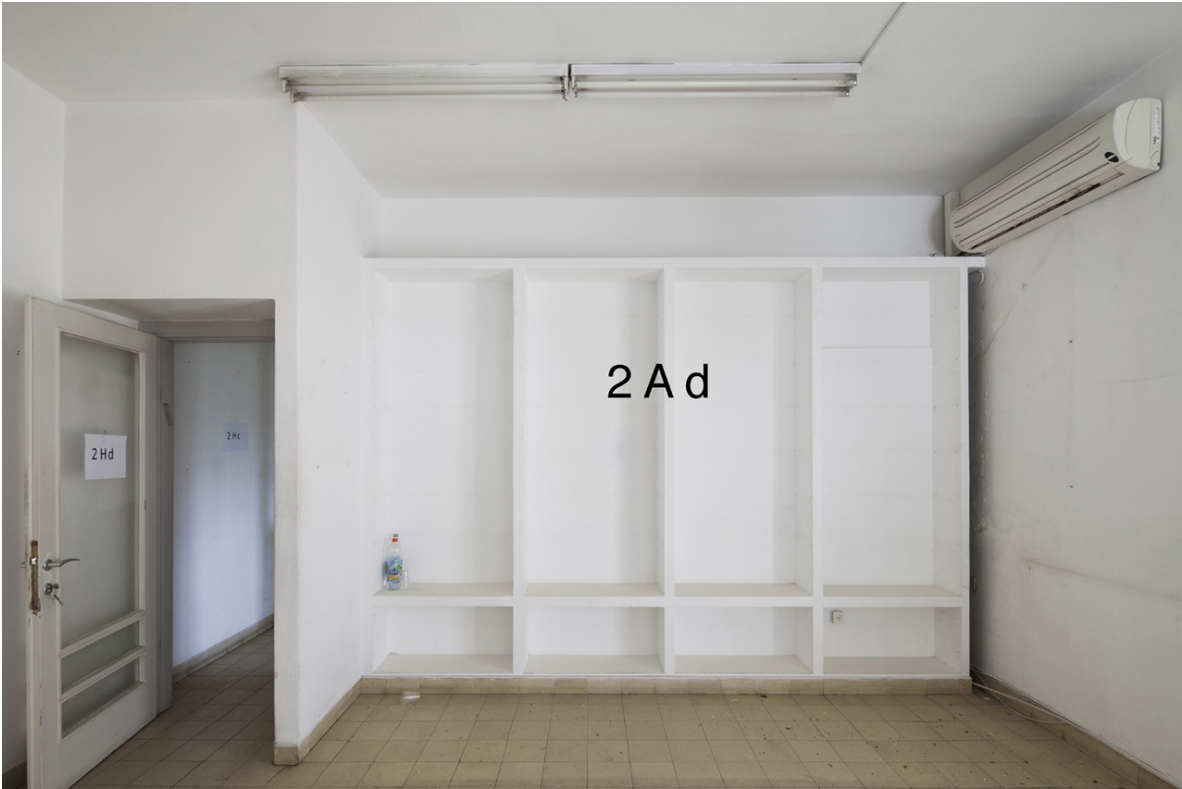
DATE		FLOOR		FUNCTION	ROOM
04/30/2015		3rd Floor		Room	02.A
ELEMENT	TYPE	DESCRIPTION	CONDITION, NOTES	DATING	ORIGINAL MATERIALS AND COLORS
FLOOR					
	F.1.1	Terrazzo floor and base tiles	Partly scratched surface, cracks, partly discolorations	1937	M4
WALLS AND BUILT-IN ELEMENTS					
a		Interior wall, presumably concrete	Surface renewed	Wall and plaster 1937	M7, (C.1.1)
b		Exterior wall; open wiring	Surface renewed; paint peeling off the wall due to moisture below the window	Wall and plaster 1937; wiring 1970s- 1990s	M7, (C.1.1)
W02.A.01	W.2.1	Double-sash casement window	Paint renewed, peeling off; original handles; roller shutter belt not original	1937	Wood: M13, (C.1.6); glass: M20; handle: M21
c		Plastered exterior wall; wall-mounted air-conditioning unit and open wiring	Surface renewed; efflorescence due to moisture in the corner to wall d	Wall and plaster 1937; wiring 1960s-1990s	M7, (C.1.1)
W02.A.02	W.1.1	Double-leaf balcony door with a wooden frame; three panes of clear glass	Paint renewed and handles replaced; roller shutter belt not original	1937; handles 1960s-1970s	Wood: M13, (C.1.6); glass: M20

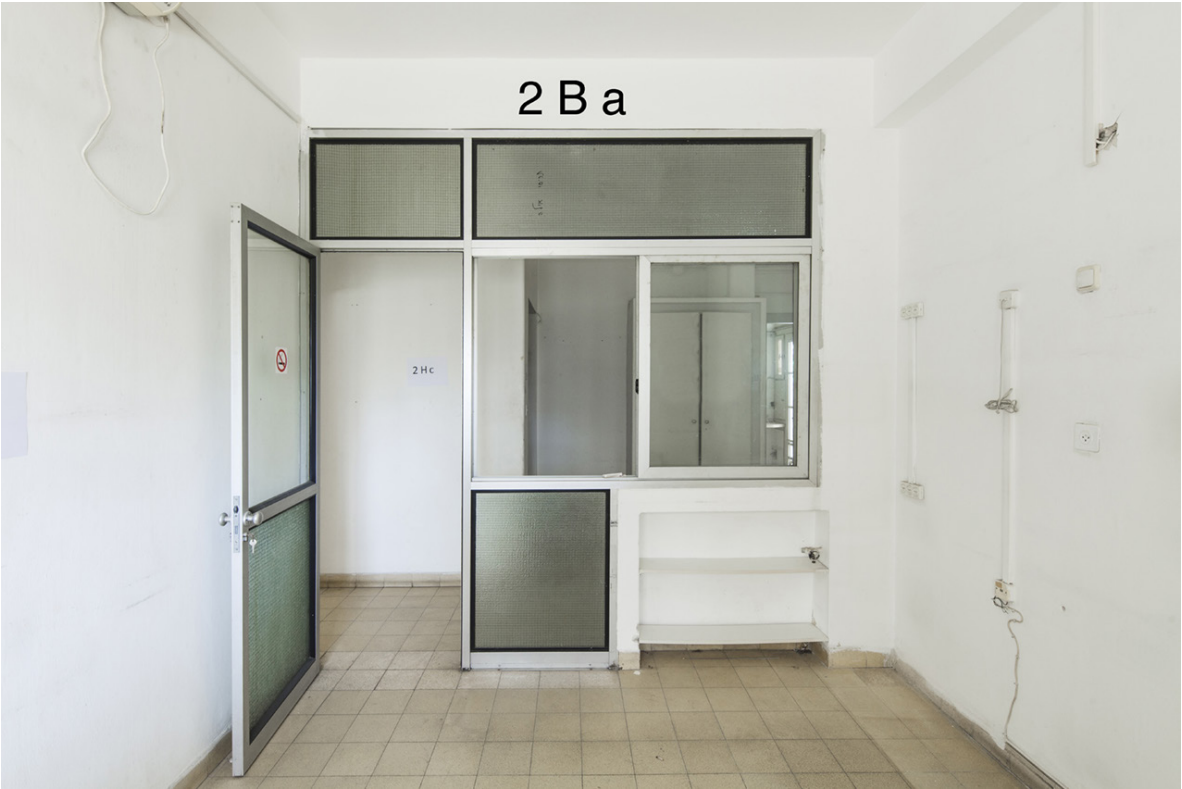
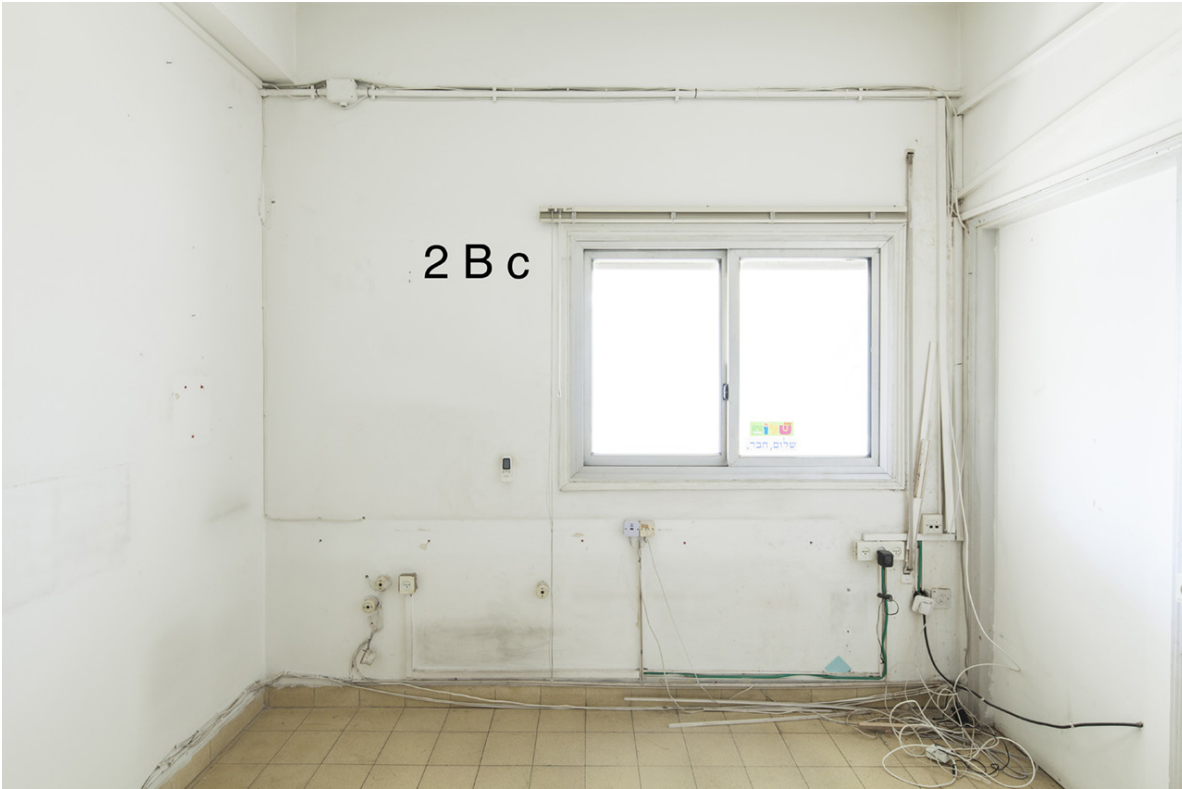
DATE		FLOOR		FUNCTION	ROOM
04/30/2015		3rd Floor		Room	02.B
ELEMENT	TYPE	DESCRIPTION	CONDITION, NOTES	DATING	ORIGINAL MATERIALS AND COLORS
FLOOR					
	F.1.1	Terrazzo floor and base tiles	Partly scratched surface, cracks; floor tiles partly replaced or supplemented with similar tiles at D02.B.01, base tiles partly replaced at D02.B.02 and in front of wall d	1937; 1960s-1990s	M4
WALLS AND BUILT-IN ELEMENTS					
a		Plastered concrete column and beam; glazed partition wall; solid dwarf wall with a terrazzo coping and a former radiator recess with remains of heating lines on the right side	Surface renewed; partition wall construction new; remains of the heating lines original	Wall, plaster and terrazzo coping 1937; glass partition wall 1960s-1990s	M7, (C.1.1); coping: M3
D02.B.01	D.2.3	Glass partition wall with a single-leaf door; aluminum frame	New	1960s-1990s	
b		Plastered interior wall; doorway closed with a drywall construction; wall-mounted air-conditioning unit and open wiring	Surface renewed; door opening probably not original	Wall and plaster 1937; closed door opening probably after 1937; wiring 1960s-1990s	M7, (C.1.1)

D02.B.02	D.2.4	Single-leaf door opening with a wooden frame and profiled casing, boarded up with a drywall construction	Door opening probably not original because the profile of the casing differs to that of all other doors in the building	later, dating unclear	
c		Plastered exterior wall; flush-mounted light switch; open wiring	Surface renewed	Wall, plaster and light switch 1937; wiring 1960s-1990s	M7, (C.1.1); light switch: M26
W02.B.03	W.4.4	Double-sash aluminum sliding window, clear glass built in an existing wooden frame construction	Frame original, new window; roller shutter belt not original	1937; 1960s-1990s	Wood: M13, (C.1.6)
d		Plastered interior wall; open wiring; flush-mounted socket	Surface renewed; presumably original wall opening on the left side subsequently closed (cf. renewed base tiles and position of the original flush-mounted socket)	Wall, plaster and socket 1937; wiring 1960s-1990s	M7, (C.1.1); socket: M26

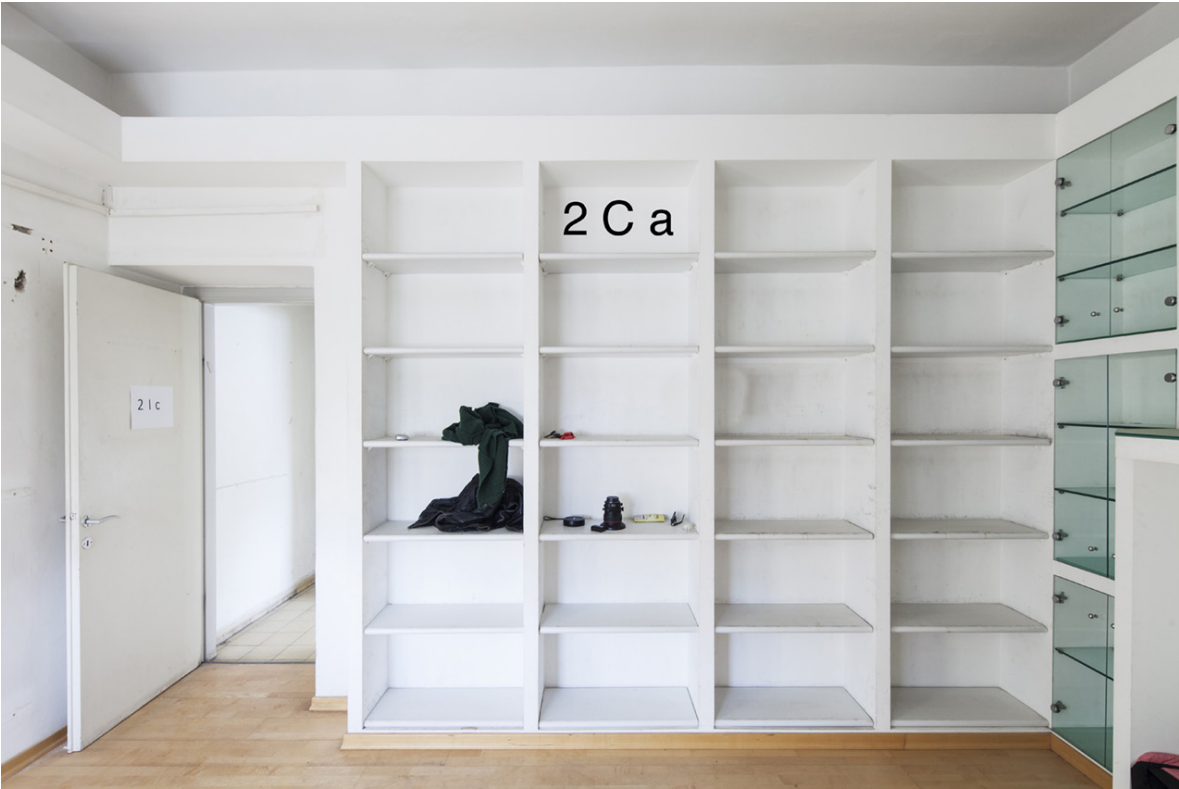
Room 02.C; _MG_3109.jpg; photo: Aviad Bar Ness, 2015

DATE		FLOOR		FUNCTION	ROOM
04/30/2015		3rd Floor		Room	02.C
ELEMENT	TYPE	DESCRIPTION	CONDITION, NOTES	DATING	ORIGINAL MATERIALS AND COLORS
FLOOR					
	F.2.1	Wood block parquet and wooden baseboard	Original terrazzo floor and base tiles beneath, condition unknown	1990s	(M4)
WALLS AND BUILT-IN ELEMENTS					
a		Plastered interior wall with a built-in shelving, dry-wall construction; open wiring	Surface renewed; shelving new	Wall and plaster 1937; shelf construction 1990s or later	M7, (C.1.1)
D02.C.01	D.1.5	Single-leaf solid door	Paint renewed and handles replaced	1937; handles 1960s-1970s	Wood: M13, (C.1.6)
b		Interior, partly exterior wall, plastered; wall-mounted air-conditioning unit and open wiring, partly covered with dry lining	Surface renewed	Wall and plaster 1937; technical installation 1990s or later	M7, (C.1.1)
W02.C.04	W.1.2	Single-leaf balcony door; three panes of clear glass	Paint renewed; roller shutter belt not original	1937; handles 1960s-1970s	Wood: M13, (C.1.6); glass: M20

c		Plastered exterior wall; window recess with a terrazzo sill; open wiring	Surface renewed	Wall and plaster 1937; wiring 1990s or later	M7, (C.1.1); sill: M3
W02.C.05	W.2.1	Double-sash casement window; original terrazzo window sill	Paint renewed, peeling off on the outside; handles replaced; roller shutter belt not original	1937; handles 1960s-1970s	Wood: M13, (C.1.6); glass: M20; sill: M3
d		Plastered interior wall with a built-in drywall construction; open wiring	Surface renewed; shelf new	Wall and plaster 1937; shelf construction 1990s or later	M7, (C.1.1)
W02.C.06	D.2.2	Double-sash casement window	Paint renewed peeling off on the outside; handles original; roller shutter belt not original	1937	Wood: M13, (C.1.6); glass: M20
CEILING					
		Beam-and-block ceiling, plaster; cornice coving along all sides with recessed halide downlights	Surface renewed	1937; light and drywall construction 1990s or later	Concrete, plaster, (C.1.1)

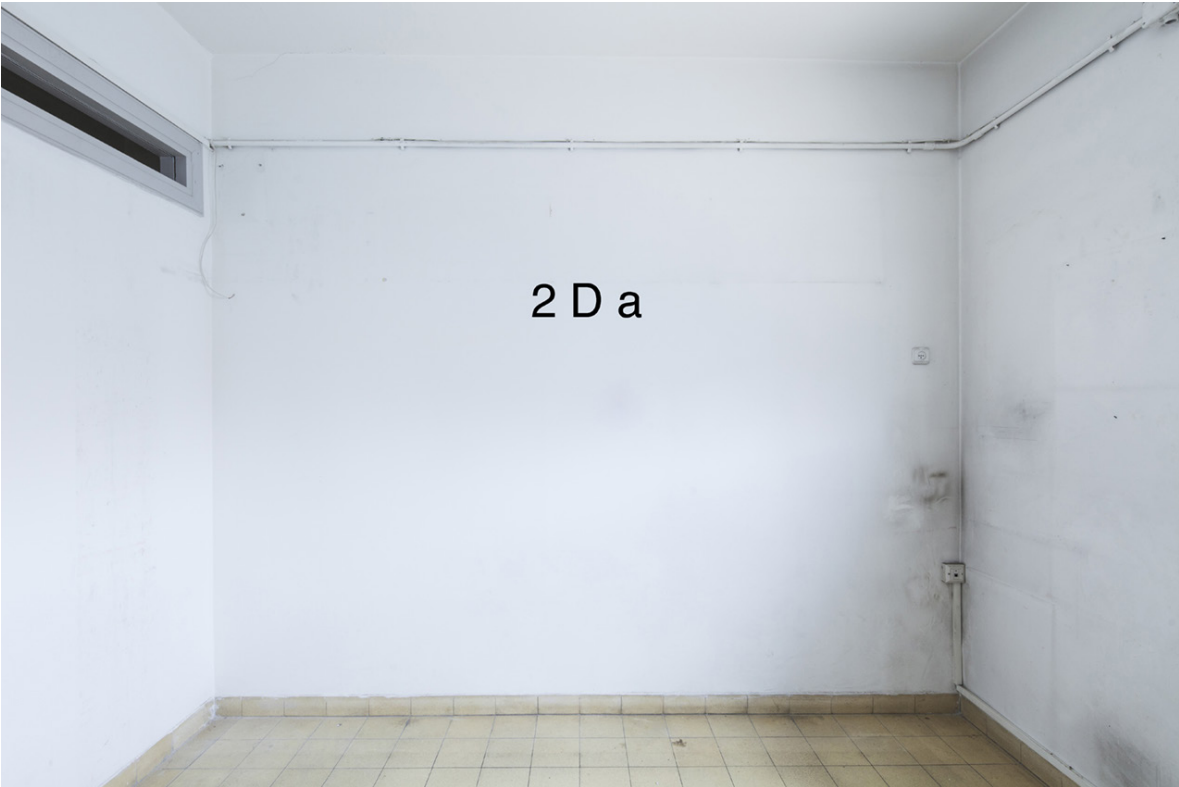
Room 02.D; _MG_3113.jpg; photo: Aviad Bar Ness, 2015

DATE		FLOOR		FUNCTION	ROOM
04/30/2015		3rd Floor		Room	02.D
ELEMENT	TYPE	DESCRIPTION	CONDITION, NOTES	DATING	ORIGINAL MATERIALS AND COLORS
FLOOR					
	F.1.1	Terrazzo floor and base tiles	Partly scratched surface, cracks, discolorations	1937	M4
WALLS AND BUILT-IN ELEMENTS					
a		Plastered interior wall; open wiring	Surface renewed	Wall and plaster 1937; wiring 1960s-1990s	M7, (C.1.1)
b		Plastered interior wall; flush-mounted light switch next to the door; open wiring	Surface renewed	Wall and plaster and light switch 1937	M7, (C.1.1); light switch: M26
W02.D.27	W.2.7	Double-sash interior sliding window	Paint renewed	1937	Wood: M13, (C.1.6); glass: M20
D02.D.01	D.1.5	Single-leaf solid door	Paint renewed and handles replaced	1937; handles 1960s-1970s	Wood: M13, (C.1.6)
c		Plastered interior wall; wall-mounted air conditioning unit, server rack and open wiring	Surface renewed	Wall and plaster 1937; technical installations 1990s or later	M7, (C.1.1)

d		Plastered interior wall; flush-mounted socket; open wiring	Surface renewed	Wall, plaster, socket 1937; wiring 1960s-1990s	M7, (C.1.1)
W02.D.07	D.2.2	Double-sash casement window	Paint renewed, partly peeling off on the outside; original handle; roller shutter belt not original	1937	Wood: M13, (C.1.6); glass: M20; handle: M21
CEILING					
		Beam-and-block ceiling, plaster; surface-mounted fluorescent lighting	Surface renewed	1937; light 1960s-1990s	Concrete, plaster, (C.1.1)
