CONSERVATION SURVEY

MAX-LIEBLING-HOUSE

29, IDELSON STREET, TEL AVIV

Tel Aviv/Berlin, 2016/17

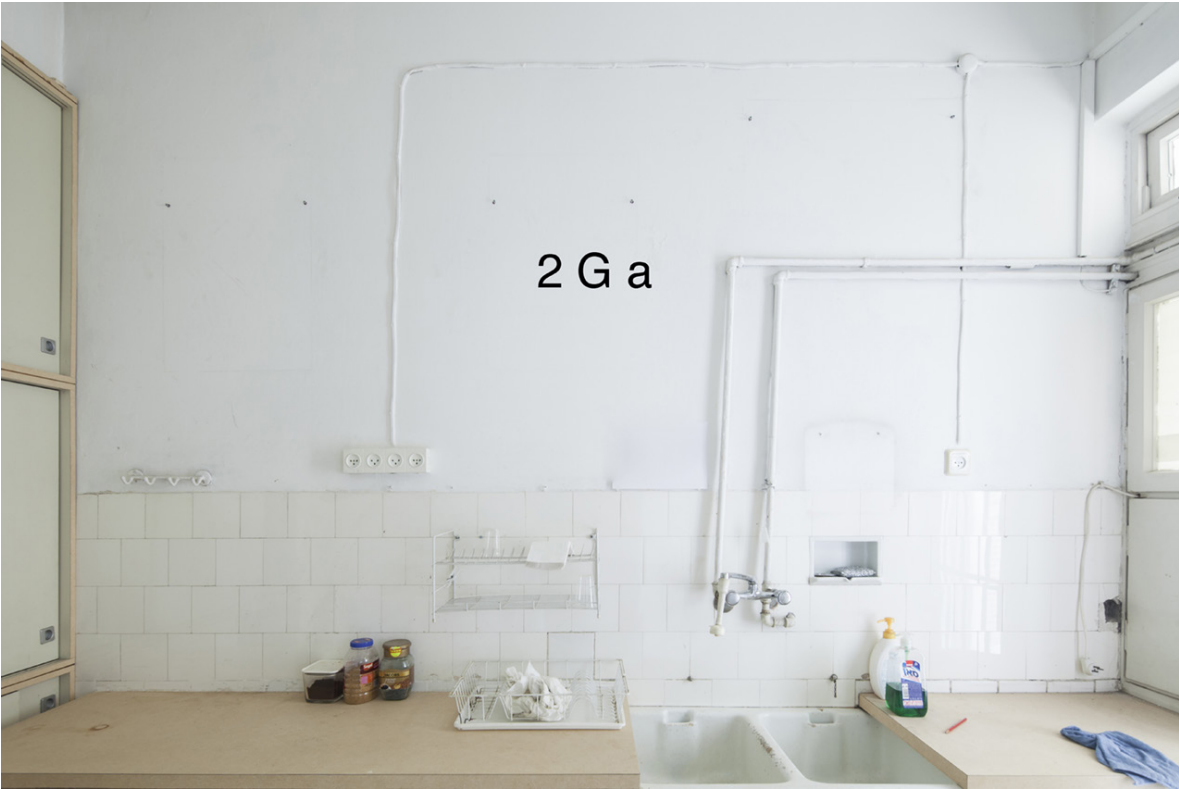
Room 02.G; _MG_3143.jpg; photo: Aviad Bar Ness, 2015

DATE		FLOOR		FUNCTION	ROOM
04/30/2015		3rd Floor		Kitchen	02.G
ELEMENT	TYPE	DESCRIPTION	CONDITION, NOTES	DATING	ORIGINAL MATERIALS AND COLORS
FLOOR					
	F.1.1	Terrazzo floor and base tiles	Partly scratched surface, cracks	1937	M4
WALLS AND BUILT-IN ELEMENTS					
a		Plastered interior wall, wall tiling up to 1.50m with an integrated ceramic soap dish; two dwarf walls and a solid plinth with tiling to receive two wooden base cabinets, a wooden countertop with remains of a natural stone counter beneath it and a ceramic sink; wall-mounted water supply with faucets; open wiring	Paint on the plaster renewed; wall tiling with soap dish original, only small repairs; position of the water supply original but lines and faucets renewed; ceramic sink original; cupboards and wooden table top new	Wall, plaster, sink and tiles 1937; natural stone slab probably original; wiring 1960s-1990s	M7, (C.1.1); tiles: M9; natural stone: M27

b		Plastered interior wall with tiling and two recesses; wooden kitchen shelf on the right (tiling up to 1.50m) with remains of a flush-mounted socket; recess for a kitchen cabinet on the left (tiling up to 2.15m); open wiring	Paint on the plaster renewed; wall tiling original and in good condition; cupboard in the right recess not original; cabinet on the left side see wall c	Wall, plaster, tiles and socket 1937; wiring 1960s-1990s	M7, (C.1.1); M9
c		Plastered interior wall with a tiled recess divided into two parts by a tiled dwarf wall; wall tiling on all sides of the recess in running bond pattern; flush-mounted socket in the left part; flush-mounted light switch next to D02.G.01; open wiring	Paint on the plaster renewed; wall tiling original and in good condition	Wall, plaster, tiles, socket and light switch 1937; wiring 1960s-1990s	M7, (C.1.1); socket and light switch: M26
Kitchen cabinet	S.5	Built-in kitchen cabinet, right side: two compartments with double doors and three drawers in the base; upper part: shelf with two sliding glass panels; left part: no fittings	Paint renewed; configuration of the cabinet original, knobs of the drawers and door leaves replaced; left recess possibly used for a refrigerator	Wall, plaster and tiles 1937; wiring 1960s-1990s	Wood: M13, (C.1.6)

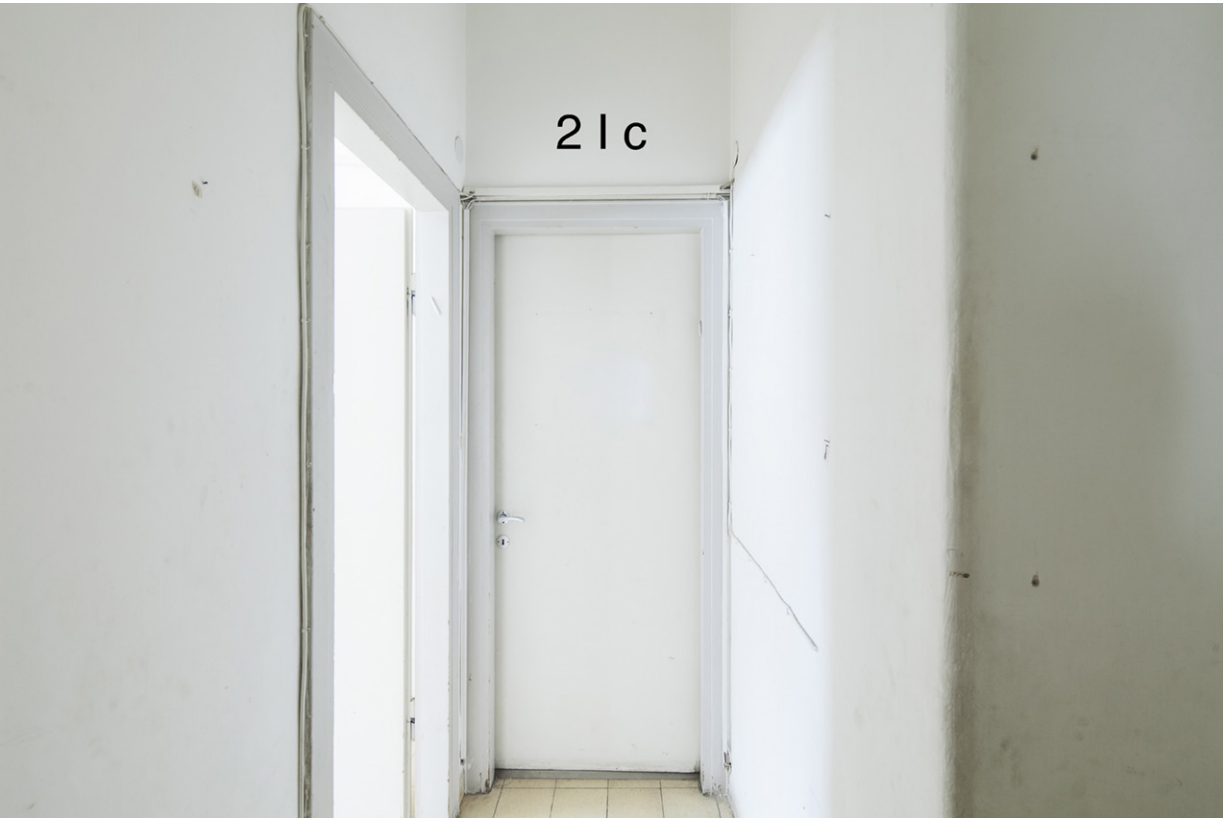
Room 02.I; _MG_3120.jpg; photo: Aviad Bar Ness, 2015

DATE	FLOOR		FUNCTION	ROOM	
04/30/2015	3rd Floor		Corridor	02.I	
ELEMENT	TYPE	DESCRIPTION	CONDITION, NOTES	DATING	ORIGINAL MATERIALS AND COLORS
FLOOR					
	F.1.1	Terrazzo floor and base tiles	Partly scratched surface, cracks; base tiles replaced at wall b adjacent to room 02.B	1937	M4
WALLS AND BUILT-IN ELEMENTS					
a		Plastered interior wall; open wiring	Surface renewed	Wall and plaster 1937; wiring 1960s-1990s	M7, (C.1.1)
D02.F.01	D.1.6	Single-leaf solid door with a small glass pane	Paint renewed and handles replaced	1937; handles 1960s-1970s	Wood: M13, (C.1.6); glass: M19
D02.G.01	D.1.6	Single-leaf solid door with a small glass pane	Paint renewed, partly peeling off; renewed handles	1937; handles 1960s-1970s	Wood: M13, (C.1.6); glass: M19
b		Plastered interior wall with a broad opening to room 01.H between two concrete columns; wall-mounted electrical distribution box	Surface renewed, distribution box new; possibly former wall opening to room 02.B (cf. 02.B, wall d)	1937; wiring and distribution box 1960s-1990s	M7, (C.1.1)

c		Plastered interior wall, open wiring	Surface renewed	Wall and plaster 1937; wiring 1960s-1990s	M7, (C.1.1)
D02.C.01	D.1.5	Single-leaf solid door with a wooden frame	Paint renewed and handles replaced	1937; handles 1960s-1970s	Wood: M13, (C.1.6)
d		Plastered interior wall; open wiring	Surface renewed	Wall and plaster 1937; wiring 1960s-1990s	M7, (C.1.1)
W02.D.27	W.2.7	Double-sash interior sliding window	Paint renewed	1937	Wood: M13, (C.1.6); glass: M20
D02.D.01	D.1.5	Single-leaf solid door	Paint renewed and handles replaced	1937; handles 1960s-1970s	Wood: M13, (C.1.6)
e		Plastered interior wall	Surface renewed	Wall and plaster 1937	M7, (C.1.1)
f		Plastered interior wall; open wiring	Surface renewed	Wall and plaster 1937; wiring 1960s-1990s	M7, (C.1.1)
D02.E.01	D.1.6	Single-leaf solid door with a small glass pane	Paint renewed and handles replaced	1937; handles 1960s-1970s	Wood: M13, (C.1.6); glass: M19

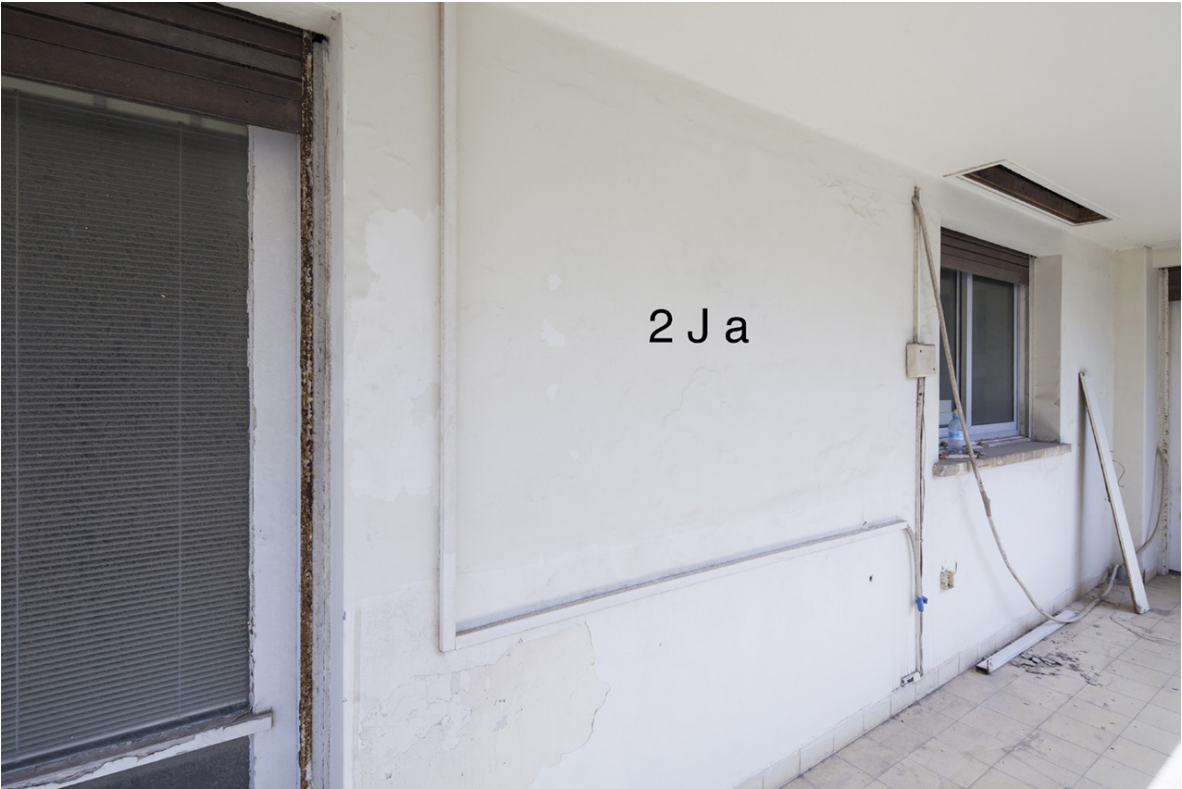
Room 02.J; _MG_3162.jpg; photo: Aviad Bar Ness, 2015

DATE		FLOOR		FUNCTION	ROOM
04/30/2015		3rd Floor		Balcony (B.1)	02.J
ELEMENT	TYPE	DESCRIPTION	CONDITION, NOTES	DATING	ORIGINAL MATERIALS AND COLORS
FLOOR					
	F.1.1	Terrazzo floor and base tiles; two floor drains with square cover plates (11.5 x 11.5cm)	Partly scratched surface, cracks; original floor drain cover plates	1937	M4; floor drain cover plates: M25
WALLS AND BUILT-IN ELEMENTS					
a		Rendered exterior wall, cased wall-mounted drainpipe in the corner to wall d; open wiring	Paint renewed	Wall and plaster 1937; paint 1990s	M7, (C.1.4)
W02.B.03	W.4.4	Double-sash aluminum sliding window with clear glass, built into an existing wooden frame construction	Frame original, new window	1937; 1960s-1990s	Wood: M13, (C.1.6)
W02.A.02	W.1.1	Double-leaf balcony door	Paint renewed and handles replaced	1937; handles 1960s-1970s	Wood: M13, (C.1.6); glass: M20
b		Rendered exterior parapet; terrazzo coping with a water drip; round steel column mounted on the coping at the corner of the balcony, with a sleeve socket at its foot and its head	Paint and terrazzo coping renewed broadly similar to the original materials; paint peeling off, cracks in the render at the connection to the coping; column probably original	Wall, plaster and column 1937; paint and coping 1990s	Railing: M7, (C.1.4); column: M23 (original color white)

c		Rendered exterior parapet; terrazzo coping with a water drip	Paint and terrazzo coping renewed broadly similar to the original materials; paint peeling off, cracks in the render at the connection to the coping	Wall and plaster 1937; paint and coping 1990s	Railing: M7, (C.1.4)
d		Rendered exterior wall	Paint renewed	Wall and plaster 1937	M7, (C.1.4)
W02.C.04	W.1.2	Single-leaf balcony door; three panes of clear glass	Paint renewed	1937; handles 1960s-1970s	Wood: M13, (C.1.6); glass: M20
CEILING					
		Plastered dropped ceiling; three openings with removable wooden covers for the shutter boxes above the windows and balcony doors; two circular ceiling lights	Paint of the wooden covers renewed; plaster probably original	Ceiling 1937; paint and lights probably 1990s	M7, (C.1.4); wood: M13, (C.1.6)

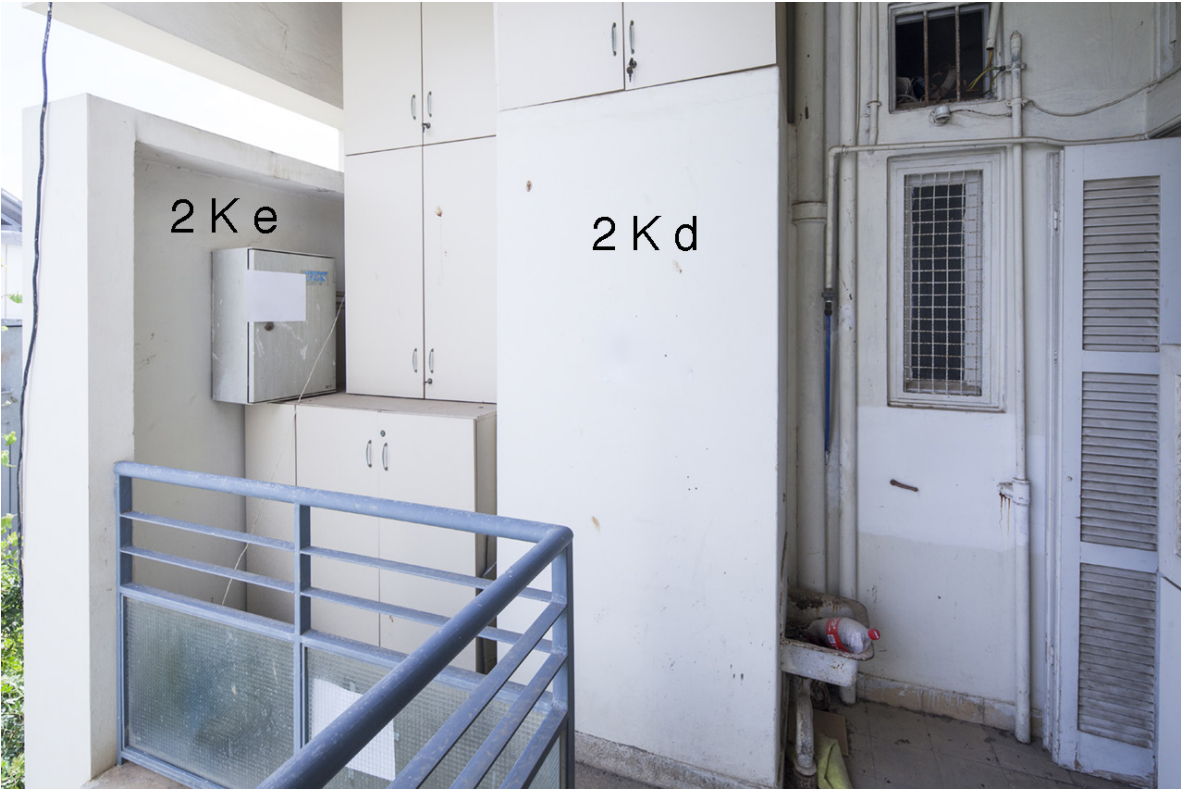
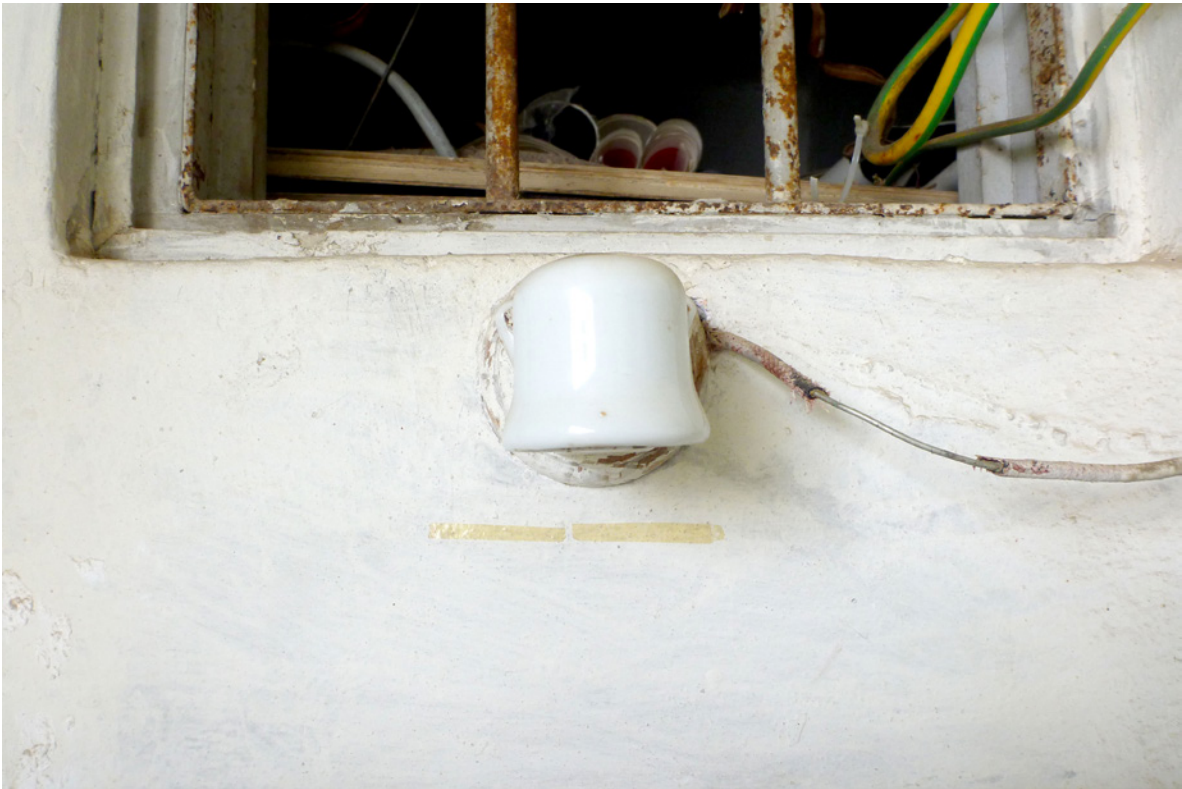
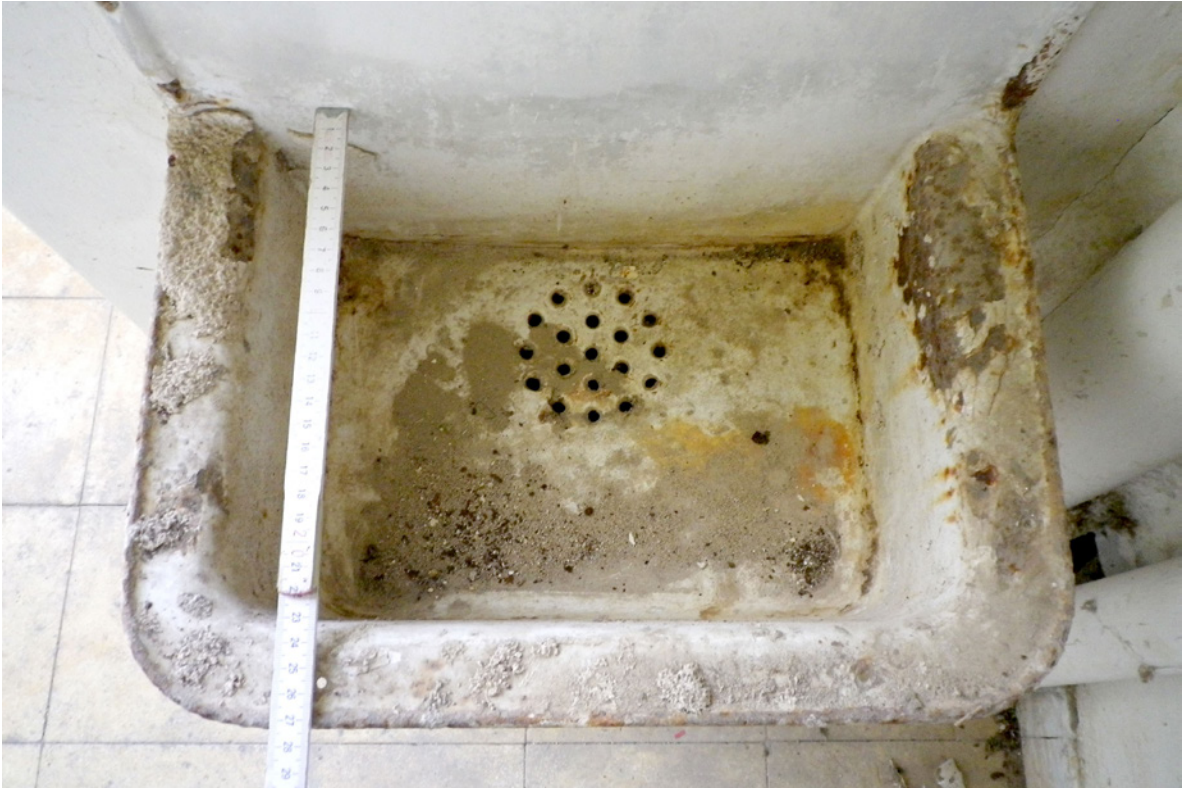
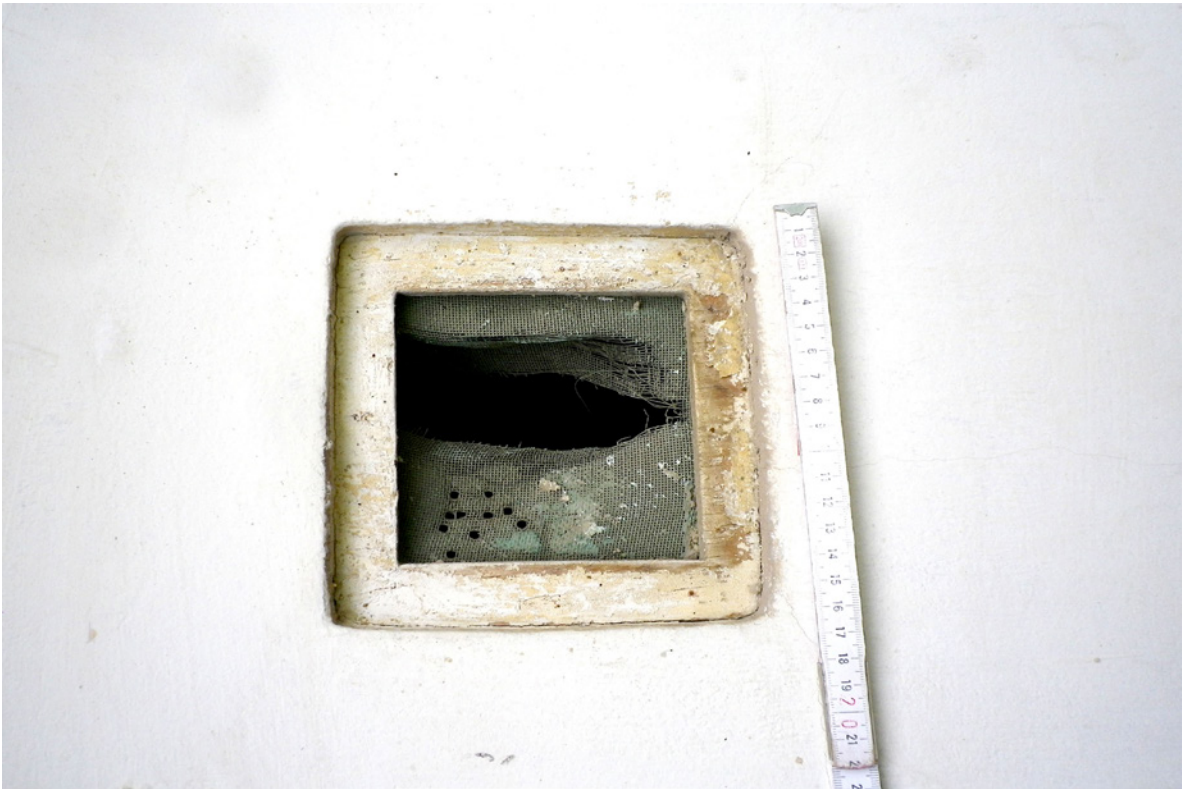
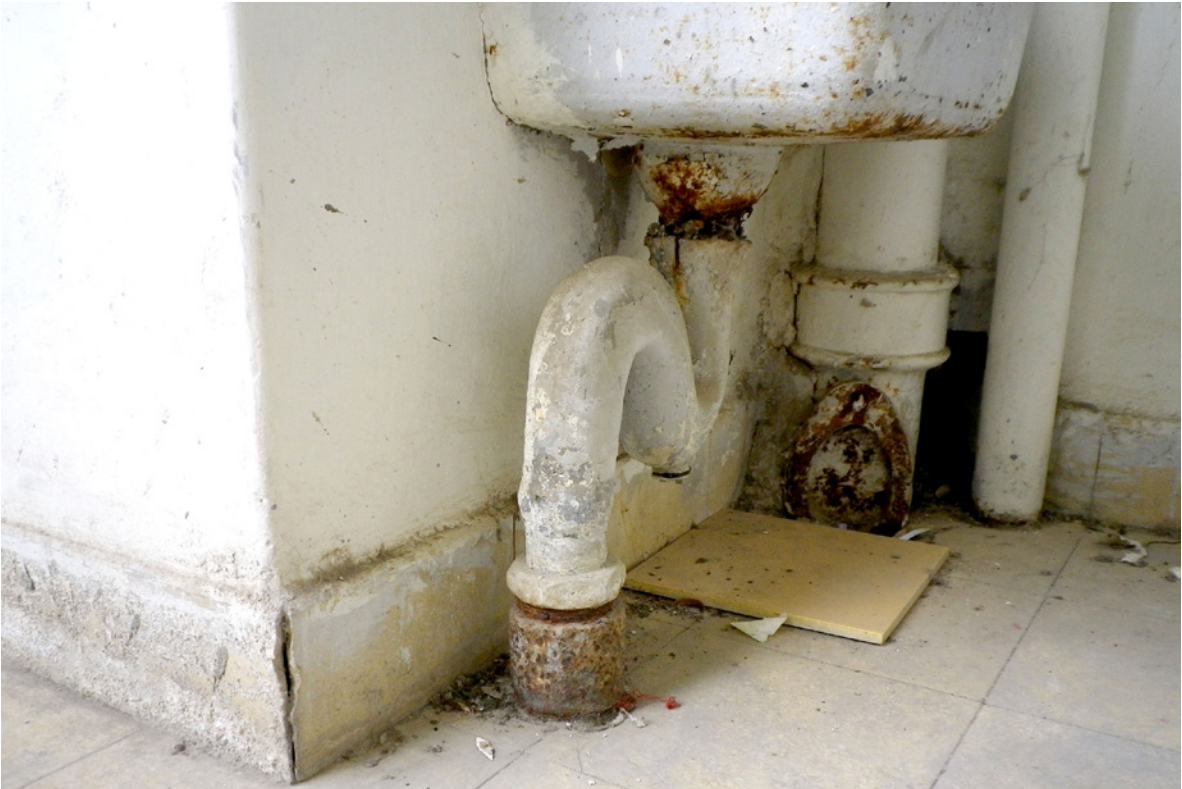
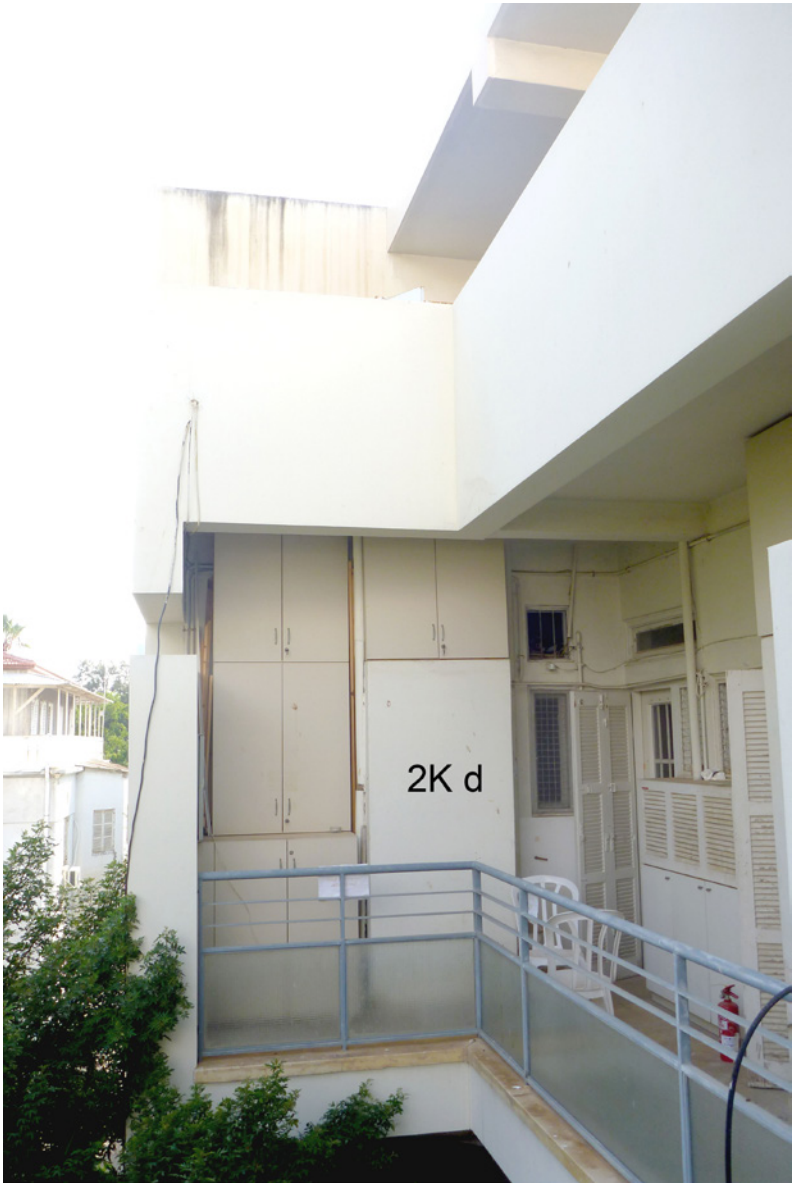
DATE		FLOOR		FUNCTION	ROOM
04/30/2015		3rd Floor		Balcony (B.2)	02.K
ELEMENT	TYPE	DESCRIPTION	CONDITION, NOTES	DATING	ORIGINAL MATERIALS AND COLORS
FLOOR					
	F.1.1	Terrazzo floor and base tiles; terrazzo curb at the balcony edge; floor drain with square cover plate (11.5 x 11.5cm)	Original flooring partly damaged, loose tiles, scratched surface, cracks, discolorations; edge blocks replaced; original drain cover	1937; balcony edge 1990s	M4; drain cover plate: M25
WALLS AND BUILT-IN ELEMENTS					
a		Rendered exterior wall with a laundry closet in a solid housing; cast-iron roof drainpipes running vertically through the closet	Paint renewed	1937	M7, (C.1.4); wood: M13, (C.1.6)
Laundry closet	S.1	Laundry closet with a hatch door combined with window W.02.P.16 of the adjacent bathroom 02.P; double doors with wooden frames and slats	Paint renewed; internal arrangement original	1937	Wood: M13, (C.1.6)

b		Rendered exterior wall; cast-iron drainage and water pipes running vertically in front of the facade; several open installations for water and electricity	Paint renewed	Wall, plaster, drainage and water pipes 1937; paint, technical installations and wiring 1960s-1990s	M7, (C.1.4)
W02.P.16	W.2.4	Double-sash window with an exterior metal grille combined with an adjacent laundry opening with two vertical iron bars	Paint renewed and partly peeling off; laundry hatch door missing; original handles; grille and iron bars not original; shutters missing	1937; grille and iron bars later	Wood: M13, (C.1.6); handles: M21
c		Rendered exterior wall, projection of the built-in food cabinet in the kitchen 02.R; wall-mounted wooden food cabinet and additional cupboard below; drainpipe running vertically in front of the facade; several open installations for water and electricity	Traces of an enameled steel sink below the food cabinet (cf. 01.K); paint renewed; additional cupboard new	Wall, plaster, wall-mounted cupboard 1937; paint, technical installations and wiring 1960s-1990s	M7, (C.1.4)

W02.Q.15	W.3.1	Single-sash window with a metal grille and wire mesh	Paint renewed, partly peeling off; grille probably original; original handle	1937	Wood: M13, (C.1.6); glass: M19; handle: M21 steel: M23
W02.R.14	W.1.3	Single-leaf balcony door with three panes of clear glass, a wooden board fixed across the inside, a locking bolt, a grille mounted on the inside; wooden exterior shutters with slats	Paint renewed, partly peeling off; lower part of the frame damaged; grille probably original; horizontal board not original; handles missing; locking bolt added subsequently	1937; bolt probably 1960s-1990s	Wood: M13, (C.1.6); glass: M20; grille: M23
W02.R.13	W.3.4	Single-sash window combined with two hatch doors to the exterior food cabinet; grille and wire mesh on the outside of the window	Paint renewed, partly peeling off; lower part of the frame damaged; original glass broken; grille and mesh probably original	1937	Wood: M13, (C.1.6); glass: M20; handles: M21; grille: M23

W02.E.08	D.2.3	Double-sash window combined with two laundry hatch doors below	Paint renewed; handles original	1937	Wood: M13, (C.1.6); glass: M19; handles: M21
e		Solid side wall of the balcony consisting of a wall with a recess, a horizontal slit and fascia; open wiring and a wall-mounted distribution box	Paint renewed; distribution box new	1937; 1990s	M7, (C.1.4)
f/g		Railing, probably powder-coated steel construction with wire glass panels and a round handrail	Renewed referring to the historical construction	1990s	
CEILING					
		Beam-and-block ceiling, plaster	Paint renewed	1937	M7, (C.1.4)

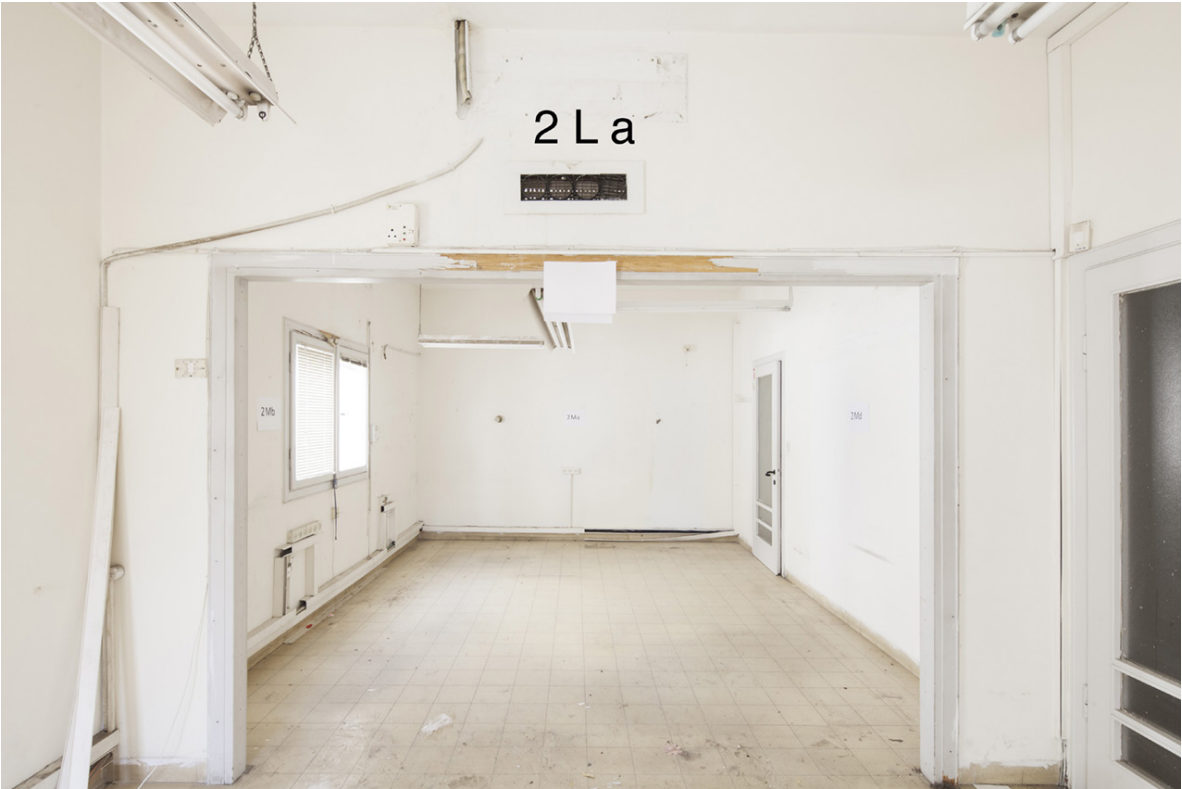
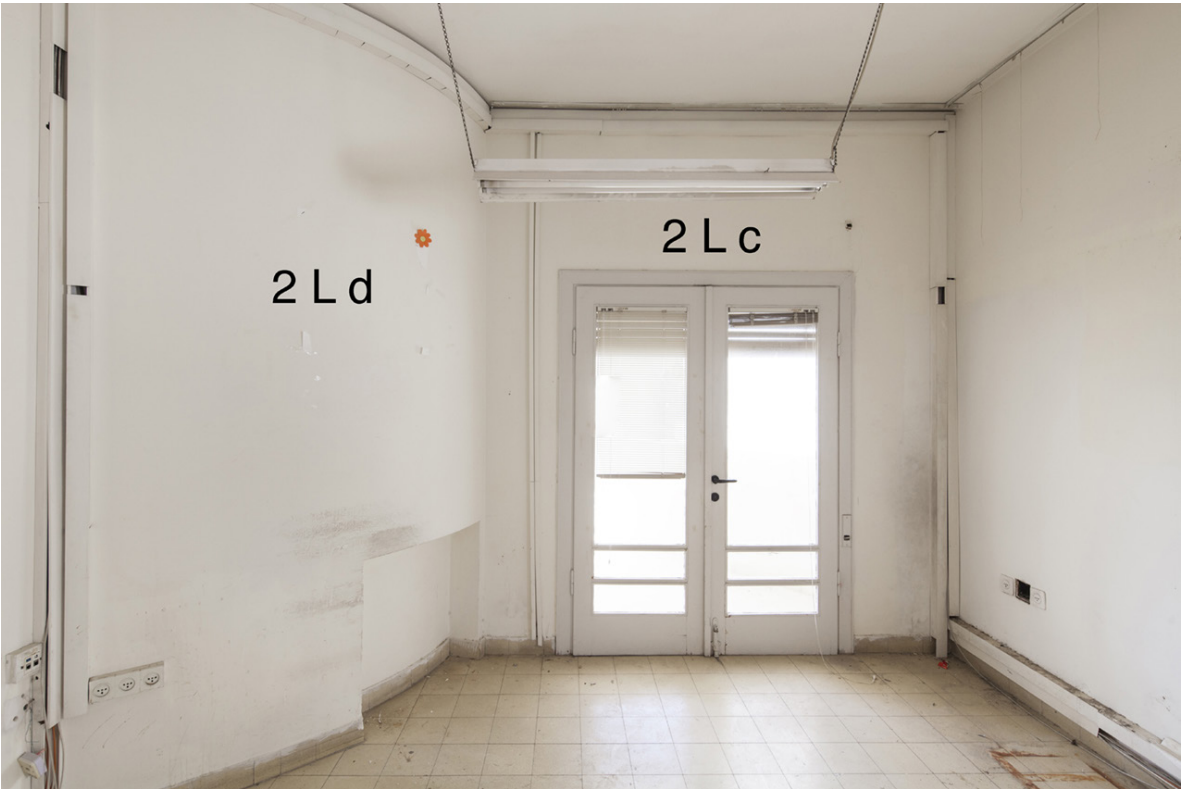
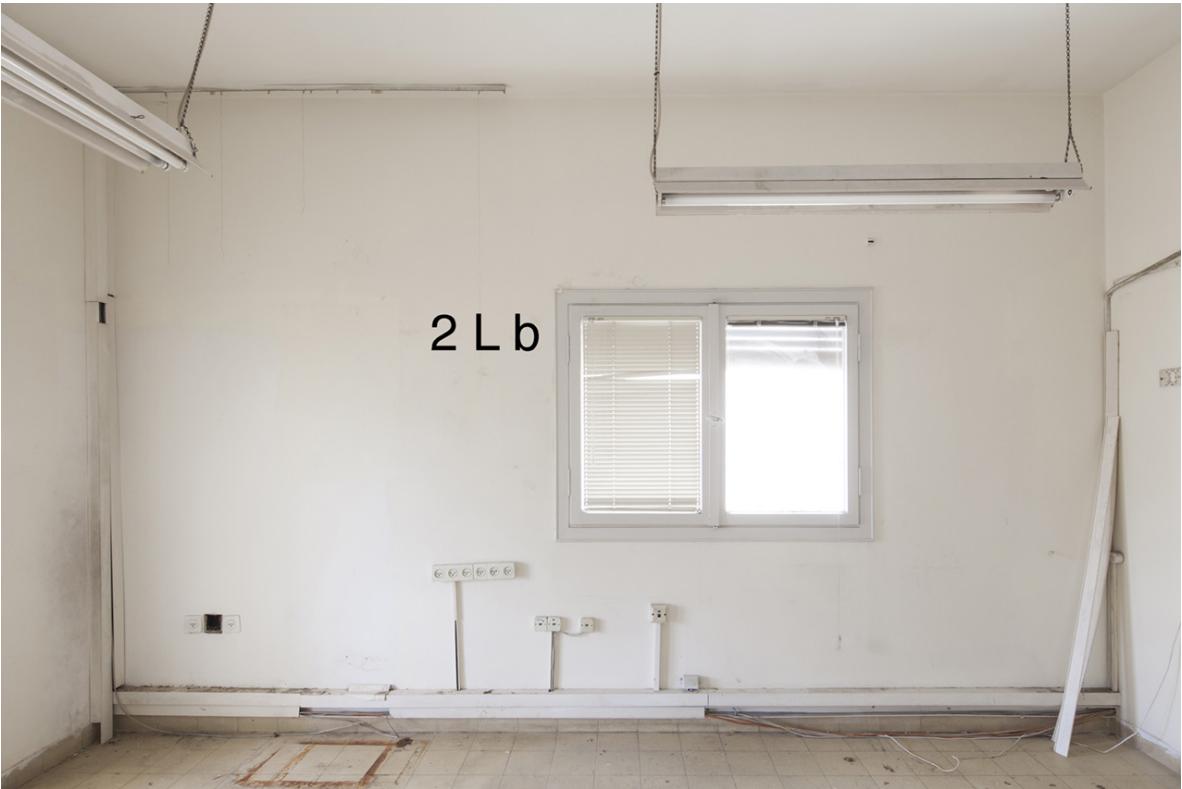
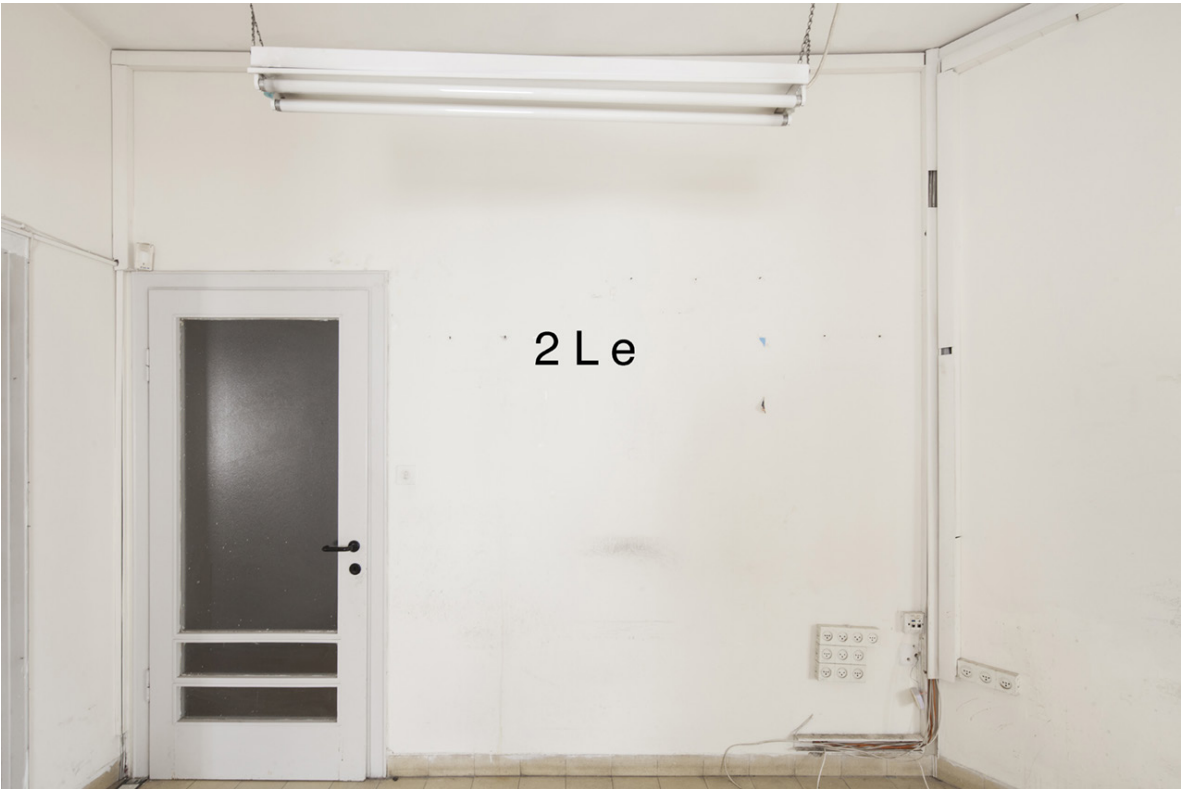
DATE		FLOOR		FUNCTION	ROOM
04/30/2015		3rd Floor		Parlor	02.L
ELEMENT	TYPE	DESCRIPTION	CONDITION, NOTES	DATING	ORIGINAL MATERIALS AND COLORS
FLOOR					
	F.1.1	Terrazzo floor and base tiles	Partly scratched surface, cracks	1937	M4
WALLS AND BUILT-IN ELEMENTS					
a		Plastered interior wall with a broad door opening to room 02.M; plastic ventilation grille with a wooden frame above the door; open wiring	Surface renewed	Wall and plaster 1937; wiring and grille 1960s-1990s	M7, (C.1.2)
D02.M.02	D.2.1	Door opening with a wooden frame, formerly with four leaves	Paint renewed, partly peeling off	1937	Wood: M13, (C.1.6) (pine); glass: M19
b		Plastered exterior wall; three flush-mounted sockets; open wiring	Surface renewed, flush-mounted sockets original, one cover missing	Wall, plaster and flush-mounted sockets 1937; wiring 1960s-1990s	M7, (C.1.2); sockets: M26
W02.L.24	W.2.1	Double-sash casement window	Paint renewed, partly peeling off; original handles painted white; shutter belt missing	1937	Wood: M13, (C.1.6); glass: M20; handles: M21

c		Plastered exterior wall; open wiring	Surface renewed	Wall and plaster 1937	M7, (C.1.2)
W02.L.25	W.1.1	Double-leaf balcony door with a wooden frame; three panes of clear glass	Paint renewed, partly peeling off; handles replaced	1937; handles 1990s or later	Wood: M13, (C.1.6); glass: M20
d		Rounded interior wall, probably concrete, plastered; open wiring; wall recess, formerly probably used as radiator recess	Surface renewed; radiator recess cf. 00.L and 01.L	Wall and plaster 1937; wiring 1960s-1990s	M7, (C.1.2)
e		Plastered interior wall; flush-mounted light switch next to the door; open wiring	Surface renewed	Wall, plaster and light switch 1937; wiring 1960s-1990s	M7, (C.1.2); light switch: M26
D02.L.01	D.1.3	Single-leaf door with a wooden frame; three panes of textured glass	Paint renewed and handles replaced	1937; handles 1990s or later	Wood: M13, (C.1.6); glass: M19
CEILING					
		Beam-and-block ceiling, plaster; suspended louvered luminaires	Surface renewed	1937; technical installations 1960s-1990s	Concrete, plaster, (C.1.2)

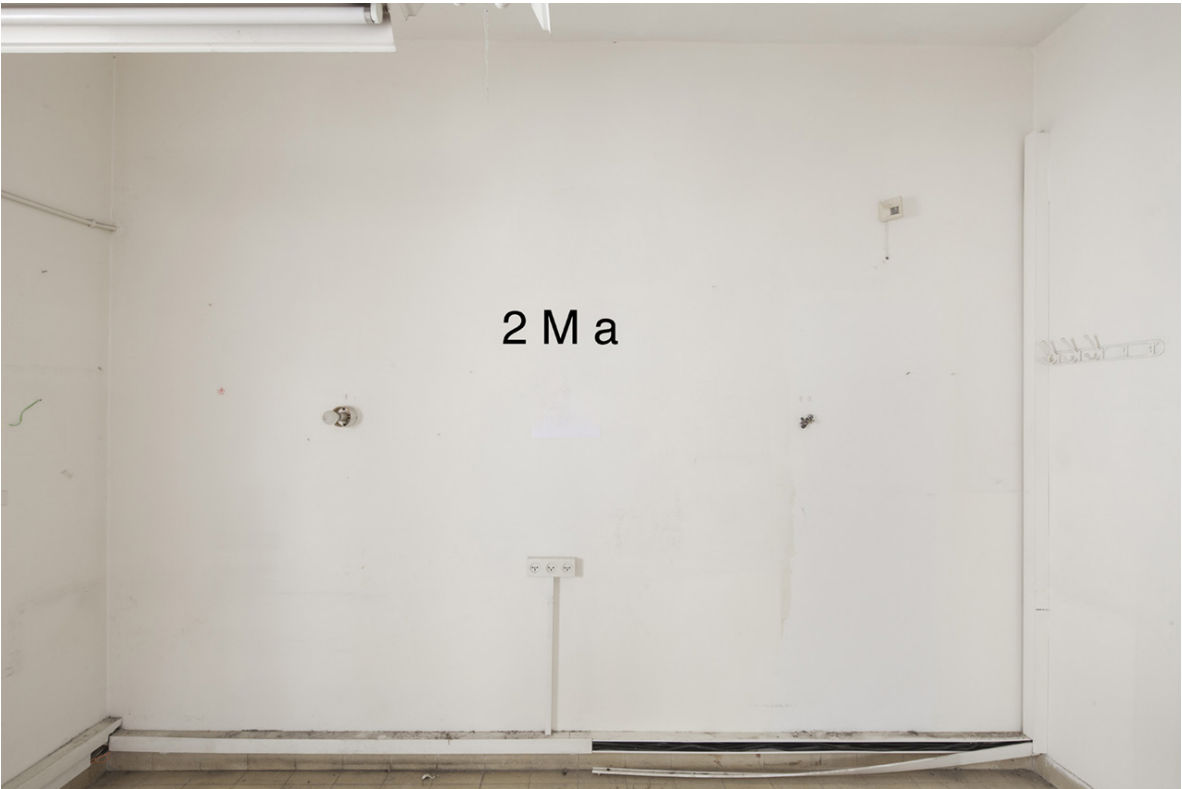
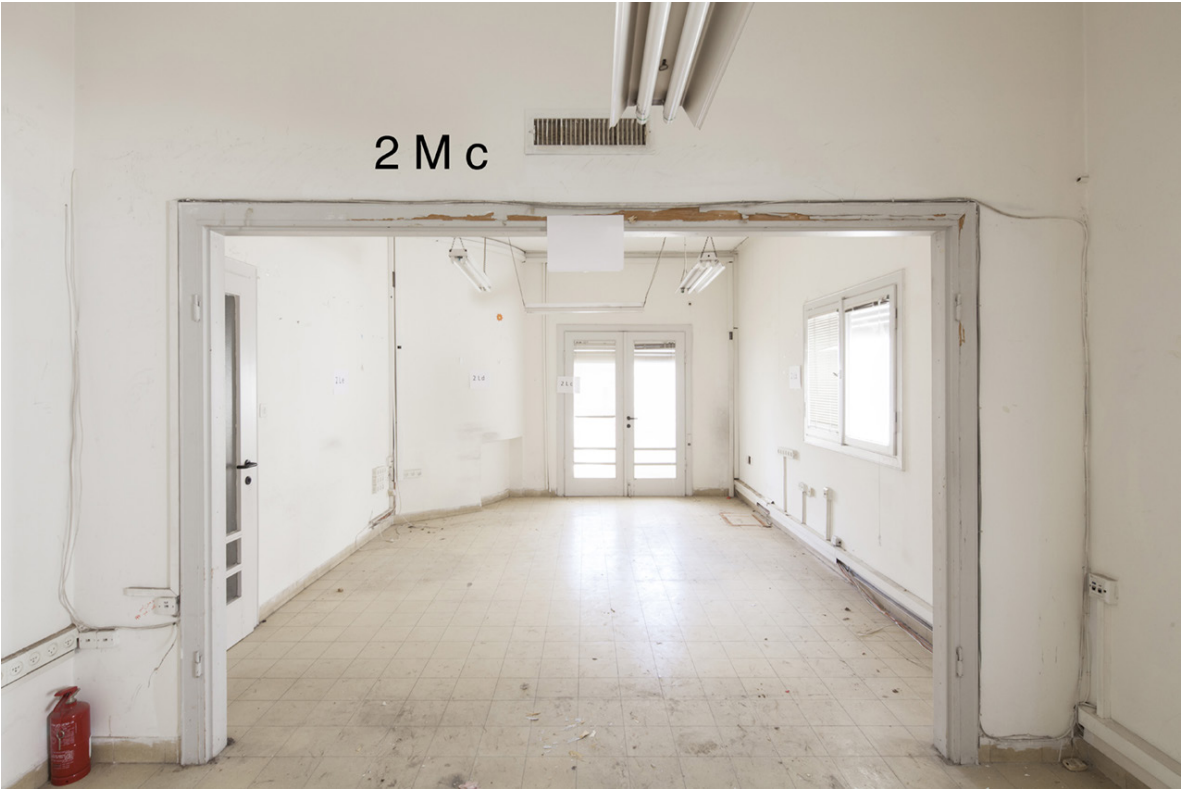
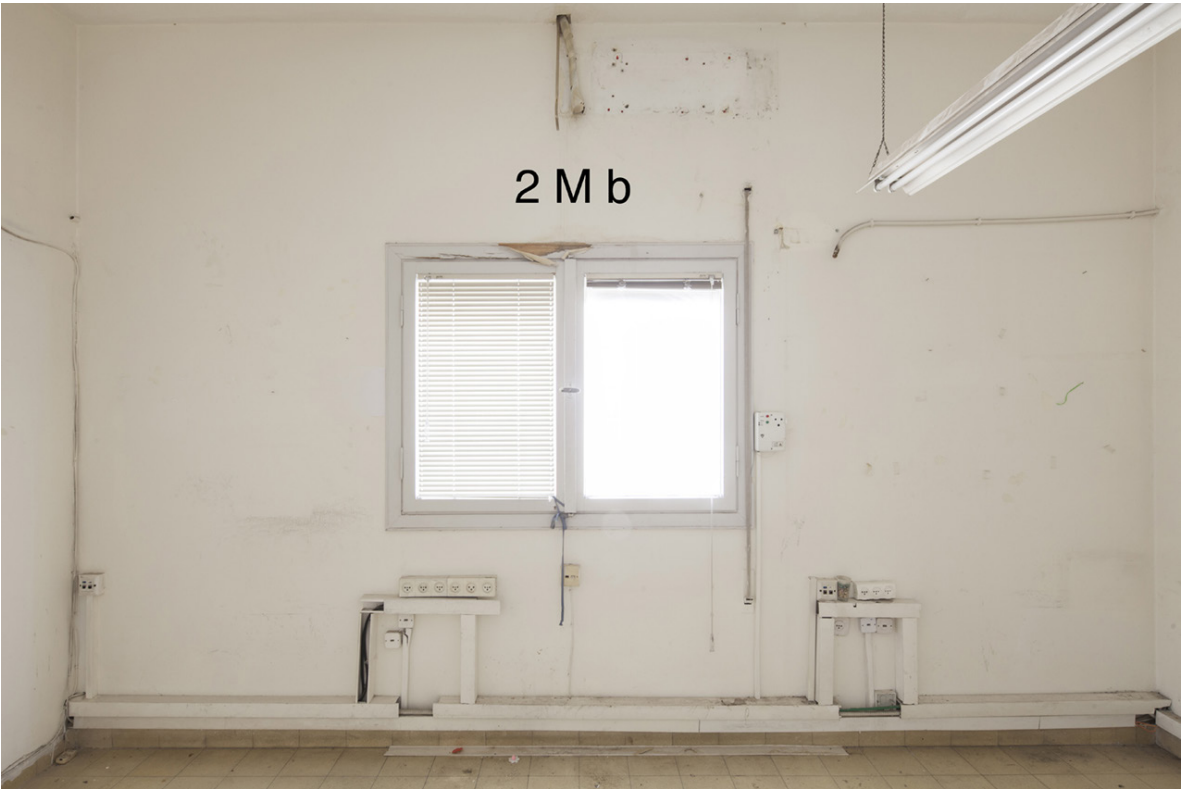
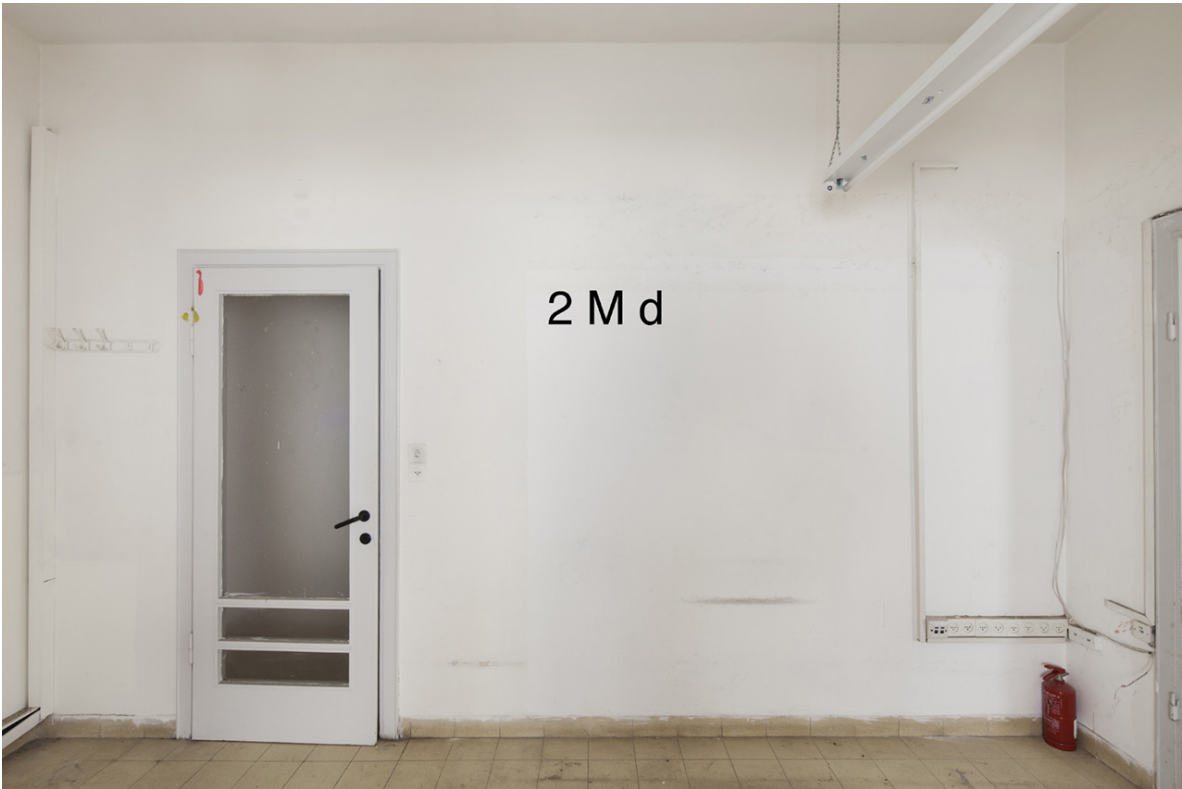
DATE		FLOOR		FUNCTION	ROOM
04/30/2015		3rd Floor		Room	02.M
ELEMENT	TYPE	DESCRIPTION	CONDITION, NOTES	DATING	ORIGINAL MATERIALS AND COLORS
FLOOR					
	F.1.1	Terrazzo floor and base tiles	Partly scratched surface, cracks	1937	M4
WALLS AND BUILT-IN ELEMENTS					
a		Plastered interior wall; wall-mounted lighting fixture; open wiring	Surface renewed	Wall and plaster 1937; wiring and lighting fixture 1960s-1990s	M7, (C.1.2)
b		Plastered exterior wall; flush-mounted socket; open wiring	Surface renewed	Wall, plaster and socket 1937; wiring 1960s-1990s	M7, (C.1.2); socket: M26
W02.M.23	W.2.1	Double-sash casement window	Renewed paint partly peeling off; original handles, painted white; roller shutter belt not original	1937	Wood: M13, (C.1.6); glass: M20; handles: M21
c		Plastered interior wall with a broad door opening to room 02.L; plastic ventilation grille above the door; open wiring	Surface renewed	Wall and plaster 1937; wiring and grille 1960s-1990s	M7, (C.1.2)

D02.M.02	D.2.1	Door opening with a wooden frame, formerly with four leaves	Leaves missing, renewed paint partly peeling off	1937	Wood: M13, (C.1.6, pine); glass: M19
d		Plastered interior wall; flush-mounted socket and light switch next to the door; open wiring	Surface renewed; light switch and socket original	Wall, plaster, socket and light switch 1937; wiring 1960s-1990s	M7, (C.1.2); socket, light switch: M26
D02.M.01	D.1.3	Single-leaf door with a wooden frame; three panes of textured glass	Paint renewed and handles replaced	1937; handles 1990s	Wood: M13, (C.1.6); glass: M19
CEILING					
		Beam-and-block ceiling, plaster; suspended louvered luminaires; cable bushing of an air-conditioning unit on wall b	Surface renewed	1937; lights and cable bushing 1960s-1990s	Concrete, plaster, (C.1.2)
