CONSERVATION SURVEY

MAX-LIEBLING-HOUSE

29, IDELSON STREET, TEL AVIV

Tel Aviv/Berlin, 2016/17

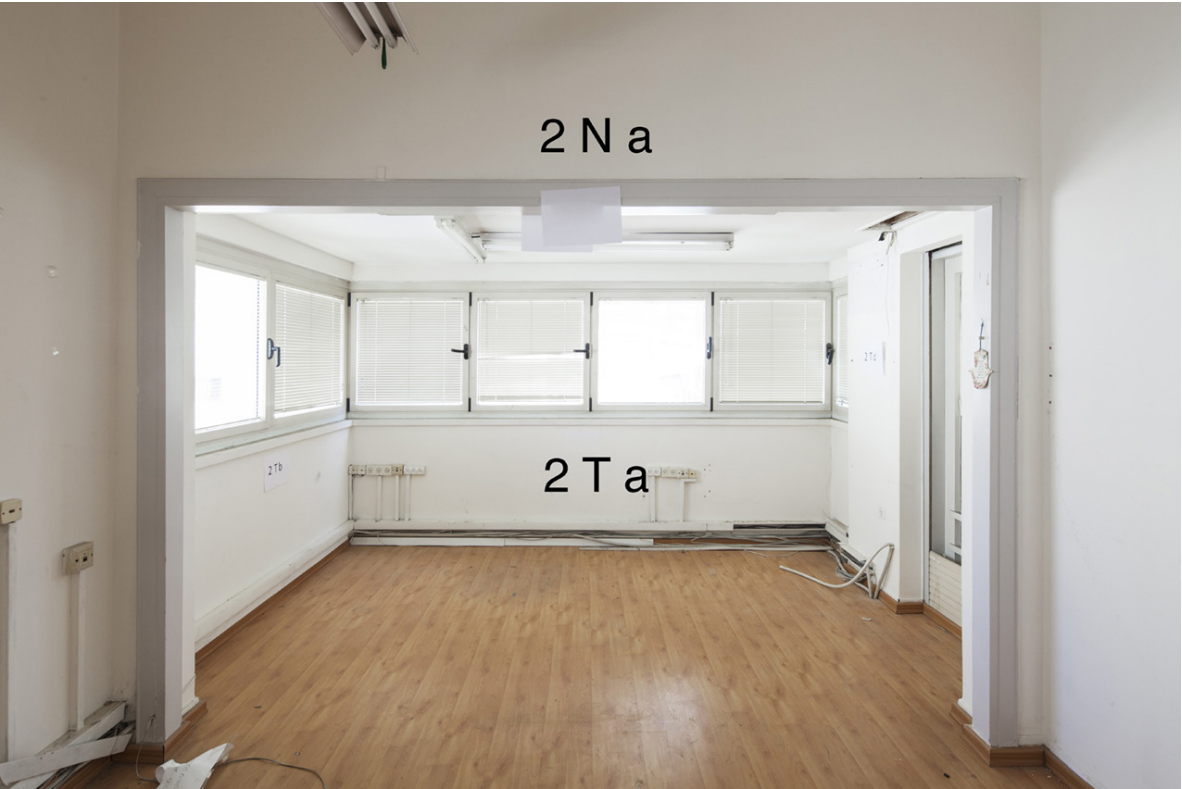
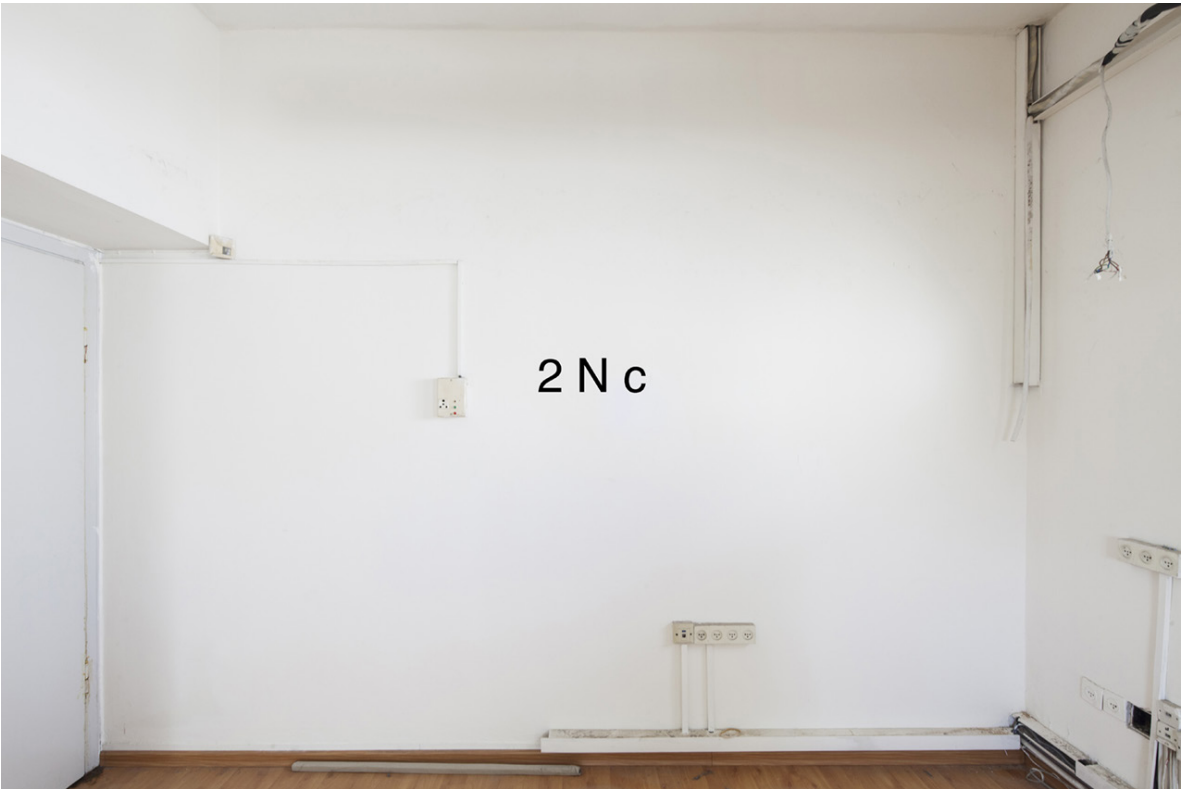
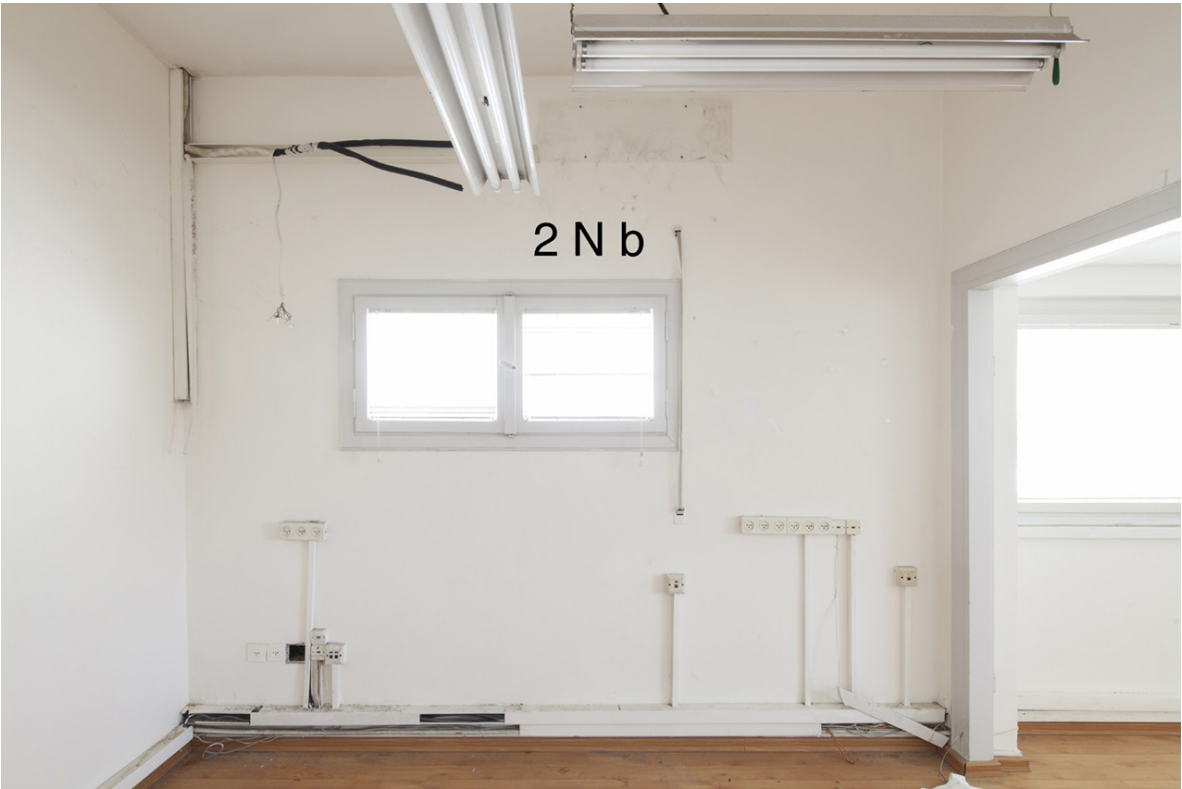
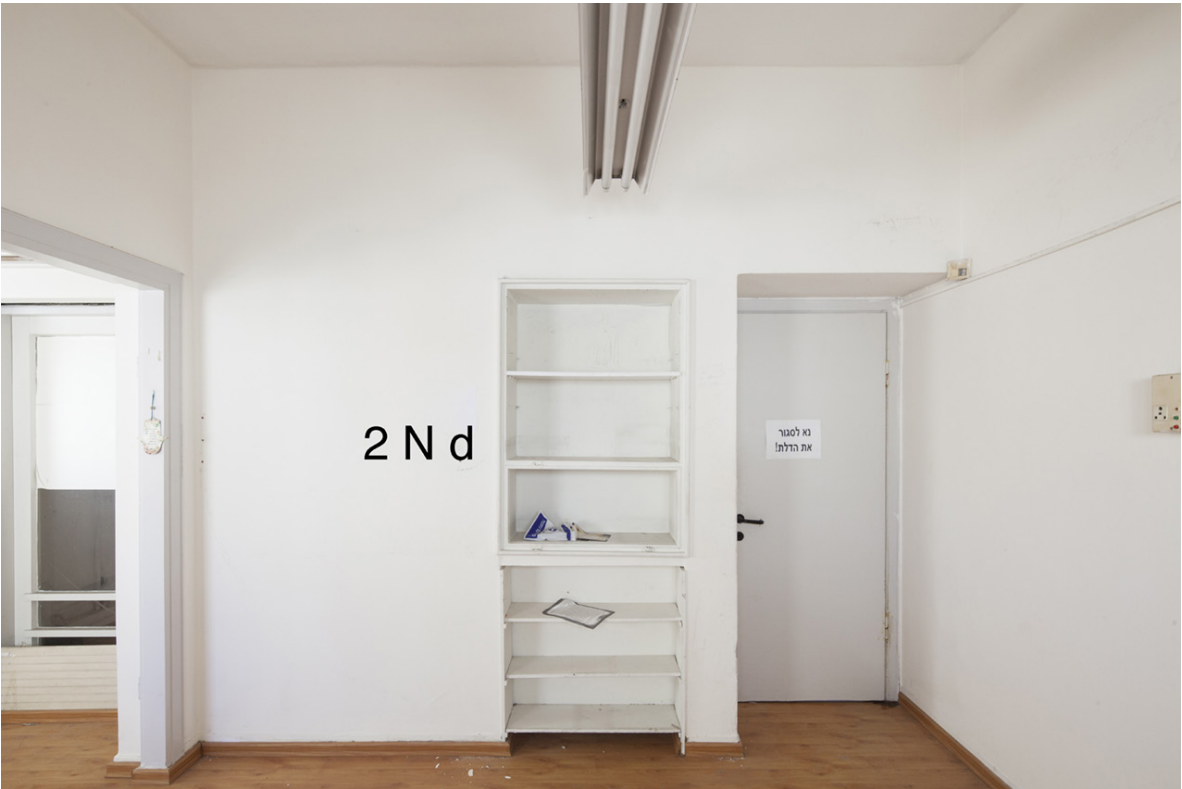
DATE		FLOOR		FUNCTION	ROOM
04/30/2015		3rd Floor		Room	02.N
ELEMENT	TYPE	DESCRIPTION	CONDITION, NOTES	DATING	ORIGINAL MATERIALS AND COLORS
FLOOR					
	F.2.1	Wood block parquet and wooden baseboard	Original terrazzo floor and base tiles beneath, condition unknown	1990s or later	(M4)
WALLS AND BUILT-IN ELEMENTS					
a		Plastered interior wall with a broad door opening to room 02.T	Surface renewed	Wall and plaster 1937	M7, (C.1.1)
W02.T.20	W.2.1	Door opening with a wooden frame, formerly probably four leaves (cf. D02.M.02)	Door leaves missing, renewed paint partly peeling off	1937	M13, (C.1.6)
b		Plastered exterior wall; three flush-mounted sockets; open wiring	Surface renewed; flush-mounted sockets original, one cover missing	Wall, plaster and sockets 1937	M7, (C.1.1); sockets: M26
W02.N.22	W.2.5	Double-sash casement window; original handles	Paint renewed, partly peeling off; original handles, painted white; roller shutter belt not original	1937	Wood: M13, (C.1.6); glass: M20; handles: M21

c		Plastered interior wall; open wiring	Surface renewed	Wall and plaster 1937; wiring 1960s-1990s	M7, (C.1.1)
d		Plastered interior wall with a built-in cabinet on the right side; flush-mounted light switch in the door recess	Surface renewed	Wall, plaster and light switch 1937	M7, (C.1.1); light switch: M26
D02.N.01	D.1.5	Single-leaf solid door with a wooden frame	Paint renewed and handles replaced	1937; handles 1990s or later	Wood: M13, (C.1.6)
Furniture	S.8	Built-in closet divided by a solid shelf into a lower and an upper part; both fitted with wooden frames and shelves; lowest compartment of the upper part was formerly closed with sliding panels, the upper two parts with a side-hung door; frame of the upper part with a half-round trim	Upper part original; sliding and side-hung cabinet doors missing, shelves not original; base part replaced subsequently	1937; lower partition later	Wood: M13, (C.1.6)

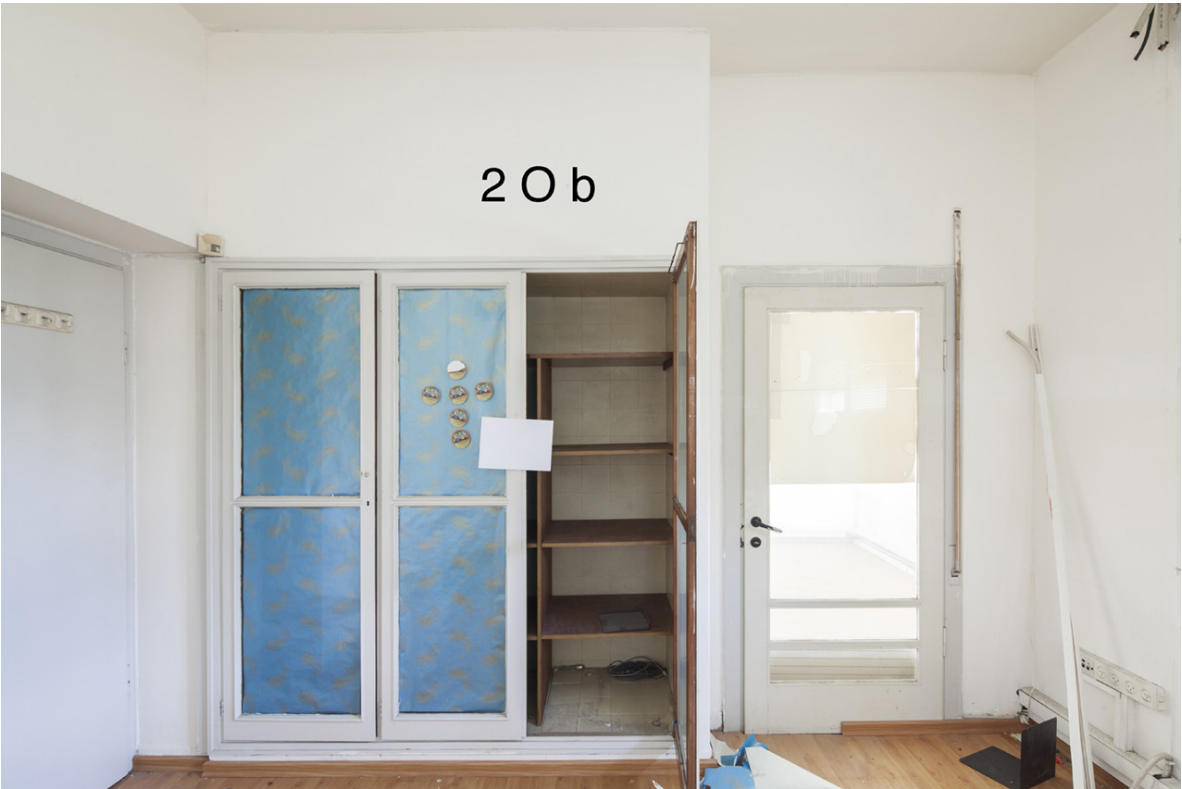
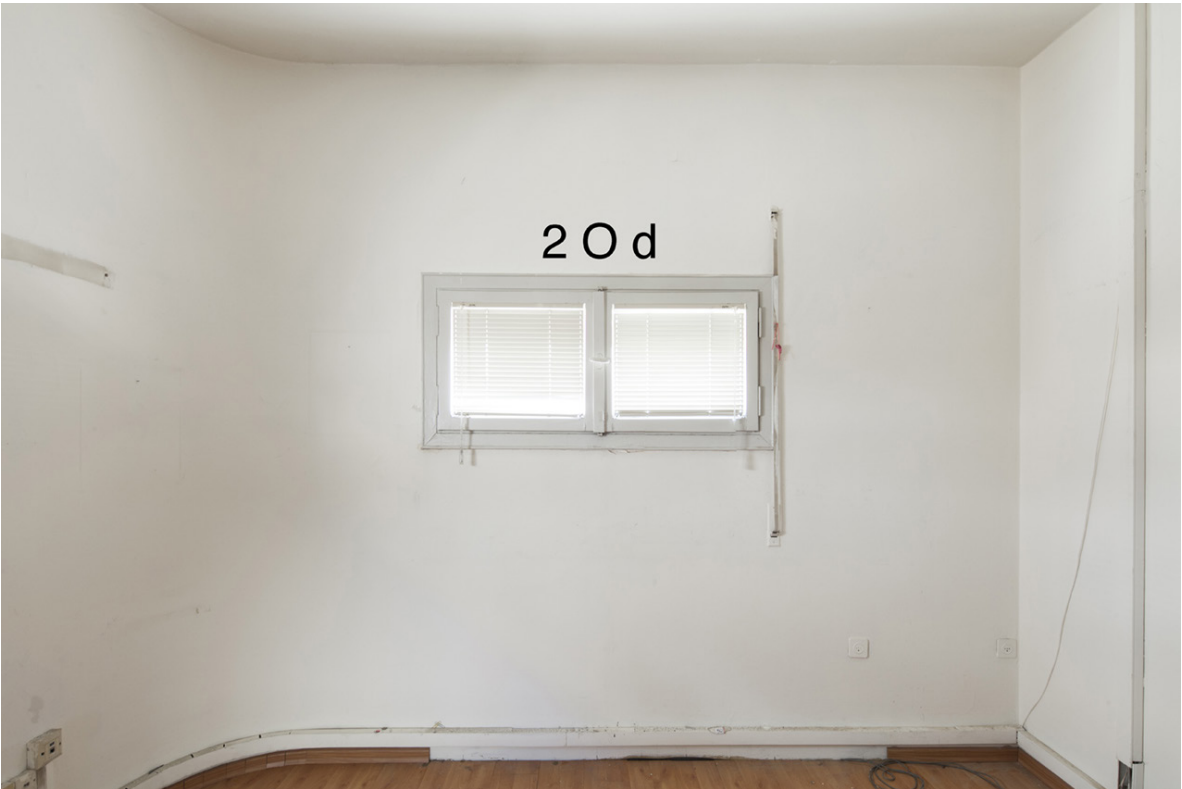
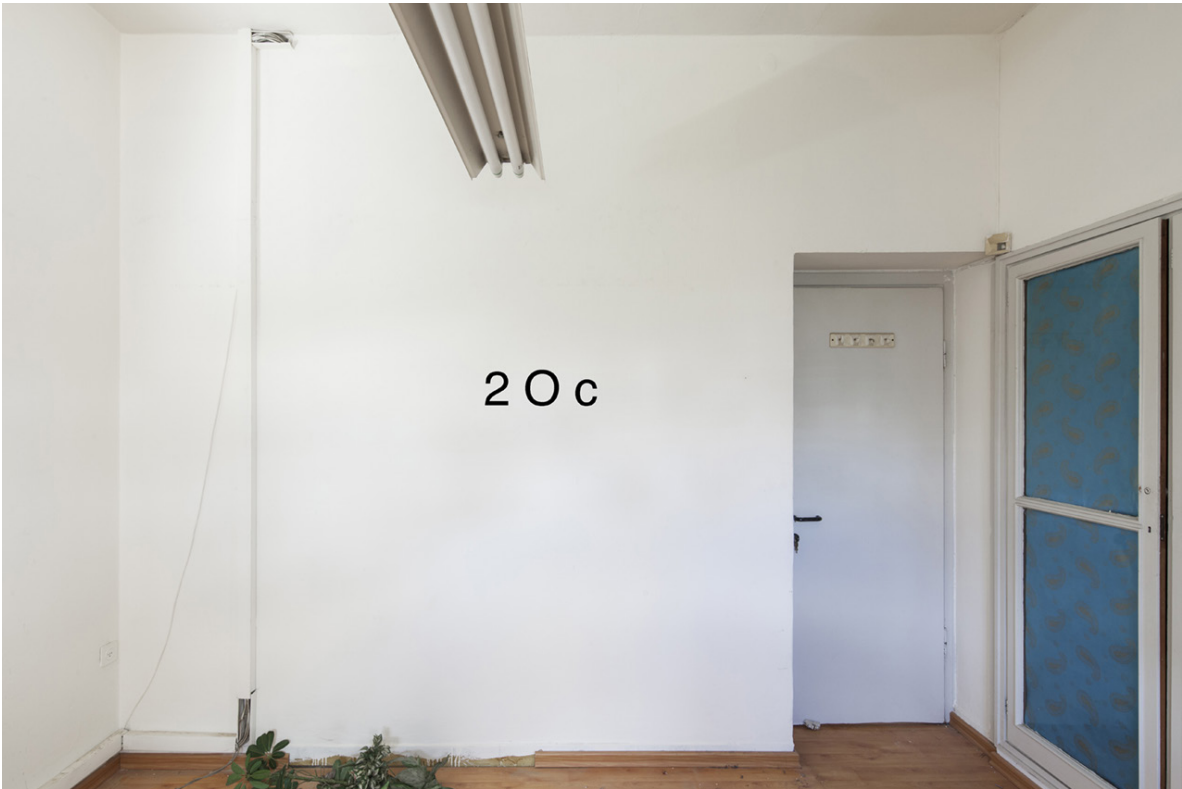
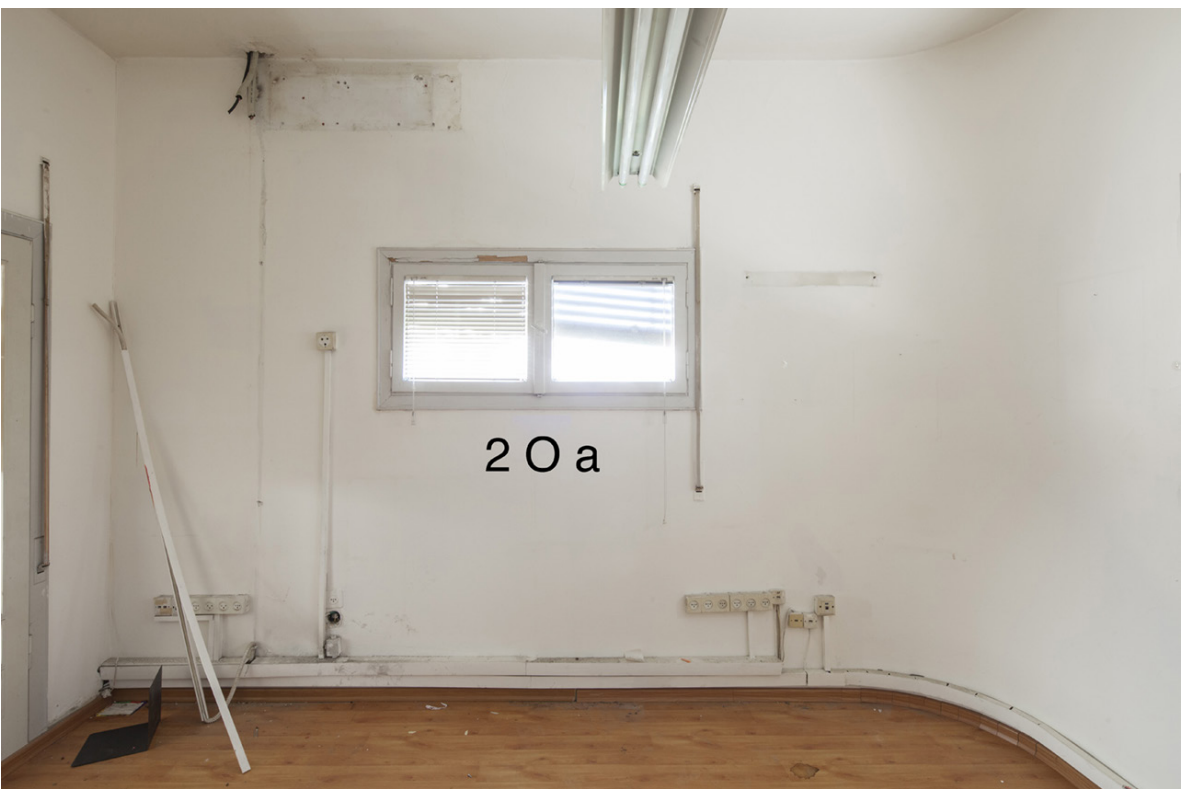
DATE		FLOOR		FUNCTION	ROOM
04/30/2015		3rd Floor		Room	02.O
ELEMENT	TYPE	DESCRIPTION	CONDITION, NOTES	DATING	ORIGINAL MATERIALS AND COLORS
FLOOR					
	F.2.1	Wood block parquet and wooden baseboard	Original terrazzo floor and base tiles beneath, condition unknown	1990s or later	(M4)
WALLS AND BUILT-IN ELEMENTS					
a		Plastered exterior wall with a rounded corner on the left side; flush-mounted socket; open wiring	Surface renewed; shutter belt not original	Wall, plaster and socket 1937; wiring 1960s-1990s	M7, (C.1.1); socket: M26
W02.O.18	W.2.5	Double-sash casement window	Paint renewed; original handles, painted white	1937	Wood: M13, (C.1.6); glass: M20; handles: M21
b		Plastered interior wall with a recess for a built-in cabinet	Surface renewed	Wall and plaster 1937	M7, (C.1.1)
W02.O.19	W.1.2	Single-leaf balcony door; three panes of clear glass	Paint renewed; original roller shutter partly preserved; roller shutter belt partly original	1937; handles probably 1990s or later	Window: M13, (C.1.6); shutter: M14; glass: M20

Wardrobe closet	S.8	Wardrobe and cabinet with two vertical partitions built into a wall recess; three doors with two glass panes each, slender profiled wooden frame; left partition provided with two sorts of drawer; right part with wall tiling and with remains of a clothes rail; secret compartment in the partition wall between the two parts	Preserved in original state only new shelves in the right partition added and clothes rail missing; right compartment formerly used as a wardrobe	1937	Wood: M13, (C.1.6); glass: M20; tiles: M9
c		Plastered interior wall; flush-mounted light switch in the door recess; open wiring	Surface renewed	Wall, plaster and light switch 1937	M7, (C.1.1); light switch: M26
D02.O.01	D.1.5	Single-leaf solid door with a wooden frame	Paint renewed and handles replaced	1937; handles 1990s or later	Wood: M13, (C.1.6)
d		Plastered interior wall; two flush-mounted sockets; open wiring	Surface renewed	Wall, plaster and sockets 1937; wiring 1960s-1990s	M7, (C.1.1); sockets: M26

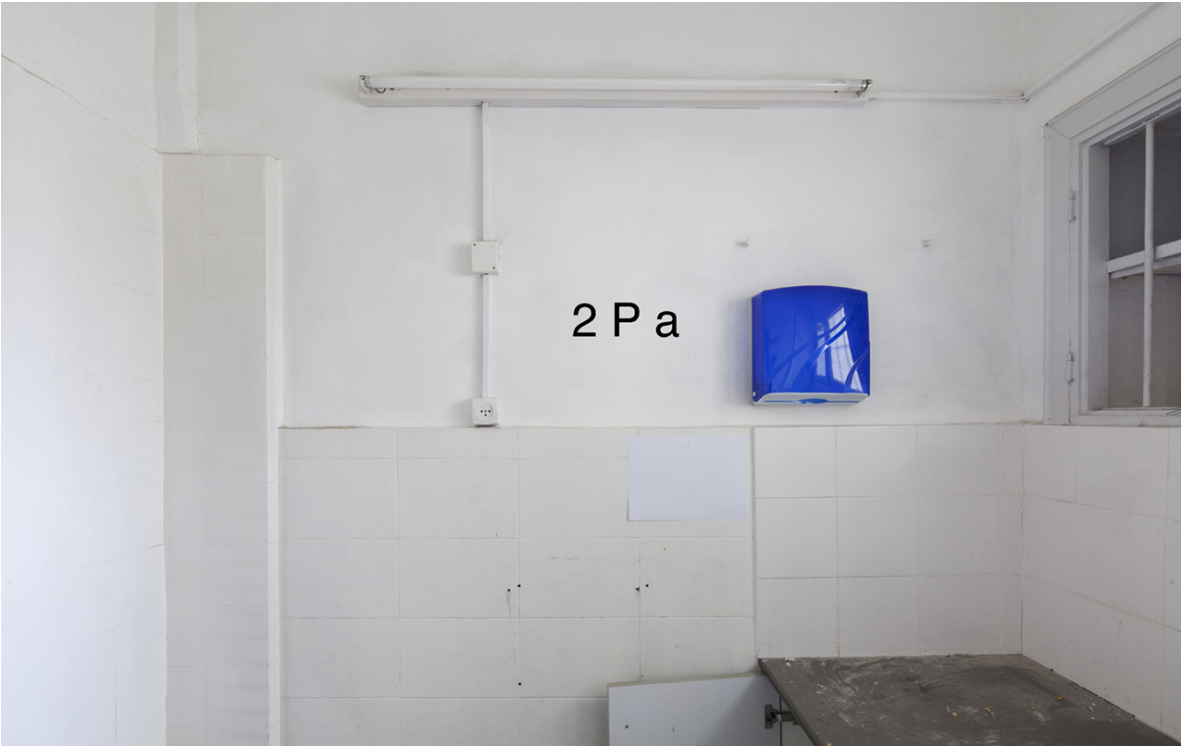
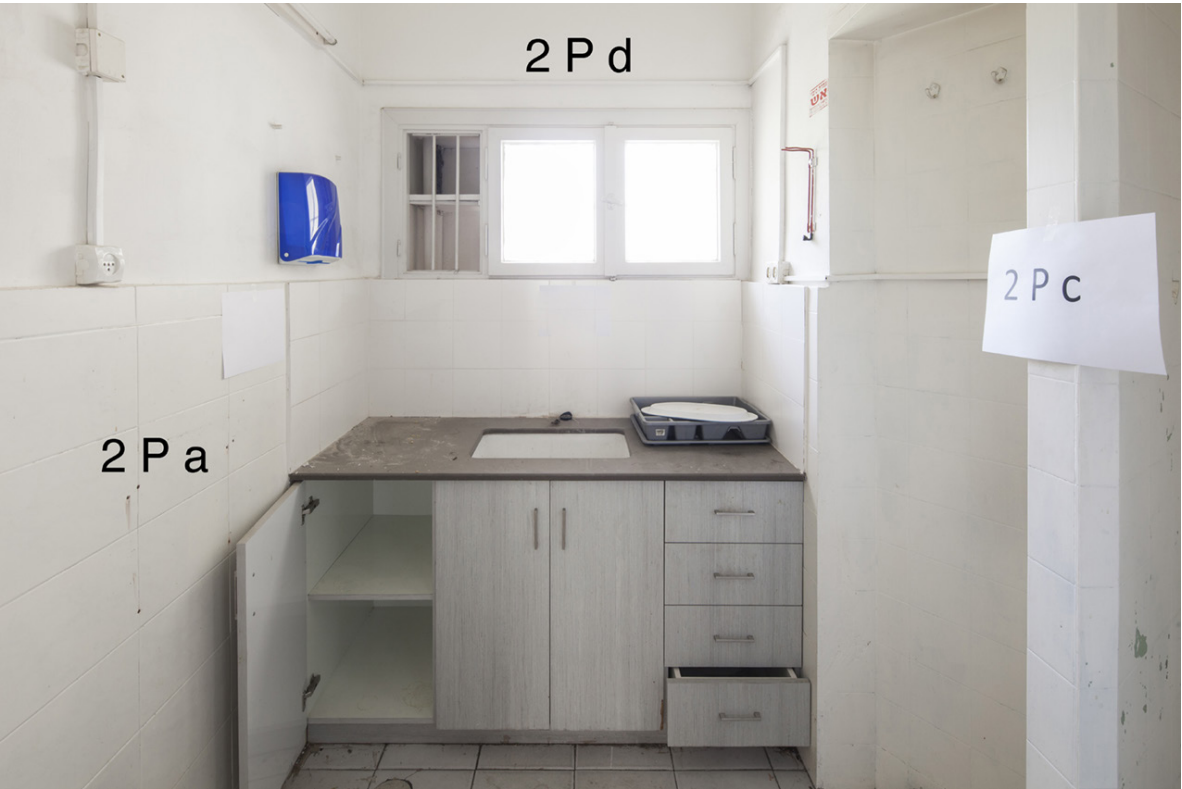
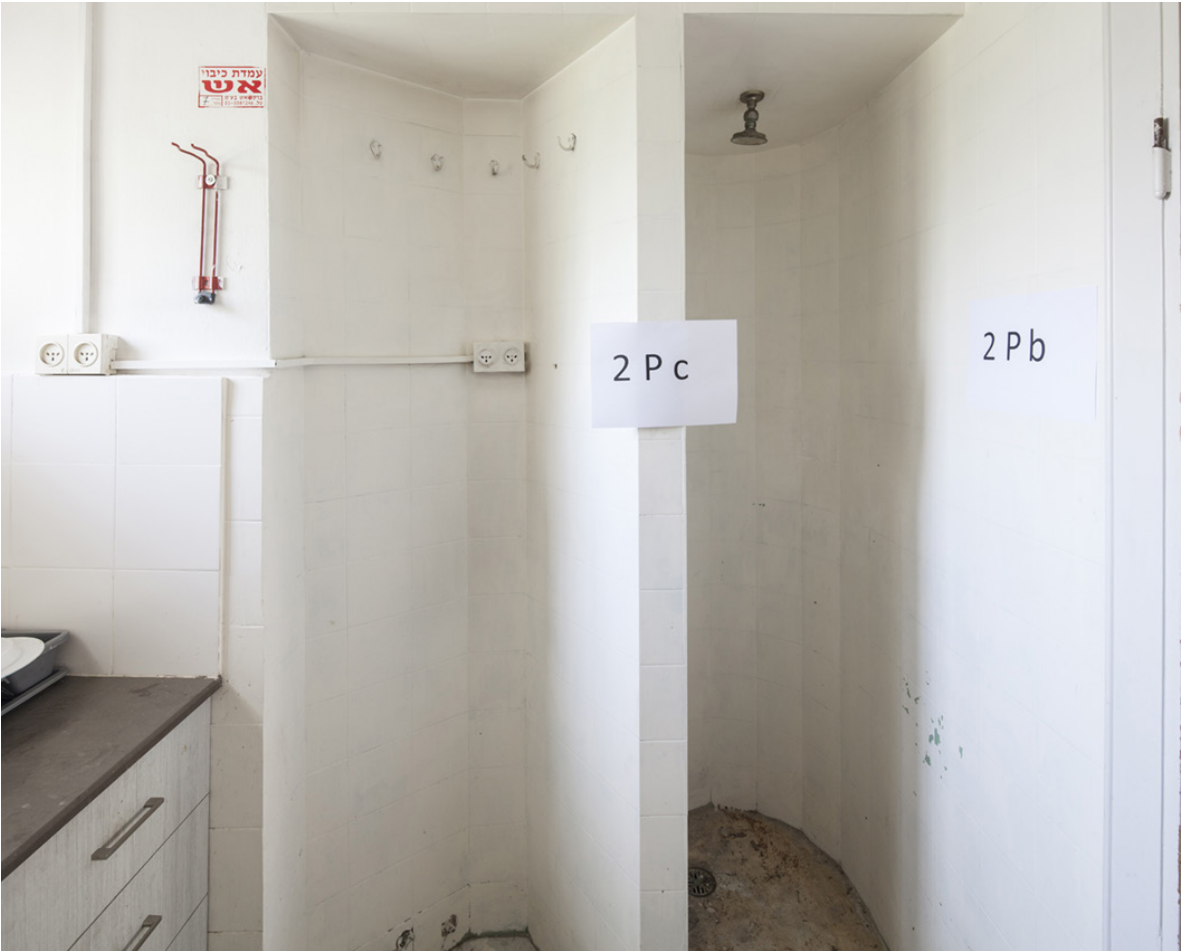
DATE		FLOOR		FUNCTION	ROOM
04/30/2015		3rd Floor		Former bathroom	02.P
ELEMENT	TYPE	DESCRIPTION	CONDITION, NOTES	DATING	ORIGINAL MATERIALS AND COLORS
FLOOR					
	F.2.2	Ceramic floor and base tiles, gray; terrazzo flooring in the shower alcove laid to falls	Original terrazzo floor and base tiles not preserved	Terrazzo flooring shower alcove original; tiles 1960s-1990s or later	
WALLS AND BUILT-IN ELEMENTS					
a		Plastered interior wall, wall tiling up to approx. 1.48m, tiled casing at the left up to 2.14m, painted white; wall-mounted fluorescent light and open wiring	Paint renewed; two layers of newer wall tiling on the right, original tiling beneath; tiles at the corner to wall b original and subsequently painted	Wall and plaster, tiling in the left corner 1937; tiling on the right side 1990s or later	M7, (C.1.1); tiles: M10
b		Interior wall with a tiled recess (possibly for a radiator, cf. 01.P) up to approx. 2.14m and a shower alcove tiled up to 2.25m; upper part of the wall plastered	Plaster and tiles subsequently painted white	Wall, plaster and wall-tiling 1937	M7, (C.1.1); tiles: M9, M10

D02.P01	D.1.6	Single-leaf solid door with a small glass pane	Paint renewed; handles original	1937	Wood: M13, (C.1.6); glass: M19; handles: M21
c		Plastered interior wall with a rounded shower alcove and a trapezoidal WC alcove; wall tiling up to approx. 2.25m in the alcoves and up to 1.48m on the left side	Plaster and tiles subsequently painted white; original tiling partly damaged	Wall, plaster and wall tiling 1937	M7, (C.1.1); tiles M10
d		Plastered interior wall, two layers of wall tiling up to the window around the built-in kitchen unit; open wiring	Wall tiling new, original tiling beneath; kitchen unit new	Wall, plaster and wall tiling 1937; kitchen unit 1990s or later	M7, (C.1.1)
W02.P.16	W.2.4	Double-sash window with an exterior metal grille combined with an adjacent laundry hatch with two vertical iron bars	Paint renewed and partly peeling off; laundry hatch door missing; original handles, painted; grille and iron bars not original; shutters missing	1937; grille and iron bars later	Wood: M13, (C.1.6); handles: M21

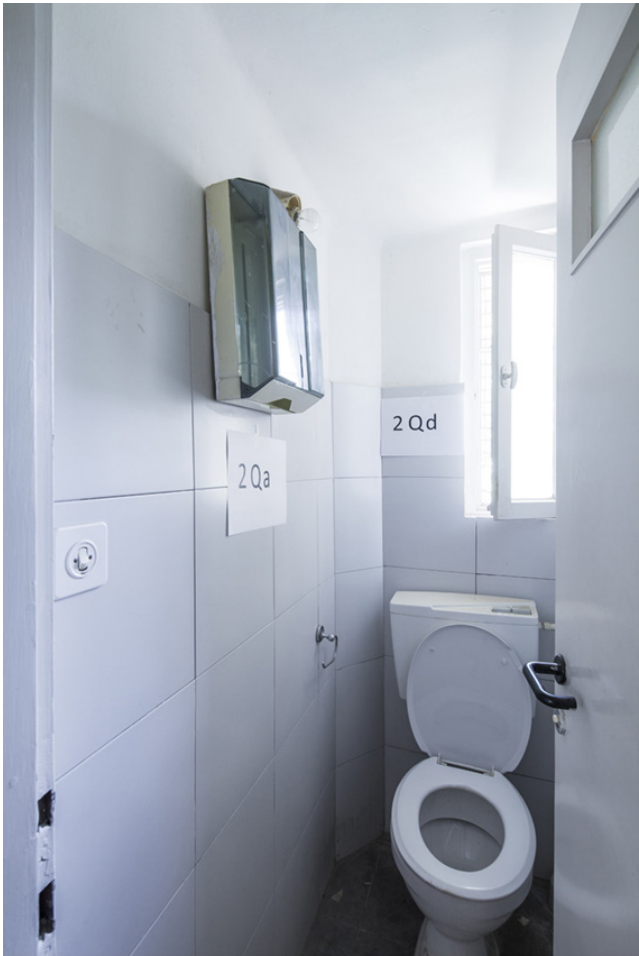
Room 02.Q; _MG_3187.jpg; photo: Aviad Bar Ness, 2015

DATE		FLOOR		FUNCTION	ROOM
04/30/2015		3rd Floor		WC	02.Q
ELEMENT	TYPE	DESCRIPTION	CONDITION, NOTES	DATING	ORIGINAL MATERIALS AND COLORS
FLOOR					
	F.2.1	Ceramic floor and base tiles, gray	Original terrazzo floor and base tiles beneath, condition unknown	1990s	(M4)
WALLS AND BUILT-IN ELEMENTS					
a		Plastered interior wall, wall tiling up to approx. 1.65m; wall-mounted lighting fixture; flush-mounted light switch	Surface renewed; wall tiling and light new; probably original wall tiling beneath	Wall, plaster and socket 1937; tiling and light 1990s or later	M7, (C.1.1)
b		Plastered interior wall, wall tiling up to approx. 1.65m	Paint on the plaster renewed; wall tiling new, probably original wall tiling beneath	Wall and plaster 1937; tiling 1990s or later	M7, (C.1.1)
D02.Q.01	D.1.6	Single-leaf solid door with a small glass pane	Paint renewed and handles replaced	1937; handles probably 1990s or later	Wood: M13, (C.1.6); glass: M19

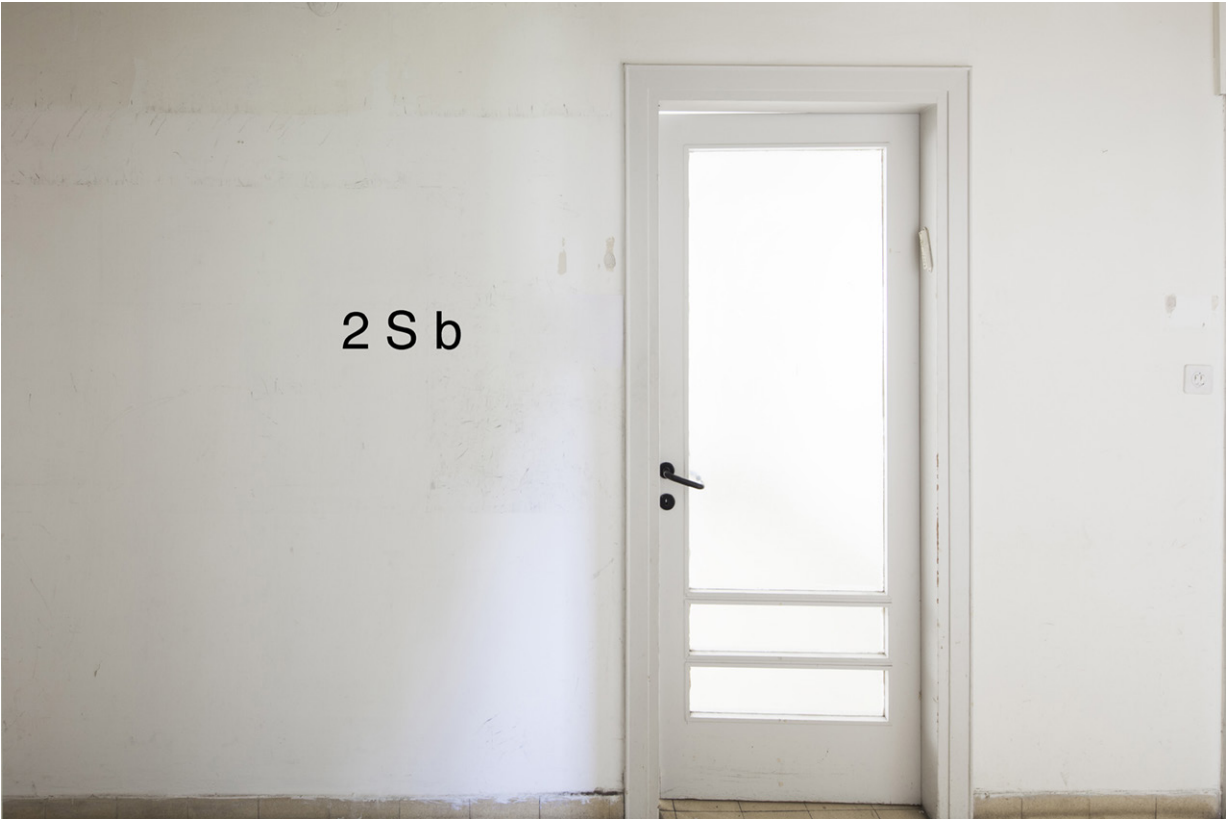
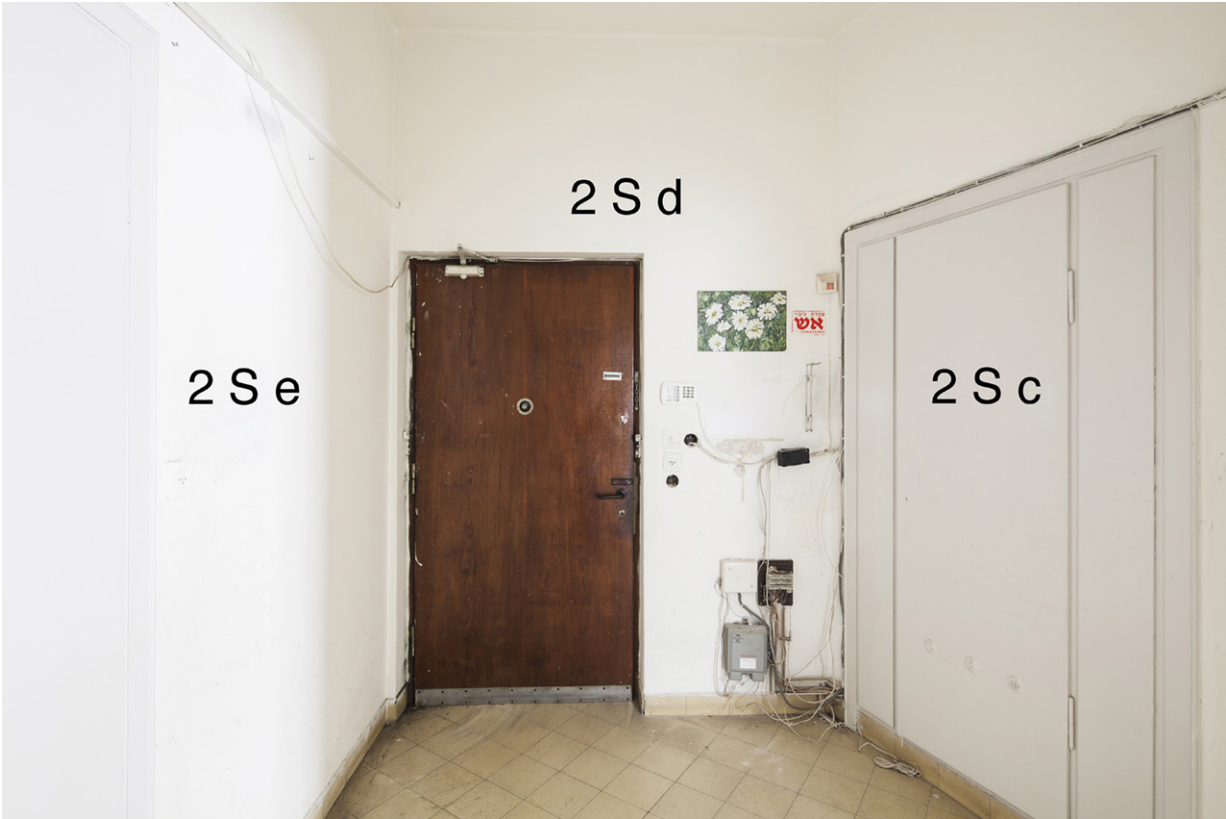
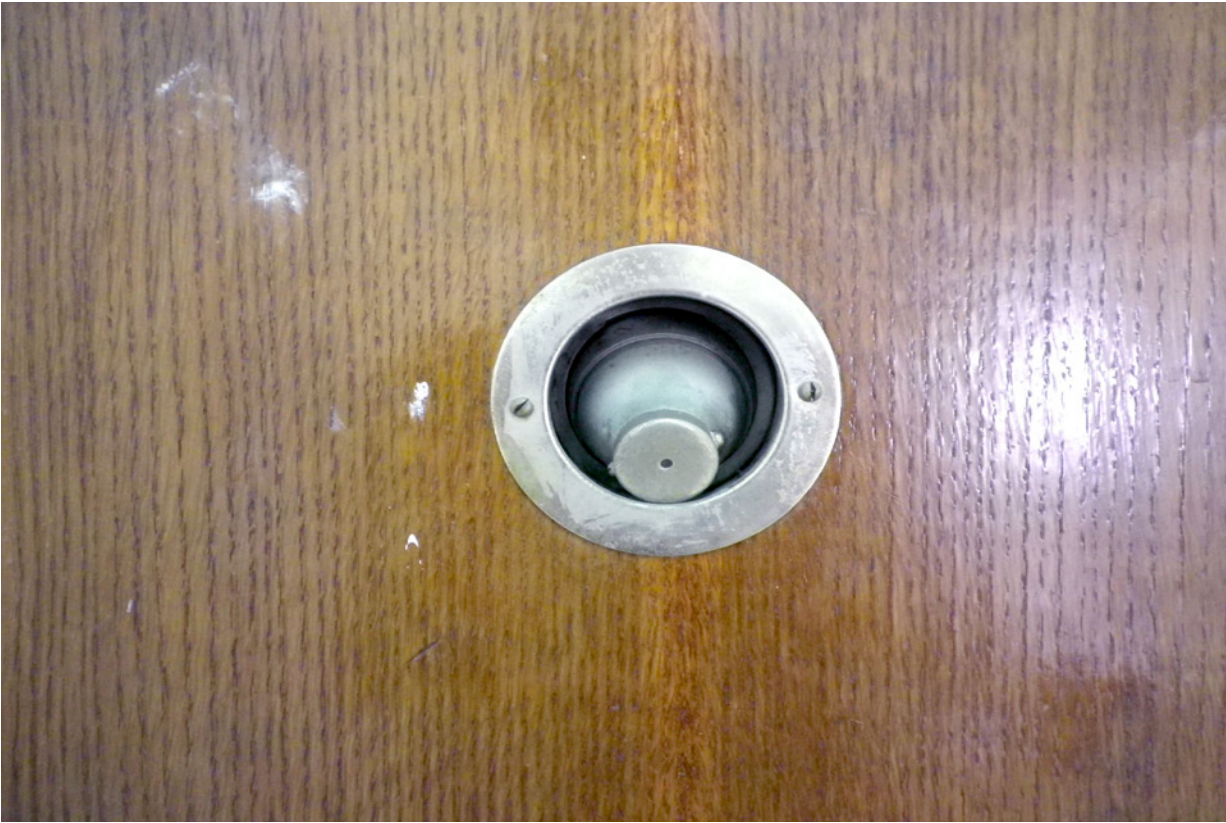
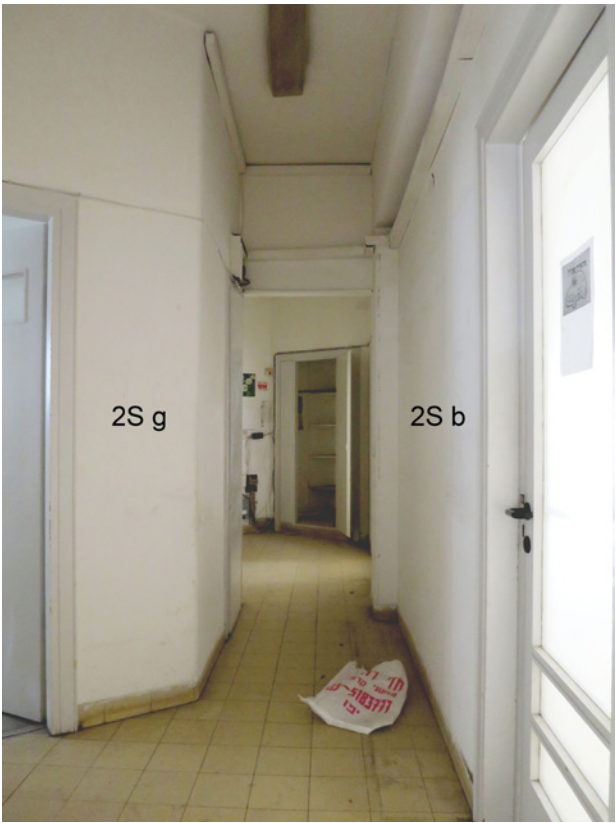
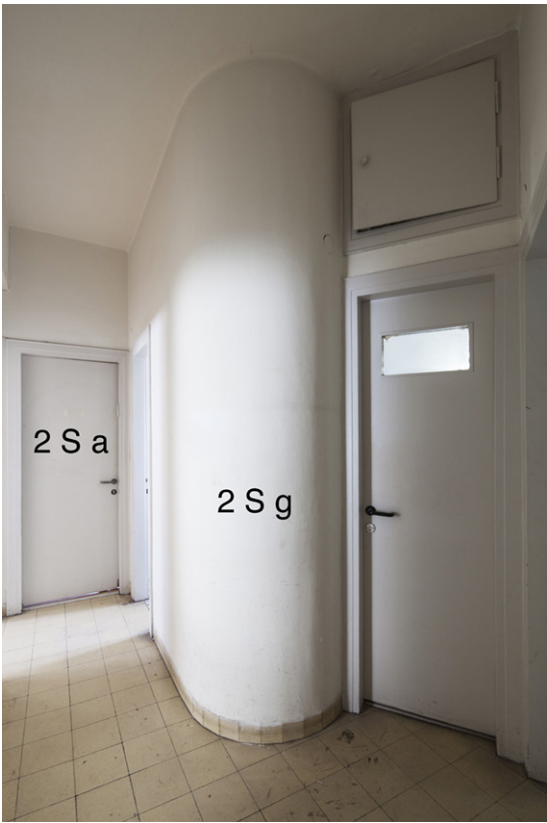
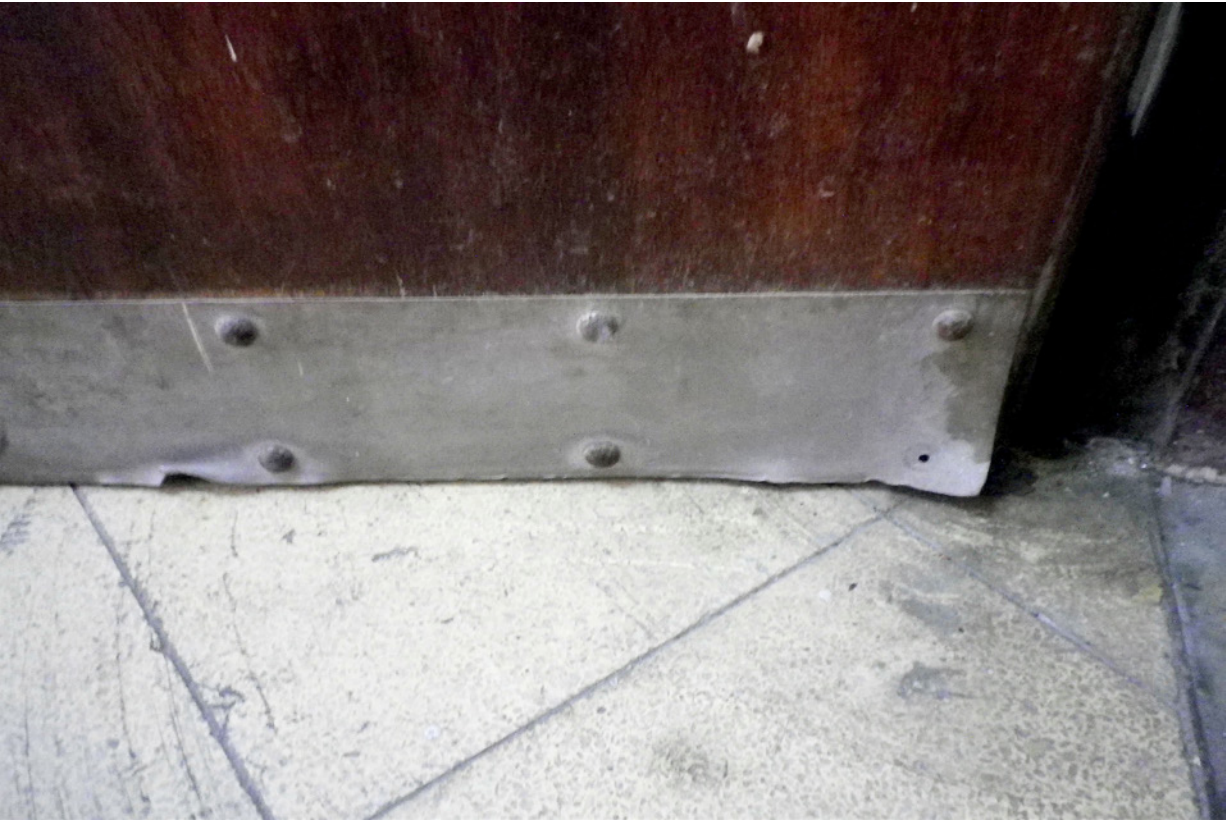
DATE		FLOOR		FUNCTION	ROOM
04/30/2015		3rd Floor		Corridor	02.S
ELEMENT	TYPE	DESCRIPTION	CONDITION, NOTES	DATING	ORIGINAL MATERIALS AND COLORS
FLOOR					
	F.1.1	Terrazzo floor and base tiles	Partly scratched surface, cracks	1937	M4
WALLS AND BUILT-IN ELEMENTS					
a		Plastered interior wall; open wiring	Surface renewed	Wall and plaster 1937; wiring 1960s-1990s	M7, (C.1.5)
D02.O.01	D.1.5	Single-leaf solid door with a wooden frame	Paint renewed and handles replaced	1937; handles 1990s or later	Wood: M13, (C.1.6)
b		Plastered interior wall; thickness of wall less than that of adjoining concrete columns and beam; flush-mounted light switch next to D02.N.01; open wiring	Surface renewed; flush-mounted light switch original	Wall, plaster and light switch 1937; wiring 1960s-1990s	M7, (C.1.5); light switch: M26
D02.N.01	D.1.5	Single-leaf solid door with a wooden frame	Paint renewed and handles replaced	1937; handles 1990s or later	Wood: M13, (C.1.6)

D02.M.01	D.1.3	Single-leaf door with a wooden frame; three panes of textured glass	Paint renewed and handles replaced	1937; handles 1990s	Wood: M13, (C.1.6); glass: M19
D02.L.01	D.1.3	Single-leaf door with a wooden frame; three panes of textured glass	Paint renewed and handles replaced	1937; handles 1990s or later	Wood: M13, (C.1.6); glass: M19
c		Plastered interior wall with a rounded corner to wall b with a recess; open wiring	Surface renewed	Wall and plaster 1937; wiring 1960s-1990s	M7, (C.1.5)
Wardrobe	S.6	Built-in wooden wardrobe closet with a side-hung door and two adjoining fixed panels; door leaf with three vent openings and a lock; four shelves and a clothes rail inside	Paint renewed, original arrangement preserved	1937	Wood: M13, (C.1.6); clothes rail: M25
d		Plastered interior wall; several electrical fuse/service boxes and open wiring; flush-mounted light switch and socket;	Surface renewed	Wall, plaster, light switch and socket 1937; wiring 1960s-1990s	M7, (C.1.5); light switch, socket: M26

D02.S.01	D.1.2	Entrance door to the apartment, solid door with a movable spyhole and a metal kickplate on both sides; door-closer, additional bolt	Handles replaced, bolt, door closer added subsequently	1937; bolt door closer and handles 1970-1990	wood: M11; spy-hole: M21; fittings: M22; base-board: M24
e		Plastered interior wall; flush-mounted socket; open wiring	Surface renewed	Wall, plaster and socket 1937	M7, (C.1.5); socket: M26
Closet	S.10	Wooden single-leaf closet, shelves, mount for a clothes rail; vent hole in the door leaf	Paint renewed; shelves added subsequently; originally only one upper shelf and a clothes rail	1937	Wood: M13, (C.1.6)
f		Plastered interior wall; open wiring	Surface renewed	Wall and plaster 1937	M7, (C.1.5)
Closet	S.10	Wooden single-leaf closet with four shelves, containing a fuse box and a door bell	Paint renewed; doorbell probably replaced; fuse box new; door leaf missing	1937; fuse box 1990s	Wood: M13, (C.1.6)

D02.R.01	D.1.6	Single-leaf solid door with a small glass pane	Paint renewed and handles replaced	1937; handles 1990s	Wood: M13, (C.1.6); glass: M19
g		Plastered interior wall with a rounded corner	Surface renewed	Wall and plaster 1937; wall protection 1960s-1990s	M7, (C.1.5)

DATE		FLOOR		FUNCTION	ROOM
04/30/2015		3rd Floor		Corridor	02.S
ELEMENT	TYPE	DESCRIPTION	CONDITION, NOTES	DATING	ORIGINAL MATERIALS AND COLORS
Storage space	S.11	Single-leaf solid hatch door to a storage space in the ceiling void	Paint renewed; knob original	1937	Wood: M13, (C.1.6); knob: (M21)
D02.Q.01	D.1.6	Single-leaf solid door with a small glass pane	Paint renewed and handles replaced	1937; handles 1990s or later	Wood: M13, (C.1.6); glass: M19
i		Plastered interior wall, rounded corner to wall h; open wiring	Surface renewed	Wall and plaster 1937	M7, (C.1.5)
D02.P.01	D.1.6	Single-leaf solid door with a small glass pane	Paint renewed; handles original	1937	Wood: M13, (C.1.6); glass: M19; handles: M21
CEILING					
		Beam-and-block ceiling, plaster; suspended louvered luminaires	Surface renewed	1937; lights 1960s-1990s	Concrete, plaster, (C.1.5)
