CONSERVATION SURVEY

MAX-LIEBLING-HOUSE

29, IDELSON STREET, TEL AVIV

Tel Aviv/Berlin, 2016/17

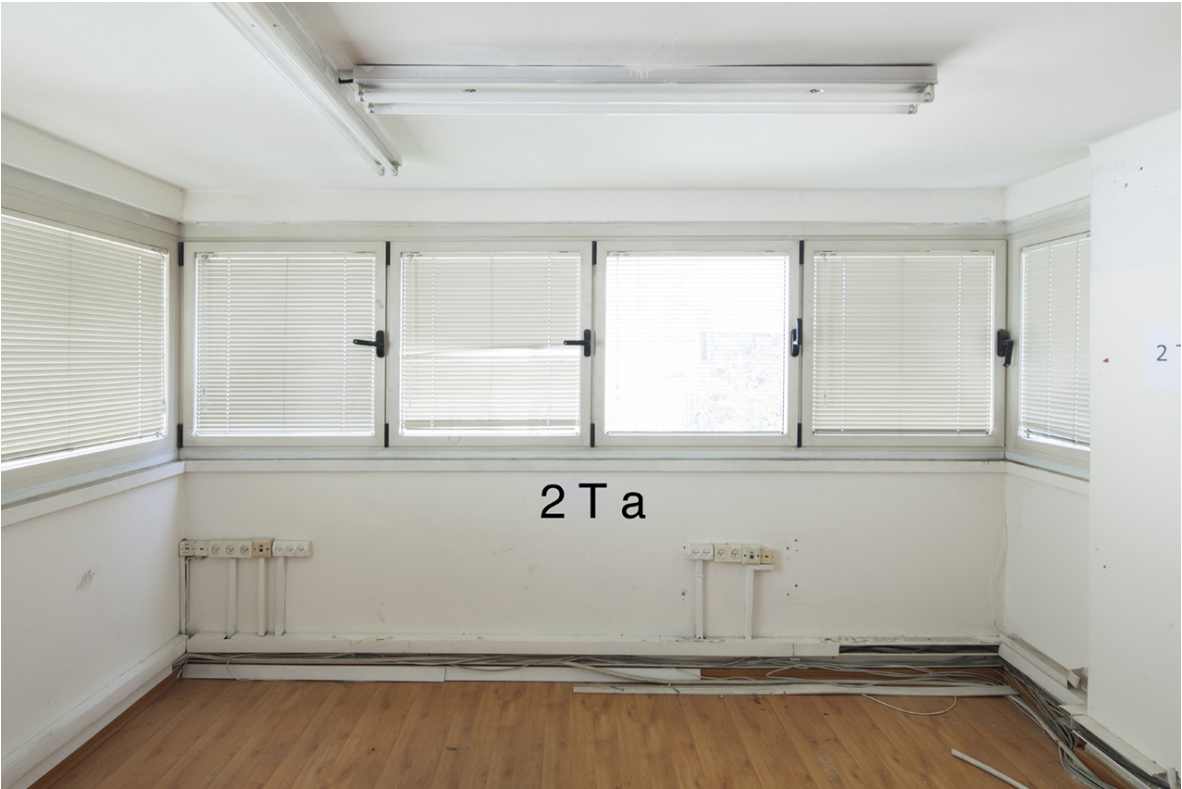
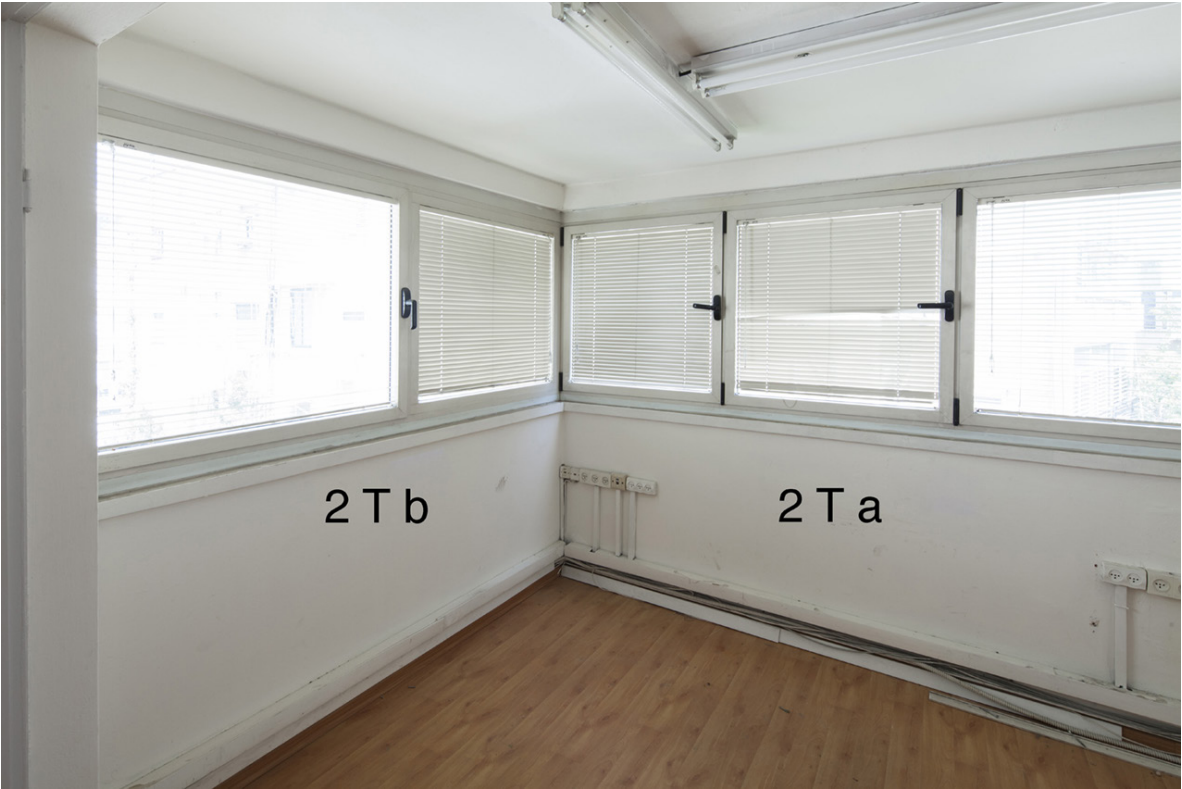
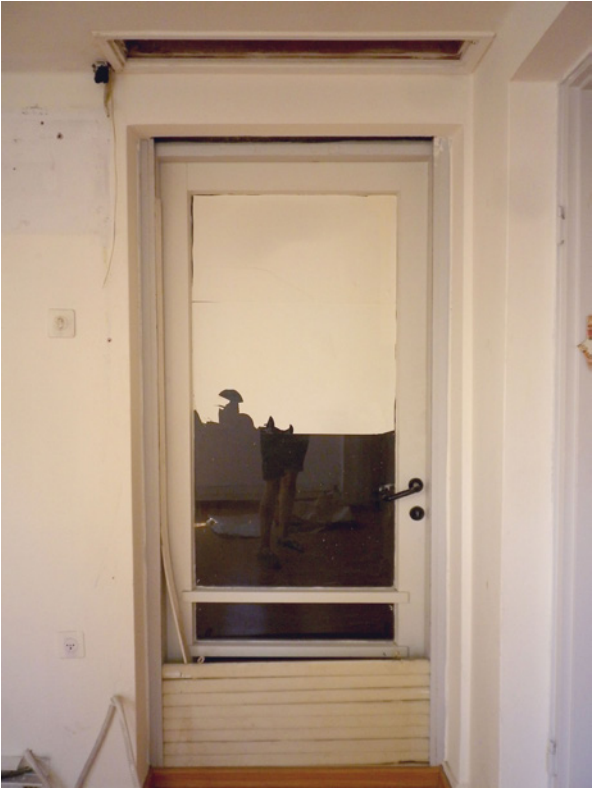
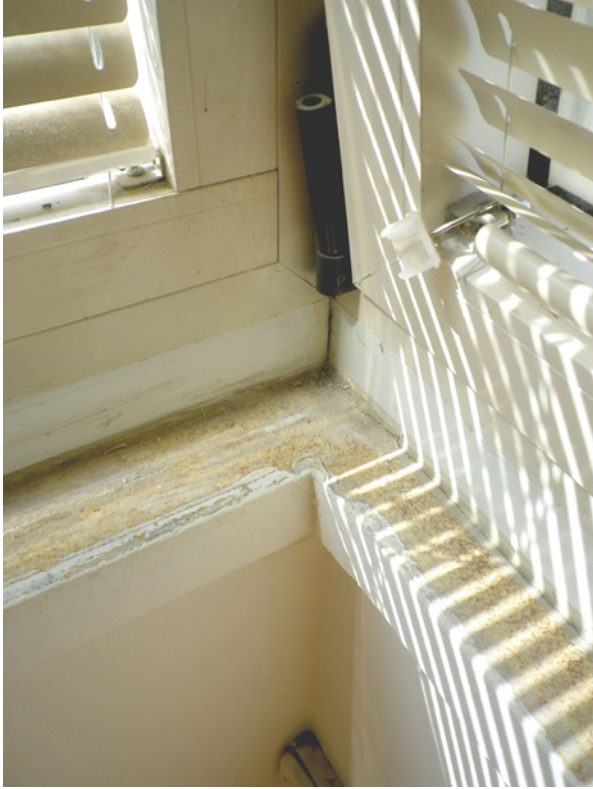
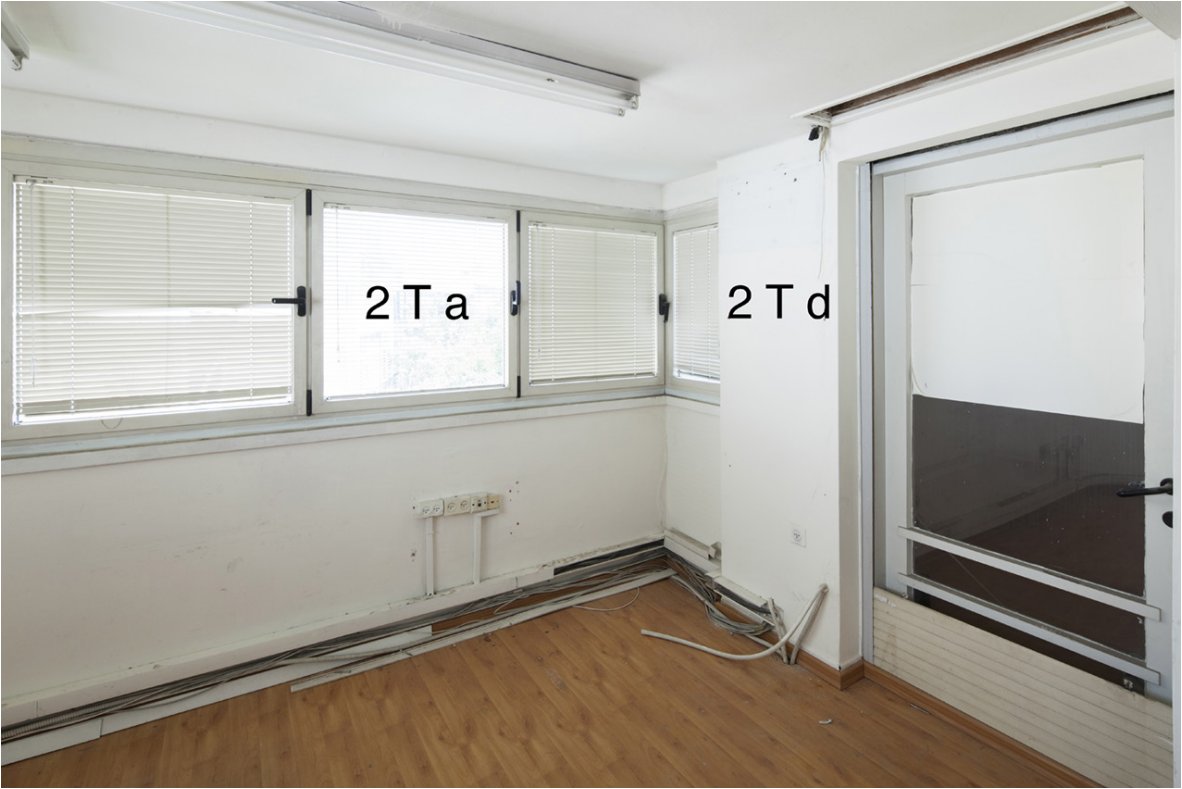
DATE		FLOOR		FUNCTION	ROOM
04/30/2015		3rd Floor		Balcony (B.3)	02.T
ELEMENT	TYPE	DESCRIPTION	CONDITION, NOTES	DATING	ORIGINAL MATERIALS AND COLORS
FLOOR					
	F.2.1	Wood block parquet and wooden baseboard	Original terrazzo floor and base tiles beneath, condition unknown	1990s or later	(M4)
WALLS AND BUILT-IN ELEMENTS					
a		Plastered exterior parapet with a terrazzo coping; glazing mounted between the balcony parapet and the upper fascia; open wiring	Surface renewed; original coping painted white	Wall and plaster 1937; windows 1960s-1990s	Railing: M7, (C.1.1); coping: M3
b		Plastered exterior parapet with a terrazzo coping; glazing mounted between the balcony parapet and the upper fascia; open wiring	Surface renewed; original coping painted white	Wall and plaster 1937; wiring and windows 1960s-1990s	Railing: M7, (C.1.1); coping: M3
W02.T.21	W.4.2	Balcony glazing, consisting of 7 single-sash aluminum windows		1960s-1990s

c		Plastered interior wall with a broad door opening to room 02.T	Surface renewed	Wall and plaster 1937	M7, (C.1.1)
W02.T.20	W.2.1	Door opening with a wooden frame, formerly probably four leaves (cf. D02.M.02)	Door leaves missing; paint renewed, partly peeling off	1937	Wood: M13, (C.1.6)
d		Plastered exterior parapet with a terrazzo coping; glazing mounted between the balcony parapet and the upper fascia; flush-mounted socket and light switch; open wiring	Surface renewed; original coping painted white	Wall, plaster, socket and light switch 1937; wiring and windows 1960s-1990s	Railing: M7, (C.1.1); coping: M3; socket, light switch: M25
W02.O.19	W.1.2	Single-leaf balcony door; three panes of clear glass	Paint renewed; original roller shutter partly preserved; roller shutter belt partly original	1937; handles probably 1990s or later	Window: M13, (C.1.6), (C.1.6); shutter: M14; glass: M20
CEILING

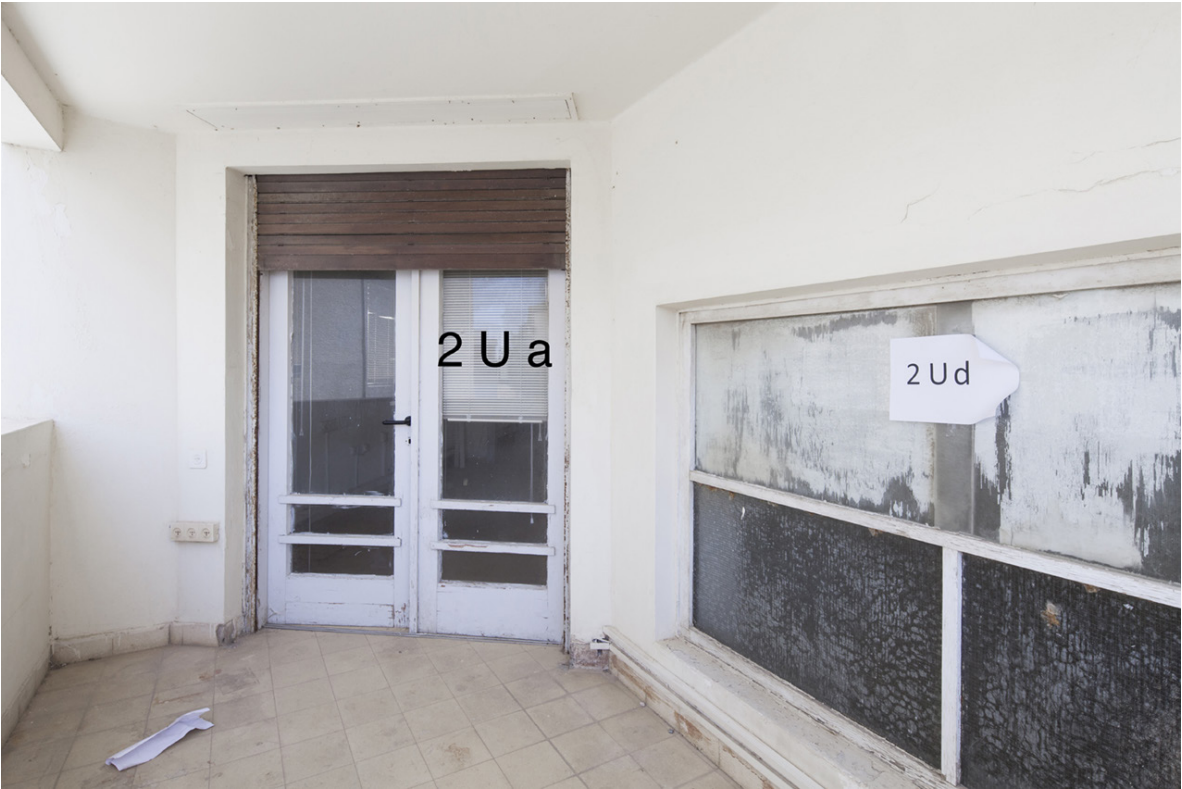
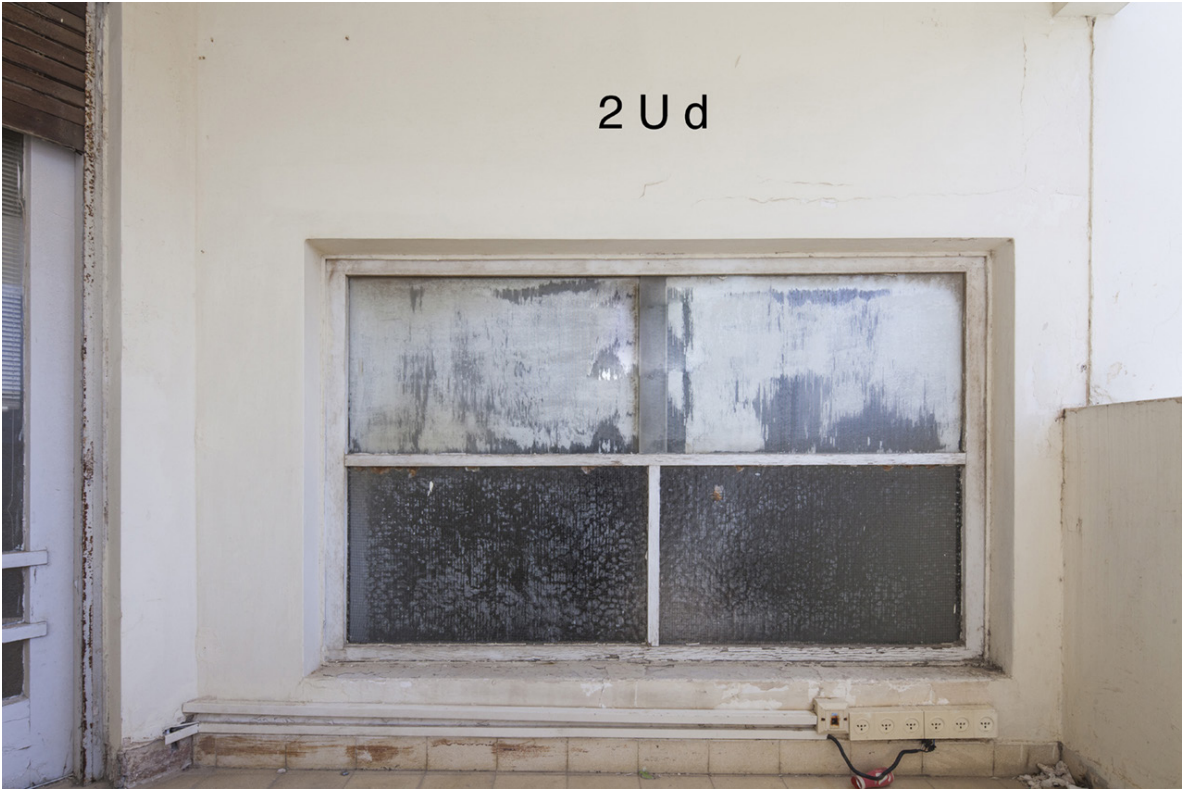
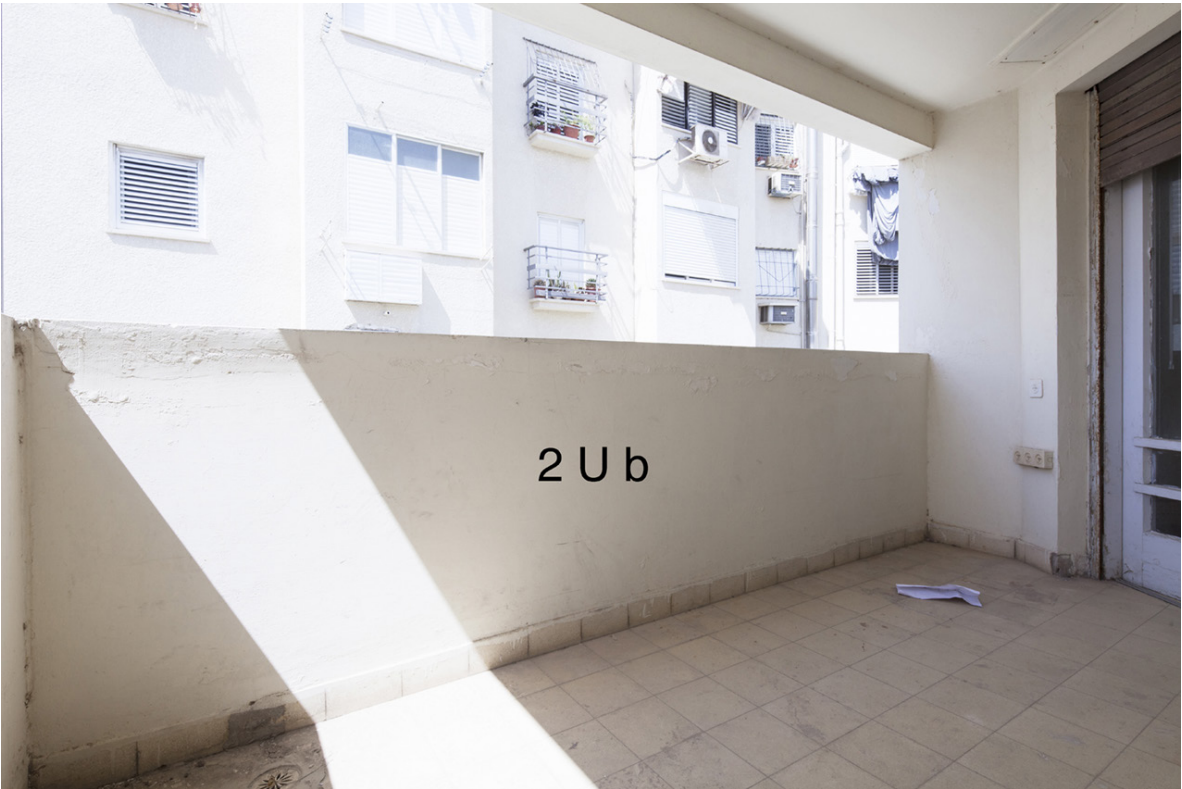
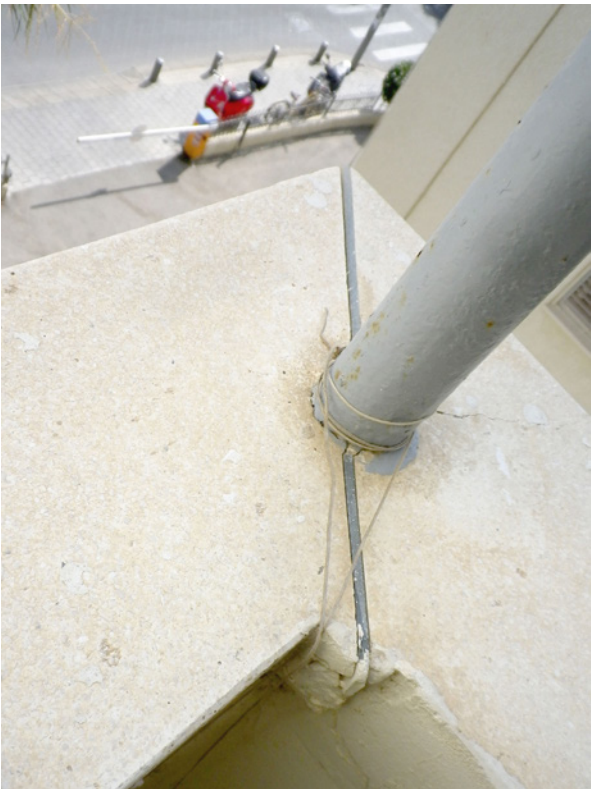
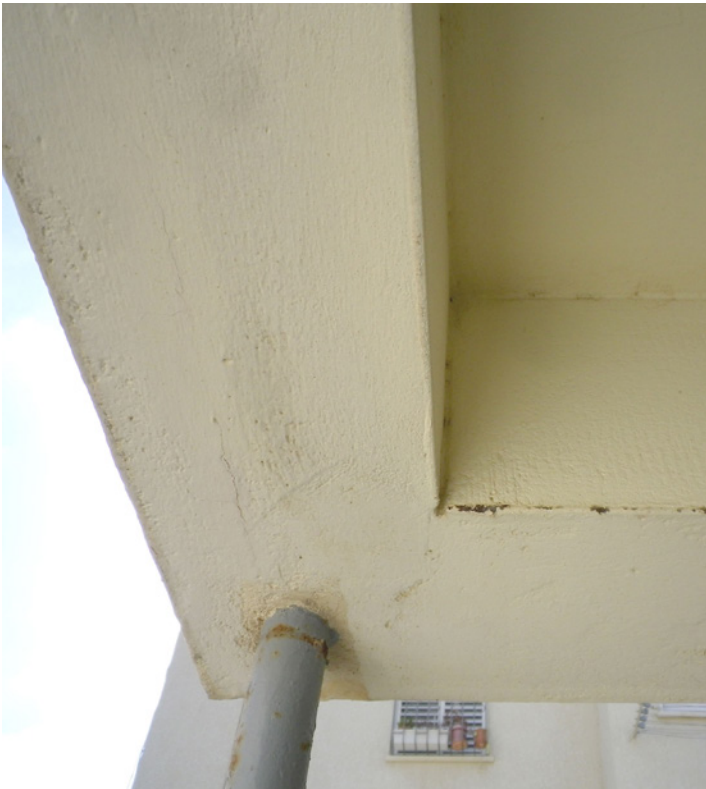
DATE		FLOOR		FUNCTION	ROOM
04/30/2015		3rd Floor		Balcony (B.4)	02.U
ELEMENT	TYPE	DESCRIPTION	CONDITION, NOTES	DATING	ORIGINAL MATERIALS AND COLORS
FLOOR					
	F.1.1	Terrazzo floor and base tiles	Partly scratched surface, cracks, few base tiles missing	1937	M4
WALLS AND BUILT-IN ELEMENTS					
a		Rendered exterior wall; flush-mounted socket	Render renewed	Wall render and socket 1937	M7, (C.1.4)
W02.L.25	W.1.1	Double-leaf balcony door with a wooden frame; three panes of clear glass	Paint renewed, partly peeling off; handles replaced	1937; handles 1990s or later	Wood: M13, (C.1.6); glass: M20
b		Rendered exterior parapet; terrazzo coping with a water drip; round steel column mounted on the coping at the corner of the balcony with a sleeve socket at its foot and head	Paint and terrazzo coping renewed broadly similar to the original materials; paint peeling off, cracks in the render at the connection to the coping; column probably original	Wall, render and column 1937; paint and coping 1990s	Railing: M7, (C.1.4); column: M23 (original color white)

c		Rendered exterior parapet with a terrazzo coping	Paint and terrazzo coping renewed broadly similar to the original materials; paint peeling off, cracks in the render at the connection to the coping	Wall and render 1937; paint and coping 1990s	Railing: M7, (C.1.4)
d		Rendered exterior wall; open wiring	Surface renewed	Wall and render 1937; wiring 1960s-1990s	M7, (C.1.4)
W02.V.26	W.1.2	Three-part window with a wooden frame, one horizontal and one vertical sash bar; upper part: two sliding sashes; lower part: two panes of fixed glazing	Exterior paint peeling off; crack in the wire glass	1937	Wood: M13, (C.1.6); glass: M18 (sliding sashes), M16 (fixed glazing)
CEILING					
		Plastered dropped ceiling; opening with removable wooden covers for the shutter box above the balcony door	Surface renewed; paint of the original wooden covers renewed	Ceiling and render 1937	M7, (C.1.1); wood: M13, (C.1.6)

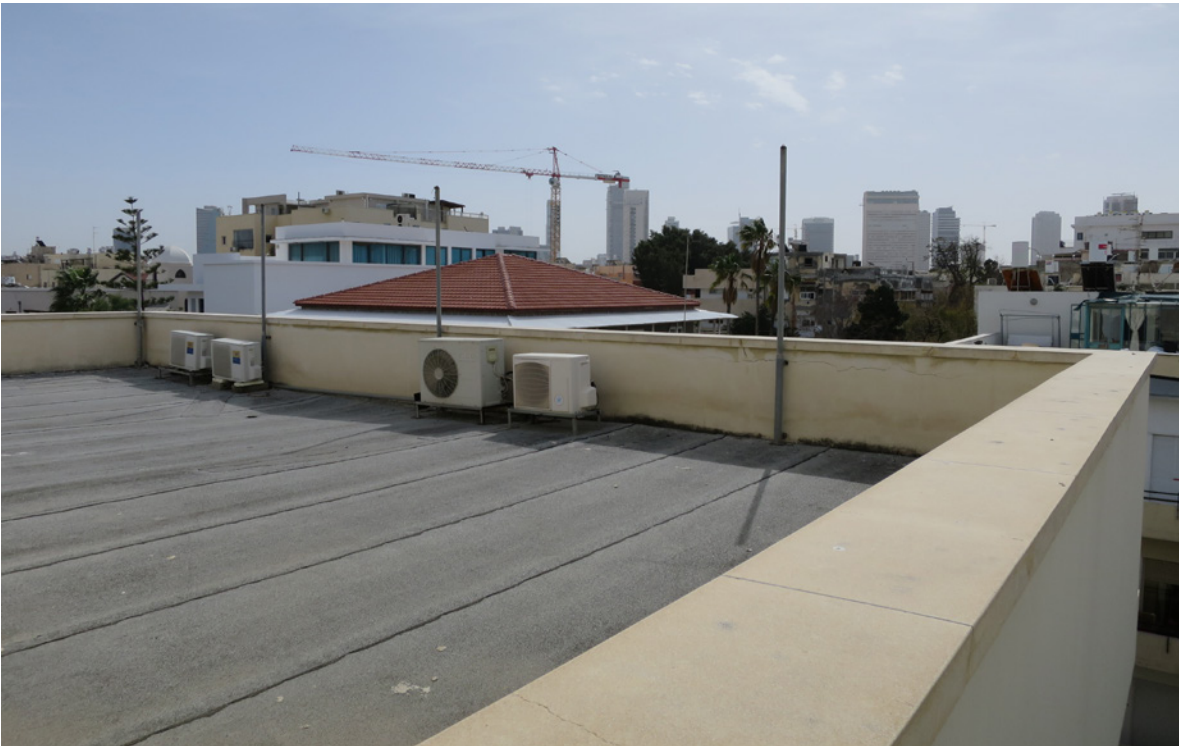
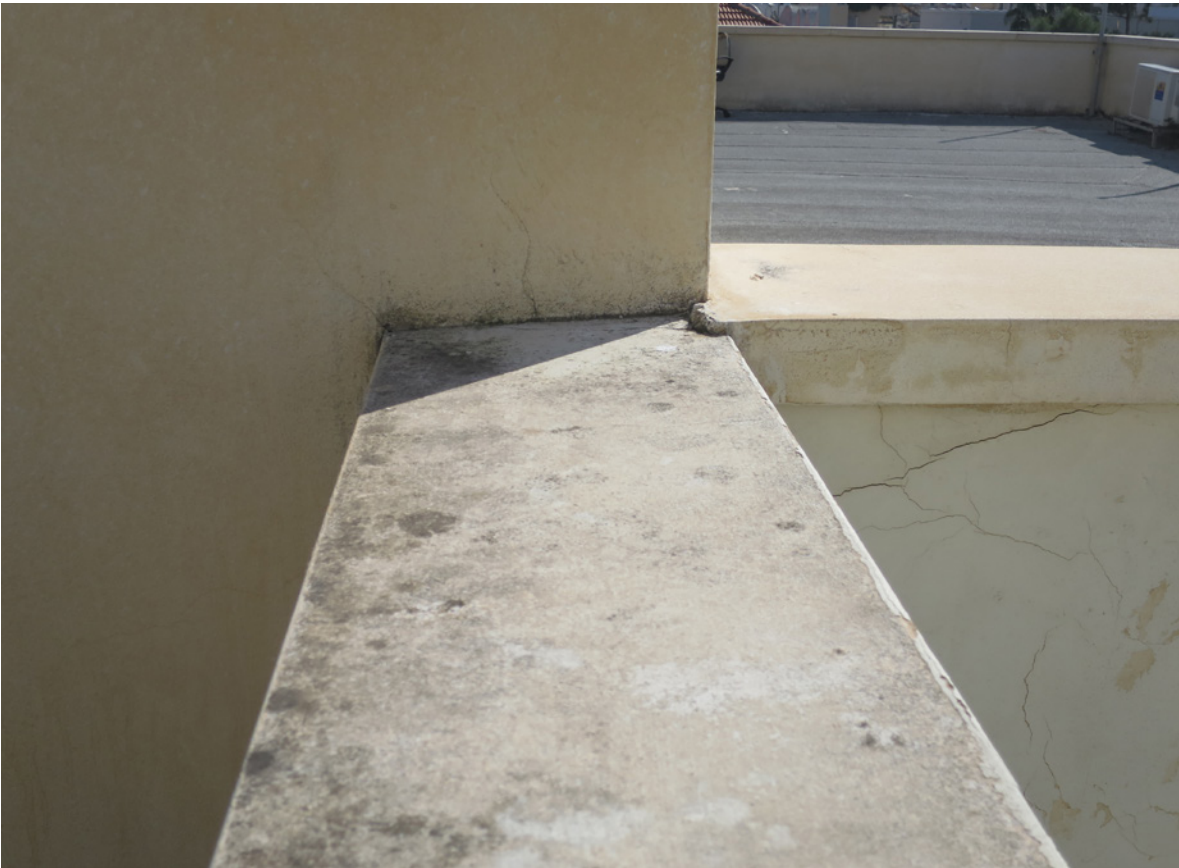
DATE		FLOOR		FUNCTION	ROOM
04/30/2015		Roof		-	03.A
ELEMENT	TYPE	DESCRIPTION	CONDITION, NOTES	DATING	ORIGINAL MATERIALS AND COLORS
FLOOR					
	F.2.1	mineral-surfaced bituminous roofing; surface-mounted air-conditioning units in front of wall e		1990s	
WALLS AND BUILT-IN ELEMENTS					
a		not accessible			
b		not accessible			
D03.V.02	D.2.3	Solid door to the staircase	Replaced, original position	1990s	
c		not accessible			
d/e/f		Rendered exterior parapet with a terrazzo coping; five wall-mounted tubular steel poles	Exterior render, paint and coping renewed broadly similar to the original materials; paint partly peeling off; cracks in the plaster at the connection to the coping	Wall 1937; render, paint, coping and poles 1990s	Parapet: cream white

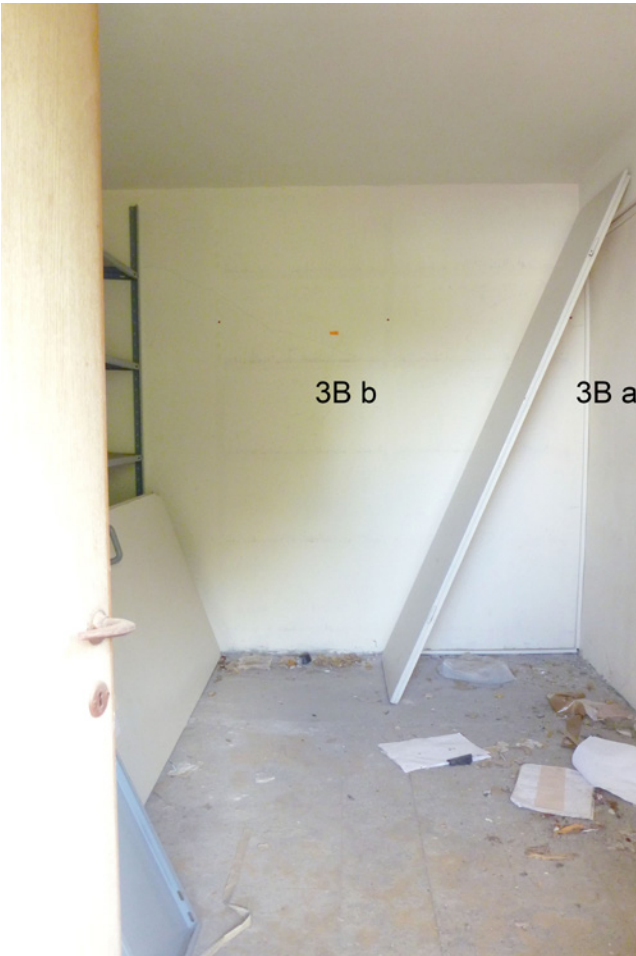
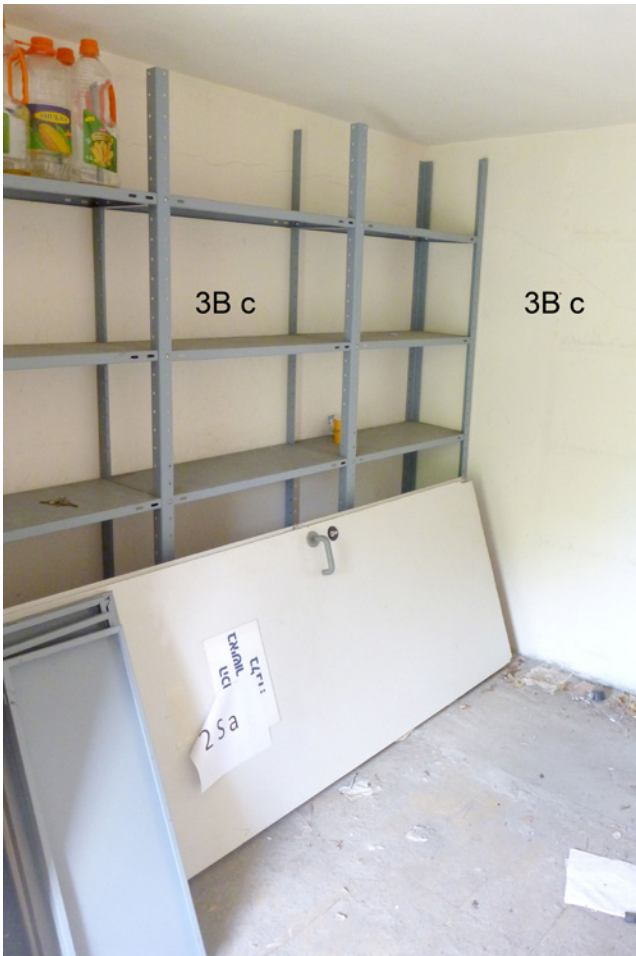
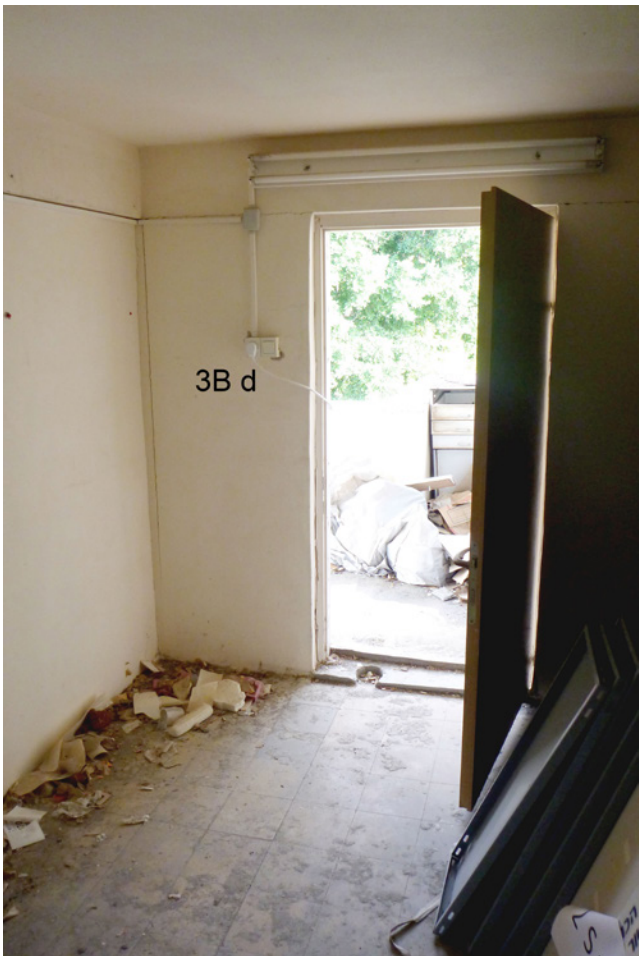
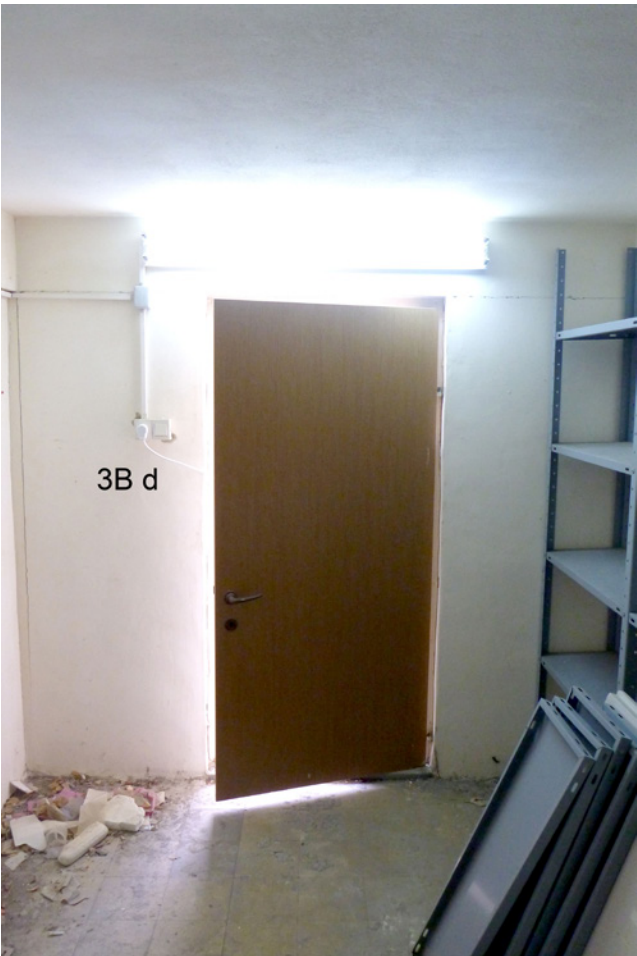
DATE		FLOOR		FUNCTION	ROOM
04/30/2015		Roof		Laundry room	03.B
ELEMENT	TYPE	DESCRIPTION	CONDITION, NOTES	DATING	ORIGINAL MATERIALS AND COLORS
FLOOR					
	F.1	Terrazzo floor and base tiles	Partly scratched surface, cracks, a few base tiles missing	1937	M4
WALLS AND BUILT-IN ELEMENTS					
a		Plastered interior wall; open wiring	Surface renewed; cracks	Wall and plaster 1937; wiring probably 1990s	M7
b		Plastered interior wall	Surface renewed	1937	M7
c		Plastered interior wall	Surface renewed	1937	M7
d		Plastered interior wall; wall-mounted lighting fixture; open wiring	Surface renewed	Wall and plaster 1937; wiring and lighting fixture 1960s-1990s	M7
D03.V.02	D.2.3	Solid wooden door to roof area	Replaced, original position	probably 1960s-1990s

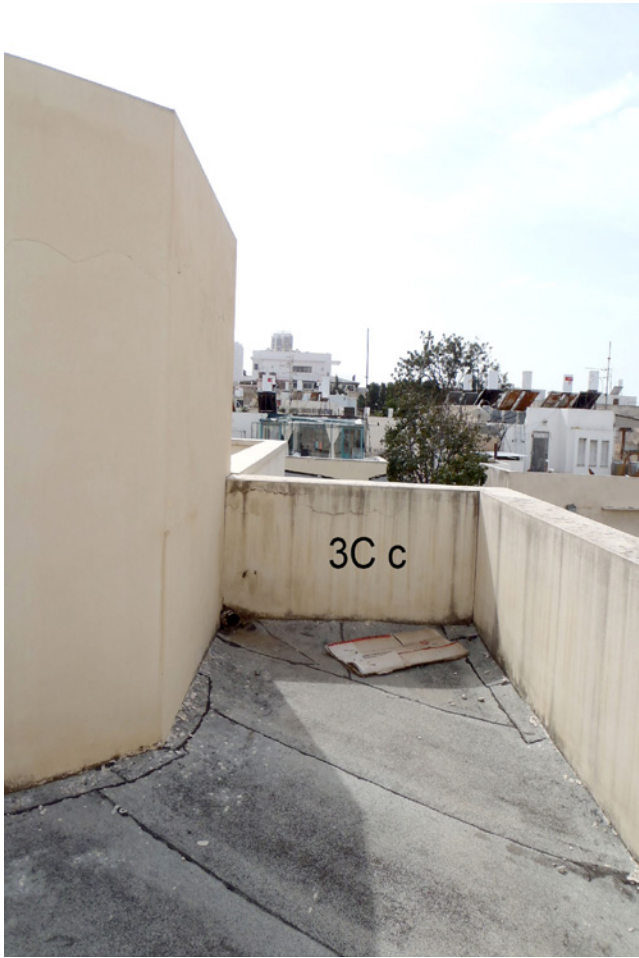
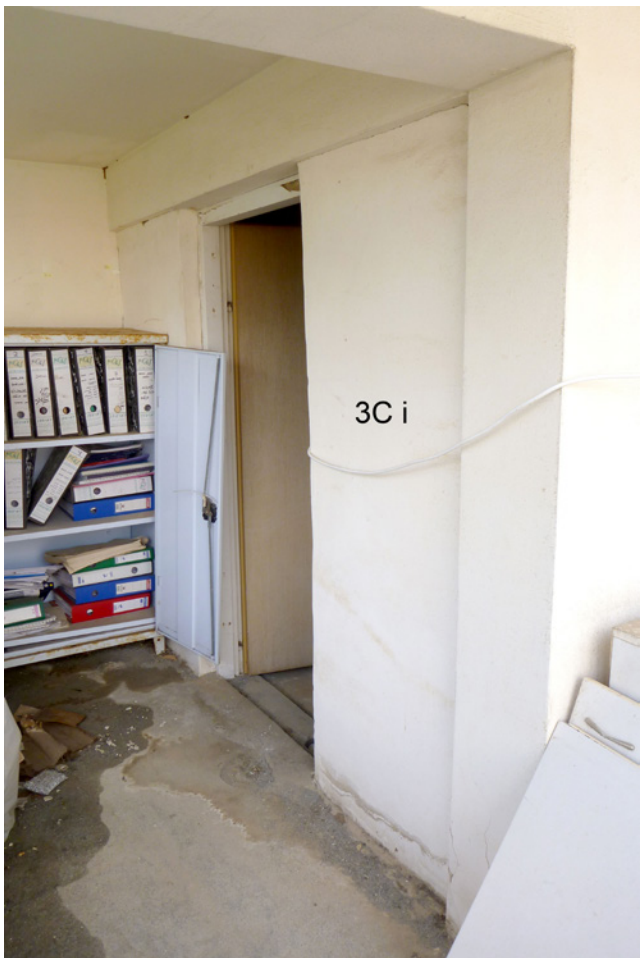
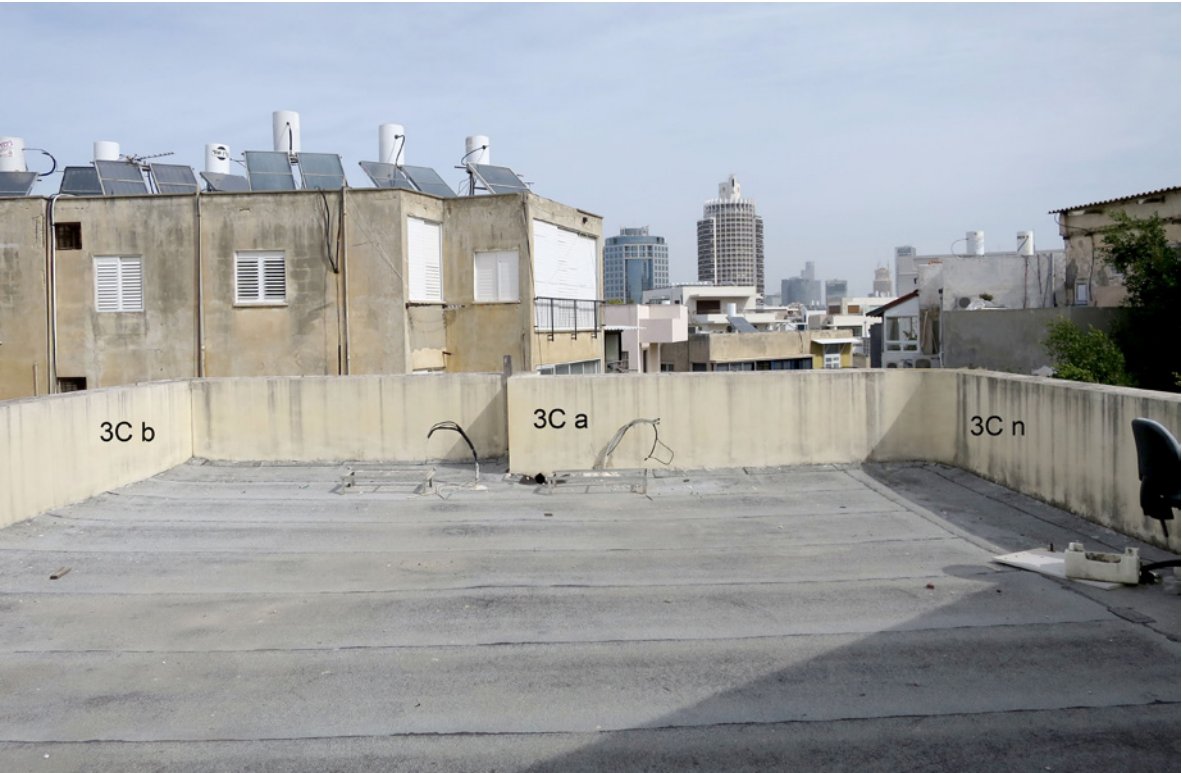
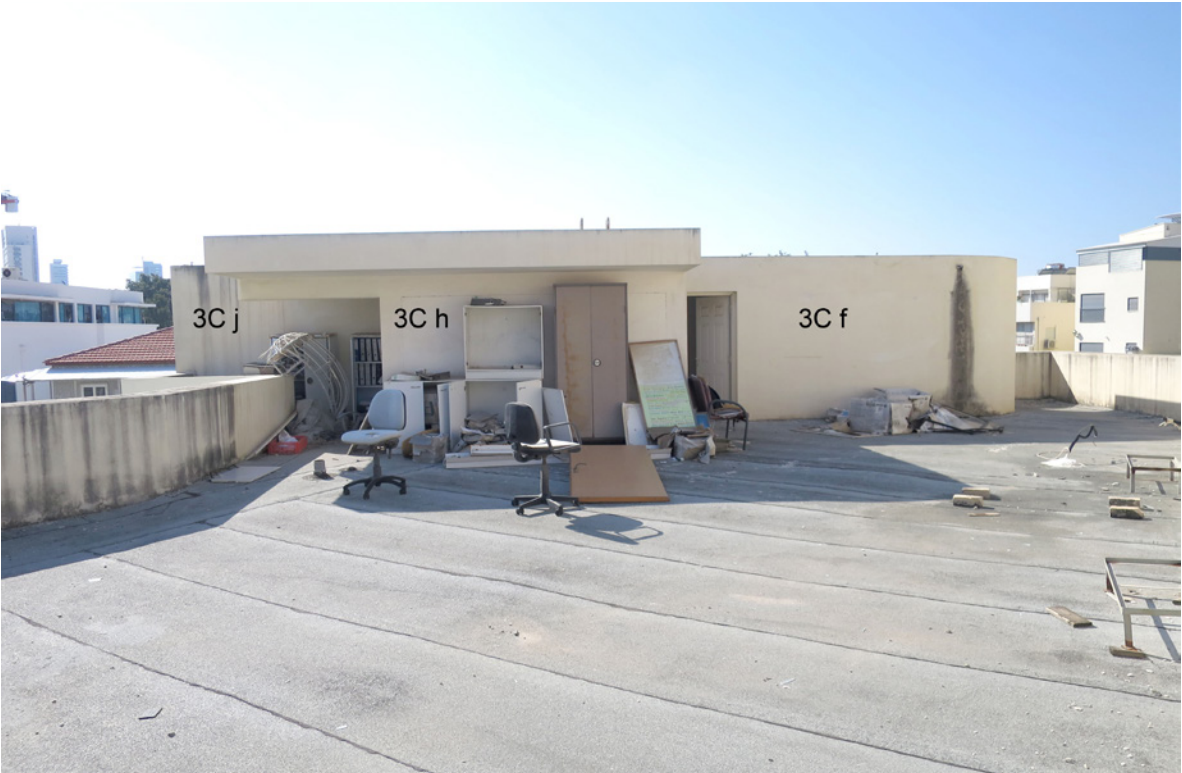
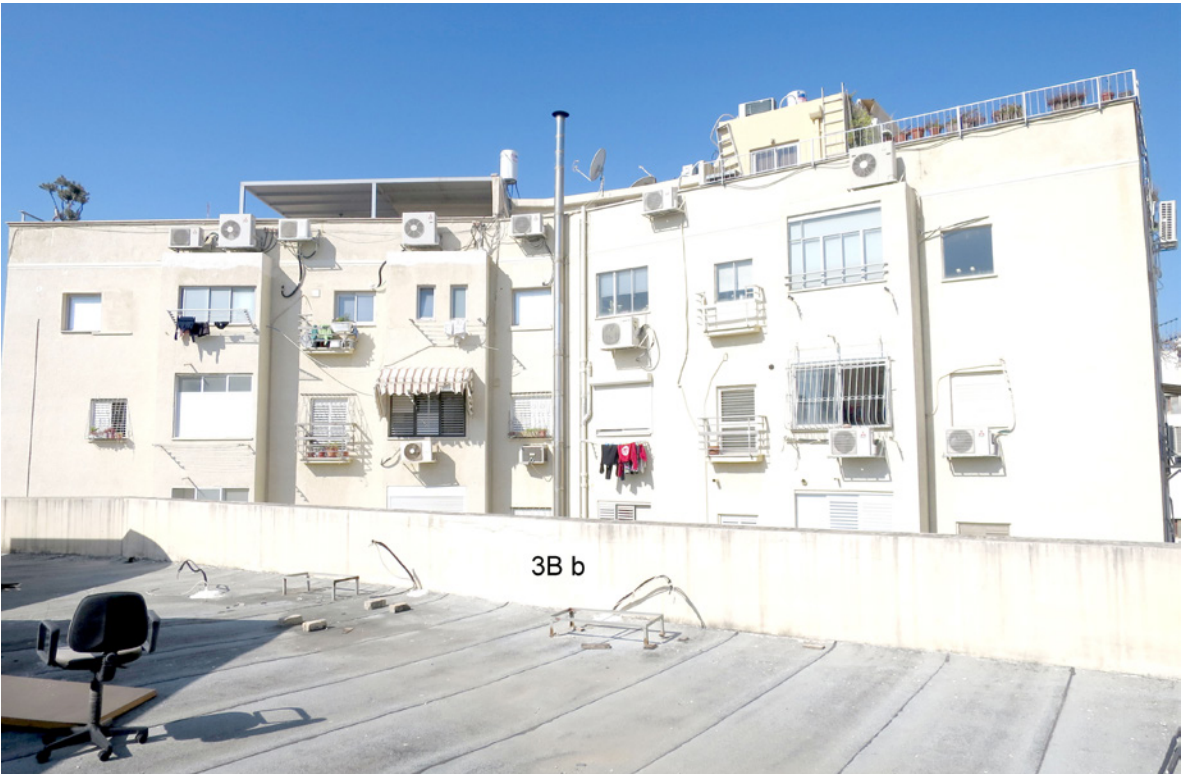
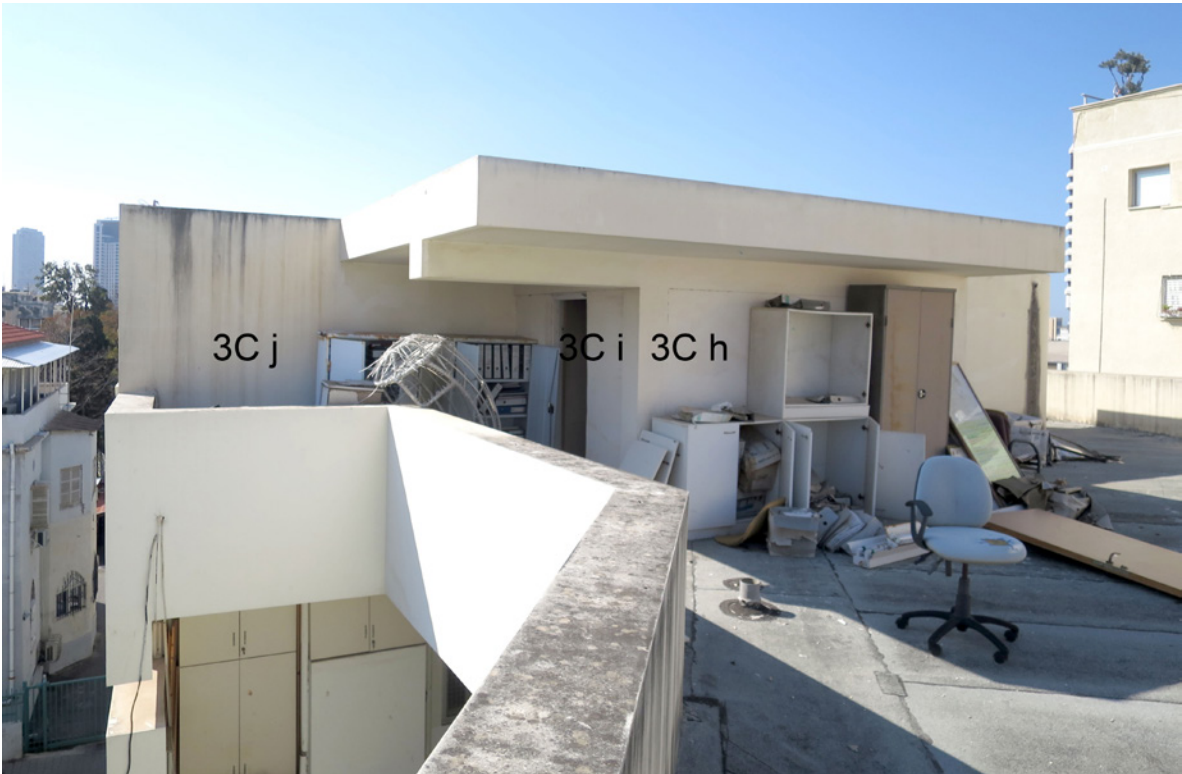
DATE		FLOOR		FUNCTION	ROOM
04/30/2015		Roof		-	03.C
ELEMENT	TYPE	DESCRIPTION	CONDITION, NOTES	DATING	ORIGINAL MATERIALS AND COLORS
FLOOR					
	F.2.1	mineral-surfaced bituminous roofing; surface-mounted cable bushings and steel racks of formerly installed air-conditioning units in front of walls a and b		1967-1990s	
Walls and built-in elements					
a/b		Rendered exterior parapet, rounded corner to wall n; rendered coping; iron drainage pipe passing through the wall into the downpipe	Exterior render and paint renewed; discoloration due to oxidation; cracks in the plaster at the coping	Wall 1937; render and paint 1990s	Parapet: cream white
d		Rendered exterior parapet, rendered coping	Exterior render and paint renewed; discoloration due to oxidation; cracks in the plaster at the coping	Wall 1937; render and paint 1990s	Parapet: cream white
e/f/g		Rendered exterior wall, rendered wall coping; iron drainage pipe of the staircase penthouse roof passing through the parapet at wall f and g	Exterior render and paint renewed; discoloration due to oxidation; cracks in the plaster at the parapet	Wall 1937; render and paint 1990s	Parapet: cream white

D03.V.02	D.2.3	Solid door to the staircase	Replaced, original position	1990s	
h/i		Rendered exterior wall with a rendered cantilevered roof on the northern and eastern sides	Exterior render and paint renewed; cracks in the plaster at the parapet	Wall 1937; render and paint 1990s	Parapet: cream white
D03.V.03	D.2.3	Solid door to the staircase	Replaced, original position	1990s	
j		Rendered exterior wall, rendered wall coping;	Exterior render and paint renewed; discoloration due to oxidation; cracks in the plaster at the parapet	Wall 1937; render and paint 1990s	Parapet: cream white
k/l/m/n		Rendered exterior parapet, rounded corner to wall a; rendered coping	Exterior render and paint renewed; discoloration due to oxidation; cracks in the plaster at the coping	Wall 1937; render and paint 1990s	Parapet: cream white

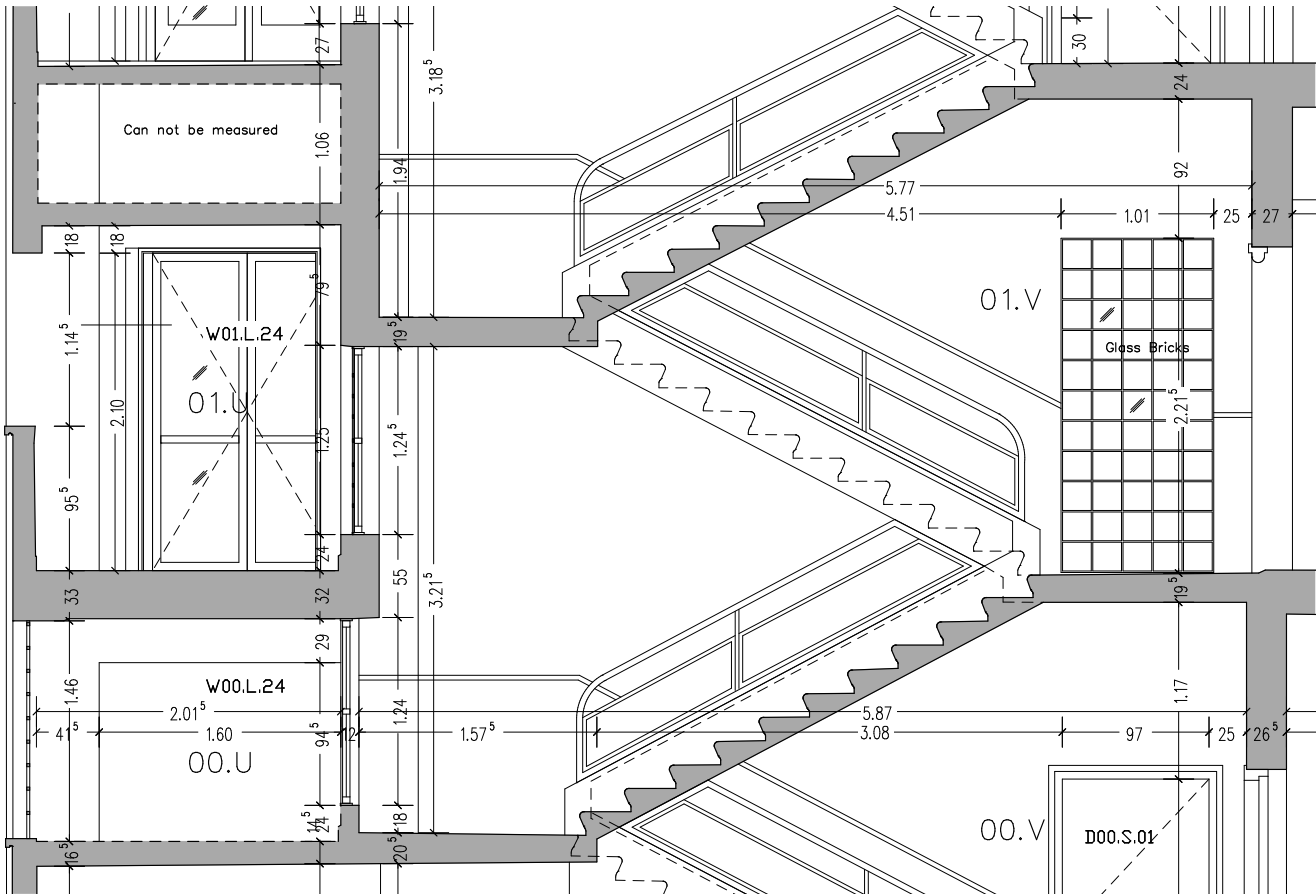
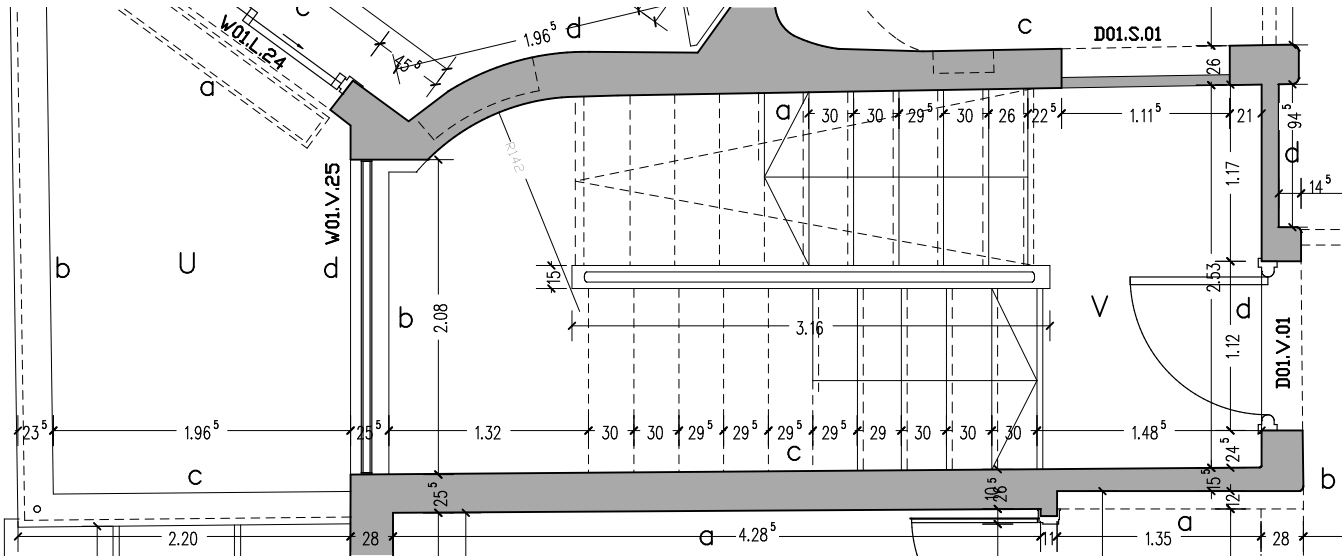
Staircase, section, 1:50, room 01.V

DATE	FLOOR			FUNCTION	ROOM
04/30/2015	Second Floor			Staircase	01.V
ELEMENT	TYPE	DESCRIPTION	CONDITION, NOTES	DATING	ORIGINAL MATERIALS AND COLORS
FLOOR					
	F.1.1	Terrazzo flooring on the stair landings; terrazzo steps; fixings of a stair rod	Partly scratched surface, cracks, traces of wear and tear	1937	M6; fixings: M25
Walls and built-in elements					
a		Plastered interior wall, wall tiling topped with a wooden dado rail up to 1.20m; rounded wall at the upper stair landing	Paint on the plaster and coating of the dado rail renewed; traces of wear and tear	1937	M7, (C.1.3); wall tiling: M8
D01.S.01	D.2.1	Wall opening of the former apartment entrance closed with glass bricks (formerly type D.1.2)		Glass bricks 1948-1990s	
b		Plastered interior wall, wall tiling topped with a wooden dado rail up to 1.10m; W00.UV.25 installed on a base covered with terrazzo	Paint on the plaster and coating of the dado rail renewed; traces of wear and tear	1937	M7, (C.1.3); wall tiling: M8

W00.V.25	W.1.2	Three-part window with a wooden frame, one horizontal and one vertical sash bar; upper part: two sliding leaves; lower part: two panels of fixed glazing	Exterior paint peeling off	1937	Wood: M13, (C.1.6); glass M18 (sliding leaves), M16 (fixed glazing)
W01.V.25	W.1.2	Three-part window with a wooden frame, one horizontal and one vertical sash bar; upper part: two sliding leaves; lower part: two panels of fixed glazing; grille (3 vertical and 7 horizontal steel bars)	Exterior paint peeling off; crack in the wire glass; grille partly corroded	1937	Wood: M13, (C.1.6); glass M18 (sliding leaves), M16 (fixed glazing); grille: M23
c		Plastered interior wall, wall tiling topped with a dado rail up to 1.20m; wall-mounted lamp holder	Paint on the plaster coating of the dado rail renewed; tile joints partly discolored, traces of wear and tear	1937	M7, (C.1.3); wall tiling: M8
d		Plastered interior wall, wall tiling topped with a wooden dado rail up to approx. 1.10m; surface-mounted wall lamp, flush-mounted light switch, door bell push and socket without cover	Paint on the plaster and coating of the dado rail renewed; tile joints partly discolored, traces of wear and tear; light switch and door bell push renewed	1937; door bell push probably 1967-1990s; light switch and light 1990s or later	M7, (C.1.3); wall tiling: M8

D01.H.01	D.2.3	Entrance door to the apartment, glazed aluminium construction	Renewed	1990s	
Stair railing		Wooden frame construction with wire glass panels mounted on a terrazzo base, partly fixed to the underside of the next stair flight	Coating renewed, some cracks in the glass	1937	M11, glass: M16
Ceiling					
		Ceiling, probably concrete construction, plastered	Paint on the plaster renewed	1937	concrete, plaster, (C.1.3)
