CONSERVATION SURVEY

MAX-LIEBLING-HOUSE

29, IDELSON STREET, TEL AVIV

Tel Aviv/Berlin, 2016/17

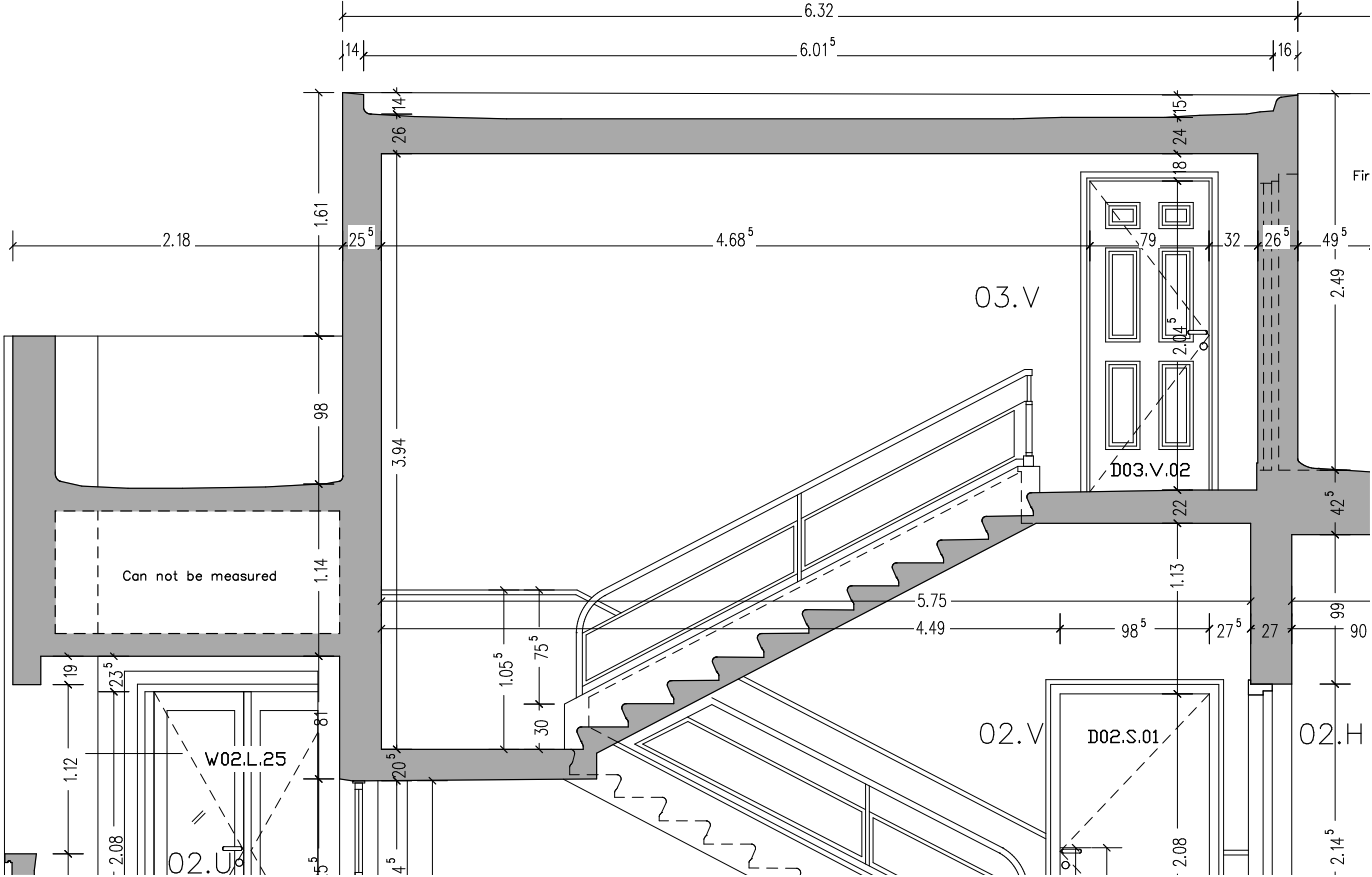
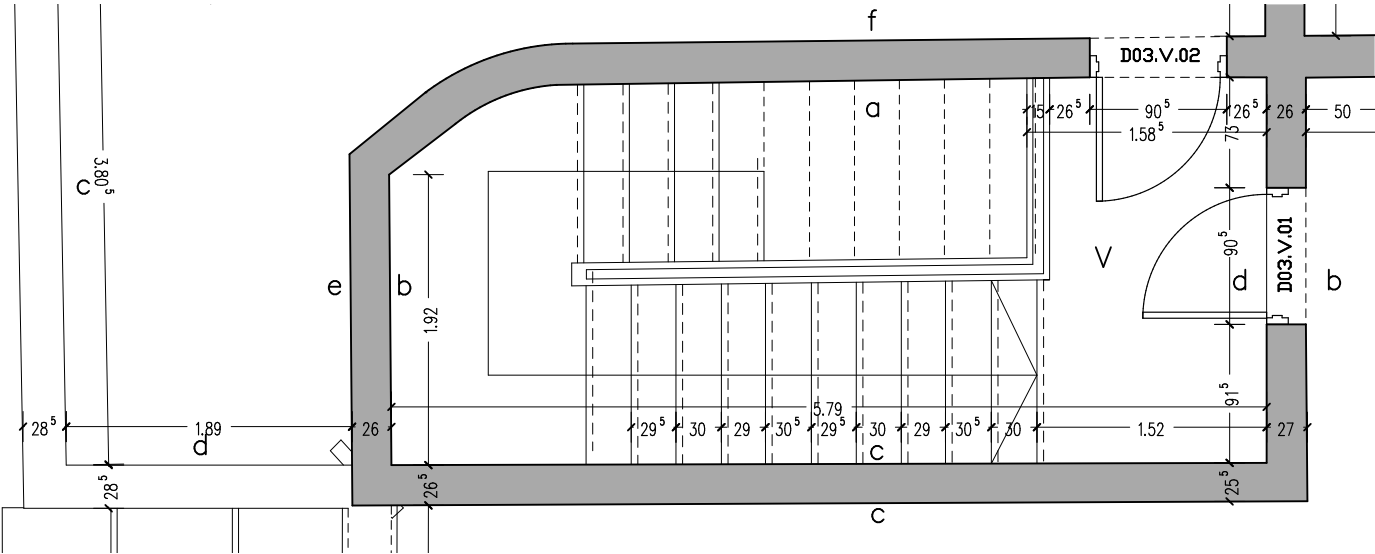
Staircase, section, 1:50, room 03.V

DATE		FLOOR		FUNCTION	ROOM
04/30/2015		Third Floor/Roof		Staircase	03.V
ELEMENT	TYPE	DESCRIPTION	CONDITION, NOTES	DATING	ORIGINAL MATERIALS AND COLORS
FLOOR					
	F.1.1	Terrazzo flooring on the stair landings; terrazzo steps; fixings of a stair rod	Partly scratched surface, cracks, traces of wear and tear	1937	M6; fixings: M25
Walls and built-in elements					
a		Plastered interior wall; terrazzo baseboard; wall-mounted lamp	Paint renewed, baseboard partly damaged, discolorations	1937; lamp 1970s-1990s	M7, (C.1.3); baseboard: M6
D03.V.02	D.2.3	Solid door to the northern roof	Replaced	1990s	
b		Plastered interior wall; terrazzo baseboard, painted white	Paint renewed, baseboard partly damaged	1937	M7, (C.1.3); baseboard: M6
c		Plastered interior wall; terrazzo baseboard	Paint renewed, baseboard partly damaged, discolorations	1937	M7, (C.1.3); baseboard: M6
d		Plastered interior wall; terrazzo baseboard	Paint renewed, baseboard partly damaged, discolorations	1937	M7, (C.1.3); baseboard: M6

D03.V.01	D.2.3	Solid door to the southern roof	Replaced	1990s	
Stair railing		Wooden frame construction with wire glass panels mounted on a terrazzo base	Coating renewed, one glass panel on the uppermost landing missing	1937	M11, glass: M16
Ceiling					
		Ceiling, probably concrete construction, plastered	Paint on the plaster renewed	1937	concrete, plaster, (C.1.3)

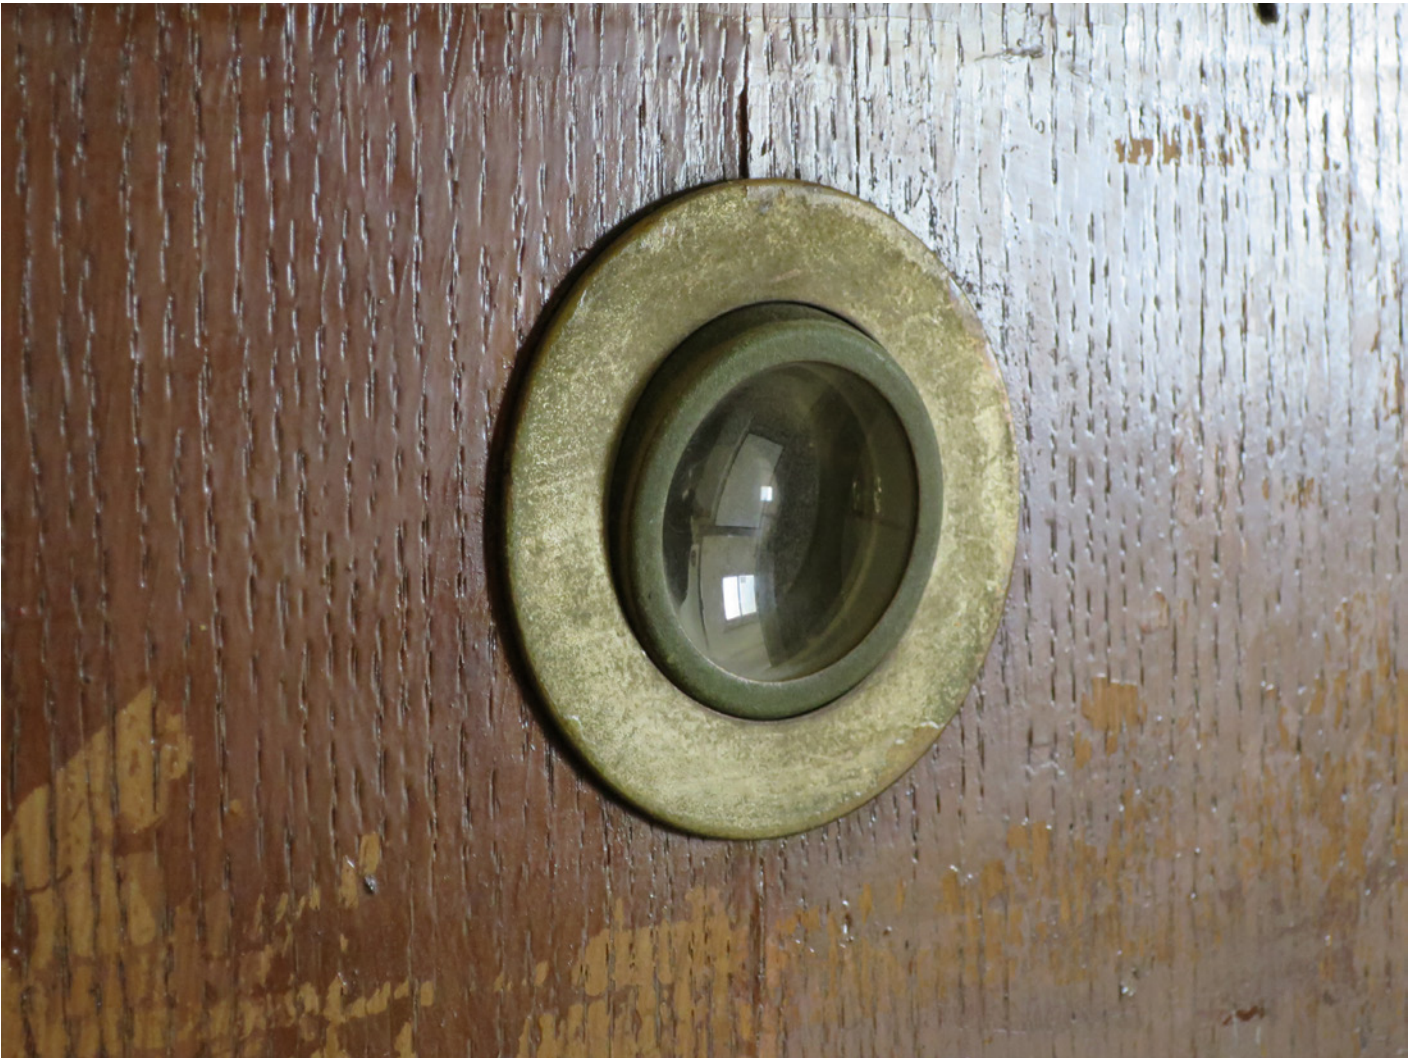
Fig. 150 Peephole in the entrance door on the third floor, 2015

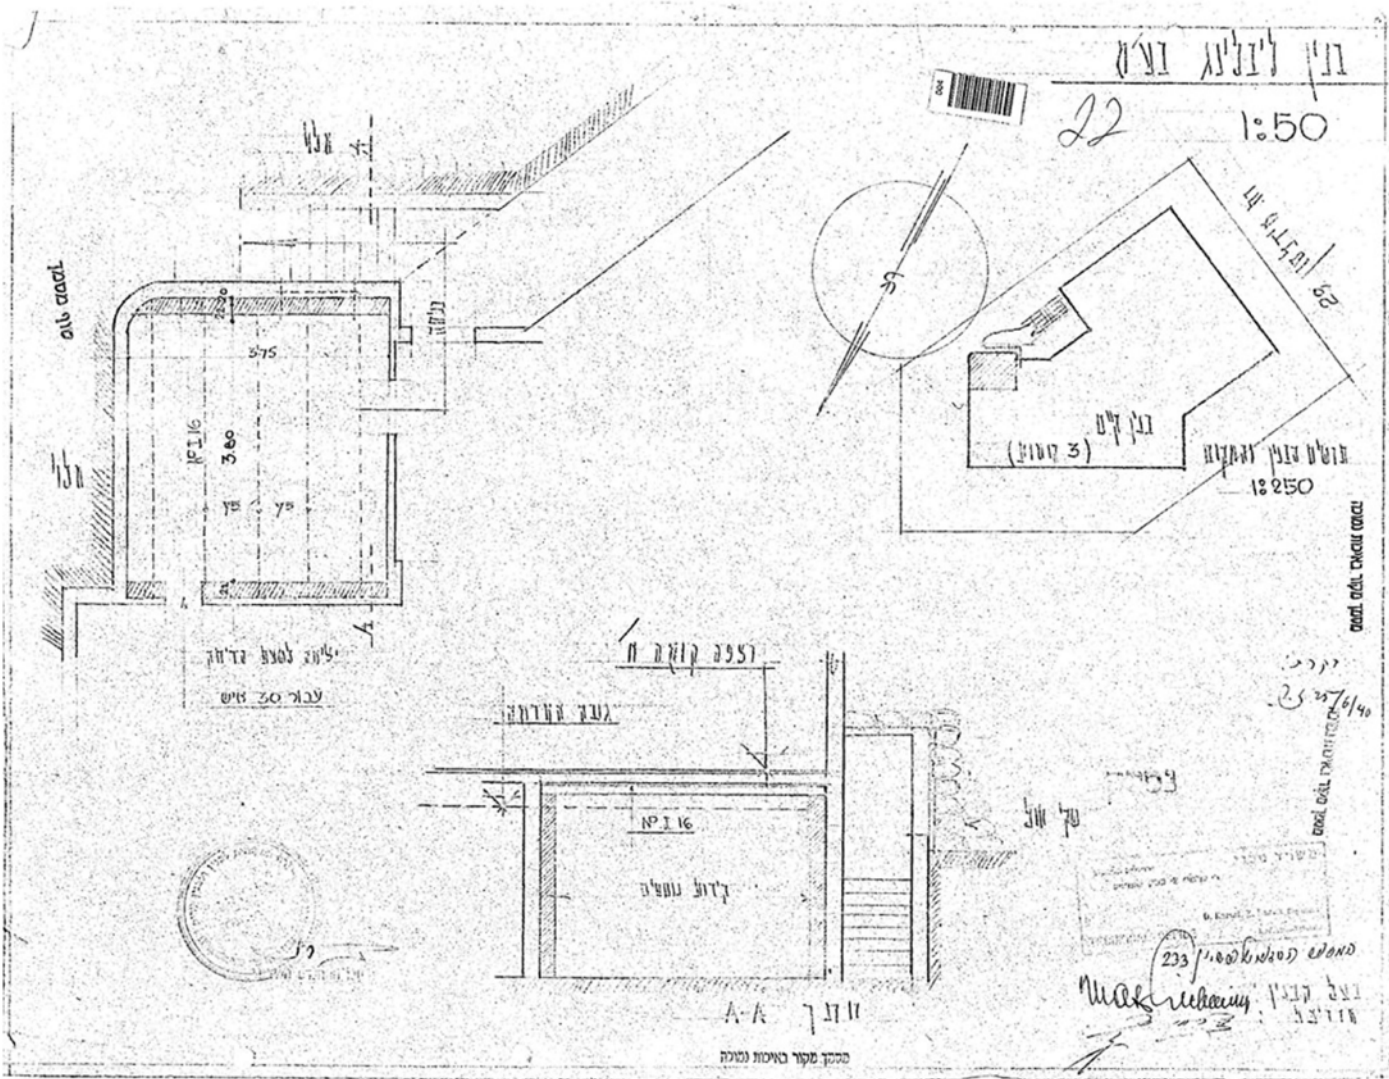
Fig. 153 Strengthening walls in the air raid shelter (room -1.C), plan 1940

1940: the reinforcement of the walls of a basement room to create an air raid shelter. Evidence of this measure can no longer be found in the existing fabric of the building, because further reinforcement work was undertaken during the third construction phase.

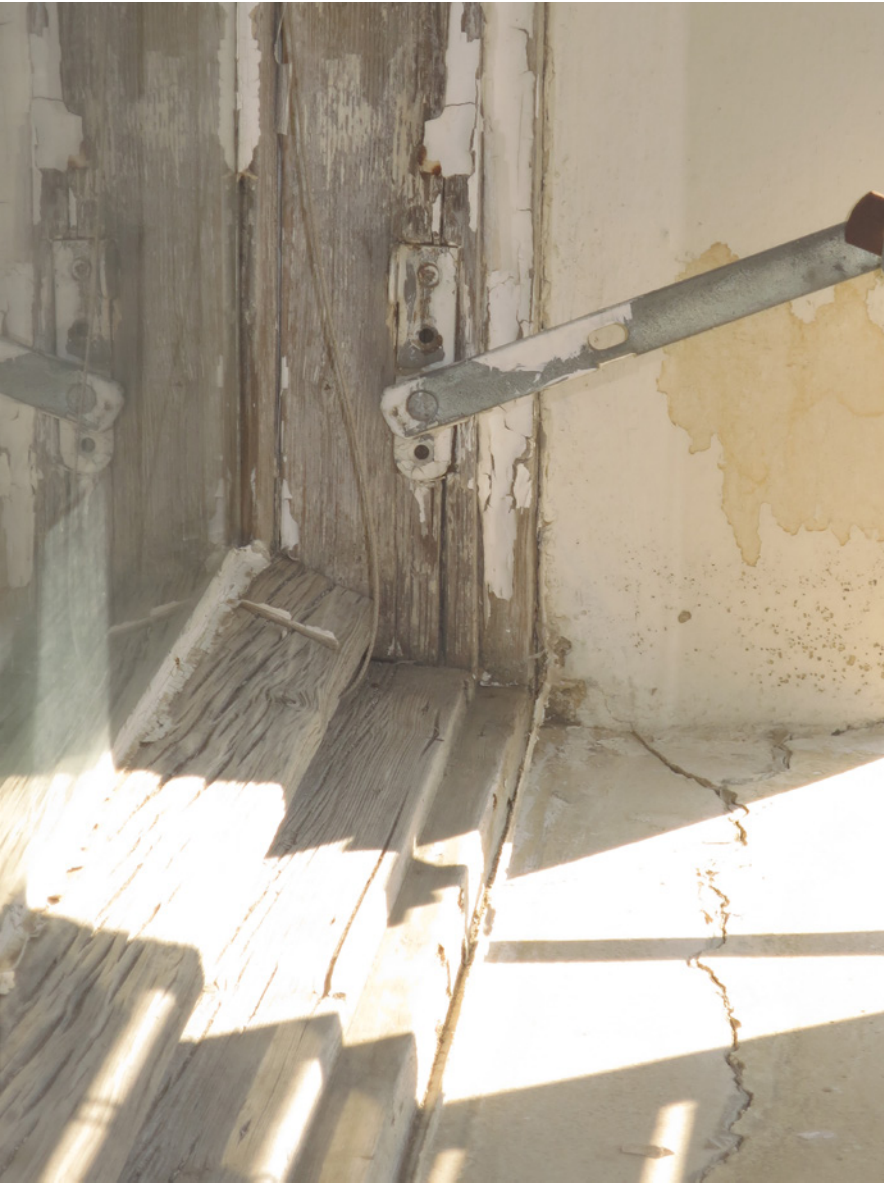
Fig. 176 Paint peeling off an original window frame, 2015

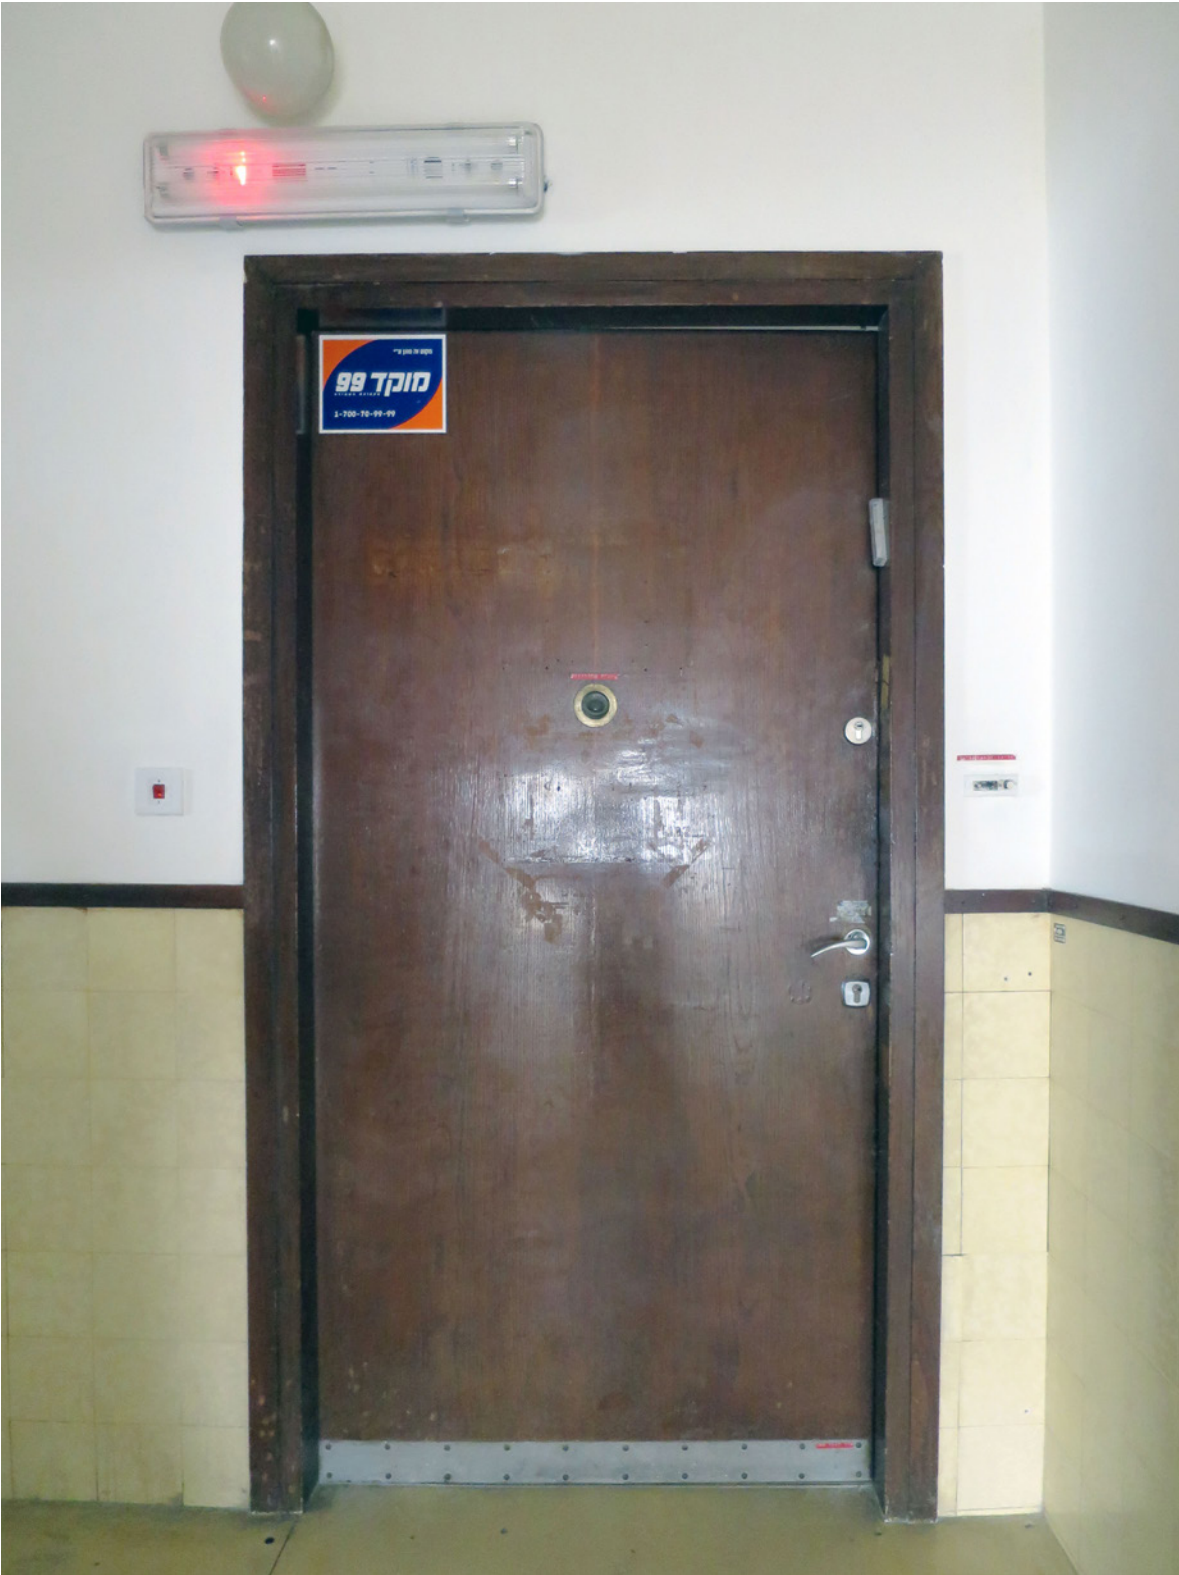
Fig. 25 Original entrance door in the staircase, subsequently added security lighting beneath an original wall lamp

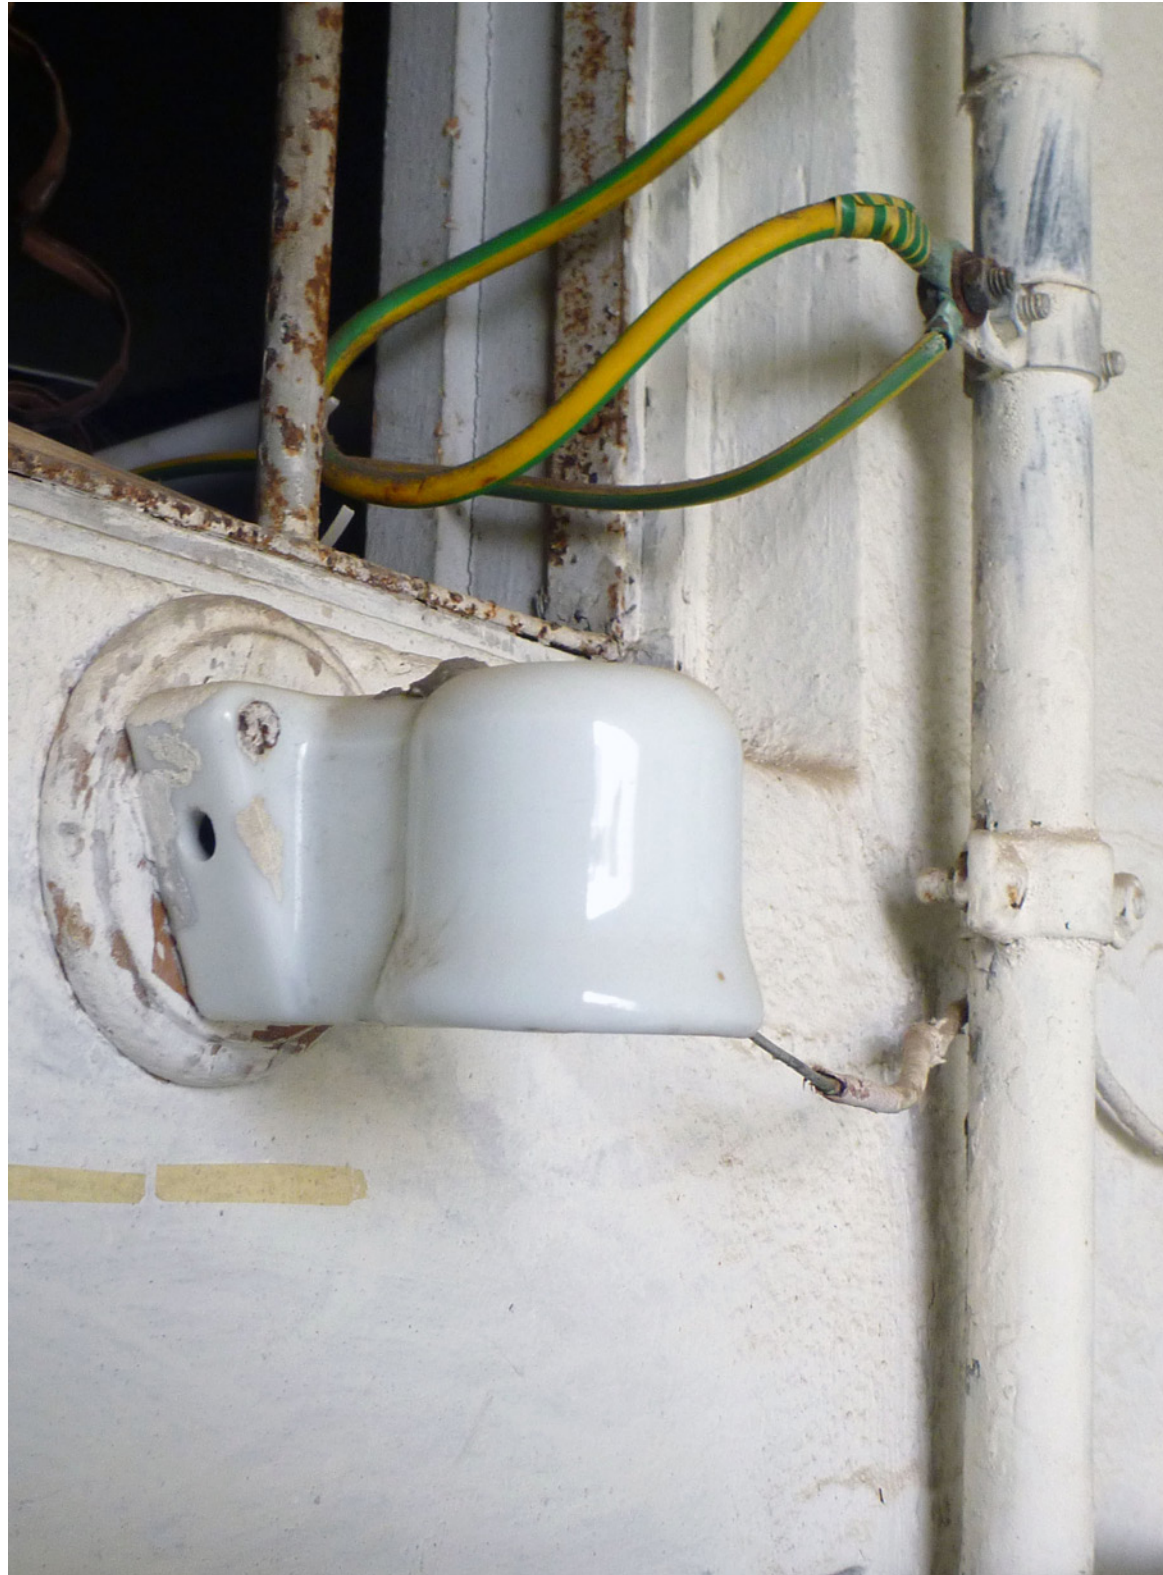
Fig. 31 Electric installations on the utility balcony 02.K

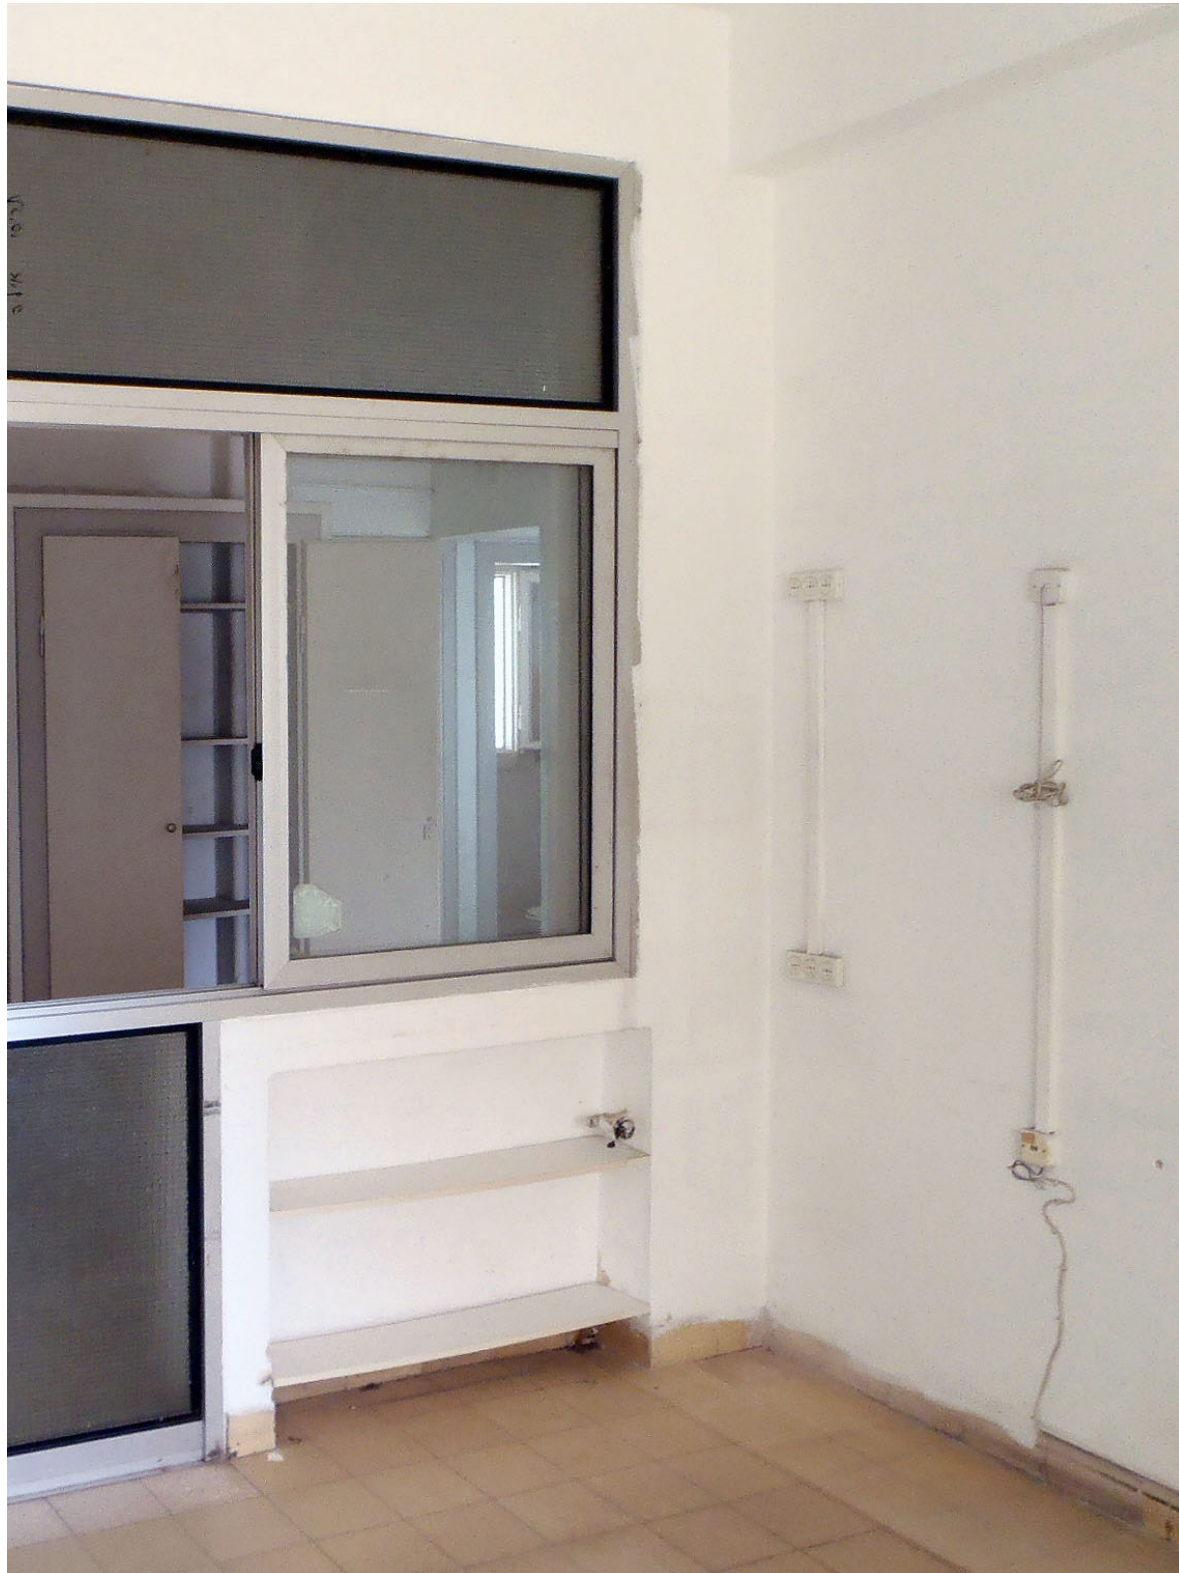
Fig. 34 Radiator recess in room 02.B with remains of a heating valve, 2015

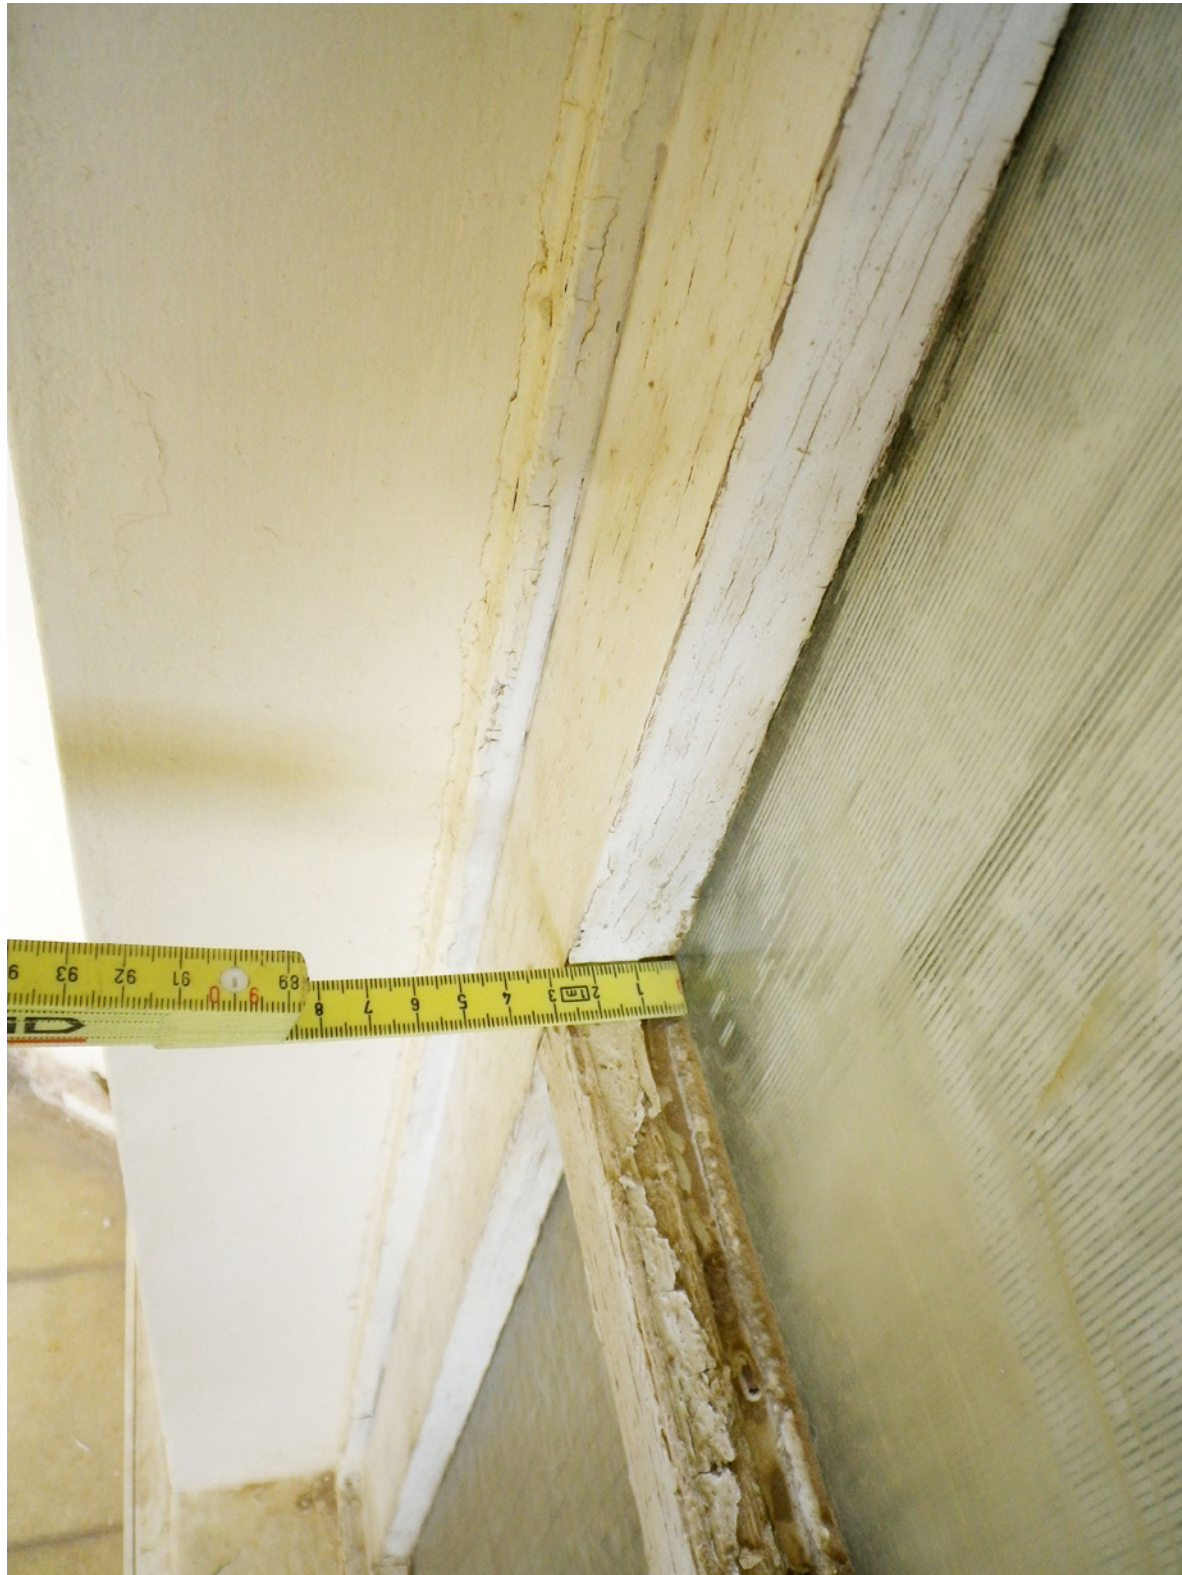
Fig. 36 Staircase window with original glazing on balcony 02.U, 2015

condition. The built-in cabinetry that was added later in the foyer is to be dismantled and the wall finishes supplemented if necessary. The apartment entrance doors on the third floor are largely intact and can be used as a model for reconstructing the doors on the second and first floors. In the case of the doors to the roof, the existing plastic doors should be replaced with new doors that are based on the original design for this building or on extant original doors of similar buildings. The positioning of wall-mounted luminaires, switches, and doorbell buttons corresponds largely to the original design from the time of construction. Therefore it should be maintained and supplemented by installations only when absolutely necessary. Later additions are to be removed. The existing lamp sockets of porcelain apparently belong to the original fittings and should be supplemented by simple (presumably lenticular) opaque glass shades like the ones stored in the storage space behind the mailbox unit at the time of the condition survey. The water basin in the entrance space is to be renovated. Its function should be indicated by restoring, at least visually, the inlet and outlet. Here, too, examples in other buildings are to be researched.

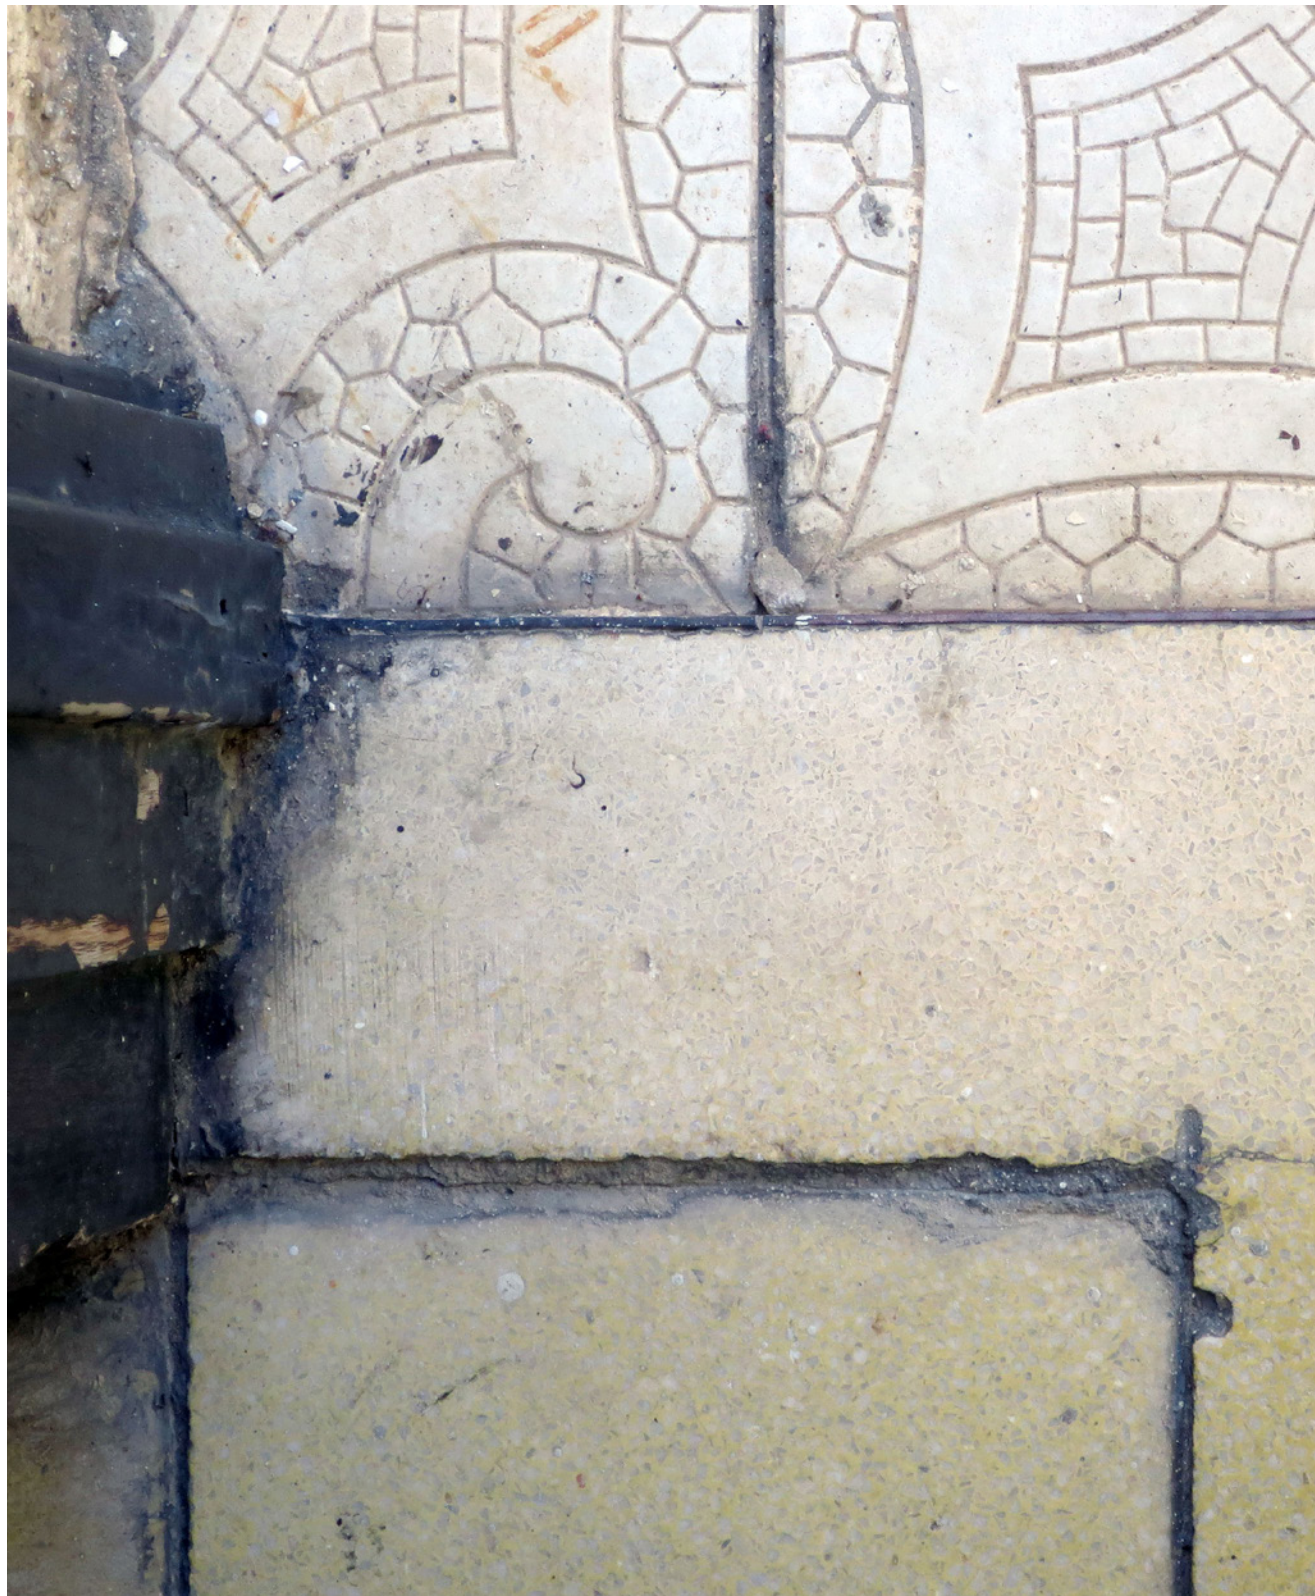
Fig. 37 Original cement and terrazzo tiles on the floor at the main entrance door, 2016

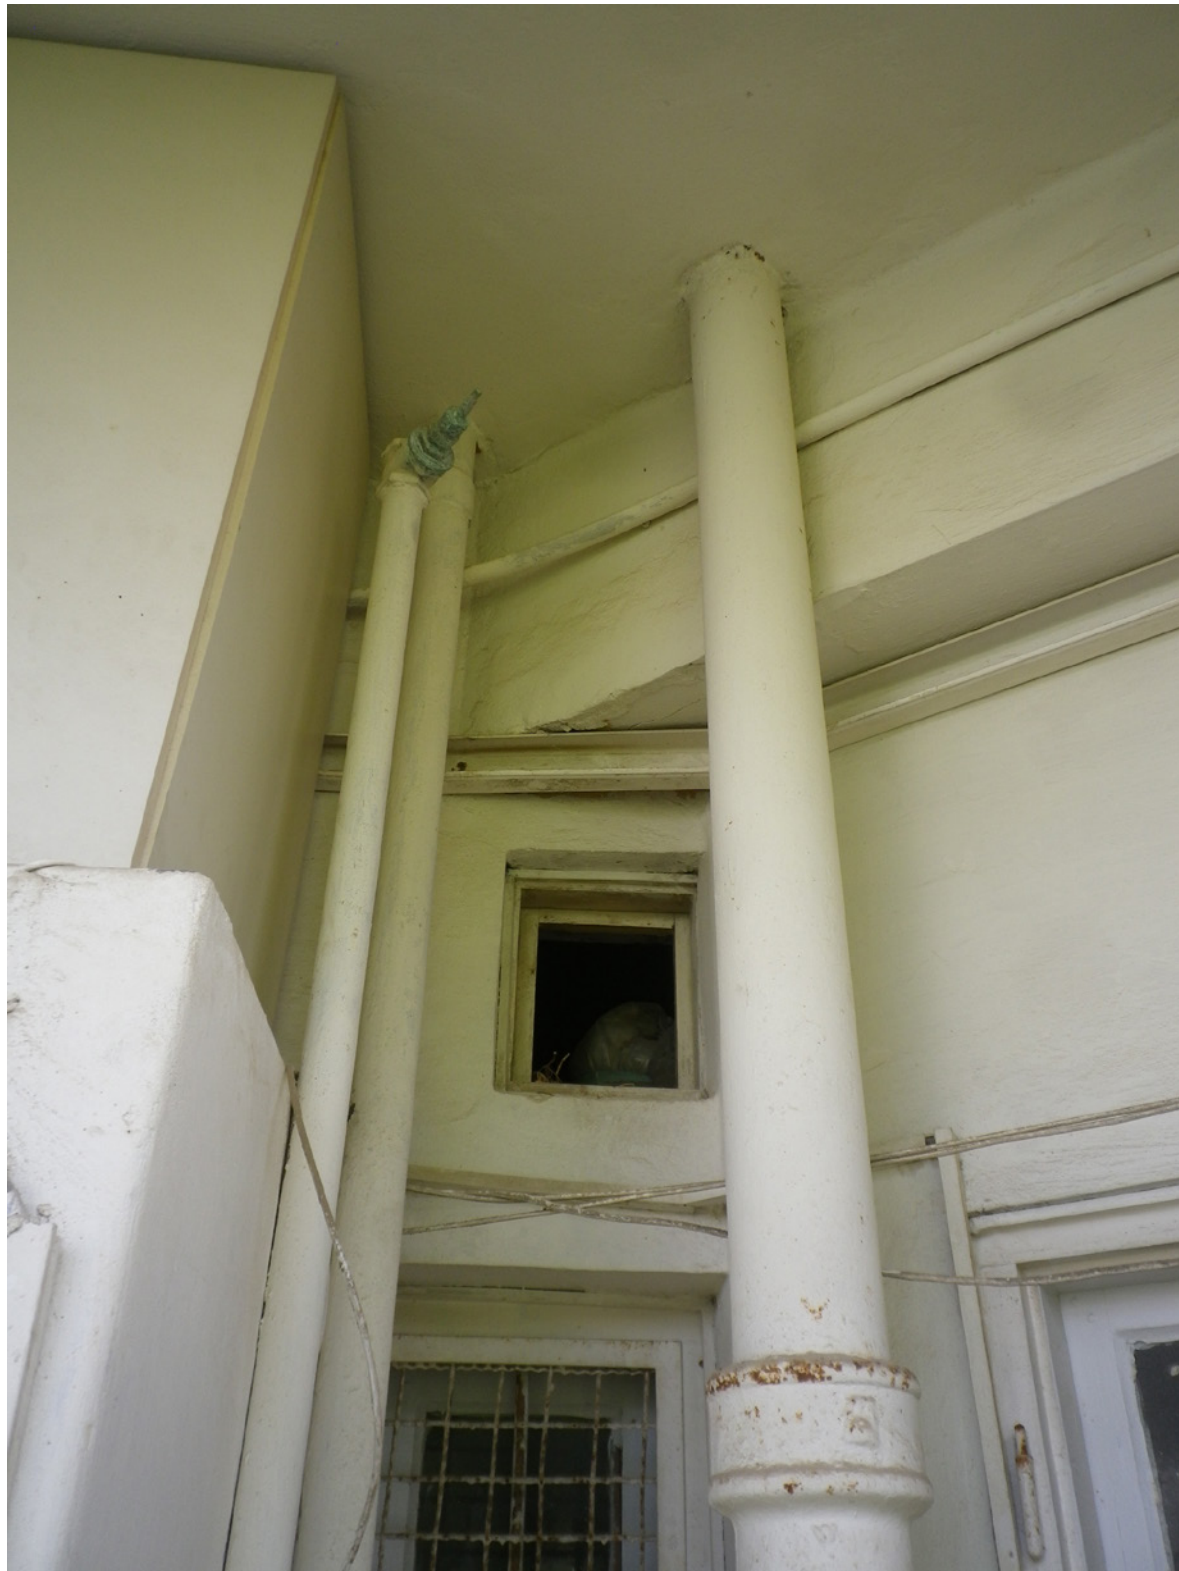
Fig. 38 Original water supply and wastewater lines on the utility balcony 02.K, 2015

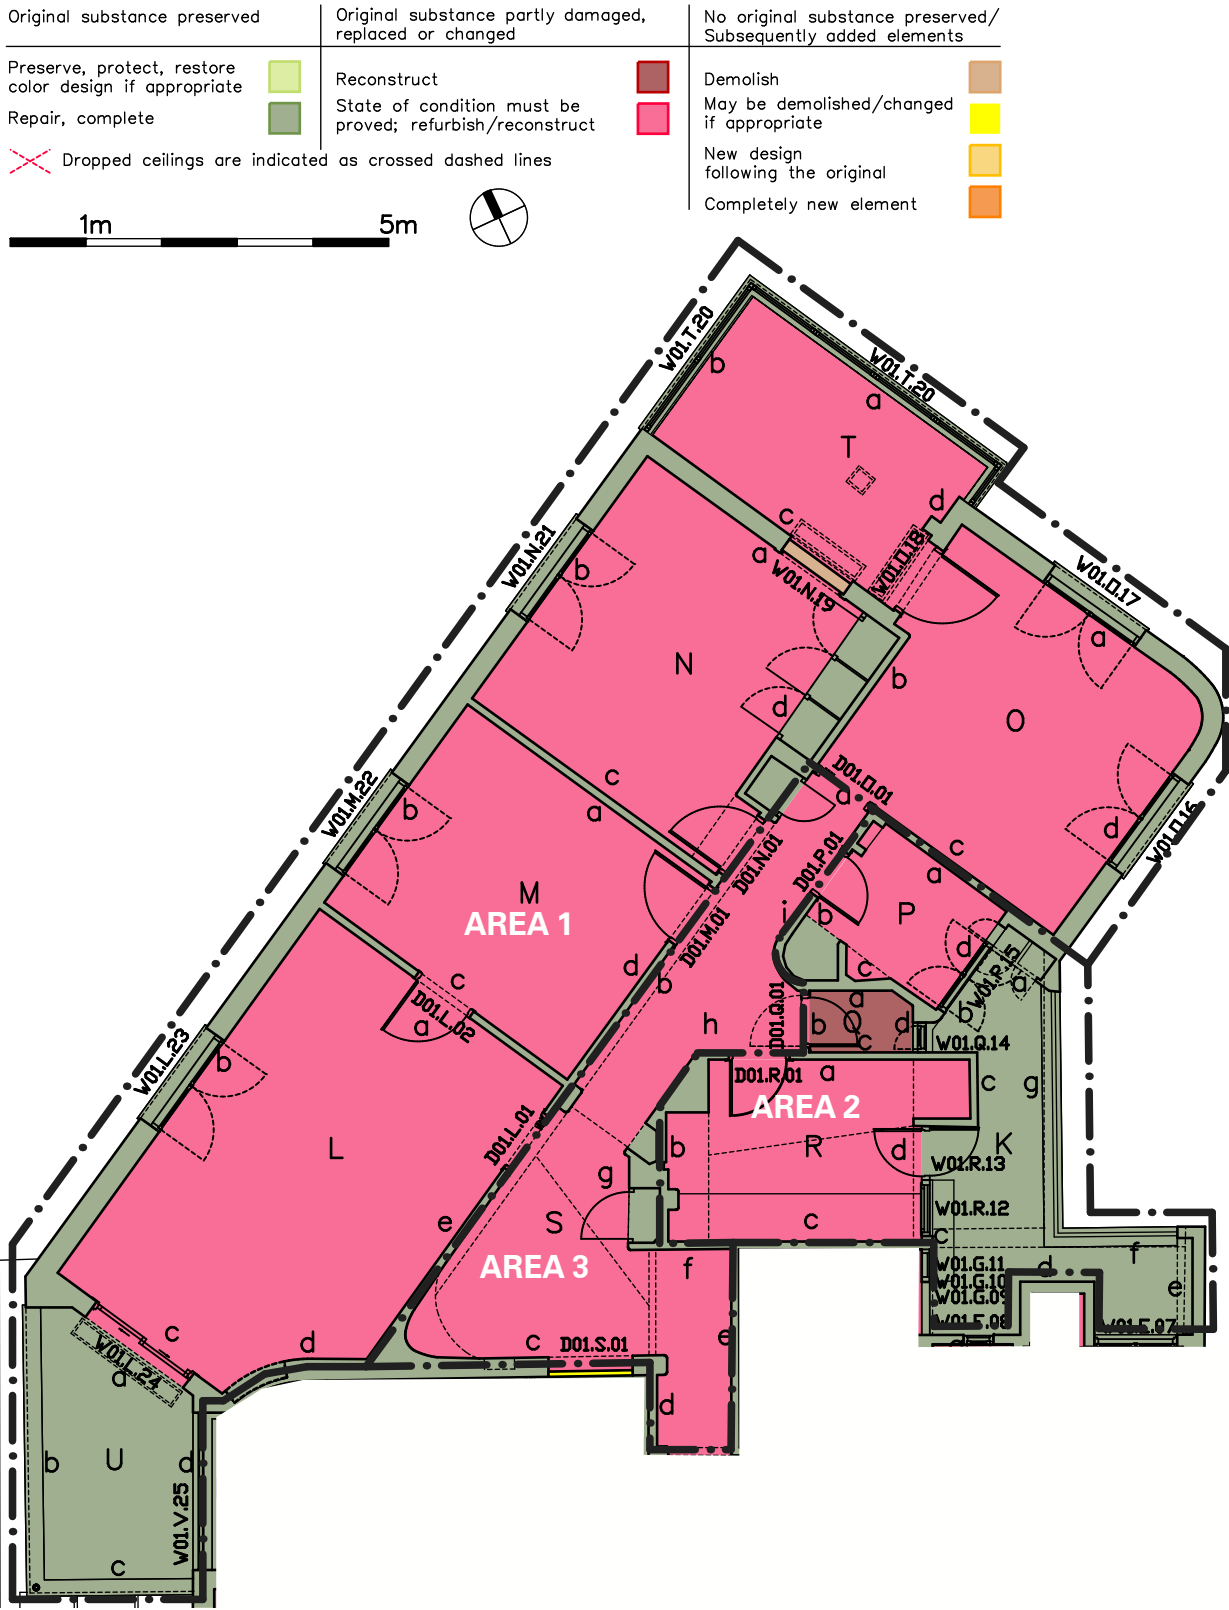
Fig. 74 2nd floor, apartment 2, preservation measures, walls and floors

AREA 1 (LIVING ROOMS L-O, BALCONIES U AND T)						
BUILDING ELEMENT	WALL	FLOOR	CEILING	WINDOWS AND BALCONY DOORS	INTERIOR DOORS	BUILT-IN FURNITURE AND FIXTURES
HERITAGE VALUE, SPECIAL ITEMS	Largely original; radiator recess in wall 01.L.d	Original terrazzo floor probably beneath the current flooring	Largely original; damaged concrete above intermediate ceilings on 01.T and 01.U	Windows original; doors leaves of W01.L.24, W01.N.19 and W.01.O.18 subsequently replaced	Doors leaves of D01.L.01. D01.O.01 subsequently replaced	Original built-in furniture in 01.N
PRESERVATION MEASURES	Repair; demolish ventilation ducts and close wall openings (remains of the air conditioning); preserve remains of the original radiator in 01.L	Repair; uncover original floor, complete or reconstruct missing or damaged areas	Repair minimally invasive	Repair windows and original door frames; uncover door opening W01.N.19; reconstruct subsequently changed doors	Repair original doors and preserved original frames; reconstruct subsequently changed door leaves	Repair and complete

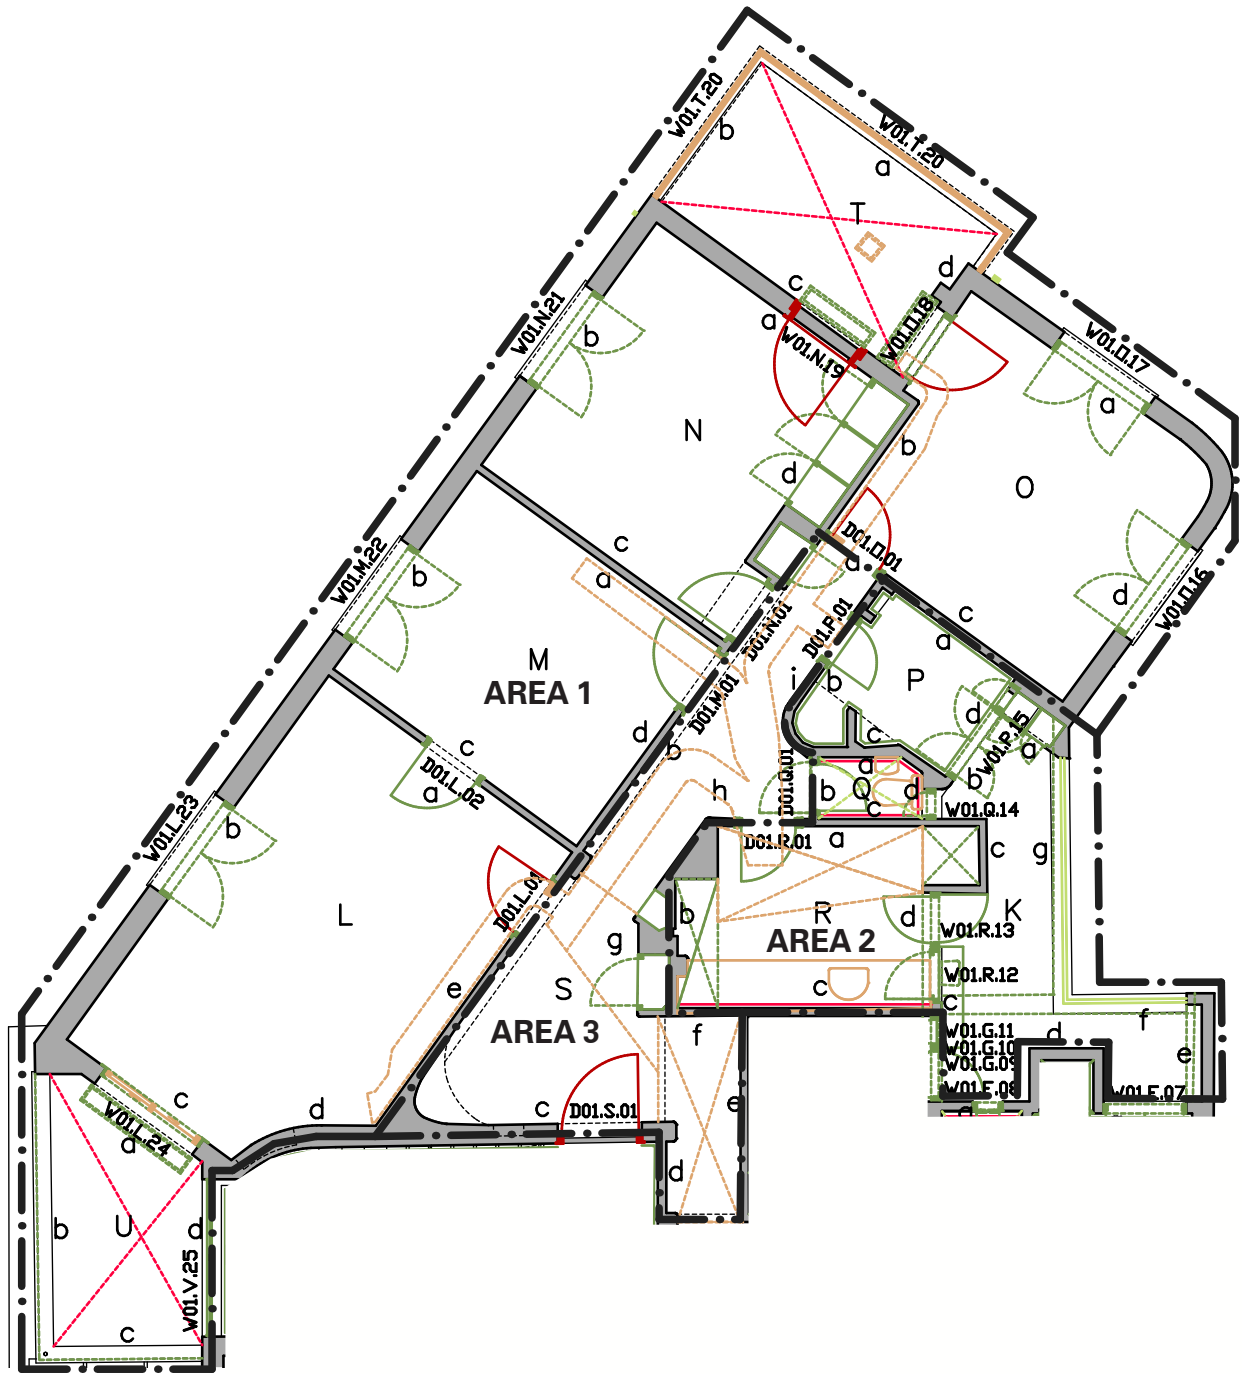
Fig. 75 2nd floor, apartment 2, preservation measures fixtures, built-in furniture, wall tiling, ceilings

AREA 2 (BATHROOM, WC, KITCHEN, ROOMS P, Q, R, UTILITY BALCONY K)						
BUILDING ELEMENT	WALL	FLOOR	CEILING	WINDOWS AND BALCONY DOORS	INTERIOR DOORS	BUILT-IN FURNITURE AND FIXTURES
HERITAGE VALUE, SPECIAL ITEMS	Wall tiling original in 01.P, tiling in 01.Q and 01.R partly missing, damaged, painted or covered with new tiles	Original terrazzo floor in 01.K; subsequently covered in 01.P; 01.R; new floor in 01.Q	Original storage space in the intermediate ceiling of 01.Q; dropped ceiling in 01.R	Largely original; windows partly combined with hatch doors to the outdoor cabinets; few original handles and window shutters partly missing	Largely original; handles partly missing	Sanitary fixtures (01.P) partly preserved; outdoor cabinets on balcony 01.K largely preserved; laundry closet in front of W01.E.07 missing
PRESERVATION MEASURES	Uncover original wall tiling; repair or complete in accordance with the original tiles	Uncover original terrazzo flooring, repair, complete or reconstruct original floor	Demolish dropped ceiling; repair	Repair, complete	Repair, complete	Repair; reconstruct missing parts of the cabinets if possible
