Managing change with a living architect OCEAN SWIMMING POOL BY ÁLVARO SIZA

CONSERVATION MANAGEMENT PLAN

Teresa Cunha Ferreira (FAUP, University of Porto)

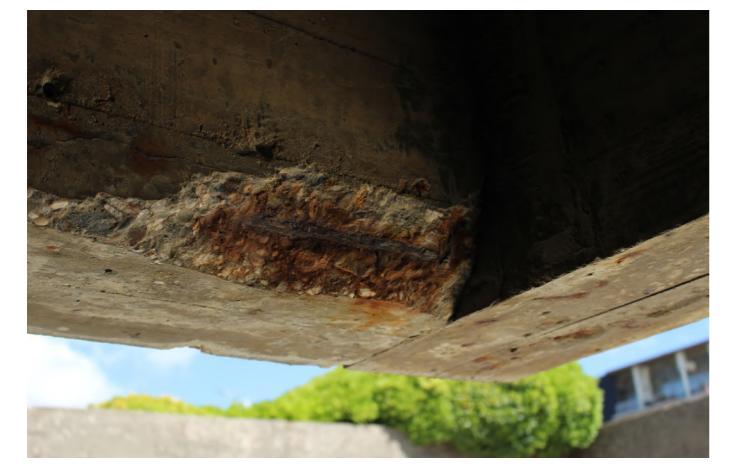
Detachment of concrete fragments. Causes: carbonation of concrete, presence of chlorides, rebar corrosion.

- 4.4 Concrete spalling (1).
- 4.5 Distributed crack pattern (2).
- 4.6 Vertical crack (3).
- 4.7 Efflorescence (4).
- 4.8 Exposed corroded rebars (5).
- 4.9 Rainwater run-off stains (6).

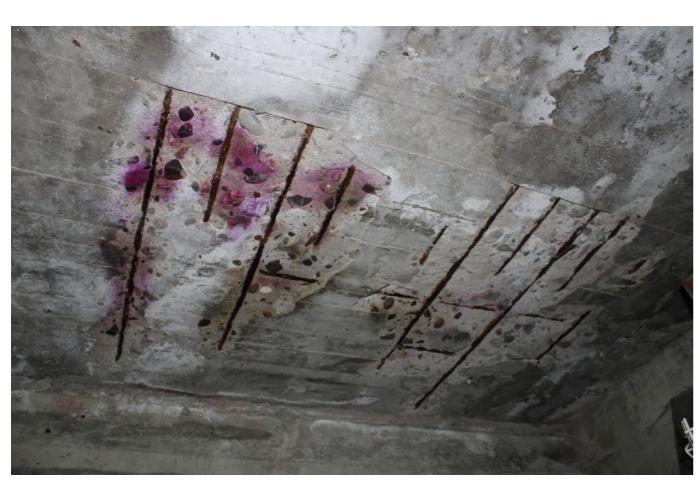
4.9

Superficial vertical tracks of diversified color. Causes: building morphology, atmospheric agents, air pollution.

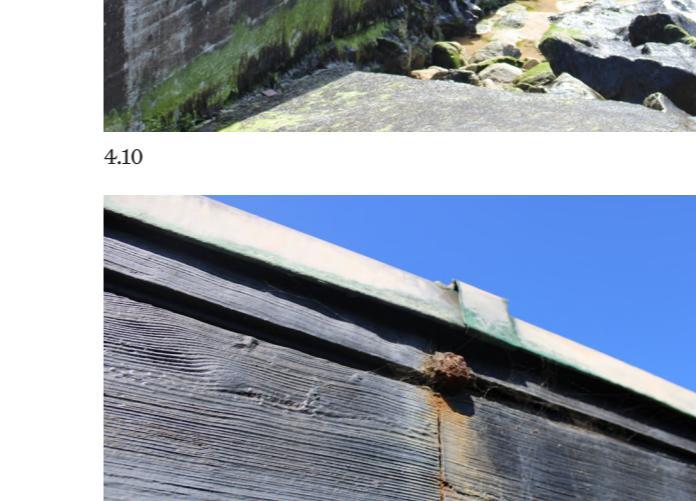
The roof's copper cladding presents a green color due to oxidation and leakages have been identified, resulting from weather exposure and lack of maintenance. The roof's timber structure and the changing rooms' partition walls present localized detachment of the coating and an oily texture, which results from the excessive amounts of linseed oil used in its maintenance. The screws used for the timber structure show signs of oxidation, with brown textured spots on their surface.

- 4.10 Biological colonization (7).
- 4.11 Incorrect repair interventions (8).
- 4.12 Corroded screws and oily texture of wooden elements (9).
- 4.13 Corroded water pipes (10).
- 4.14 Condition survey photographs location.

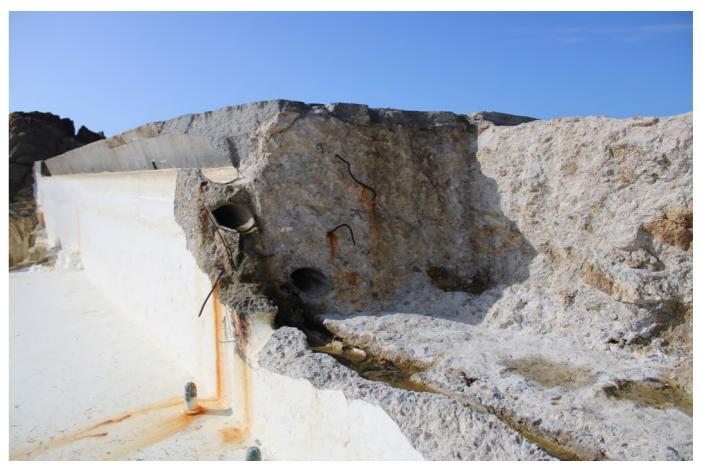
Finally, the most notable deficiency in the building's use is related to the plumbing system, as many of the pipes of the water system have either been destroyed by corrosion or are clogged with sand, which means that they were compromising the Ocean Swimming Pool's functionality (closed to the public in 2018 and reopened in 2021).

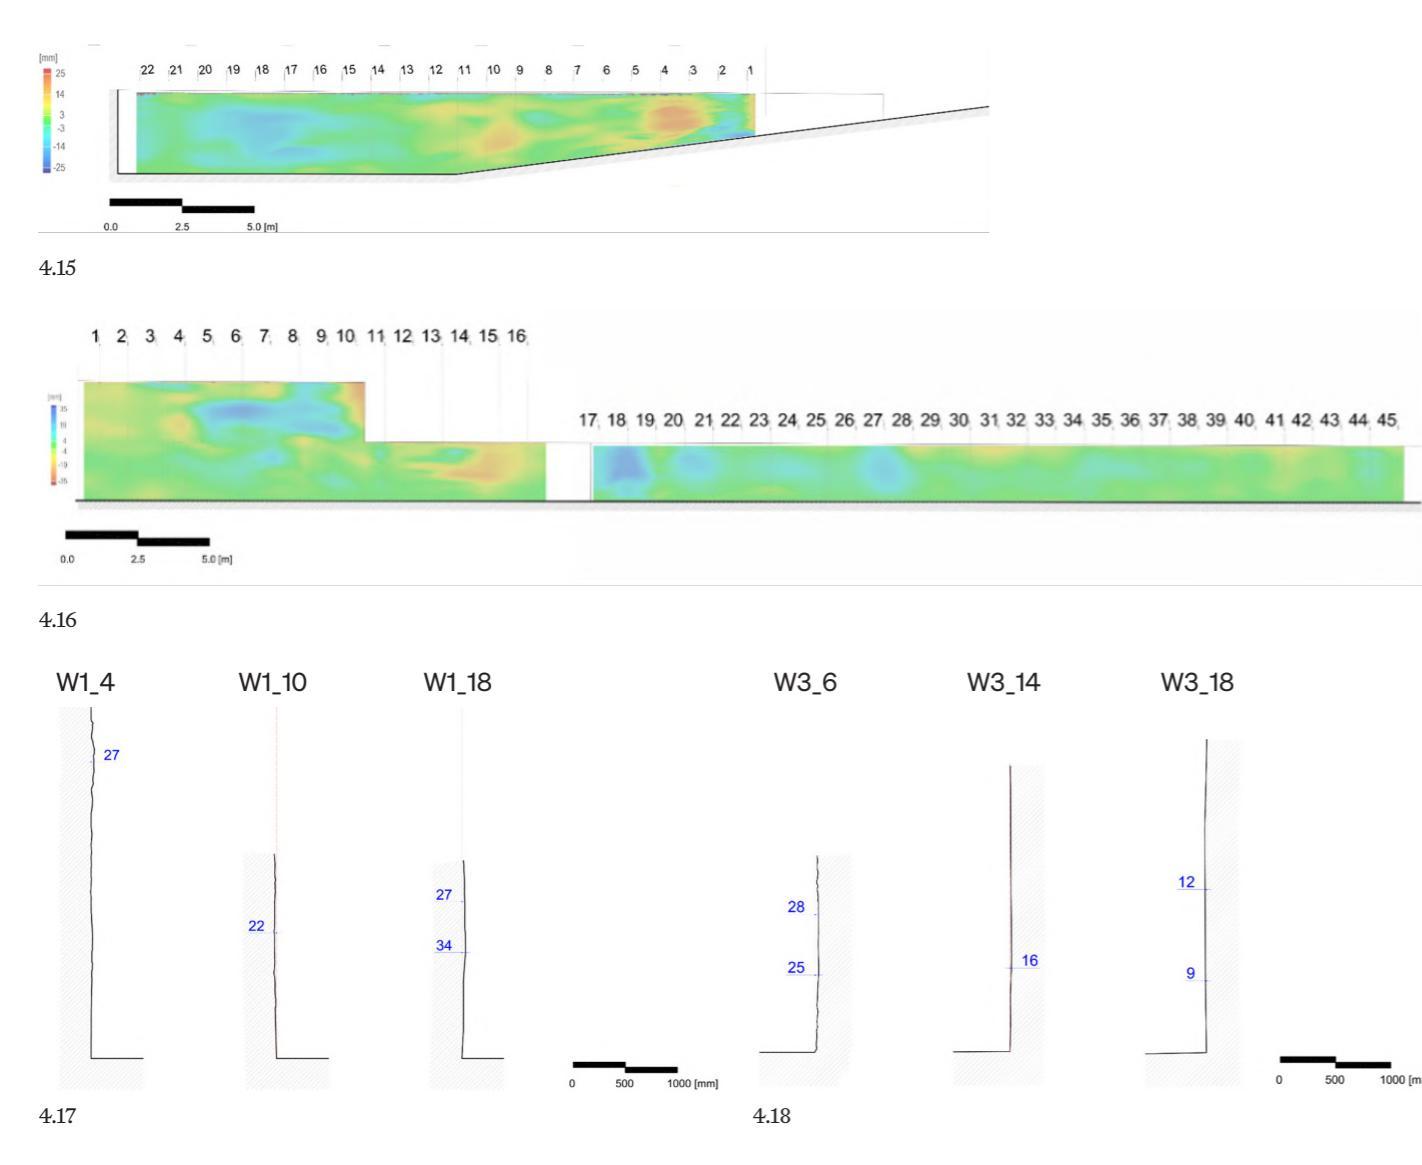
to 28 mm and occurs at the cross-section W1_4 in the east direction (inwards) (fig. 4.15 and 4.17). The maximum out-of--plane deformation in the west direction (outwards) is equal to 12 mm (cross-section W1_18). In the main façade's North, the maximum out-of-plane deformation is equal to 34 mm and occurs at the cross-section W3_18 in the west direction (fig. 4.16 and 4.18). In the opposite direction, the maximum deformation of this wall is equal to 27 mm (cross-section W3_6). Although these deformations are low, the out-of-plane deformation of the other walls may be also evaluated in the future for further documentation.

4.15 Colormap of the retaining wall out-of-

plane deformation (section AA). 4.16 Colormap of the main façade north out-of-

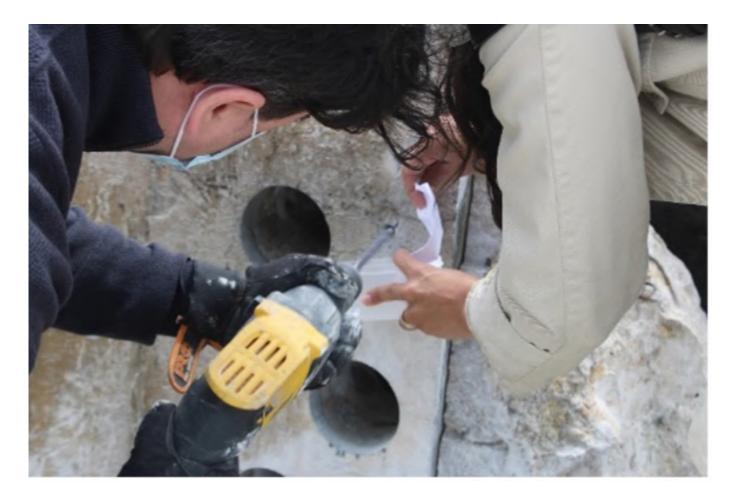
The following table (fig. 4.29) presents the results of the chemical tests with the estimation of chloride content in the cement paste. In general, the results present a significant chloride content (higher than 1% - upper limit defined by EN 206-1 (CEN, 2000), which decreases in depth. In contrast, the samples of the adults' tank present an increase in the chloride content in depth. It is noted that it corresponds to a cyclopean concrete with large stone aggregates and, consequently, the samples can also include stone, influencing the percentage of chlorides in the sample. The samples of the bar also present an unexpected evolution of the chloride content in depth. However, as it was previously referred to, the collection of these samples did not follow the typical procedure. It is also noted that the concrete of the water collection area (interior wall) presents a significant reduction of the chloride content in the

4.27 Cement paste sample collection. 4.28 Cement paste samples. 4.29 Results of the chemical tests to estimate the chloride content in the cement paste.

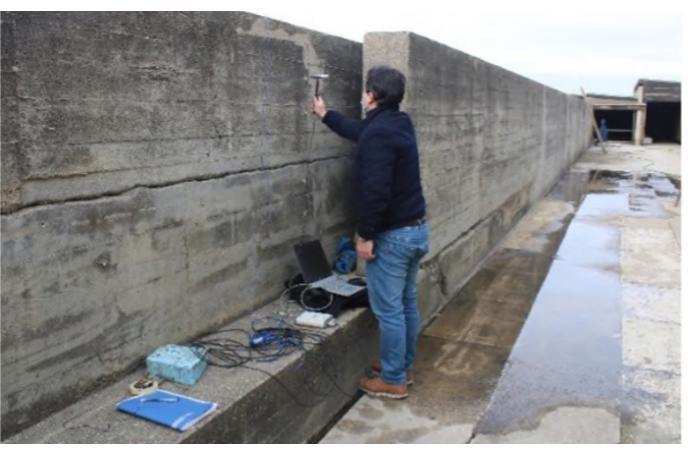
The results of the direct sonic tests (fig. 4.35) show that the average velocity of the waves ranges from 2326 m/s (main's façade South) to 2898 m/s (changing rooms), in which the coefficient of variation is equal to 8%. The tested walls of the South corridor. South bathrooms, and Water treatment area present similar results (velocity about 2580 ms/s; coefficient of variation of 1%), leading to the conclusion that the concrete of these walls does not present significant differences in the elastic properties.

4.35 Sonic testing of the west wall.

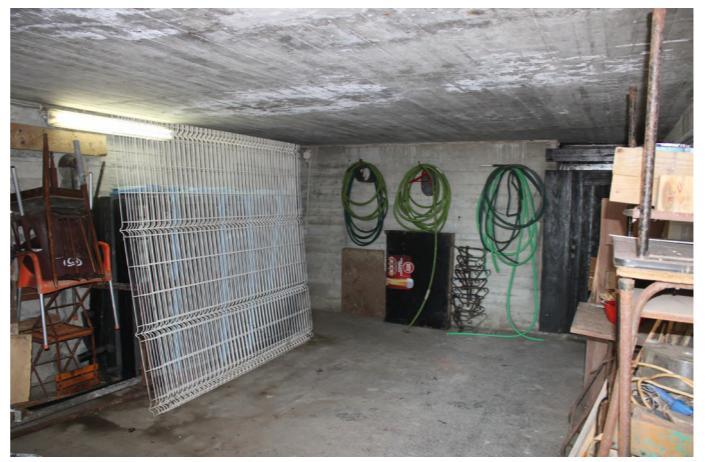
- 4.59 South storage room before the interven-
- tion.
- 4.60 Walkway before the intervention.
- 4.61 Foot wash before the intervention.
- 4.62 Children swimming pool before the inter-
- vention.
- 4.63 Adults swimming pool before the inter-
- vention.

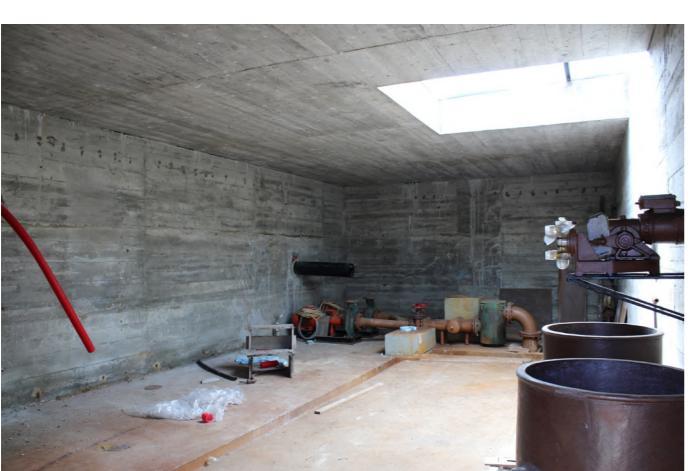
4.69 Water treatment room after the removal of the original equipment.

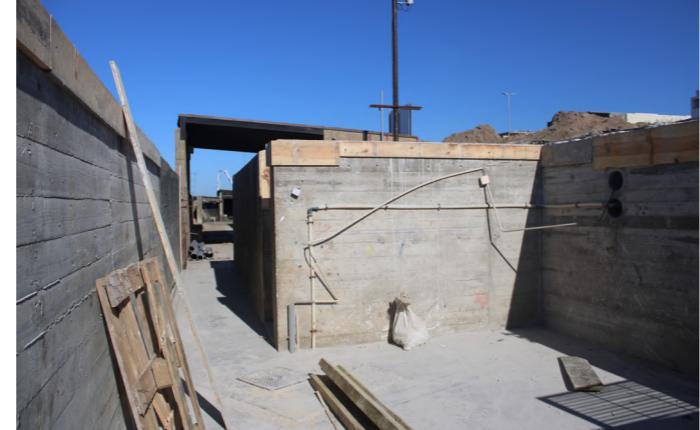
4.70 South storage room after the demolition of the roof slab.
4.71 Formwork of the walkway rebuild.
4.72 Concrete pouring over the new technical galleries.
4.73 Concrete pouring in the curved wall of the children swimming pool.
4.74 Demolition of the inner side of the adults swimming pool concrete walls.

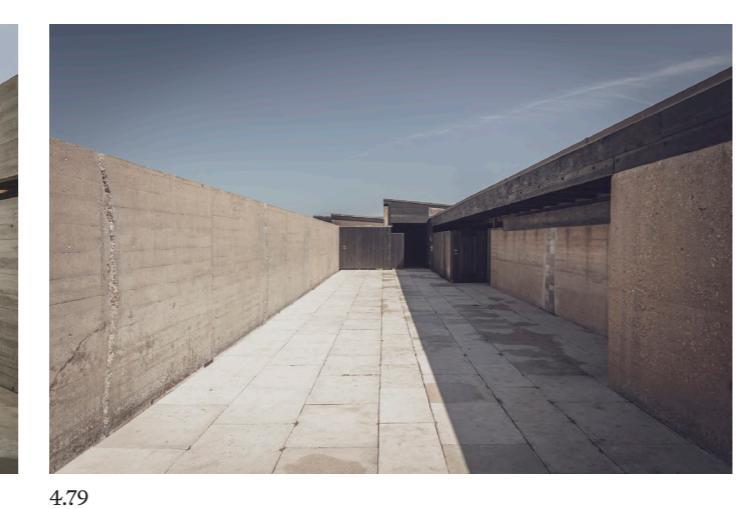
- 4.76 Rebuilt north volume and retaining wall.
- 4.77 North platform extension.
- 4.78 Rebuilt north volume.
- 4.79 Changing rooms' hallway after the intervention.
- 4.80 Water treatment room after the interven-
- tion.
- 4.81 South storage room after the intervention.
- 4.82 Rebuilt walkway.

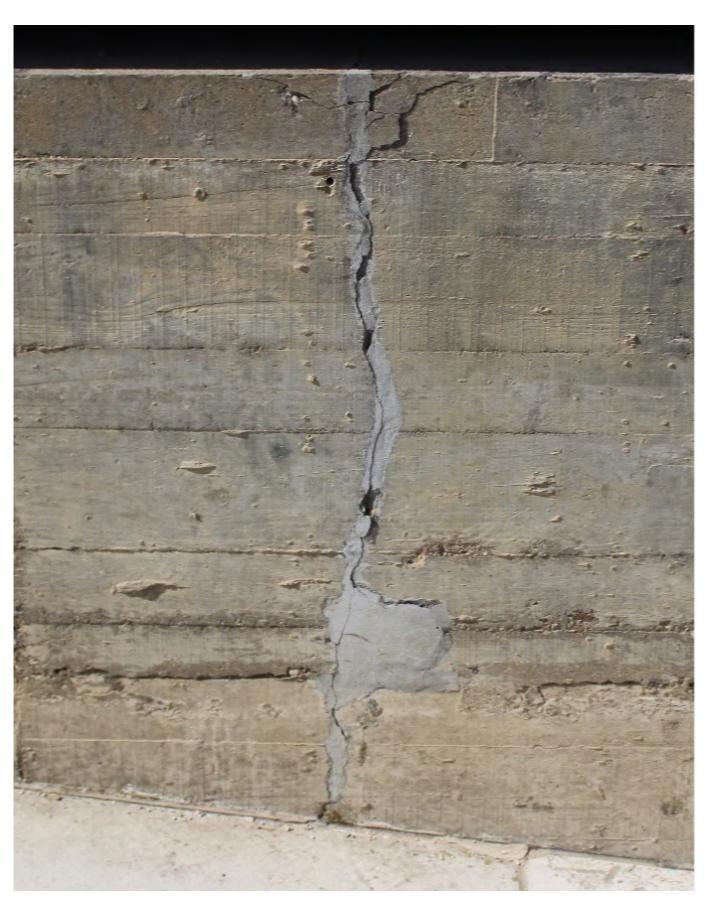
4.90 Vertical crack on the wall by the entrance ramp before the intervention (filled with an inadequate mortar).

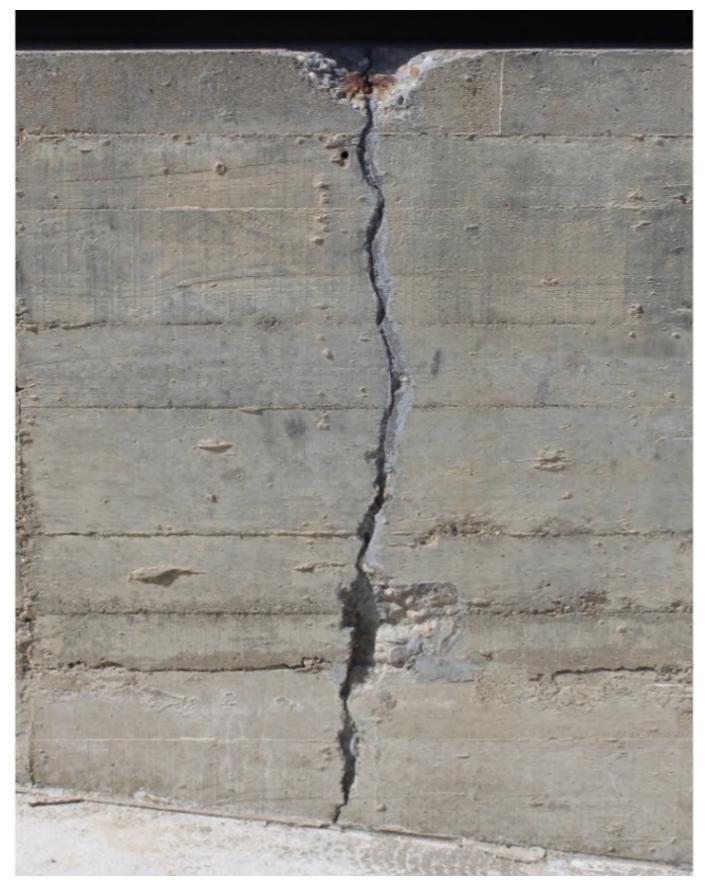
4.91 Vertical crack on the wall by the entrance ramp after the intervention (cleaned and left exposed).

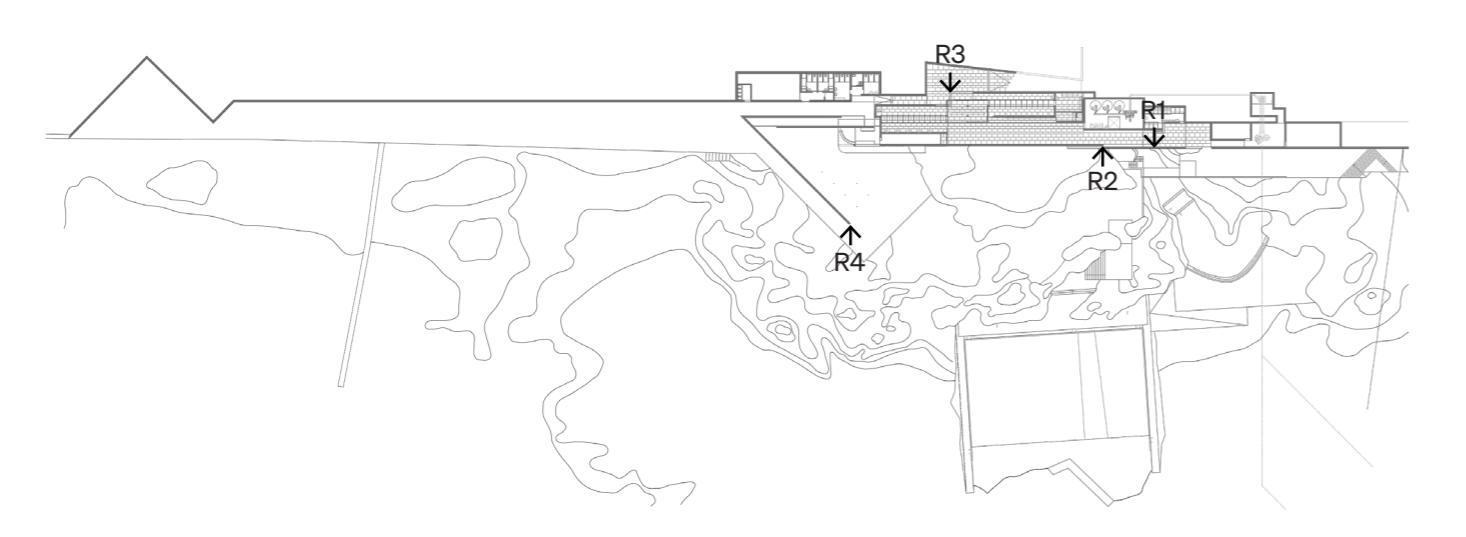
4.92 Location of the concrete repair interventions

There were four types of approaches to concrete repair: i) demolition and replacement of concrete structures with same texture and formwork integration (this was the case of the suspended walkway and the roof slab of the south storage room, where the condition of the concrete was beyond repair); ii) localized repair of concrete spalling with chromatic, texture and formwork integration (in the cantilever beam over the changing room's entrance); iii) localized repair of material loss or detachment (in specific locations with impact on the geometry or the continuity of wall planes); iv) maintenance of cracks that did not present signs of steel corrosion and therefore did not pose a risk to the building's structure, some of which were left open as signs of the material history of the building.

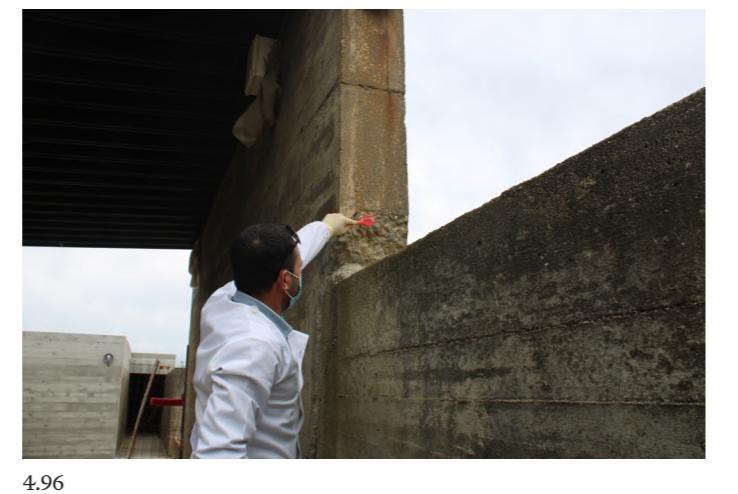
The west façade presented a concrete detachment of about 0.5 m² in the angle between a higher and a lower wall (R1). caused either by the lack of movement joints or by foundation movement (fig. 4.95). The same façade also presented, at the lower corner of the wall over the concrete bench, a material discontinuity that led to the separation of a wall fragment, possibly due to the dilatation of a corroded vertical rebar (fig. 4.105).

- 4.94 Restoration mortar validation.
- 4.95 Joint between a higher and a lower section
- of the west wall before the intervention (R1).
- 4.96 Brushing of the intervention area (R1).
- 4.97 Drilling for the insertion of rebar (R1).
- 4.98 Application of glue in the rebar holes (R1).
- 4.99 Initial restoration mortar filling (R1).

The first repair (R1) required the reconstruction of the detached portion. For this purpose, 316 stainless steel threaded rods were inserted in the preexisting concrete and coated with epoxy resin before the application of the restoration mortar. A siliconized sheet was then applied on top of it to keep the joint open and allow structural movements. Wooden planks were used as formwork to achieve the intended texture in keeping with the original. The repair mortar was gently introduced inside the formwork and after ten to fifteen minutes of curing, a water-soaked sponge was used to mimic the wear of the existing surfaces, followed by a supplementary localized chromatic reintegration to mimic the concrete wall's pigmentation (fig. 4.103).

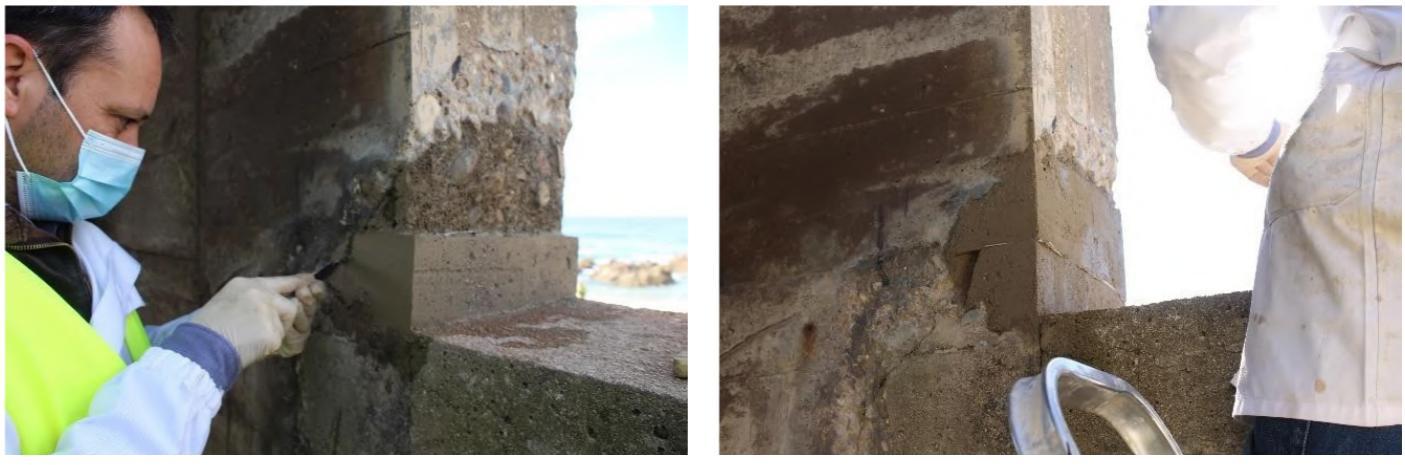
4.100 Application of formwork to the lower section (R1).
4.101 The lower section after the removal of the formwork (R1).
4.102 Application of restoration mortar on the upper section (R1).
4.103 Color and texture corrections (R1).
4.104 Final result after the intervention (R1).

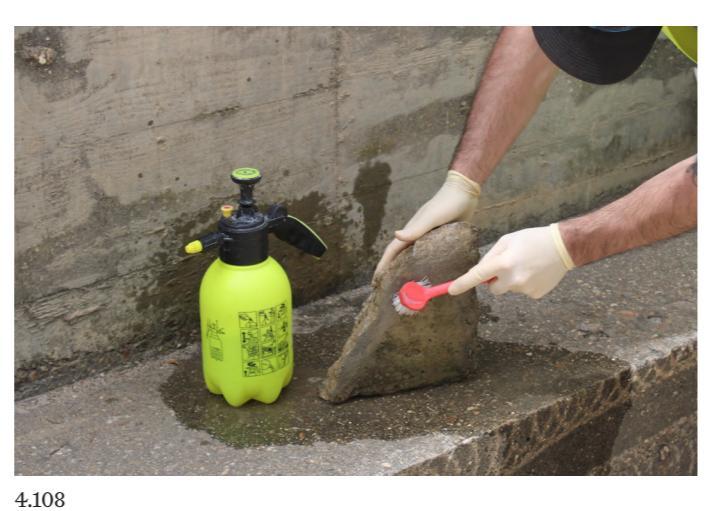
- 4.105 Joint between the west wall and the con-
- crete bench before the intervention (R2).
- 4.106 Bioccide application (R2).
- 4.107 Removal of loose fragments (R2).
- 4.108 Cleaning of loose fragments (R2).
- 4.109 Application of epoxi resin on the exposed
- steel rod (R2).4.110 Application of glue on the loose fragments
- (R2).

The second repair (R2) started with the removal of the loose fragments and their numbering for later repositioning. The 2 cm corroded vertical rebar was subjected to mechanical and chemical cleaning, followed by the application of a rust converter and an epoxy resin coating to prevent future corrosion. The fragments' inner surfaces were punctured to allow their realignment with the wall and then glued with an epoxy resin. Lastly, the remaining gap created by the fragmentation was filled with the same mortar and methodology used in the previous intervention (Cinábrio, 2021).

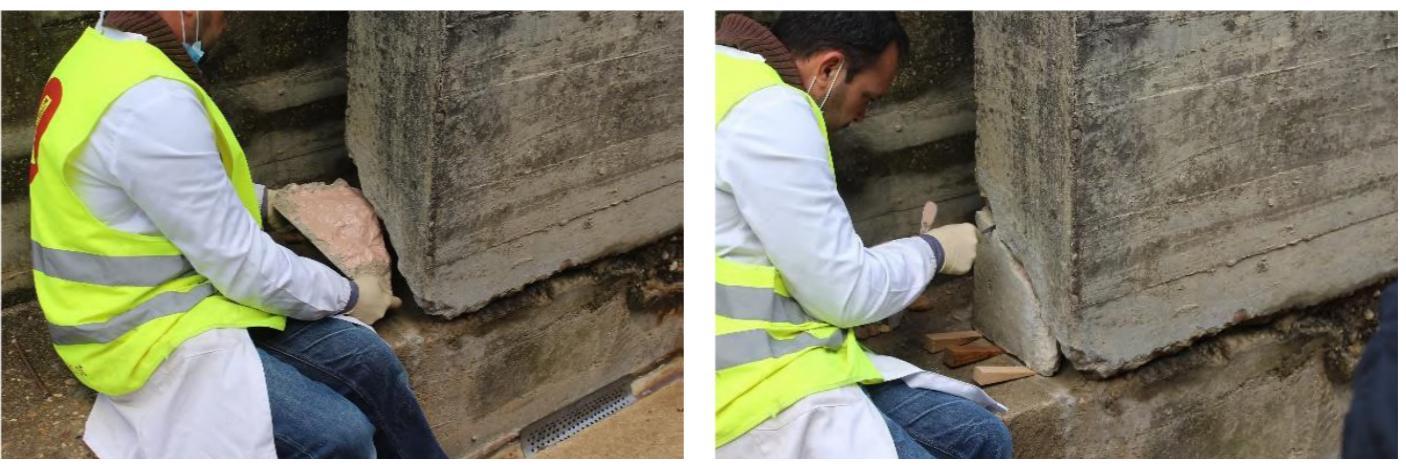
- 4.111 Placement of the loose fragments (R2).
- 4.112 Placement of the loose fragments (R2).
- 4.113 Application of the restoration mortar (R2).
- 4.114 Color and texture corrections (R2).
- 4.115 Horizontal joint that was maintaned
- (R2).
- 4.116 Final result after the intervention (R2).

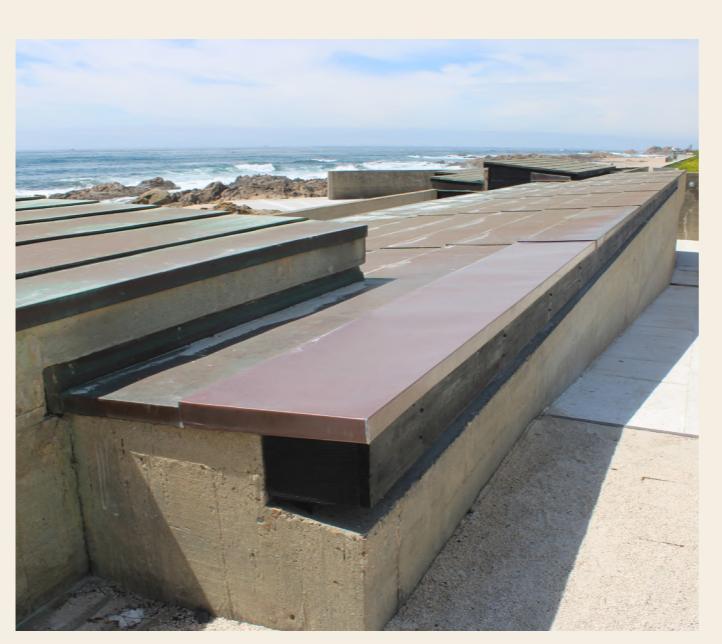
- 5.36 Changing rooms' roof, 1968.
- 5.37 Changing rooms' roof detail, 1966.
- 5.38 Changing rooms' roof, 1968.
- 5.39 Changing rooms' roof detail, 1965.
- 5.40 Changing rooms' roof, 2021.

The roof's copper cladding was cleaned with a soft brush so as not to damage the patina and overhauled, including the replacement of elements, welding, the strengthening of joints and tops, and the replacement of seam clips.

i. Inspection Annual condition check-up and record to ensure that there is no damage, such as signs of corrosion (especially from pitting and/or interstitial), cracks in the joints between the sheets, deformations (kinks and warping) or other anomalies, observing if the copper plates are mounted correctly; semi-annual condition check--up and record of the water drainage components, to ensure that no blockages occur from the accumulation

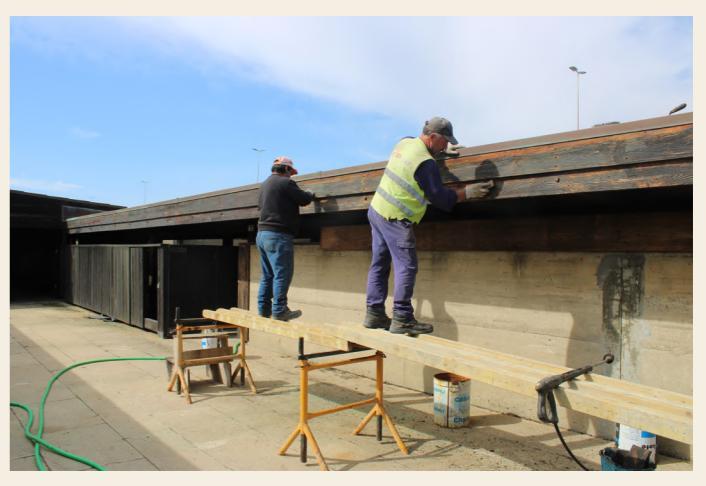
5.41 South bathrooms roof's wooden structures, n/d.
5.42 South bathrooms roof's wooden structures, n/d.
5.43 Wooden structures details, 1965.
5.44 Wooden structures during conservation works, 2020.
5.45 Wooden structures during conservation works, 2020.

The beams and other wooden components of the roofs were overhauled and cleaned in order to remove all contaminants from the surfaces. To do so, a universal stripper (ref. 8015) and a steel wire brush were applied following the wood grain direction until it was in its natural state. This was followed by cleaning with a water jet and the application, without dilution,

of a coat of 'Bondex Classic Mate' stain (ref. 4385 black) with a brush following the wood grain direction.

The existing mosquito nets and metal crates between the bar's beams were removed, as well as the stainless steel cladding on the kitchen ceiling. The screw holes were filled with bitumen made from polyester resins.

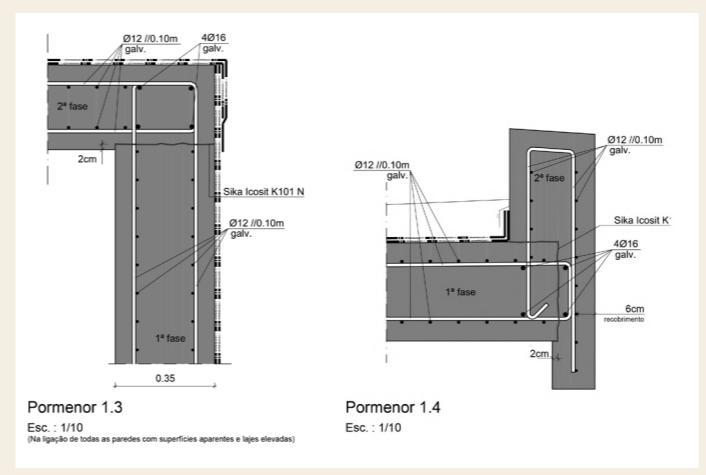
5.46 South storage room's roof slab during con-

The roof slabs of the north and south storage rooms, which showed an advanced state of rebar corrosion, were demolished. They were rebuilt with A400NR galvanized steel rebars, and wooden plank formwork with the same stereotomy as the existing one on all exposed concrete surfaces. Two-component structural epoxy binder was applied to all bonding surfaces between new and existing concrete and water-stop joints were applied to all construction joints. The existing waterproofing membranes over the roof slab of the water treatment room were removed, including cleaning the surfaces with solvent gel suitable for removing bituminous material

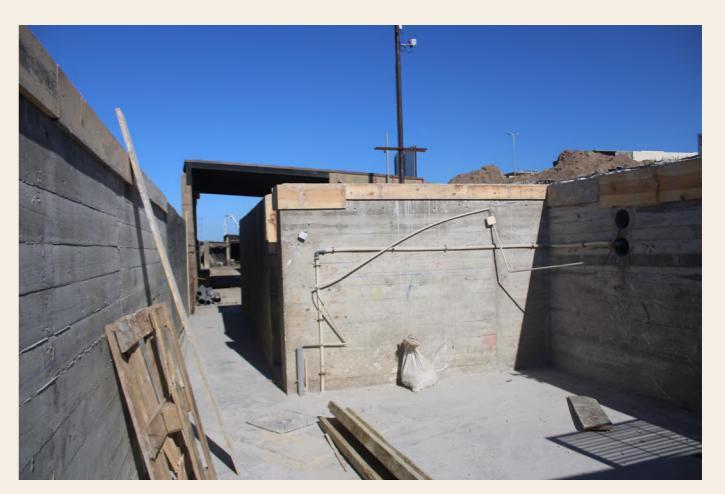
5.50 South stora	age room after the roof slab				
demolition, 2019.					
	ACTION				
i. Inspection	Annual condition check-up and record of the sla (among the most common: cracking, blistering, integrity check-up must be carried out by a struct or the aggravation of existing ones.				
ii. Cleaning	Annual cleaning of concrete surfaces by manual				
iii. Proaction	Every five years, the waterproofing should be in damaging the membranes; pay special attention evaluating their elasticity.				
iv. Repair	If necessary, any material replacement must res wood formwork finish. New concrete must be caparity with the preexisting surfaces. The compl between 15 to 20 years. These works must include

and high-pressure sprayed water. The adopted waterproofing system consists of a bitumen emulsion primer, a welded bitumen membrane modified with APP polymers and 3kg/mC of nominal mass, preceded by another bitumen membrane modified with APP polymers and 4kg/mC of nominal mass, overlapping and folding at least 20 cm over the vertical planes, the application of finishing profiles and their respective sealing. Additionally, shrubby species were planted to avoid the use of a fence similar to the one that existed before the intervention.

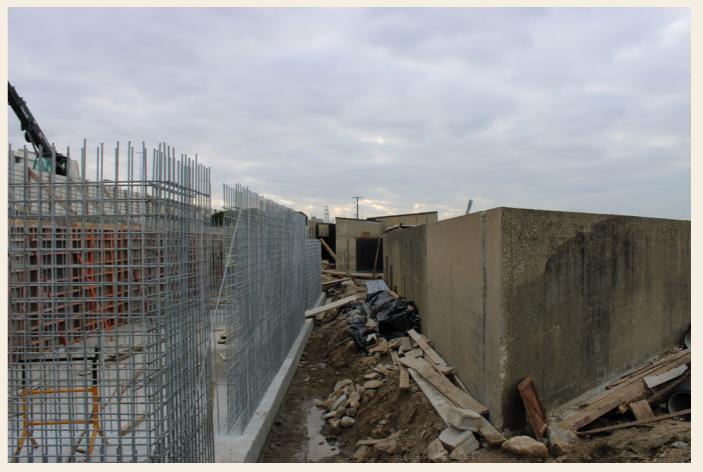
walls, 2018. 5.61 North extension during construction, 2019.

The former north building was demolished, giving way to a new construction with concrete walls with A400NR galvanized steel reinforcement and wooden plank formwork in keeping with the existing stereotomy to that existing on all

exposed concrete surfaces. A 2-component structural epoxy binder was applied to all bonding surfaces between new and existing concrete and water-stop joints were applied to all construction joints. The façade of the new building is 30 cm thick and the beam that tops the longitudinal span has a section of 17 × 15 cm. Inside, 15 cm thick walls and 10 cm prefabricated partitions were built, also in exposed concrete, suspended from the perimeter walls through stainless steel anchors, nailed with chemical anchors for heavy loads.

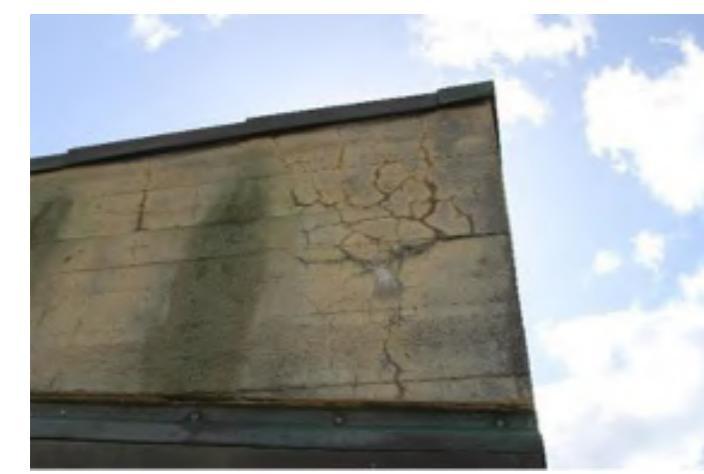
Fig. 36 – Concrete slabs severely affected by the corrosion of the reinforced steel.

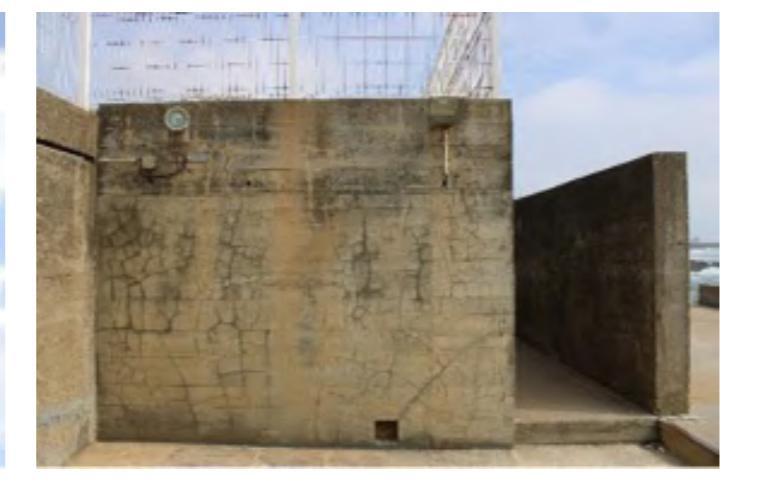
There is also damage associated to distributed cracking (taking the form of a polygonal net, similar to a spider's web) caused by the addition, in the 1980s, of a 4 cm concrete layer (with light mesh) over some walls, because of incompatibility with the preexisting concrete walls or shrinkage. (Fig. 37).

Fig. 37 – Distributed crack pattern.

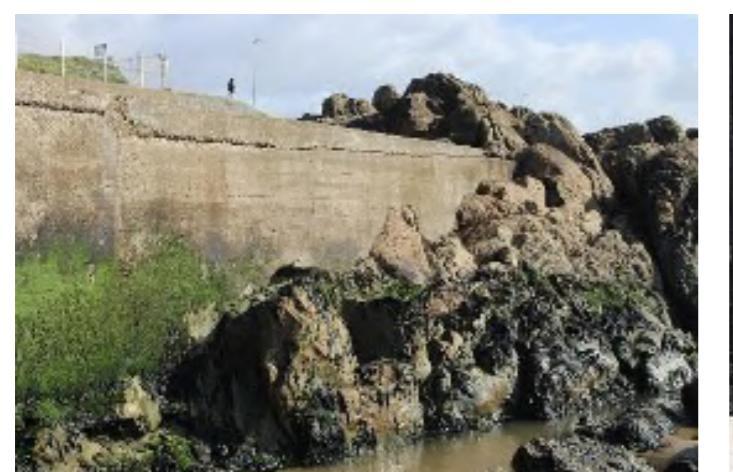
Some of the walls show signs of efflorescence in the form of a textured white stain (Fig. 38), which is caused by the infiltration of water in the concrete. The building also suffers from localized spots displaying a chromatic change that has a "dragged" appearance (Fig. 39). This is the result of the rainwater running off the surface and leaving a deposit. There are also the effects of biological colonization (Fig. 40) growing on the concrete surface, which, again, changes its texture and color.

Fig. 38 – Crack in the concrete wall and efflorescence on the north wall of the reception area.

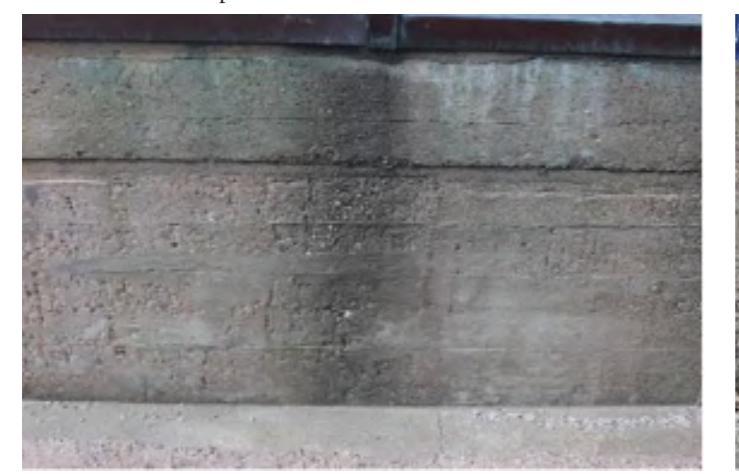
Fig. 39 – Stains created by rainwater run-off.

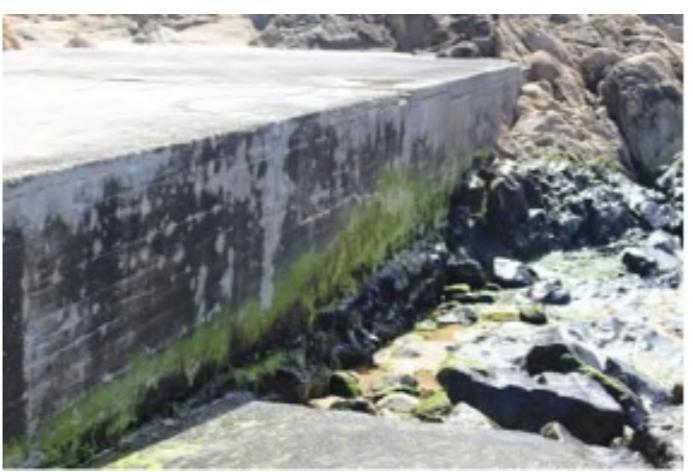
Fig. 40 – Biological colonization.

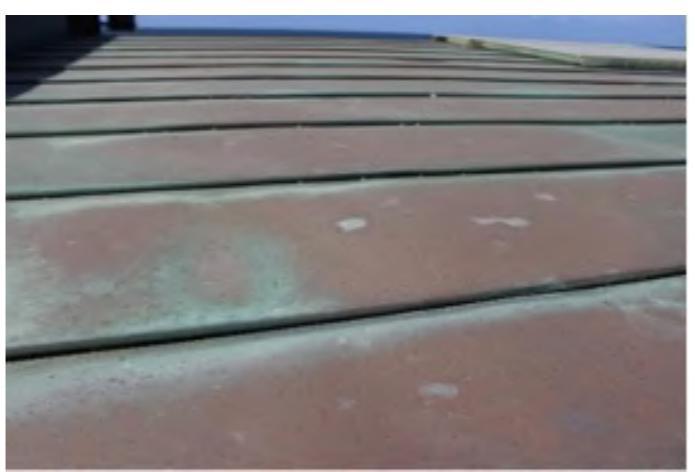
Moreover, the copper surface of the building's roofs has a green color due to oxidation (Fig. 41) and leakage has been identified in the assembly of the copper elements, resulting from the exposure and lack of maintenance. In addition, the timber structure of the roof and of the changing rooms' partition walls presents localized detachment of the coating, and an oily texture (Fig. 41) that results from the excessive amounts of linseed oil used in its maintenance. The screws used for the timber structure show signs of oxidation, with brown textured spots on their surface. Finally, the adults' tank presents spots and biological colonization.

Fig. 41 – Oxidized copper roofs, corroded screws and an oily texture of the wood.

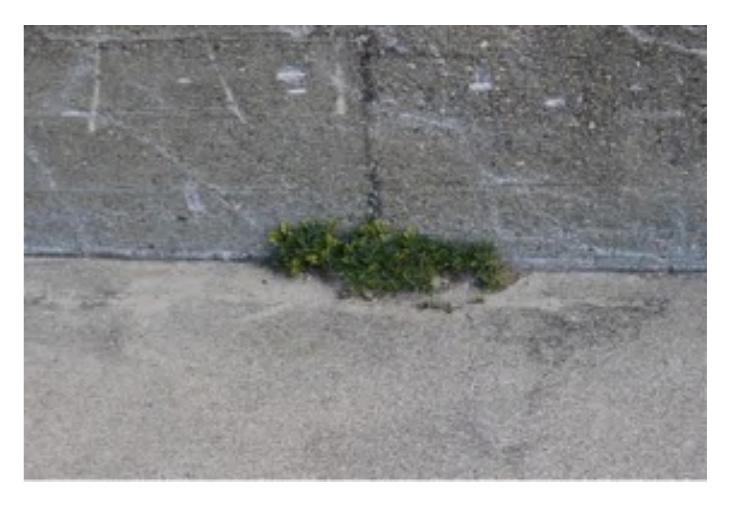
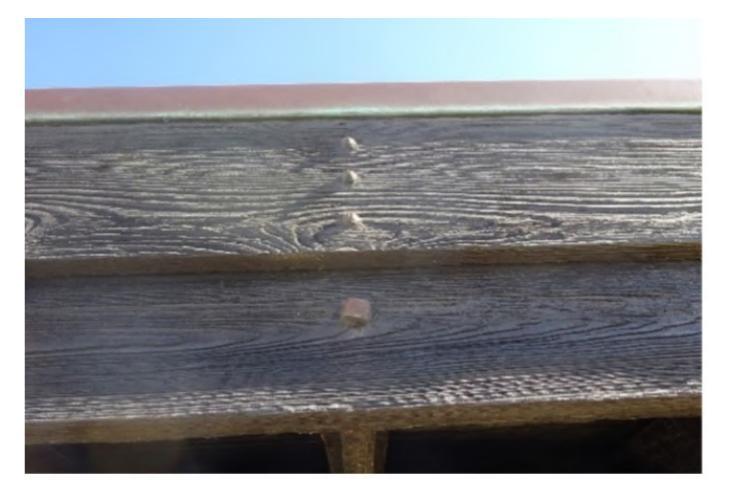
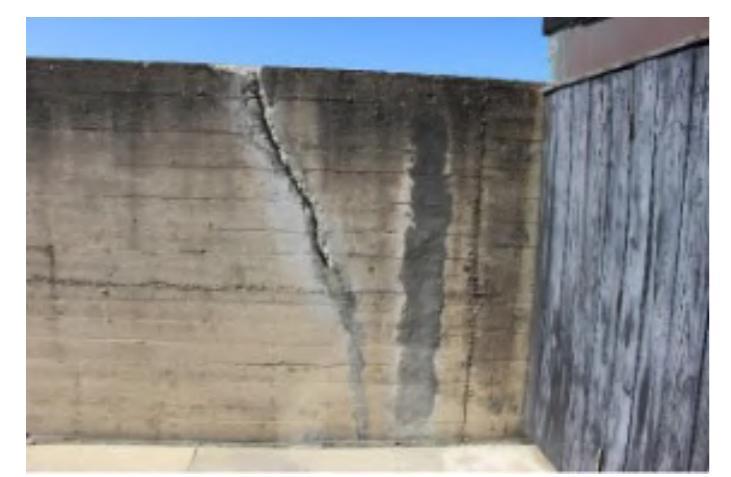
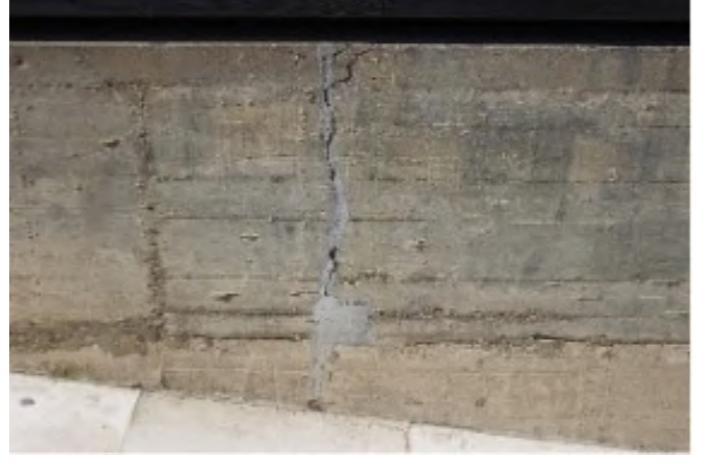
Despite the reported condition, the problem that has most seriously affected the building's integrity and authenticity is the series of interventions performed by the Municipal Council over the years, such as the introduction of incompatible repair mortars, as well as unauthorized electrical installations (Fig. 43), which have a distinctive light grey color and smooth texture, in comparison with the preexisting concrete. Also, the bar concession holder has performed unauthorized alterations to the interior of the building and the original design was not preserved. Thus, the Conservation Management Plan will also be an important tool for providing guidelines as to the correct use of the building in the future.

Fig. 43 – Incorrect interventions.
