Managing change with a living architect OCEAN SWIMMING POOL BY ÁLVARO SIZA

CONSERVATION MANAGEMENT PLAN

Teresa Cunha Ferreira (FAUP, University of Porto)

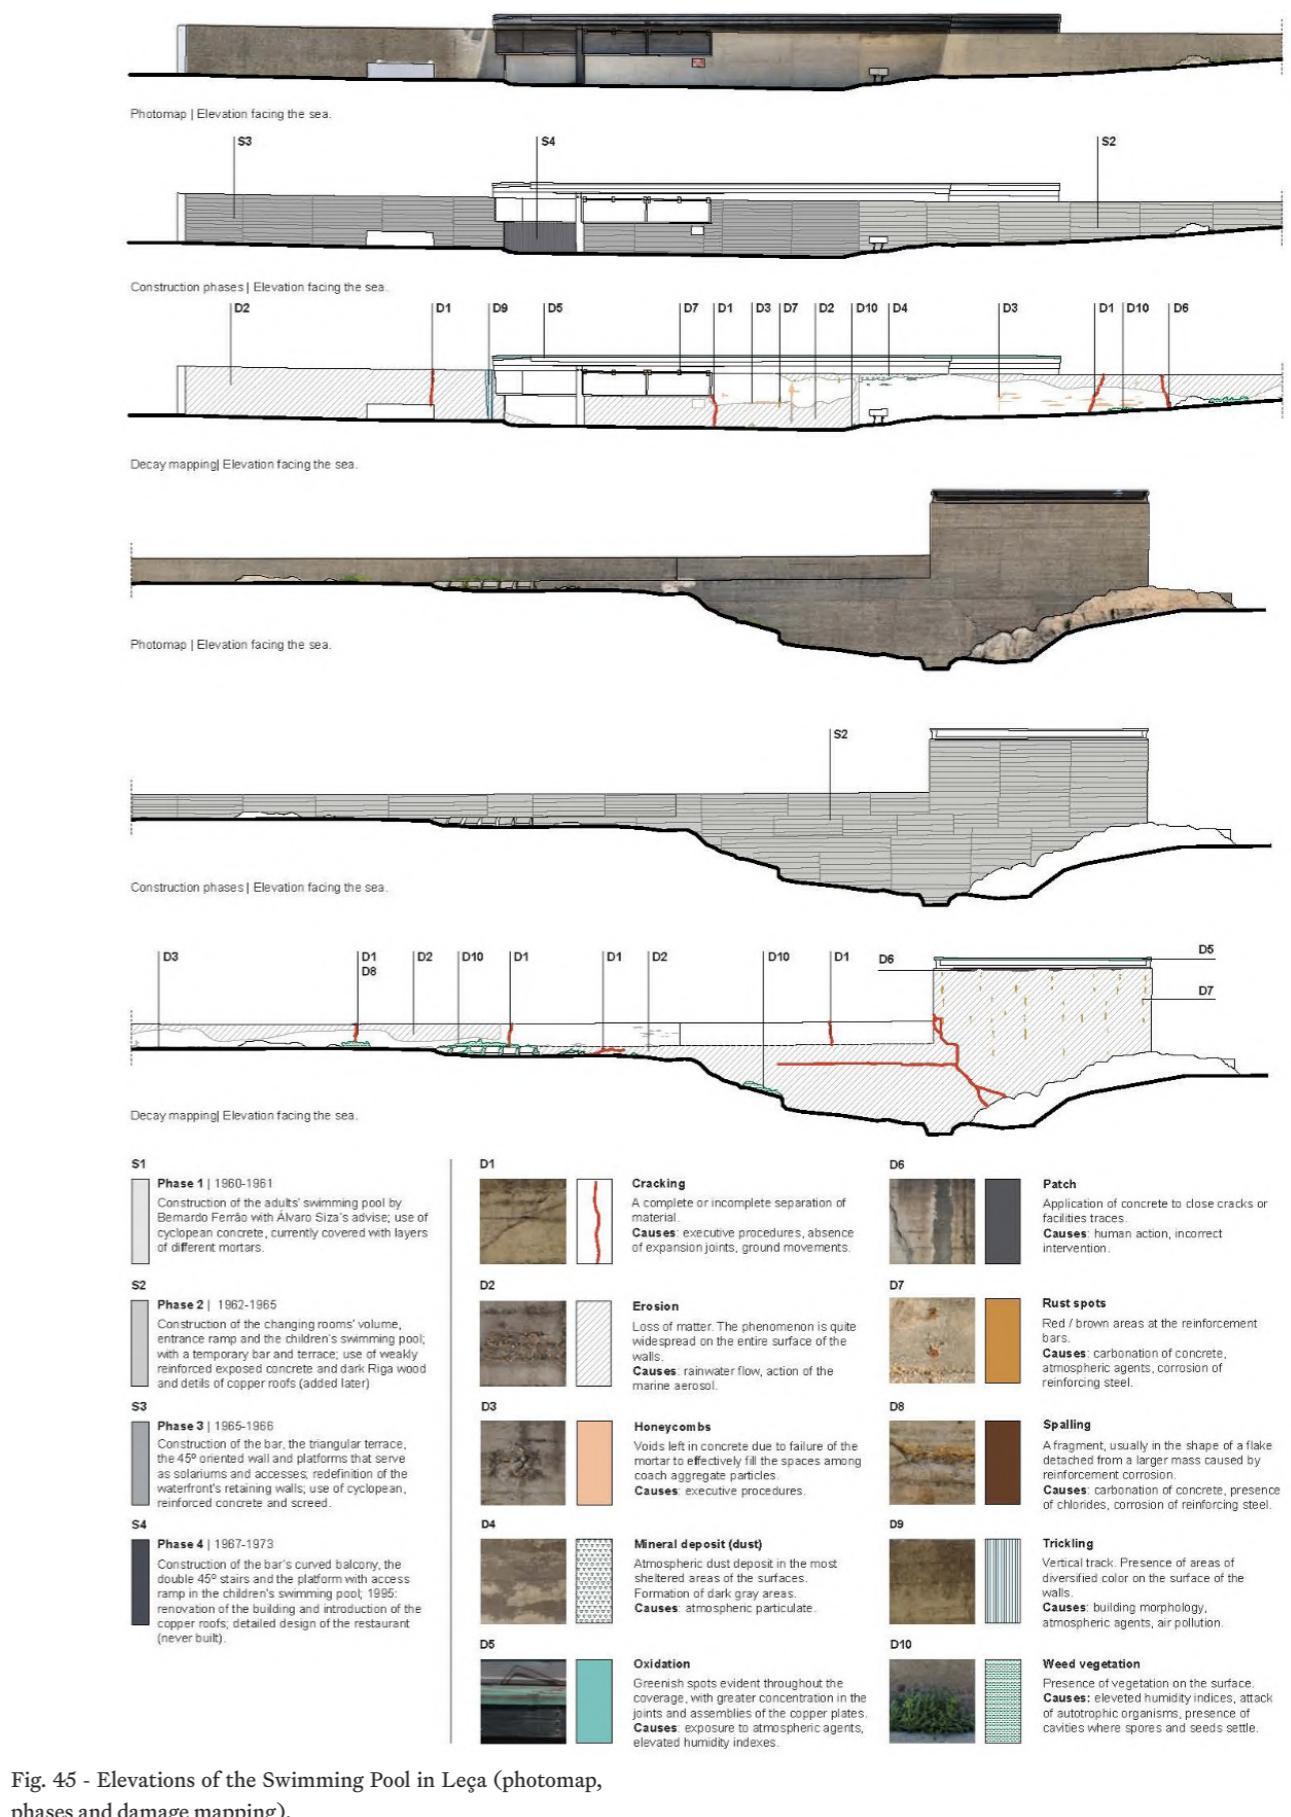
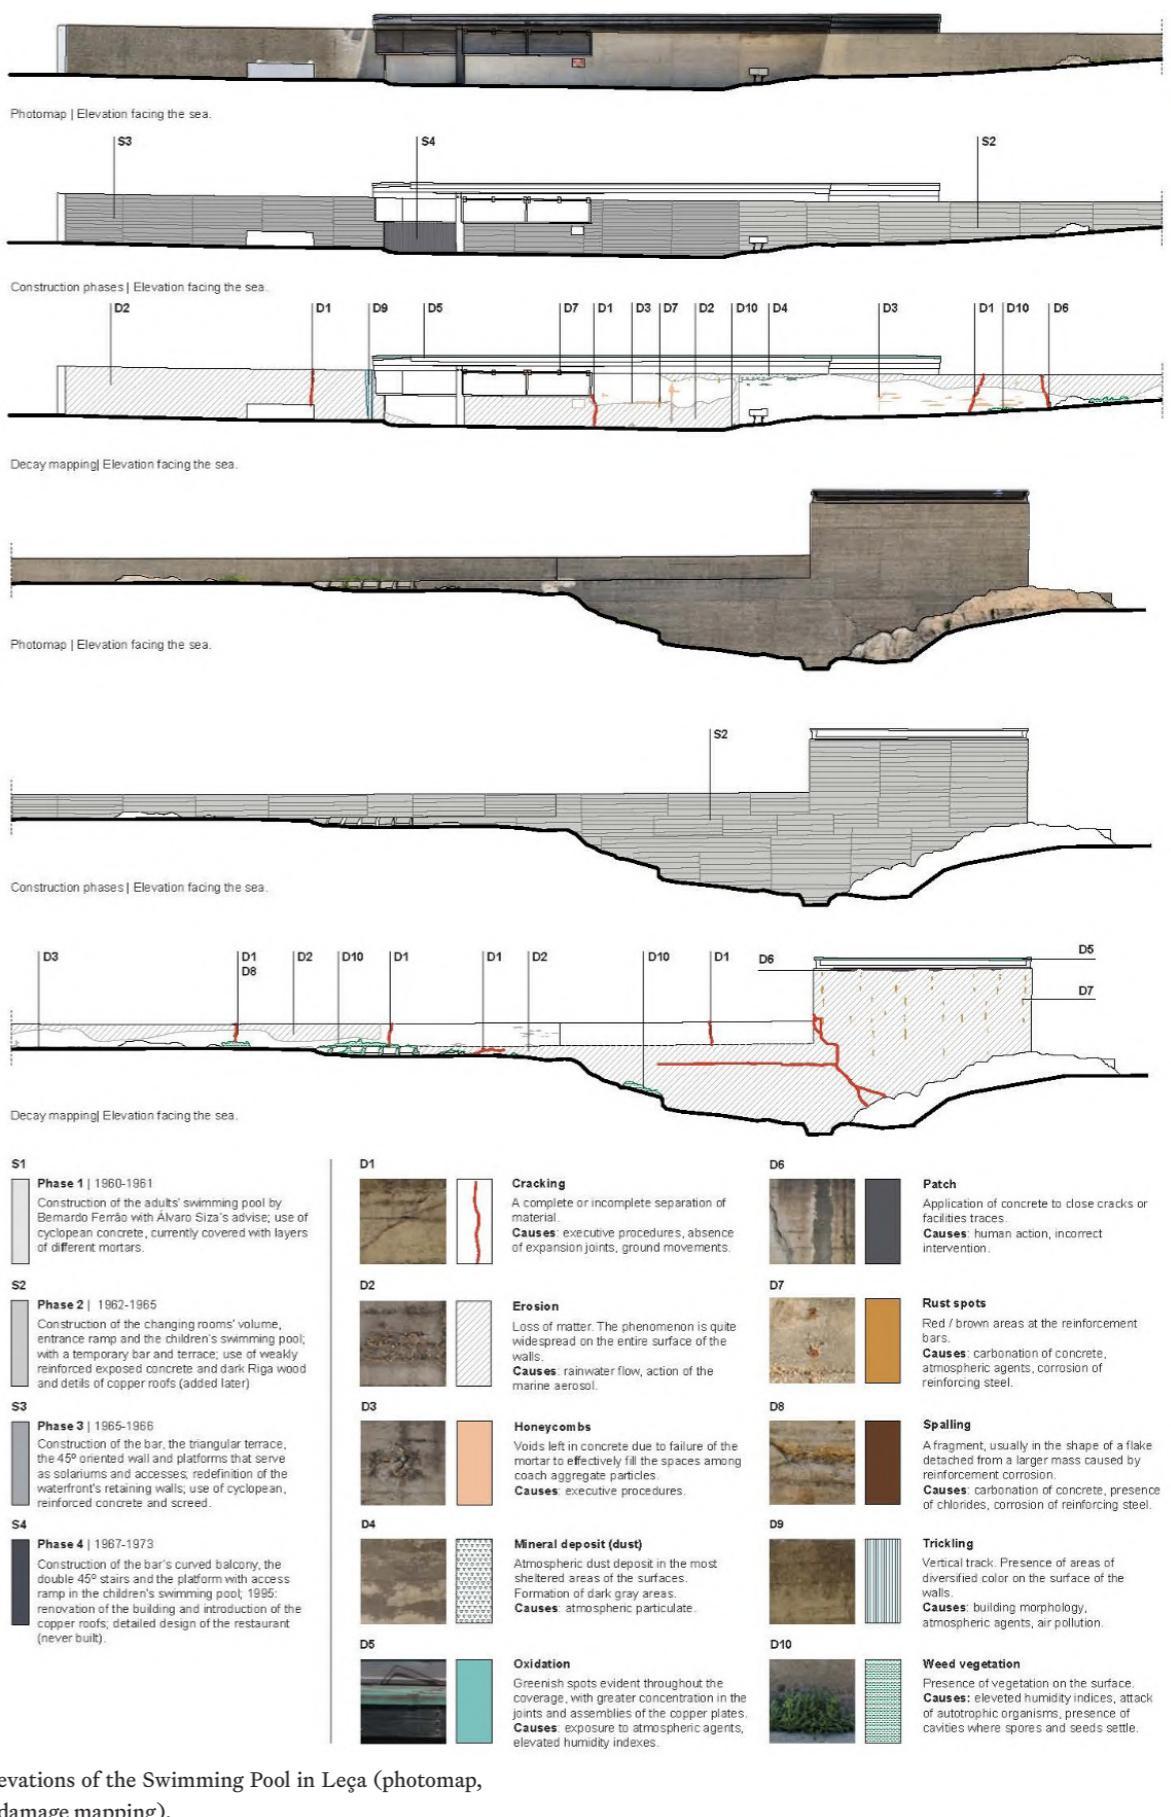
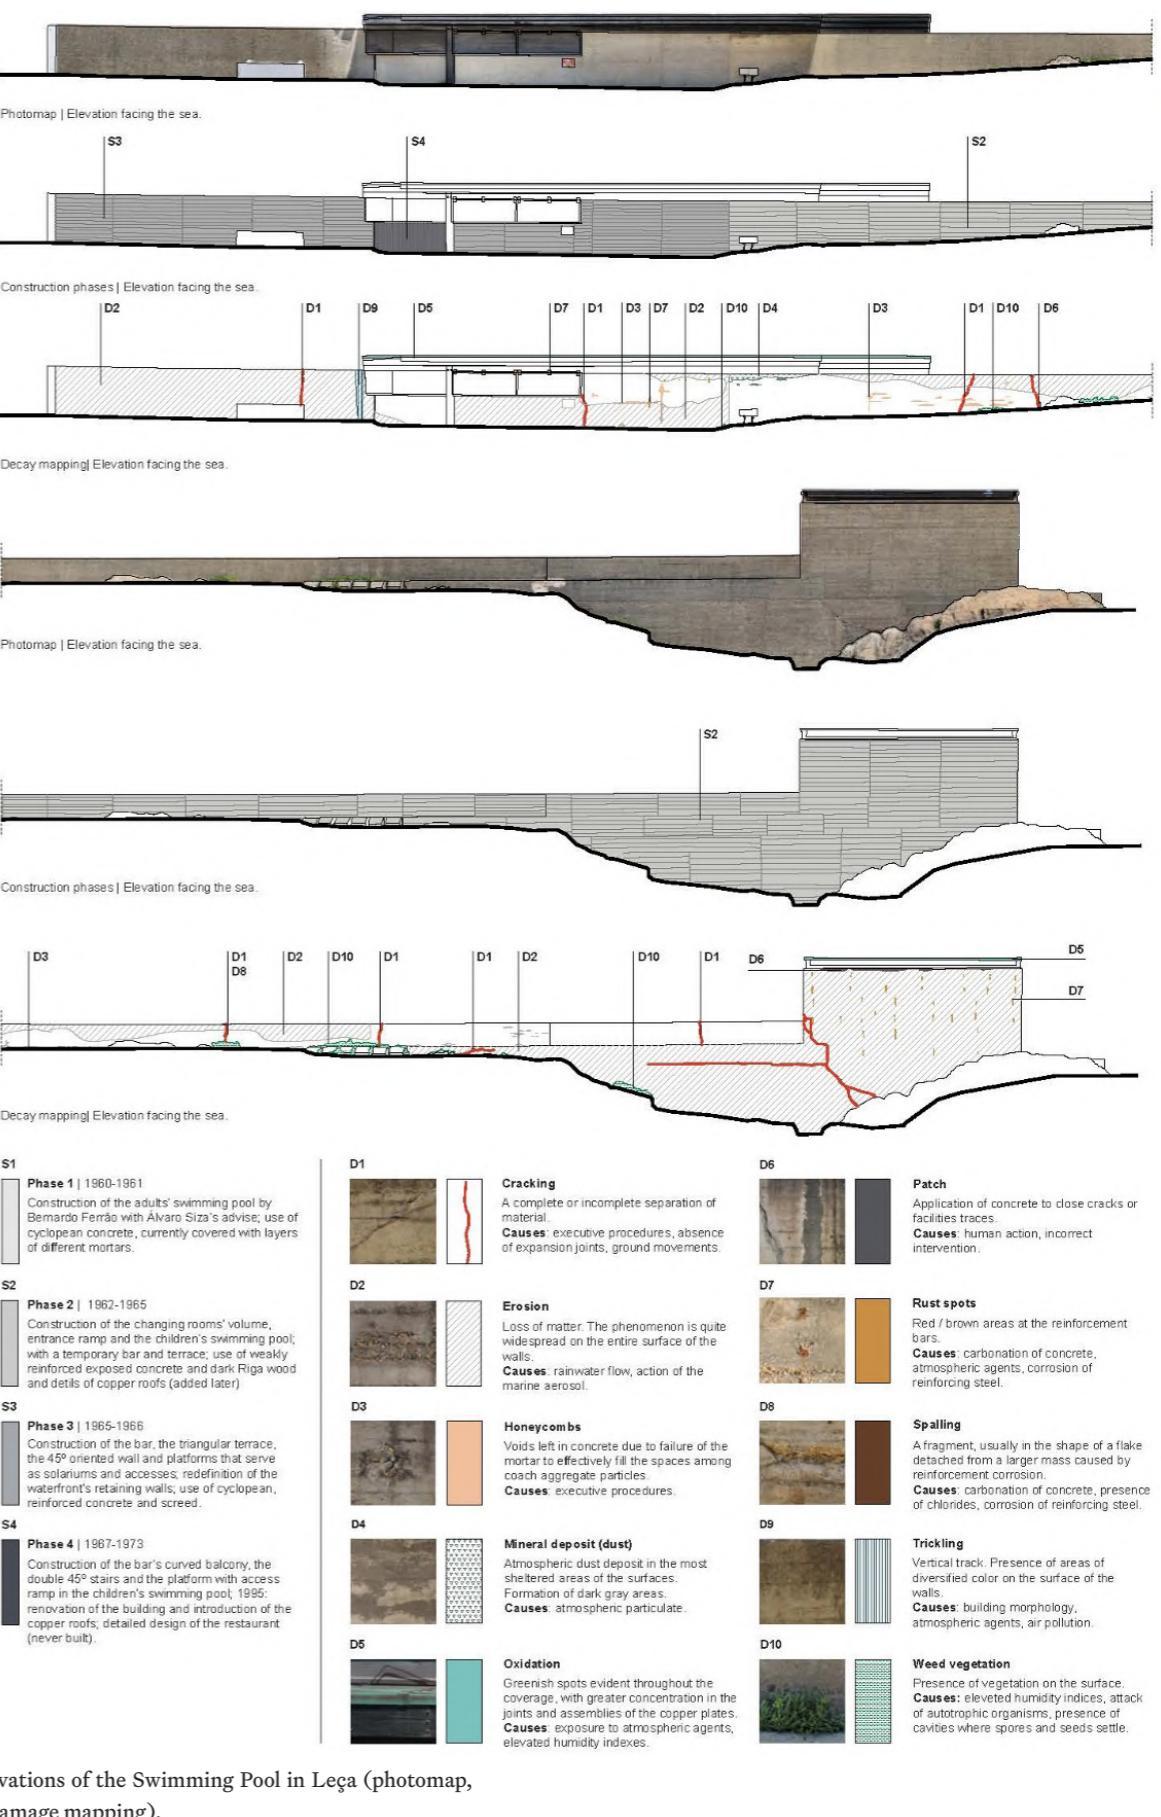
The most notable deficiency in the building's use is related to the hydraulic infrastructure, as many of the pipes of the water system have either been destroyed by the corrosion or are clogged with sand (Fig. 44), which means that they were compromising the pools' functionality (the pools were closed to the public in 2018 and have reopened in 2021). Finally, Fig. 45 presents the damage mapping of the building.

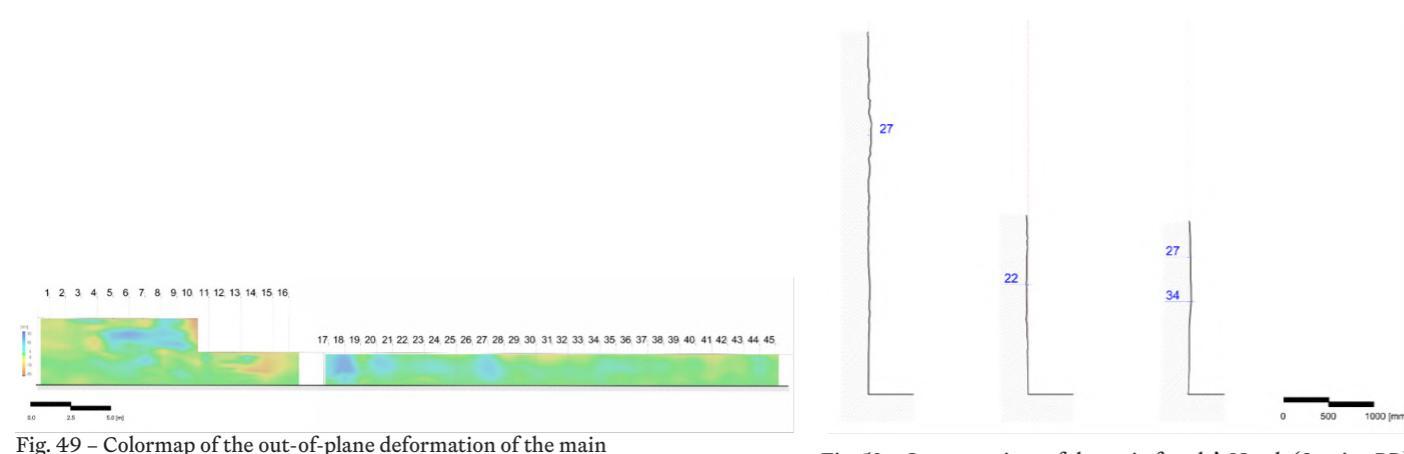
Fig. 50 - Cross-sections of the main façade's North (Section BB) with the highest out-of-plane deformation.

and occurs at the cross-section W3 18 in the west direction (Fig. 49 and 50). In the opposite direction, the maximum deformation of this wall is equal to 27 mm (cross-section W3_6). Although these deformations are low, the out-of-plane deformation of the other walls may be also evaluated in the future for further documentation.

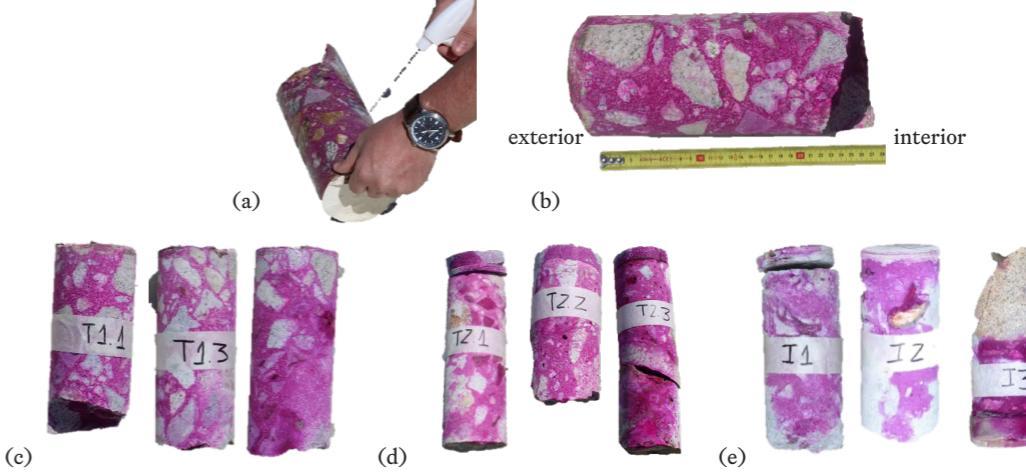
Fig. 52 presents the concrete cores sprayed with the phenolrelative humidity and the carbonation testing with the phenolphthalein solution, and it is possible to observe that the entire phthalein solution (simplified method) includes uncertainties. surface of all the concrete cores is pink, meaning the concrete Thus, cement paste samples were collected and tested at the in these zones of the building is not carbonated. However, the laboratory to conclude on the carbonation of the concrete. concrete elements are located in an environment with high (Section 3.3.10.1).

Fig. 52 - Carbonation concrete tests: (a) application of the phenolphthalein solution; (b) detailed view of a concrete core of the adults' tank; (c) general view of the concrete cores of the adults' tank; (d) general view of the concrete of the children's tank; (e) general view of the concrete of the water collection area.

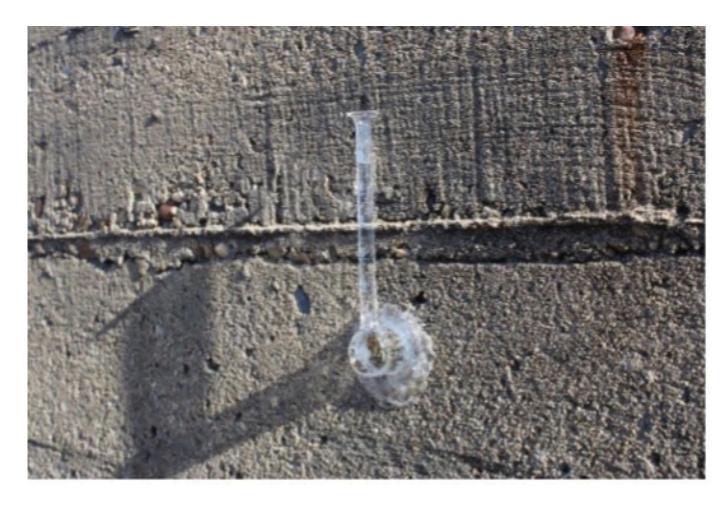
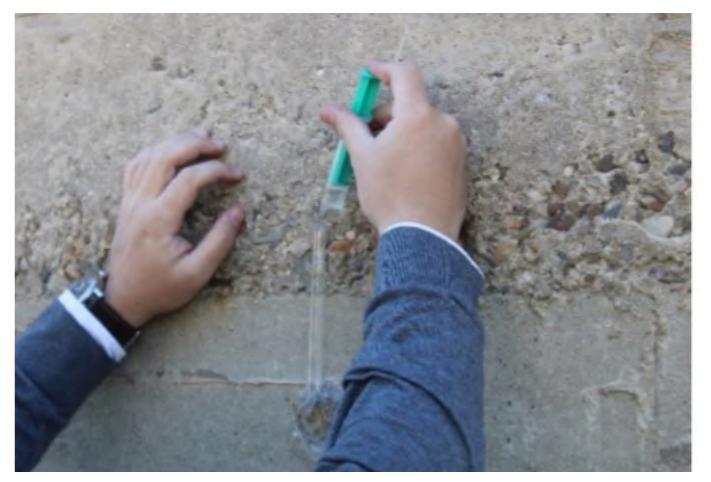
Table 5 presents the results of the water penetration tests, in which it is observed that the surfaces of the tested walls present significant different performances. The highest water absorption (permeability of the concrete) occurs at the wall of the water treatment area (1.6 ml and 1.1 ml at the interior and external surface, respectively, after 20 min), which corresponds to a water absorption coefficient of 1.00 kg/m². min0.5 after 20 min (for example, the expected range for traditional cement-based renders is 0.2-1.5 kg/m².min0.5). The tested surface of the wall of the South's corridor showed low permeability and no water absorption was observed at the tested wall of the changing rooms, during 20 min of the test. The results are according to the expected, since the external surfaces of the concrete walls present a significantly different appearance.

Fig. 56 – Examples of water penetration tests at the: (a) external surface of the wall of the water treatment area (Q2); (b) external surface of the wall of the changing rooms (PV).

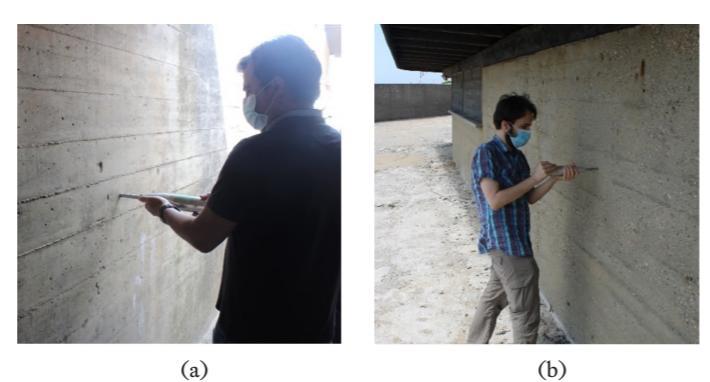
Fig. 57 – Examples of concrete testing with Schmidt hammer: (a) wall of the South's corridor; (b) main façade's North.

Table 6 presents the resume of results, namely the mean compressive strength (fcm) and the coefficient of variation (CoV). The original concrete of the adults' tank presents an average compressive strength equal to 42 MPa (15% higher the value obtained from the laboratory tests). On the other hand, the original external mortar of the children's tank presents an average compressive strength equal to 54 MPa. The average compressive strength of the new concrete applied in the tanks during the intervention is equal to 25 MPa. The

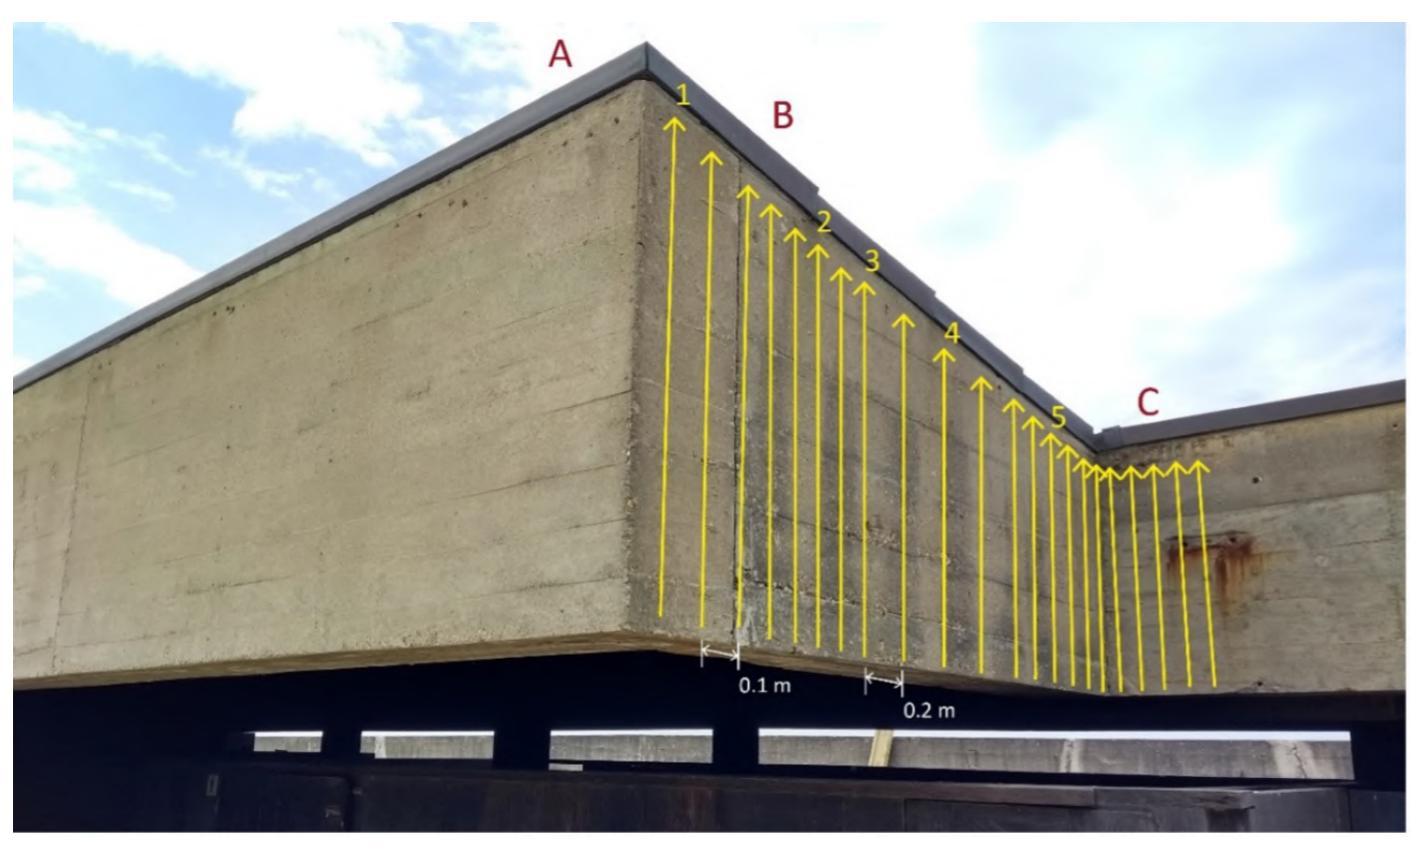
beams, vertical GPR profiles were carried out each 10 cm (close to the connection) and each 20 cm (around the center of beam B). The test aimed to determine two specific construction details: (1) the number of dowels connecting the beams; (2) the length of the dowels. Fig. 63 shows schematically the number and location of the profiles carried out.

Fig. 63 - Location of the GPR profiles carried out on the tree cantilever beams over the changing rooms.

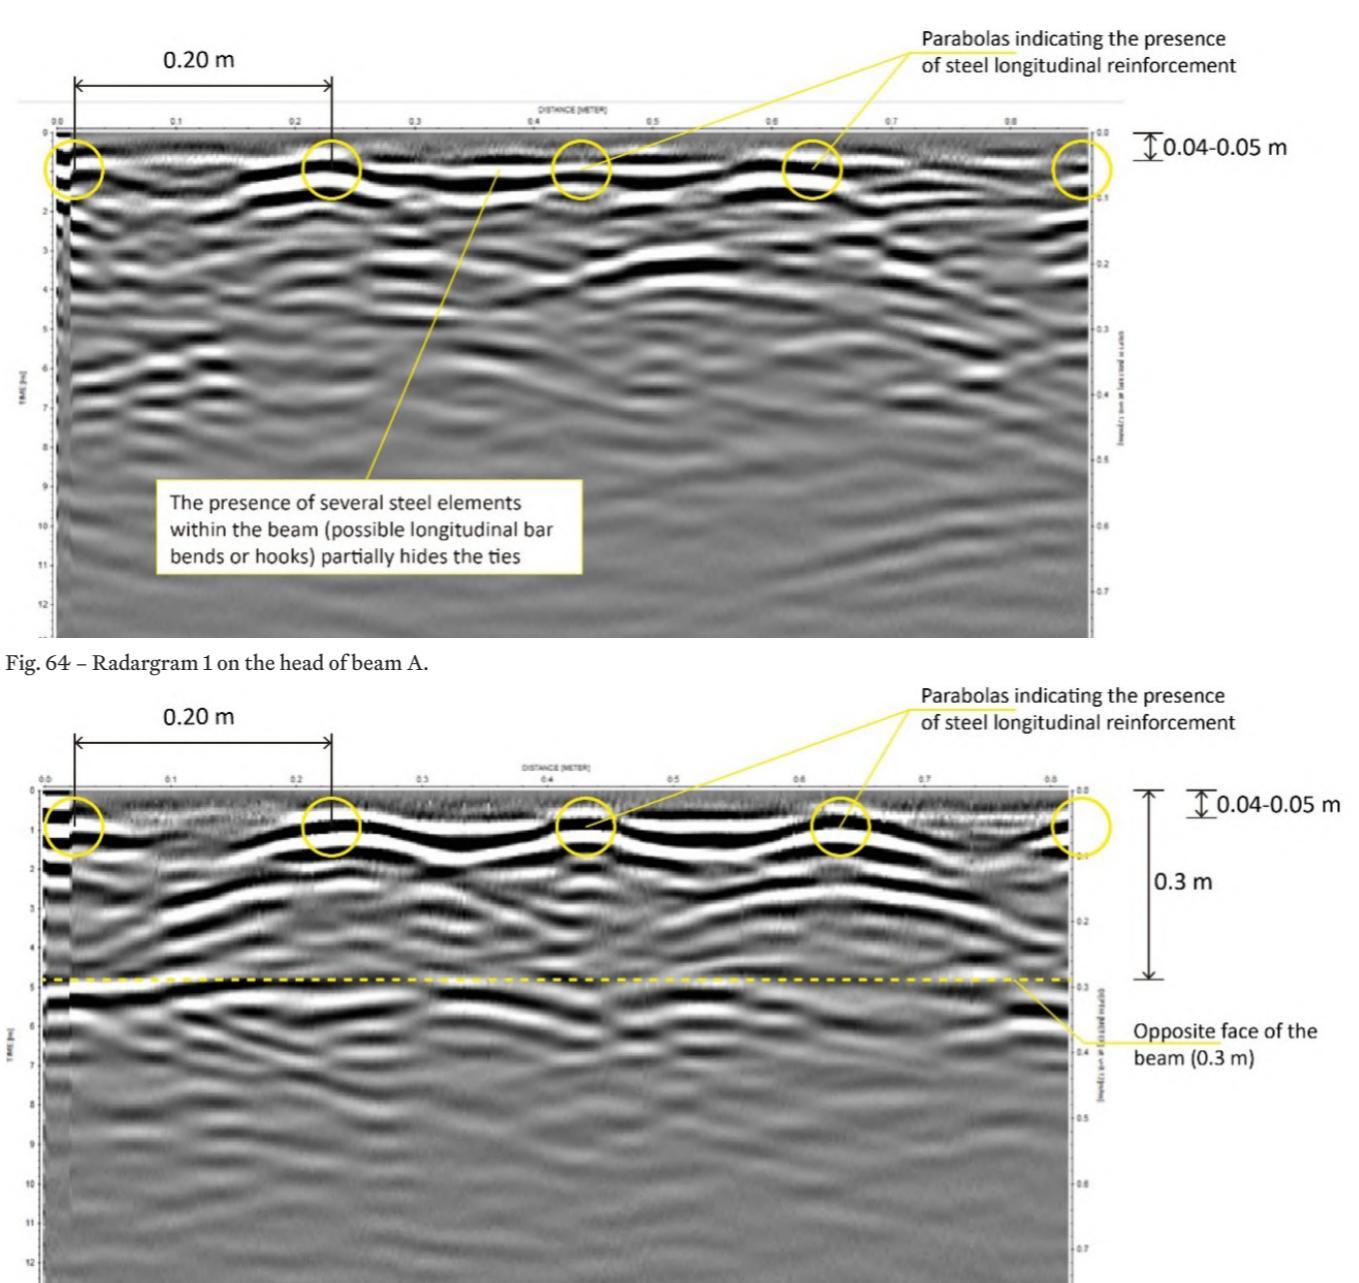
Fig. 64-68 show five representative radargrams corresponding to locations 1-5 (as indicated in Fig. 63). The first radargram (Fig. 64) was obtained at the head of beam A. The radargram shows parabolas that indicate the presence of steel reinforcement elements, separated approximately 20 cm. These reinforcement elements can be more clearly detected in the second radargram (Fig. 65), carried out on beam B, 30 cm from the joint between beams A and B. Therefore, there

seem to be five longitudinal reinforcement elements bars in beam B. Among these five rebars, some of them should go through the joint and penetrate the perpendicular cantilever beam (beam A) to make the connection between the two beams. These five bars are spaced 20 cm in height and are located at a depth of approximately 4-5 cm within the beams. Fig. 65 clearly shows the opposite face of the beam (at 30 cm), indicated as a yellow discontinuous line. Note that this known thickness was used to calibrate the velocity of the radar waves throughout the concrete. Note also that only the bars located close to the inspected surface are clearly observed. The bars from the opposite surface are hidden by the initial reflections. Nevertheless, a symmetric configuration is observed by tests carried out at both surfaces, showing five longitudinal reinforcement elements in both faces.

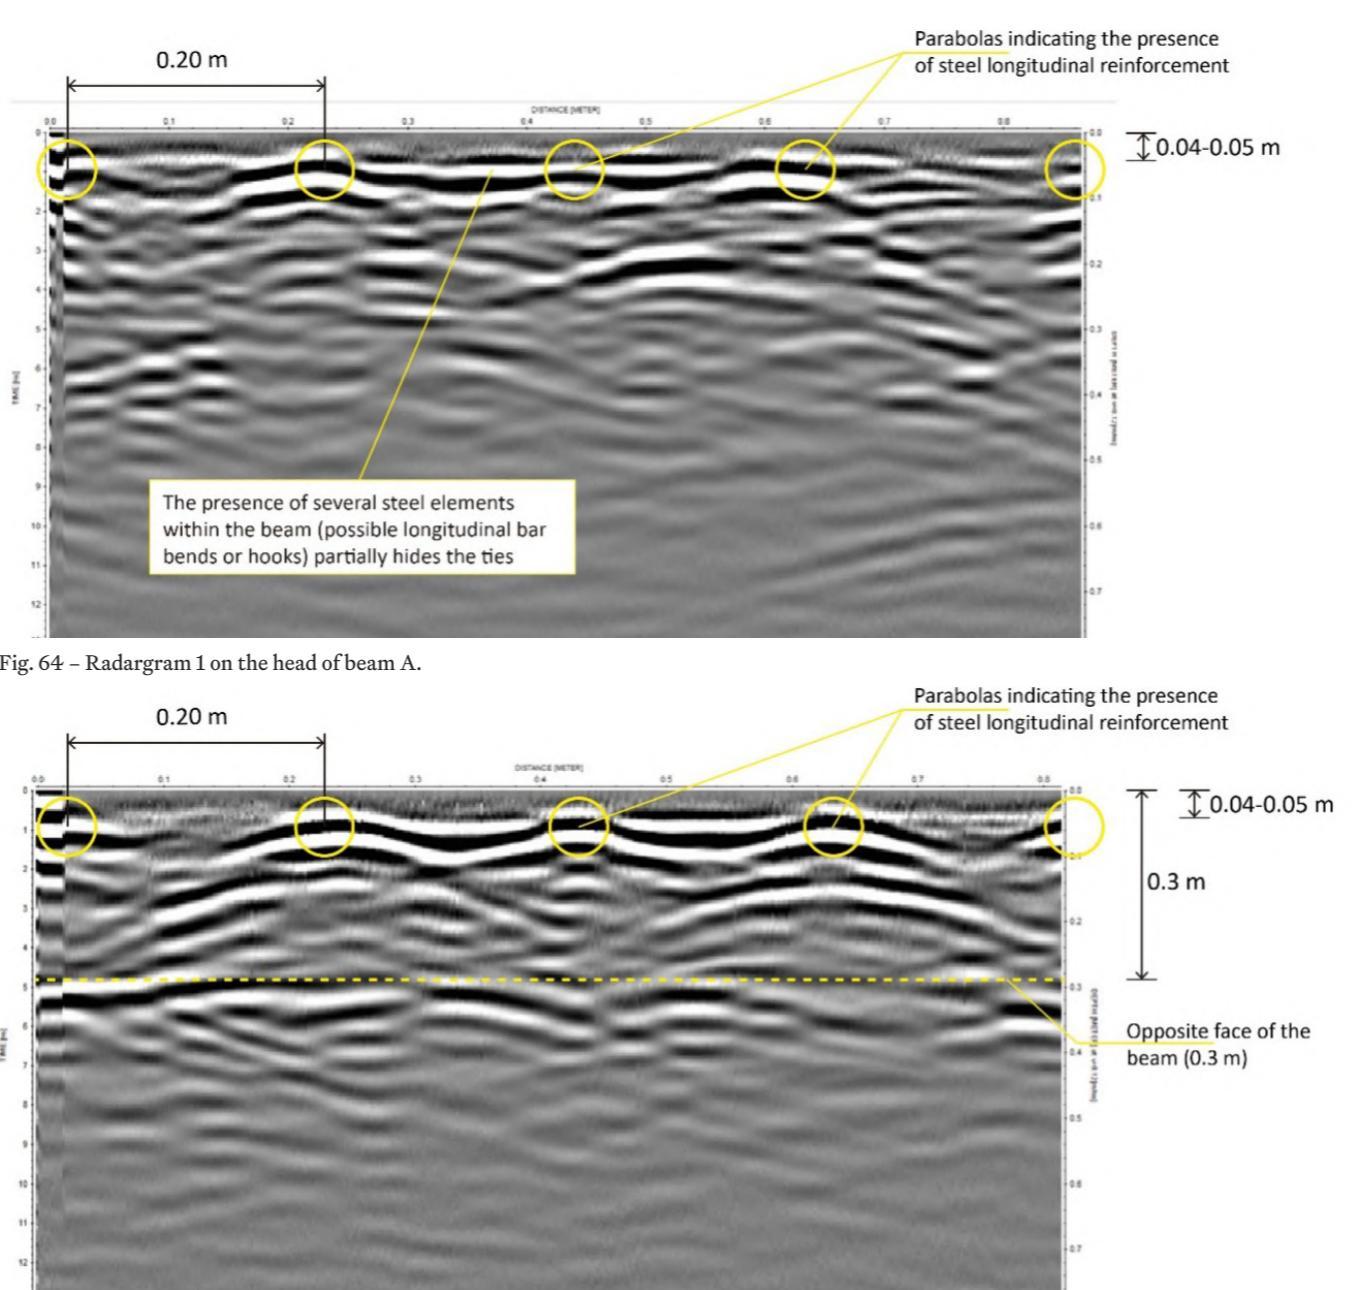
Fig. 65 – Radargram 2 on beam B, 30 cm from the joint between beams A and B.

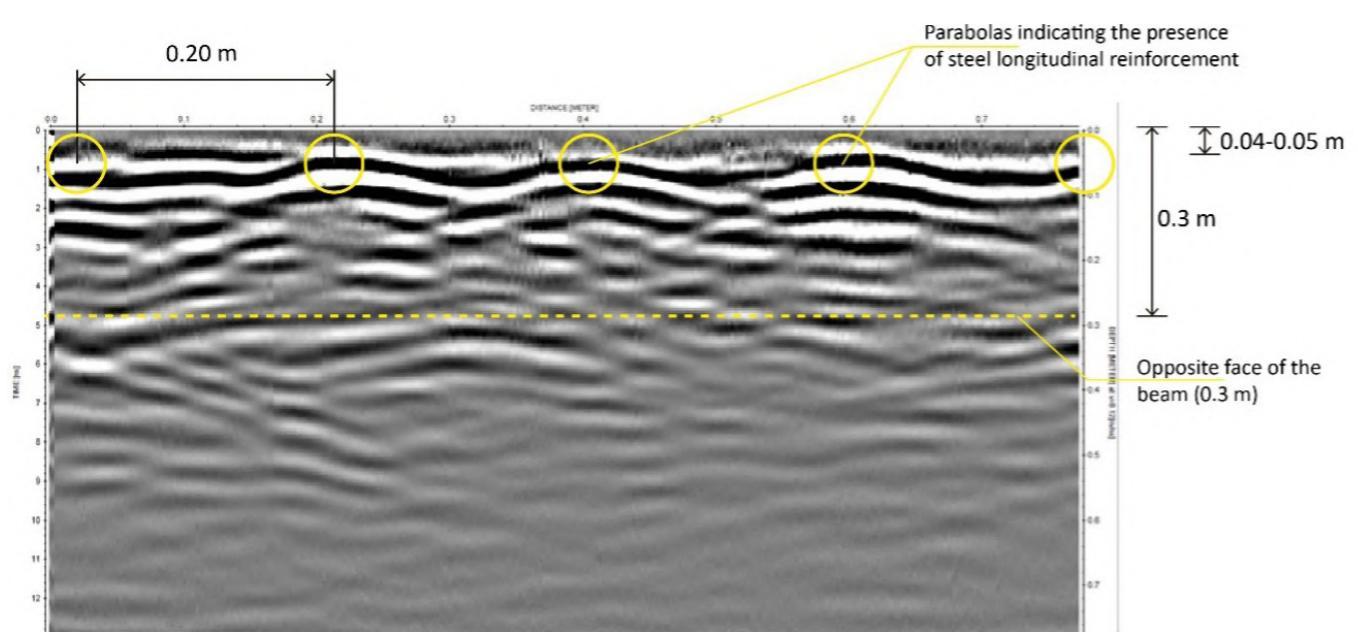
Radargram 3 (Fig. 66) was carried out 50 cm away from the forcement of beam B, located at the top, bottom, and middle joint between beams A and B, confirming the presence of of the height given the beam large size. the five reinforcement bars) and indicating that their length Radargram 5 (Fig. 68) was carried out 180 cm away from the within beam B is greater than 50 cm. The tests performed at joint between beams A and B and 30 cm away from the joint a location further than 50 cm from the joint no longer show between beams B and C. The radargram shows again five the presence of the five bars. As an example, Fig. 67 shows reinforcements, indicating the presence of dowels in the interadargram 4, carried out 110 cm away from the joint between rior of beam B at this end of the beam to connect with beam beams A and B. Only three steel reinforcement elements can C. The reinforcement details thus seems to be similar at both be detected. In conclusion, the dowels that connect beams A ends of the beam. The tests carried out led to determining and B seem to have a length of 50 cm within beam B and there that two dowels were used to connect the beams. These doare two of them (the two longitudinal reinforcement elements wels are separated 40 cm, located approximately 40 cm from that are no longer visible in Fig. 67). The three reinforcement the top and 40 cm from the bottom of the beam. They have a elements located in Fig. 67 seem to be the longitudinal reinlength of approximately 50-60 cm within beam B (beam with no vertical supports).

Fig. 66 – Radargram 3 on beam B, 50 cm from the joint between beams A and B.

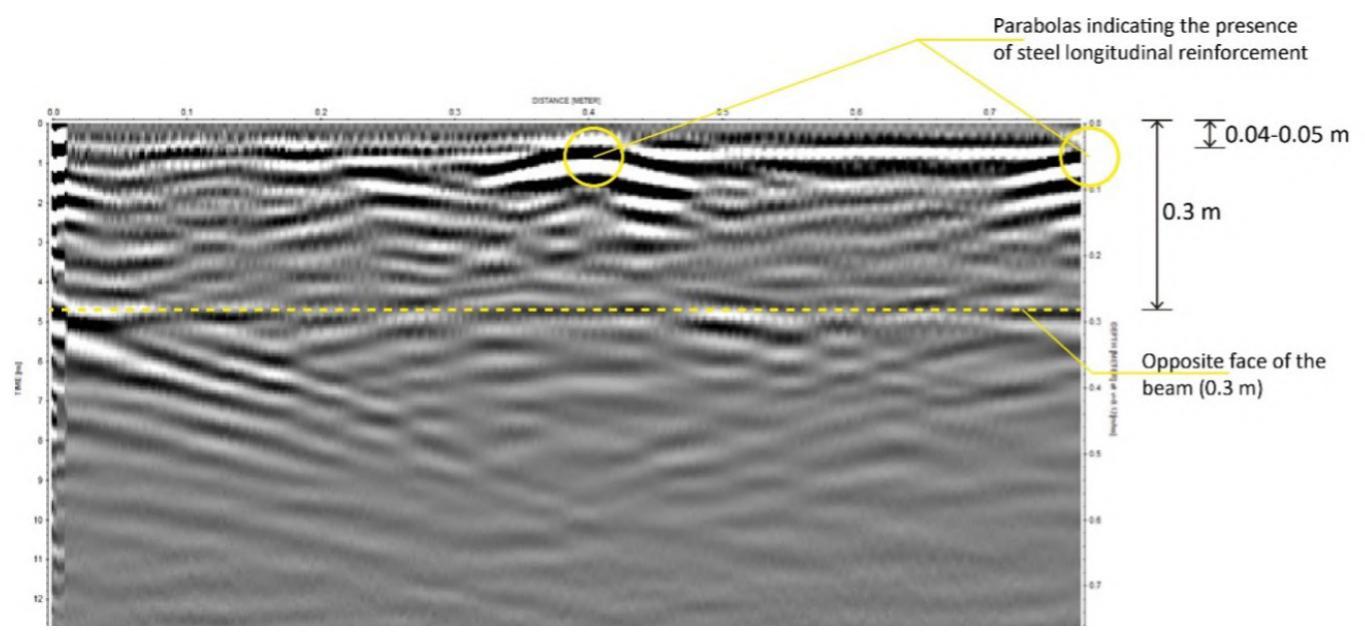
Fig. 67 – Radargram 4 on beam B, 110 cm from the joint between beams A and B.

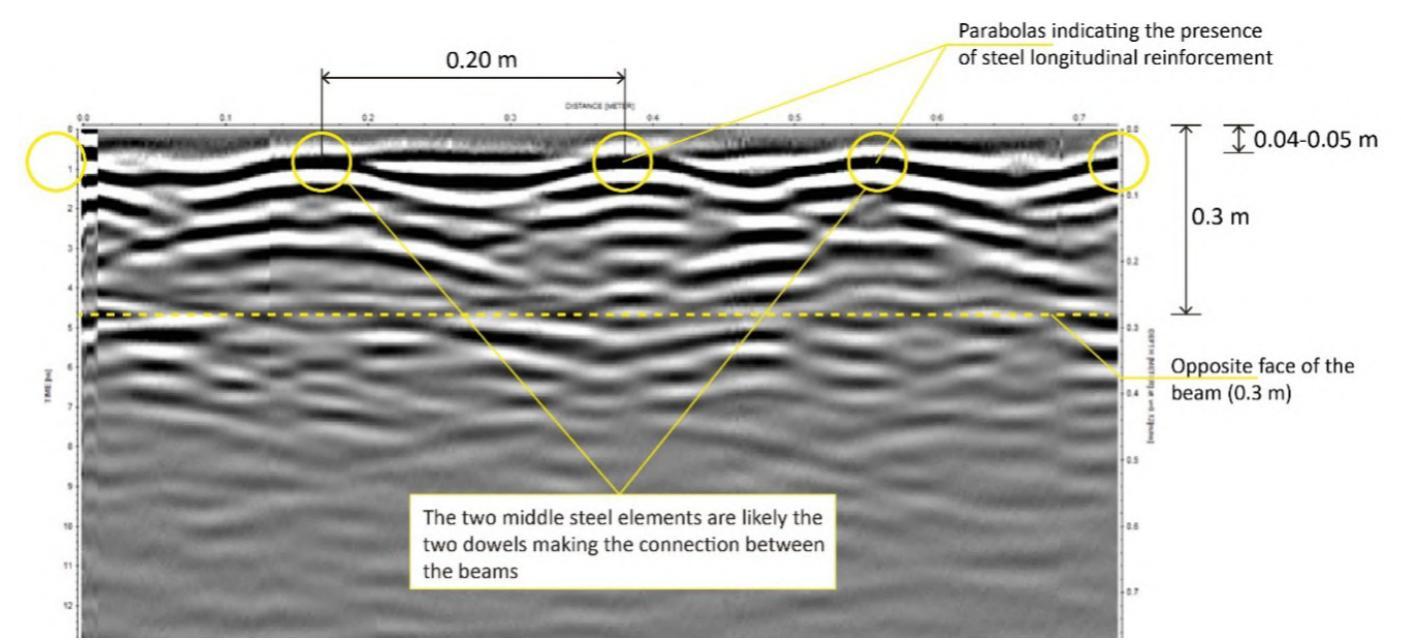
Fig. 68 – Radargram 5 on beam B, 180 cm from the joint between beams A and B.

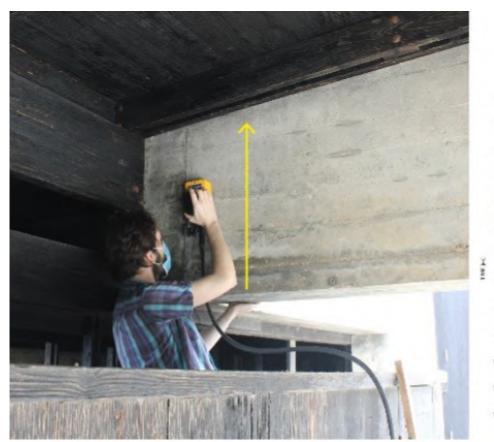
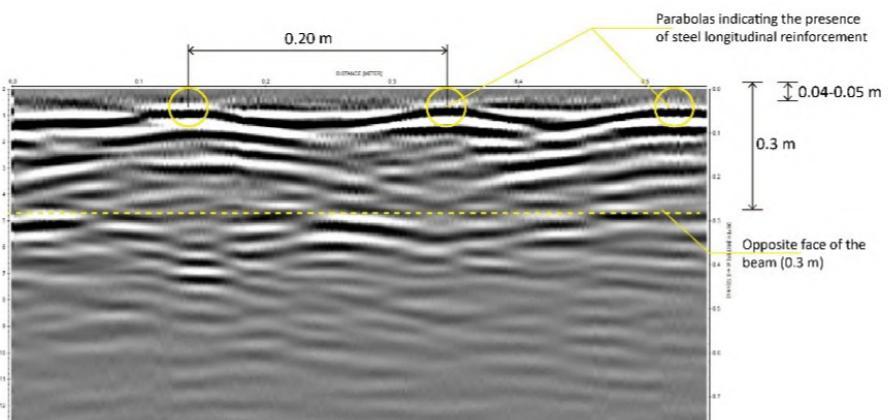
Several radargrams were carried out on the interior face of the beam, leading to similar conclusions. The results indicate that the same reinforcement detail was used at both faces of the beams. For example, Fig. 69 shows a radargram carried out on the interior face of the beam, 30 cm away from the joint between beams B and C. The radargram shows the longitu-

Fig. 69 – Radargram carried out on beam B (interior face), 30 cm from the joint between beams B and C.

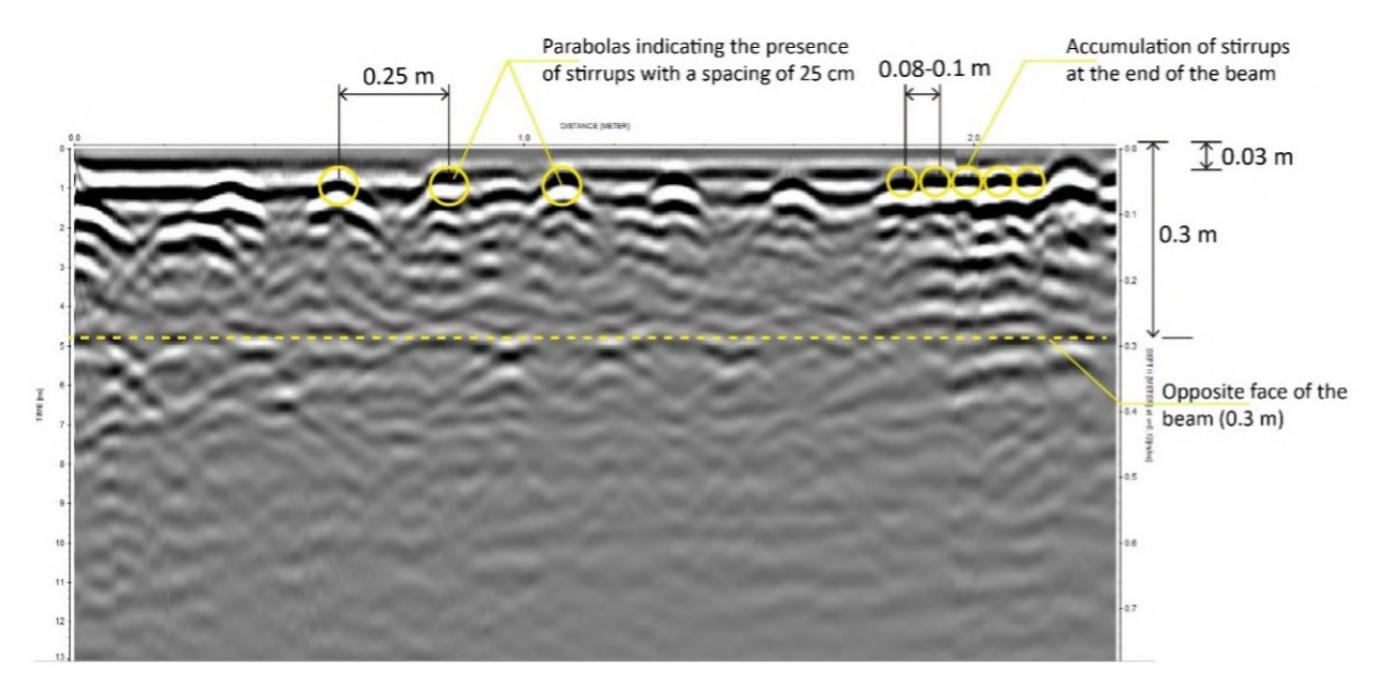
Another test was carried out on beam B in the longitudinal horizontal direction, aiming to determine the spacing between the stirrups. Fig. 70 shows that the stirrups have a regular spacing of 25 cm throughout the beam length. However, the spacing is reduced close to the beam ends. The radargram indicates that the spacing of the stirrups at the beam ends

Fig. 70 - Longitudinal radargram carried out on beam B.

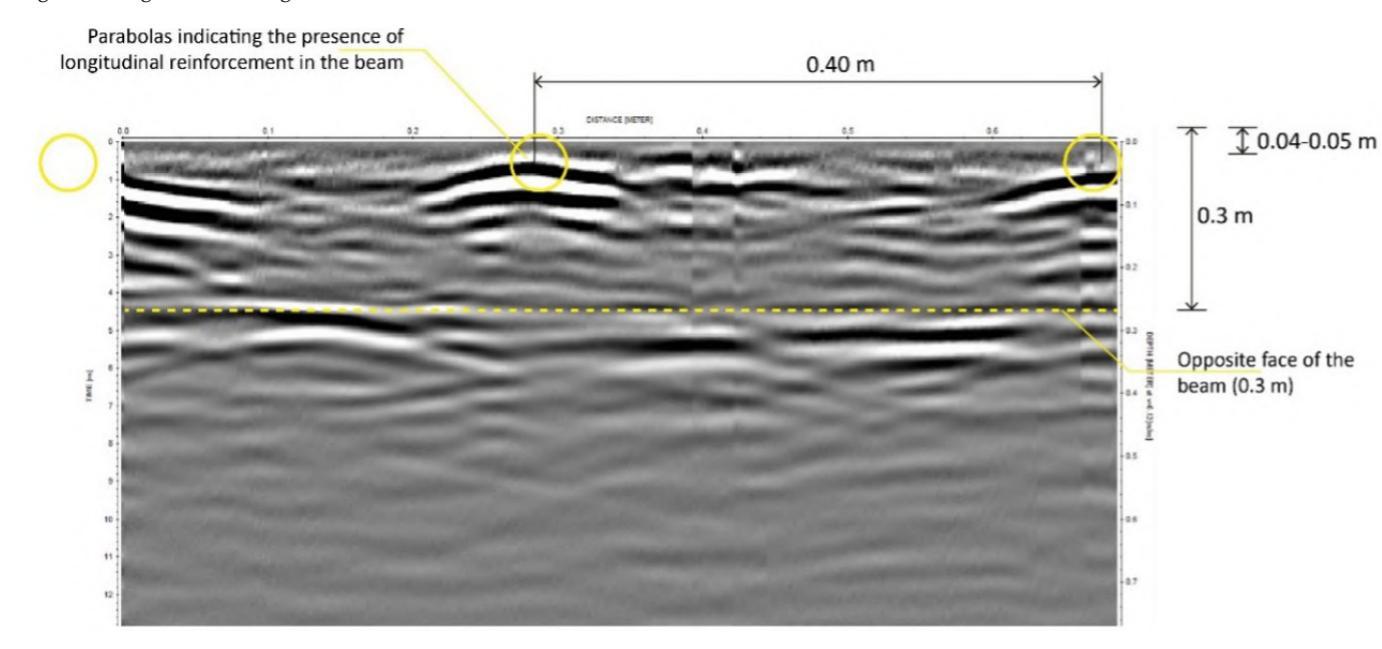
Fig. 71 - Vertical radargram carried out on beam C.

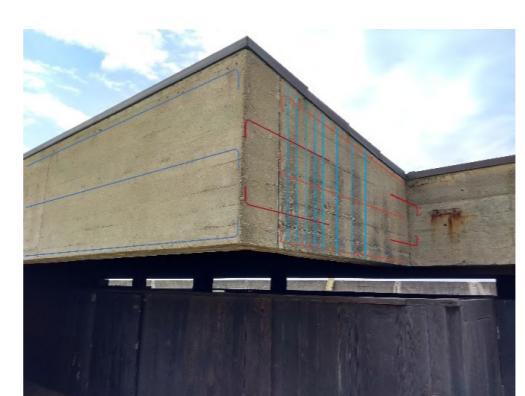
In conclusion, Fig. 72 shows a hypothesis of the connection between the cantilever beams over the changing rooms. The hypothesis that is shown in Fig. 72 indicates the probable presence of two dowels connecting the perpendicular beams in each face (in dark red), making it four it total. It also shows an approximate distribution of the stirrups (in light blue) and the longitudinal reinforcement bars (in orange) of beam B, again in each face. The probable location of the three longitudinal reinforcement bars in beams A and C (in dark blue), and in each face, is also shown. The arrangement is assumed to be symmetric from the vertical axis of the beams.

Fig. 72 - Likely reinforcement details of the connection between the cantilever beams over the changing rooms, and beams main reinforcement.

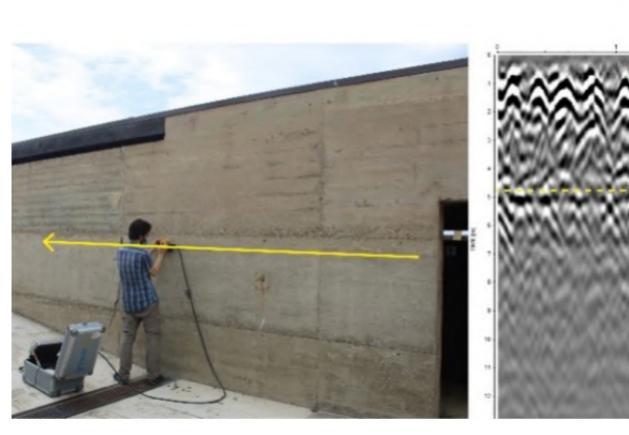
rizontal alignment at the exterior wall of the changing rooms. Variable spacing between vertical reinforcement bars could be estimated. There is a vertical separation between two

Fig. 73 - Horizontal radargram carried out on the exterior wall of the changing rooms.

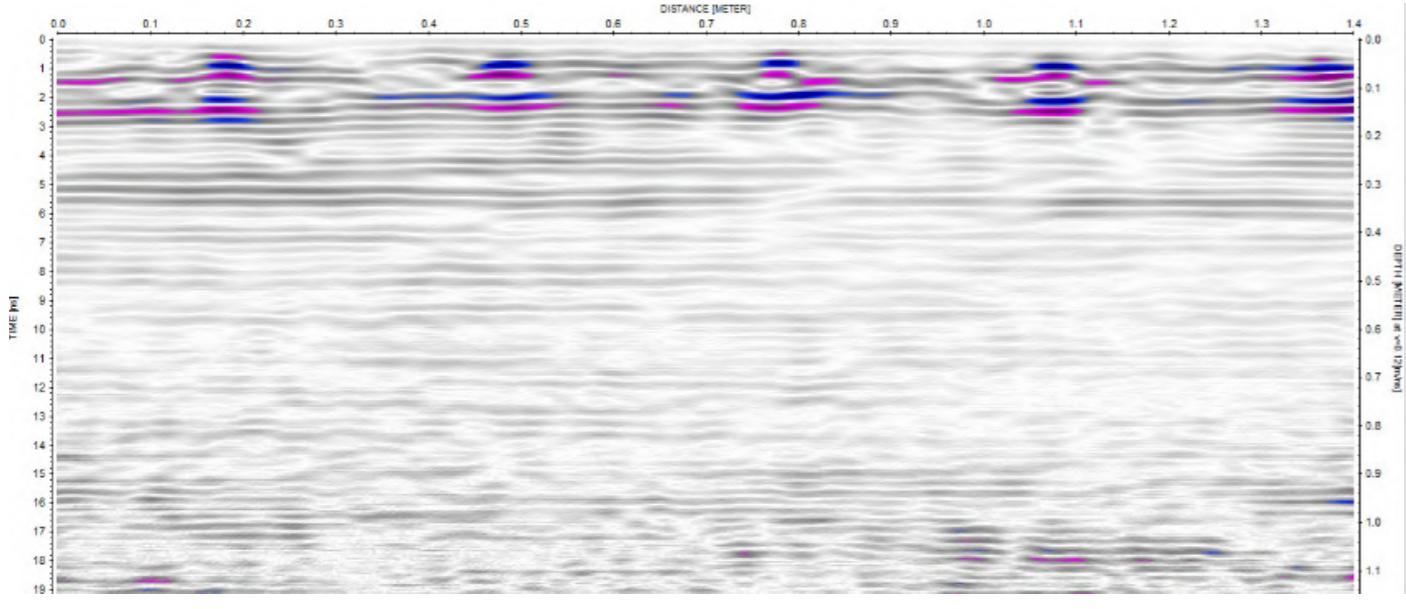
In the exterior wall of the south's corridor, the tests were carreinforcement bars can be clearly observed. Similarly, Fig. 80 ried out in a grid following the orthogonal directions on the shows a representative vertical radargram carried out on the walls. A total of 8 parallel scans were carried out in the horiwall of the south's corridor. In this case, a spacing of 10 cm zontal and vertical direction (Fig. 75). The separation between between horizontal reinforcement bars can be also clearly scans was 20 cm, covering a total area of 1.4 m x 1.4 m. Fig. observed. 76 shows a representative horizontal radargram carried out on the south's corridor. A spacing of 30 cm between vertical

Fig. 76 - Representative example of horizontal radargram carried out on the wall of the south's corridor.
