Managing change with a living architect OCEAN SWIMMING POOL BY ÁLVARO SIZA

CONSERVATION MANAGEMENT PLAN

Teresa Cunha Ferreira (FAUP, University of Porto)

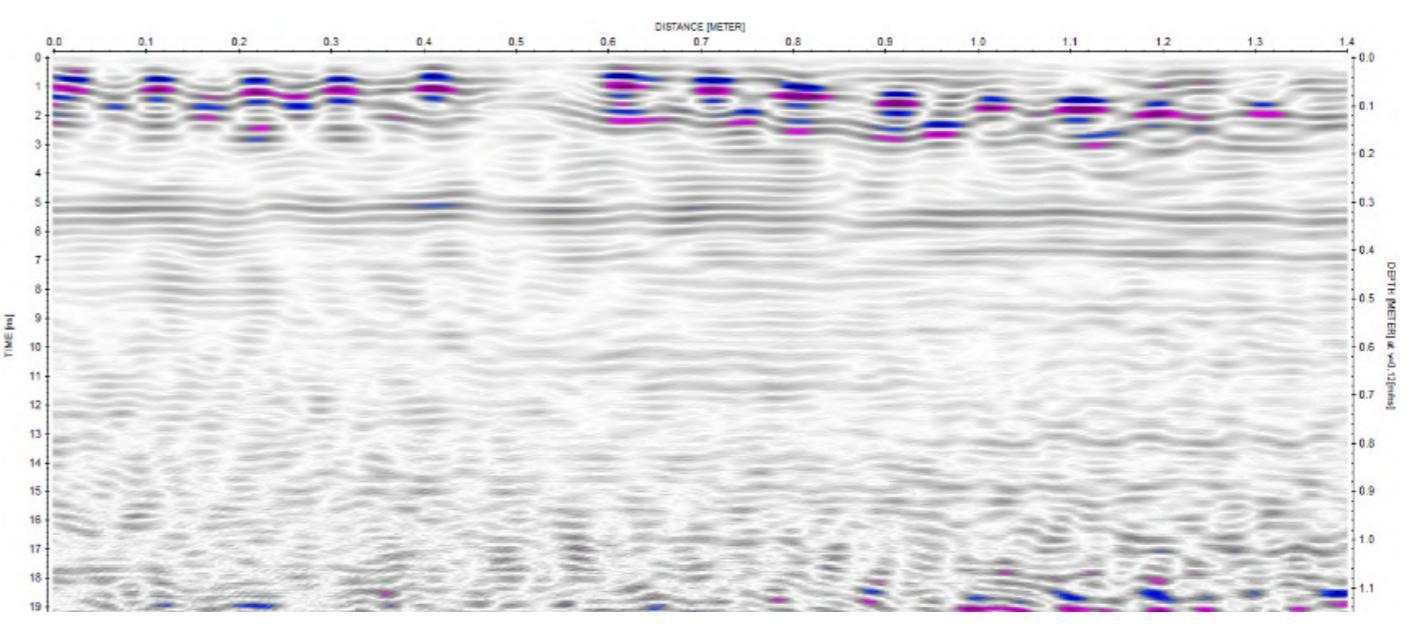
Fig. 77 - Representative example of vertical radargram carried out on the wall of the south's corridor.

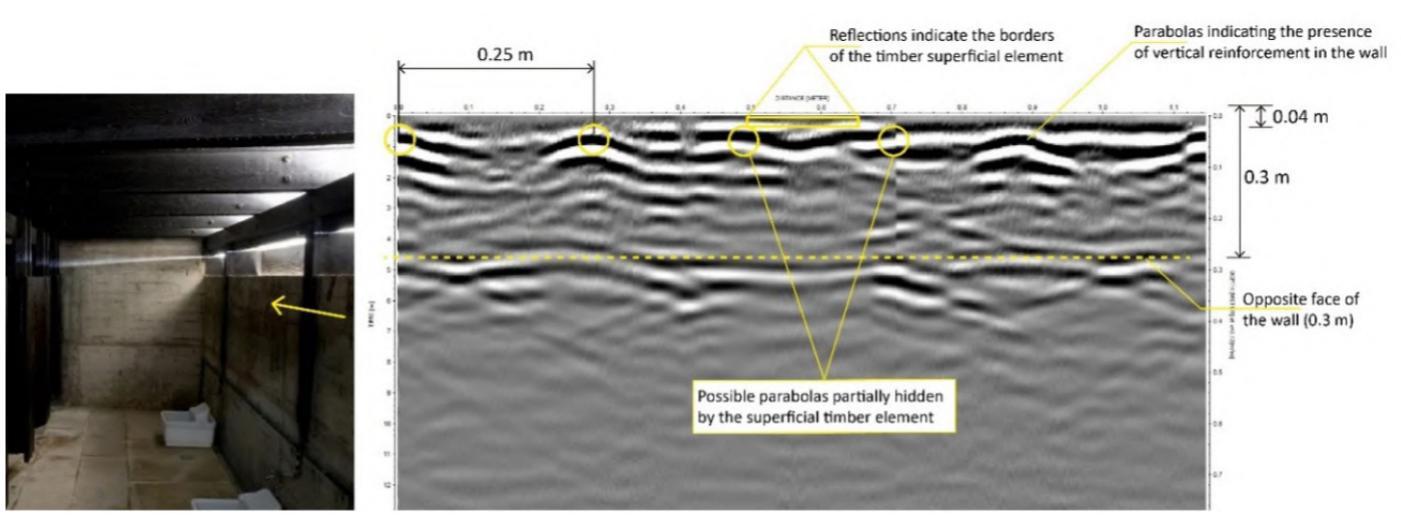
Finally, the last GPR test was carried at the wall of the wash foot's room, aiming to understand the construction detail of the connection between the concrete wall and the timber elements. Fig. 80 shows that the vertical timber element is superficial with a thickness of approximately 1 cm. Thus, the timber element is not a continuation of the timber element

Fig. 80 – Horizontal radargram carried out on the wall of the wash foot's room.

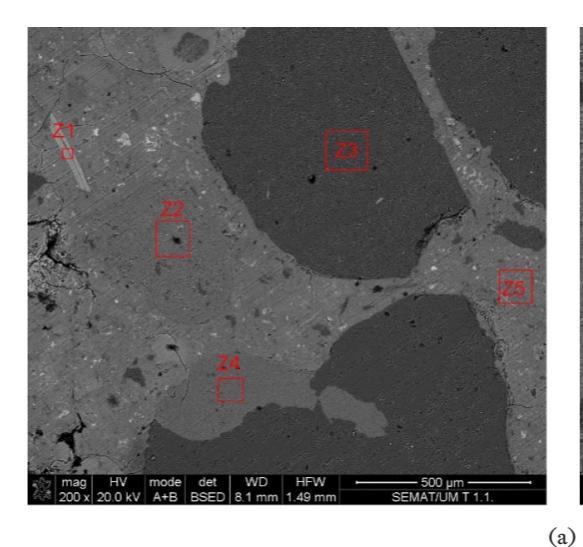
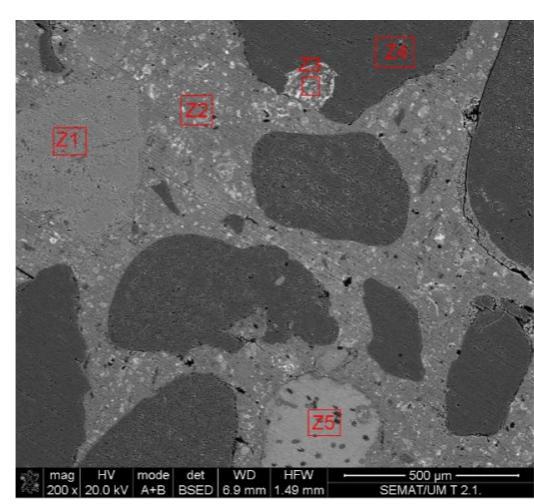
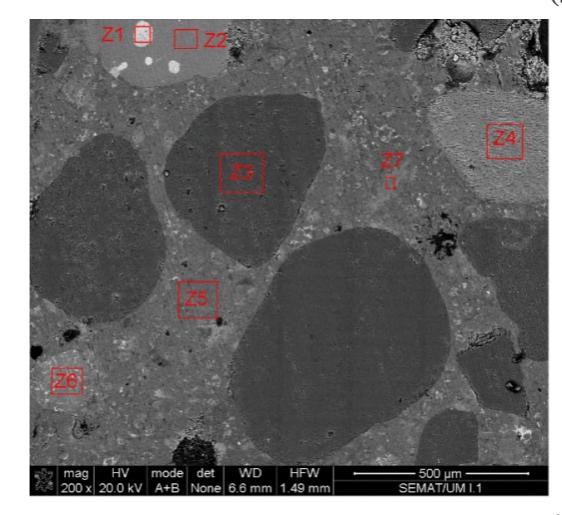
The scanning electron microscopy (SEM) allows to create and interfacial transition zones. The results show the presence of chloride (Cl and Na) in the samples T2.1 (Fig. 100b, Z2) and B1 (Fig. 101c, Z1), which is in agreement with the results of the EDS (Section 3.3.10.5) and the chloride content tests pozzolans in the composition of the concretes, which has been a common practice for many years to improve the durability of the concrete.

Fig. 100 - Examples of images obtained from SEM analysis (magnification: 200x and 500x): (a) T1.1 sample; (b) T2.1 sample; (c) I1 sample.

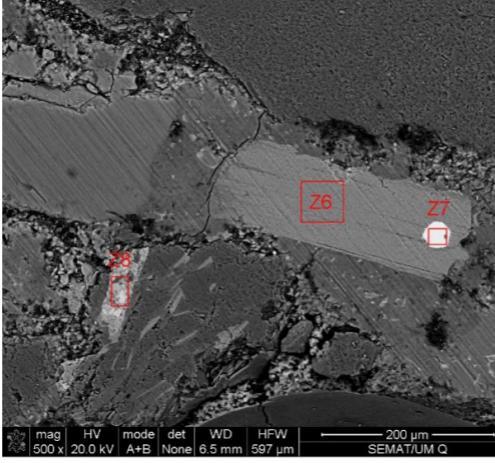
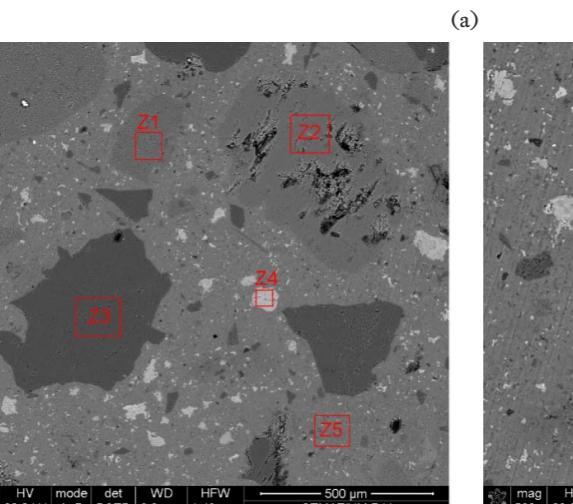
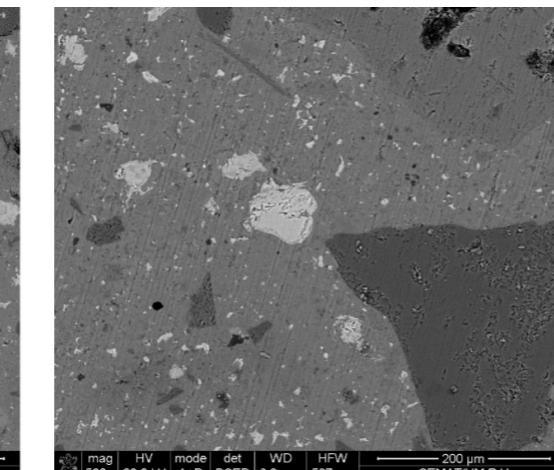
Fig. 101 - Examples of images obtained from SEM analysis (magnification: 200x and 500x): (a) Q sample; (b) PV sample; (c) B1 sample.

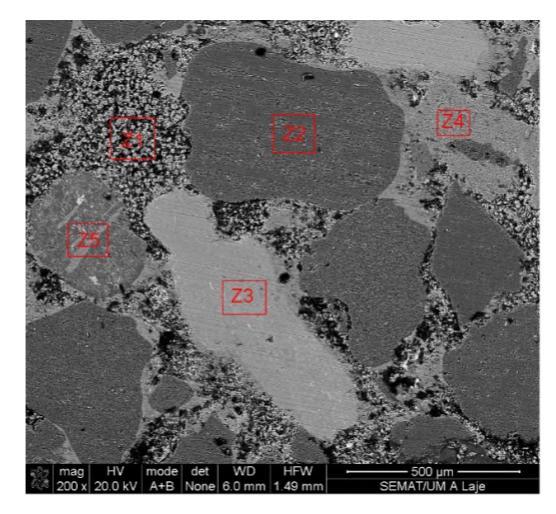
Fig. 102 – Examples of images obtained from SEM analysis (magnification: 200x and 500x) of the A sample.

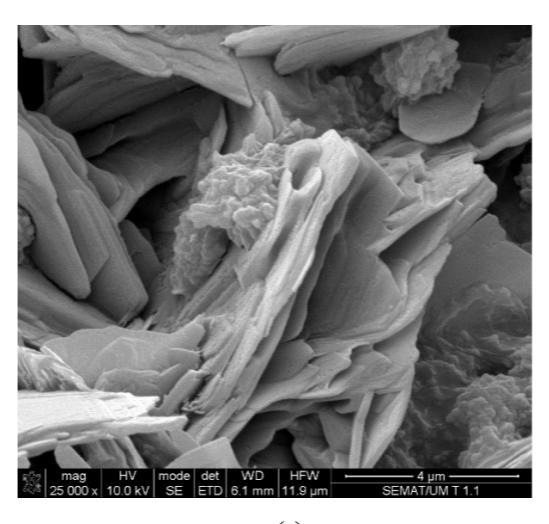
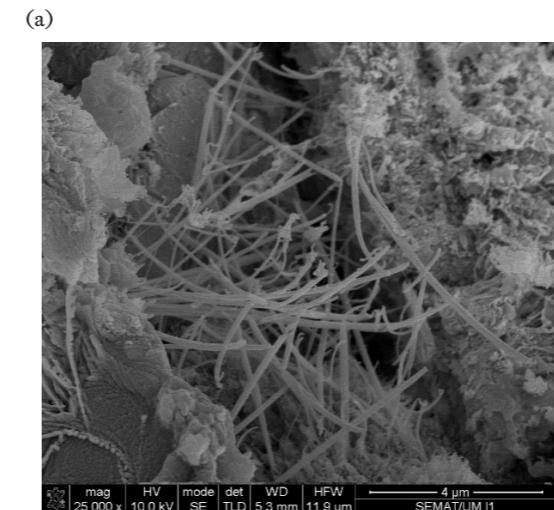
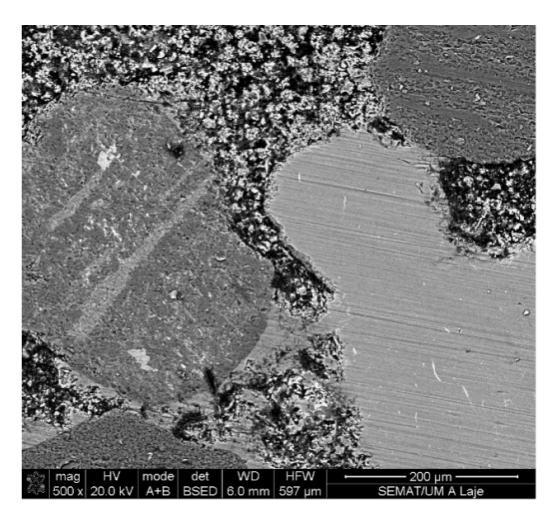
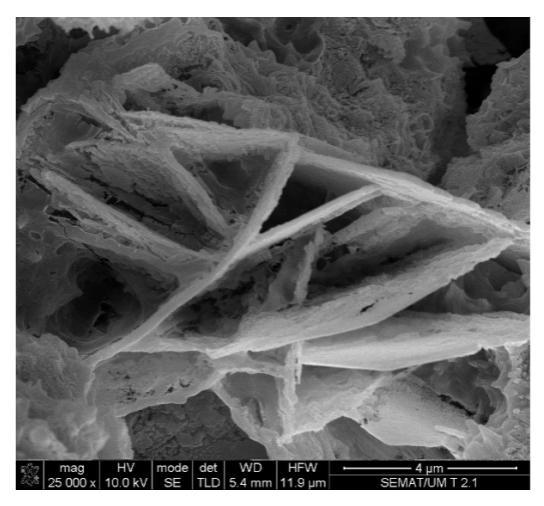
images of samples by scanning their surfaces with a low-energy beam of electrons, achieving high resolutions (in the low nanometer range). The high-resolution images provide information on the surface morphology and composition of (Section 3.3.3). The samples present several impurities in the the samples. In the first analysis, images with magnification aggregates, which can be an indicator of lack of quality conof 200x and 500x were created for all samples (Fig. 100 to trol in the aggregates (e.g. absence or deficient washing and/ Fig. 102). Additionally, images with a magnification of 1000x, or uncontrolled origin of the aggregates). Finally, the results 5000x, 10000x and 25000x were also obtained for the T1.1, of this analysis do not allow to conclude on the presence of T2.1, I1 samples (Fig. 103). All images are presented in the Annex (SEM and EDS).

Fig. 103 – Examples of images obtained from SEM analysis (magnification: 25000x): (a) T1.1 sample; (b) T2.1 sample; (c) I1 sample.

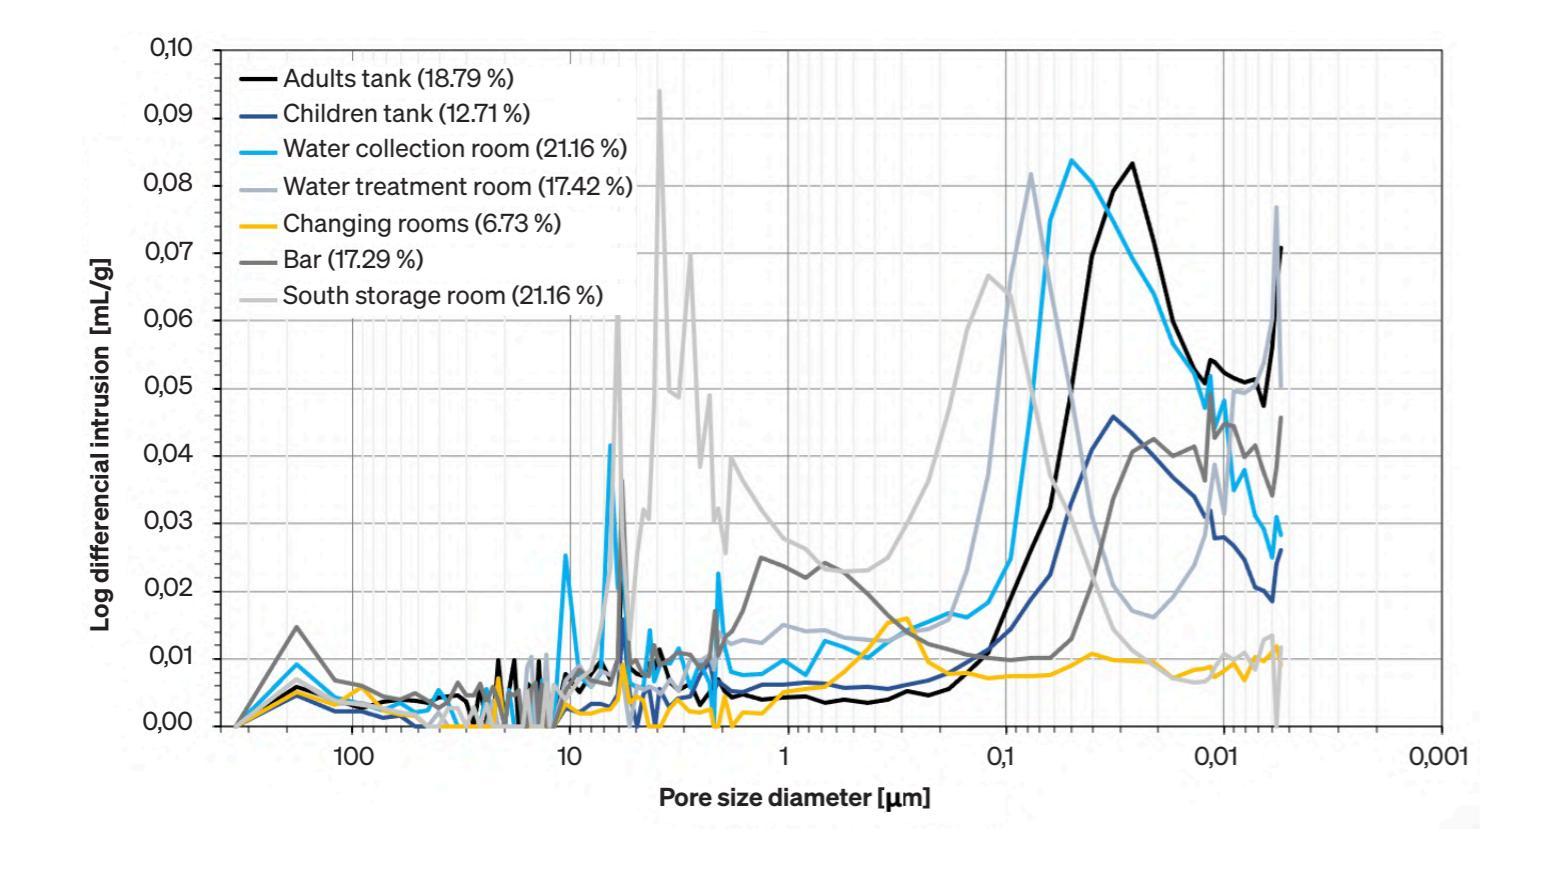
Fig. 104 – MIP results: Logarithmic differential intrusion vs. pore size diameter.

The logarithmic differential intrusion curve (Fig. 104) shows that the lowest dc is equal to $0.026\,\mu$ m and is associated with the sample T1.1 (adult's tank, phase 1). The dc of the samples

of phase 2.2 ranges from $0.032 \,\mu$ m (T2.1) to $0.077 \,\mu$ m (Q). It is noted that the sample I1 (phase 2.1) presents also three relevant peaks for the 10.5114 μ m, 6.5834 μ m and 5.714 μ m pore size diameter. The sample PV (phase 2.4) presents a dc of 0.2840 μ m associated with the lowest porosity (6.73%), which is in agreement with the results of the water penetration tests (Section 3.3.4). Sample B1 (phase 3) presents two relevant ranges of pore size diameter, namely 0.0263-0.0055 μ m and 1.3312-0.4341 μ m. Finally, sample A (phase 3) presents the highest dc, namely 3.8968 μ m (sample collected from a slab with carbonated concrete and corroded rebars).
