Final report of the Grantee

Milan, December 23rd, 2020

This publication is made possible with support from the Getty Foundation through its Keeping It Modern initiative

Scientific Coordinator Prof. DAVIDE DEL CURTO Politecnico di Milano, Department of Architecture and Urban Studies

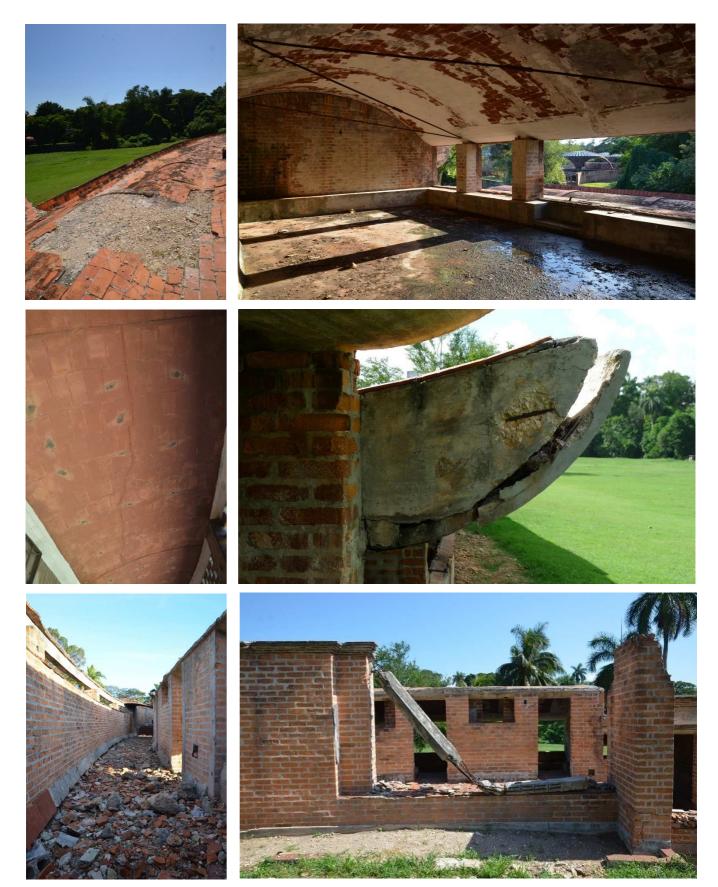
Figure 41 - Main criticalities detected (2019-2020).

Currently, the most deteriorated portion of the construction is the part of the lower level located in the proximity of Rio Quibù, starting from the point where the higher and lower level divide. Extensive portions of the roofs collapsed, and pavements disappeared under the rubbles making the entire area hard to access (Figure 41 - bottom). The central portion of the building, organized on two levels, also shows signs of deterioration, mostly caused by the lack of maintenance and the consequent decay of building materials. The main issues are related to the diffuse detachment of the outermost layer of tiles on the vaults, which resulted in water infiltrations and humidity stains at the intrados. Also, due to the complete absence of windows, wind and water often enter the cubicles, leaving mud and deposits on the ground (Figure 41 - top).

Longitudinal cracks run along with the seemingly catalan vaults of the porticoed corridor on the upper level, suggesting a true thin-shell nature (Figure 41 - middle, left). Given that several original vaults already collapsed, the cracking seems to indicate a serious structural failure. Collapsed vaults were replaced with new reinforced-concrete ones.

The reinforced concrete structures also show signs of deterioration. In particular, the beam-planters completing the tile-covered vaults lost part of the concrete cover, leaving rebar exposed to weathering (Figure 41 - middle, right). The sanitary system is unusable and needs renovation. Spaces that are currently used are provided with electricity (e.g., the carpenter's workshop). A water tank has been positioned on the rooftop, towards the head of the *gusano* building.

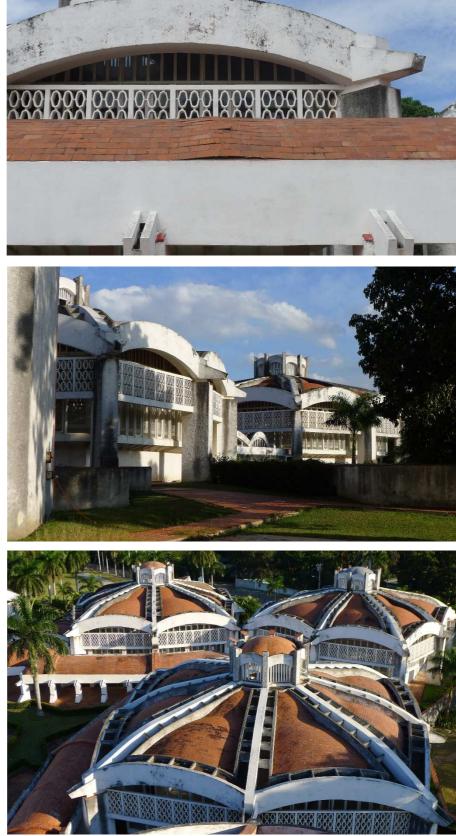
Figure 65 - Main criticalities affecting the building (2019-2020).

Thanks to the maintenance works, and to the constant use, the building appears to be in a good state of repair. The most significant deterioration phenomena currently concern the masonry and the roofs, and they are connected to problems that are intrinsic to the architectural design. The fact that the tiles composing the eaves are not jutting enough to grant a correct outflow of rainwater and the peculiar shape of the walls are the main causes of the plaster finish's leaching (Figure 65 - middle).

Moreover, the outermost layers of tiles of the vaulted covering are starting to show some decay. In particular, during the on-site investigations carried out in 2019, it has been possible to notice the uplift of consistent portions of clay tiles, as illustrated in Figure 65 (top, right). Limited humidity stains and efflorescence also started to appear at the vaults' intrados, highlighting the mediocre efficacy of the 2000-2005 restoration intervention (Figure 65 - top and bottom, left).

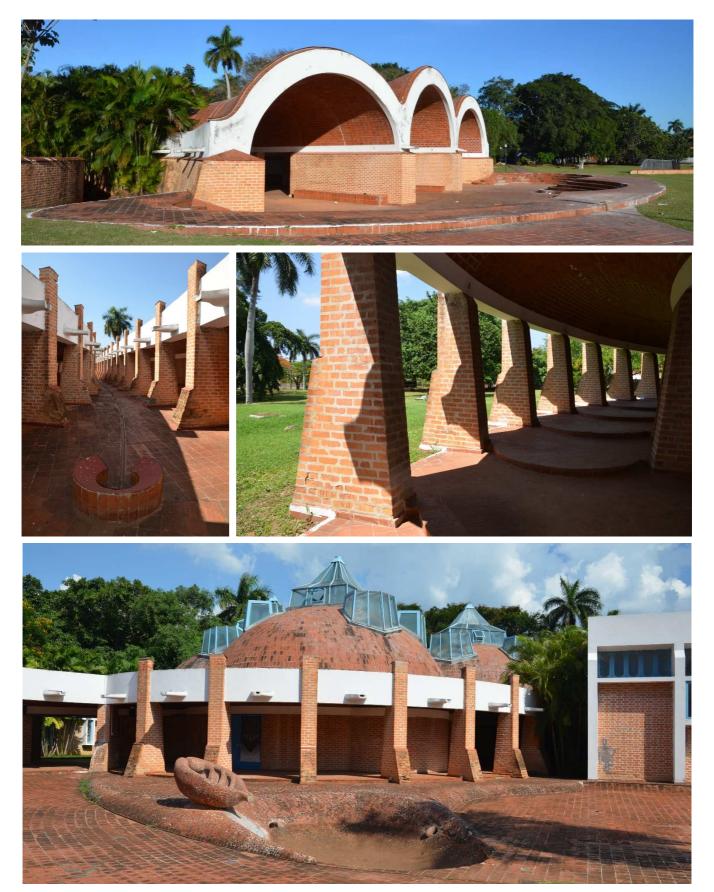
Between 2000 and 2008, the building has undergone restoration works that mostly focused on the reinstatement of finishing materials (terracotta tiles covering the domes) and the total remake of skylights, windows, and doors. The operations, promoted by the Cuban Government, were led by Universo Garcia Lorenzo and started with an investigation of the building and an assessment of its state of repair. This resulted in a topographical survey of the building and several technical reports regarding the chemical characterization of the building materials, the main structural problems, and the environmental issues.

Unfortunately, most of the operations ended up causing further deterioration phenomena connected to the choice (and sometimes even the incompatibility) of the employed materials. Indeed, the new terracotta tiles replacing the original ones already show signs of detachment.

The bricks employed to repair walls after the construction of the reinforced concrete buttresses have suffered severe deterioration due to their faulty composition. The renewal of the skylights has partially modified the domes' original shape as a new profile has been inserted where the clearstory touches the roof. This element, employed to prevent water infiltrations, has proven inefficient, and it has caused further damage to the lower structures.

Figure 75 - The School in its current state.

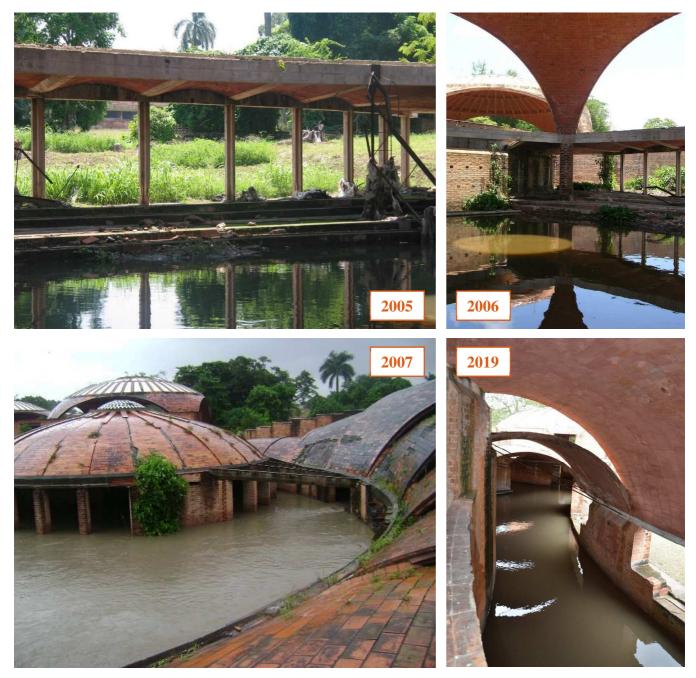
Figure 100 - The School of Ballet flooded on the occasion of different on-site inspections: 2005 - 2006 - 2007 - photos stored in the ISA archive; 2019 - photo taken within the Keeping It Modern Initiative.

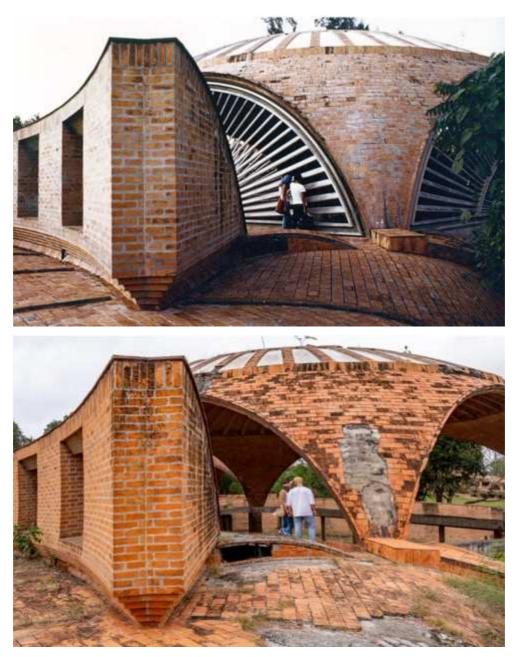
Figure 107 - School of Ballet by architect V. Garatti. n.d. author Lorenzo Carmellini vs 2020.

A first concerns the School of Ballet. The photo in Figure 107 was taken on February 21, 2020, at 5:10 pm with a SonyILCE-7M3 camera with FE 16-35 mm F4 ZA OSS lens, focal length 32 mm, exposure 1/500 sec, f/4, ISO 125. The comparison between the two pictures highlights the state of decay and abandonment currently affecting the School of Ballet. It is also possible to notice the complete disappearance of the medio-punto window frames, designed to block the tropical sun while guaranteeing air circulation. A diffused detachment of the outermost layer of clay tiles regards both the Dance Pavilion's pendentive and the extrados of the seemingly Catalan vaults covering Garatti's *paseo arquitectonico*. The growth of weeds and shrubs worsened the situation, contributing to the structure's decay.

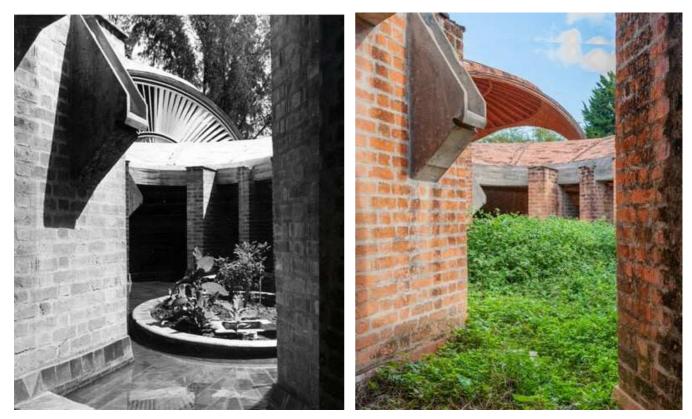
Figure 108 - School of Ballet by architect V. Garatti. 1965 (ISA archive, author: Paolo Gasparini) vs 2020.

The historical picture here portrays an interesting and peculiar architectural feature of the project. Indeed, the fountain located in this patio, while contributing to the building's temperature regulation, aimed at offering a pleasant perception to the user, providing him with a space of undeniable quality. The depicted patio was originally intended to be the school's main recreational point, where students could hang out while enjoying products from the cafeteria. The image on the right brings us back to reality, showing an abandoned - and yet fascinating - space.

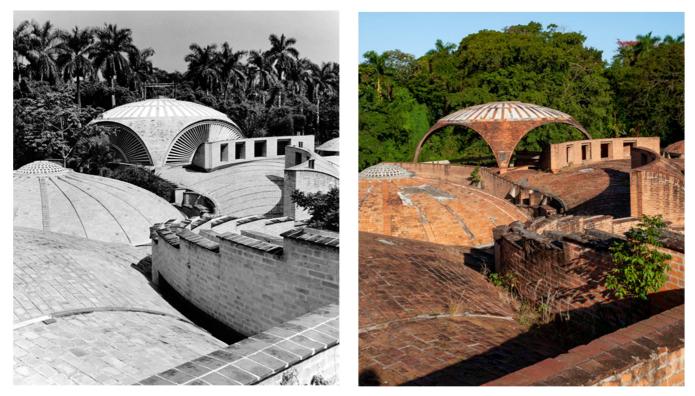
Figure 109 - School of Ballet by architect V. Garatti, 1965 (ISA archive. Author: Paolo Gasparini) vs 2020.

Figure 109 is the last image that was selected among the shots from the School of Ballet. It was taken on the morning of February 20, 2020. In order to reproduce the 1965 shot, the camera operator used a Nikon D5000 with 18 - 55mm f/3.5 - 5.6 lens, 24mm focal length, 1/500 sec exposure, f/9, ISO 200. As in previous cases, the comparison between the two images recounts a history of slow pillaging and deterioration, which resulted in the complete removal of the wooden jalousie of the Dance Pavilions' arched windows. Vaults and domes diffusely lost portions of the clay tile covering, and vegetation attempts to grow in mortar joints, producing further damages.

All things considered, despite the neglected appearance of the building, its actual state of repair is rather good.

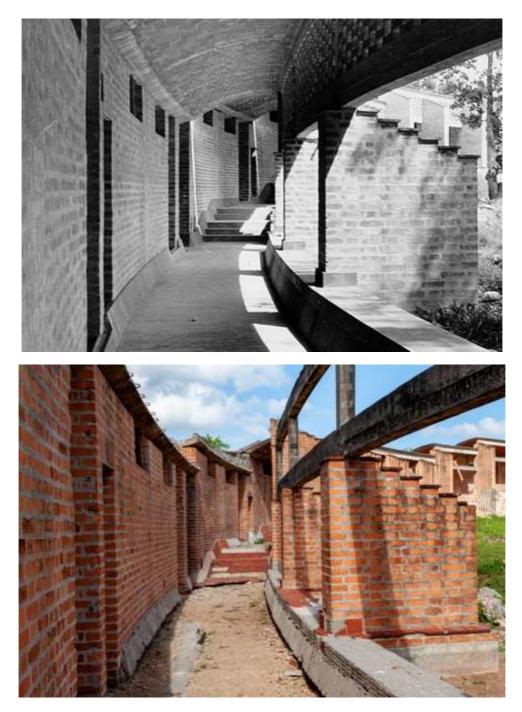
Figure 110 - School of Music by architect V. Garatti, 1965 (ISA archive. Author: Paolo Gasparini) vs 2020.

Figure 107 is the first shot concerning the School of Music. The photo was taken with a Nikon D5000 camera with 18-55 mm f/3.5-5.6 lens, 24 mm focal length, 1/400 sec exposure, f/10, ISO 200. The image represents the covered external path connecting the spaces located on the upper level of the *gusano*. The changes between 1965 and today are evident, as the vaults covering this portion of the corridor disastrously collapsed. Damages extended to the flooring, where tiles are completely missing. The spatiality and rhythm we witness in the image on the left are long gone and can only be imagined thanks to the remaining vertical elements.

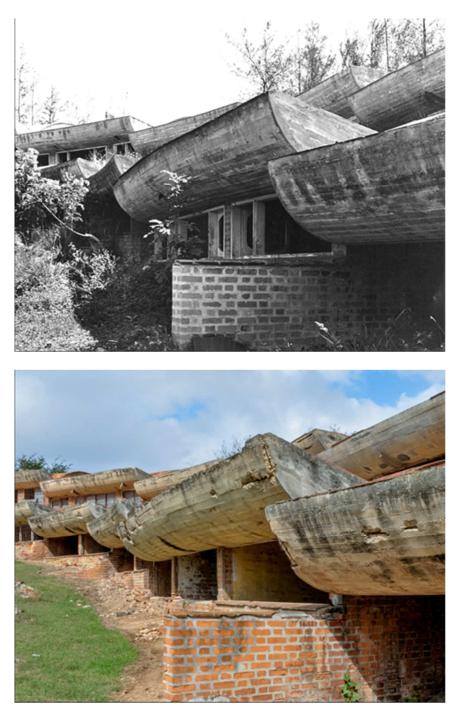
Figure 111 - School of Music by architect V. Garatti, 1990s vs 2020.

A further shot of the School of Music aims to portray the changes occurred on the curved concrete beam-planters completing the classrooms' vaulted roofs. The photo was taken at 04:04 pm on February 21, 2020, with a Nikon D5000 camera with 18 - 55 mm f / 3.5 - 5.6 lens, 24 mm focal length, 1/125 sec exposure, f / 13, ISO 200.

The comparison between the two shots displays the poor state of repair of the building material, which, having lost part of the concrete cover now presents widespread oxidation of the rebars.

kept away from the architecture to protect it from humidity. The window frames, partially present in the photograph on the left, today appear are completely gone.

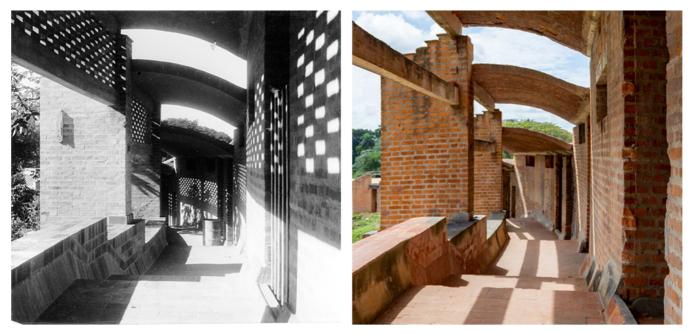
Figure 112 - School of Music by architect V. Garatti, 1965 (ISA archive. Author: Paolo Gasparini) vs 2020.

The first difference that can be observed from the comparison between the two shots (in addition to the exposure), is the complete loss of the brick shutters. Such elements were originally designed to project a pleasant alternation of lights and shadows on the masonry of the classrooms' plain wall, also resulting in improved climatic conditions. The deprivation of door and window frames is also evident. Unlike Figure 107, both the vaults and the floors seem to be in a fair state of repair.

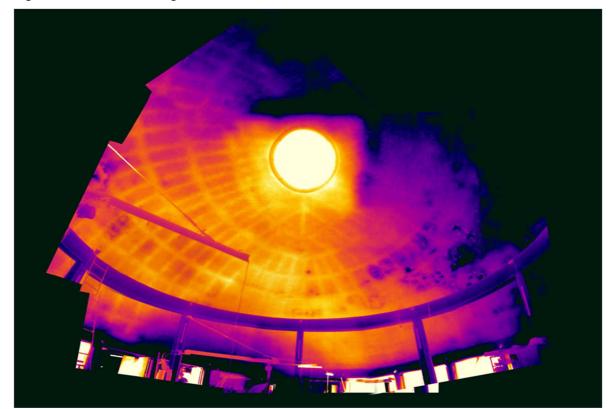
In this particular case, thermography has proven essential in order to understand the structural organization of the domes of the School of Plastic Art, which, like the ones of the School of Ballet, are supported by a reinforced concrete grid-shell framework (Figure 5).

Figure 5 - Thermography of the School of Plastic Arts, intrados of the dome of the Foundry. 19th Feb. 2020, 1.00 p.m. Range: 28.5-30.4°C, Air: 29.1°C, 67.0% (Luca Valisi - Politecnico di Milano).

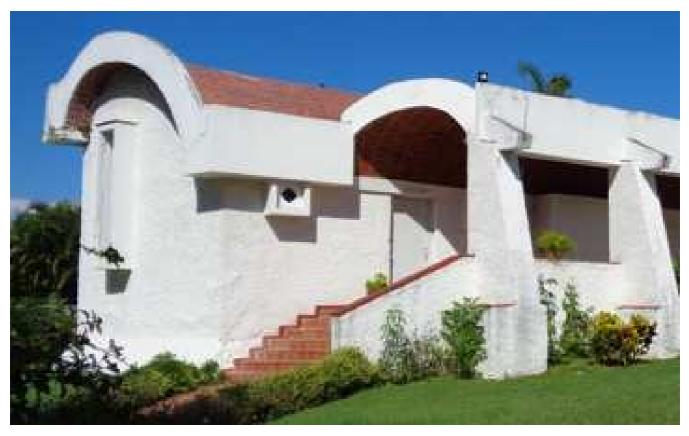
This covering coating makes the surface uniform and hides any traces of production but at the same time contributes to the good conservation of the elements, acting as a protective layer. Some cracks or limited phenomena of expulsion of material are observed at points of discontinuity, stagnation of rainwater, or the presence of higher plants' root systems. On the other hand, algal patinas are widespread.

Figure 9 - School of Modern Dance, External façade.

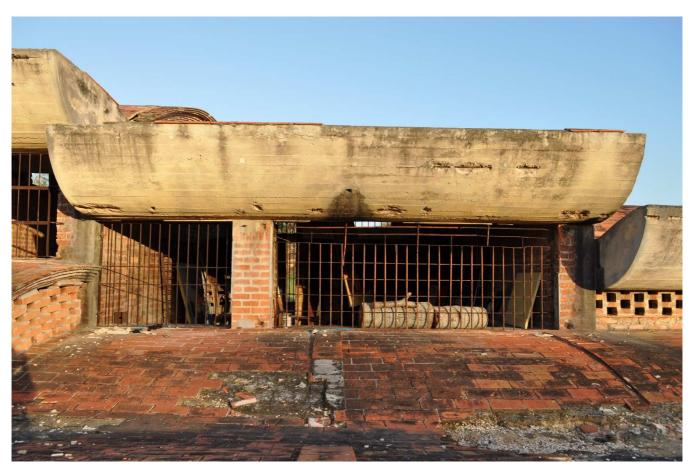
The pilot site took place during the mission of February 2020 (13/02/2020 - 18/02/2020). The site's choice was made in collaboration with ISA, in particular with the director of the *Facultad de Artes de la Conservación del Patrimonio Cultural (CECREM)*, Silvia Ramirez Paseiro. The upper-level tub was selected as the action area, in correspondence with the classrooms granted for use by some school students.

The selected area has good accessibility and conservation conditions that can be considered representative of the entire building.

Figure 10 - School of Music, area of intervention.

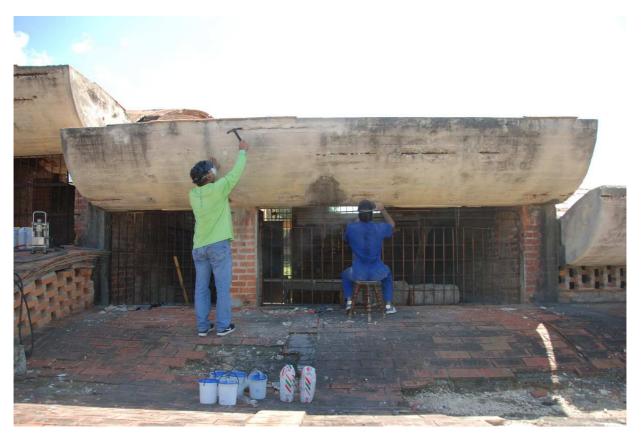
The first phase of the intervention consisted of removing the deteriorated material until the solid and resistant substrate was reached. All the operations to remove the deteriorated material were carried out until the complete uncovering of the reinforcements to ensure the additions' better adhesion.

Figure 11 - Deteriorated material removal.

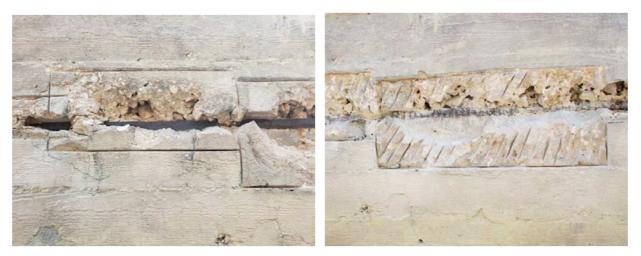
In some cases, the chance of making regular shape integrations was tested, making cuts with angle grinders, also in order to ensure better adhesion of the patch.

Figure 12 and Figure 13 - Cuts with angle grinders.

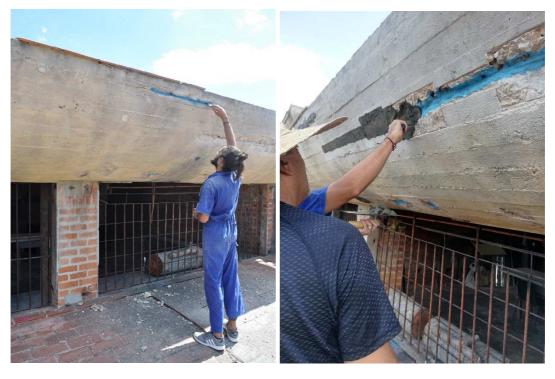
Figure 15 - Treatment of protective irons.

Figure 16 - Fiber-reinforced mortar addition

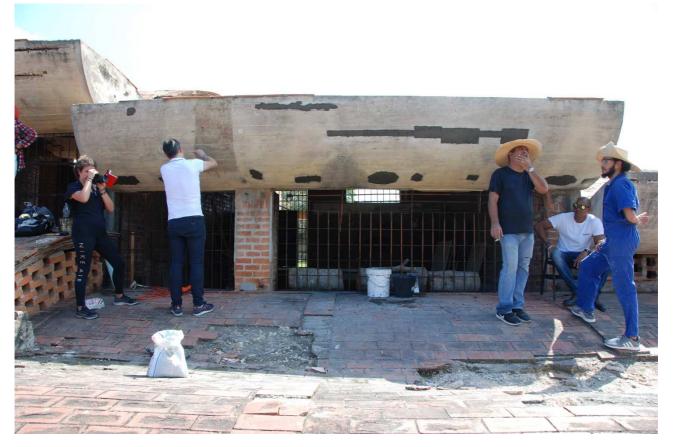
Figure 17 - Finishing with semi-covering acrylic paint.

- Finishing with semi-covering acrylic paint (Colorite Beton MAPEI). The product was applied by brush in three different dilution ratios to indemnify the best coverage level and match with the concrete color:

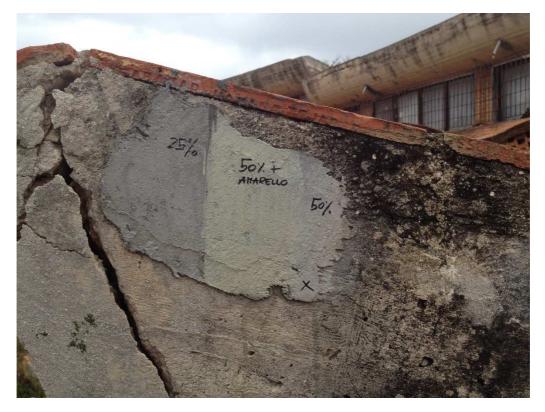
- 1. a solution in 25% water;
 - 2. a solution with 50% water + color in tempera (turned out to be the best solution);
 - 3. a solution in 50% water.

Figure 18 - Three finishing color tests.

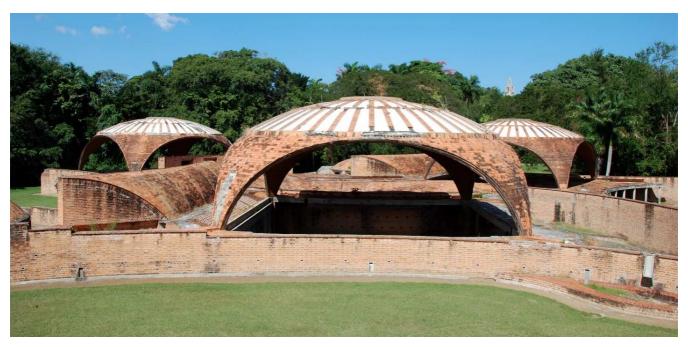
Figure 34 - Current view of the three dance pavilions.

Today, due to disuse, poor maintenance and continuous exposure to weathering, the structures of the School of Ballet are slowly deteriorating, uncovering their real constructive system and giving us the chance to truly study and understand the structural behavior of this nonetheless beautiful architectures.

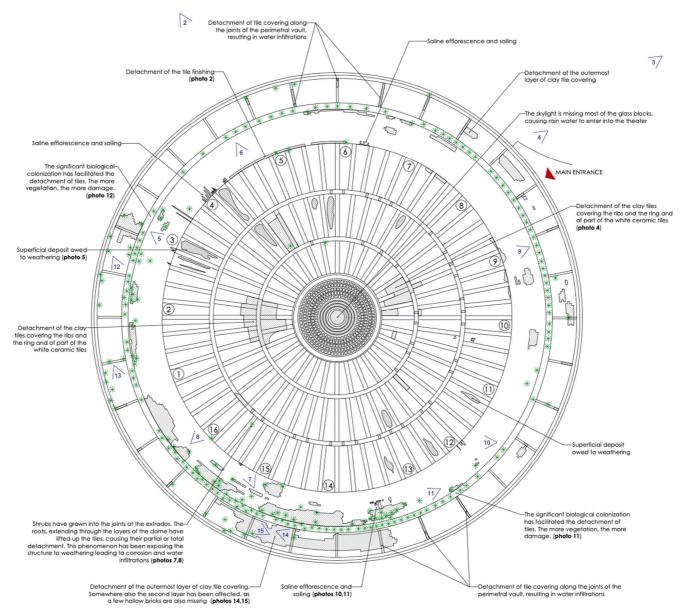
The lack of use and maintenance suffered during the last decades left its mark on the theater which nowadays lays in an advanced state of decay. Surprisingly enough however, despite the long abandonment, at a first (qualitative) glance, the global conditions of this dome do not seem to be particularly worrying from a structural point of view. As a matter of fact, the main issues appear to be the direct result of the absence of an appropriate system of protection against water. Despite humidity is a relevant problem, it does not seem to have seriously compromised the structural elements of the dome, which doesn't present, up to now, severe damages, significant cracks or deformations. So far, moisture seems to have mostly affected the surface of the dome (both internally and externally), resulting in biological colonization and efflorescence (Figure 47).

Figure 47 - Plan view of exterior damage which shows the extreme amount of biological damage in the lower left: a tree leans over the dome in this location, which may be encouraging further plant growth.

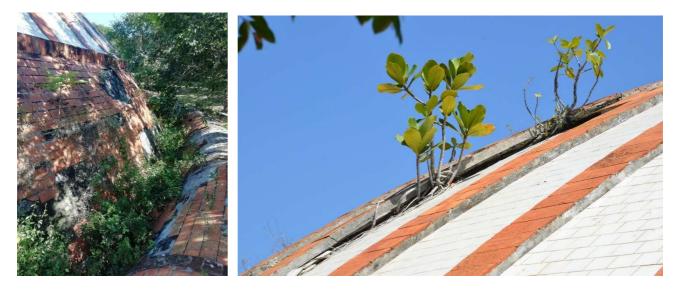
In particular, shrubs have been growing into the interstices between the extrados tiles lifting them up and causing their partial or total detachment from the lower layers (Figure 48).

Figure 48 - View of the extrados of the dome of the Choreography Theater affected by the diffused presence of vegetation.

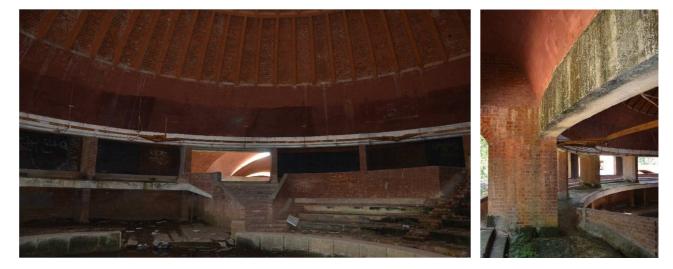
This phenomenon has been exposing the structure to weathering leading to further water infiltrations. Passing through the layering of the dome, moisture generated saline efflorescence and humidity stains on the inner surface, as well as on the pillars and on the concrete ring beam. Moreover, due to the lack of covering of the top oculus and to the frequent floods of the Rio Quibù, the floor of the theater is almost constantly wet. This condition has been fostering the development of bio-deterioration agents, such as moss and lichens, which can be diffusely found both on the ground and on the ring beam at the base of the dome (Figure 49). What is more worrying are the corrosion phenomena that have been observed on the mezzanine reinforced concrete slab, as well as the presence of some minor cracks on the masonry pillars, owed to the load of the dome above it.

Figure 49 - View of the intrados of the dome (left) affected by moist stains, soiling, efflorescence and biological colonization, particularly evident on the ring beam (right).

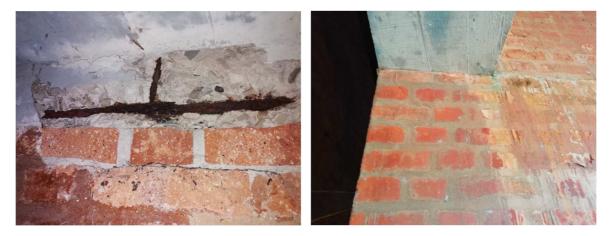
Figure 50 - On the left, corrosion phenomena of the bars in the mezzanine beam (due to water infiltration). On the right, the trace of a thin presso-flexion crack on the pillar, under the ring beam (for the load of the dome).

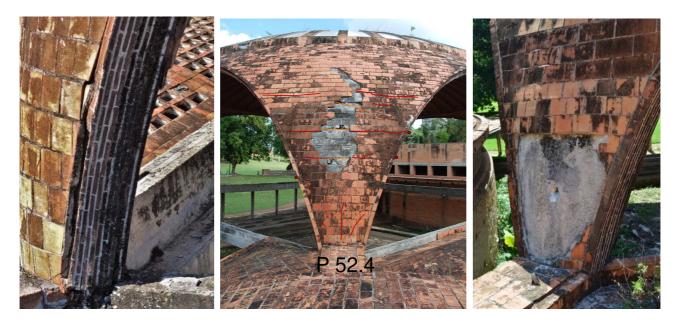
Figure 54 - Cracking and tile detachment at the extrados of the pendentives, approximately at the hinges zone. On the right, the zone of pendentives without bricks, where SON-REB tests have been performed.

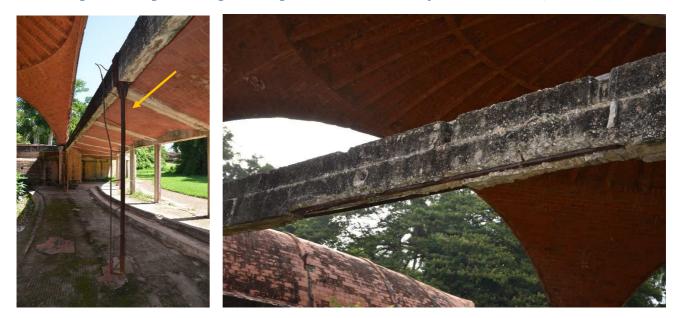
Conversely, the state of decay of the materials really requires some attention. Due to long-term exposure to weathering, the beams have suffered a diffuse loss of the concrete cover, which has largely started to fall down, leaving the underneath iron bars exposed to corrosion phenomena (Figure 57, right). Spalling is also consequence of corrosion in rebars and some section loss at several supports was observed.

Figure 57 - On the left, view of one of the metallic pillars located nearby the corners of the pavilion. On the right: diffused loss of the concrete cover resulting in rebar corrosion.

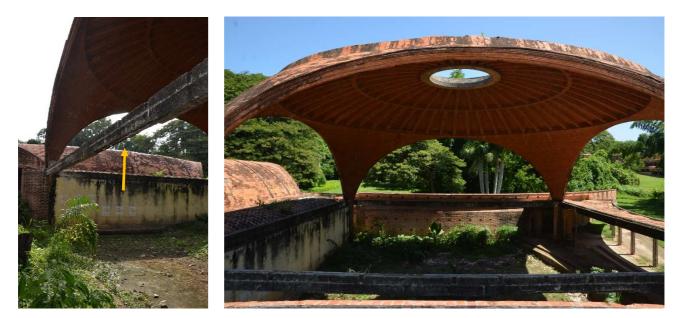
itself and does not seem to be excessively worrying. Nevertheless, this deformation (together with some vertical tension cracks visible at the top of the beam, near the pendentives) seems to exclude any proper tensional work carried out by these elements, thus refuting, at least in the "normal state" of the structure, their function as "tie rods" for the thrust of the dome. This limited structural function has been underlined also by the results obtained by the FEM analysis, which have shown a substantial primary bending behavior for the ties⁴⁷.

Figure 58 - On the left, the inflection of one of the tie beams, with evident loss of materials at the bottom in the middle span (bending behavior). On the right: overview of dome and the auxiliary support structures surrounding it.

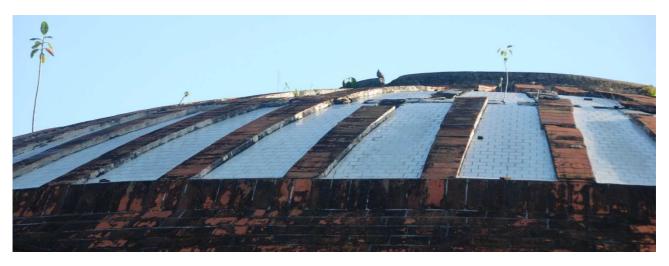
Vegetation has grown into the interstices of the roof tiles or between the ribs of the dome's joints, causing the detachment of the superficial layer in large zones (Figure 59), especially, as stated before, at the base of the pendentives (Figure 60). This degradation phenomenon can lead to structural disease in the long term, exposing the structure to weathering (thus leading to corrosion of rebar and significant reduction of section).

Figure 59 - Detachment of extrados tiles owed to vegetation growth.

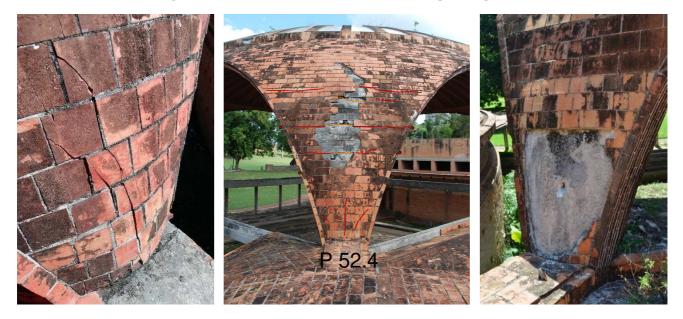
Figure 60 - Cracking and tile detachment at the extrados of the pendentives.

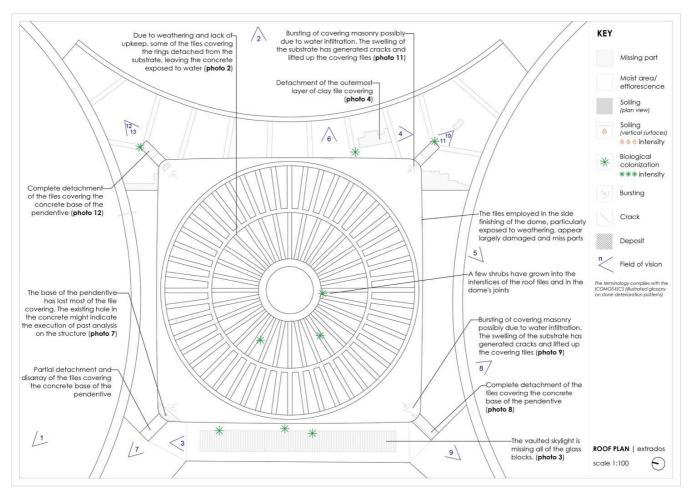
Figure 61 - Mapping of the damages and deteriorations surveyed on the extrados of the Pavilion dome. A detailed survey of damage and decay is reported Annex 2 F of the present report.

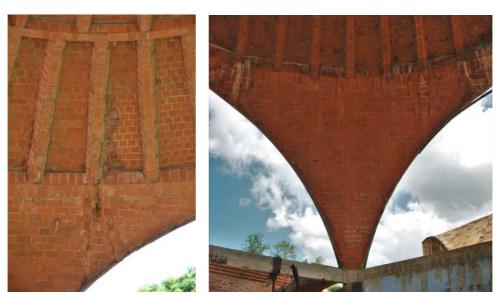
At the intrados of the dome, there is a widespread presence of moist stains and efflorescence, which are particularly concentrated:

Figure 62 - Moist stains and efflorescence at the intrados of the dome, concentrated on the attachment between the ribs and the annular ring/pendentives; on the right, the percolation on the hinges.

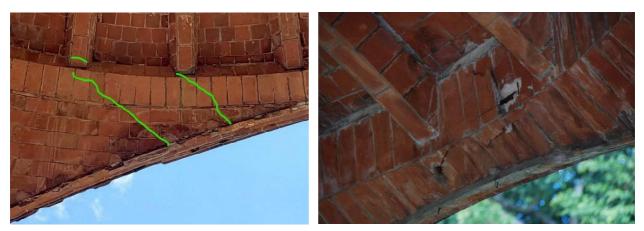
Figure 63 - Damage and degradation in arch near apex (right) and at the hinges (left).

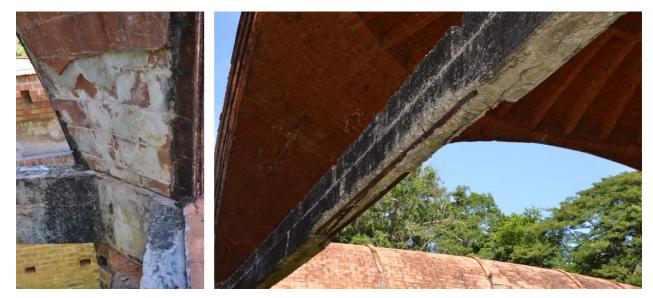
Figure 64 - Damage and degradation at the base of the pendentives (at the intrados) and decay of the tie beams (with loss of material and corrosion of the bars).

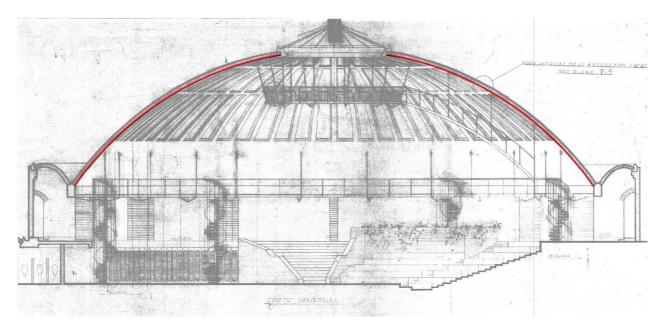
Figure 68 - The superimposition of the current dome profile (in red) obtained from the laser scanner survey, and the original curvature of the dome (in the back, original drawing by Garatti stored in the ISA archive).

Indeed, the good functioning of this vaulted system is testified by the lack of serious damages and the slight deformations of the dome, evident by the comparison between the original geometry and the last precise survey (superposed on the original drawing in Figure 68. Also the results of the numerical model have confirmed these slight deformations, thus confirming the stability of this structure.

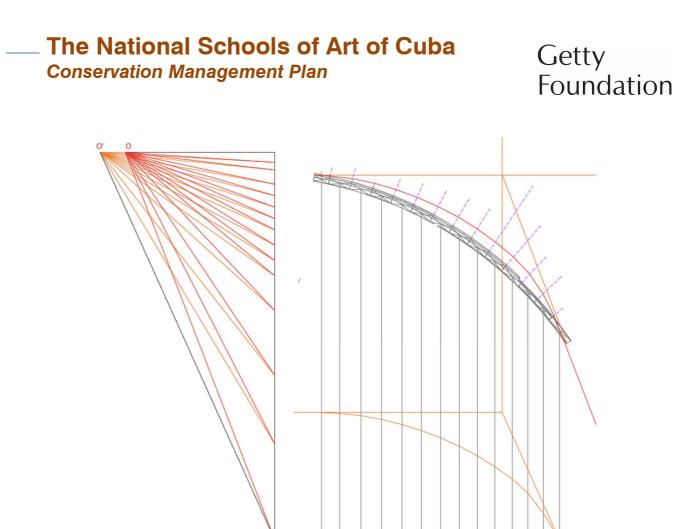
Nevertheless, a further analysis has been made by supposing the entire section made of bricks, as the vault originally hypothesized, and the line of thrust in this case (as visible in Figure 69), is not properly contained into the vertical section of the arch, thus evidencing the inconsistency of the hypothesis of an original "pure Catalan vault" design. However, we have to stress that, in this simplified graphic model of the "pure masonry dome" hypothesis, the confinement effect of the Catalan vaults inserted between the ribbed structure (simplified into this 1/16 slice) is not taken into account. Indeed, as in other major domes (for example in Santa Maria del Fiore in Florence⁵⁷, as reported in Figure 70, right), the radial disposition of the bricks (which has primarily a constructive and functional reason) gives to the dome an "encircling effect": the composition of the thrust forces of two consecutive arches along each parallel, could act, actually, on the inclination of the line of thrust, slightly reconducting it towards the axis of the examined arch (Figure 70) and thus making the most of compressive properties of masonry. Despite this confinement effect, after this first simplified graphic analysis, the original hypothesis of a "pure masonry dome" can be definitely discarded.

Figure 69 - On the left, the two polygons of forces with the fictitious pole (O') and the real one (O) and (on the right) the graphic construction of line of thrust in the case pure masonry (Catalan vault) dome.

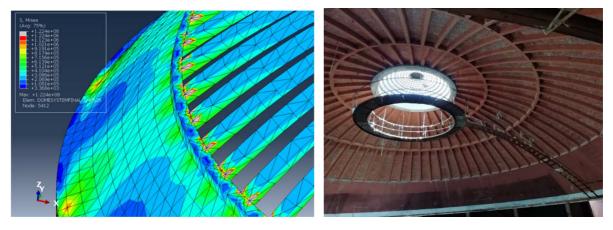
Under simple gravity load condition, the dome appears to be subjected to low stresses except at the locations where the ribs connect to the lower crown. FEA predicts minor damage at the connections between the ribs and concrete crown which is concurrent with observations of the structure that show significant efflorescence damage at these points (i.e., water infiltration in the cracks through the dome shell) as evidenced in Figure 72. This damage is the most likely a result of high stress concentrations due to force flow from an area of low stiffness (the ribs and thin shell) to an area of very high stiffness (the reinforced lower crown).

Figure 72 - On the left, Von Mises stress on dome shell due to gravity load; red-colored contours at ribs-crown connection indicate locations of potential damage. On the right Damage on dome shell due to gravity load indicated with bright and red colored areas.

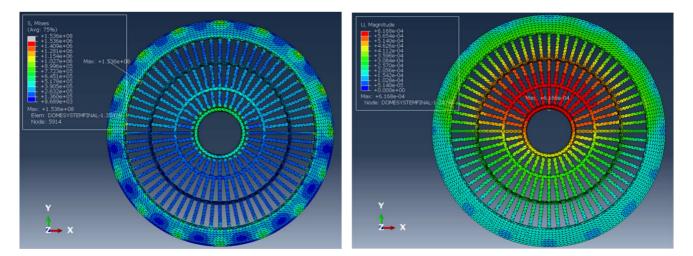
Figure 74 - Von Mises stresses (left) and displacement (right) in dome shell due to wind load and dead load.

In comparison to the gravity load model, the addition of the wind load does elicit a higher magnitude of deformation, with around 0.6 mm of deformation exhibited at maximum rather than 0.5 mm with gravity loading (Figure 74). Because this deformation was not accompanied by damage, the structural behavior in the event of a severe hurricane is much better than originally anticipated.

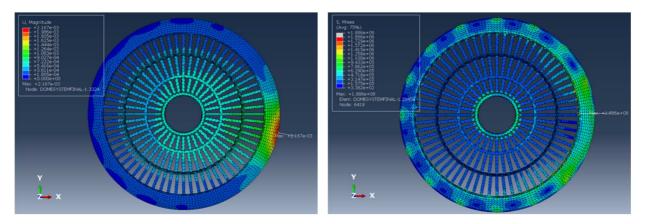
Finally, two pillars were removed from the structure to simulate settlement loading. Since two boundary conditions were removed from the model, this will be an extreme case that is not necessarily anticipated in the lifetime of the structure. This increased the span between supports from approximately 6 meters to 18 meters, tripling the free span on one side. The irregular boundary condition also produced a moment throughout the structure as gravity loads were unable to be resolved at the missing pillar. As expected, the removal of two pin supports produced irregular displacement on the structure, with the ABAQUS model showing a maximum deformation of 2 mm (Figure 75, left). Meanwhile, the deformation at the oculus ring remained similar to the gravity case at around half a millimeter. The Von Mises stress distribution in the dome also mirrors these trends highlighting the major stress:

Figure 75 - Displacement (left) and Von Mises stresses (right) in dome shell due to settlement load.

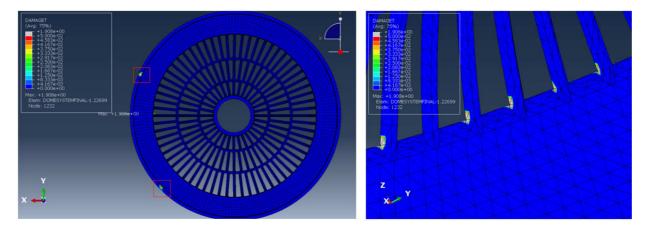
- at the edges of the free span, likely because the moment induced in that section is most significant if the crown is considered as a beam undergoing bending;
- where the lower ribs frame into the crown above the two supports next to the longer span: because the dome is curving in this location, the induced rotation at the base of the beams creates a high stress (Figure 76, right).

Figure 76 - Damage under settlement load. On the right it can be seen that the major damage is concentrated in the connection between the beam crown and the ribs (as in the case of simple gravity load) for difference of stiffness.

As observed in both the gravity loading and wind loading model, the beam-crown connections are again the location of highest Von Mises stress and are most likely to be damaged in the event of significant settlement.

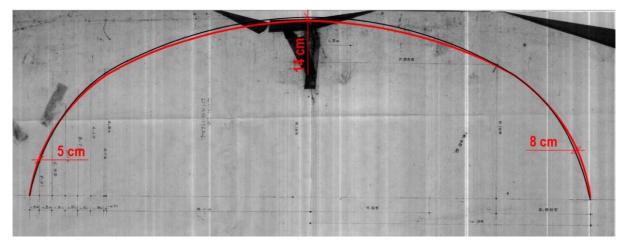
This type of analysis is really interesting in this case because, unlike the previous analyzed dome, the Dance Pavilion shows, as stated before⁷⁴, significant deformations, especially in the pendentives (Figure 78).

Figure 78 - The superimposition of the current dome's profile (in red) obtained from the laser scanner survey, and the original curvature of the dome (as in Garatti's original drawing, ISA archive) considering the diagonal arch (and thus, the pendentives).

This simplified construction has confirmed the deformative state of the pendentives, evidenced also by the FEM analysis and confirmed by a comparison between the laser scanner survey and the original drawing by Vittorio Garatti (as plotted in Figure 78). Indeed, as stated before (chapter 2.4 of the present report), the first one concern is about the pendentives which show deformations and about three horizontal cracks of various extent, coupled with diffuse bursting phenomena at their base, which have resulted in crack paths and tile loss, as previously described in the analysis of the state of repair of the dome.

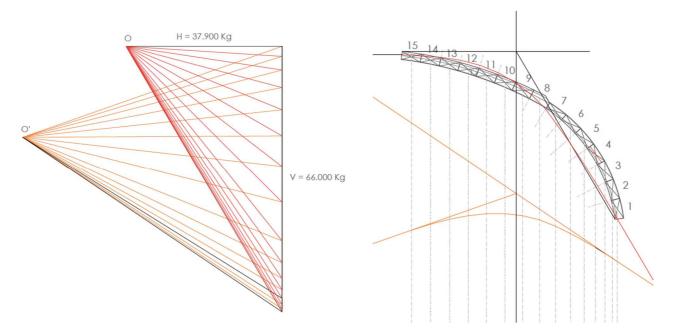
Figure 79 - On the left, the two polygons of forces with the fictitious pole (O') and the real one (O) from which the inclination of the line of thrust of the dome can be obtained (right).

This worrying state of damage can be confirmed in the drawing of the thrust line, which, even if considerably simplified and substantially referred to a "masonry" dome (with no tensile resistance hypothesis and completely neglecting the encircling effect of the rings), is completely outside the section in the pendentives (Figure 79, right), thus anticipating the concentration of tensile stresses in their extrados, furtherly found by the FEA.

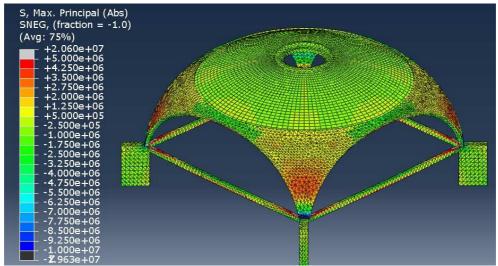
The principal stress plot for the entire structure under dead load exhibits stress concentrations at predictable locations (red zones in Figure 83 and Figure 84)⁸¹:

Figure 83 - Maximum principal stress under dead load for entire structure (excluding embedded reinforcement).

Consequently, cracking is expected to occur at these locations in the model, as was visible during the site inspection.

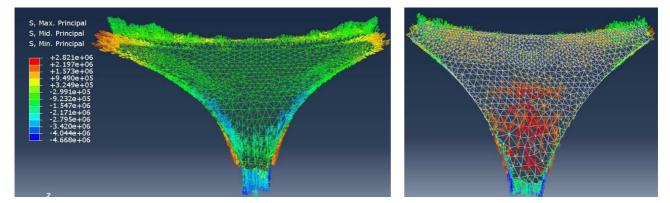
Figure 85 - Vector plot of principal stress within pendentives under dead load case (identical scale) for intrados (left) and extrados (right).

In Figure 85 is plotted the magnitude and orientation of the maximum principal stress in the pendentives, which can help in clarify their structural behavior: the maximum principal stress is directed parallel to and along the edges of the pendentive and is oriented vertically near the middle region of the pendentive. The tension and compression on opposite faces of the pendentives and arches demonstrate that the elements sustain bending stress. Moreover,

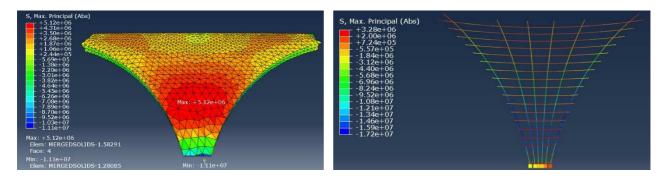
The results of the finite element analysis for these six critical load cases have confirmed what is visualized in Figure 86 (left), which plots only one of the analyzed load cases but can be considered representative of the general results: for all cases the stress at the base of the pendentive (in 1D) exceeds the tensile strength (3.9 MPa), and in the middle region of the pendentives it exceeds the tensile strength for about half of the cases.

Figure 86 - Maximum principal stress under live load + settlement (left) and axial stress in pendentive rebar for dead load case (right).

The lack of tension stiffening due to the misplacement of the rebar in the pendentive cross-section - also anticipated by the graphic method results - is confirmed by the analysis results, as shown by Figure 86 (right), which displays the dead load stress results (in Pascals), with rebar compression appearing in the regions of highest concrete tensile stress.

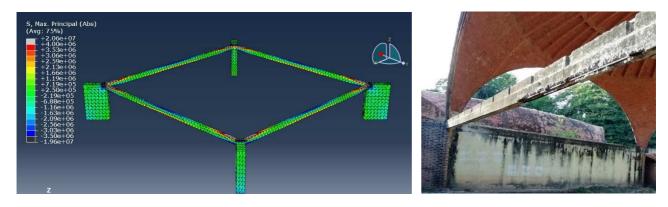
As for the four tie-beams at the base of the dome, the finite element analysis has shown that they are not necessary for the stability of the structure under largely gravity loadings. They primarily function under bending, due to their long span and large weight, as indicated by the tension and compression on opposing faces along the beam, with the largest tension occurring at midspan (Figure 87, left).

Indeed, this result is fully consistent with the surveyed damage on these four beams: a significant deformation (deflection of about 4-5 cm at mid-span) and the loss of material in correspondence to the most stressed zones (Figure 87, right).

Figure 87 - Maximum principal stress in support structure under dead load (left) confirmed by the surveyed damage (right).

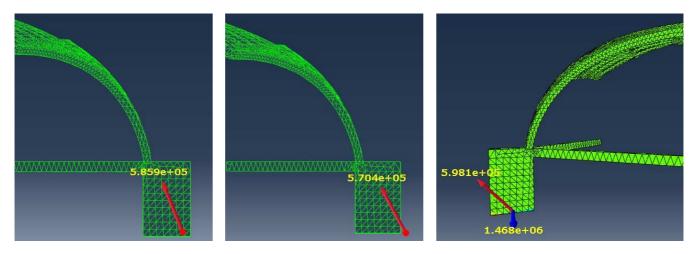
As for the four angular pillars, their typical reaction under the self-weight of the structure indicates that the pillars are fairly well-dimensioned for the dead loads carried, keeping the structure stable without requiring the lateral support of the tie beams (Figure 88, left).

Figure 88 - Typical resultant force in pillars for dead load (left) and wind load (center) while, on the right, the resultant force (red) and moment (blue) in pillar are plotted for the most critical load case 4 (live roof + differential settlement).

Under the lateral wind load, the resultant force shifts about 0.24 meters outside the pillar cross-section (Figure 88, center), thus introducing the risk of overturning or tensile failure in the masonry pillar, which is maximum when

even a small amount of settlement displacement occurs (Figure 88, right). Consequently, when a differential settlement occurs to the structure, additional lateral support is required for the pillars: in the real structure, it is either provided by the tie beams or the perimeter masonry walls to which the pillars are attached.

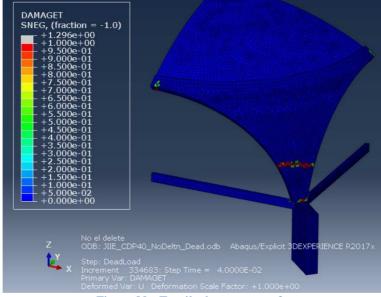
Figure 89 - Tensile damage stage 2.

- [1] The tie beams and then the arch apex develop tensile cracking.
- [2] The pendentive extrados, which is the tensile face, cracks under the applied self-weight. The tensile stress is then carried by the rebar at this location:

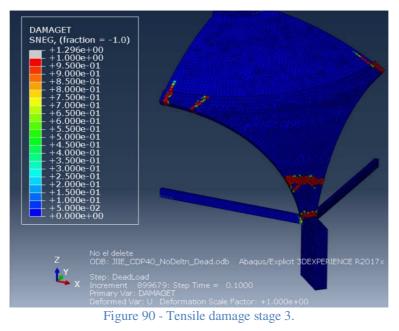
[3] The pendentive crack quickly migrates across the cross-section. Cracking also develops at the third points of the arch:

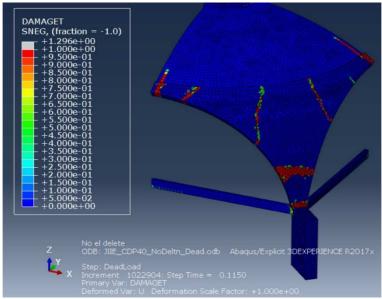
Figure 91 - Tensile damage stage 4.

[4] More cracks develop along the arch, with the pendentive continuing to deform under its self-weight:

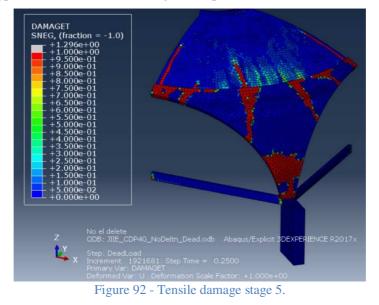
[5] In the pendentive, the rebar yields in tension and the bending crack(s) continue to form. Radial cracks develop in the upper dome as the tension ring is compromised:

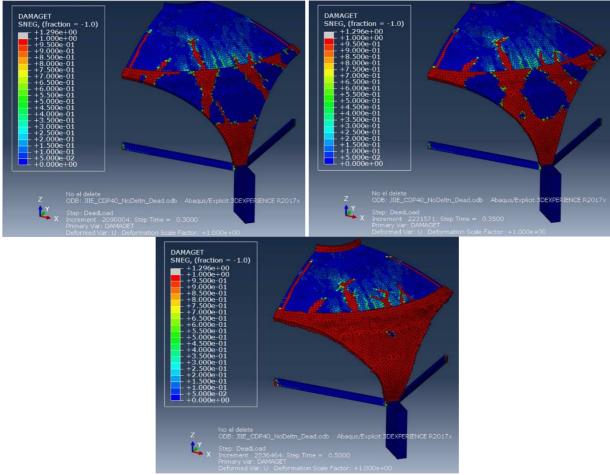
Figure 93 - Tensile damage stage 6 (failure stage).

[6] The radial dome cracks and horizontal pendentive cracks continue to develop until the pendentive has failed. The pendentives buckle outward and the structure collapses:

From this damage progression, it is clear that several structural elements are critical. The pendentive rebar carries high tensile loads and, when yielded, allows the pendentive to buckle. The tension ring restrains the tensile hoop/bending stress in the upper dome. When it is compromised, the upper dome develops radial cracks which are part of the collapse mechanism.

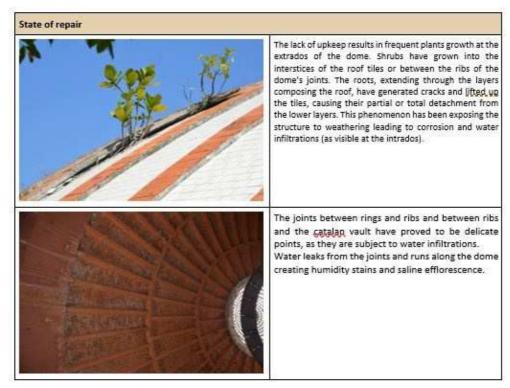
The following sections in the worksheets also regard the global structure, providing information regarding its main dimensions, structural organization, building techniques and current state of damage (Figure 96).

Figure 96 - Summary description of the individual constructive elements composing the analyzed structure.

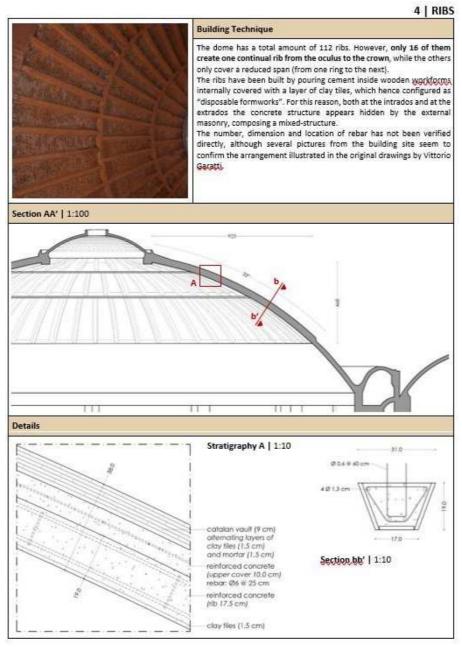
Priority		9
Architectural value		
Consistency with the original design	The current configuration of the catalan vault is consistent with arch. Vittorio Garatti's original drawings	
Technical complexity	Reinforced concrete ribs casted on-site by pouring cement into wooden workforms internally covered with a layer of clay tiles	
State of repair	- Antonio and a second second second and a second second second second second second second second second secon 191	
Material decay	The deterioration is punctual, mosity related to humidity and vegetation. Water infiltration cause the decay of the clay tiles	
	Deformations	
Structural issues	Suitability of dimensions	
	Cracks

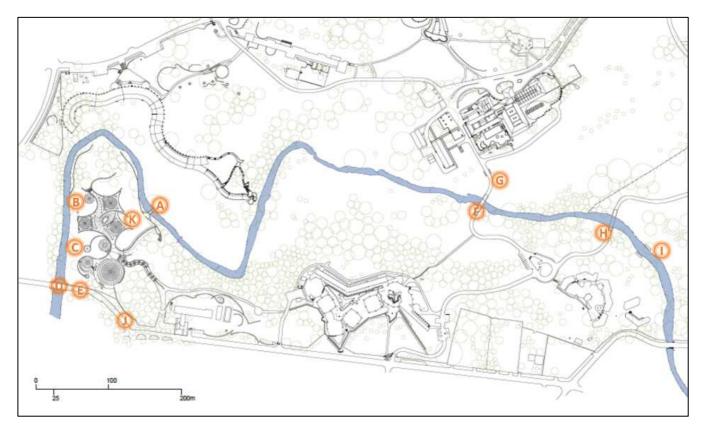
- A. The ruined bridge to reach Ballet building coming from music;
- B. The interrupted floodwall alongside the Ballet school area;
- C. The unprotected riverside alongside the Ballet school area;
- D. The bridge of 15th road;
- E. The external perimeter of Ballet school area just before the bridge of 15th road;
- F. The bridge to reach the rectorate building at the center of the park;
- G. The culvert below the way to reach the rectorate building;
- H. The bridge to reach the Drama school building;
- I. A hold artifact inside the Rio Quibù;
- J. The road aside from the hill from upstream of the school of Ballet;
- K. The soil depression inside the Ballet school area unfavorable to the outflow of water.

Figure 1 - First criticalities found during field survey in the Schools Park area.

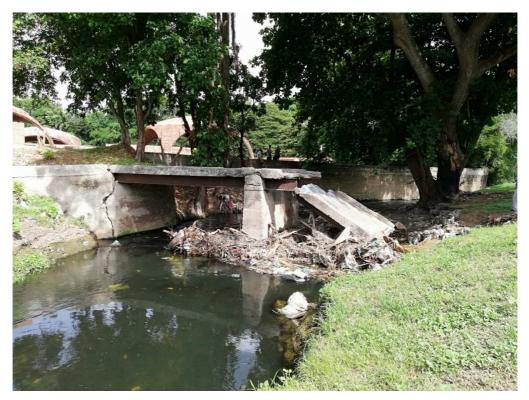
Figure 2 - The ruined bridge to reach Ballet building seen from upstream - Criticality A (Bignami D.F., 2019).

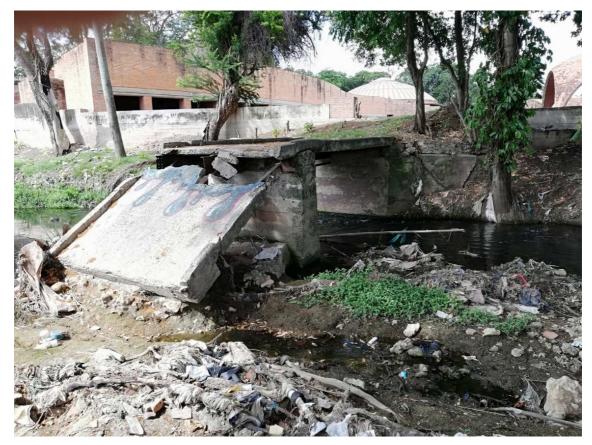
Figure 3 - The ruined bridge to reach the Ballet building seen from downstream - Criticality A (Bignami D.F., 2019).
