Final report of the Grantee

Milan, December 23rd, 2020

This publication is made possible with support from the Getty Foundation through its Keeping It Modern initiative

Scientific Coordinator Prof. DAVIDE DEL CURTO Politecnico di Milano, Department of Architecture and Urban Studies

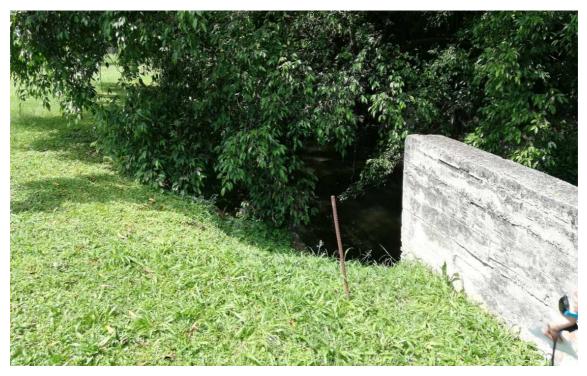
Figure 4 - The interrupted floodwall alongside the Ballet school area- Criticality B (Bignami D.F., 2019).

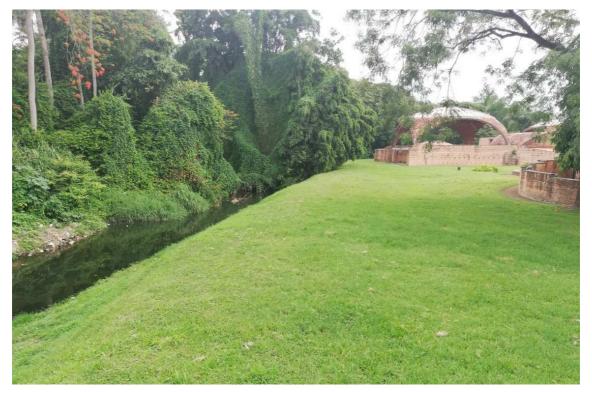
Figure 5 - The unprotected riverside (Ballet school area) - Criticality C (Bignami D.F., 2019).

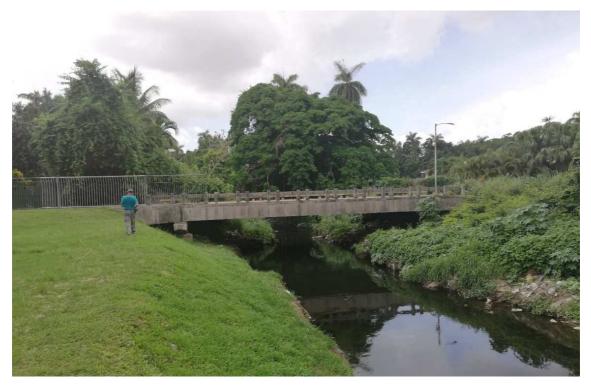
Figure 6 - The unprotected riverside (Ballet school area) and the bridge of 15th road - Criticality D (Bignami D.F., 2019).

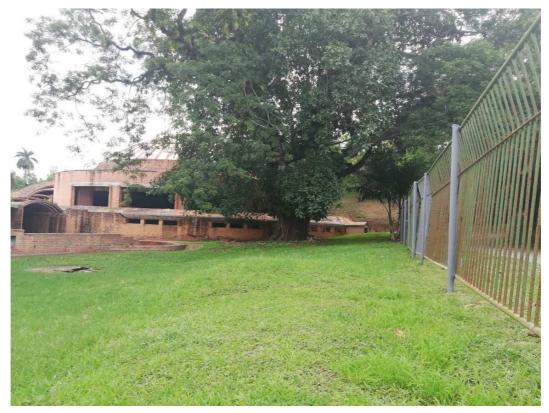
Figure 7 - The external perimeter of Ballet school area (inside view) - Criticality E (Bignami D.F., 2019).

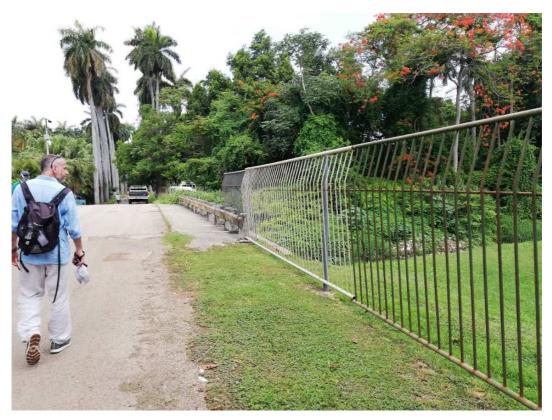
Figure 8 - The external perimeter of the Ballet school area (external view) - Criticality E (Bignami D.F., 2019).

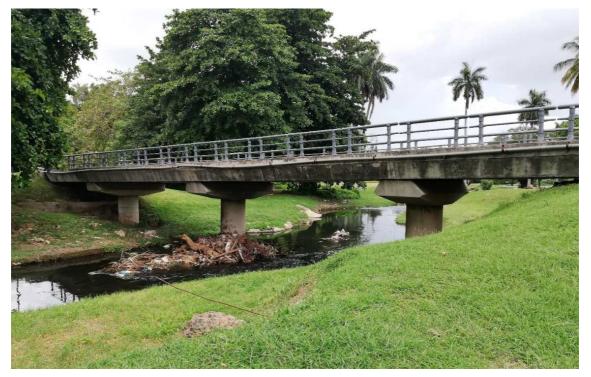
Figure 9 - The bridge to reach the rectorate building at the center of the park - Criticality F (Bignami D.F., 2019).

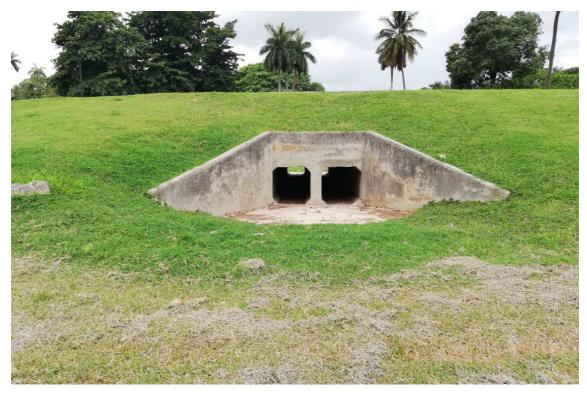
Figure 10 - The culvert below the way to reach the rectorate building - Criticality G (Bignami D.F., 2019).

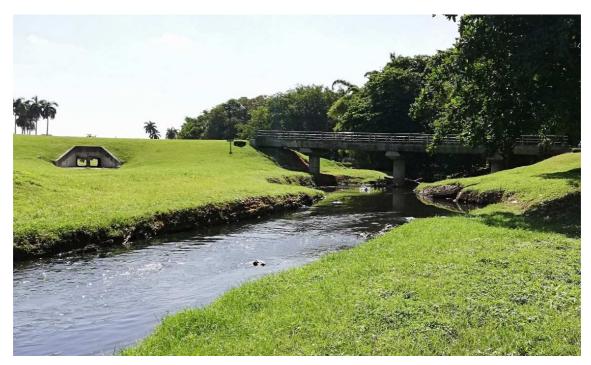
Figure 11 - The bridge and the culvert along the way to reach the rectorate building - Criticalities F and G (Bignami D.F., 2019).

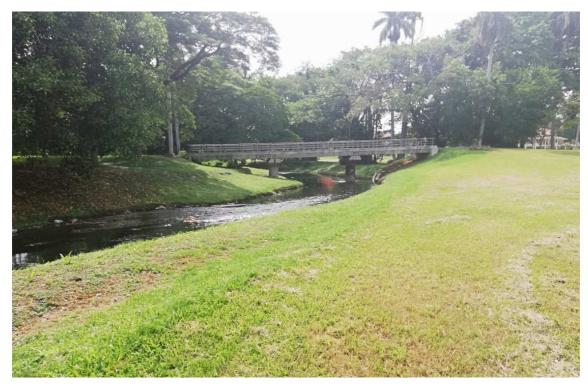
Figure 12 - The bridge to reach the Drama school building - Criticality H (Bignami D.F., 2019).

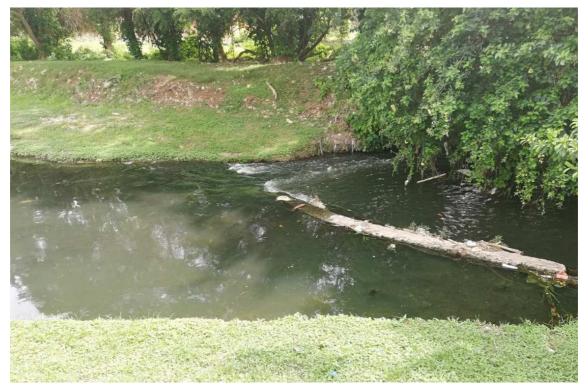
Figure 13 - A hold artifact inside the Rio Quibù - Criticality I (Bignami D.F., 2019).

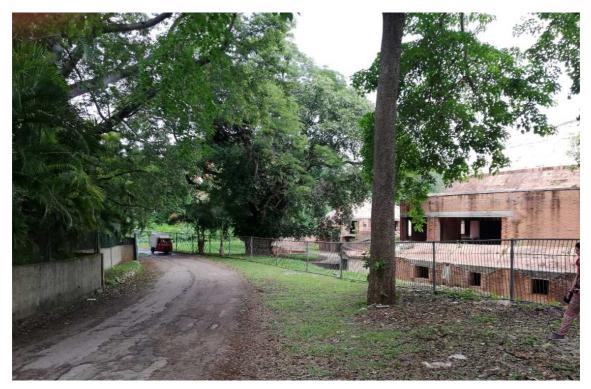
Figure 14 - The road aside from the hill from upstream of the school of Ballet - Criticality J (Bignami D.F., 2019).

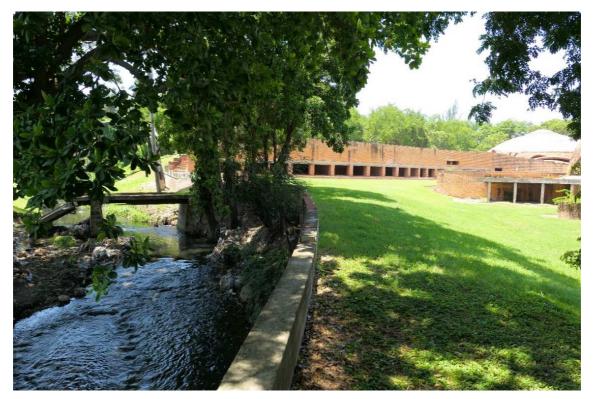
Figure 15 - Ballet school: soil depression and slope unfavorable to the outflow of water - Criticality K (A. Garzulino, 2019).

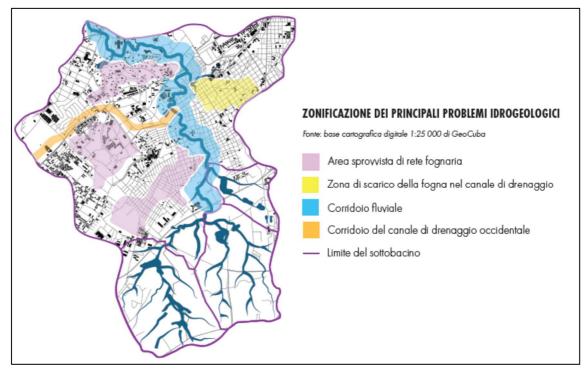
Figure 20 - Rio Quibù basin area: water-related criticalities (by Land Planning for Disaster Risks Management course of Politecnico di Milano - Prof. D.F. Bignami, student group 18: Sara Mazzola, Guendalina Nozza, Greta Possi, Anna Puricelli, Greta Weber). Pink: areas with no sewers system. Yellow: catchment area of sewers delivering within the Rio Quibù. Blue: river corridor of Rio Quibù. Orange. Western drainage channel delivering in the Rio Quibù.

Visibly from Figure 20, a number of the drainage channel, or sewers, deliver water to the Rio Quibù before it reaches the Country Club area. Accordingly, the Rio Quibù river is, in fact, a collector of water from the land and from urbanized areas, including with and without sewers systems.

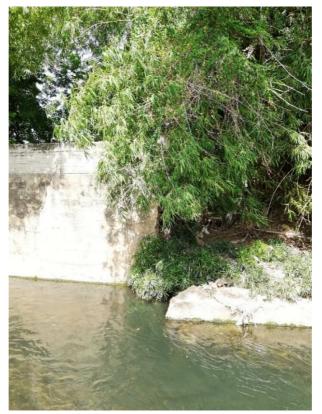
Figure 31 - A view of the Rio Quibù worn and unstable wall alongside the Ballet area (Bignami D.F., 2019).

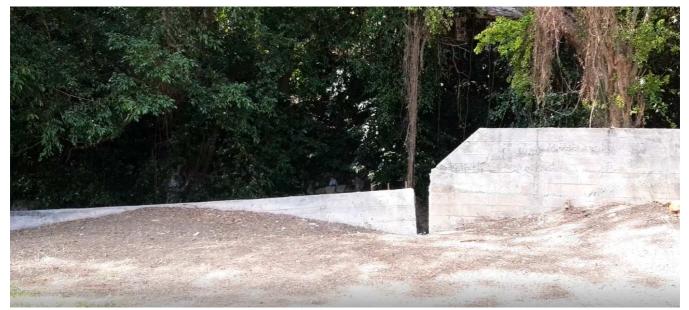
Figure 35 - A view of the Rio Quibù wall alongside the Ballet area, to be noted the wall discontinuity (Del Curto D., 2020).

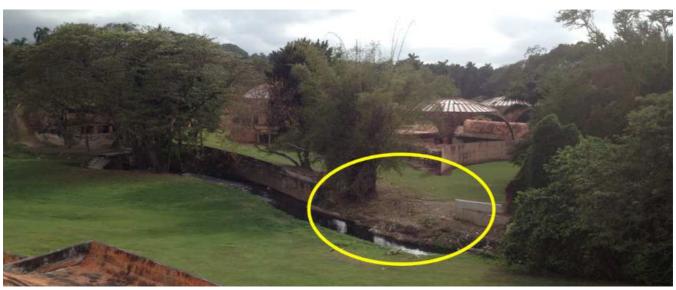
Figure 36 - View from the roof of the School of Music of Rio Quibù: notice the wall discontinuity alongside the Ballet area (Del Curto D., 2020).

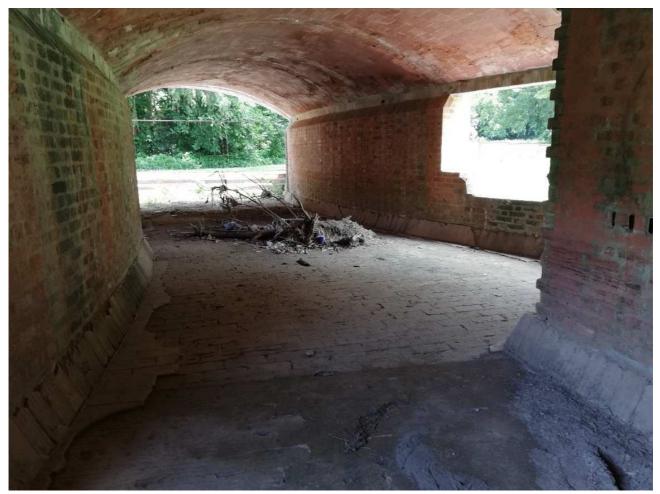
As widely known, these marks indicate in practice the full entrance of the flood water within the school. Paradoxically enough, the external flood water pressure would have damaged (and even collapsed) the building whenever kept outside, so in practice, water entering the building does not provide large damage due to pressure. However, clearly damage to the masonry occurs due to continuous touch with water and to debris transport of wood, and sediments, as clearly visible from jamming within the buildings.

Figure 39 - The marks and debris left by the water inside the ballet school (Bignami D.F., 2019).

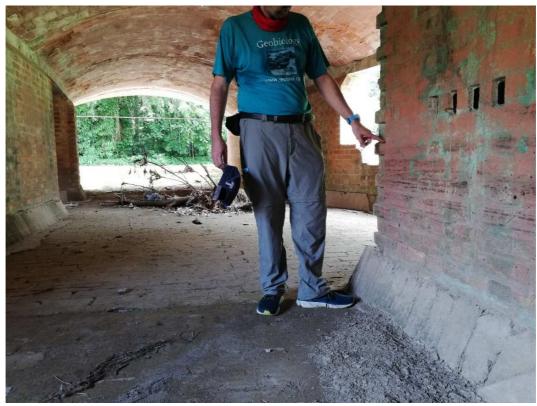
Figure 40 - The marks and debris left by the water inside the ballet school, approx. 1 m above the floor level (Bignami D.F., 2019).

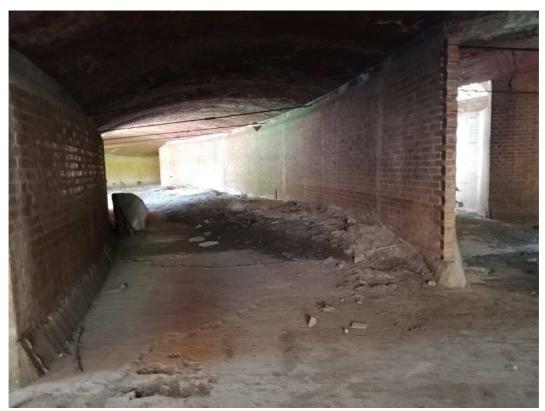
Figure 41 - The marks and debris left by the water inside the ballet school (Bignami D.F., 2019).

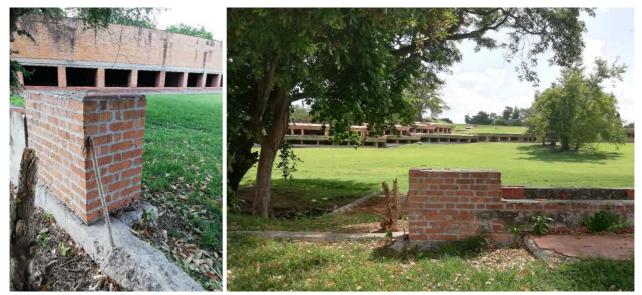
Figure 42 - The water level during a recent flood according to a witness in the Ballet school area (Bignami D.F., 2019).

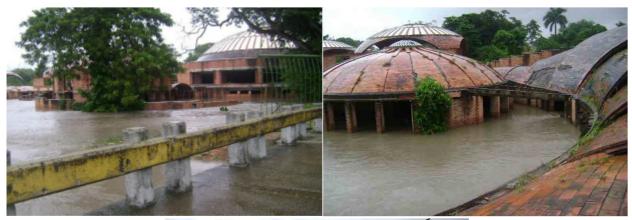
Figure 44 - The School of Ballet flooded after a cyclone. Year 2007. Photos by Christian Zecchin.

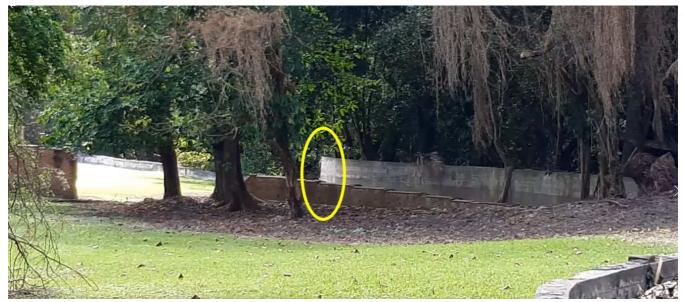
During the above reported five days (10-14 June) campaign, some information about the river and schools' buildings were collected. The wall surrounding the School of Ballet, which is now partially collapsed and offers no protection to the School, has been inspected, so verifying its state, and the chance to integrate the missing parts with mobile structures to reduce flood risks. Ten cross-sections of the river were measured inside the ISA area (from the bridge of 15° Av. to the bridge of 23^{rd} Av.), including four bridges, and one pedestrian bridge, that were used to

Figure 55 - The discontinuity of the existing wall protecting the Ballet Scholl from the floods of the Quibù river.

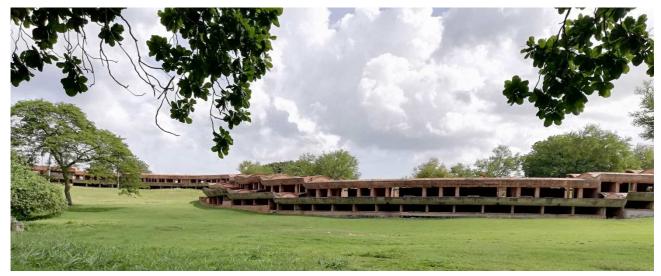
Also, the school of Music could be partially, but significantly, involved in its south and east portions. As in the previous case, our flood scenarios would impose constraints on construction and renovation activities. Accordingly, risk reduction activities are urgent, as in the previous case, even if the magnitude of the consequences would be smaller. The mechanisms acting on the edifice are different in the south and in the east portion of the edifice. In the side at the south of the edifice, slow-rising water, in case of bad scenarios, can reach the classrooms of the lowest floor. The next Figure shows the unprotected in front of the school.

Figure 70 - School of Music, south side: lowest classroom.

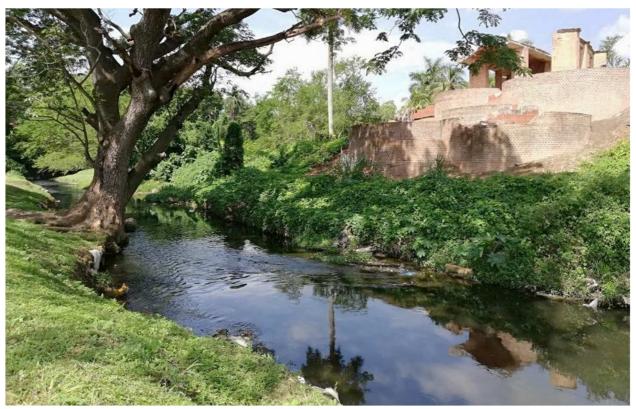
East of the building, terraces walls, in a bad state of conservation, are unprotected and exposed to the erosive action of water in case of flood, as shown below. Moreover, the stability of the foundation appears not completely guaranteed. As a matter of fact, the scenarios obtained give water depth rapidly reaching two or three meters, when the flood return period grows over five years or so.

Figure 71 - School of Music, east side: the walls unprotected, exposed to the erosive action of water in case of a flood (upstream view).

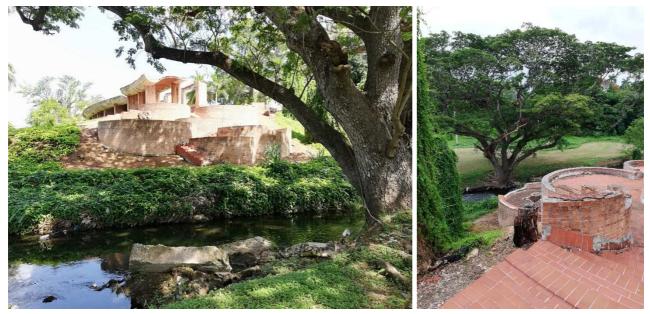
Figure 72 - (a - left; b - right) - East side of School of Music, views from downstream and from the top of the terraces.

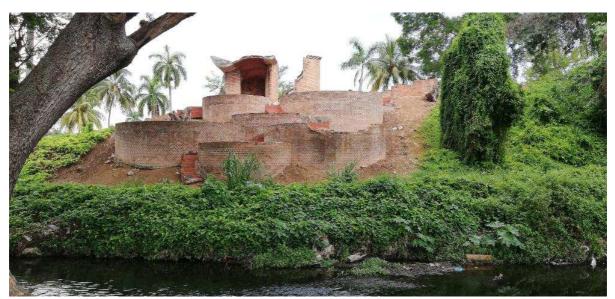
Figure 73 - East side of the School of Music: front view.

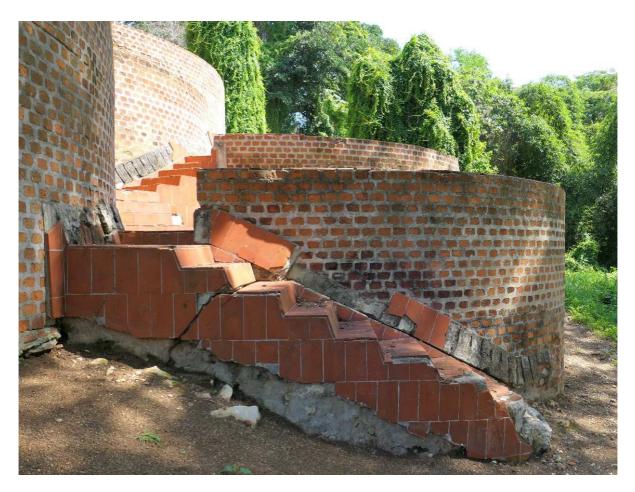
Figure 74 - East side of the School of Music: detail.

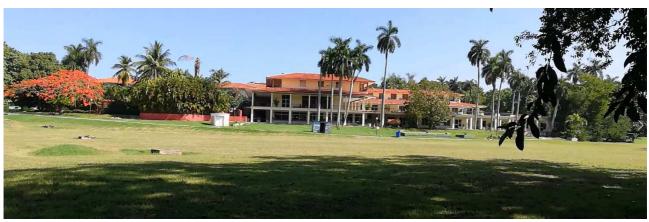
The Rectorate, south front, and the School of Dramatic Arts, north and east fronts would be rarely touched by Rio Quibù floods. Damages may be caused by water contact due to slow-rise depth because flood advancement should be without significant velocity. In addition, the flood height predicted is not alarming. The position of Rectorate is probably more affected than that of the Dramatic Art Schools. That condition, together with the directional function of the rectorate for all the schools, made us put these buildings in a similar priority level, even if the Rectorate is not a national monument (but, as a matter of fact, its exposed value is high).

The specific mechanism affecting these two edifices would be slow-rising water; that is, in case of rare scenarios, water can reach the lowest floors.

Figure 75 - Rectorate south front. The picture is taken from the right side of the Rio Quibù bed.

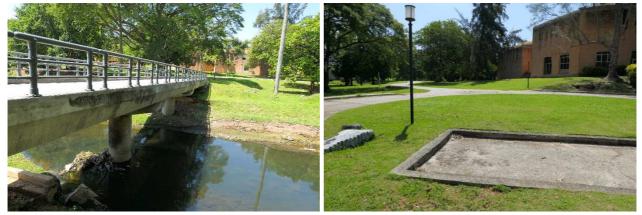
Figure 77 - Dramatic Arts School: north front (A. Garzulino, 2019).

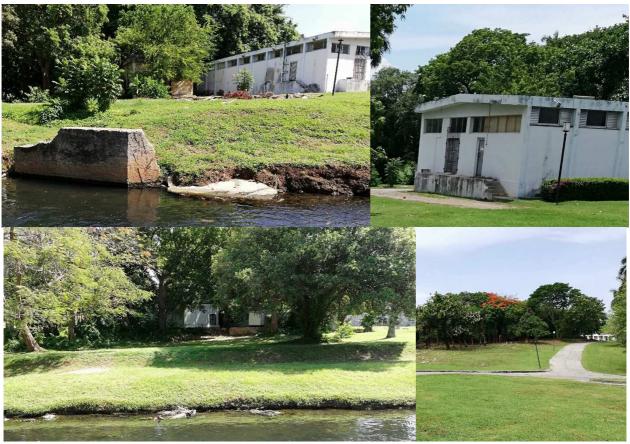
The situation of the south front of warehouses at the center of the park is similar to that of the Rectorate. The function and the magnitude are probably less critical (from which a less important exposed value), although it would be better to carefully check the material, documents, and goods stored inside these buildings, and in case, relocate them in safer areas. In addition to that consideration, from a vulnerability point of view, the doors/gates position here seems to have been conceived in a prudential manner, and potentially above the levels of first slow-water rising up until the buildings.

Regarding roads, public lighting poles, etc., the situation seems not largely worrying, being such material either easily replaceable/repairable, or apparently able to resist to the actions of water, that, in this case, would not only be by slow-water rising up, but also by hydrodynamic pressures.

Figure 78 - Warehouse views and public lighting poles and roads (bottom-right) at the center of the park.

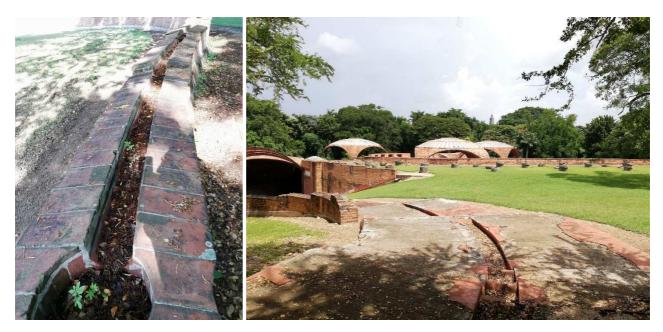
In the School of Ballet, the water drainage systems, i.e., small ditches, and canals, are likely clogged and disrupted, and water collection tanks seem not to work correctly. As a result, many incorrect water diversions are present, and overland rainfall reaches the internal spaces, causing large puddles outside the building, but in not foreseen positions, and localized phenomena of erosion.

Figure 79 - Clogged and disrupter drainage system of Ballet School.

The problem is exacerbated by the local terrain morphology, seeing the school positioned downstream of a hill, whose water, being not channeled, is conveyed towards the school.

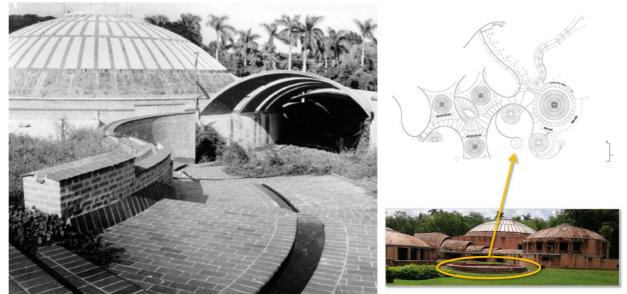
Figure 80 - The original drainage system at the entrance of the Ballet School (picture by Paolo Gasparini); a particular water collection system conceived by Garatti - right.

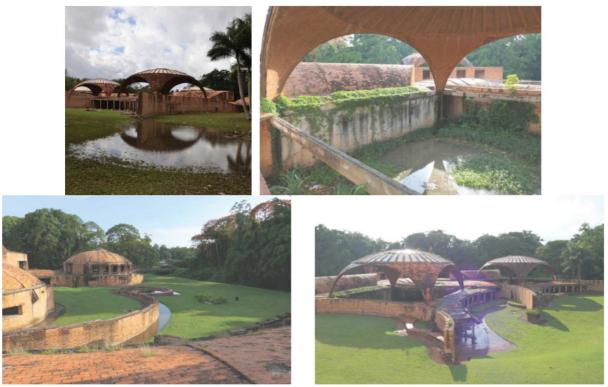
Figure 81 - Puddles inside and outside the Ballet School.

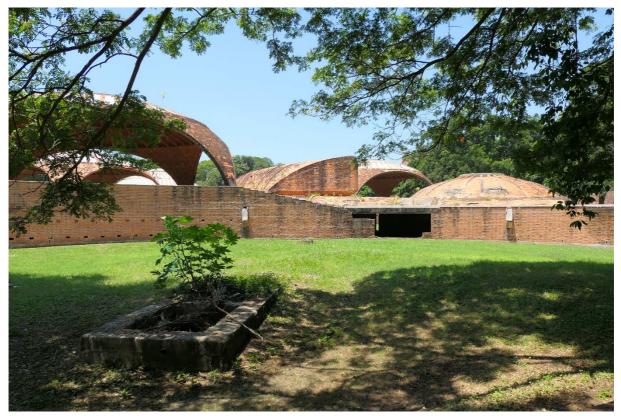
Figure 86 - A concrete tank, possibly a structure originally used for water storage (A. Garzulino, 2019).

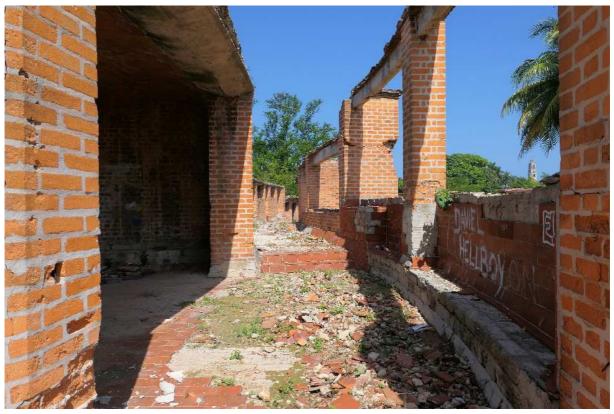
Due to the aging conditions and state of conservation, and probably because it is partially uncompleted (architectural finishes), the sites of the school of ballet, primarily, and the site of the school of music (north side), secondarily, are affected by the actions of water frequently coming in touch with their structure. This is as a result of a surface runoff not well controlled and causing water stagnation and erosion, and as a result of the absence of windows, frame, doors, etc.

Figure 87 - Erosion and stagnation at the school of music - north side (A. Garzulino, 2019).

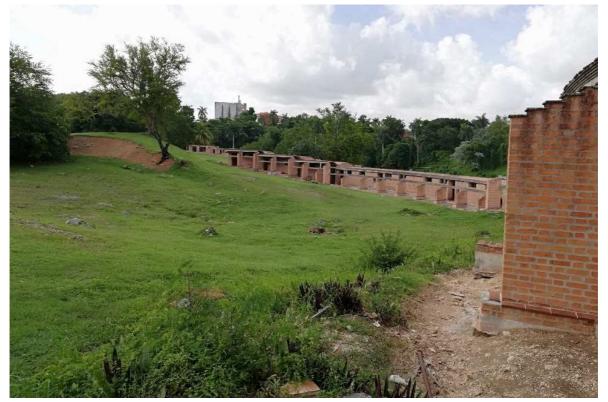
Figure 88 - Erosion and stagnation at the School of Music - North side (Bignami, 2019).

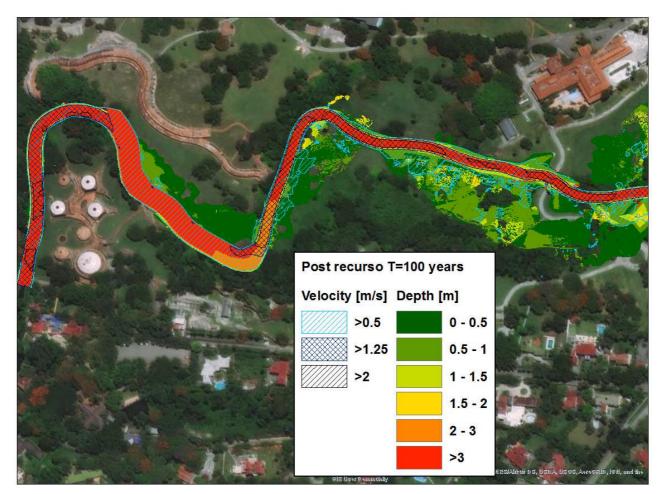
The results are reported in Figure 89. Visibly, while the perimetral wall actually seems to be able to defend the School of Ballet area, flooding of the upstream part of the area, including towards the School of Music, and the rectorate area seems not visibly limited at all when putting in place the proposed options.

Figure 89 - Map of flooded areas with R=100, conditioned on the implementation of INRH solutions. Flow depth and velocity using HEC-RAS 2D.

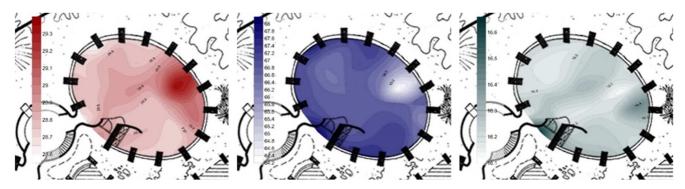
Figure 19 - 14.2.2020 - PHOTO LAB - PSYCHROMETRIC MAPS T °C (RED), RH % (BLU), MR g/kg (GREEN), Environment C.

The medium-sized dome (C) was chosen at a different point from that where the sensor 04 is located (the choice was caused by limited accessibility to the spaces during the site inspection). The T $^{\circ}$ C values are slightly lower than the outside, while RH corresponds and is partly higher. It has values and characteristics of use similar to the previous dome and MR rates of +0.8 g / kg, probably due to a lower air exchange compared to the outside. Plus, on rainy days, there is an infiltration of rainwater from the vaults in this dome.

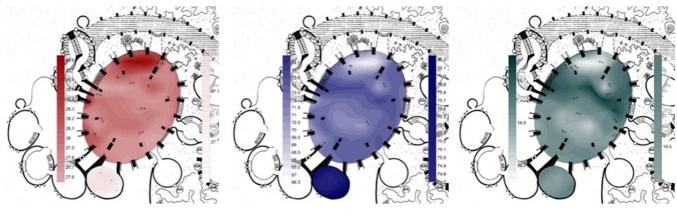
Figure 20 - 14.2.2020 - PHOTO LAB - PSYCHROMETRIC MAPS T °C (RED), RH % (BLU), MR g/kg (GREEN), Environment D.

The last room analyzed is the foundry (D)'s large dome, which has been compared with the smaller secondary dome. The large room is continuously ventilated, as windows are frequently open during the day. The small dome connected to the foundry, on the other hand, has no openings except for the connection with the main dome. When comparing the values, it can be notice that they are similar to the other domes. Indeed, the instruments detected a very high RH rate in the small dome, but not a high MR. The value is explained by observing the lower temperature of about 1°C, and RH, with the same water vapor, appears higher. RH in the foundry does not at any point reach the peaks reached in the domes seen previously, remaining around 60%.

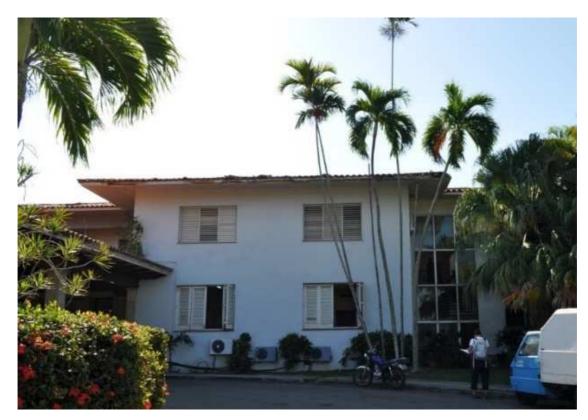
The air-conditioning system designed for a part of the Rectorate building has an inadequate response from a practical perspective and has involved installing external equipment (Figure 25). These impact the building's façades, in contrast to the conservation of a historic structure and an intelligent design that cleverly considers shaded and naturally ventilated areas to improve users' comfort.

Figure 25 - External units that compromise the aesthetics of the building.

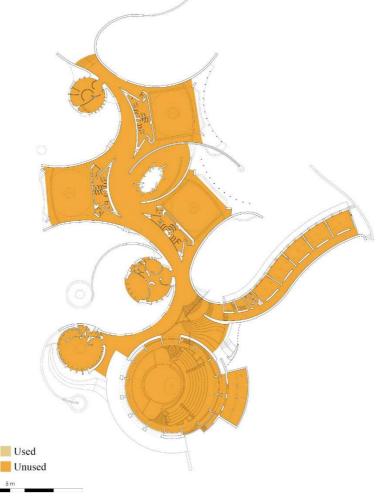
The School of Ballet was designed by Arch. Garatti and is located near the Rio Quibù. Since its construction, the building has never been unused, and this led to the removal of most of the window frames that were laid during construction as well as to the complete absence of technical systems (Figure 34). To date, this School is therefore comparable to a large abandoned covered space.

Besides, the building is cyclically flooded due to the overflow of the Rio Quibù and the absence of protective barriers. This implies the need to control the rooms' humidity level and the conservation of the structures and building materials.

Figure 34 - School of Ballet, ground floor use.

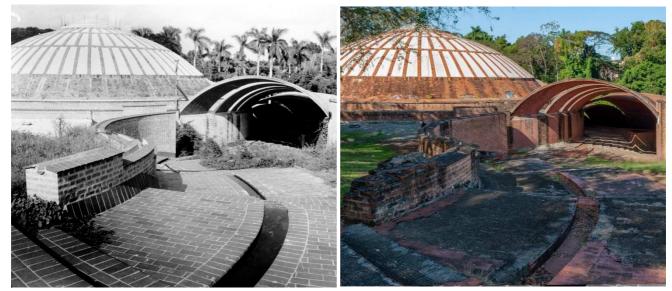
Figure 39 - School of Ballet, ISA archive, external canals (before). Figure 40 - School of Ballet, external canals (today).

An element that helps achieving comfort, especially in a hot humid climate, is moving water that gives a refreshing sound. This is accomplished by designing fountains at different points and a series of little canals outside the building. Of these design details, you can only perceive the external elements' design and architectural presence. The fountain in the patio is not even visible due to the high presence of weeds.

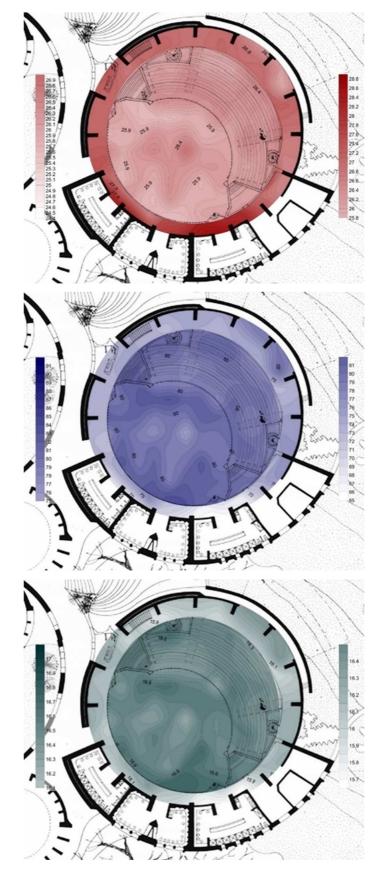
Figure 47 - 13.2.2020 - PHOTO LAB - PSYCHROMETRIC MAPS. T $^{\circ}C$ (RED), RH % (BLU), MR g/kg (GREEN), Environment A

From the maps shown in Figure 47 and Figure 48, it can be seen that in the points with higher temperatures, the RH% is lower and the other way around.

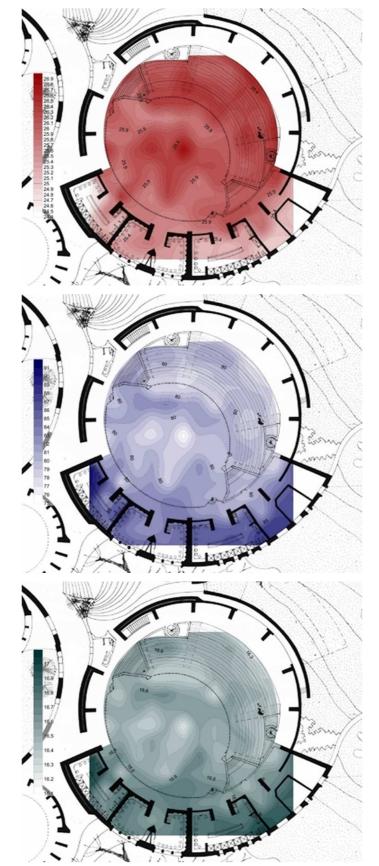
Figure 48 - 13.2.2020 - PHOTO LAB - PSYCHROMETRIC MAPS. T °C (RED), RH % (BLU), MR g/kg (GREEN), Environment A (lower level)

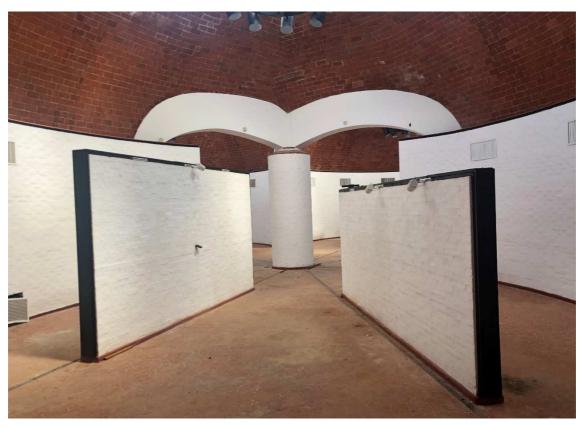
Figure 111 - School of Plastic Arts; exhibition space.

The same goes for the School of Plastic Arts exhibition space that is substantially locked, despite being in excellent repair condition and equipped with adequate systems, including a modern air conditioning system. The external exhibition space adjacent to the 5th year workshop is also unused.

A similar reorganization should concern the adjacent technical spaces. As mentioned, given the current needs and mission of ISA, it is hardly credible to expect that each school can keep its own theater. The exhibition space of the schools of Plastic Arts and the theater of the school of Modern Dance, now nearly unused, could be used for educational activities with very limited interventions. Events, concerts, and performances could instead be relocated to the Ballet School. Environmental protection is, in any case, a priority, and any other intervention should be carried out in progressive stages and with minimal interventions. One of the three practical classrooms could be recovered to host exhibitions and shows, rethinking the access from the outside and the relationship with the external spaces.

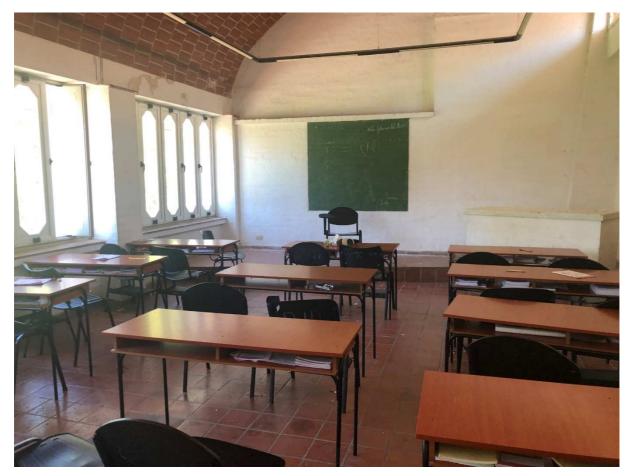
Figure 115 - School of Modern Dance - theoretical classrooms.

The façade is marked by the regular rhythm of the windows and reflects the rooms' regular shape. The theoretical rooms are not provided with dedicated service spaces, and the toilets are freely accessible from the internal route. The three classrooms of the School of Plastic Arts have a small paved patio; nowadays, these spaces are scarcely used because of the hot weather and can be revised by providing shading elements that would help manage the solar gain. All the theoretical classrooms have maintained their function over time, and the only changes concerned the furnishings and windows, which have been completely replaced. All the classrooms are equipped with air conditioning units, which, however, cannot be used.

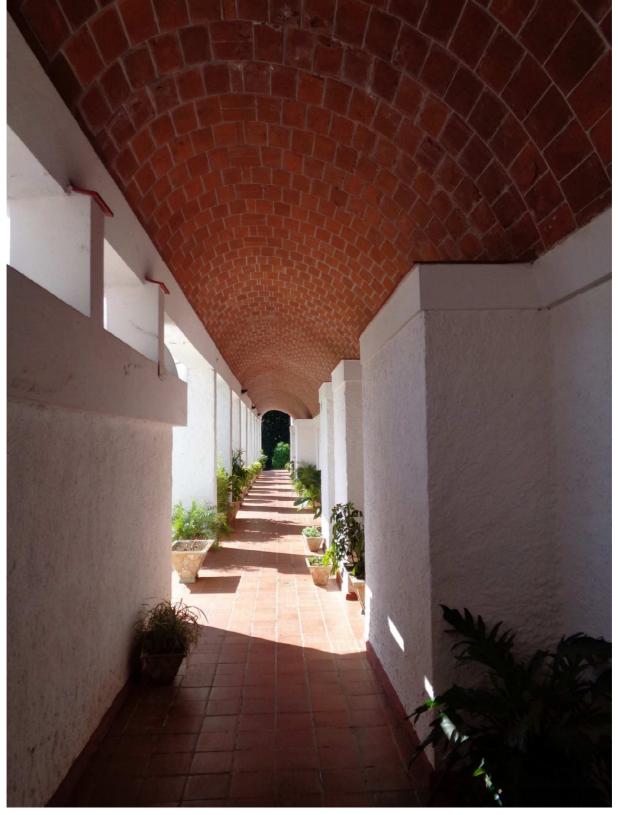
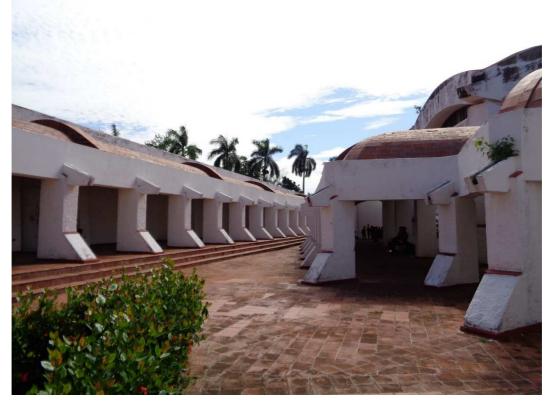
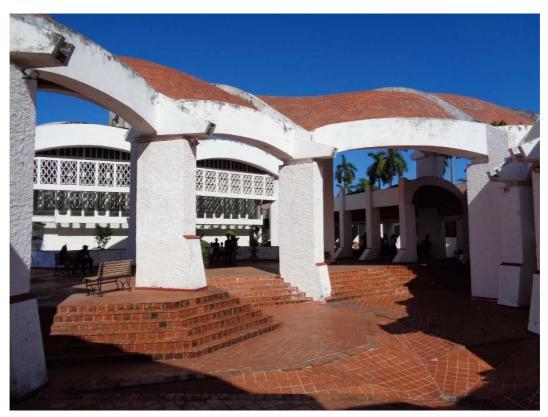
Figure 116 - School of Modern Dance, covered paths.

The conservation of the roofs is a critical issue; over time, given the delamination of the bricks on the vaults' inner surface, waterproofing interventions were carried out. At the upper level of the *Gusano*, layers of cladding were superimposed on the inner surface. The uncovered external paths (Pe) are minor ones and can be modified as needed in a general reorganization of the park's paths. Indeed, some of these paths lead to secondary entrances, which are now locked.
