UNITY TEMPLE -- FINAL OUTCOMES REPORT

Project Location:	Oak Park, Illinois
Work Completed:	Restoration Master Plan, testing for new geothermal heating system, art glass window study, south roof repairs. Full \$25 restoration project including complete exterior, interior and all building systems.
Date Completed:	Master Plan: 2006; South Roof Repairs: 2010; Million Restoration project: 2015-2017.
Client:	Unity Temple Restoration Foundation
Client Contact:	Mr. Brad White Associate Director Alphawood Foundation PO Box 146340

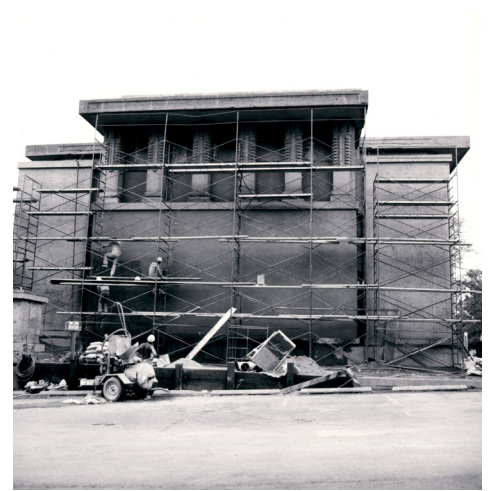
The North Façade Project was a part of the overall building restoration project. It focused on the restoration of the 1973-74 applied shotcrete finish, which closely matched the original concrete in color and aggregates, but has become severely deteriorated in many locations. The deterioration includes areas of cracking, delamination and spalls that allowed water infiltration into the concrete walls, which, in turn, led to further damage through freeze thaw expansion as well as some corrosion of reinforcing steel.

Figure 2. 1974 photo of shotcrete application. (UTP LLC)

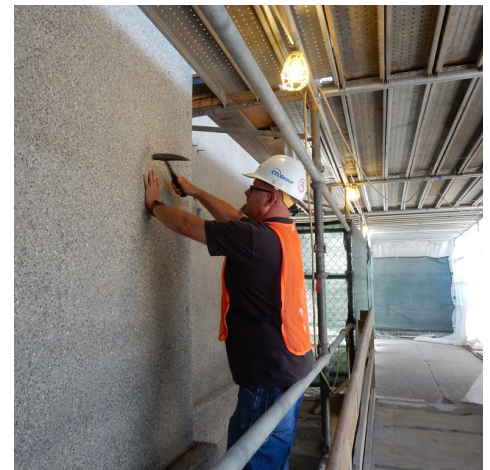
At the beginning of the project, all of the exterior shotcrete was surveyed with hands-on techniques via scaffolding. Sounding with a hammer identified spalled and delaminated concrete areas. These were marked on the façade with crayon and documented on drawings. During the repairs, areas were resounded to confirm that all damaged areas were included in the repairs. Cracked concrete that was sound and stable was also marked on the façade and documented on drawings.

Figure 3. CTL Group conducting a condition assessment of the existing shotcrete.

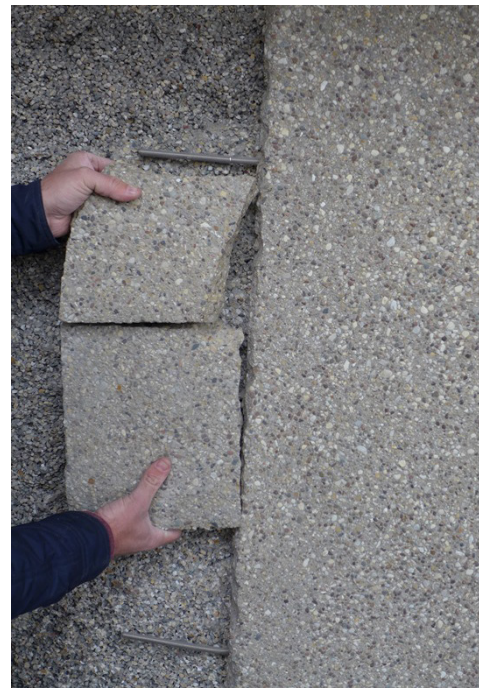
The selective replacement of delaminated shotcrete proved to be very challenging. The existing 1973 shotcrete exhibited several different colors of concrete paste, likely due to variances in the original cement color from batch to batch. In addition, the exposure and color mixture of aggregate had a wide range of variation. These variations in paste and aggregate color as well as aggregate exposure often resulted in the shotcrete having a different appearance on each surface of corners, as well as across large wall surfaces, such as the north façade. These variations in appearance created a challenge to matching the new shotcrete repairs to the adjacent existing material when the repair areas crossed multiple zones of finish appearance. Many repair areas were at corners, requiring the new shotcrete material to be placed on both wall surfaces for the same repair area. A mix design that provided a good visual match to one of the corner wall surfaces would have a contrasting visual appearance with the existing shotcrete when the repair turned the corner. Also in the large flat surface of the north façade a large repair area crossed four different appearances of existing shotcrete. These variations were likely due to the 1970s work having been applied in several vertical "lifts". They were not really noticeable until new repair shotcrete was placed, cured and finished.

Figure 5. *Selecting custom shotcrete mixes for repairs.* (Harboe Architects)

- *Selecting a mix design that minimized the visual contrast with existing adjacent shotcrete* – Careful selection of the mix design for repair areas was critical to achieving a good visual match with the adjacent existing shotcrete. Each area was evaluated to select the closest color match for that specific area. At patches that crossed multiple colors of existing shotcrete a mix color that provided that closest overall appearance was utilized. To be successful, the mix tended to be closer to the lighter color of the existing shotcrete. Once placed the aggregate exposure was tweaked to help the mix blend with the darker colors of existing adjacent shotcrete.

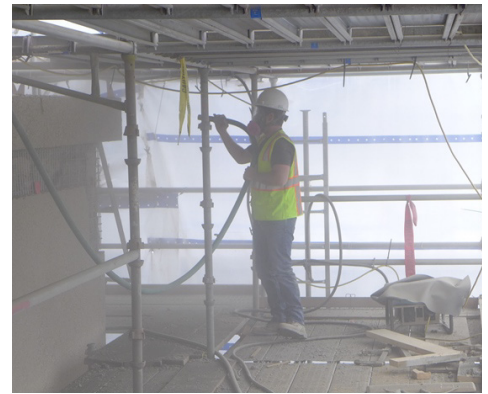
- *Varying the level of aggregate exposure across repair areas* – The appearance of the repair shotcrete can vary depending on the amount of aggregate that is exposed while finishing the shotcrete. Several of the repair areas required using different levels of aggregate exposure across the new repair shotcrete to achieve acceptable visual matches to the adjacent existing shotcrete. This repair approach was successfully executed by slowly increasing the aggregate exposure a little at a time until the optimal appearance was achieved. Great care was required to ensure that the aggregate exposure was not too aggressive compared to the adjacent existing shotcrete, since once the finishing becomes too aggressive it cannot be reversed.

Figure 8. The shotcrete aggregate was exposed utilizing abrasive blasting. (Harboe Architects)
