CONSERVING MODERN HERITAGE

Concrete

Case Studies in Conservation Practice

Edited by Catherine Croft and Susan Macdonald

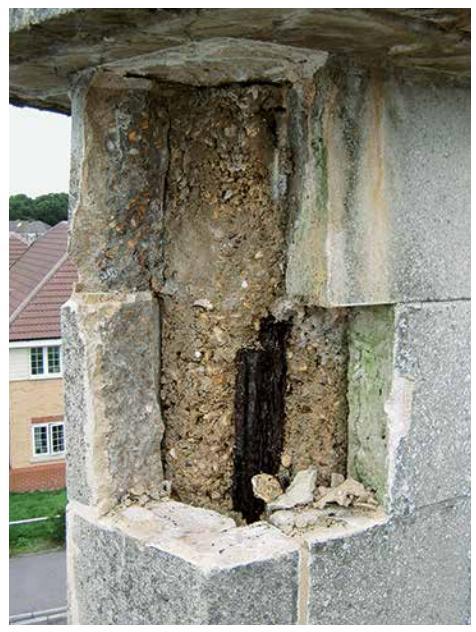
Sometimes the reinforcement in historic concrete can be centralized and deeply embedded, and CP can then be applied using anode ribbons mortared into existing joints, as shown in the church steeple in figure 1.4. The steeple had initially been built with concrete blocks. These concrete blocks were used as permanent shuttering, with the concrete poured in from the top, but its poor quality, in conjunction with marine rainwater ingress, had resulted in corrosion of the steel. For this application, anode ribbon (½ in. [1.27 cm] wide by 40 milli-inches [1 mm] deep) was introduced into alternate joints cut to a depth of 2 in. (5.08 cm) between the concrete blocks and mortared in

Fig. 1.4. Damage to a reinforced concrete steeple due to poor-quality concrete in combination with marine rainwater entry. The outer concrete blocks were placed and used as permanent shuttering, then the concrete poured around the internal steel reinforcement.

Fig. 1.5. Alternative arrangement of installing anode ribbon into every other horizontal joint in concrete block construction, suitable if the steel is deeply embedded.

place (fig. 1.5). This type of arrangement may also be suitable where individual corroding steel reinforcements are encountered. Chases may be cut directly into the sides of the concrete following the lines of the reinforcements to allow anode ribbons to be inserted; these can subsequently be covered by pointing, the visibility of which will depend on the nature and articulation of the concrete surface.

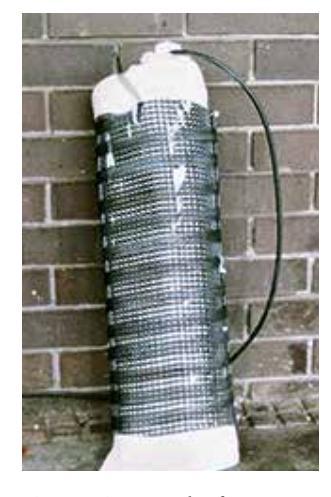
Fig. 1.9. An example of a remote sacrificial anode. RSAs were used to power the cathodic protection system to the 30-foot Listening Mirror. The magnesium anode is covered in muslin and surrounded by the metallic current collector.

Two remote sacrificial anodes were built to power the trial CP system; an example is shown in figure 1.9. The RSAs comprised 22 lb (9.98 kg) of high-grade magnesium that

was surrounded by a backfill mix consisting of 75% calcium sulfate, 20% bentonite, and 5% sodium sulfate. The calcium and sodium sulfates react with the magnesium anode and the system becomes active within a short time; the bentonite clay allows the backfill to retain moisture during dry periods. The backfill was contained in a muslin bag surrounded by a stainless steel current collector. The two wires from the RSA (–ve from the magnesium anode and +ve from the current collector) exited from the top of the RSA. Two of the RSAs were buried at a depth of 3 feet (.91 m), under the shingle at the left side of the 30-foot mirror (fig. 1.10). The spacing between the two RSAs was 10 feet (3.05 m). They also had polymer jackets fitted, which enabled them to be electrically isolated from each other. The wires from the RSAs led to a manhole, where they were connected in series to double their driving voltage to 3 VDC.

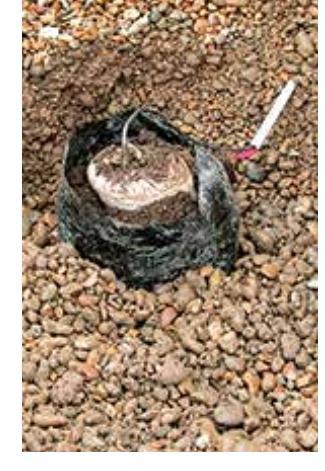
Fig. 1.10. Two RSAs were buried under the shingle with a spacing of 10 feet (3.05 m) and electrically isolated using polymer jackets. The RSA wires were fed through to a manhole and connected in series to double the driving voltage to 3 VDC.

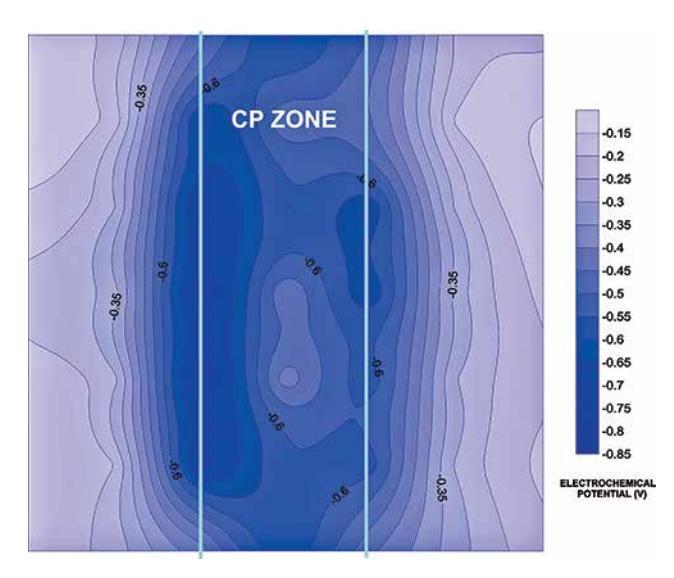
Fig. 1.11. Electrical potential map of the trial CP area of the 30-foot Listening Mirror showing good polarization of the steel reinforcements in 2005.

A portable silver/silver chloride reference electrode was used to take polarization measurements (power on results) on the top surface of the repaired concrete dish. A map of the front of the CP trial area after three months of operation is shown in figure 1.11. The steel, which initially had measured electrical potentials of between -150 mV and -200 mV (with respect to the silver/silver chloride reference electrode), was successfully polarized down to below -800 mV with the protection extending beyond the CP trial area. Potential measurements were also made on the back of the mirror, and these showed that the polarization from the RSAs was effective even through the 10 in. (25.4 cm) thickness of the dish.

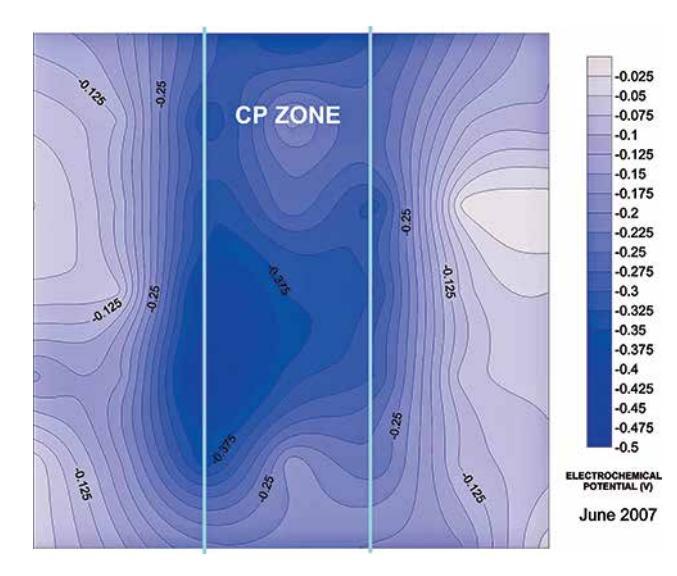
Fig. 1.12. Electrical potential map of the trial CP area of the 30-foot Listening Mirror in 2007.

The potential map of the front of the CP trial area in 2007 (after two years of operation) is shown in figure 1.12. The embedded steel in the test area is still successfully polarized, although the level of polarization is lower than that seen after the first three months of operation. The maximum polarization was recorded as 500 mV (with respect to the silver/silver chloride reference electrode). This was expected, as the magnesium-based RSAs initially give a high driving potential and current, but these decrease once the anode starts to form corrosion products on its surfaces, as this reduces its activity.

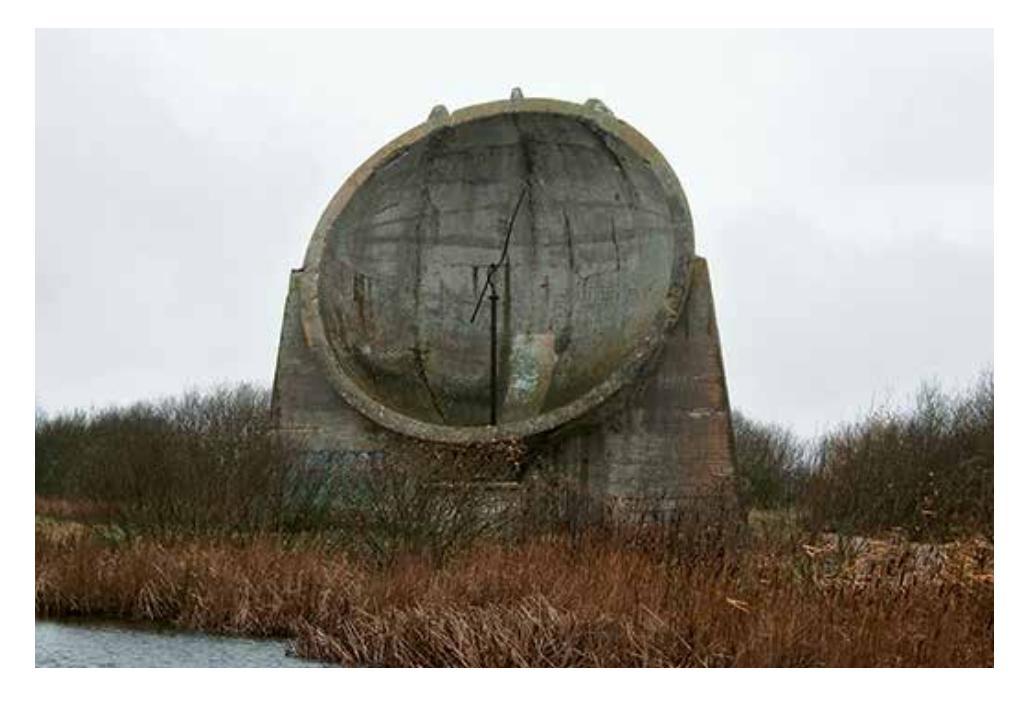
Fig. 1.13. View of the 30-foot Listening Mirror in 2016 showing the beginning of weathering, with algal and lichen growth starting to become established on the repaired concrete cover to the CP trial area.

The Listening Mirrors continue to be visited regularly to monitor the repair work and the efficacy of the CP system. During the visit in December 2015, it was noted that one of the underground wires from an RSA had been exposed and damaged by vandals. The RSA was still outputting 1.5 VDC but was disconnected from the CP circuit. One of the problems with connecting RSAs in series is that if one of the wires becomes damaged, then all current is lost to the CP system, whereas if they are connected in parallel, then only half the current is lost. Repairs were duly made and the RSA system to the CP trial area was reactivated.

A view of the 30-foot mirror in 2016 is shown in figure 1.13. The lightened area of top concrete on the CP trial area has now weathered, and both algal growth and green lichens have become established on its surface.

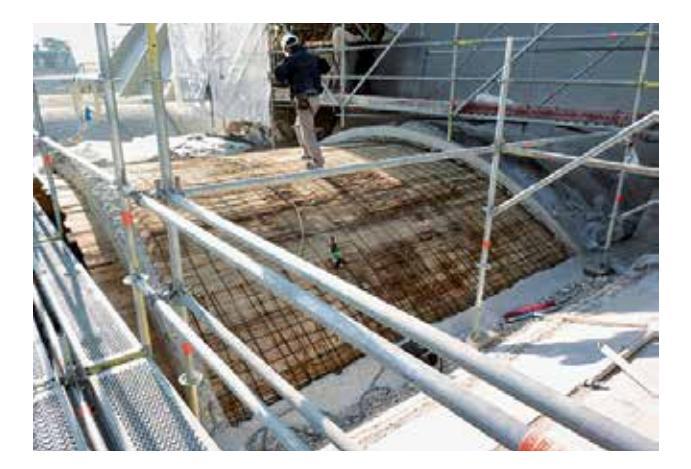
Fig. 2.7. Re-casting the entire thin shell of a lateral arch, 2011. Photo: François Chatillon

modified fine-aggregate concrete of similar strength to the old concrete (fig. 2.7). At the same time, the small-diameter reinforcing steel was replaced by new welded steel mesh. Elsewhere small patch concrete repairs were carried out to restore the surface profile. Significant cracks were repaired by raking out a V channel on the outer surface and filling it with mastic. The entire outer surface of the arch, including the stiffening arcs, was then sealed by application of a three-layer acrylic resin waterproof membrane (fig. 2.8). Junctions between different surfaces were reinforced with a fine PVC mesh; bands of this material were also placed along repaired cracks after first fixing a narrow band of polythene to act as a bond breaker in the event of continued crack movement. This avoided placing excessive stress on the waterproof membrane in order to avoid cracking. The

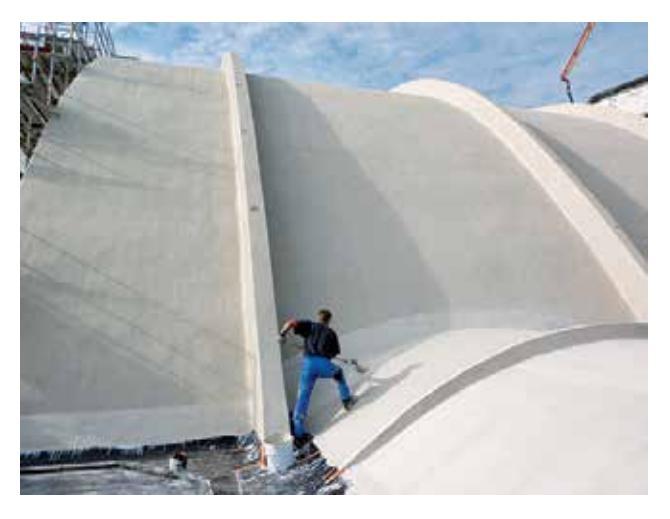
Fig. 2.8. Application of the external acrylic resin waterproof membrane, 2011. Photo: François Chatillon

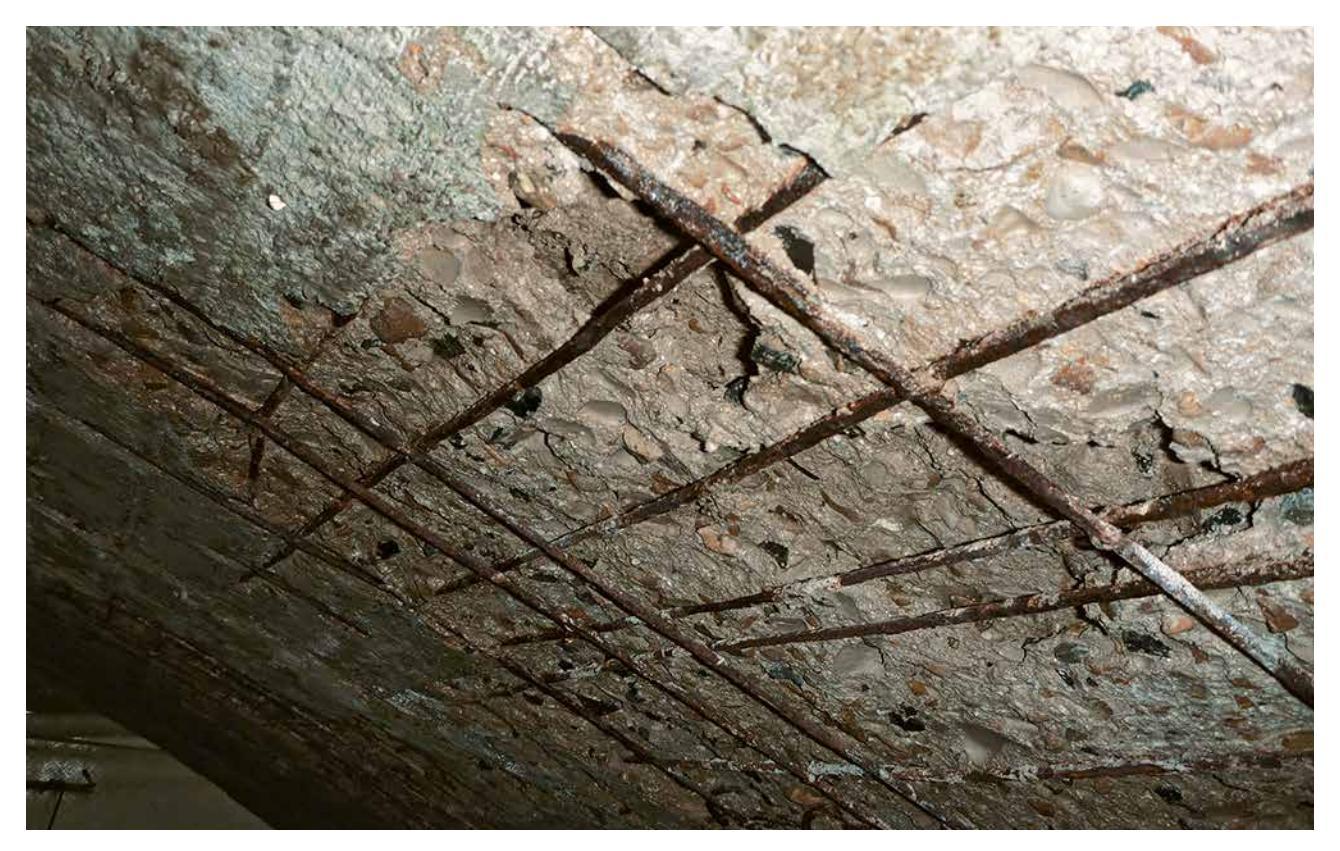
Fig. 2.9. The roof of a lateral arch after removal of deteriorated concrete. Photo: Richard Palmer

At the inner surface of the parabolic arch, areas of deteriorated concrete were removed using high-pressure waterborne abrasive blasting, a technique that also served to clean corrosion scale from the surface of the reinforcing steel (fig. 2.9). The concrete surface profile was restored by patching with a trowel-applied, polymer-modified, fineaggregate mortar, the distinctive shutter board marking being re-created by lightly tapping timber bars against the still-soft mortar surface.

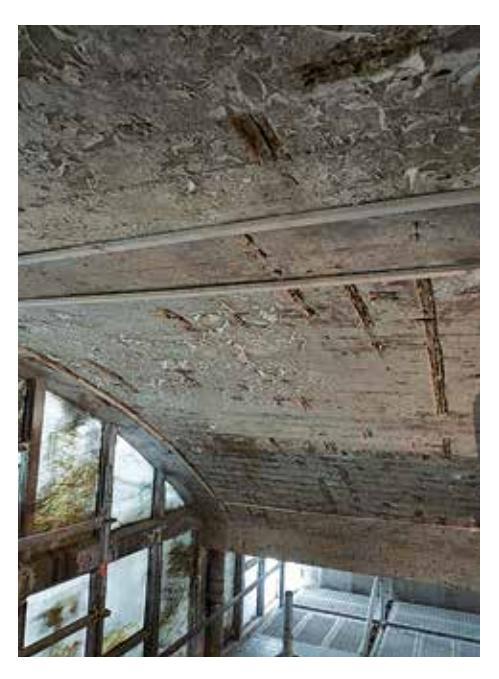
Fig. 2.11. Dry MFX inhibitor gel after application to a lateral arch during initial trials. Photo: François Chatillon

Sample analysis during the repair trials had confirmed that efflorescence appearing after application of the penetrating sodium monofluorophosphate corrosion inhibitor was due to high concentrations of sulfate in the concrete. A subsequent, more detailed analysis revealed the sulfate to be a mixture of thenardite and mirabilite. In addition to the unsightly nature of surface efflorescence, there was concern regarding durability, because relative humidity and temperature changes cause conversion between these sulfate types, as shown by the phase diagram in figure 2.10. The mirabilite crystals occupy far greater volume (on the order of 300%), and this would lead to cracking of the cement paste, giving rise to further deterioration. However, these sulfate crystals are very soluble, particularly as thenardite, hence a pretreatment by washing with hot water was devised to dissolve and thereby allow removal of the sulfate before application of the migrating corrosion inhibitor. The generally high porosity of the thin-shell concrete contributed to the effectiveness of this action. The migrating corrosion inhibitor was applied to the entire inner surface of the parabolic arch and its lateral stiffening arches. Application was done by projecting an inhibitorloaded gel onto the concrete surface. By this method, a liquid high inhibitor concentration was maintained at the concrete surface, ensuring an optimum concentration gradient for maximum penetration. Once dry, the gel was easily brushed from the surface (fig. 2.11).

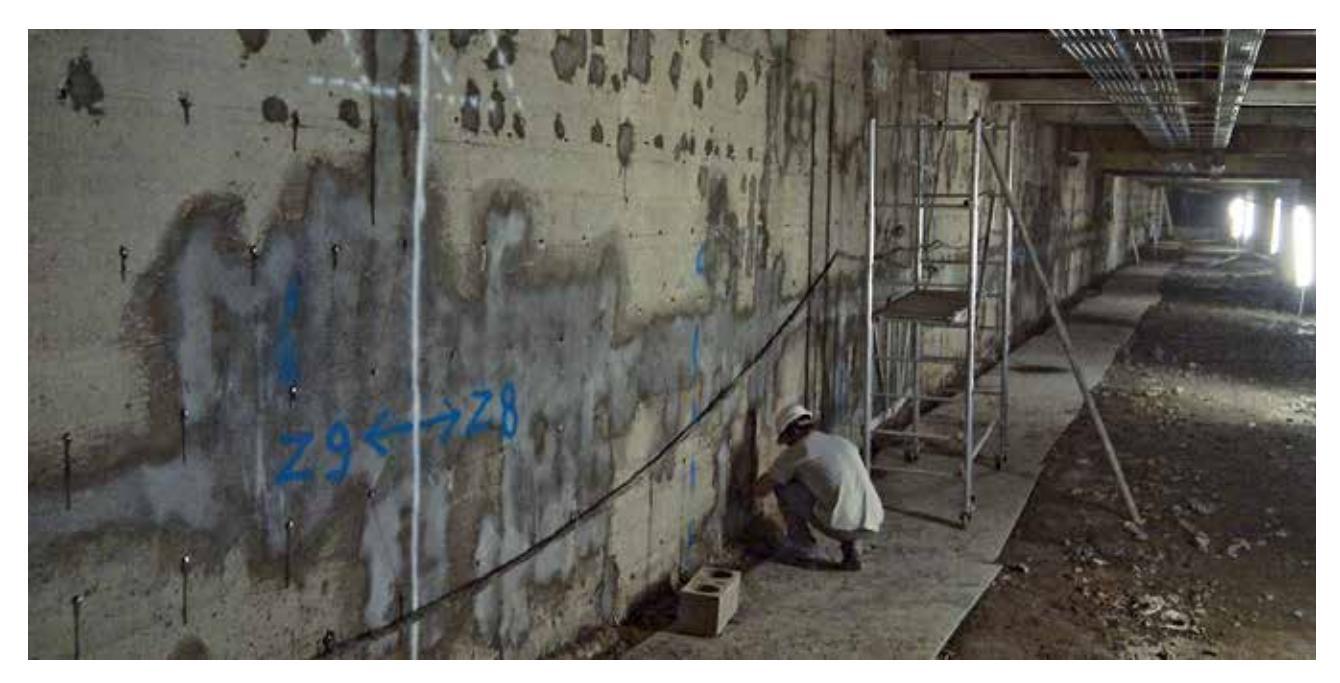
Fig. 2.12. Cathodic protection applied to the peripheral basement walls. Photo: Richard Palmer

The reinforced concrete basement walls were also carbonated, and they were affected by rising damp and the lack of an external waterproof membrane. It was not possible to dig down and add an external membrane, as that would have changed the static lateral force and hence destabilized the arched roof. Treatment by penetrating corrosion inhibitor was discounted, as the constant movement of water across the wall would wash out the active inhibitor reserves. Therefore, impressed current cathodic protection was chosen as the optimal solution for protecting the steel reinforcement. The chosen cathodic protection anode system comprises a grid of interconnected discrete anodes (fig. 2.12). There are eleven independently controlled grids of anodes that cover the entire basement peripheral wall surface. The active anode surface is a mixed metal oxide coating on a titanium substrate, which has an operating lifetime in excess of one hundred years. Each discrete anode has an integral resistor that serves to balance the current applied to protect the steel reinforcement. This ensures that changes of system resistance, due principally to variations of moisture content, do not greatly perturb the protective current distribution. Each of the eleven cathodic protection zones has its own local control unit, each one connected to a central control unit that permits the entire system to be monitored and controlled from one location as well as remotely, via a GSM modem link. Control of the system was undertaken by Lefevre during the first year following installation and has now passed to another specialist company. The monitoring has been principally via modem link and all results to date satisfy the required performance criteria.

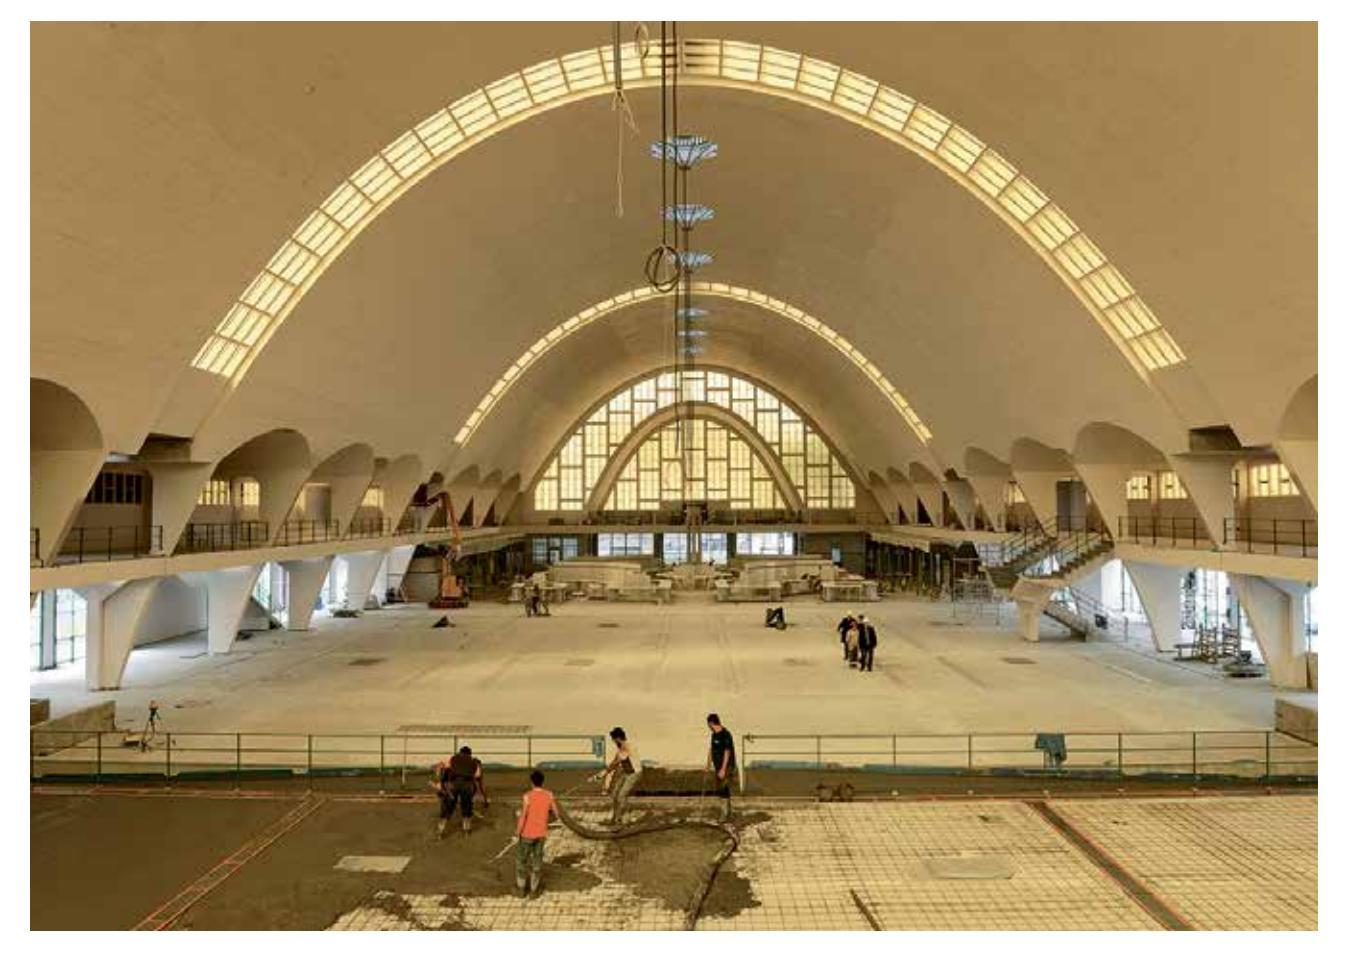
Fig. 2.13. Interior view nearing the end of restoration, 2012. Photo: Alain Hatat

The soffit of the ground floor slab was subject to local patch repairs where necessary. Otherwise, for reasons of economy, no additional treatment was prescribed. The soffits of the gallery floor slabs were destined to be hidden. It was therefore decided, for structural as well as economic reasons, to deal with local areas of corrosion damage by patch repairs and then install a reinforcing steel framework to accommodate the increased imposed loadings due to the new use and as required for compliance with current regulations (fig. 2.13).

The Thermalux windows installed to replace the originals after their destruction in 1940 were an early attempt at double glazing made by the company Saint Gobain. These comprised a 3 cm sandwich of inner plain glass and outer armored glass, with the space between the two panes filled with glass fiber. Unfortunately, the cold bridge created by the glass fiber negated the insulating effect, resulting in continued problems with condensation on the inner surface. The Thermalux windows of the two parabolic-arch skylights and the inclined skylights were replaced with double-glazed units, fabricated using Polish-manufactured, yellow-tinted armored glass externally and clear glass internally. These echo the original appearance while meeting today's safety requirements. The glazing of the tympana of the main and smaller lateral arches was replaced with single-glazed units fabricated using the same yellow-tinted armored glass (see fig. 2.13).

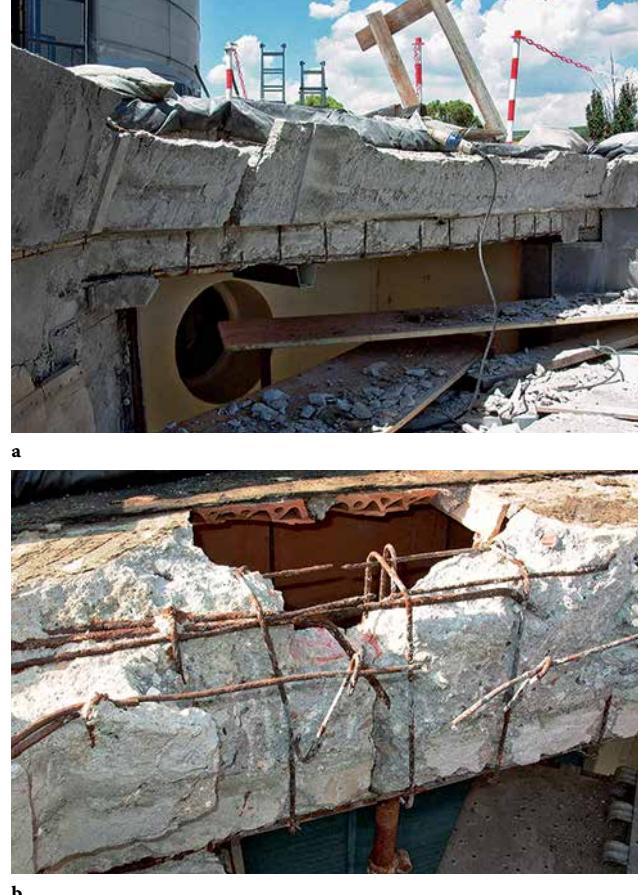
Thorough inspection of the beam connecting the two wings of the building revealed severe damage to its sides, with widespread corrosion and breaking of the shear rebar due to water infiltration (figs. 3.10a, 3.10b). Over time, more waterproofing materials had been added in an attempt to address the widespread degradation due to water ingress. The original waterproofing system consisted of natural asphalt along the gutters and on the vertical coverings along the borders of the terrace, while the remaining parts were covered by a complex sandwich of a layer of Ruberoid felt bitumen, two thick layers of tar paper, and four layers of Holzcement, a waterproofing material that consists of four or five tar paper layers bound together with a bitumen varnish.

Figs. 3.10a and 3.10b. Degradation of the beam connecting the two wings of the building, before (a) and after (b) the removal of the concrete collar, 2003.

The concrete beam connecting the two wings of the building was so badly damaged that a more invasive solution was required. Deep through cracks in the concrete toward the edges of the structural element had been caused by extensive water infiltration leading to severe corrosion of the rebar and the breaking of the shear bars (see figs. 3.10a, 3.10b). This beam was largely demolished and reconstructed by pouring within plastic formworks a fiber-reinforced, shrinkage-compensated cementitious mortar, with coarse aggregates added to the premixed product (fig. 3.12). Surface preparation of the existing concrete is critical to successful concrete repairs of this type to create a good bond with the existing concrete elements. Therefore, it is important to achieve a sufficiently rough surface exceeding 5 mm in depth to guarantee an adequate bond with the new repair material, with the surface adequately prewetted. The possibility of preparing the surfaces by hydroblasting was rejected because of difficulties in water disposal, so sandblasting was adopted. This also provided the ideal surface roughness for the adhesion of the repair mortar.

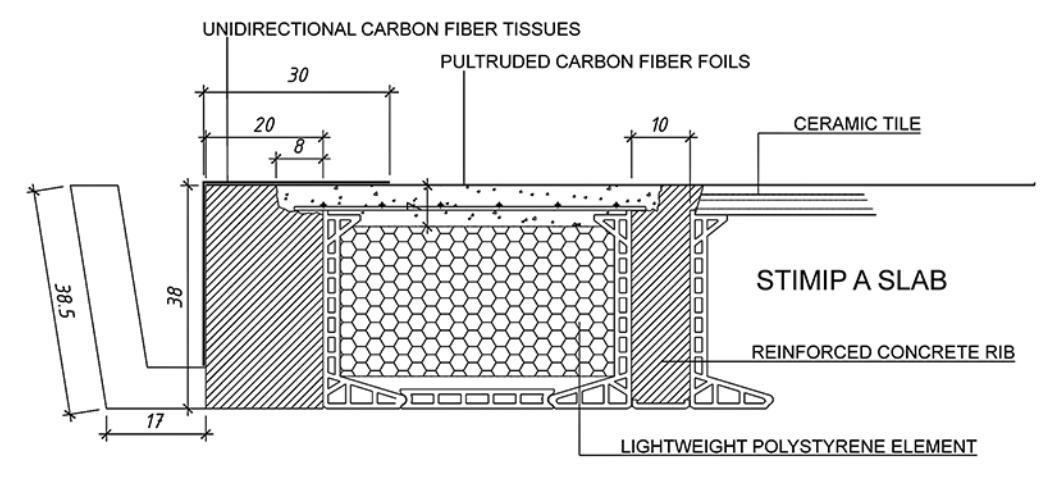
Fig. 3.11. General section of the repair strategies adopted for the right-wing slab.

chosen for the slab was strengthening by the application of carbon fiber-based foils and tissues (fig. 3.11). The detached superficial portions of both tiles and concrete elements were removed through sandblasting and pressurized air until a sound and dry surface was obtained. Then the external upper angle of the edge beam was rounded in order to allow the carbon fiber sheets to be bent around it (care was taken to ensure sufficient concrete cover was maintained). A layer of bi-component epoxy-polyamide primer (Degussa MBT MBrace Primer) was applied to the surface, and then a series of carbon fiber sheets (carbon fibers in polymer resin) with a 50 by 1.4 mm section and high elastic modulus (Degussa MBT MBrace Laminate) were glued on the treated surface with a thixotropic bi-component epoxy adhesive (Degussa MBT MBrace Laminate Adesivo). A layer of sand was applied on the lateral surface of the edge beam to increase the surface roughness, and the treated surface was refined with a final layer of

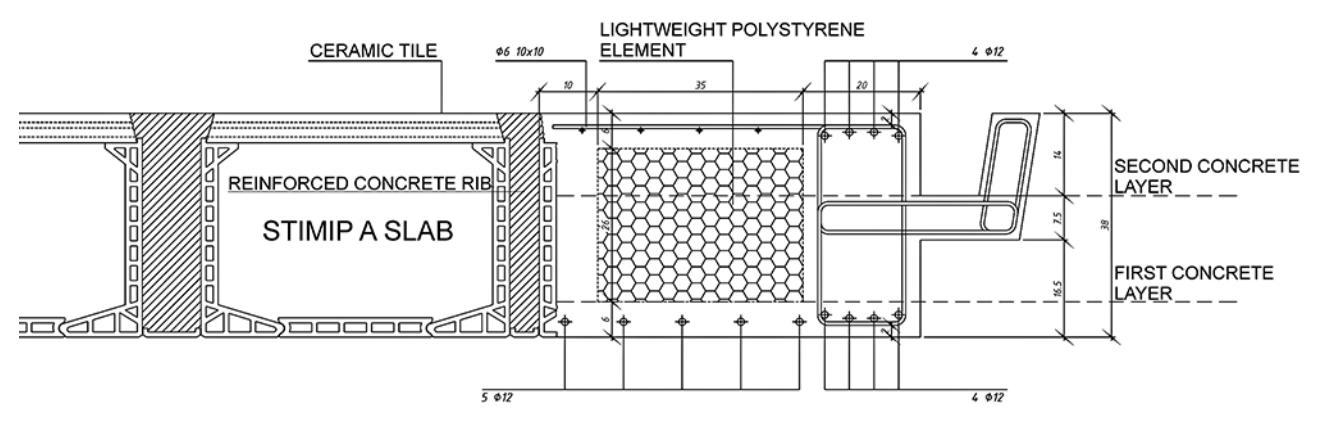
Fig. 3.12. General section of the repair strategies adopted for the connection beam.

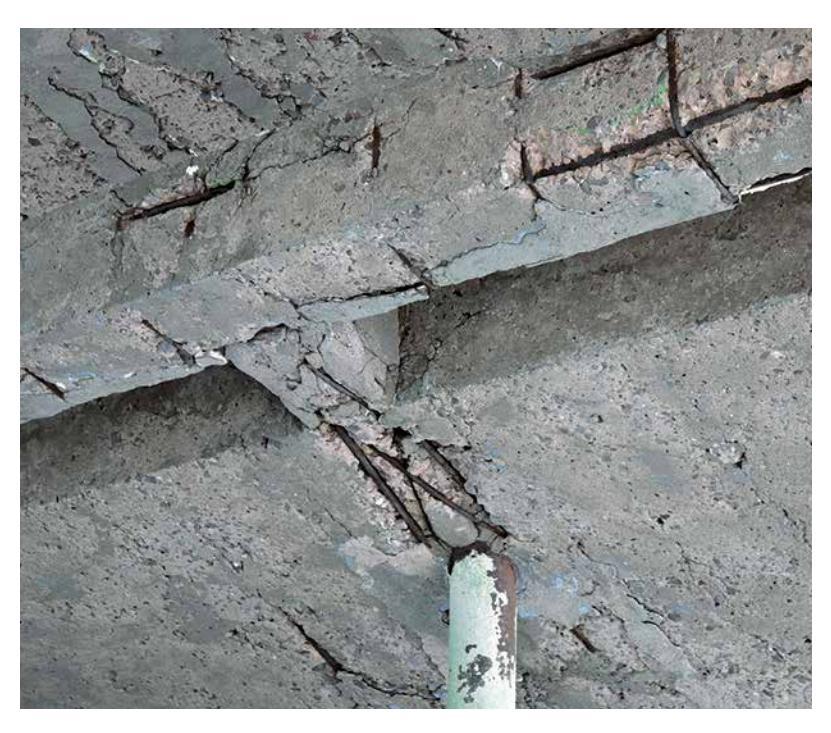
Fig. 4.4. A typical area of damage to the underside of one of the entrance canopy slabs, 2012.

There is little information from the 1930s about how reinforcement was to be supported during concreting. One contemporary reference, in *Cassell's Reinforced Concrete*, mentions the use of notched timber templates that "can be removed shortly after the concreting has begun, quite a small quantity of concrete sufficing to hold the rods in place" (Jones and Lakeman 1920, 140). If this was the method used here, then the undulating shape of the slabs meant it was almost inevitable that the bars would slump toward the bottom of the wet concrete and rest on the shuttering. We can only surmise that the pressure to open the zoo to the public led to a make-do approach, with a render coat and paint applied to hide the exposed reinforcement (fig. 4.4).

There were some locations, mostly to the soffit of the slabs and beams, where a repair using a traditional concrete mix was not possible without significant implications for the historic fabric. Either it would involve the removal of all the existing concrete to re-cast around retained reinforcement, thus sacrificing significant amounts of historic fabric, or the thickness of the slab would have to be increased to place concrete from below in order to provide an acceptable cover to the bars. This option would have structural implications from the additional weight of concrete and would have significantly changed the appearance. Both of these options were rejected. Instead, a 4 mm-thick polymer-modified repair render was applied to the cleaned and primed surface and then manually worked on the surface to match the surrounding, original board marks. For the entrance roof slabs, the tender drawings provided an allowance for this render coating to all of the soffits.

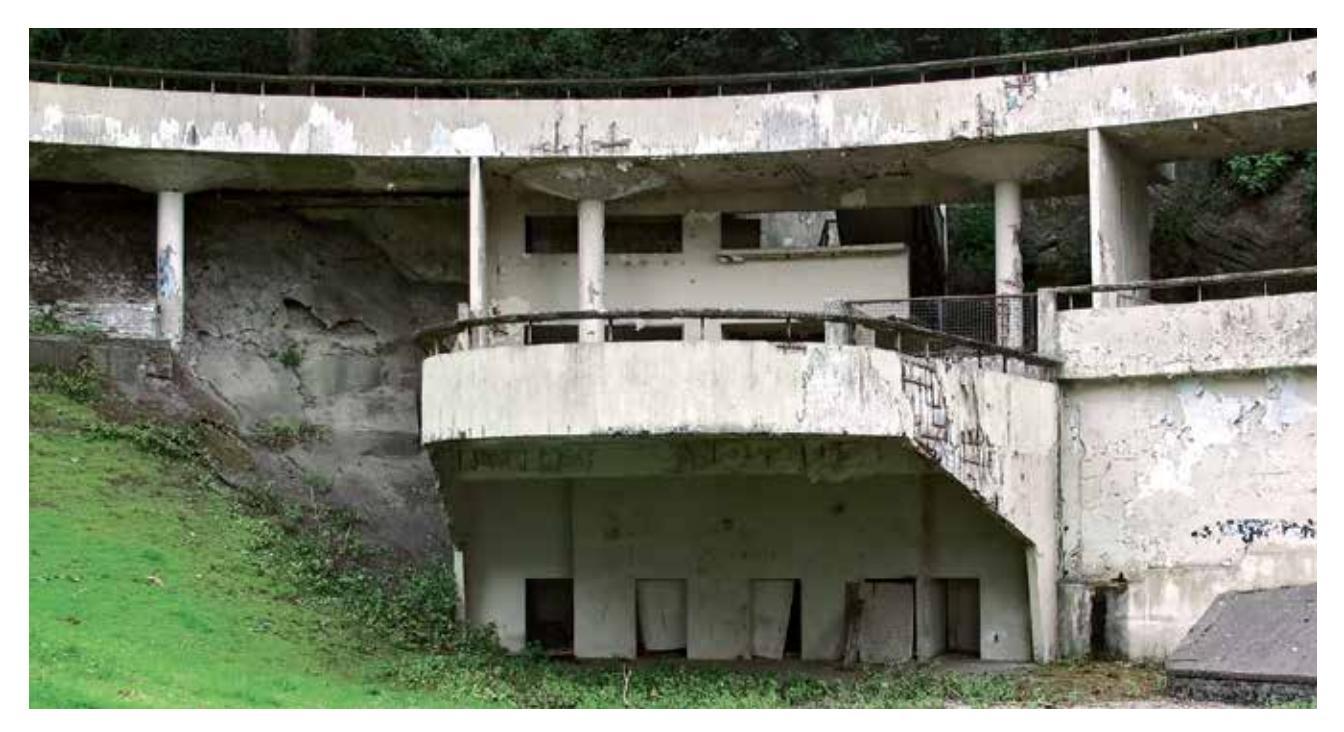
There were also areas of exposed reinforcement and spalled concrete present at the shop and kiosk buildings, but the greatest damage was to the bear ravine. On the

Fig. 4.5. The bear ravine prior to repairs, 2011.

cantilevered viewing platform, there were large areas on both faces of the parapet where the concrete had fallen away and exposed the corroded reinforcement behind. The extent of corrosion to some of the circular hollow steel columns around the stairwell to the upper viewing level was of sufficient concern to prompt immediate installation of temporary props (figs. 4.5, 4.6). By the end of this initial appraisal, the report to the HLF placed the structural defects into two broad categories. The majority were due to poor-quality construction and subsequent deterioration, with a second, smaller category of damage that indicated structural issues that would require a more extensive intervention. The initial appraisal also confirmed that the proposal to avoid modern polymer-modified

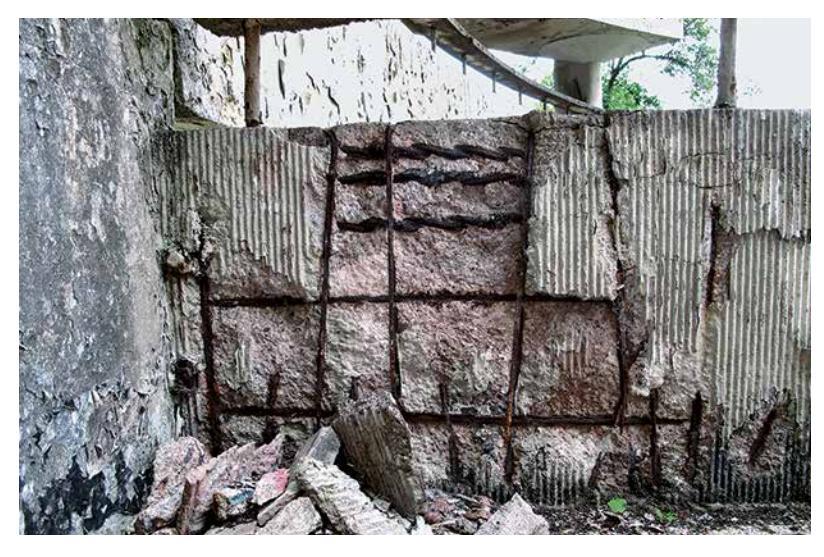
Fig. 4.6. Detail of the bear ravine prior to the works, 2012.

Investigations found two layers of 9.5 mm (% in.) diameter bars at 100 mm centers near the bottom of the slab. The downstand beam had six Isteg bars at the bottom and 9.5 mm diameter links at 200 mm centers. Isteg bars were also found in the parapet wall, as can be seen in figure 4.6.

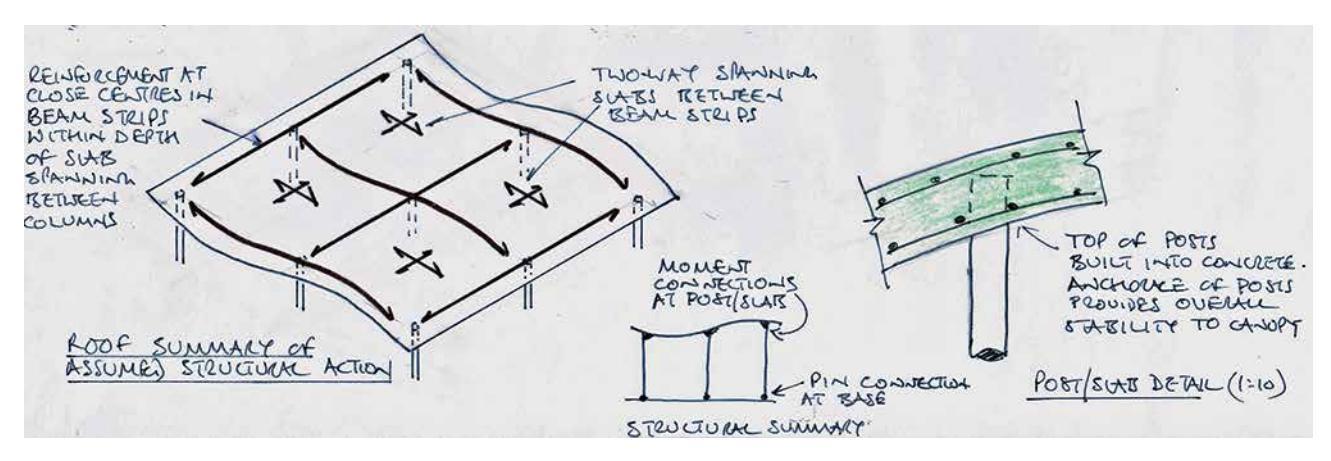
There were, however, some areas with structural problems generated by their daring form. At the entrance building, transverse cracks were identified in similar locations on the top faces of each of the five curved slabs. There were also concerns about the integrity of the connection between the tops of the solid steel columns and the roof slabs. At the bear ravine, there were cracks in the side walls of the cantilevered viewing platform, a longitudinal crack in the top face of the slab above a downstand beam, and a distinct bounce when walking at the outside edge of the platform.

Fig. 4.7. Structural summary of entrance roofs.

The entrance to the zoo is formed of five undulating reinforced concrete slabs above individual ticket kiosks that are built of brickwork and timber. Each roof slab is 175 mm thick and approximately 7 by 7 m on plan. The slabs have a projecting edge beam on three sides that prevents rainwater runoff from staining the outside edges. The slabs are supported on nine solid steel posts, each 90 mm in diameter, on a grid of 3 by 3 m. The posts bear onto shallow concrete pad foundations. Two layers of ½ in. (12.7 mm) plain round bars that were observed close to the surface of the soffit indicated that they were designed as two-way spanning slabs. The overall stability is provided by a moment connection between the head of the columns and the slab. The entrance is on sloping ground, and the design cleverly exploits this by having the end of one slab overlapping the next. At each overlap, the three edge columns pass through the lower slab and into the slab above, a detail that provides an additional restraint against lateral movements. This is summarized on the extract from the project drawing by Stand Consulting Engineers in fig. 4.7.

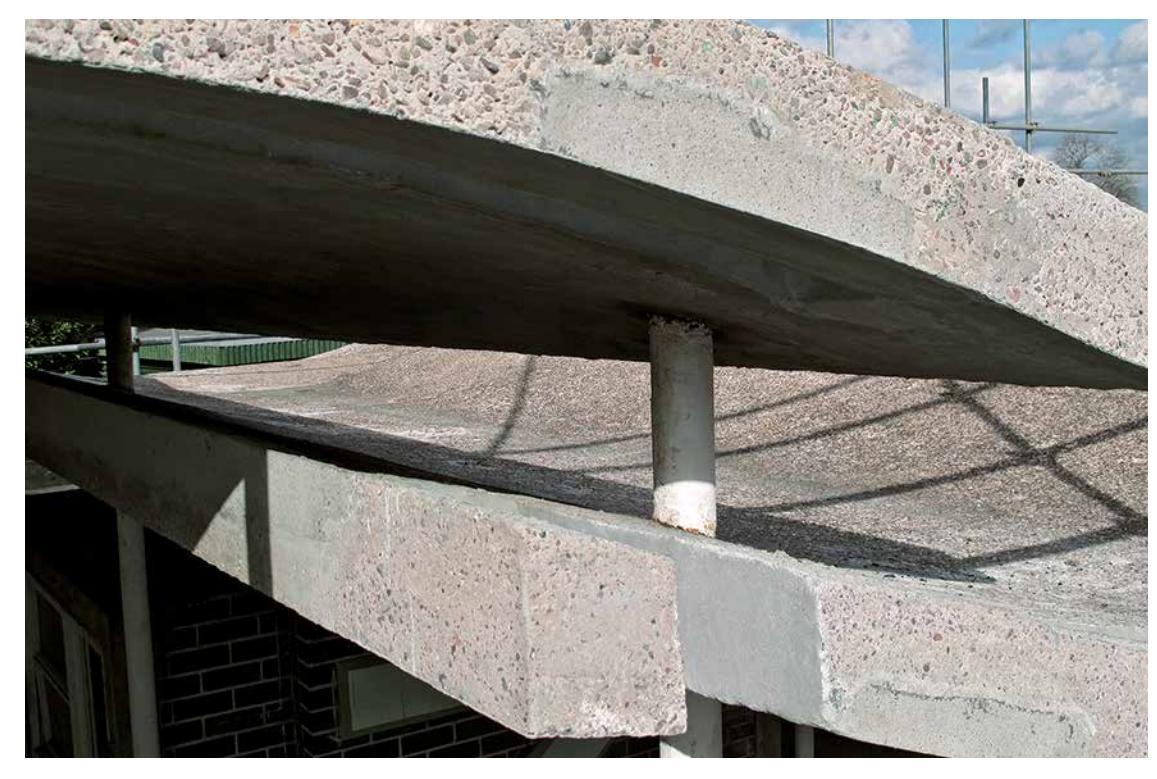
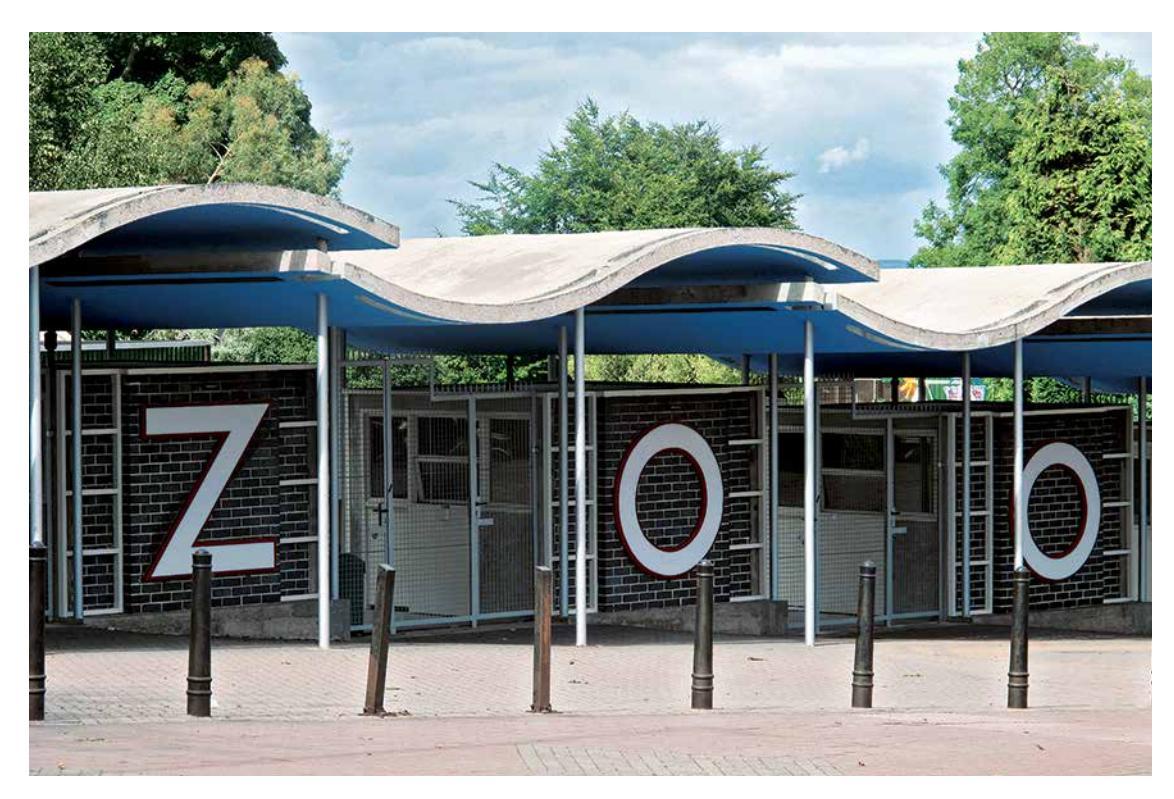
As mentioned earlier, there were cracks on the top surface of each canopy of the entrance building, which were on the hogging curve of the slabs. There were no obvious structural reasons for this, and the most likely cause was small-scale folding of the slab from thermal expansion and contraction. As it is not possible to stop these movements, the initial suggestion was to fill these cracks with a soft lime mortar and accept that this was an area that would need a higher level of ongoing maintenance. However, it was decided that water ingress into the slab had to be prevented to inhibit damage to the newly repaired and painted soffit.

Fig. 4.8. Repair to the entrance canopy slab, 2014.

Fig. 4.9. The entrance following conservation work, 2015.

A roof covering was therefore proposed and the design criteria included the need to be reversible and to accommodate thermal movements. It also needed to be visually acceptable, as the roof of the entrance building can be seen from the top of Castle Hill and the nearby chair lift. No flashings or mechanical fixings could be used, as this would impact on the slender edge detail of the wave forms. With the exposed location of the entrance, the new covering would also need to resist uplift pressures. Through discussions with the project team and agreement with the local conservation officer and English Heritage (now Historic England), a liquid applied membrane was selected. Resinset quartz was then applied to the top to match the surface color and texture of the existing concrete. The aggregate for the quartz was sourced from a local quarry to match the tone and consistency of the concrete. The resulting view from the chair lift is of five seemingly untreated concrete canopies (figs. 4.8, 4.9).

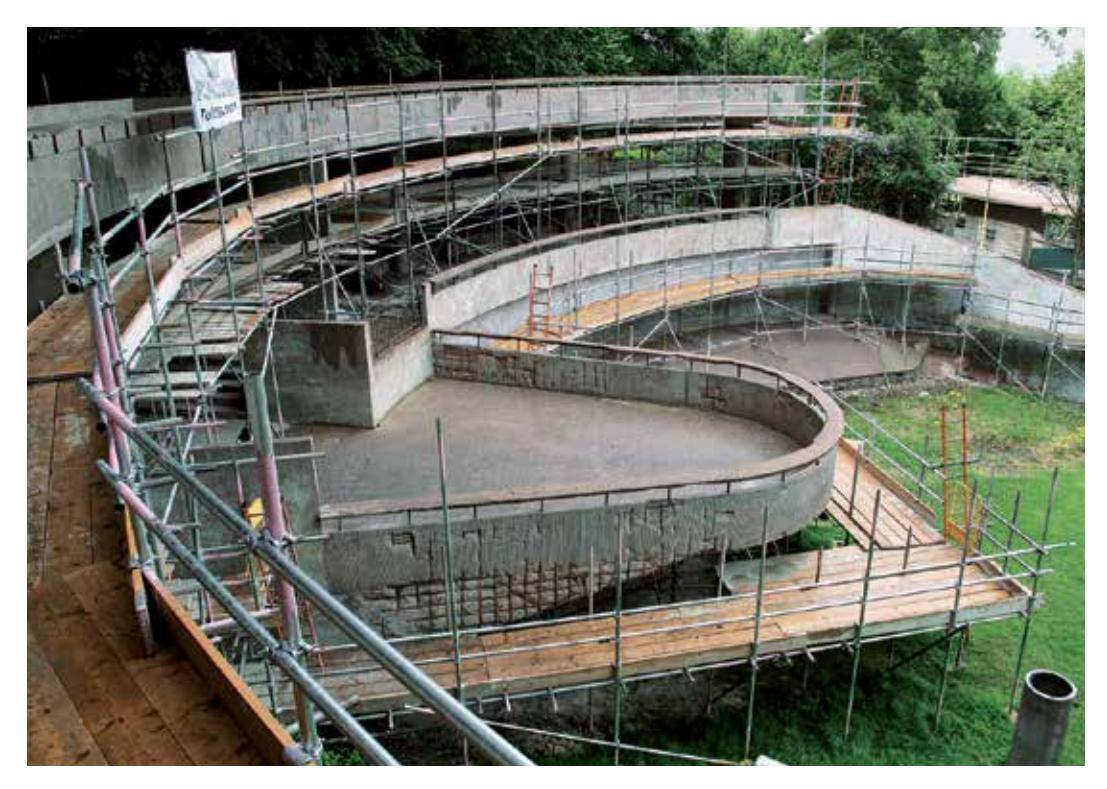
Fig. 4.13. Bear ravine during the repair works, 2014.

With the slab propped by a support scaffold, the layers of paint were removed by the steam cleaning process along with loose and damaged areas of concrete. This revealed that the underlying concrete was in a much better condition than anticipated (fig. 4.13). This enabled the parapet to be repaired rather than rebuilt, as shown in figure 4.12. An alternative to the addition of mesh reinforcement to the slab was also explored.

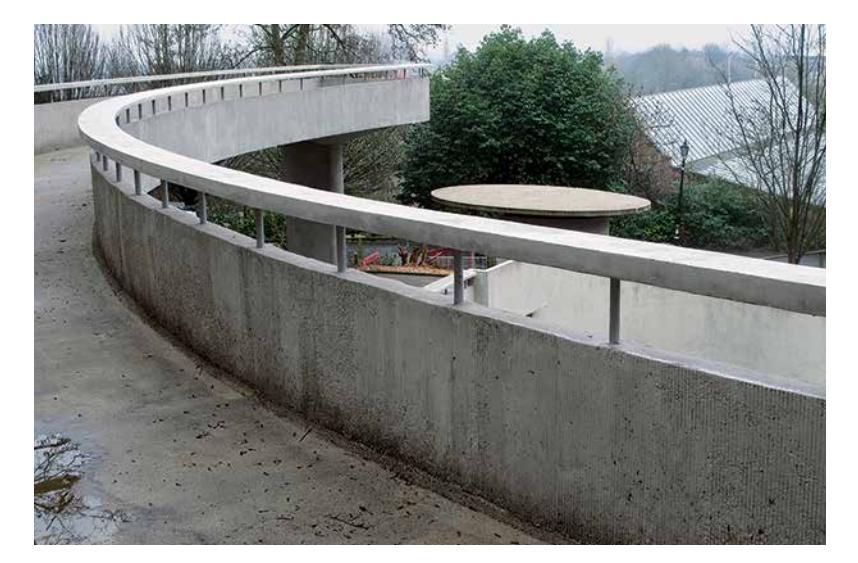
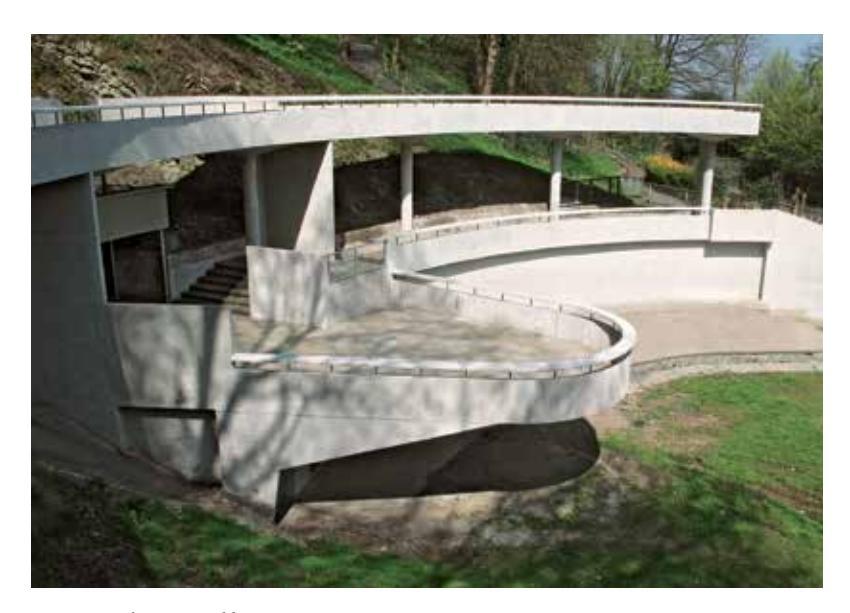
Fig. 4.14. Bear ravine after the repair works, 2015.

Fig. 4.15. The repaired bear ravine, 2015.

The concrete repairs to the bear ravine, though on a much larger scale than those undertaken on the other buildings, followed the same philosophy. Cement and aggregate mixes were used on all vertical and horizontal surfaces and the polymer-modified repair mortar was used for the undersides of the slabs. The quality of the repairs to the corrugated finish of the parapet walls was a significant achievement by the on-site team. A series of tools were developed, ranging from a float profiled by a latex mold taken from an original section of corrugated metal shuttering to a bespoke timber profiled float. The most useful tool turned out to be a simple round timber dowel that was used to line the profiles through. When breaking out the damaged concrete, any sound surfaces were left in place, no matter how small. These areas ensured that the rhythm of the corrugation matched the existing pattern (figs. 4.14, 4.15).

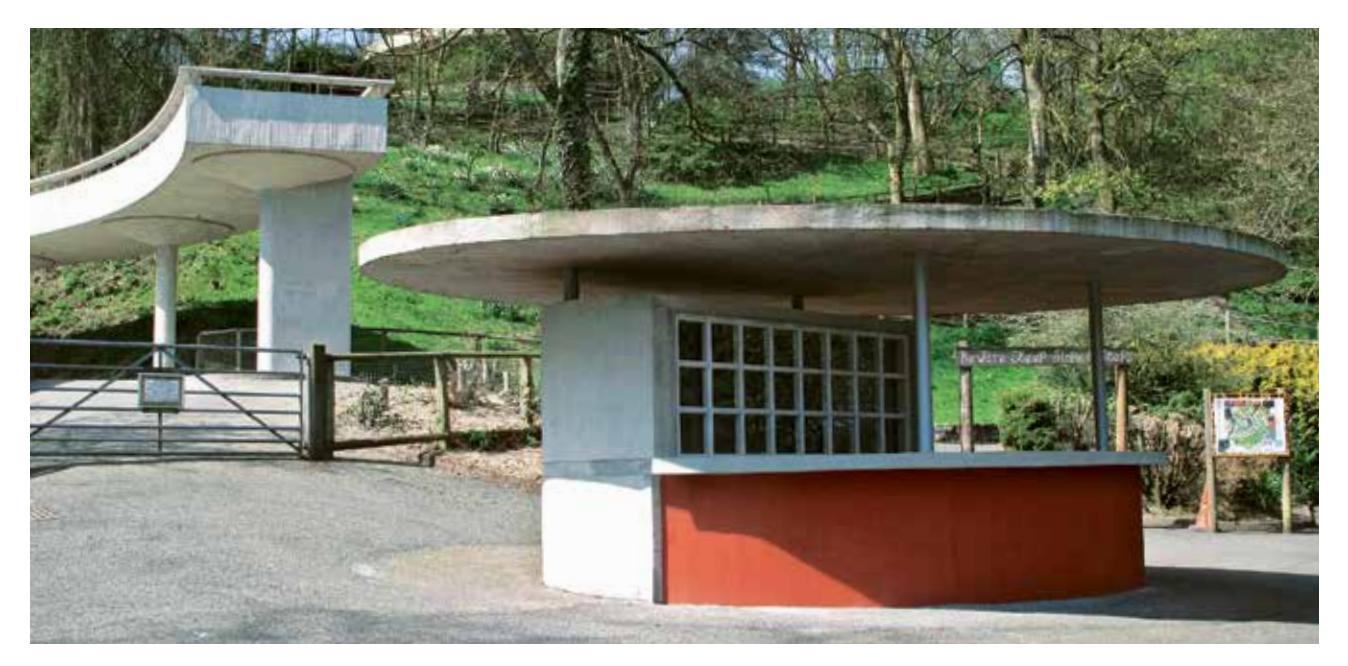
Fig. 4.16. The kiosk with bear ravine behind, following repair works, 2016.

The structural repairs to the nearby kiosk were relatively minor. The hollow steel columns had all corroded at the base, which meant that the support to the roof relied on friction where the columns passed through the reinforced concrete slab that formed the counter to the kiosk. Temporary props were installed before the permanent repair of steel sleeves was welded around the base of each post to reinstate the original support (fig. 4.16).
