CONSERVING MODERN HERITAGE

Concrete

Case Studies in Conservation Practice

Edited by Catherine Croft and Susan Macdonald

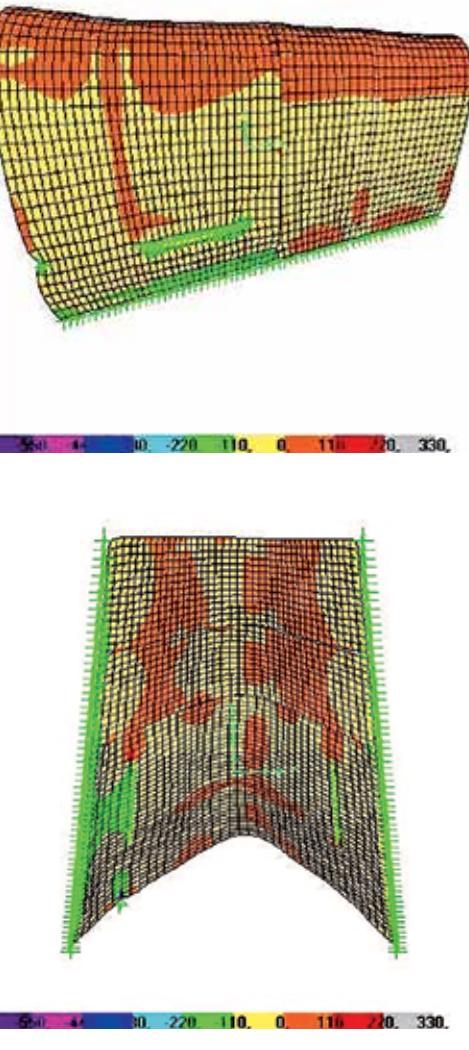
Fig. 5.7. Core structure behavior simulation, modeling the two existing expansion joints. The orange area indicates a concentration of stress in the location originally proposed for a third expansion joint. Image: Arquivo IPHAN/MG

Given that the historical research revealed that only two of the three originally proposed joints were constructed, simulations were carried out modeling both two and three expansion joints based on a temperature variation of o° to 50°C (32° to 122°F). The simulation of the building with the two existing expansion joints showed a concentration of radial stress, which could be observed in the front portion of the main vault. This indicated the need to introduce a third expansion joint in that location (fig. 5.7). Cracks found in this location on the building also indicated this need. Thus, it was concluded that the main cause of cracking to the outer layer (ceramic mosaic tiles and bedding mortar) and subsequent water ingress into the structure was due to the lack of a third expansion joint rather than problems with the foundations, as had been initially suspected. The studies also demonstrated that the cracks affected only the outer layer (ceramic mosaic tiles and bedding mortar) and not the underlying concrete structure.

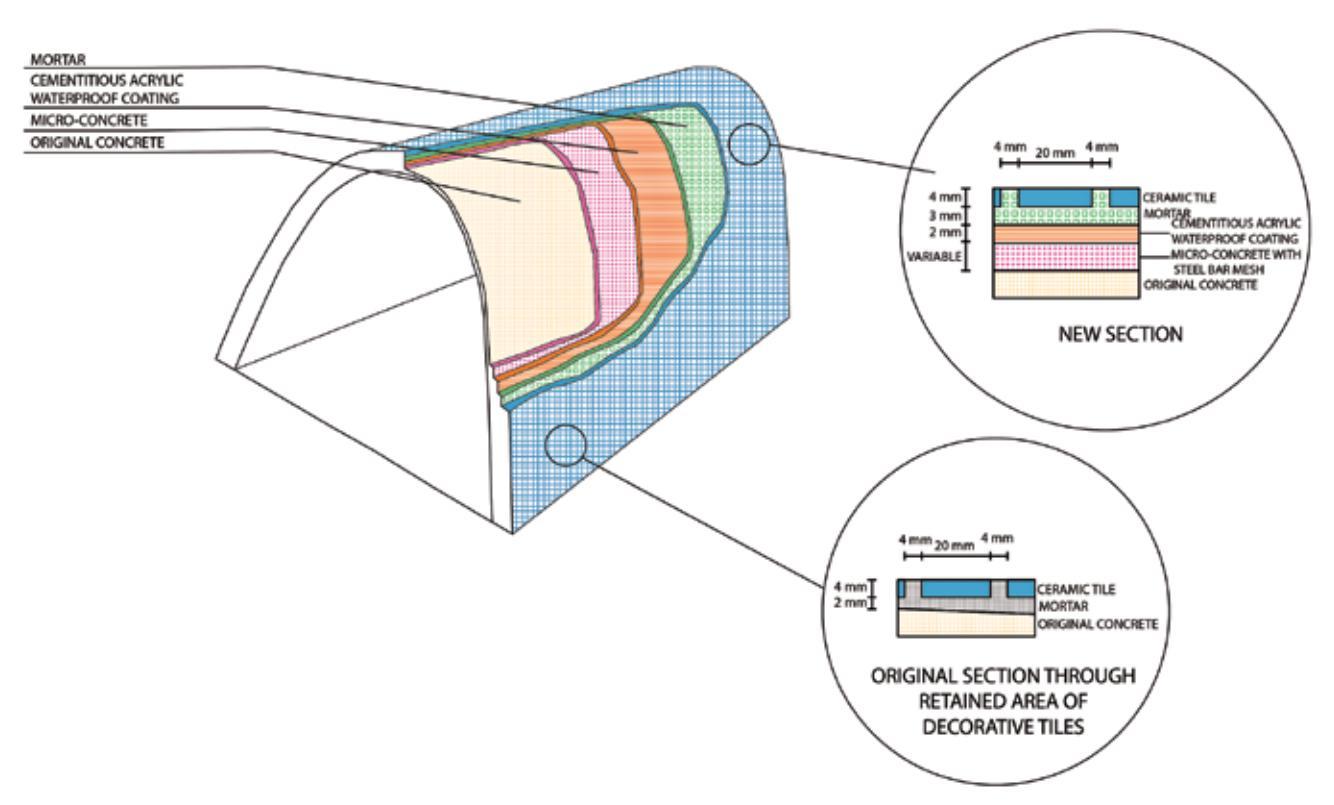
Fig. 5.8. Illustration comparing the section of the original outer layer that was retained in the area covered by an organic decorative mosaic and the new outer layer that replaced the 1990s intervention. The thickness of the original concrete structure and new micro-concrete vary depending on location. Image: Ana Marta Lins, 2016, based on an illustration from IPHAN report on the conservation of São Francisco de Assis Church.

To provide a solution to the surface cracking of the outer layer, all materials added in the prior interventions were removed. The previous interventions had all preserved the original ceramic tiles that form an organic design on the main vault, and the current intervention used the same approach. The original ceramic mosaic tiles were retained, while the non-original tiles were replaced along with layers of material down to the concrete substrate. The outer layer was then reconstructed with a leveling base of cementbased mortar (thickness of up to 3 cm) and with microconcrete (thickness of greater than 3 cm) (fig. 5.8) reinforced with a mesh of 15 by 15 cm with 3.2 mm steel reinforced bars (fig. 5.9). These materials were selected because they were compatible with each other and the original concrete. This new outer layer replaced the air-entrained concrete blocks that were installed in the 1990s.

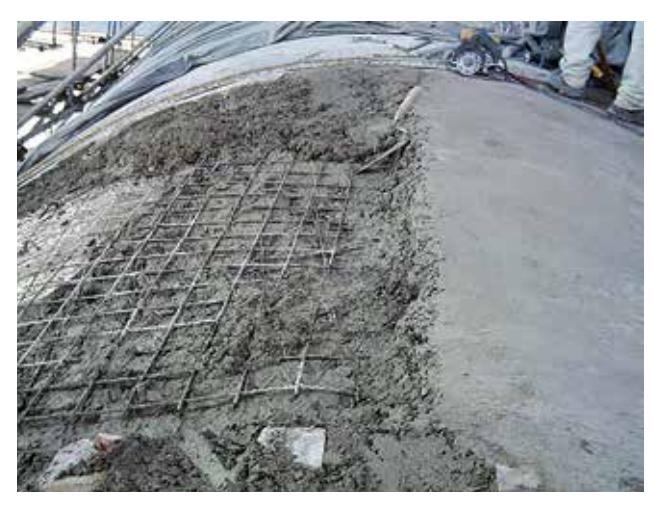
Fig. 5.9. The new mesh of steel reinforcement bars added to the leveling mortar. Photo: Arquivo IPHAN/MG $\,$

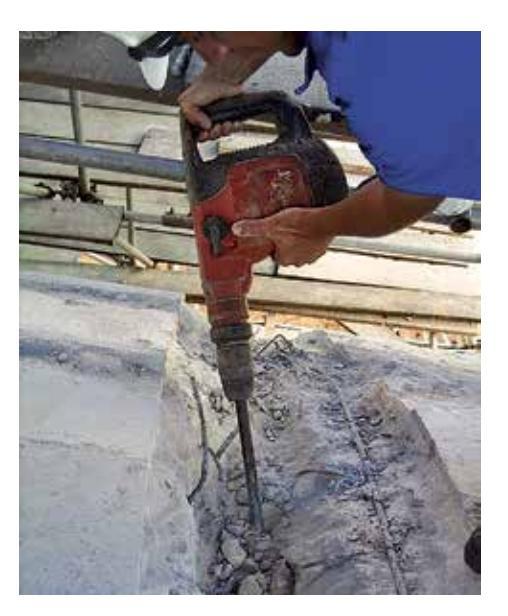
Fig. 5.10. Construction of the new expansion joint.

A major challenge was how to introduce the new expansion joint so as to accommodate the necessary stresses but also minimize physical intervention into the original materials. As a consequence, the opening of the joint was achieved by cutting through the concrete vault after removal of non-original outer-layer material (fig. 5.10) and careful localized removal of original mosaic tile, with proper documentation and numbering of each piece so that

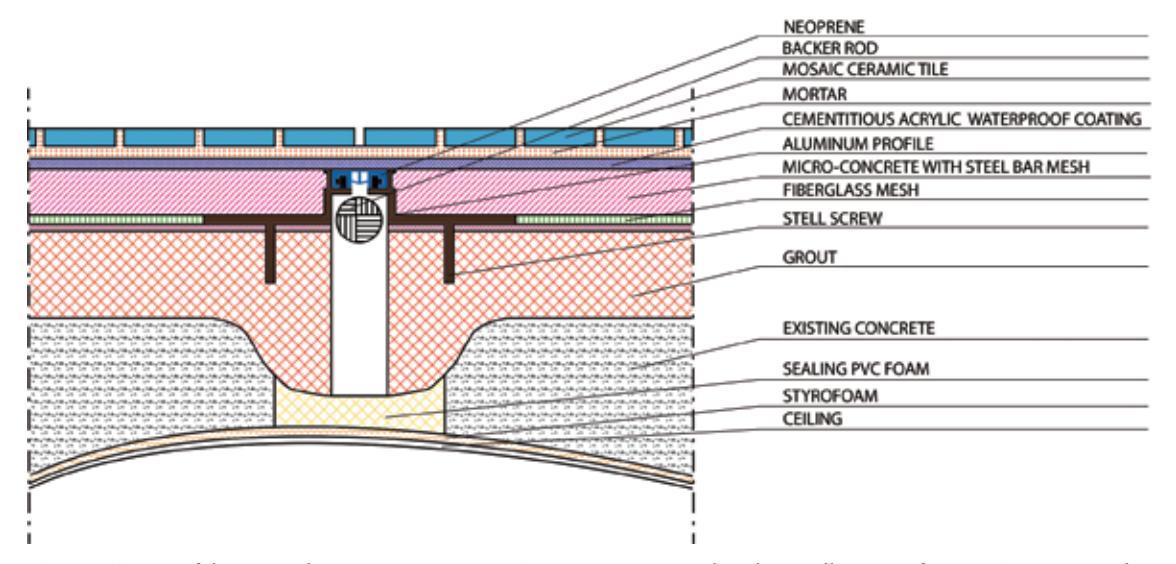
Fig. 5.11. Section of the executed expansion joint. Image: Ana Marta Lins, 2016, based on an illustration from IPHAN report on the conservation of São Francisco de Assis Church.

the original tiles could be later reinstalled. New and old joints received the same treatment: aluminum profiles were attached to the reinforced concrete vault by galvanized screws with a neoprene sealant (figs. 5.11, 5.12). The aluminum profiles were adapted to the parabolic format of the structure. To achieve this, incisions were made in the metal, and later soldered, in such a way as to guarantee a continuous structure without infiltrations. The external layers at the expansion joint were installed in the same way as in the rest of the structure, with only grout and fiberglass mesh added around the galvanized screws. This was finalized by saw-cutting the mortar and tile layers on top of the expansion joints and sealing with silicone (fig. 5.13).

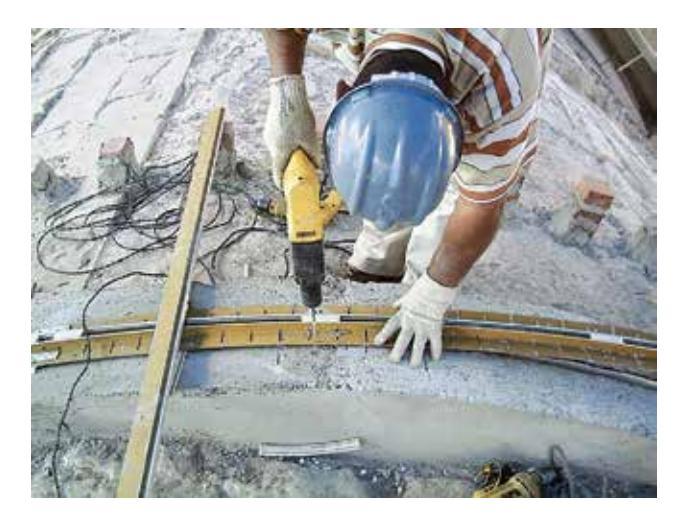
Fig. 5.12. Installation of expansion joint aluminum profiles.

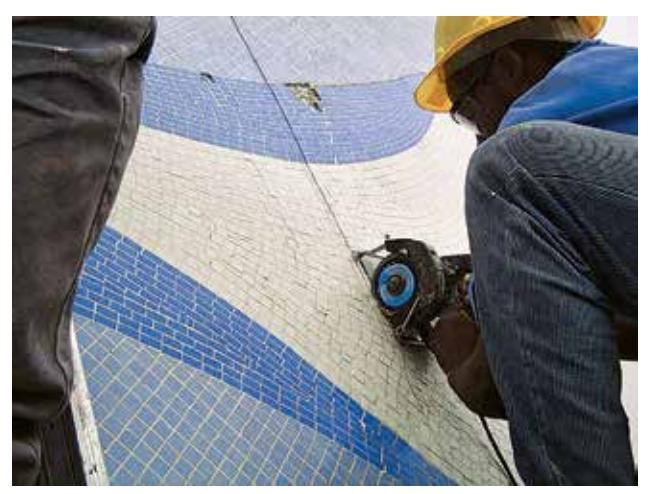
Fig. 5.13. Cutting the ceramic tiles over the expansion joint.

Following the diagnostic and research work conducted in 2003, the repair work to the church was performed between 2004 and 2005. Unfortunately, following this work, the mosaic tiles began to detach on the edges of the expansion joints, and later water started to infiltrate through the expansion joints in the main vault. The current problems have prompted a new repair proposal for the expansion joints of the main vault.

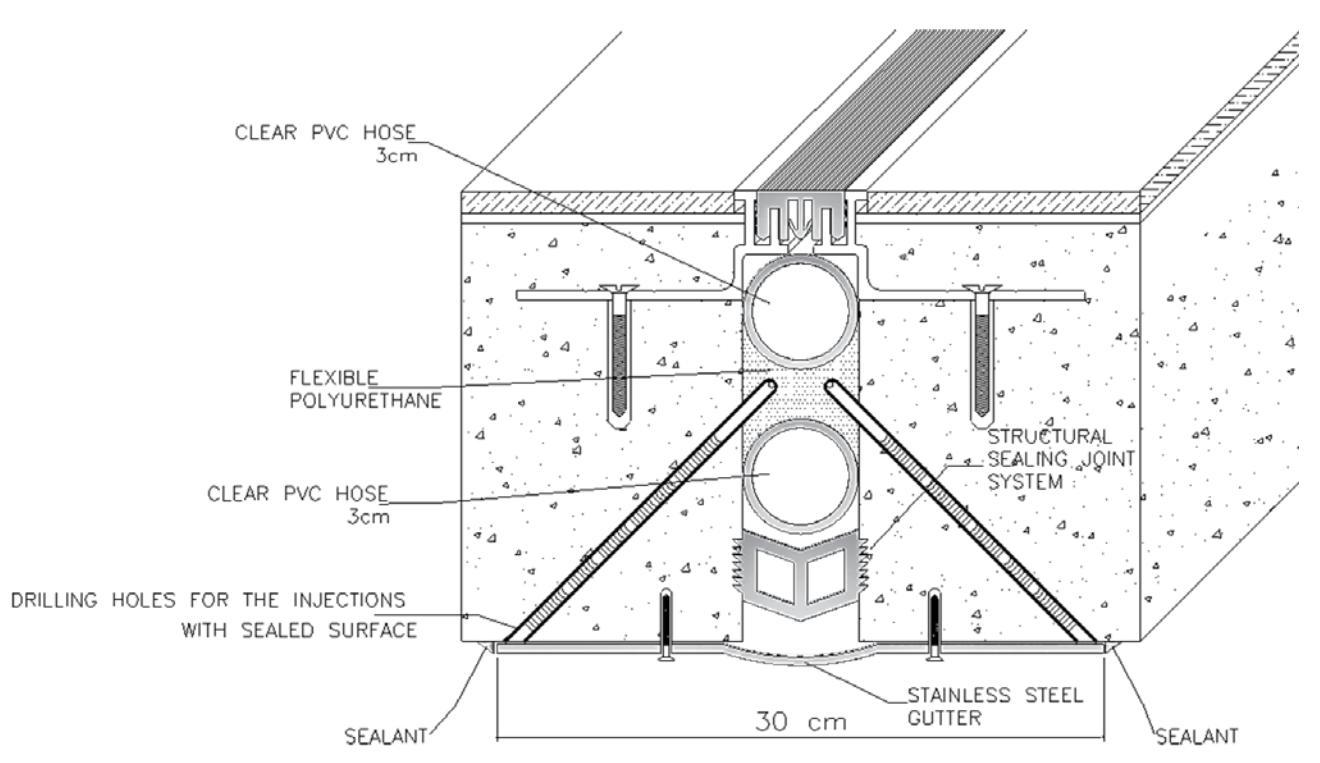
Fig. 5.14. New proposed solution for the expansion joints on the main vault.

to the need to respect the original layout of the tile, which runs diagonally to the new expansion joints, the proposed solution proved to be impossible, as it required laying the tiles in parallel to the joints. Therefore, it was later decided to apply the tiles directly to the mortar. This option required the use of a mechanical saw to cut the ceramic tiles following the position of the joints. It is likely that the neoprene sealant was cut when this work was undertaken, due to a lack of proper control of the cutting depth. Unfortunately, this was not realized until the first leaking was noticed inside the church some years after the repair.

Current leaking is restricted to the location of each of the expansion joints. A repair project will be undertaken to solve that problem and a proposal has been developed (fig. 5.14). It includes injection of flexible polyurethane by low pressure between two clear PVC hoses and the use of a Jeene rubber sealing joint system. This work also proposes the installation of a stainless steel gutter under each joint on the interior surface of the vault. This intervention will be executed from the inside of the church without removing the exterior tiles. The wood-paneled ceiling will be partially removed to give access to the repair area, but reinstalled once work is complete. Since this repair campaign requires closing the church to the public, the authorities are currently waiting until the end of the upcoming scheduled weddings to begin the execution.

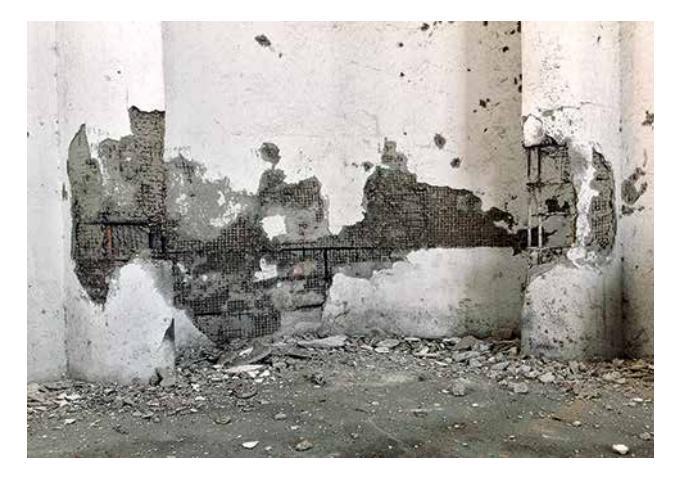
Fig. 6.8. Condition of one of the perimeter walls of the Magliana Pavilion before conservation, 2013. Photo: SIXXI Collection, Rome Tor Vergata University

Various deterioration effects and mechanisms were present prior to the conservation of the pavilion. Vast portions of the concrete were missing, and the metal mesh reinforcement was corroded in areas. Most of the damage was concentrated in the lowest horizontal area ringing the pavilion, caused by impact damage from cars during parking (fig. 6.8). The upper sections of the walls, which initially appeared to be better preserved, in fact had suffered more severe deterioration, which was revealed after removal of the surface coating. The coating had masked previous, inappropriate interventions that patched over large areas of concrete loss. Many of these were caused by attempts to hang lamps or security devices from the thin ferrocement walls.

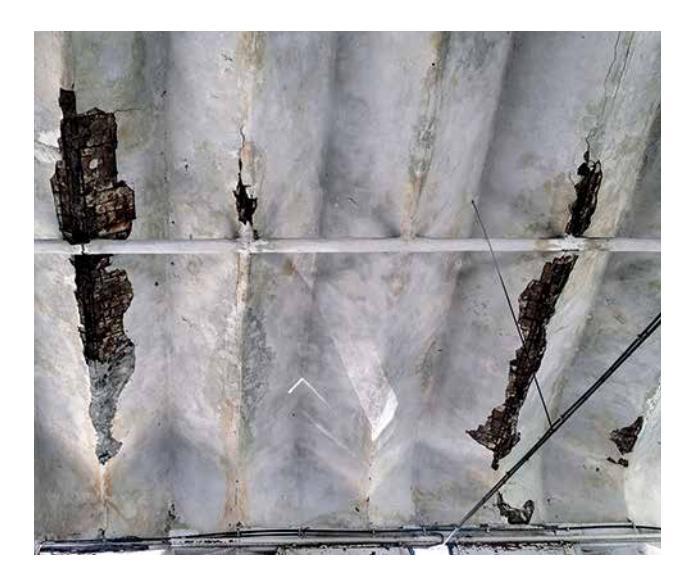
Fig. 6.9. Condition of the roof of the Magliana Pavilion, seen from the inside, before conservation, 2013. Photo: SIXXI Collection, Rome Tor Vergata University

The exterior surface of the concrete roof of the pavilion was also badly damaged. In fact, the roof had not originally been coated to waterproof it (fig. 6.9). Rather, in an effort to test the properties of the ferrocement, Nervi said, "It is also foreseeable that the impermeability of the roof will remain intact, without the need for an additional protective layer or moisture barrier, yet in this respect, we cannot draw definite conclusions until it has undergone the seasonal change from summer to winter at least two times" (Nervi 1945, 133).⁵ However, a coating of bituminous tar was applied a few years after construction when water infiltration became apparent, disappointing the engineer. When conservation work began, widespread damage to the external impermeable coating and the resulting clumsy attempts at maintenance had created pools of standing rainwater, leading to infiltration and resulting in clearly evident corrosion of the metal reinforcement and subsequent spalling of the concrete. Unfortunately, the extent of damage was more than anticipated, and the available funds were inadequate to cover the costs associated with retreatment of the roof with an impermeable barrier. This work is still urgently needed.

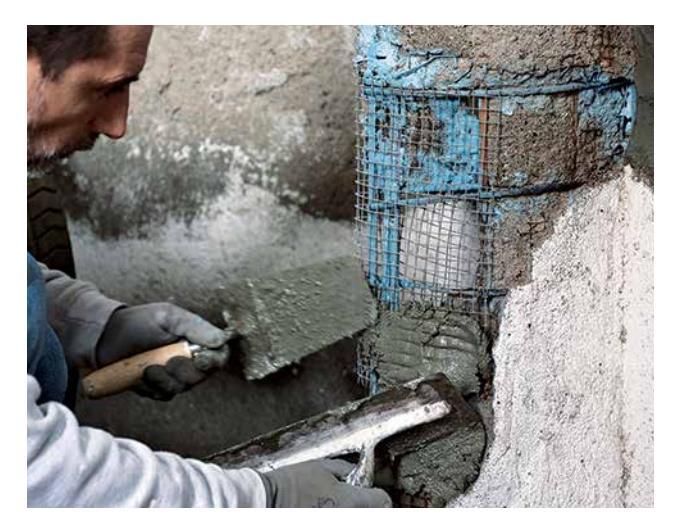
Fig. 6.13. Repair of the perimeter walls, 2013. Photo: SIXXI Collection, Rome Tor Vergata University

Portions of the metal reinforcement that had been exposed after cleaning and hammering were cleaned by hand with metal brushes and treated with a protective realkalizing corrosion-inhibiting protective coating. Sections of the original metal reinforcement that had been lost due to corrosion and breakage were replaced with a new layer of mesh of the same diameter and weave spacing. The new reinforcement was secured to the existing steel rods. In one section of the roof, corrosion of the principal framework of steel reinforcement rods had progressed to the stage where it compromised structural integrity and needed to be replaced. The rest of the structure was well preserved. In no case was it necessary to replace the wooden slats in the walls, which were perfectly anchored in the cement and as a result in an excellent state of preservation.

As the material is workable only for a limited time, it was mixed with water in small quantities and immediately applied with a plastering trowel (fig. 6.13). Its application, carried out by the firm SA.GI. Lavori snr of Rome, required exceptional care, following the curvature of the walls and roof (fig. 6.14). The repair mortar was extensively applied, in some places for only a few millimeters in depth; in others the full depth of the wall was reconstructed. The resulting somewhat patchy surface appearance is similar to its original state. This reflects the building's utilitarian function as a warehouse and the experimental use of the material. The surface was not repainted, enabling monitoring of the repair over time.

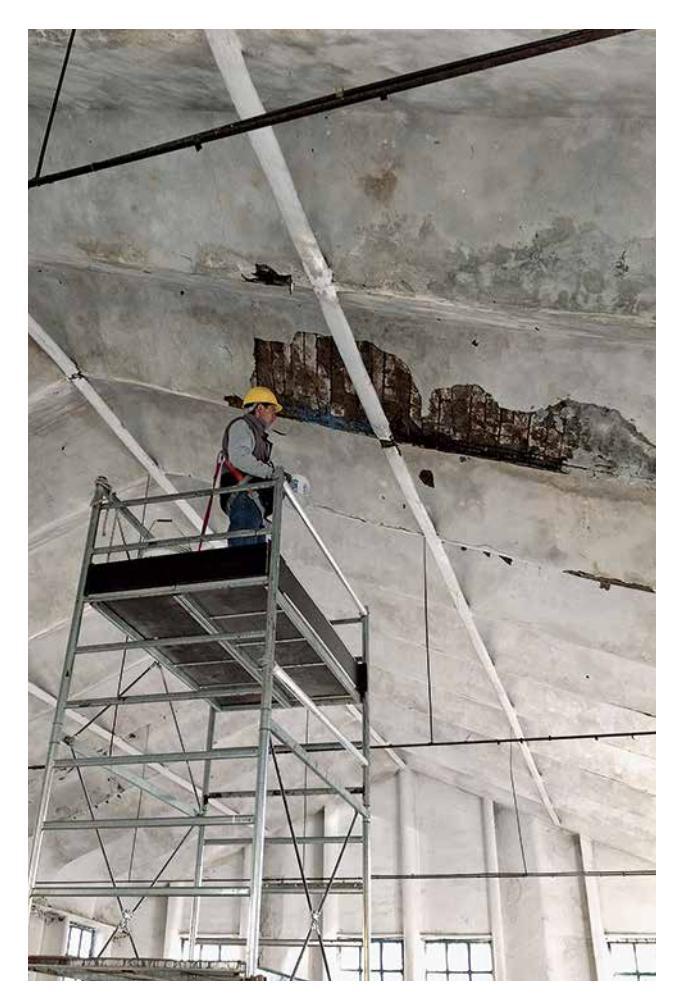
Fig. 6.14. Repair of the roof, 2013. Photo: SIXXI Collection, Rome Tor Vergata University

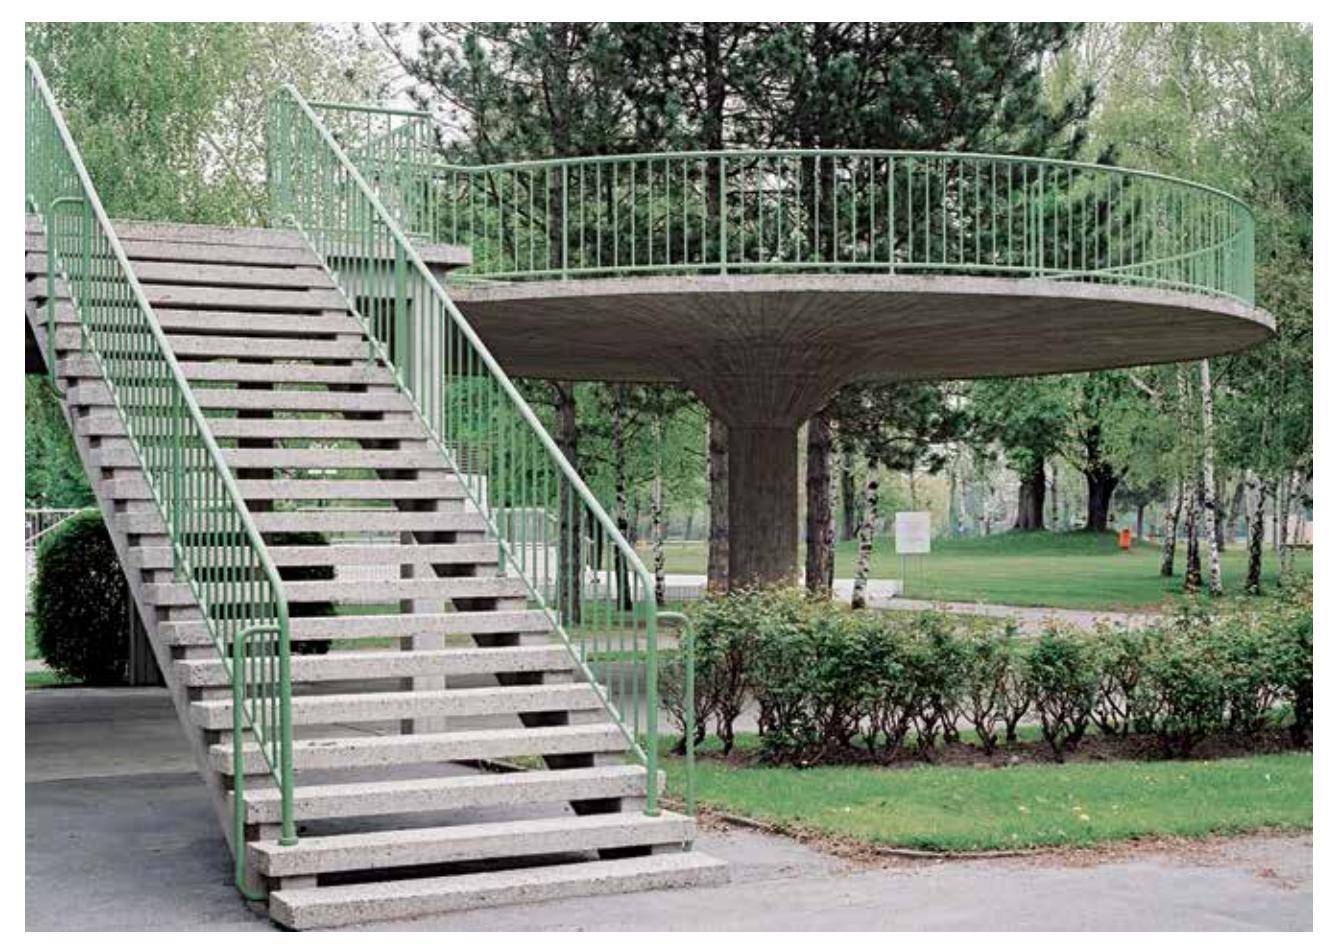
Fig. 7.5. The terrace to the café-restaurant is supported by a mushroom-head column, shown here following conservation. Photo: Bettina Neubauer-Pregl / Courtesy of Federal Monuments Authority Austria, Vienna

The architects paid special attention to the placing of the formwork joints. For instance, for the soffits of the rounded building volumes, such as the water tower, clock tower, and terrace to the café-restaurant on the mushroom head column (fig. 7.5), they produced special formwork plans that specified the direction and position of the formwork joints. In producing the concrete, the greatest care was also taken. It was regarded as imperative to avoid any honeycombing that would have to be remedied later.

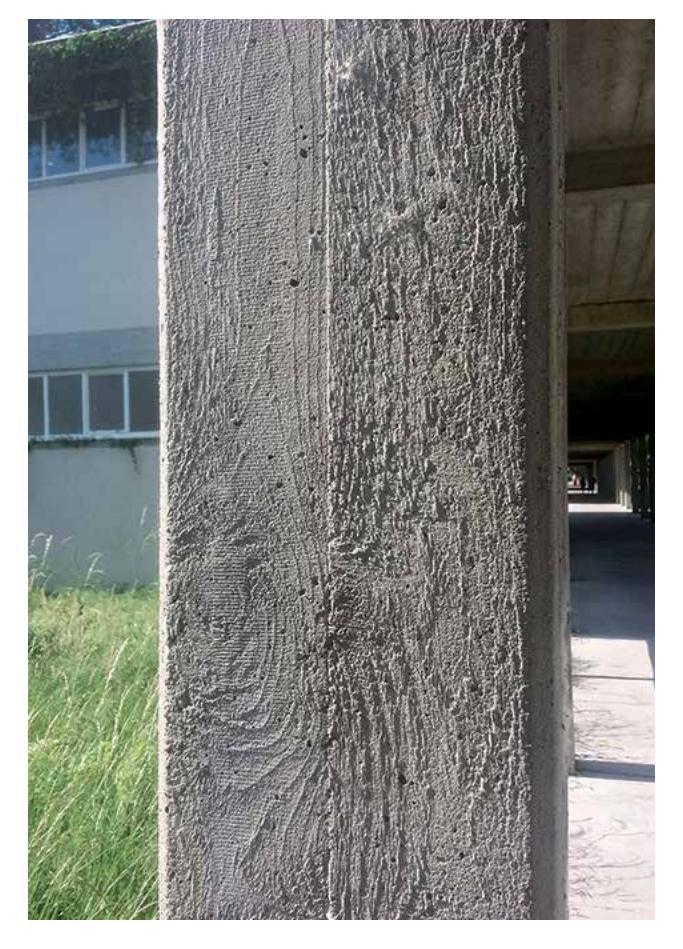
Similar to Auguste Perret's concrete architecture in Le Havre, in the Gänsehäufel buildings great importance was attached to carefully designed details and surfaces. These surface finishes are an important part of their architectural significance. From a conservation viewpoint, the uncoated, fair-faced concrete surfaces (fig. 7.6) of the buildings are an essential element of the architecture as a whole.

Fig. 7.6. Detail of a restored walkway column showing the exposed concrete surface, which was re-created using boards to match the original wood-grain surface finish.

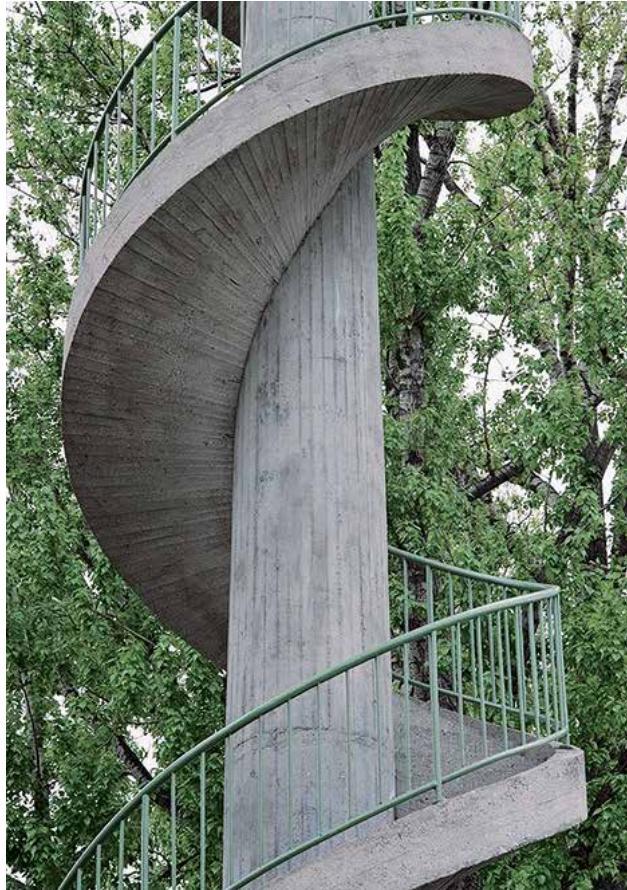
Fig. 7.7. The spiral staircase to the clock tower, shown here following cleaning and repair, had suffered less damage than the central shaft, and it proved possible to avoid giving the exposed concrete a full coating. Photo: Bettina Neubauer-Pregl / Courtesy of Federal Monuments Authority Austria, Vienna

ment stirrups and to corrosion of the main reinforcement. In some places, even the principal reinforcement was exposed. The damage was generally the result of insufficient concrete cover and was restricted to the load-bearing structure of the tower. Only some slight cracking and minor spalling were discovered in the staircase.

The clock tower (fig. 7.7) is a slender, conical reinforced concrete tower 27 m high. Its diameter in the lower area is 1.05 m, in the upper section 0.35 m. A spiraling reinforced concrete staircase with ninety-nine steps winds around it. At the top there is a platform (3.85 m in diameter), a loudspeaker system, and a clock with four faces, each 2 m in diameter (Fellerer and Wörle 1951b). As reinforcement, TOR-steel-40 rebar was used. This slender tower is regarded as a technical masterpiece.

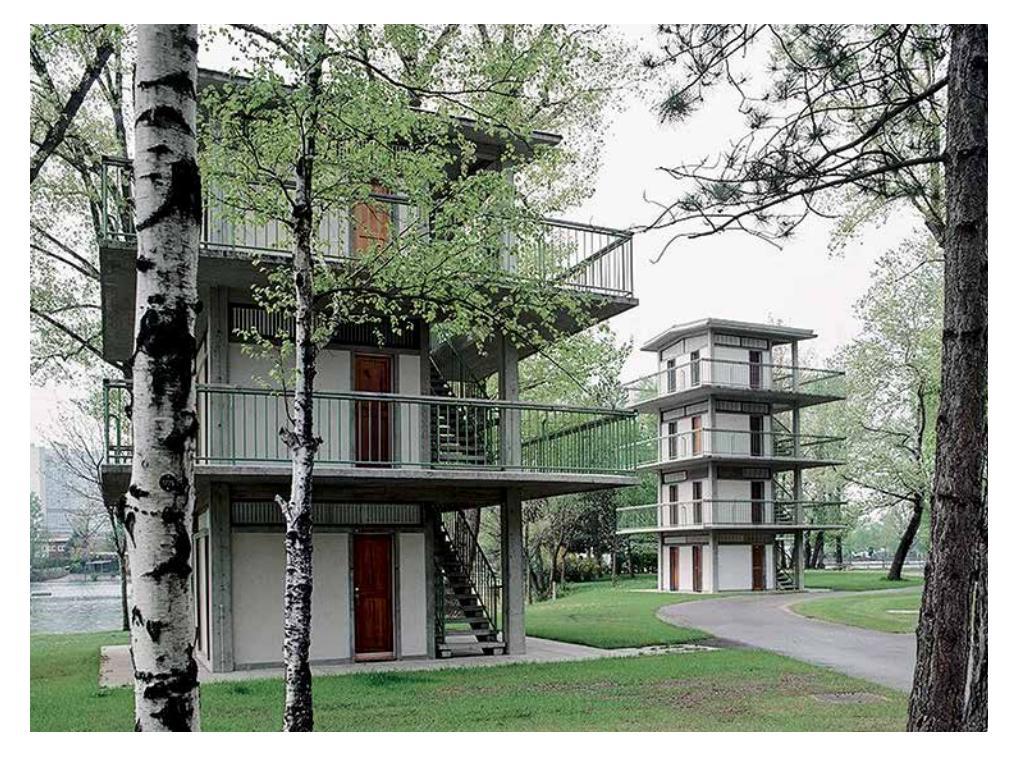
The changing cubicles are in three four-story towers and one three-story tower (fig. 7.9). The towers are particularly slender in terms of construction. Each structure is a reinforced concrete frame, with the cubicles on each level connected by continuous, open, cantilevered access decks. The reinforced concrete slabs are covered with a screed. The individual levels are connected by external single-flight staircases.

Fig. 7.9. The repair of the four cubicle towers with their thin projecting platforms, shown here following conservation, presented a particular challenge. Photo: Bettina Neubauer-Pregl / Courtesy of Federal Monuments Authority Austria, Vienna

The examination showed that the reinforced concrete slabs of the different levels in the cubicle towers were extremely thin (between 8 and 10 cm), there was insufficient reinforcement, and the existing reinforcement had not been well placed. The screed, particularly on the upper levels, had a number of open cracks. Here rainwater could enter the slab construction, leading to increased corrosion and consequently damaging the slabs.

To achieve a structurally acceptable solution for the concrete slabs, the protective screed on the access decks was removed and new reinforcement was bonded to the existing construction by means of synthetic resin. Instead of the screed, a very fine-grained and dense composite concrete was applied. Together with the additional reinforcement, this new concrete layer is only 4 cm thick. Between the outer edges of the slabs and the increased slab thickness a wedge of polymer concrete was made at the railings. This allowed the original, clearly visible thin edge of the slab to be retained. The new composite concrete slabs were given a synthetic resin coating that allows the rainwater to run off. This prevents moisture from reaching the construction of the thin floor slabs. These measures have ensured that the building can now take a load of 400 kg/m², which is in accordance with the standards.

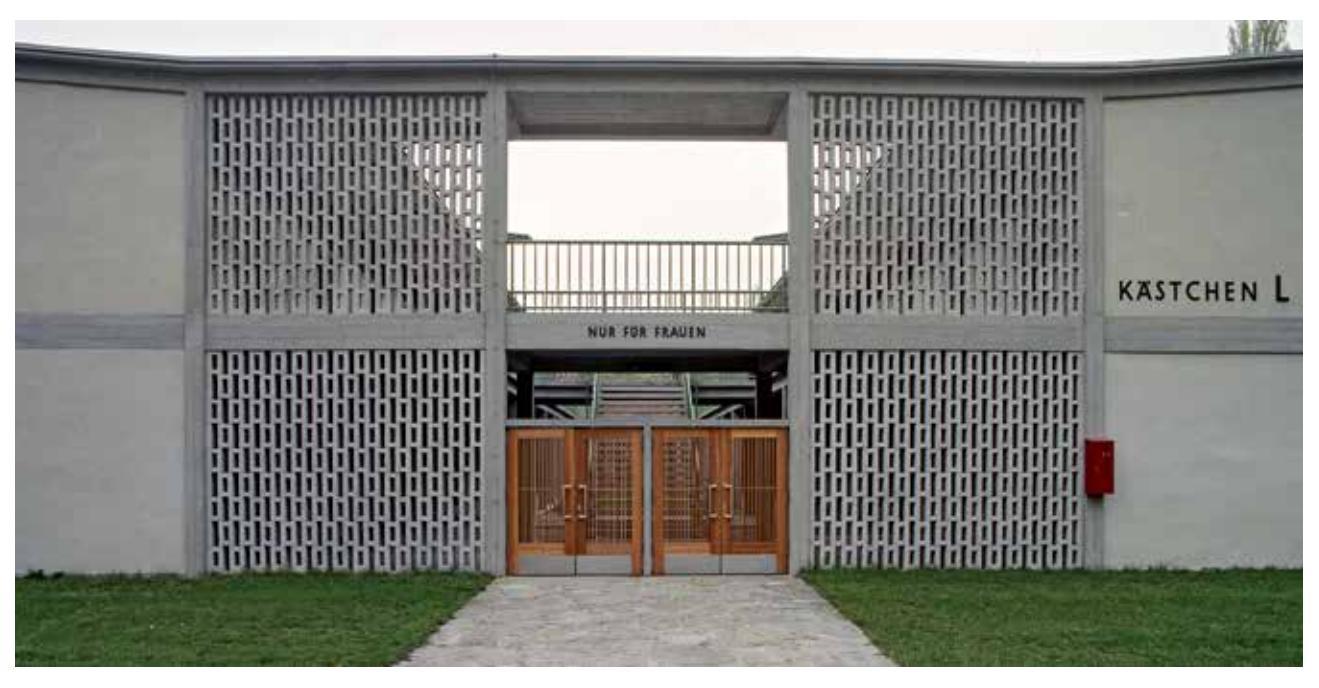
Fig. 7.10. Perforated concrete blocks, shown here following cleaning and repair, form a light curtain between the more intimate inner courtyard of the changing pavilions and the surrounding area. Photo: Bettina Neubauer-Pregl / Courtesy of Federal Monuments Authority Austria, Vienna

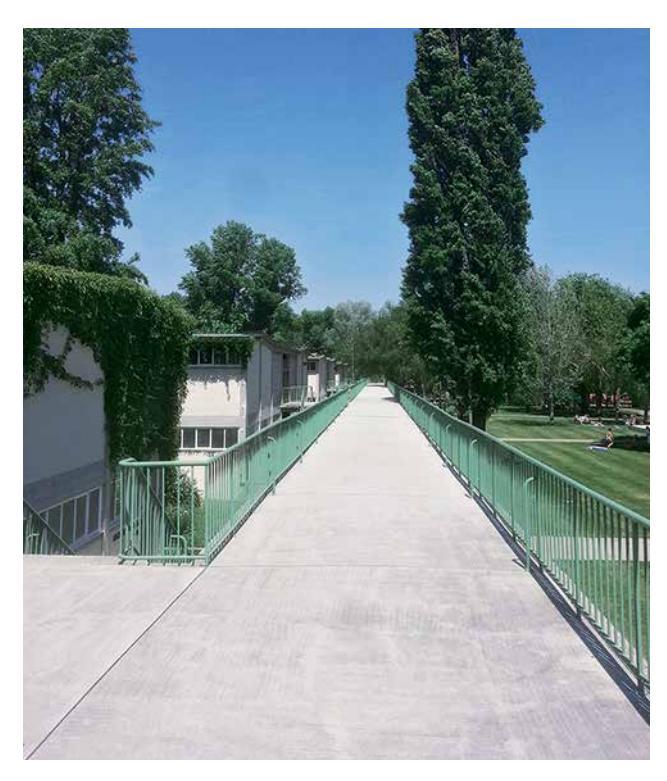
Damage caused by freeze-thaw and mechanical stress was discovered in the screed that had been applied as the finished surface to the walkway. The expansion joints that were filled with bituminous jointing material were not watertight. The walkway surface was applied directly to the structure, no sealing layer was used, and the structure had no rainwater drainage system. As a result, water

Fig. 7.13. A walkway 172 m in length, shown here following conservation, connects the changing pavilions. Due to its exposed location and the lack of a sealing layer, the screed and the 8 to 10 cm thick reinforced concrete slab had suffered serious damage.

and freeze-thaw damage had occurred to the reinforced concrete slab below. Particularly in the area of the expansion joints and brackets, serious corrosion damage had occurred with substantial reduction of the cross-sectional area of the steel reinforcement. A suitable way of sealing the slab construction had to found and adapted to the existing structure by means of tests on sample areas.

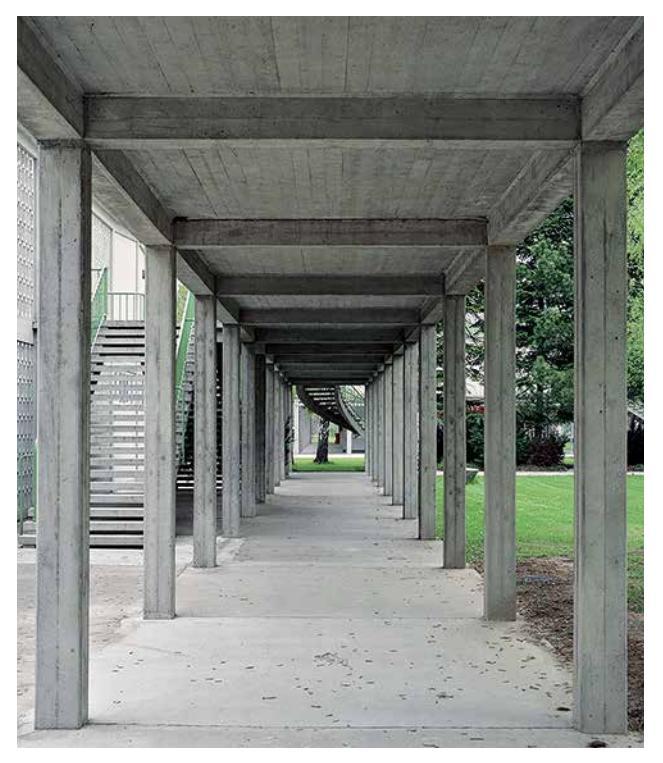
In 27% of the columns, the main reinforcement was exposed. The damage was principally at the base and lower ends of the columns. As the columns are overdimensioned, there were no stability problems. In 33% of the columns, there were cracks and spalling; in 40% of them, no visible defects were detected.

Fig. 7.14. The eighty-four square columns of the covered walkway had suffered damage, especially in the lower areas. This photo, taken following conservation, shows the original surface finish with partial, visually matching improvements. Photo: Bettina Neubauer-Pregl / Courtesy of Federal Monuments Authority Austria, Vienna

The concrete surrounding the heavily rusted reinforcement in the columns was chipped away as far as possible, sandblasted (surface preparation grade of steel substrate: SA 2½ International ISO-norm 8501-1: 2002-03, which is comparable with SP10 Near White Metal Blast Cleaning) (International Organization for Standardization 2002–3; Society for Protective Coatings [SSPC] 2007), and cleaned with dry air, and, without any waiting period, the reinforcement was immediately completely treated with an epoxycement-based bonding agent and anticorrosion coating

for steel reinforcement (Sika Top Armatec 110 EpoCem). A second coating followed after the first one had dried.

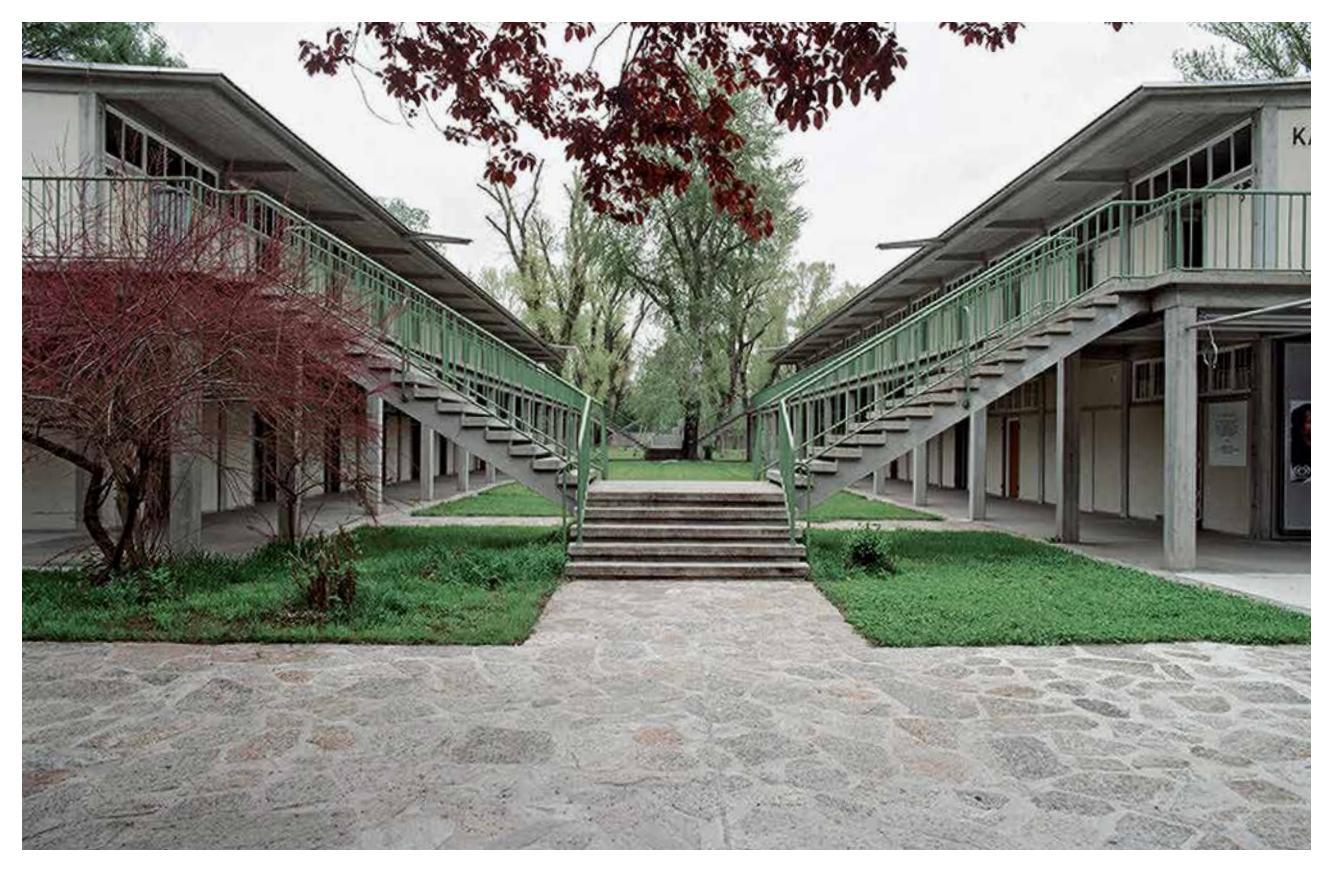
Most of the external staircases (fig. 7.16) in the Gänsehäufel were built from prefabricated elements and consist of two beams that carry slab-like steps. In the main beams to the staircases and at the bearing brackets, deep spalling with exposed and corroded reinforcement was visible. In places, the cross-sectional area of the main reinforcement had been clearly weakened due to corrosion. The evaluation of the main beams to the staircases produced the following

Fig. 7.16. It was by and large possible to preserve the precast concrete staircases between the changing pavilions. Photo: Bettina Neubauer-Pregl / Courtesy of Federal Monuments Authority Austria, Vienna

results: 0% had no visible damage, 39% had cracks and spalling, and 61% had exposed reinforcement. Most of the staircases could be repaired. A number of steps were replaced as precast elements, after being surface treated to achieve a good visual match.

In the case of the cabin pavilions (see fig. 7.16), in the area of the staircases, repairs had been carried out earlier. Below the upper bearing points of the staircases, transverse galvanized steel beams that are bolted to the columns had been introduced. These are barely visible. In addition, cracks and areas of spalling were closed in the course of restoring the concrete. Through this measure, the stability of the main staircase beams has been ensured in the medium term. Consideration was given to rebuilding the staircases to match the originals, but it was decided for the time being to retain the existing solution with the steel beams.

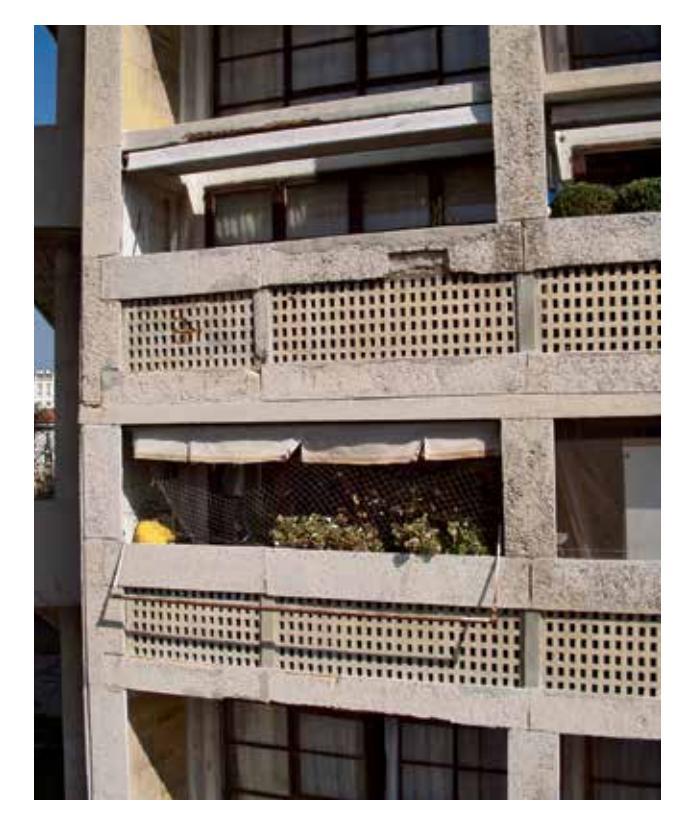
Fig. 8.3. Detail on west facade showing damage before conservation, 2001.

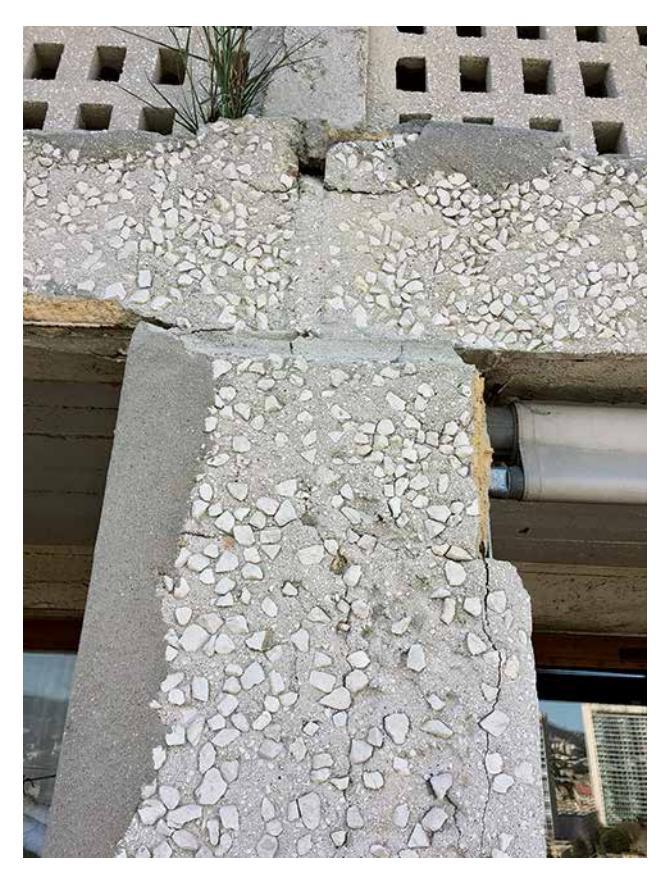
Fig. 8.5. Damage on prefabricated panels and trace of former repairs, 2016.

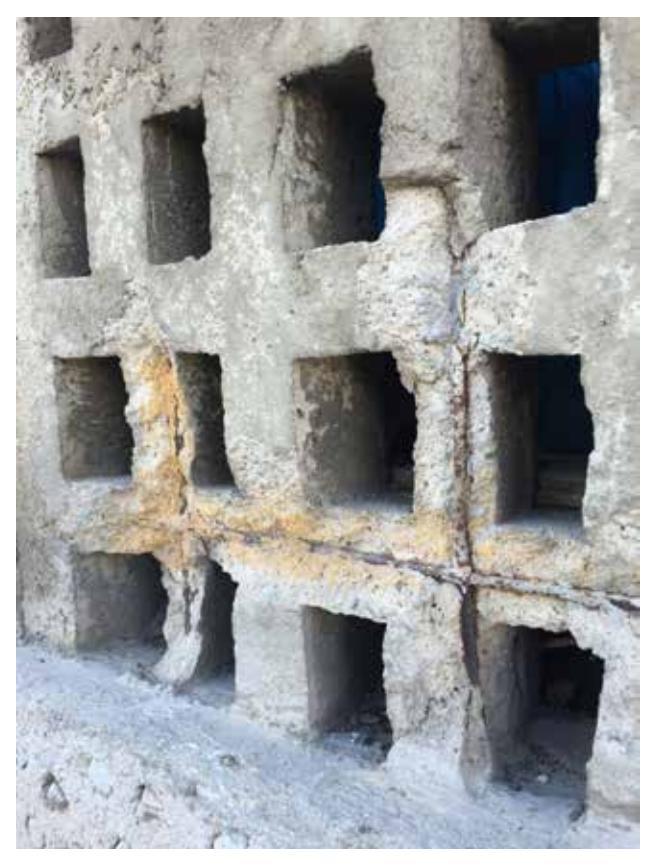
Fig. 8.6. Damage on a prefabricated parapet, 2016.

rigorous criteria. Elements that were cracked, either lengthwise or crosswise, were systematically removed since their limited thickness (4 to 7 cm) precluded any lasting repair. Irregularities located at the edge of an element, if only one per piece, were repaired following the same method as for formed concrete (cutting out, cleaning, placing of repair concrete, surface treatment, and application of decorative aggregate to the surface). Any elements with extensive damage or more than a single irregularity were removed (fig. 8.10).

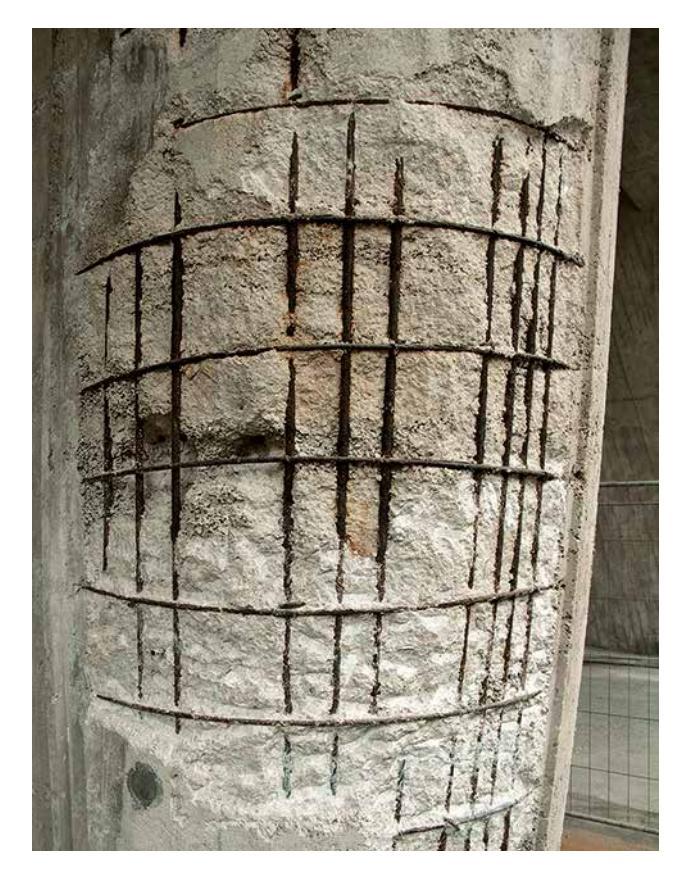
For one of the pilotis that was highly degraded with very significant honeycombing, the amount of concrete to repair was so great that temporary shoring had to be put in place

Fig. 8.7. Condition of piloti number 2: poor quality of concrete and corroded reinforcement bars, 2004.

while the repair was carried out (figs. 8.7, 8.8). The shoring was calculated to compensate for the loss of load-bearing capacity equivalent to the capacity of the concrete removed. The reinforcement was either replaced or repaired, and then the new concrete was poured into formwork (fig. 8.9). The concrete was formulated to match the original, following the analyses conducted during the preliminary studies, with no additives. A light cement wash was applied after pouring the concrete in order to cosmetically harmonize the conserved parts and the new ones. The result was quite satisfactory.

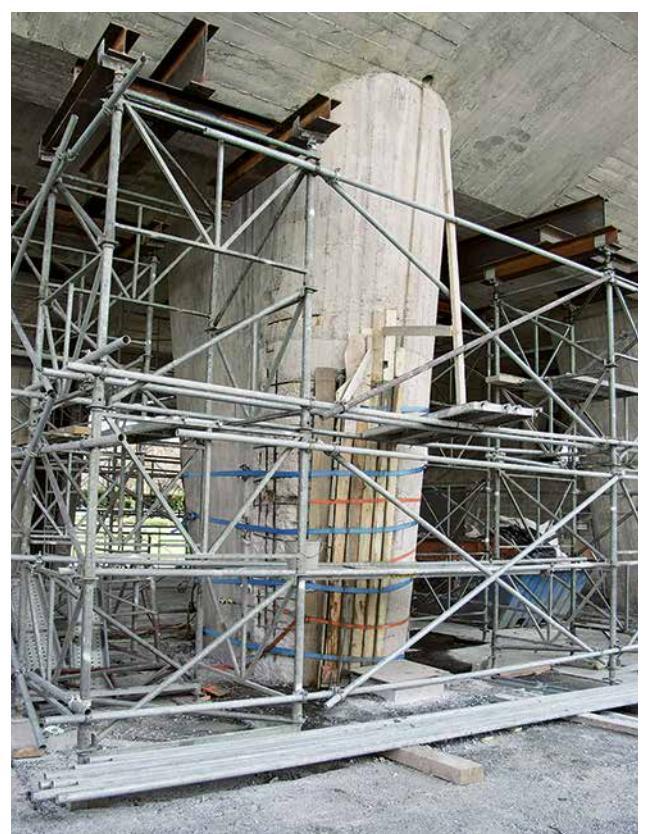
Fig. 8.8. Partial reconstruction of piloti number 2, 2004.

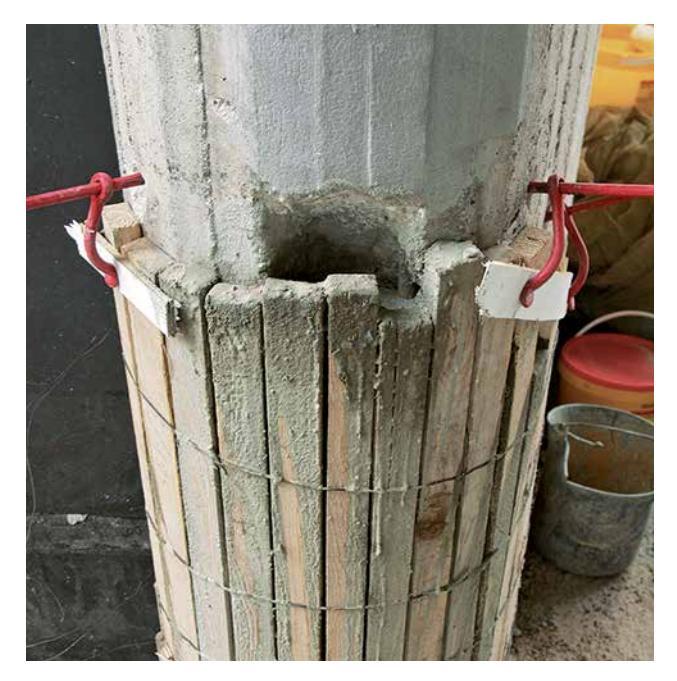
Fig. 8.9. Reconstruction of piloti showing board formwork, 2004.
