CONSERVING MODERN HERITAGE

Concrete

Case Studies in Conservation Practice

Edited by Catherine Croft and Susan Macdonald

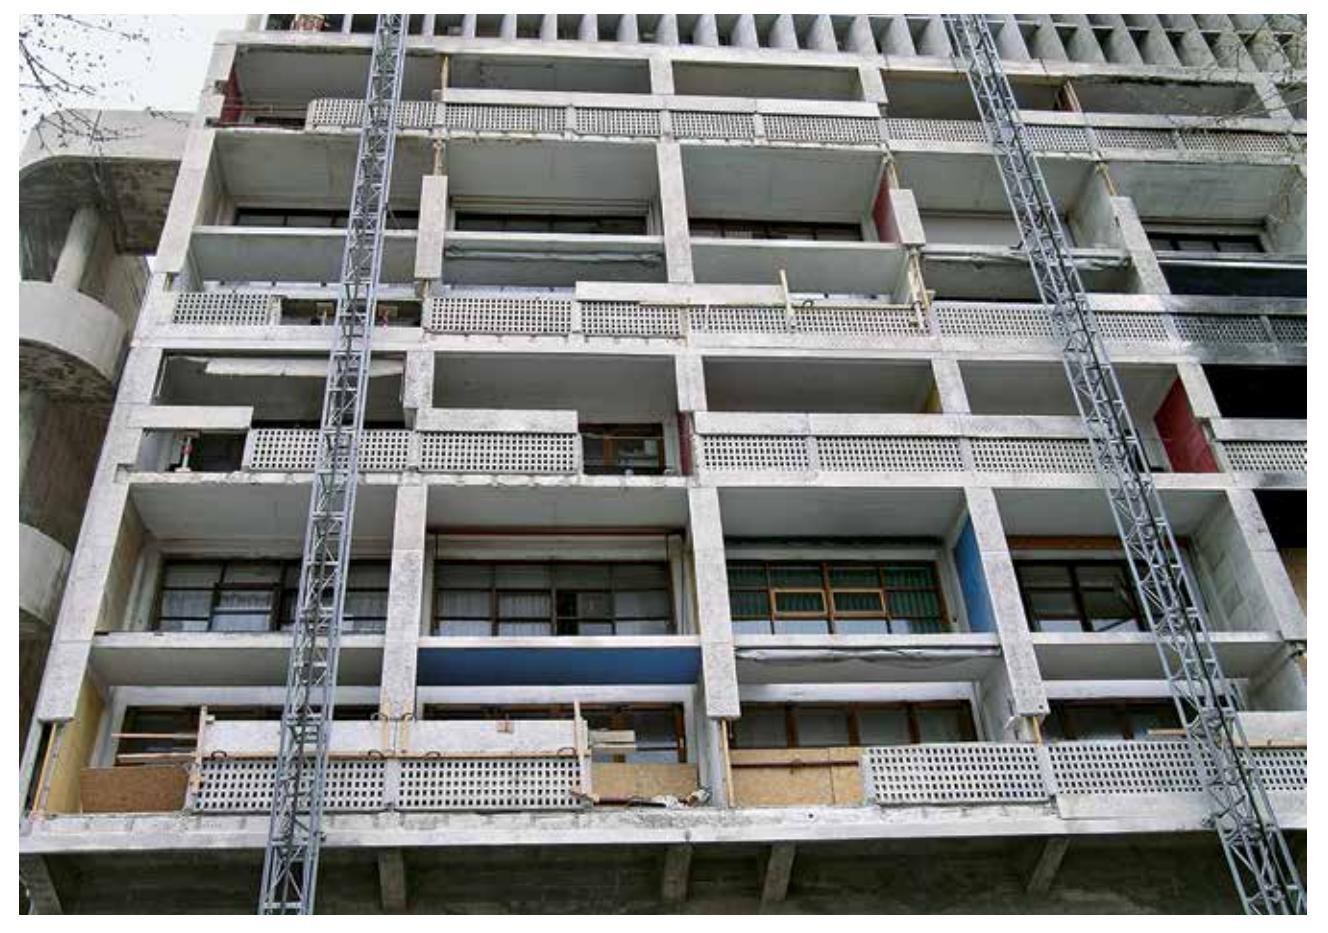
rigorous criteria. Elements that were cracked, either lengthwise or crosswise, were systematically removed since their limited thickness (4 to 7 cm) precluded any lasting repair. Irregularities located at the edge of an element, if only one per piece, were repaired following the same method as for formed concrete (cutting out, cleaning, placing of repair concrete, surface treatment, and application of decorative aggregate to the surface). Any elements with extensive damage or more than a single irregularity were removed (fig. 8.10).

Fig. 8.10. Section of a facade after selective removal of panels to be replaced, 2003.

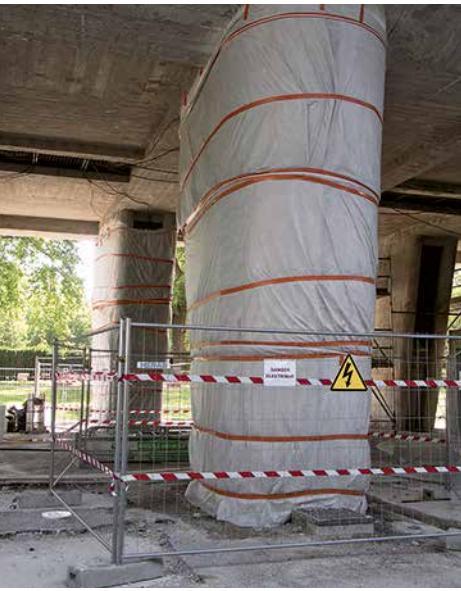
Fig. 8.15. A piloti undergoing realkalization, 2005.

The method for realkalization commenced with an assessment of the reinforcement. The extensive collection of plans and construction site photos at the Le Corbusier Foundation were used to identify and locate the distribution of the rebar and the connections. It was difficult to achieve electrical continuity in zones where the reinforcement was corroded and verification of electrical continuity needed to be confirmed through the assessment process. Placement of power supply points on the reinforcement was the next step, then the installation of the anode network in the form of titanium mesh. This was followed by the application of electrolyte paste, then alkaline impregnation and covering of the surface with plastic foil to prevent evaporation. The system was then powered on and the current left in place for about three weeks, after which it was removed and checked (fig. 8.15).

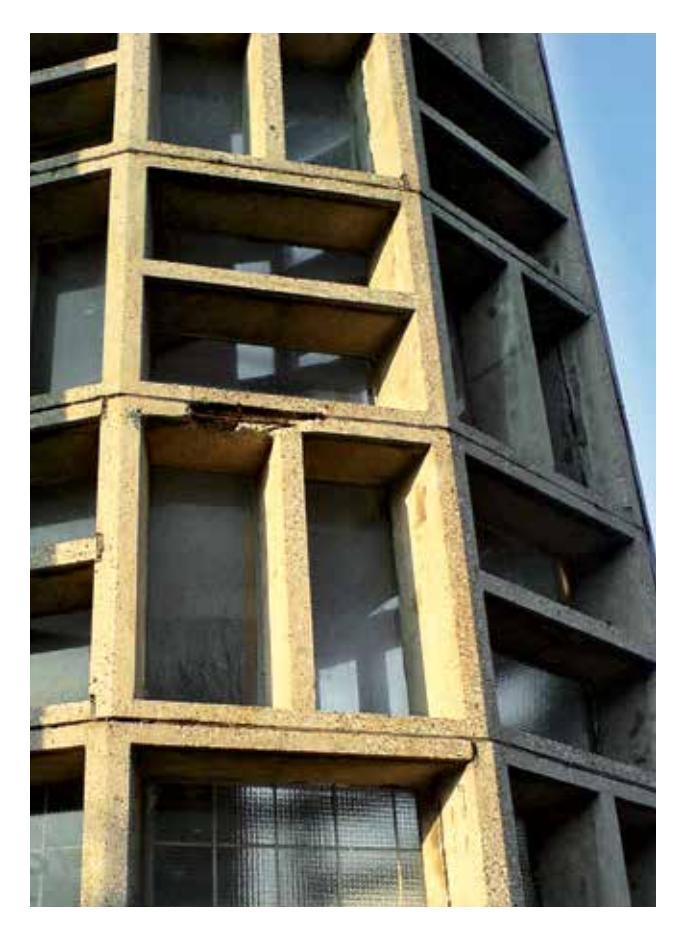
On the other hand, the thin cladding panels and the segmented facade elements of the cylindrical staircase, which both have a sandblasted surface showing a rough texture exposing coarse aggregates, were believed to have been produced by the shockcrete process because of their shallow dimensions. This assumption was later supported by the low carbonation depths that were found, which are typical for mechanically compacted concrete (fig. 9.6).

Fig. 9.6. The segmented facade elements of the cylindrical staircase feature shallow members just 40 mm wide, with integrated glazing rebates. Although generally in good condition, some of the members showed spalling due to rebar corrosion. Photo: © Wessel de Jonge Architects, Rotterdam

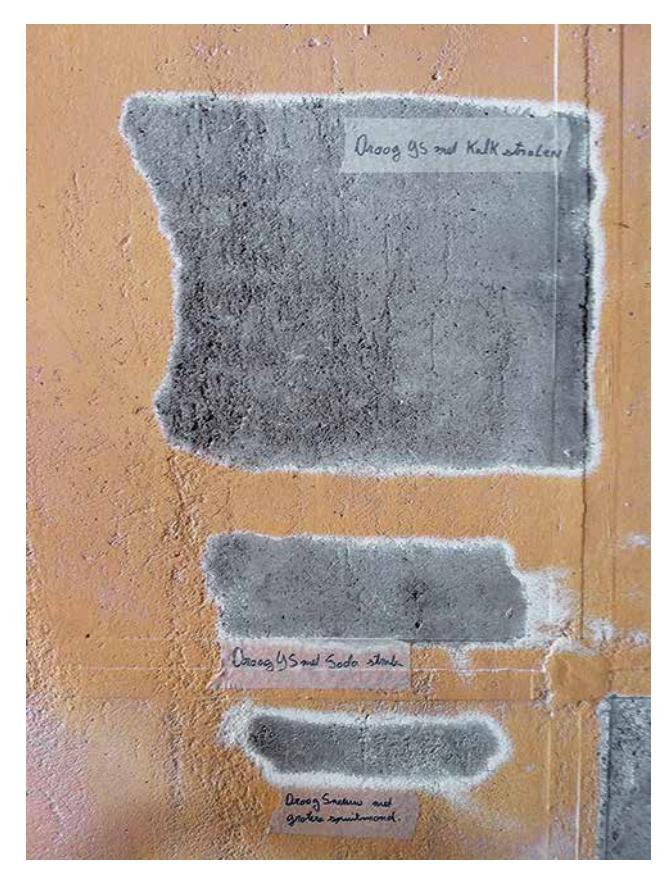
Fig. 9.9. Tests of paint removal around the main bas-relief by blasting with a mixture of dry ice and lime (top), and dry ice and soda powder (middle). Blasting with just dry snow using a variable nozzle width (bottom) was finally selected for the area adjacent to the artworks. Photo: © Wessel de Jonge Architects, Rotterdam

Ultimately, dry snow blasting was chosen, as it appeared that the original texture of the concrete surface was hardly affected, if at all. Indeed, the finer nozzles allowed work within millimeters of the artwork. By filling the bas-relief grooves with rubber strings during the works, the coloring on the bas-relief itself could effectively be protected from the impact of the snow crystals (fig. 9.10).

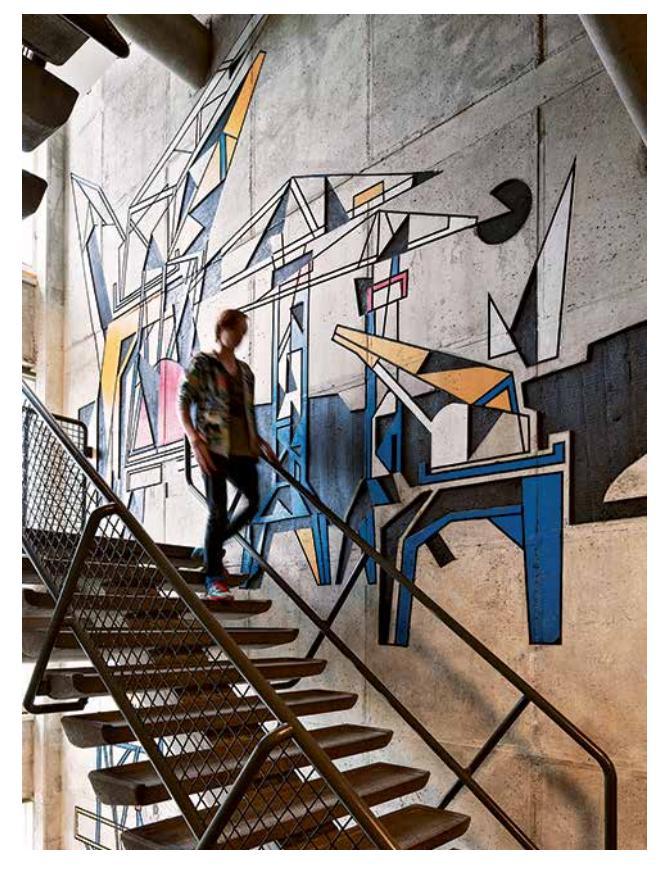
Fig. 9.10. The bas-relief in the main staircase after carefully removing the peach-colored paint around it, successfully using the snow-blasting technique. Photo: Raoul Suermondt Architectural Photography

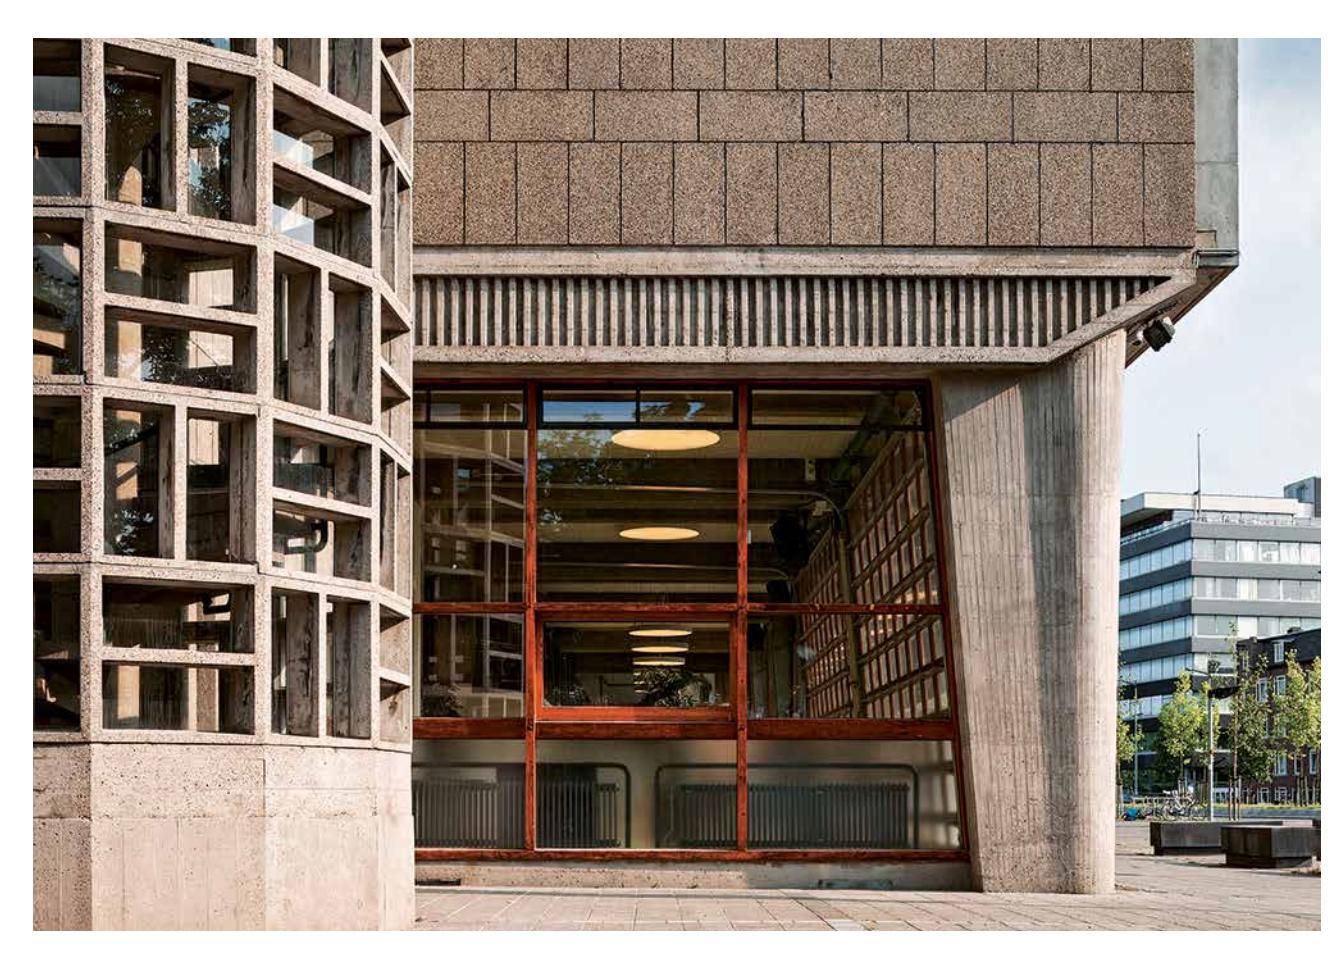
Fig. 9.12. The north end of the school building after conservation works, showing the repaired shockcrete facade panels (top) and segmented elements of the cylindrical staircase (left), and the chassis on pilotis cast in situ (right). The lower 2.5 m of all concrete work was treated with a matte anti-graffiti coating that is almost invisible. Photo: Raoul Suermondt Architectural Photography

A semipermanent reversible coating that includes natural polysaccharides dissolved in water was applied as an antigraffiti coating to the exterior concrete surfaces. This was applied up to a level of about 2.5 m from street level, which is all in situ concrete. Sprayed on the vertical surfaces after humidifying the substrate, it leaves an extremely thin protective film that is invisible to the human eye and is completely vapor permeable. The coating is harmless to the concrete itself and even slightly assists in reducing porosity and carbonation risk. The applied product was PSS-20, provided by the Dutch firm Gevelmeesters. The agent is matte and slightly buff-colored, which worked well on the concrete work of the school building (fig. 9.12).

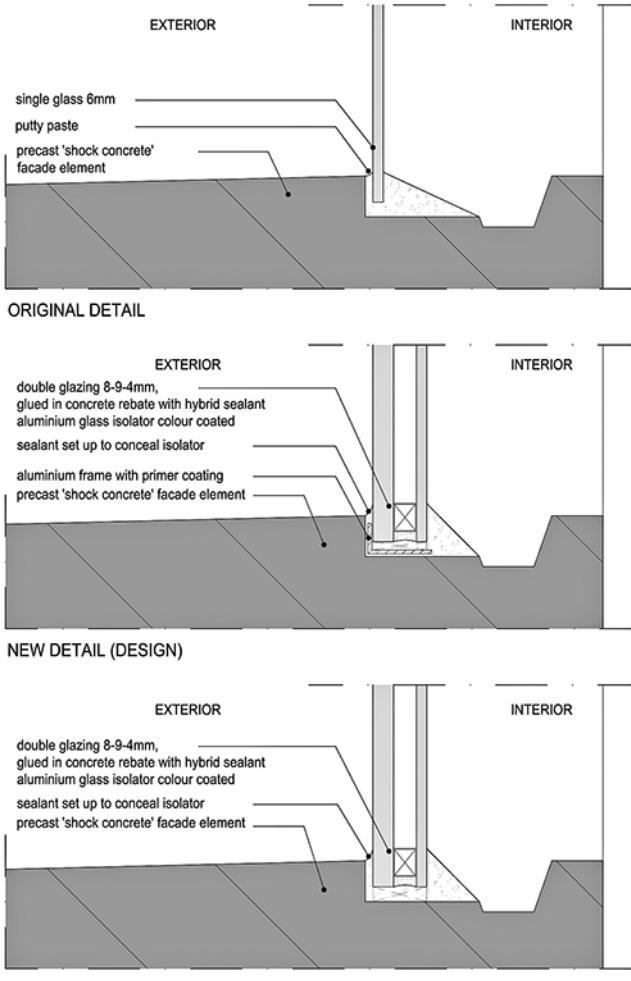
Fig. 9.13. Schematic drawing of the original glass-in-concrete detail of the brise-soleil elements (top), the new detail with insulated glass units in an aluminum profile as specified for the works (middle), and as proposed by the supplier and finally made (bottom). Drawing: © Wessel de Jonge Architects, Rotterdam

A detail was developed with an aluminum profile that would smoothly receive the glazing, but after contracting the works, the supplier unexpectedly came up with a solution to glue the glazing straight into the concrete rebates with a sealant. Using a product the same color as the concrete made the improved fixing of the double-glazing units unobtrusive (fig. 9.13). Waterproofing relies completely on the sealant, but as the windows are recessed behind the brise-soleils that act as windbreakers, the settings are less directly prone to wind or rain impact. Still, the sealant must be periodically checked from inside and outside, and replaced when necessary, to prevent water infiltration.

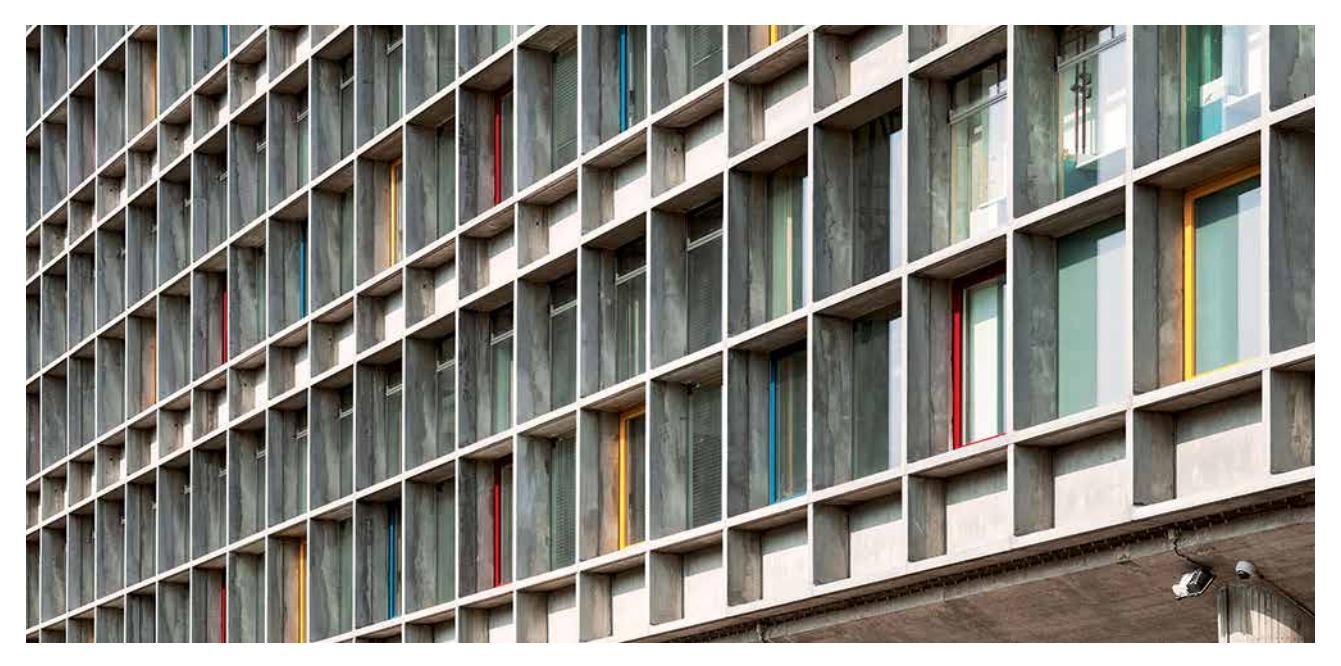
Fig. 9.15. Close-up of the brise-soleil facade. Earlier patch repairs are concealed by the light-and-shadow effect, which allowed them to be left as they were and the budget to be spent on the other facade panels. Photo: Raoul Suermondt Architectural Photography

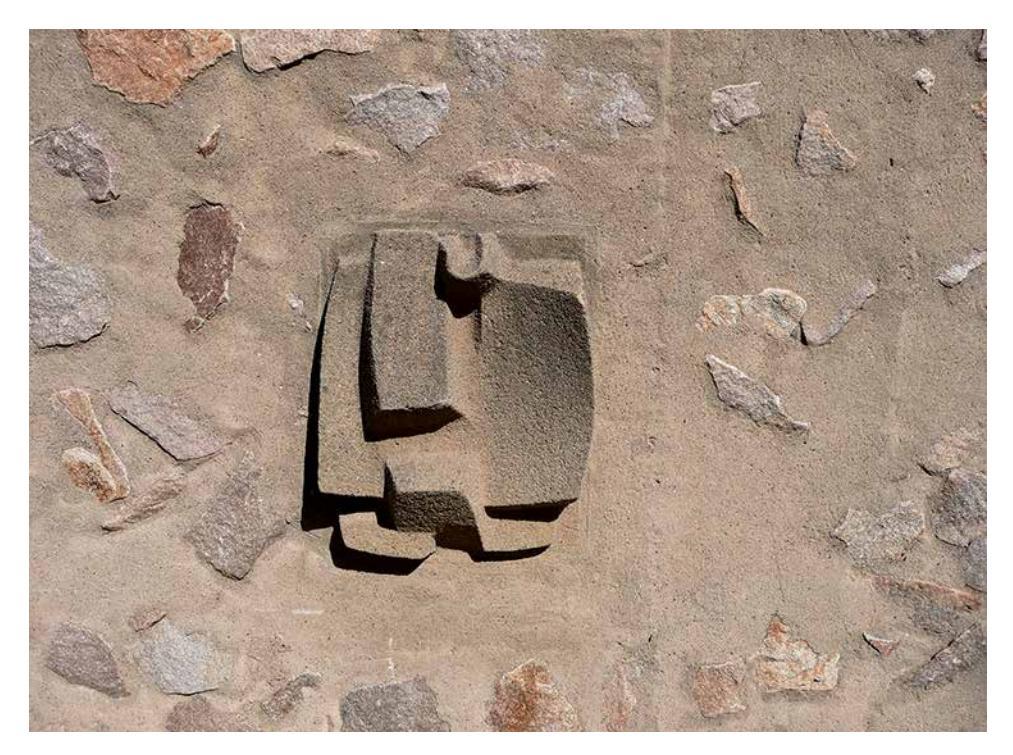
Original construction also included sculptural elements of smooth-finished concrete, embedded in the exterior walls or as freestanding sculpture along walkways and in courtyards (fig. 10.3). Some of these elements had been marred by inappropriate previous repairs that required removal and further repair.

Fig. 10.3. Concrete sculpture with smooth finish set in rubble concrete wall. The sculpture appears to have been mortared in place after construction of the rubble wall. Photo: Wiss, Janney, Elstner Associates, Inc.

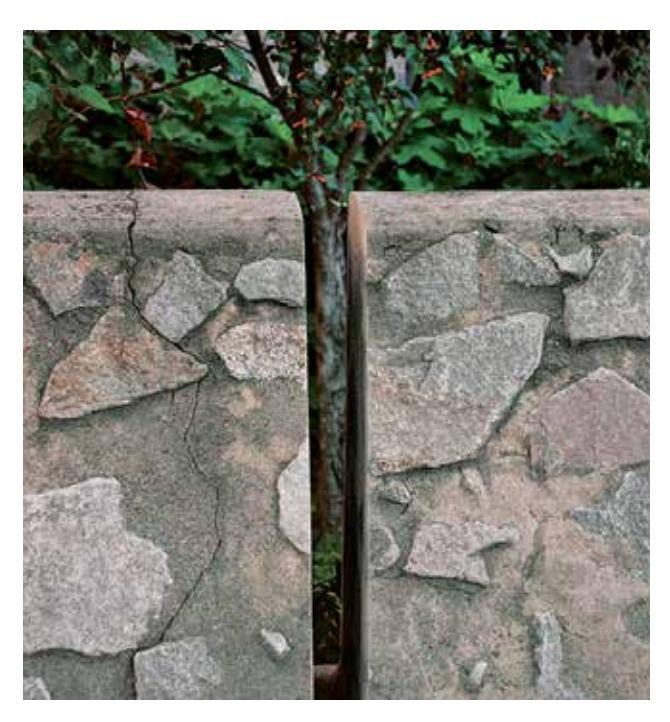
Fig. 10.5. Detail of adjacent sections of rubble concrete site wall. The top surface of the wall was pargeted with a cementitious mortar as part of original construction to provide a finished surface and enhanced moisture resistance. Note the vertical cracks in the concrete. Photo: Wiss, Janney, Elstner Associates, Inc.

Field investigation was conducted, relying primarily on visual inspection and nondestructive techniques such as sounding and use of cover meters to locate embedded reinforcing steel. Investigation revealed that the existing concrete was generally in good condition, with minor cracking (fig. 10.4) and localized deterioration at the tops of walls (fig. 10.5). Soiling, deterioration, and localized freeze-thaw damage were observed primarily at the tops of walls, at parapets, and at water outlets, where the concrete elements are exposed to moisture and the elements on multiple sides. Spalling adjacent to windows was found to be related to corrosion of embedded steel window frames. Thus, patch repairs were needed at relatively small and localized areas (fig. 10.6). The fact that the original concrete was air entrained contributed to improved durability in service.

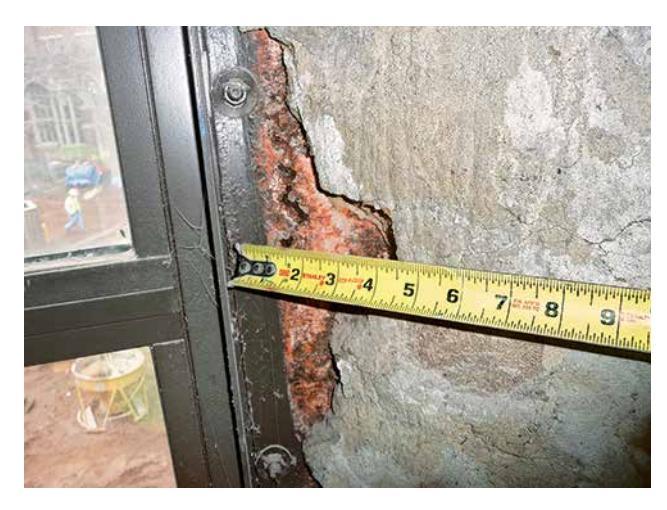
Fig. 10.8. Detail at window showing typical deterioration of interior concrete due to corrosion of embedded steel window frame anchorage. Also note previously installed cementitious patches. Photo: Wiss, Janney, Elstner Associates, Inc.

An example of a repair that required particular care in implementation involved the thin jamb sections of concrete at the large vertical windows (fig. 10.8). This repair was required at exposed edges of the rubble concrete on the building interior. Because of the complex configuration of the building footprint, the interface at some windows was approximately a 30° angle. The highly textured rubble concrete created a highly uneven surface to be repaired, and the location of the window frame was another constraint on preparation and patch installation.

Surface preparation is one of the most important steps in any concrete repair. It begins with removal of loose and unsound concrete at spalls or failed previous patches; saw cutting the perimeter edges of the repair area to a depth of 1 in. (2.54 cm) and approximately 1 in. (2.54 cm) beyond visible corrosion of the embedded steel; chipping of concrete within the patch area to a minimum of ¾ in. (1.91 cm) deeper than the reinforcing steel; sandblasting and air blasting of the patch area to clean away laitance, dirt, and other debris from the exposed concrete; and cleaning,

preparation, and priming and coating of exposed steel with a rust-inhibitive coating, followed by installation of the new patch material.

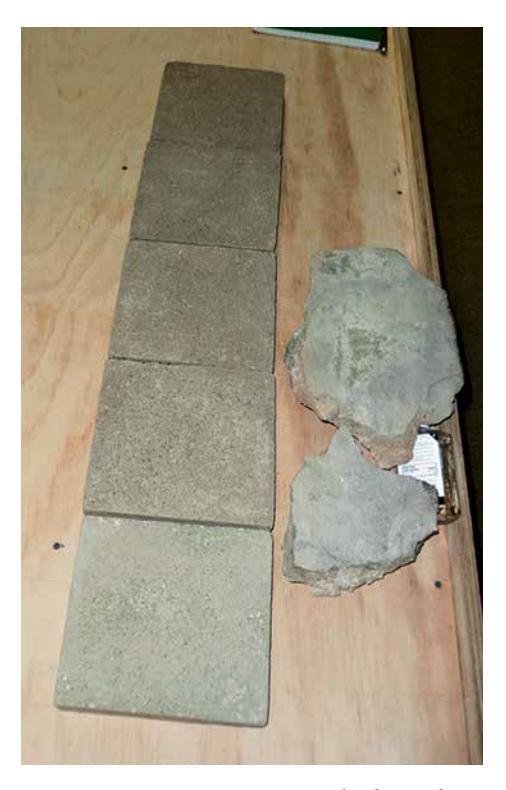
Fig. 10.9. Various concrete mix samples designed to match the original architectural concrete, shown at right. Photo: Wiss, Janney, Elstner Associates, Inc.

The contractor developed trial mixes and repair techniques that were performed on shop samples to determine how to best match the original appearance while providing a durable repair (fig. 10.9). Next, in-place trial repairs were performed to permit technical and aesthetic evaluation of the completed repairs and an assessment of the scope of work and the contractor's procedures (fig. 10.10). Once the repair mix and installation procedures were confirmed through the samples and trials, preparation at repair locations was completed; exposed steel cleaned, primed, and painted with a rust-inhibitive coating system; and the new concrete installed and cured.

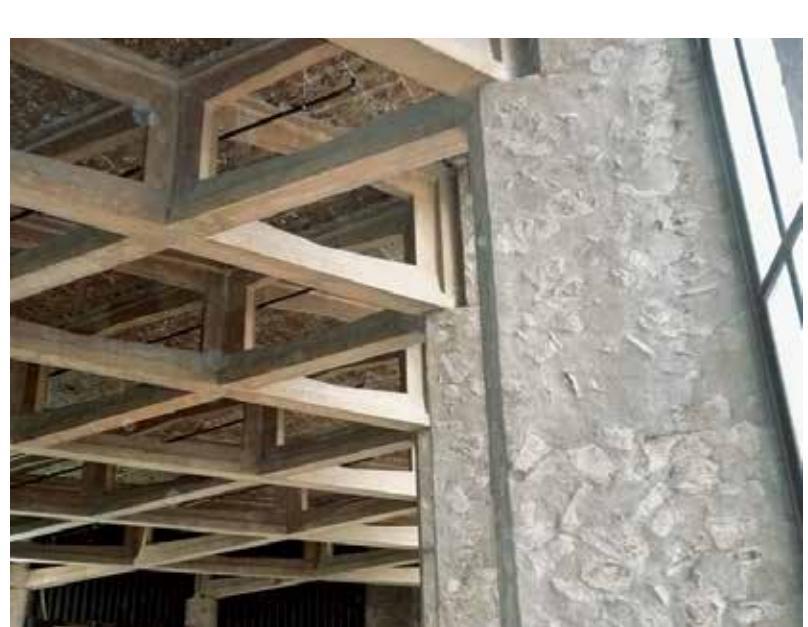
Fig. 10.10. View of interior concrete pier after repair to address corrosion of embedded steel window anchorage and prior to final cleaning. Photo: Wiss, Janney, Elstner Associates, Inc.

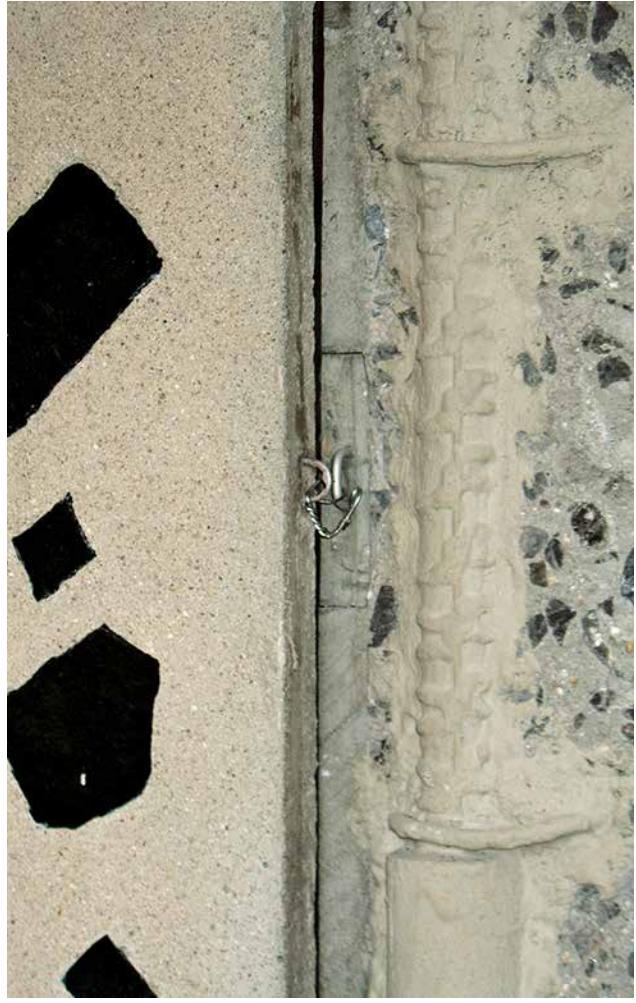
Fig. 11.3. Deterioration at the coffers of freestanding wall, 2009. The conservation contractor removed delaminating concrete with hand tools before chipping the concrete to form the desired patching profile. Photo: Building Conservation Associates, Inc.

in the cast-in-place concrete resulting from corrosion of ferrous metal reinforcement installed with inadequate concrete cover (fig. 11.3). A 1990 repair campaign included numerous exterior patches, which had begun to fail at feathered edges and shallow cover over the steel reinforcement. Cracks and spalls subsequent to the 1990 repair campaign were also observed in the original concrete, indicating ongoing decay.

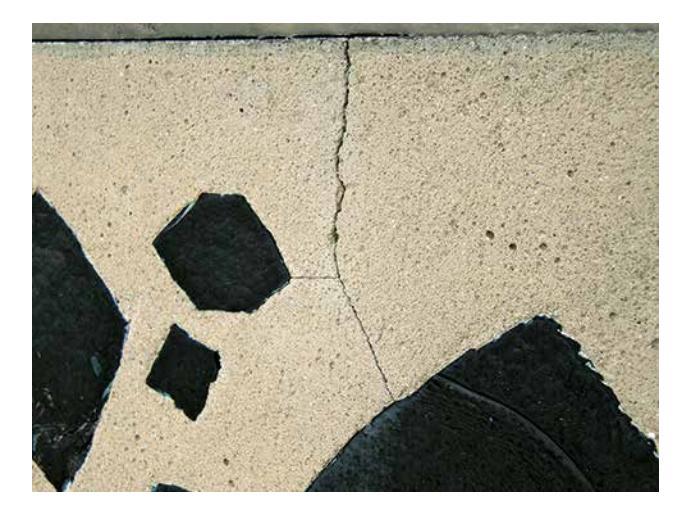
Fig. 11.5. Typical crack in a panel, stretching from glass to panel edge, 2009. Photo: Building Conservation Associates, Inc.

each long edge (fig. 11.4). Cracks, often penetrating the full depth of the panels, were found to typically radiate from the glass dalles to the panel edges, usually at locations where metal loops are embedded (fig. 11.5). The installation of conduits and equipment had damaged some panels, but the embedded ferrous wire reinforcement successfully cohered even the most severely compromised panels (fig. 11.6). Close-up inspection indicated that the exterior panel surfaces were friable, and isolated locations exhibited severe erosion that exposed corroding reinforcement.

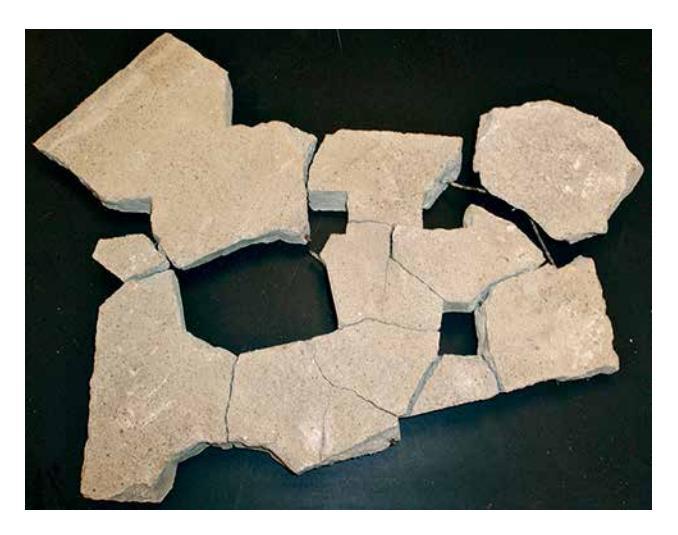
Fig. 11.6. Deteriorated panel broken apart for laboratory testing, 2009. Ferrous wire reinforcement made it difficult to separate the concrete fragments. Photo: Building Conservation Associates, Inc.

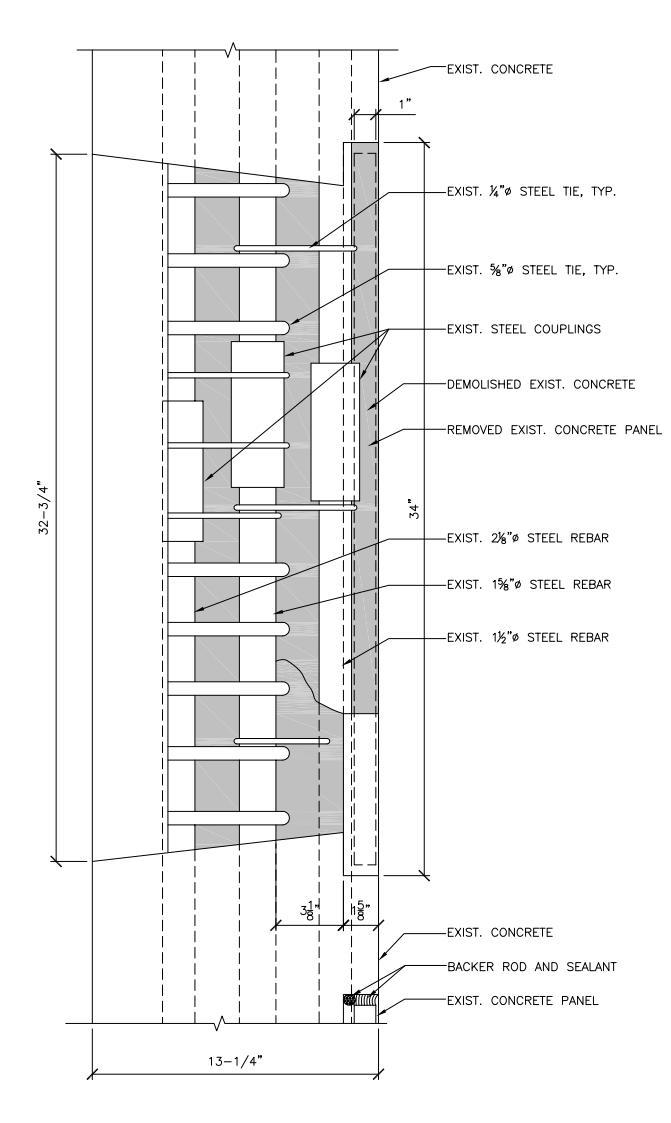
Fig. 11.7. Section showing a typical existing rebar configuration within a vertical column at coffers and the surface of the flush walls of the Great Hall. Each column has five vertical strips of rebar; only three are visible in this section due to the rebar configuration. Drawing: Building Conservation Associates, Inc.

The faces of the cast-in-place concrete spandrels and columns measure approximately 7½ in. (19.05 cm) wide at the coffer side and 5½ in. (13.97 cm) wide on the flush side. Each of the vertical columns contains five vertical strips of rebar (fig. 11.7). Archival drawings indicate that these range in size from #8 to #11 (1 to 1.41 in. [2.54 to 3.58 cm] in diameter). At the horizontal spandrels, four strips of reinforcing range in size from #8 to #10 (1 to 1.27 in. [2.54 to 3.23 cm] in diameter). In both the columns and the spandrels, the rebar varies in diameter depending on where it is located, measuring larger at the bottom of the building and smaller at the top (Harrison and Abramovitz 1963b).

Archival drawings specified 1 in. (2.54 cm) of concrete cover at the center of the spandrels on the coffered side of the wall and 2³/₄ in. (6.99 cm) of cover at the center of the spandrels on the flush side of the wall. The architects anticipated some variation in the concrete cover at the panel rabbets because of the configuration of flat panels installed in a curved wall (Harrison and Abramovitz 1963a). During the conservation, the authors measured representative areas of concrete cover and found that it ranged from ¹/₁₆ to 2¹/₄ in. (0.16 to 5.72 cm) in the horizontal spandrels, soffits, and sills. The concrete cover in the vertical columns was found to range from less than ¹/₁₆ to 1¹/₂ in. (0.16 to 3.81 cm). Carbonation of exterior concrete at the Great Hall was found to occur as deep as 1¹/₄ in. (3.18 cm) (Materials Technologies 2005, table 3). The existing cover is generally less than is acceptable by the standards of the American Concrete Institute. According to ACI 318, Section 7.7.1, #6 to #18 rebar exposed to weather should have 2 in. (5.08 cm) of cover. This standard has not changed substantively since 1965 (Hageman, Beeston, and Hageman 2008, 151).

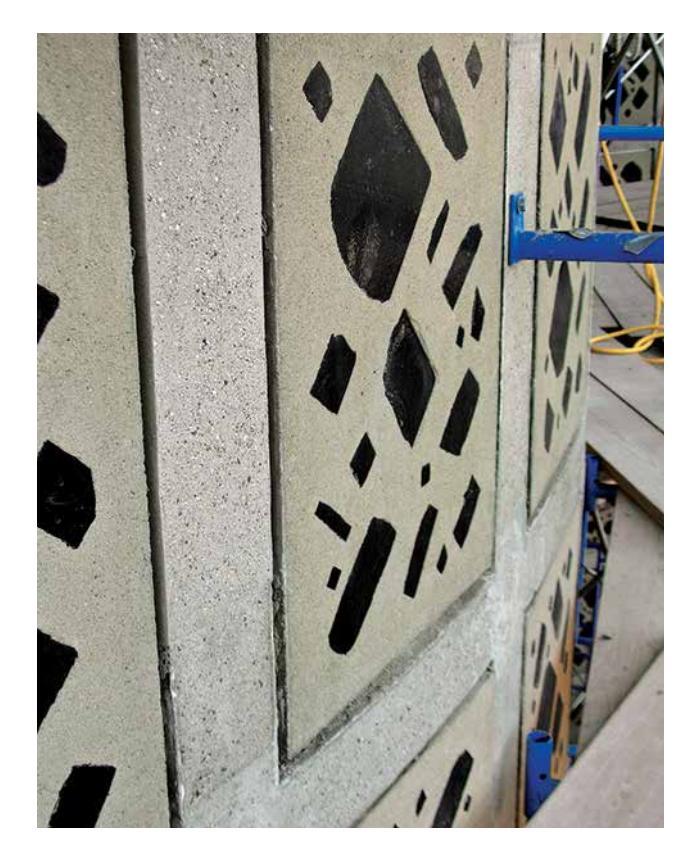
Fig. 11.8. A patch with surface-applied aggregate is installed at the top two-thirds of the column at the left, 2009. The bottom third of the column is the original weathered concrete. Photo: Building Conservation Associates, Inc.

During construction, five custom colors of Jahn M90 were selected to match the varying concrete colors, and the aggregate blend was troweled onto the surface of the patches to simulate the weathered appearance of the adjacent concrete. The concrete conservation contractor, Structural Preservation Systems, adjusted the aggregate sieving to match the varying levels of weathering across the facade (fig. 11.8). In areas less subject to weathering, such as within the coffers at the base of the freestanding wall, aggregate

was mixed into patches and etched with a weak acid to create a mildly weathered but overall smooth surface.¹⁰

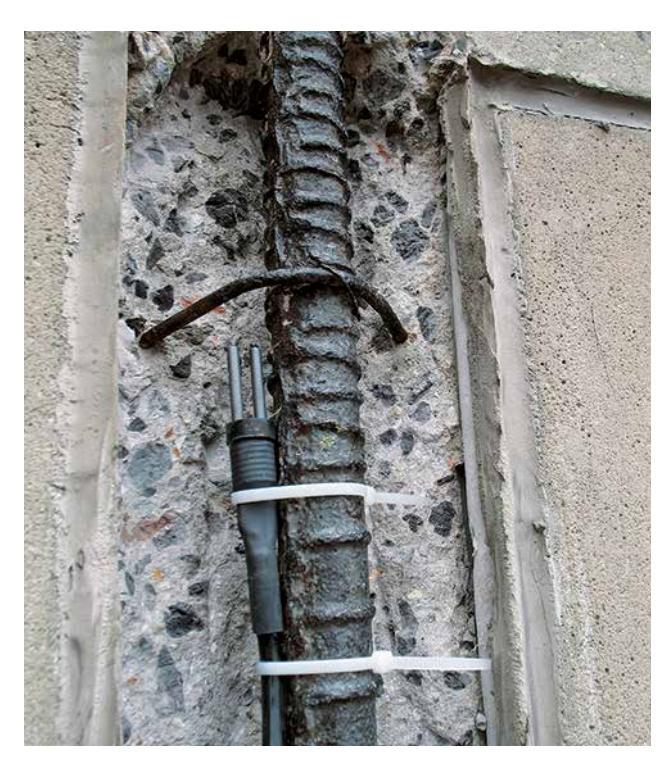
Fig. 11.9. Electrodes of probe installed for field testing adjacent to existing cleaned rebar, 2005. Photo: Building Conservation Associates, Inc.

the patching material adjacent to the rebar, with carbon steel electrodes designed to corrode at the same rate as the rebar (Rohrback Cosasco Systems 1999, 3). Where the rebar was coated with the potassium silicate rust inhibitor, electrodes were also treated.

Field testing was performed at four locations on the west facade of the building. Cracked and spalling patch material was removed from this area for the probe installation. Exposed rebar at each location was cleaned with a wire wheel, and the probes were installed at three of the four test locations, with the electrodes parallel to and equidistant from the concrete surface and not touching the rebar (fig. 11.9). Table 11.1 summarizes the materials installed at each test location. Because the testing was performed to independently evaluate the effectiveness of the consolidant and water-repellent system with the addition of a rebar coating against the use of the migrating corrosion inhibitor alone, the effect of combining all coatings was only evaluated qualitatively.

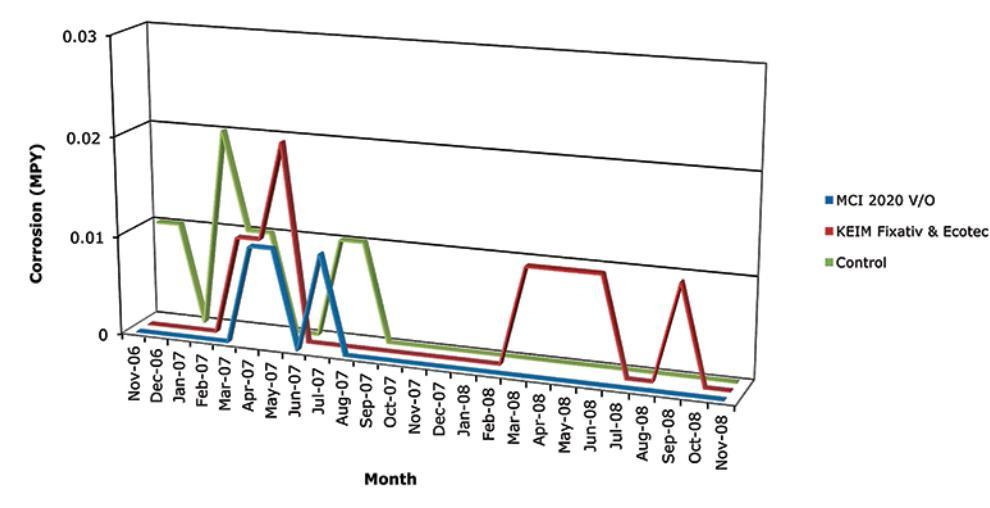
The instantaneous corrosion rate of the electrodes was measured regularly over a two-year period. The control sample initially exhibited the highest rate of corrosion, but this condition abated after ten months. The electrodes in the patch treated with the migrating corrosion inhibitor exhibited a measurable rate of corrosion during only three months. The corrosion rate of the electrodes coated with the rust inhibitor and embedded in the patch coated with the consolidant and water repellent exhibited the most fluctuation. However, the measurements from all of the probes remained relatively low, less than 1 mil per year (MPY), throughout the monitoring process (fig. 11.10). According to Rohrback Cosasco Systems, the manufacturer of the probes, the range of corrosion measured is typical for rebar embedded in a concrete facade.¹³

Fig. 11.10. Measured corrosion rates of the probes embedded in the facade from November 2006 to November 2008. Graph: Building Conservation Associates, Inc.

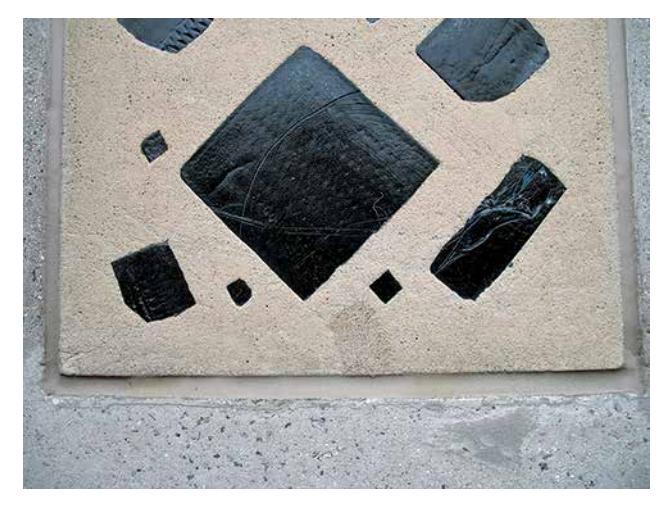
Fig. 11.12. Patch repair with surface applied aggregate at the bottom center of the panel, 2010. Photo: Building Conservation Associates, Inc.

Although the original panels at the Hall of Science were cast from a prepackaged concrete mix, they exhibit a wide variation in colors. For efficiency, only two colors of patching mortar, a gray and a tan, were selected for the exterior panel repairs. Aggregate was applied to the surface of the patches to further blend them with the adjacent concrete (fig. 11.12).

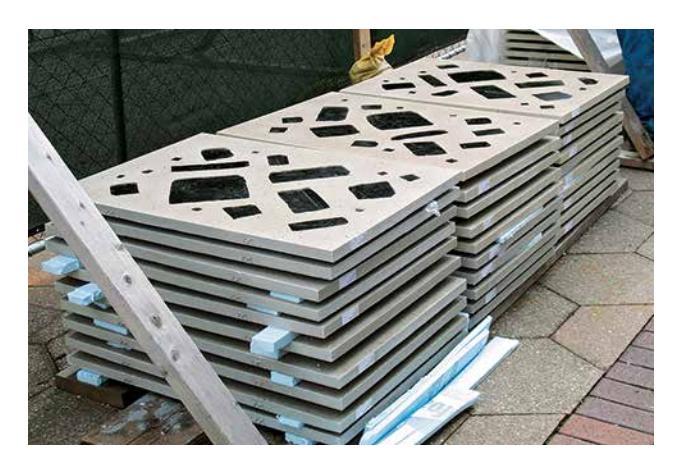
Fig. 11.13. New replacement panels with an epoxy matrix matching the exterior appearance of the original precast concrete panels, 2009. Photo: Building Conservation Associates, Inc.

Panels exhibiting multiple wide cracks, deflection, and/ or damaged or destabilized glass were selected for replacement by the architect. While dalle de verre is still commonly produced with a concrete matrix elsewhere in the world, the current industry standard in the United States is to produce panels with an epoxy matrix. The original manufacturer of the concrete panels, now called Willet Hauser Architectural Glass, produced replacement panels cast with an epoxy matrix. Two colors of epoxy were selected and a mix of silica and mason sand was broadcast onto the surface of the epoxy to simulate the appearance of the original concrete panels. Natural variations in the aggregate resulted in a range of tan and gray replacement panels nearly identical in appearance to the exterior surfaces of the original panels (fig. 11.13).

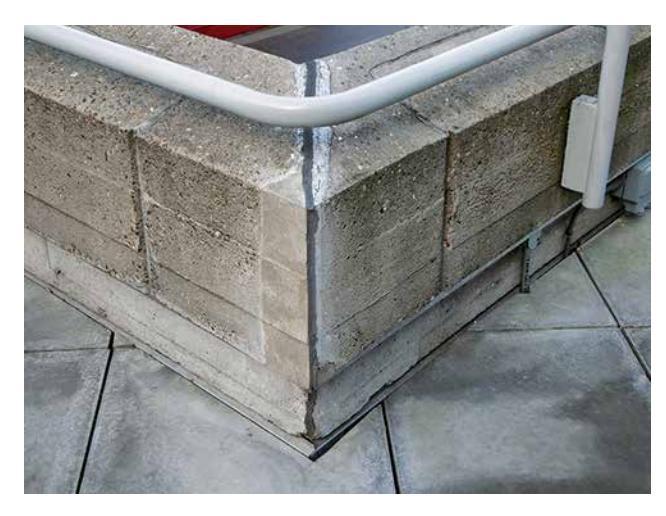
In the 1990s, a program of works was undertaken in which proprietary repair materials were used to carry out repairs to the concrete. These tended to be epoxy/polymer based and used in small quantities to undertake cosmetic repairs. These were found to have performed in an unsatisfactory manner, and some had failed. Some experienced shrinkage and allowed a buildup of moisture around the repair that accelerated deterioration; others became discolored and very prominent, even white, as they aged (figs. 12.2, 12.3). A small number provided a satisfactory repair in that they sealed the defect, but without a pleasing aesthetic.

Fig. 12.3. Recent repair of the 1990s epoxy-based repair using a cement mix, 2016.

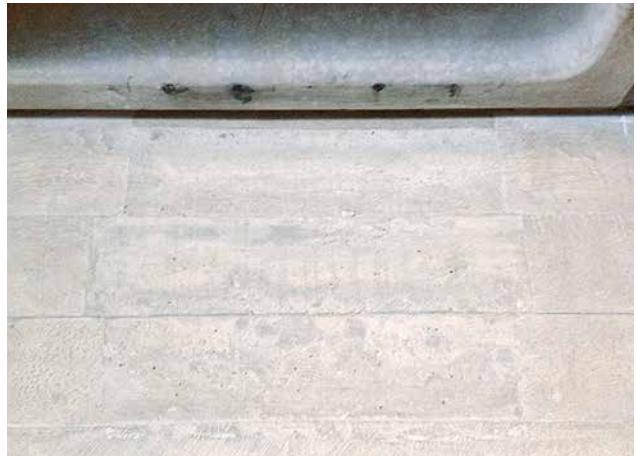
Fig. 12.6. Repaired redundant penetration, 2015.

The NT Future works included some areas of new construction and reconfiguration of existing areas. This resulted in removal of sections of concrete, repositioning of services, and various other alterations. Where service ducts became redundant, these were filled and finished to match the surrounding area (figs. 12.5, 12.6). Using the original mix,

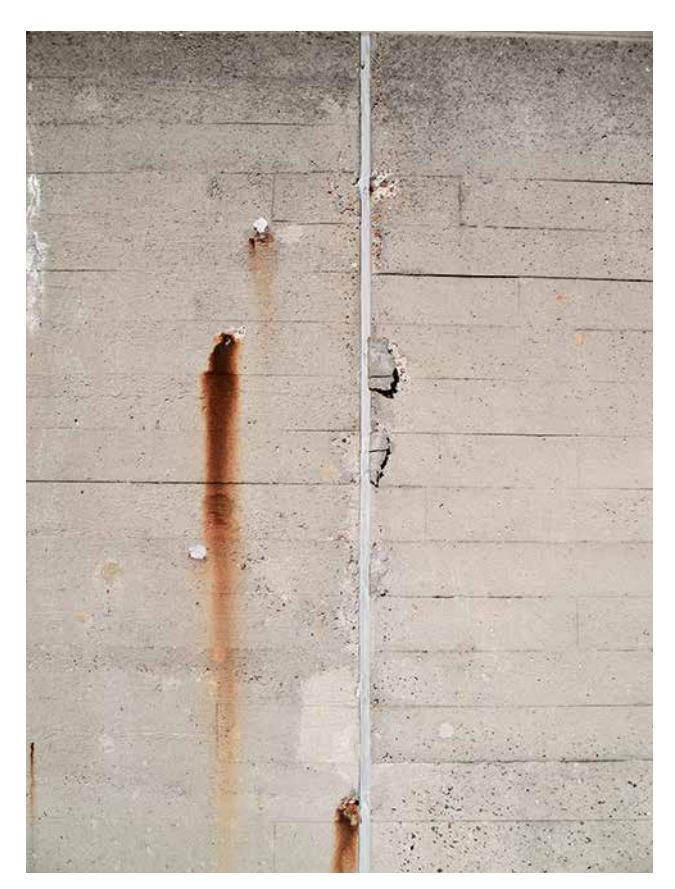
Fig. 12.7. Spalling, joint, and pyrite (rust) staining, 2013.

Large pyrite (rust) stains were present on some faces and levels of the building (fig. 12.7). Detailed surveys undertaken prior to the works identified these as ferrite-containing aggregate in the original mix rather than corrosion of the reinforcement, which had initially been suspected. While these were not detrimental to the structure, the staining

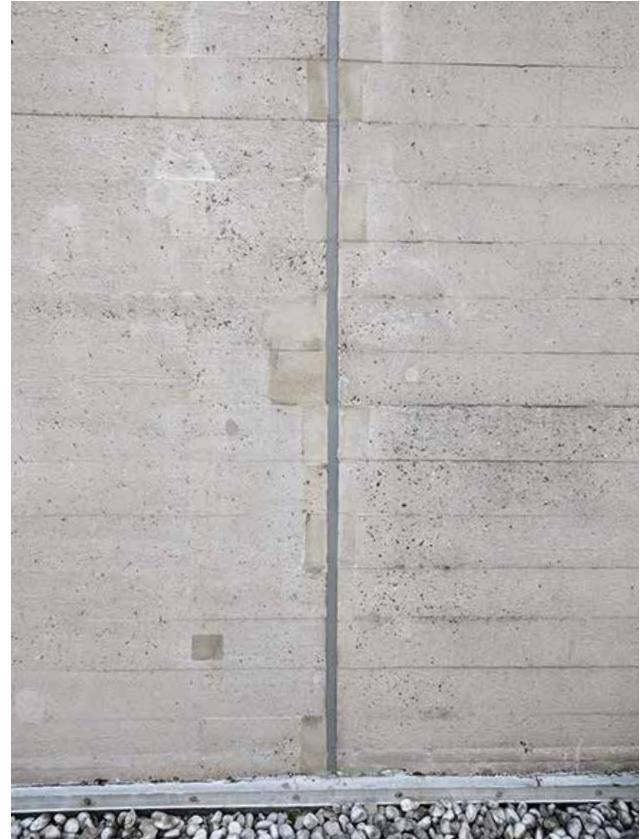
Fig. 12.8. Repairs to spalling, joint, and pyrite staining, 2016.

the repair to the cored holes seems to have survived the weathering process better than some of the crack repairs (fig. 12.8).

detracted from the solid architectural presence of the building, so for aesthetic reasons it was agreed that these were to be addressed. Trials undertaken in discrete areas found that a 20 mm diameter core to a depth of approximately 50 mm would remove the offending piece of aggregate. The core was taken at the highest point of the stain, as that was where the ferrous aggregate was usually found. The rust staining below the core was removed using hand tools and a dilute nitric acid (30%) solution while ensuring that the surrounding areas were properly protected. In some cases, particularly where rope access was used, the staining was removed using only tungsten-tipped hand tools to scrape the rust off the surface of the concrete, taking great care not to damage the board-marked finish. The cored hole was made good using the mortars previously described, with the repair built up in layers before being finished by hand to replicate the adjacent grain. These repairs have performed well over the first twelve months, with the areas of rust removal starting to weather to match the surrounding concrete. The areas that were particularly prominent on the fly towers are now barely visible, and

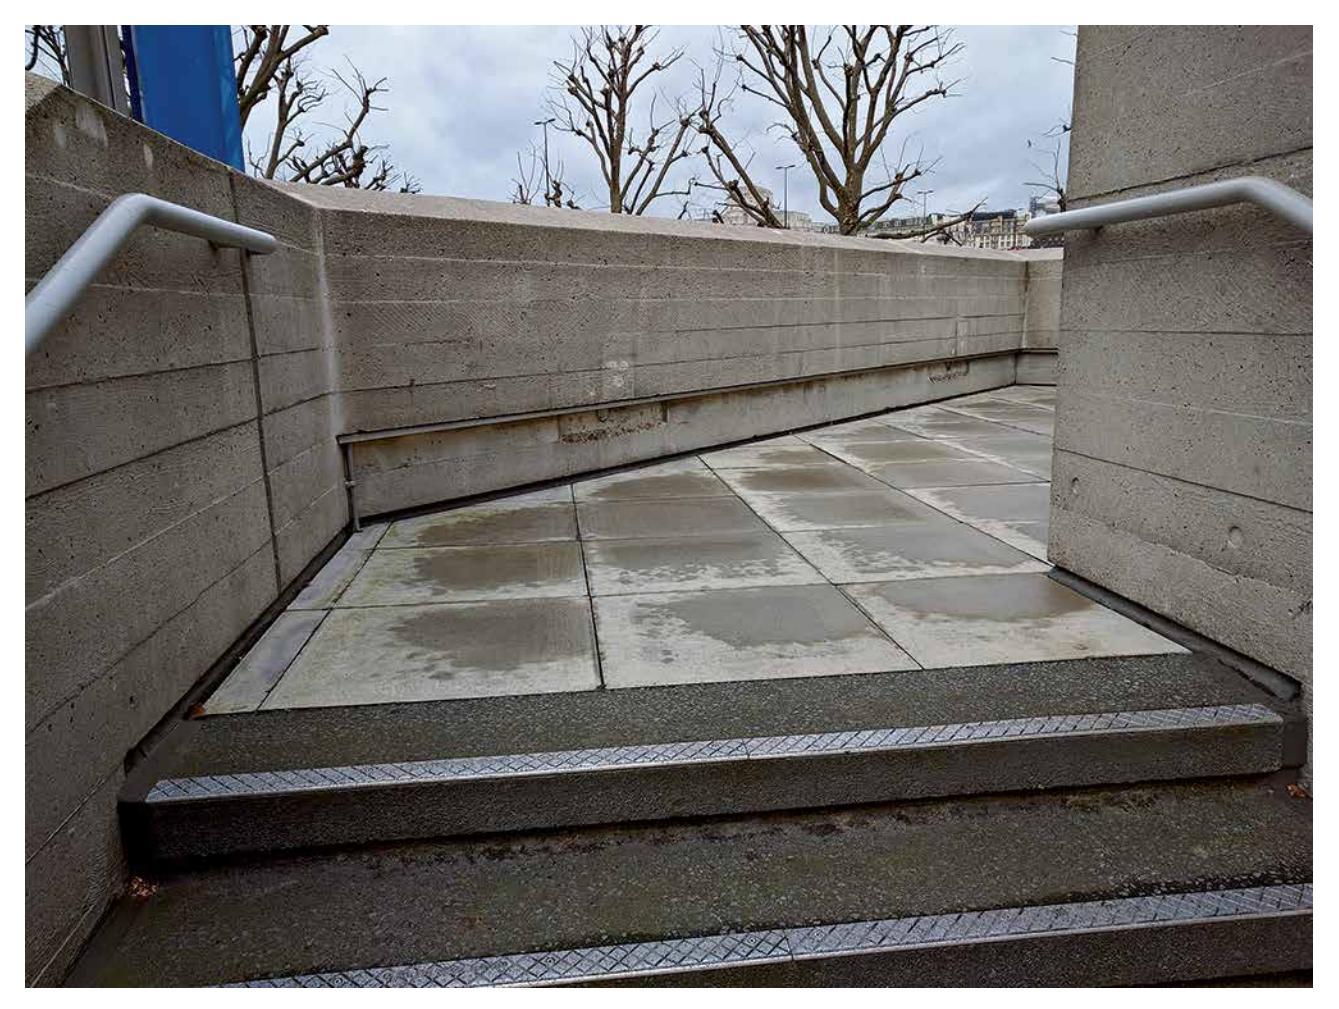
Fig. 12.10. Results of thorough cleaning of concrete stairway, 2016.

board-marked concrete has been lost as a result of earlier overzealous graffiti removal. The stairs are now more inviting and are being used to access the theater and its restaurants (fig. 12.10). Other graffiti-prone but less prominent areas were used to trial additional removal methods. Where graffiti had been in place for some time, it was very difficult to successfully remove. Graffiti attack is now dealt with immediately by the building maintenance team, before the paint fully penetrates the concrete. Specialist graffiti removal teams may not be experienced in treating historic buildings with sensitive surfaces; therefore, the development of in-house teams with knowledge and experience in removing graffiti and sympathetically cleaning concrete surfaces are an important component of the ongoing maintenance strategy.

The anchor stairs had been subject to a number of graffiti attacks over many years, and while the graffiti had been removed, the impact on the underlying board-marked concrete had not been considered (fig. 12.9). This resulted in an uninviting area that had fallen out of general use. This area was cleaned using the specialist steam cleaning equipment, successfully restoring a consistent finish to this area. Unfortunately, some of the fine detail to the
