CONSERVING MODERN HERITAGE

Concrete

Case Studies in Conservation Practice

Edited by Catherine Croft and Susan Macdonald

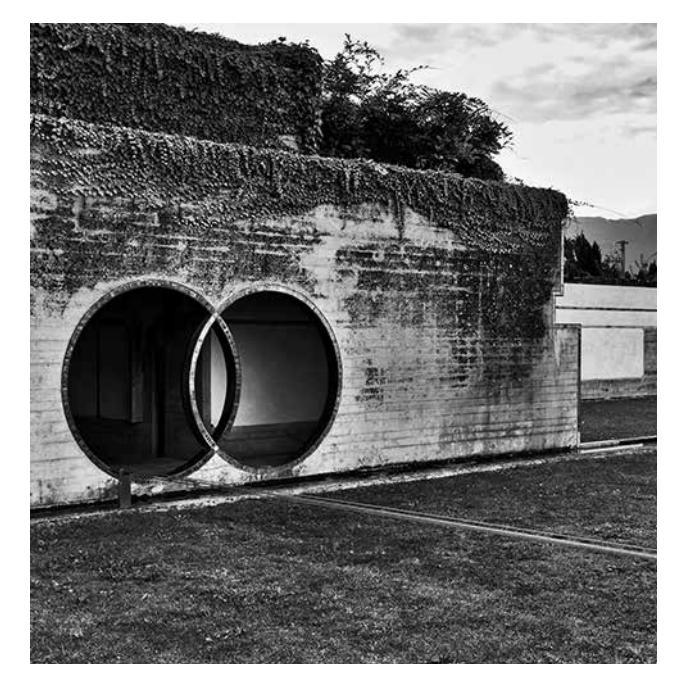
The exposed concrete, which has so defined Scarpa's architecture, in this case is characterized by the imprint of the spruce formwork in a horizontal-vertical pattern (fig. 13.2). The texture is intensified by traces of the wooden formwork left by the removal technique. The concrete elements are defined by indentations and metal-rimmed cutouts; the surface is modulated by cement that dripped from the formwork and was then hammered off. The reddish, sloped roofing was created with a special proprietary mix of concrete and iron oxides (McMaster, originally made by Mac Spa). Certain modifications in the casting made it possible to embed black or white marmorino tiles on a *cocciopesto* (lime-sand mortar with brick or tile fragments) background.

Fig. 13.2. Detail of tomb, Brion Cemetery, 2012. Photo: SEIER+SEIER / Courtesy of Flickr, CC BY-2.0

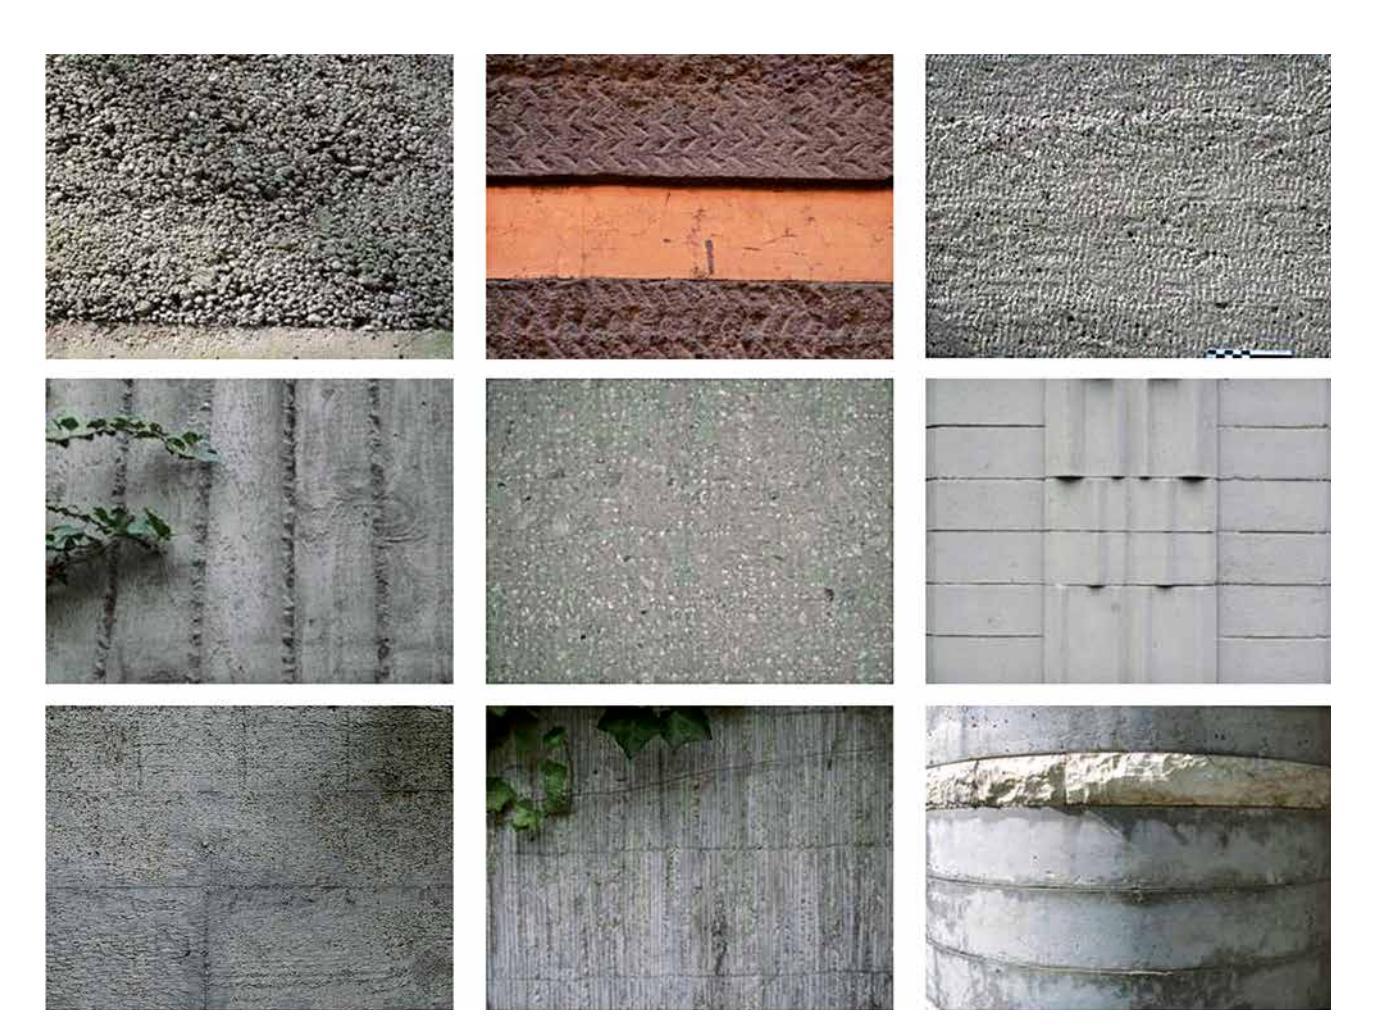
The most prevalent and visible degradation is caused by the corrosion of the reinforcement bars due to minimal covering of concrete. This is the most difficult problem to address in repairing historic concrete. Another prevalent deterioration mechanism at Brion is biodeteriogens that can trigger corrosion. The presence of this organic growth on the concrete surface, which Scarpa had anticipated, creates challenges to conserving its historic and aesthetic significance, specifically in balancing how the organic

Fig. 13.3. Carlo Scarpa's multifarious use of concrete.

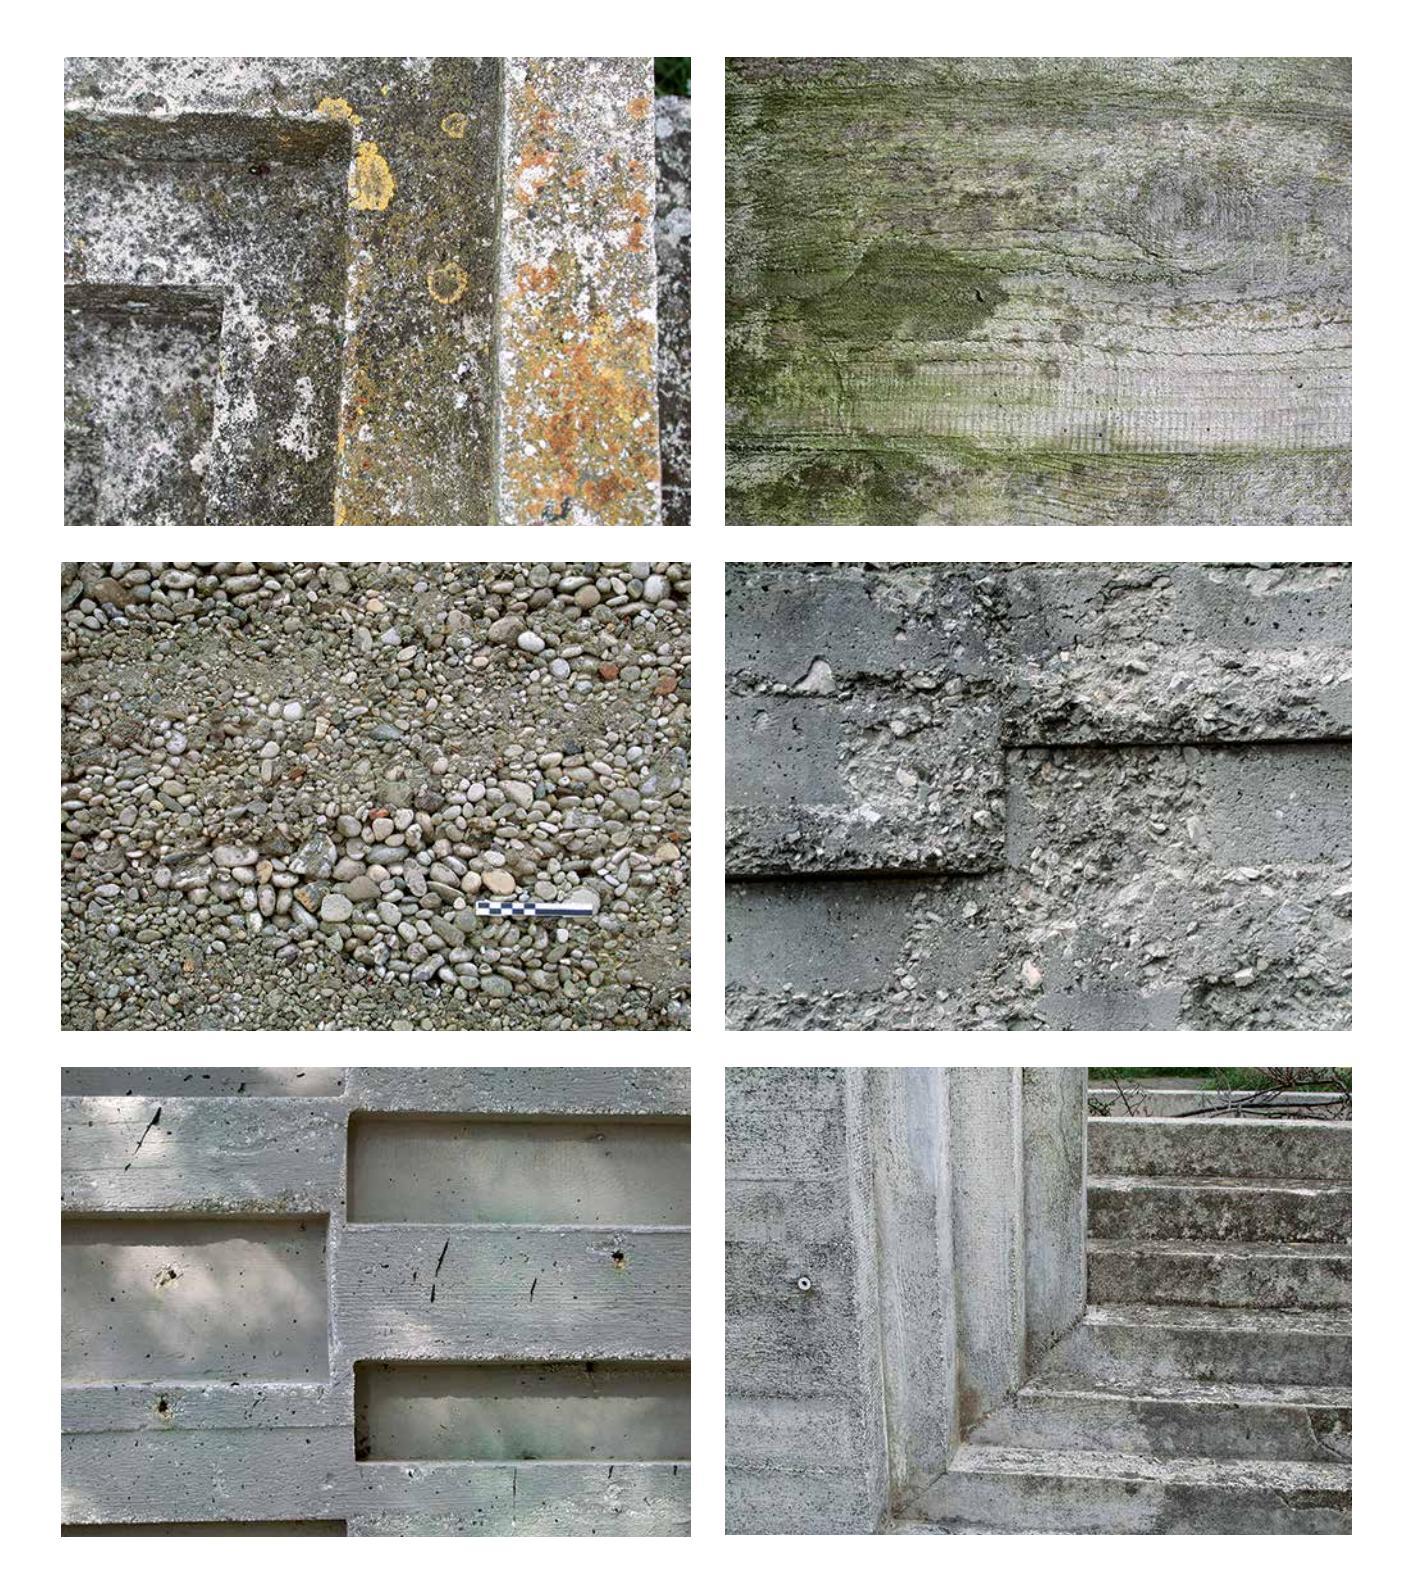
Fig. 13.4. Examples of the highly textured concrete and its patina, which is partially caused by its degradation.

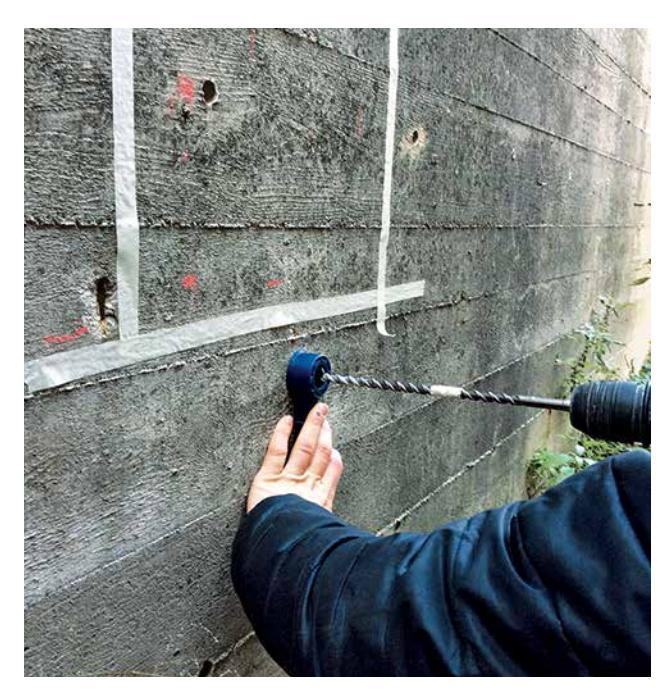
The work had three objectives. The first was to thoroughly assess the current state of degradation using appropriate diagnostics, including carbonation depth, chloride content, and the identification and assessment of prior treatments, coatings, and the extent/rate of corrosion of reinforcement (fig. 13.5). This, coupled with accurate analyses of the material (components, mix design, and depth of cover), enabled the forecasting of potential ongoing change and progressive damage and helped to determine the material's—and thus the structures'—durability. This investigation was needed in order to develop repair approaches that minimized major intervention to the concrete surface.

Fig. 13.5. Testing to determine the depth of carbonation.

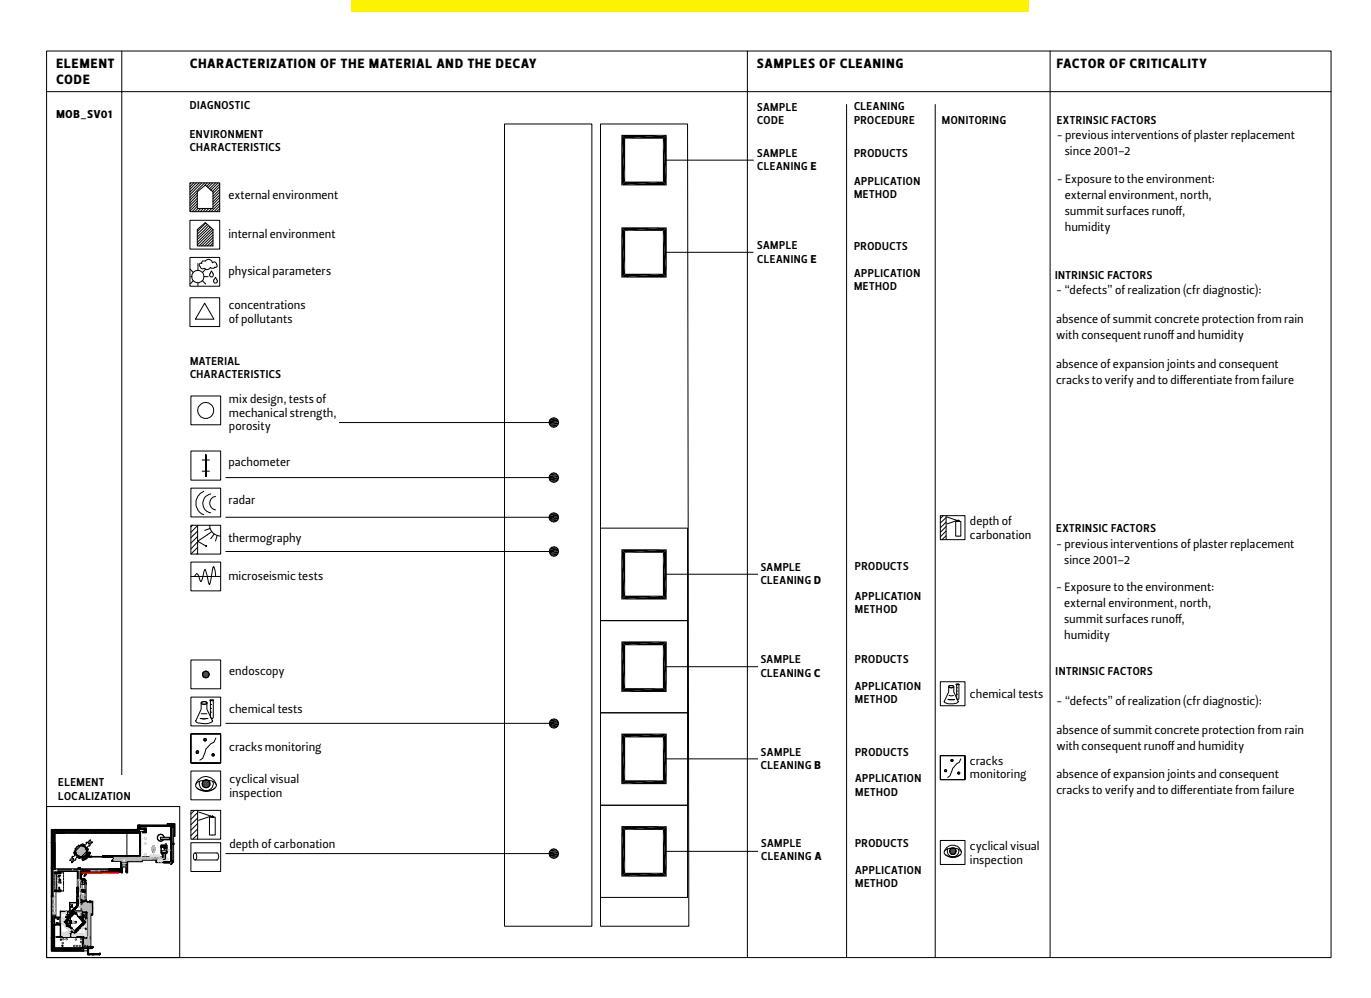
Fig. 13.6. Sample of survey characterizing the concrete and its degradation, with planning of diagnostic, assessment, and testing program.

The proposed solution was twofold. First, it addressed the causes of deterioration and included indirect interventions aimed at dispersing and/or redirecting rainwater away from the structures. Reducing the infiltration of moisture into the concrete is the first step in slowing down the corrosion of the reinforcing bars and in limiting the proliferation of biological patinas. Suggested interventions included improving the waterproofing system on the flat roofs; verifying the efficiency of rainwater disposal systems (sloping, interior drainpipes, shafts, and gathering systems); waterproofing the wall tops; removing and/or dispersing rainwater from the foot of the concrete walls in direct contact with the ground; potentially waterproofing the pools and reorganizing the greenery; and waterproofing or introducing drainage in the concrete planters. The second component of the project involved repairs to the concrete itself and included testing techniques and materials in the laboratory and subsequently in situ (on the eastern outer wall) (fig. 13.6).

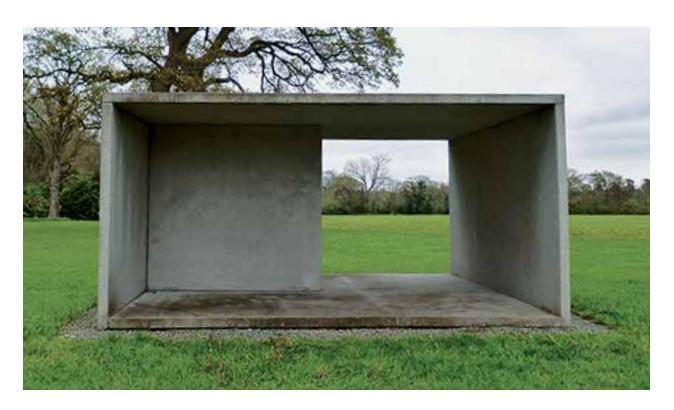
The work is owned by a private collector and located as part of an extensive collection of outdoor sculpture around a private house in southwest England. The collection is well cared for and regularly monitored by an experienced sculpture conservator who carries out annual inspections and maintenance. Considerable attention is given to the potential impact of climatic conditions, with the work being protected by a specially constructed cover that does not touch its surfaces when the property is empty and in the winter. The work is well protected from potential damage by landscape maintenance (grass, cutting machinery, etc.) and human interaction. Documents record that the work was moved from a previous location on the estate to the current site, and that problems with insufficient footings had led to some subsidence in the previous location. Due to the damage caused by the subsidence, a cement screed had been applied over the skyward-facing surface of the work in a bid to cover cracks, but this also obscured the natural aggregate characteristic of Judd's concrete sculpture work.

Fig. 14.2. Donald Judd's untitled (1988–91), pictured here prior to conservation, sits in a landscape setting. Photo: Catherine Croft. Donald Judd Art © 2018 Judd Foundation / Artists Rights Society (ARS), New York

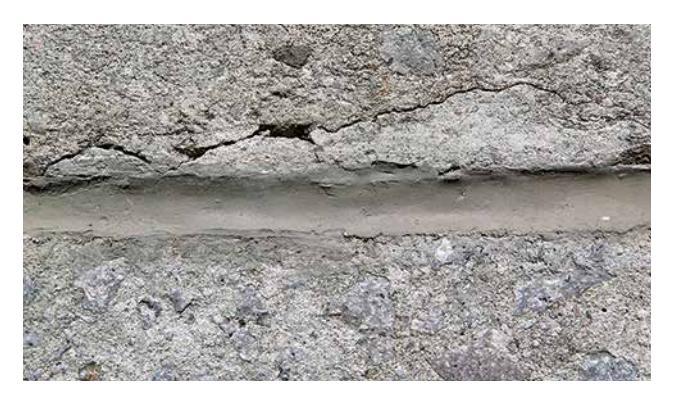
Fig. 14.3. Detail of damage after non-original caulking and repairs were removed. Photo: Tessa Jackson. Donald Judd Art © 2018 Judd Foundation / Artists Rights Society (ARS), New York

the cracks and details in order to monitor any changes. The decision was made to remove the screed layer from the top, along with all other repairs and caulking, and strip the piece down to its original, albeit damaged, state (fig. 14.3).

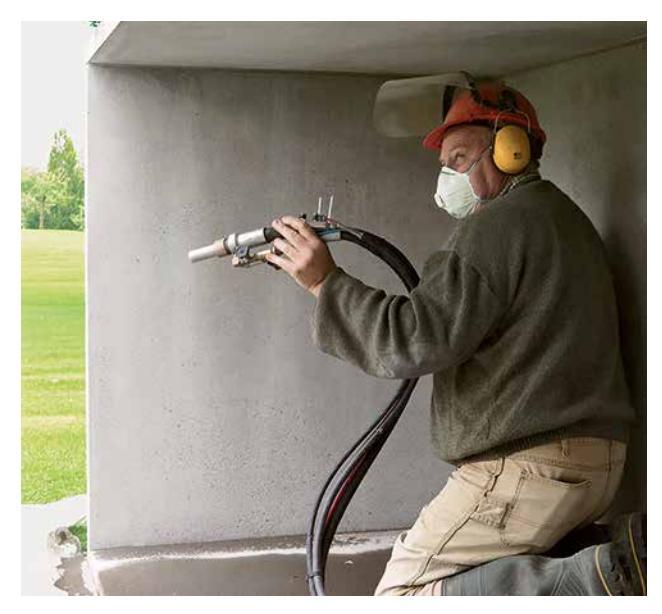
Fig. 14.4. The conservator closely supervised the Thermotech cleaning process. Photo: Tessa Jackson. Donald Judd Art © 2018 Judd Foundation / Artists Rights Society (ARS), New York

The second year it was decided to address cleaning of the piece and seek to reduce the visual impact of previous poorly matched repairs and the screed on the skywardfacing surface. The Jos Vortex/Thermotech system (a proprietary blasting cleaning system) was selected and operated by a specialist cleaning contractor (fig. 14.4). The conservator was present throughout the cleaning process in order to decide on the levels of cleaning. Very careful monitoring ensured that enough cleaning was carried out to create a unified visual appearance, but that cleaning stopped as soon as any original material loss from the surface was detected. On examination after cleaning, very small fragments of original shuttering could be seen at the surface, confirming that loss of original surface was minimal. A crack on the lower horizontal surface had been previously filled with silicon, which Thermotech would not remove, and trials of a poultice treatment to remove this were carried out but proved unsuccessful. The silicone fill was mechanically removed, as were isolated previous fills elsewhere, in cases where they were particularly visually intrusive or unstable.

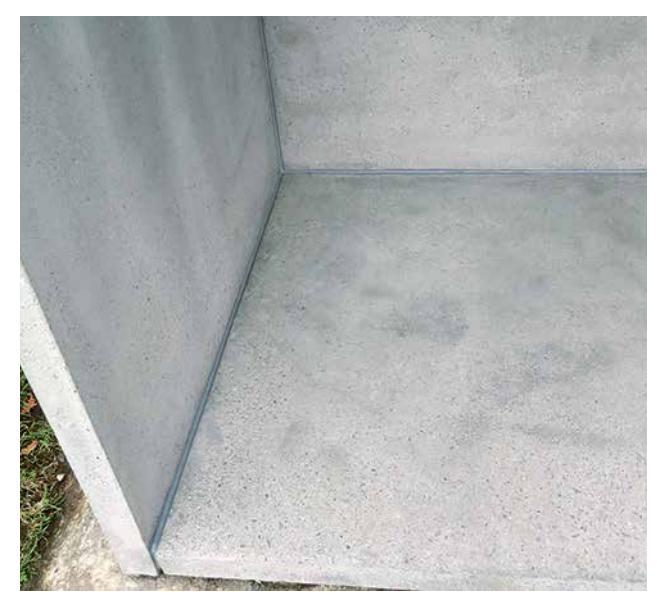
Fig. 14.6. The final result was a uniform, clean surface, with discreetly recessed caulking, allowing the form of the piece to read clearly. Photo: Tessa Jackson. Donald Judd Art © 2018 Judd Foundation / Artists Rights Society (ARS), New York

Because this is a precious artwork that is valued for its materiality as well as its concept and has substantial monetary value, it was possible to undertake a collaborative and labor-intensive approach involving a number of specialists to gain the best possible result (fig. 14.6; see also fig. 14.1). The owner's commitment to ongoing maintence and monitoring was also essential to a strategy of carrying out only minimal interventions where possible. Although most architectural projects have to operate in very different circumstances, the approach of minimal intervention and regular maintenance may be sometimes applicable.

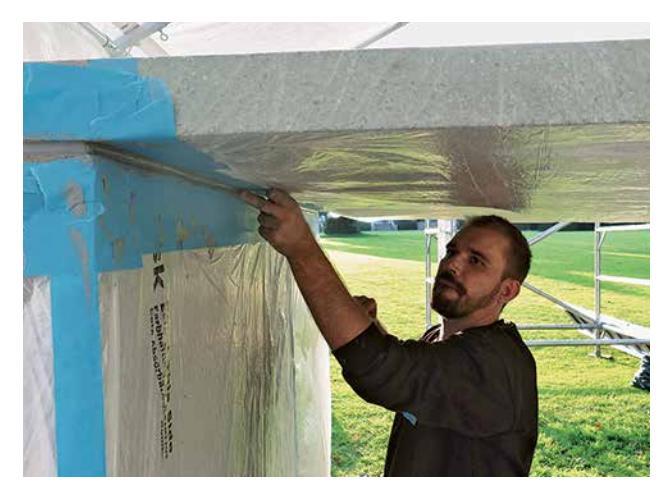
Fig. 14.5. The sculpture was thoroughly masked before a sealant specialist replaced the caulking. Photo: Tessa Jackson. Donald Judd Art © 2018 Judd Foundation / Artists Rights Society (ARS), New York

498, an acrylic adhesive chosen for its stability with UV, and colored with earth pigments to visually integrate them. The caulking had been patched on many occasions, resulting in unsightly protrusions in some areas and cracking in others with little original material retained, so the decision was taken to remove it. This decision also responded to the need to limit water penetration at the joints and prevent standing water from collecting on the tops of the vertical slabs. Trials to remove the caulking with scalpels proved that this would be extremely slow and likely to damage fragile arrises of the slabs, so a wet abrasive cleaning method was used here, as this was faster and the calibration of when to stop was easier (all caulking was to be removed). Scalpels were then used to remove some remaining areas of backing rod, before the whole work was masked with sheet polythene and masking tape. Dow Corning C60 mid-gray caulking was then applied by a silicone sealant specialist. This is a one-part, low-modulus silicone polymer sealant with good adhesion to porous surfaces and resistance to UV radiation and temperature extremes (fig. 14.5).
