Consolidation Studies

THE GETTY ADOBE RESEARCH PROJECT AT FORT SELDEN.
I. EXPERIMENTAL DESIGN FOR A TEST WALL PROJECT

Neville Agnew
Getty Conservation Institute
4503 Glencoe Ave. Marina del Rey, CA 90292
U.S.A.

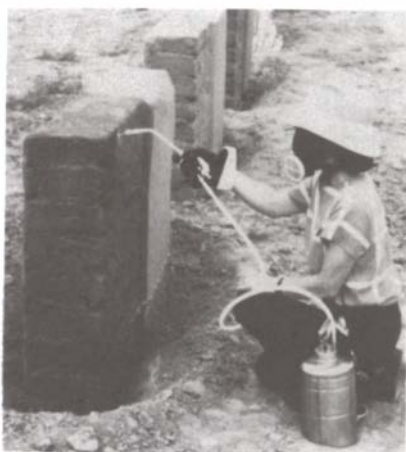
Figure 4. Photograph showing chemical consolidant being applied to adobe test wall by spraying.

Consolidant solutions were applied to the test walls by spray, brush and from reservoirs with infiltration tubes into the core of the wall (bulk infiltration) as shown in Figs. 4-6. Five basic patterns of consolidant application were used. These are: surface coating (using minimal material); multiple surface coating (wet-on-wet) to achieve good depth of penetration; bulk infiltration to fully permeate the test wall; surface coating together with basal infiltration of the wall footings; and partial infiltration of the top and bottom of the wall and footings, with only light surface treatment on the vertical face. These patterns are depicted schematically in Figs. 7-11 which were chosen to provide as full a range of treatment responses to the perceived patterns of erosion of adobe walls.

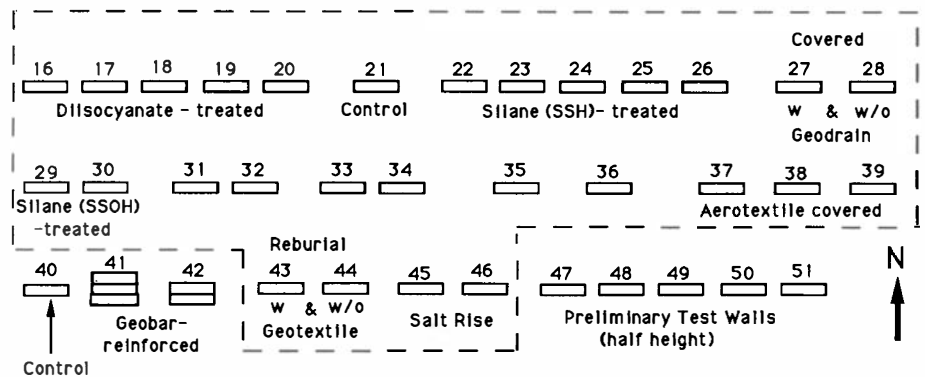
Figure 1. Map view of test walls at Ft. Selden, N.M. showing wall number and type of treatment / experiment. Area enclosed by dashed line represents walls subjected to accelerated (water spray) weathering.

After completion of an archaeological survey of the area for the test walls at Fort Selden, and final approval of the test wall design, construction began in December 1987. Figure 1 shows the plan view of the test wall site along with some individual wall treatment / experimental conditions. The standard test wall was 1.52 x 1.52 m by approximately 0.25 m thick (5 x 5 feet x 10 inches) constructed from nominal sized bricks 35.5 x 25.4 x 10 cm (14 x 10 x 4 inches). Wall foundations were 20.3 cm (8 inches), or two adobe bricks into undisturbed earth (Fig. 2). Diagonally opposite sides of the walls were mud-plastered (Fig. 3).

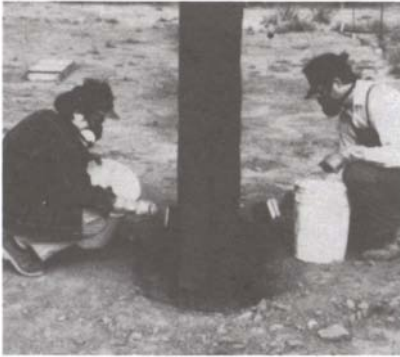
Figure 5. Photograph showing chemical consolidant being brushed onto adobe test wall.

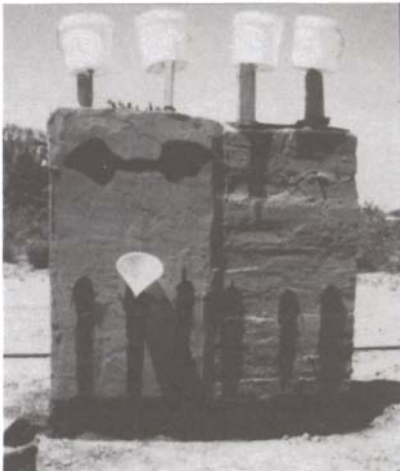
Figure 6. Photograph showing adobe test wall being treated with chemical consolidant using bulk infiltration technique.

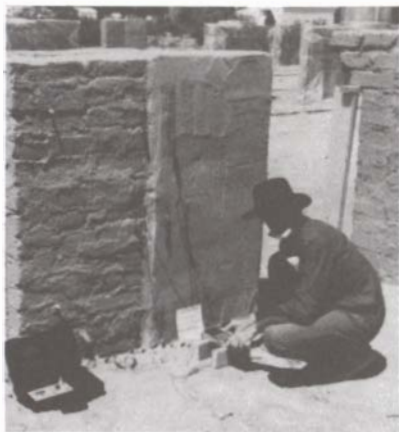
Figure 13. Photograph of control wall (#40) with thermocouples hooked up to data logger for exterior surface and internal temperature monitoring.

Surface and interior temperatures of the master control wall (#40) are monitored for 24 hours at a time on a seasonal basis using thermocouples and a 16-channel data logger system. This system is shown in Fig. 13. Thermocouples are embedded on the surface and at depths of 2.5 cm and 12.5 cm on the east and west faces of the wall both on the adobe brick and the mud-plaster surfaces.

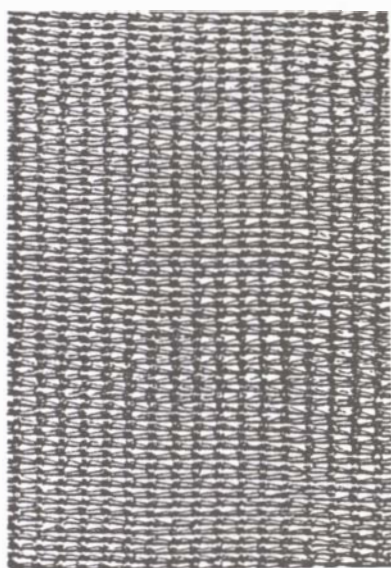
Figure 14. Structure of aerotextile material with 70% shade density.

A synthetic, knitted shade cloth (or "aerotextile"), originally developed for the horticultural industry, was chosen for evaluation as a shelter material. Fig. 14 shows the structure of the 70% shade density grade. Shelter designs usually try to totally protect easily weathered material like adobe. The basic premise in proposing this open-weave textile for testing was that in many cases a completely water-proof shelter may not be needed, particularly if the adobe site can be treated, as part of the site protection program, with a chemical preservative.

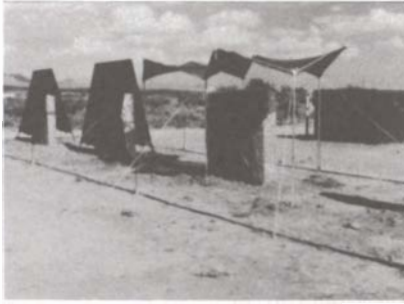
Figure 16. Photograph showing adobe test walls (#38, 39) protected by A-frame, aerotextile-covered shelters, and (#37) by hexagonal shaped 'puckered' shelter with aerotextile roof.

Technology transfer of existing materials - such as aerotextiles and geotextiles (as discussed in the next section) - from the horticultural and civil engineering fields respectively, to applications in adobe site-preservation research, indeed, heritage sites in general, has many clear benefits. The development work has been done and the materials are being marketed internationally and have proven acceptance and durability. Furthermore, they are often available in a range of grades which allows matching with site requirements. Thus, by comparison with steel-roofed constructions, material such as aerotextiles would appear to have great advantages in cost-effectiveness, ease of erection, and aesthetic acceptance with minimal intrusion on the historic site landscape. Two aerotextile shelter designs were used at Fort Selden and are shown in figure 16. These are an A-frame shelter (walls #38 & 39) and a puckered hexagonal ring structure (wall #37).

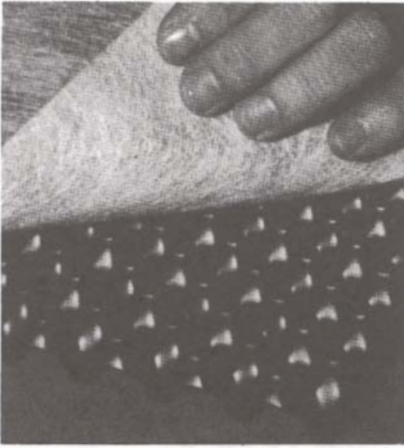
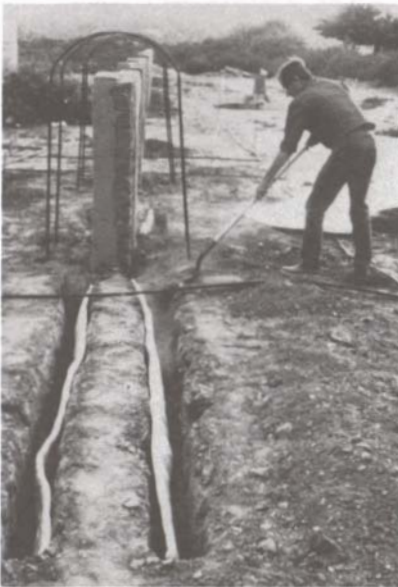
Figure 17. a) Close up of geodrain showing black plastic core and white geotextile fabric. Manufactured under the name Cordrain, by Nylex Corp., Australia. b) Photograph showing geodrains in place and being buried by author.

In general, ground-water control is best handled by installation of drainage systems. Trials are being carried out at Fort Selden on drains of advanced design. These are less intrusive of soil (and archaeological deposits) around the base of adobe structures than traditional gravel-filled drains (Fig. 17). Stripdrain and Cordrain are such drains. They consist of a non-woven polyolefin geotextile sheath, as a filter to prevent clogging, surrounding a dimpled plastic core (40 mm wide in the case of Stripdrain). This material is superior to conventional slotted agricultural drain-pipe on the following counts:

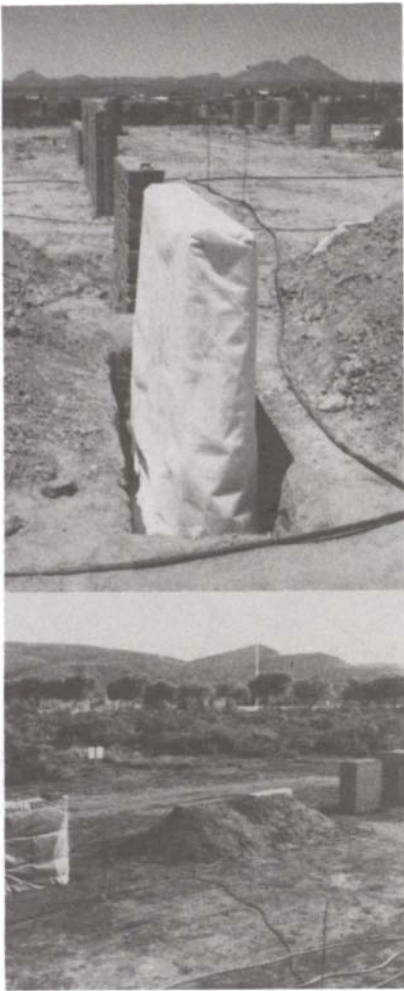
Figure 18. Photographs showing geotextile-covered and uncovered walls (#43, 44, respectively) a) prior to burial, and b) after burial.

Two walls (#43, 44) have been used for this experiment, in which half the

wall was built below grade (see Fig. 18). The experimental wall was draped with Mirafi 140 NS geotextile and then buried until only the top of the wall showed. The control wall was not draped but was similarly buried. Both walls have been water sprayed.

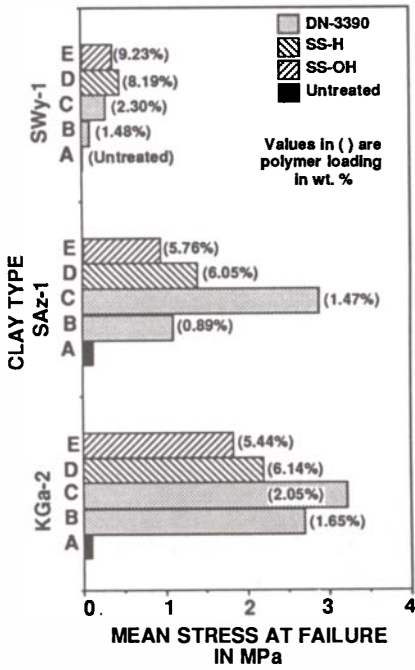
Figure 1. Results of compression tests showing mean stress at failure for untreated and isocyanate- or silane-treated sand:clay plugs.

Clay type (Letter refers to figures 1 and 2)	Mean Stress & (Std. Deviation) at Failure in MPa	Mean Modulus & (Standard Deviation) in MPa
KGa-2 (A)	0.099 (0.027)	11.124 (4.305)
KGa-2 (B)	2.695 (0.380)	116.563 (35.335)
KGa-2 (C)	3.220 (0.918)	147.491 (64.594)
KGa-2 (D)	2.196 (0.180)	124.931 (42.099)
KGa-2 (E)	1.827 (0.200)	92.169 (15.699)
SAZ-1 (A)	0.131 (0.037)	10.776 (5.418)
SAZ-1 (B)	1.104 (0.212)	74.167 (19.838)
SAZ-1 (C)	2.878 (0.308)	181.605 (68.047)
SAZ-1 (D)	1.400 (0.226)	99.407 (27.434)
SAZ-1 (E)	0.931 (0.140)	87.423 (25.340)
SWy-1 (A)	0.015 (0.003)	1.648 (0.819)
SWy-1 (B)	0.099 (0.041)	13.748 (8.042)
SWy-1 (C)	0.297 (0.297)	20.353 (3.791)
SWy-1 (D)	0.458 (0.059)	45.501 (10.837)
SWy-1 (E)	0.365 (0.027)	27.221 (5.356)

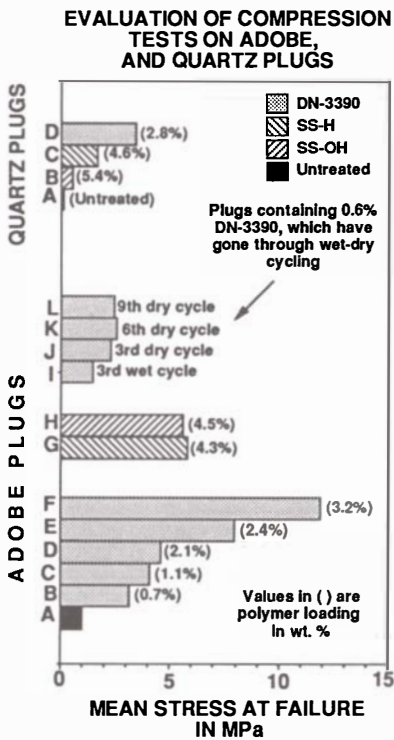
Figure 2. Results of compression tests showing mean stress at failure for untreated and isocyanate- or silane-treated adobe, and quartz plugs.

Table II and figure 2 also show that wet, isocyanate-treated adobe has a compressive strength similar to dry, untreated adobe. Isocyanate-treated adobe subjected to multiple wet-dry cycles is weaker than a similarly treated adobe not exposed to wet-dry cycling, although it still remains stronger than the initial untreated adobe. The compressive strength of untreated and treated pure quartz plugs is also presented in table II and figure 2. Isocyanate treatment increased the compressive strength of the quartz plugs eighty-fold, whereas silane treatment resulted in a ten- and thirty-three-fold increase (SS-OH and SS-H, respectively).

The effect of grain size and composition is further demonstrated by the enhanced compressive strength of consolidated pure quartz plugs, as shown in figure 2 and table II. The initial strength of the plugs, which is similar to that of sand-clay plugs, is due to the quartz grains and a weak cohesion between the variable-sized particles. However, the compressive strength of treated pure quartz plugs more closely approximates the compressive strength of treated adobe plugs. This is probably because the initial strength of the quartz particles is enhanced by the supporting silica-polymer network.

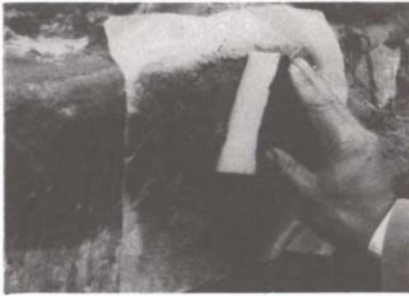
Figure 3. Application of moistened rice paper: the pressure allows adhesion to be reestablished.

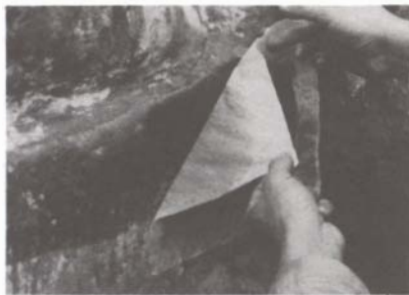
Figure 4. Detachment of the paper without any loss of surface material.

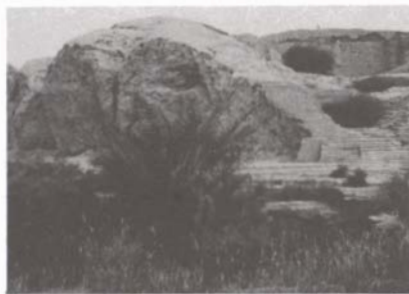
Figure 5. Overall view of the capping with one layer of strengthened bricks at Tell 'Umar, showing the plant overgrowth.

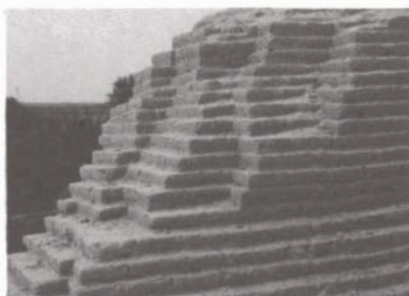
Figure 6. A section of the covering with one layer of strengthened bricks, still in perfect condition. (Tell 'Umar).

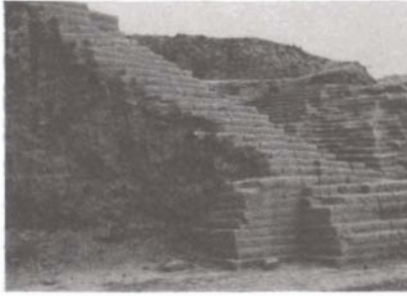
Figure 7. On the north side, the unprotected wall has suffered an enormous loss of material, due to the rain. (Tell 'Umar).

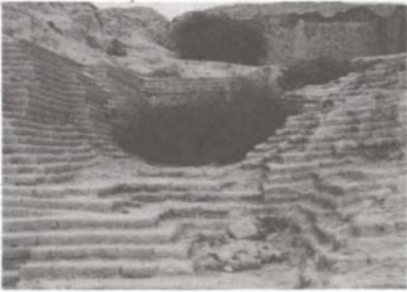
Figure 8. The canalization of rain water over Tell 'Umar. In spite of some plant growth and some minor damage, this drainage system worked properly.

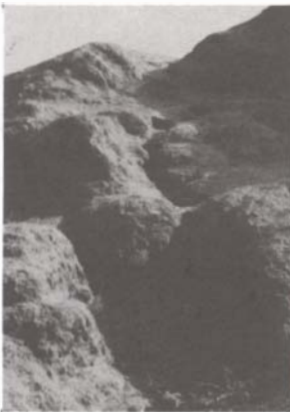
Figure 9. A natural canalization of water, left unprotected, to be compared to Fig. 8 (Tell 'Umar).

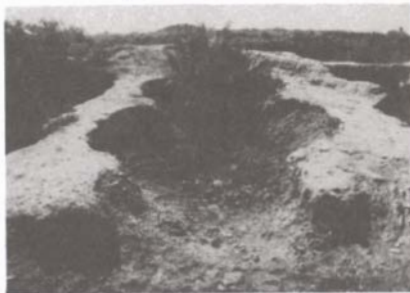
Figure 10. A view of the "Archives" in Seleucia. The top of the walls was capped with soil-cement, which did not prove to be effective, since there was formation of water pools at the bases of the walls.

The general condition of the Archives was disappointing (see figs. 10,11). Most of the small rooms were filled with earth, in part fallen from the walls, in part carried in by the wind. In some parts the capping had resisted, while in other parts it was

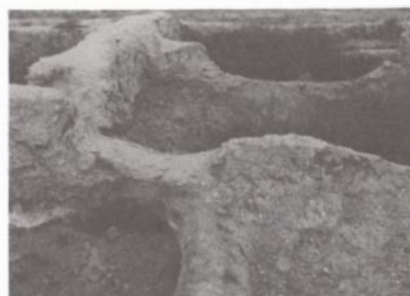
Figure 11. Another view of a small room in the "Archives".

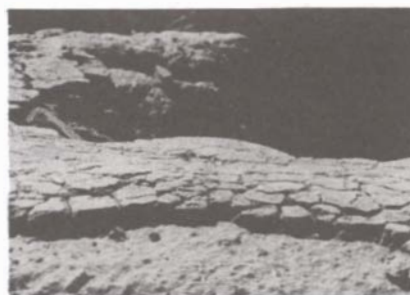
Figure 12. Detail of the soil-cement capping, partially detached and cracked. Besides damage due to temperature changes and water infiltration, it should be remembered that people walked on the capping.

cracked, allowing water infiltrations (See fig. 12). This confirms the opinion [8,9], that in the case of small rooms located below the field level, without drainage and with the possibility of water pool formation at the base of the walls, the only possible intervention is complete, immediate backfilling.

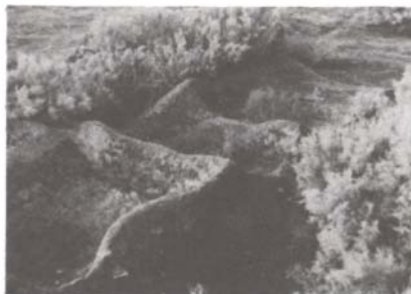
Figure 13. Rooms at "Via Porticata", in the Seleucia area, without any conservation work.

To check if the capping reduced in any way the speed of deterioration, a comparison was done with the nearby excavation of "Via Porticata", which had undergone the same abandonment for twenty years. Most of the walls completely disappeared, with the exception of two rooms, capped with soil cement (see figs. 13,14).

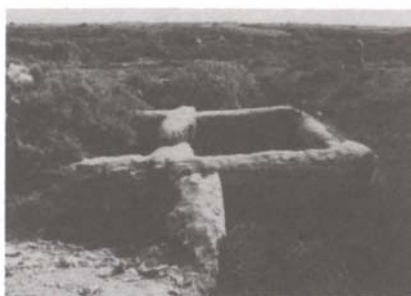
Figure 14. Two rooms at "Via Porticata" which were protected with the soil-cement capping. In this case the capping performed better, probably because people did not walk over it.

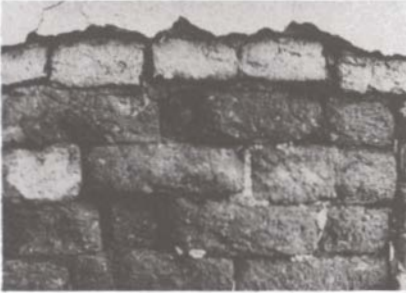
Figure 15. Wall treated with ethyl silicate in Hatra, as it appeared in 1969. The top layer of bricks was not consolidated.

In Hatra environmental conditions are different from Seleucia. The rainfall is more or less the same, but the water table is much lower. The treated wall had a stone base and did not collapse. The effect of rain alone on treated and untreated parts can be seen. One row of bricks at the top was left untreated for comparison. Figures 15 and 16 show that clay from the top row was washed down and covered the treated bricks. This clay encrustation was easily removed by the use of a rough brush, without effecting the consolidated surface. Even very fine details (see figs. 17,18) were perfectly preserved.

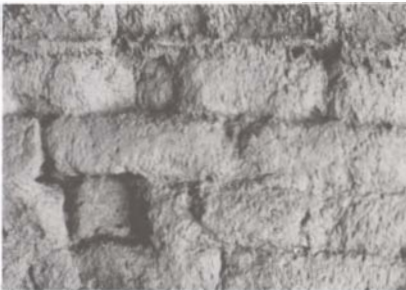
Figure 16. View of the same wall in 1989. The bricks on the top are washed away from the rain, and the material ran over the lower, consolidated part.

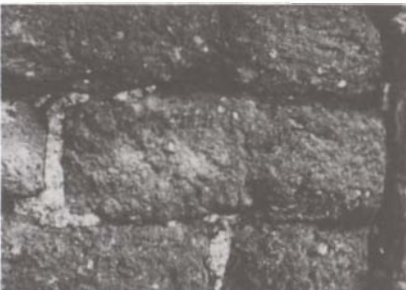
Figure 17. Detail of the same wall in 1969.

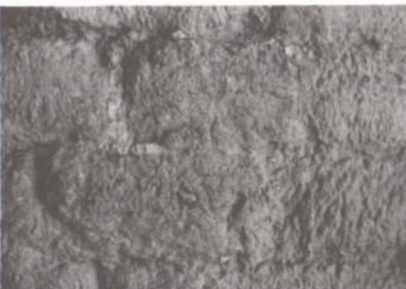
Figure 18. Same detail after partial cleaning with a harsh brush (see especially the white gypsum mortar). Even small details are well preserved.

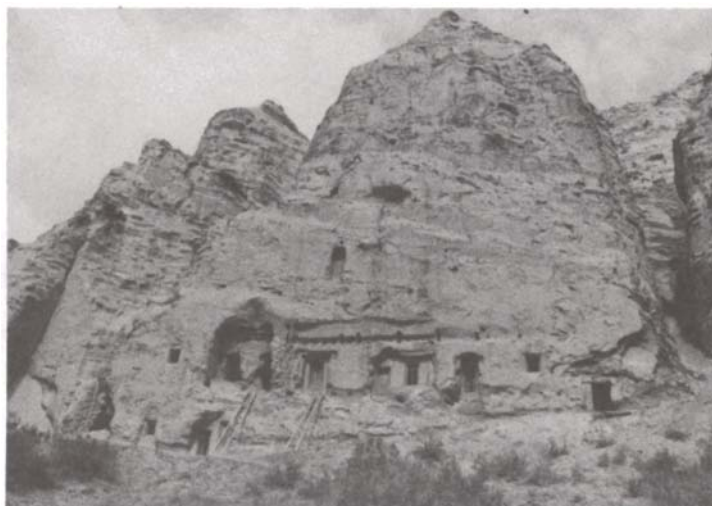
Fig.1 Kezier Grottoes; view near Cave 18 on the western side.

The Kezier Grottoes (Fig.1) are located in the Xinjiang Autonomous Region of northwestern China. They were carved in Tertiary mudstones and sandstones which are so poorly consolidated and cemented that they disintegrate immediately upon being wetted. In this respect they are similar to man-made earthen materials.

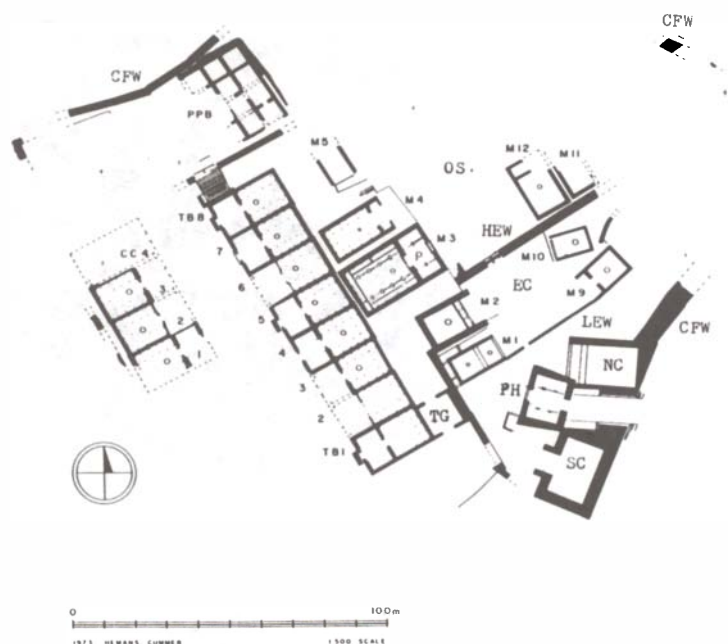
Figure 1. Gordion, overall plan of destruction level.

The Early Phrygian citadel, called the "Destruction Level" because of the significant fire damage and collapse of many of its structures, is divided into three main precincts: a palace area to the northwest, a high terrace to the southwest supporting two long service structures, and a multiroomed building that bordered the

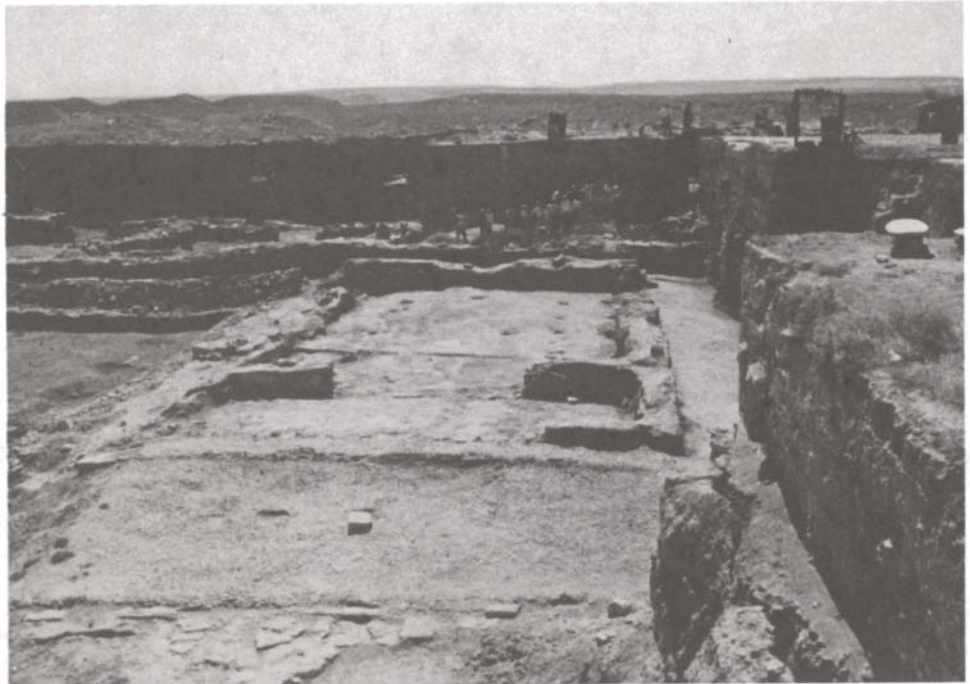
Figure 3. 1961- Megaron 4 just after excavation.

southwest terrace. The structure has exterior dimensions of 12.3 x 22 m (See fig. 3). The interior arrangement consists of a very shallow front porch and a deep inner room connected by a central doorway in the cross wall between the two rooms that is matched by a doorway of the same width between the facade's returns. Unlike Megaron 1, the walls were made of solid mud brick without a wood frame and range from 1.32-1.45 m in thickness. There are no vertical niches in the inner and outer faces and no bricks preserved at a uniform level to suggest horizontal string courses. Charred wood and reed found on the floors indicate that Megaron 4 had a roof similar to Megaron 1, and a pattern of post holes in the main room suggests that there was once a three-sided gallery level in the rear chamber along the back wall and flanks. As with other examples of this gallery system found in many buildings of the Destruction Level, Megaron 4's gallery provided its own support without piercing the actual wall fabric.

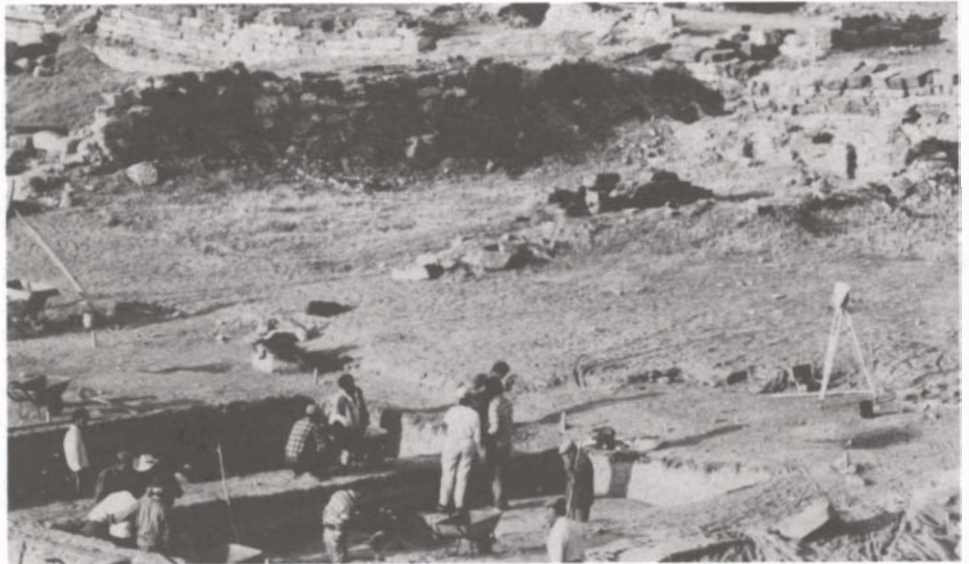
Figure 4. Overall deterioration of Megaron 1.

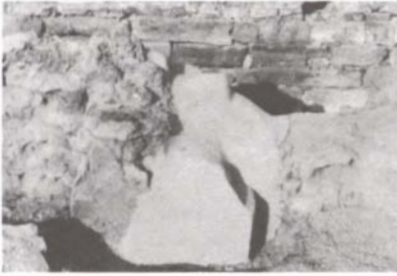
Figure 5. Section/pier of Megaron 1 after mud plaster application.

replastering the mud brick in the Gordion excavation compound (house and walls), mixed up a thick mud plaster and carefully applied it directly over one of the mud brick sections/piers. This was allowed to dry and touch-up was done in any cracks that developed. Detailed photographs were taken to record the treatment so that any weathering and change over the winter can be compared in 1990 (see fig. 5).

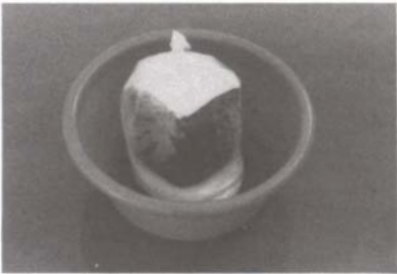
Figure 6. Consolidation test using 4% WS-24 on mud brick.

The first method chosen was by simple wetting: dripping and pouring various concentrations of WS-24 directly onto the mud brick. This was done only to one end (the small end) and it was found that concentrations up to 20% resin were readily absorbed by the porous brick, except in the areas where the brick fabric had been sintered or fused by the destruction fire. A 4% solution of WS-24 was chosen for the complete consolidation, and after thorough wetting (at which point a build-up of consolidant occurred on the surface), the brick was left in the shade to dry.

In order to assess the penetration of the consolidant, the brick was broken in half after forty-eight hours when it felt dry to the touch. It was easy to see where the consolidant had penetrated because it had slightly darkened the substrate and, in fact, had not completely dried in the center. Complete penetration was achieved except on the one side where the brick was burned.

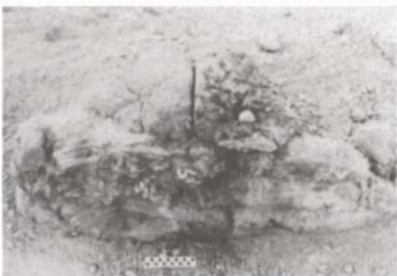
Figure 7. Section/pier of Megaron 1 after 4% WS-24 application.

On site, one of the smallest and most deteriorated sections/piers in the SW corner of Megaron 1 was consolidated using WS-24. In this case, a 4% solution was both sprayed on with an atomizer and dripped from the top into one of the most exposed areas. The section, although only four courses high and two wide, literally drank up the consolidant, and over 2 liters of solution were applied. As the upper bricks became saturated, an excess of resin began to build up in one area, and it was decided that the end point had been reached. The excess was lightly brushed off using deionized water. Photographs were taken throughout all stages of the treatment in order to record and compare any changes the next summer (see fig. 7).

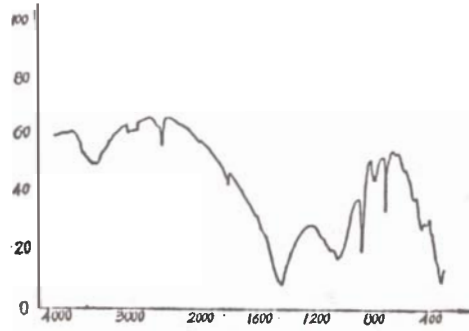
Fig.5 Infrared spectrum of PS-C.

Fig.4 is the infrared spectrum of clay containing montmorillonite; Fig.5 is the infrared spectrum of PS-C. The infrared spectrum shows that the OH peak intensity near 3500 cm^{-1} of the mass has dropped considerably, and the OH shifted by 10 wave numbers. This is another reason why the PS-C cemented mass has higher water resistance.

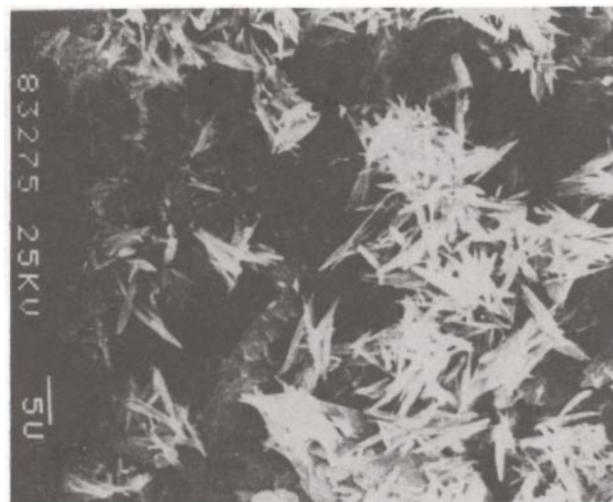
Fig 9 SEM photograph of PS-C, 9000 x.

Fig.8 is a SEM photograph of clay contained montmorillonite; Fig.9 is a SEM photograph of PS-C. The SEM photograph shows that an interwoven fibrous network of crystals, similar in structure to that found in hydrated gypsum, has formed. This is an important factor in imparting to the PS-C composite good water resistance and mechanical strength.

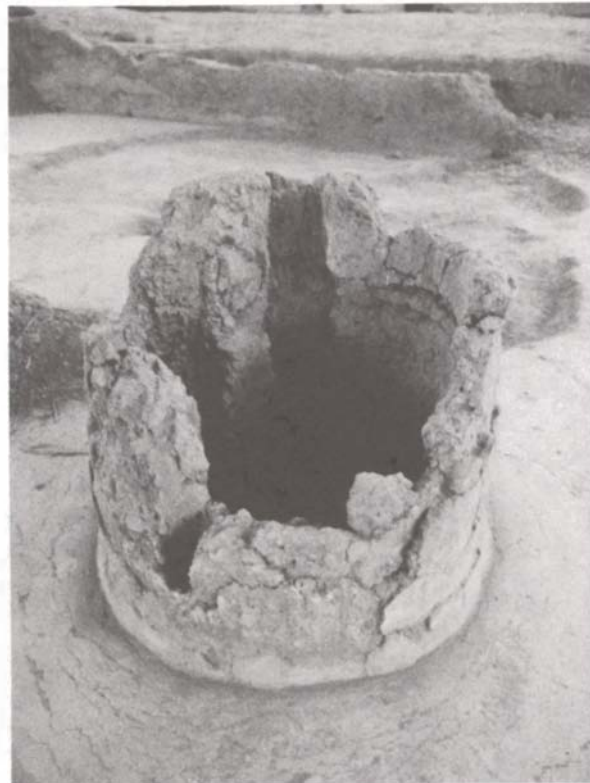
Fig.11. The Pillar hole of propping beam wooden pillar of F₉₀₁ house-ruins after consolidation. (Photo, March 1990.)

In August 1984 and in October 1985, site consolidation was undertaken on the weathered remains of the Yangshao house by spraying with PS solution. A 13-meter wall, one cooking stove and two post holes have been consolidated. Up to now, five years later, no abnormal changes have taken place on the surface of the structures. In our view an ideal effect was achieved (Figs. 10, 11).

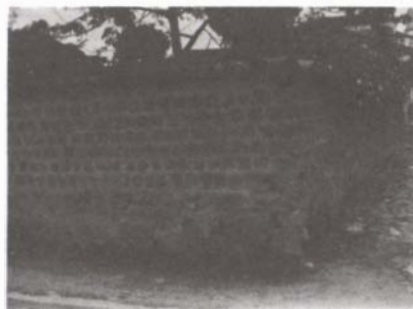
Fig. 1: Wall with "mole-do" base and adobe masonry. Tiradentes, Minas Gerais. Photo: Lima.

Moledo: This is a conglomerate made of clays, "saibro" (fine gravel) and decomposed rock, removed in blocks from the mines, in the shape of cobble stones of varying dimensions. Because this material is very resistant, it is applied "in natura."

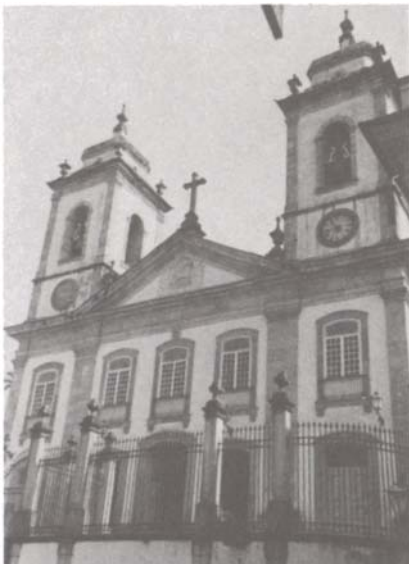
Fig. 3: Façade of the Basilica Cathedral of Our Lady of Pillar. Photo by Lima.

The construction includes an area of 1.056 m² with an average of 5.50 m height. The church square covers an area of 129 m², reached by a flight of stairs made of "cantaria" (carved stone). The construction consists of two parts, a posterior one which includes the high chapel and sacristy and another, anterior, which includes the main nave and the lateral corridors extending into the main façade, which was rebuilt during the middle of the nineteenth century in stone masonry. (See fig. 3.)

The main façade has a central door in the lower part, flanked by four smaller doors symmetrically set in relation to the central axis under five windows of the balcony finished by a triangular "frontão" topped by a stone cross. The façade is flanked by two towers provided with pyramid domes. All the details of the façade are made of carved stone. Inside, the temple is one of

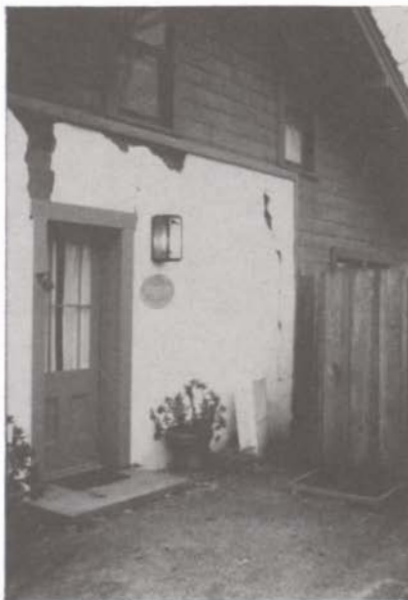
Figure 2. North end wall, Branciforte Adobe, 1990

Besides the usual diagonal cracking about the door and window openings, through the wall vertical cracks occurred at the previously undamaged northeast and northwest corners of the adobe. A vertical crack widened near the northwest corner where an opening had been cut and partially filled by a cupboard.

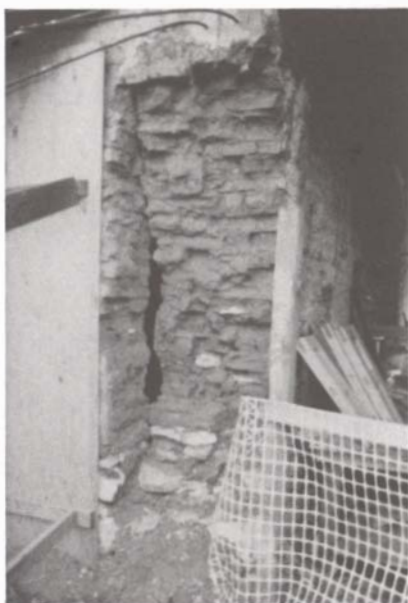
Figure 6. Southwest corner, the Santa Cruz Mission Adobe, 1990

At the west end or short wall, a pre-existing vertical crack which had been repaired with Portland cement stucco in 1966 widened and deepened, extending through the wall at the corner. At the same corner a wide vertical crack opened in the south long wall, leaving an essentially freestanding column of adobe which toppled in an aftershock, cracking the bond beam on the west side. The upper portion of the west short end wall moved outward horizontally to the west beneath the bond beam leaning more than 10 cm from vertical. The lower portion of the wall suffered some out-of-plane damage with loss of stones from the foundation.

Factors contributing to the instability of the west end include: 1) failure to properly repair the existing vertical crack at the corner; 2) a later door cut into the west wall west face close to the corner; 3) unstable foundation conditions not completely remedied; 4) recent archaeological excavations very near the wall; and 5) lack of vertical anchorage of the bond beam to the wall.

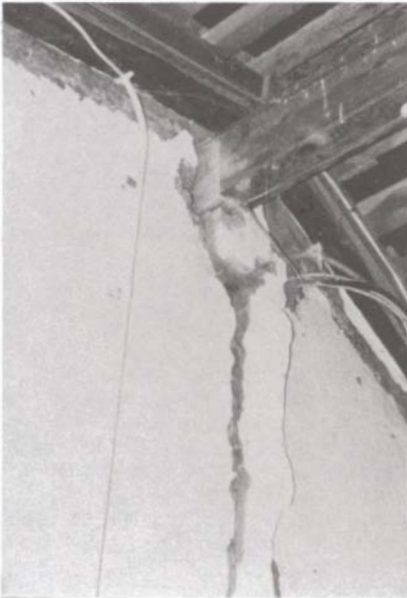
Figure 8. Damage from cocina ridge beam, the Castro Adobe, 1990

North of the two story block, a one-story adobe *cocina*, or kitchen, was constructed against the north wall with an oversized opening in the east long wall. Within the last 30 years the roof of the *cocina* was altered in seismically unsound ways. That is, the roof rested directly on the east long wall but was raised about 10 cm above the west long wall bearing on narrow adobe infill between short studs and was not anchored to either side wall. During the earthquake, the roof's massive laminated ridge beam rammed a hole into the midpoint of the two-story north wall and cracked it vertically through the wall. The roof moved as a unit about 15 cm north thrusting out the west long wall and producing a vertical crack at the northwest corner over 10 cm wide. The north gable end wall of the *cocina* suffered major out-of-plane damage about a meter from the base. Finally, a tiny pre-existing vertical crack through the north gable end wall, where a corbel was inserted in the 1950s, widened about 10 cm. With aftershocks, the northwest corner and part of the north end wall became a freestanding column of adobe leaning outward.

At the north end of the two-story block, the long walls cracked at the corners to beyond the wooden tie beam, which proved of dubious value. Both the long and short walls cracked diagonally around doors and windows. A vent, which had been opened through the wall without a header, exacerbated severe through-the-wall diagonal cracks.

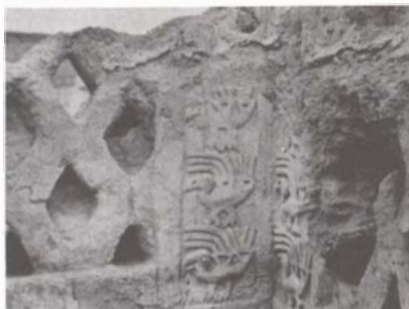
Friso con figuras en relieve en la ciudad pre-hispánica de Chanchán, tratados con silicato de etilo.

Un especialista de la Universidad de Turín enviado al Perú por la UNESCO probó la aplicación de un producto remineralizante, el éter de ácido silícico para reforzar los silicatos que se encuentran en la composición del barro, haciéndolo impermeable. El silicato de etilo se disuelve en alcohol y se caracteriza por tener gran capacidad reticular y por lo tanto se obtiene buena penetración en frisos y muros.

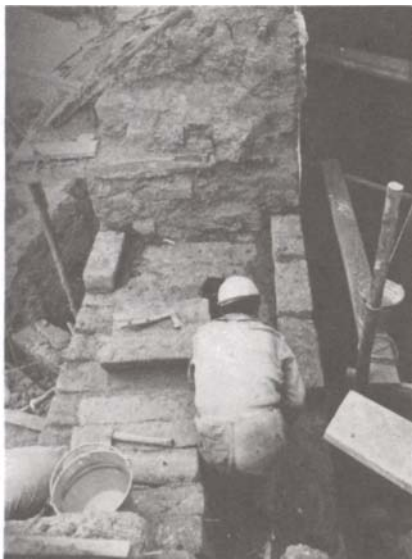
Las técnicas que pueden ser correctas para la consolidación de los muros de adobe, pueden afectar la pintura mural.

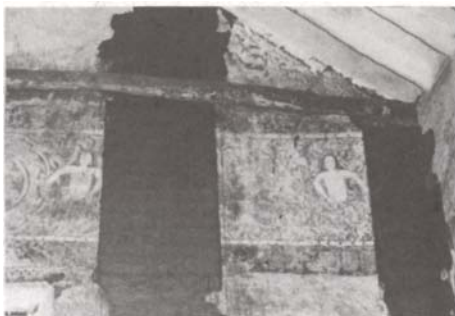
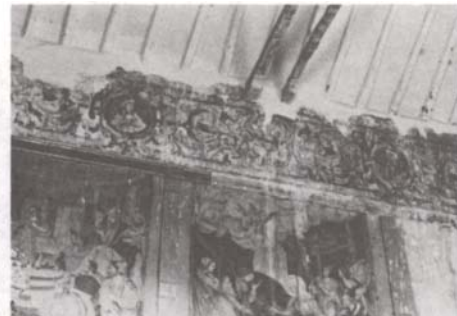
Lamentable intervención reciente para reparar fisuras en el muro de adobe sin respetar la pintura. A la derecha se ven los daños en la pintura al reparar la cubierta.

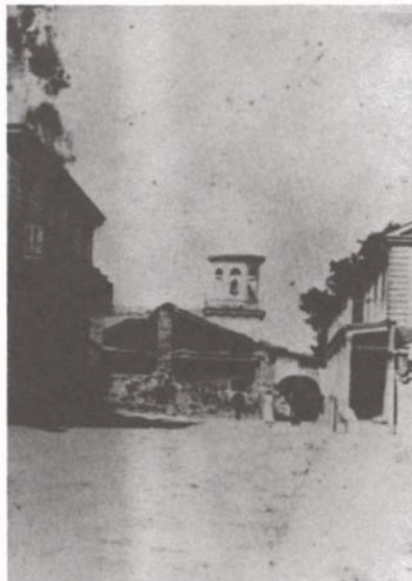
Figure 2. Mission San Juan Bautista, Convento Wing. View of damage after the 1906 earthquake. (Photograph from San Juan Bautista Historical Society)

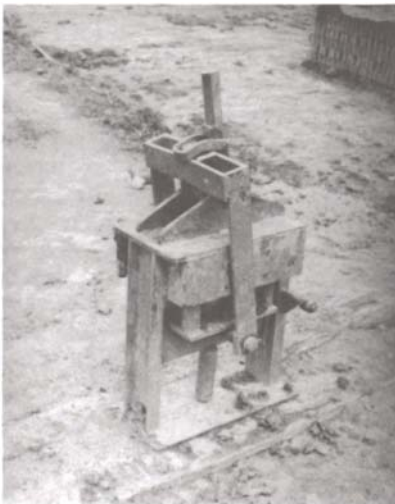
MOULDS
The adobes can be manufactured using a cinva-ram press or a wooden mould.

It is possible to use a two-brick, four-brick, or single mould. The simplest and most practical method is the single, bottomless wooden mould. It can be lined with sheet metal to allow the mould to slip easily away from the adobe when lifted. The adobe size depends on the mould; the most common has dimensions of 10 x 20 x 35 cm. The single mould has been used in a quick way that produces the same quantity of mud bricks as the multiple moulds. Special closer brick will be required for bonding, for this kind of adobes it is necessary to fix suitably shaped pieces of wood inside the mould.

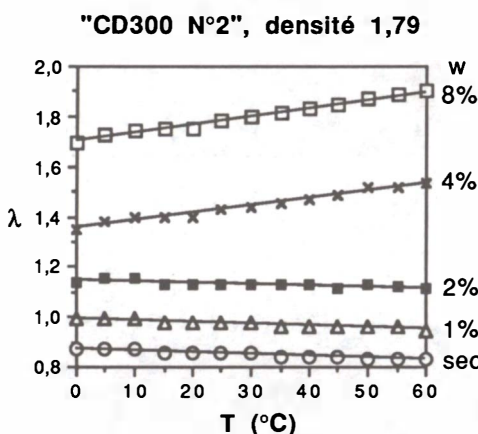
Fig. 5 : $\lambda = f(T, w)$

Fig. 6 : $C = f(w)$ à 20°C

Fig. 5 & 6 : Exemples d'évolutions mesurées des paramètres thermiques en fonction de la température et de la teneur en eau

3. Interprétation des résultats obtenus : Toutes les mesures réalisées en fonction de la teneur en eau ont montré que l'on pouvait admettre une variation linéaire de la capacité calorifique en fonction de la teneur en eau avec une pente égale à la capacité calorifique de l'eau (Voir exemple Fig. 6). On peut donc estimer la capacité calorifique d'un matériau terre humide à partir de la valeur obtenue à sec (Voir Tab. IV) par :

Si l'on considère maintenant l'évolution de la conductivité thermique en fonction de la teneur en eau pondérale (Voir exemple Fig. 5), on constate également une variation pratiquement linéaire aux faibles teneurs en eau. De plus, ce comportement est indépendant de la densité sèche du matériau considéré. On pourra donc estimer simplement la conductivité thermique d'un matériau terre humide, quelle que soit sa densité, par :

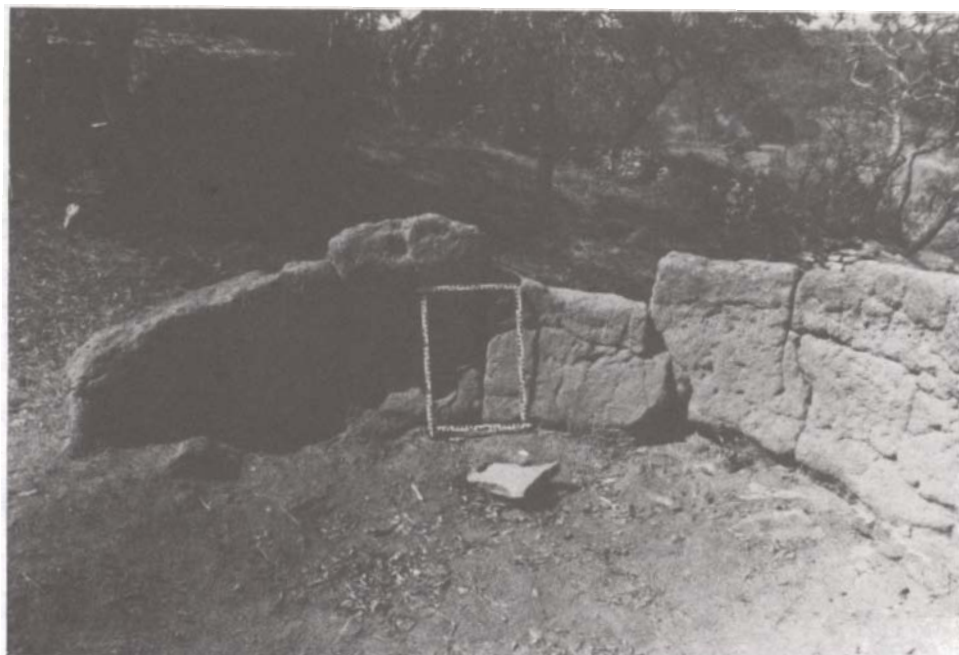
Fig. 2: Prehistoric structure-interior decay.

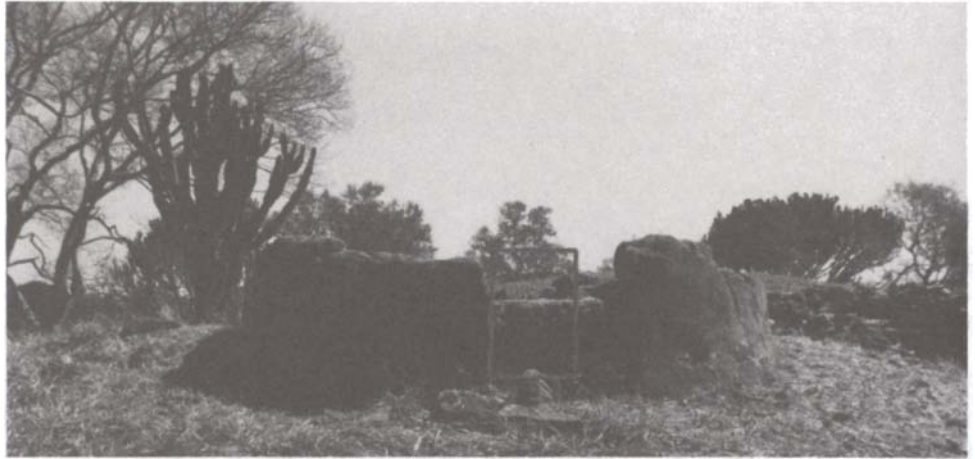
Fig. 3: Prehistoric structure-exterior decay. Note flaking towards base of wall

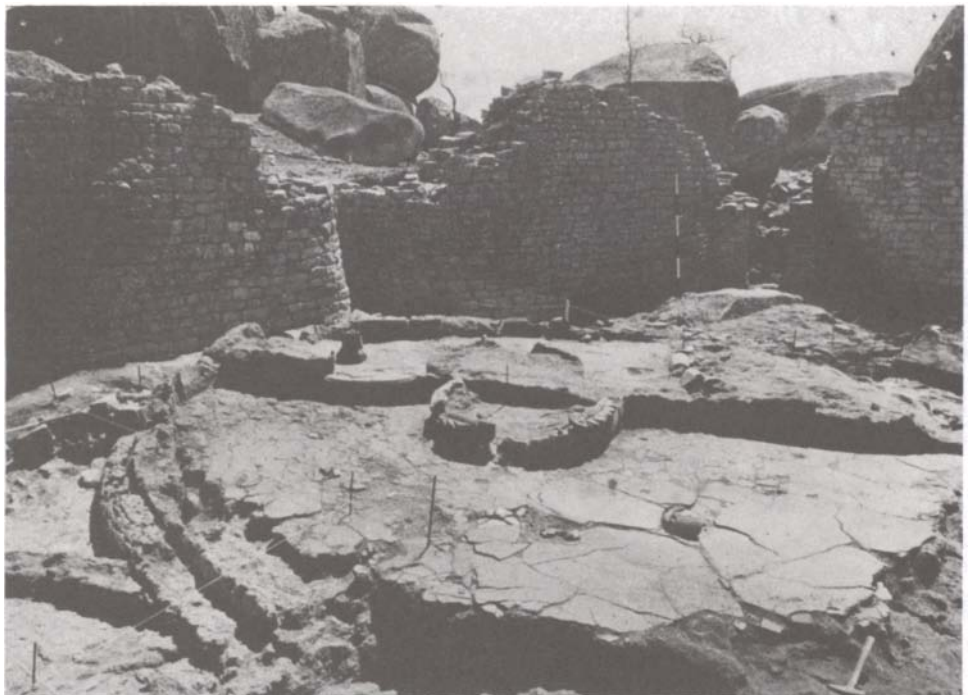
Fig. 4: House floor with features- a month after excavation. Note random cracking and weathering.

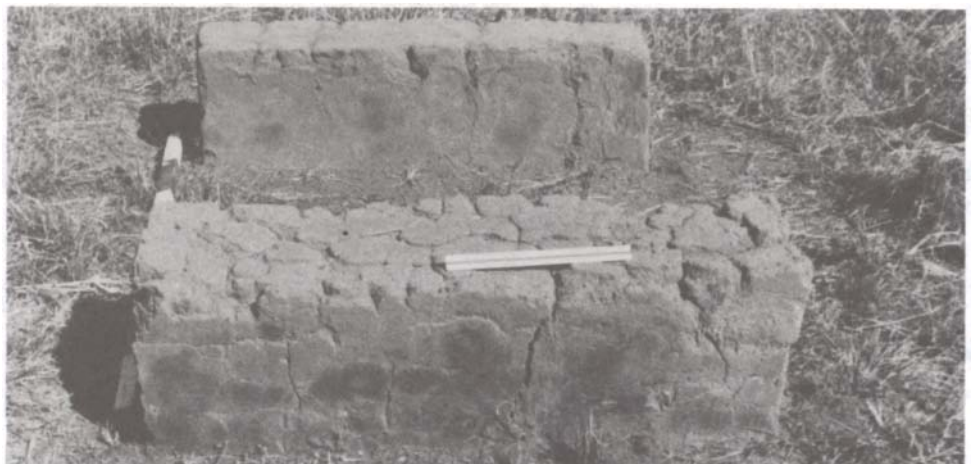
Fig. 5: Experimental wall-after a year of exposure to elements of nature.

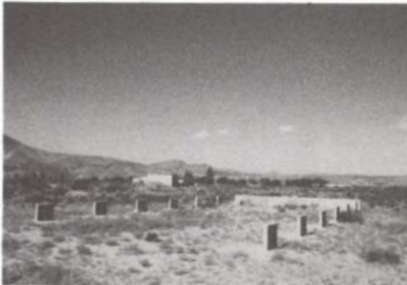
Fig. 1 Test walls, looking west, southwest. The historic ruins and the visitor center are in the background.

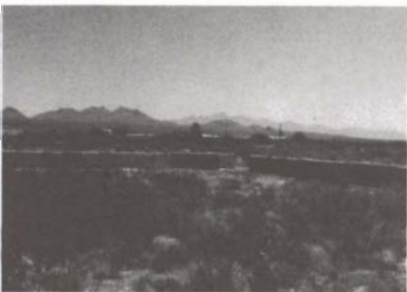
Fig. 2 Test walls, looking east.

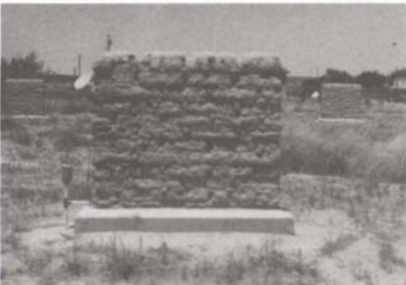
Fig. 4 Example of test wall constructed with concrete wainscot installed along the base.

8. Unamended adobe foundation with cement stucco over the wall surface
9. Unstabilized adobe foundation with a poured and formed concrete wainscot, exposed adobe wall surface

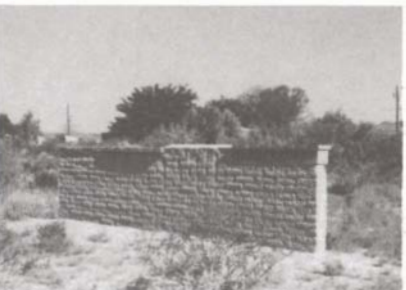
Fig. 5 Wall cap experiment, looking northwest.

Four different wall caps, each 1.52 meters long (5 feet), were applied to an unamended adobe wall 6.1 meters long (20 feet), (fig. 5). The types of capping materials used are commonly found in New Mexico. The four wall caps are: (1) A course of adobe bricks stabilized with asphalt emulsion placed on top of and flush with the wall, (2) a course of adobe bricks stabilized with asphalt emulsion placed on top of and perpendicular to the wall face, thus creating a 5.1 cm overhang on each side of the wall sloping to the north, (3) a rounded cement cap troweled on to the top of the wall, and (4) three courses of fired brick applied to the top of the wall to form a denticulated cap.

The four different types of caps installed on the 6.1 meter-long test wall are providing some interesting results. All four wall caps, including the one with an overhang, are experiencing accelerated erosional patterns at the interface between the cap and the top of the unamended wall. This is anticipated to some extent since rain quickly runs off the fairly impervious caps and is directed into the top of the unamended wall where the moisture can penetrate.

The cap with the overhang is failing in part because the south overhanging portion which slopes to the north has no drip edge, causing water to run back under the overhang and penetrate the unamended wall top. On the north side of this same cap, moisture is eroding the unamended wall top, probably because the overhang does not extend out sufficiently away from the wall. The important question here is how much do impervious caps, similar to the ones used here, protect the wall tops, as compared to leaving the wall tops exposed with no protection. When comparing the loss of the top of the walls between this wall cap experiment and the top of the uncapped walls in the wall base experiment, some useful conclusions can be drawn. First, the caps have indeed protected the tops of the walls. Approximately 3 cm of wall top has been lost from the uncapped walls, whereas no loss in height of the wall has occurred on the capped walls. What is interesting, however, is that the wall that has been capped has lost considerably more vertical wall surface on the upper portion of the wall, just below the interface between the cap and the unamended wall, than the uncapped walls. Comparisons in upper wall thickness between uncapped walls and this capped wall indicate that as much as 3 cm of vertical wall fabric has been lost.

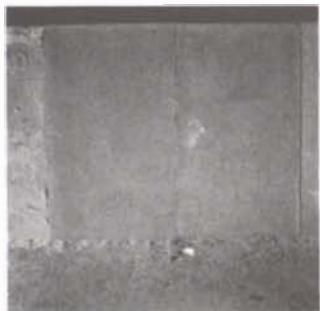
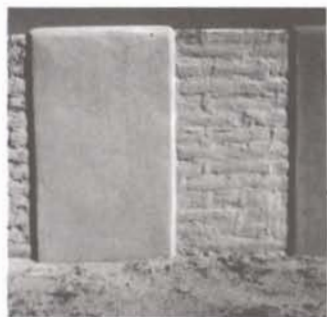
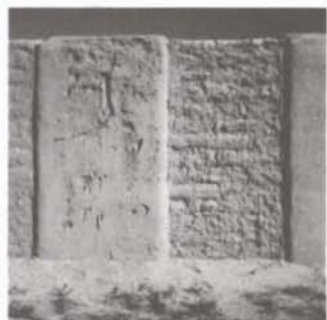
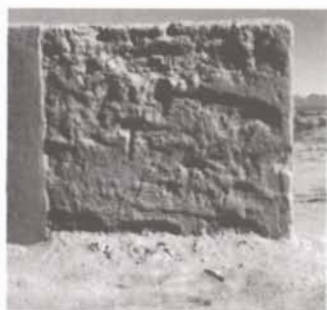
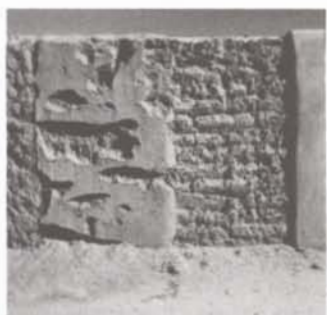
Fig. 6 Examples of Erosion rates.

Very little erosion.

Little erosion.

Moderate erosion.

Serious erosion.

Very serious erosion.

It should be stressed that the results of this experiment to date are specific to the particular conditions of the site. These include soil particle size and mineralogical content of the soil used in the manufacture of the adobes and mortar, application technique, and climatic conditions that existed when the treatments were applied and that have existed since. What is reported to have favorable or unfavorable results in this test wall experiment may provide different results under other conditions. Recommendations, however, can be made for further testing based on the positive results reported in this paper. The test walls have provided interesting results since they were constructed five years ago. Refer to Table IV for each panel's condition and to (Fig. 6) for examples of erosional rates.

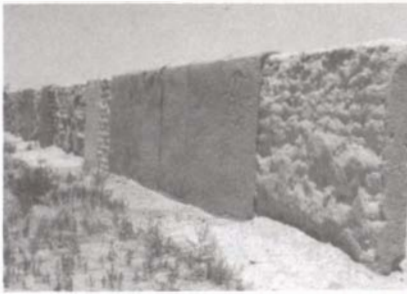
Fig. 7 Amended wall west face. Control panel is on the right.

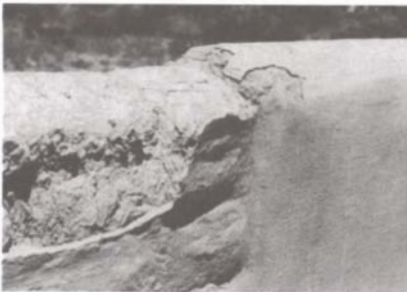
Fig. 8 Detail of the erosional pattern on the Super Quickseal panel.

The Super Quickseal roll-on exhibits considerable checkered cracking (see fig. 8). Thorocoat has begun to crack, allowing moisture to enter (fig. 9).

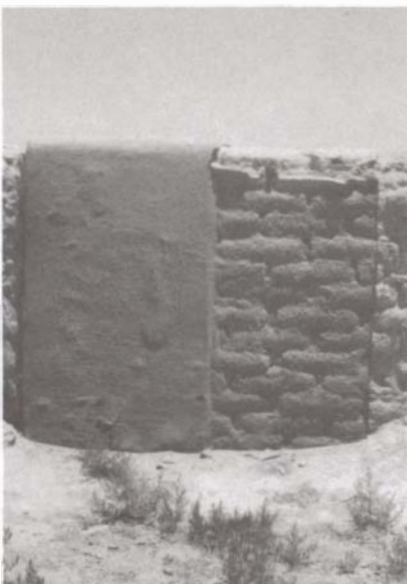
Fig. 9 Thorocoat panel. Note cracks and deteriorating coating.
