OTHER TOOLS FOR INVESTIGATION AND MONITORING

Overview of Diagnostic Indirect Tools for Conservation

John A. Fidler

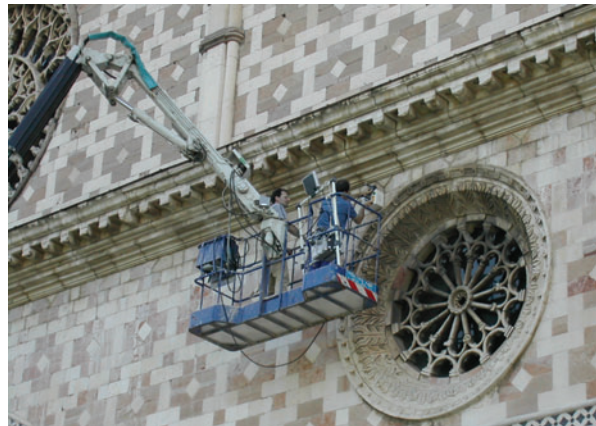
Technicians using GPR for data acquisition near the basilica's rose window. The GPR system was applied directly to the building's surface. Photo: © Marco Tallini.

GPR was more appropriate for this study because it is a nondestructive technique that requires little contact with the medium. In addition, this tool has a good level of accuracy and is easy to handle and transport. GPR testing was therefore used in order to understand the internal masonry structure of the facade by determining the thickness of the wall, to locate cracks and areas of detachment, and to identify where consolidation treatment was needed.

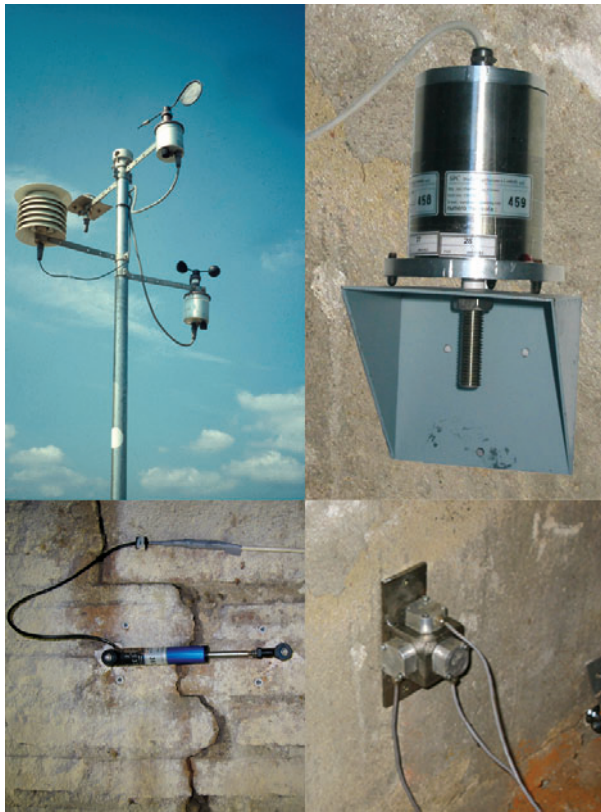
Clockwise from top left: weather station; biaxial inclinometer, which measures tilt in both north–south and east–west directions; accelerometers, which measure three-axis seismic acceleration; transducers, which measure strain on cracks. Photos: © Giorgio Croci.

movement is due to a strong wind, a sunny day, or, more important, their intervention or an impending failure. A weather station was positioned on top of the tower to record wind direction and speed, ambient temperature, and radiation from the sun. Thermometers were placed inside the masonry on different floors to correlate deformations of the structure with temperature. These measurements record how the structure reacts to environmental forces and were useful before and during work on the tower.

Cracks are also typical in masonry buildings, especially in towers eight hundred years old. They can be beneficial by relieving stress but also can be a warning sign of more serious issues. Strain gauges were installed to measure crack propagation or reduction in twenty-five different locations. These highly sensitive instruments were affixed to the cracks and essentially converted mechanical motion into an electronic signal. The gauges were calibrated to take into account temperature changes and other material properties. As with environmental measurements, the crack monitors served to inform the engineers as they conducted their studies and made changes to the tower.

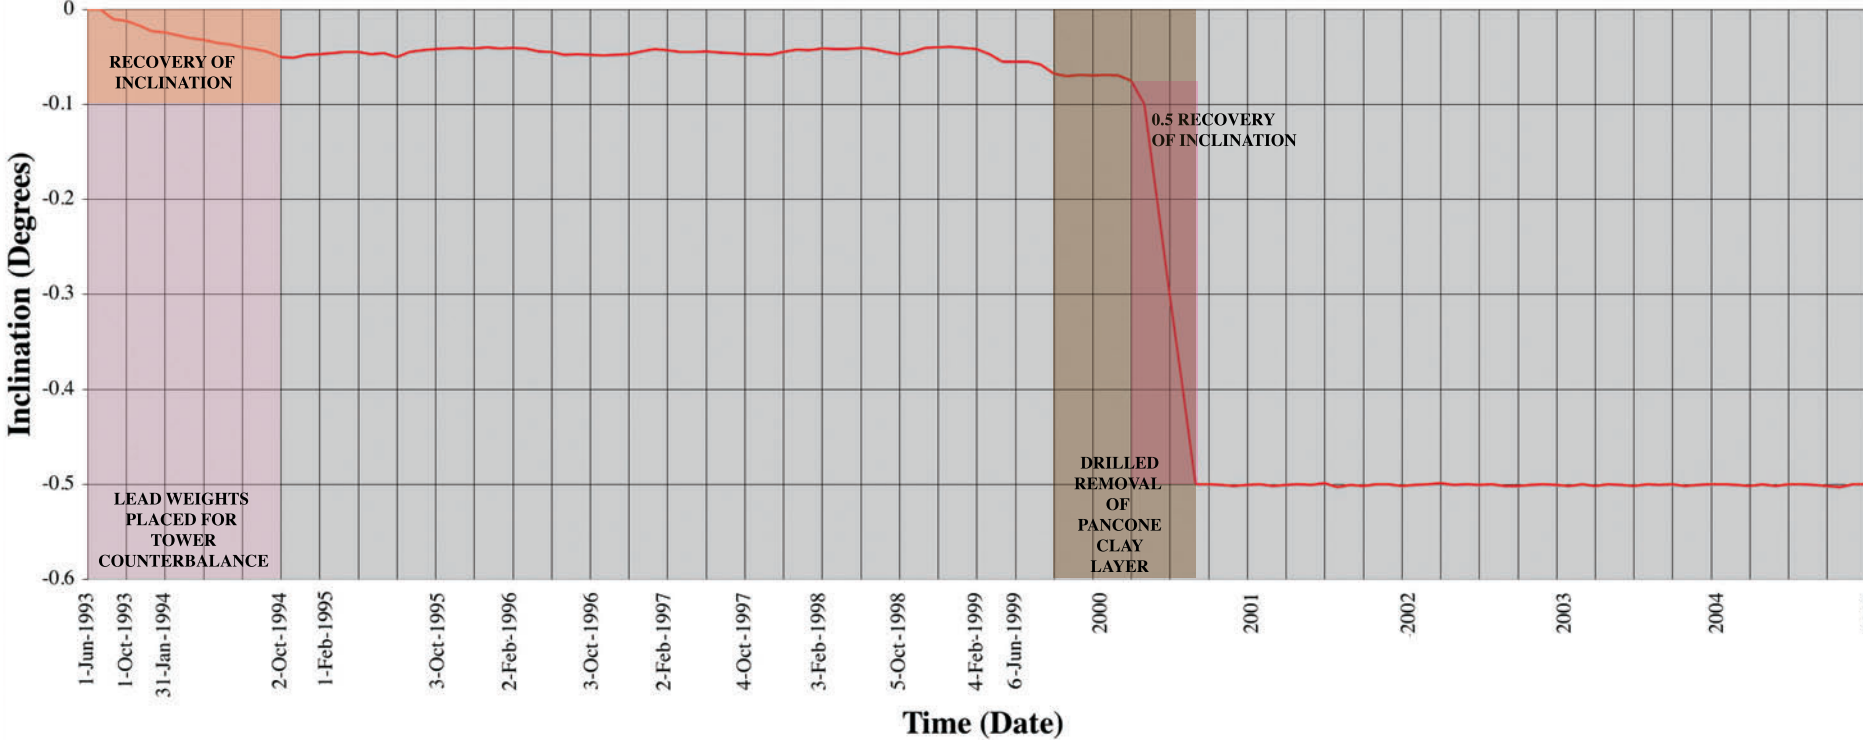
Recovery of Inclination Along the North-South Axis, 1993-2005

Chart showing recovery of inclination. Lead weights reduced tower lean by 52 seconds. With the removal of the clay layer, the lean was further reduced by a half degree (nearly 10%) and stabilized. Chart: © Giorgio Croci.

In 1993, the committee set urgent provisional measures to prevent further movement by applying 600-ton blocks to the north side of the tower's foundation. This was later increased to 900 tons. The sophisticated monitoring system already in place reflected a reduction in the inclination of around 52 arc/seconds, or about 0.014 degrees. More important, the tilt of the tower was halted. In 1998, cables were provisionally applied around the tower and anchored to massive weights hidden behind other buildings. This was done as a precautionary measure before starting further interventions.

When the operation was completed in 2001, nearly 10 percent of the tilt had been recovered. The committee and the Italian Ministry of Culture agreed that this value retained the important lean while guaranteeing stability. At present, the monitoring system continues to operate, showing that the tower is stable and its inclination is the same as it was in the middle of the eighteenth century.

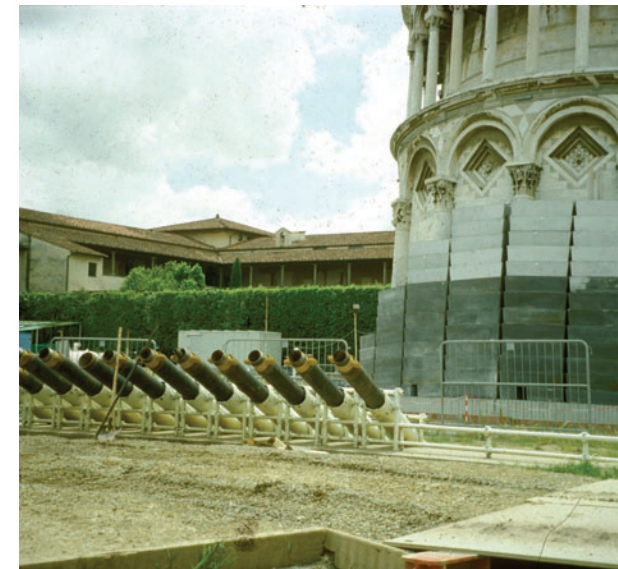
Lead weights were used to reduce the tower's lean. Photo: © Giorgio Croci.

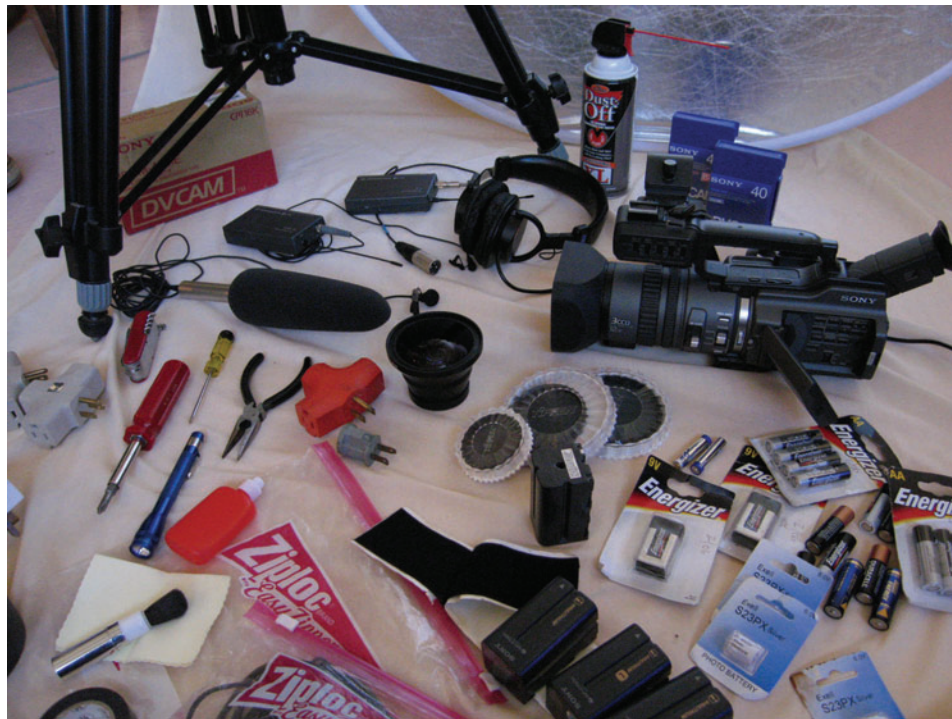
Field equipment used to make the documentary video, including a mini-digital video camera (DV cam pictured), tripod, extra rechargeable batteries, microphones, and various tools for work in the field. To protect the equipment from dust and sand, the camera and tapes were stored in resealable plastic bags. Photo: © Caterina Borelli.

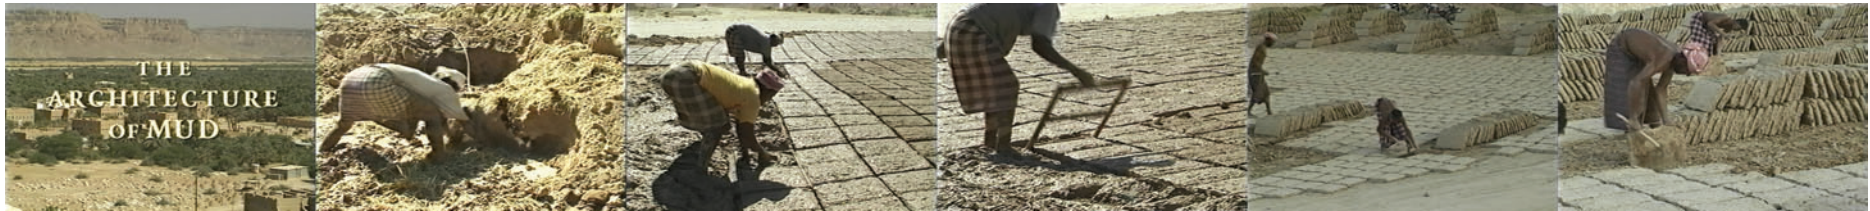
Series of stills from the documentary, showing workers in Seyoun creating mud bricks for new construction. Soil is gathered and mixed with straw and water. The mixture is spread out evenly in a mold, which is lifted immediately. The mud bricks are then left to dry in the sun for a week. Photos: © Caterina Borelli.

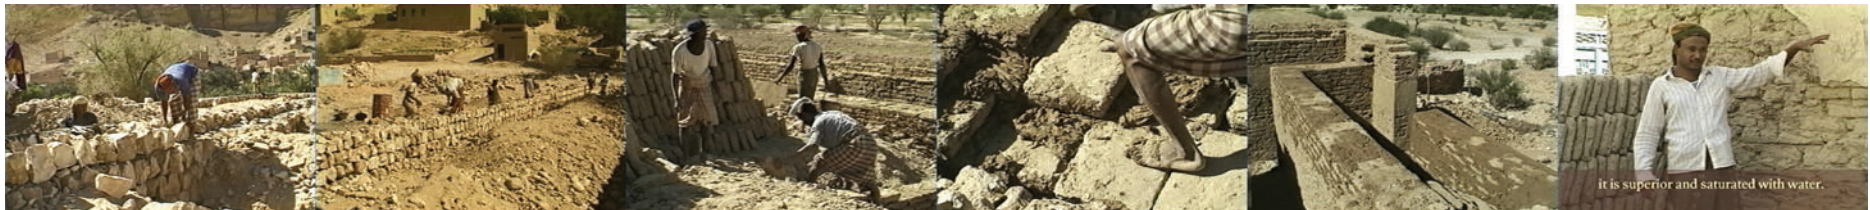
Series of stills from the documentary, showing workers erecting a new building. After the stone foundation is laid, the mud bricks are stacked to build a wall. Photos: © Caterina Borelli.

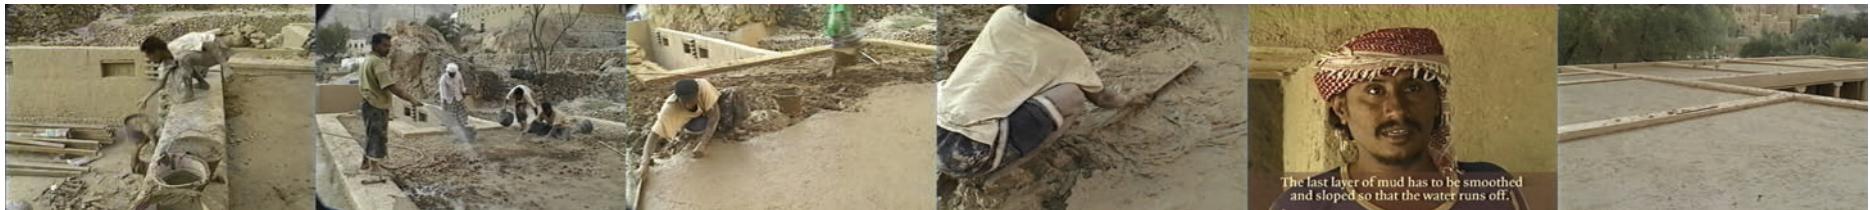
Series of stills from the documentary, showing the completion of a building. Workers are finishing off the new roof with mud. Photos: © Caterina Borelli.

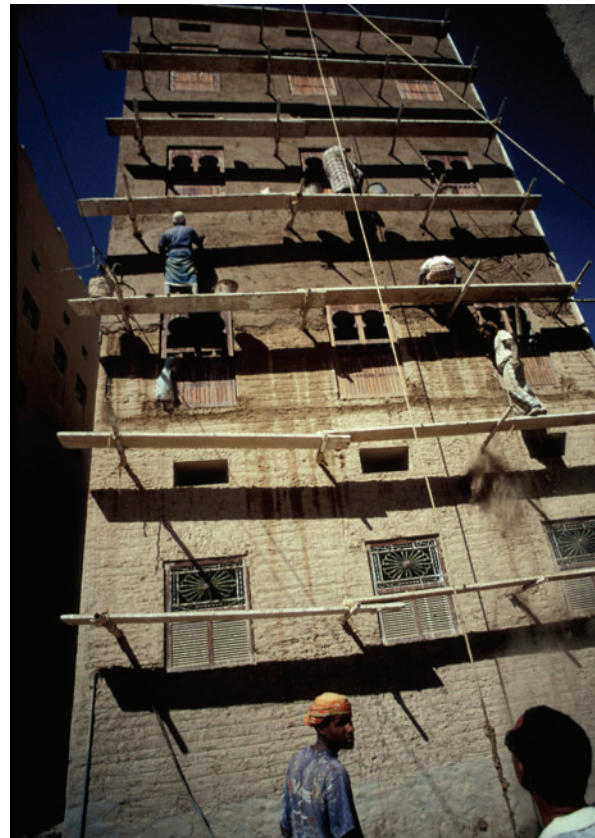
Ongoing maintenance efforts in Hadhramaut also involve plastering the exterior of buildings with mud to conserve the mud-brick construction. Photo: © Caterina Borelli.

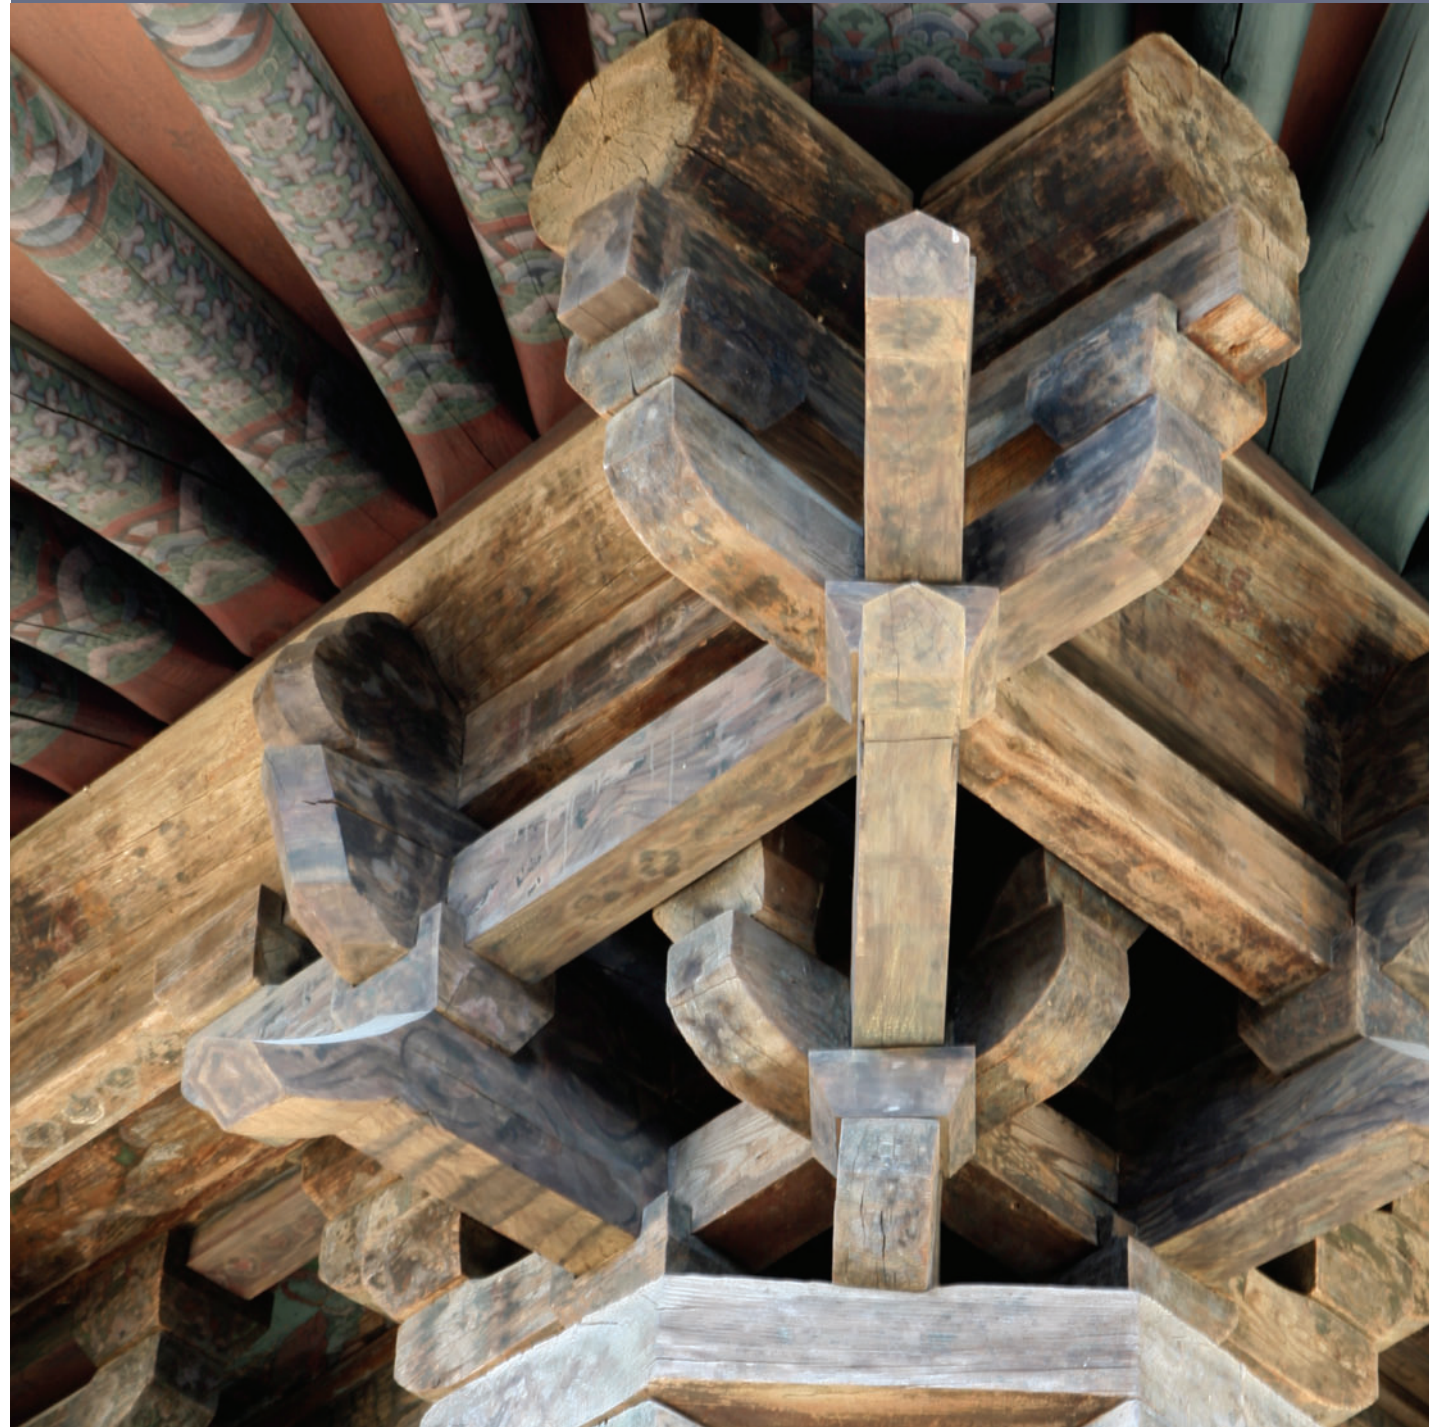
Detail of the multibracket system used in the construction of the Hall of Paradise (Geukrakjeon), in Bongjeong Temple, South Korea. Photo: Jong Hyun Lim.

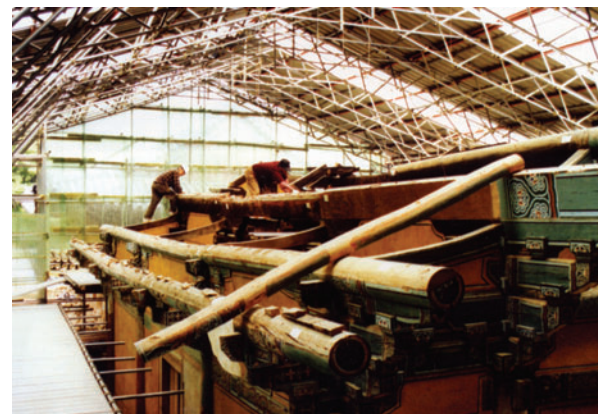
The Hall of Paradise, during restoration. Dismantlement of the temple allowed each building component to be documented individually. Photo: © Soon-Kwan Kim.

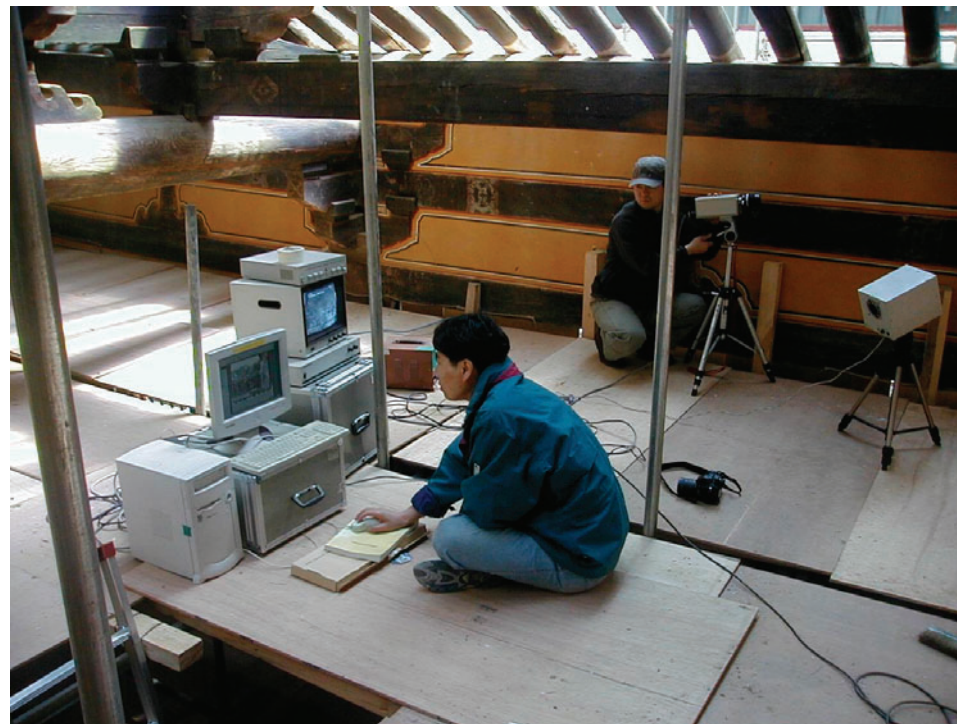
IRR acquisition of the images was conducted both on the individual components and in situ for the composite building. Photo: © Soon-Kwan Kim.

IRR instrumentation is affected by environmental conditions such as ambient temperature and humidity and is very sensitive to light and motion. Therefore, members of the study team carefully controlled their surroundings by positioning the instrument on a flat, stable work surface and maintaining uniform lighting. They also bracketed exposures, taking multiple images of the same subject using slightly different settings. This
