Geotechnical Issues in the Conservation of Sites

Robert E. Englekirk

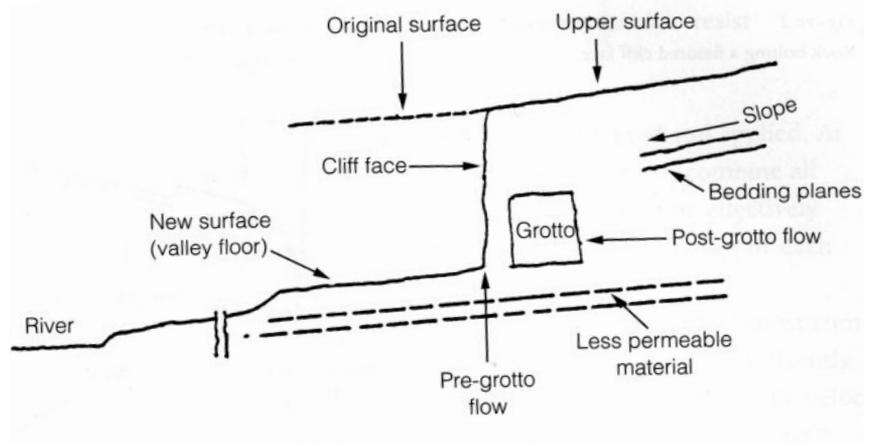
Figure 1
Schematic cross section through the cliff face
at Yungang.

A sandstone cliff face, as shown in cross section in Figure 1, is usually created by the formation of a river valley. Water will flow through the ground in the direction of the valley floor, especially if the bedding planes slope in that direction. The toe of the cliff will usually coincide with a change in the character of the sedimentary material near the valley floor, which is often less permeable than that of the cliff face. Water will descend to this less permeable stratum and then flow toward the river valley. Before the grotto was excavated, water would, because of the change in overburden pressure, tend to flow out at the intersection of the valley floor and the cliff face, contributing significantly to its recession. With the excavation of the grotto and the associated change in overburden soil pressure inside the grotto, the water intrusion point moved back to the intersection of the grotto floor and wall.

In general, source reduction will, if effectively accomplished, reduce the level of moisture experienced in the grotto walls as well as eliminate the water flow into the grotto. The major drawback is the difficulty associated with identifying the source of the water supply to the aquifer. If site geology and hydrology are complex, it is unlikely that the source of water to the aquifer will be sufficiently reduced by surficial treatments. Water interception, on the other hand, allows for an accurate location of the aquifer and its effective control. An effective, peripheral drainage system will rely on pressure relief much the same way as the subterranean flow was initially attracted to the grotto (Fig. 1). Accordingly, it may be impossible to

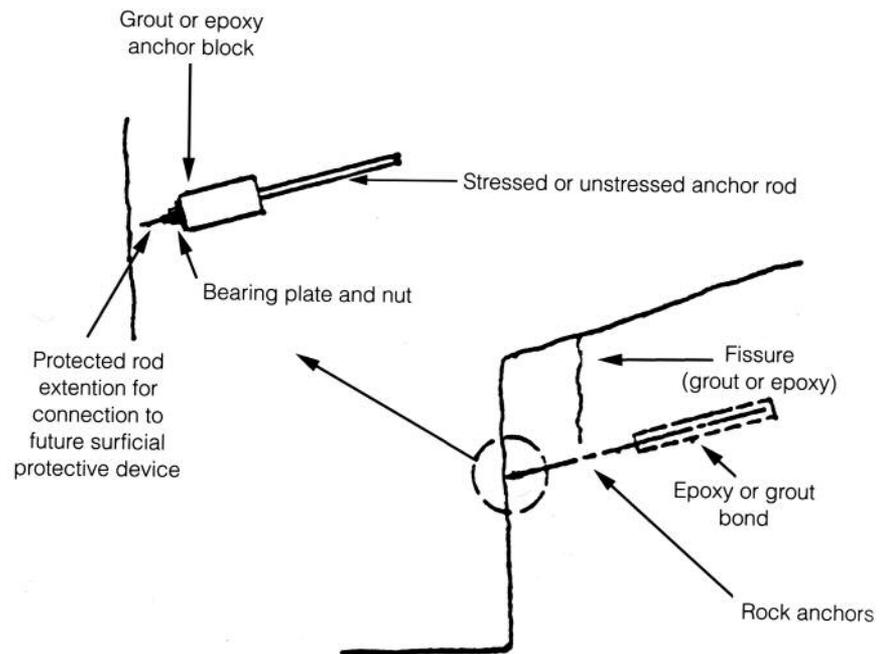
Figure 2
Rock bolting a fissured cliff face.

Where cliff recession rates can be tolerated but block failures seem likely, mitigation measures may be undertaken. Rock bolting, in conjunction with crack or fissure repair, may proceed in anticipation of the future addition of a surficial cliff-protection device. One means of accomplishing this staged abatement process is described in Figure 2.

about the same as at Dunhuang, although the rate is not regular. Block failures may be prevented by anchoring the separating block to the base material with rock anchors, as shown in Figure 2. At Yungang, fissure propagation is more rapid than at Dunhuang because rainfall is greater and the surface of the grotto roof tends to drain toward the cliff face. The effectiveness of any rock-anchoring procedure will require a thorough fissure-repair program and may be enhanced by a diversion of the surficial water flow above the grottoes.

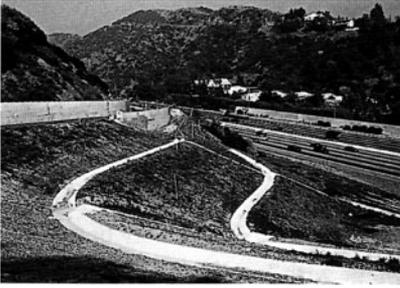
Figure 3
Erosion control by controlled-velocity vertical channels and gradual swales at the Getty Center, Los Angeles.

Limiting the impact of the erosive agent is the method most commonly used to control erosion by water, since water will not significantly erode a surface if both the quantity flowing over the surface and the velocity of flow are controlled. This is accomplished by reducing the slope length and steepness and increasing its roughness. Time-tested methods include terracing and roughening the surface by plowing it across the slope. Channeling the flow of the erosive material is also a commonly adopted methodology. The construction of channels controls the velocity, direction, and location of flow. The introduction of gradual swales and controlled-velocity vertical channels is shown in Figure 3. Clearly, the aesthetic impact is significant. Swales and channels must be continuously maintained, as the concentrated flow, if allowed to deviate from protected paths, will cause local failures that may be of significant proportion. Treatment between swales, usually vegetation, must also be maintained in a manner consistent with the mitigation program.

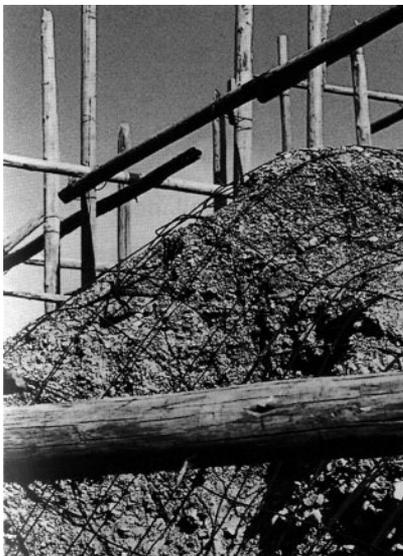
Protecting or isolating the surface material from the erosive agent by installing a layer of concrete is a method commonly used to protect highways in Japan. The basic features of this technique include rock bolts that extend through loose surficial deposits and are anchored into firmer substrata; a mat of ferrous reinforcement placed over the surface material; and, finally, concrete applied over the existing surface. An appropriately designed and installed application, if maintained, should virtually eliminate longevity concerns. Unfortunately, concrete is not easily applied to difficult surfaces and volume changes in the material itself will cause cracks to form, especially where the surface is irregular and material thickness is not uniform. Cracks will allow water to penetrate, causing the reinforcement to rust and creating flow channels or piping in foundation material below the concrete. Thus, the protective device may itself become a significant problem. For example, the installation of a reinforced concrete surficial device at the Yulin grottoes near Anxi was in progress in 1991, and some of the difficulties described above are apparent in Figure 4. Given the extremely irregular nature of the exposed cliff face at Yulin, this type of surface protection is probably the appropriate solution, but its maintenance will undoubtedly be a problem.

Figure 4
Steel reinforcing laid on the surface in preparation for application of surficial concrete as an erosion-control measure, Yulin grottoes.

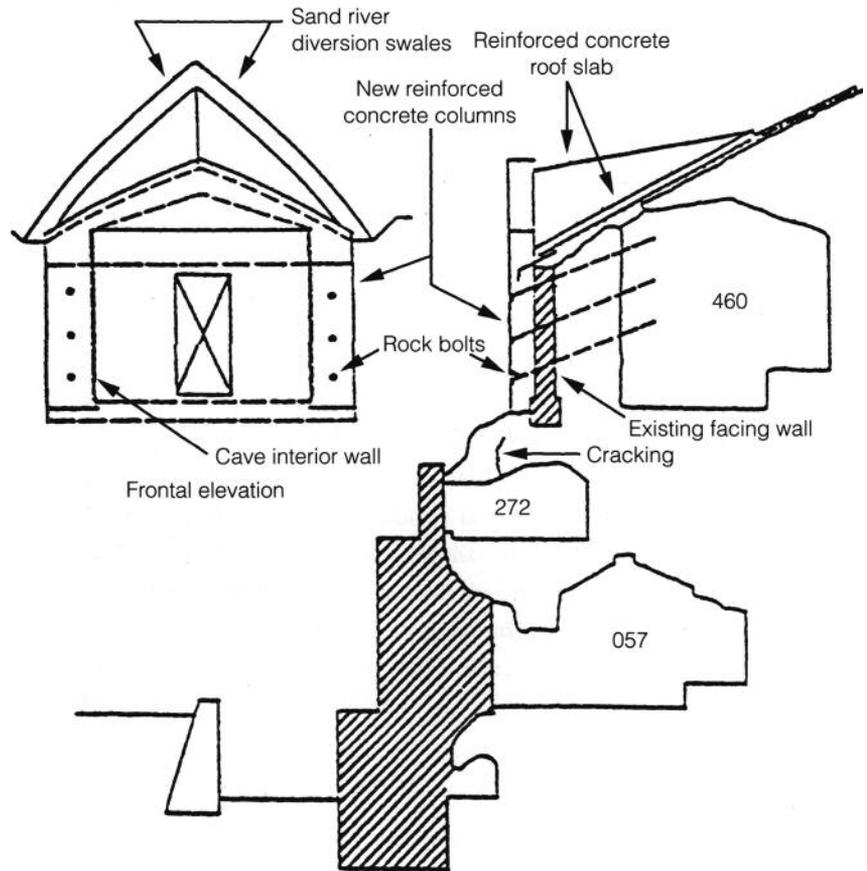
Figure 5
 Cross section of Caves 272 and 460 at Mogao.

The treatment of anomalies will undoubtedly require a combination of solution methodologies. One example is the condition that now exists at caves 272 and 460. A cross section through this portion of the cliff (Fig. 5) graphically illustrates the problems. Major issues that must be addressed by any solution include the cracking and differential settlement in the roof of Cave 272, the expanding hole in the roof of Cave 460, and the accelerated erosion caused by the “river of sand” flowing over Cave 460.

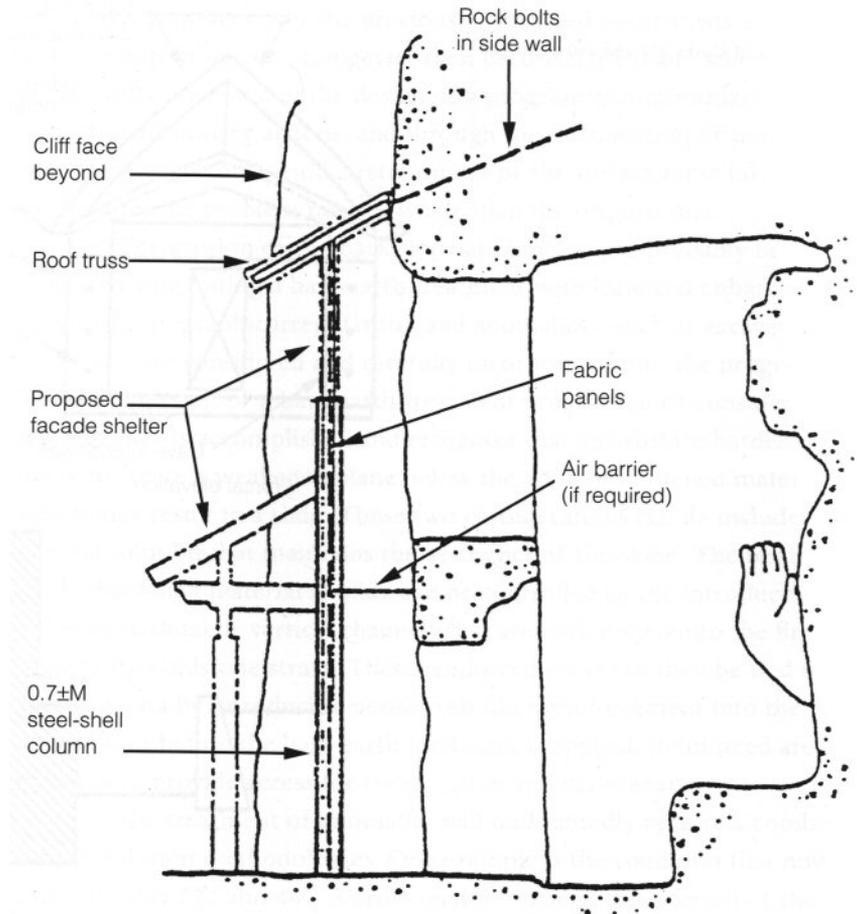
Cave 19 at Yungang poses a special problem of cliff face delamination, as the roof over the grotto does not appear to be thick enough to safely accept rock anchors. Figure 6 shows a section of what remains of Cave 19, once the inner chamber of the original shrine. The antechamber no longer exists, as it was the victim of successive surficial block failures. Figure 7 shows an elevation of the extant exterior wall of Cave 19. The left side window once contained two smaller windows similar to those that still exist on the right side. Clearly, the structural deterioration of the facade is in immediate need of abatement. A physical enclosure of the grotto has been proposed, the primary intent being to control pollutant intrusion via fabric filters. The strengthening described in Figures 6 and 7 may be integrated into the facade development. The two major elements of the strengthening program are the provision of a vertical support for the grotto roof over the left window and the construction of a horizontal truss within the roof enclosure. The latter will provide lateral support for

Figure 6
Vertical section of Cave 19 at Yungang grottoes.

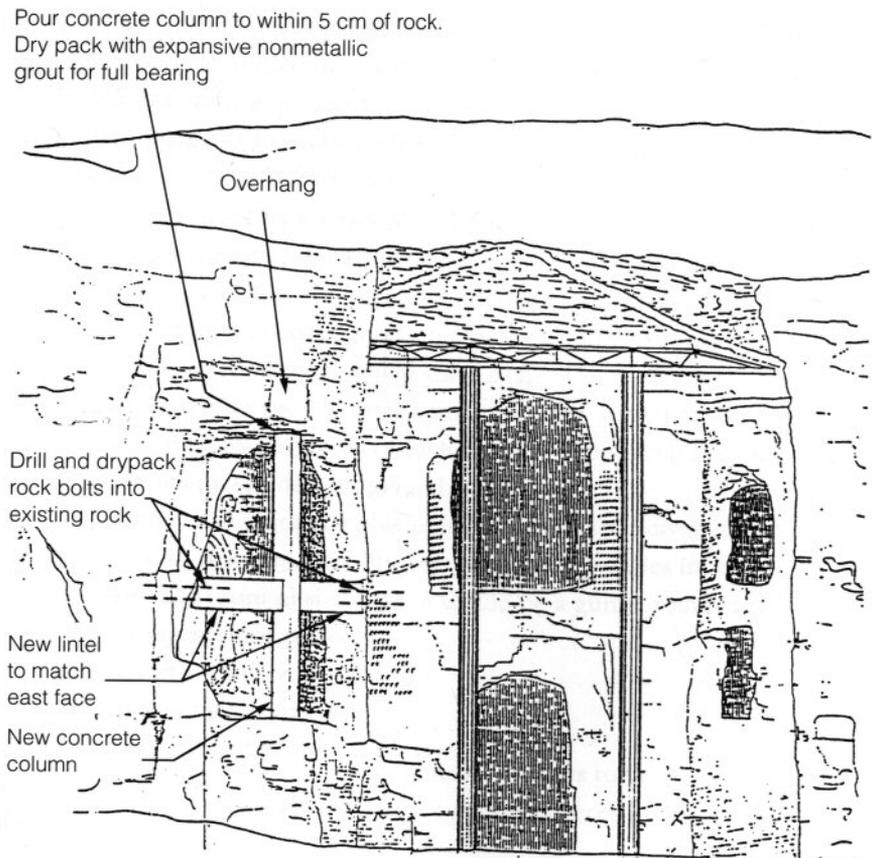
Figure 7
Frontal elevation of the extant exterior wall of Cave 19, Yungang.

the sandstone fascia over the door, allowing it to be anchored into the side walls of the grotto instead of the fragile roof of the grotto itself. The only constraints to the aesthetic objectives of this strengthening strategy will be the need to provide vertical support for the overhanging ledge at the left window and the provision of lateral support to the blocks of sandstone over the grotto entrance at the roof line. The latter support must be high enough to reach competent material that can be penetrated with confidence on either side of the grotto.

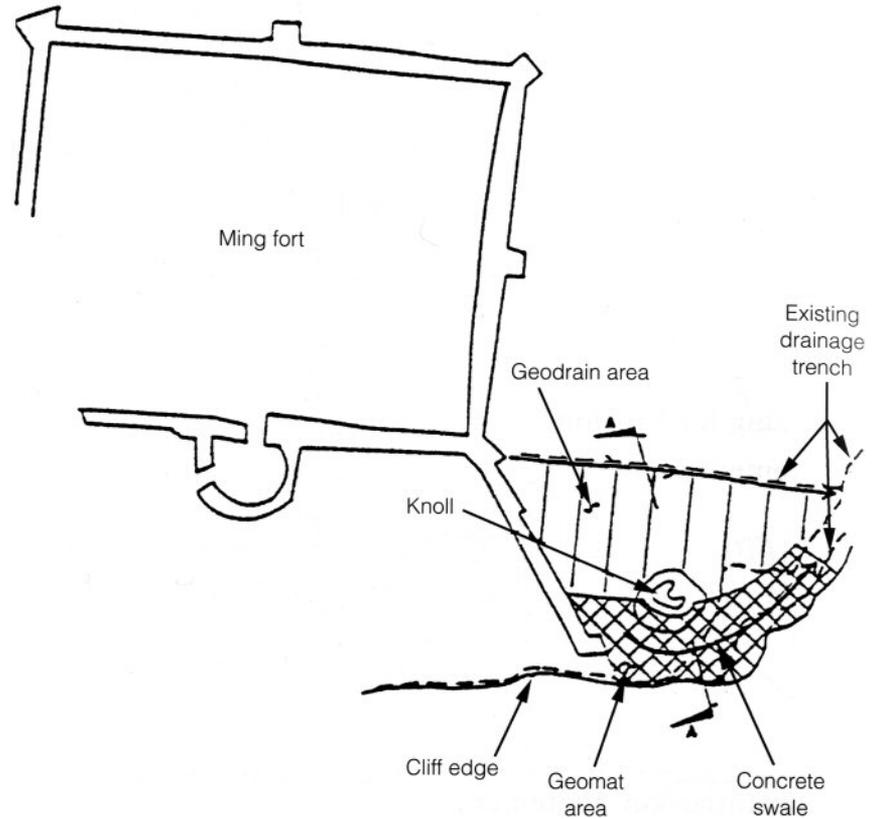
Figure 8
Plan of proposed surface drainage-control system, Yungang.

Each mitigation system has proved effective, depending on site characteristics. Site geology and hydrology are typically complex, especially in sedimentary formations. The drainage, or source-control, system illustrated in Figures 8 and 9 appears to have a reasonable chance of success. Its

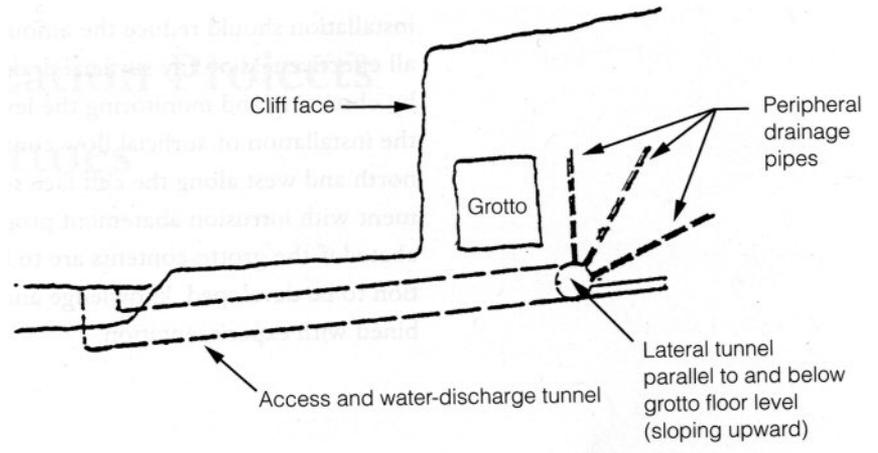
Figure 10
Schematic section of a conceptual water-inception system for Yungang.

Water interception can be an effective means of diverting the flow of underground water. This procedure involves the construction of a major access tunnel or tunnels from which a peripheral drainage system may be constructed. The major access tunnel usually serves as the drainage channel, collecting water from the peripheral tubes and discharging the flow beyond the area of concern. Advantages associated with a water-interception program include the ability to more accurately locate the aquifer and alter the intercept field until the objectionable flow has been eliminated. The conceptual development of a water-interception program is described in Figure 10, with a typical detail connection of a collector tunnel shown in Figure 11.

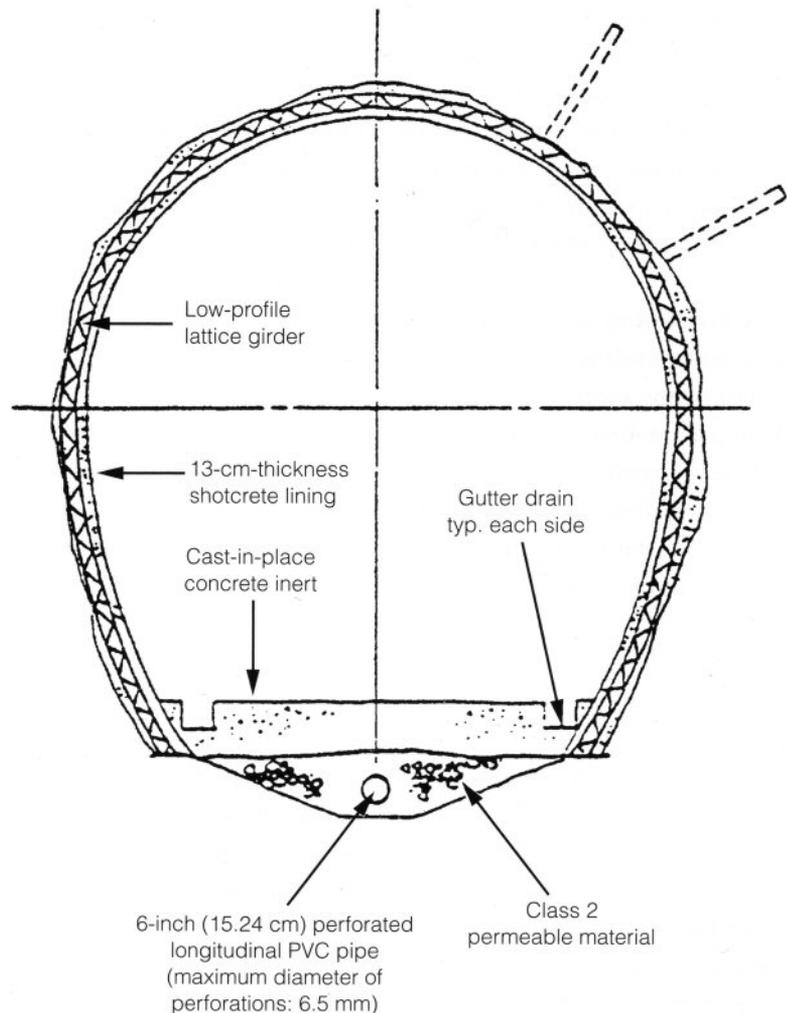
Figure 11
Typical water-interception system used in tunnels.

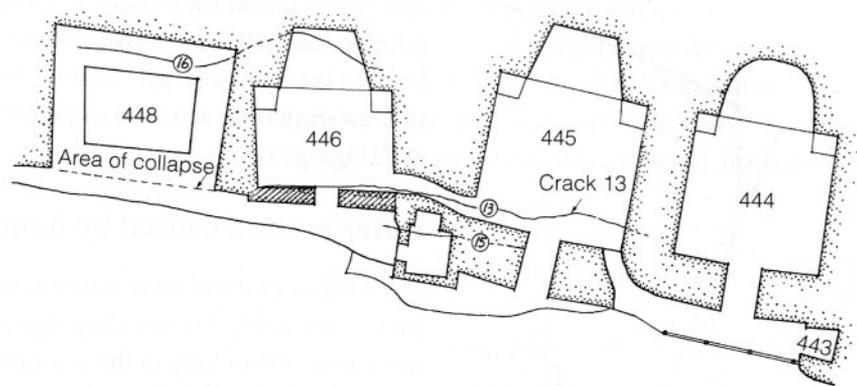
Figure 1

The front part of Caves 446 and 448, fourth level, section 3, collapsed along crack 13. The front adobe wall of Cave 446 was built in the Song dynasty. About 20 m on that level are affected by this crevice.

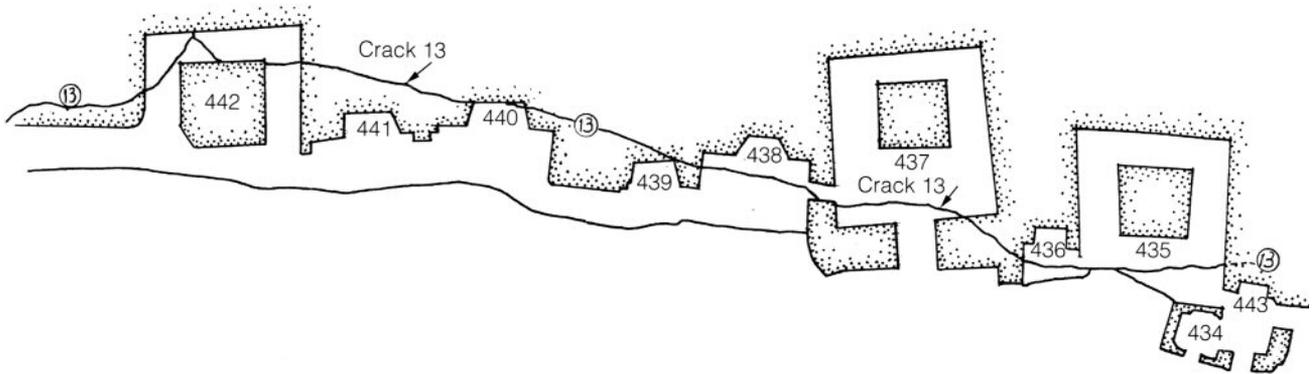
*Figure 2*

The front part of five caves (third level, section 3), with wall paintings dating from the Five Dynasties period, has collapsed. About 40 m on this level are affected by crack 13.

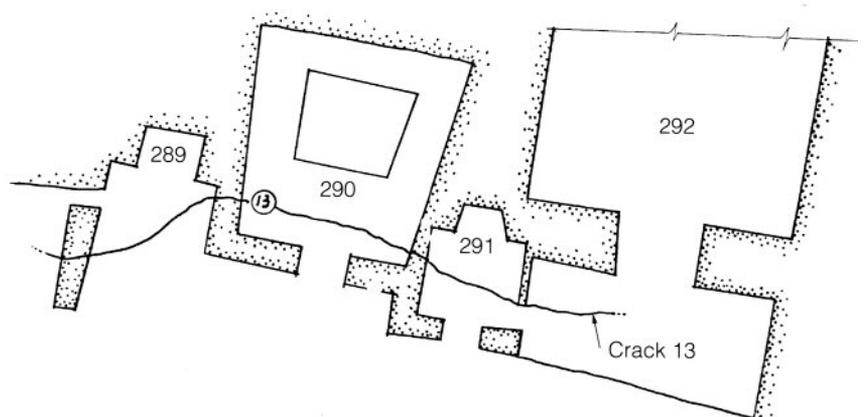
Figure 3

Second-level caves in section 3. About 15 m are affected by crack 13.

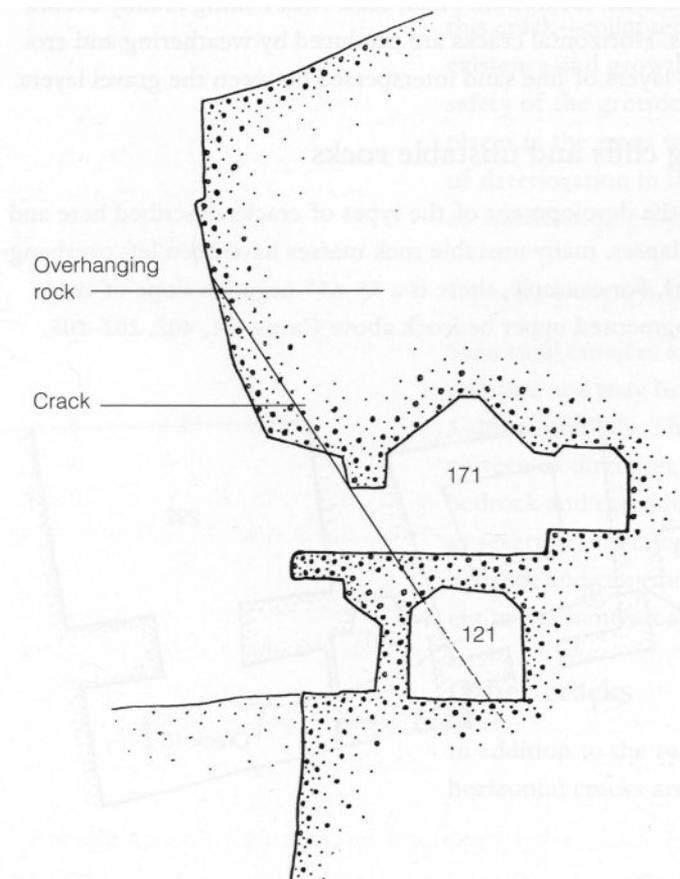
Figure 4, above
Section showing cracks of many types in the same vicinity.

and 170–172. The rock edges of Caves 328–365 have been eroded over a long period by wind-driven sand and occasional rain. This has left many isolated overhanging rock masses; these subsequently disintegrate due to the moisture from rain and snow, and shed material that falls down the cliff (Figs. 4, 5).

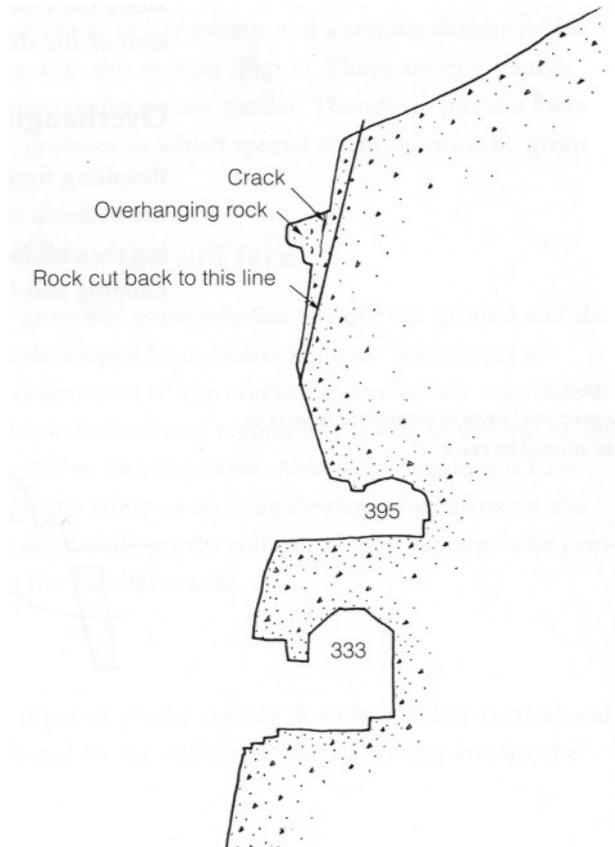
Figure 5, below
Sections showing suspended rock masses and cracks, and reduction of dangerous overhangs by cutting back the rock face.

Unstable and dangerous external overhanging rock masses were reduced or rebated by chiseling. This was done not only to remove precarious rocks from the cliff edge but also to reduce the load on the bedrock (Fig. 5).

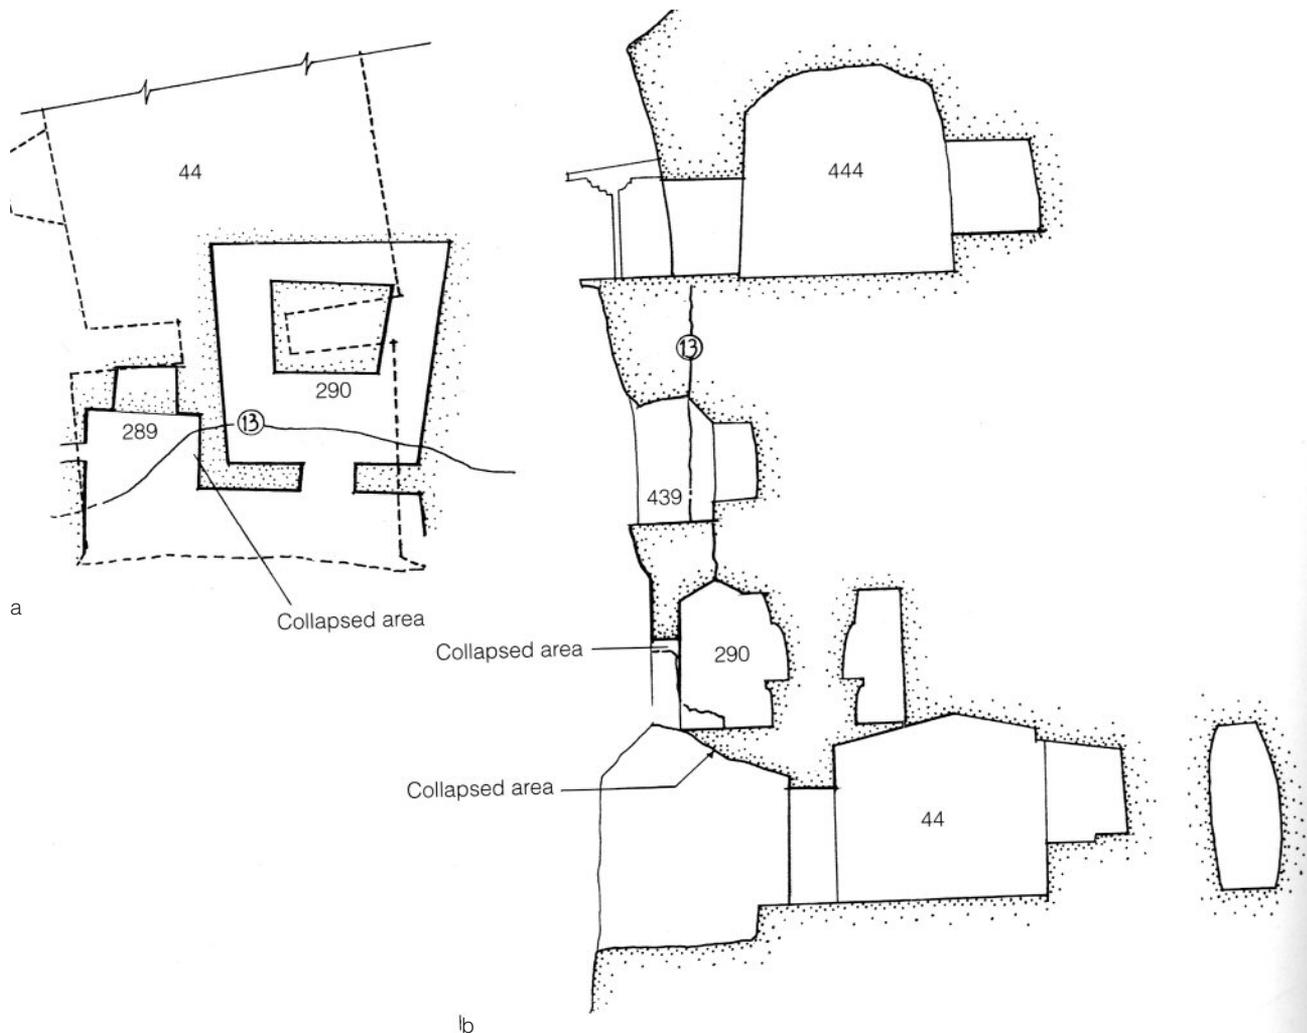
Figure 6a, b

Plan (a) and cross section (b) showing the relationship between deterioration of Cave 44 and Caves 289 and 290. The wall separating Caves 289 and 290 fell onto the roof of the anteroom of Cave 44, collapsing the left side of Cave 289 and the front part of the right side of Cave 290. Cave 44 was created during the Tang dynasty, with a span of nearly 8 m and a depth of 5 m. The excavation of this cave caused the front part of Caves 289 and 290 to collapse.

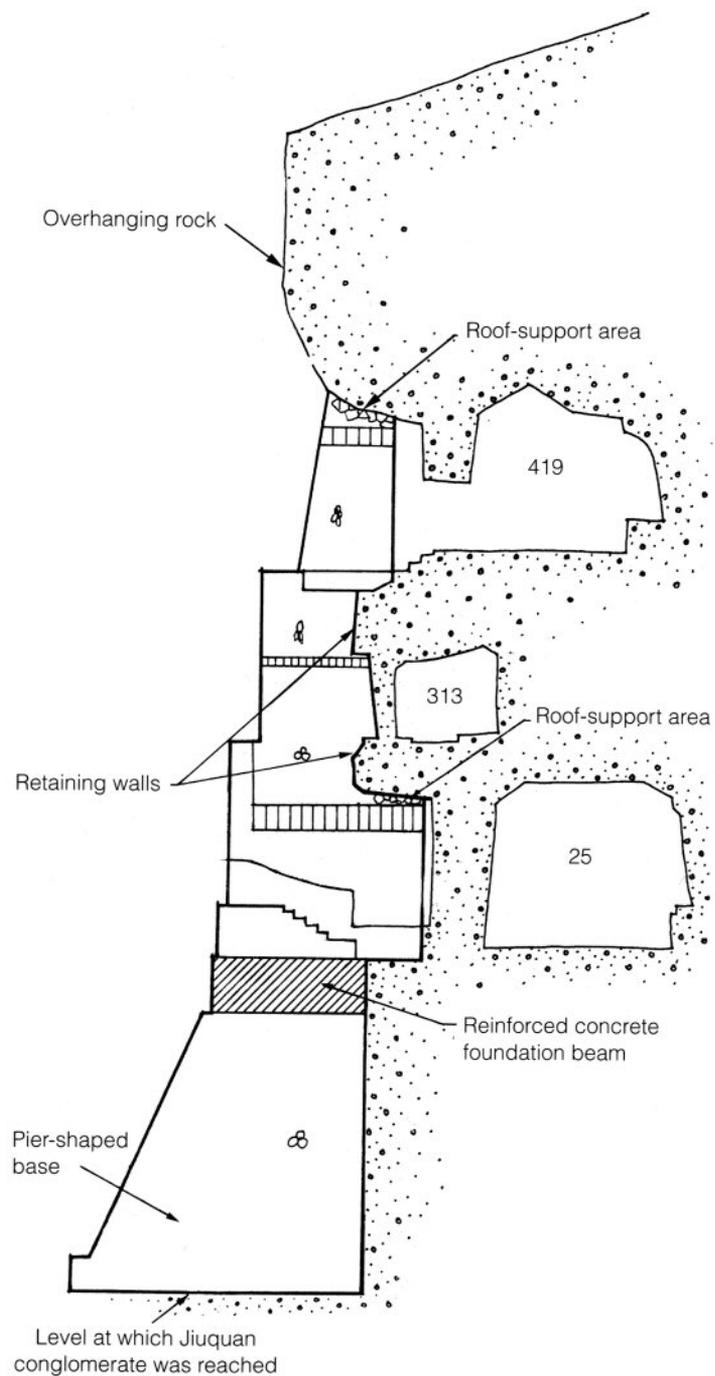
Retaining walls or buttress walls built with large stones or reinforced concrete have been constructed in front of the sloping faces of the grottoes to resist the lateral pressure of earthquakes and prevent bedrock from buckling outward along cracks parallel to the cliff. In the Mogao grotto stabilization projects, this retaining technique has been extensively

Figure 7
Section through a portion of a retaining wall.

vent further deterioration in the antechambers of Caves 351, 342, 334, 202–205, 218, 217, 61, 171, and 172, among others (Fig. 7).

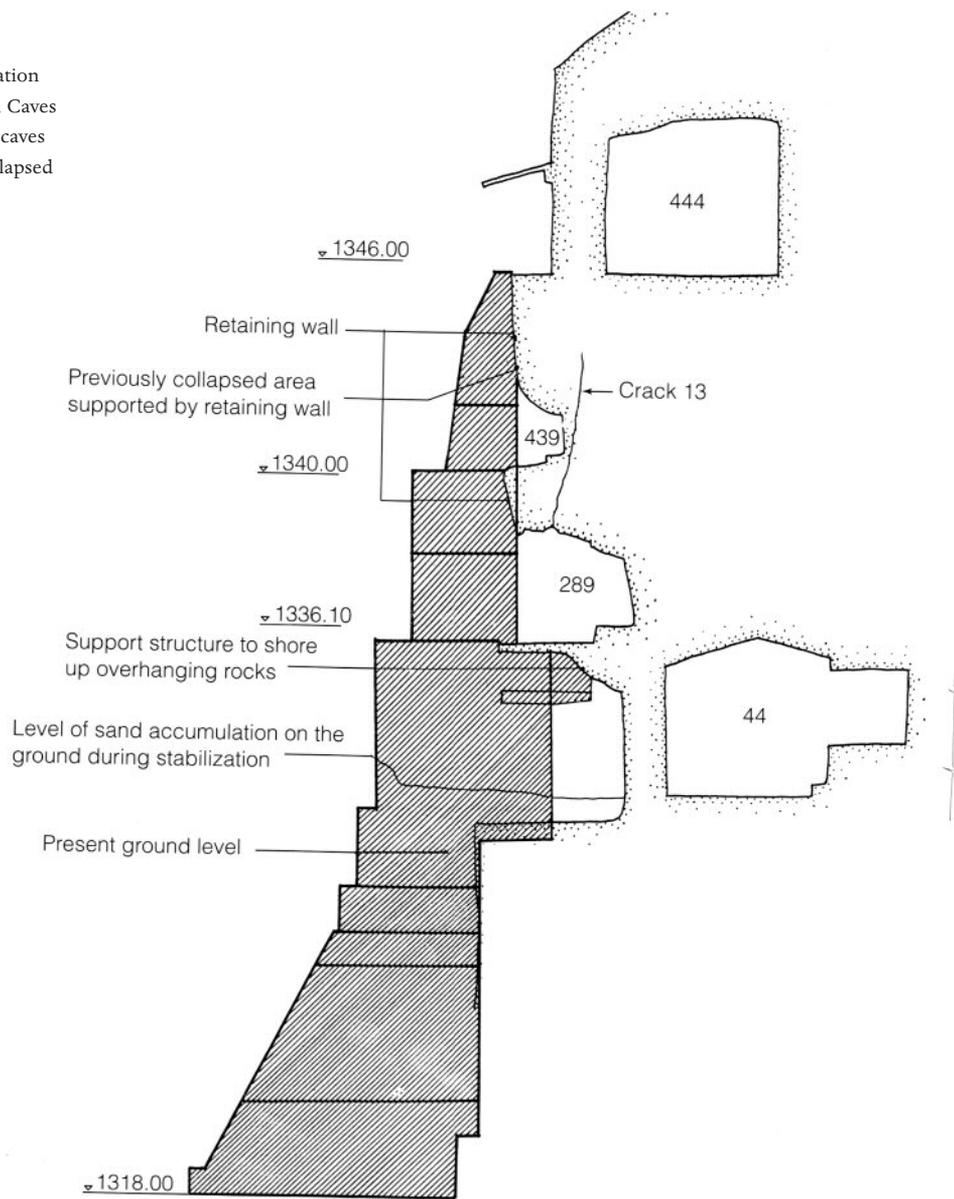
Figure 8
Section showing retaining-wall stabilization and support on the four levels between Caves 289 and 439. The front part of the five caves to the north and south of Cave 439 collapsed long ago.

employed and has been an important means of preventing bedrock from collapsing (Fig. 8). When a retaining wall is designed, architectural style must be determined while mechanical and structural requirements are simultaneously met. Practical installations, such as scaffolding with wooden walkways, were constructed to facilitate the work.

The following techniques were designed to combine roof-support and retaining-wall measures. Depending on the condition of the cliff face, support systems fall into three general categories: post-and-lintel, pillar, and retaining-wall structures. Post-and-lintel structures act only as apex supports. The base is built directly on the rock floor, and the lintel stone slabs are placed in close contact with the overhanging bedrock. When pillars are used, they are placed away from the antechamber walls to protect wall paintings. The retaining wall is used when stabilization of a fairly large area of the grotto cliff face is necessary. To satisfy various mechanical requirements, the retaining-wall structure should have sufficient mass and strength, and yet leave room for grotto entrances. It should be broader at the base and gradually decrease in cross-sectional area from base to top, forming what is essentially a pyramid-shaped stairway on which walkways can be built on different levels (Fig. 8).

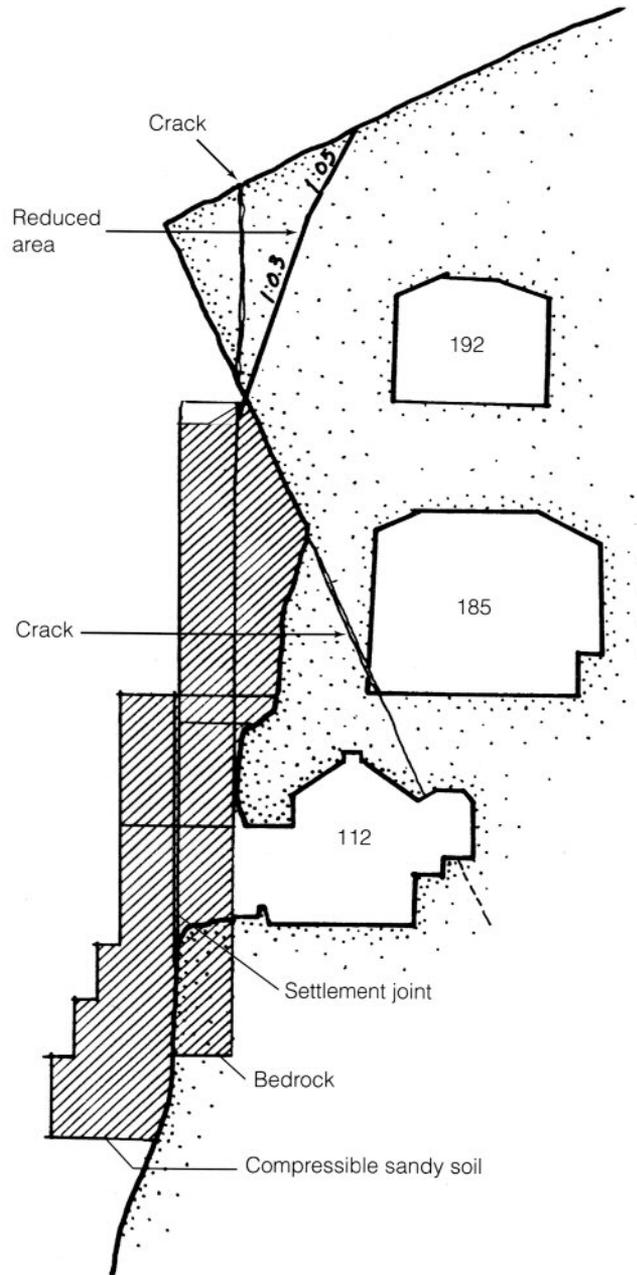
Figure 9

Section showing the foundation of a retaining or buttress wall. The foundation of the retaining wall outside the settlement joint is on compressible sandy soil. Reduction or rebating of the unstable, cracked section was carried out to remove dangerous rock and to reduce load.

When a support structure needed to be wide enough for part of it to stand on bedrock and the other part on compressible soil, two separate foundations were constructed with settlement joints between them (Fig. 9). Since the outer parts of a structure may also settle to a certain extent, those areas of the foundation should be established on the same soil to maintain a uniform degree of subsidence for the entire structure. If a fairly large area and variable foundations were required, a horizontal deformation joint should be constructed every 20–30 m to serve as both the expansion and settlement joints.

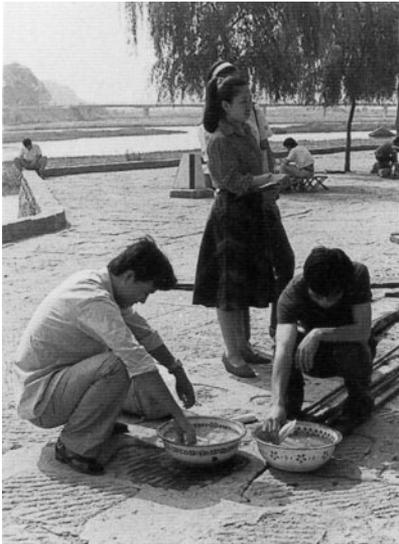
Figure 1
Soaking cartridges in water.

has an extremely high water-absorption capacity. The cartridge is soaked in water immediately before it is inserted into the bolt hole (Fig. 1); after it has been soaked in water, the paper can easily be torn. The water rapidly permeates the bag to form a concrete mortar with a water:solid ratio of 0.4:0.5 within one to three minutes. At this point, the cartridge is rigid and can be inserted easily into the bolt hole. A steel bolt can be placed into the bolt hole after it has been calculated that a sufficient number of cartridges are in place. At this time, the paper cartridges will break and release the mortar into the hole, with the mortar completely filling the hole and enclosing the bolt. Better results are achieved if the steel bolt is pushed in using a rotational motion. Setting of the mortar begins in less than eight minutes; complete setting can be adjusted by the user to between ten and forty minutes by varying the quantity of additive. Within two to four hours after the bolts have been inserted, resistance to extraction can reach 20–40 kN at room temperature and can increase to more than 80 kN after ten hours.

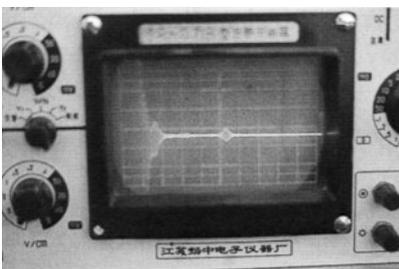
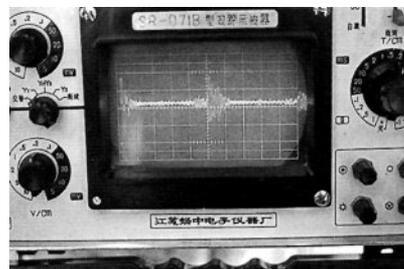
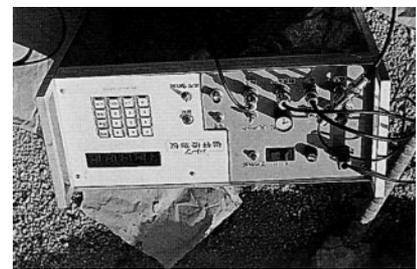
Figure 2a–c

Tests for completeness of filling: (a) drill hole is partially filled with grouting material; rock bolt is 2 m in length and 16 mm in diameter; (b) drill hole contains no grouting material; rock bolt is 2 m in length and 16 mm in diameter; and (c) readout equipment for determining completeness of grout filling.

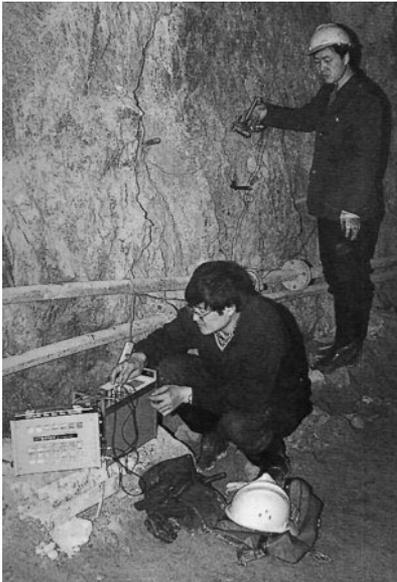
Figure 3
In situ test of the degree of mortar filling.

Water is then poured to fill the inside wall of the coupling apparatus as well as any voids that may exist on the surface of the outside end of the grouting bolt.

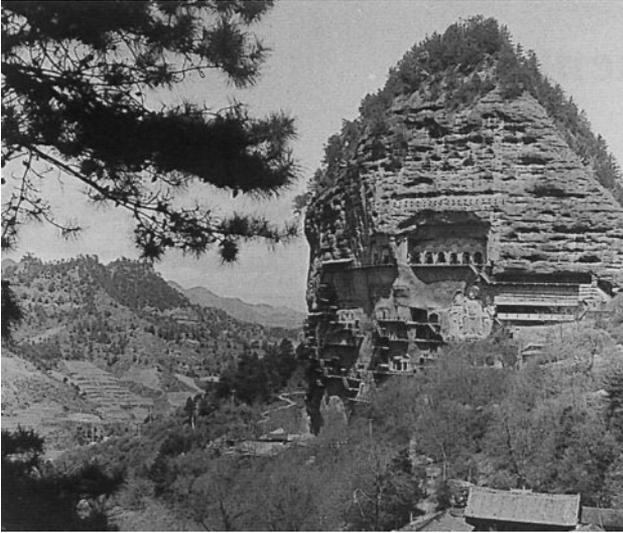
Figure 1
Maijishan grottoes after the 1984 stabilization.

Shaped like a haystack, Maijishan mountain is 142 m high (Figs. 1, 2). The east, west, and south sides are barren and steep with a slope of 95°. The bedrock is exposed and the lower part of the cliff has talus deposits. The Maijishan stratum, of Upper Tertiary period, is a purplish and brick-red conglomerate interspersed with thin layers of sandstone and mudstone loosely cemented by fine red clay containing calcium and iron (Huang 1976).

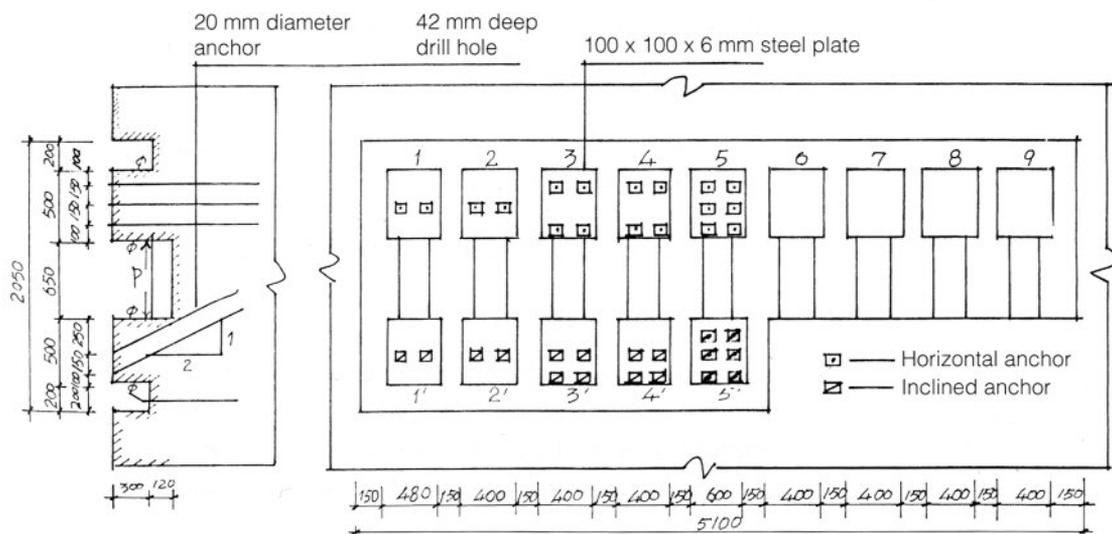
Figure 3
Plan of the shear testing site of the Maijishan conglomerate with and without anchor bolts.

To obtain test results that approximated actual conditions, bolted and unbolted conglomerate blocks were comparison tested in situ (Fig. 3), with the bolted samples anchored directly to the cliff face with horizontal and inclined rods. A hydraulic jack was used to shear the blocks. Results were as follows:

First, both horizontal and inclined rods produced a remarkable improvement in the crack-resistance and ultimate-rupture loads of the conglomerate (Table 1). Blocks reinforced with two steel rods of 20 mm diameter showed average increases of 36% in crack-resistance load and 100% in ultimate-rupture load.

A second important effect of the steel-rod reinforcement was improvement in the sudden shear rupture characteristics of the conglomerate. Unbolted blocks ruptured under a 10 t load, whereas the bolted blocks only fractured. These tests indicated that bolted blocks can sustain 21–55% more load than unbolted blocks.

Bolting also increased the maximum shear displacement of the conglomerate. Tests found the shear displacement of the bolted blocks to be five to nine times that of the unbolted conglomerate before rupture.

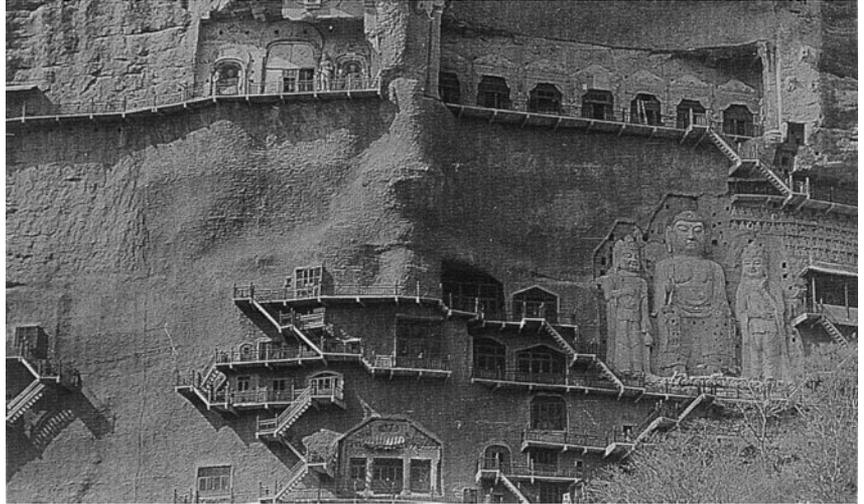
Figure 5

Grotto 15 to the fifth section after stabilization.

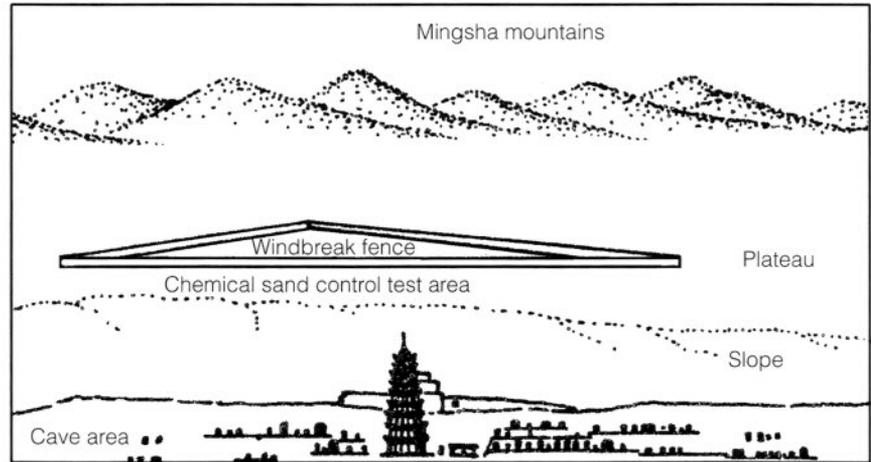
Figure 2

Schematic drawing showing the locations of the A-shaped windbreak fence and chemical consolidation test area.

This has resulted in the sand carried by the wind being deposited around the windbreak fence or diverted to outside the grotto area, thus reducing the sand deposit in the grotto area by 60%. However, since the installation of the windbreak fence, the balance of supply of sand to the cliff face has been disturbed. Wind has stripped the 30° slope and plateau behind it of its residual sand, exposing the weak conglomerate of the cliff to more rapid erosion than it experienced previously (Fig. 3). Analysis of the sand grains collected from sand traps placed on the walkways and around the grotto area shows that after the installation of the windbreak fence, coarser sand grains and even pebbles were deposited (Ling et al. 1993). The upper layers of the Quaternary argillaceous conglomerate cliff rock are loosely cemented and easily eroded by wind, causing pebbles to fall from the top of the cliff. This is not only dangerous to pedestrians on the walkways below, but thinning of the rock of the roofs of some of the upper-level caves—a phenomenon already well advanced—will further endanger these caves. It is presently considered that it will probably be necessary to chemically consolidate the sand in front of the windbreak fence, and the exposed rock of the cliff slope. In fact, the latter is the principal objective of the testing described in the present paper because of the ease of erosion of the exposed rock on the 30° slope. With the installation of the windbreak fence completed, testing of chemical consolidation became the next priority, the use of both the windbreak fence and chemical consolidation being planned as a comprehensive sand-control system.

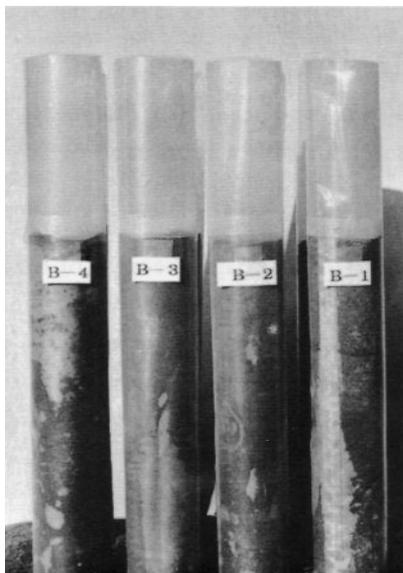
Figure 4
Sand samples for consolidant permeation test
(45 × 300 mm).

Two types of sand were selected to test the depth of penetration of consolidants. One was from the chemical consolidation area on the eastern side of the windbreak fence (designated A), the other was from the fine-grained deposit on the north side of the Nine-Story Pagoda (designated B). Samples were introduced into transparent cylindrical tubes (45 × 300 mm). Samples were packed by the same method so that the compaction would be essentially similar. Consolidants were diluted to suitable concentrations and dripped onto the top of the samples at the same speed; the permeation rates were recorded (Fig. 4; Table 3).

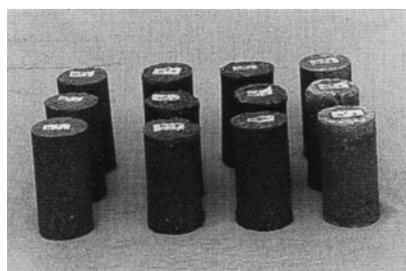
Figure 5
Sand samples for water absorption test
(50 × 100 mm).

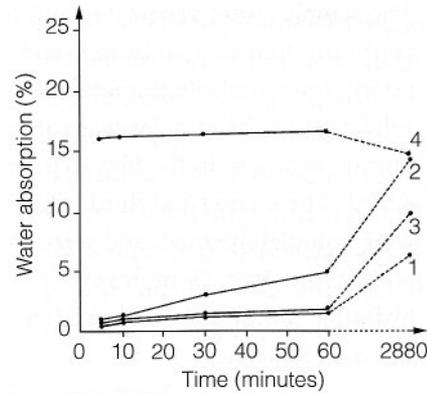
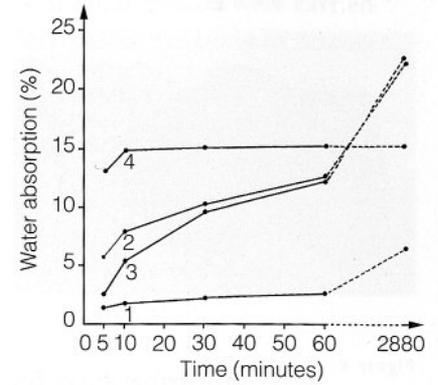
Figure 7

Water absorption of consolidated group B sand: 1 = AC; 2 = AS; 3 = SS; 4 = PS.

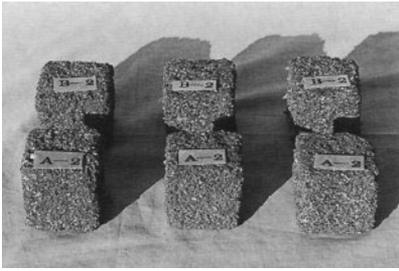
Figure 8
Consolidated rock samples prepared for property tests (50 × 50 × 50 mm).

Rock collected from severely weathered areas in the northern region of the Mogao grottoes was made into 50 × 50 × 50 mm samples (Fig. 8).²

The samples were permeated and consolidated with AC, AS, and SS in concentrations of 1:10 (water) and with 10% PS. Because the cliff rock is poorly cemented conglomerate of low strength, the permeation and consolidation of the samples was carried out in several steps to avoid disintegration in water. In the first step, only a small amount of consolidant was added. The second and third steps were not carried out until the samples were completely dried, and were continued until the samples were completely saturated. Compressive strength was determined using a Newton hydraulic universal testing machine (model WE-10A, 1004). Test results are given in Table 5.

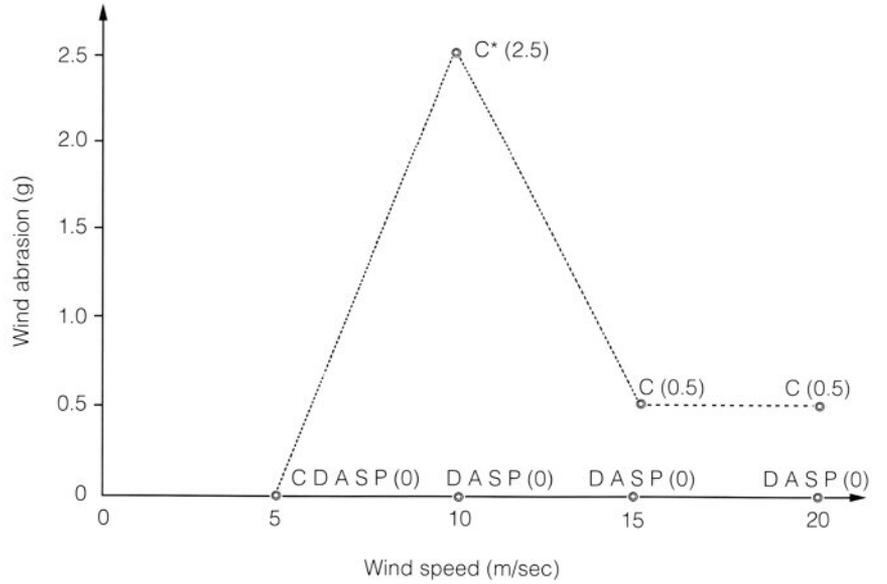
Figure 9

Abrasion loss of consolidated rock sample in the wind tunnel test (wind only): C = unconsolidated; D = AC; A = AS; S = SS; P = PS.

The wind-tunnel simulation tests of wind erosion were carried out at the Desert Research Institute of the Chinese Academy of Sciences in Lanzhou. The wind tunnel is 38.78 m in length, the testing segment length being 16.23 m with a cross-sectional area of $1 \times 0.6 \text{ m}^2$. Wind speed is continuously adjustable from 2 to 35 m s^{-1} , and turbulence intensity is below 0.4%. During the test, samples were set horizontally on sample trays capable of being elevated to any desired position. Samples were placed 12 m from the entrance of the tunnel in the wind direction. Test results are shown in Table 7 (Figs. 9, 10).

conglomerate of the cliff was extremely susceptible to wind erosion. When the wind speed reaches 10 m s^{-1} , even a wind not carrying sand can bring about rock erosion. When the speed of a “clean” wind was greater than 15 m s^{-1} , there was a distinct erosion effect at a rate of $0.21 \text{ kg m}^{-2} \text{ hr}^{-1}$. The wind-erosion effect of a sand-carrying wind was even greater. When the velocity of the sand-carrying wind reached 7 m s^{-1} , there was distinct erosion of the rock. When the velocity of the sand-carrying wind reached 10 m s^{-1} , there was a startling increase with an erosion rate as high as $123.80 \text{ kg m}^{-2} \text{ hr}^{-1}$. When the velocity of the sand-carrying wind was 20 m s^{-1} , three-fourths of a $50 \times 50 \times 50 \text{ mm}$ rock sample was eroded within three minutes (Fig. 13). After the cliff rock had been consolidated with AC, AS, and SS, and with PS, it displayed a relatively ideal resistance to wind erosion. Comparatively, the samples exhibiting the best resistance were those consolidated with SS and PS. The erosion rates of these two were close to zero when the wind velocity reached 20 m s^{-1} even when loaded with sand. The high compressive strength and the high wind-erosion resistance of the PS consolidated samples are consistent. Conversely, the compressive strength of samples consolidated with a 1:10 water solution of SS was low, whereas their wind-erosion resistance was high. This appears to be because SS exhibits high flexibility after solidification.
