Geotechnical Issues in the Conservation of Sites

Robert E. Englekirk

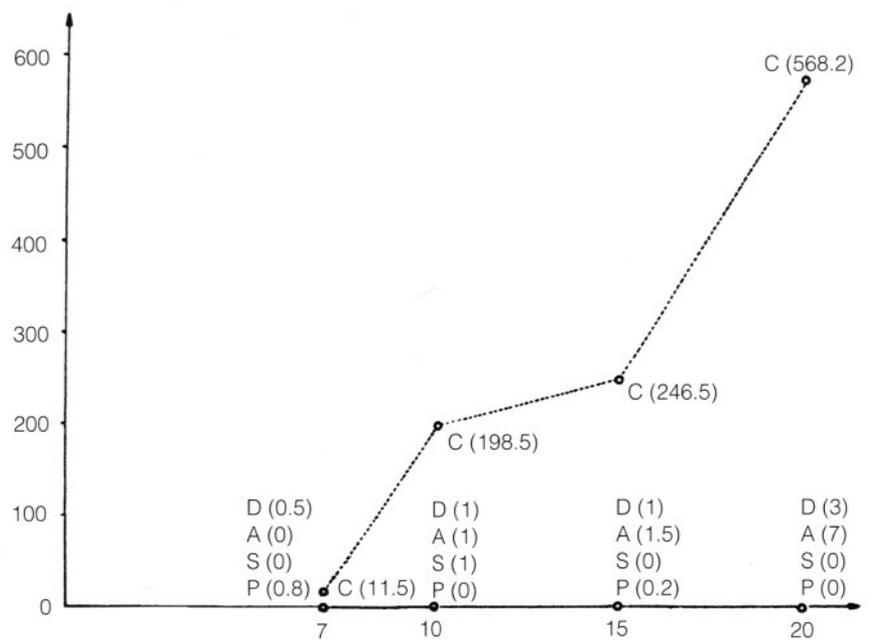
Figure 10

Abrasion loss of consolidated rock sample in the wind tunnel test (wind plus sand): C = unconsolidated; D = AC; A = AS; S = SS; P = PS.

The wind-tunnel simulation tests of wind erosion were carried out at the Desert Research Institute of the Chinese Academy of Sciences in Lanzhou. The wind tunnel is 38.78 m in length, the testing segment length being 16.23 m with a cross-sectional area of $1 \times 0.6 \text{ m}^2$. Wind speed is continuously adjustable from 2 to 35 m s^{-1} , and turbulence intensity is below 0.4%. During the test, samples were set horizontally on sample trays capable of being elevated to any desired position. Samples were placed 12 m from the entrance of the tunnel in the wind direction. Test results are shown in Table 7 (Figs. 9, 10).

conglomerate of the cliff was extremely susceptible to wind erosion. When the wind speed reaches 10 m s^{-1} , even a wind not carrying sand can bring about rock erosion. When the speed of a “clean” wind was greater than 15 m s^{-1} , there was a distinct erosion effect at a rate of $0.21 \text{ kg m}^{-2} \text{ hr}^{-1}$. The wind-erosion effect of a sand-carrying wind was even greater. When the velocity of the sand-carrying wind reached 7 m s^{-1} , there was distinct erosion of the rock. When the velocity of the sand-carrying wind reached 10 m s^{-1} , there was a startling increase with an erosion rate as high as $123.80 \text{ kg m}^{-2} \text{ hr}^{-1}$. When the velocity of the sand-carrying wind was 20 m s^{-1} , three-fourths of a $50 \times 50 \times 50 \text{ mm}$ rock sample was eroded within three minutes (Fig. 13). After the cliff rock had been consolidated with AC, AS, and SS, and with PS, it displayed a relatively ideal resistance to wind erosion. Comparatively, the samples exhibiting the best resistance were those consolidated with SS and PS. The erosion rates of these two were close to zero when the wind velocity reached 20 m s^{-1} even when loaded with sand. The high compressive strength and the high wind-erosion resistance of the PS consolidated samples are consistent. Conversely, the compressive strength of samples consolidated with a 1:10 water solution of SS was low, whereas their wind-erosion resistance was high. This appears to be because SS exhibits high flexibility after solidification.

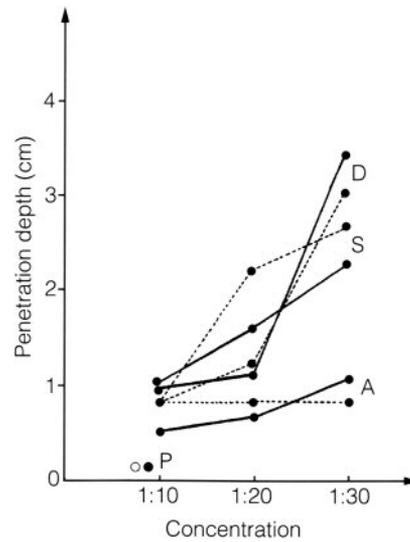
Figure 11

Puncture test: D = AC; A = AS (dry); S = SS;
P = PS (prewetted).

612.5 g. As shown in Figure 6, the steel pipe was held vertically and dropped from a height to the tip of 60 cm. The depth of penetration was measured. Three determinations were made on each test square. Results are given in Tables 8–11 and in Figure 11.

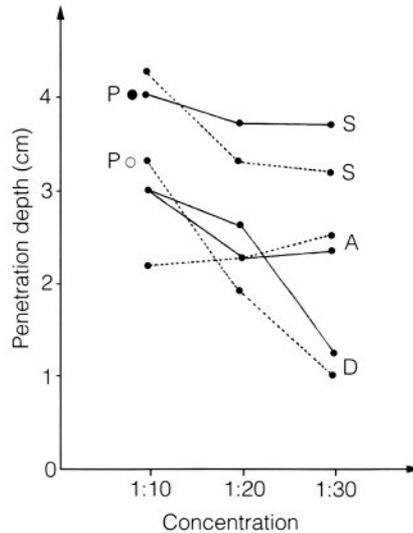
Figure 12

Penetration depth of the consolidants
(at 5.75 l m^{-2}): D = AC; A = AS; S = SS;
P = PS. Solid line: prewetted sand. Dashed
line: dry sand.

The depth to which the consolidant penetrated was roughly estimated after completely drying by removing a block of consolidated sand and measuring its thickness. In part because spraying was done by hand, the depth of penetration was not uniform. Three points were selected for each test square for measurement of penetration depth. Results are given in Tables 8–11 and Figure 12.

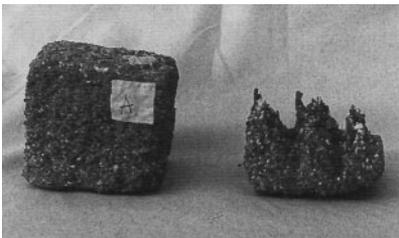
Figure 13
Rock samples before and after the wind-tunnel test.

Wind-tunnel simulation tests of wind erosion of the consolidated rock samples indicate that the weak, semicemented argillaceous

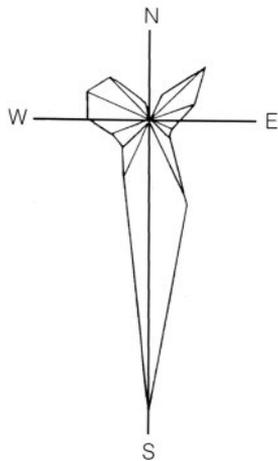
Figure 3
Wind rose at the Mogao grottoes (1990–91).

The Mogao grottoes are situated in a windy region having an annual average wind velocity of 3.5 m s⁻¹. However, it is a region in which there is great variation in wind direction (Fig. 3). The south wind is the most common and accounts for 31% of the wind frequency. The southerly winds, including the south-southeast and south-southwest winds, account for 47.9% of the wind frequency. However, the wind speeds are not very great. For example, 39% of the south winds have a wind speed less than that required for saltation of sand (5.0 m s⁻¹ at a height of 2 m), whereas only 1.5% of the winds have a velocity higher than 8.0 m s⁻¹, and 59.2%

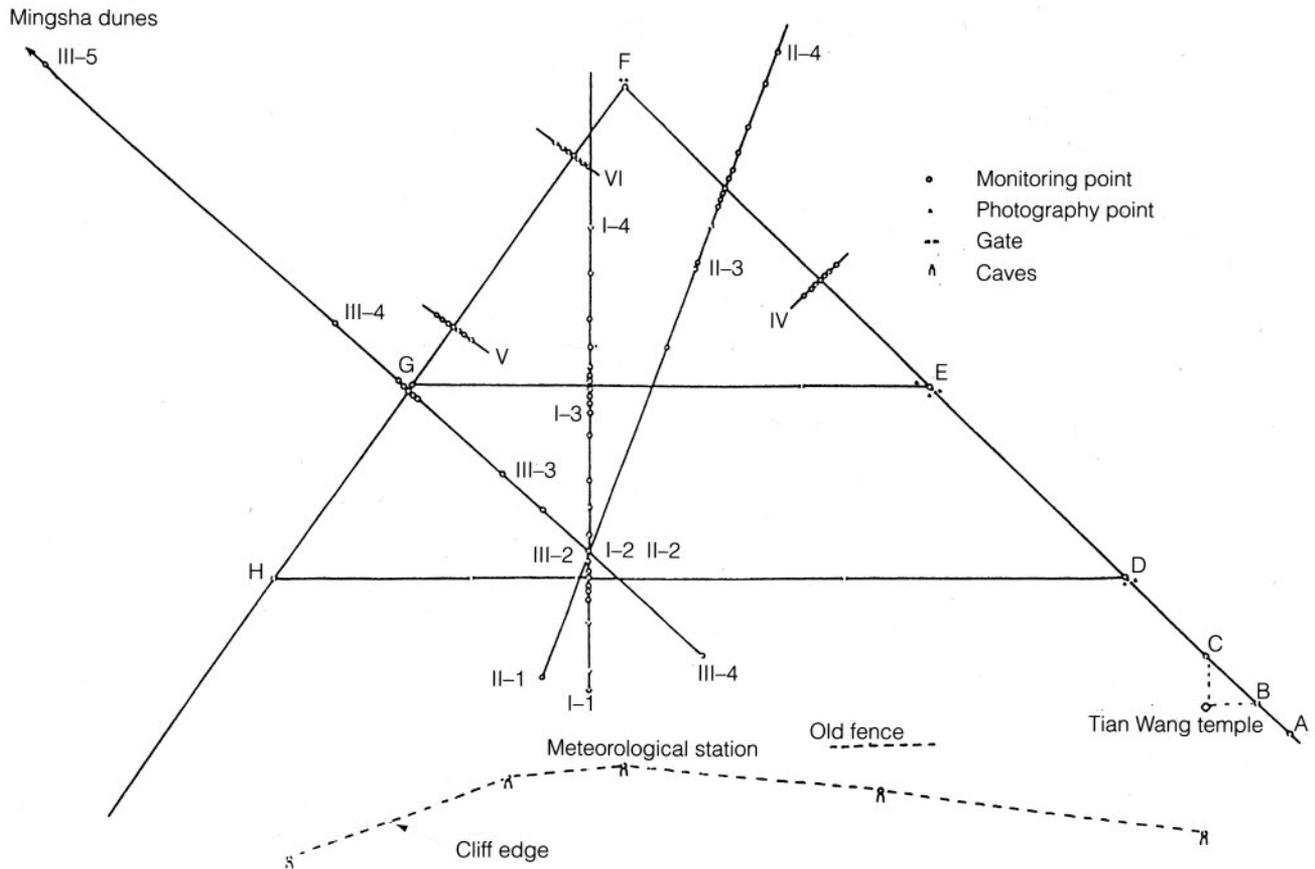
Figure 5
Plan of the synthetic textile wind fence on the plateau above the grottoes, and sand-monitoring Sections I-VI.

In view of the aforementioned circumstances, and in consideration of the characteristics of the windblown sand activity in this region, an A-shaped windbreak fence system was designed and installed in a triangular form (Fig. 5). The three sides of the triangle are at an effectively larger angle to the dominant wind directions and at a smaller angle or nearly parallel to the secondary wind directions. Thus, the fence can block sand carried in the dominant wind directions and divert the sand carried in the secondary wind directions. It is an effective and comprehensive control system that is capable of controlling windblown sand from multiple wind directions. The fact that ripples that are formed on the surface of the

The windbreak fence is 1.8 m high with a void space of 20% and a resistance coefficient of 1.5. When the average wind velocity is 11.1 m s^{-1} , the windbreak fence is subject to a wind pressure of 17 kg m^{-2} . Angle steel posts were used for the fence, set with 3 m spacing. The posts were installed in a $20 \times 20 \times 30 \text{ cm}$ concrete foundation. The textile net was further reinforced with 45° wires running diagonally between posts.

To deter sand accumulation in front of and in back of the fence, other measures were taken. In order to monitor the effectiveness of the windbreak fence, six sections were selected along the fence for study of the sand accumulation (Fig. 5). The results are shown in Figure 6. Section I

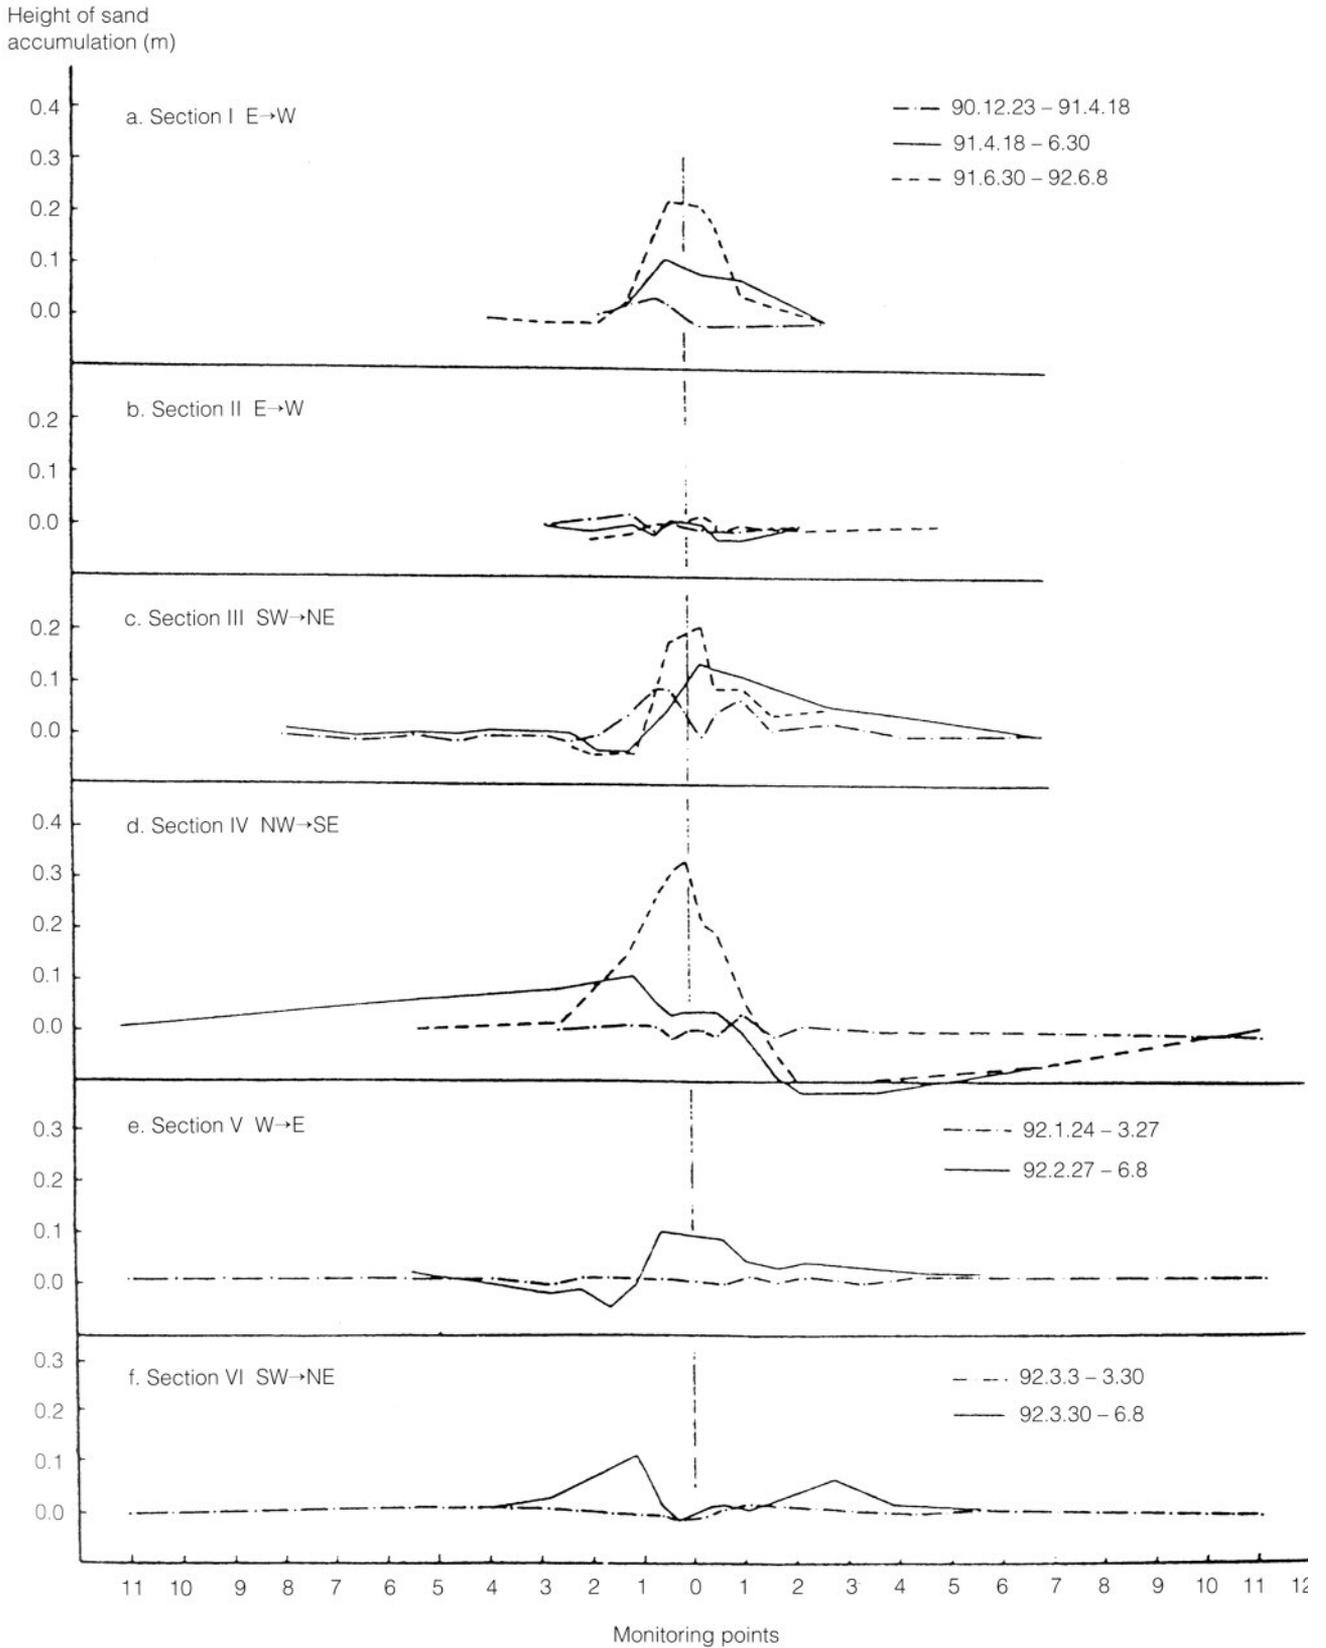
Figure 6 Sand accumulation profiles at monitoring points along Sections I-VI.

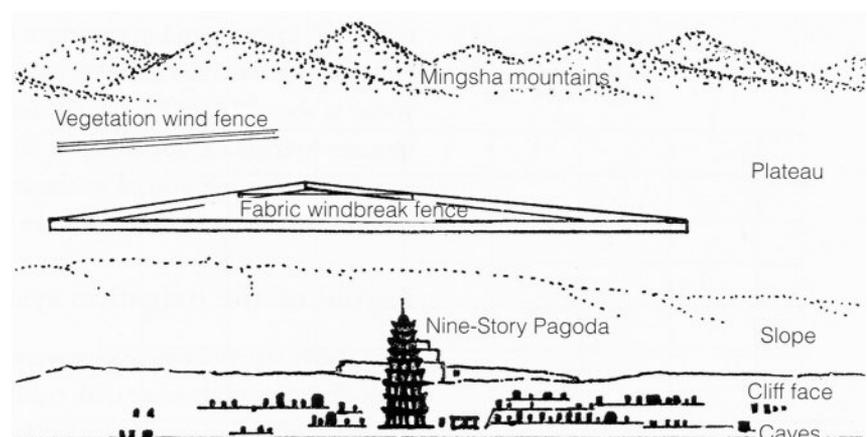
Figure 1
Schematic drawing showing the location of the vegetation windbreak fence.

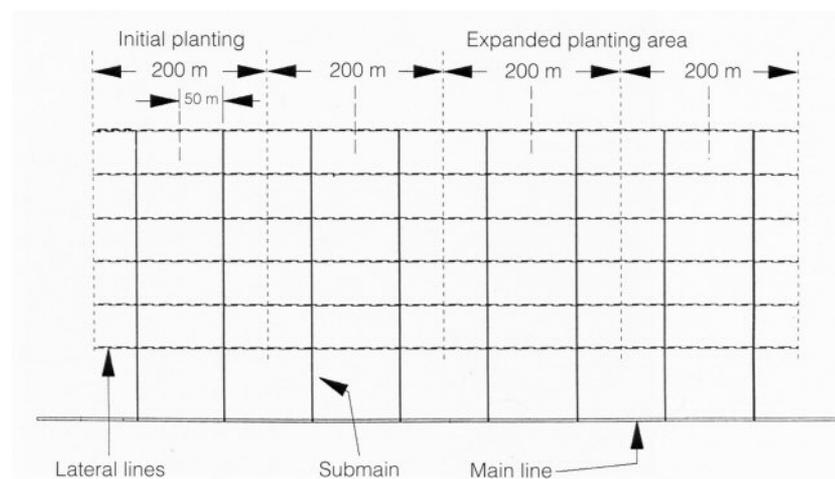
Figure 2
Layout of the system.

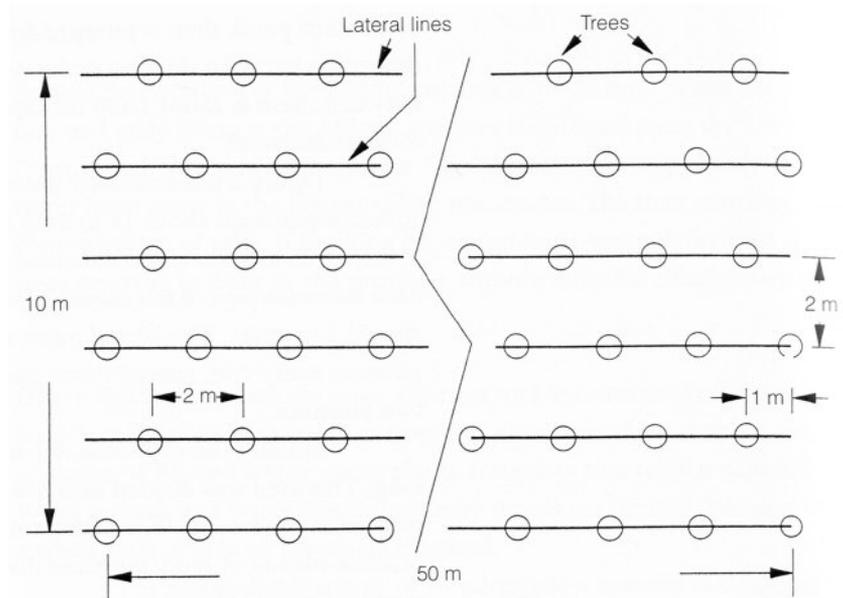
Figure 3
Offset pattern of planting.

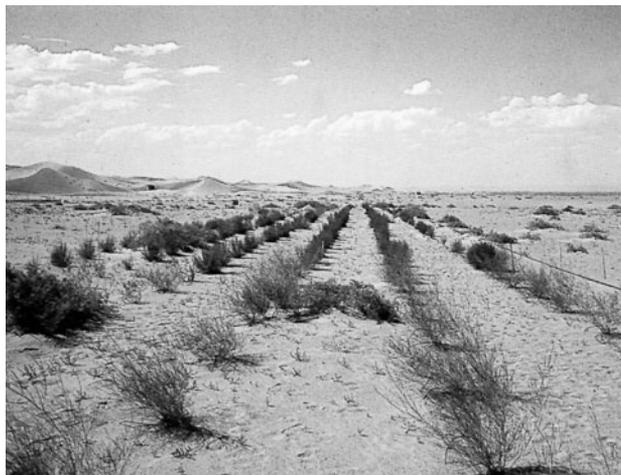
Figure 4
Plateau above the Mogao grottoes, showing the growth of vegetation in 1993.

As of 1993, the four species of shrubs were growing well (Fig. 4), and the survival rates were *Haloxylon ammodendron* 100%, *Tamarix chinensis* 99.2%, *Calligonum arborescens* 82%, and *Hedysarum scoparium* 94.2%.

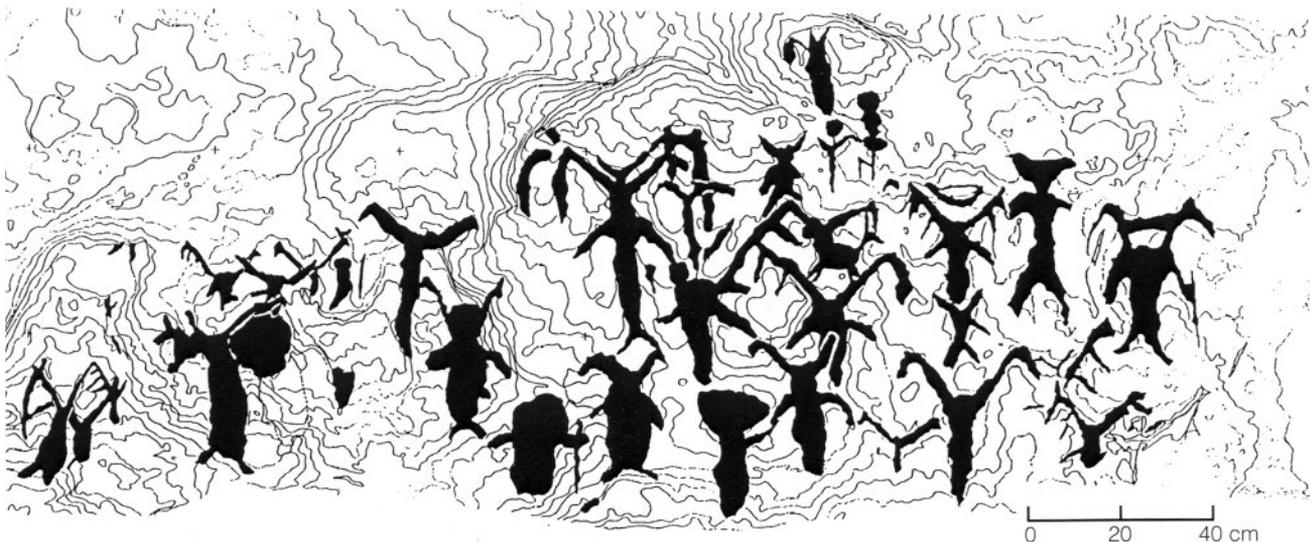
Figure 4
Photogrammetric plot of the inscribed characters, 1993.

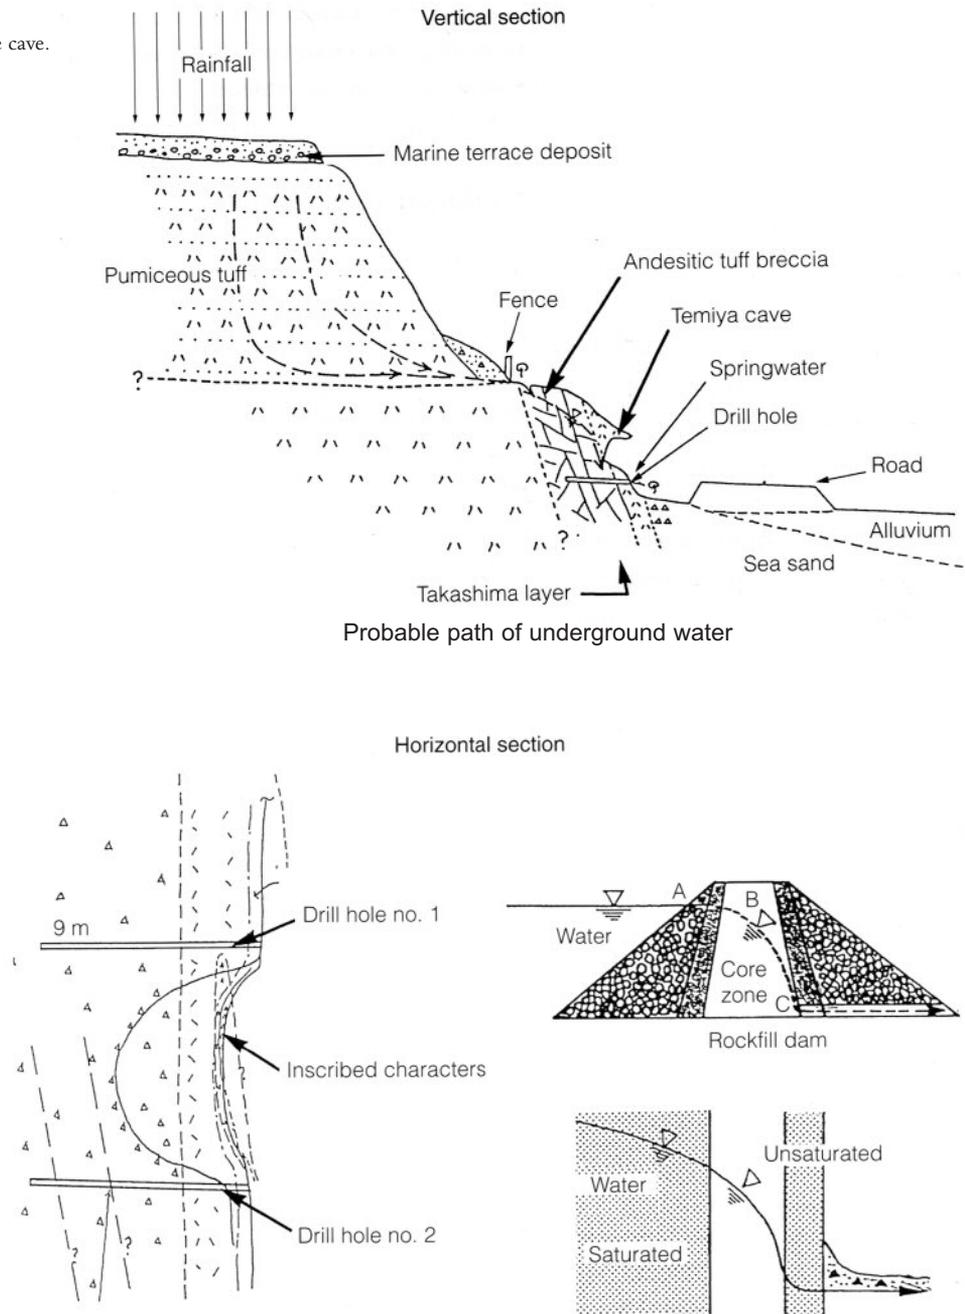
Figure 5
Geological structure in and around the cave.

The pumiceous and andesitic tuffs corresponding to the Takashima stratum form alternating layers, and their distribution is considered to be nearly parallel to the slope surface. The surface on which the ancient characters are inscribed consists of andesitic tuff breccia, which is considered to be different from the geological feature found by drilling to a depth greater than 2.5 m. The andesitic tuff breccia is presumed to be distributed in a lens shape, judging from its relationship to surrounding geological features (Fig. 5).

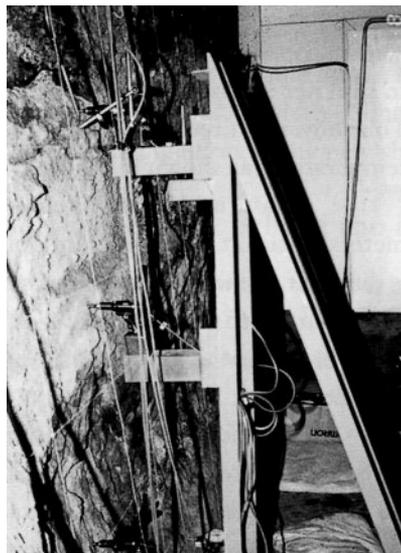
Figure 6
Displacement meters (transducers) installed inside the cave.

Monitoring instruments could not be installed directly on the inscribed characters because of their cultural value. Therefore, six displacement meters (transducers) with highly sensitive dial gauges were installed at different positions in the vicinity of the inscribed characters. Each of the meters was attached to a specially made magnetic stand with steel legs. The bottom of each leg was fixed to a concrete base (Fig. 6). In addition, nine displacement meters were installed across the open cracks at different points to measure changes in crack width (Fig. 7).

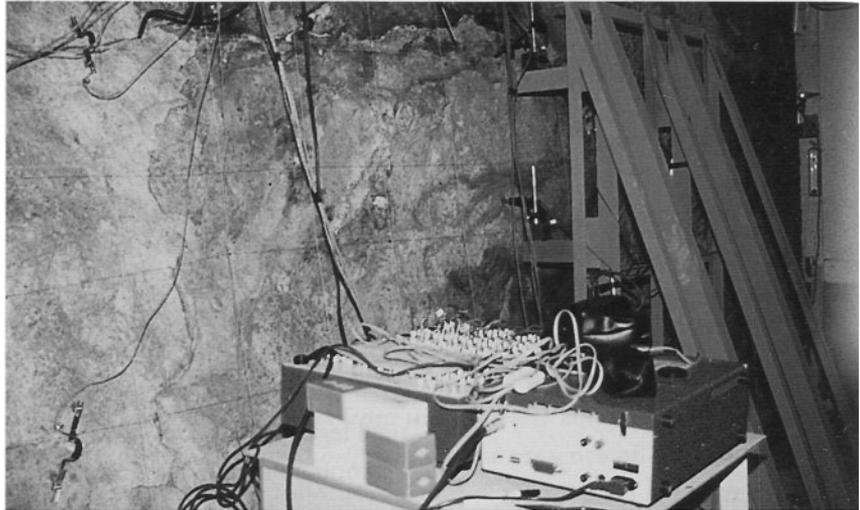
Figure 8
Displacement monitor shown inside the cave.

The individual displacement meters were connected to a central monitor (Fig. 8) connected to a personal computer that automatically records the data sent from each of the displacement meters. Measurements are taken four times a day, and the average value constitutes the displacement value for the day.

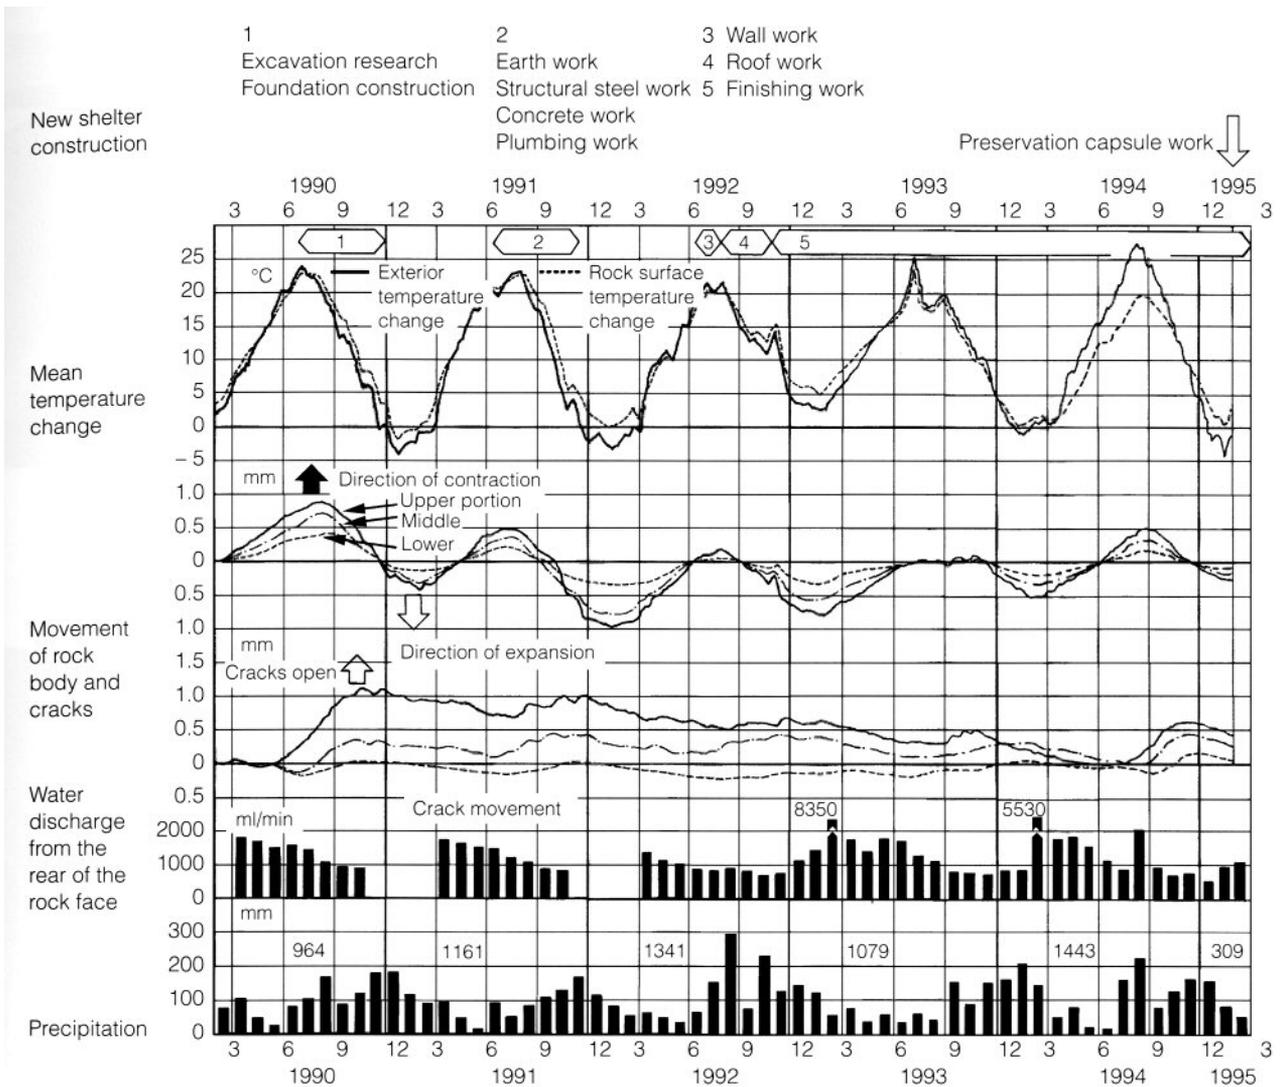
Figure 9
Observation of annual cyclical change. Numbers in bands at top of table indicate stages of new shelter construction and conservation research over a period of five years: 1 = excavation research and foundation construction; 2 = earth work, structural steel work, and concrete and plumbing work; 3 = wall work; 4 = roof work; 5 = finishing work. The arrow at the upper right indicates work on the preservation capsule, which is not yet complete.

The inscribed rock surface moves toward the rear of the cave from spring to summer and returns to its forward position from autumn to winter. This movement recurs regularly every year in proportion to the change in temperature, as shown in Figure 9.

Water is being pumped out from behind the inscribed rock, using the holes made during the core-sample drilling. Drainage volume is measured in milliliters per minute as it gushes out of the pumping holes each month (Fig. 9). Previously, this measurement had not been taken in winter because the water was frozen. The construction of the new shelter, however, has retained warmth and has made it possible to measure pumped water throughout the year. The new shelter has thus had a profound effect on the ability to remove the water that has long been destroying the rock.

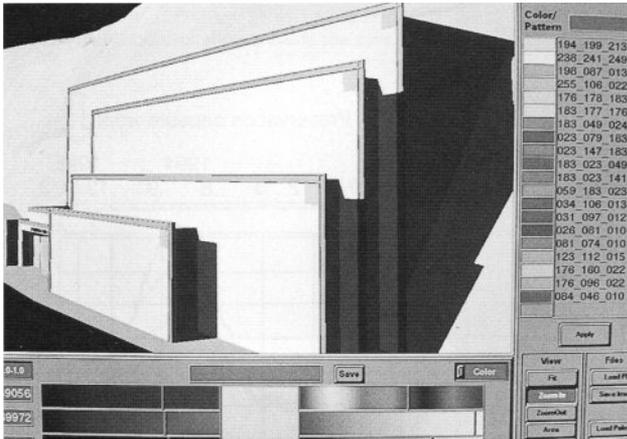
Figure 10
Computer simulation of cave exterior.

Conditions of the inscribed rock surface were simulated using computer graphics software. Topographical data and information about the conditions of the road running close to the side were based on existing topographical maps on a reduced scale of 1:2500, with data on the new shelter provided by blueprints (Fig. 10). The colors of the exterior of the shelter can be easily simulated by balancing red, blue, and green color values in many different ways on the computer. Different appearances as seen from different perspectives are also possible. Decisions can be made on how to match the shelter with its surrounding environment in regard to color, shape, and a range of other factors (Fig. 11). Many different plans are possible for a shelter's interior design—including colors, displays of exhibitions, lights, preservation capsules, and so on (Fig. 12).

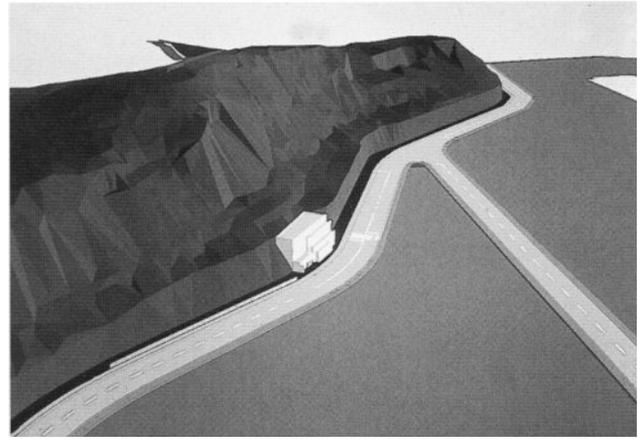
Figure 11
Computer simulation of shelter location and environment.

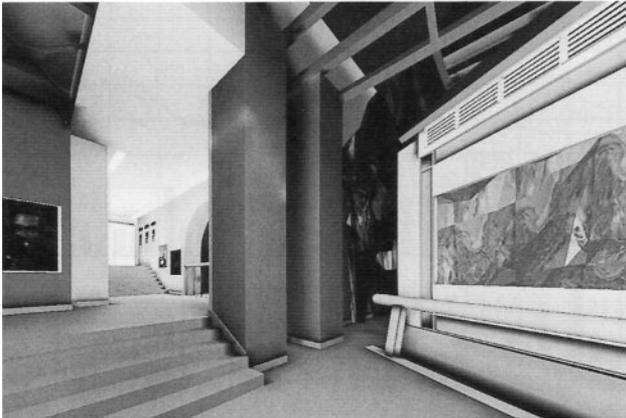
Figure 12
Computer simulation of shelter interior.

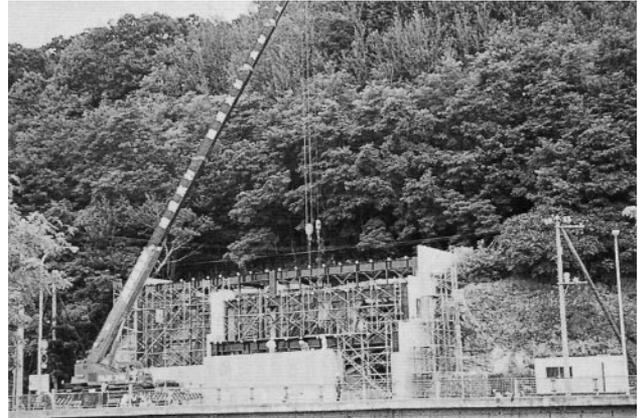
Figure 13
The new shelter under construction.

Earthquakes are frequent in Japan, especially Hokkaido, and many people visit the Temiya cave. For this reason, the new shelter was constructed with a steel-reinforced concrete structure (Fig. 13).

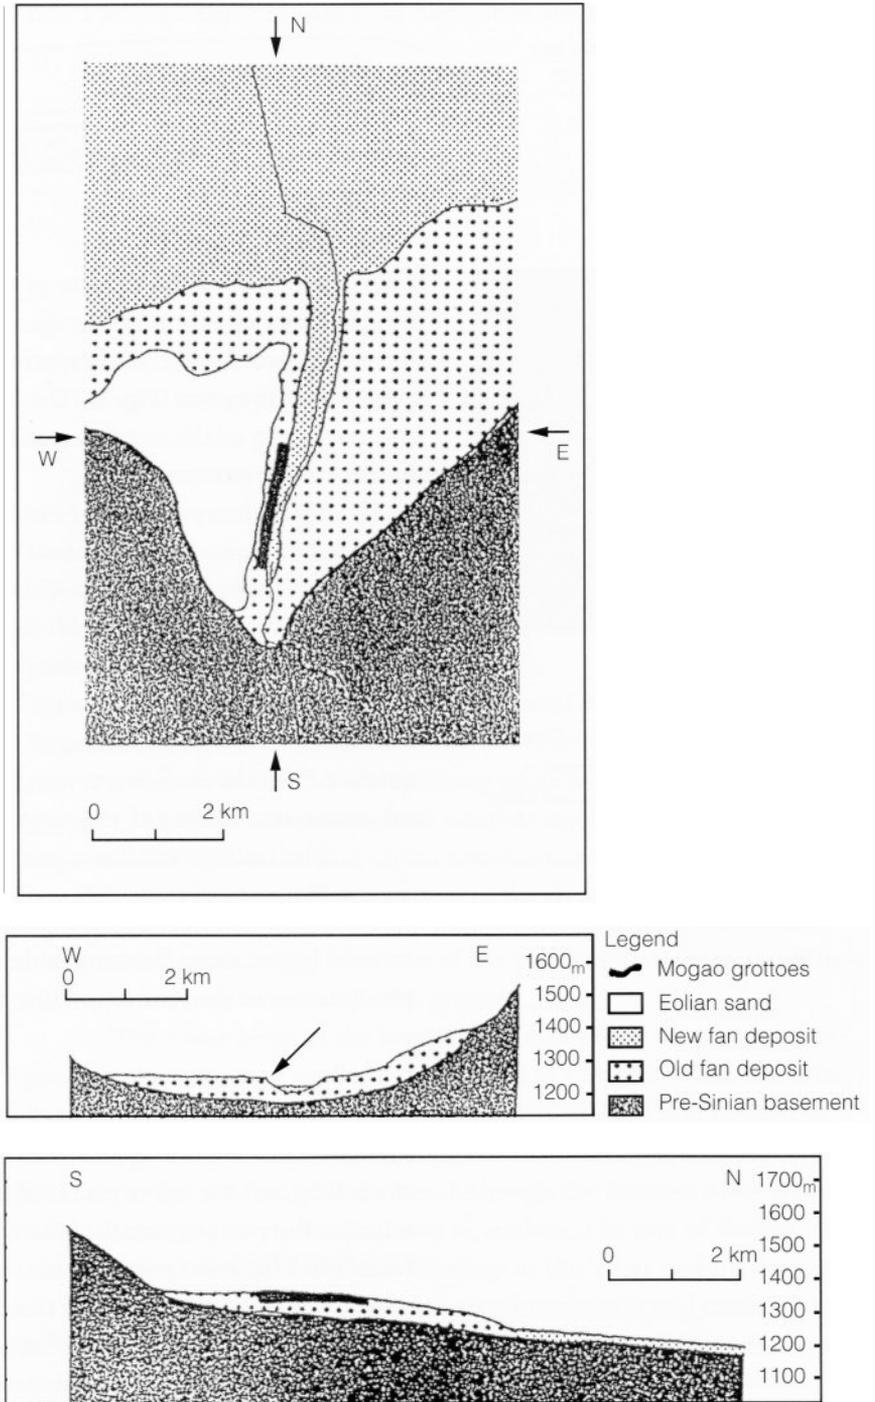
Figure 1
 Geological map and cross sections in the vicinity of the Mogao grottoes, Dunhuang.

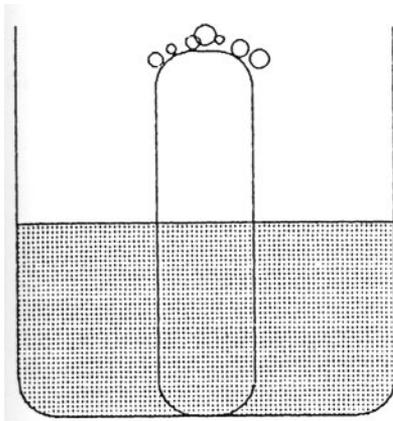
Figure 4 Research on the interaction between river water and the ground layer of paint. A sample of the ground layer of Cave 53 was added to a water sample from the Daquan River. Results show that gypsum crystals form in three days.

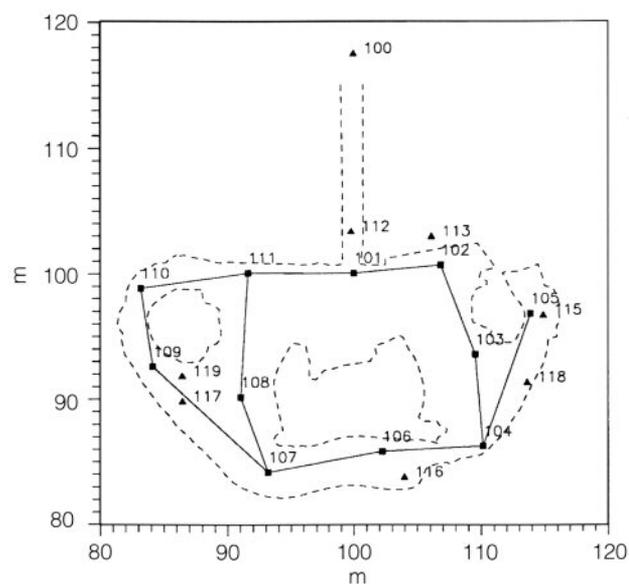
Figure 1
Survey reference points. Points 112 and 113
are in the openings on the first floor of the
front temple.

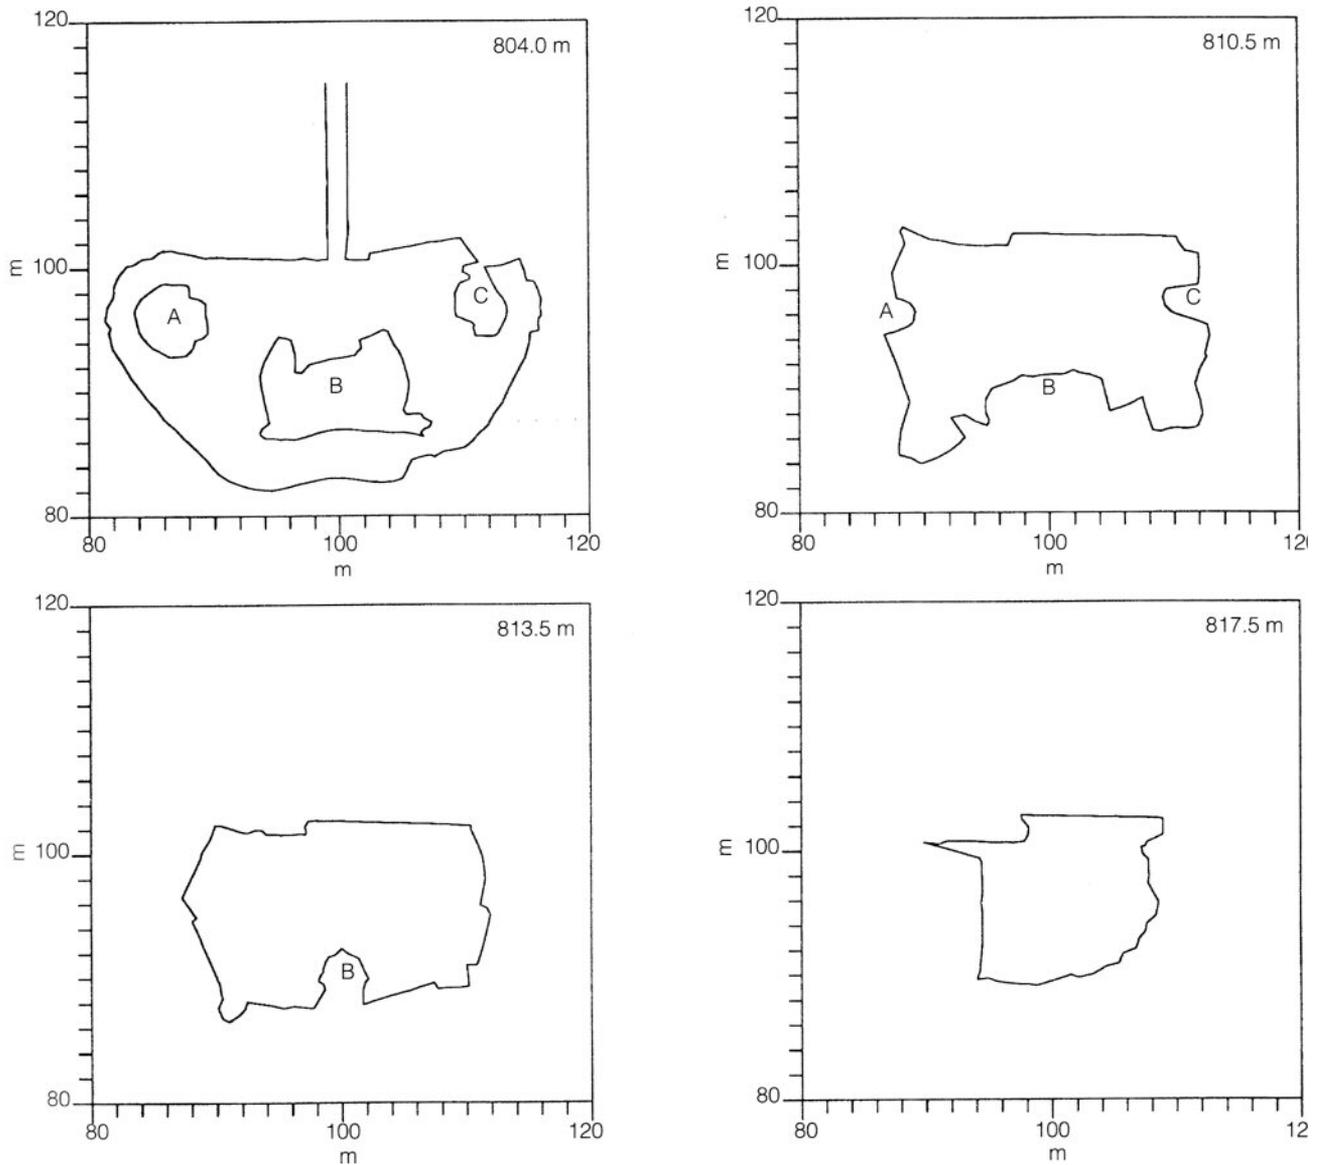
Figure 2
Horizontal cross sections at four elevations above the grotto floor with letters indicating the statues, as follows: A = Bodhisattva Avalokiteshvara, B = the Great Buddha, C = Bodhisattva Mahastamaprapta.

Vertical coordinates were interpreted from the reference points, a process that yielded forty-one sets of elevation data (0.5 m, 1.0 m, 1.5 m, and so on) with a range of 0.25 m. The coordinates of the whole ceiling, with a wider range, were stored in the forty-first set. Figure 2 shows horizontal cross sections in four elevations that were prepared with these data sets. Figure 3 demonstrates how the same can be done for any vertical section. Other sections of this kind can easily be made so a rough impression of shape, size, and relative orientation can be obtained.

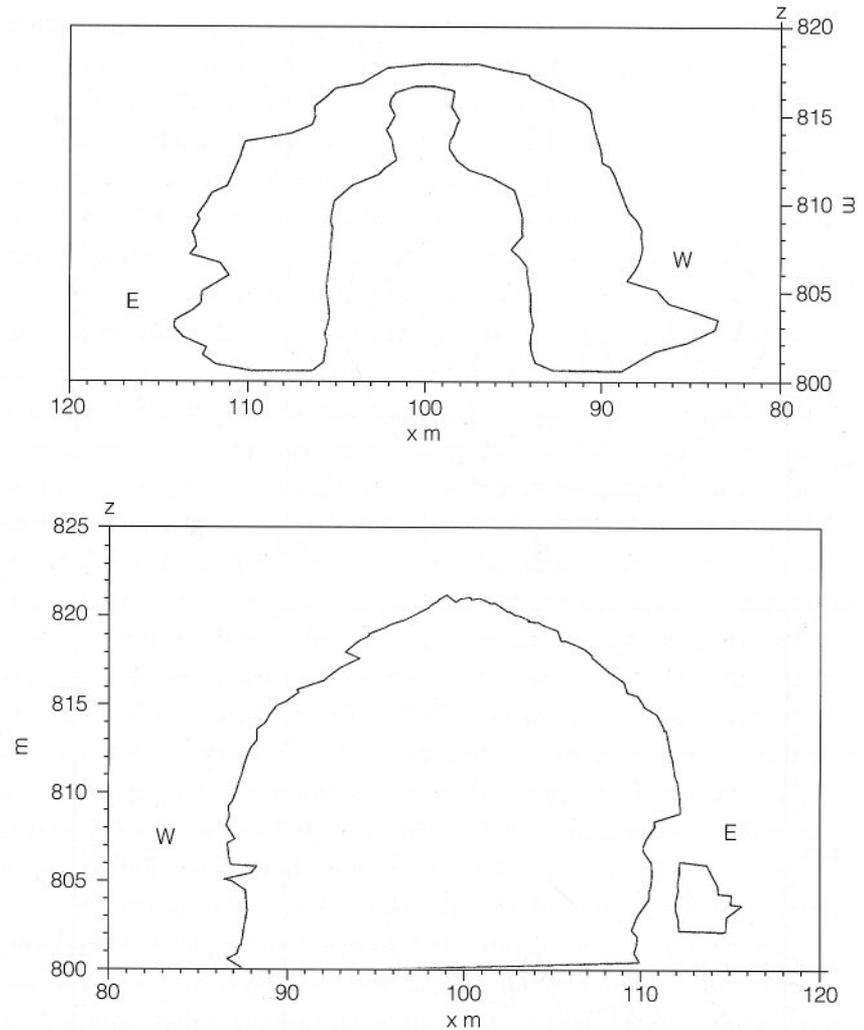
Figure 3
Two vertical cross sections.

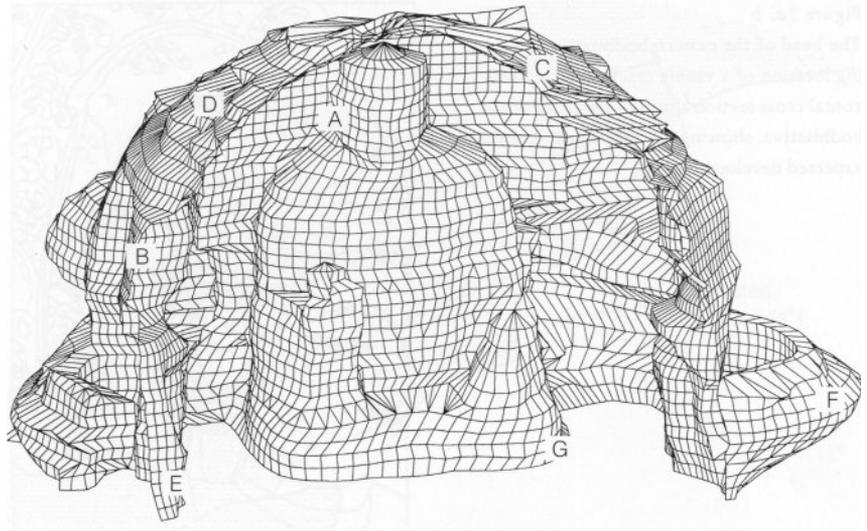
Unshaded CAD model. Point of view from the northeast. Letters mark vulnerable parts of the grotto surface and statues: A = head of the Great Buddha, B = eastern bodhisattva, C = ceiling to the left and in front of the Buddha, D = area of dangerous “coffin lids,” E = foot of the eastern bodhisattva, F = circuit behind the statues, G = base of the Buddha.

Figure 4 gives a rather complete impression of the grotto except for the remaining cliff wall and the front temple, which are omitted. The

sitting Buddha fills the grotto almost to the ceiling. The two bodhisattvas are leaning toward the walls and are clearly subordinate. A kind of circuit surrounds the statues near their bases. The grotto surface is roughly shaped as one-quarter of an ellipsoid. Convexities of this surface carry decorative parts, such as the Buddha's halo. Concave parts are largely the result of losses from rupture in the upper half of the grotto and erosion in the lower half.

The ceiling to the left and in front of the Great Buddha (Fig. 4, area C; Fig. 8) contains a few very loose protruding blocks with masses of up to about 50 kg. One of these blocks fell in 1992; this dangerous event led to the decision to erect the scaffold and conduct a close inspection. Other very loose small blocks, previously unseen, were then identified from the vantage point of the scaffold. Because their documentary value appeared low relative to the cost of stabilizing them, they were removed immediately.

Close inspection itself posed a high risk. A very dangerous area was discovered to the right of the Buddha's head (Fig. 4, area D). In that spot, orthogonal patterns of joints almost permit the separation and falling of a series of slabs or plates weighing about 2 t each (Fig. 9). Gentle tapping applied experimentally to these plates caused them to vibrate with a low frequency—an indication that the plates are attached on only one side. The term “coffin lids,” used by miners for such slabs, indicates the danger they pose.

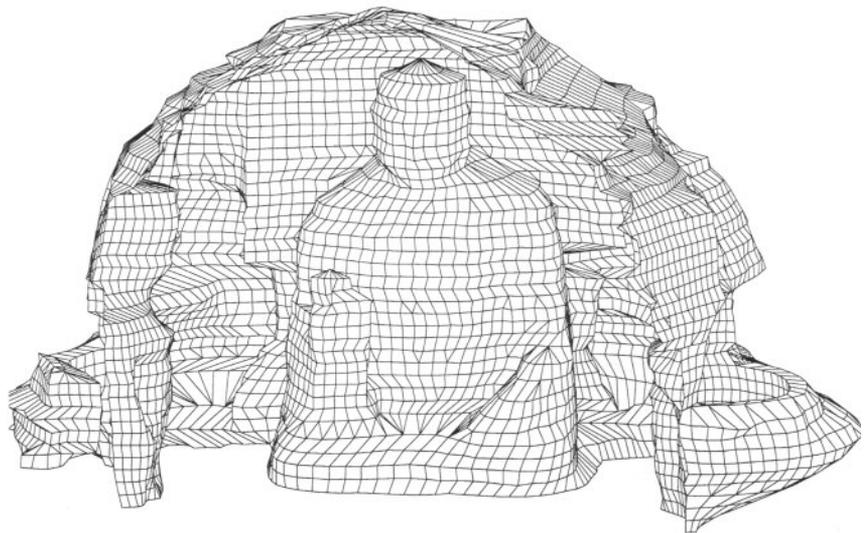
Unshaded CAD model. Point of view from the north.

Figure 5 shows another image of this kind. The observer's point of view can be chosen arbitrarily, and various parts of the CAD model can be removed to achieve a better perspective. The images have been enhanced with shadows and colors to strengthen the spatial impression. It is evident that photographs and videos are needed to obtain more detailed pictures, but these can be far better understood with the aid of the CAD images. These graphics form a substantial part of the authors' geotechnical reports; they are also useful in the authors' own work and in collaborating with other scientists.

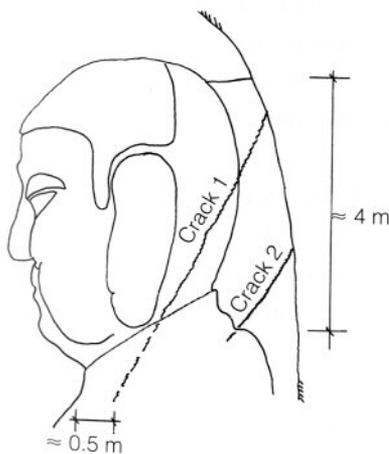
Figure 6

Cracks at the Buddha's head with an inclination of approximately 60°.

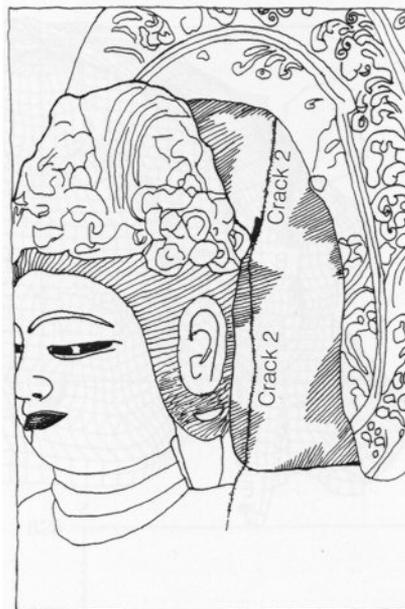
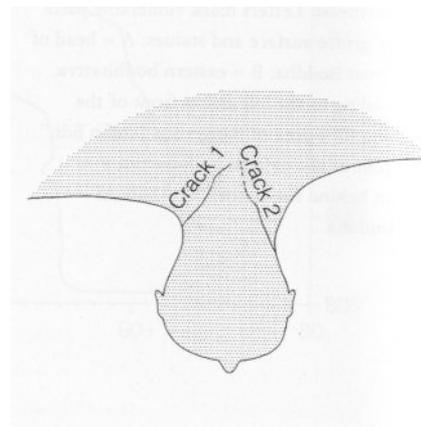
Figure 7a, b

The head of the eastern bodhisattva (a) showing location of a visible crack; and (b) horizontal cross section through the head of the bodhisattva, showing existing cracks and their expected development.

shock waves reveals that the two cracks pass through the stone horizontally. It can also be seen that part of the cracks appear to be fresh and thus are developing. Indeed, the head will eventually break off when the cracks are sufficiently deep. The eastern bodhisattva, on the right side of the Great Buddha, has a similar weakness: the head is partly separated from wall and body by two cracks (Fig. 4, area B; Fig. 7a). Only one crack is visible from the floor, and only a very close inspection revealed the danger presented by the second one (Fig. 7b). As the head is inclined toward the Buddha, it is likely to fall in this direction.

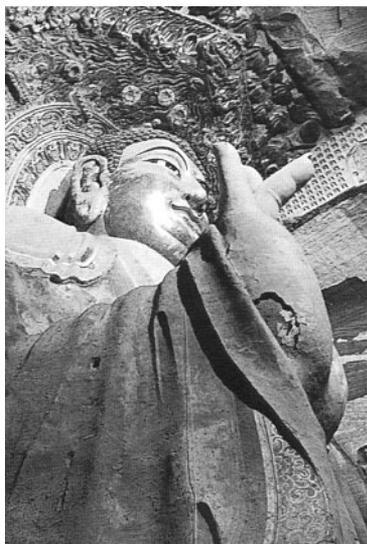
*Figure 8*

View of the Dafosi grotto, showing rock outcrops (upper right) in ceiling area to the left of the Buddha.

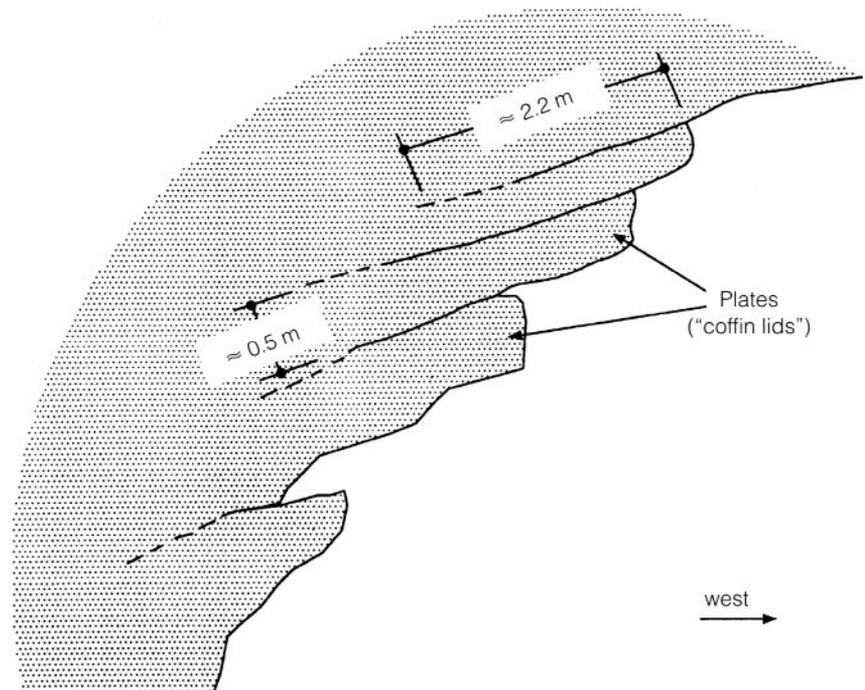
Figure 9

Vertical cross section through the ceiling and head of the eastern bodhisattva, showing the dimensions and shape of the "coffin lids."
