Geotechnical Issues in the Conservation of Sites

Robert E. Englekirk

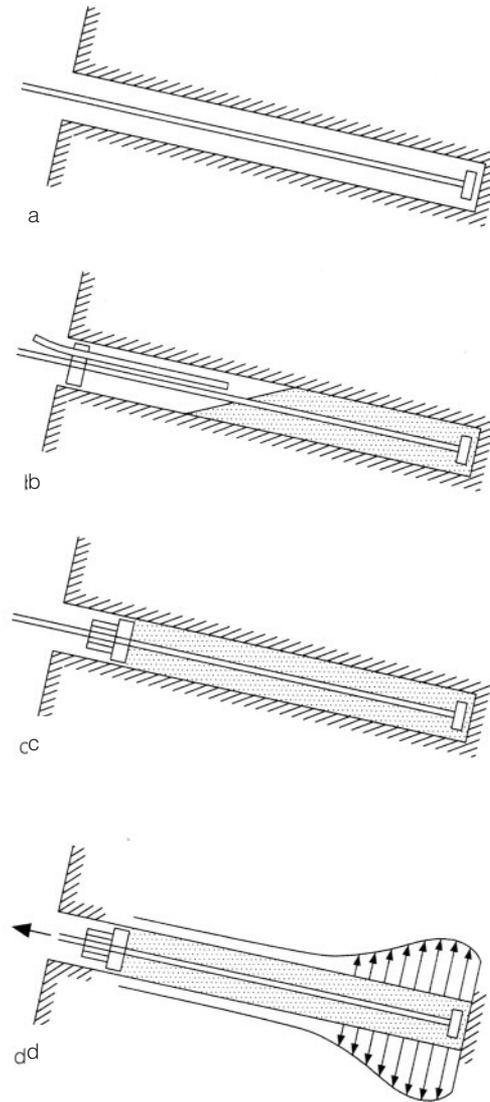
Figure 10a–d
Schematic drawing, showing installation of a sand anchor in rock.

For this type of repair, stainless steel or fiberglass bolts will be placed into the drill holes (Fig. 10a). Filling the holes with compacted sand (Fig. 10b) and prestressing the bolts with screw nuts (Fig. 10c) will achieve the necessary static contact (Fig. 10d). This type of rock anchor, which was developed at the Institute of Mining of the Russian Academy of Science in Novosibirsk (Stashevski and Kolymbas 1993), is strong and durable. It is also chemically neutral and therefore reversible from a conservation standpoint. The anchor system was further developed at the Institute of Soil and Rock Mechanics in Karlsruhe and tested on sandstone blocks, including overhead installations. Field tests have also been performed on this anchor system in soil—for example, in the stabilization of retaining structures. The installation of anchor systems combining bolts and sands has been extensively and successfully achieved under various conditions (Gudehus 1994). In Bulgaria, such sand anchors have been used to fix rock blocks in steep slopes in cases where they threaten to destroy historic buildings (Stashevski and Kolymbas 1993).
