Seismic Retrofitting Project

Testing of Materials and Building Components of Historic Adobe Buildings in Peru

Research Report

Daniel Torrealva, Erika Vicente,
and Tim Michiels

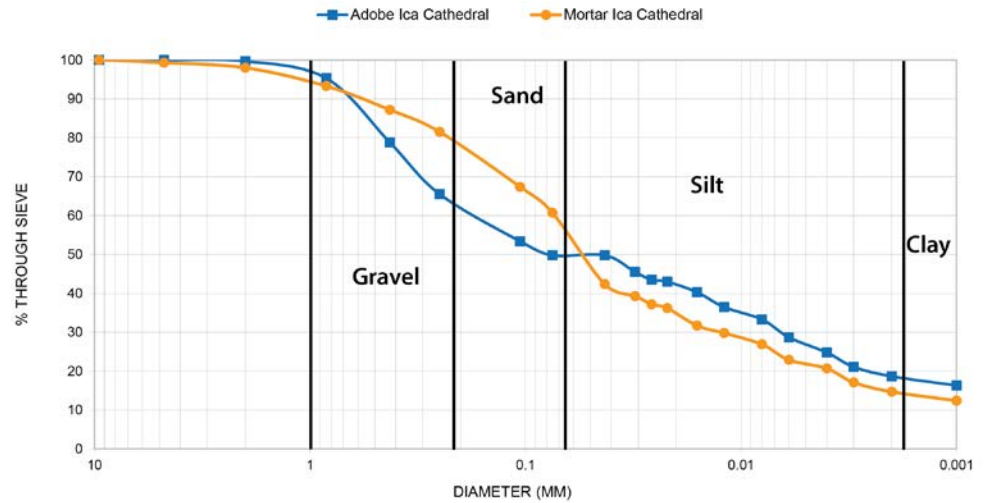
FIGURE 2.2.
Granulometric curve for Ica Cathedral, showing mud mortar (orange) and adobe (blue).

Granulometric curves are provided for Ica Cathedral (fig. 2.2), Hotel El Comercio (fig. 2.3), and other buildings in Lima (fig. 2.4). Figure 2.5 combines all granulometric curves of adobe blocks; figure 2.6 combines all granulometric curves for soil from the original mortar.

In general, the soil composition of adobe units and mortars present low-plasticity clays. The soils from Ica Cathedral contain more silt. The amounts of coarse and fine particles were similar in all cases (see figs. 2.5, 2.6): 30–40% for coarse material and 60–70% for fine material. The similarity of grain-size distribution of the soil used for mortar and adobes per location confirms that traditionally the same soil was used for making both mud mortar and adobe.

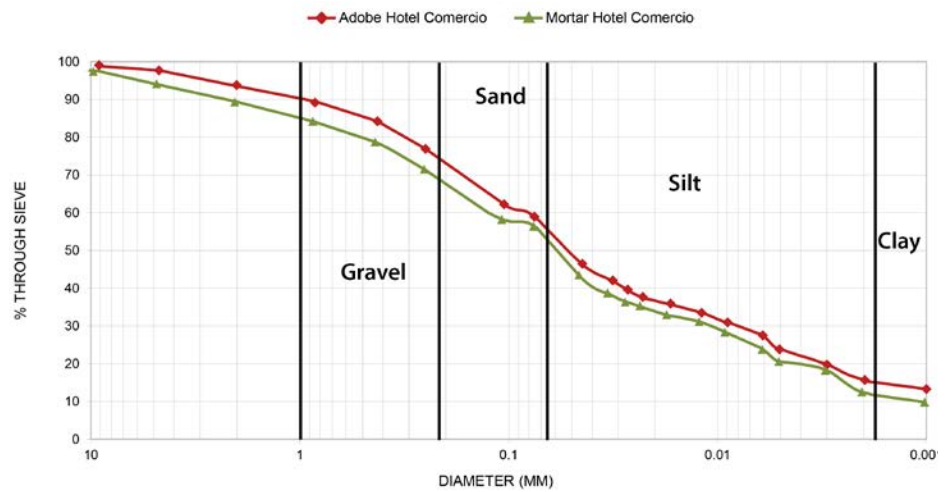
FIGURE 2.3.
Granulometric curve for Hotel El Comercio, showing mud mortar (green) and adobe (red).

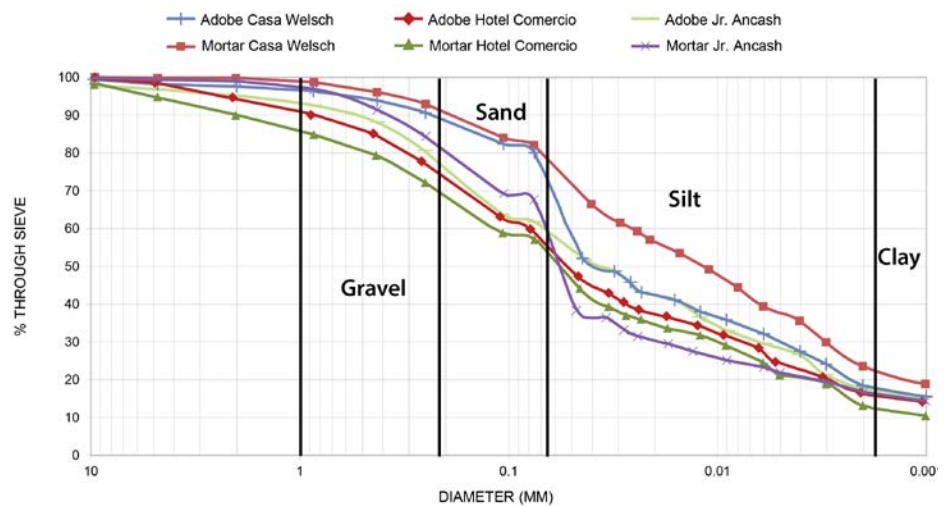
FIGURE 2.4.
Combined granulometric curves for Casa Ancash, Casa Welsch, and Hotel El Comercio.

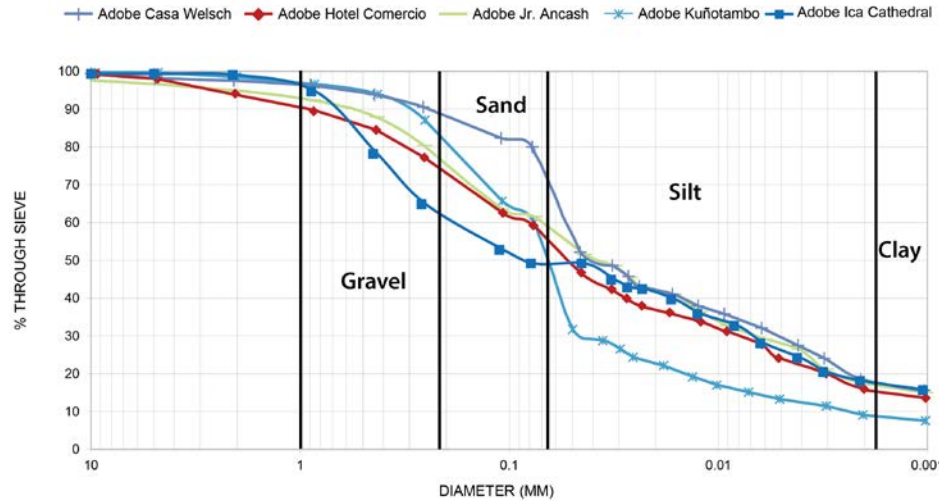
FIGURE 2.5.
Combined granulometric curves for
all adobe blocks.

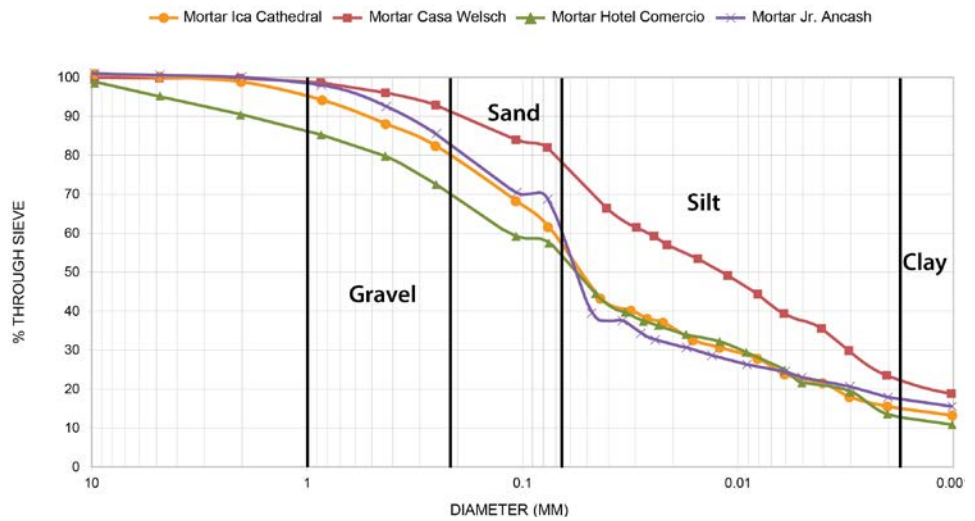
FIGURE 2.6.
Combined granulometric curves for
soil from the original mortar.

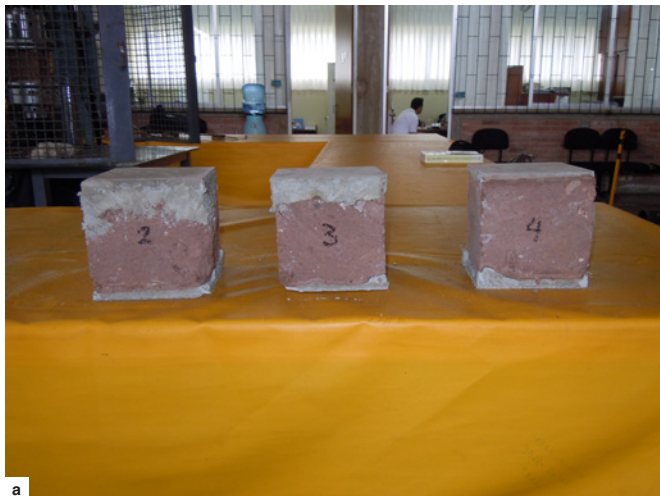
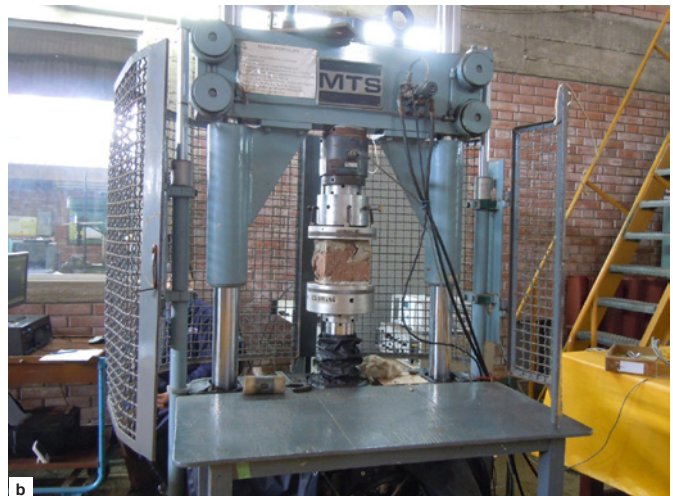
FIGURE 2.7.

Adobe test sample cubes (a) were tested for uniaxial compression strength on a displacement-controlled MTS machine (b).

The uniaxial compression strength of the adobe units was tested on cubes approximately 10 × 10 × 10 cm (fig. 2.7). The cubes were tested using a displacement-controlled material testing system (MTS) machine. The tops and bottoms of the cubes were covered with a thin layer of gypsum to ensure a level testing surface. The units were collected inside the historic buildings, but their exact origin, age, and state of deterioration is unknown. Units from Ica Cathedral were obtained from a rubble pile within the cathedral; units from Hotel El Comercio were taken from the collapsed area at the rear of the building. One adobe unit

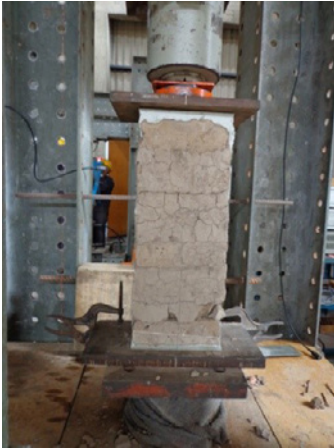
FIGURE 2.8. Compression test on adobe pile. Vertical cracks are visible in the units and the mortar.

The failure mode for all specimens was a vertical crack pattern running through the units and the mortar, as can be observed in figure 2.8. The piles from Ica Cathedral provided consistent results (variation of less than 10%), with an average compression strength of 0.46 MPa. The average compression strength of the masonry from Hotel El Comercio was 0.39 MPa. The masonry of the other buildings in Lima had a compression strength ranging from 0.39 to 0.76 MPa. Overall, the obtained values for the masonry piles were in the same range. The admissible value of compression strength in Peruvian Adobe Code E-080 is 0.2 MPa, while values of experimental analysis for Peruvian new adobe masonry are between 0.77 and 3.72 MPa (Vargas and Ottazzi 1981; Vargas, Bariola, and Blondet 1983; Vargas et al. 1986).

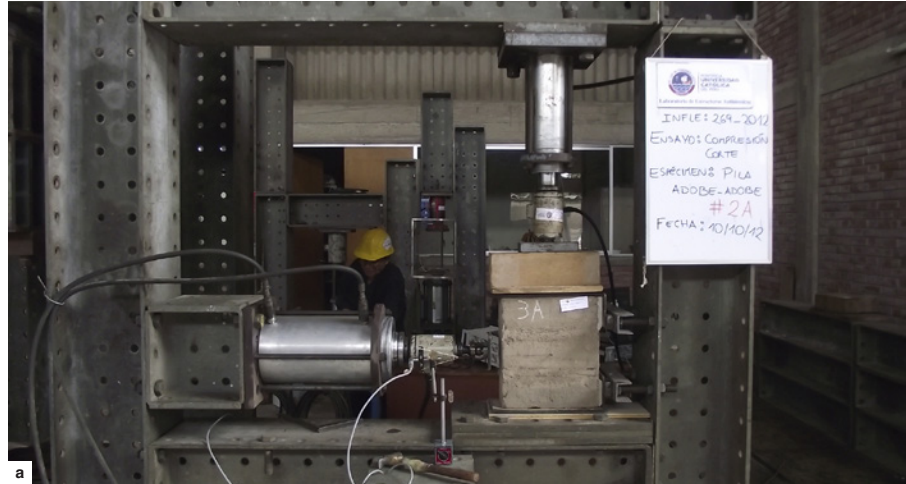
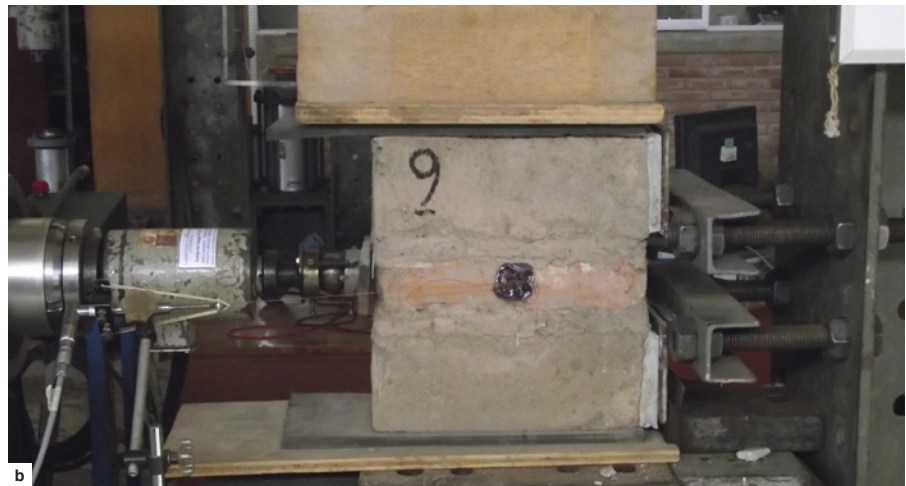
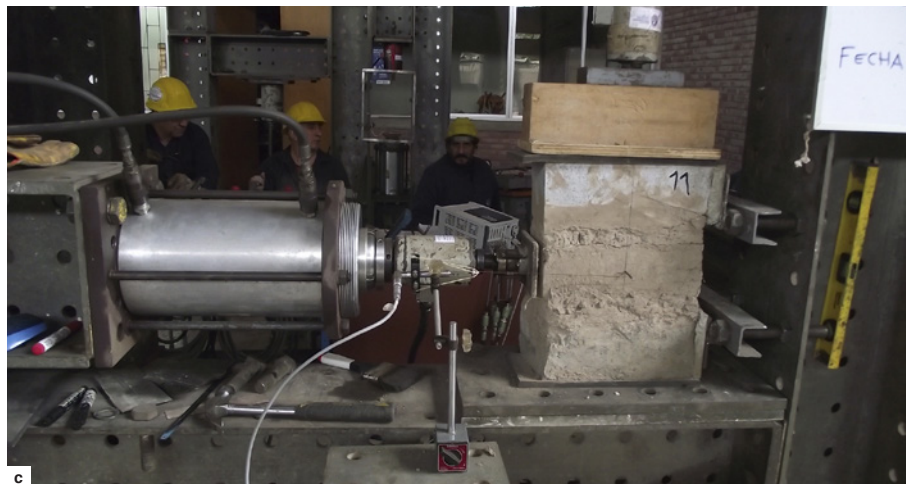
FIGURE 2.9.

Shear-compression tests performed on three types of triplets:
 (a) adobe/adobe;
 (b) adobe/brick;
 (c) stone/adobe.

Cohesion and angle of friction of the masonry were tested through a combined compression-and-shear test. In this procedure, a vertical force was applied on the triplet first, followed by a horizontal force exerted on the central unit until failure occurred (fig. 2.9). Three types of triplets were considered, all using the same mud mortar made from soil obtained from Ica Cathedral, mixed with sand and straw (1 part sand, 3 parts soil, 1 part straw):

Dimensions of the adobe units were $13 \times 30 \times 10$ cm. Thickness of the mud mortar joints was 2 cm. Horizontal load rate was 150 N/s, following British Standard BS EN 1052-3 (British Standards Institution 2002).

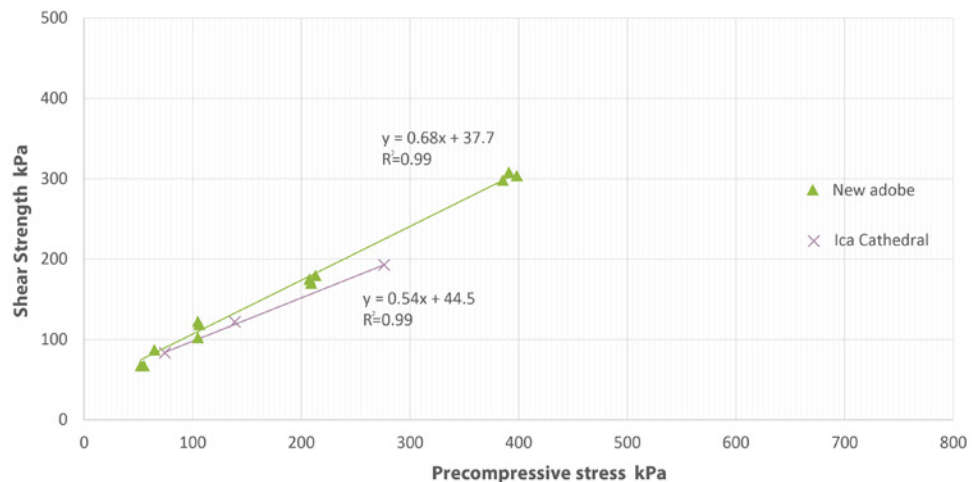
FIGURE 2.10.
Graph showing shear-compression curve for adobe/adobe triplets.

The shear-compression tests on the triplets provided consistent results that allow clear estimations to be made of the cohesion and friction angle of the masonry. The adobe/adobe and adobe/brick exhibited a similar failure pattern: sliding between the interface of the mud mortar and the adobe. This is reflected in the values obtained for cohesion and friction angle, which are similar. Cohesion and friction angle values for the new adobe masonry are 38 kPa and 0.60 rad, respectively. Specimens with historical material from Ica Cathedral have a cohesion value of 45 kPa and a friction angle of 0.50 rad. The obtained cohesion and friction angle for the adobe/brick triplets were 38 kPa and 0.64 rad, respectively, almost identical to the values obtained for the new adobe/adobe masonry. It can furthermore be noted that the regression lines fit the samples extremely well, with R^2 values of 98% and higher (figs. 2.10, 2.11).

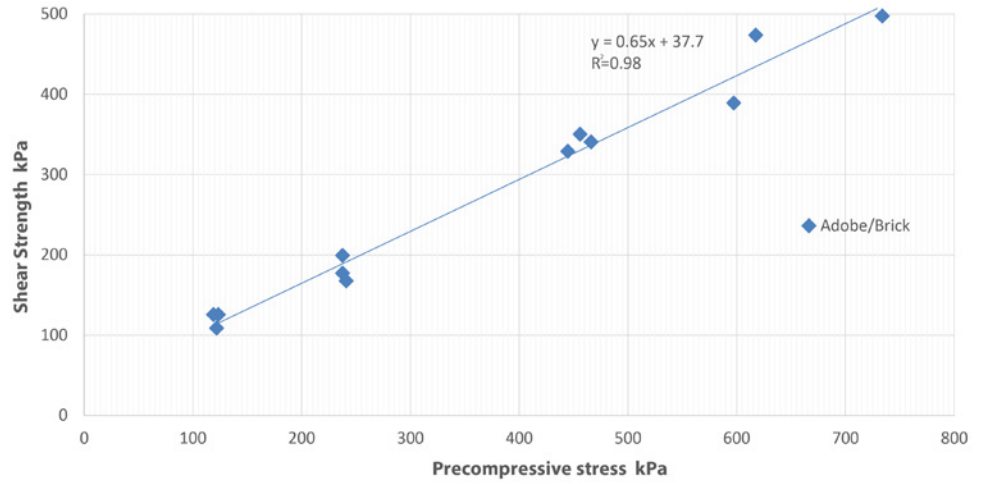
FIGURE 2.11.
Graph showing shear-compression curve for adobe/brick triplets.

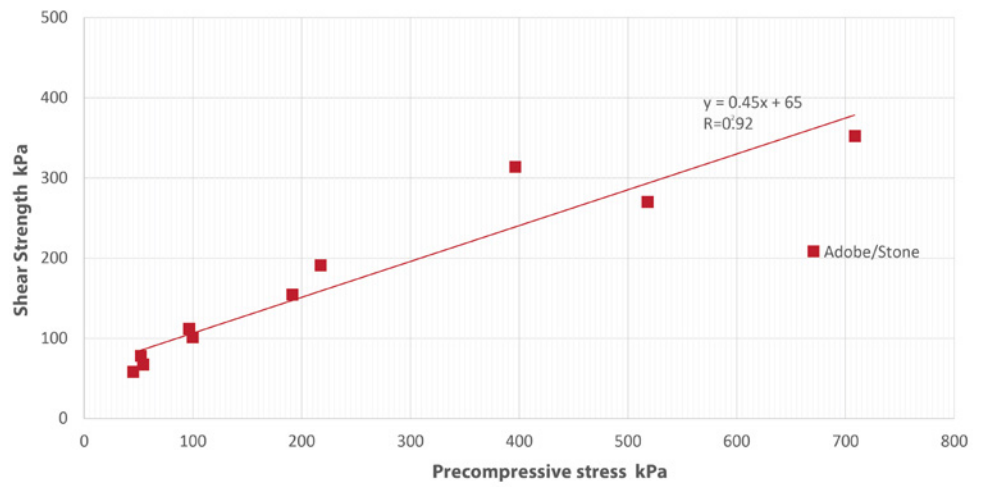
FIGURE 2.12.
Graph showing shear-compression curve for stone/adobe triplets.

The adobe/stone triplets failed on the interface between adobe and stone, leading to cohesion and friction angle values equal to 65 kPa and 0.45 rad, respectively. This friction angle of the adobe/stone masonry is thus lower than that observed in the adobe/adobe and adobe/brick interfaces because the failure interface is no longer between the adobe and the mud mortar but along the mud mortar and stone. This lower adherence of the mud mortar to the stone, compared to the adobe or brick, can be explained by the lower porosity of the stone. It can also be observed in figure 2.12 that the regression curve does not match the data points for the mud mortar–adobe interface, mostly due to the values under higher pre-compression distorting the plot. Ignoring these data points would lead to a more realistic lower cohesion value like the one observed for the other triplets (fig. 2.13).

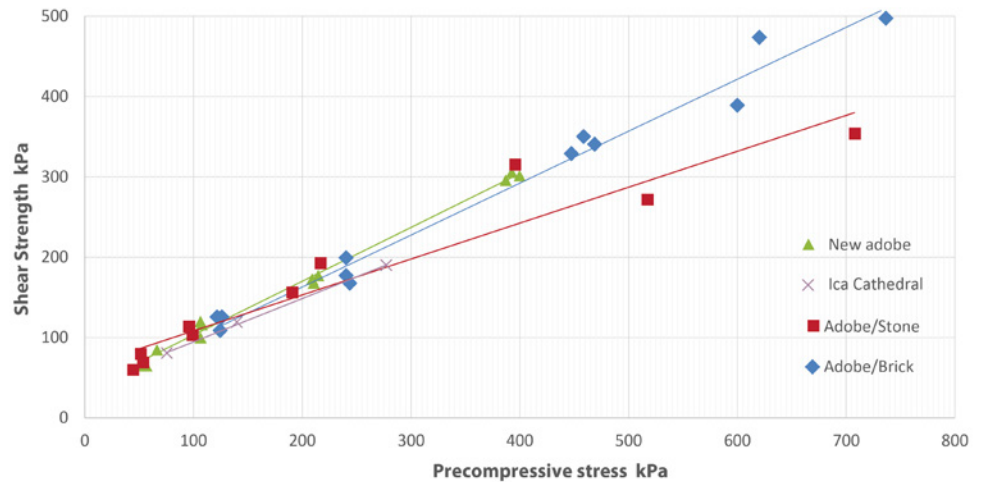
FIGURE 2.13.
Graph showing comparison of results for all triplets.

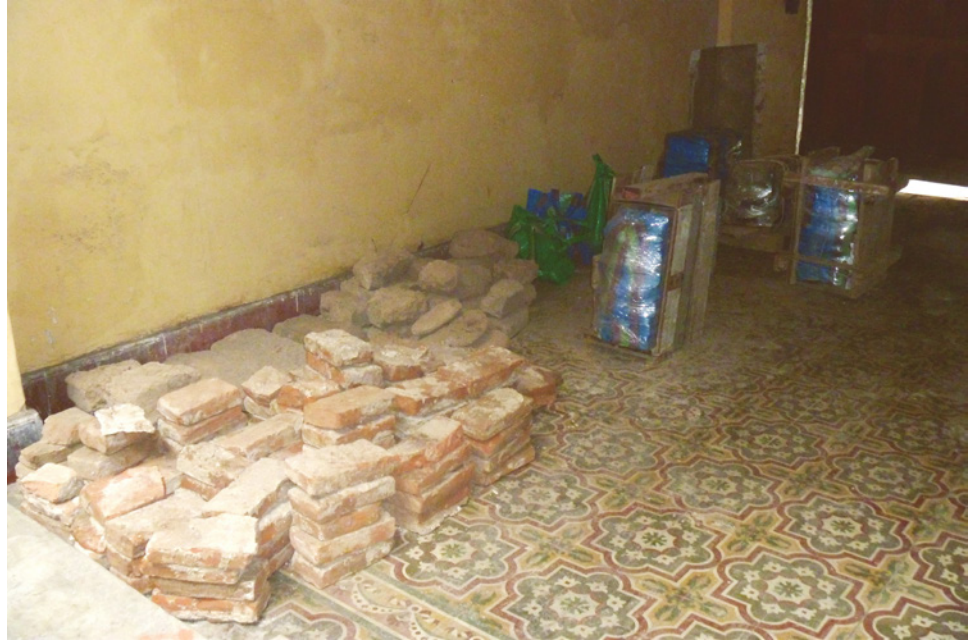
FIGURE 2.14.

Brick units from Hotel El Comercio used in compression strength testing.

The compression strength of brick units obtained from Hotel El Comercio was determined based on Peruvian Standard E-070, Norma Técnica de edificación E.070 Albañilería de Peru (Ministerio de Transportes 2006a). Five tests were carried out on bricks approximately 25 × 13 × 5 cm (fig. 2.14). The average compression strength was 12.51 kN (table 2.7). This compression strength of the original brick units is similar to the values prescribed in the Peruvian code for the industrial bricks.

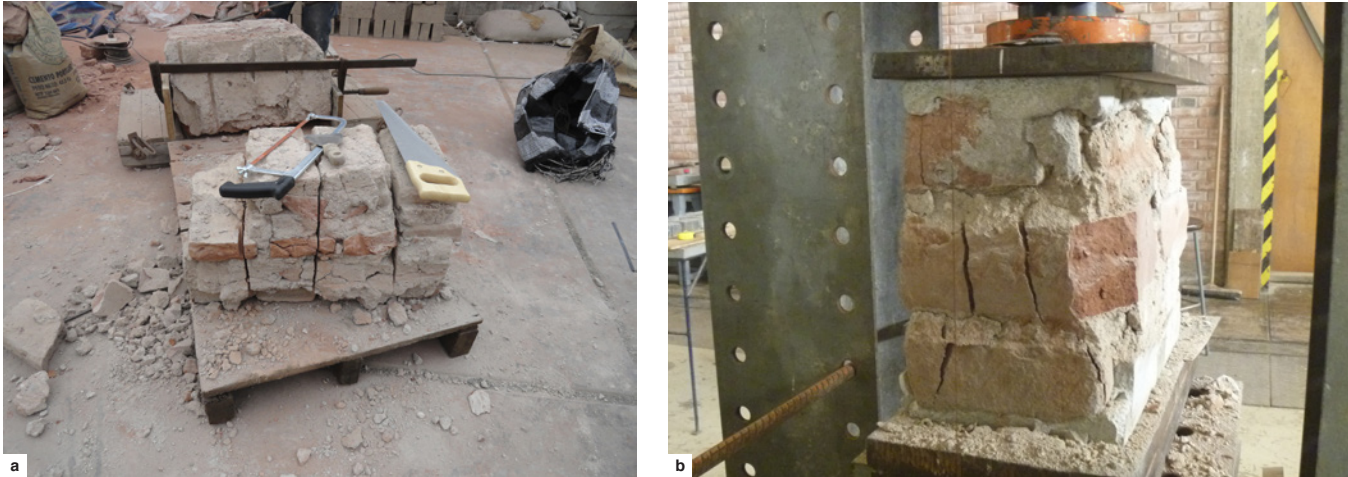
FIGURE 2.15.

Brick pile (a) cut from a portion of masonry wall; brick pile (b) extracted from Hotel El Comercio for axial compression testing.

to the brick, resulting in low strength (fig. 2.15). Peruvian code E-070 for masonry states that the compression strength of piles made of cement mortar varies between 3.5 and 11.0 MPa depending on the type of brick, which is consistent with the obtained results. The E-modulus of the historical masonry piles could not be accurately measured, as measurements varied from 38 to 199 MPa (more than 500%). The average E-modulus of the newly constructed brick piles was 558 MPa.

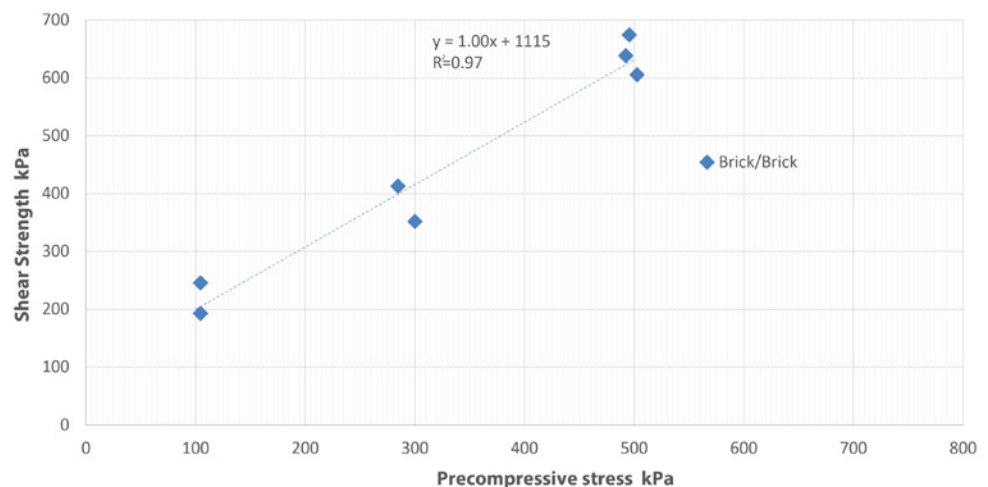
FIGURE 2.16.

Graph showing shear-compression curve for brick triplets.

construction. The obtained cohesion value was 111 kPa and the friction angle was 1 rad, as seen figure 2.16.

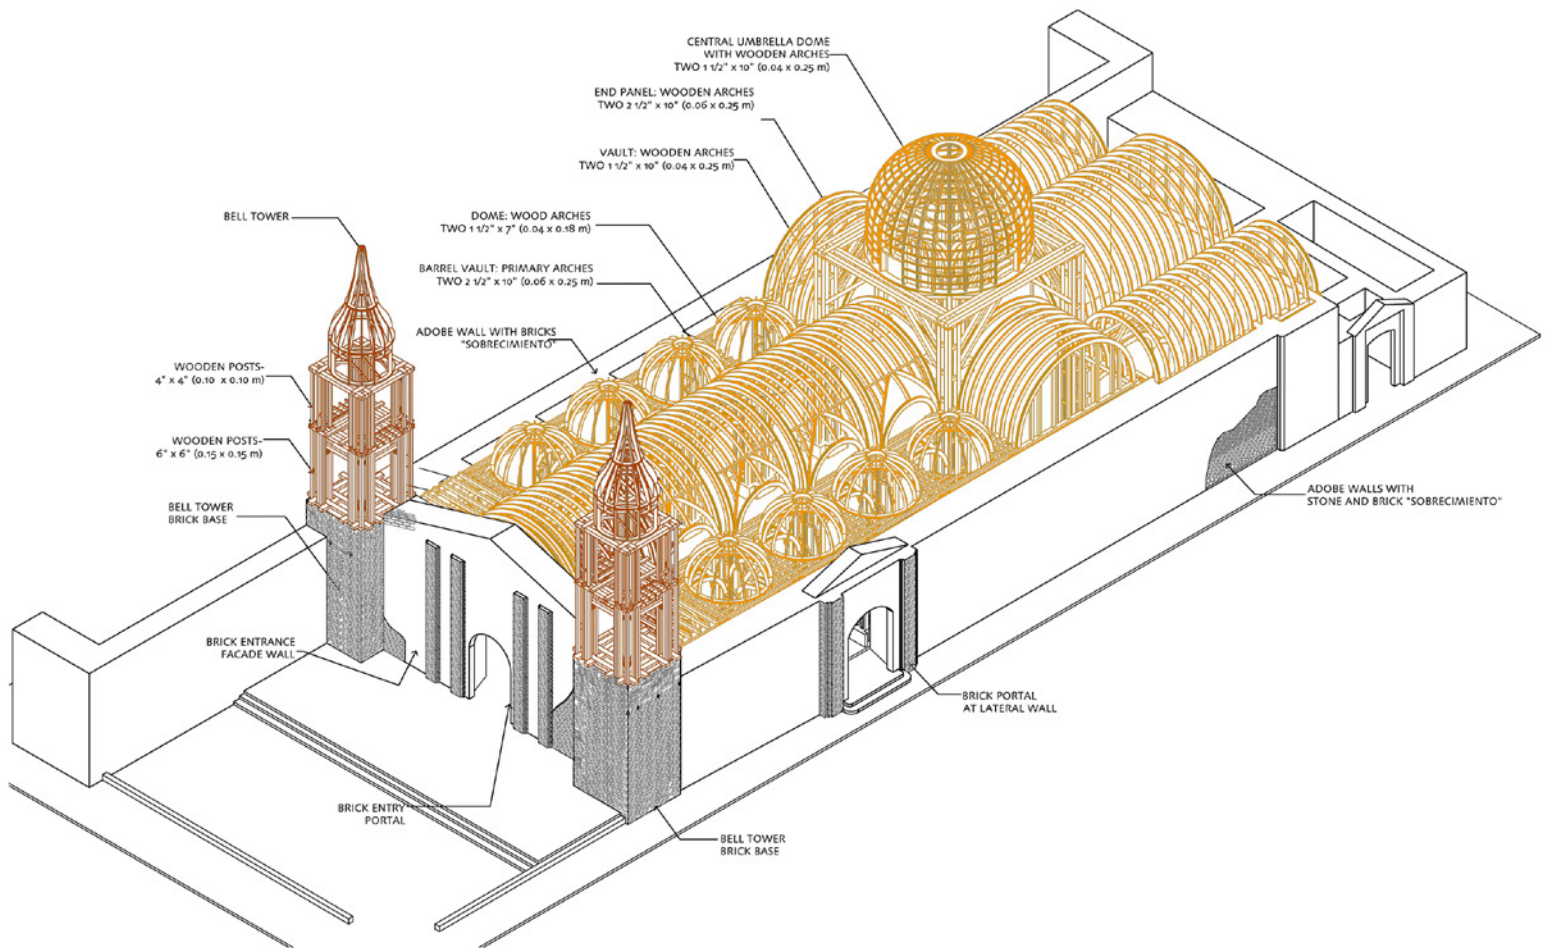
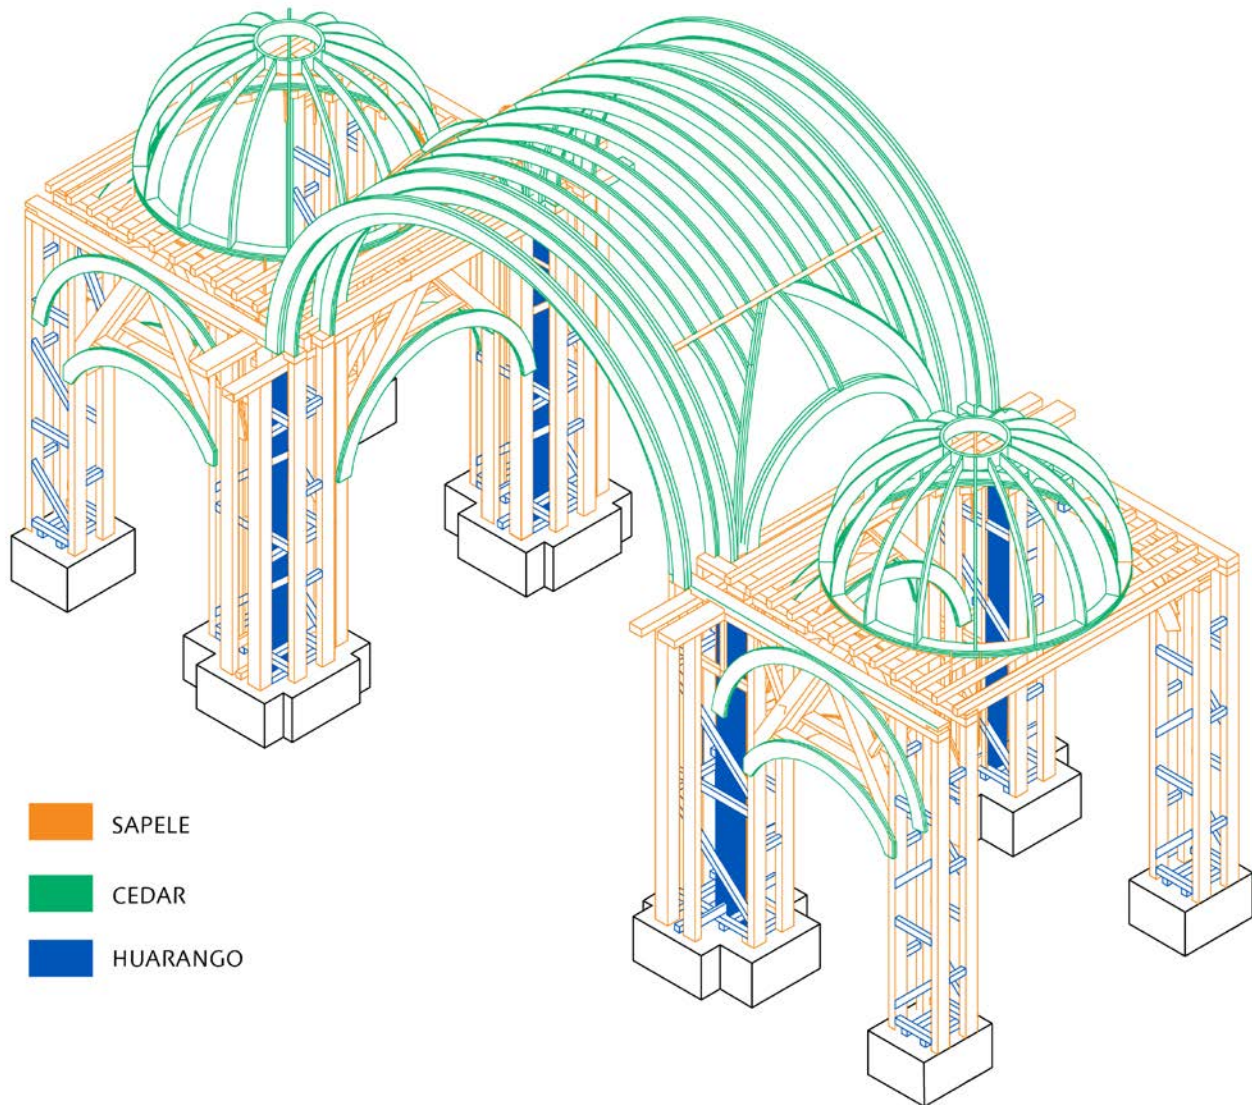
FIGURE 3.2.
Distribution of timber species in a
typical bay of Ica Cathedral.

- The longitudinal **beams** of the **central nave** and **lateral nave** are made of sapele. The arches of both naves are made of cedar.
- The **main cupola**, as well as the **cupolas of the lateral nave**, are made of cedar.

A typical bay in the cathedral is shown in figure 3.2 as an example.

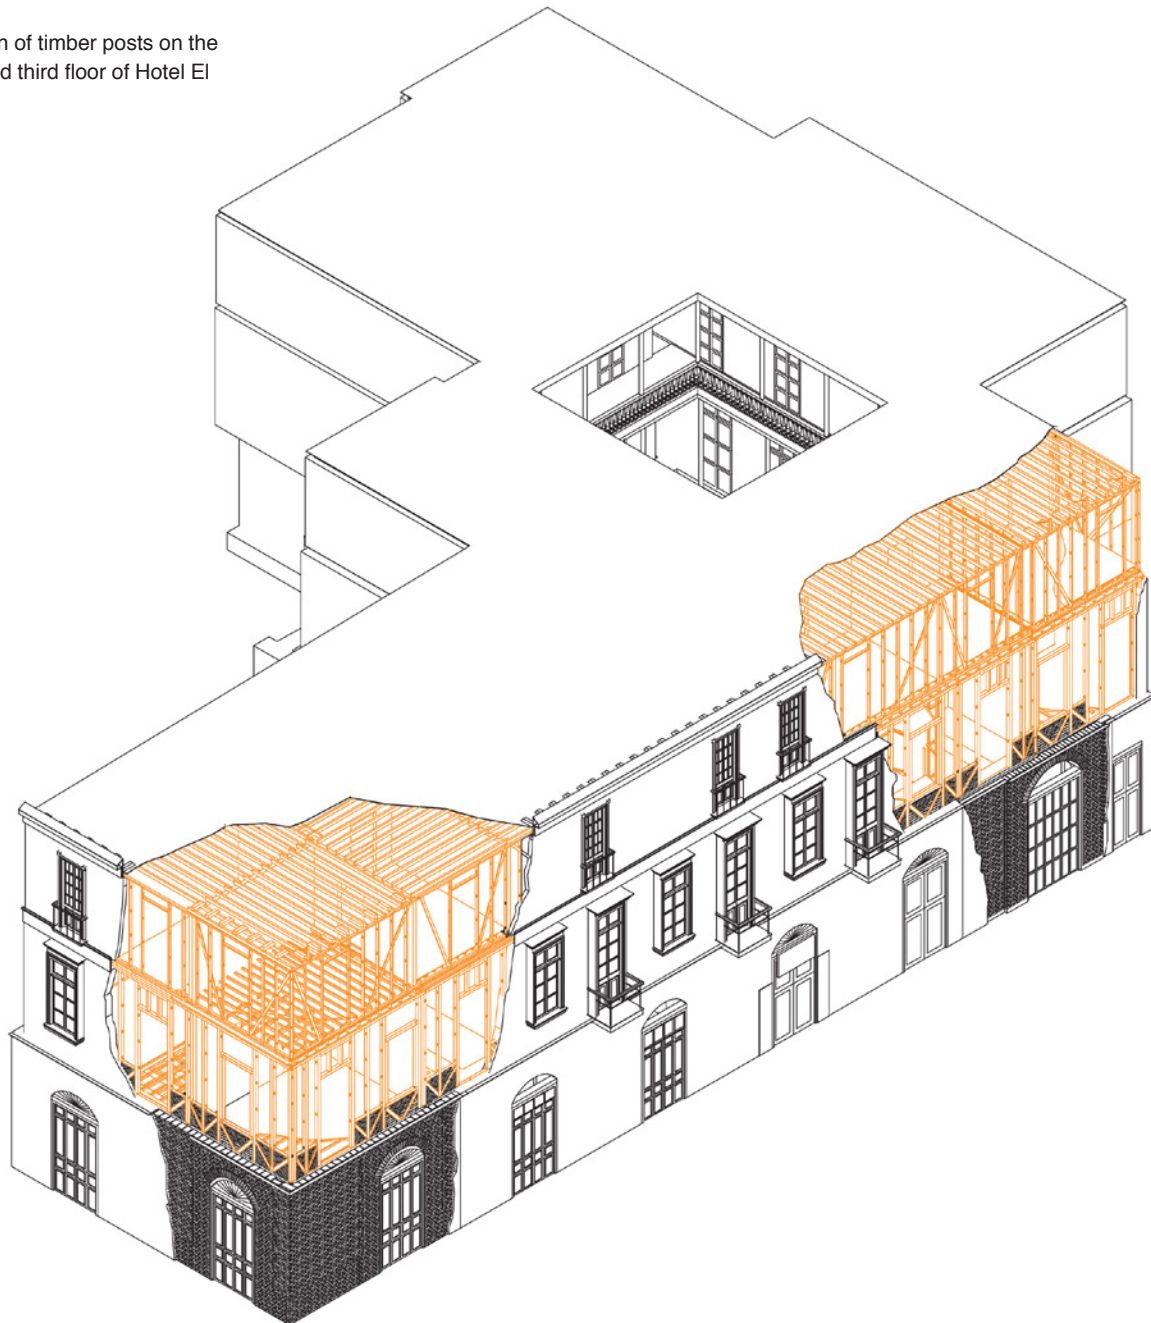
FIGURE 3.3.
Distribution of timber posts on the second and third floor of Hotel El Comercio.

A major portion of the structural elements in Hotel El Comercio is made of timber. The quincha panels have timber frames, and the floors and roofs have timber beams, purlins, and joists (fig. 3.3). As in Ica Cathedral, sapele is a recurring wood species. The other two most prominent species are cypress (*Cupresses* sp.) and Oregon pine (*Pseudotsuga menziesii*). The timber is distributed as follows:

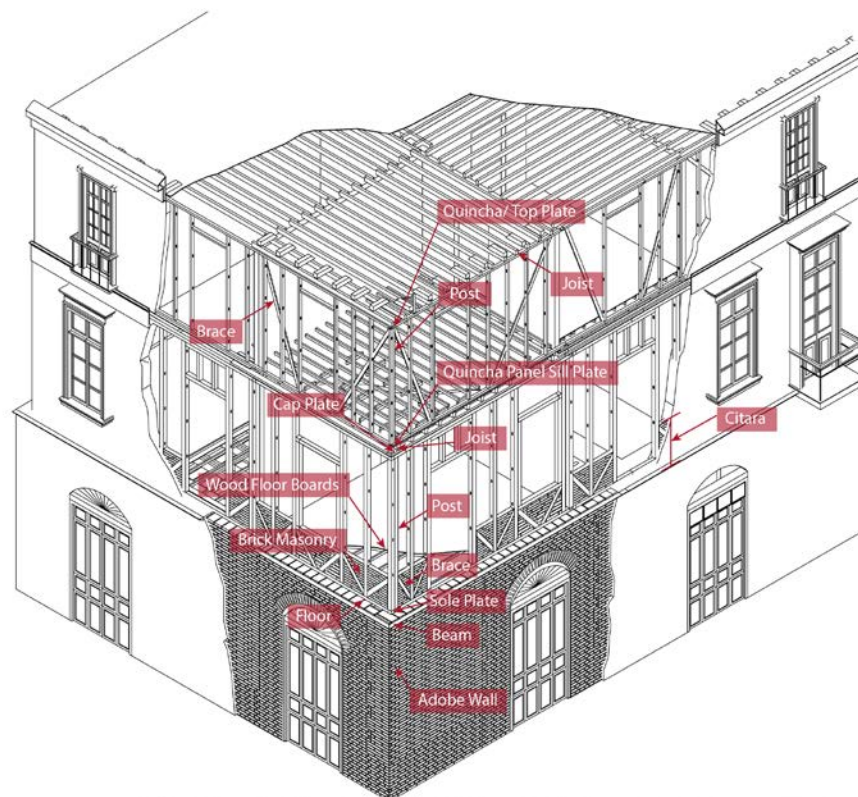
FIGURE 4.1. Diagram showing the structural characterization of the three-story Hotel El Comercio.

In Hotel El Comercio, two types of quincha paneling can be found. The second-floor walls are made of quincha with an adobe brick base called the citara (fig. 4.1). These walls have a height of 4.80 m, and the elements are constructed from timber posts and upper and bottom timber beams. A citara of 90 cm high is situated at the lower part of the second-floor wall and is characterized by a set of diagonal timber struts (cross section of 10 × 10 cm) that are infilled with adobe masonry, thus providing cross bracing for the wall base. Beams and posts have similar dimensions, with cross sections of 10 × 10 cm. The horizontal distance between posts varies between 50 and 80 cm but is typically 60 cm. The posts are connected to the upper and lower beams by mortise-and-tenon joints (fig. 4.2). Whereas the citara is infilled with adobe masonry, the rest of the wall is infilled with woven

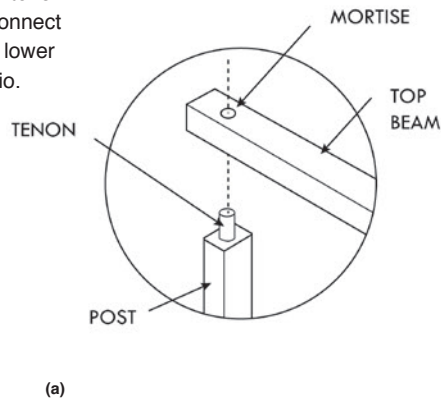
FIGURE 4.2. Schematic (a) and photograph (b) of a typical mortise-and-tenon connection. These joints connect the posts to the upper and lower beams in Hotel El Comercio.

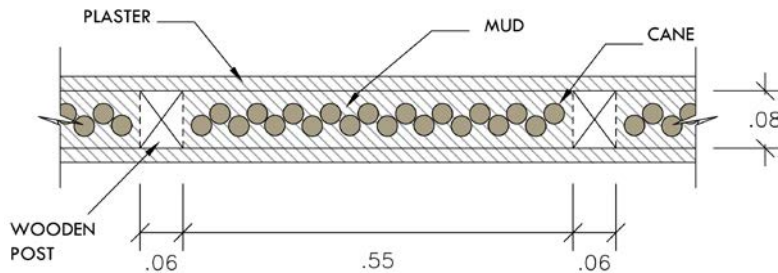
FIGURE 4.3. Transversal section of a quincha wall on the third floor of Hotel El Comercio, showing the woven cane and mud mortar.

On the third floor of Hotel El Comercio, the walls are quincha with diagonal elements, but without citara. These walls are 3.20 m high and are similarly composed of timber posts and upper and lower beams, which have a smaller cross section (8 × 6 cm) than those on the second floor. Instead of a citara, the quincha elements have a diagonal timber element (3 × 9 cm) that crosses the entire panel and functions as a cross brace over the entire height of the wall. Distance between the posts is, as on the second floor, typically 60 cm. The third-floor quincha panels are filled with woven cane and mud mortar, coated with layers of mud plaster, and finished with a fine gypsum layer (fig. 4.3).

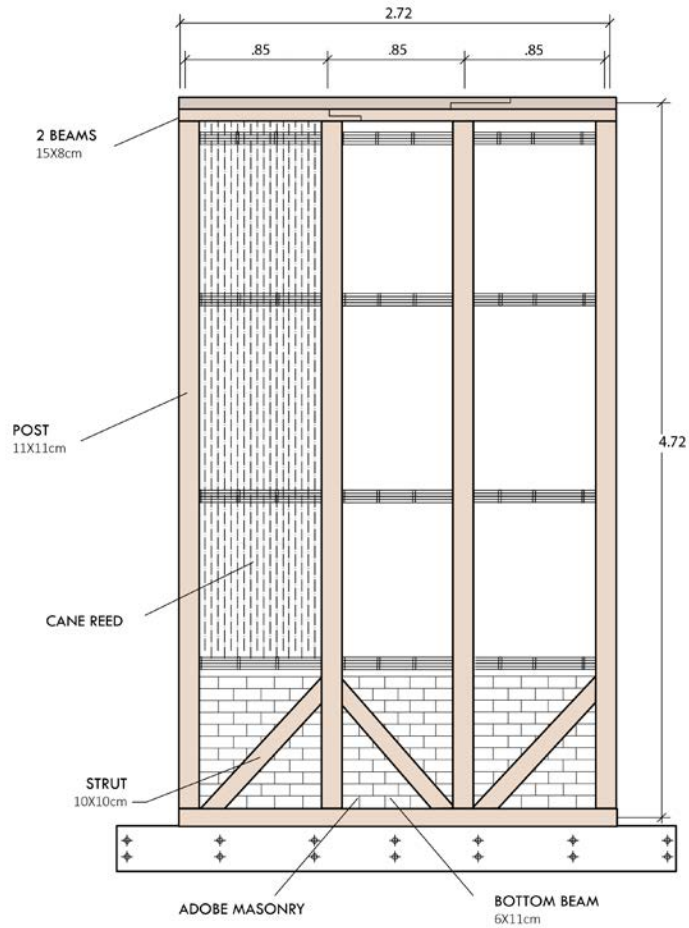
FIGURE 4.4.
Diagram showing configuration of original quincha panel.

Thirteen quincha panels were tested: of these, twelve were newly constructed and one original panel (fig. 4.4) was taken from the second floor of Hotel El Comercio. The upper beam of the original panel was severely damaged and was replaced with an existing beam found on site. The twelve new quincha test sample panels were constructed of new wood and cane to match the original design of the existing walls. Six panels matched the configuration found on the second floor (quincha with citara), referred to as specimens MA (fig. 4.5); the remaining six matched the configuration found on the third floor with the diagonal across the panel, referred to as specimens MB (fig. 4.6).

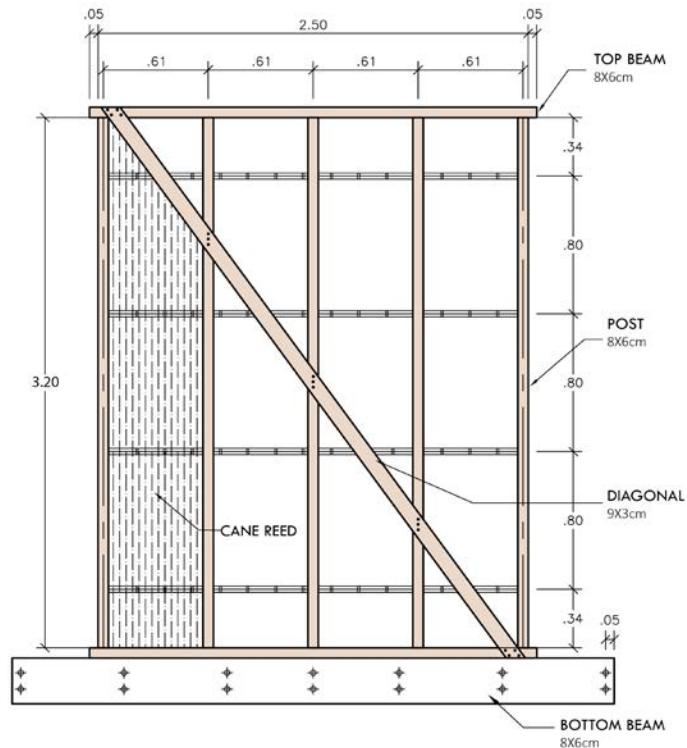
FIGURE 4.5.
Diagram showing configuration of the six panels matching the second floor, known as specimens MA.

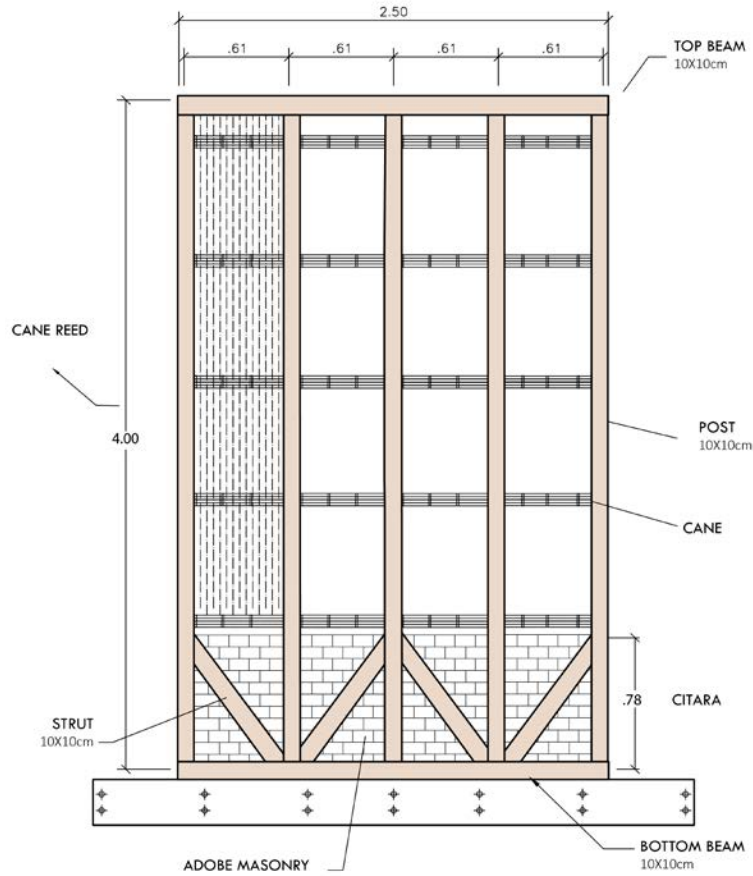
FIGURE 4.6.
Diagram showing configuration of the six panels matching the third floor, known as specimens MB.

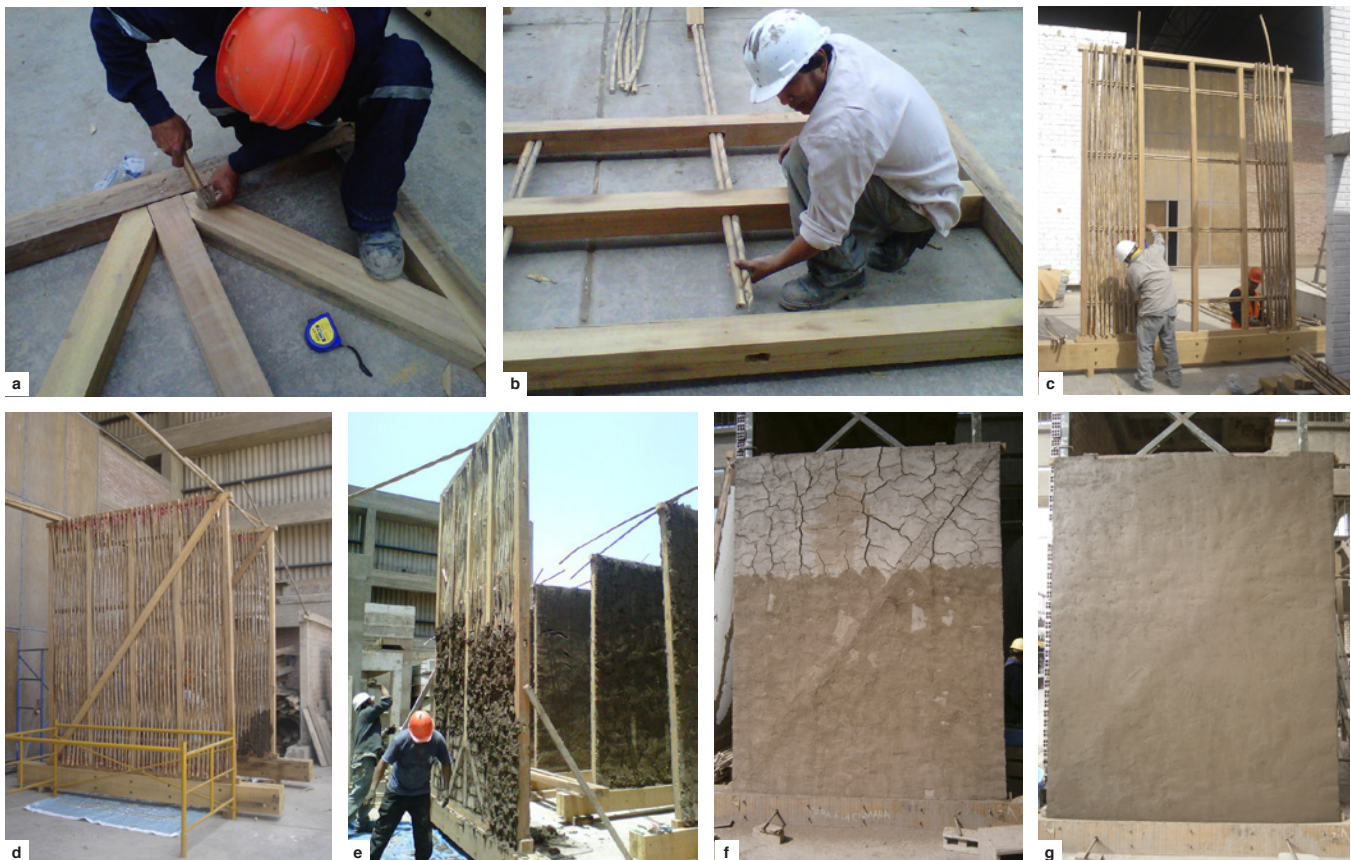
FIGURE 4.7.
Construction of new quincha test sample panel: (a) fastening of the citara (diagonal element at base), representative of the second-floor structure (MA); (b) insertion of transversal canes into posts; (c, d) construction of third-floor panel (MB) with diagonal timber element; (e) infilling of the panel (MA) with mud mortar; (f) quincha panel showing shrinkage cracks in the first layer of mud plaster; (g) quincha panel after application of a second layer of mud plaster.

with one-inch thick mud mortar joints were used for the one original quincha panel; for the six new quincha panels, all masonry infill consisted of new adobe units. Figure 4.7 shows the construction process of the newly constructed quincha panels. The original quincha panel was dismantled and rebuilt in the laboratory, as detailed in figure 4.8.

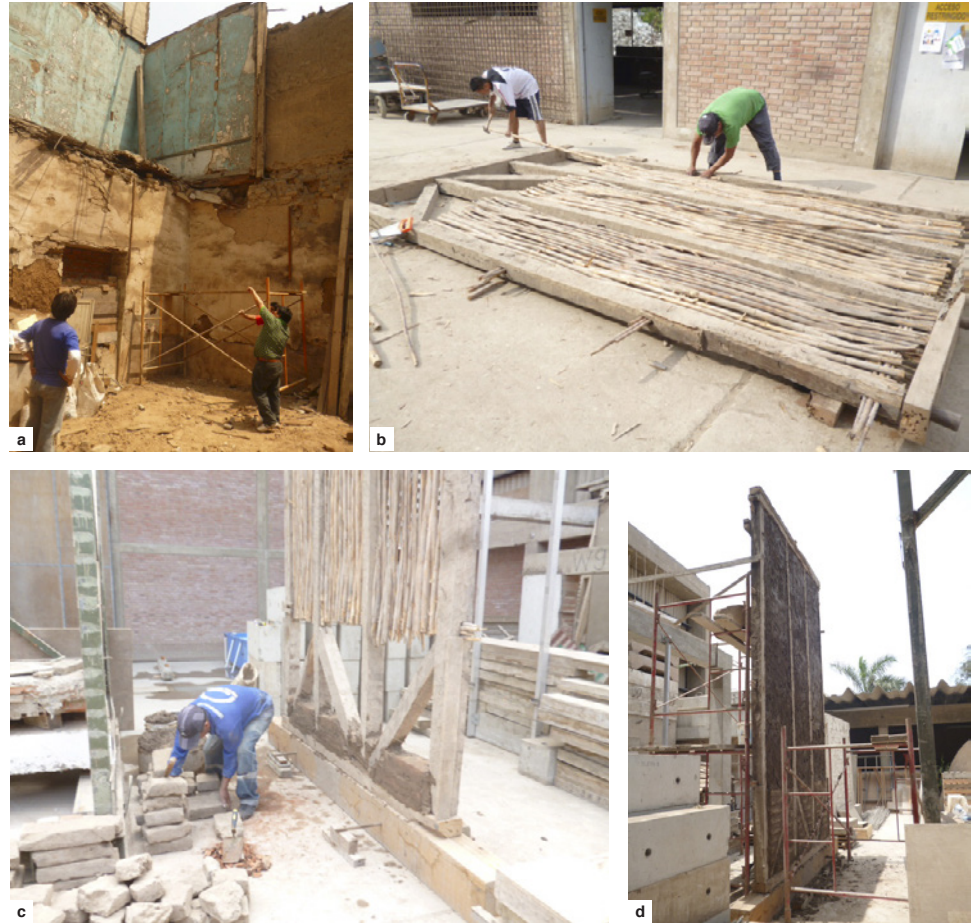
FIGURE 4.8. Construction of original quincha test sample panel: (a) original quincha panel in existing location (second floor of Hotel El Comercio); (b) reassembly of panel; (c) insertion of masonry infill at citara base; (d) panel prior to mud plaster finish, with mud mortar over canes and complete infill at base.

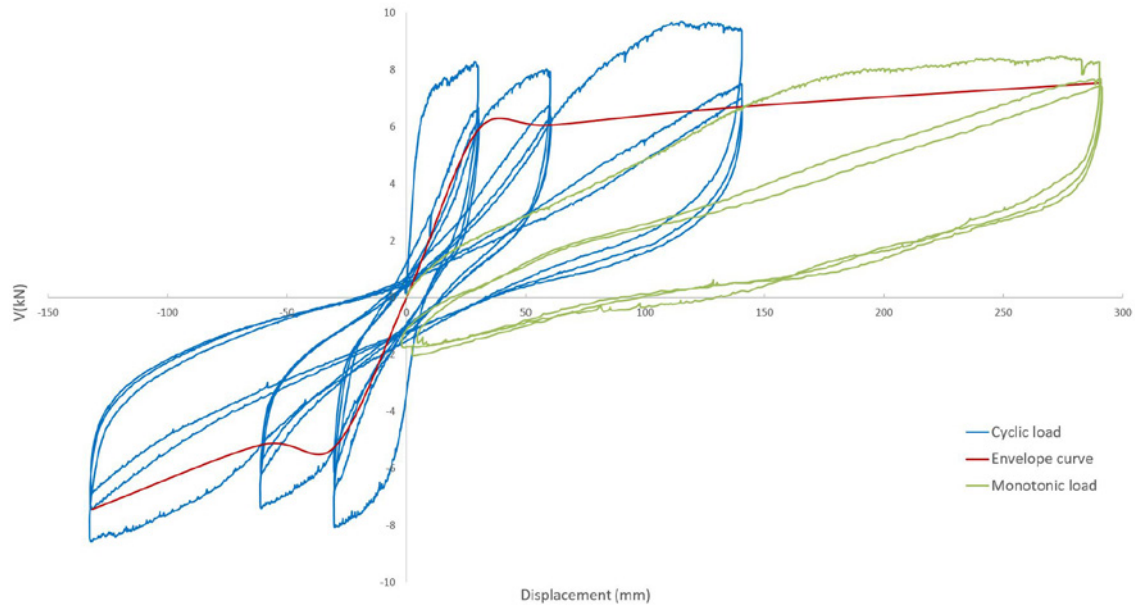
FIGURE 4.10.
Graph showing hysteresis curve of original test sample panel (monotonic loading).

The hysteresis loops for the panel under cyclic loading are shown in figure 4.10. Each test peak corresponds to a hysteresis loop associated with the displacements shown in table 4.3. The envelope curve (in orange) shows that the maximum obtained lateral capacity before entering the inelastic range is 7.17 kN. The greatest shear strength measured is 9.53 kN. The maximum deformation in the elastic range is around 9.8 mm when forced displacement is 150 mm. Due to application of the unidirectional monotonic displacement of 290 mm, the cracks widened and mud portions detached around the upper and lower beams, as well as around the posts (fig. 4.11). The lower left side of the wall lifted 7 cm.

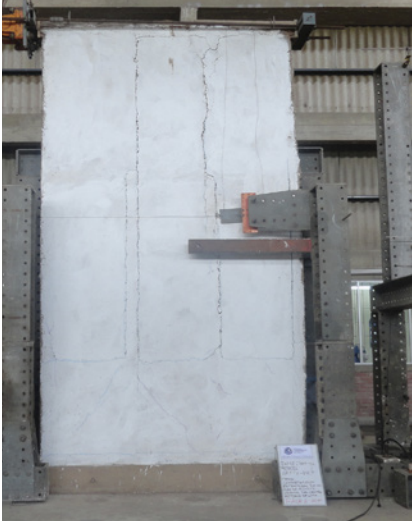
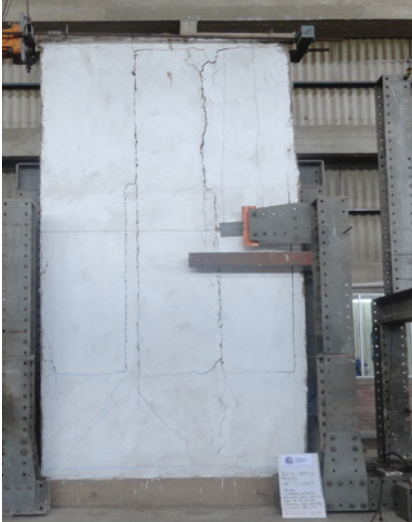
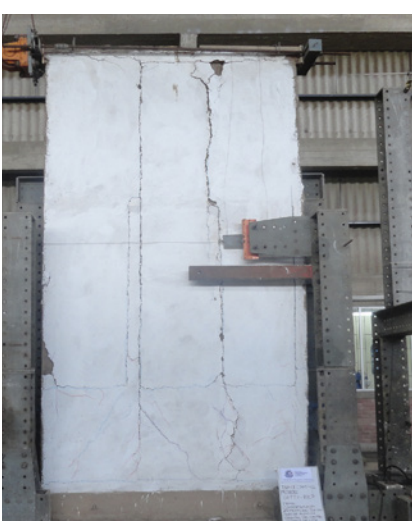
FIGURE 4.11.
Description of conditions of original panel after testing from Hotel El Comercio.

Original Panel	Description
Phase 1 – Max. D = 30mm

Cracks appeared close to the position of the posts and upper beam, due to cracking of the dried mud. Only small cracks were detected.
Phase 2 – Max. D = 60mm

Width of the cracks around the wooden elements observed in the first phase increased. Cracks also appeared in the struts at the level of the citara.
Phase 3 – Max. D = 140mm

Width of the existing cracks increased further. Additionally, a small detachment of mud at the top of the wall next to the second post from the left was observed. An uplifting of 1 cm at the bottom right and of 2 cm at the lower left of the wall base was observed.
