Seismic Retrofitting Project

Testing of Materials and Building Components of Historic Adobe Buildings in Peru

Research Report

Daniel Torrealva, Erika Vicente,
and Tim Michiels

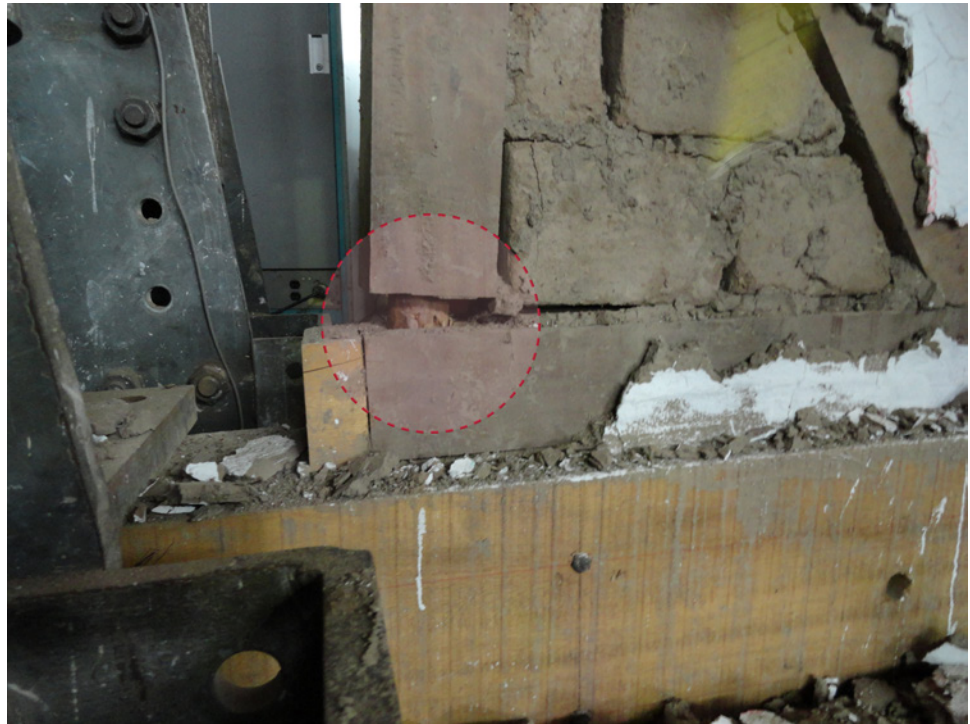
FIGURE 4.14.
Image showing the tenon lifting from the mortise (red circle) at maximum horizontal displacement of specimen MA.

Behavior of all six panels is quantified in the load-displacement curves of the panel under horizontal cyclic shear force (fig. 4.12). The blue curves in each graph represent the behavior for the cyclic displacements of up to 150 mm in two directions. The red line in each graph represents the envelope curve of the elastic loading. Finally, the green line represents the part of the load test when the total displacement of 300 mm was applied in the positive direction. This unilateral displacement was applied because the normal cyclic test induced little damage, and no sign of strength decay was observed. However, even after applying the additional displacement, the quincha panels were still far from collapse (figs. 4.13, 4.14).

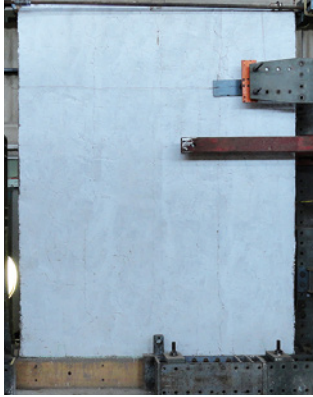
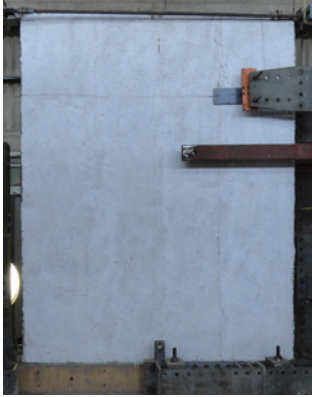
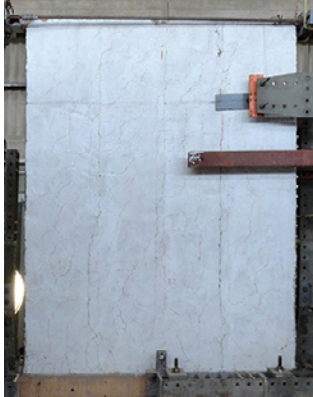
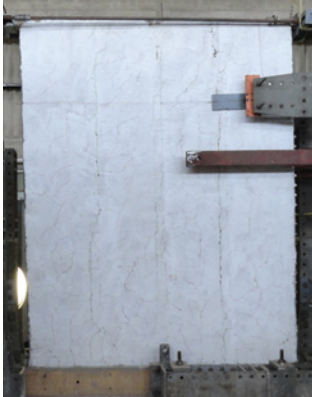
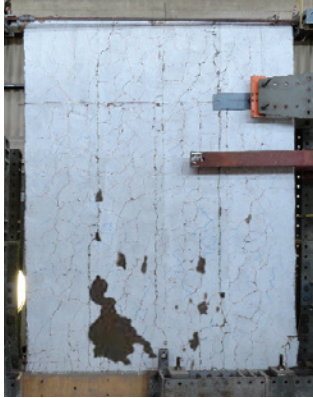
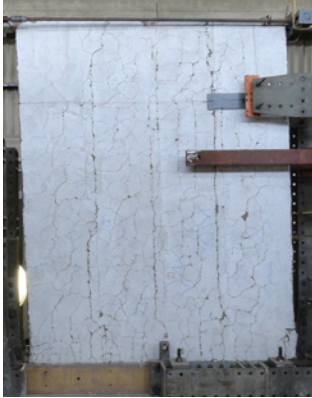
FIGURE 4.15.
Condition description of panels MB1 and MB2 after testing from Hotel El Comercio.

MB1	MB2	Description
Phase 1 – Max. D = 25mm D/H = 0.0078

Cracks appeared on the plaster aligned with the posts and the base. Note: The diagonal was located on the opposite side of the one displayed in the images.
Phase 2 – Max. D = 50mm D/H = 0.0156

Crack width increased and new cracks appeared randomly in the panel surface. The tenons in the lower part of the posts started to detach from the mortises. The nails that connected the diagonal to the posts started to bend, and a crack appeared along the diagonal element.
Phase 3 – Max. D = 100mm D/H = 0.0313

Cracks increased in width. The lower tenons lifted 1 cm from the mortises. The timber diagonal (not displayed) cracked at the locations of the nailed connections. The nails in the intermediate connections became bent. In MB1 the plaster started to detach.
Phase 4 – Max. D = 140mm D/H = 0.0438

Extensive plaster detachment in MB1. Plaster detached from the posts in MB2. The timber diagonal detached at both ends, and the nails at the intermediate connections were bent even further. The tenons in the lower part lifted 2.5 cm from the mortises. Both panels maintained lateral load capacity.

Specimens MB1 through MB6 cracked primarily around the locations of the timber elements, as observed in the other quincha panels. However, because these elements also have diagonal timber elements, additional cracks were observed around these diagonals (see the detailed description of each panel in figs. 4.15–4.17). Furthermore, connection of the diagonal element to the rest of the frame failed, reducing the stiffness of the panels, as reflected in the hysteresis curves (fig. 4.18).

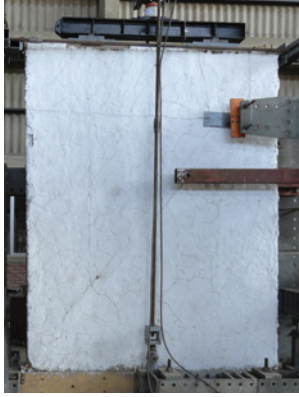
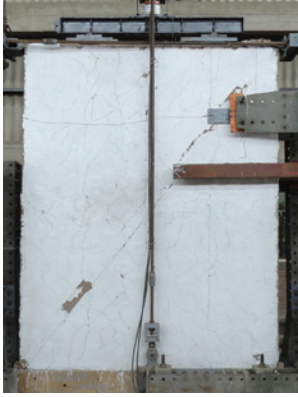
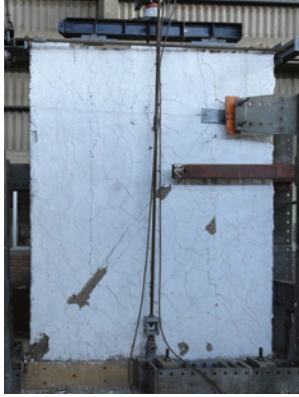
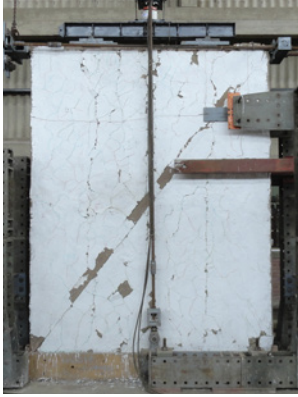
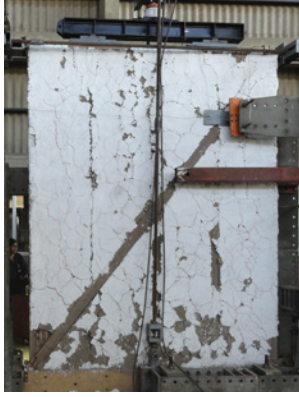
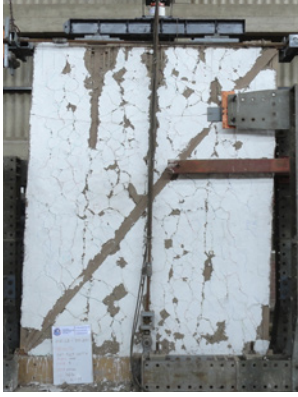
FIGURE 4.16.
Condition description of panels MB3 and MB4 after testing from Hotel El Comercio.

MB3	MB4	Description
Phase 1 – Displ. = 25mm D/H = 0.0078

Some cracks appeared on the upper section of the panel due to application of the vertical load. Cracks also appeared along the timber diagonal and in the base. Note: In these panels the diagonal was on the front side.
Phase 2 – Displ. = 50mm D/H = 0.0156

Cracks formed along the posts and the timber diagonal and were distributed over the entire. The lower tenons started to lift from their mortises. The nailed connections of the diagonal started to detach.
Phase 3 – Displ. = 100mm D/H = 0.0313

The plaster detached along the posts and diagonal. Cracks increased, and the tenons lifted 1 cm from the lower mortises. Timber diagonal detached almost completely from the ends, and the nails of the intermediate connections started to bend.
Phase 4 – Displ. = 140mm D/H = 0.0438

Severe detachment of the plaster and the mud infill near the diagonal occurred at this stage. The timber diagonal broke at both ends, and the nails of the intermediate connections bent further. The lower tenons lifted 3 cm from the mortises in each loading and unloading cycle.

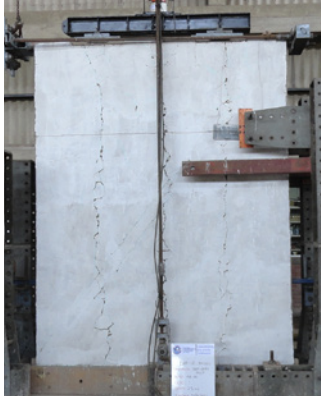
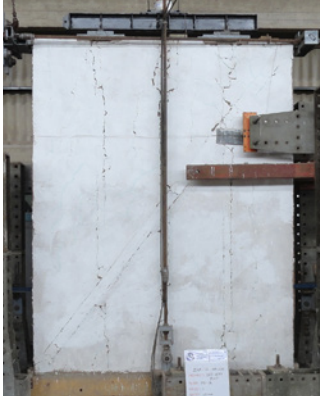
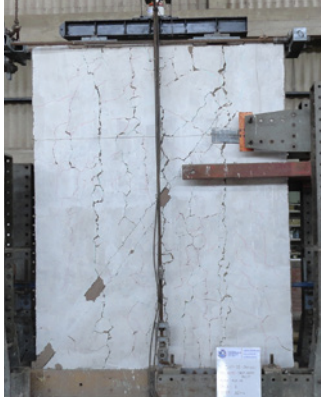
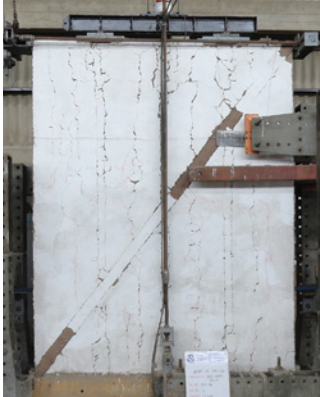
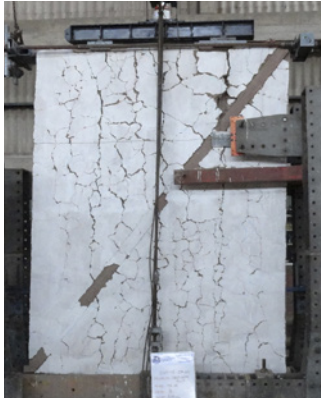
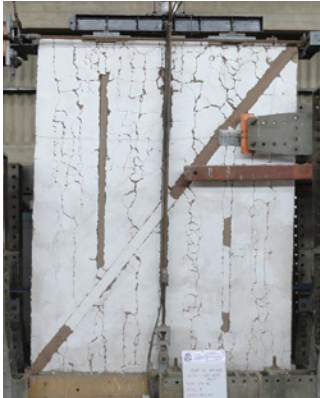
FIGURE 4.17.
Condition description of panels
MB5 and MB6 after testing
from Hotel El Comercio.

MB5	MB6	Description
Phase 1 – Displ. = 25mm D/H = 0.0078

Some cracks appeared on the upper part due to vertical load application. Cracks also appeared along the timber diagonal and in the base. Note: In these panels the diagonal was on the front side.
Phase 2 – Displ. = 50mm D/H = 0.0156

Cracks increased along the posts and the timber diagonal. The lower tenons start to lift from their mortises. The nailed connections of the diagonal started detaching at both ends. Plaster started detaching along the diagonal.
Phase 3 – Displ. = 100mm D/H = 0.0313

Plaster detached along the posts and diagonal. Crack widths increased and tenons lifted from the lower mortises. The timber diagonal detached almost entirely from their ends, and the nails in the intermediate connections started to bend.
Phase 4 – Displ. = 140mm D/H = 0.0438

The plaster detachment increased and the connections of the diagonal failed almost entirely. The lower tenons lifted 3 cm from the mortises. In MB5 loss of infill occurred as well.

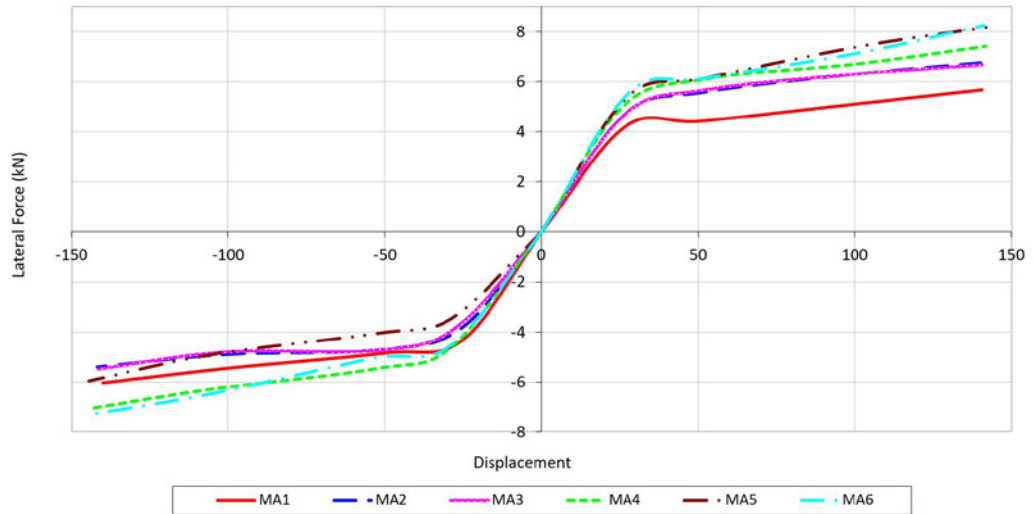
FIGURE 4.19.
Combined envelope
curves for MA panels.

Stiffness of the MA panels (0.23 kN/mm) is influenced by the presence of the citara. This element reduces the free height of the posts and thereby provides additional stiffness compared to systems without an infill base. Still, the stiffness is less than that of the panels with diagonal; however, the stiffness does not provide information on maximum capacity of the panels. The hysteresis curves for the MA panels show that after achieving the maximum displacement in both directions, the panels have not yet reached maximum displacement capacity during these tests. This is illustrated in figure 4.19, which combines all envelope curves obtained for specimens MA. As all envelope curves have a positive slope, there is no softening behavior of the panels, which implies that maximum capacity of the panels has not yet been reached. Therefore, it can be concluded that the panels indeed have a very large in-plane flexibility, allowing them to deform without significant damage.

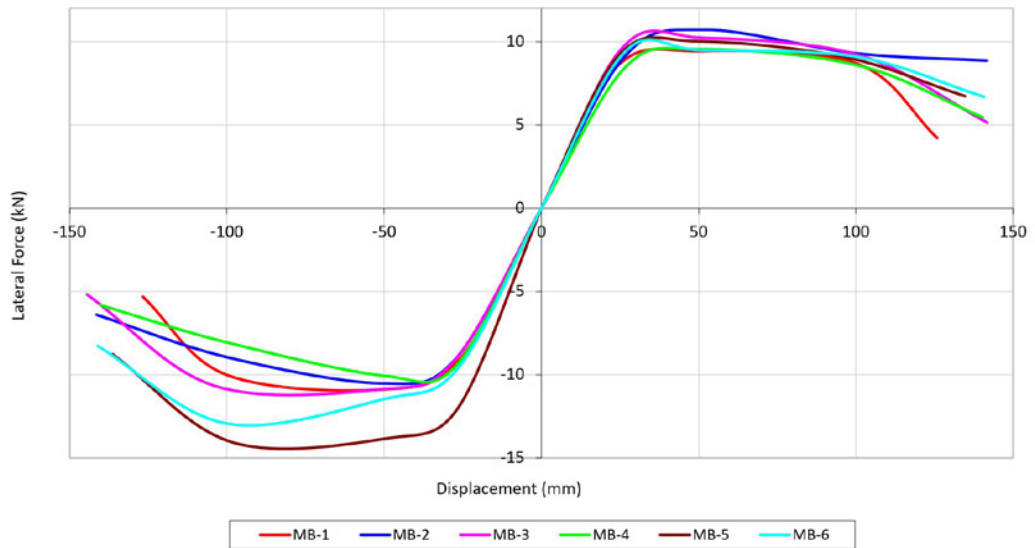
FIGURE 4.20.
Graph showing
evolution curves for
all MB panels.

Similar curves for all specimens with diagonal (MB) are shown in figure 4.20. The diagonal element in these panels increases the initial stiffness. Maximum capacity is reached when the top displacement is around +/-100 mm, at which point the nailed connections between the diagonal timber element and the posts fail. At this point, stiffness decreases significantly. Nonetheless, the panels remain stable, and as the diagonal bracing is lost, the panels start behaving like MA walls, similarly relying only on the vertical posts connected to the horizontal beams and the cane and mud infill.

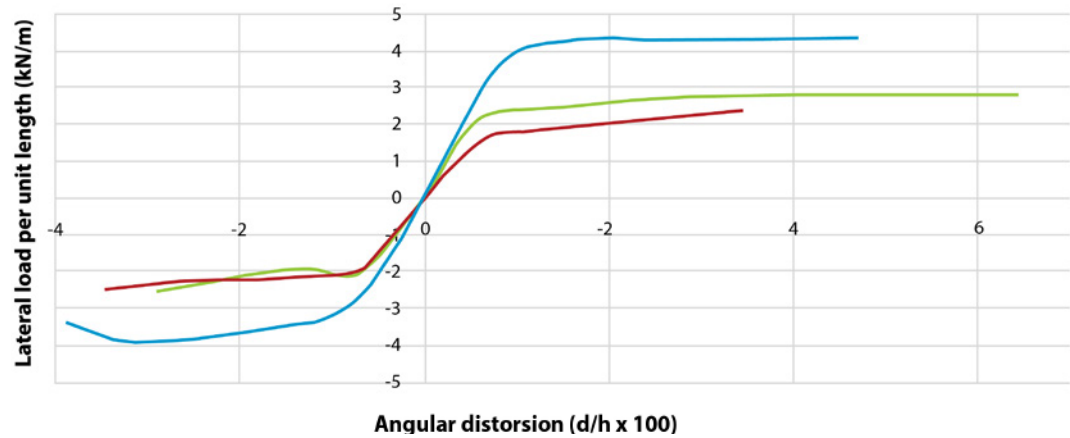
FIGURE 4.21.
Shear per unit length
vs. angular distortion
for the three types of
quincha panels.

Figure 4.21 compares behavior of the three types of quincha panels. The MB panels have the highest lateral resistance, which can be attributed to the diagonal brace. The original quincha panel performed slightly better than the newly constructed MA panels. This is probably due to the presence of a double upper beam (connected with a longer pin to posts), which increased the stiffness of the panel and provided greater load capacity.

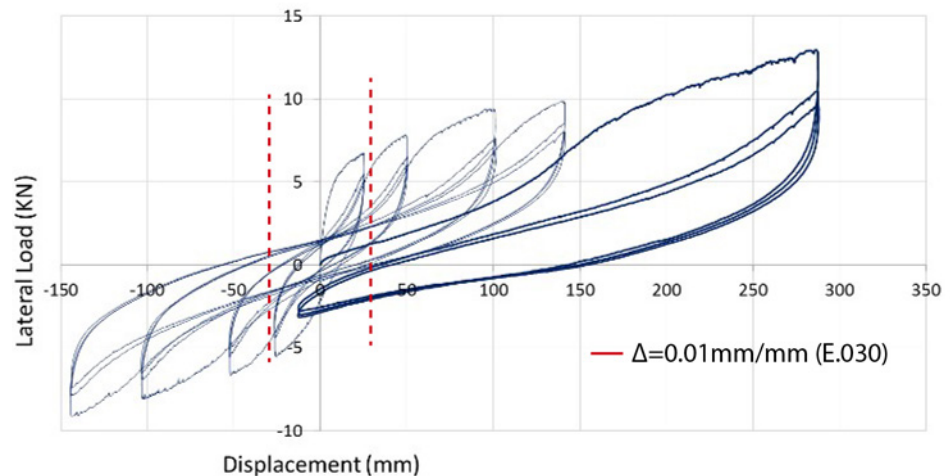
FIGURE 4.22. Comparison of the MA6 curve, showing maximum lateral drift (dashed red lines) for timber structures according to the Peruvian Design Code (E-010).

Figures 4.22 and 4.23 show the load-displacement curves for MA6 and MB6, respectively. These curves correspond to the panels exposed to the larger vertical loads. In both figures, the dashed red lines represent the maximum lateral drift allowed by the Peruvian Design Code (NTE E-010) for timber design in new construction (Ministerio de Transportes 2006b). The code specifies that the maximum lateral displacement allowed for timber structures is the height of the wall multiplied by 0.01, which amounts to an admissible drift of 42 mm for MA panels and 35 mm for MB panels. The panels tested reached displacement values seven times higher than the maximum allowable drift specified in the standard (300 mm for MA, 250 mm for MB) without collapsing. Therefore, it can be concluded that the limit of lateral deformation imposed by the Peruvian standard is very conservative when applied to the traditional quincha panels.

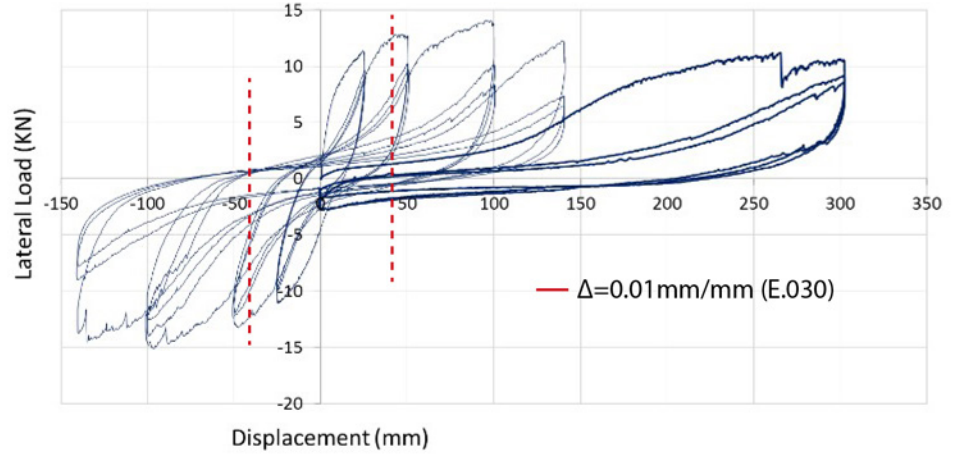
FIGURE 4.23.
Comparison of the MB6 curve,
showing maximum lateral drift
(dashed red lines) for timber struc-
tures according to the Peruvian
Design Code (E-010).

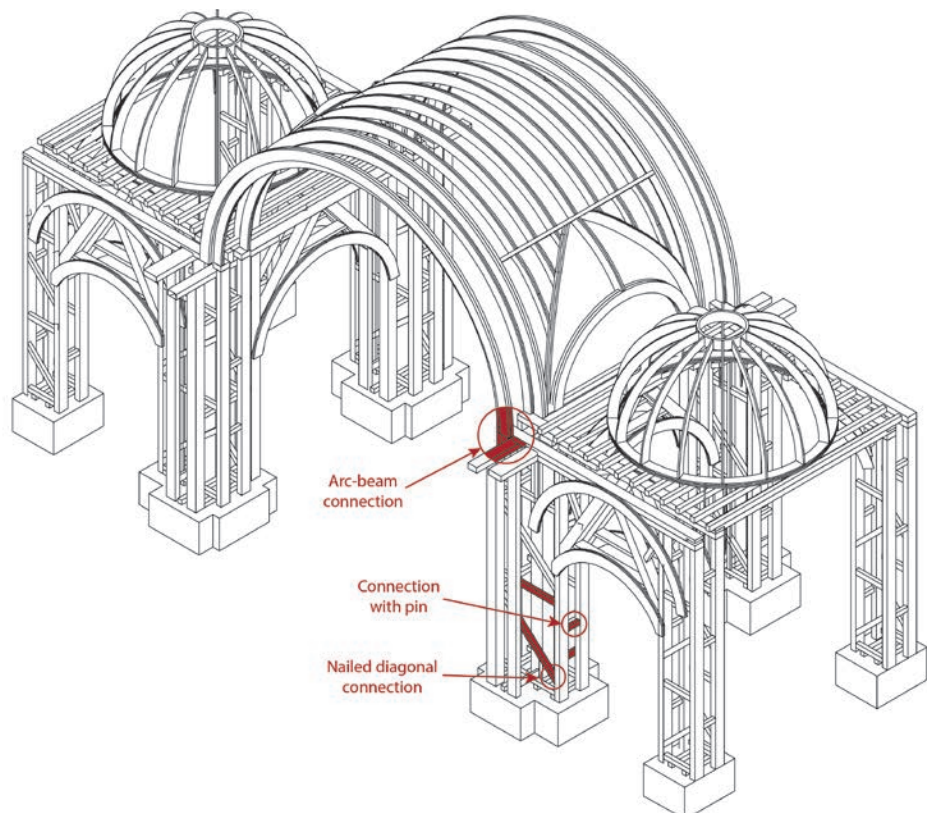
FIGURE 5.1. Diagram of Ica Cathedral, showing locations of three typical connections studied: pinned, nailed, and mortise and tenon.

The locations of the three connections are shown in figure 5.1. Photographs of the pinned connection and its test setup are shown in figures 5.2 and 5.3.

A test was developed for each of the three connections shown in figure 5.1. Each test reproduced elements similar in size to those found on site, and full-scale specimens were constructed using new wood with properties similar to those found on site. The mechanical actions that each joint was expected to sustain was mimicked as closely as possible.

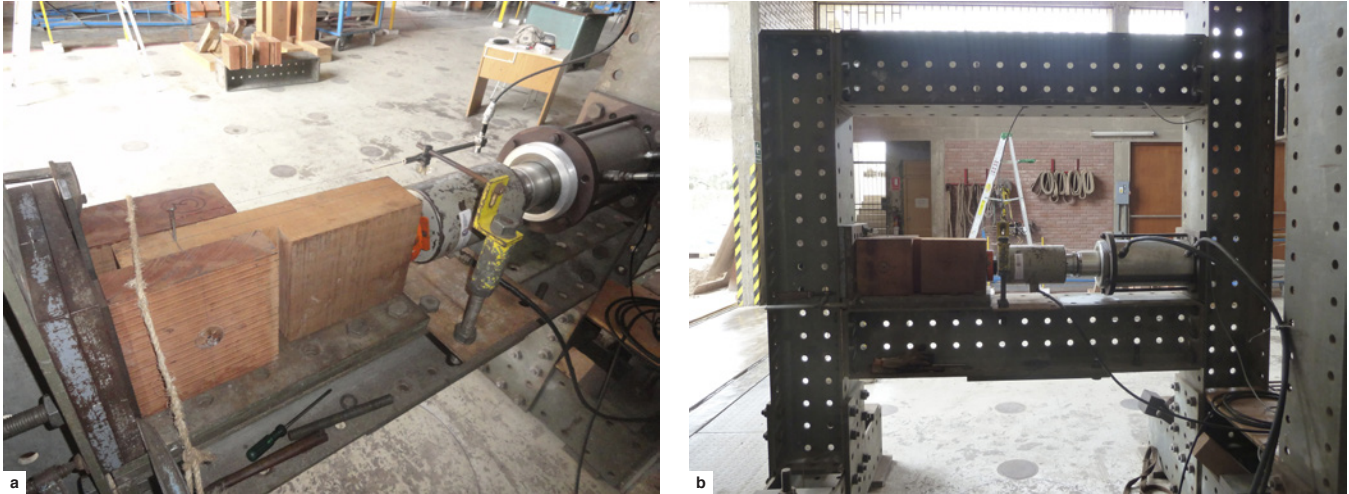
FIGURE 5.2.

Pinned connection between post and horizontal bracing: (a) view of the specimen; (b) view of the test setup.

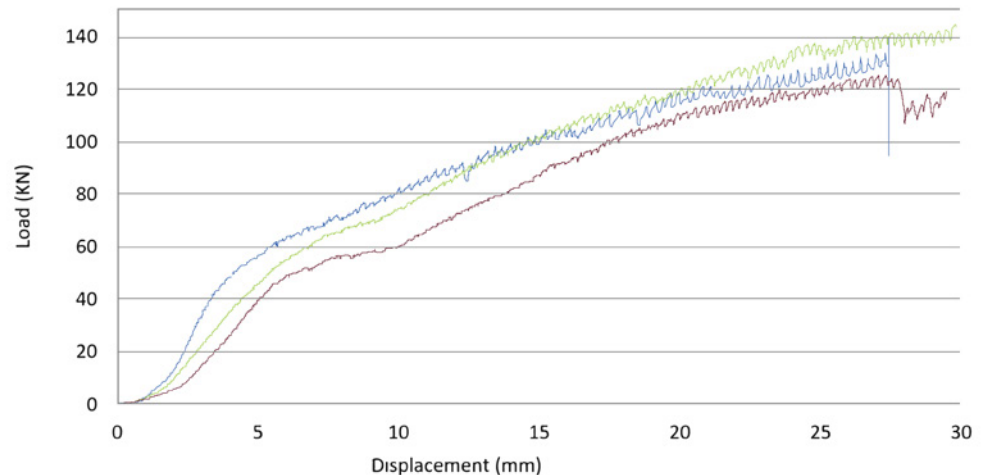
FIGURE 5.4.

Graph showing load-displacement curves for the three specimens with pinned connections.

In all executed tests, the pin bent and crushed the adjacent areas of the supports without breaking. This confirmed the field observation that none of these pins had failed during the Pisco earthquake in 2007 experienced by Ica Cathedral. The maximum loads sustained by the three samples were 140 kN, 144 kN, and 125 kN, respectively. The results showed that the capacity of the pinned joint is very high and that the pinned connection will behave elastic under the expected loads. This is illustrated by the load-displacement curves in figure 5.4.

In conclusion, the ultimate load capacity of the connection is very high: an average maximum load of 132 kN associated with a displacement of 27 mm that is unlikely to be exceeded during seismic action. Therefore, it can be safely assumed that the connection itself will not fail during strong seismic events and will continue behaving like a pin.

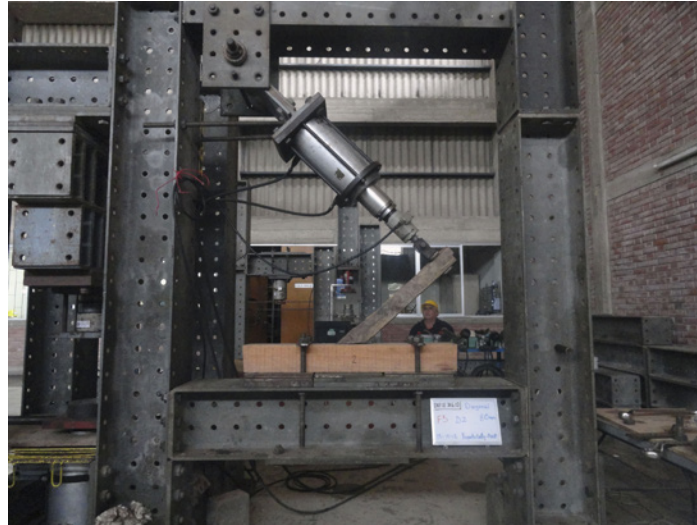
FIGURE 5.5.
Test setup for the nailed connection between post and diagonal bracing.

(*Cedrelinga catanaeformis*), from the same type C timber class specified in the Peruvian code. Original pieces of huarango timber in good condition were collected from the collapsed material in Ica Cathedral and used in the testing. The diagonal was connected to the base with an original, single nail. The test was performed in a cyclic manner, controlling the displacement and measuring the force. The force was applied at the end of the diagonal perpendicular to its axis. The three specimens were tested in three phases of maximum displacement of 20, 40, and 80 mm, respectively. Three cycles were performed for each phase. The test setup is shown in figures 5.5 and 5.6.

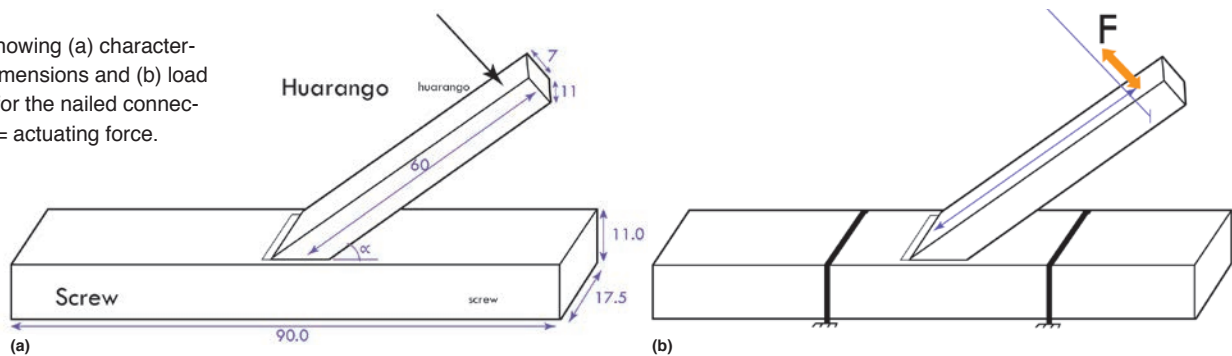
FIGURE 5.6.
Diagrams showing (a) characteristics and dimensions and (b) load application for the nailed connection, with F = actuating force.

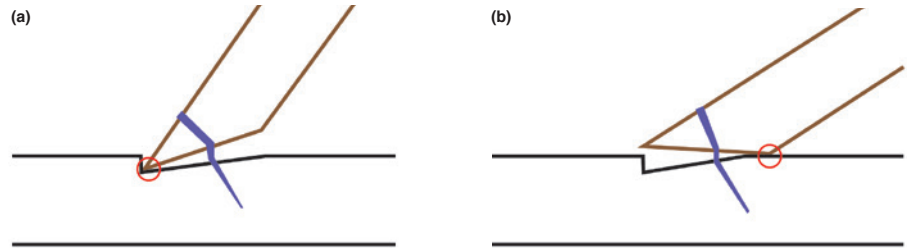
FIGURE 5.7.

Distance between the nail and the center of rotation. When F pulls the diagonal outward, distance is greater (a) than when F pulls in the opposite direction (b).

Figure 5.7 shows the position of the nail and its distance from the center of rotation in the cyclic test. These rotation centers are at both ends of the area of contact between the two elements. When the actuating force (F) pulls the diagonal outward, the distance to the center of rotation in the three specimens is greater (10, 10, and 7.5 cm) than when F acts in the opposite direction (6, 4, and 7 cm). This asymmetry of the centers of rotation, combined with the asymmetry of the nail, results in much higher loads experienced by the joint in one direction than in the other (fig. 5.8). Figure 5.9 shows the asymmetrical load-displacement curves obtained for the three specimens. This plot is proportional to the moment-rotation curve, since the values displayed on the axis are $moment = force \times d$; and $angle\ of\ rotation = displacement/d$.

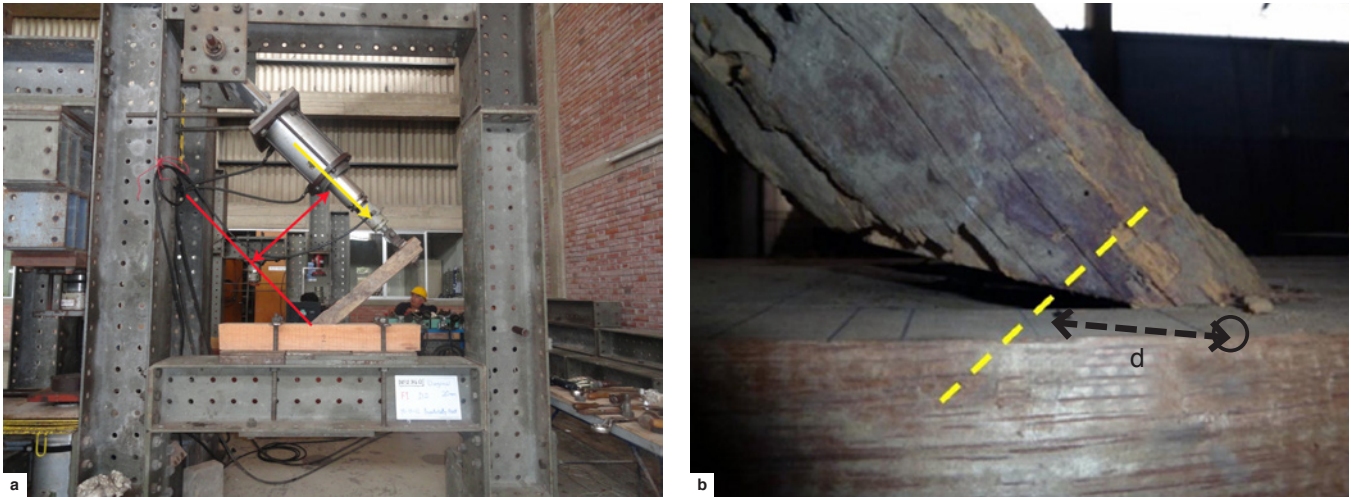
FIGURE 5.8.

(a) Direction of F (yellow arrow) and distance to the center of rotation (double red arrow). (b) Detail showing rotation of diagonal at distance d from center when the pulling force (dashed yellow line) is acting.

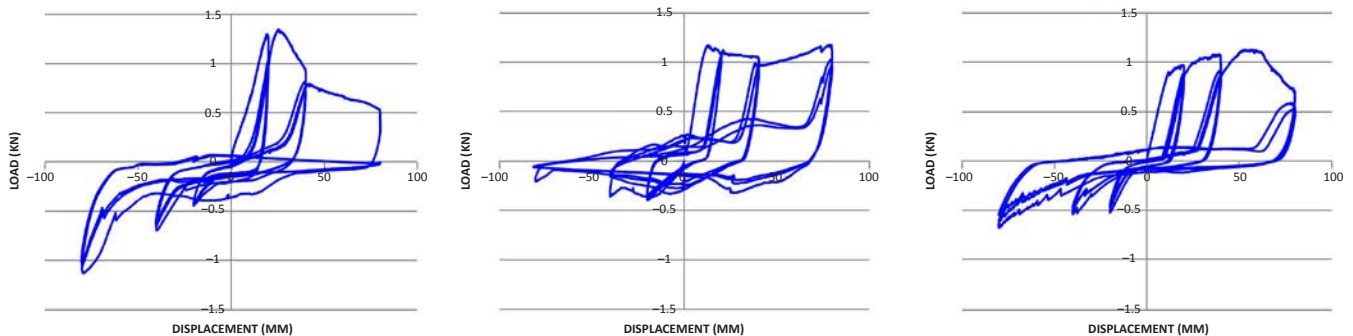
FIGURE 5.9.

Load-displacement curves for the nailed connections between post and diagonal.

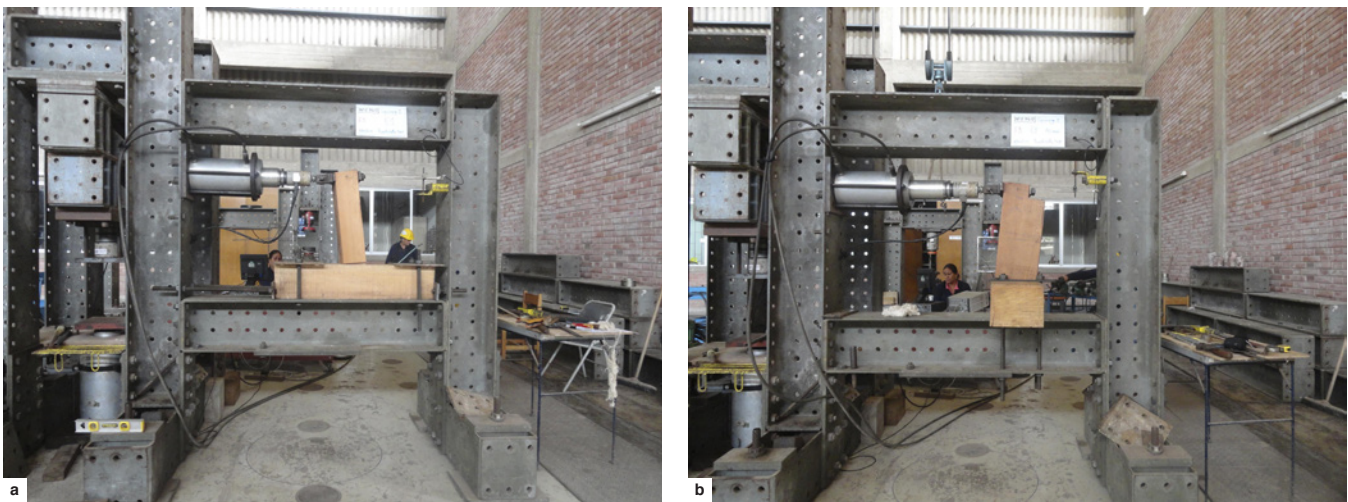
FIGURE 5.10.

Test setup for the connection between arches and beams (mortise and tenon): (a) test parallel to beam; (b) test perpendicular to beam.

Six specimens replicating the connection between arches and beams were tested. Tornillo (*Cedrelinga catanaeformis*) was used for the beams to replace the unavailable sapele timber. Cedar (*Cedrela odorata*) was used for the arches as in the original structure. The test was set up so that the tenon was in the middle of the longitudinal direction of the beam. The load was applied cyclically at the end of the element representing the arch. Three of the six specimens were subjected to a force parallel to the longitudinal direction of the beam; the remaining three were subjected to a force perpendicular to the longitudinal direction of the beam (figs. 5.10, 5.11). In the transversal direction, however, the tenon was located off center, creating an asymmetrical setup (fig. 5.12). Testing was performed in a displacement-controlled environment while measuring the force. Each test was subjected to three phases of maximum displacement: ± 20 , ± 25 , and ± 50 mm.

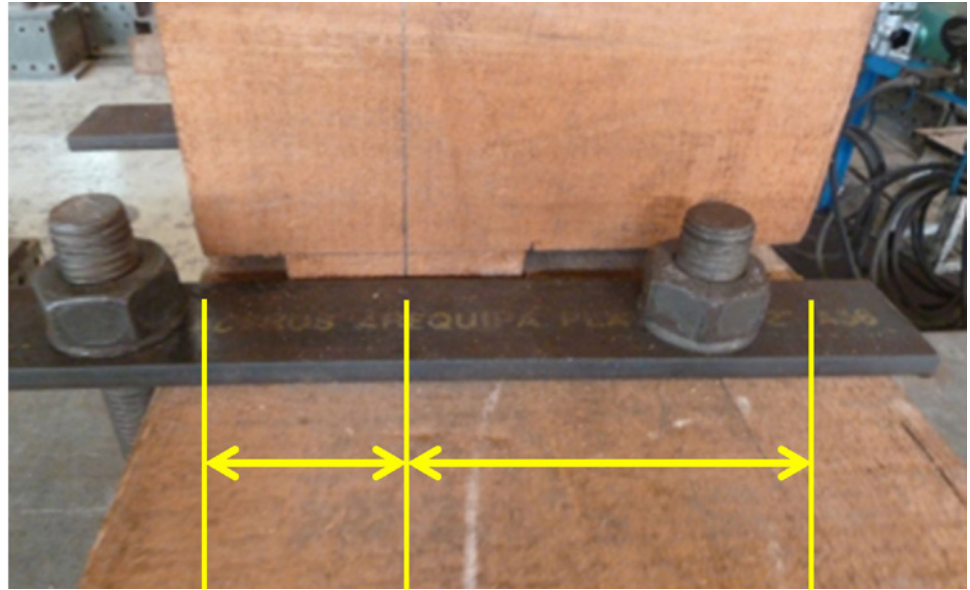
FIGURE 5.12.

Setup of transversal direction, showing the tenon placed off center, creating an asymmetrical setup.

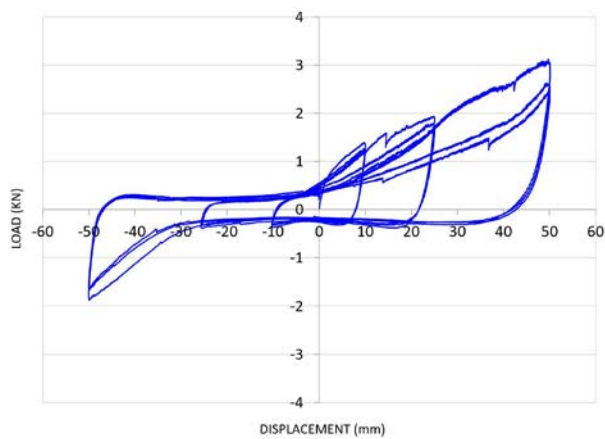
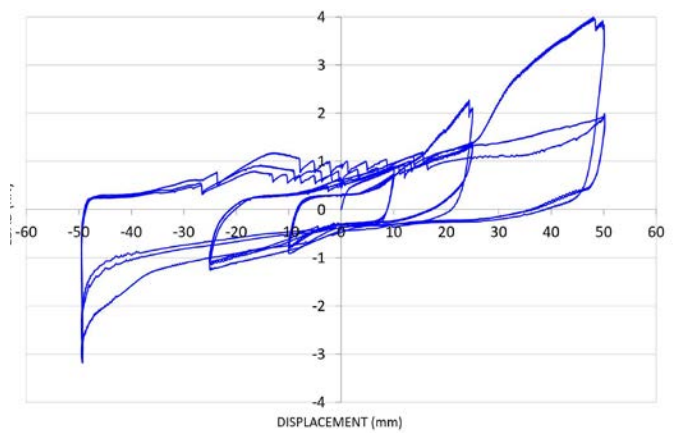
FIGURE 5.13.

Load-displacement curves for the arch-and-beam connection for specimens 1, 2, and 3 (parallel loading).

The load-displacement curves for parallel loading (specimens 1, 2, and 3) and perpendicular loading (specimens 4, 5, and 6) to the longitudinal direction of the beam are displayed in figures 5.13 and 5.14, respectively. When the connection is loaded in the parallel direction, its behavior is slightly asymmetrical. In fact, even though the tenon is symmetrically

located, it pulls out from the mortise and returns fully to its initial position because of friction. The moment resistance of the connection can be computed by multiplying the forces obtained in each direction (3 kN and 3.6 kN on average) by the distance to the base (0.50 m). The resisting bending moments of the connection in the direction, aligned with the beam, thus become 1.5 kNm and 1.8 kNm depending on whether the force is exerted in a positive or negative direction along the beam. The central part of the load-displacement curve for all specimens loaded parallel to the beam shows a near-horizontal slope, indicating that the bending stiffness is almost zero. Therefore, the rotational stiffness is also close to inexistent, and the connection behaves like a hinge. The connection did not fail, nor did the tenon loosen from the mortise.

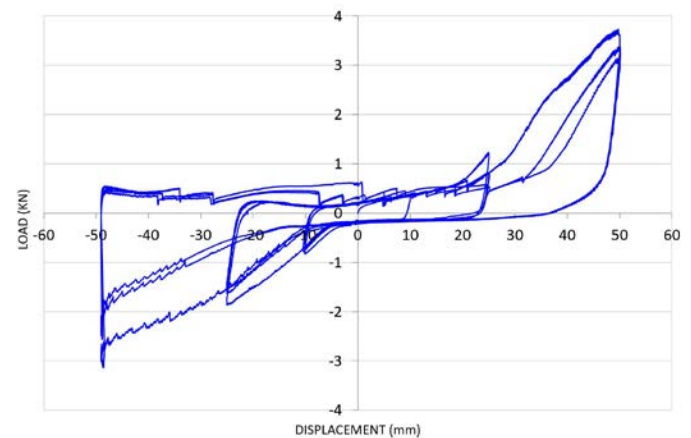
FIGURE 5.14. Load-displacement curves for the arch-and-beam connection for specimens 4, 5, and 6 (perpendicular loading).

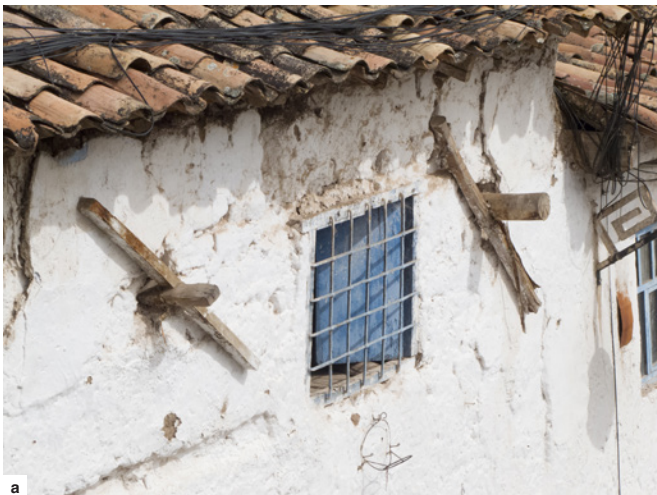
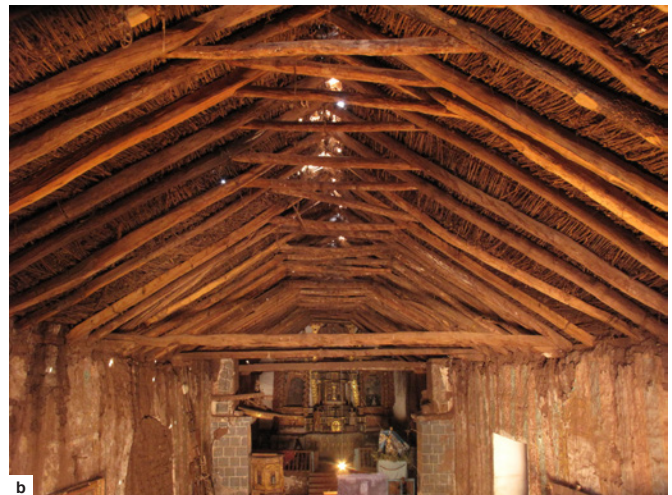
FIGURE 6.1.

- (a) Tie beams as seen in the outside wall of a house in Cuzco.
 (b) Tie beams visible at the roof level inside the church of Kuñotambo.

The anchoring of tie beams to adobe walls is often a critical factor in determining the effectiveness of the beams (fig. 6.1). Therefore, the objective of pull-out testing is to understand the behavior of a system of tie beam and anchor key as it connects to an unfired-brick masonry wall. Testing was accomplished by analyzing the system's failure mode and defining the maximum capacity of the connection.

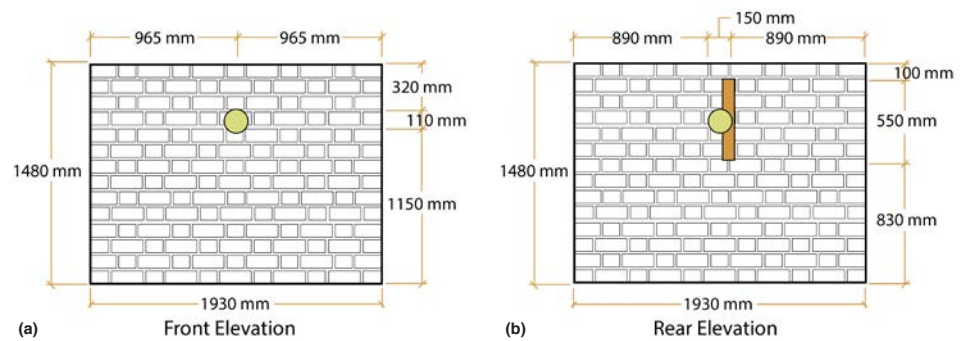
FIGURE 6.2. Schematic used for construction of the nine test walls, with w = vertical load and P = tensile force.

For the testing, nine walls with embedded ties were constructed following the schematic shown in figure 6.2. Each of the nine walls had a width of 1.90 m and a height of 1.50 m (fig. 6.3). The walls were divided into three test groups; the three walls in each group had a thickness of 0.26, 0.54, and 0.84 m, respectively (fig. 6.4). Larger vertical load (w) was placed on the two thicker samples (0.54 and 0.84 m) in each group (fig. 6.5). Width, height, thickness, and load for the nine wall samples are provided in table 6.1. Each wall was restrained both at the bottom and at the top. The placement of a restraint at the top inhibited the rotation around the bottom hinge. A tensile force (P) was applied at the end of the tie beam using a hydraulic jack, while the horizontal displacement was recorded using a linear variable differential transformer (LVDT).

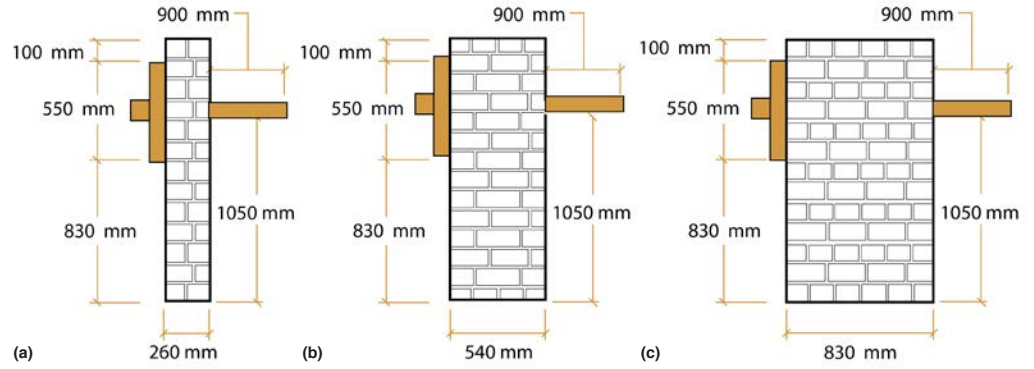
FIGURE 6.4.

Side views of the test samples, showing the three different thicknesses: (a) 0.26 m, (b) 0.54 m, and (c) 0.83 m.

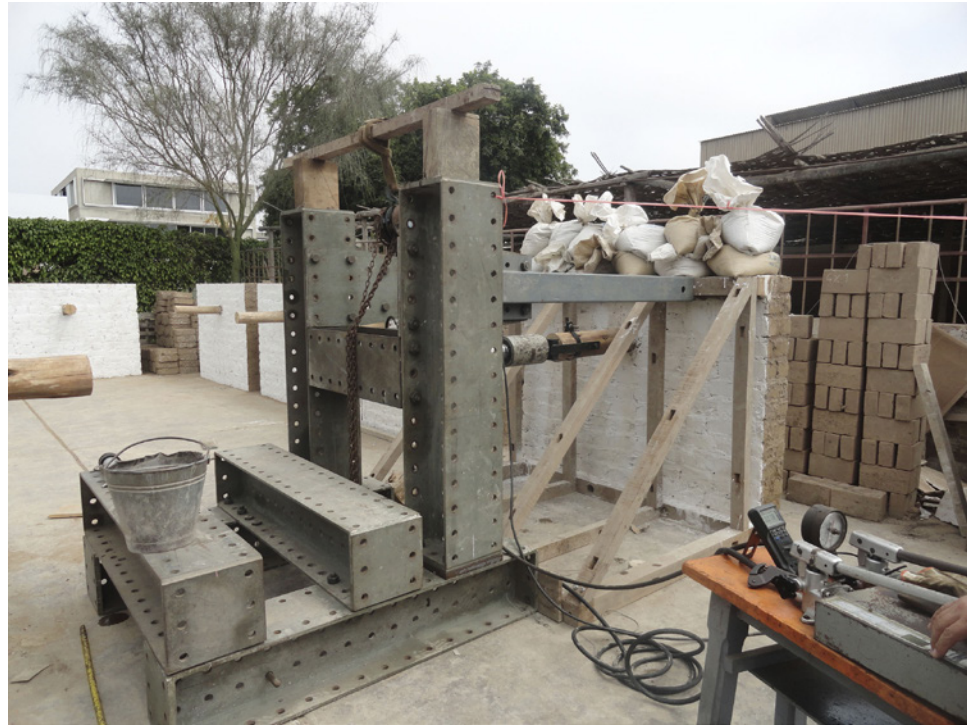
FIGURE 6.5.

Photograph of test setup, showing the application of the vertical load on a wall sample.

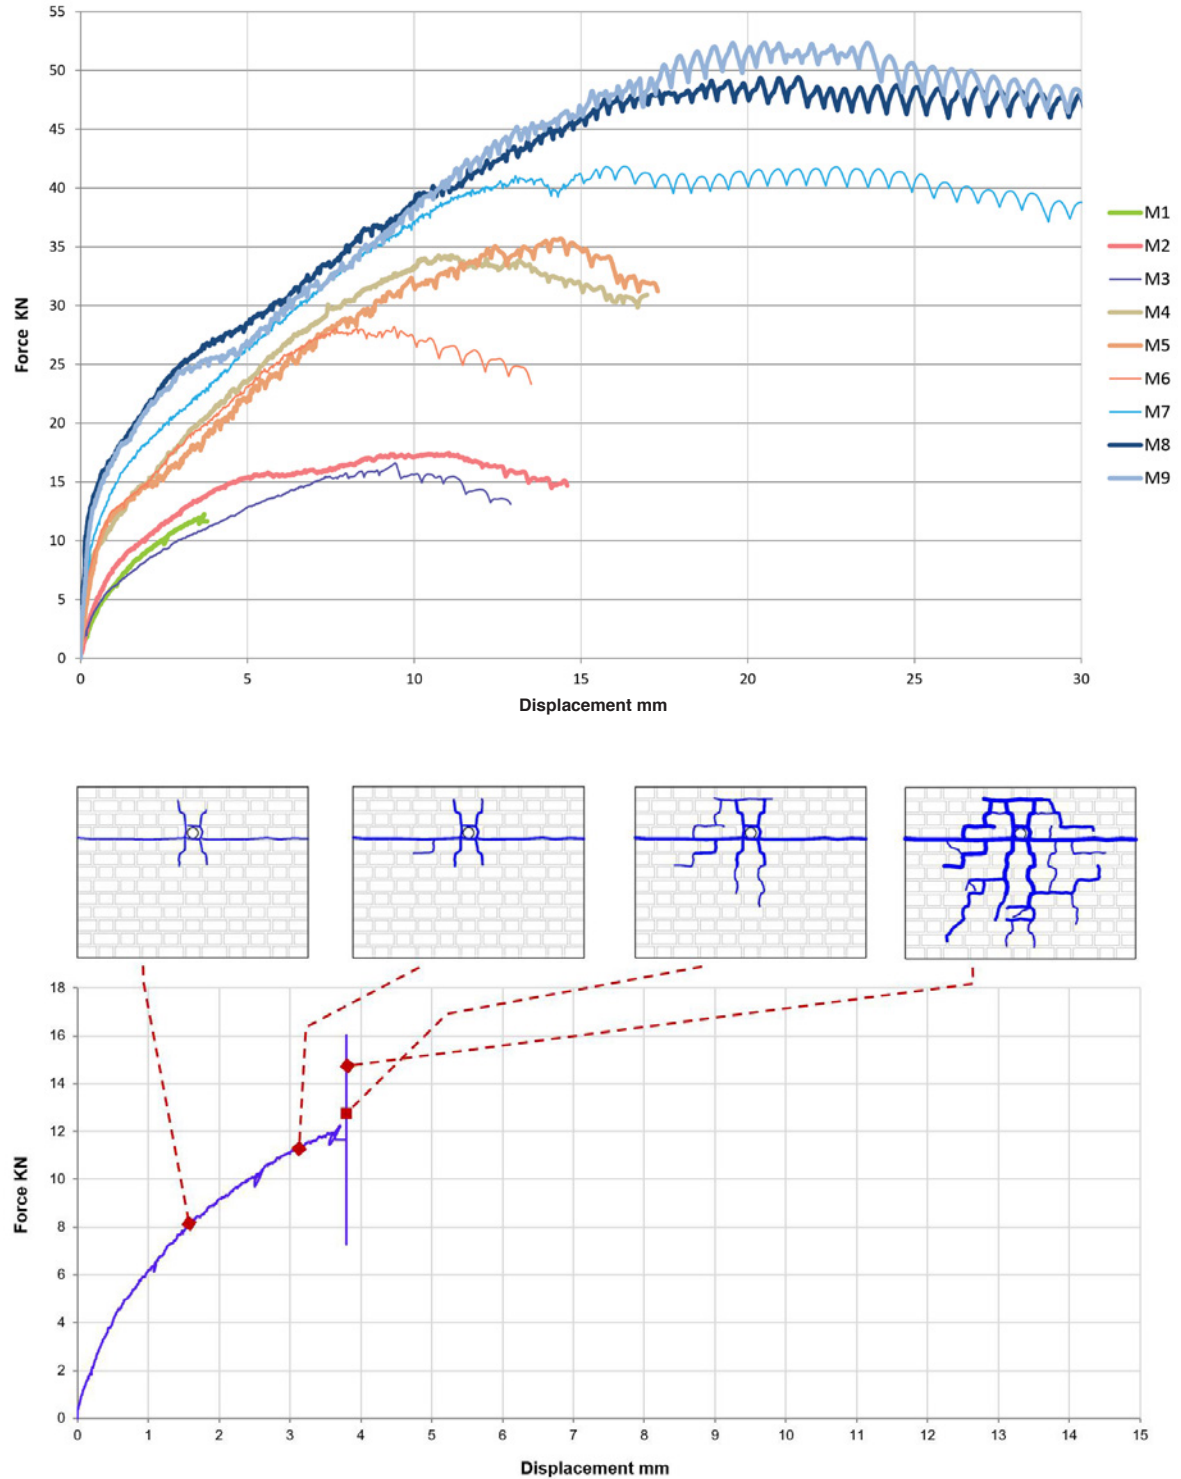
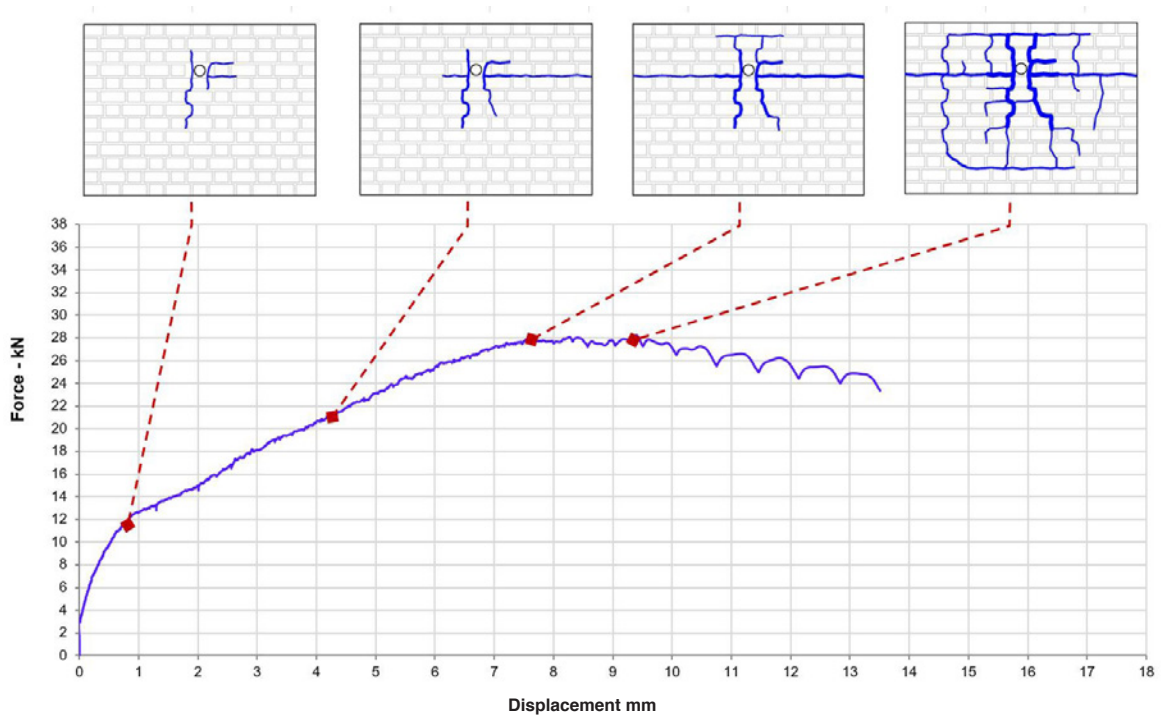
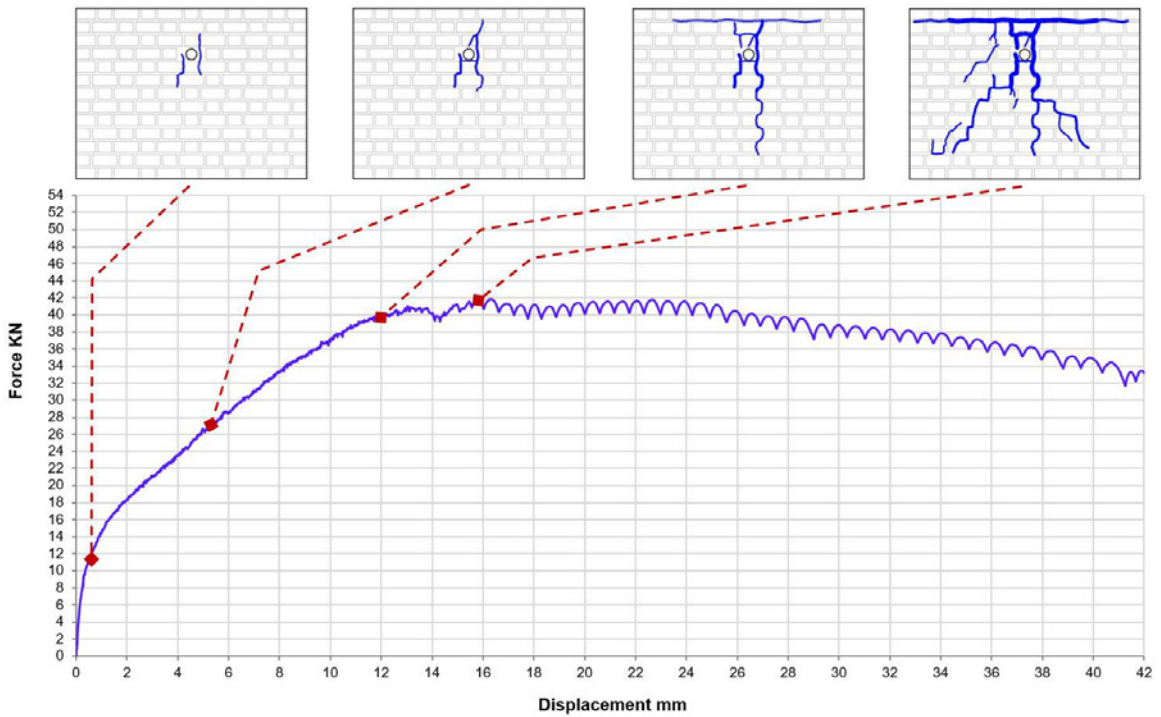
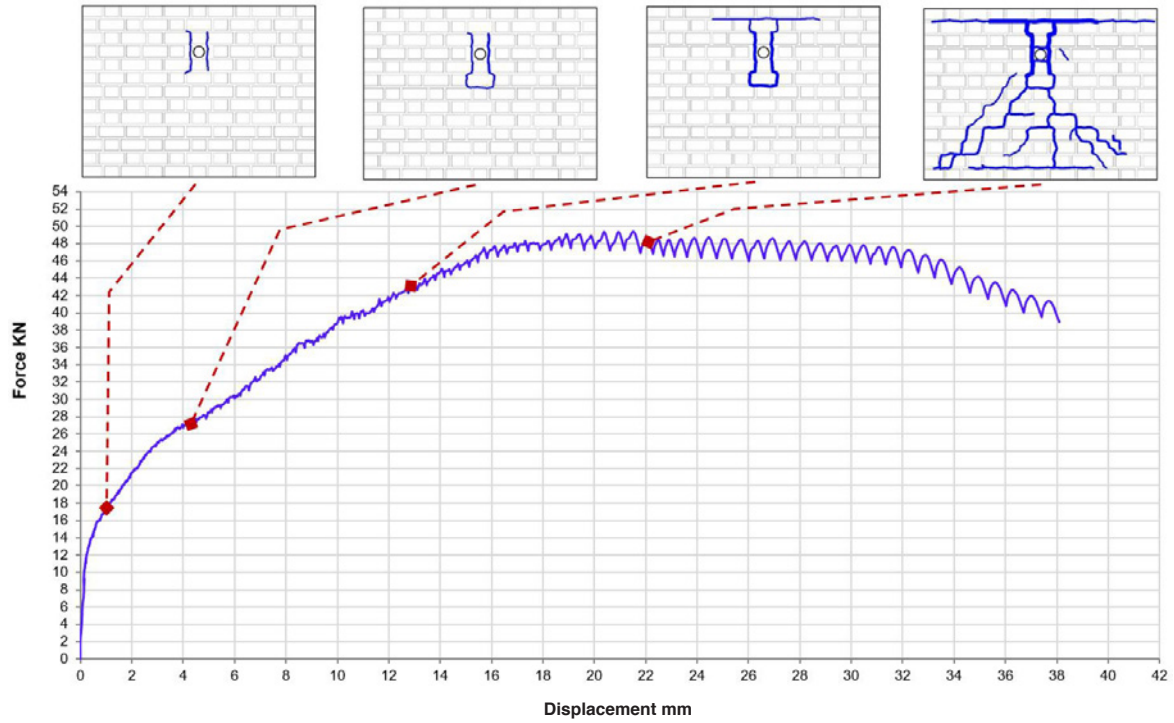
FIGURE 6.6.

Graph showing load-displacement curves and corresponding crack formations on the outside plane of the nine wall samples.

The load-displacement curves and the corresponding crack formations on the outside wall surfaces are shown in figure 6.6. All walls experienced a conical shear failure that started from the anchor and developed toward the inside wall (fig. 6.7). The 0.26-m-thick walls (M1 to M3) experienced out-of-plane bending at first, but as the load increased, the failure mechanism turned into a punching shear failure. The 0.54-m- and 0.83-m-thick walls (M4 to M6 and M7 to M9, respectively) similarly failed due to punching shear (fig. 6.8). In the 0.83-m-thick walls, the failure surface did not reach the frontal face of the wall; instead, cracks appeared on the lateral sides.
