Seismic Retrofitting Project

Testing of Materials and Building Components of Historic Adobe Buildings in Peru

Research Report

Daniel Torrealva, Erika Vicente,
and Tim Michiels

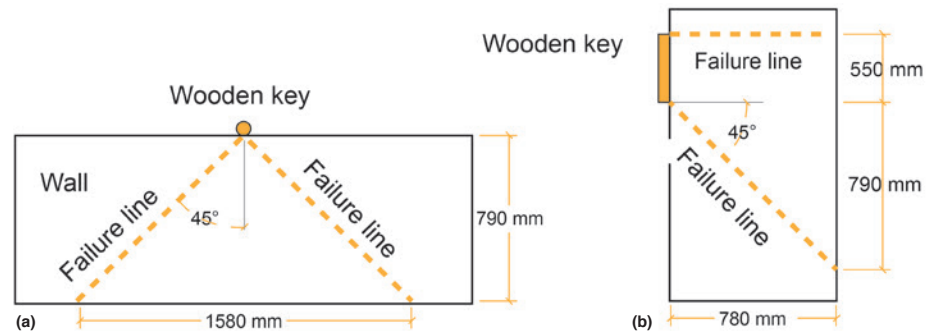
FIGURE 6.7.

Diagrams showing (a) front view and (b) side view of failure surfaces.

The load-displacement curves and the corresponding crack formations on the outside wall surfaces are shown in figure 6.6. All walls experienced a conical shear failure that started from the anchor and developed toward the inside wall (fig. 6.7). The 0.26-m-thick walls (M1 to M3) experienced out-of-plane bending at first, but as the load increased, the failure mechanism turned into a punching shear failure. The 0.54-m- and 0.83-m-thick walls (M4 to M6 and M7 to M9, respectively) similarly failed due to punching shear (fig. 6.8). In the 0.83-m-thick walls, the failure surface did not reach the frontal face of the wall; instead, cracks appeared on the lateral sides.

The maximum pull-out force applied to the nine wall specimens is shown in table 6.2. It can be observed that the 0.26-m-thick walls (M1 to M3) reached values that are independent from the vertical load, whereas for the remaining walls, the maximum pull-out force increased approximately 20% when a vertical load was applied. Shear strength for the 0.54-m- and 0.83-m-thick walls was computed assuming a conical failure surface that crossed the entire width of the wall. However, this failure cone developed only for the wall with a thickness of 0.54 m. It was noted that for this thickness, the computed value of shear strength without vertical load was 0.043 MPa, which is very close to the value obtained from the diagonal compression tests (0.044 MPa). The shear cone (see fig. 6.7) could not fully develop in the other tests because of the geometric setup.

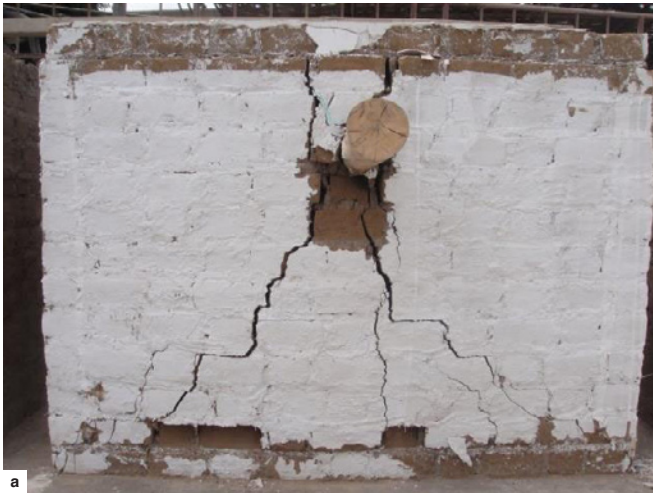
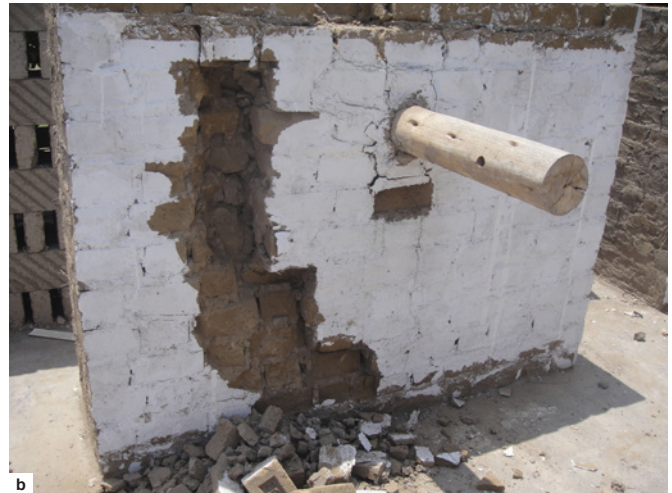
FIGURE 6.8.

Photographs of wall specimens (a) M5 and (b) M8, showing failure mode due to punching shear of the tie through the masonry.

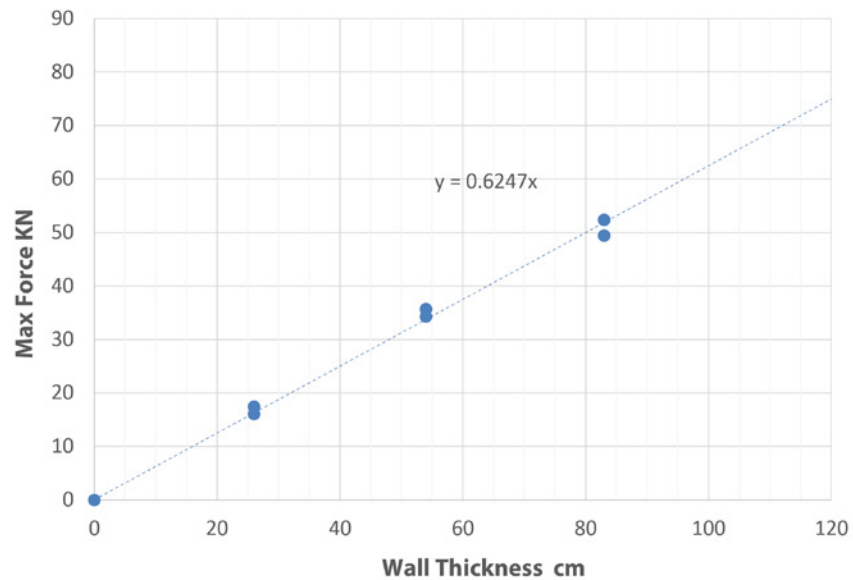
FIGURE 6.9.

Graph showing correlation between the maximum tensile capacity of the ties and the thickness of the walls.

In this program, pull-out tests were executed on adobe walls of varying thickness. Failure occurred through punching shear of the tie through the adobe masonry, as the test setup inhibited overturning failure. A clear linear relationship could be discerned between the ultimate load capacity of the tie and the thickness of the wall. In turn, this relationship can be traced back to a shear-strength calculation based on a 45-degree failure cone. Due to the presence of the upper support, however, the wall could not rotate around a point at its base. Therefore, failure due to bending, or combined shear-bending behavior, was ruled out through the test setup, while these failure mechanisms or even failure of the key are likely to occur during a real seismic event.

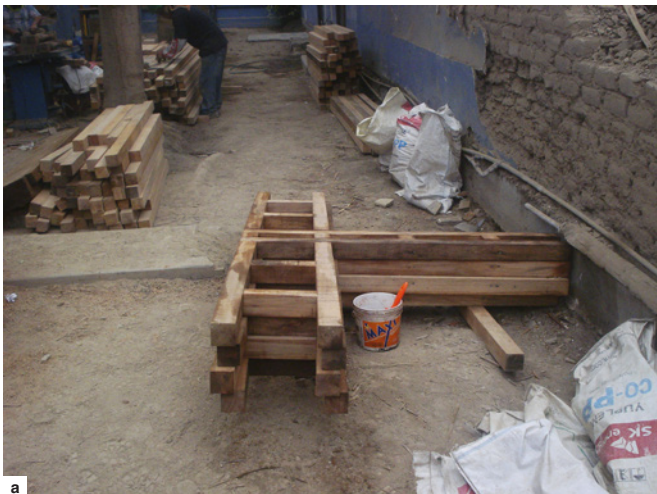
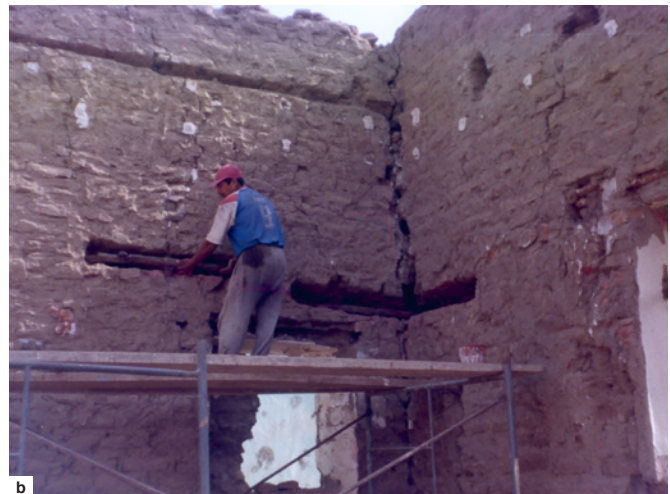
FIGURE 6.10.

- (a) Timber corner key assembly;
(b) worker installing corner key installed in wall.

Corner keys are wooden elements that are employed at different heights of perpendicular walls to stitch these walls together. Cracks commonly occur between orthogonal walls due to the differences in out-of-plane and in-plane motion; accordingly, corner keys are installed to allow the members to work together (fig. 6.10).

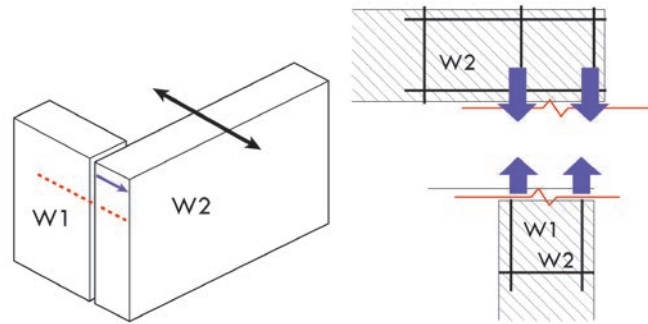
FIGURE 6.11.
Structural scheme of the mechanism of a typical corner key.

Figure 6.11 shows a schematic of the mechanism of a typical corner key. When cracks are activated between perpendicular walls, they typically appear on a plane that belongs to the wall perpendicular to the one that tends to overturn outward. Wall W2 is the one that tends to fail, and the vertical crack will develop in wall W1.

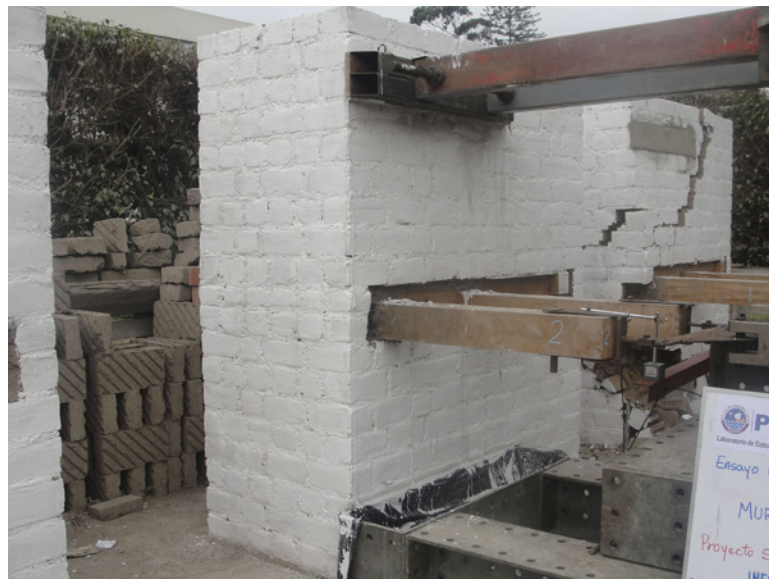
FIGURE 6.12.
Corner-key full test setup.

Six masonry walls with embedded corner keys were needed for testing. These walls were built using the same type of unfired bricks as those used for the tie beams (dimensions 90 × 115 × 205 mm, compression strength 2 MPa). Composition of the mortar was 1 part soil, 1/4 part sand, and 1/20 part straw. The timber species used was tornillo (*Cedrelinga catenaeformis*). The connections were executed half-lapped with nails. For a photo of the full test setup, see figure 6.12.

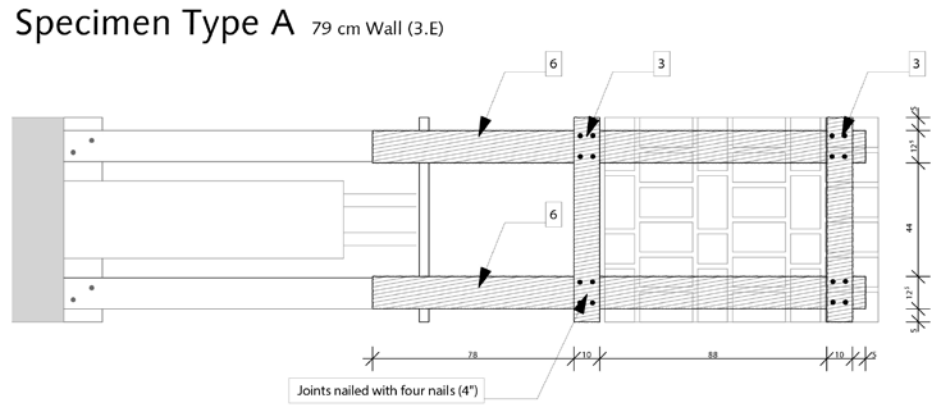
FIGURE 6.13.

Type A specimen (timber assembly), where key is embedded in the longitudinal wall (W1) and pulls out parallel to the wall.

Three different geometric configurations of the wall specimens were built (types A, B, and C) in order to represent the behavior of the corner key. Two tests were executed for each configuration. The first configuration, type A, consisted of a timber assembly in which the key was embedded in longitudinal wall W1 and pulled out in the direction parallel to the wall (fig. 6.13). In contrast, in the second configuration, type B, part of the key was embedded in wall W2 and pulled out in the direction perpendicular to the wall (fig. 6.14). A third set of tests (type C) was set up similar to the configuration of type B but with an additional anchor key added at the outer end of the assembly in an attempt to increase load capacity (fig. 6.15). A pull-out force was applied incrementally at a constant rate of 2 kN/min using

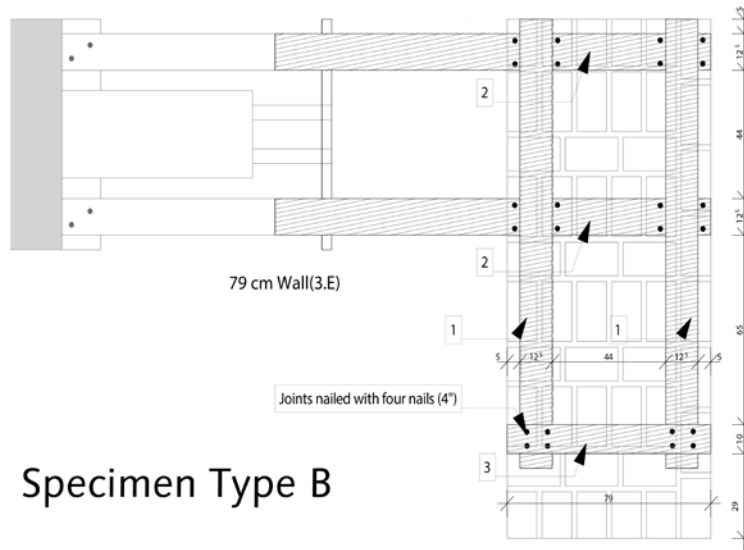
FIGURE 6.14.

Type B specimen, where part of key is embedded in wall W2 and pulls out perpendicular to the wall.

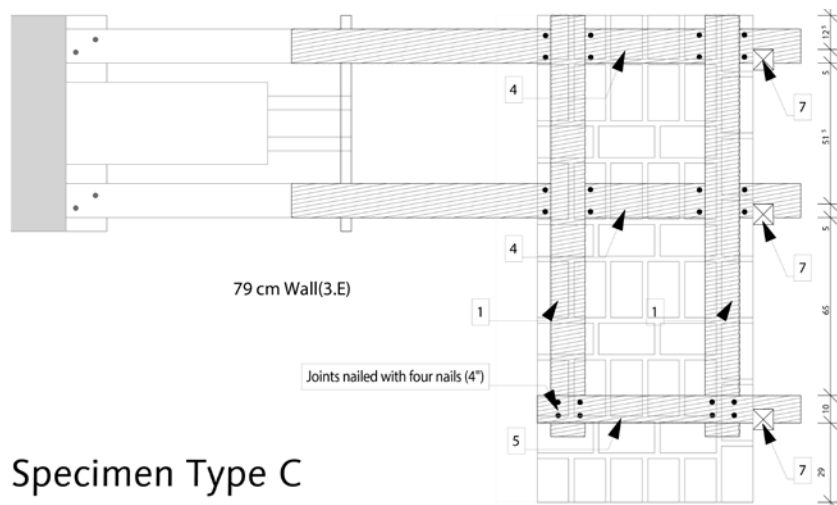
FIGURE 6.15.

Type C specimen, similar to type B except for an additional anchor key added to increase load capacity.

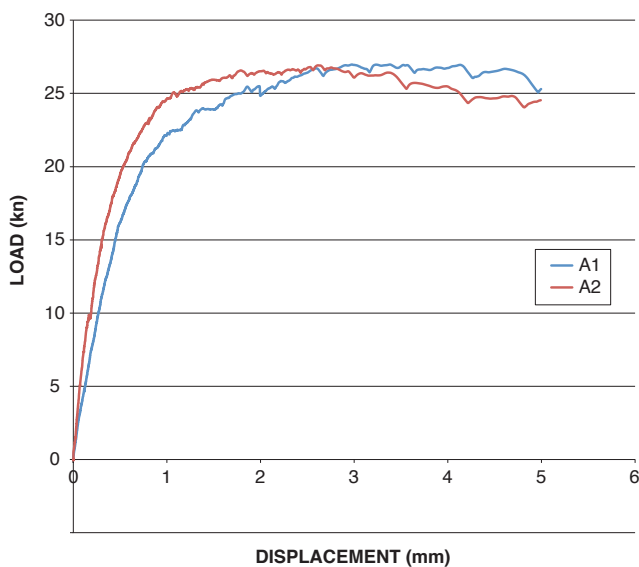
FIGURE 6.16. Graph showing load-displacement curves for type A specimens.

Table 6.3 shows the maximum pull-out force for all six specimens. Figures 6.16 and 6.17 show the load-displacement curves for type A specimens and type B and C specimens, respectively. Figures 6.18, 6.19, and 6.20 show development of crack patterns during testing. The maximum pull-out force is governed by the failure in shear of the masonry wall, on a plane inclined approximately 45 degrees with the horizontal plane of the key. The load-displacement curves indicate an elastoplastic behavior until the timber key detaches from the adobe wall.

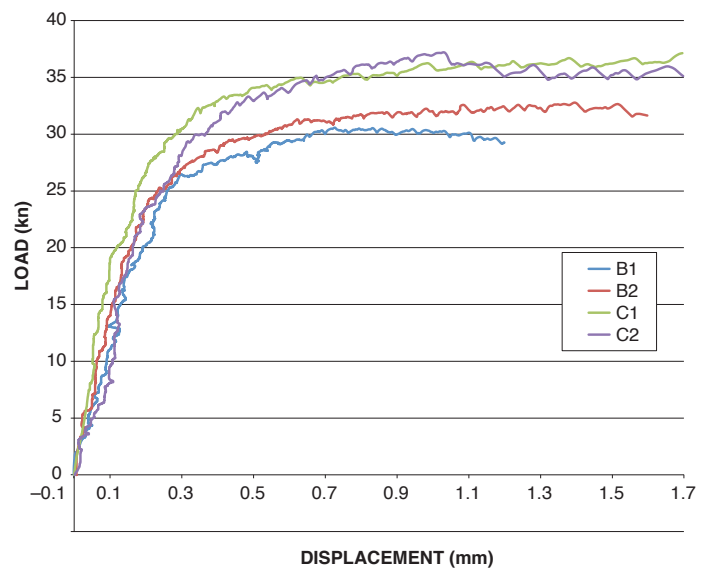
FIGURE 6.17. Graph showing load-displacement curves for type B and C specimens.

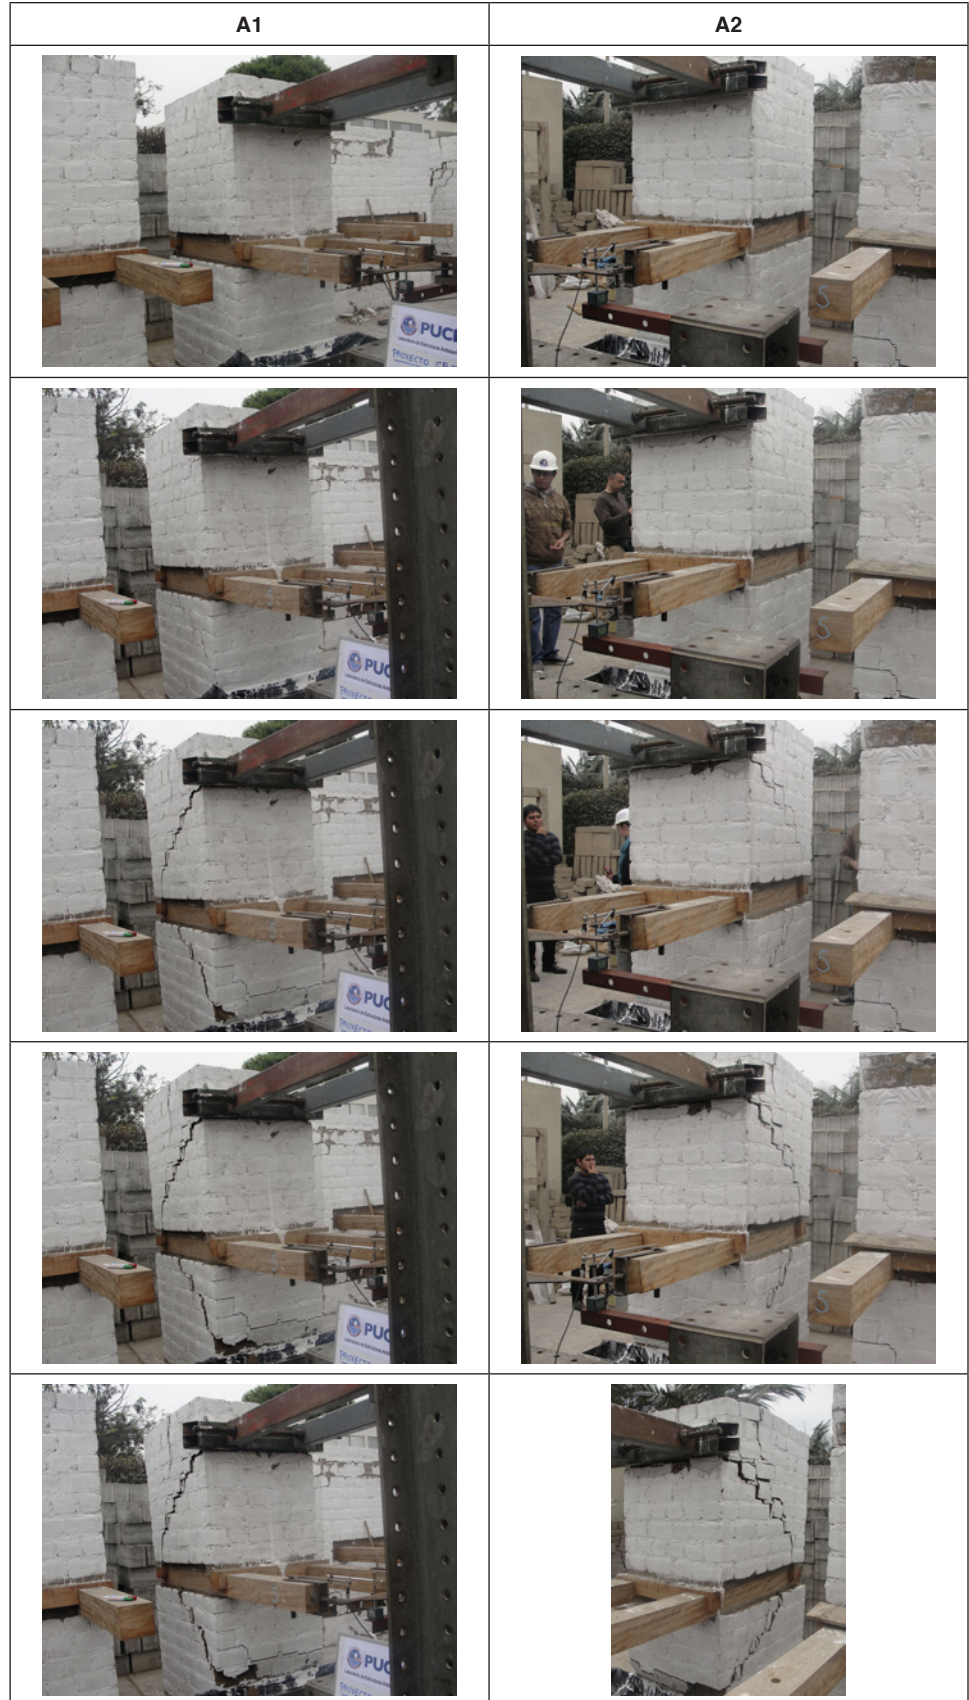
FIGURE 6.18.
Crack propagation during testing of
type A specimens.

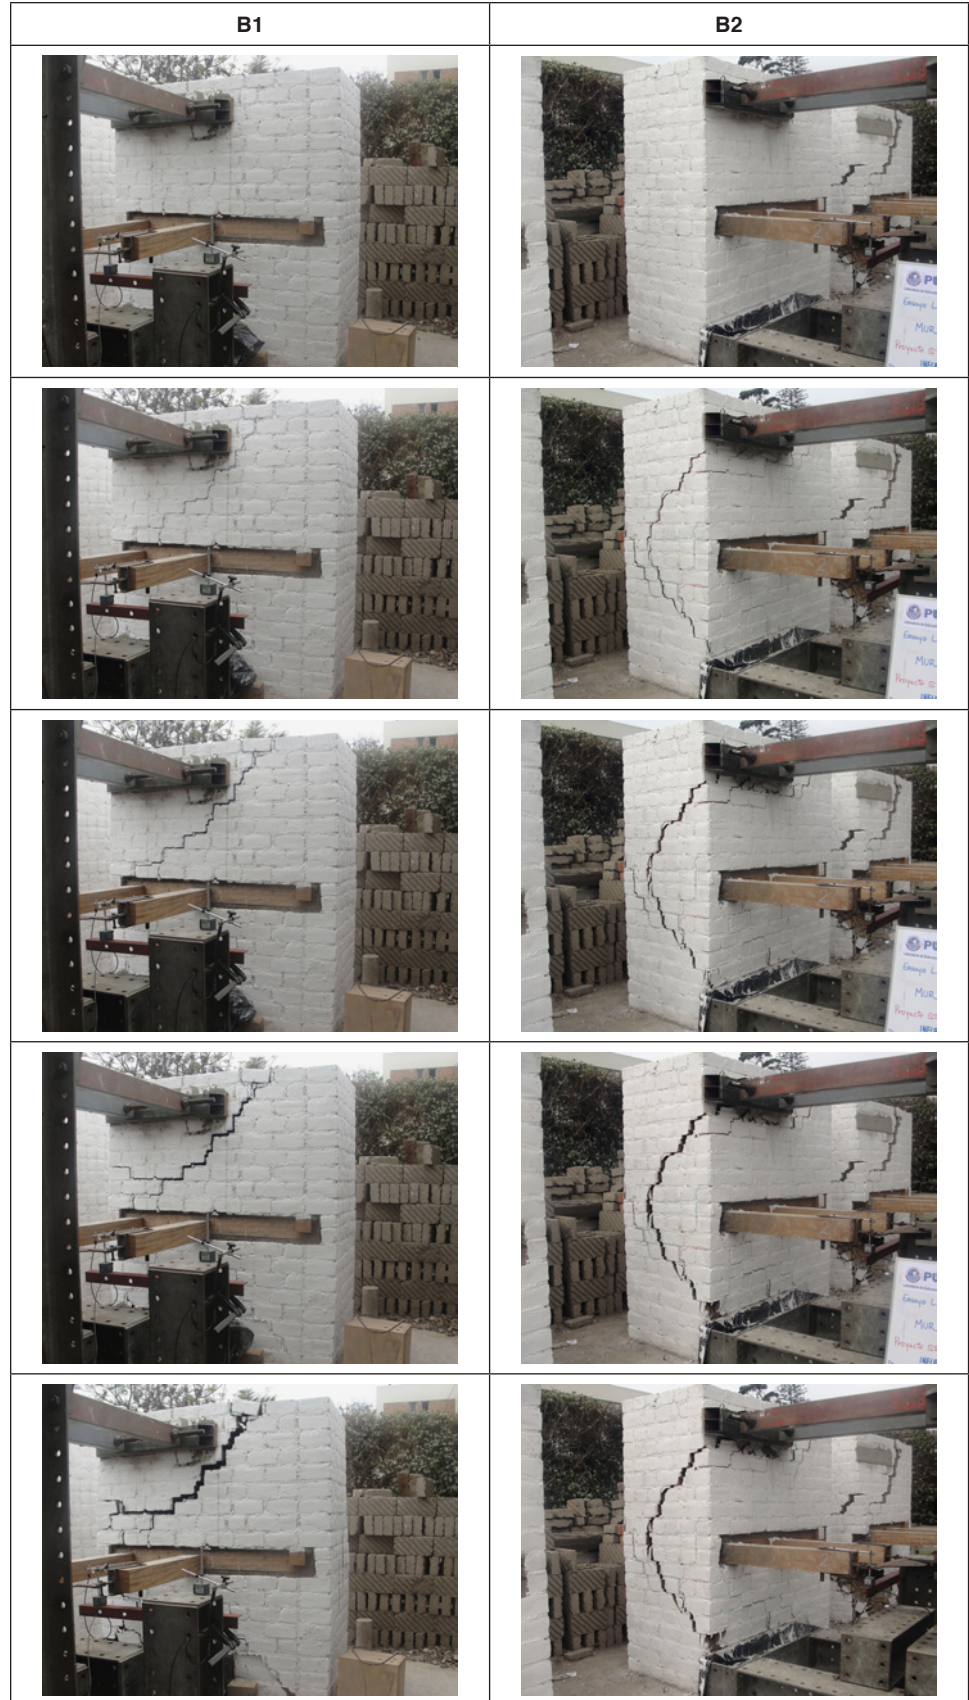
FIGURE 6.19.
Crack propagation during testing of
type B specimens.

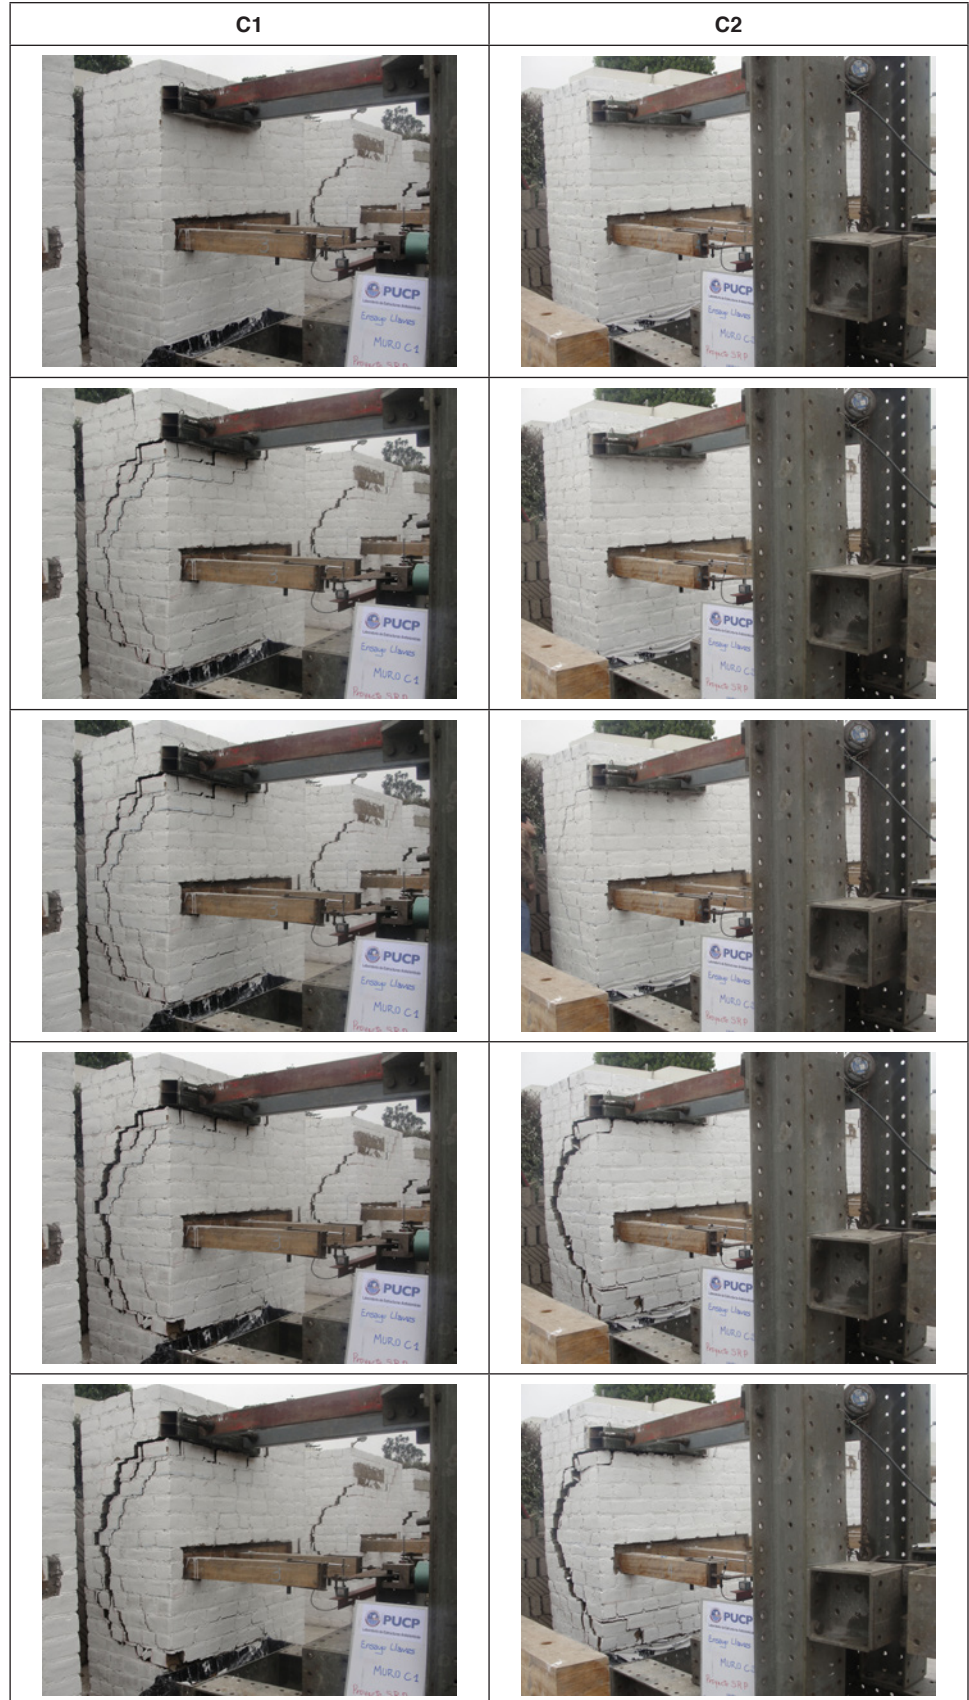
FIGURE 6.20.
Crack propagation during testing of
type C specimens.

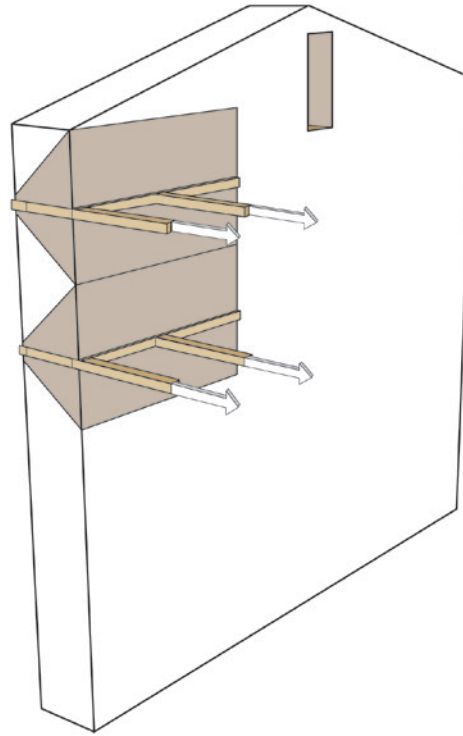
FIGURE 6.21.

Diagram showing the shear cone that is activated through pull-out of the corner keys, which can inform the vertical distance between keys.

In this test setup, failure of the corner key is governed by the section embedded in wall W1, as the masonry of this wall fails when subjected to a pull-out force (27 kN, type A) lower than the pull-out force needed to cause shear failure in the transversal wall (31 kN, type B). The overall shear capacity of wall W1 is lower than the shear capacity of the transversal wall (W2); the latter has a larger area to develop the shear failure cone (fig. 6.21). Calculating the associated shear stress for type A specimens, assuming a 45-degree failure plane, results in a shear-compression stress of 0.023 MPa, about half the shear strength capacity measured in diagonal compression tests. For type B and C specimens, the failure plane is not uniform over the section due to the fact that the force is applied off center, leading to an asymmetrical loading pattern. Assuming a uniform plane of failure for the calculation of the associated shear stress in types B and C, this leads to even lower shear stress values. The incorporation of vertical anchors at the end of the corner key in the type C specimens increased the ultimate force by 20%. Development of the failure plane starts in the transversal piece of the key, embedded in W1 located farthest from the intersection of the walls. Therefore, maximum load capacity is directly related to length of the key.
