Seismic Stabilization of Historic Adobe Structures

Final Report of the Getty Seismic Adobe Project

E. Leroy Tolles
Edna E. Kimbro
Frederick A. Webster
William S. Ginell

GCI Scientific Program Reports

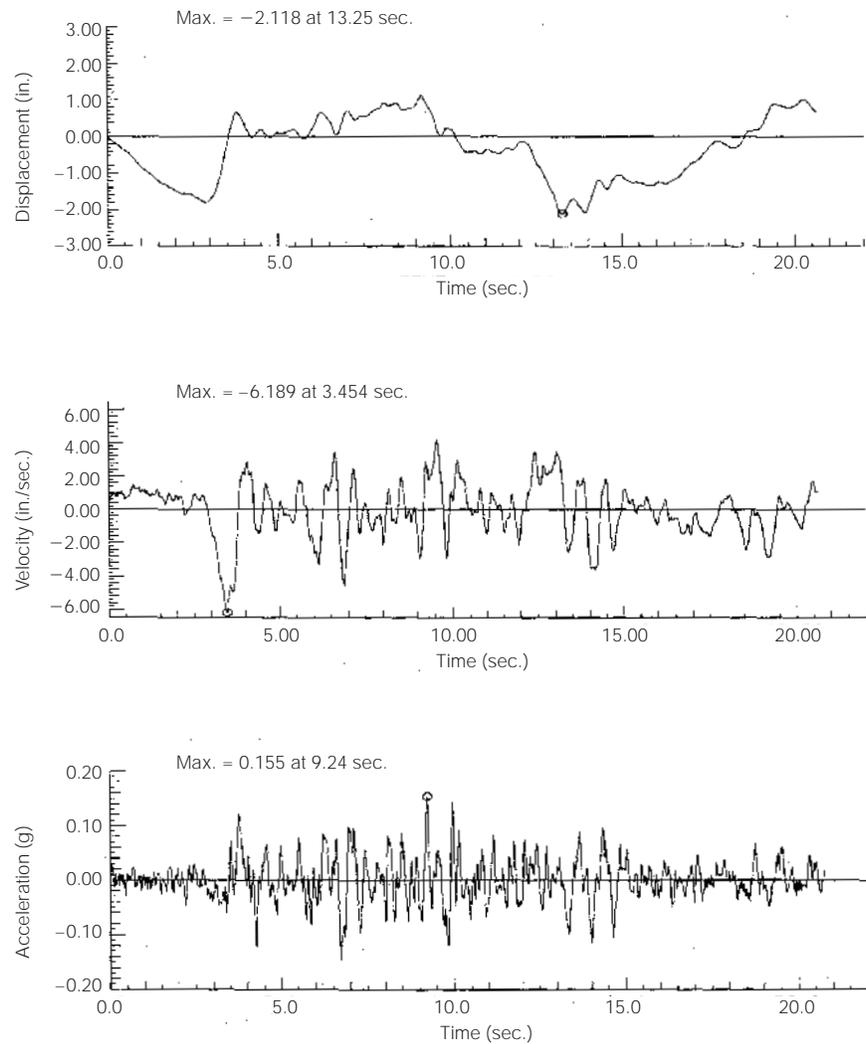
Figure 2.1
Graph of N21E component of 1952 Taft earthquake (displacement, velocity, and acceleration).

The earthquake motion used in these tests was based on the N21E component of the 1952 Taft earthquake in Kern County, California. Each model was subjected to a series of ten simulated earthquake displacement motions. Each subsequent displacement motion was 20–30% larger than the previous one. The displacement, velocity, and acceleration records for the N21E component of the Taft earthquake are presented in figure 2.1. The maximum simulated earthquake motion was 6–7 times larger than the original earthquake, based on comparison of the displacement records.

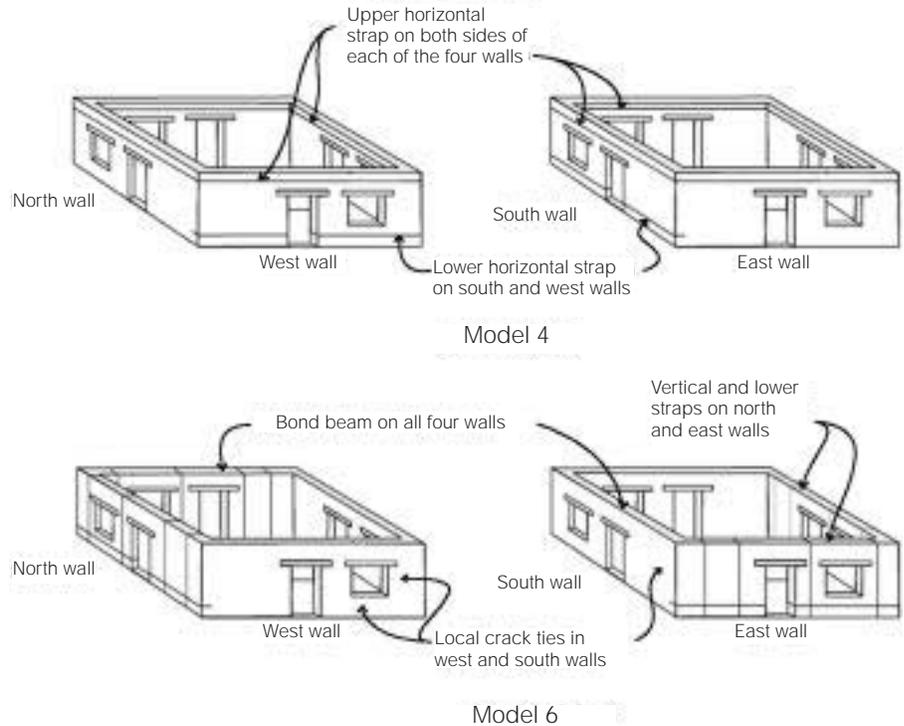
Figure 3.1
General layout of models 4 and 6, showing inner and outer wall straps connected through the wall by thin nylon cords at 15.2–20.3 cm (6–8 in.) intervals.

The general layout of the models is shown in figure 3.1. Each wall had a door and a window. The door was located near the center of the wall, and the windows were located close to the southwest and northeast corners. The same retrofit was used on two adjacent walls, allowing simultaneous evaluation of a specific retrofit on both in-plane and out-of-plane walls. Table motion was uniaxial in an east-west direction.

The retrofits used on model 6 were similar to those used on model 2; the north and east walls (see fig. 3.1) were retrofitted in an identical manner. A bond beam was applied at the top of all four walls in addition to the vertical straps and lower horizontal straps that were applied to two of the walls (the north and east walls in model 6 and the south and west walls in model 2). Small-diameter center-core rods were used in the north

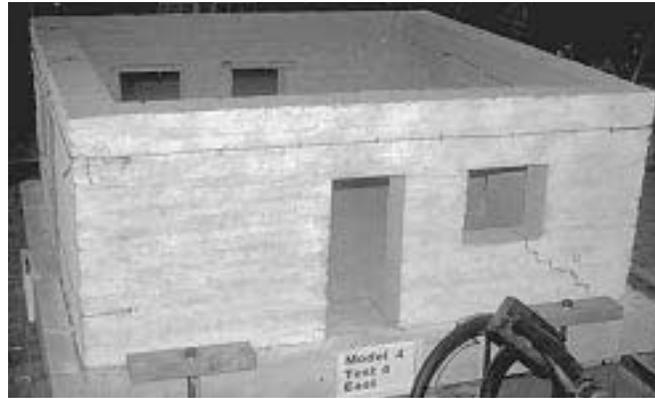
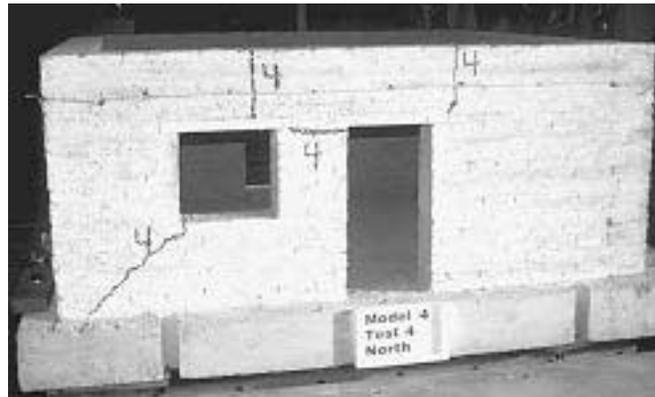
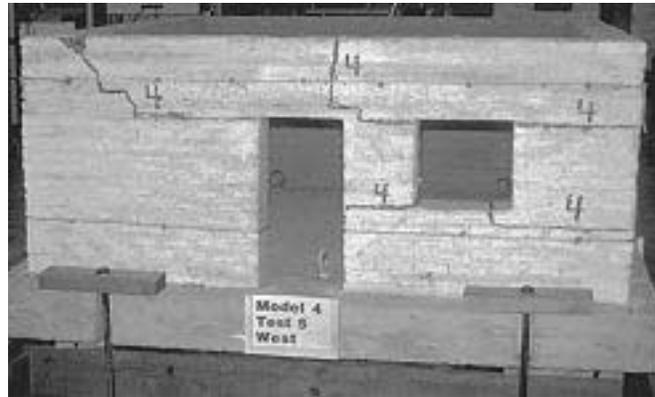
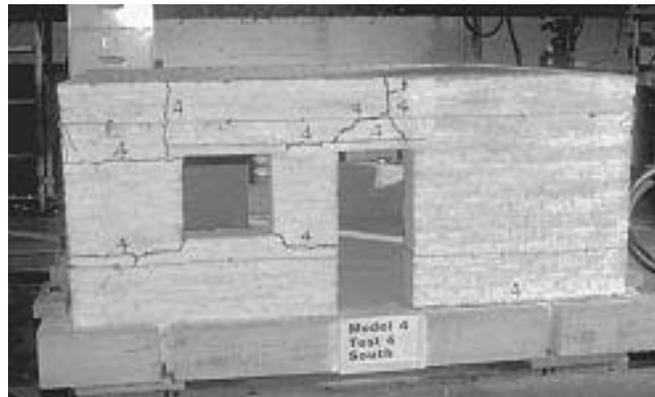
Figure 3.2

Model 4, test level IV, showing (a) east wall (out of plane); (b) north wall (in plane); (c) west wall (out of plane); and (d) south wall (in plane). Crack initiation occurred, with crack pattern in walls showing little differentiation between in-plane and out-of-plane directions. Cracks in the in-plane walls (north and south) started at the corners of openings and at the pier between door and window. In the out-of-plane direction, the west wall sustained crack damage in several locations, while the east wall had only one crack, extending diagonally from the bottom of the window toward the lower north corner. Note that in this thick-walled model, cracks began in the in-plane walls.

Damage began during test level IV when cracks developed primarily in the in-plane walls (fig. 3.2). The thick walls ($S_L = 5$) resisted the out-of-plane motions, but the in-plane forces exceeded the strength of the adobe.

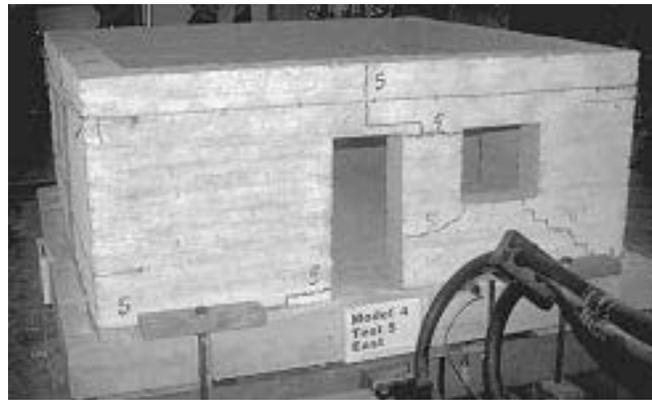
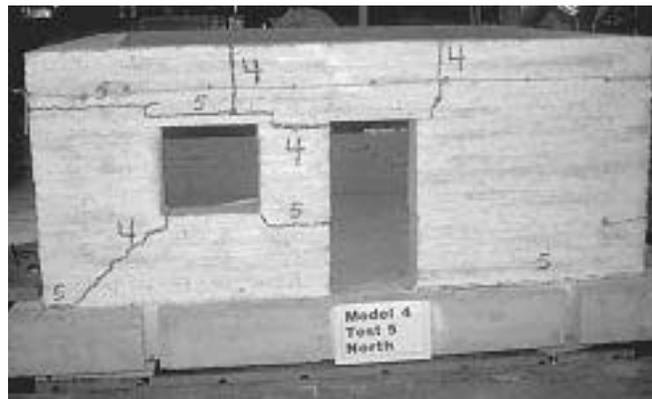
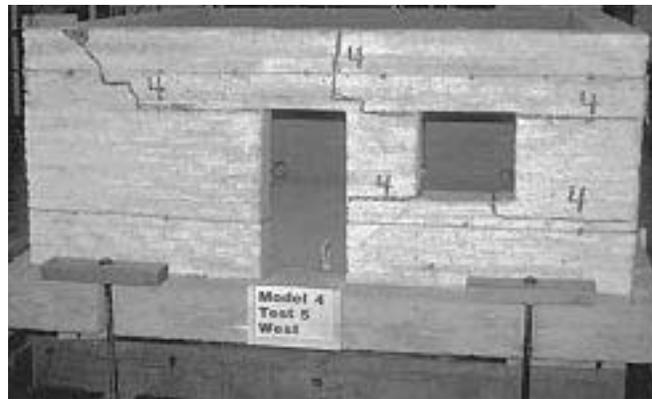
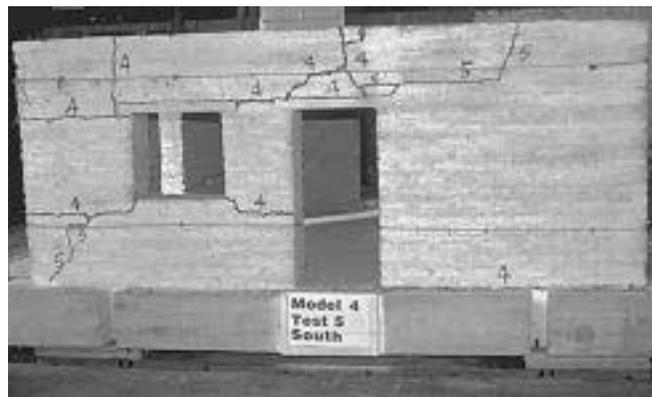
Figure 3.3

Model 4, test level V, showing (a) east wall (out of plane); (b) north wall (in plane); (c) west wall (out of plane); and (d) south wall (in plane). Some additional cracks were initiated in the in-plane walls and the east, out-of-plane, wall. No additional crack damage was observed in the west wall. At this point in the testing, dynamic displacements remained small and the retrofit system (horizontal straps) had little or no effect on the model's performance.

The development of the primary system of cracks was completed during test levels V and VI (figs. 3.3 and 3.4). At this point in the test sequence, the retrofit system became active.

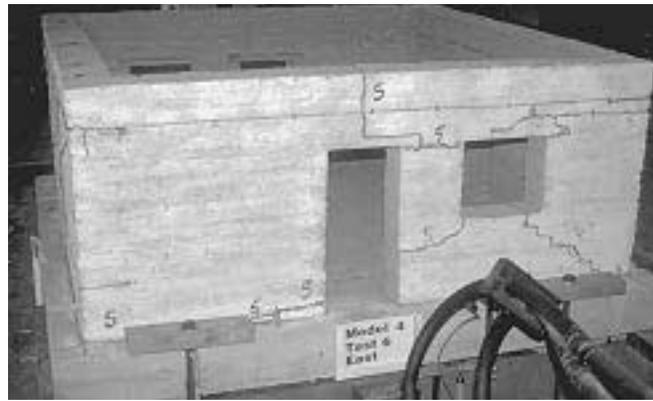
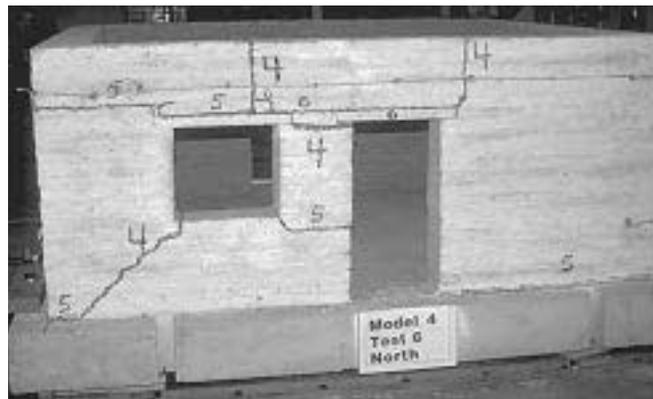
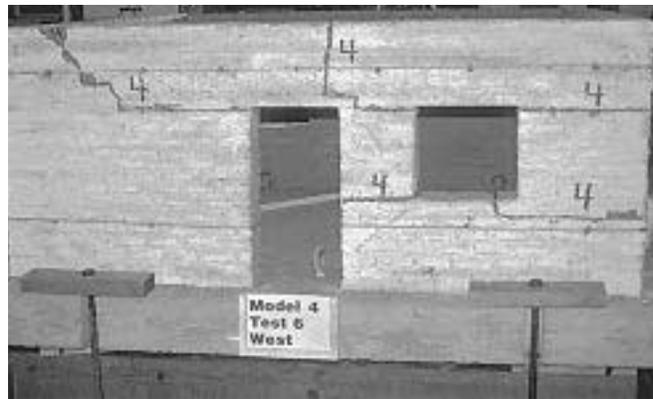
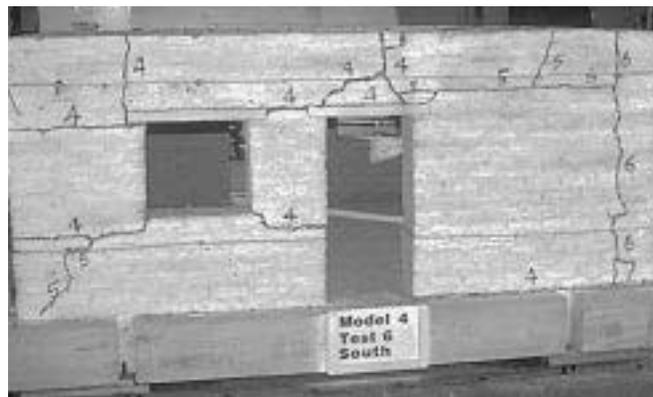
Figure 3.4

Model 4, test level VI, showing crack damage in (a) east wall (out of plane); (b) north wall (in plane); (c) west wall (out of plane); and (d) south wall (in plane). Although cracking remained nearly constant from that of test level V, the motion of the cracked wall sections became substantially larger during this test level as the cracks began to open up and the wall sections started to move relative to one another. There was little rocking of the cracked wall sections in the out-of-plane walls. The retrofit straps were engaged during this test sequence.

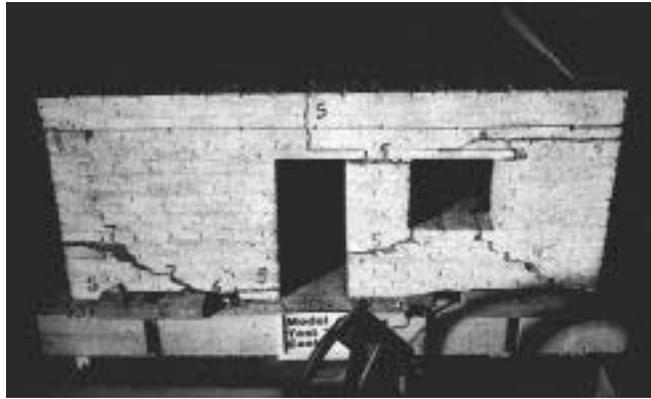
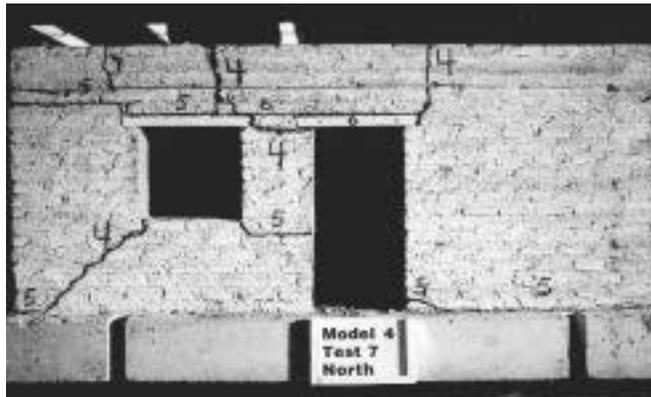
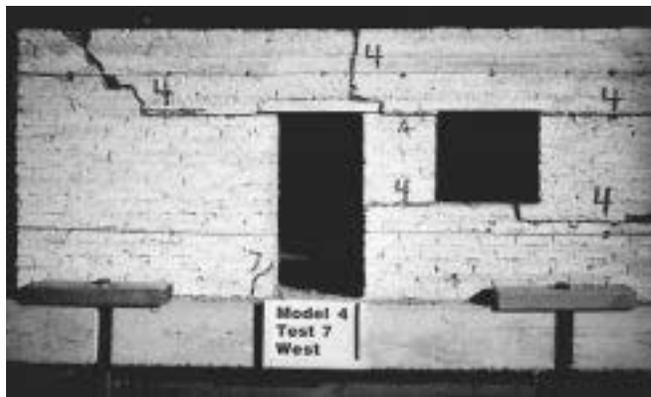
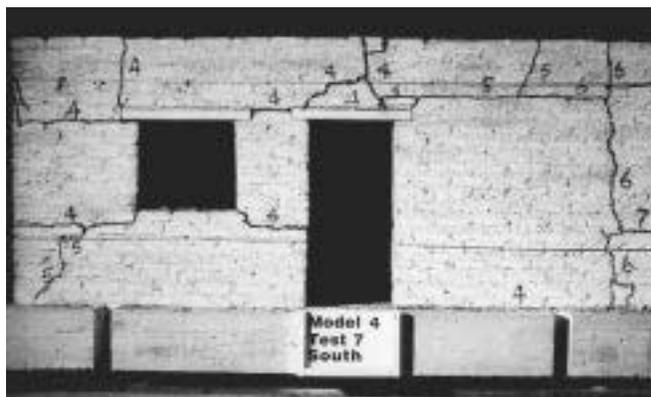
Figure 3.5

Model 4, test level VII, showing crack pattern in (a) east wall (out of plane); (b) north wall (in plane); (c) west wall (out of plane); and (d) south wall (in plane). Crack pattern was nearly complete. In the east wall, cracks developed along the base of the main panel as the wall rocked back and forth at the base. A similar crack extended completely across the base of the west wall. The retrofit straps were definitely effective during this test. They acted to restrain the out-of-plane motions of the walls and the relative in-plane displacements of the cracked wall sections. (Note: The photographs for test level VIII, which show only a few additional cracks and crack extensions, are not included here.)

Although no thick-walled ($S_L = 5$) control model was tested, it would appear that an unretrofitted model ($S_L = 5$) would have collapsed during test level VII (fig. 3.5) or VIII. During these tests, the retrofit system was very active, and the cracked wall sections began to undergo permanent displacements.

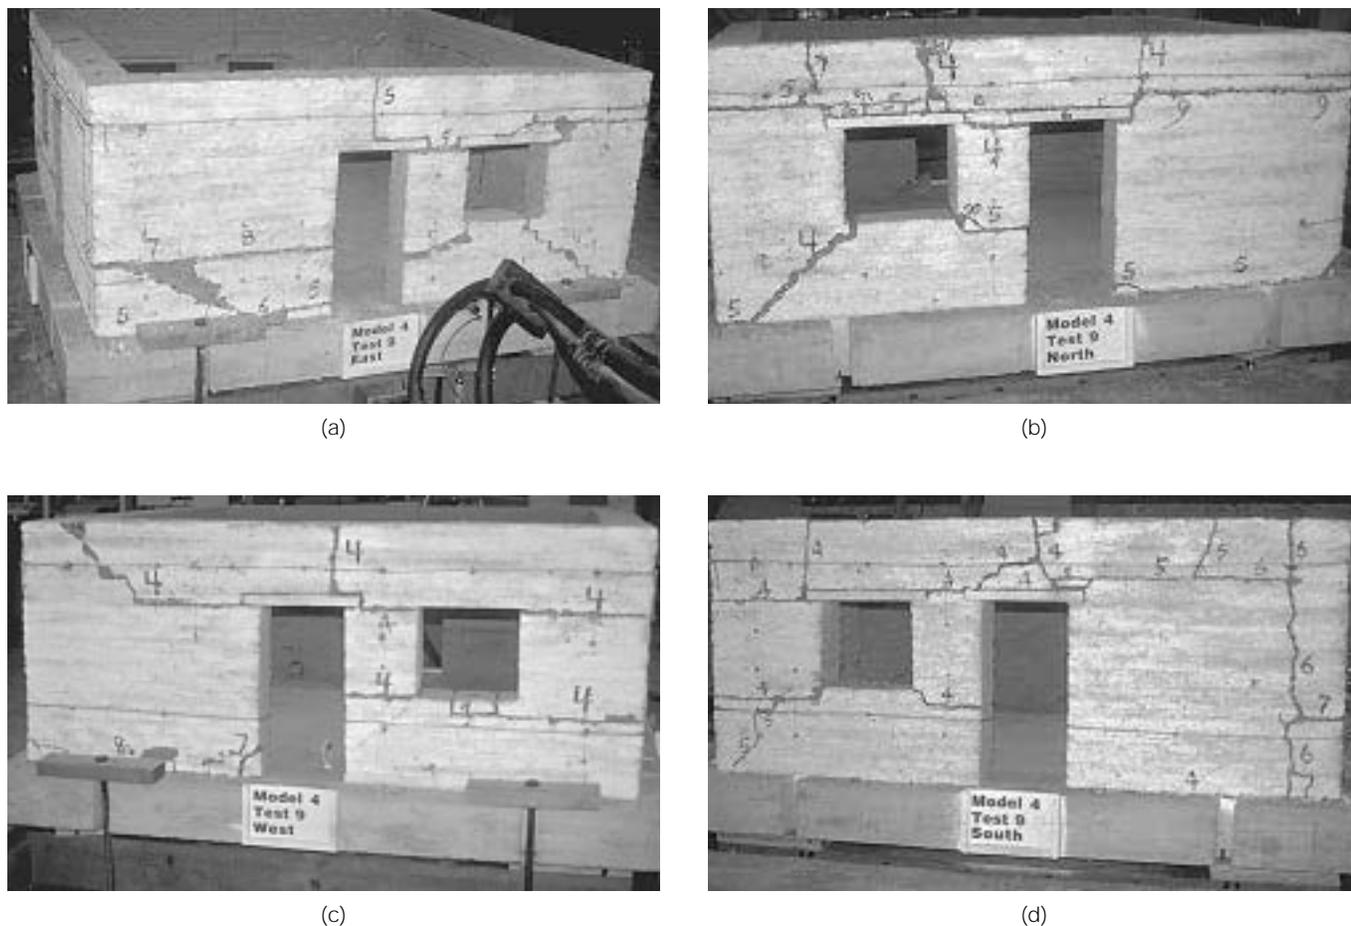
Figure 3.6

Model 4, test level IX, showing crack damage to (a) east wall (out of plane); (b) north wall (in plane); (c) west wall (out of plane); and (d) south wall (in plane). (Test level cracks are not marked on east and west walls; see Fig. 3.7a and c.) Before this test level, local crack ties were added to the pier blocks between the doors and windows because of the large displacements sustained during test level VIII. During test levels VIII and IX, rocking of the wall sections was greatly restrained by the upper horizontal strap. This restraint generated additional horizontal cracks in the large panel to the left of the door in the east wall at about one-third height.

offsets sustained during test level VIII. These blocks were pushed back into position before the ties were applied. The model behaved well during test level IX (fig. 3.6), although there were permanent offsets between many cracked wall sections.

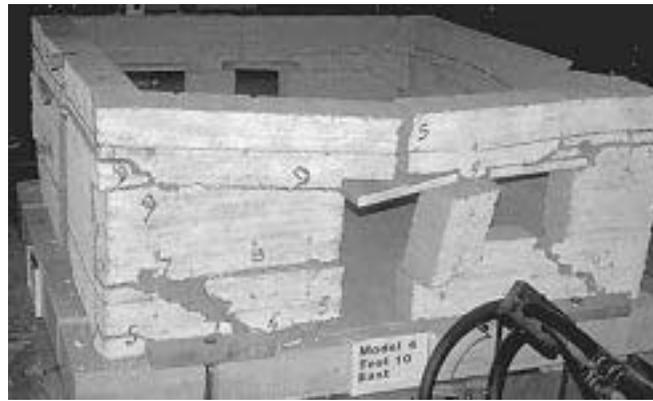
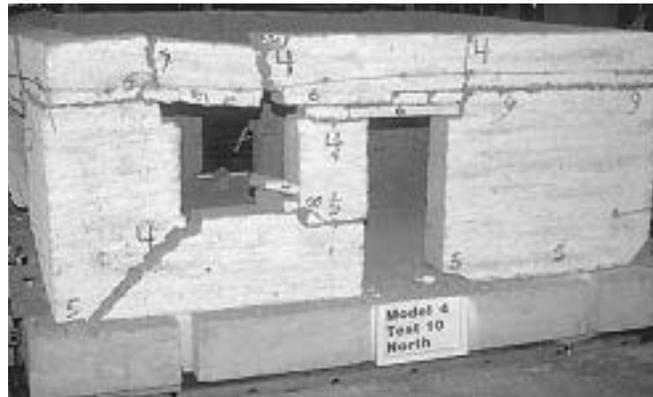
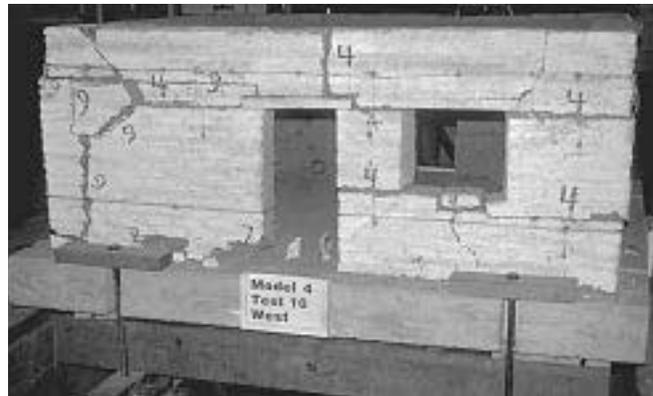
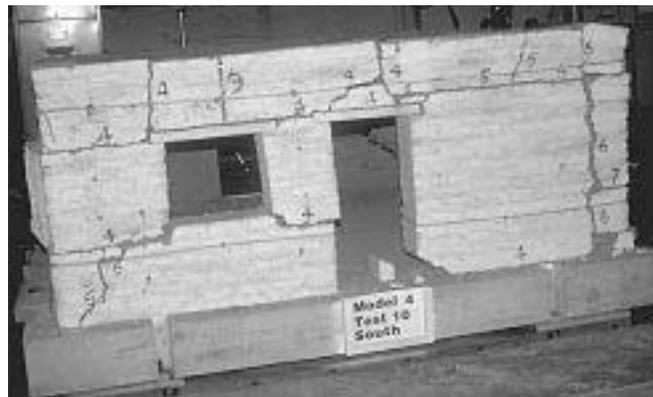
Figure 3.7

Model 4, test level X, showing damage to (a) east wall (out of plane); (b) north wall (in plane); (c) west wall (out of plane); and (d) south wall (in plane). The model nearly collapsed at this test level. The east wall was leaning outward, and the west wall would have fallen if not for the upper horizontal strap. The wood lintel over the window in the north wall was dislodged. A horizontal crack in the upper portion of the walls extended around the entire model. The piers between the door and window on both east and west walls were held in place by local ties that were added after test level IX.

The model nearly collapsed during test level X (fig. 3.7). The east wall was leaning outward at the end of the test. The wood lintel over the door of the east wall was dislodged, and the adobe block above it was nearly dislodged.

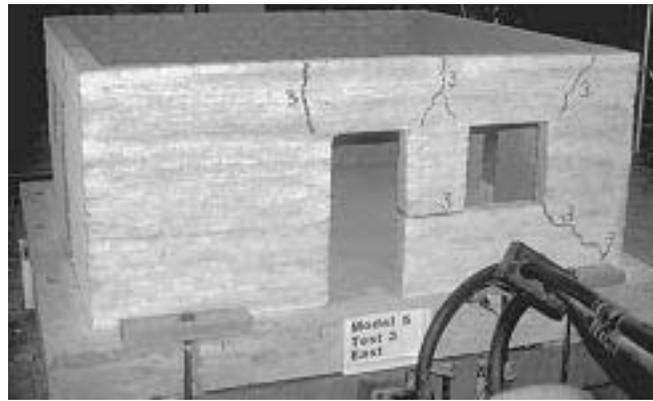
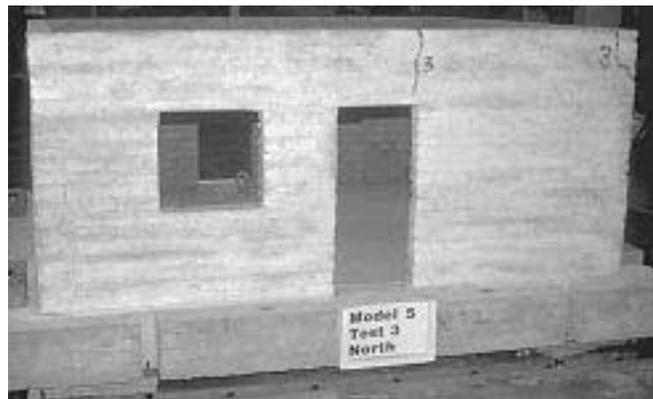
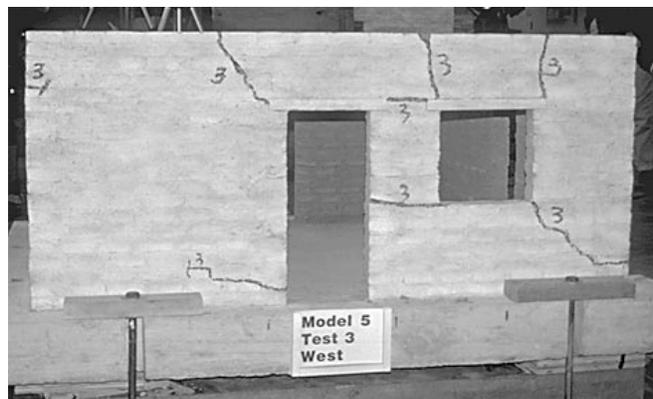
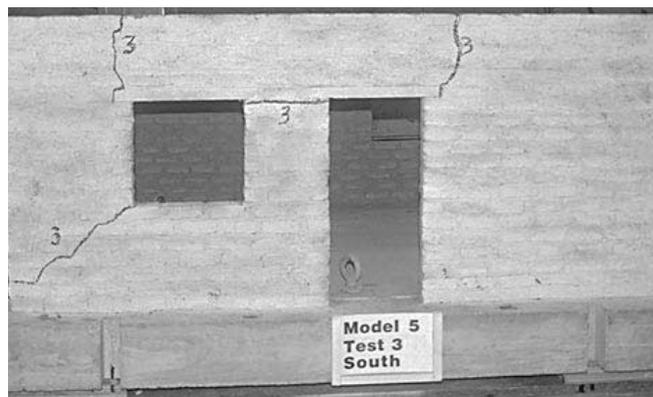
Figure 3.8

Model 5, test level III, showing (a) east wall (out of plane); (b) north wall (in plane); (c) west wall (out of plane); and (d) south wall (in plane). Minor cracking is seen with little visible out-of-plane wall displacement. Similar types and numbers of cracks developed in both in-plane and out-of-plane walls.

Model 5 was an unretrofitted control model, tested to demonstrate the vulnerability of unretrofitted adobe walls with $S_L = 11$. Cracks began to form during test level III (fig. 3.8), and the crack pattern fully developed during test level V (fig. 3.9) with the formation of flexural cracks in the out-of-plane walls and shear cracks in the in-plane walls (test level IV was omitted; table 3.2). Considerable rocking was observed during this test. The sequence was advanced to test level VIII, the fifth test in this series, which resulted in the complete collapse of the east wall and most of the west and south walls (fig. 3.10). The north wall was severely damaged, and the eastern corner was completely destroyed.

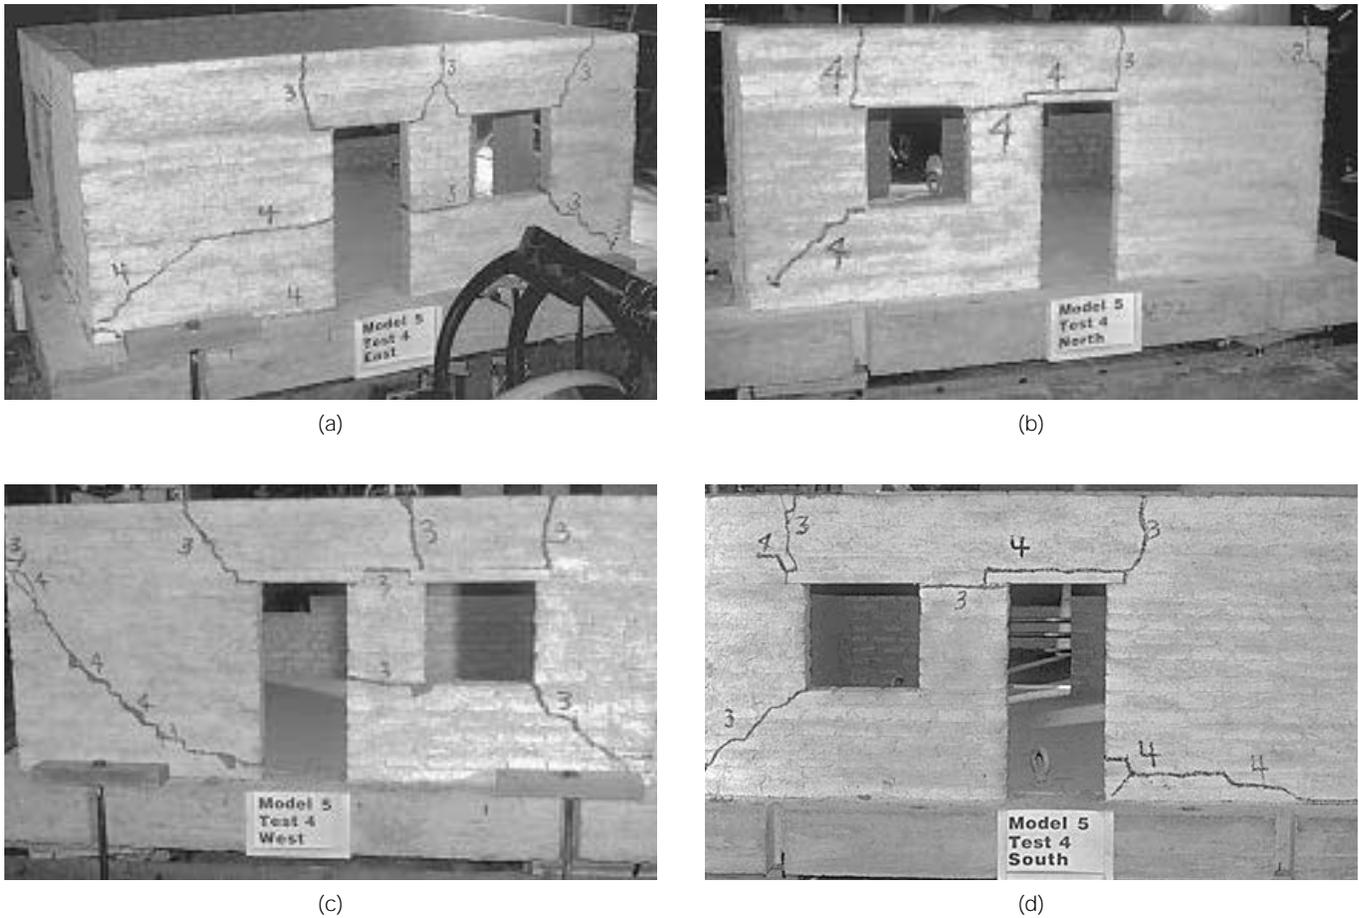
Figure 3.9

Model 5, test level V (fourth in the test sequence), showing cracking in (a) east wall (out of plane); (b) north wall (in plane); (c) west wall (out of plane); and (d) south wall (in plane). Fully developed crack pattern is visible with flexural cracks in the out-of-plane walls and shear cracks in the in-plane walls. The walls rocked noticeably during the test but did not collapse.

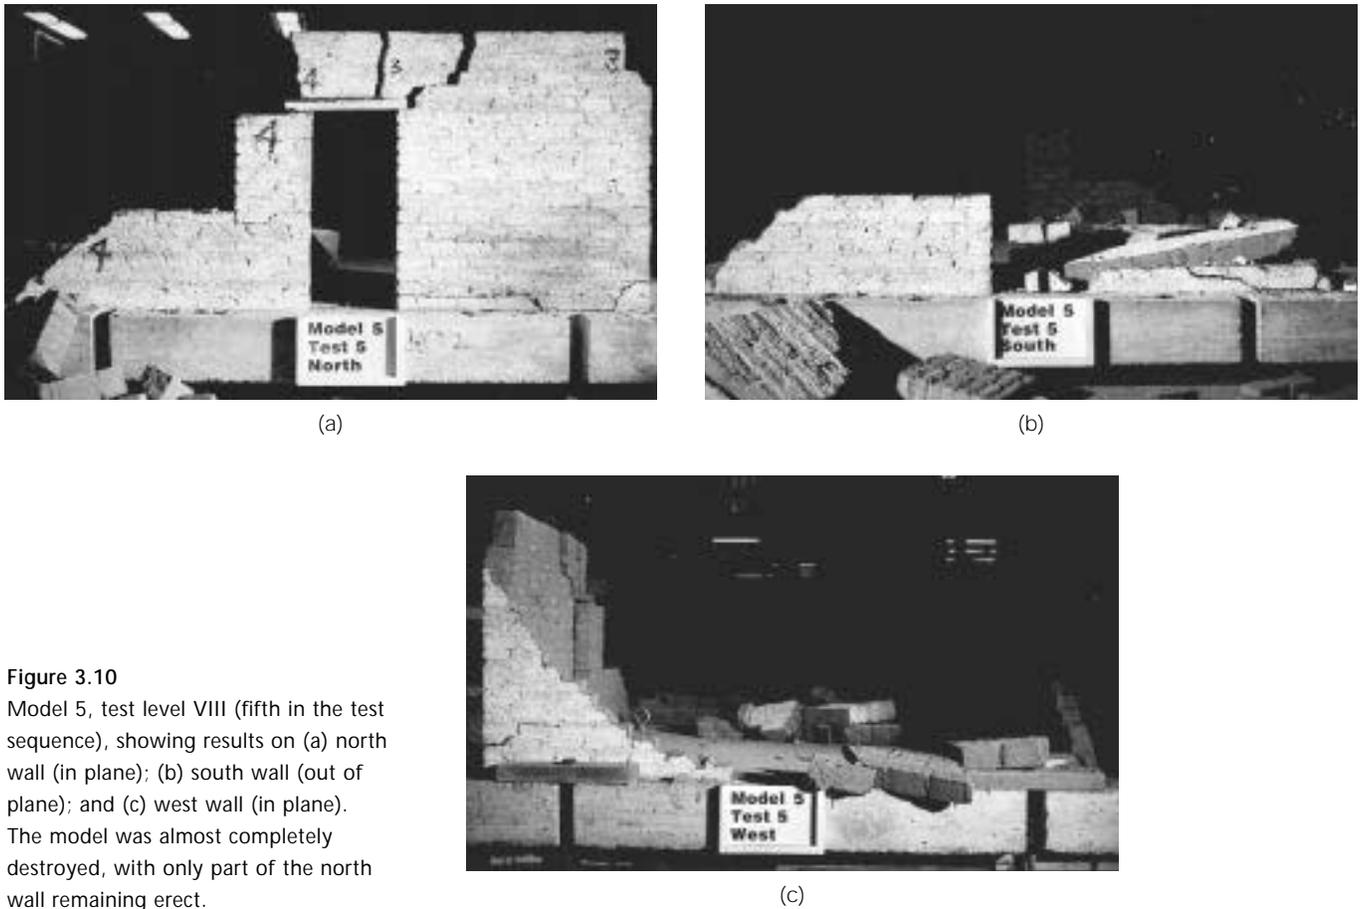
Figure 3.10

Model 5, test level VIII (fifth in the test sequence), showing results on (a) north wall (in plane); (b) south wall (out of plane); and (c) west wall (in plane). The model was almost completely destroyed, with only part of the north wall remaining erect.

The unretrofitted model 5 building collapsed almost completely during test level V (fig. 3.10). Unretrofitted model 9 nearly collapsed during test level V. In-plane walls suffered severe damage, offsets, and partial collapse during test level VI (fig. 5.28).

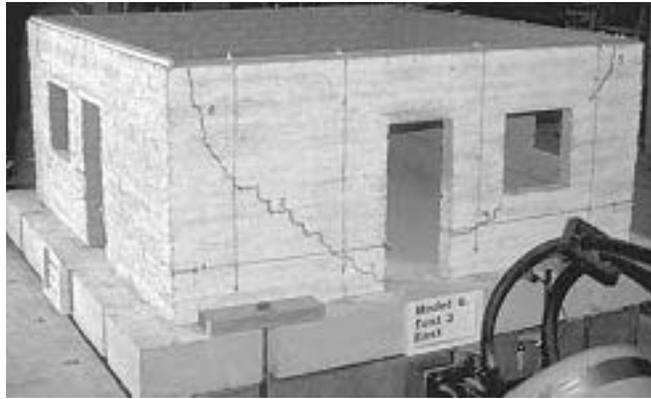
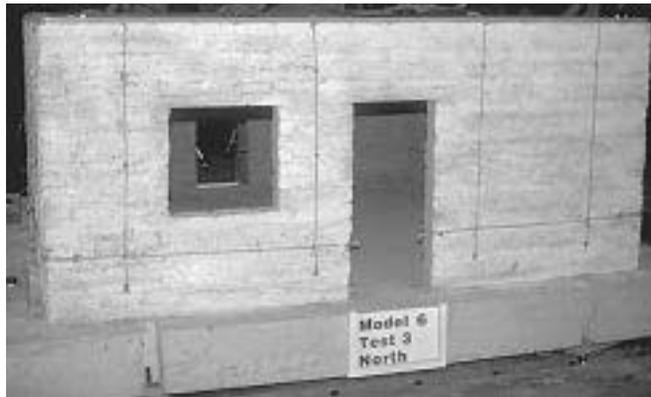
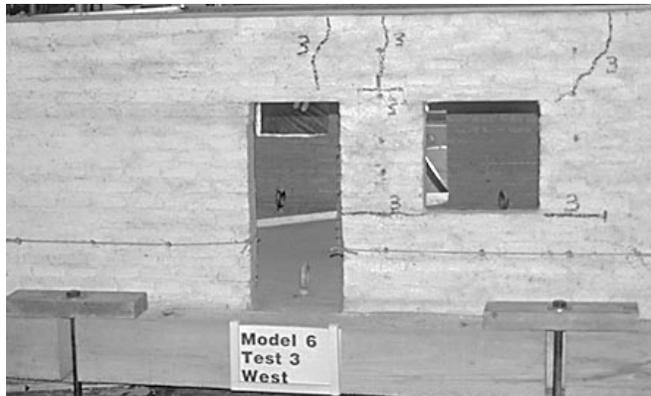
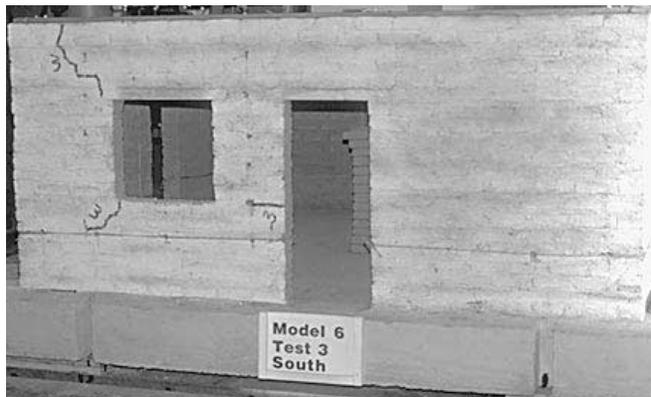
Figure 3.11

Model 6, test level III, showing (a) east wall (out of plane); (b) north wall (in plane); (c) west wall (out of plane); and (d) south wall (in plane). Initial cracking is visible, and a classic flexural pattern was observed in the east wall, though only small cracks were observed in the west wall. No cracks developed in the north wall, and only two or three slight cracks developed in the south wall.

As expected, the performance of the retrofitted model 6 was much better than that of model 5. During test levels III–V, the crack patterns were similar to those of the unretrofitted model (table 3.3; figs. 3.11–3.13). Large flexural, yield-line cracks developed in the east and west walls, which demonstrated that the bond beam had little effect on the elastic behavior of the model. Few additional cracks developed between test levels IV and VI.

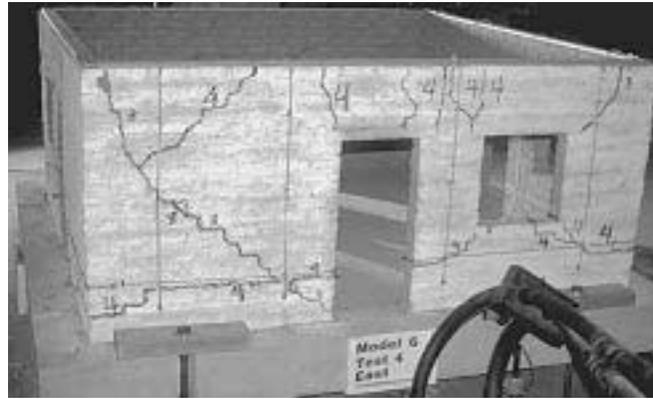
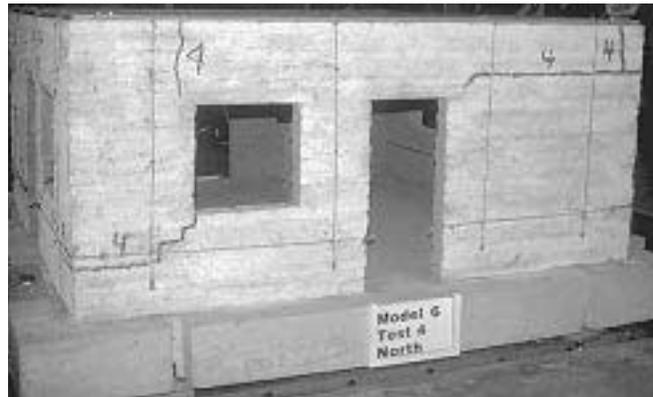
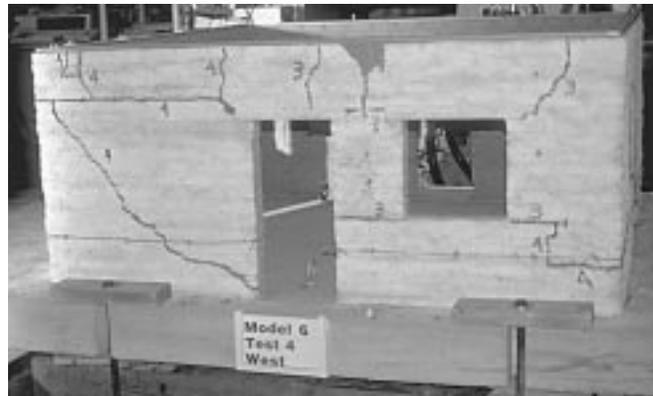
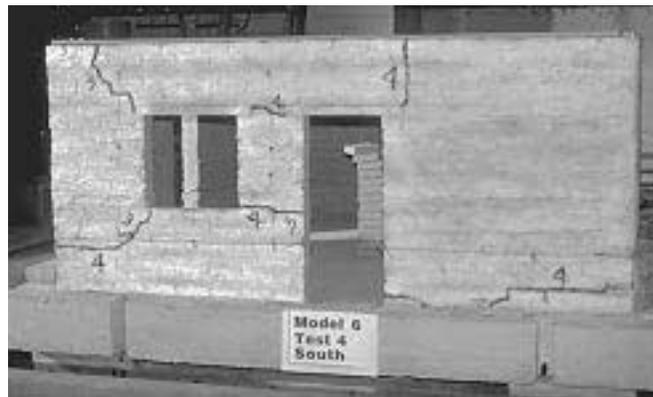
Figure 3.12

Model 6, test level IV, showing (a) east wall (out of plane); (b) north wall (in plane); (c) west wall (out of plane); and (d) south wall (in plane). A more complete crack pattern is apparent, particularly in out-of-plane walls. Flexural displacements at the tops of these walls are clearly visible. Spalling at the top of the west wall is indicative of large displacement motions; the diagonal cracks in the large solid wall sections of both east and west walls are typical of flexural cracking. Damage to the north and south walls is still relatively minor. The horizontal crack in the upper right corner of the north wall is typical of cracking in walls reinforced with a bond beam.

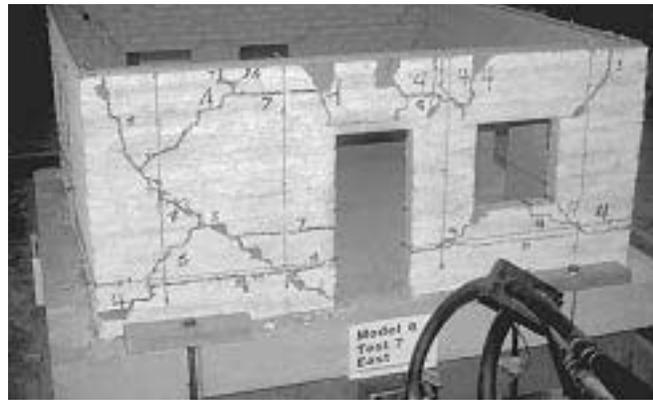
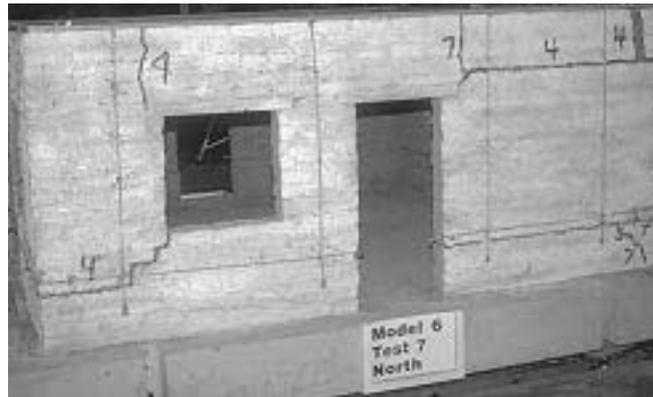
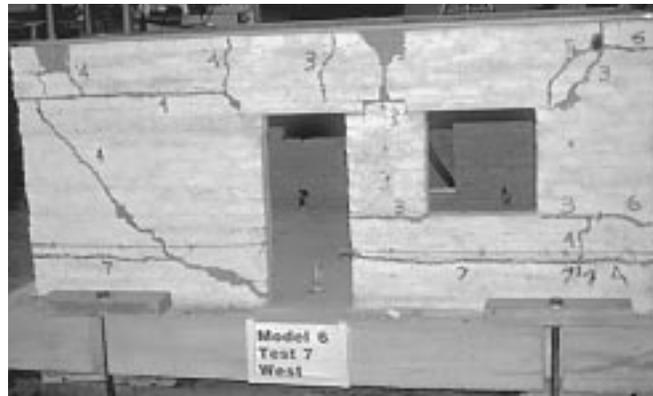
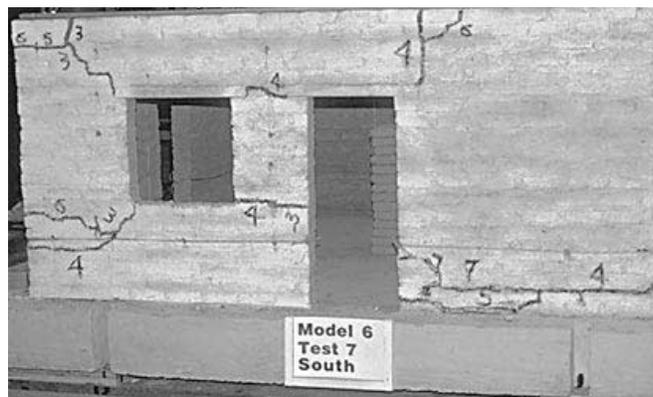
Figure 3.14

Model 6, test level VII, showing (a) east wall (out of plane); (b) north wall (in plane); (c) west wall (out of plane); and (d) south wall (in plane). Spalling at the top of the east and west walls is indicative of large out-of-plane displacements. Some additional minor cracks developed during this test. In-plane displacements of north and south walls became more substantial, but little new cracking developed. Some small permanent displacements occurred at the end of this test.

During test levels VI and VII, the retrofit system was very active (figs. 3.13 and 3.14). The out-of-plane walls rotated about their bases, allowing substantial dynamic displacement of the east and west walls. The magnitude of these displacements was governed by the mass of the wall, coupled with the stiffness of the bond beam.

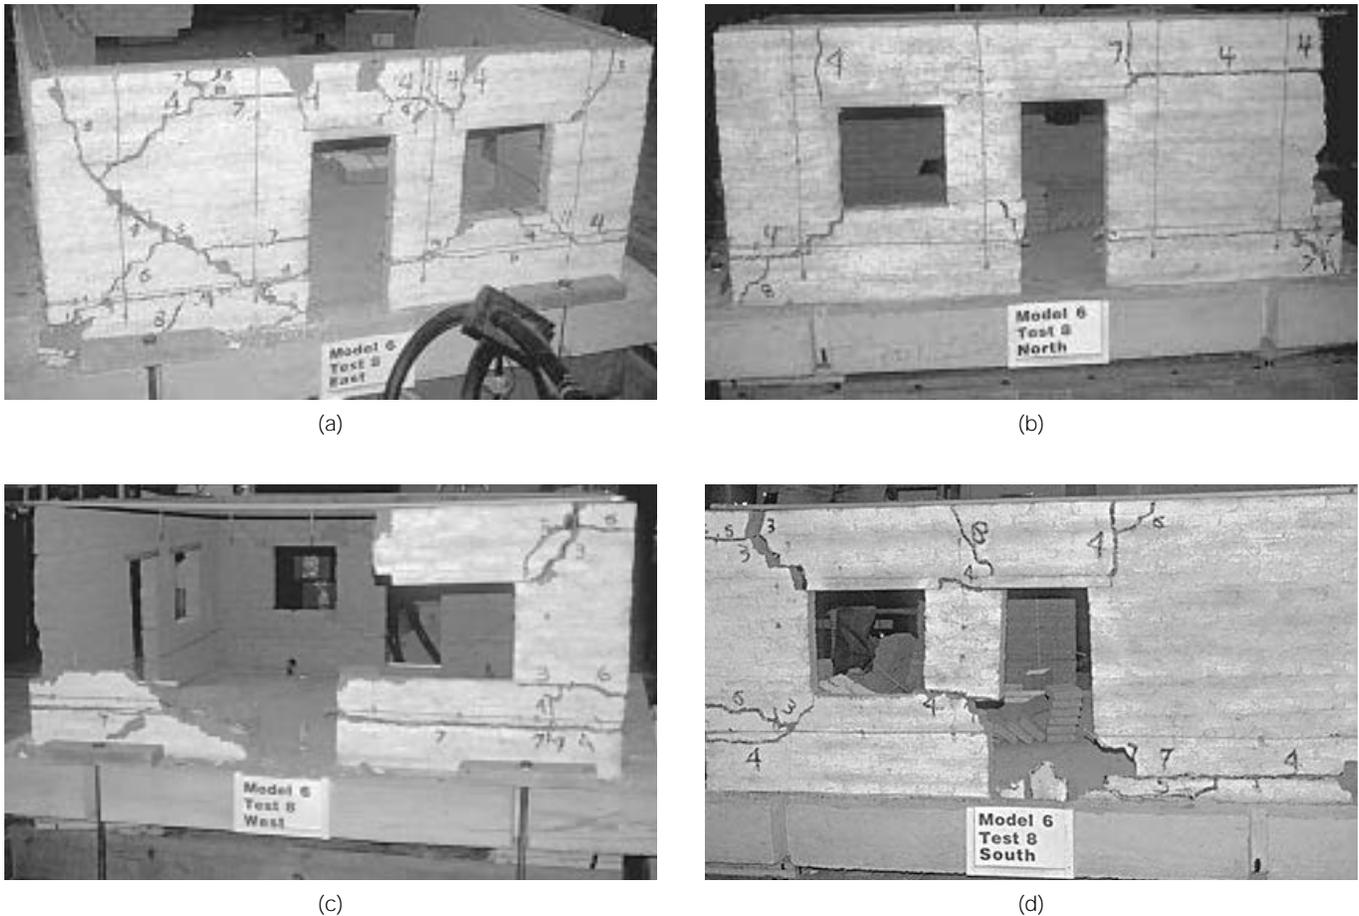
Figure 3.15

Model 6, test level VIII, showing (a) east wall (out of plane); (b) north wall (in plane); (c) west wall (out of plane); and (d) south wall (in plane). Dynamic motions of the model were substantial. During test levels VI and VII, stability of the out-of-plane walls was dependent on the bond beam. During test level VII, out-of-plane stability became dependent on both the bond beam and the vertical straps. Collapse of the west wall by overturning started below the horizontal crack that formed during test level IV at the north end of the west wall. The north and south walls were also subjected to substantial movement, resulting in significant permanent displacements. Relative displacements of cracked wall sections were less severe in the north wall, which had vertical straps, than in the south wall, which had only local through-ties.

In test level VIII, the lightly retrofitted west wall collapsed (fig. 3.15). Local crack ties had been applied at several locations but were not effective in preventing out-of-plane collapse.

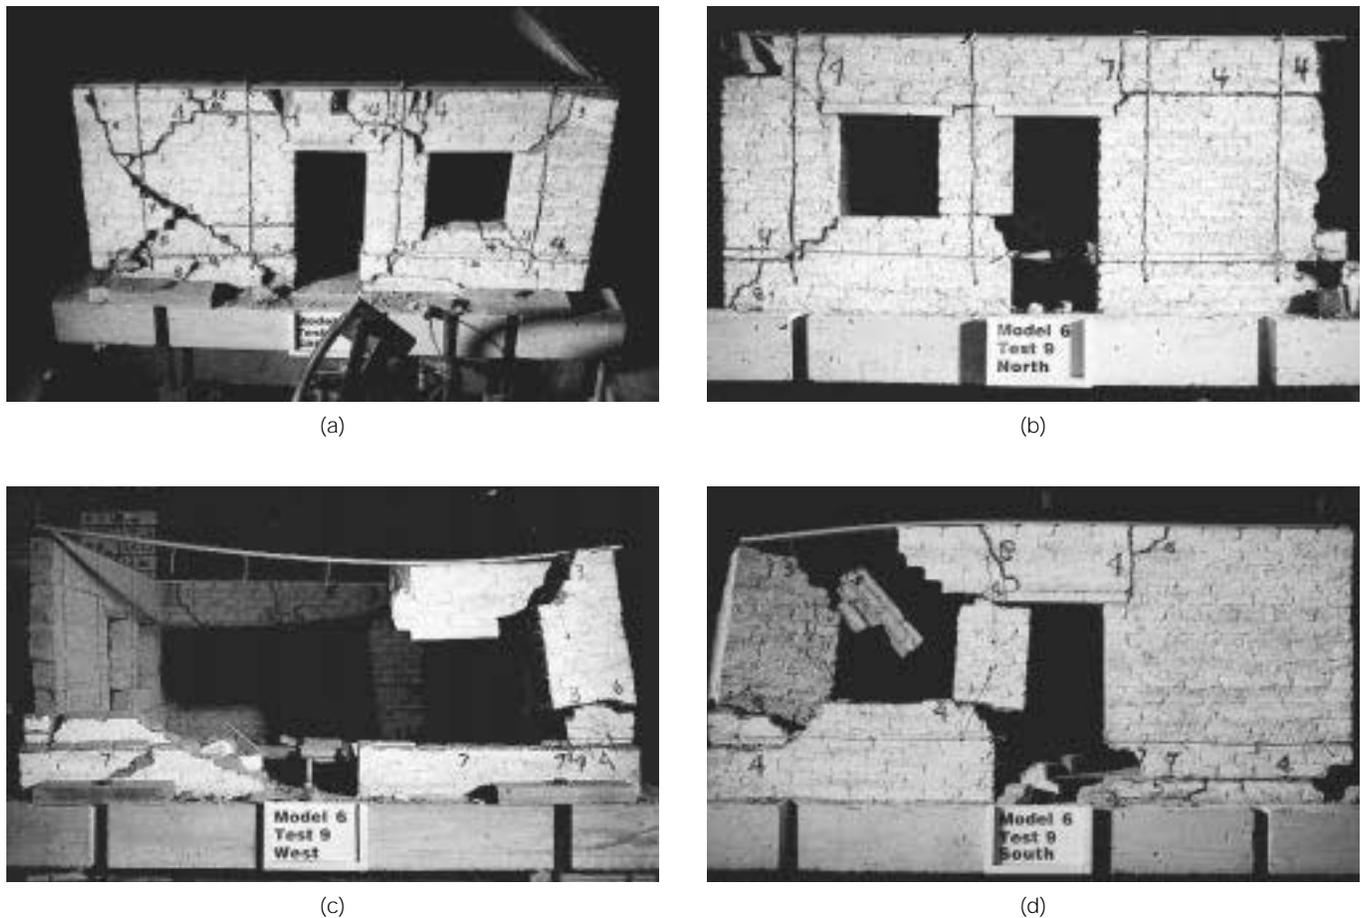
Figure 3.16

Model 6, test level IX, showing (a) east wall (out of plane); (b) north wall (in plane); (c) west wall (out of plane), collapsed at test level VIII; and (d) south wall (in plane). The test sequence continued, despite the collapse of the west wall, which undoubtedly compromised the structural performance of the south wall. Nevertheless, the continuous successful performance of the north and east walls demonstrated the robustness of the retrofit system used on these two walls. The east wall again showed large displacements, but the dynamics of the wall was also largely affected by displacements of the in-plane walls. Overall displacements in the north wall were smaller than those in the south wall. Local ties have some overall stabilizing influence but seem to be relatively poor as displacement controls.

A portion of the in-plane south wall collapsed (fig. 3.16) during test level IX. Nevertheless, the two sections of the north wall that were retrofitted with vertical straps continued to perform well.

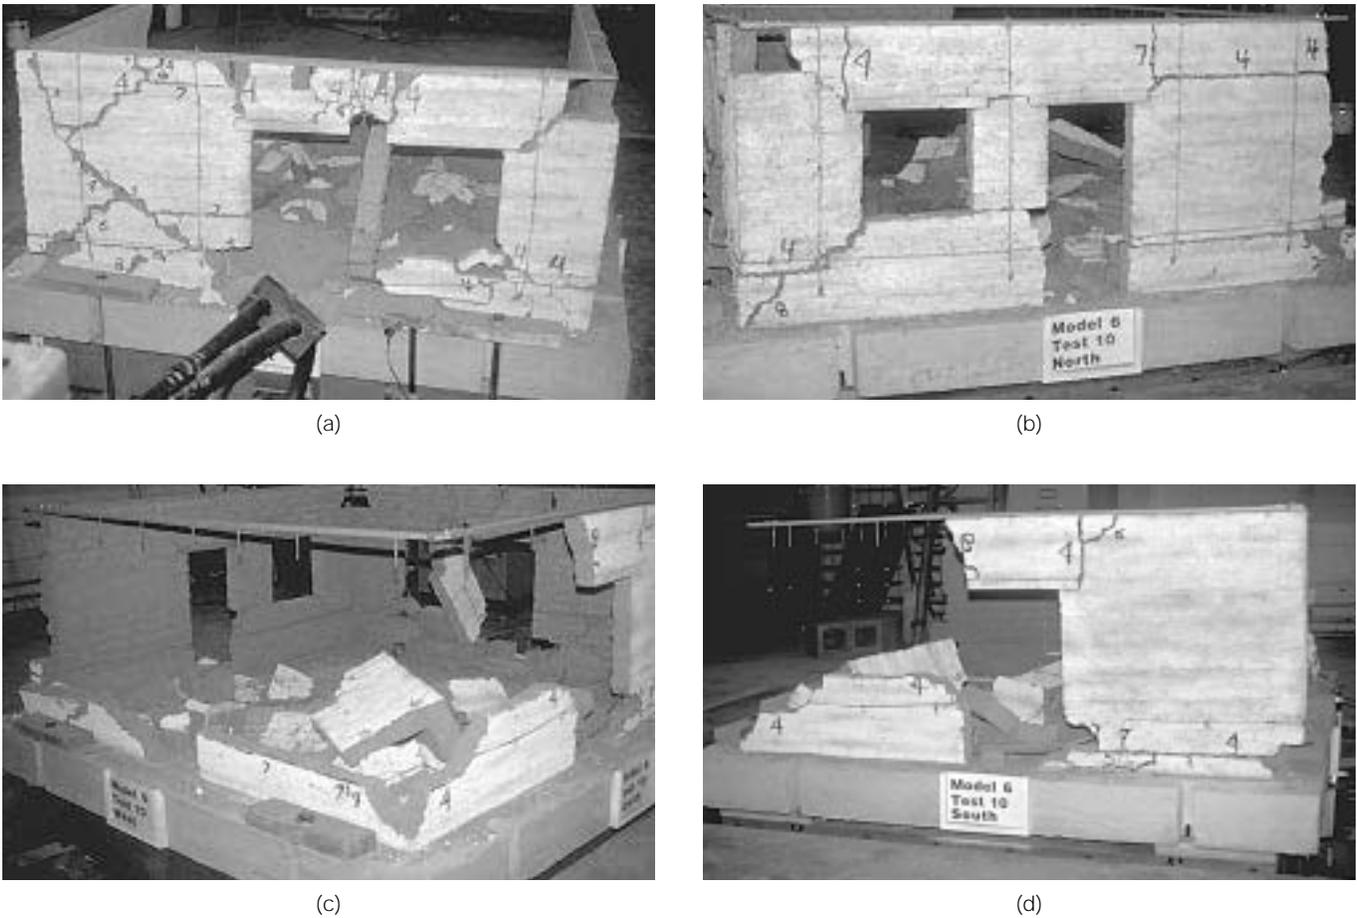
Figure 3.17

Model 6, test level X, showing (a) east wall (out of plane); (b) north wall (in plane); (c) west wall (out of plane); and (d) south wall (in plane). Model approached complete collapse. The north wall behaved well, the bond beam and vertical straps being quite effective. On the east wall, the vertical strap on the central pier did not provide enough stability to prevent collapse. The remainder of the east wall degraded severely, showing that this type of retrofit system for walls with $S_L = 11$ is not as robust as on walls with $S_L = 7.5$ (model 2), which withstood several repetitions at test level X.

Most portions of the north and east walls performed well through test level X (fig. 3.17). The walls did not collapse nor was the building in the unstable condition noted for model 4 after test level X. The pier between the door and window was dislodged during the test and was suspended by the vertical straps. There were insufficient displacement controls on this pier to prevent it from being dislodged.

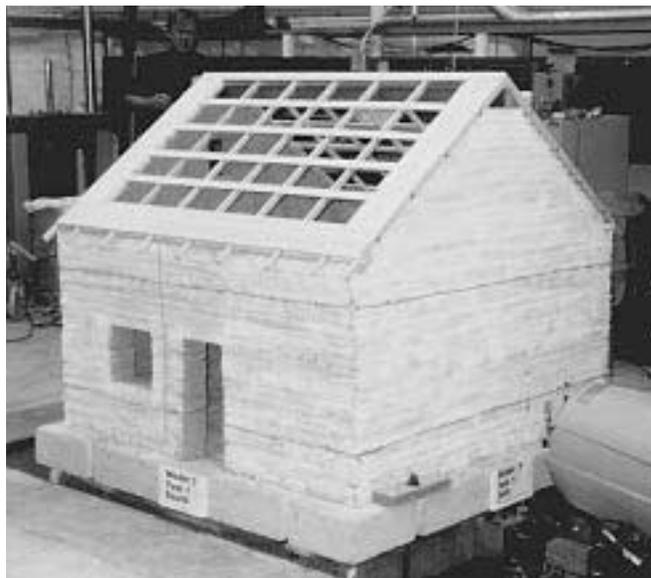
Figure 4.1
Model 7 before testing.

The models and tests discussed in the previous chapters were designed primarily to study the behavior of adjoining adobe walls during and following simulated seismic excitation. Model 7, however, was the first model tested in this research project that resembled a real building—with an attic and a roof—that could be used to study the global response of an essentially complete structure (fig. 4.1).
