Seismic Stabilization of Historic Adobe Structures

Final Report of the Getty Seismic Adobe Project

E. Leroy Tolles
Edna E. Kimbro
Frederick A. Webster
William S. Ginell

GCI Scientific Program Reports

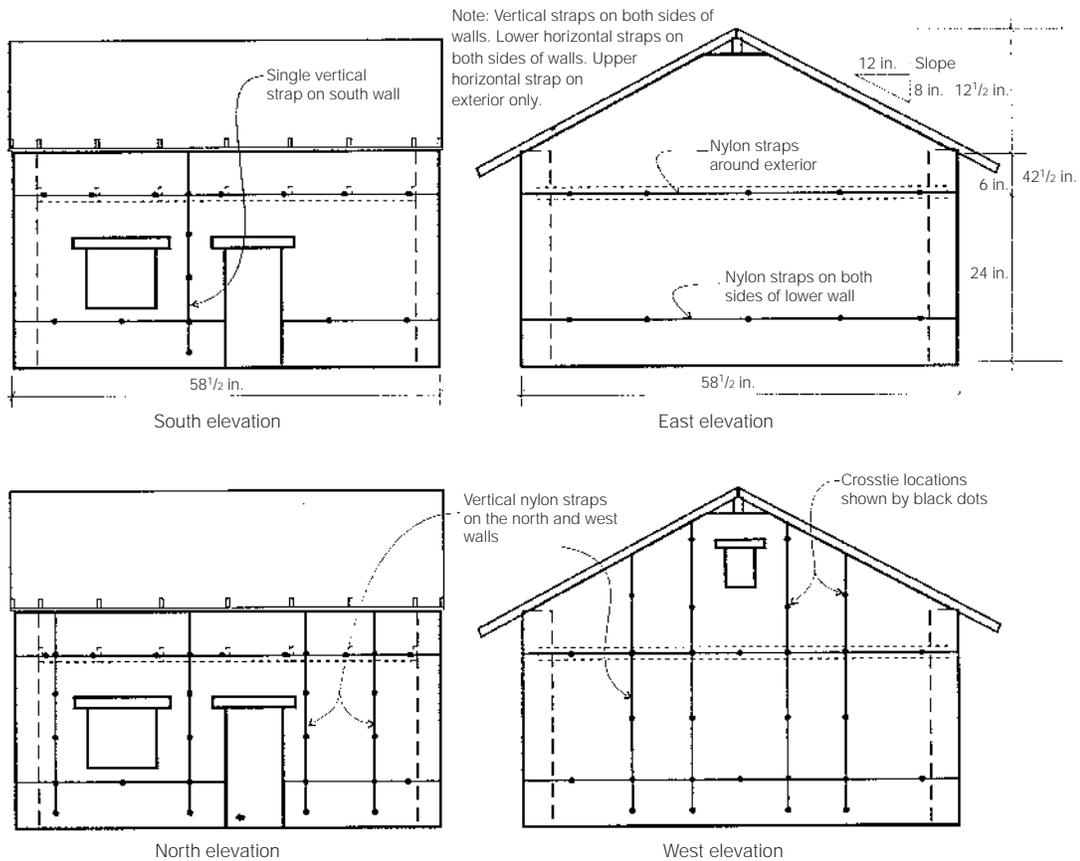
Figure 4.2

Elevations showing retrofit measures applied to model 7. The south wall has only one vertical strap, and the east wall has none, whereas the north and west walls have four vertical straps each.

The design of model 7 was based on the tapanco-style adobe architecture commonly seen in the southwestern United States. These historic structures were characterized by walls that extended 61–91 cm (2–3 ft.) above an attic floor and had a pitched roof (8:12) that covered the attic and gable-end walls ($S_L = 5$). The load-bearing north and south walls each had a door and a window, the west gable-end wall had a small attic window, and the east wall was windowless (figs. 4.1 and 4.2).

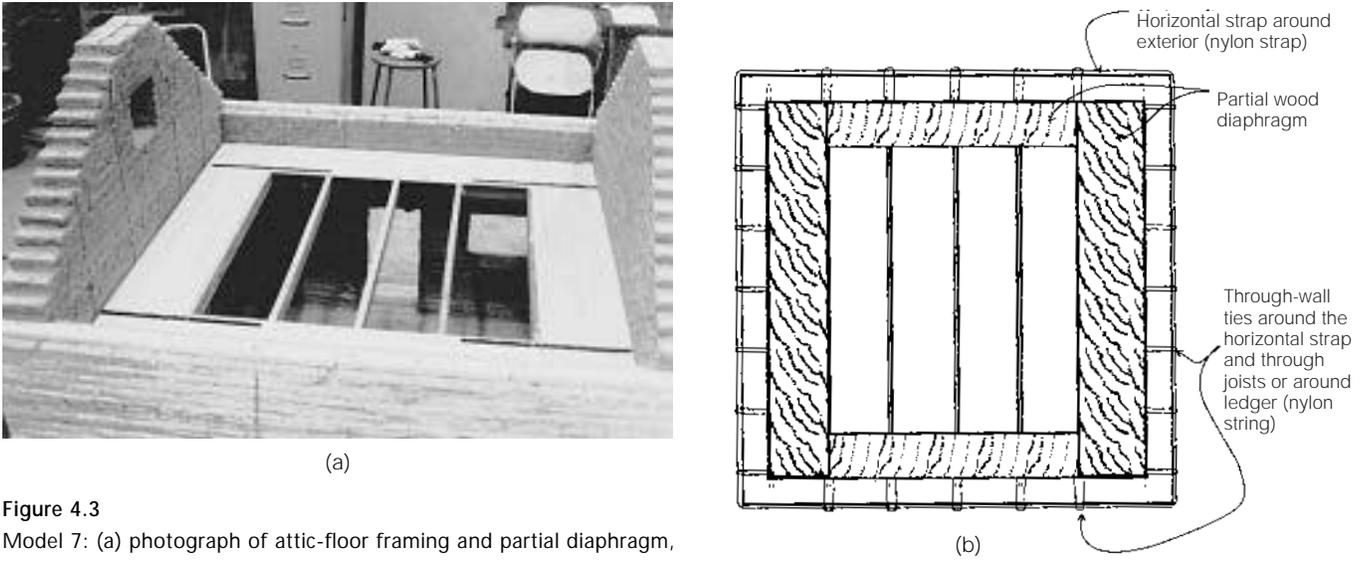
Figure 4.3
 Model 7: (a) photograph of attic-floor framing and partial diaphragm, made of wood; and (b) attic plan, showing retrofit measures applied at floor level.

The retrofit measures used with model 7 were based on the more successful measures tested in models 1–6, with the addition of partial diaphragm systems on the attic floor and roof. The retrofitting system consisted of horizontal and vertical straps applied to the walls, and partial wood diaphragms anchored to the attic floor and roof. The remainder of the retrofit system consisted of connection details. Details of the system are shown in figures 4.3–4.5.

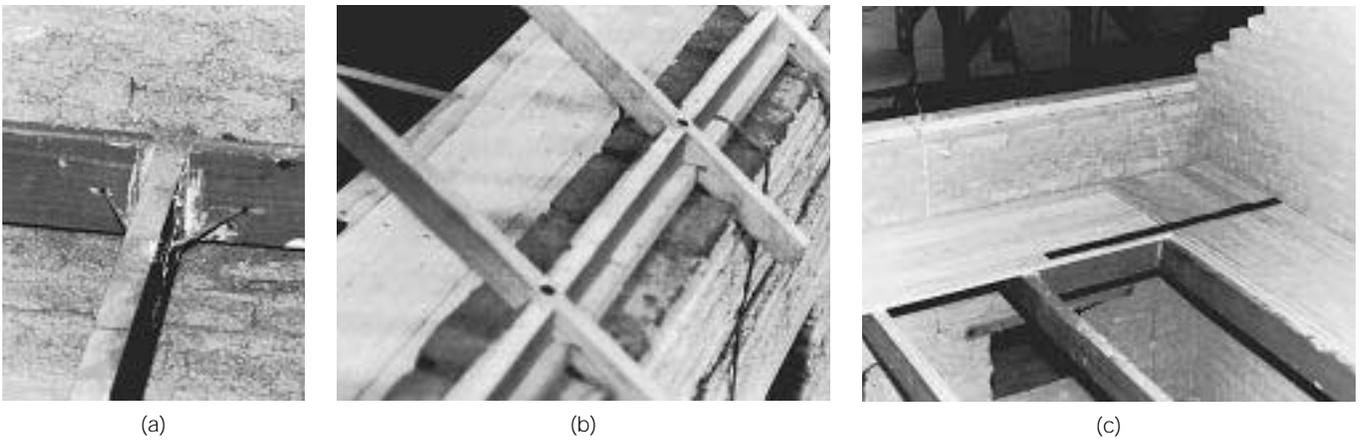
Figure 4.4
 Details of model 7: (a) inside of attic floor, showing through-ties connecting joist and wall; (b) roof line of load-bearing wall; (c) interior corner of partial wood diaphragm; and (d) section drawing of wall, roof, and attic floor, showing retrofit measures.

The bearing plates on the tops of the load-bearing walls (fig. 4.4) were segmented so as not to act as stiffening flexural elements. The plates were cut into four segments on the tops of the north and south walls and were anchored to the walls with 7.6 cm (3 in.) long, coarse-thread (gypsum wall board) screws.

The attic-floor joists were anchored to the walls with small-diameter through-wall ties that were threaded through small holes in the center of the attic-floor joist, as shown in figure 4.4a. The cord was passed through the adobe wall on both sides of the joist and was attached to the horizontal strap on the exterior face of the wall. The roof rafters were anchored with screws to the bearing plates, and blocking was placed between each of the roof rafters (fig. 4.4b).

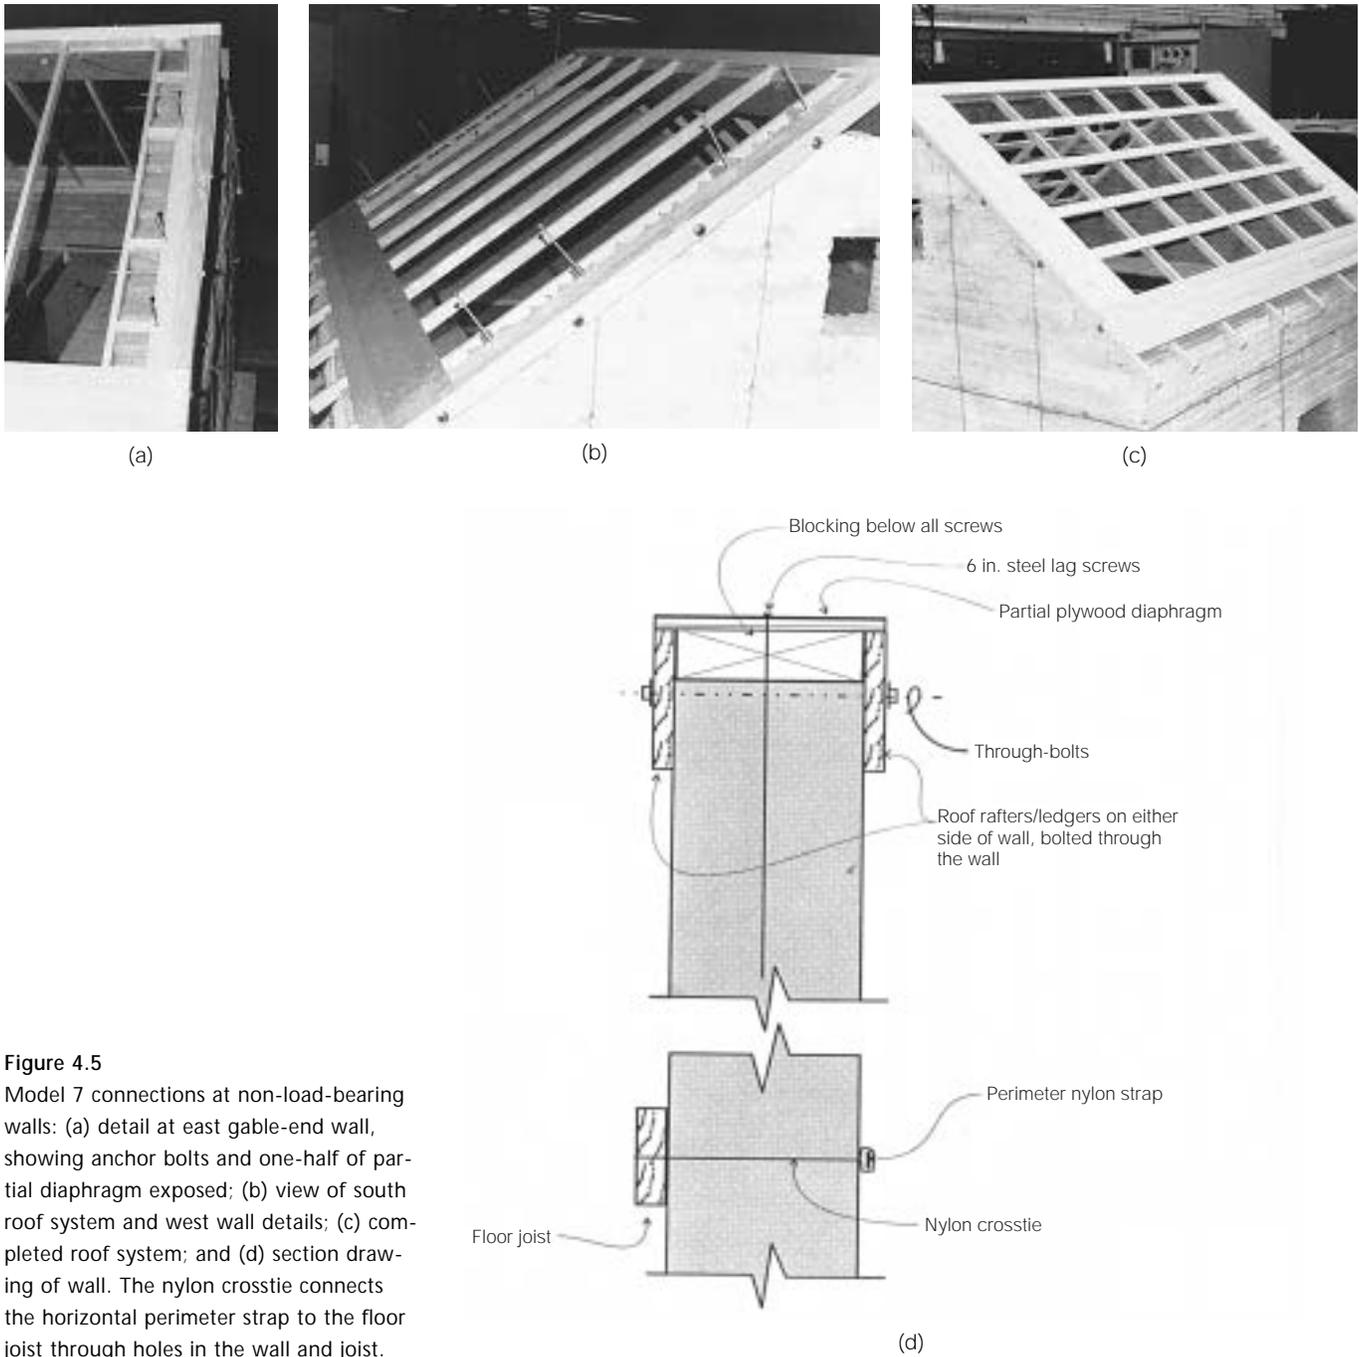
Figure 4.5

Model 7 connections at non-load-bearing walls: (a) detail at east gable-end wall, showing anchor bolts and one-half of partial diaphragm exposed; (b) view of south roof system and west wall details; (c) completed roof system; and (d) section drawing of wall. The nylon crosstie connects the horizontal perimeter strap to the floor joist through holes in the wall and joist.

On the non-load-bearing walls, the roof rafters were placed directly on both sides of the wall and tied together with bolts through the wall. The partial roof diaphragm was attached to the tops of the roof rafters. Coarse-thread screws 15 cm (6 in.) long extended through the roof diaphragm and blocking into the wall (see fig. 4.5). The purpose of these details was to anchor the tops of the gable-end walls to the roof system. These connections worked well and did not fail during the tests.

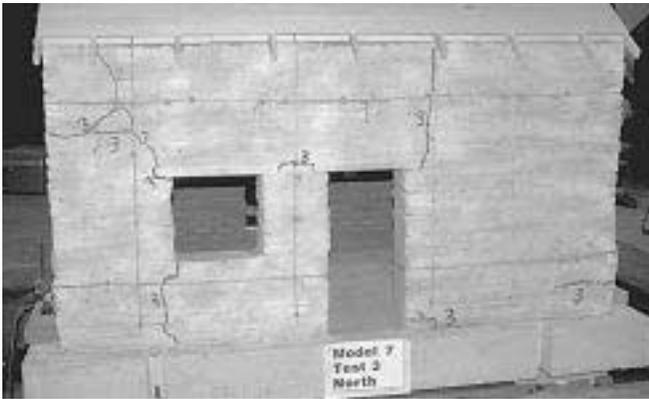
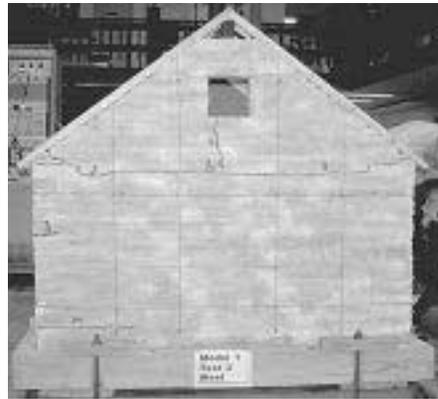
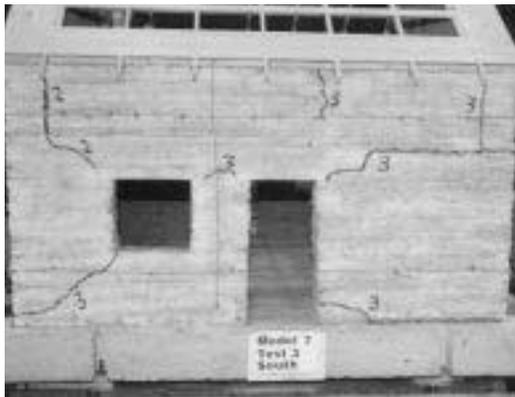
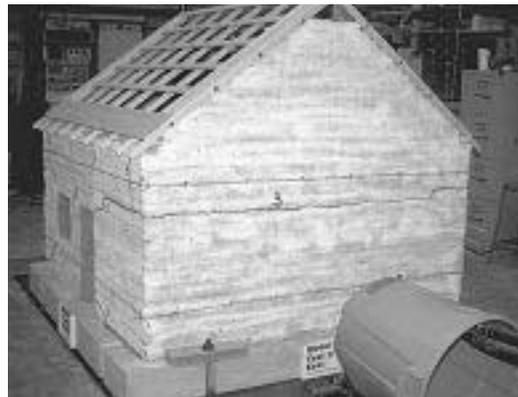
Figure 4.6

Model 7, test level III, showing (a) north wall (in plane); (b) west wall (out of plane); (c) south wall (in plane); and (d) east wall (out of plane). Initial cracking is visible. Shear cracks developed in the north and south walls at the corners of openings and at the base of the large wall panel to the right of the doorway. In the east and west walls, a single horizontal crack developed in each wall. In the east wall, the crack was just below the attic-floor line. In the west wall, the crack was just above the attic-floor line.

Overall, the performance of model 7 and the behavior of the retrofit measures were very satisfactory (figs. 4.6–4.12). A review of the videotape that recorded wall motions during the tests indicated that substantial sections of the model would have collapsed during test level VI or VII.

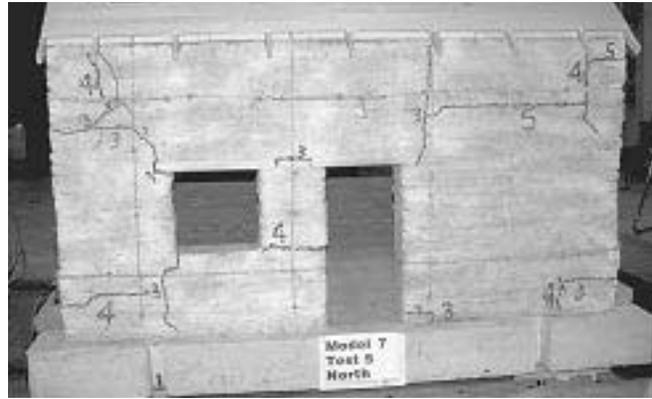
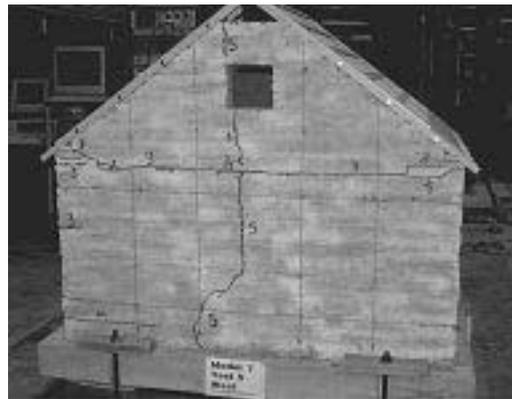
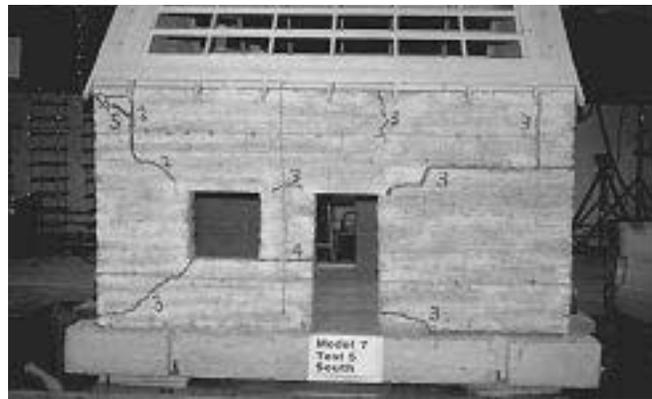
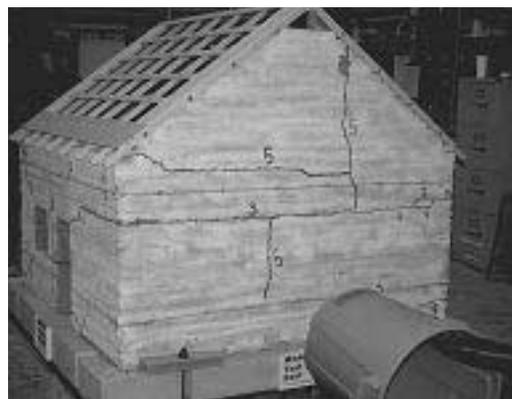
Figure 4.7

Model 7, test level V, showing (a) north wall (in plane); (b) west wall (out of plane); (c) south wall (in plane); and (d) east wall (out of plane). Most new damage was in the east and west walls. The upper section of the walls continued to rock, and vertical cracks developed near the center of both the east and west walls. An additional horizontal crack developed in the east wall above the attic-floor line. The north and south wall damage remained relatively constant, although a new horizontal crack developed in the north wall in the large panel at the attic-floor level.

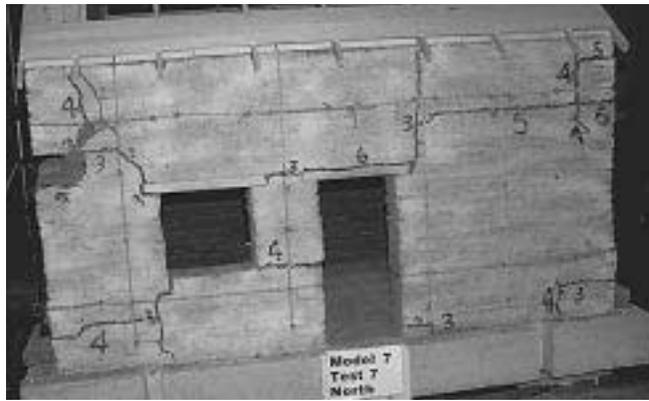
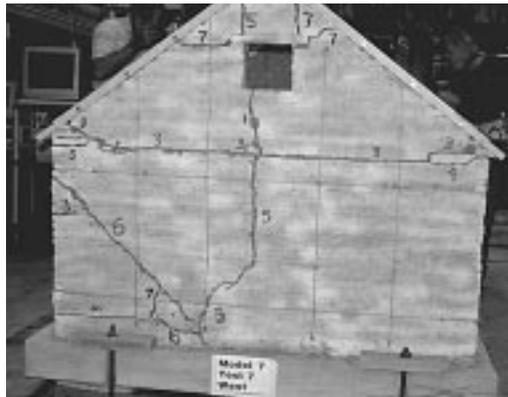
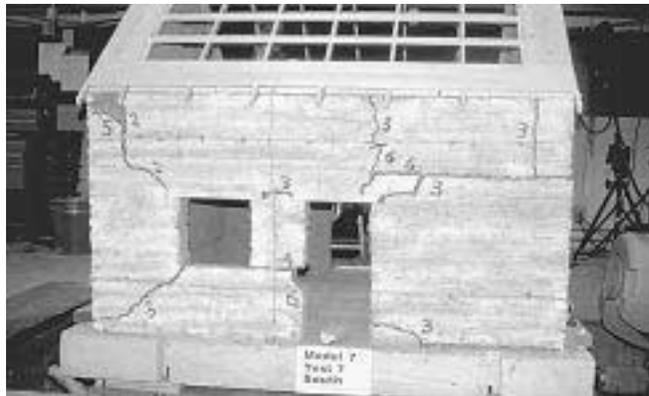
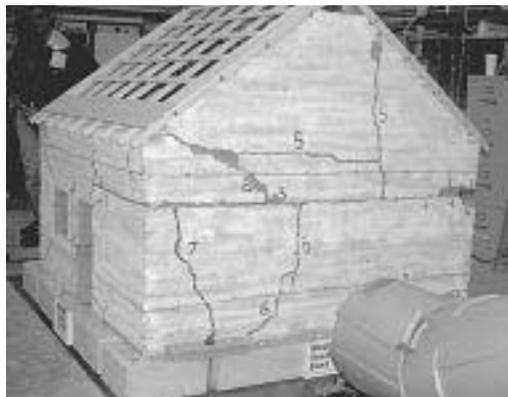
Figure 4.8

Model 7, test level VII, showing (a) north wall (in plane); (b) west wall (out of plane); (c) south wall (in plane); and (d) east wall (out of plane). Major crack patterns were nearly complete after test level V. During test levels VI and VII, some cracks were extended, but most remained unchanged. The principal exceptions were a diagonal crack in the west wall near the north end during test level VI and a similar crack in the east wall during test level VII. Only a few new cracks developed in the north and south walls during these tests. During test level VII, a section in the upper east corner of the north wall dislodged, and a permanent displacement occurred at the lower east corner of the window on the north wall.

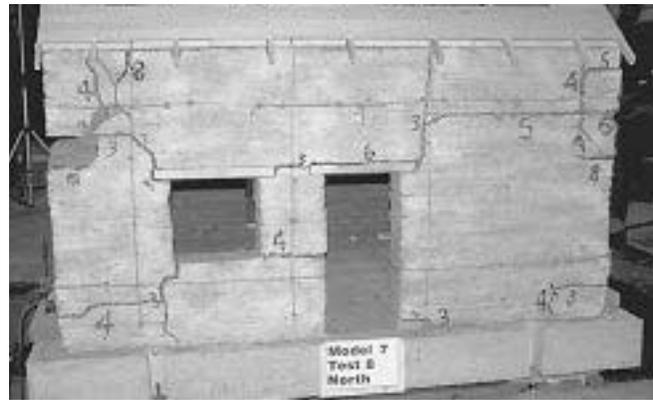
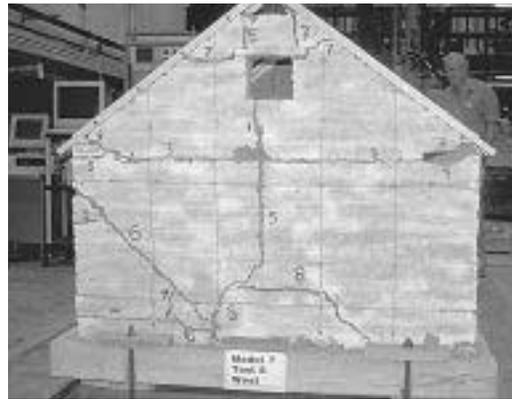
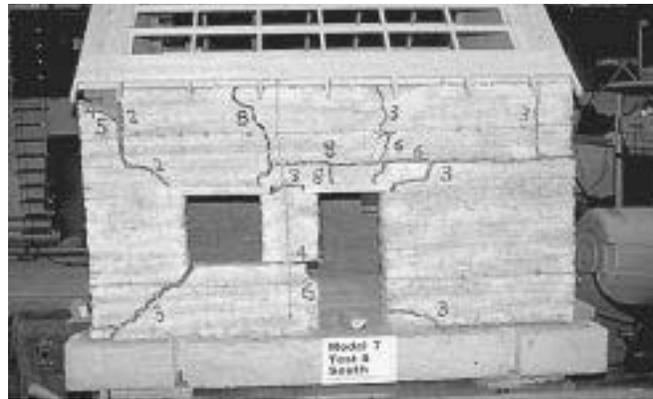
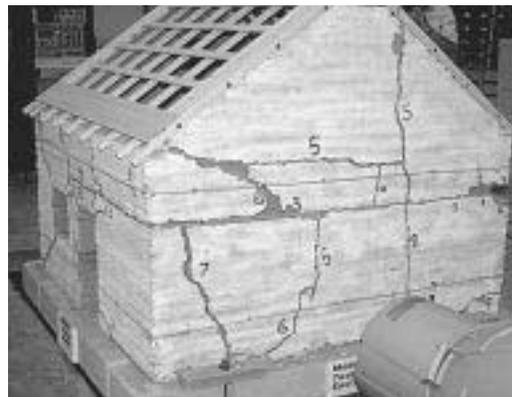
Figure 4.9

Model 7, test level VIII, showing (a) north wall (in plane); (b) west wall (out of plane); (c) south wall (in plane); and (d) east wall (out of plane). Additional cracks developed in the east and west walls, notably a horizontal crack in the lower portion of the west wall and a vertical crack in the right lower portion of the east wall, which was a continuation of an existing vertical crack in the upper gable portion of the wall. Additional cracks developed in the north and south walls. Of further significance were the permanent offsets of 0.64–1.27 cm (0.25–0.5 in.) at some locations.

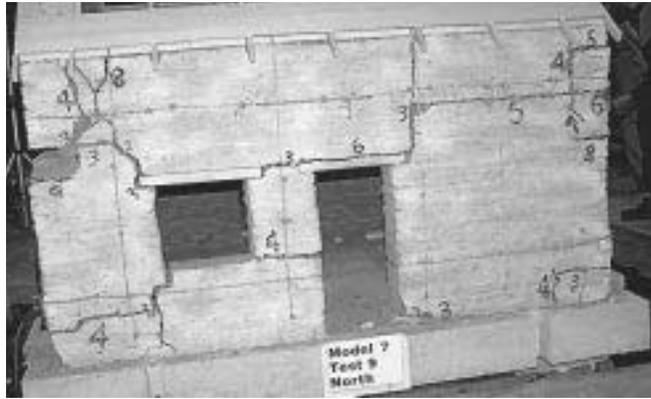
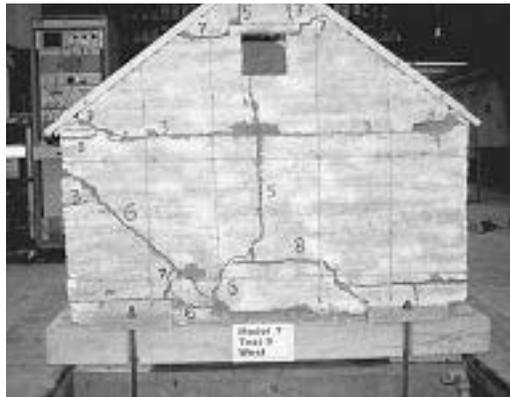
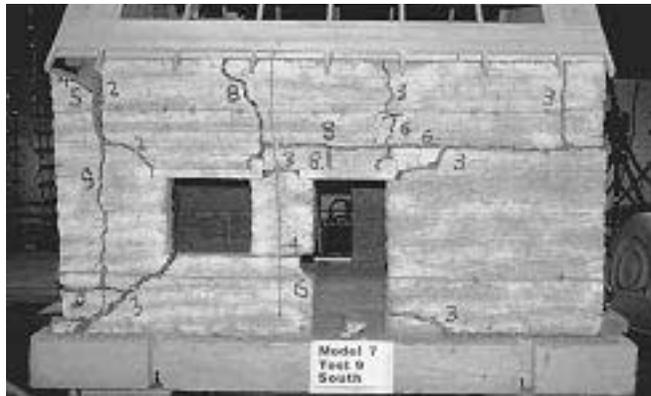
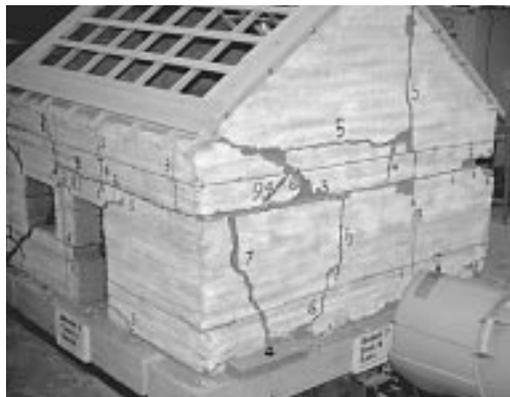
Figure 4.10

Model 7, test level IX, showing (a) north wall (in plane); (b) west wall (out of plane); (c) south wall (in plane); and (d) east wall (out of plane). Only a few new cracks developed in the model during the test, and wall motions were confined mainly to sliding and rocking of the cracked wall sections. In the east and west walls, some permanent offsets occurred at the horizontal cracks. The permanent offsets observed in the north and south walls continued to increase.

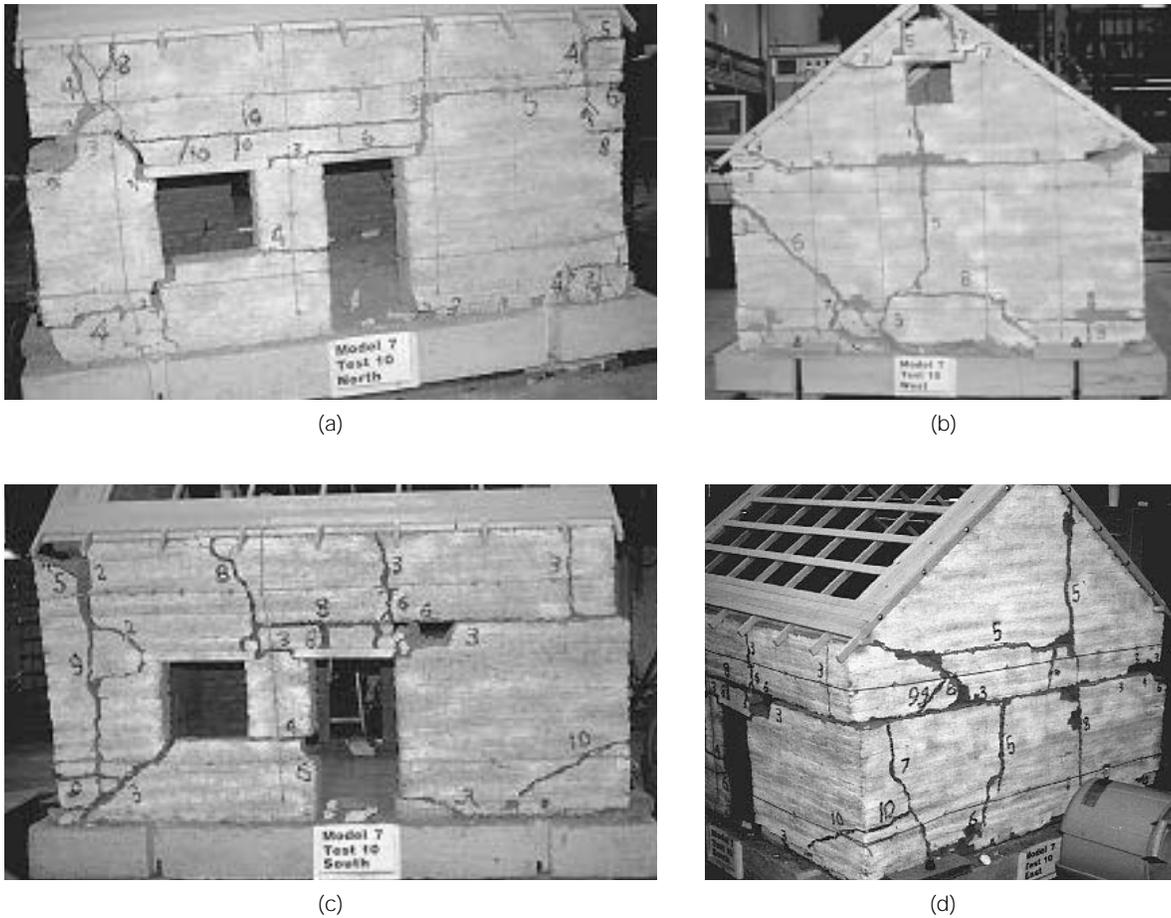
Figure 4.11

Model 7, test level X(1), the first of two tests at this level, showing (a) north wall (in plane); (b) west wall (out of plane); (c) south wall (in plane); and (d) east wall (out of plane). The dynamic stability of the structural system is clearly in question here. Horizontal offset at the attic-floor level in the east wall is most visible on the east side of the south wall elevation. The condition of the north and south walls continued to degrade. The section of the wall to the left of each window had offsets of approximately 1.88 cm (0.75 in.). The offsets at the upper west side of the south wall were largest. Both north and south walls had offsets of approximately 3.8 cm (1.5 in.) along the diagonal crack at the lower left corners of the windows.

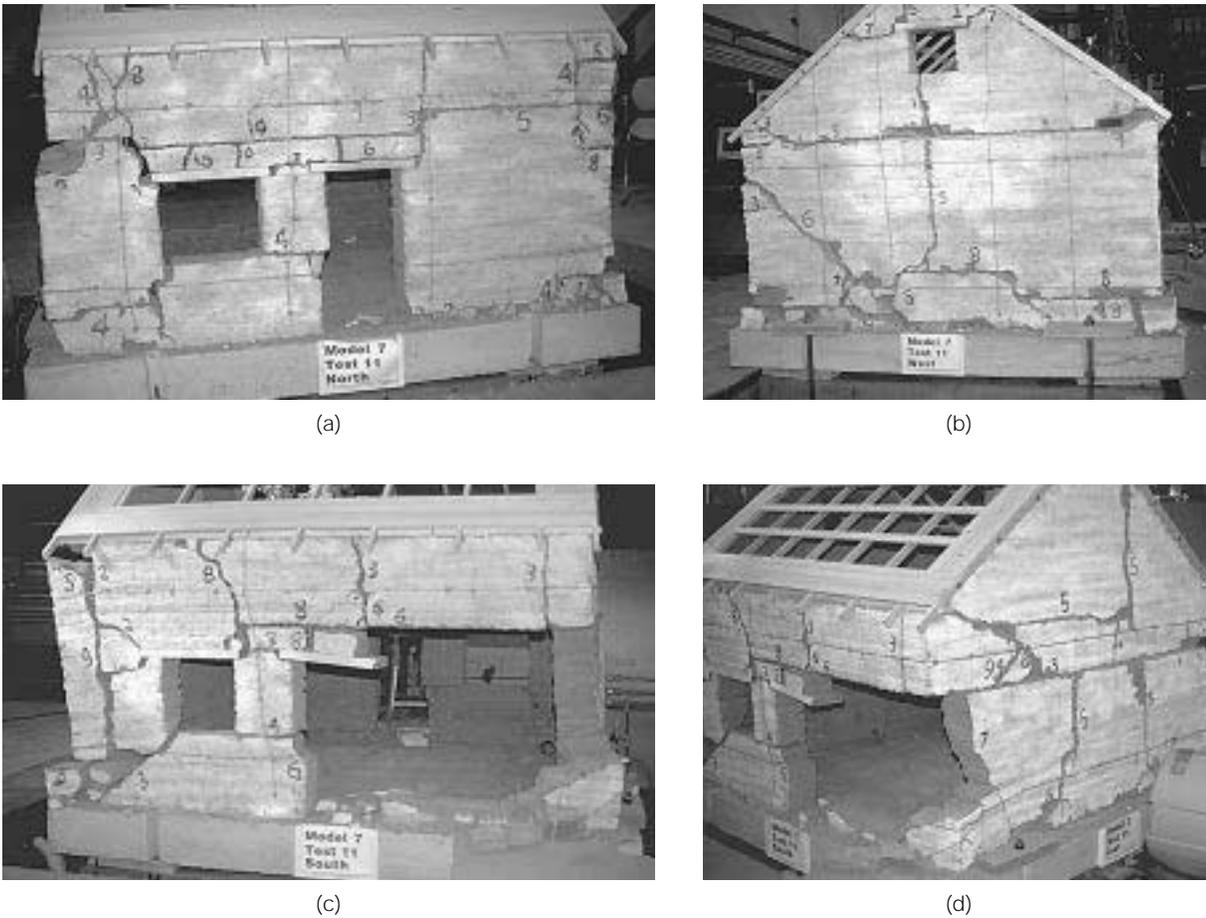
Figure 4.12

Model 7, test level X(2), the second of two tests at this level, showing (a) north wall (in plane); (b) west wall (out of plane); (c) south wall (in plane); and (d) east wall (out of plane). Lack of restraint in the southeast corner allowed the unstable wall section to collapse at the end of this test. The retrofit measure on the north and west walls, where vertical straps were used, provided sufficient restraint on the cracked wall sections to ensure overall structural stability.

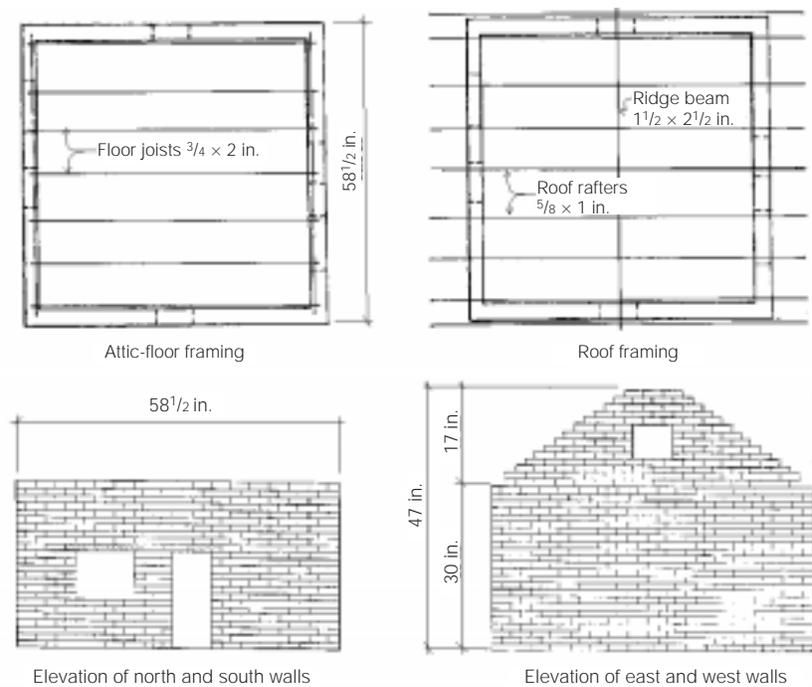
Figure 5.1
Plan and elevations for models 8 and 9.

The layout of models 8 and 9 ($S_L = 7.5$) was the same as that of model 7 ($S_L = 5$) (except that an attic window was added to the east wall) and was typical of tapanco-style adobe construction. The plans and elevations for these models are shown in figure 5.1. The walls were one wythe wide and the bricks were laid in a running bond pattern.

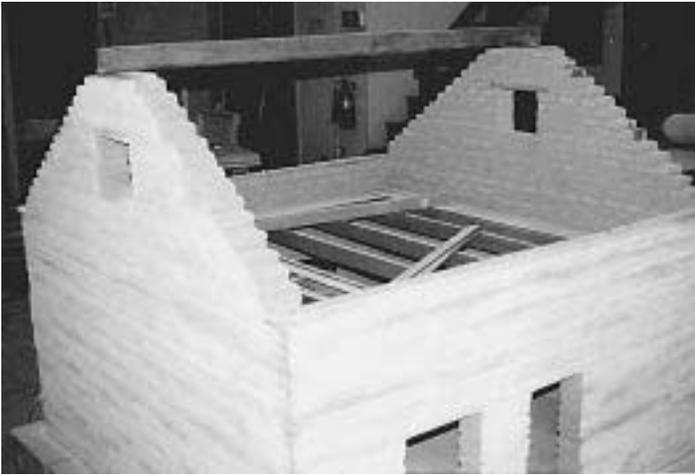
Figure 5.2
Model 8 before roof framing was added, with ridge beam in place.

Construction details are shown in figures 5.2–5.5. In model 8, the floor framing and ridge beam were installed before the roof rafters were in place (fig. 5.2). Figure 5.3 shows model 9 with the complete roof system, which represents the basic structural system to which the retrofit measures were added in model 8. For construction purposes on the small-scale models, much of the retrofit systems for models 7 and 8 needed to be installed before the roof was constructed. The roof sheathing was widely spaced to ensure that the roof system did not significantly affect the out-of-plane motions of the gable-end walls.

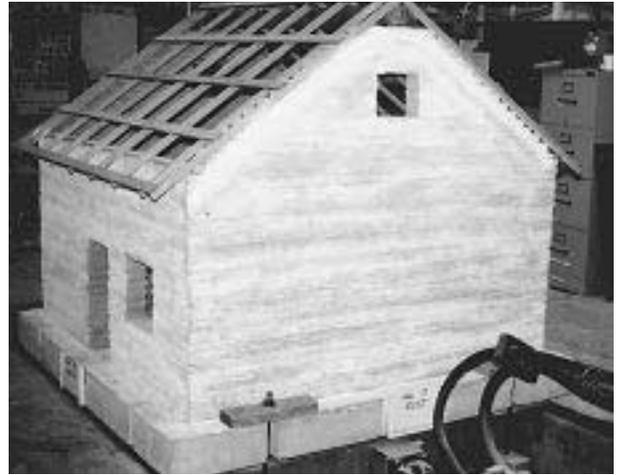
Figure 5.3
Model 9 after roof framing was installed.

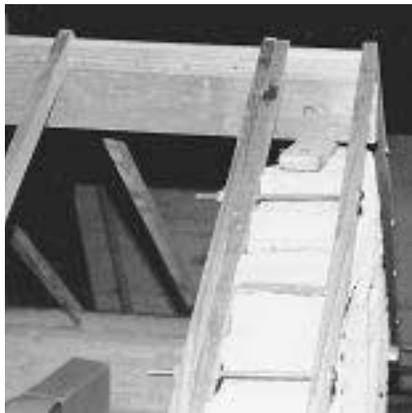
Figure 5.4
Detail of model 8, with through-bolts tying roof rafters together on both sides of the gable-end walls. This retrofit measure was used only on this model.

Roof-end rafters were placed on both sides of the gable-end walls so the walls were partially bearing against them (figs. 5.4 and 5.5). Through-bolts were used only on model 8. Even without these through-bolts, the joists did provide some lateral restraint to the tops of the

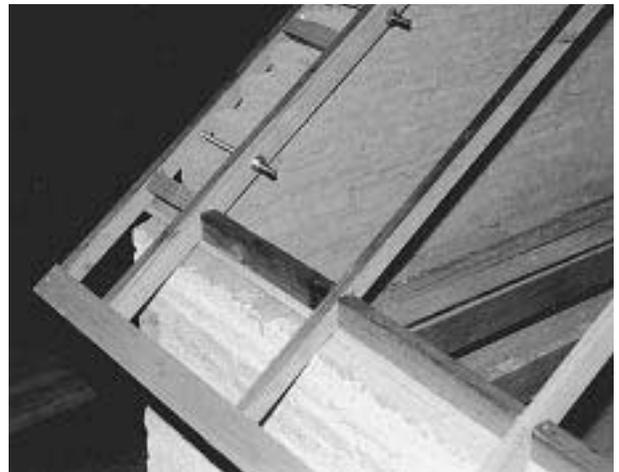
Figure 5.5
Blocking between roof rafters screwed to sill plate, used on models 8 and 9.

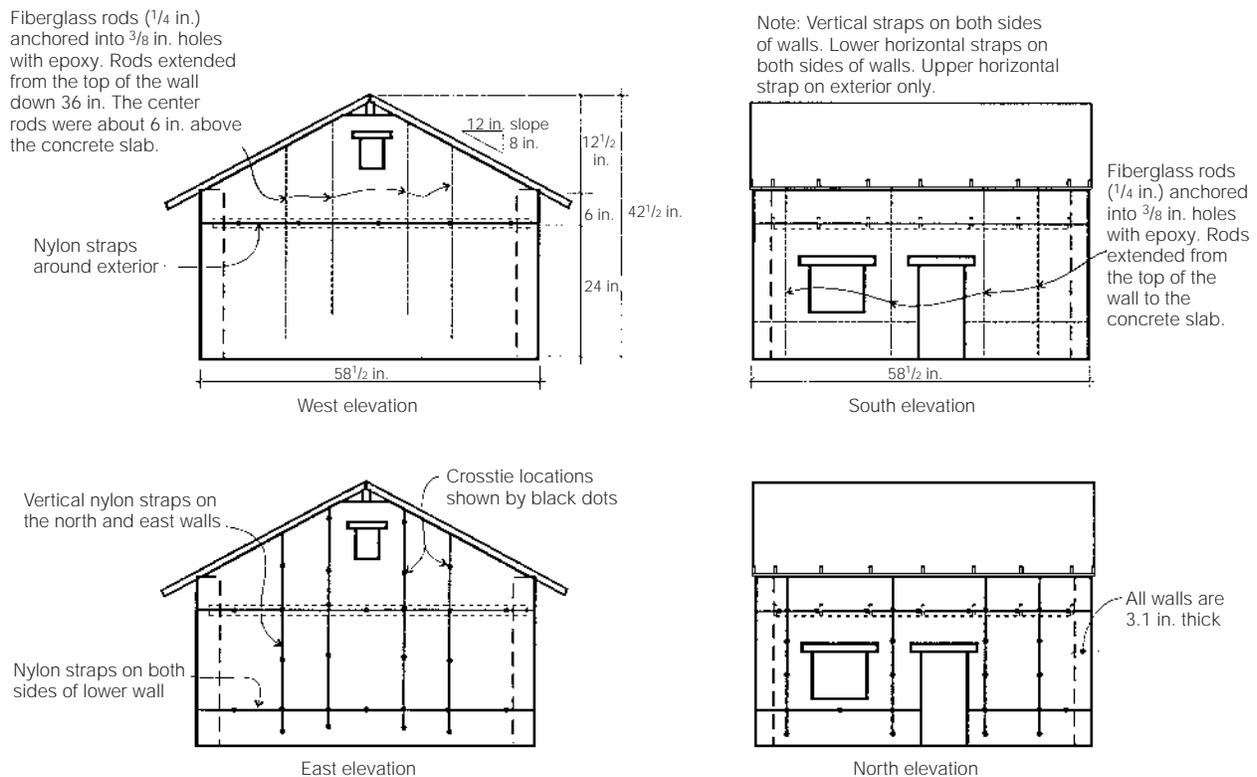
Figure 5.6
Elevations showing retrofit measures applied to model 8.

Model 8 was retrofitted with measures similar to those used on model 7. As in previous models, the retrofit strategy was different on the west and south walls than that of the east and north walls (fig. 5.6). The retrofit system for model 8 consisted primarily of the following:

An upper horizontal strap was placed at the attic-floor line and encircled the perimeter of the building (fig. 5.6). This was attached to the floor framing, which was connected to the partial floor diaphragm.

On the north and east walls of model 8, the lower horizontal strap was located on both sides of each section of wall at a level approximately two courses below the bottom of the window. These walls had four vertical straps on each wall, again with nylon straps used as cross-ties, as shown for the east wall in figure 5.6.

The south and west walls were retrofitted using measures designed to minimize damage to the wall surfaces. The vertical elements were fiberglass center-core rods embedded in an epoxy grout at the same intervals as used for the vertical straps on the north and east walls. The only exterior element on the south wall (fig. 5.6) and west wall (fig. 5.10)

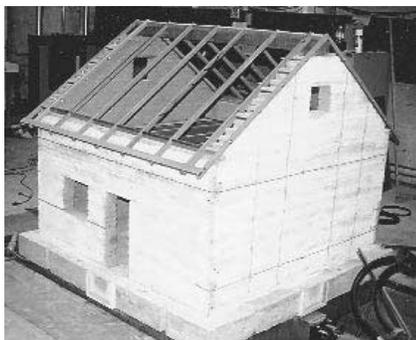
Figure 5.7
Model 8 before roof framing was completed, with ridge beam in place.

Details of many aspects of the retrofit system and its installation for model 8 are shown in figures 5.7–5.15. The connection details were nearly the same as those for model 7 (figs. 4.3–4.5).

Model 8 before the roof diaphragm was added is shown in figure 5.7. Figure 5.8 shows the attic-floor diaphragm at one of the corners. The partial attic-floor diaphragm in model 8 was not as wide as that used in model 7. In model 8, the floor diaphragm was 11.4 cm (4.5 in.) wide; in model 7 it was 19 cm (7.5 in.). A nylon strap was added to ensure transfer of the horizontal loading at the corner of the diaphragm. As demonstrated by the tests, this diaphragm size provided adequate stiffness to control the wall loads and displacements.

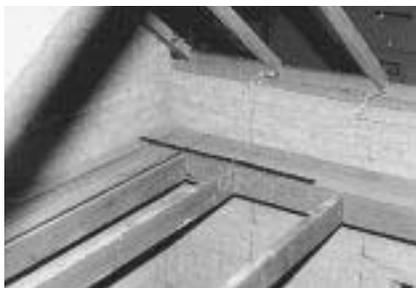
Figure 5.8
Partial diaphragm at the southeast corner of model 8. A nylon strap connected adjacent sections of the wood diaphragm.

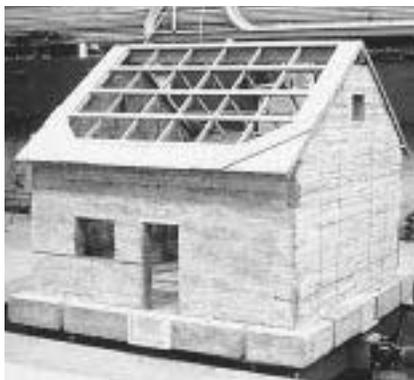
Figure 5.9
Model 8 after the final retrofit. Diagonal bracing was added in the corners to stiffen the partial roof diaphragm.

The roof framing and partial roof diaphragm are shown in figure 5.9. The roof diaphragm was only 11.4 cm (4.5 in.) wide over the gable ends and 19 cm (7.5 in.) wide over the bearing walls. The discontinuity in the diaphragm at the ridge along the gable-end wall allowed large displacements at the ridge in model 7. To help control these displacements, diagonal sheathing was added at each of the four lower corners of the roof to stiffen the partial diaphragm.

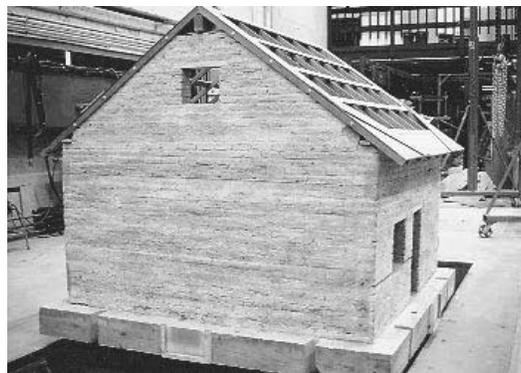
Figure 5.10
West gable-end wall of model 8 after retrofit system was completed. The only sign of the retrofit system on this wall is the horizontal strap at the attic-floor line.

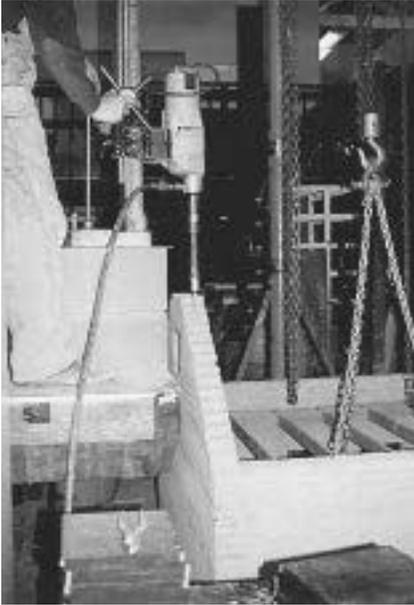
Figure 5.11
Center-core holes being drilled in the west gable-end wall.

was a horizontal strap at the attic-floor line. The lower horizontal strap on the south wall was placed inside a horizontally drilled hole. The west wall had no lower horizontal strap at this level because a drill bit of sufficient length was unavailable. Drilling of the holes and injection of the epoxy grout are shown in figures 5.11 and 5.12, respectively. The center-core rods in the west wall terminated just short of the wall base because the drill bit was not long enough to reach the slab level. The outside center-core rods extended to about 5 cm (2 in.) above the slab level, and the inner center-core rods extended to approximately 12.7 cm (5 in.) above the slab. On the south wall, the center-core holes were drilled to, but not into, the slab.

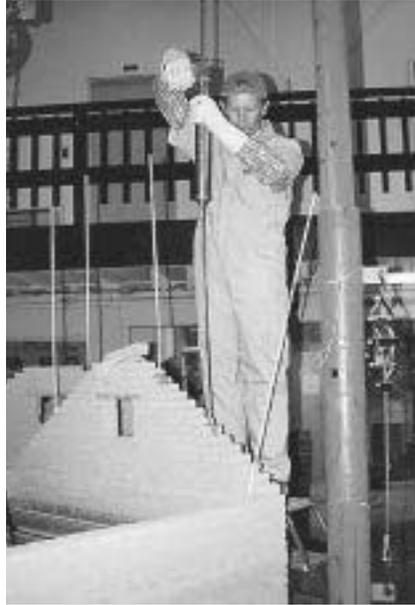
Figure 5.12
Epoxy resin grout being injected into model. This measure was used to attain continuity between the center-core rods and the adobe wall.

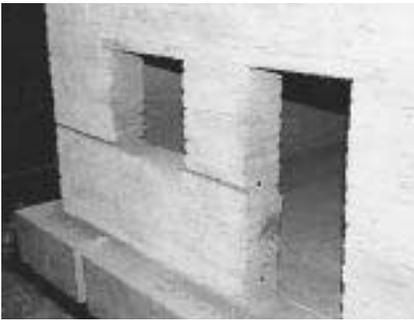
Figure 5.13
Piers on either side of the windows, showing horizontal cuts made to encourage horizontal cracks at these locations.

Horizontal saw cuts were placed on both sides of the piers adjacent to the windows (fig. 5.13). In model 3, saw cuts were used in combination with center-core rods in an attempt to control crack locations. In that test, the saw cuts were successful in controlling cracks at these locations. The test on model 3 also showed the favorable structural performance of the combination of a horizontal crack with vertical center-core elements in controlling the displacement along the cracks.

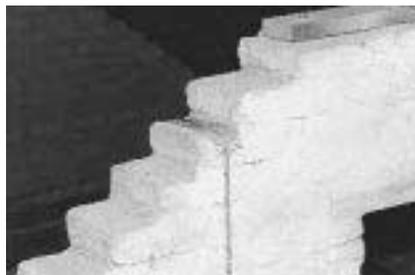
Figure 5.14
West gable-end wall of model 8, showing wire mesh used for bearing load distribution under vertical straps at the top of the walls.

Small sections of wire mesh were used at a number of corner locations throughout the building to provide a wide bearing area for the nylon straps. Wire mesh is flexible and ductile, and it distributes the load over a wide enough area to prevent the strap from digging into the adobe wall (figs. 5.14 and 5.15).

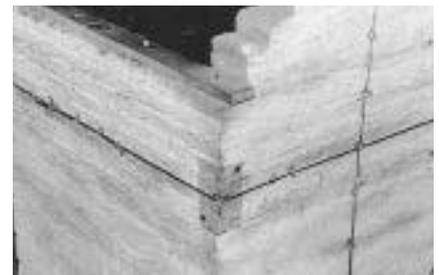
Figure 5.15
Wire mesh used under upper horizontal straps at the building corners.

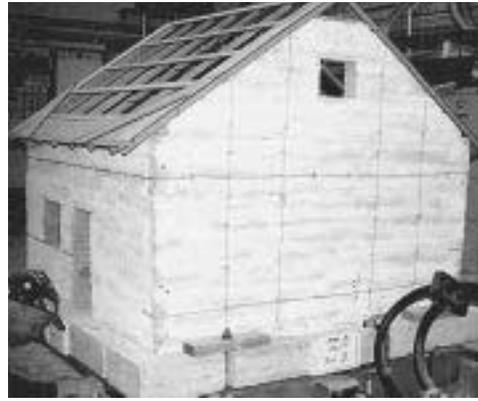
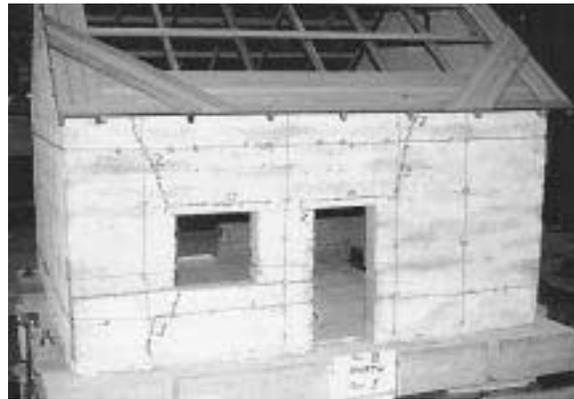
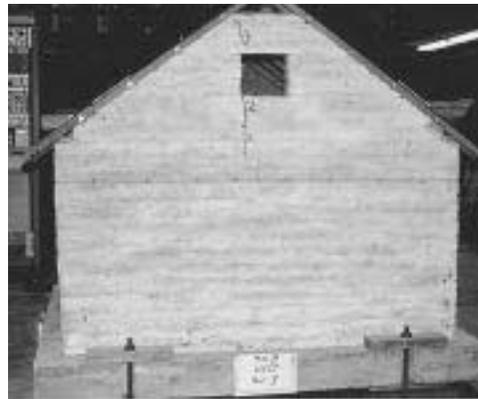
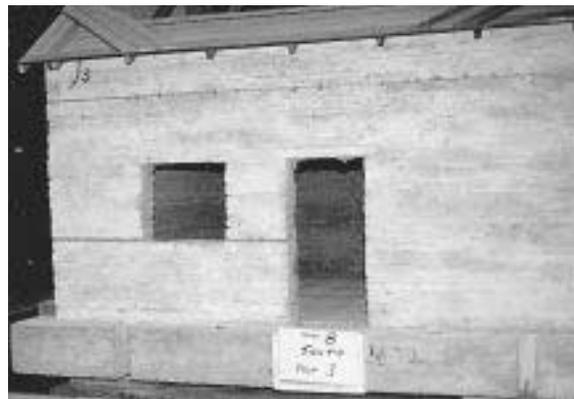
Figure 5.16

Model 8, test level III, showing (a) east wall (out of plane); (b) north wall (in plane); (c) west wall (out of plane); and (d) south wall (in plane). A few minor cracks were found during test levels II and III. More cracks were observed in the north (in-plane) wall than in the out-of-plane walls. In the north wall, cracks developed at the upper corners of the door and window. The only crack in the south (in-plane) wall was in the upper corner near the west wall. In the out-of-plane direction, the west and east walls suffered little damage. The west wall had a small vertical crack above and below the window. No damage was observed in the east wall.

A summary of the important aspects of the results of the test sequence for model 8 is listed in table 5.1. Photographs of model 8 after each test, starting with test level III, are shown in figures 5.16–5.24.

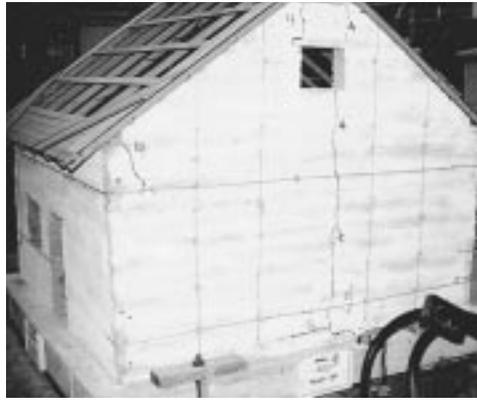
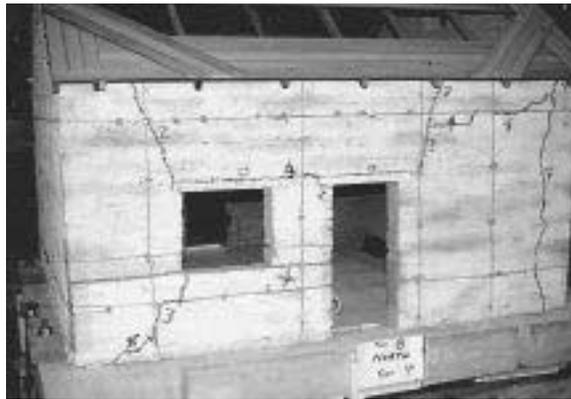
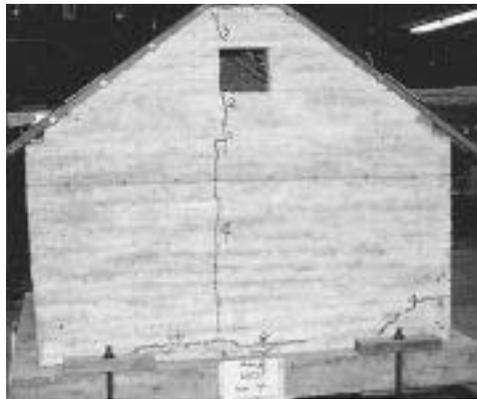
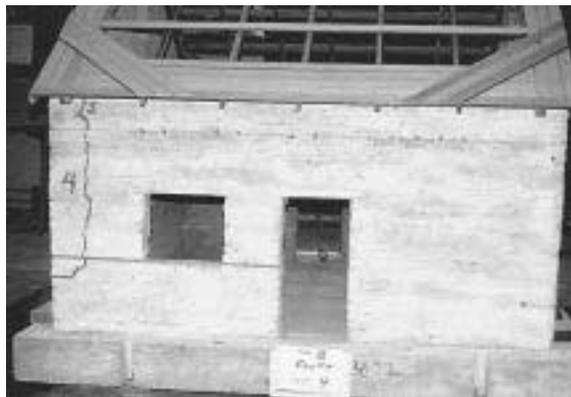
Figure 5.17

Model 8, test level IV, showing (a) east wall (out of plane); (b) north wall (in plane); (c) west wall (out of plane); and (d) south wall (in plane). In the out-of-plane direction, both the east and west walls developed vertical cracks near the center of the wall, and both had some horizontal crack damage near the base. The out-of-plane walls acted as plates with vertical yield lines at mid-span. In the in-plane direction, the north wall (straps) developed a more complete crack pattern that included a horizontal crack in the west side near the top of the wall and a vertical crack at the west end. The south wall (center cores) had a vertical crack at the west end caused by lateral movements of the west gable-end wall.

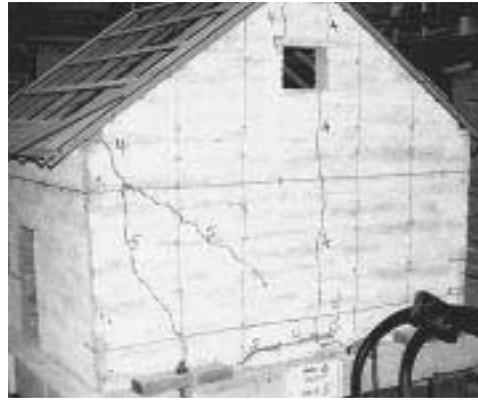
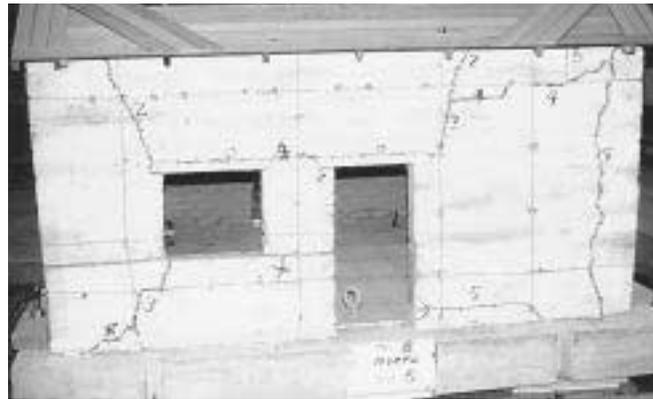
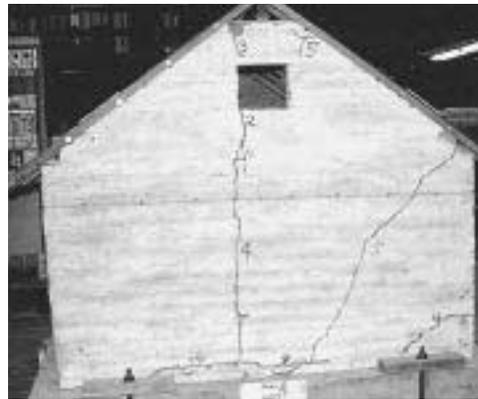
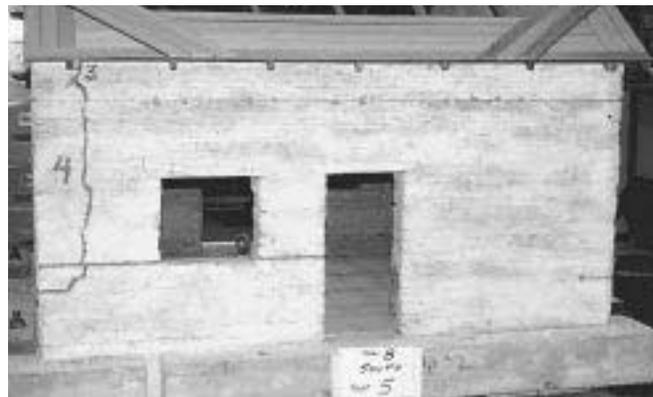
Figure 5.18

Model 8, test level V, showing (a) east wall (out of plane); (b) north wall (in plane); (c) west wall (out of plane); and (d) south wall (in plane). The in-plane walls sustained little additional damage. Minor cracks developed in the north wall, and no cracks appeared in the south wall. The out-of-plane walls developed considerably more cracks. The location of the cracks followed typical yield-line patterns. Each wall developed a diagonal crack from the upper corner on one side, extending to the center of the base of the wall. The east wall developed an additional, nearly vertical crack near the south end.
