Seismic Stabilization of Historic Adobe Structures

Final Report of the Getty Seismic Adobe Project

E. Leroy Tolles
Edna E. Kimbro
Frederick A. Webster
William S. Ginell

GCI Scientific Program Reports

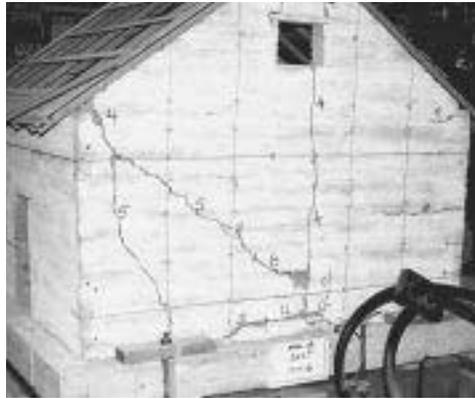
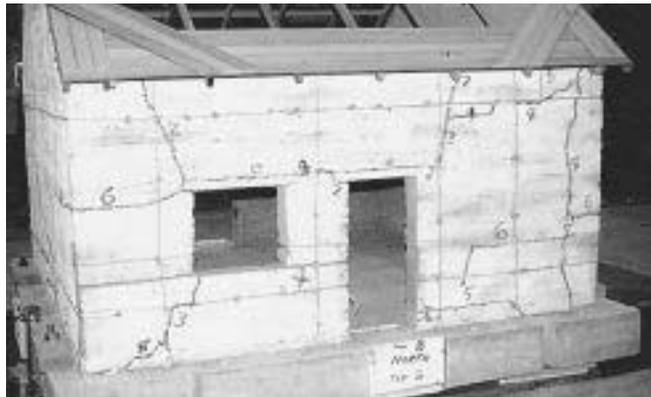
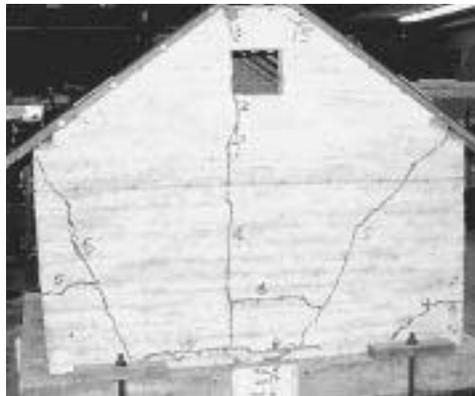
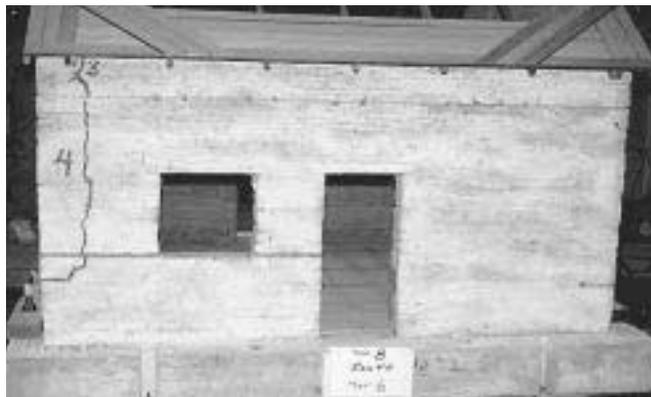
Figure 5.19

Model 8, test level VI, showing (a) east wall (out of plane); (b) north wall (in plane); (c) west wall (out of plane); and (d) south wall (in plane). Crack patterns continued to develop in the east and west walls. The west wall sustained additional diagonal cracking at the northern end and a horizontal crack near the center, located at about the level of the end of the center-core rods. The two rods near the center of the wall did not extend to the slab. In the in-plane walls, there were no additional cracks in the south wall, but further cracks appeared in the north wall. The basic crack pattern in each wall was nearly complete except for the lack of damage to the south wall.

The performance of the walls with epoxied center-core elements was the exception to this observation. The epoxied rods acted as effective reinforcements and delayed the appearance of crack damage. Damage to the walls of model 8 (fig. 5.19) and to the walls with epoxied center cores was very slight compared to the full crack development of the walls fitted with vertical straps.

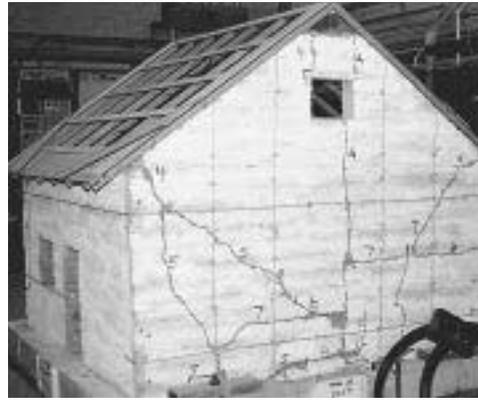
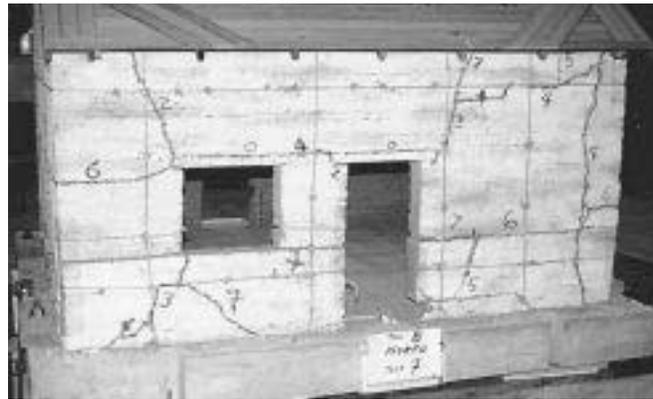
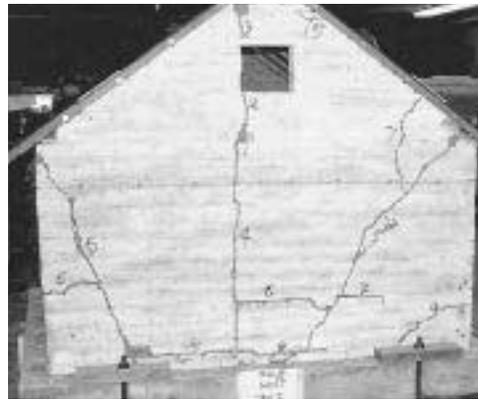
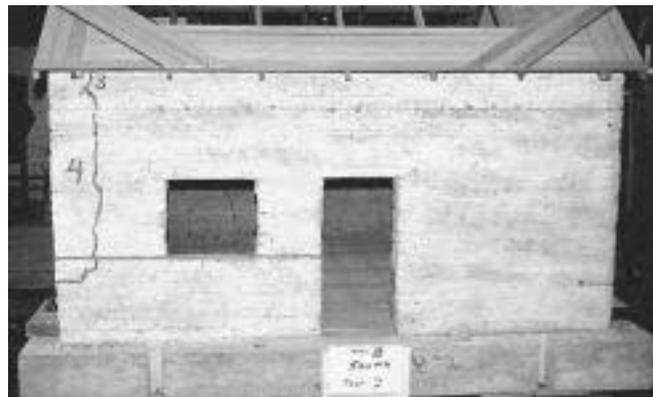
Figure 5.20

Model 8, test level VII, showing (a) east wall (out of plane); (b) north wall (in plane); (c) west wall (out of plane); and (d) south wall (in plane). At this point, the building walls had cracked into major sections that allowed them to move dynamically without sustaining substantial additional damage. Minor fragmentation of the wall continued in the north and west walls (straps), and little additional damage developed in the west wall (center core). The center cores in the south wall continued to provide adequate reinforcement that prevented cracks from occurring.

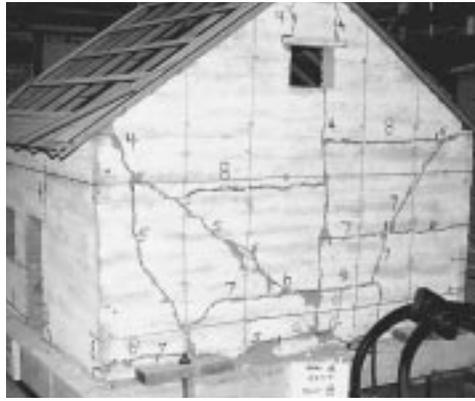
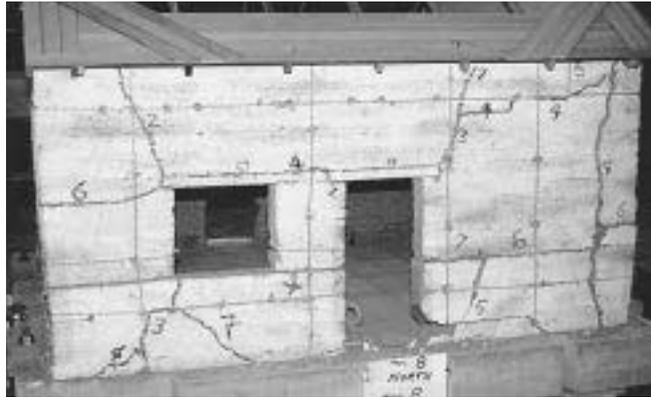
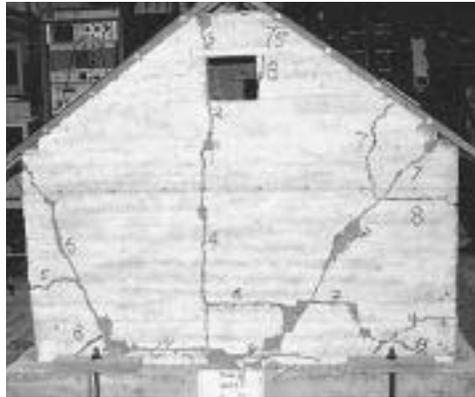
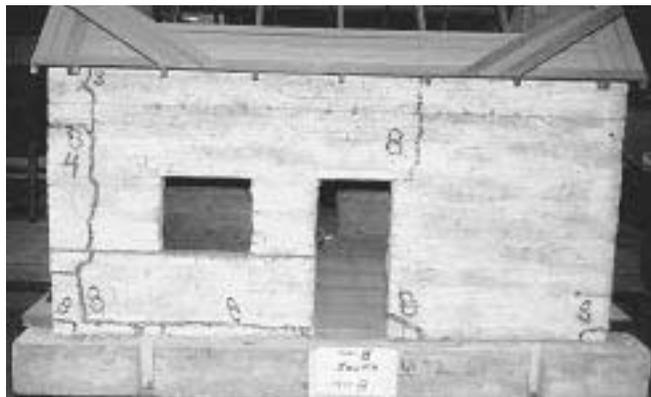
Figure 5.21

Model 8, test level VIII, showing (a) east wall (out of plane); (b) north wall (in plane); (c) west wall (out of plane); and (d) south wall (in plane). Several cracks finally developed in the south wall of this model, including a vertical crack at the door and a horizontal crack at the base of the wall below the window. The cracks that had developed in the other three walls remained fairly stable, although offsets of about 0.6 cm (0.25 in.) were observed in the north and east walls.

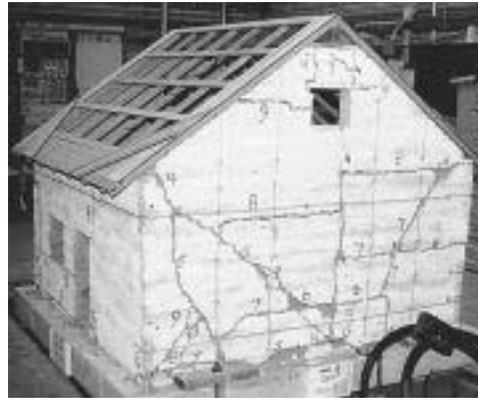
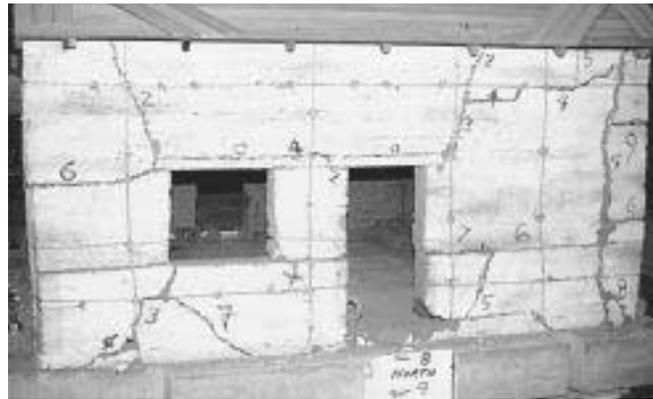
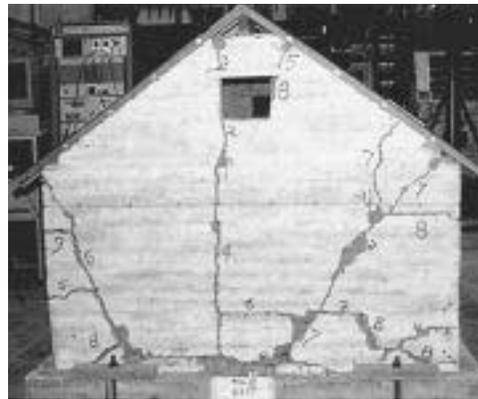
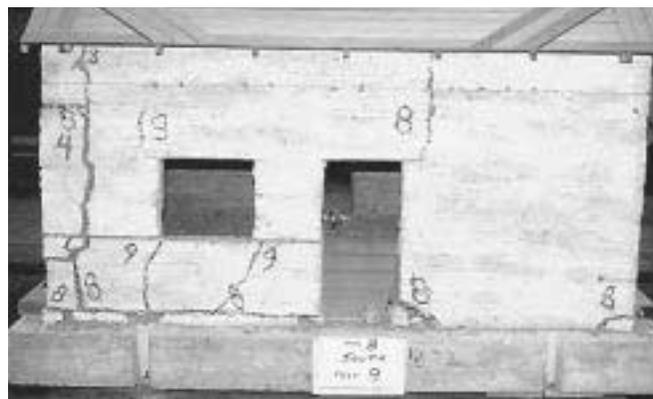
Figure 5.22

Model 8, test level IX(1), the first of two tests at this level, showing (a) east wall (out of plane); (b) north wall (in plane); (c) west wall (out of plane); and (d) south wall (in plane). Crack patterns changed little, but the substantial amount of additional spalling at crack edges and corners was indicative of the large motions to which the building was subjected during this test. The center cores in the west wall allowed the formation of major blocks with two center-core rods in each block. Damage to the south wall (with center cores) increased but was considerably less than that observed in the north wall (with straps).

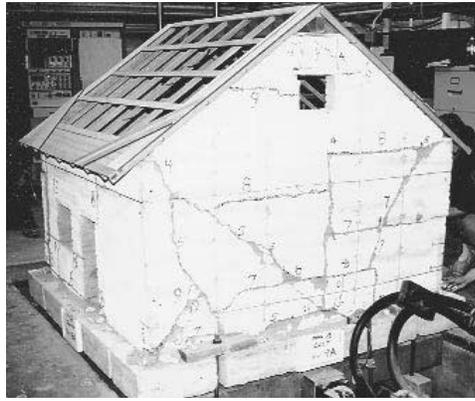
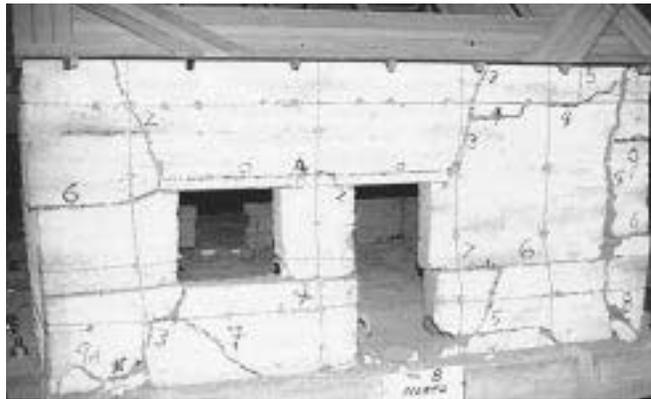
Model 8, test level IX(2), the second of two tests at this level, showing (a) east wall (out of plane); (b) north wall (in plane); (c) west wall (out of plane); and (d) south wall (in plane). Offsets at existing cracks increased to about 1.25 cm (0.5 in.). Damage to the basic panels in the south wall was still negligible. The walls were beginning to slide at the foundation level.

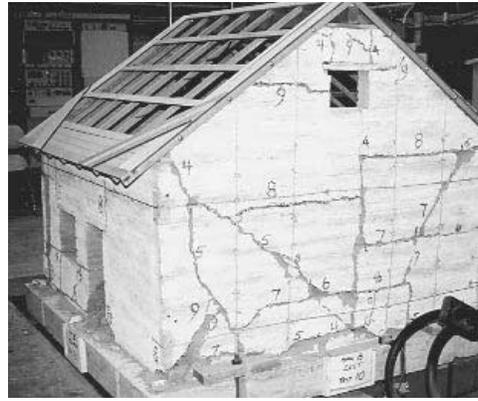
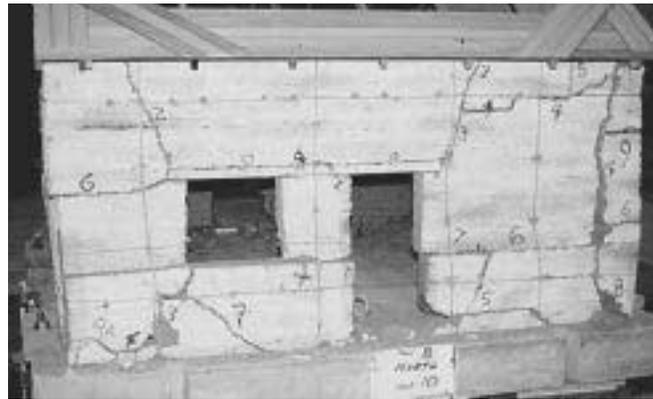
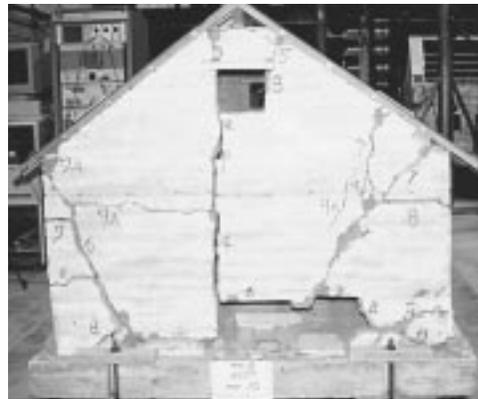
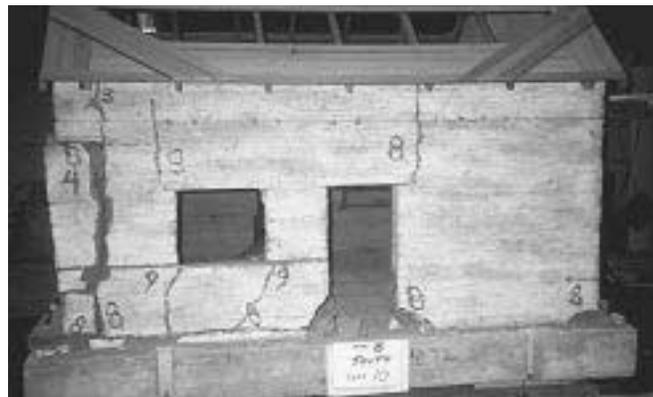
Figure 5.24

Model 8, test level X, showing (a) east wall (out of plane); (b) north wall (in plane); (c) west wall (out of plane); and (d) south wall (in plane). Crack pattern remained fundamentally the same, and no new cracks were created. The center-core rods prevented major damage from occurring in the walls in which they were installed. For the most part, cracks formed in the area just outside of the center-core rods. There were no rods or straps in the section at the west end of the south wall, which permitted an offset of more than 1.25 cm (0.5 in.) at that location. The offsets in the east and north walls increased to about 1.8 cm (0.7 in.). The straps did an effective job of maintaining stability but were less effective than center-core rods at controlling damage.

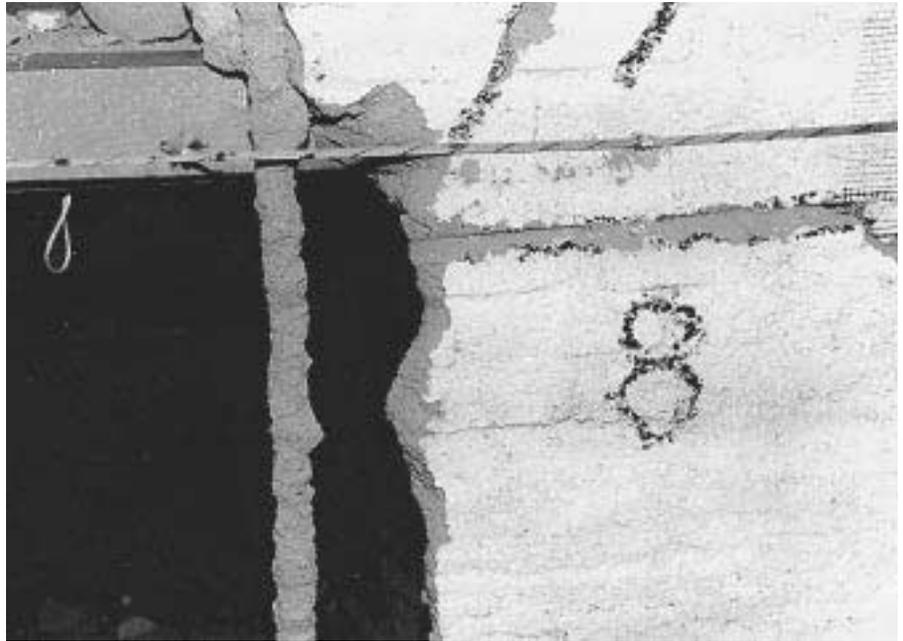
Figure 5.25
Close-up of center-core rod epoxy after removal of adobe.

As mentioned, the performance of the walls that had been retrofitted with fiberglass center-core rods embedded in an epoxy grout was unexpectedly good. These walls—south (in plane) and west (out of plane)—suffered very little damage during the tests. During placement of the center-core rods, the epoxy grout was absorbed unevenly into the adobe and permitted the rods to bond effectively to the adobe material.

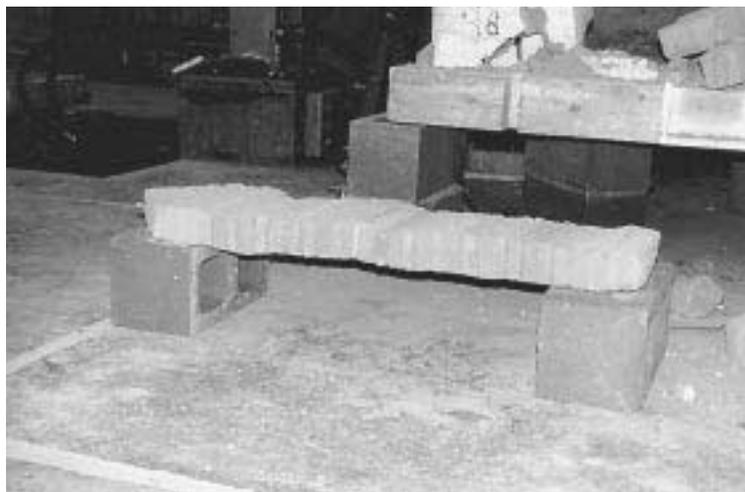
Figure 5.26
Section of wall panel containing center-core rod before static-loading test.

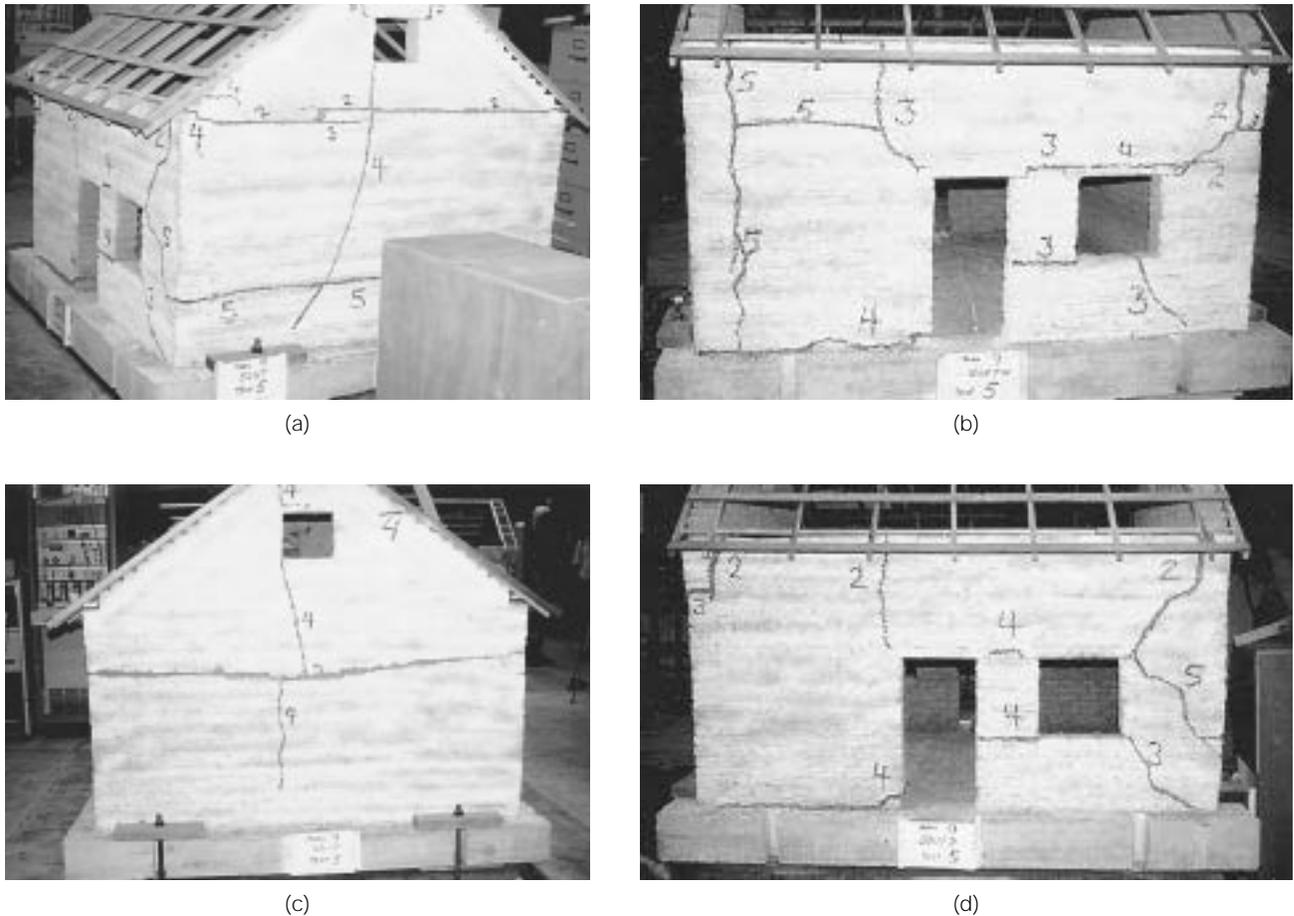
Figure 5.27

Model 9, test level V, showing (a) east wall (out of plane); (b) north wall (in plane); (c) west wall (out of plane); and (d) south wall (in plane). The dynamic motion of the gable-end walls increased substantially, and the model became nearly unstable. The slight resistance provided by the roof framing may have prevented out-of-plane collapse of the gable-end walls. A permanent offset of approximately 1.9 cm (0.75 in.) perpendicular to the plane of the wall occurred at the center of the upper horizontal crack in the east wall. A few additional cracks developed near the base of the east wall, and the vertical cracks in the west wall continued to extend downward.

the fragility of an unretrofitted adobe building. Cracks began during test levels II and III and continued to develop during test level IV. The dynamic motions of the gable-end wall became apparent during test level IV, and the model nearly collapsed during test level V. The roof rafters on both sides of the gable-end walls provided some resistance to the motion of these walls and probably were responsible for the stabilization of the model during test level V (fig. 5.27).

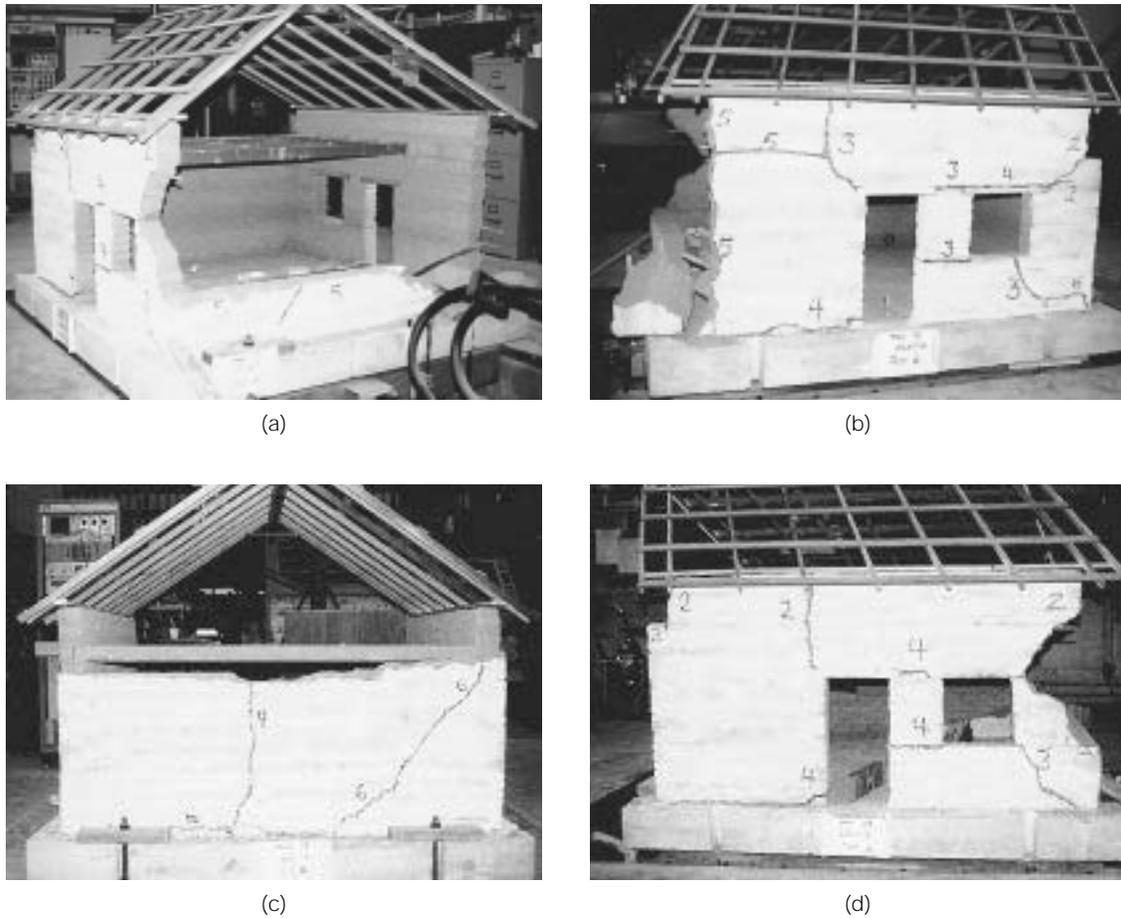
Figure 5.28

Model 9, test level VI, showing (a) east wall (out of plane); (b) north wall (in plane); (c) west wall (out of plane); and (d) south wall (in plane). Large sections of both gable-end walls collapsed. The upper section of the east wall collapsed inward at the beginning of the test, followed by the collapse of the lower section of that wall. In the latter part of the test, the upper section of the west gable-end wall also collapsed. The conditions of the in-plane walls did not worsen significantly during this test. The missing section at the east end of the south wall was attached to the section of the east wall that collapsed out of plane.

Both gable-end walls collapsed during test level VI (fig. 5.28). The collapse of the east wall was more complete because the upper section of the wall collapsed inward and, simultaneously, the lower section of the wall collapsed outward. The west wall collapse was incomplete. The difference in the behavior between the two walls can be attributed to the crack patterns that developed during earlier tests. There were two horizontal cracks in the east wall, and both the upper and lower sections

The unretrofitted model 5 building collapsed almost completely during test level V (fig. 3.10). Unretrofitted model 9 nearly collapsed during test level V. In-plane walls suffered severe damage, offsets, and partial collapse during test level VI (fig. 5.28).

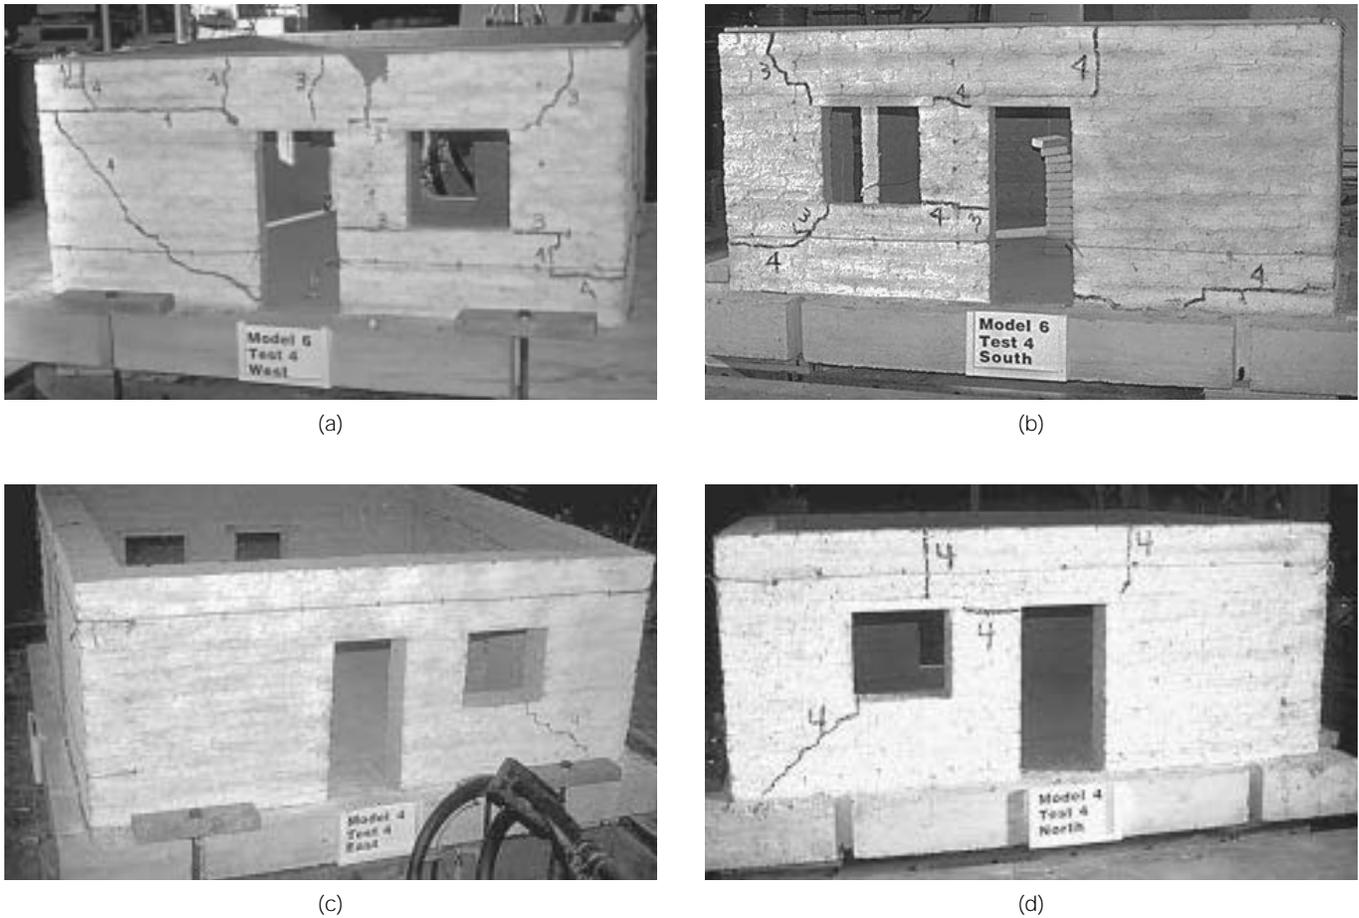
Figure 6.1
Comparison of crack initiation after test level IV for thin-walled model 6 ($S_L = 11$), showing (a) west wall, and (b) south wall; and thick-walled model 4 ($S_L = 5$), showing (c) east wall and (d) north wall.

The test level required to cause damage to out-of-plane walls was one of the greatest differences in the performance of thick and thin walls (fig. 6.1). Thin walls ($S_L = 11$) are shown in figure 6.1a, b, and thick walls ($S_L = 5$) are shown in figure 6.1c, d. As would be expected from an elastic analysis, the crack pattern in the out-of-plane walls (fig. 6.1a) occurred first, followed by cracking in the in-plane walls. Once cracks had developed in the out-of-plane walls, the loads were quickly transferred to the

in-plane walls through the attached bond beam, causing cracks in the in-plane walls (fig. 6.1b).

In contrast, the out-of-plane thick walls ($S_L = 5$) suffered very little damage during test level IV, while the in-plane walls suffered cracking at the corners of some of the openings (fig. 6.1c, d). The thick walls had much greater flexural stiffness and strength than the thinner walls and were mostly able to resist the loading with only a minor crack at the bottom of the window opening. The out-of-plane thick walls were strong enough to resist the loading and were sufficiently stiff to transfer the load to the in-plane walls, which suffered damage similar to that of the thin walls. As would be expected from an elastic analysis, the thin walls ($S_L = 11$) were much more susceptible to out-of-plane damage than the thick walls ($S_L = 5$). There was little difference in the initial crack patterns of the in-plane walls.

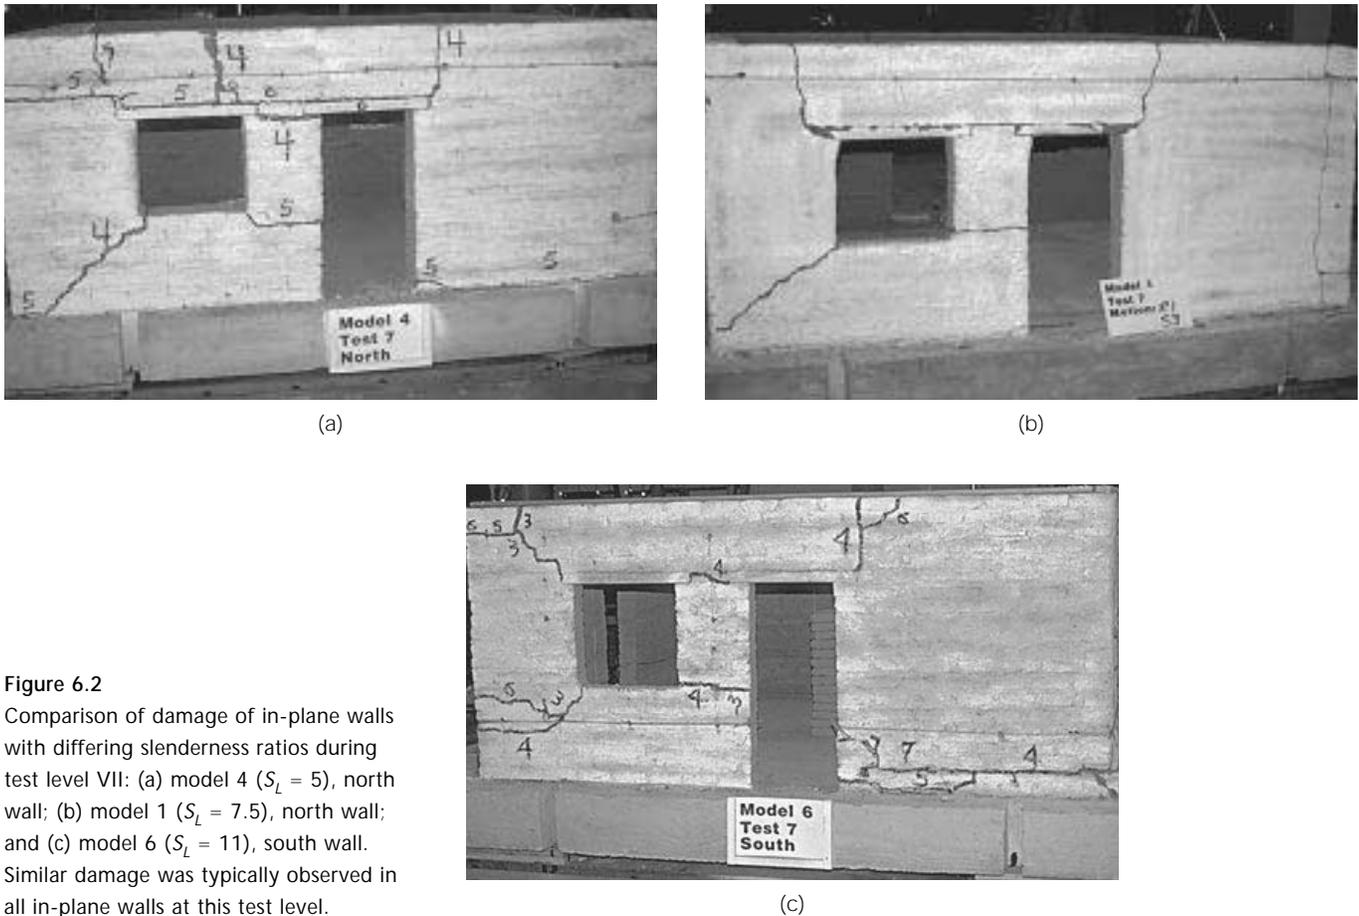
Figure 6.2

Comparison of damage of in-plane walls with differing slenderness ratios during test level VII: (a) model 4 ($S_L = 5$), north wall; (b) model 1 ($S_L = 7.5$), north wall; and (c) model 6 ($S_L = 11$), south wall. Similar damage was typically observed in all in-plane walls at this test level.

In general, the level of damage to the in-plane walls was independent of wall thickness. A comparison of in-plane wall damage after test level VII for walls with differing slenderness ratios ($S_L = 5, 7.5$, and 11) is shown in figure 6.2. Damage was similar for each of these walls. The principal damage occurred at the corners of the doors and windows and at the top and bottom of the pier between the door and the window, which was typical of both laboratory and field observations.

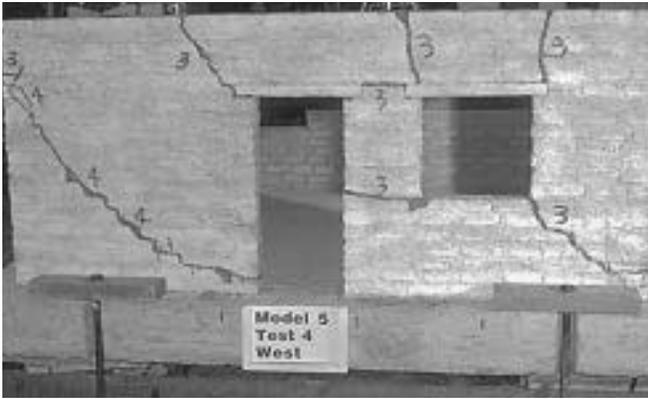
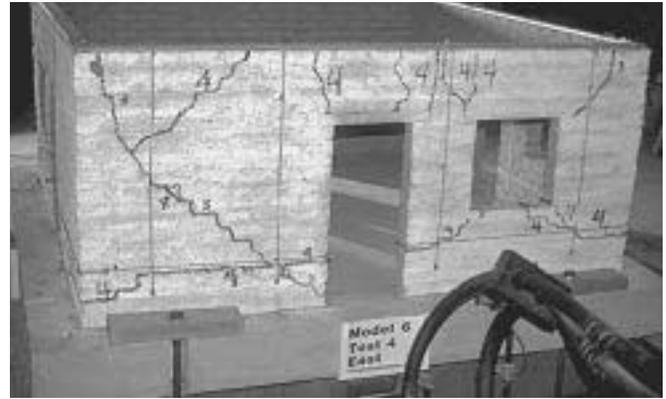
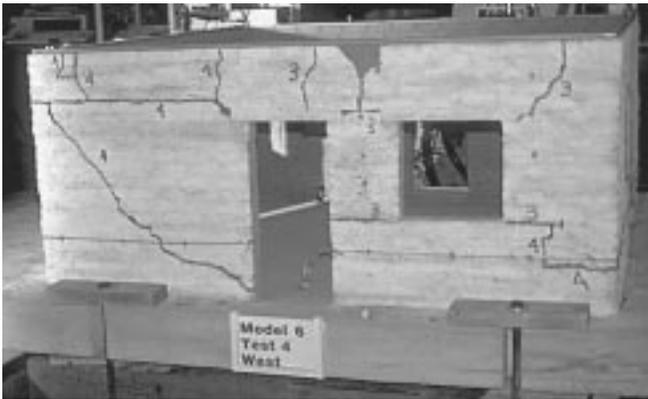
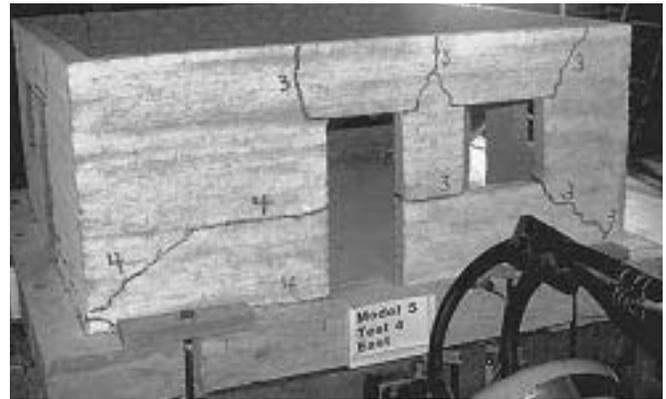
Figure 6.3

Comparison of crack patterns in out-of-plane walls with the same slenderness ratio ($S_L = 11$) after test level IV:

The crack patterns of corresponding walls were often consistent from one model to the next and in opposite walls of the same building. Nevertheless, there was one difference between similar walls that were subjected to the same input motions. The four walls shown in figure 6.3 were all thin walls ($S_L = 11$). The retrofit measures had a negligible effect on their elastic performance, and the resulting crack patterns had many similarities. The principal motion of the walls was out-of-plane rocking of the center panel, as shown in the whitened area in figure 6.4. In figure 6.3a–c, the crack pattern is nearly the same. This pattern is defined by a crack in the upper left corner of the wall that extends diagonally to the base of the door. From the right side, the crack starts at the upper right corner of the wall and extends through the window opening. However, in figure 6.3d, no major diagonal crack in the large left-hand panel is observed, suggesting that variability in material and construction typically exists in adobe structures, which could account for the difference.

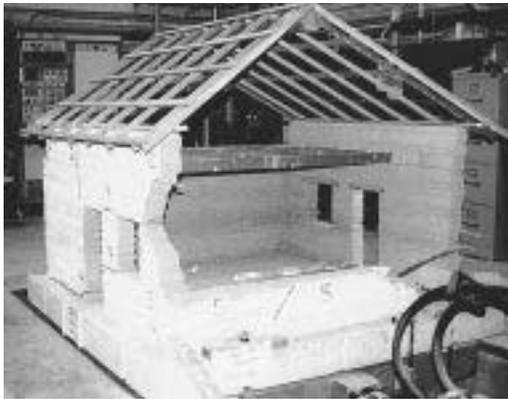
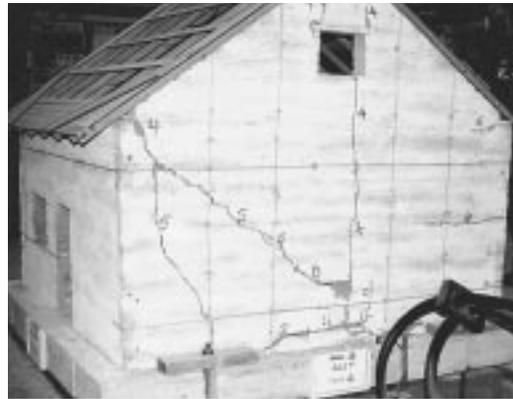
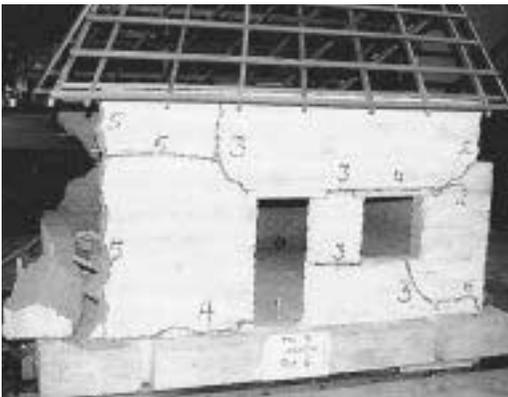
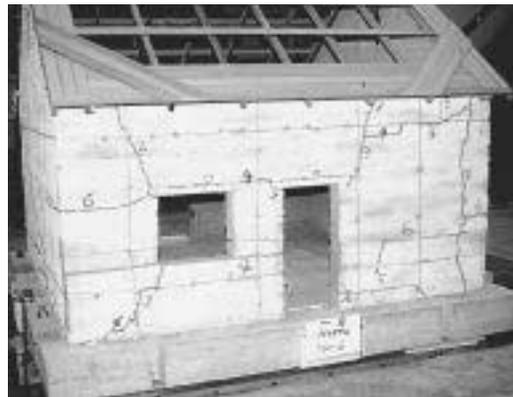
Figure 6.6

Comparison of tapanco-style control model 9 and retrofitted model 8 after test level VI: (a) east wall of model 9 (unretrofitted) vs. (b) east wall of model 8 (retrofitted); and (c) north wall of model 9 (unretrofitted) vs. (d) north wall of model 8 (retrofitted).

The effectiveness of the retrofit measures during test level VI is shown by the performance of the tapanco-style buildings, as illustrated in figure 6.6. Unretrofitted gable-end walls, tested out of plane, collapsed during test level VI (fig. 6.6a). The retrofitted gable-end walls suffered crack damage, but the model was very stable (fig. 6.6b). Damage to the in-plane unretrofitted walls was similar (fig. 6.6c), and those in the retrofitted structure (fig. 6.6d) suffered some additional cracks not observed in the unretrofitted model. Presumably, these were due to the additional load transferred through the partial diaphragms and upper horizontal straps.

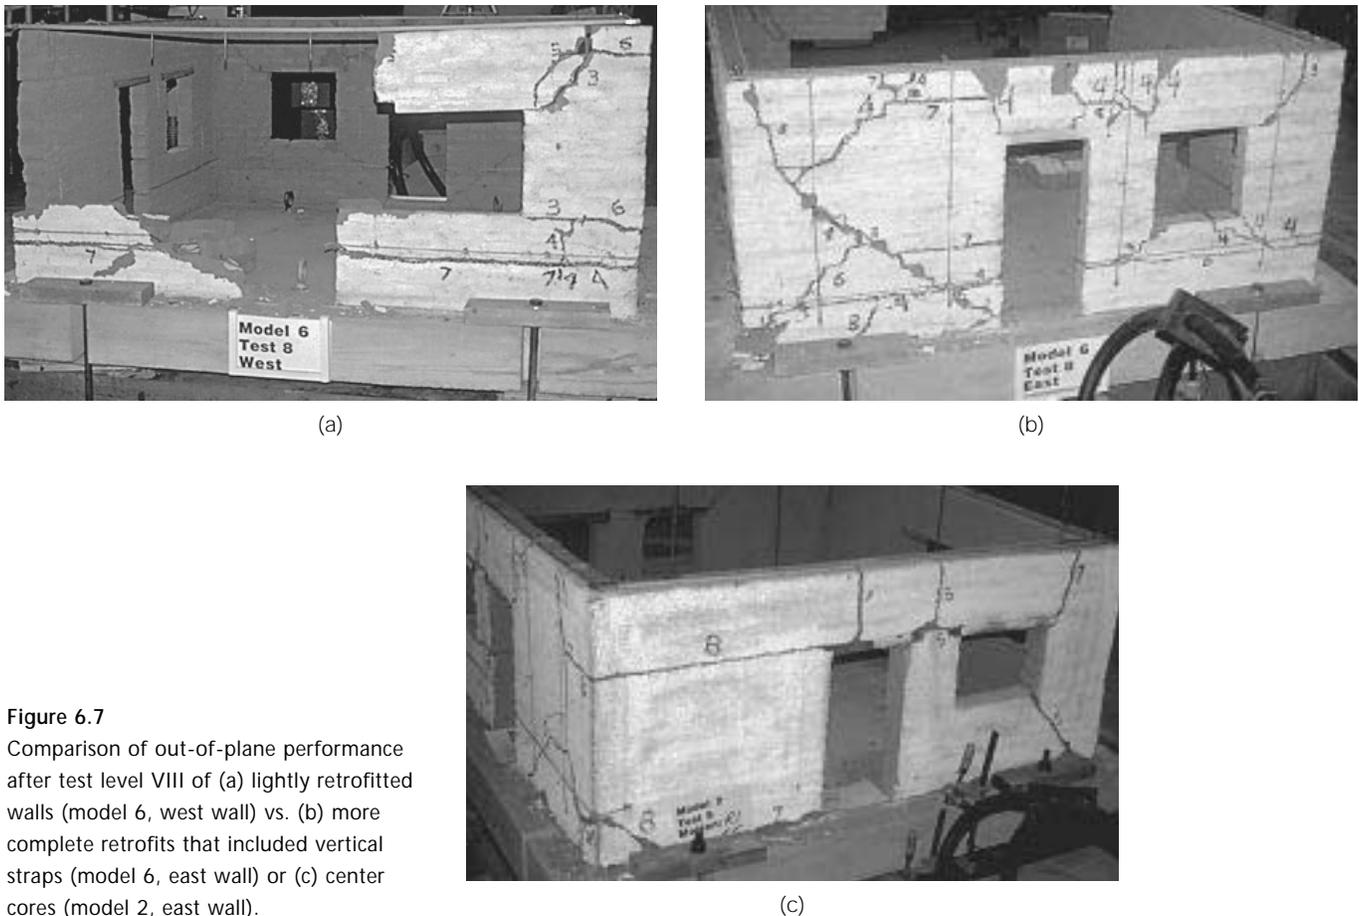
Figure 6.7

Comparison of out-of-plane performance after test level VIII of (a) lightly retrofitted walls (model 6, west wall) vs. (b) more complete retrofits that included vertical straps (model 6, east wall) or (c) center cores (model 2, east wall).

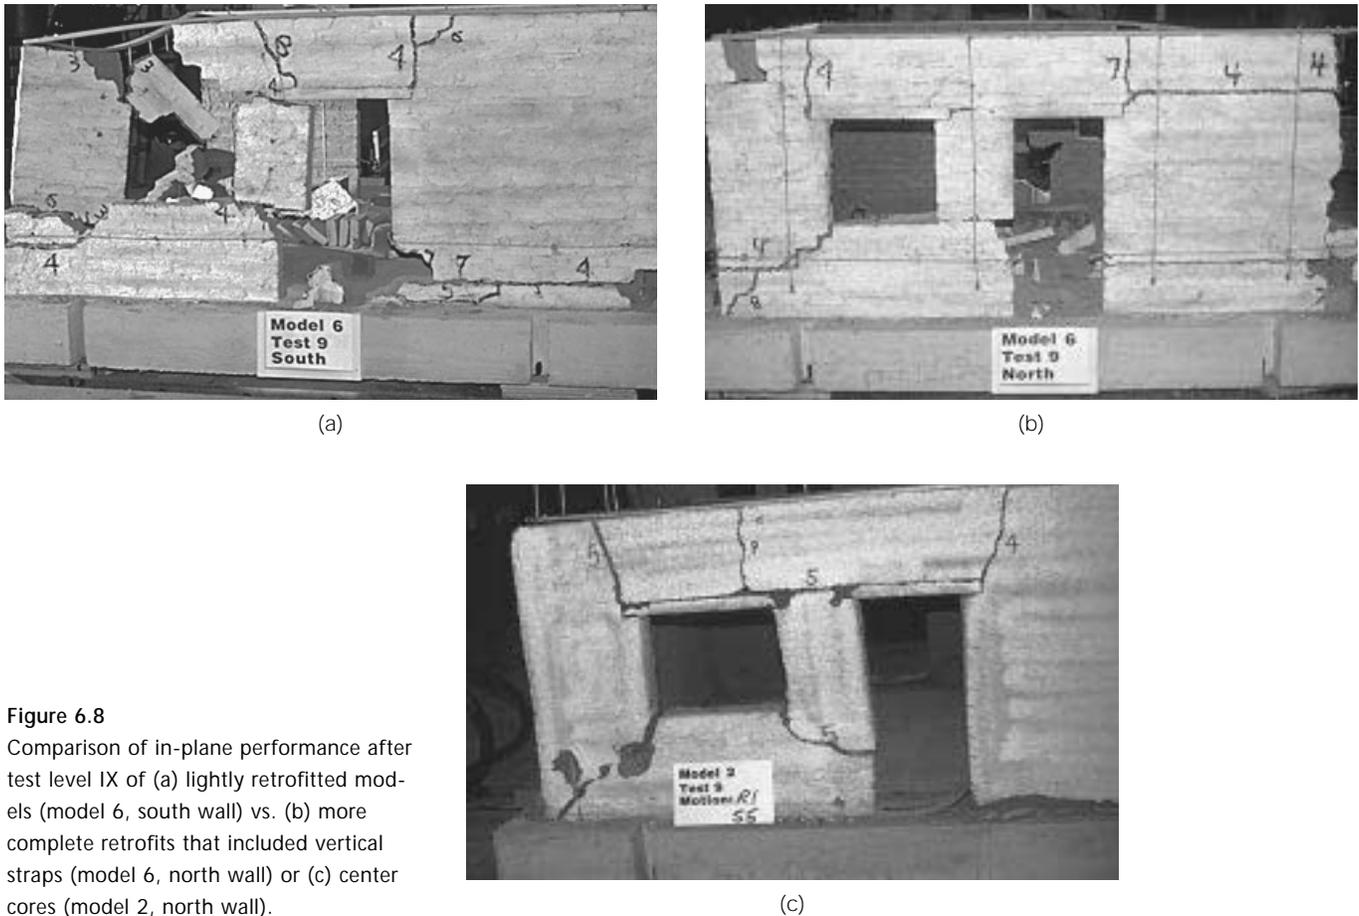
Figure 6.8

Comparison of in-plane performance after test level IX of (a) lightly retrofitted models (model 6, south wall) vs. (b) more complete retrofits that included vertical straps (model 6, north wall) or (c) center cores (model 2, north wall).

Test level IX was even more of a challenge to some of the lightly retrofitted model buildings. A large section of the in-plane thin wall with bond beam and local ties collapsed during this test (fig. 6.8a). Again, the

The addition of vertical straps instead of local ties improved the performance of the thin walls. The condition of the thin wall with a bond beam and vertical straps after test level IX is shown in figure 6.8b; the cracked wall is still stable and generally in good condition. The condition of the two in-plane walls shows the difference between the use of local ties (fig 6.8a) and the use of vertical straps (fig. 6.8b). Good behavior was also observed in the moderate walls with a bond beam and center cores during test level IX (fig. 6.8c).

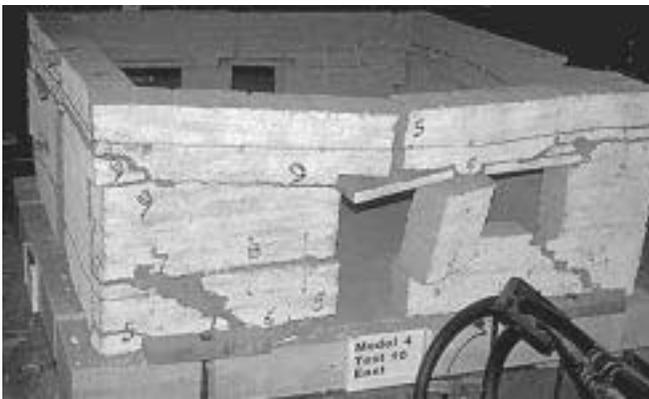
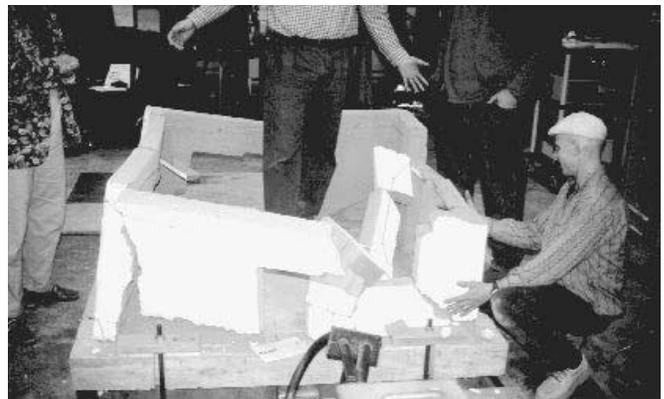
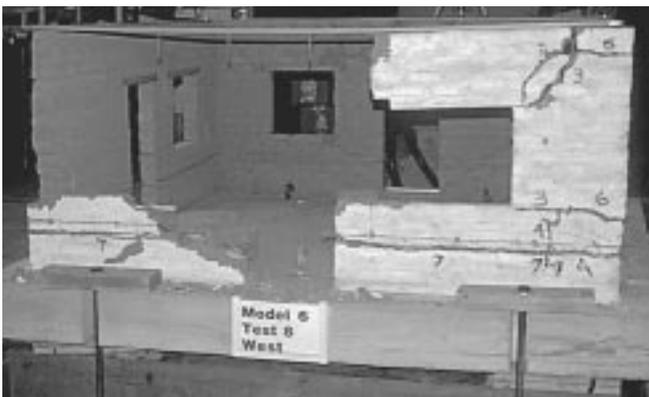
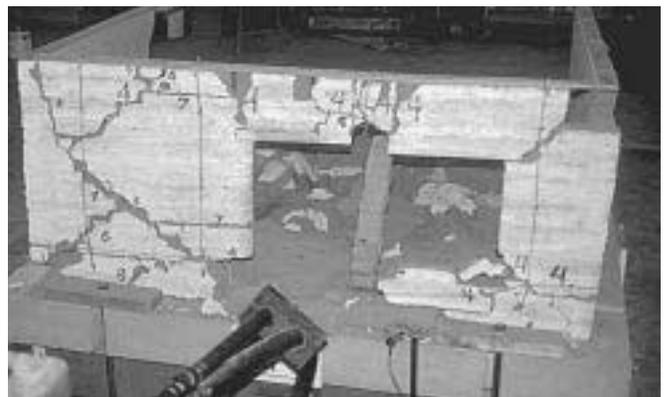
Figure 6.9

Comparison of out-of-plane wall performance in lightly retrofitted models after partial collapse: (a) model 4 ($S_L = 5$), east wall, test level X; (b) model 1 ($S_L = 7.5$), east wall, test level X; (c) model 6 ($S_L = 11$), west wall, test level VIII; and (d) model 6 ($S_L = 11$), east wall, test level X.

The performance of a thin wall with a bond beam and local ties showed that modest improvements to the retrofit systems on a thin-walled building still may not be sufficient. The out-of-plane walls collapsed during test levels VIII and IX, respectively (fig. 6.9c, d). These two walls had a bond beam, lower horizontal straps, and local ties in critical locations.

The other two walls of the same model behaved considerably better with the addition of vertical straps. Nevertheless, during test level X, the out-of-plane east wall lost the pier between the door and window even with the vertical strap (fig. 6.9d). This type of damage was not observed in other buildings with thicker walls when vertical straps or center-core rods were installed.

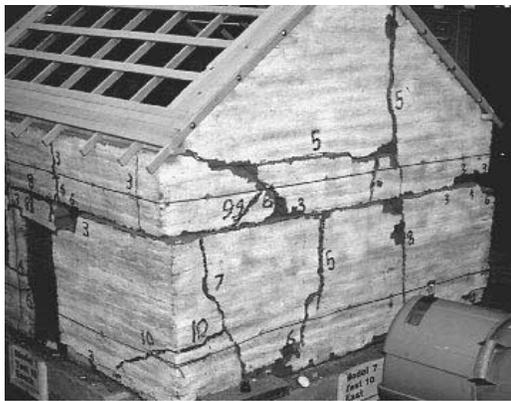
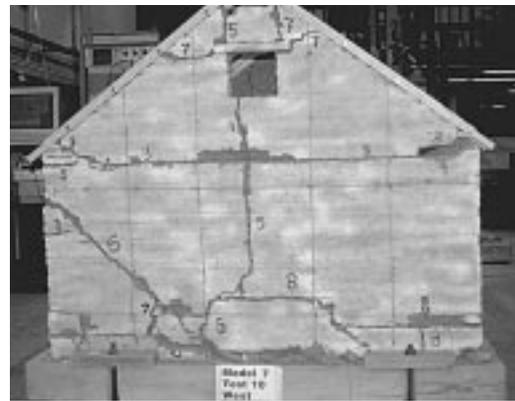
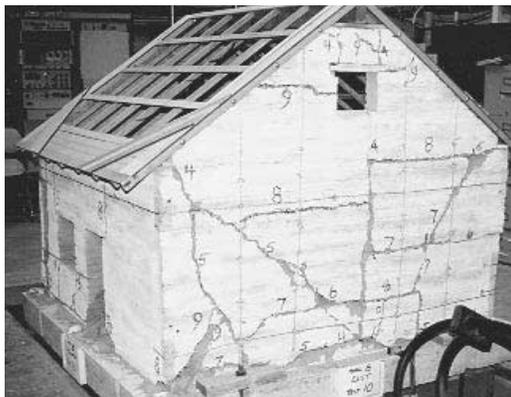
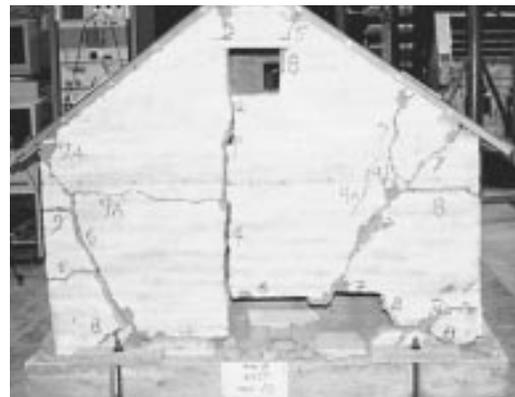
Figure 6.10

Comparison of the out-of-plane wall performance of tapanco-style models with differing retrofit systems after test level X: (a) model 7, east wall; (b) model 7, west wall; (c) model 8, east wall; and (d) model 8, west wall.

The gable-end walls of the tapanco-style models were all tested out of plane. In addition to the partial diaphragms on each building, the minimum retrofits were upper and lower horizontal straps. The only gable-end wall that did not have lower horizontal straps was the west wall of model 8 (fig. 6.10d), which had center-core rods. In model 7, the east wall (fig. 6.10a) had only upper and lower straps, yet the thick walls ($S_L = 5$) remained stable. There was an approximately 3.8 cm (1.5 in.) offset at the mid-height horizontal crack, because there was little restraint across this crack plane.

Vertical straps provided additional restraint that minimized the extent of dynamic and permanent crack offsets. In model 7, the performance of the west wall (fig. 6.10b) was somewhat better than that of the east wall as a result of the vertical straps that provided restraint for block movements along horizontal and diagonal cracks.

The retrofit system used on model 8 ($S_L = 7.5$) was modified slightly to try to decrease the amount of offset at horizontal cracks. The east wall (fig. 6.10c) had vertical straps, and the wall cross-ties were spaced closely together to limit the relative displacement between adjacent blocks. The displacements in the gable-end wall were limited to 1.25–1.9 cm (0.5–0.75 in.) in the model domain, which was an improvement over the

The performance of the west wall of model 8 showed the extent to which center-core rods can reduce the offset across cracks during out-of-plane ground motions (fig. 6.10d). This wall had center-core rods that extended from the top to almost the base of the wall. Most of this wall was retrofitted with epoxied center-core rods and sustained minimal crack damage. There were no measurable offsets across center-core rods. Extensive damage to this wall occurred near the base in the area where the center-core rods did not extend. Most of the energy was dissipated in the areas outside of the center-core rods. If the center-core rods had extended into the foundation, there may have been additional damage in the upper part of the wall since there would have been no clear area for energy dissipation.
