Seismic Stabilization of Historic Adobe Structures

Final Report of the Getty Seismic Adobe Project

E. Leroy Tolles
Edna E. Kimbro
Frederick A. Webster
William S. Ginell

GCI Scientific Program Reports

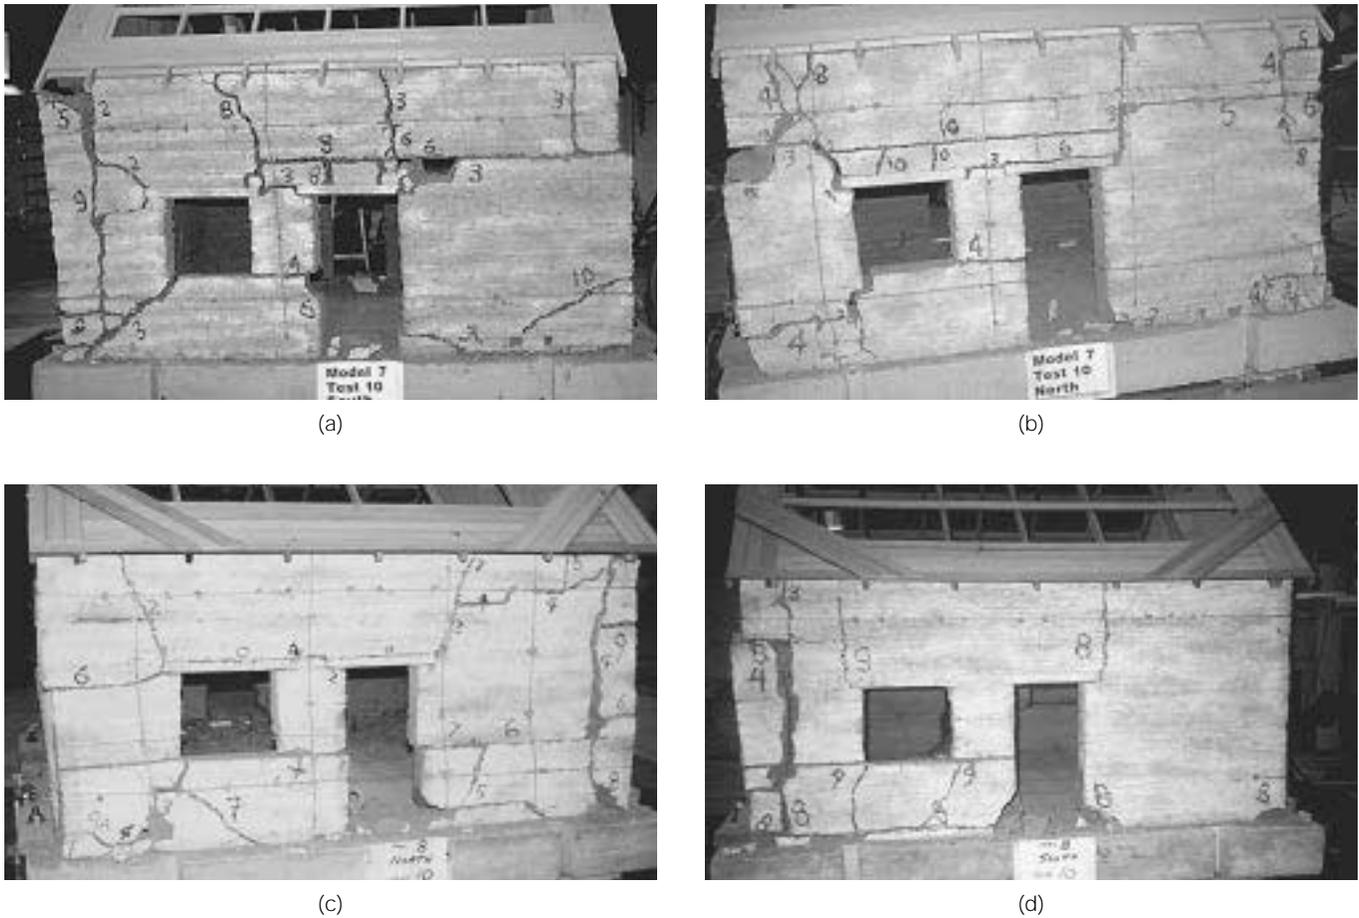
Figure 6.11

Comparison of the in-plane wall performance of tapanco-style models with differing retrofit systems after test level X: (a) model 7, south wall; (b) model 7, north wall; (c) model 8, north wall; (d) model 8, south wall.

In the in-plane direction, center-core rods were also most effective at preventing permanent offsets. Figures 6.10 and 6.11 show the damage to the retrofitted tapanco-style models at the end of the testing sequence. In general, the cracks opened to approximately 1.9 cm (0.75 in.) in each of the walls except where epoxied center-core rods were installed. The horizontal straps restrained the development of permanent offsets in the walls but still allowed displacements of the blocks. Stiffer straps may have been used to provide greater restraint against damage, but two factors would need to be taken into account: (1) a failure plane might develop just above the strap that would permit slippage, or (2) the strap may dig into the adobe material and loosen, even with a stiffer strap. To try to control the latter, a wire-mesh screen was added at the exposed corners. The straps were still able to dig into the adobe at the through-wall holes. Minimal damage was observed in the in-plane wall of model 9, where the vertical center-core rods were used (fig. 6.11d).

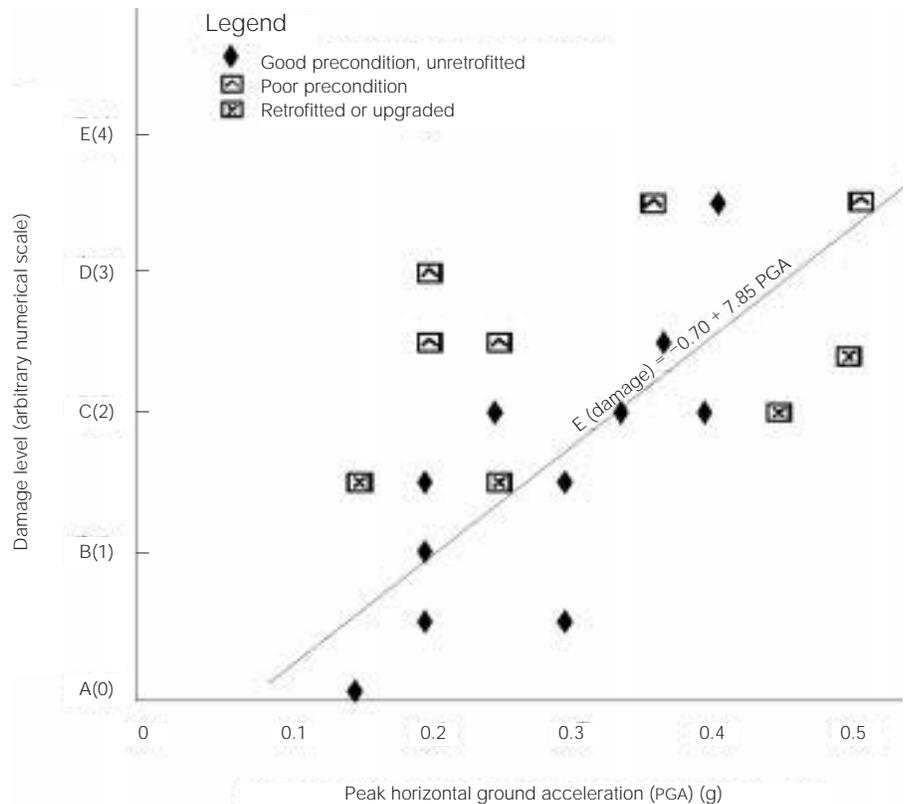
Figure 6.12
Observed damage level vs. peak horizontal ground acceleration for historic adobe buildings after the 1994 Northridge earthquake.

Figure 6.12 shows the relationship between the PGA level and damage for well-maintained historic adobes. Ground acceleration in the range of 0.1 g to 0.2 g PGA seems to be required to initiate damage in such buildings. At this level of ground motion, cracks begin to form at door and window openings and at the intersections of perpendicular walls. At the Southern California adobe sites studied where PGA was in this range, the Miguel Blanco Adobe, San Marino, was undamaged; the Purcell House, San Gabriel, was slightly damaged; the Plaza Church, Los Angeles, was also slightly damaged; and the Centinela Adobe, Los Angeles, experienced slight to moderate damage. These adobes were well maintained and had not been reinforced or retrofitted.

Preexisting conditions affect the observed damage level greatly. In figure 6.12, all data on buildings with preexisting water and

earthquake damage are found above the expected damage line for well-maintained adobes, indicating that severe damage can be expected for buildings in poor condition. Even for ground motions of moderate intensity (0.1–0.2 g), poorly maintained buildings are likely to suffer substantial damage.

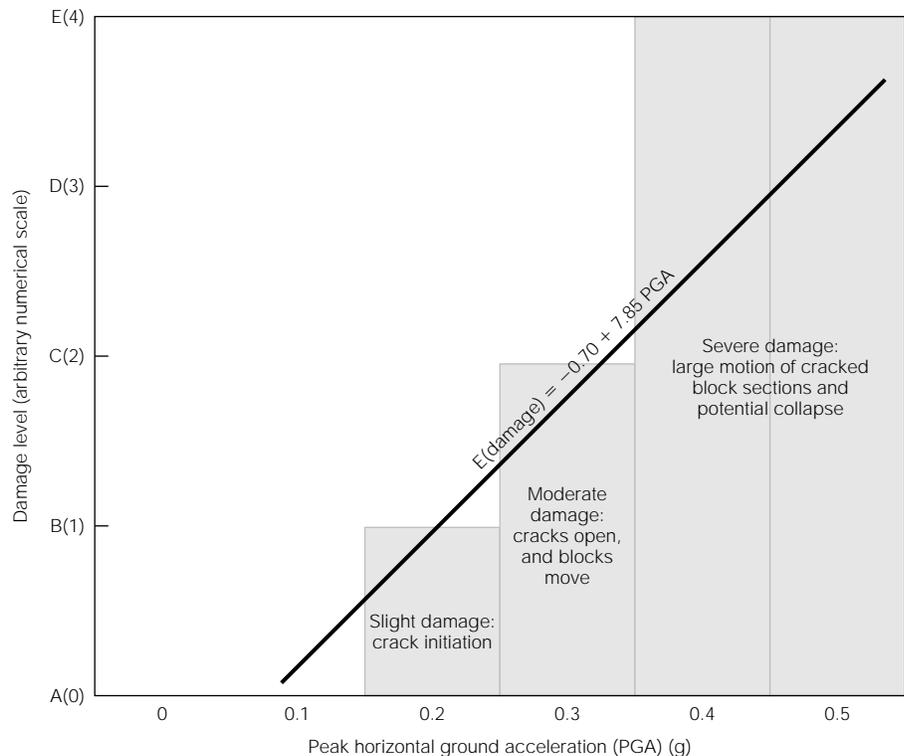
Figure 6.13

Damage level vs. peak horizontal ground acceleration for historic adobe buildings after the 1994 Northridge earthquake.

average strength. The presence of higher-strength adobe material may delay the onset of cracking. Low-strength adobe or previously damaged walls will have a negative impact on performance, and thinner walls will be more likely to collapse. Nevertheless, these general categories can help determine the effects of larger seismic events. A graphic representation of these basic concepts is shown in figure 6.13, which is based on observations of buildings affected by the 1994 Northridge earthquake.

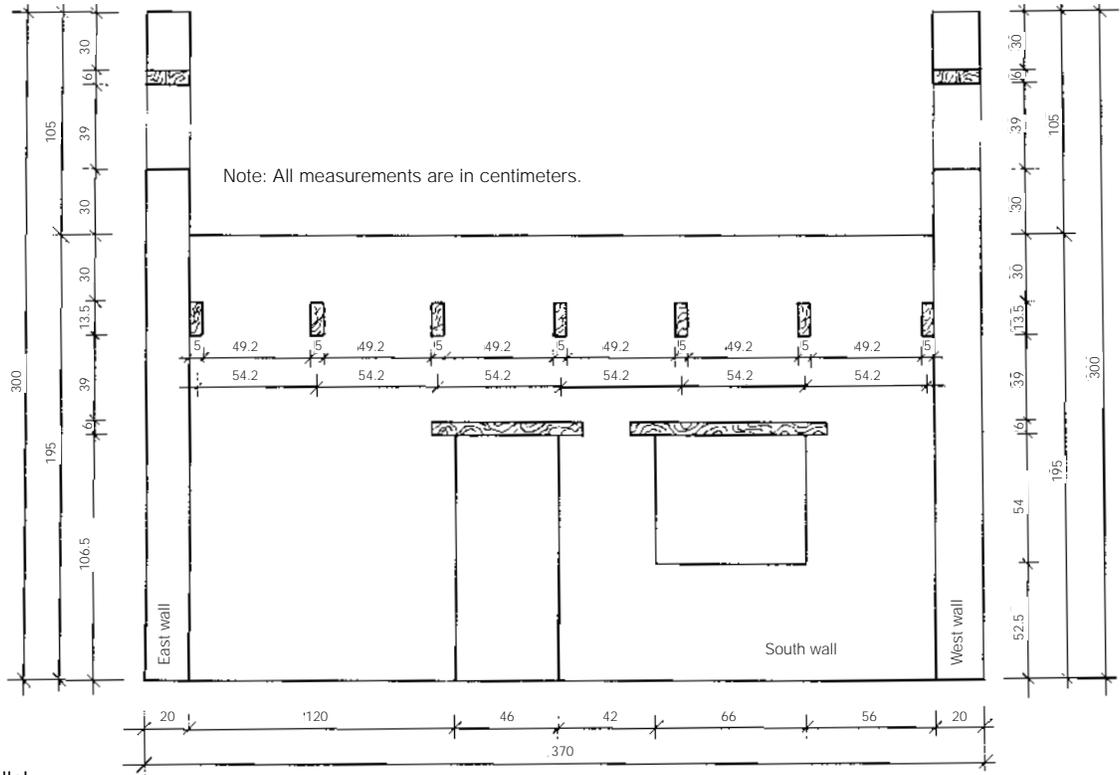
Figure 7.1
Model 10 section parallel
to north-south walls.

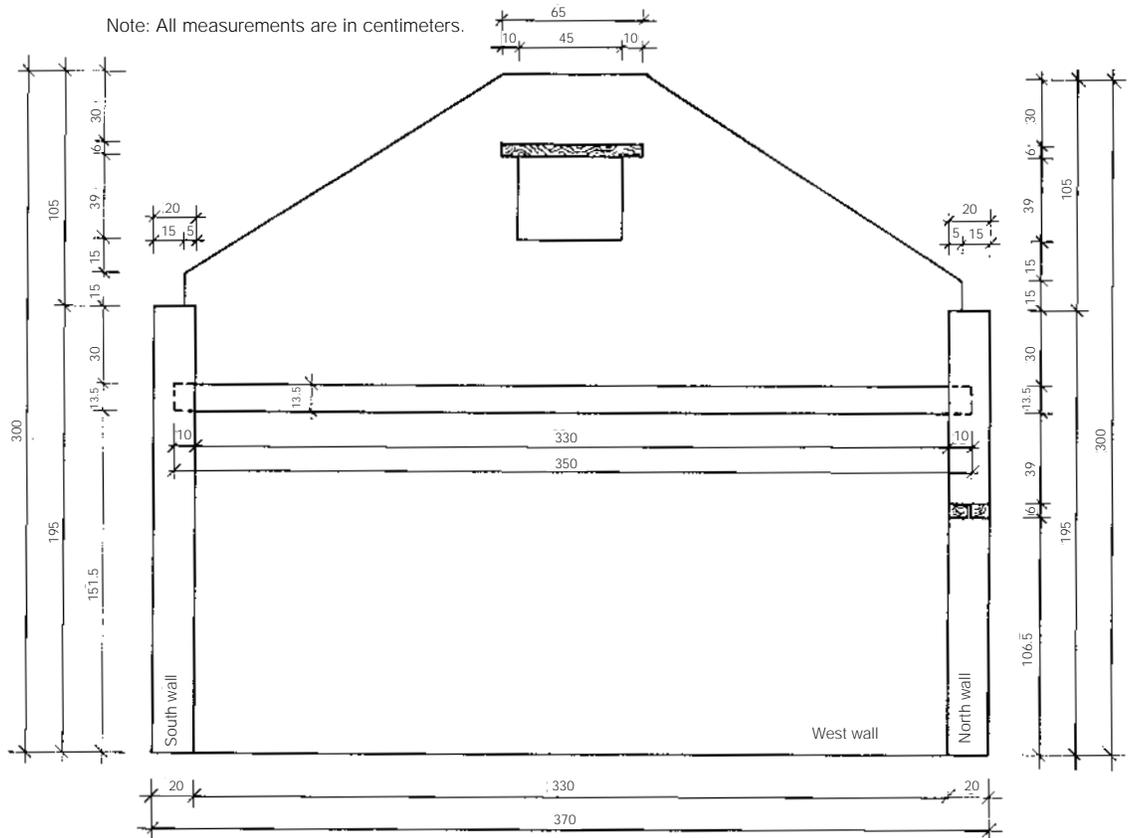
Figure 7.2
Model 10 section parallel
to east-west walls.

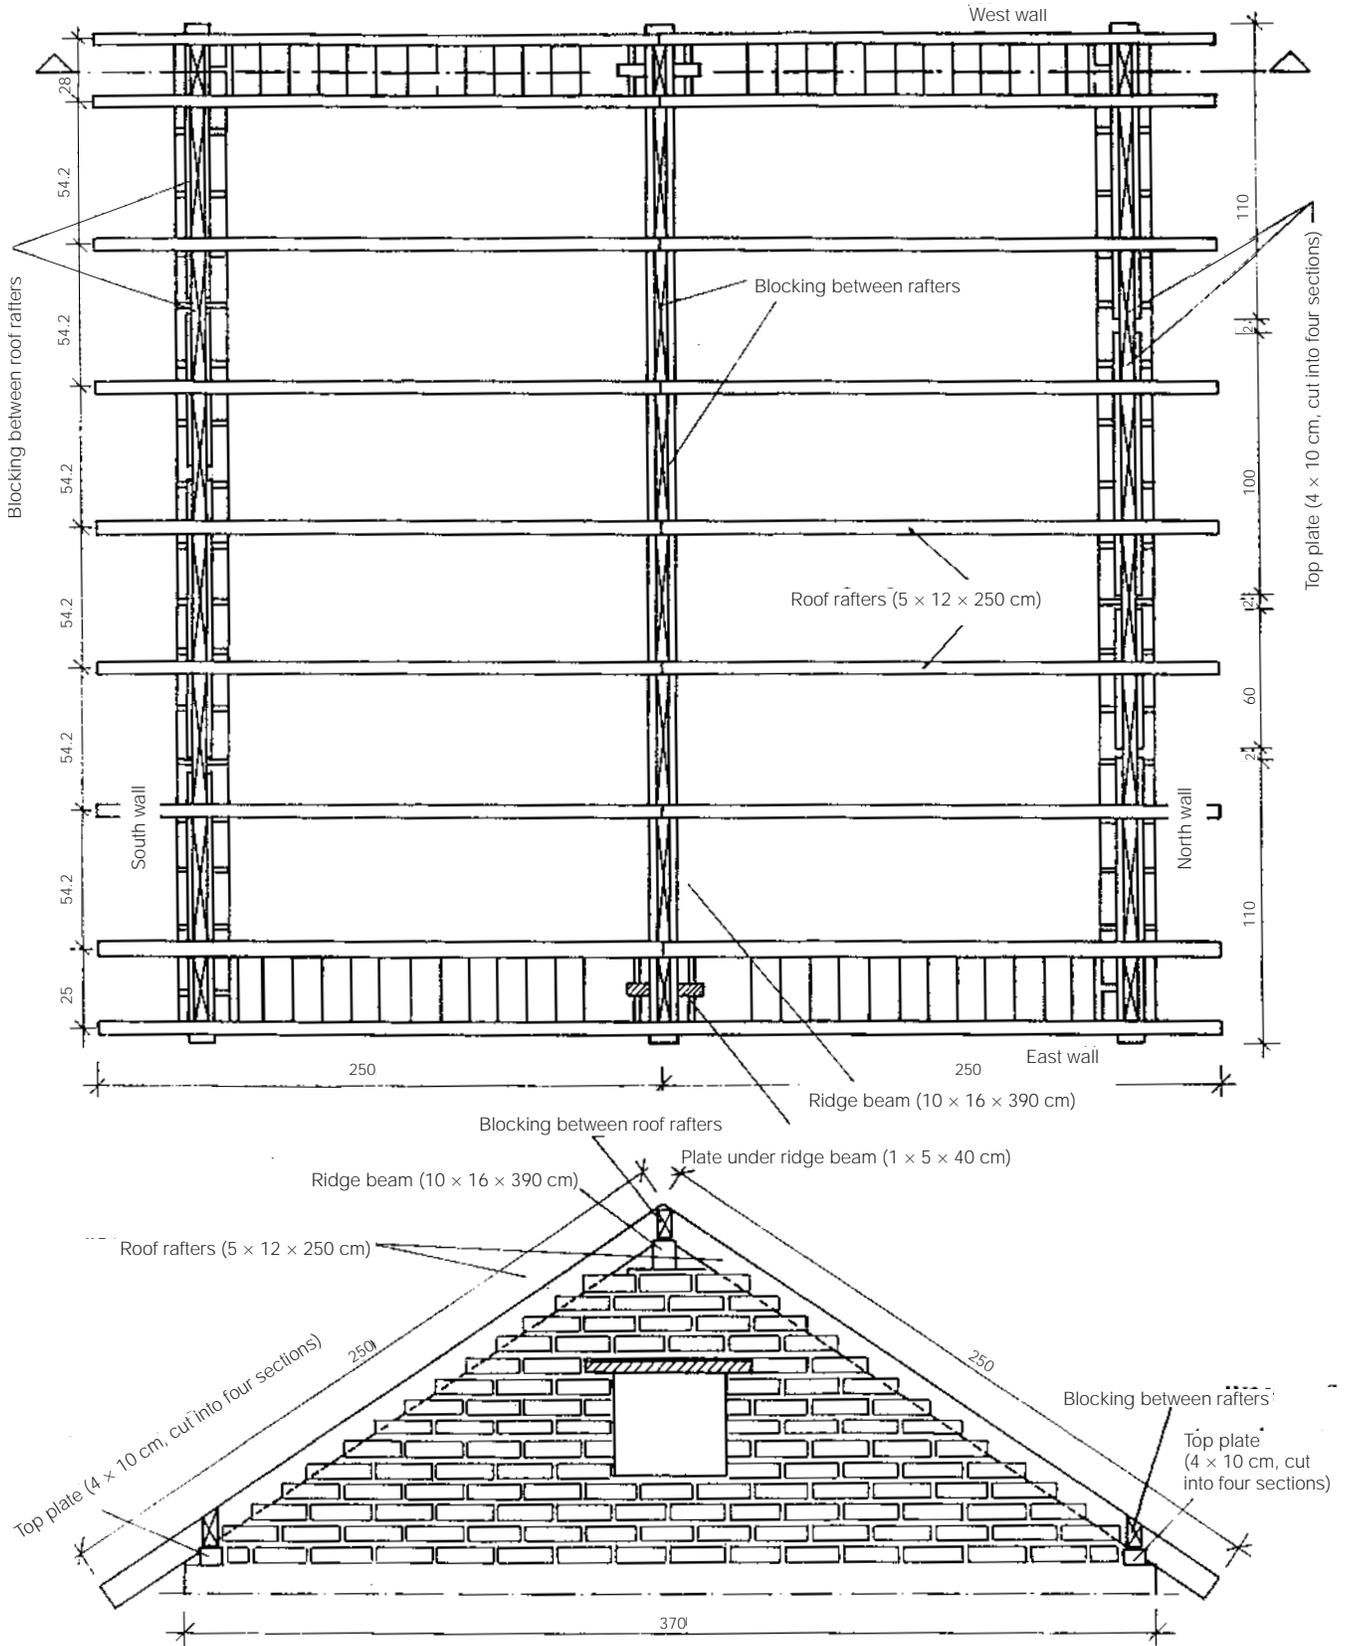
Figure 7.4
Model 10 roof framing plan.

Note: All measurements are in centimeters.

Models 10 and 11 were built to a scale of 1:2 ($S_L = 7.5$) and had identical plans, dimensions, and wall layouts. The only difference was that model 11 was retrofitted. The models were erected on reinforced concrete foundations, and the adobe structure was doweled to the foundation to minimize slipping. The models were aged indoors for 80 days before testing to allow for complete drying. Dimensional and construction details of the unretrofitted model are shown in figures 7.1–7.4.

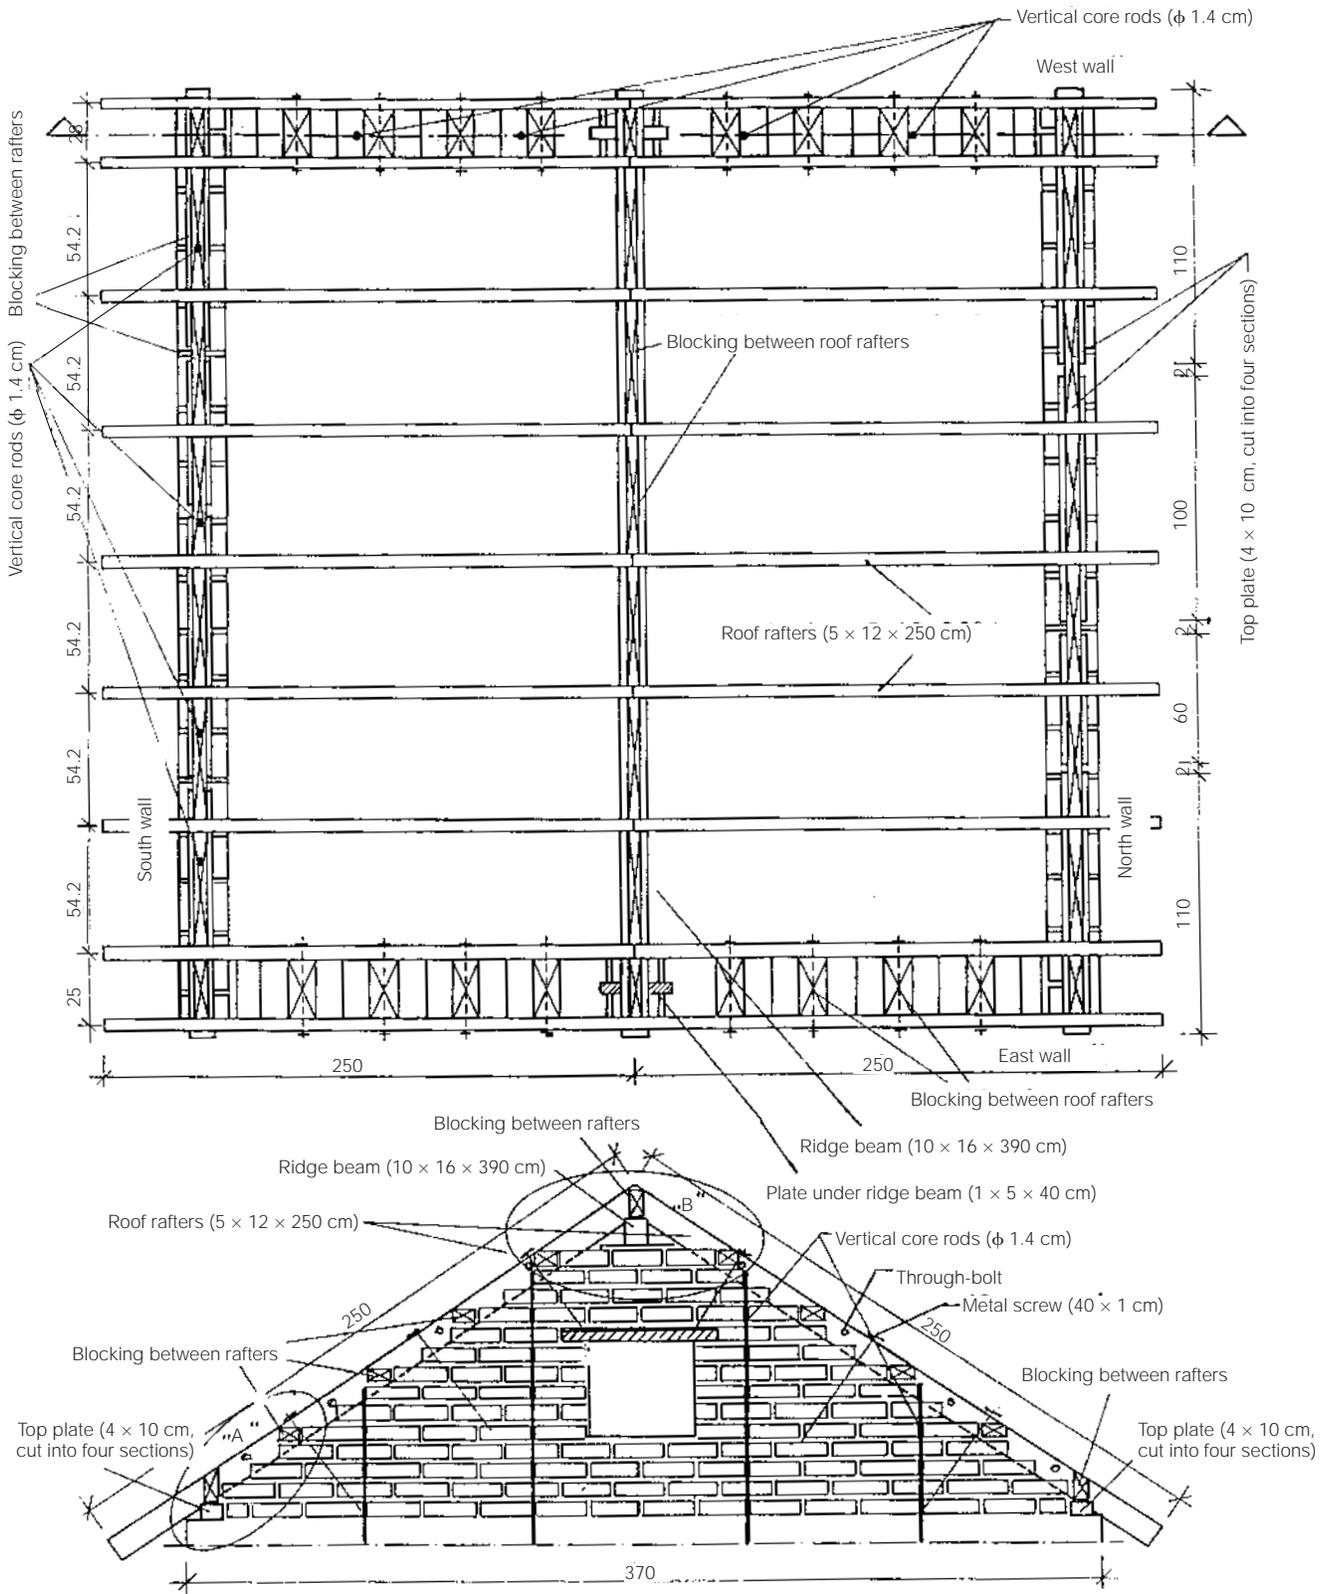
Figure 7.11
Model 11 roof framing plan.

Note: All measurements are in centimeters.

On the load-bearing walls, the bearing plates on the tops of the walls were discontinuous; that is, they were cut into four sections. These plates were attached to the walls with 8 mm (0.31 in.) diameter steel screws anchored with epoxy grout. The roof rafters were anchored with nails to the bearing plates, and blocking was placed between each of the roof rafters (fig. 7.11).

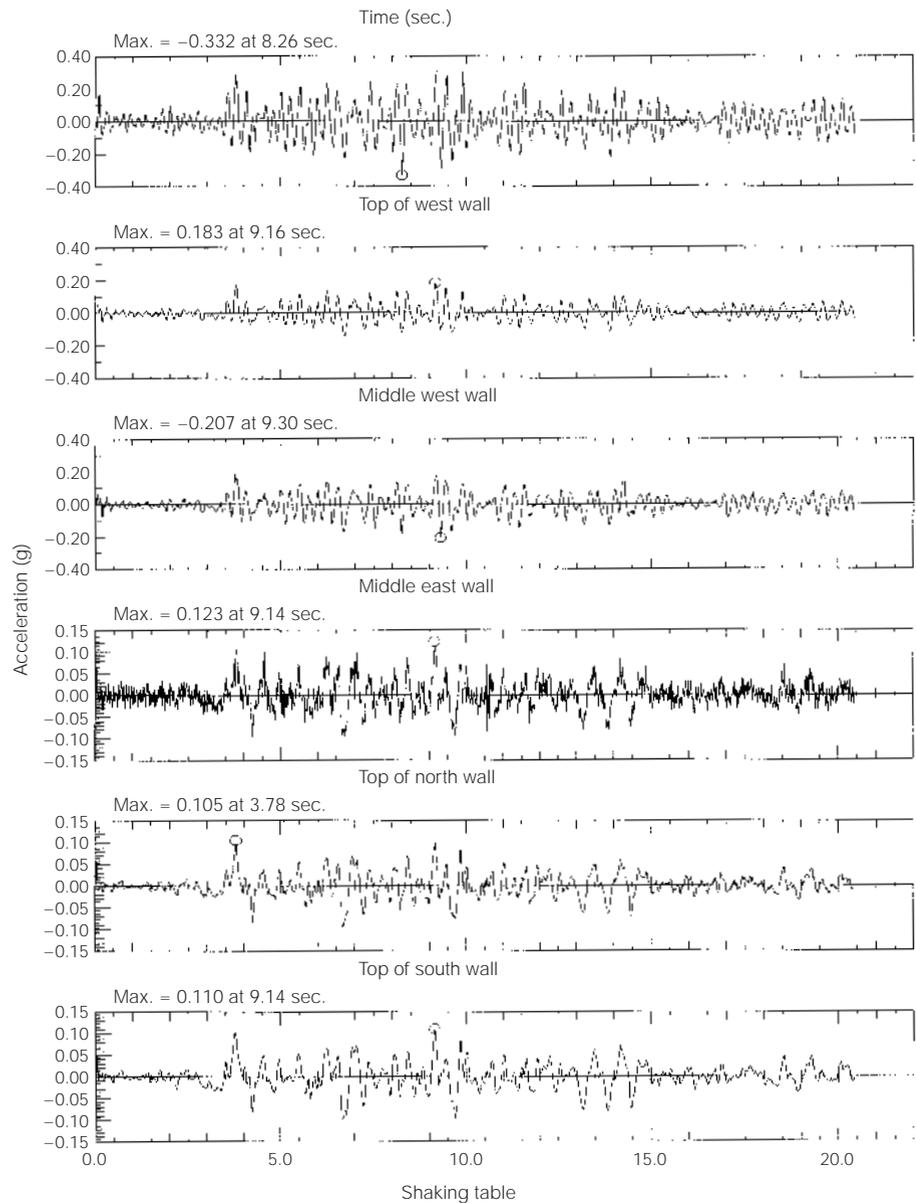
Figure 8.1

Acceleration measurements for model 10, test II. The peak acceleration magnitude and the time at which the peak occurred are indicated by a circle around the maximum peak on the time-history plot. The value on each plot is shown toward the left side just above the top border of each time history.

The dynamic response of the undamaged control building was largely as expected. The time histories of the wall and table accelerometers are shown in figure 8.1. By comparing the peak values for each plot, it can be seen that the peak acceleration at the top of the west wall (0.332 g)

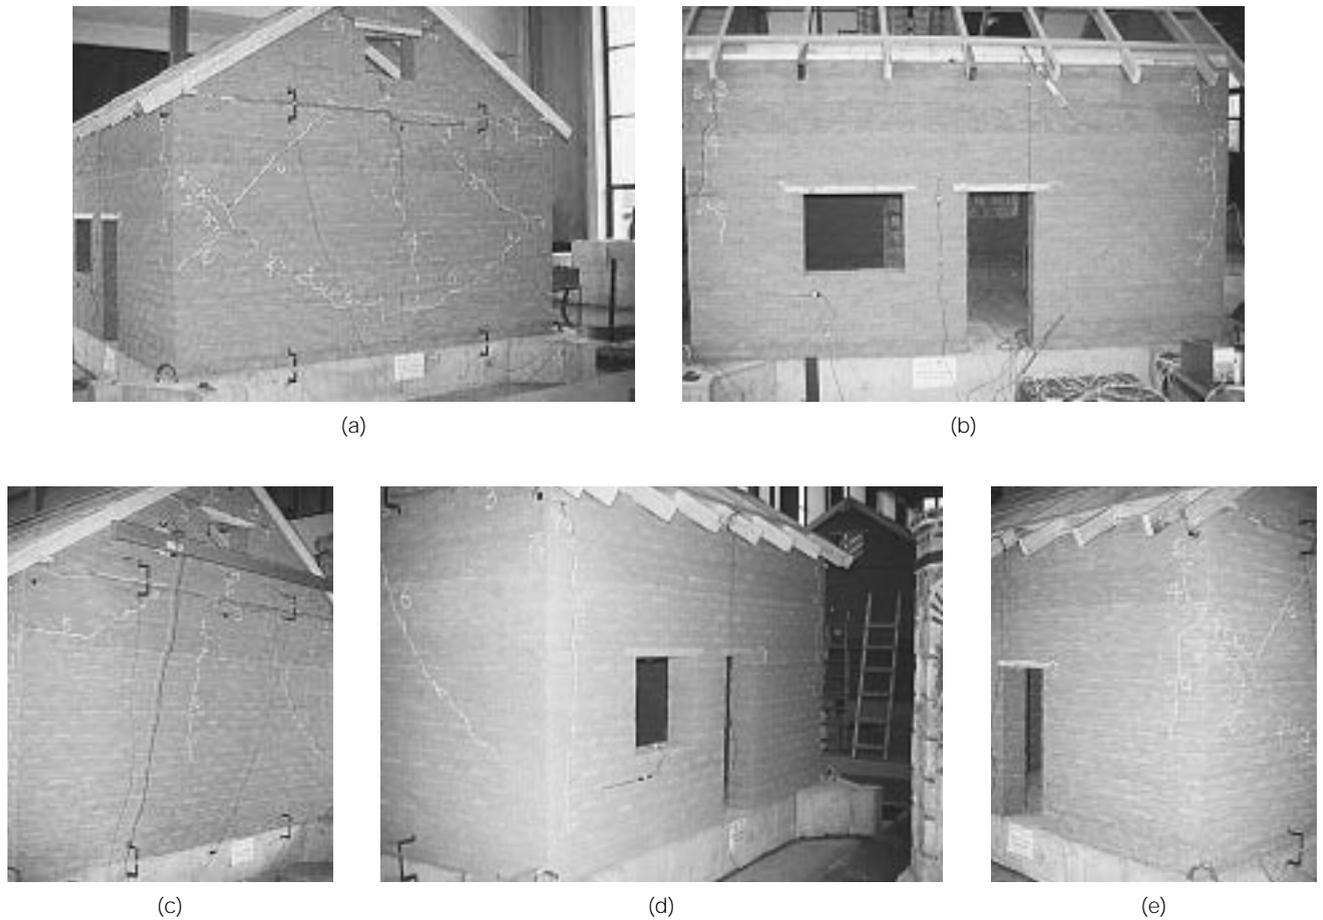
Figure 8.4

Photographs of model 10, test VI, crack patterns on (a) east wall; (b) north wall; (c) west wall; (d) south wall, west side; and (e) south wall, east side.

During test VI (figs. 8.3 and 8.4), the out-of-plane motions of the gable-end walls were significant, with peak displacements of nearly 16.5 cm (6.5 in.). Cracks developed more fully during this test and completed the principal crack patterns for the out-of-plane walls. The patterns that occurred in the east and west walls were different due to the variability in the adobe masonry and the asymmetry of the ground motions. Spalling continued along the major cracks. Without the restraint of the roof system, the gable-end walls would have had a tendency toward instability. Minimal restraint was required to significantly affect the out-of-plane dynamics of thick walls.

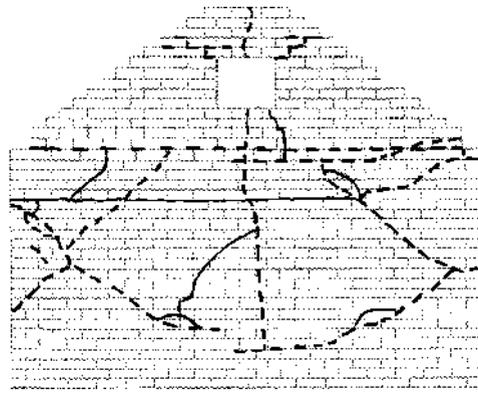
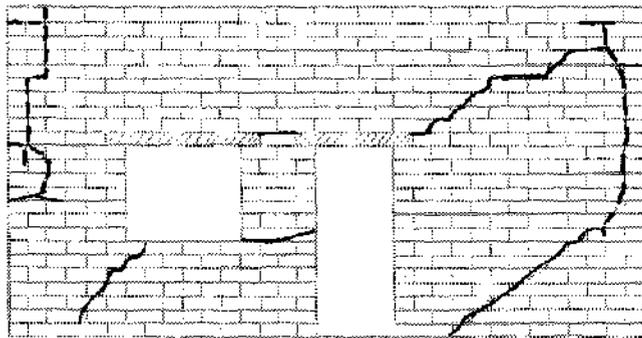
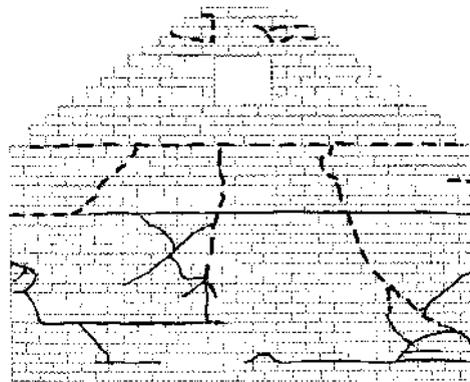
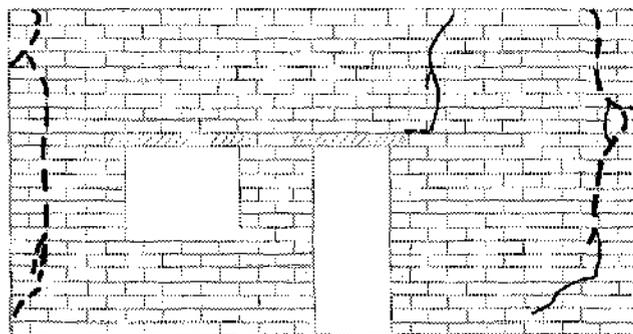
Figure 8.5

Diagram of model 10, test VII, crack patterns on (a) east wall; (b) north wall; (c) west wall; and (d) south wall.

Cracks during this test —————
 Preexisting cracks - - - - -

During test VII (figs. 8.5 and 8.6), the out-of-plane motions were very great and caused cracking and popping noises in the wood framing of the roof. The out-of-plane walls would very likely have overturned had it not been for the restraint provided by the roof framing system. Spalling continued along the major cracks. Diagonal cracks

developed during test VII in the north wall (fig. 8.5b). This was the first test during which typical diagonal in-plane cracks developed; there were no similar in-plane cracks in the south wall. The out-of-plane displacement of the west gable-end wall was 23.6 cm (9.3 in.) during test VII.

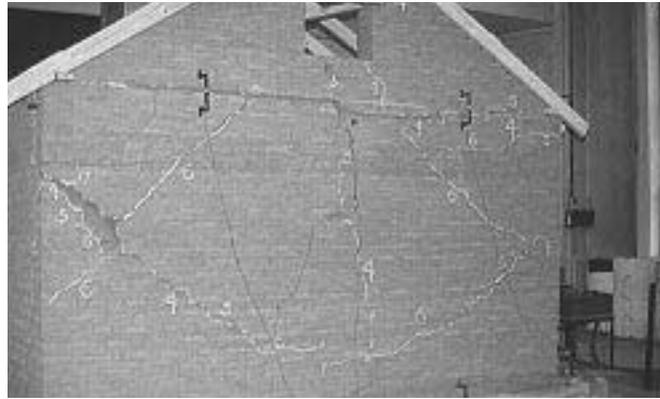
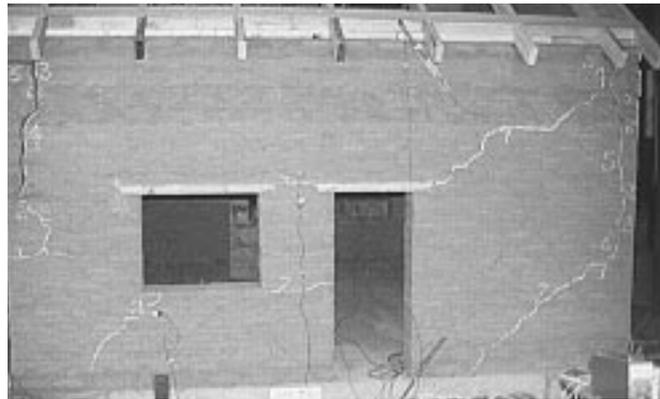
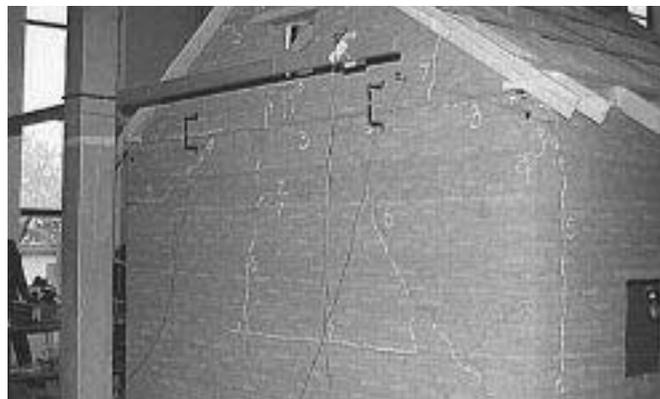
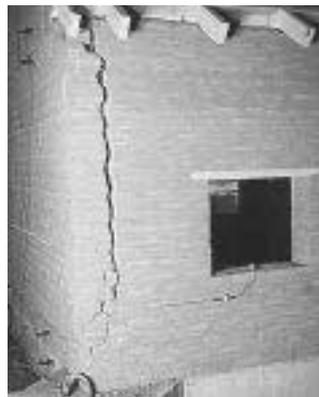
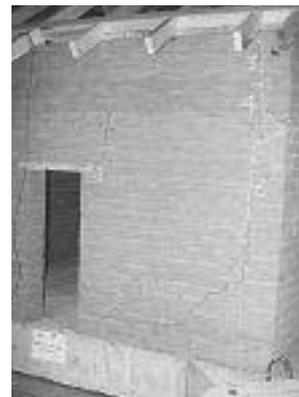
Figure 8.6

Photographs of model 10, test VII, crack patterns on (a) east wall; (b) north wall; (c) west wall, south side; (d) south wall, west side; and (e) south wall, east side.

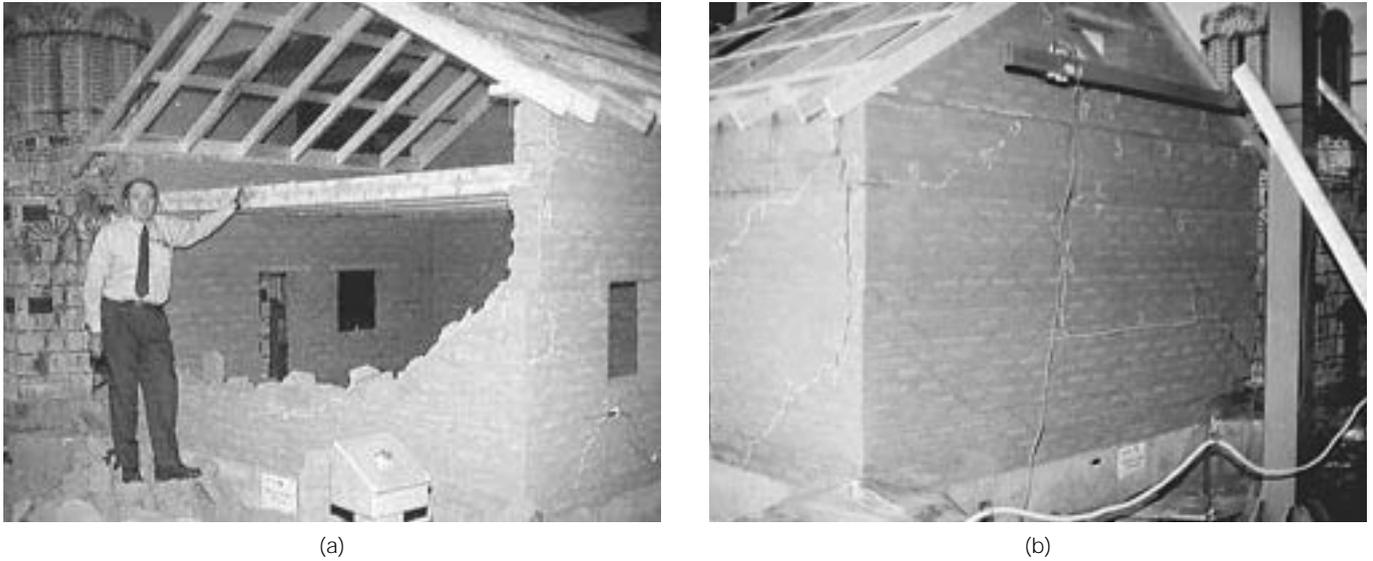
Figure 8.7
 Model 10, test VIII, showing (a) east wall collapse; and (b) crack patterns in north-west corner.

During test VIII (fig. 8.7), the east wall collapsed from the center of the wall rather than overturning due to restraint by the roof system. Test VIII lasted only about 3 seconds because the programmed table accelerations exceeded the capacity of the earthquake simulator. Due to the short length of the test, little additional damage occurred in the other walls of the building. The overturning failure mode occurs by rotation about the lowest horizontal crack, and the maximum displacement occurs at the top of the wall (fig. 8.8a). This type of collapse is referred to as “mid-height, out-of-plane collapse” (fig. 8.8b).

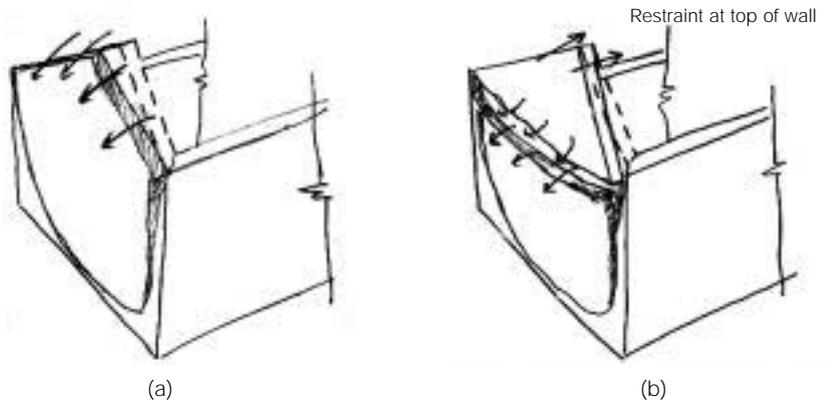
Figure 8.8
 Drawings of out-of-plane modes of failure, illustrating (a) typical overturning failure as the wall rotates about its base; and (b) mid-height, out-of-plane collapse observed in the east wall of model 10. The latter mode of collapse occurred due to the restraint provided by the roof system at the top of the wall.

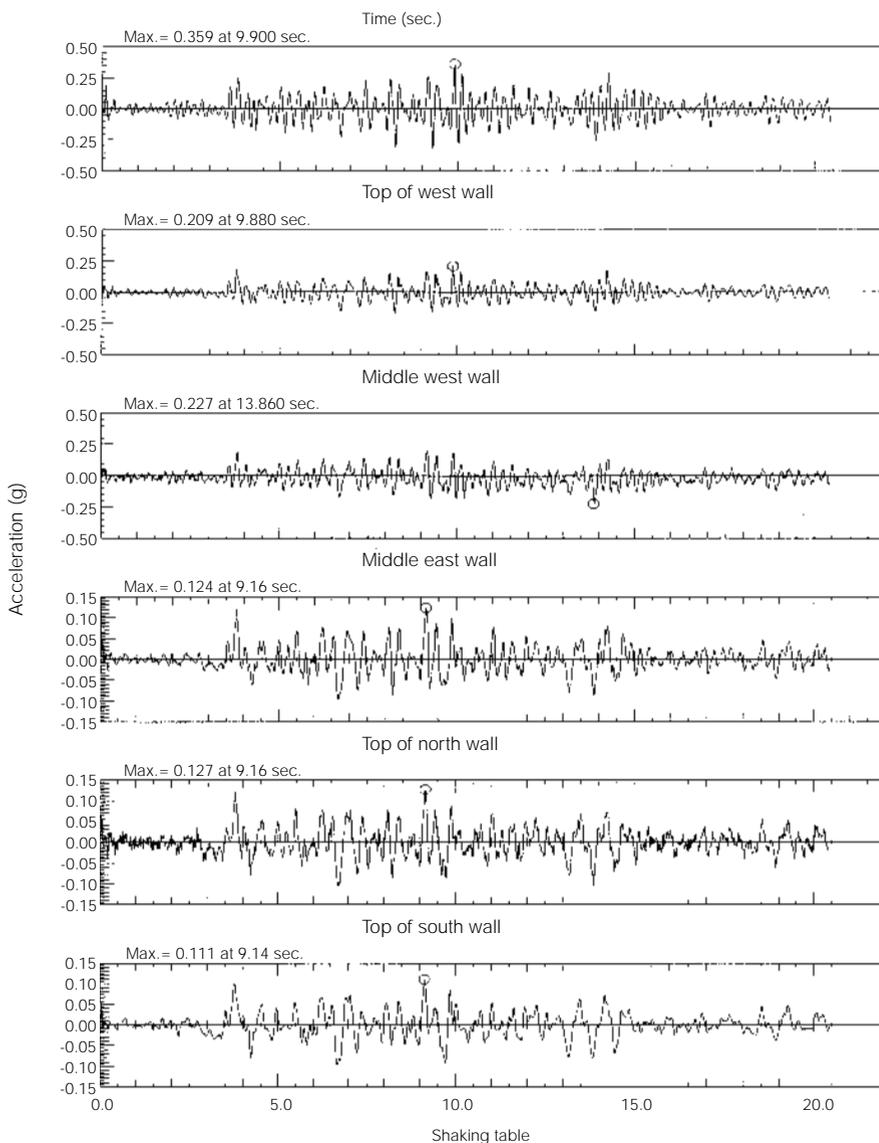
Figure 8.9

Acceleration measurements for model 11, test II. The peak acceleration magnitude and the time at which the peak occurred are indicated by a circle around the maximum peak on the time-history plot. The value on each plot is shown toward the left side just above the top border of each time history.

Plots of the dynamic motions of the walls during test II are shown in figure 8.9. The peak acceleration of the top of the out-of-plane west wall was 0.359 g compared to the table acceleration maximum of 0.111 g, an amplification factor of 3.25. The accelerations at the mid-

height of the west and east walls were 0.209 g and 0.227 g, respectively. The accelerations of the north and south (in-plane) walls were 0.124 g and 0.127 g, respectively, only slightly greater than the table acceleration. It is also interesting to note that the peak acceleration of the damaged north wall was the same as that of the undamaged south wall.

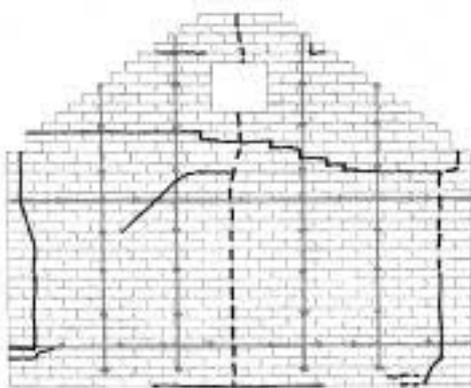
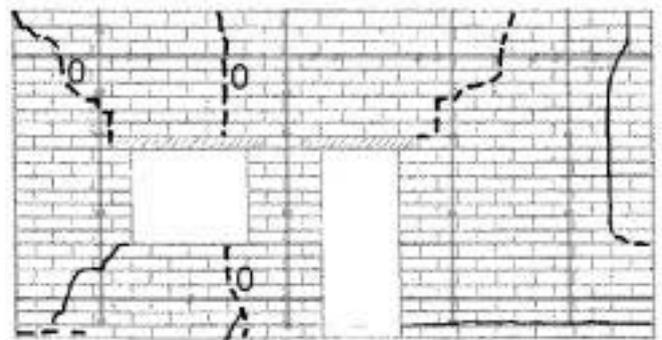
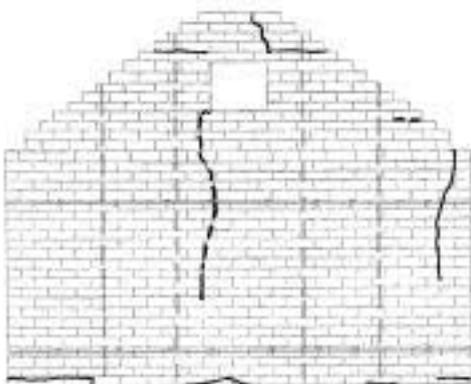
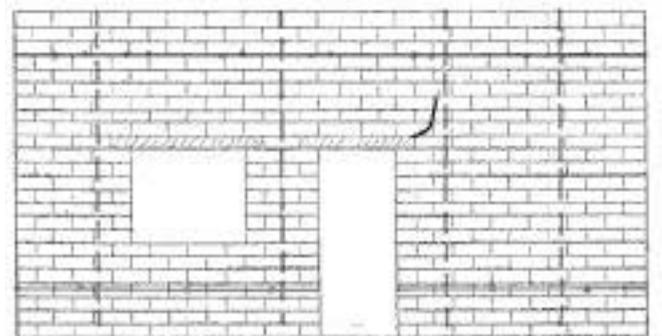
Figure 8.10

Diagrams of model 11, test V, crack patterns on (a) east wall; (b) north wall; (c) west wall; and (d) south wall. Earlier cracks are marked with zeros and dashed lines.

New crack damage did not develop until test IV or propagate until test V. The location of the crack damage after test V is shown in figure 8.10. Damage to the two out-of-plane walls was similar in some respects to that in model 10 but different in others, indicating the influence of the retrofit strategies. The vertical straps used on the west walls were not stiff enough to prevent or change the development of crack damage in the wall. The strap system affected only the dynamic performance after cracks had developed. As a result, the crack pattern in the east out-of-plane, gable-end wall consisted of both vertical and horizontal cracks similar to those

The in-plane north wall with vertical and horizontal straps developed additional cracks during both tests IV and V (fig. 8.10b). These cracks occurred earlier than in the in-plane walls of model 10 for two reasons: (1) some cracks existed before the testing began, and (2) the retrofit system resulted in higher forces being transferred to the in-plane from the out-of-plane walls. More than likely, both factors contributed to greater cracking in the north wall of model 11 compared to the north wall of the unretrofitted model 10.

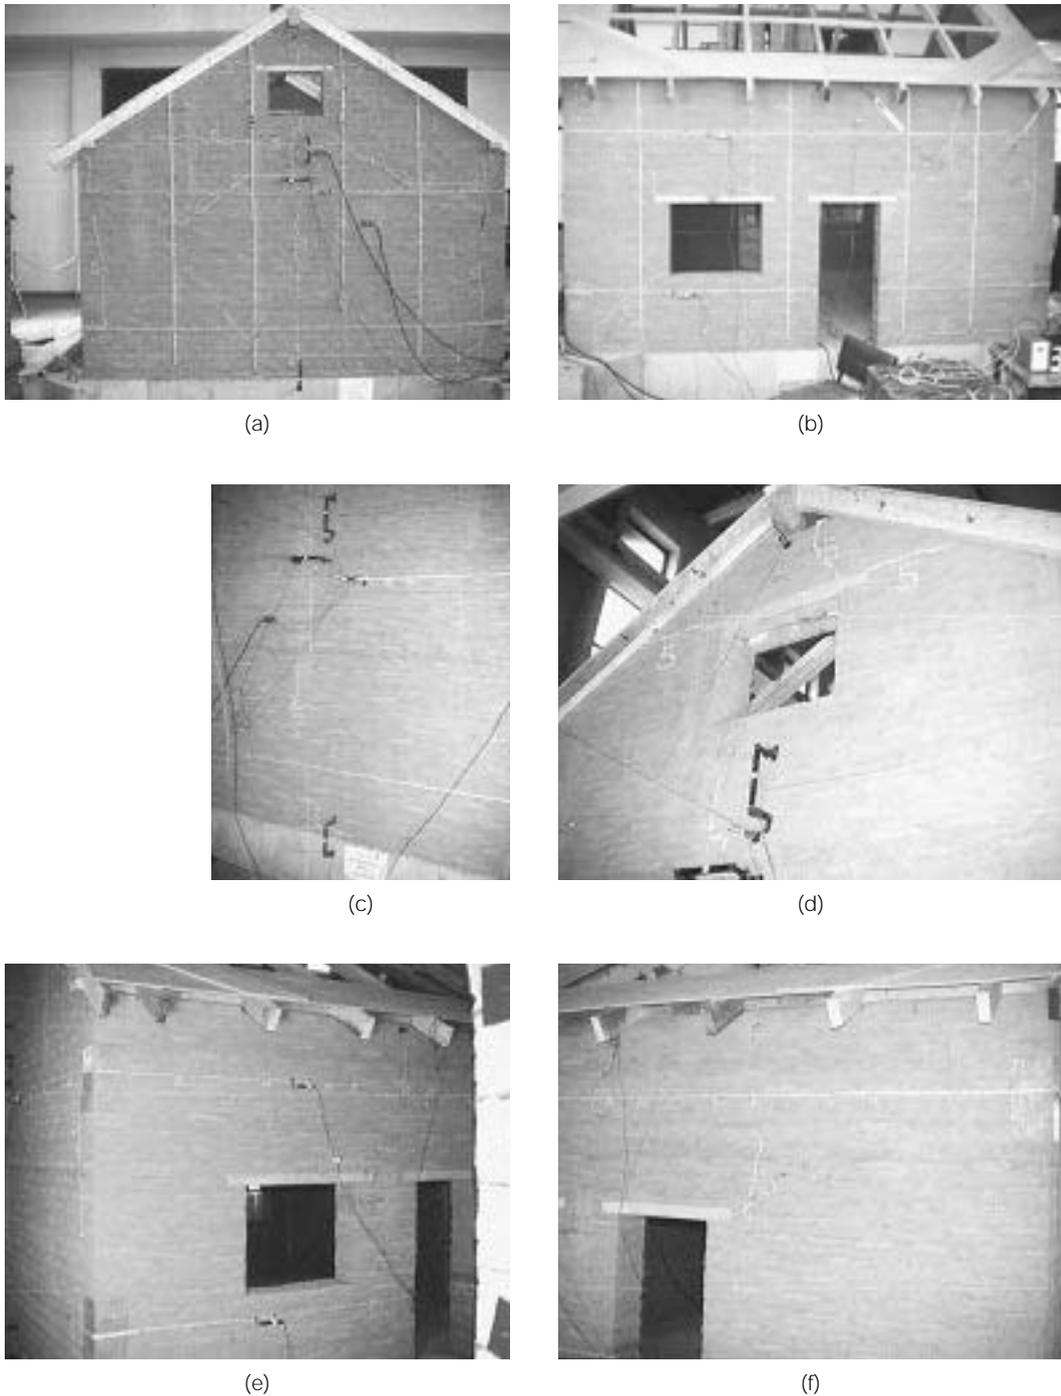
Figure 8.11

Photographs of model 11, test V, crack patterns on (a) east wall; (b) north wall; (c) west wall; (d) west wall gable; (e) south wall, west side; and (f) south wall, east side.

In viewing the dynamic tests, the cracks that developed during tests IV and V were relatively minor in terms of the amount of displacement that occurred in the out-of-plane walls. In the photographs of figure 8.11, it is difficult to discern the locations of the cracks because they were highlighted with chalk only, and no spalling had occurred around the cracks. Not until test VI did larger displacements develop and spalling become significant.

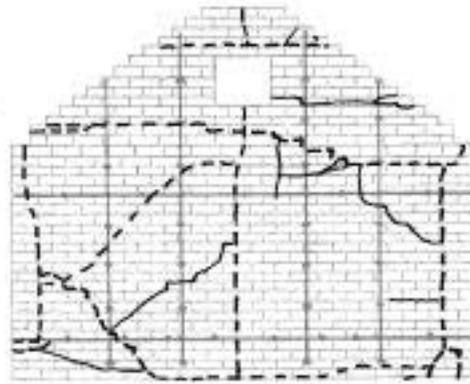
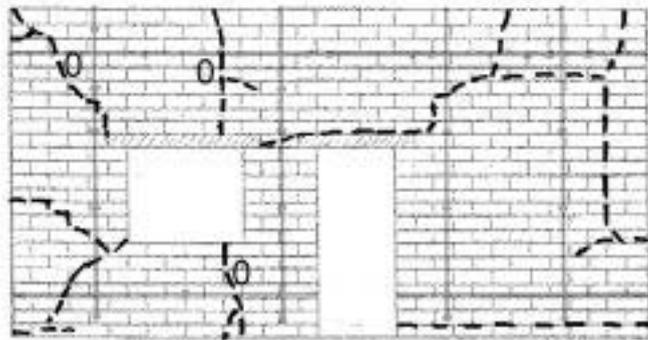
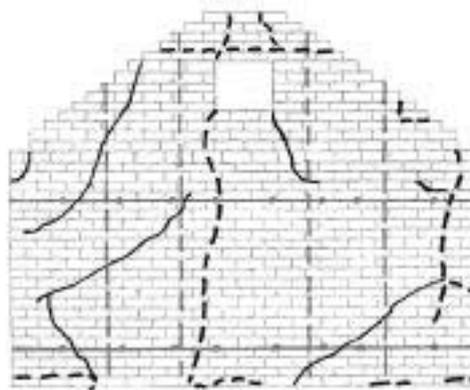
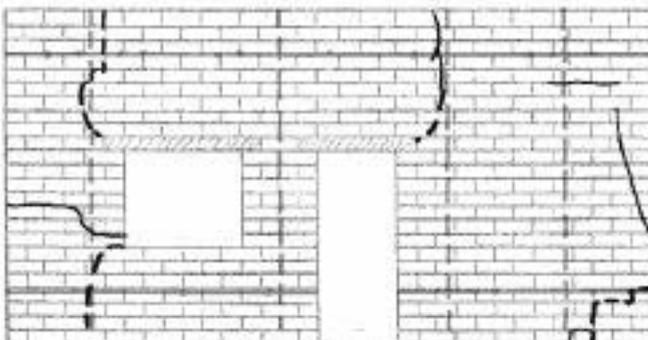
Figure 8.12

Diagram of model 11, test VII, crack patterns on (a) east wall; (b) north wall; (c) west wall; and (d) south wall.

- Cracks during this test
- Preexisting cracks
- Straps
●
●
●
- Center cores

During the strong ground motions of tests VI–VIII, all of the retrofit measures on the building became significant with regard to the performance of model 11. The walls with vertical straps, both in-plane and out-of-plane, sustained much higher levels of damage than the walls with the vertical center cores. The drawings and photographs of model 11 after test VII are shown in figures 8.12 and 8.13.
