Seismic Stabilization of Historic Adobe Structures

Final Report of the Getty Seismic Adobe Project

E. Leroy Tolles
Edna E. Kimbro
Frederick A. Webster
William S. Ginell

GCI Scientific Program Reports

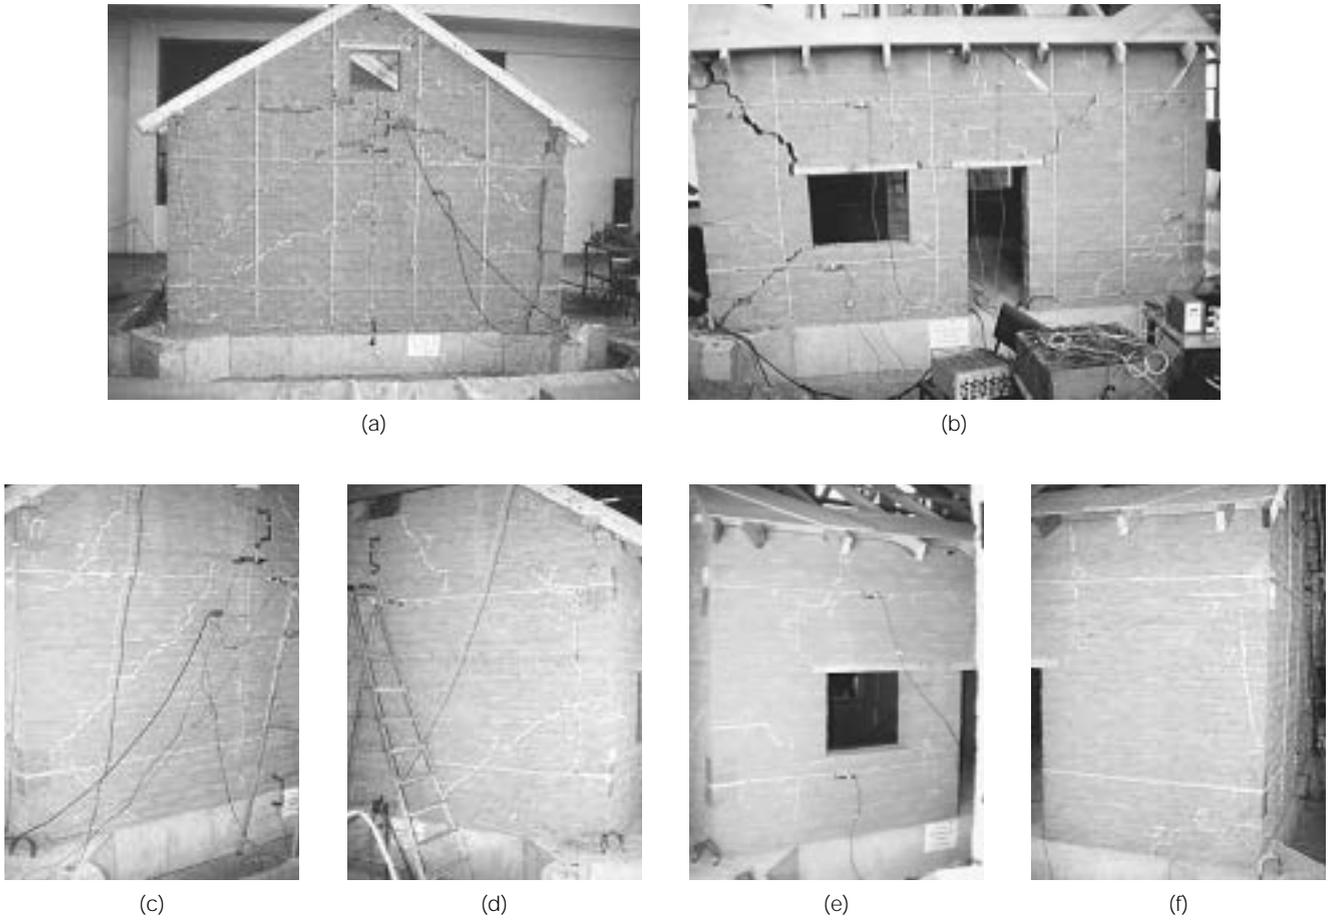
Figure 8.13
 Photographs of model 11, test VII, crack patterns on (a) east wall; (b) north wall; (c) west wall gable; (d) west wall, south side; (e) south wall, west side; and (f) south wall, east side.

During the strong ground motions of tests VI–VIII, all of the retrofit measures on the building became significant with regard to the performance of model 11. The walls with vertical straps, both in-plane and out-of-plane, sustained much higher levels of damage than the walls with the vertical center cores. The drawings and photographs of model 11 after test VII are shown in figures 8.12 and 8.13.

The most significant damage may have been the displacement of the block at the east end of the north wall (fig. 8.13b). The section of the wall defined by the diagonal cracks at the upper and lower left corners of the window created a cracked wall section along which the permanent displacements continued to grow as the tests proceeded, beginning with test VII. The crack at the top of this panel developed a permanent displacement of approximately 3.8 cm (1.5 in.) during this test, and significant loads were applied to both the upper and lower horizontal straps. The load on the upper strap was great enough to result in a secondary horizontal crack that developed just below this strap. This section of wall was difficult to restrain because it continued to move downward and out along the lower diagonal crack. Gravity and dynamic motions continually moved this section outward. In this type of damage, a diagonal crack at the end of a wall section creates a condition in which damage progressively worsens during continued earthquake motions and may eventually lead to catastrophic failure.

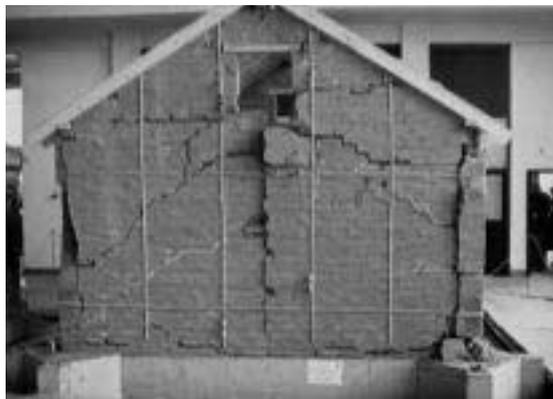
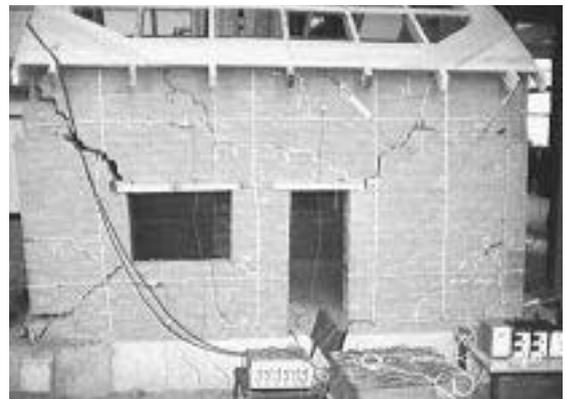
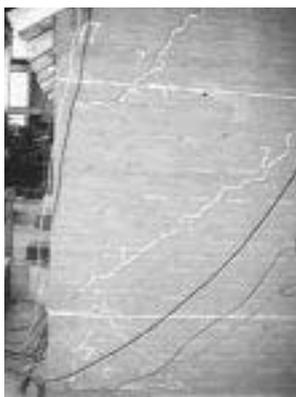
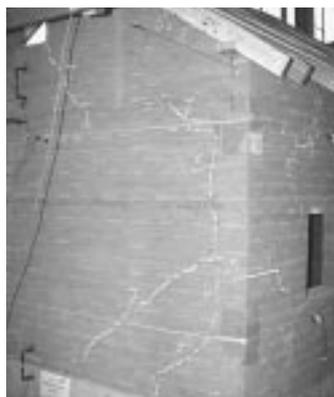
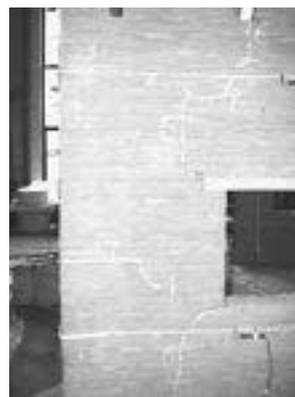
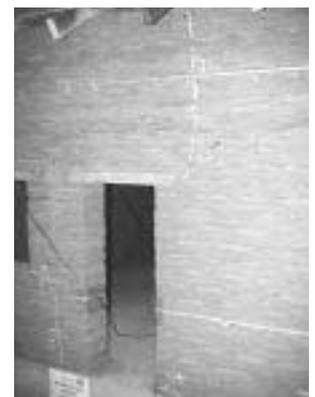
Model 11, test VIII*, crack patterns on (a) east wall; (b) north wall; (c) west wall, south side; (d) west wall, north side; (e) south wall, west side; and (f) south wall, east side.

Large displacements were obtained during test VIII* by decreasing the time-scaling factor from 2 to 1.5. Because the model was 1:2 scale and neglected gravity loads, the correct test acceleration was obtained by multiplying the original accelerations by a factor of 2. Once the model was severely cracked, however, the development of large displacements was the most characteristic effect of the ground motions. Test VIII* had the same table displacements as the previous test VIII for model 10, but the duration of the test was slightly longer. All accelerations were 50% greater, rather than 100% greater, than the original record. Since the force on the drive system for the shaking table is a function of peak acceleration times mass, this decrease was sufficient to prevent overloading of the shaking-table control system. Figure 8.14 shows model 11 after test VIII*.

The east gable-end wall suffered significant additional damage during test VIII*. A small block just below the window was dislodged (see fig. 8.14a), and the offsets at the cracks in the center were nearly 7.6 cm (3 in.). Although large dynamic displacements occurred during the test, the wall never appeared to have been close to collapse.

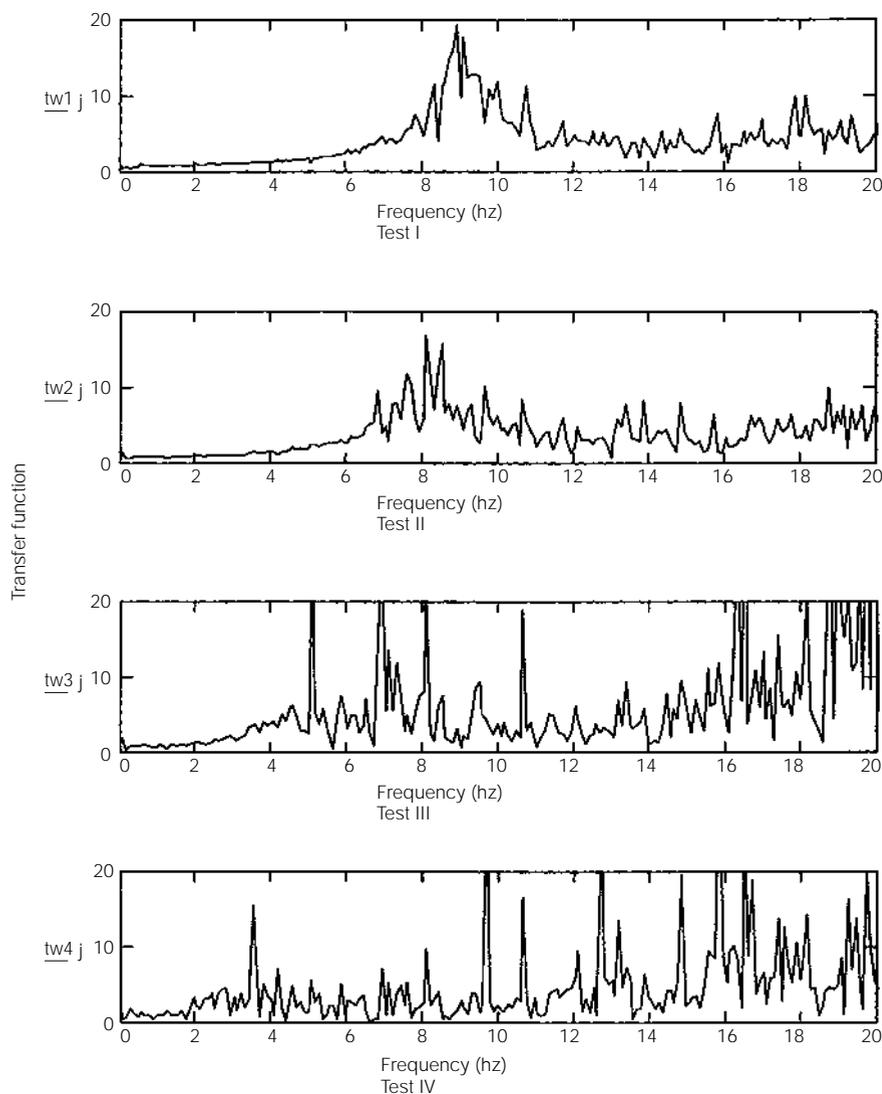
Degradation of the frequency response of model 10 during tests I–IV. Plots are the acceleration transfer functions for the top of the west gable-end wall.

The first evidence of damage can be seen by examining degradation in acceleration transfer functions. Figure 8.15 shows plots of the transfer function for model 10 during tests I–IV. There was little change between tests I and II, as indicated by the similar shapes of the transfer functions. Significant degradation began during test III with the loss of the defined

peaks in the 8–9 second range, which represents the principal mode of vibration, and with the shortening of the flat part of the spectrum starting at zero and extending to the right. The spectrum of test IV shows complete degradation even in the lowest part of the spectrum.

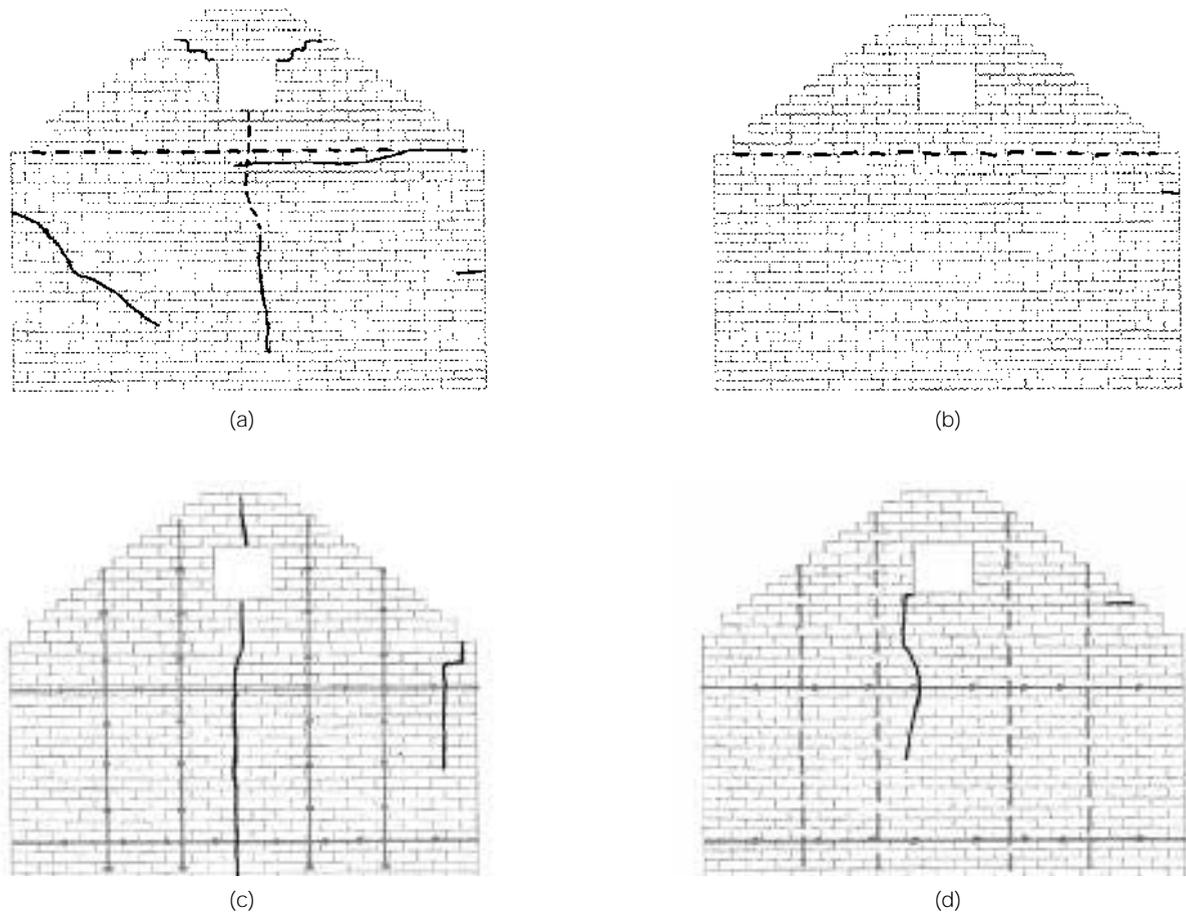
Figure 8.16

Comparison of crack patterns after test IV in out-of-plane walls for (a) model 10, unretrofitted east wall; (b) model 10, unretrofitted west wall; (c) model 11, retrofitted east wall; and (d) model 11, retrofitted west wall. Solid lines indicate cracks that occurred during test IV; dashed lines indicate cracks that typically occurred during test III.

Comparison of the damage to the out-of-plane and in-plane walls for the two models is shown in figures 8.16 and 8.17, respectively. Drawings of the crack damage that developed during tests V–VII are shown in figures 8.18–8.23.

Crack development of the out-of-plane walls during moderate-level tests was affected by the retrofit system. The stiffness of the roof diaphragm was sufficient to prevent horizontal cracks from occurring in both the east and west gable-end walls of model 11 during test IV, whereas both walls of model 10 developed horizontal cracks during test III (fig. 8.16). Vertical cracks developed during test IV in both retrofitted and unretrofitted models.

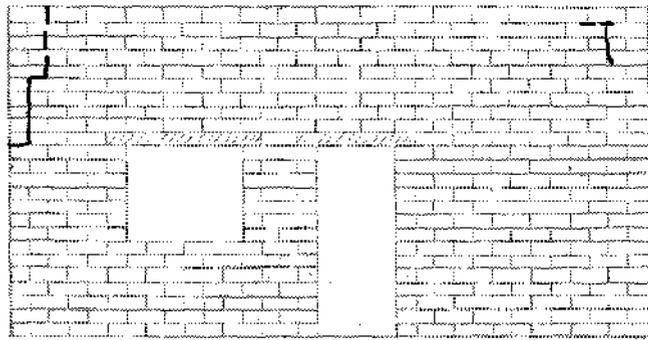
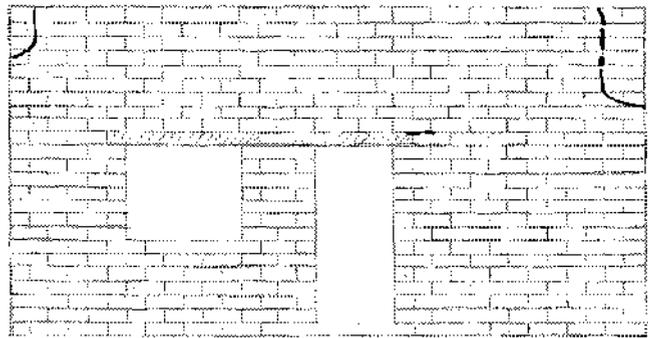
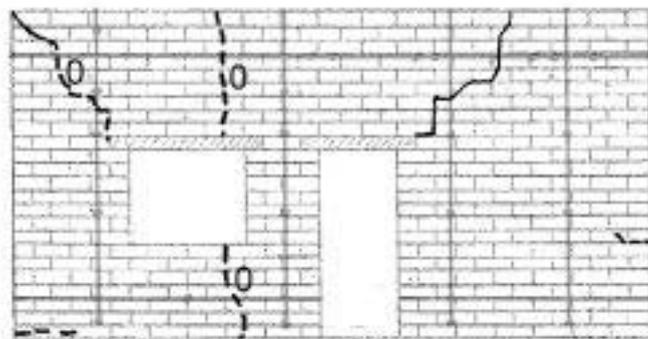
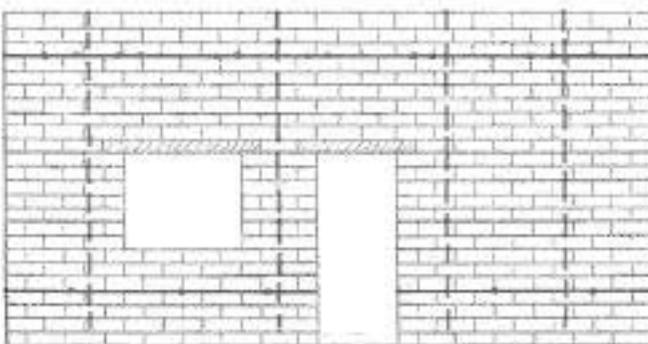
Figure 8.17

Comparison of crack patterns after test IV in the in-plane walls for (a) model 10, unretrofitted north wall; (b) model 10, unretrofitted south wall; (c) model 11, retrofitted north wall; and (d) model 11, retrofitted south wall. Solid lines indicate cracks that occurred during test IV; dashed lines indicate cracks that typically occurred during test III; cracks labeled "0" occurred before the start of the test series.

pull-out forces exerted on them by the gable-end walls. The gable-end walls were beginning to pull away from the in-plane walls, which led to crack damage in the upper corners of the in-plane walls (fig. 8.17a, b). The in-plane walls of model 11 did not develop these cracks because of restraint on the dynamic motions of the out-of-plane walls provided by the diaphragms.

In the in-plane walls of the retrofitted model, the only crack that developed during test IV was the diagonal crack that extended from the upper right corner of the doorway in the north wall of model 11 (fig. 8.17c). This crack occurred because the wall already had sustained crack damage and was subjected to greater loads from the roof and floor diaphragms, which transferred loads from the out-of-plane walls to the in-plane walls. It is not possible to determine the extent to which each of these factors contributed to the development of these cracks. During test V, a small in-plane crack also developed at the upper right corner of the doorway in the south wall (fig. 8.19d). This crack turned upward and terminated when it intersected the vertical center-core bar. Nevertheless, the development of a shear crack in the south wall indicated that the loading in the in-plane walls of the retrofitted model was greater than the loading in the corresponding walls of the unretrofitted model.

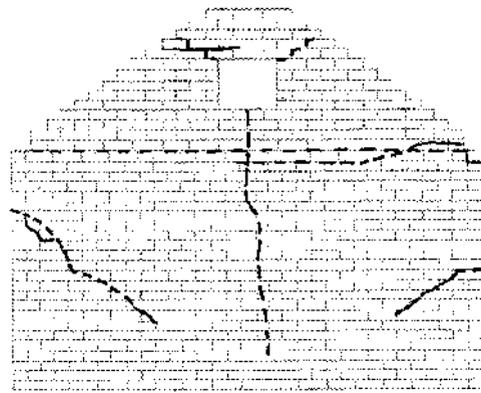
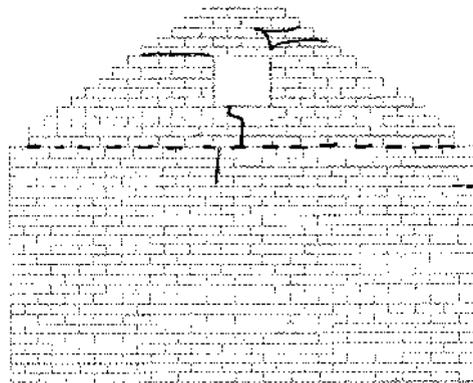
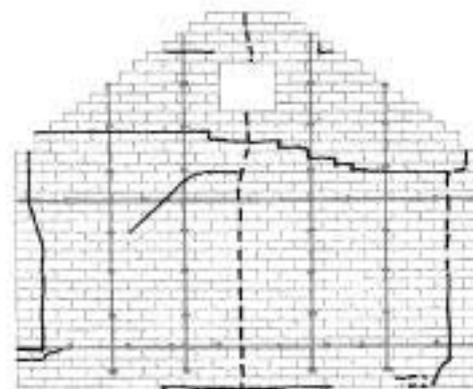
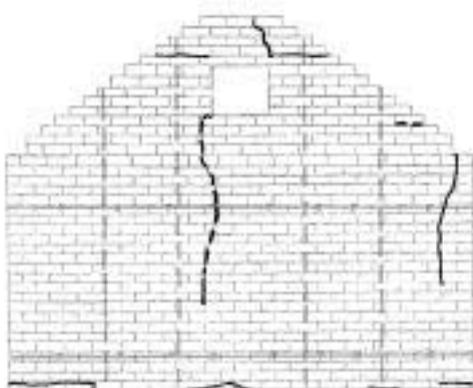
Figure 8.18

Comparison of crack patterns after test V in out-of-plane walls for (a) model 10, unreinforced east wall; (b) model 10, unreinforced west wall; (c) model 11, retrofitted east wall; and (d) model 11, retrofitted west wall.

Crack damage to the out-of-plane walls continued to worsen during tests V and VI as shown in figures 8.18 and 8.20, respectively. During test V, a horizontal crack developed in the east wall of model 11

(fig. 8.18c). The roof system restrained the top of the wall, but the vertical straps were not able to prevent this type of damage. The crack damage to the east wall of models 10 and 11 was similar though not identical (fig. 8.20a, c). The vertical and horizontal strap system had no significant effect on the elastic behavior and crack development; it had an observable effect only after cracks had developed and displacements were large. Nevertheless, the effect of the strapping system is very significant. Stiffness of the roof diaphragm affected all phases of dynamic performance.

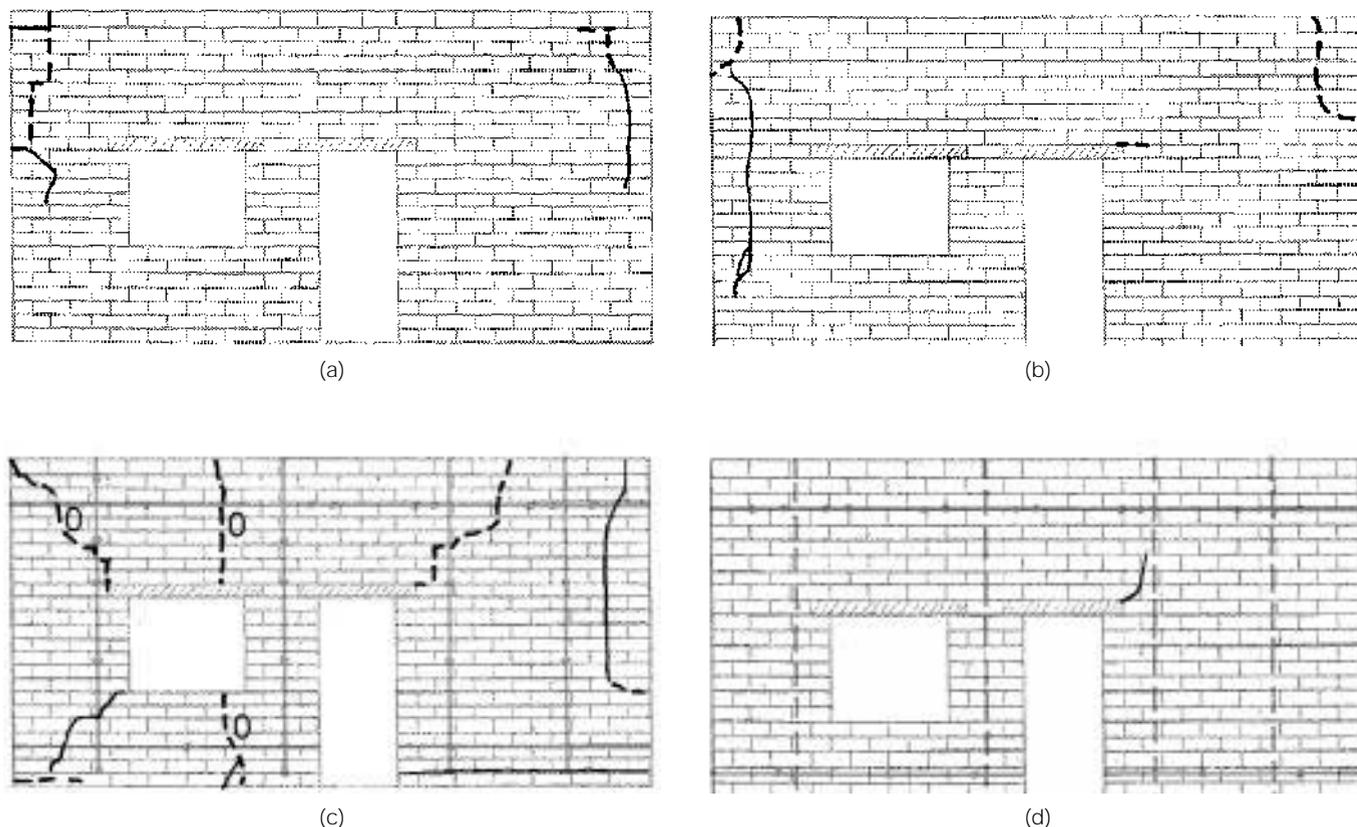
Figure 8.19

Comparison of crack patterns after test V in the in-plane walls for (a) model 10, unretrofitted north wall; (b) model 10, unretrofitted south wall; (c) model 11, retrofitted north wall; and (d) model 11, retrofitted south wall.

Crack damage to the in-plane walls continued to progress in both walls of model 11 during tests V and VI (figs. 8.19 and 8.21). In model 11, the damage to the north wall worsened considerably, whereas the crack damage to the south wall propagated to the reinforcing bars, where the cracks terminated. In model 10, crack damage was limited to the ends of the walls and was caused by tensile stresses, not in-plane shear stresses. The differences in behavior are due largely to the additional loading that resulted from the anchorage to the roof and floor diaphragms.

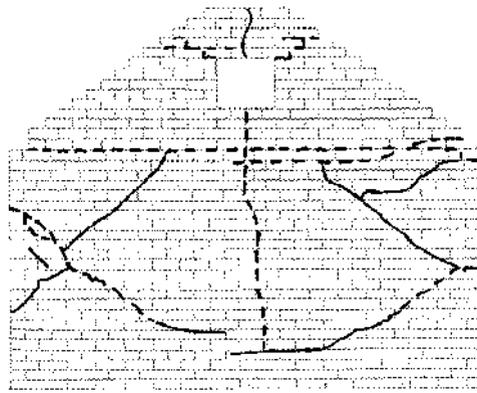
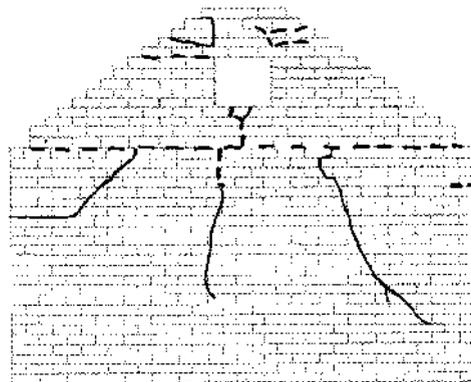
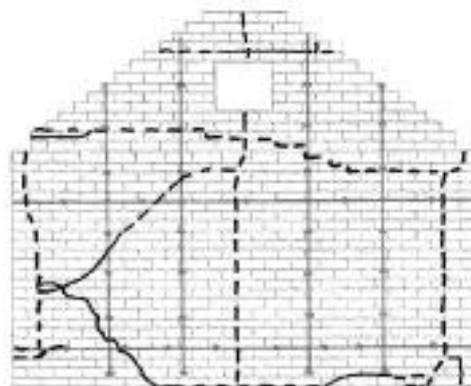
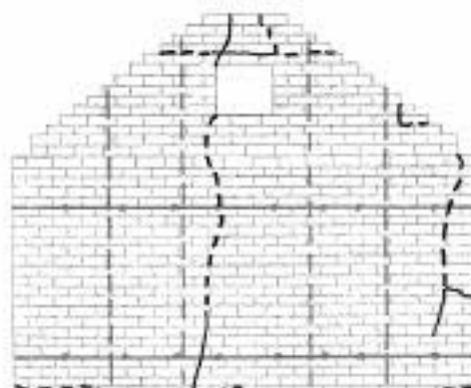
Figure 8.20

Comparison of crack patterns after test VI in out-of-plane walls for (a) model 10, unreinforced east wall; (b) model 10, unreinforced west wall; (c) model 11, retrofitted east wall; (d) model 11, retrofitted west wall.

The crack damage to the west wall of model 11 shows the significant effect of the center-core rods. Through test VI (fig. 8.20), the only long cracks in the west wall were the vertical crack at the center of the wall and the vertical crack on the right (south) side of the wall. Other cracks in the wall were small and not significant. The center-core rods prevented the development of any horizontal or diagonal cracks through test VI.

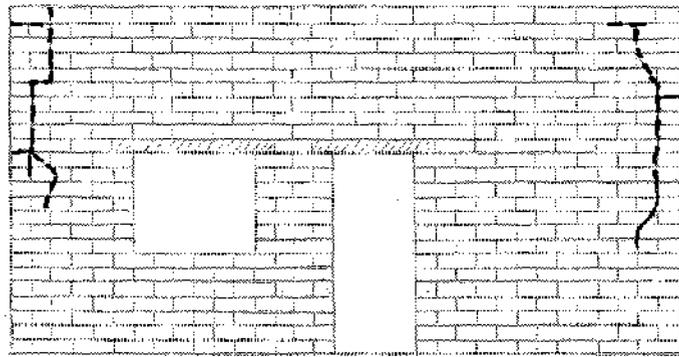
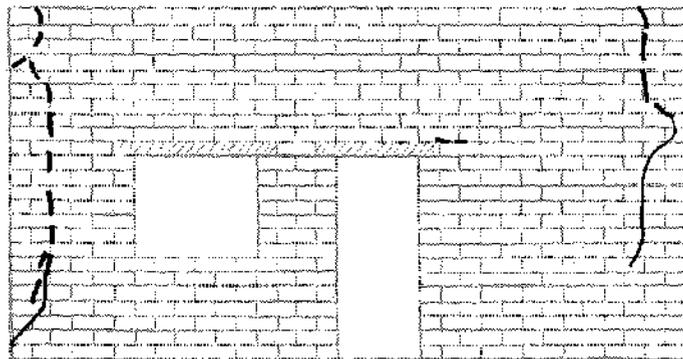
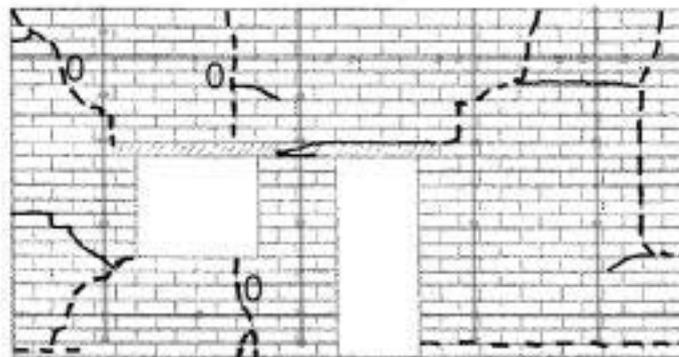
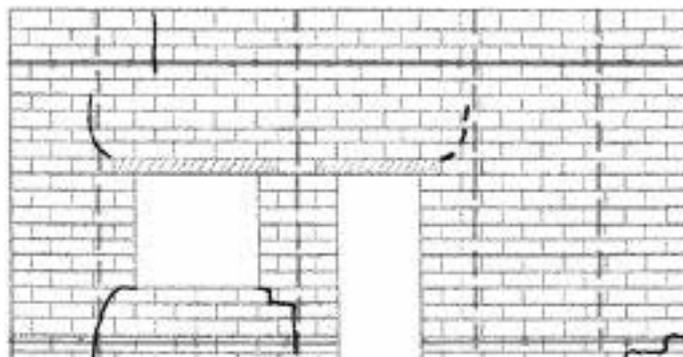
Figure 8.21

Comparison of crack patterns after test VI in the in-plane walls for (a) model 10, unreinforced north wall; (b) model 10, unreinforced south wall; (c) model 11, retrofitted north wall; and (d) model 11, retrofitted south wall.

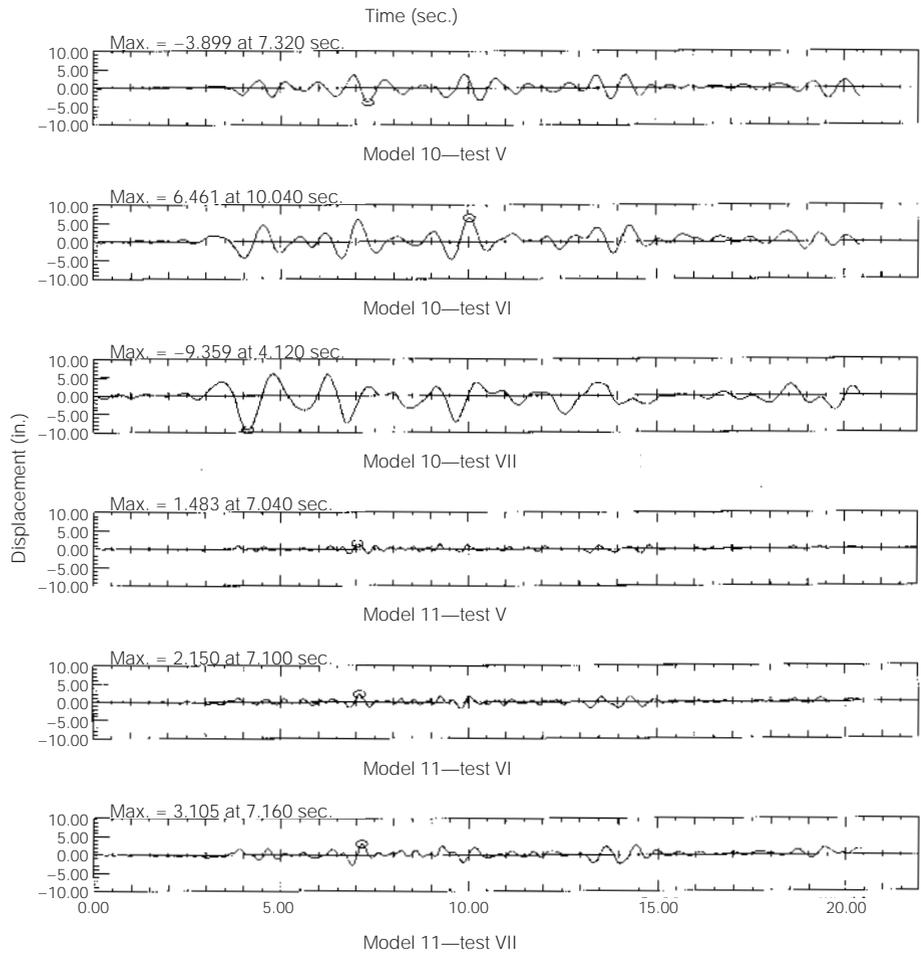
Figure 8.22
 Comparison of displacement measurements at the top of the west gable-end walls for models 10 and 11 during tests V, VI, and VII.

The effect of the retrofit system can be seen in the relative out-of-plane displacements of the top of the west gable-end walls of models 10 and 11 during tests V–VII (fig. 8.22). The displacements at the middle of the west wall (fig. 8.23) were smaller than those in the east wall because the strapping system allowed greater displacements than those in the wall retrofitted with center-core rods. The time histories show that the displacements in the retrofitted west gable-end wall were approximately one-third as large as those in the unretrofitted model as early as test V, and the difference continued through test VII.

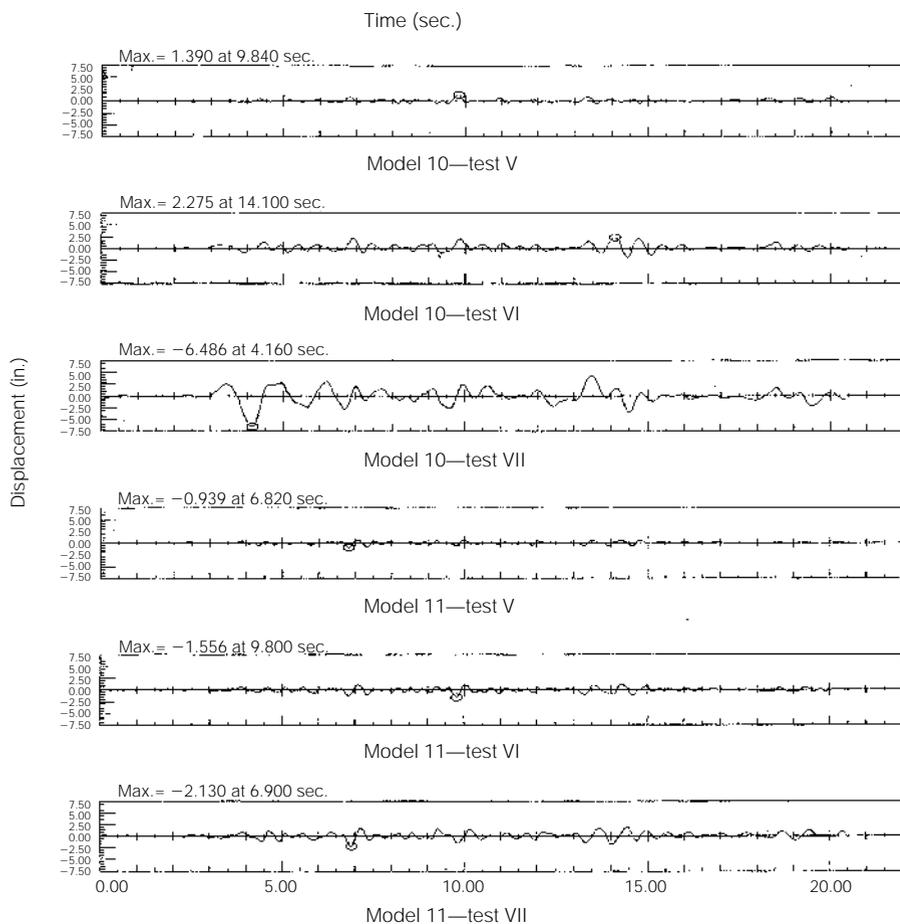
Figure 8.23

Comparison of displacement measurements at the middle of the west gable-end walls for models 10 and 11 during tests V, VI, and VII.

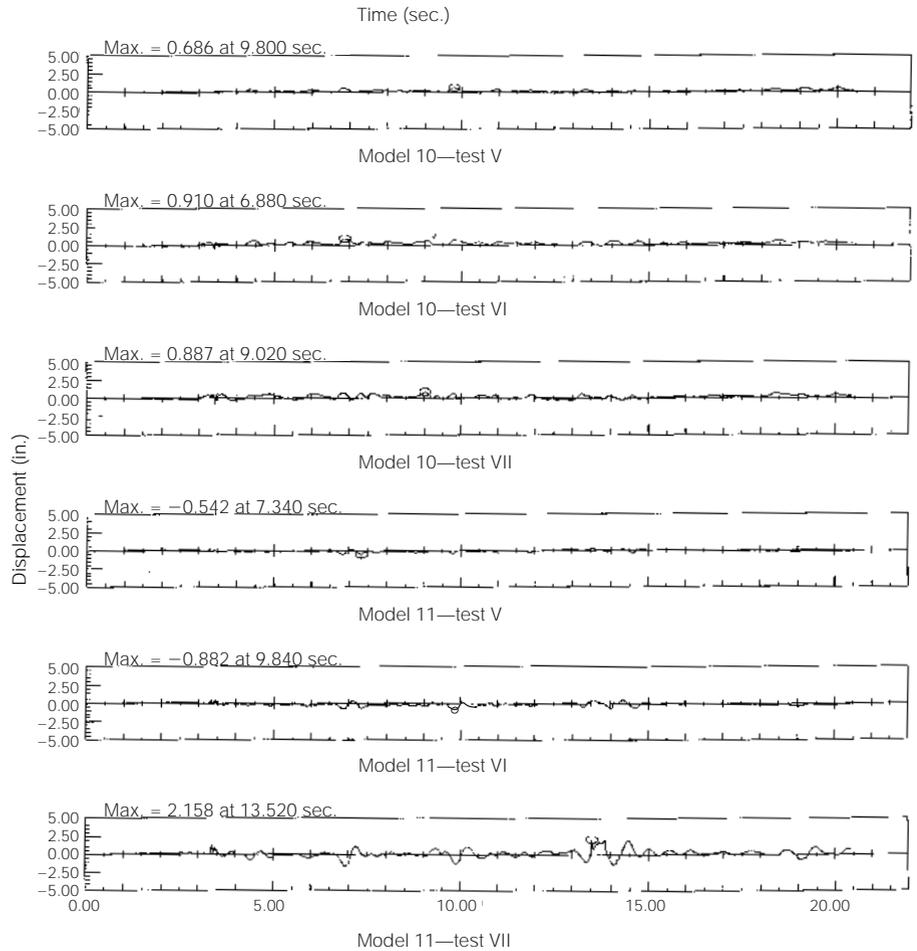
Figure 8.24
Comparison of displacement measurements of the north walls for models 10 and 11 during tests V, VI, and VII.

The opposite was true for the displacements of the in-plane north and south walls (figs. 8.24 and 8.25, respectively), in which the displacements of model 11 were slightly larger than those of model 10. Displacements were measured at the west end of each wall and therefore are not completely representative of the entire wall but may reflect those of cracked wall sections at the ends of the north and south walls. This cracking can be attributed largely to the additional loading transferred to these walls through the diaphragm.

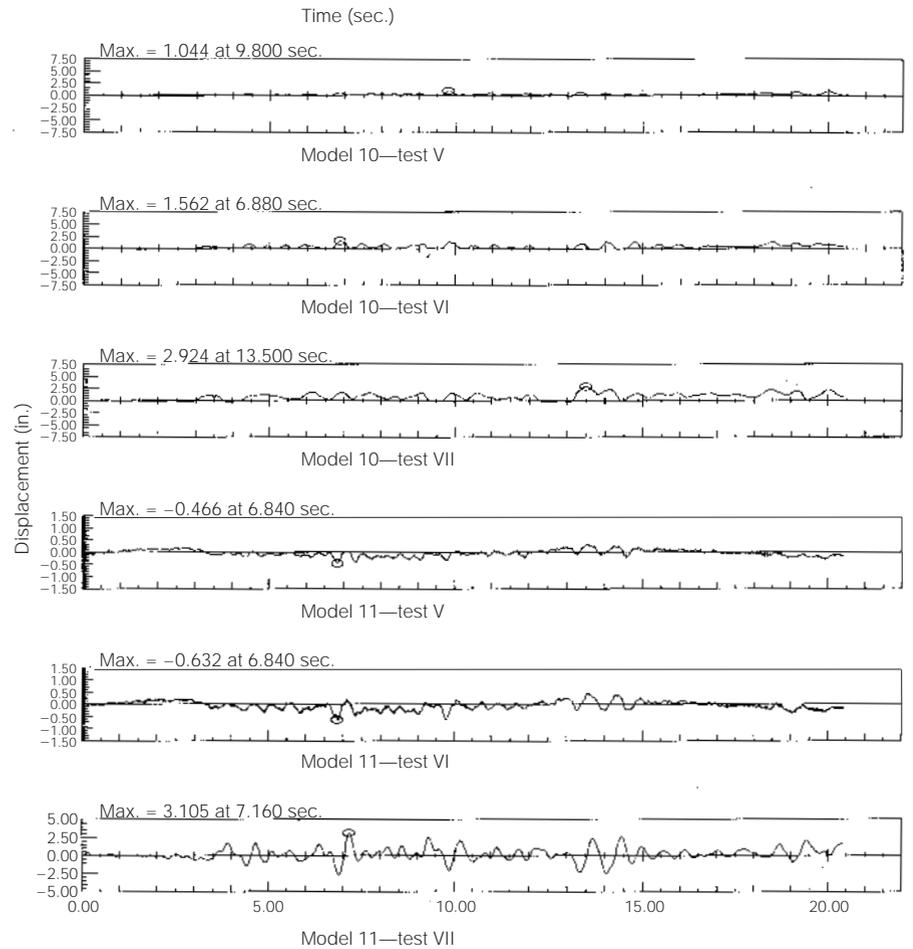
Figure 8.25
Comparison of displacement measurements of the south walls for models 10 and 11 during tests V, VI, and VII.

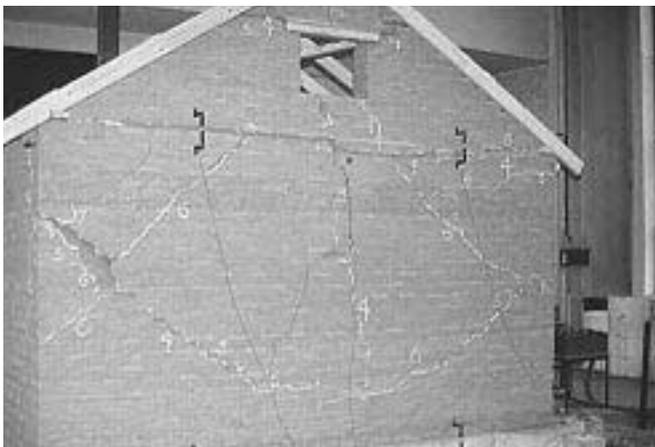
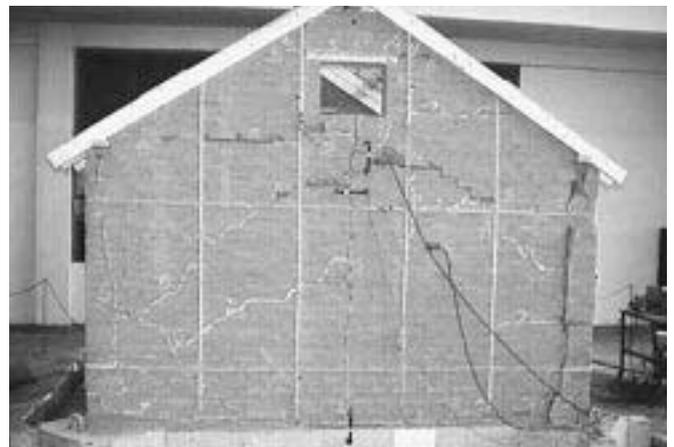
Figure 8.27
Comparison of damage to the west walls for (a) model 10 and (b) model 11 after test VII.

Photographs of the damage to each wall after test VII appear in figures 8.26–8.29. Crack patterns are shown in figures 8.30 and 8.31. Damage to the out-of-plane walls was significant after test VII in both walls of model 10 and in the east wall of model 11 (fig. 8.30a–c). Although the crack pattern was somewhat different, the extent of the cracks and the amount of spalling was similar in both models. The vertical straps had little effect on the extent of damage; their principal purpose was to reduce damage progression and prevent instability. The extent of damage to the west wall of model 11 was the least of all four walls because of the ductility and strengthening provided by the center-core rods (fig. 8.27).

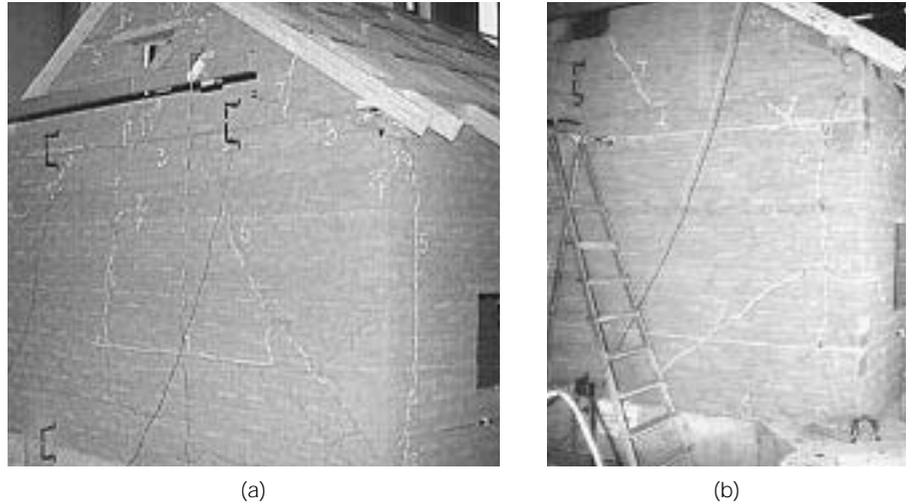
Figure 8.28
Comparison of damage to the north walls for (a) model 10 and (b) model 11 after test VII.

During the severest tests, additional cracks developed in the in-plane north and south walls (figs. 8.28, 8.29, and 8.31). For the most part, the crack damage in these walls was relatively minor. One exception was the section to the east side of the window at the end of the north wall of model 11, where diagonal cracks developed at the top and bottom

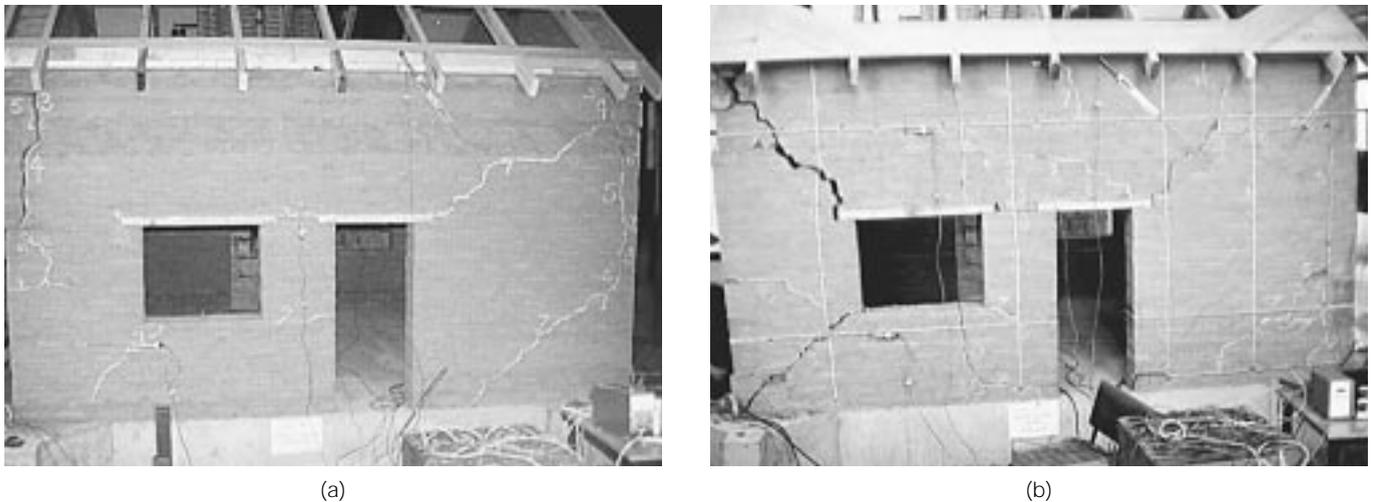
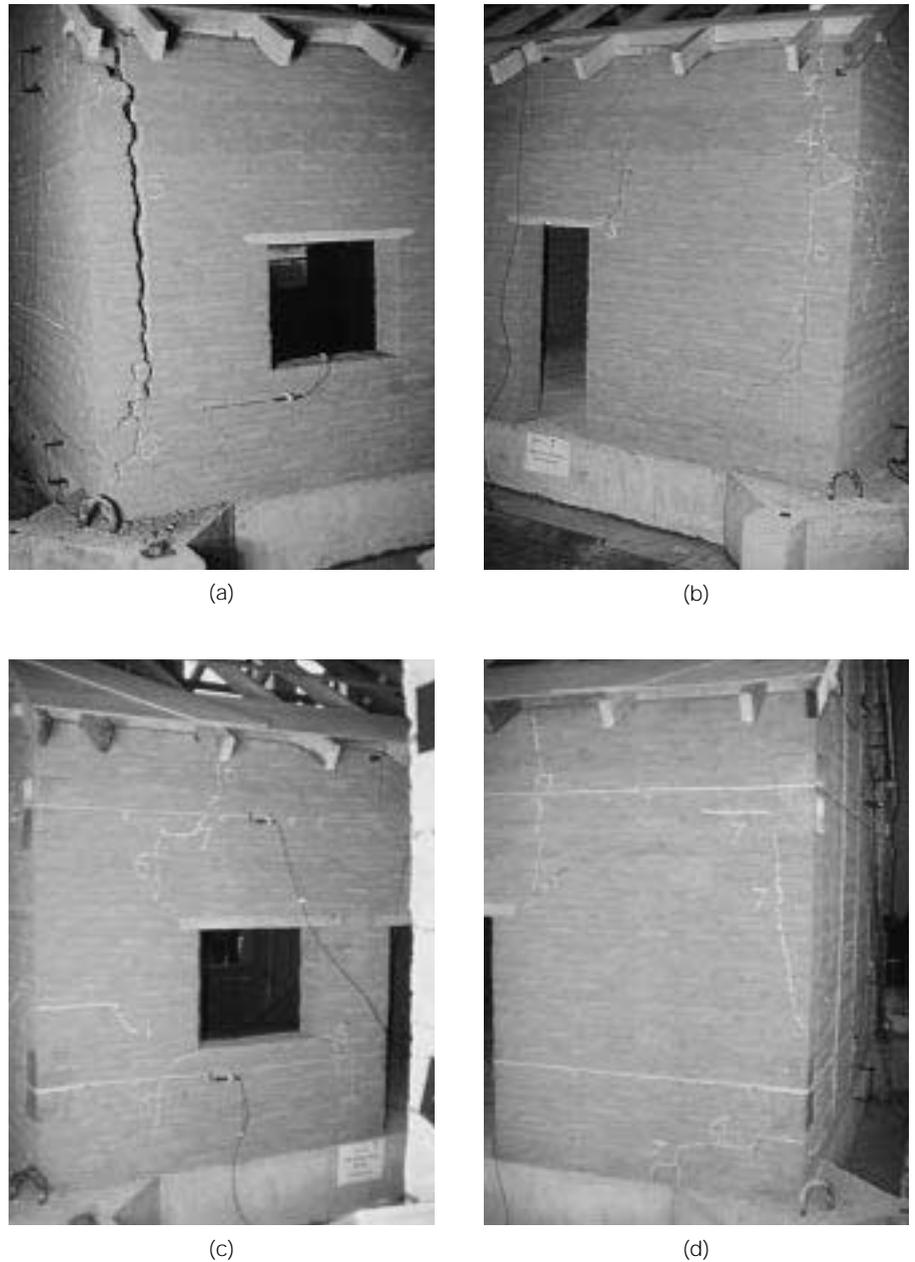
Figure 8.29

Comparison of damage to the south walls for models 10 and 11 after test VII, showing (a) model 10, south wall, west side; (b) model 10, south wall, east side; (c) model 11, south wall, west side; and (d) model 11, south wall, east side.

A second exception to the minor damage of in-plane cracks occurred in the south wall of model 10, as illustrated in figure 8.29a. The crack shown on the left in this photograph is a tension failure caused by the out-of-plane motions of the west wall and is not a typical shear crack.

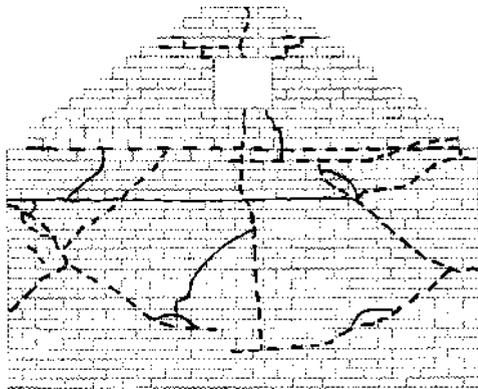
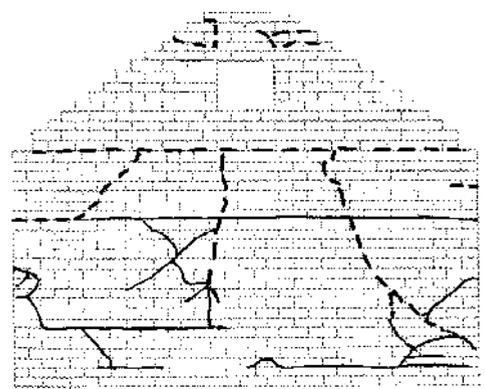
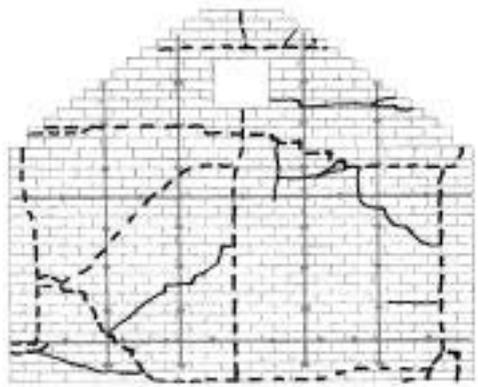
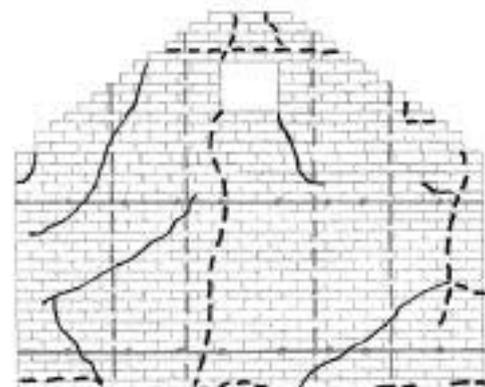
Figure 8.30

Comparison of crack patterns after test VII in the out-of-plane walls for (a) model 10, unretrofitted east wall; (b) model 10, unretrofitted west wall; (c) model 11, retrofitted east wall; and (d) model 11, retrofitted west wall.

In the out-of-plane walls, full crack development occurred during tests V (PGA = 0.23 g) and VI (PGA = 0.27 g). (Fig. 8.30 shows crack patterns in these walls after test VII.) Full crack development did not occur in the in-plane walls, except perhaps in the north wall of model 11 after test VIII*. (Fig. 8.31 shows crack patterns in these walls after test VII.) Full crack development is the point at which all the edges of the major sections of a wall are defined by cracks. A drawing of the crack pattern in the out-of-plane east wall of model 11 after test VI is shown in figure 8.32a. The major cracked sections or "blocks" of this wall are labeled B1 through B5. Each section is bounded by a free surface or by a crack on all four sides. Despite the increased intensity of the table motion in test VII, the only major crack that developed was the one that split B4 into two sections (fig. 8.32b). Once cracks developed,

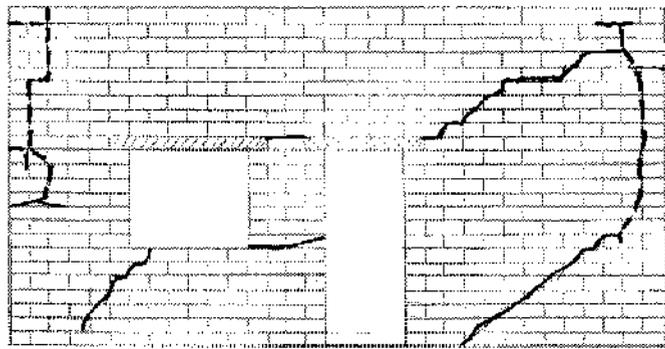
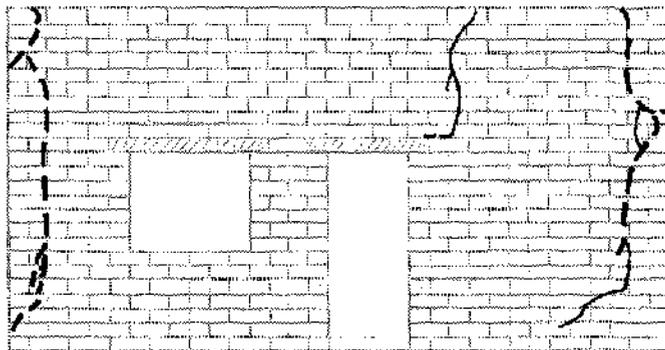
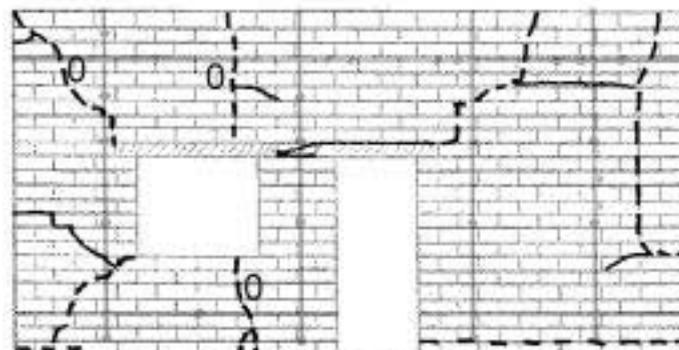
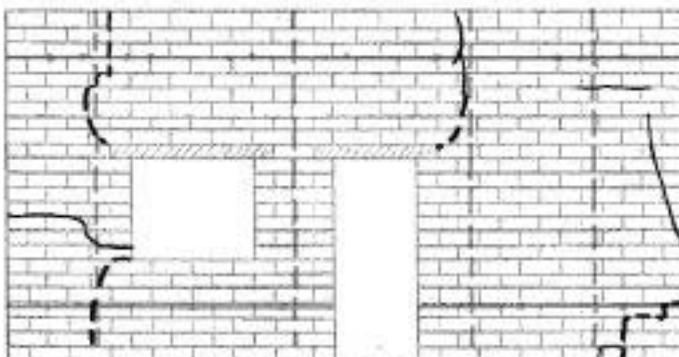
Figure 8.31

Comparison of crack patterns after test VII in the in-plane walls for (a) model 10, unretrofitted north wall; (b) model 10, unretrofitted south wall; (c) model 11, retrofitted north wall; and (d) model 11, retrofitted south wall.

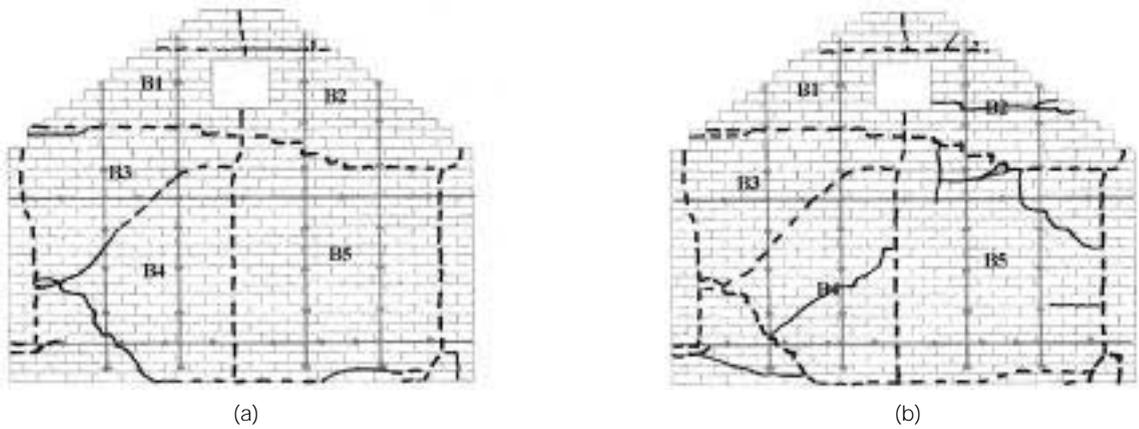
Figure 8.32
Crack pattern development in east wall of model 11 (a) after test VI and (b) after test VII. During test VI, the wall cracked into five major sections, or blocks, labeled B1 through B5. During test VII, three of the major blocks remained intact, but B2 and B4 each cracked into two sections.

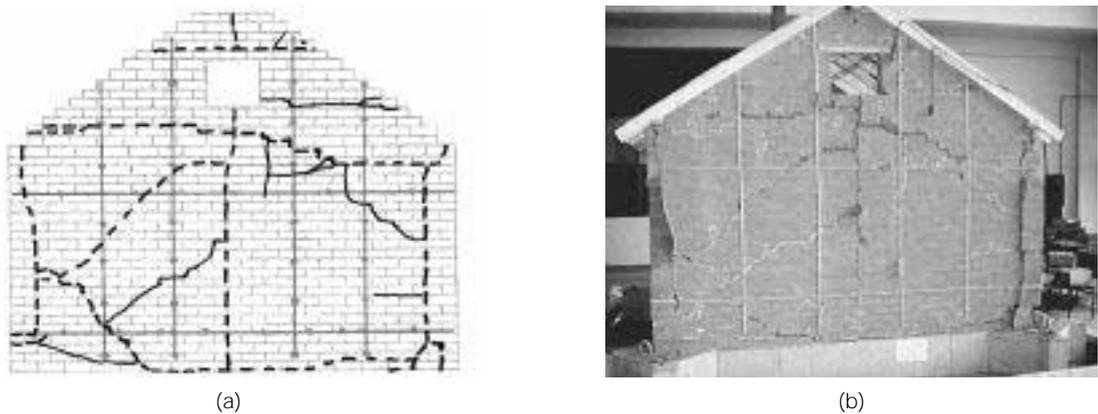
Figure 8.33
Damage to model 11, east wall (retrofitted with vertical straps) after test VII, shown in (a) diagram of crack pattern, with vertical lines indicating position of straps; (b) photograph of strapped wall; and (c) detail of north side of wall.

The strapping system used on the east wall of model 11 was effective in providing wall stability. A drawing of the crack pattern after test VII and photographs showing the condition of the walls are presented in figure 8.33. Cracks and spalling were significant, and an offset of almost 5.1 cm (2 in.) occurred at the northeast corner (fig. 8.33c).

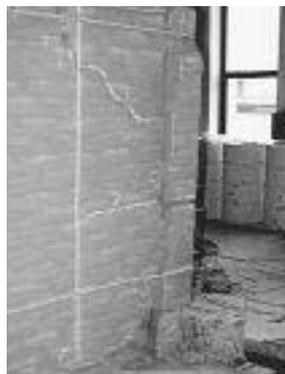
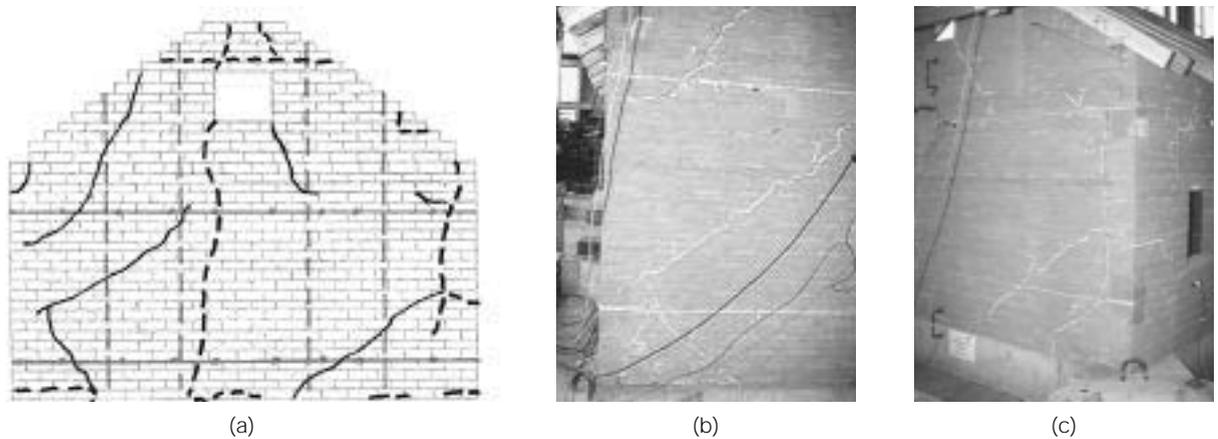
Figure 8.34

Damage to model 11, west wall (retrofitted with center-core rods) after test VII, shown in (a) diagram of crack pattern; (b) photograph of north side of wall; and (c) photograph of south side of wall.

The center-core system used on the west wall of model 11 performed extremely well. The condition of the wall after test VII is shown in figure 8.34. Although the full crack patterns developed during tests VI, VII, and VIII*, the wall was stabilized by the center-core rods. There were no large cracks, offsets, or spalling on this wall; despite the cracks, the wall remained in very good condition.
