Seismic Stabilization of Historic Adobe Structures

Final Report of the Getty Seismic Adobe Project

E. Leroy Tolles
Edna E. Kimbro
Frederick A. Webster
William S. Ginell

GCI Scientific Program Reports

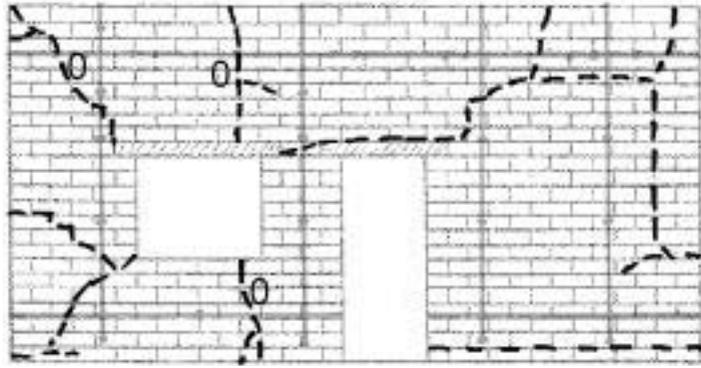
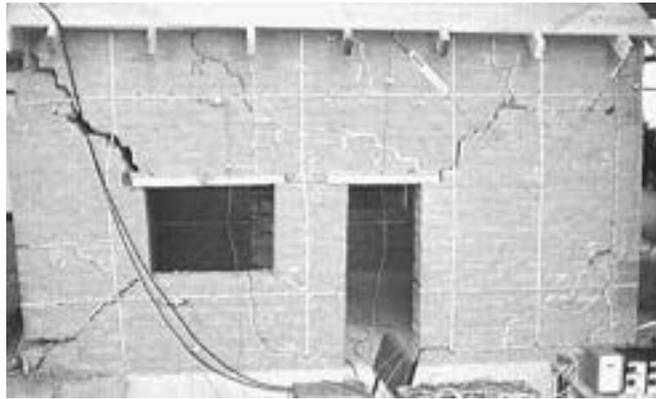
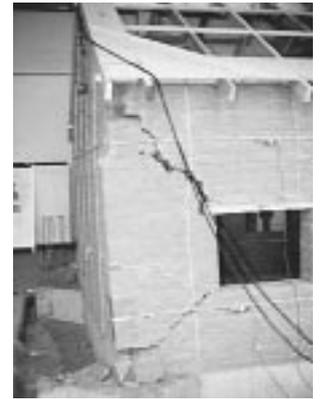
Damage to model 11, north wall (retrofitted with vertical straps), shown in (a) diagram of crack pattern after test VII; (b) photograph after test VIII*; and (c) detail of east side of wall after test VIII*.

Cracks during this test —————
 Preexisting cracks - - - - -
 Straps —●—●—●—
 Center cores - - - - -

The strapping system of model 11 was not effective in controlling the in-plane diagonal cracking at the east end of the north wall (fig. 8.35). The upper and lower straps were highly stressed, which resulted in some damage to the adjacent adobe. Nevertheless, the straps continued to perform well throughout the testing program. Some additional retrofit measures need to be installed to minimize this type of damage, which could lead to the collapse of the corner section of the wall.

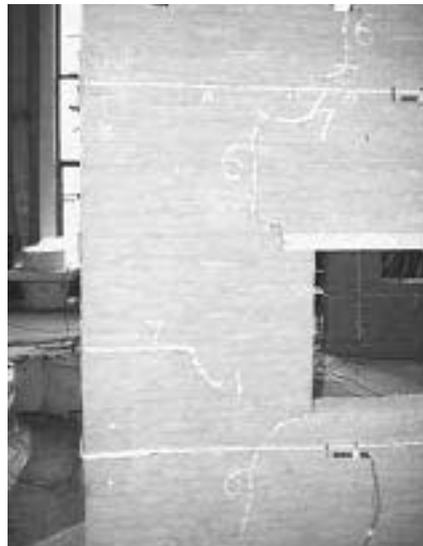
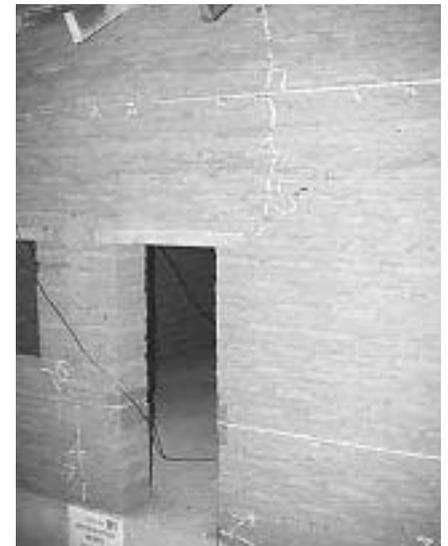
Figure 8.36

Damage to model 11, south wall (retrofitted with center-core rods) after test VIII*, showing (a) west side and (b) east side of wall.

The center-core elements in the south wall of model 11 were extremely effective in controlling the initiation and progression of crack damage (fig. 8.36). Three of the cracks that started at the corners of the openings in the wall were arrested when they reached the center-core rods. In the later tests, the cracks continued to progress but never became very large.

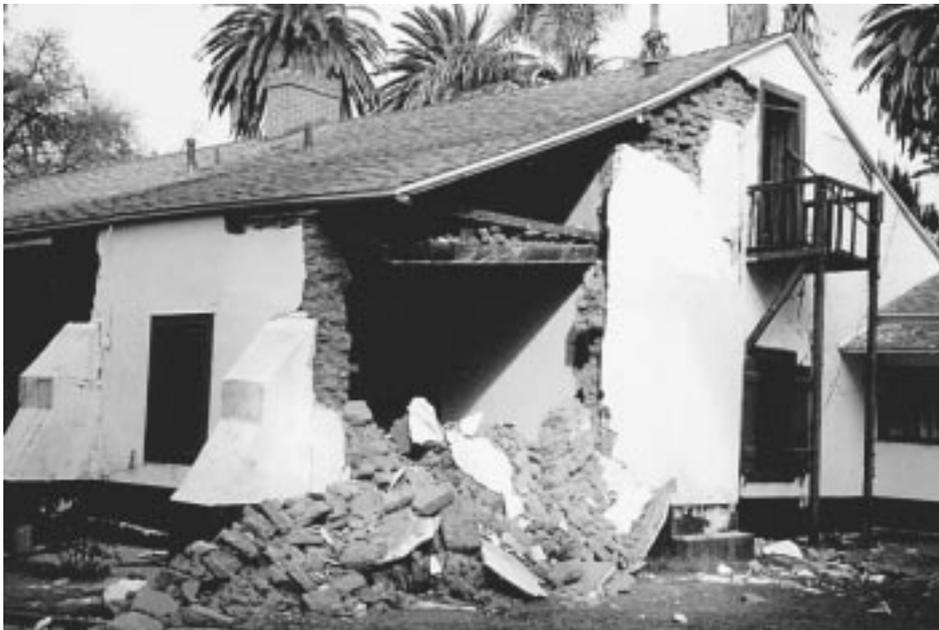
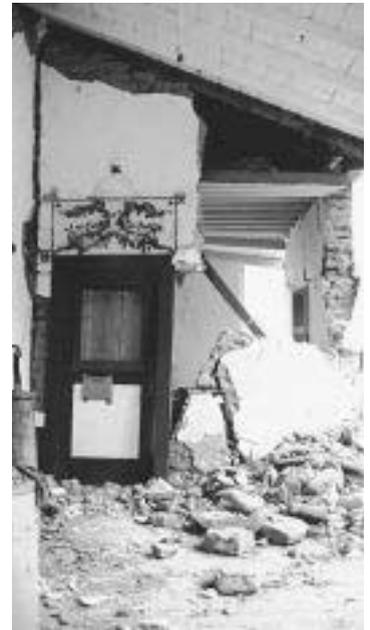
Figure 9.1
Ramona's room, Del Valle Adobe at Rancho Camulos, Piru, California, after the 1994 Northridge earthquake, showing (a) southeast corner of building and (b) west wall of room. Buttresses on the south wall prevented the total collapse of that wall.

In many locations, the walls had pulled away from the ceiling joists, and damage to the walls further reduced their ability to support the joists. Three major physical conditions—water damage, preexisting cracks, and material weakness—influenced the performance of the Del Valle Adobe during the Northridge earthquake. The most significant was moisture damage. There had been water damage to the lower adobe walls and foundation in several locations. Repeated wet/dry cycling has resulted in deteriorated and weakened adobe at the base of many walls. To hide the moisture damage, the lower section of the adobe walls had been covered in many areas with large concrete patches, which forced the water to rise even higher in the walls.

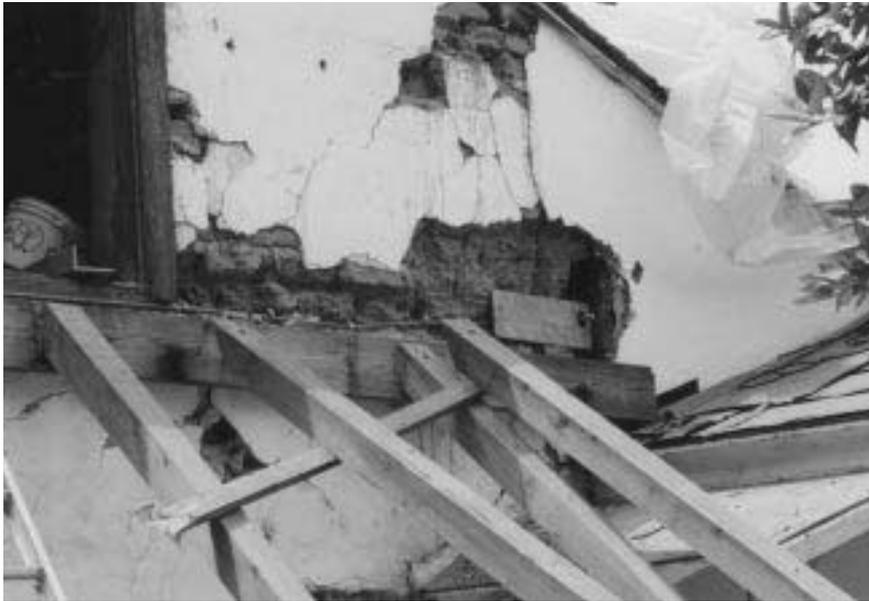
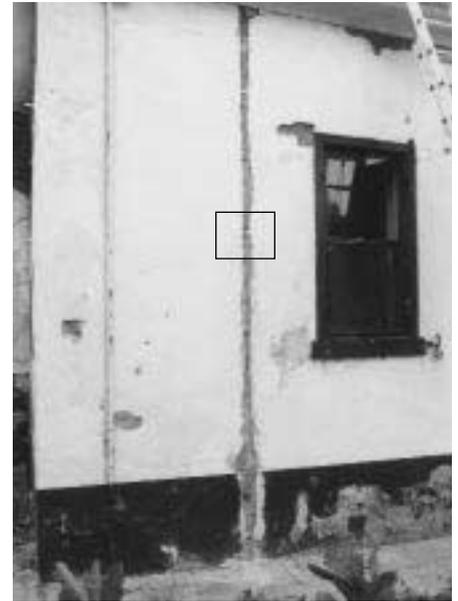
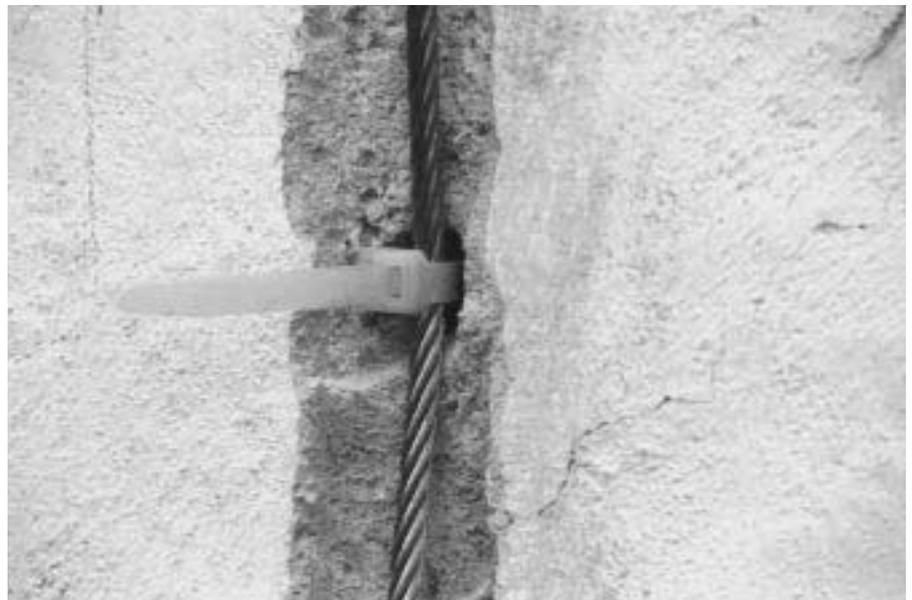
Figure 9.2

Installation of steel cables at the Del Valle Adobe, showing (a) horizontal cable anchored to ceiling joists; (b) vertical cable installed in previously damaged walls; and (c) enlarged detail of cable anchor (area of enlargement shown in b).

The design of the retrofits for Rancho Camulos was based largely on the results of GSAP research.¹ A careful review of the proposed retrofit measures was carried out by the designers and state and county officials. The measures that have been approved and installed included placing horizontal stainless-steel cables or nylon straps around perimeter walls, which in some cases were anchored to ceiling joists (fig. 9.2a); installing vertical pre-tensioned steel cables on both sides of thin walls ($S_L > 8$), or on walls that were particularly vulnerable because of previous earthquake damage (fig. 9.2b, c); inserting epoxy-grouted vertical center-core rods in newly constructed adobe walls; and installing appropriate anchorage between the walls and roof at the floor and ceiling levels.
