This report was commissioned to the UDD School of Architecture and Arts, by the Benedictine Monastic Community of Las Condes through their Father Abbot, Benito Rodríguez, for the development of a conservation and maintenance plan for the conventual church designed by the monks Gabriel Guarda (+) and Martín Correa between the years 1960 and 1964.

First Edition; Santiago Chile; Jun 2024.

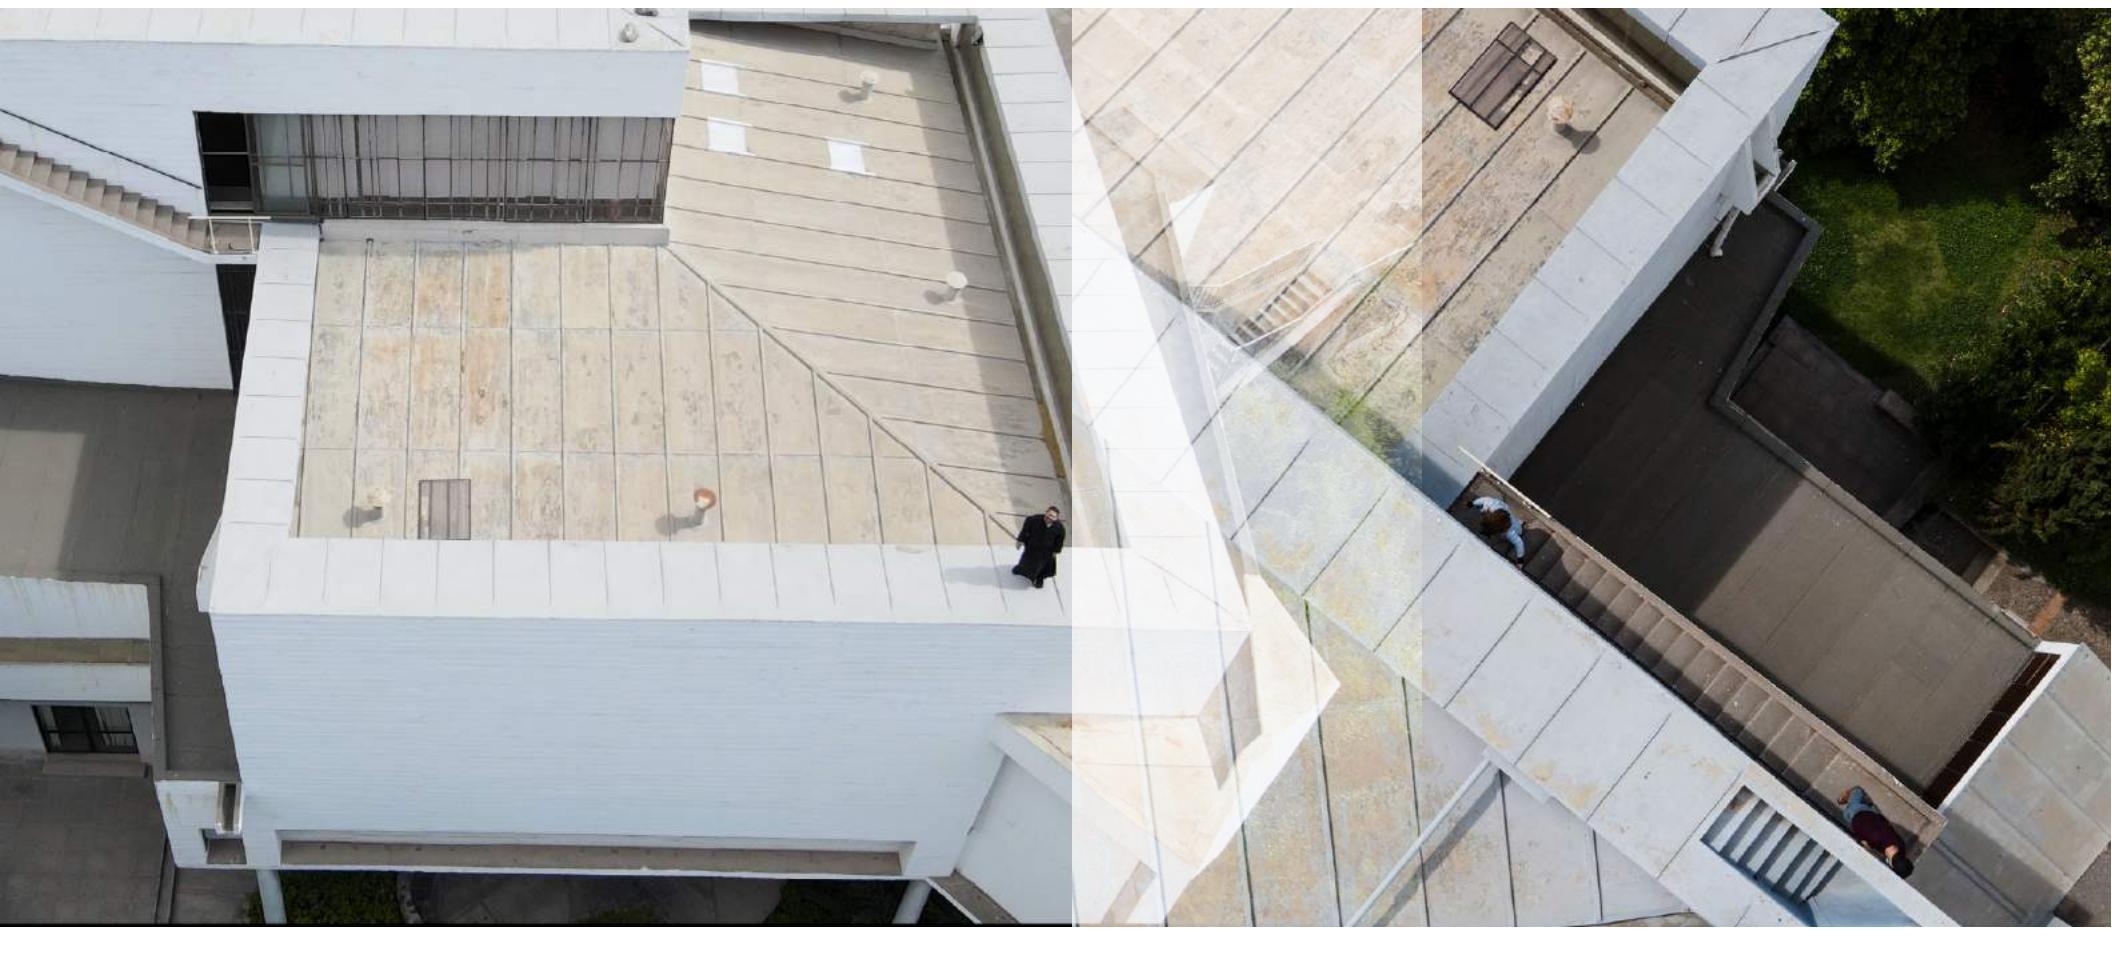
▲ Fig. 08 / Visual inspection of the roof of the main cube to check the condition of seals and waterproofing

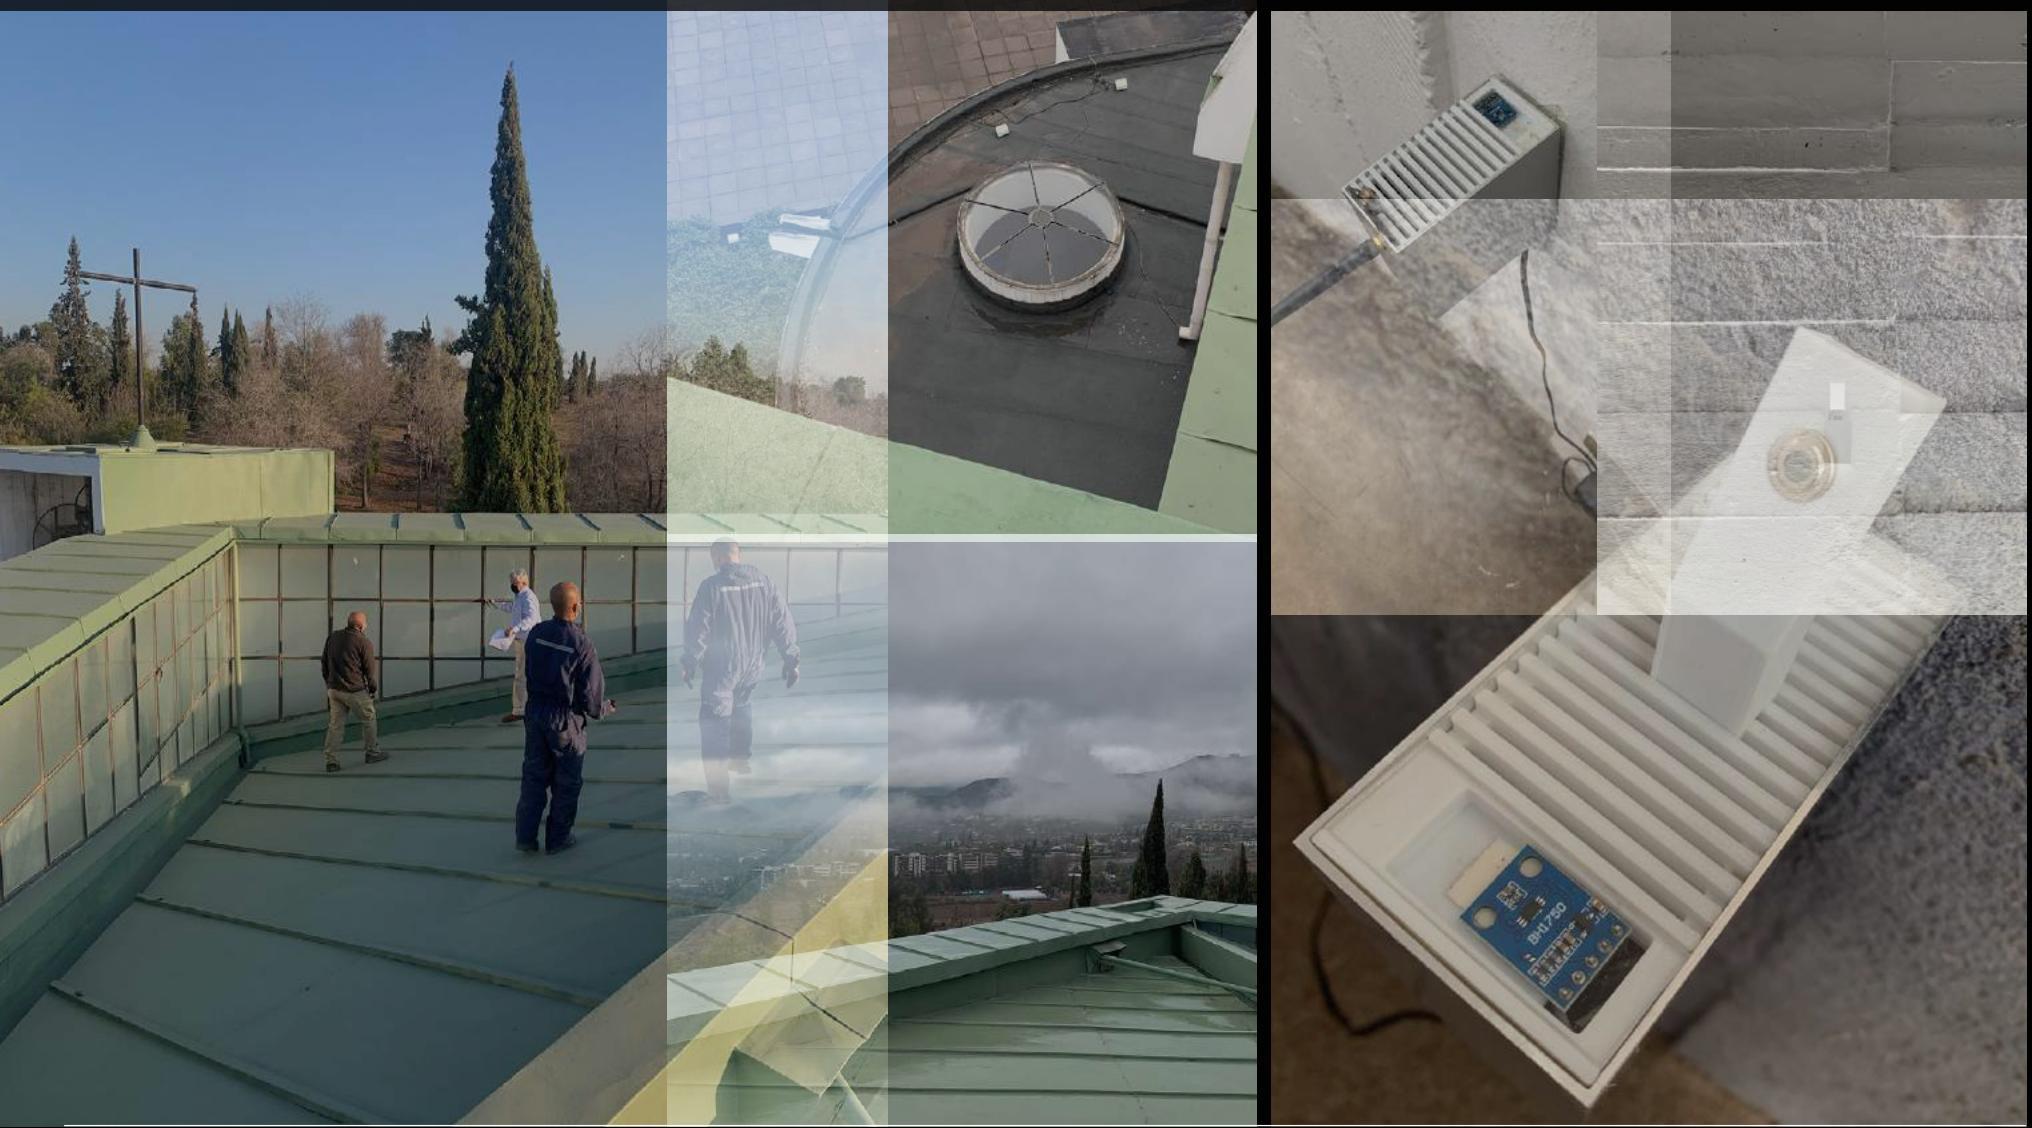
Fig. 92 / Visual inspection of the waterproofing and rainwater drainage system on the roof. ▲ Fig. 93 / Sensors installed for one year to monitor environmental conditions inside the church.

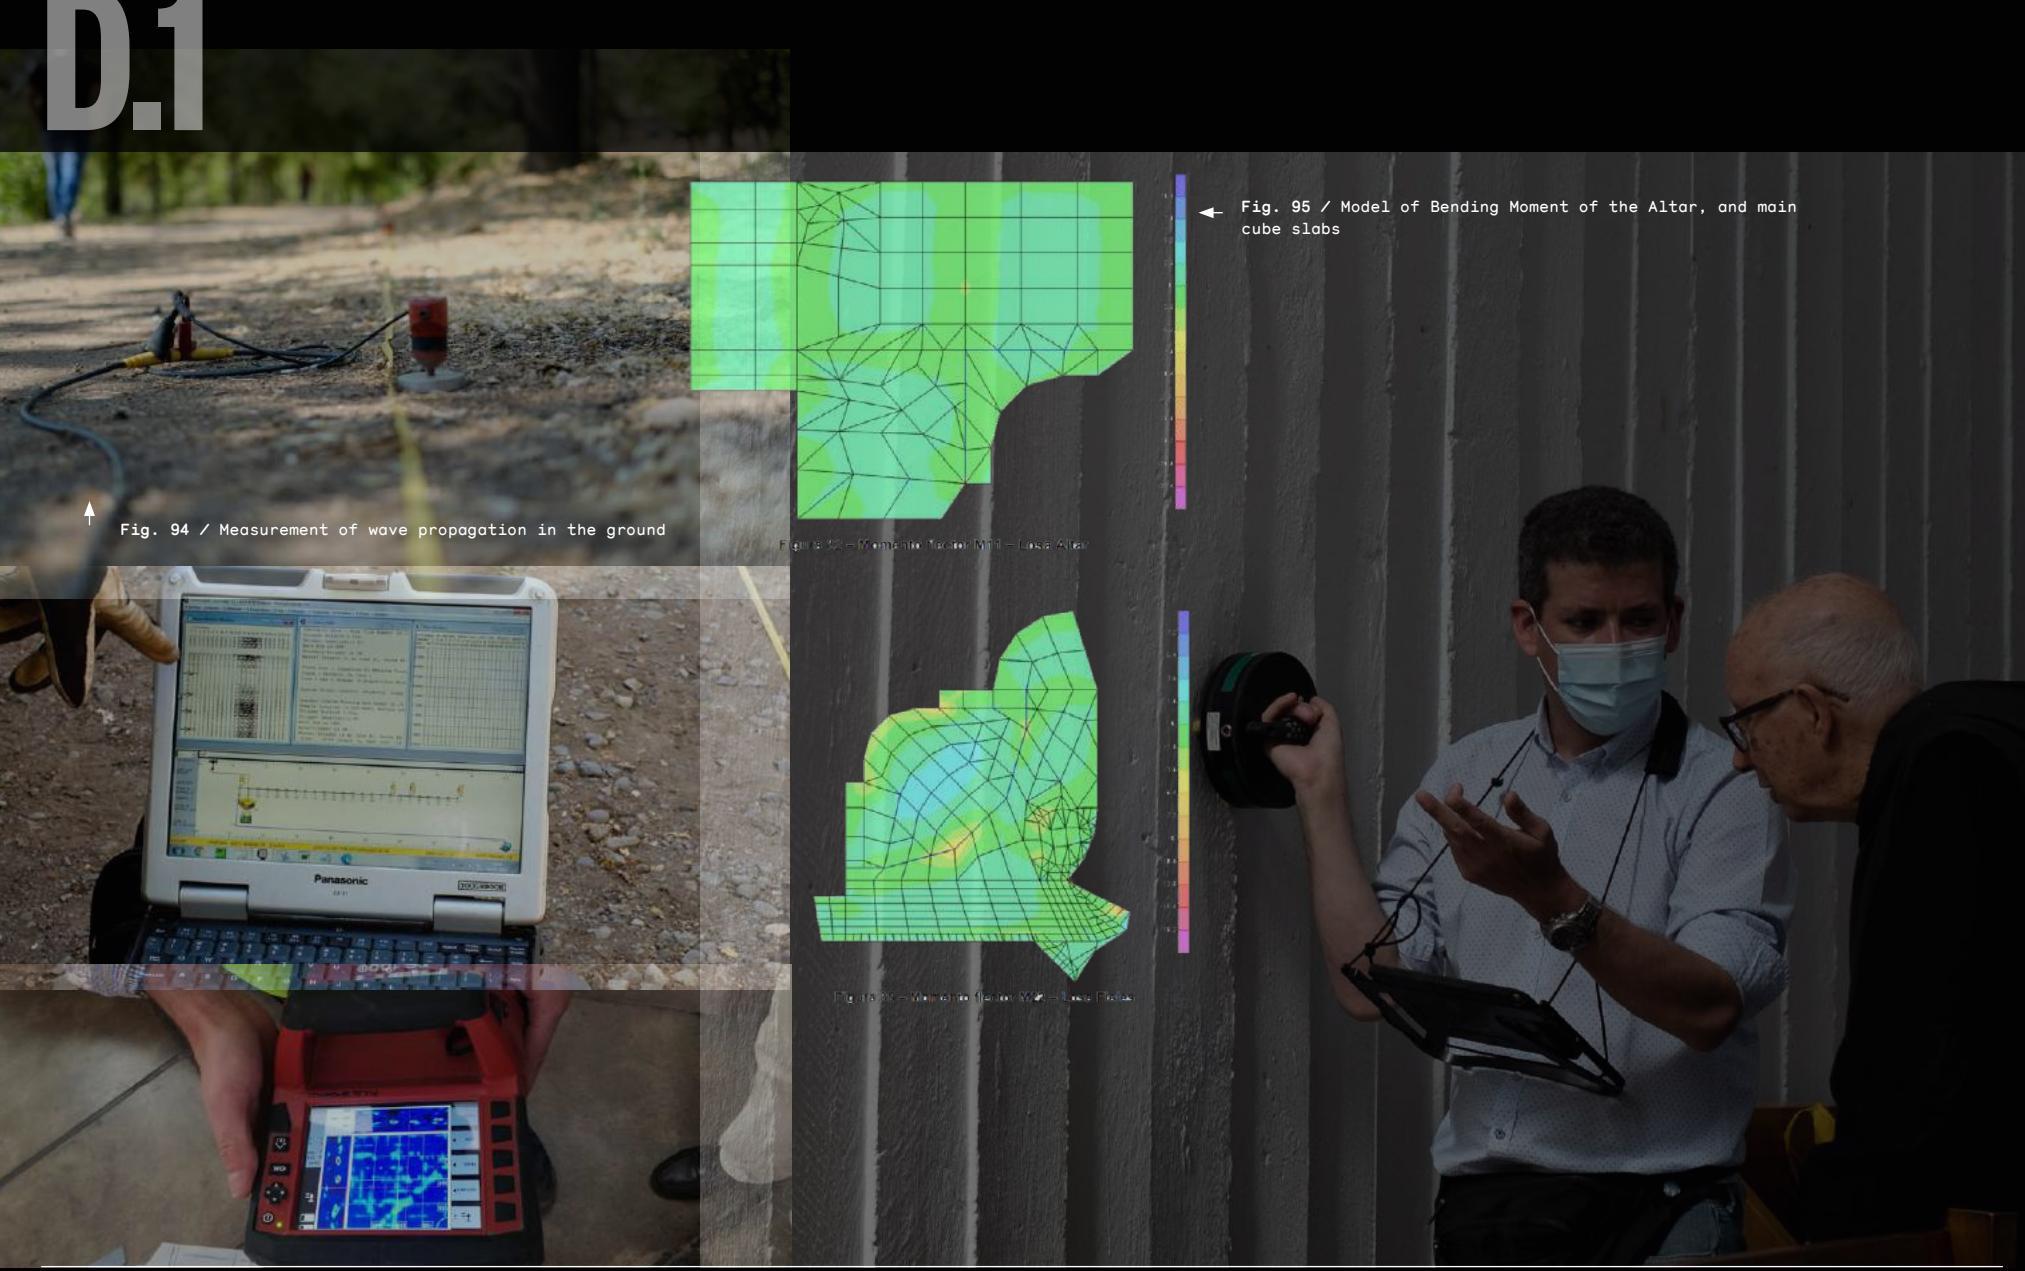
▲ Fig. 96 / Non-destructive inspection of the condition of reinforcing bars in reinforced concrete walls

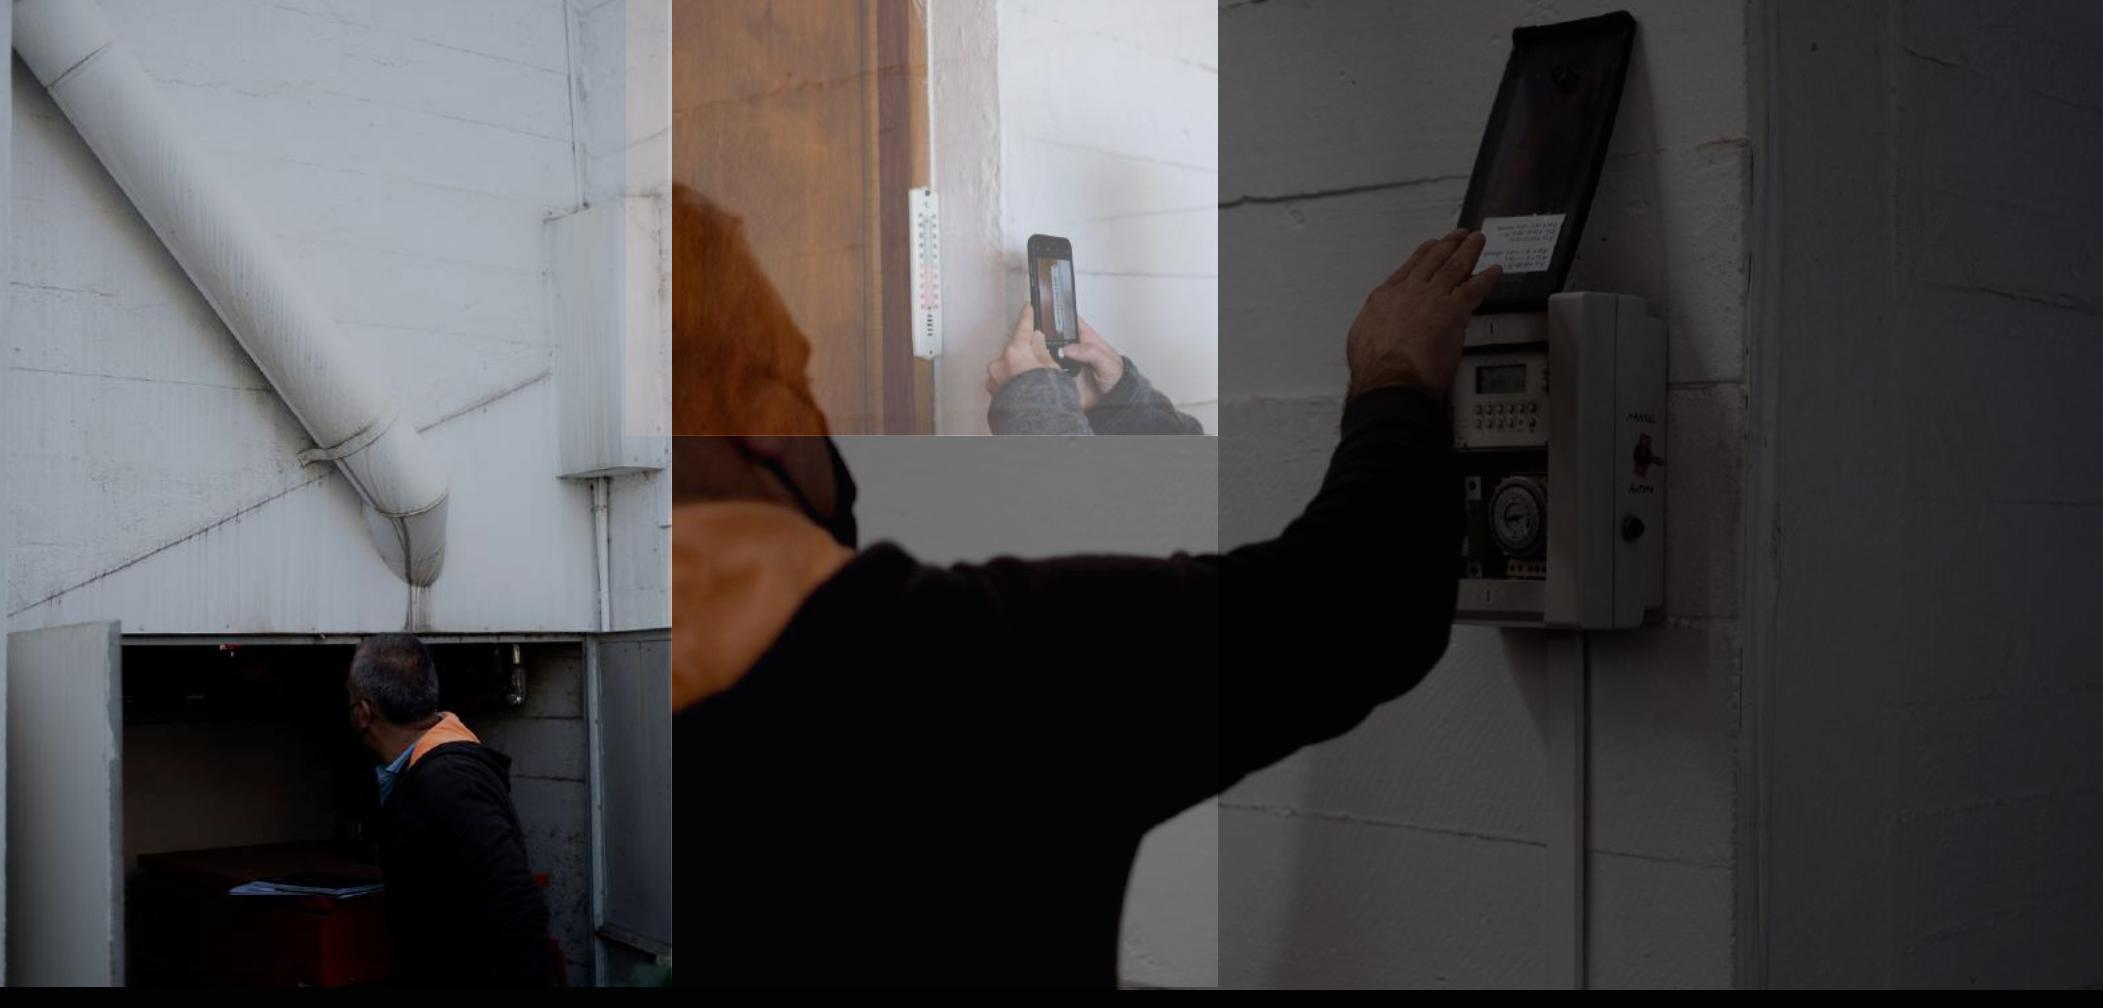
Fig. 99 / Assessment and maintenance of the heating boiler system of the building.

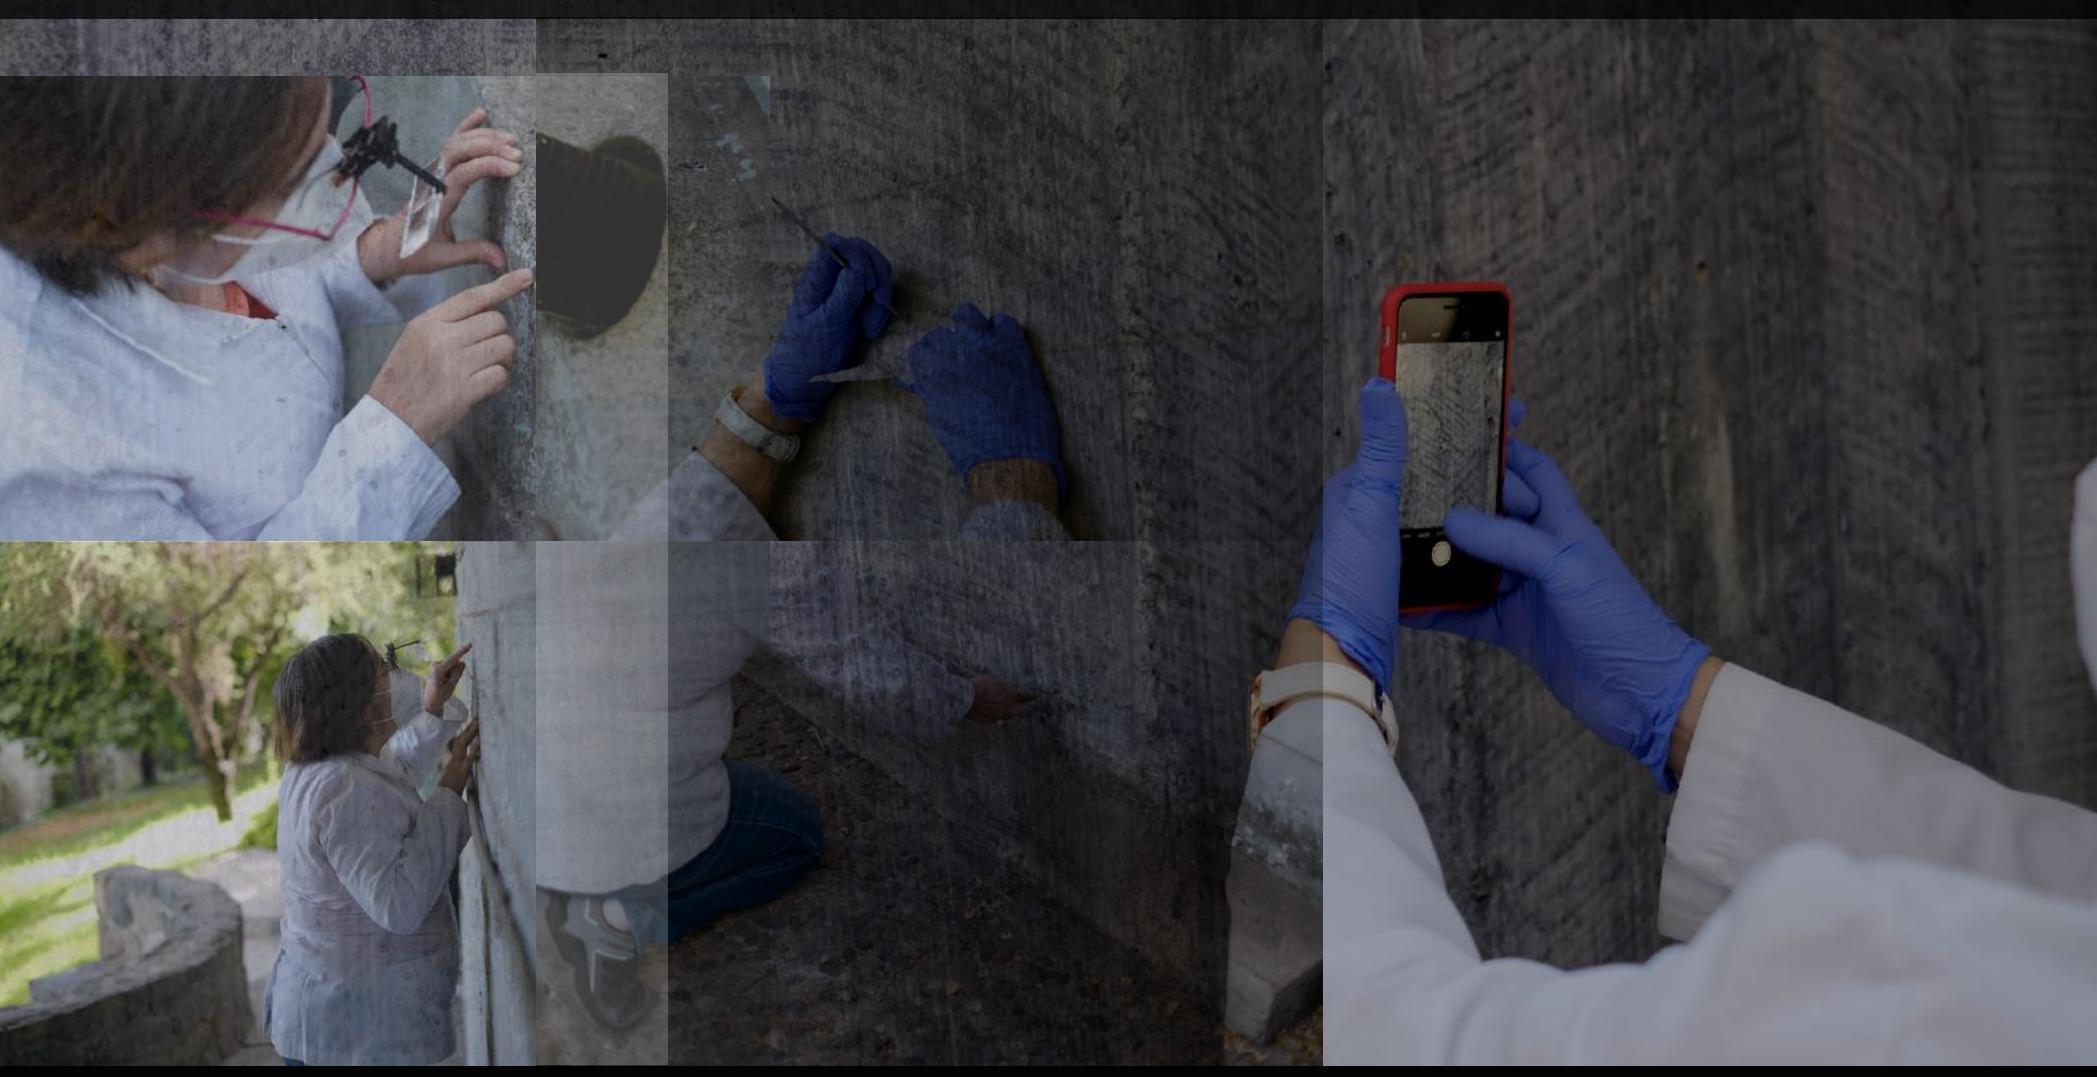
▲ Fig. 100 / Study of stratigraphy to determine the layers of paint on the different walls of the building and their chromatic components. **DIAGNOSIS OF THE STATE OF CONSERVATION**

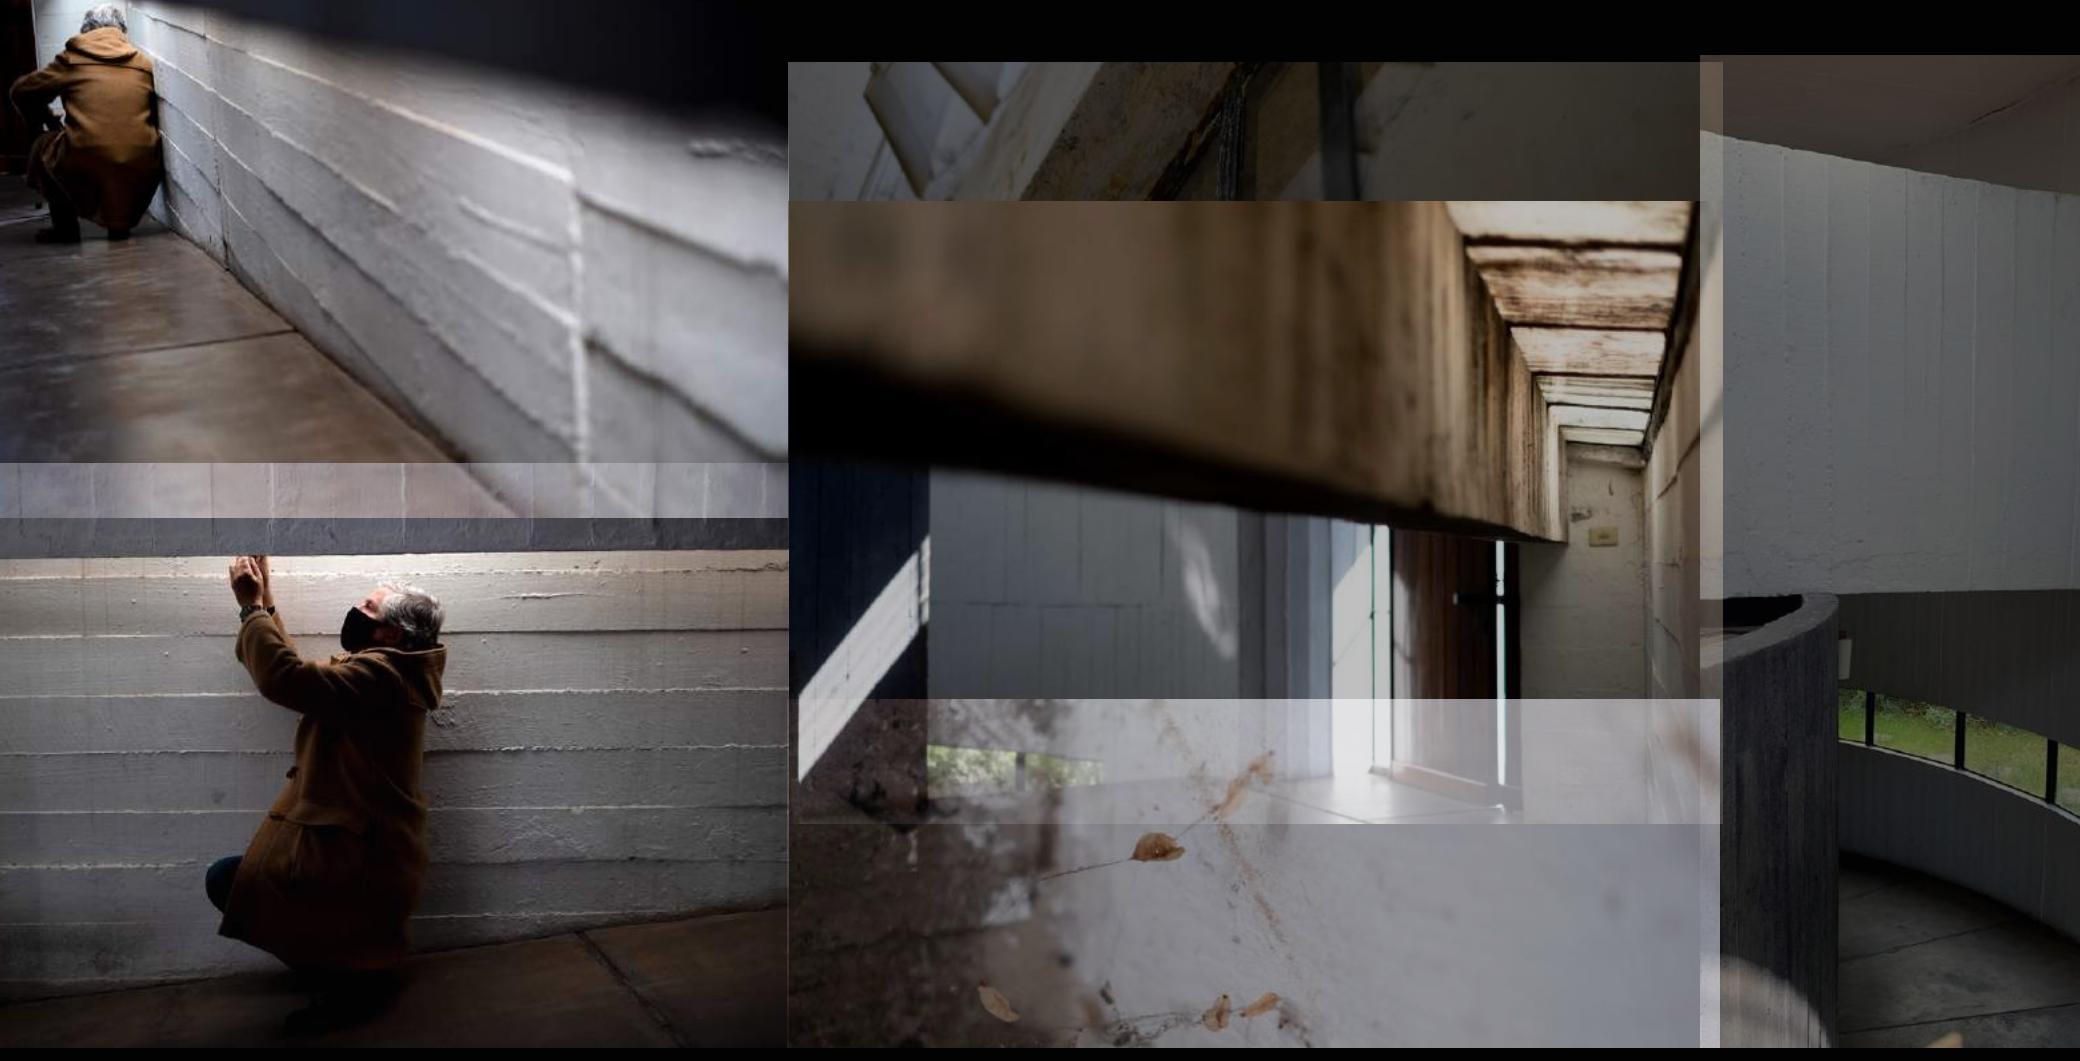
▲ Fig. 101 / Visual inspection of the conservation status of skylights and waterproofing seals.

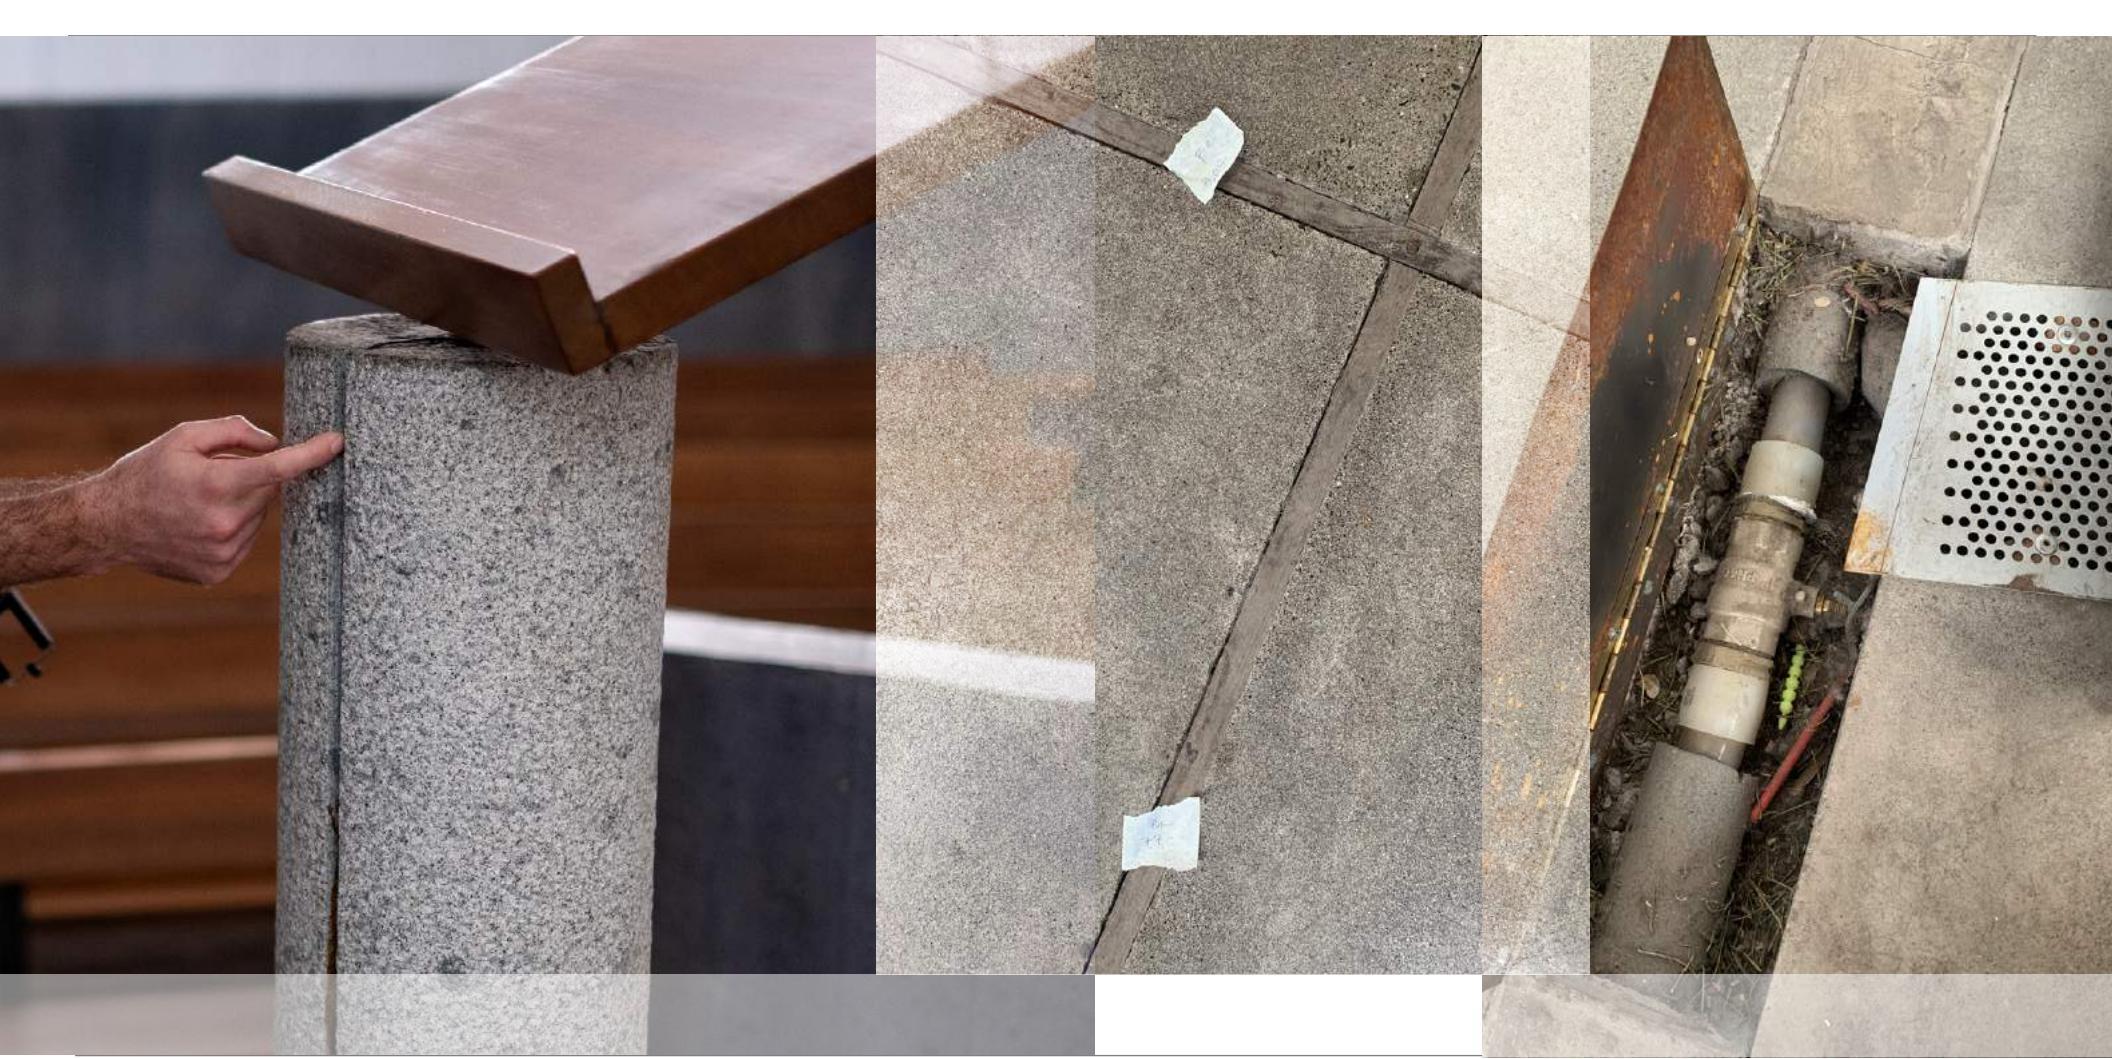
Fig. 108 / Assessment of the conservation status of the ornamental / liturgical components and artworks. ▲ Fig. 109 / Assessment of the conservation status of wooden pieces inserted in the concrete slabs. ▲ Fig. 110 / Manual control for heating system in the main cube.

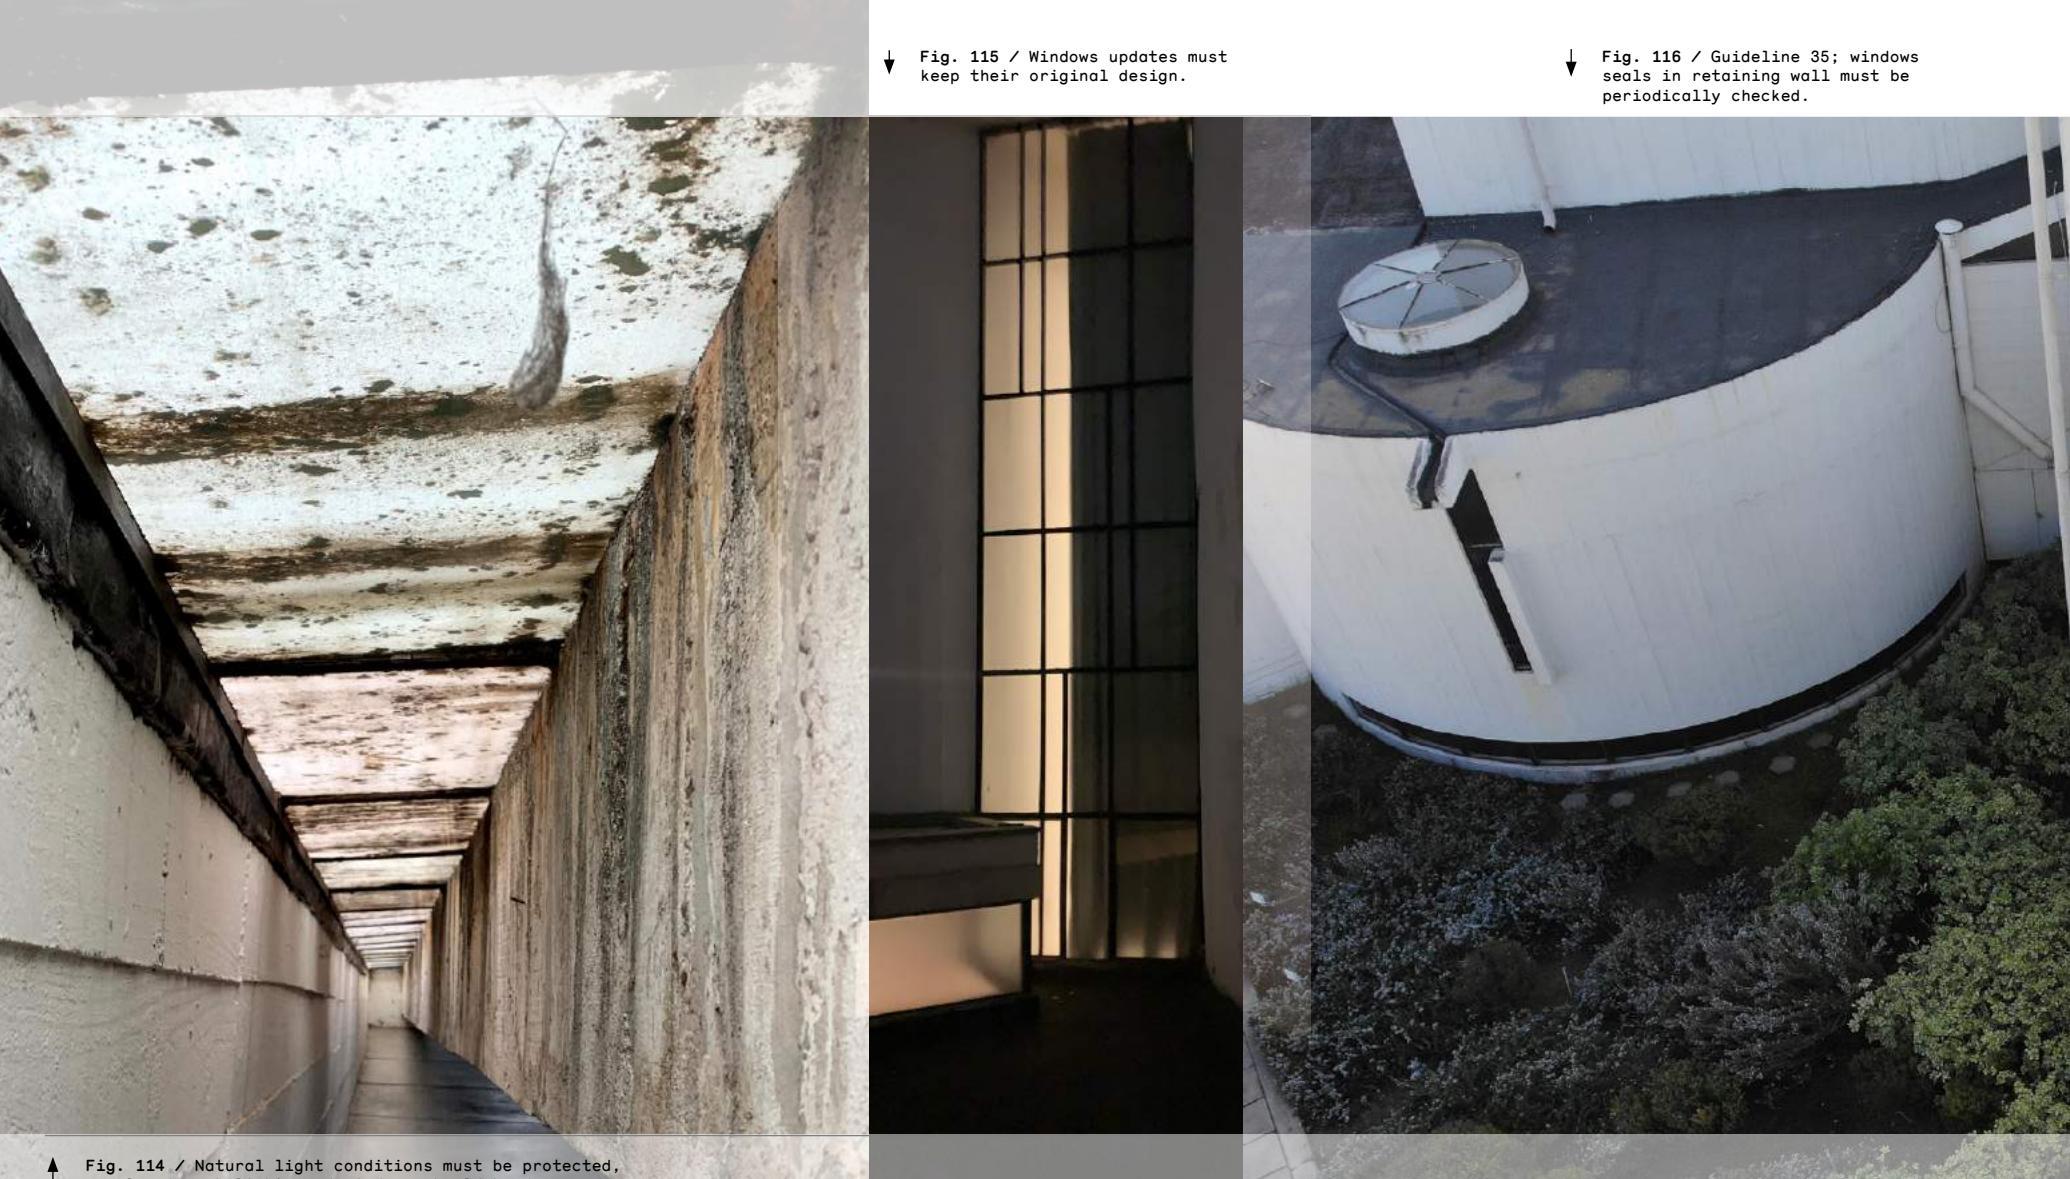
Fig. 114 / Natural light conditions must be protected, so cleaning skylights and windows should be done on a periodic basis

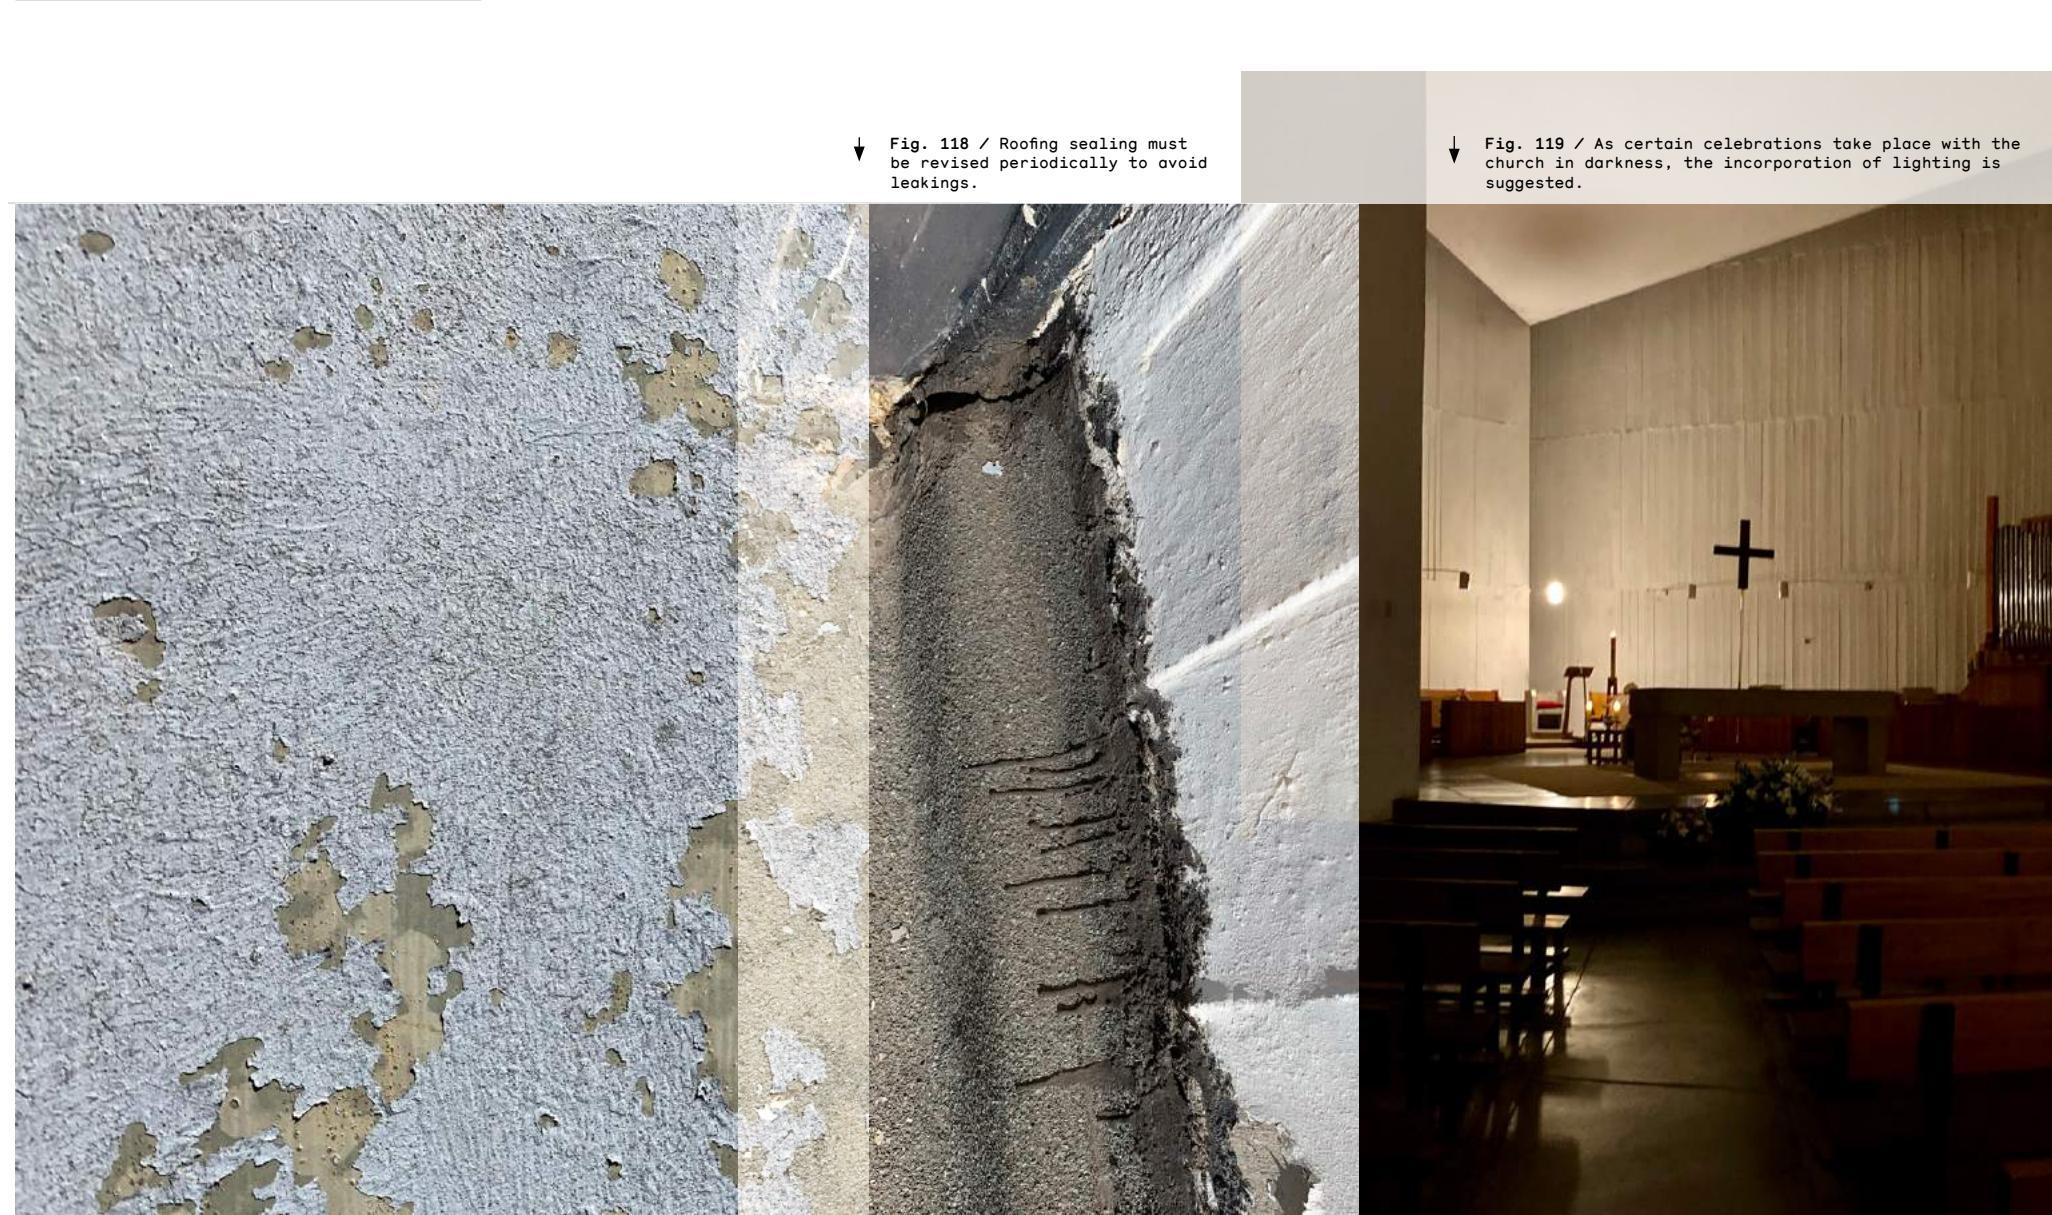
Fig. 117 / Roofing coating must be revised periodically to avoid leakings.

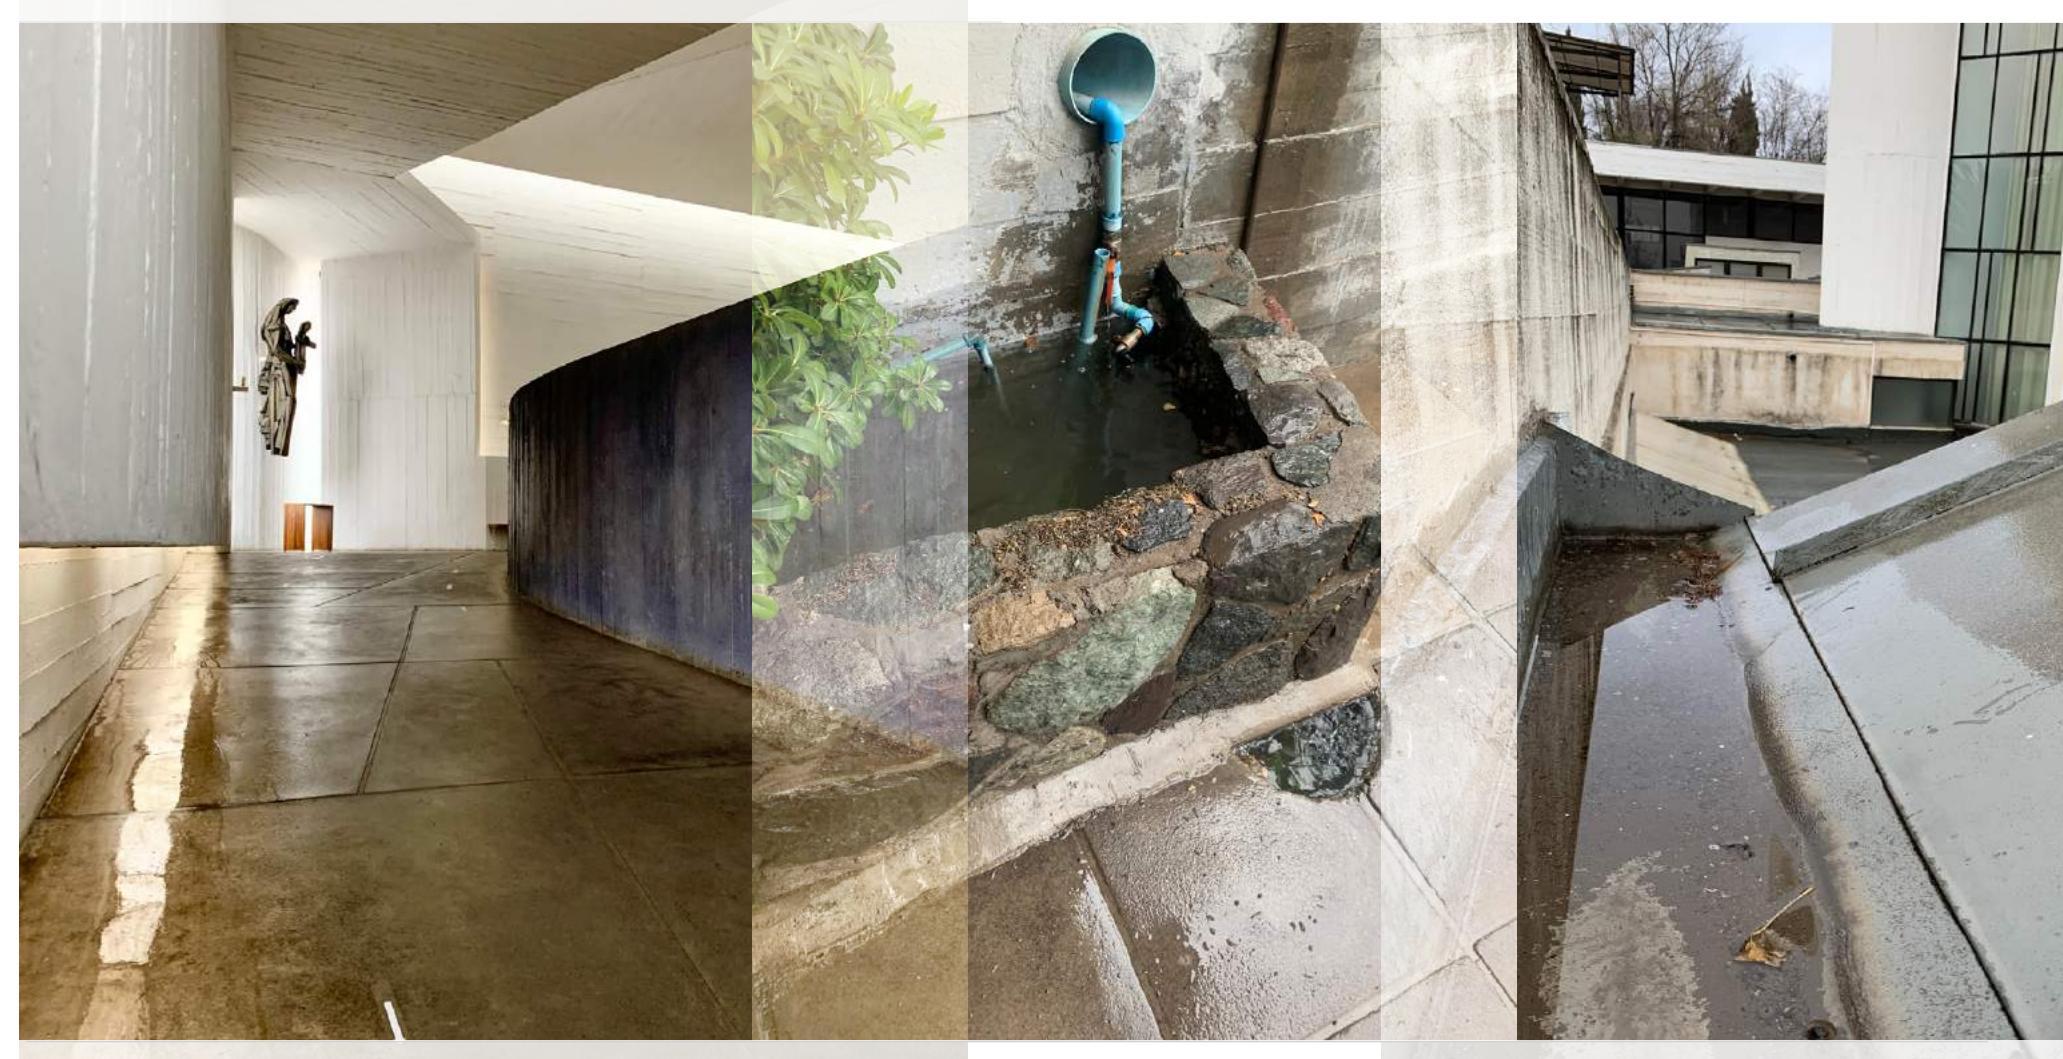
▲ Fig. 124 / Water pooling over the Sacristy roof

[▲] Fig. 123 / Exterior gardens saturation due to intense rainfalls episodes in winter.
