This report was commissioned to the UDD School of Architecture and Arts, by the Benedictine Monastic Community of Las Condes through their Father Abbot, Benito Rodríguez, for the development of a conservation and maintenance plan for the conventual church designed by the monks Gabriel Guarda (+) and Martín Correa between the years 1960 and 1964.

First Edition; Santiago Chile; Jun 2024.

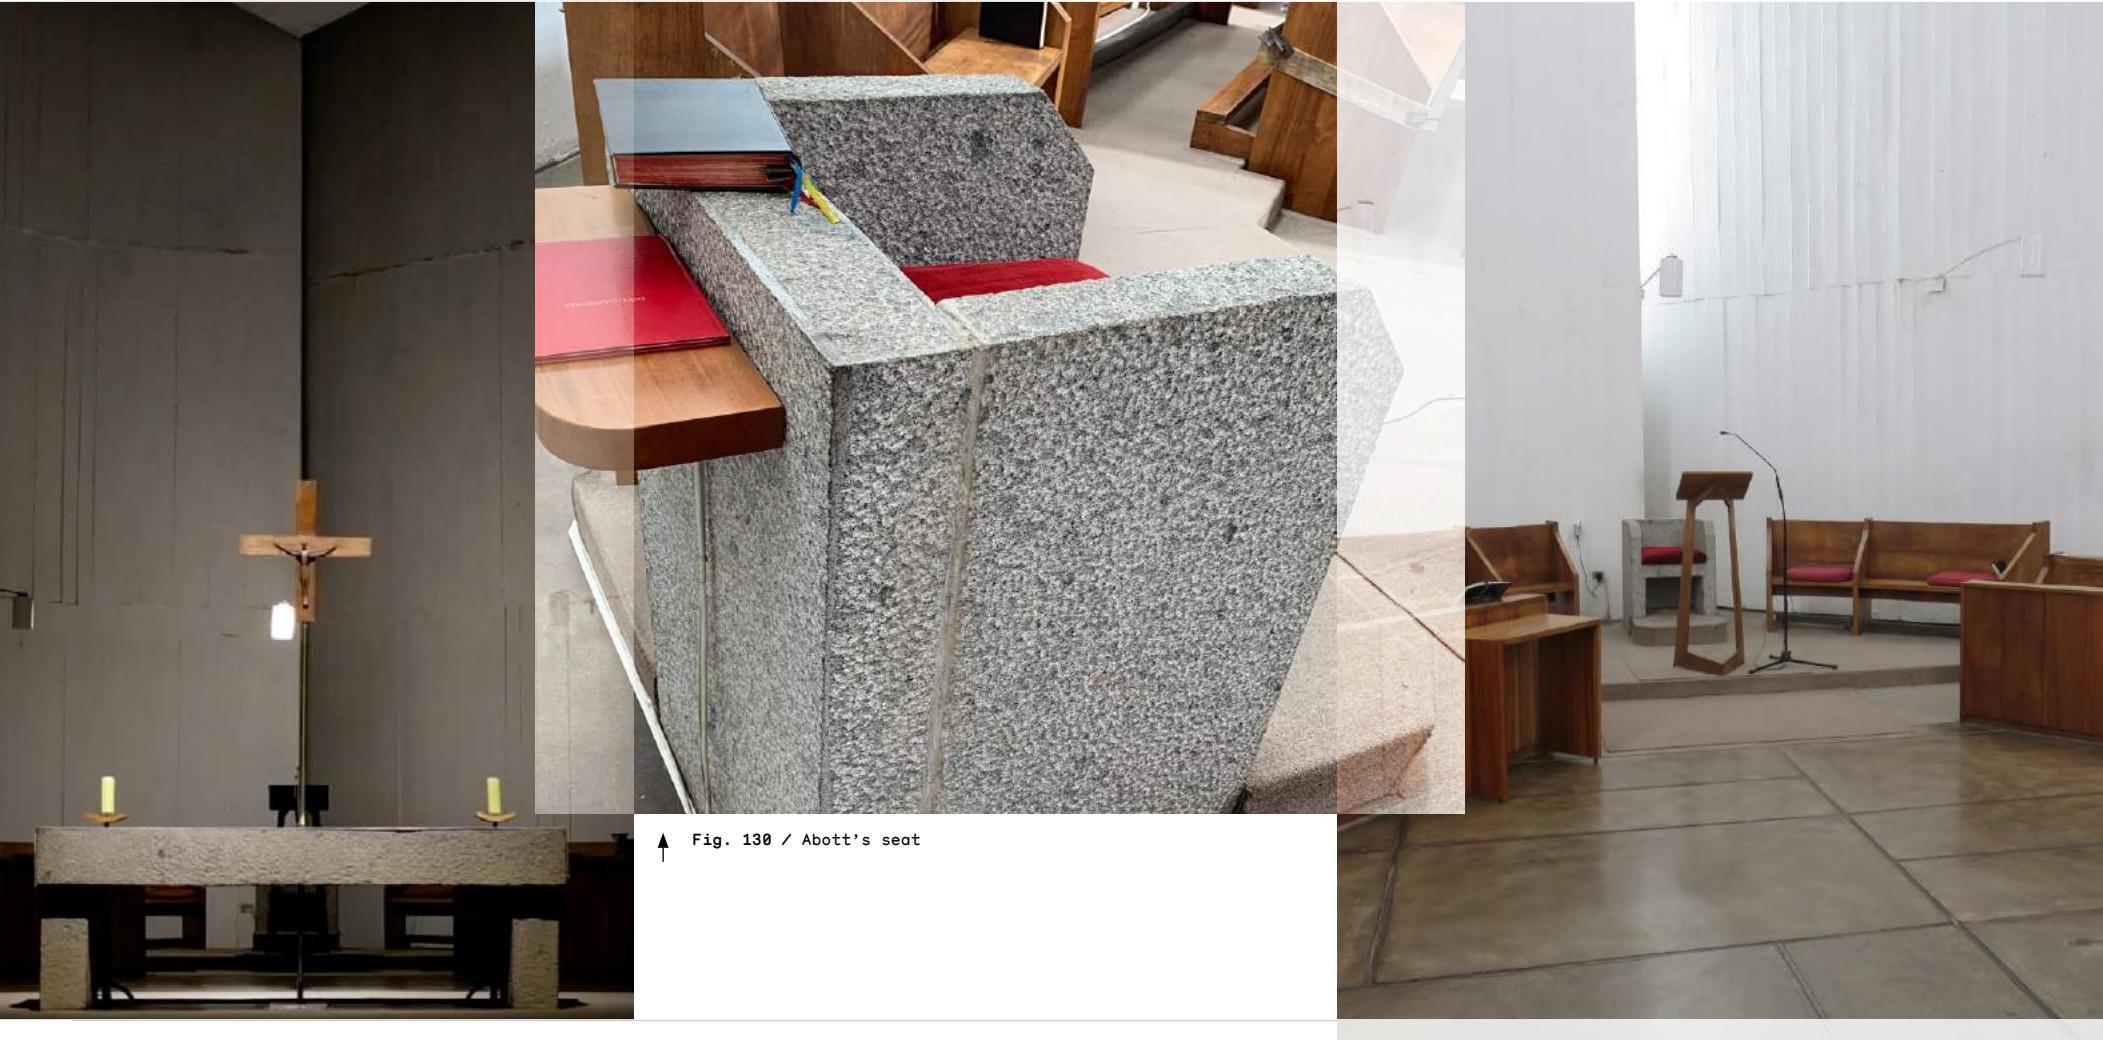
↓ Fig. 131 / Abott ambo

GUIDELINE 67 Since the ambo has an integrated amplification system, it is essential to periodically review the microphone to ensure that the assembly receives the reader's message clearly.
