PHYSICAL STRATEGIES – NON STRUCTURAL INTERVENTIONS FABRIC INTERVENTIONS This session was created by Mike Taylor and modified by Claudia Cancino.

For the purpose of this session, capping and sacrificial rendering will be further detailed. Capping techniques are interventions used to protect the tops of exposed earthen walls at archaeological sites. Sacrificial renders of earthen plasters or amended earthen plasters are intended to protect original vertical wall surfaces, which undergo weathering from rain and wind.

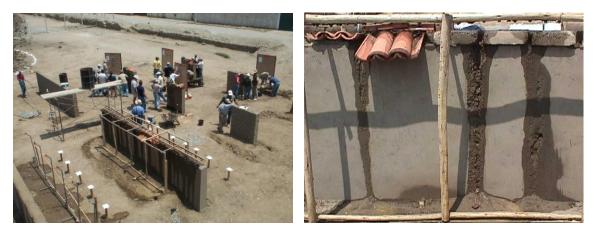
Figure 5.2.1 (left) and 5.2.2 (right) Left: View of demonstration walls for capping and rendering Right: Capping demonstration wall after accelerated weathering PAT course, 1999 © J. Paul Getty Trust

A demonstration of six capping techniques will be provided to the group on two demo walls, each 6 meters long, by two meters high. Each individual capping technique used will be two meters in length. The caps will be the following:

- Un-amended mud plaster cap
- Un-amended mud brick cap
- Stabilized brick cap
- Pitched roof cap
- Ceramic tile cap with overhang
- Brush and straw cap

One demo wall will have already had the caps applied to it two weeks earlier so that the caps will have fully cured. Each cap will be explained. Water will be introduced to the tops of the walls by way of a horizontally suspended hose that will apply water evenly to the tops of the walls in order to demonstrate the efficacy of the capping systems. At the end of the accelerated weathering, differential erosion patterns will be noted and discussed.

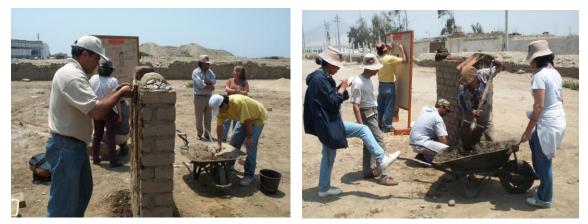
Figure 5.2.3 (left) and 5.2.4 (right) PAT students capping test walls with different methods PAT course, 1999 © J. Paul Getty Trust

The instructor, with the help of the assistants, will install the six capping techniques on another six meter long demonstration wall, explaining the methodology for each system. Each group will rotate to each of the six walls, working on a specific capping technique on each wall. The six capping techniques to be applied are those listed above.

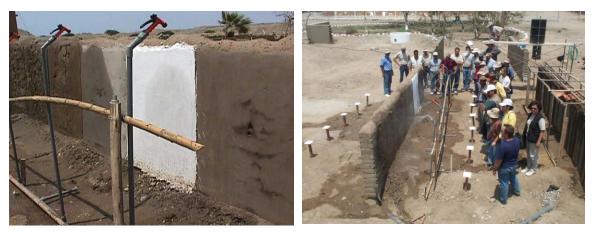
Figure 5.2.5 (left) and 5.2.6 (right) Right: Partial view of demonstration wall for rendering exercise Right: PAT students observing the performance of sacrificial renders under weather acceleration PAT course, 1999 © J. Paul Getty Trust

One demonstration wall, 6 meters long and 2 meters high, will have already had the renders applied to it two weeks earlier so that the renders will have fully cured. Each render will be explained. Water will then be sprayed evenly to the entire vertical

surfaces of the wall by way of three hoses mounted on a bracket five feet in front of the wall, and equidistant apart in order to demonstrate the efficacy of the render applications. By the end of the accelerated weathering, differential erosion patterns will be noted and discussed.

A demonstration of the six sacrificial renders will then be applied by assistant instructors with the help of participants to another demonstration wall, 6 meters long and 2 meters high. The renders to be applied are the following:
