殊像寺 建筑表面装饰、 塑像、陈设物 状况评估

Condition Assessment
of
Painted Architectural
Surfaces, Sculpture,
Furnishings and Objects

会乘殿 状况评估

Huicheng Hall Condition Assessment

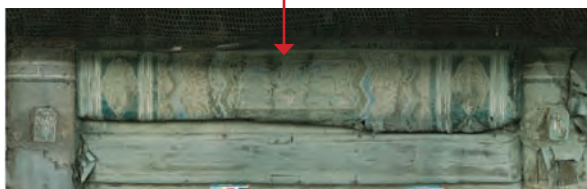
2004年5月照片中可见，西间小额枋上已无彩画。

The further west bay in May 2004 showing loss of the painting on the lesser architrave.

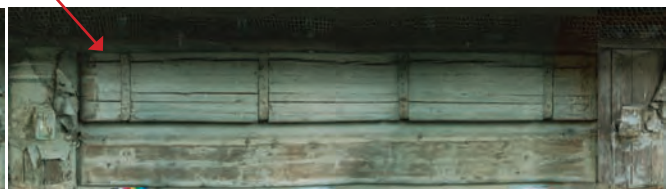
2004年5月照片中可见的南立面西次间，几乎无彩画留存。

The next west bay of the south facade in May 2004. Almost no painting survives today.

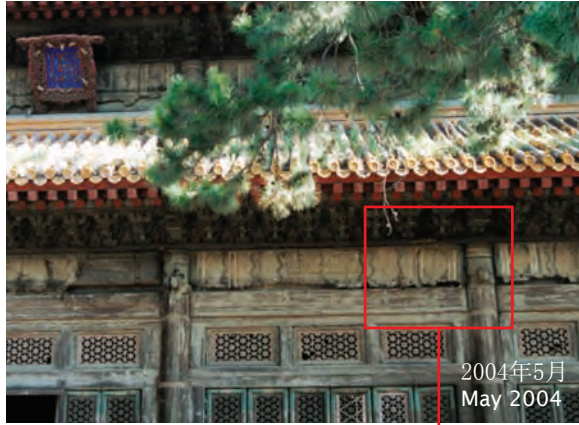
2004年5月的南立面东次间下檐彩画局部，在此后2004年7月的追踪调研中可见已经脱落。

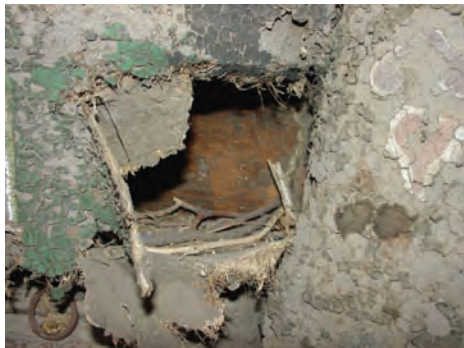
西次间彩画背面的鸟巢。

Bird nest behind the painting on the westmost bay.

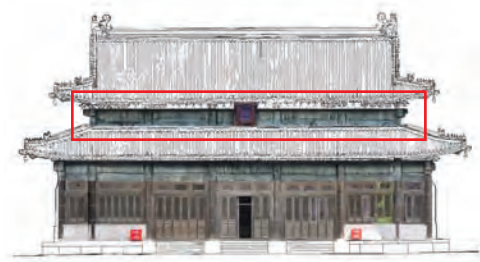
动物排泄物

Animal droppings

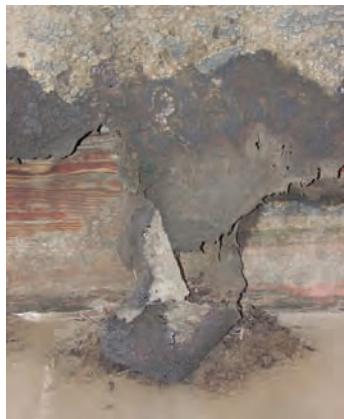
由于动物活动造成的彩画黑化及残损状态。

Blackening and deteriorated state of the paintings due to animal activity.

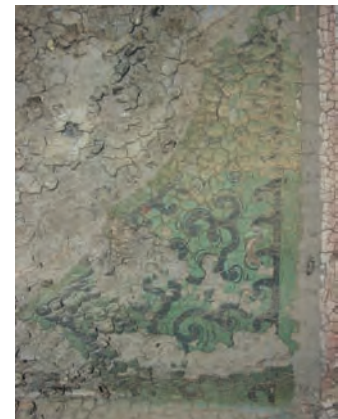
表面污迹覆盖彩画。

Surface dirt covering the painting.

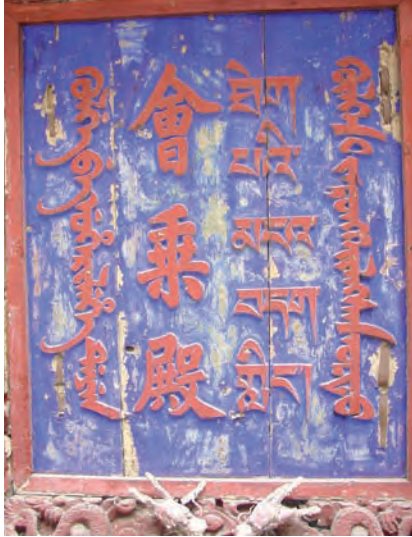
明间匾额细节。

Detail of plaque on center bay.

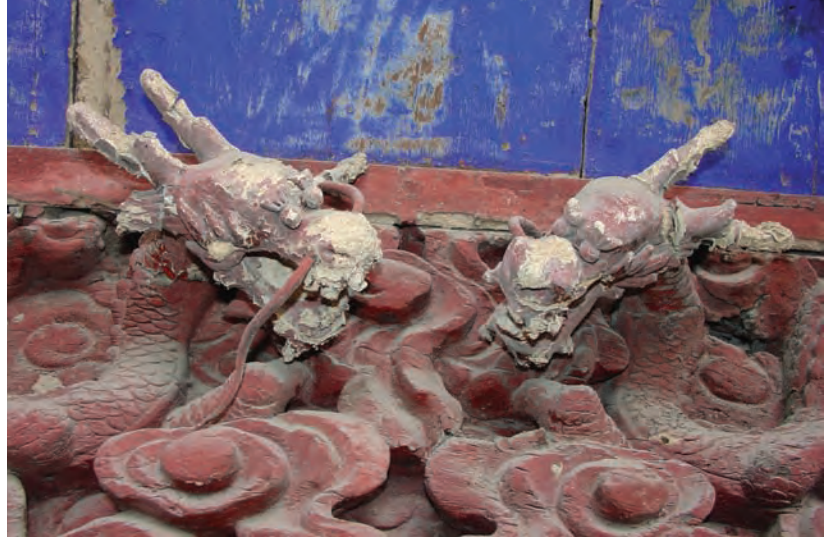
龙头上可见的小面积脱落。

Small losses are visible on dragon heads.

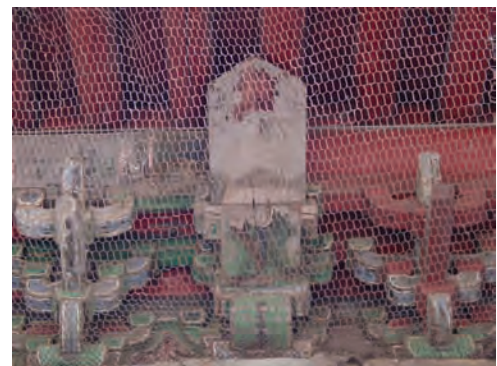
东次间与明间上已经更换过的檩子与斗拱。经过替换的挑檐檩。

Replaced purlins and bracket pieces on next east and center bays.

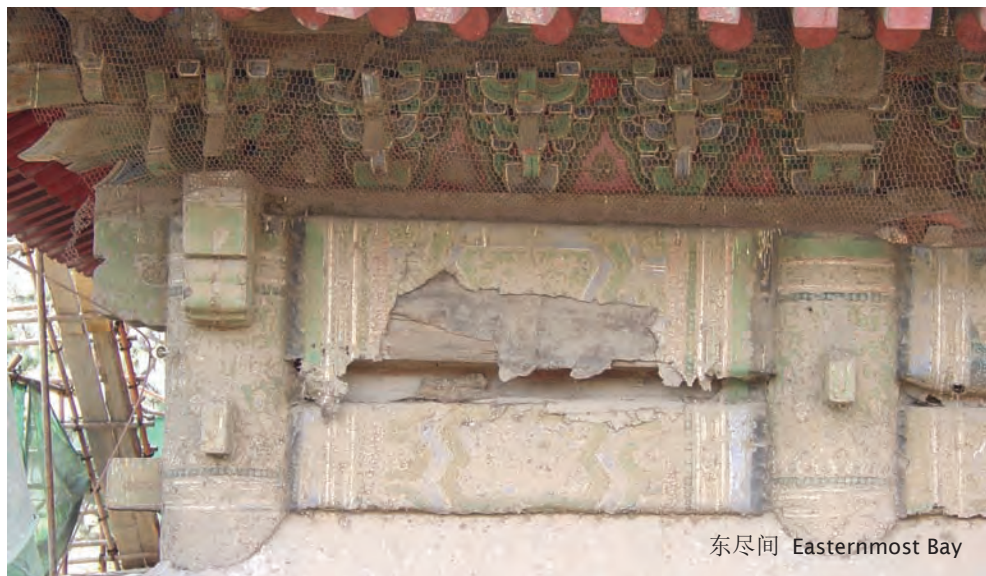
东尽间 Easternmost Bay

Easternmost Bay: greater architrave painting is in good condition and is well attached to the cushion board between the architraves. There are bird droppings on the greater architrave painting. The lesser architrave decoration is completely lost.

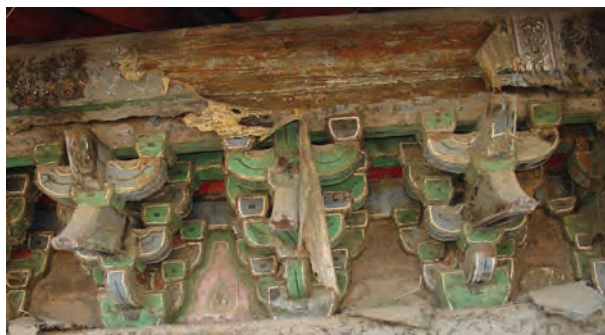
第四间檩子与垫拱板上的彩画。

Painting on purlin and bracket-arm cushion board on the fourth bay.

第四间：大额枋上有部分彩画完全脱落，并有部分上层地仗缺失。遗存彩画残损严重。垫板彩画脱落，掉在小额枋上面。小额枋彩画上存在水平裂缝。部分挑檐檩及3处垫拱板上的三宝珠装饰彩画脱落。

Fourth Bay: there is an area of complete loss in the greater architrave painting and also areas of loss of the upper plaster layer. Surviving painting is very deteriorated. Painting on the cushion board between the architraves has detached and now rests on the lesser architrave. The lesser architrave painting has a horizontal crack, Part of the purlin (not visible in photograph) and three areas of the fire and three pearl decoration on the bracket-arm cushion board are lost.

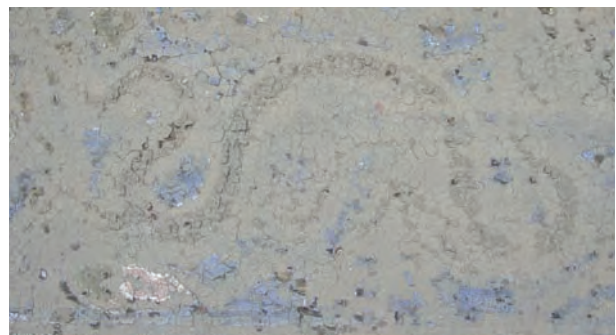
在彩画贴附状况与彩画本身处于较好状况的区域，颜料层的典型残损状态。

Typical deteriorated condition of the paint layer in an area where the painting remains attached and in relatively good condition.

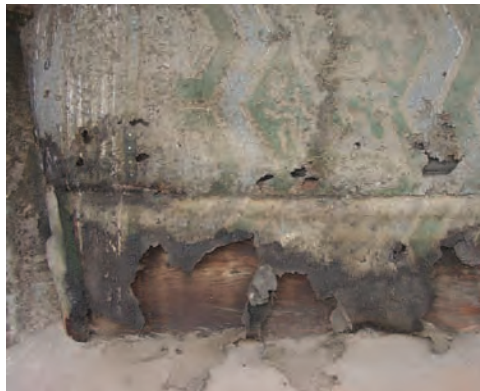
第一间：动物活动导致的彩画变黑与脱落。

Blackening and loss of the painting caused by animal activity, first bay.

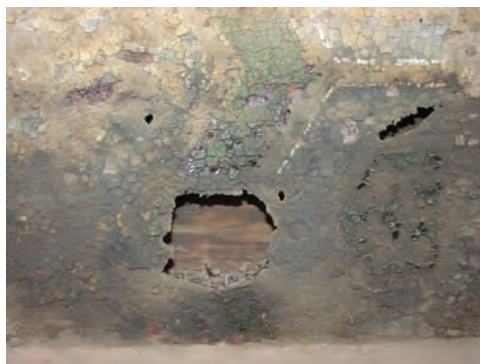
第一间：动物排泄物堆积在彩画背面。

Animal droppings accumulated behind painting, first bay.

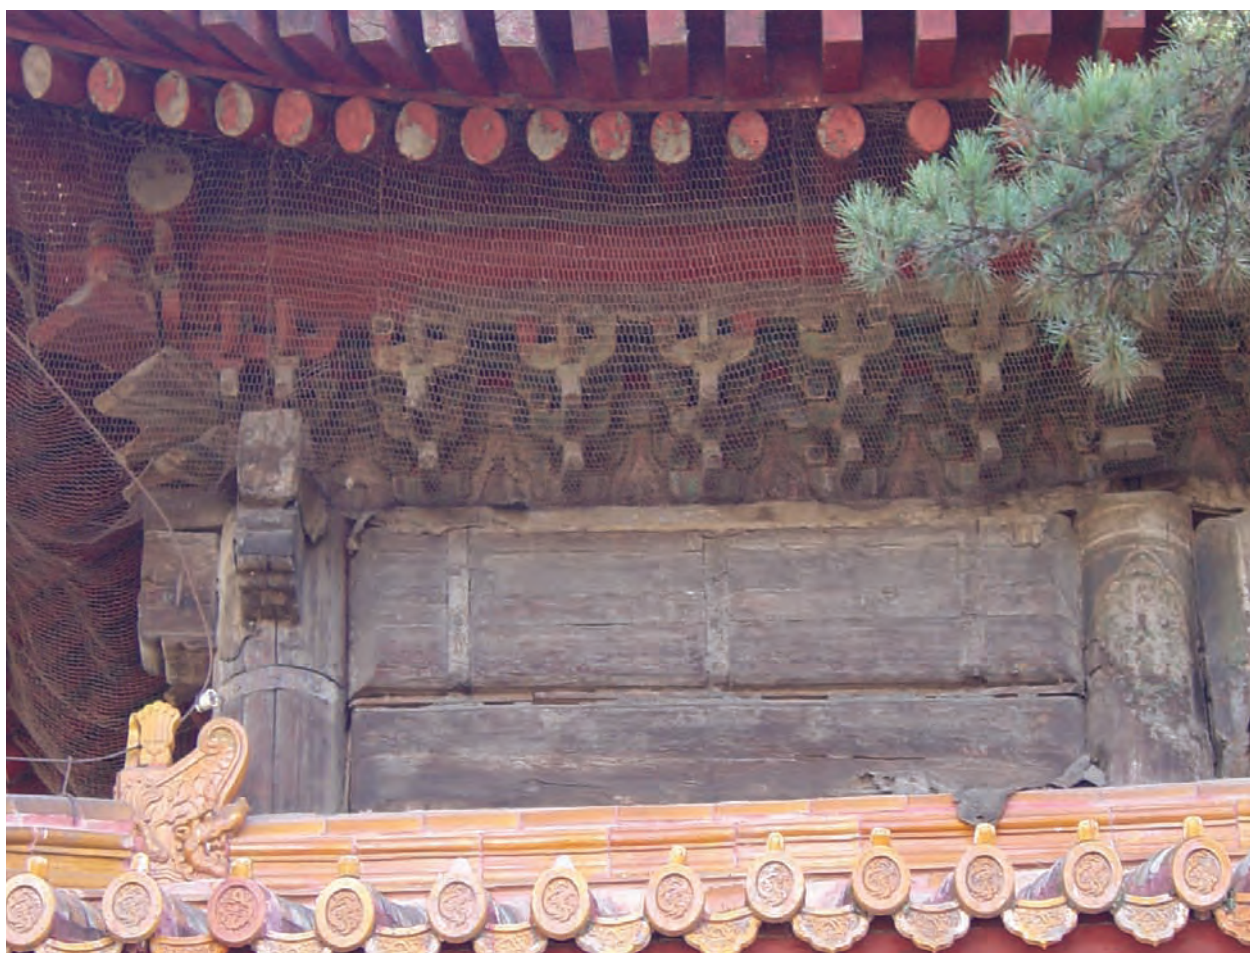
第三间 Third Bay

第三间彩画几乎完全脱落的区域可见木材上的水平裂缝。挑檐
標，转角部分构件， 及一些斗拱已被补换并涂上红漆。

Horizontal cracking is visible on the exposed beam of the southernmost bay where the painting has been almost completely lost. The purlin, upper corner elements and pieces of the brackets on the third bay have been replaced and are painted red.

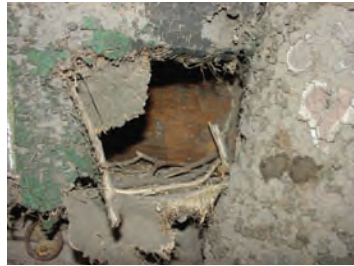
彩画后面的鸟巢。

Bird nest behind the painting.

In many places the netting was found to be torn or not properly secured allowing birds to freely nest inside the roof structure. This leads to bird droppings on the paintings, creation of nests behind detached areas of the painting and possible dislodging of fragile areas of painting caused by movement of the birds.

It is recommended that this netting be replaced with netting that does not obscure the paintings and which prevents birds from nesting in the roof.

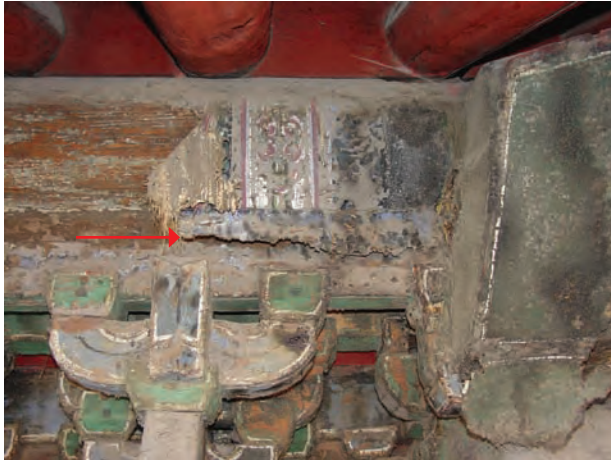
挑檐檩彩画有地仗及一层纤维层。地仗层终止于挑檐枋上半部。除挑檐檩及挑尖梁头之外，斗拱各部件使用极薄的地仗，不含麻。

Eave purlin painting is executed with plaster and a single fiber layer. You can see the point where this plaster stops on the axial tie-beam. Apart from the purlin and *tiaojianliang tou* the rest of the bracket set decoration is painted on a thin skim of plaster - without a fiber layer.

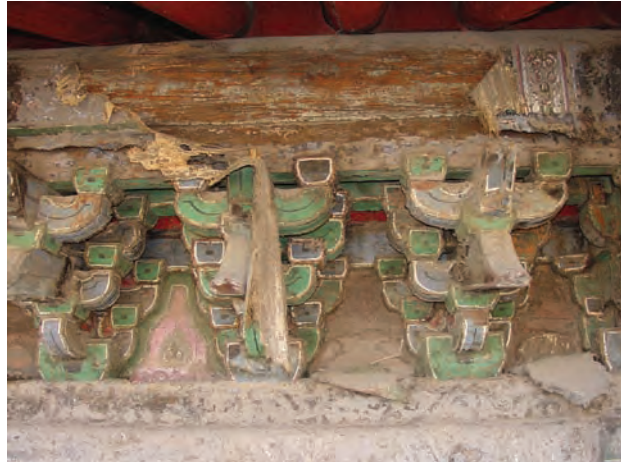
有麻层的挑檐檩及挑尖梁头通常比直接在薄地仗的木材上施彩绘如斗拱等部位面临更高的彩绘脱落危险。

The purlin and *tiaojianliang tou* with fiber layer often seem to be at a higher risk of loss than areas of decoration on the brackets that are painted directly onto the wood with only a thin skim of plaster.

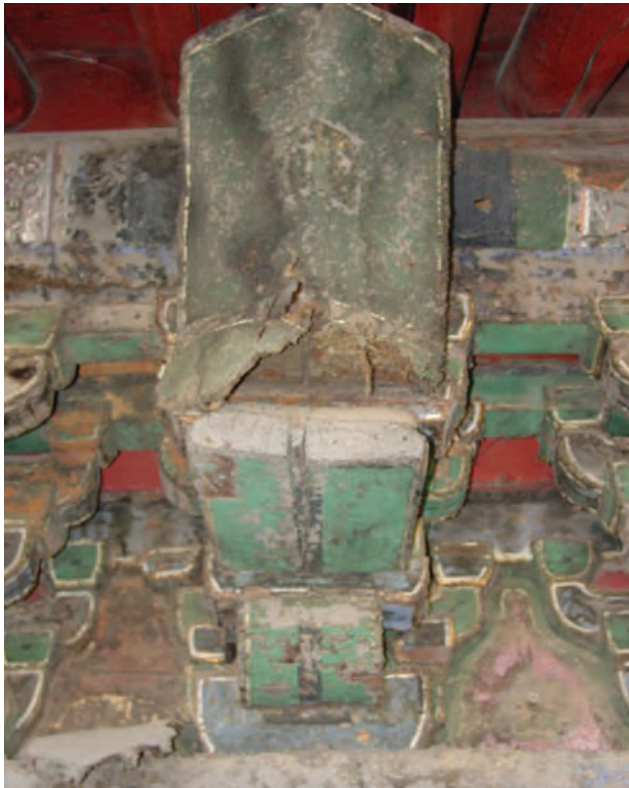
有彩画存在的挑尖梁头。

Tiaojianliang tou with surviving painting.

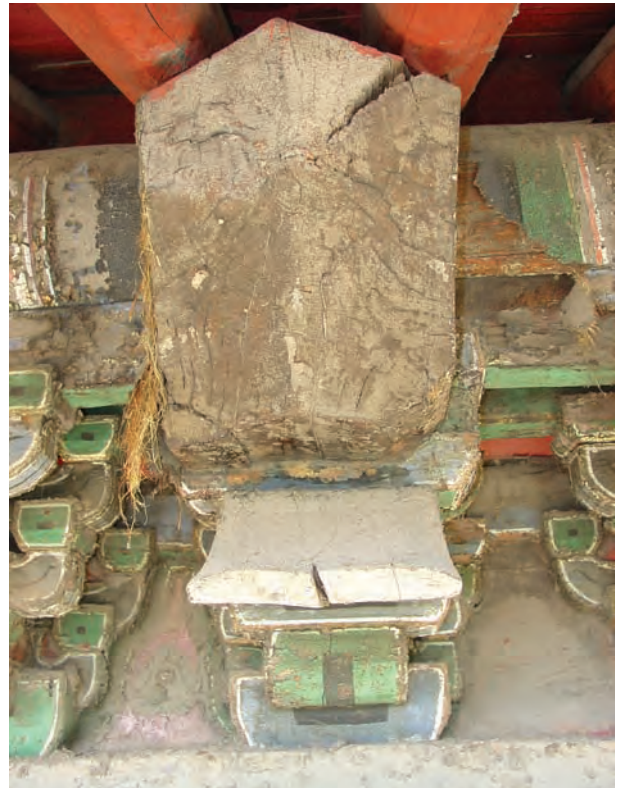
无彩画存在的挑尖梁头。

Tiaojianliang tou with painting lost.

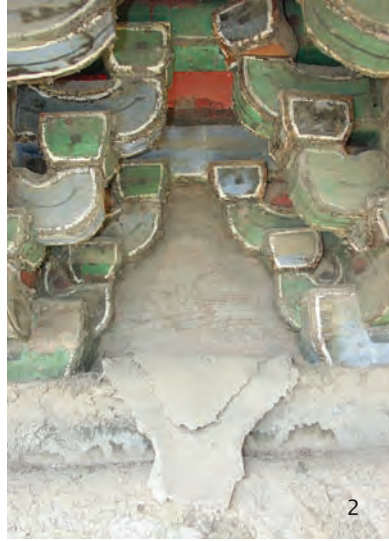
斗拱之间（垫拱板上）的三宝珠装饰，图中可见其彩画(1) 遗存(2)，剥落及(3) 完全缺失的状况。

The "fire and three pearl motif" decoration on the area between the brackets, known as the bracket-arm cushion board shown with surviving painting (1), painting detached (2) and complete loss (3).

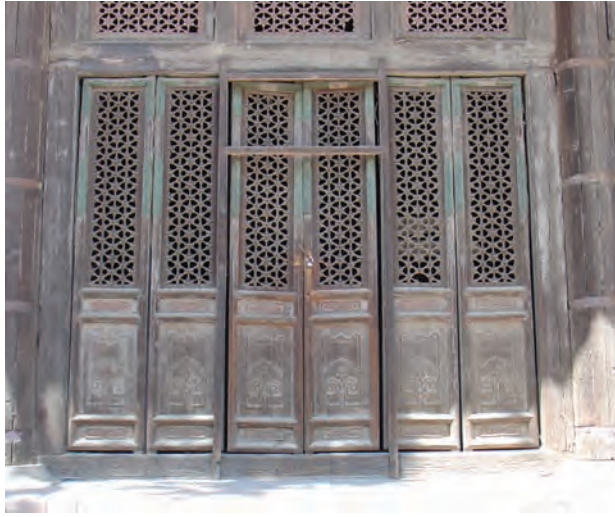
会乘殿南面大门。极少量的漆或地仗残留下来，木质部分暴露。

The south entrance doors of Huicheng Hall. Very little paint or plaster survives leaving the wood exposed.

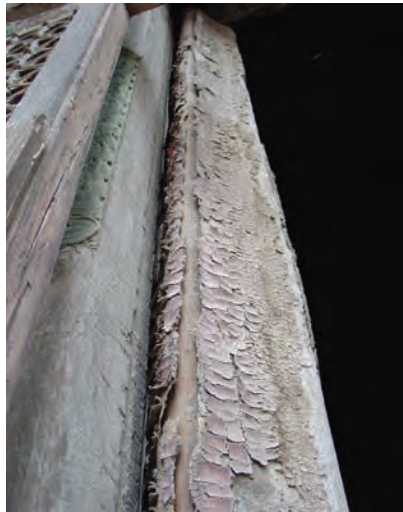
门框的内侧较有保护的地方保留了较多的油饰，但保存状况很不好。

Painted plaster survives on the more protected inner door frames but the condition is very deteriorated.

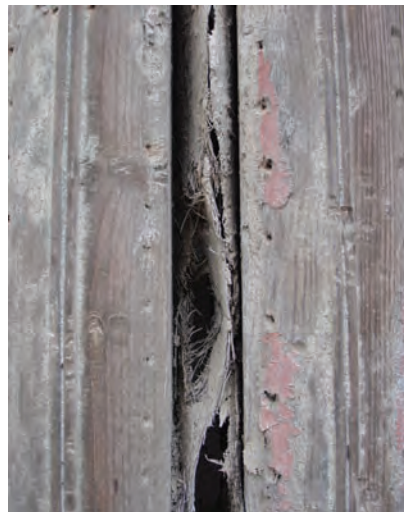
门框上也可看到大片脱落的油饰地仗。

Note also the large piece of detached painted plaster in the door frame.

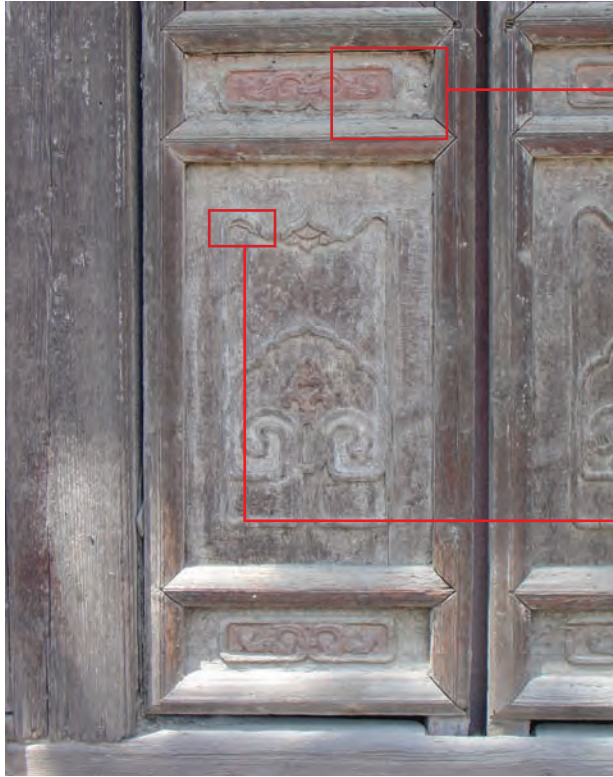
会乘殿南面室外门面细部。

Detail of door on exterior south facade of Huicheng Hall.

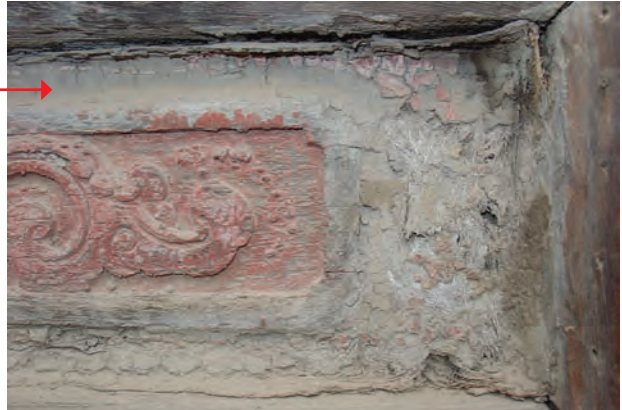
门板装饰细节。

Detail of door panel decoration.

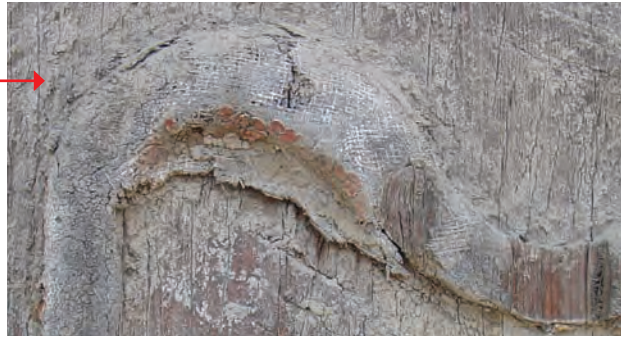
立体装饰细节显示底层的木材、地仗、麻布层和残留的漆层。

Detail of raised decoration showing underlying wood, plaster and textile layers and surviving traces of paint.

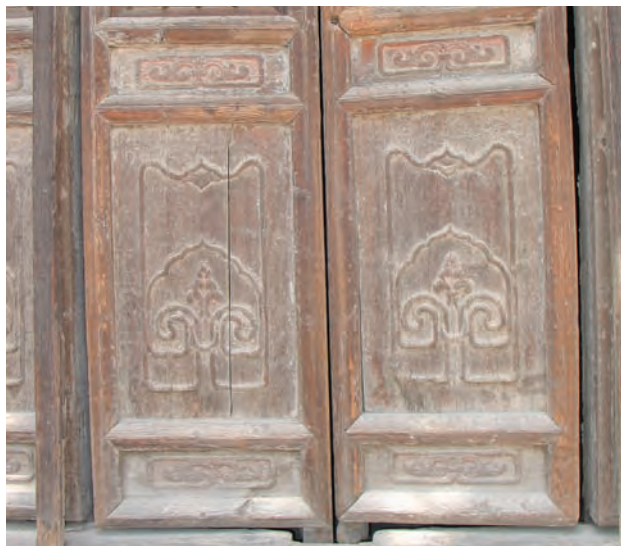
会乘殿南面大门。

Doors on the south facade of Huicheng Hall.
