附件1：名词图解

APPENDIX 1: VISUAL GLOSSARY

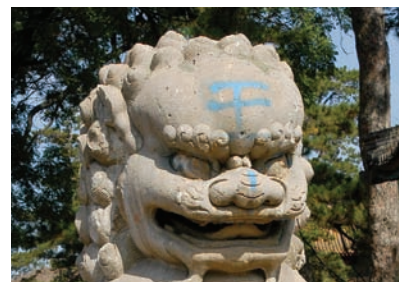
石狮子，
山门前面
鸚鵡岩
油漆的涂写
Stone Lion, S of Shanmen
Tuff (*yingwuyan*)
Graffiti (paint)

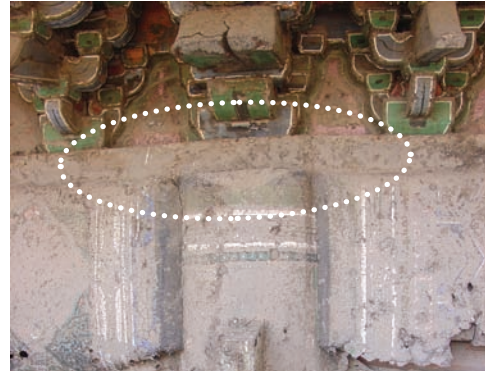
会乘殿，东立面
平板枋
弯曲

Huicheng Hall,
E Facade,
Lower Eave
Flat tie beam
Warping

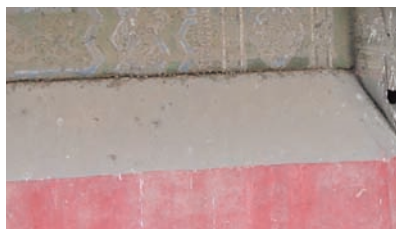
会乘殿，北立面
红色抹灰
污垢堆积及鸟类粪便

Huicheng Hall, N Facade
Red-colored stucco
Dirt accumulation and bird droppings
