Keeping It Modern

Luce Chapel is a renowned architecture in Taiwan. With its outstanding achievements, it certainly stands out in the modern architectural movement of post-war Taiwan. In October 2014, Luce Chapel was chosen to be one of the ten global classic modern architectures, and the first project within Asian architecture, which received the first "Keeping It Modern" (hereafter abbreviated as KIM) Grant from the Getty Foundation. The Grant acknowledges these 20th century modern architectures as milestones of human civilization. With high experimental mentalities, groups of architects and engineers of the previous century boldly tried out exploratory materials and cutting edge construction techniques, and built innovative architectures that have stimulated changes in their surrounding environments, histories, local culture, and forever transformed the philosophical approaches of architecture. However, the Getty Foundation also regards these architectures to be under various degrees of risks. Being fifty to sixty or even older, many of these innovative materials and techniques boldly used at the time of their construction were not, and still have not been scientifically tested

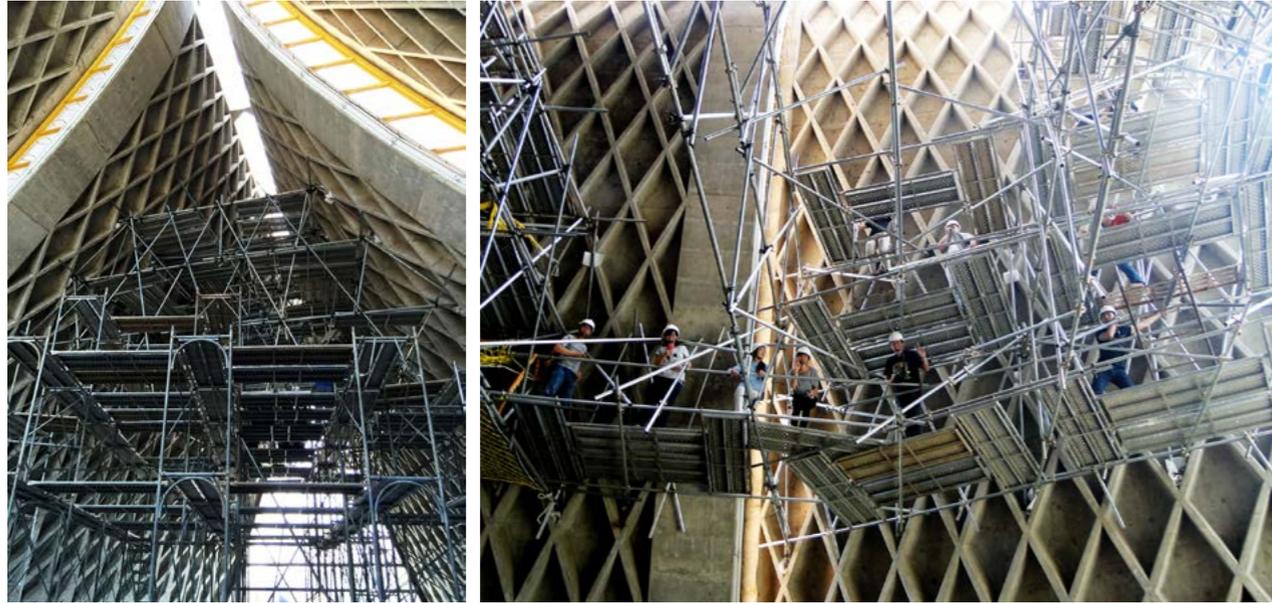
Pic.29 During the conservation research period, the research set up the scaffolding for a thorough inspection of the shell structure and steel frames and glasses. The scaffolds was standing on the lattice beam 8 meter height and above in order to keep the weekly activities taking place as usual.

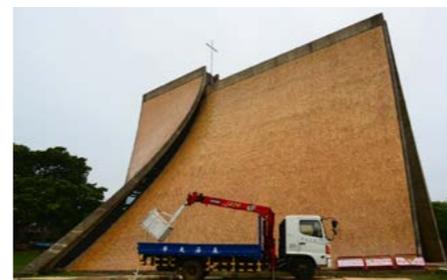
2.22 Methods of test for tiles: Sprinkler test

- I. Condition settings (Fig. 2.22)
 - i. Test day: Sprinkle the tiles for a day (09:00~12:00 ; 14:00~15:00). Observe and record the next day
 - ii. 1.5HRS/per side/sprinkled on all four walls
 - iii. Water velocity: similar to the flow of average hand washing sinks
 - iv. Avoiding the skylight window
- II. Result:
 - i. Inner wall: No leakage.
 - ii. Indoor basement: Constant leakage

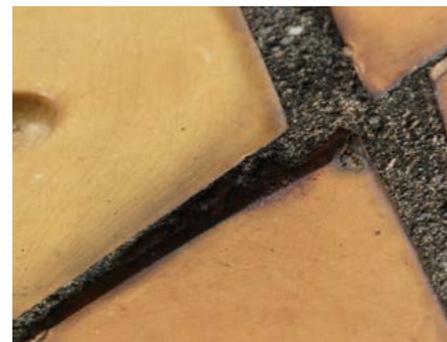
2.30 Tiles having apparent defects due to manufacturing flaws were excluded in the damage records

Tiles with apparent defects caused by manufacturing flaws, such as furnace transmutation defects, or faulty products, were excluded in the damage records (Fig. 2.30). For example:

- I. Hidden cracks: Hairline cracks paralleled to the kiln. This type of cracks happens when the tiles are being taken out of the kiln. The cracks take place without any early warnings.
- II. Chips: This happens when the clay is too dry or when the pieces collide.
- III. Cooling cracks, hard cracking, lack of heat, calcification, defects in color and luster, etc.

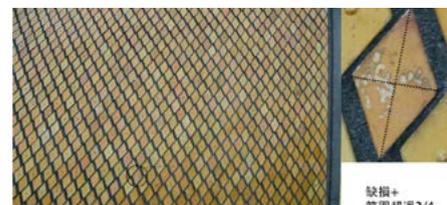
2.31 I. Erosion, exfoliation and pitted tesserae

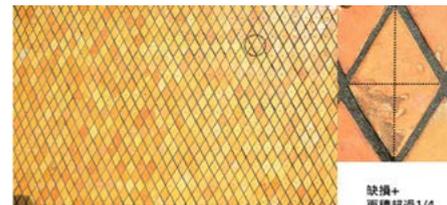
2.32 Erosion, exfoliation and pitted tesserae

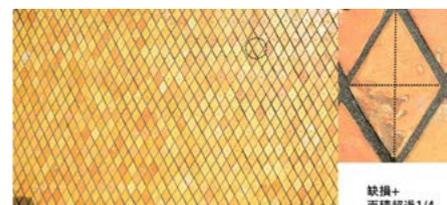
2.33 Erosion, exfoliation and pitted tesserae

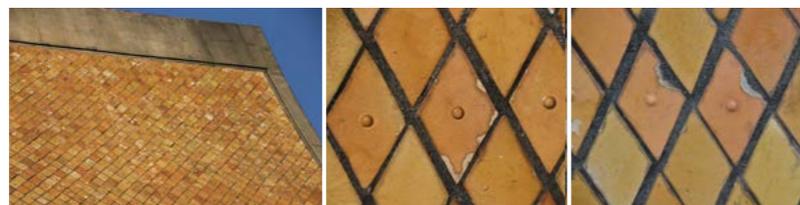
2.34 Erosion, exfoliation and pitted tesserae

These are the tiles under erosion and attrition. White adobe would also exfoliate under these conditions (Fig. 2.34). The deteriorations were classified as acute or slight according to the scale of deterioration (Fig. 2.35). The coordinates of these fractures are as recorded on the graphic (Fig. 2.35).

The tile eroded, exfoliated and pitted tesserae occur mostly on roof-S2, roof-N1, and roof-N2. The main cause of erosion on roof-N1 and roof-N2 are most likely the nature of gradient and flow rate of the roofs (Fig. 1.34). Serious deteriorations at the bottom of roof-S1 are probably artificial damages.

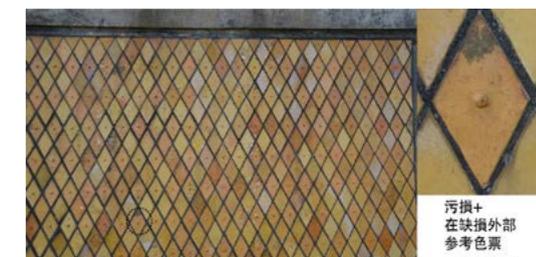
2.36 Tile color alteration and contamination

The tile color alteration and contamination distribution (Fig. 2.39) closely relate to the distribution of tile erosion, exfoliation and pitted tesserae (Fig. 2.35). The contamination on top of N1, N2 and the side frames are the most severe (Fig. 2.36). Areas close to the ground also suffer serious contamination (Fig. 2.38). The contamination on N1 and N2 was most likely caused by the gradient of the roof and the insufficient drainage of the roof gutter.

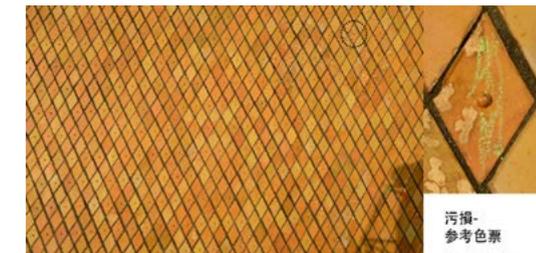
2.37 Tile color alteration and contamination

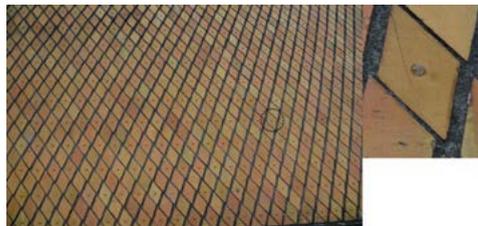
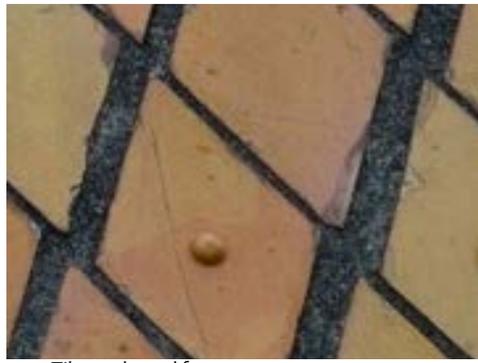
2. 40 Tile cracks and fractures

III. Tile cracks and fractures (Fig. 2.40~2.42)
 According to our primary and comprehensive investigation record (Fig. 2.42), individual and slight tile cracks and fractures are the major issues (Fig. 2.41). The cracks of adjoining cracks can form a long continuous fracture. However there are only two continuous fractures, one perpendicular and one horizontal (Fig. 2.40). Both of the fractures are only on the surface of the tiles, thus do not jeopardize the chapel structure.

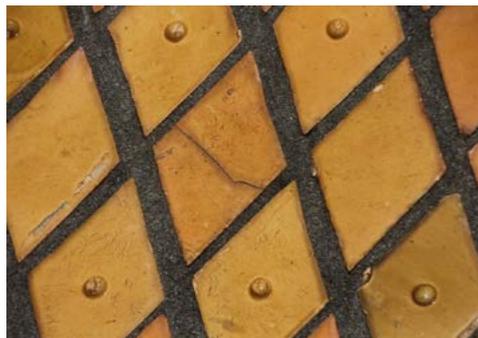
2. 41 Tile cracks and fractures

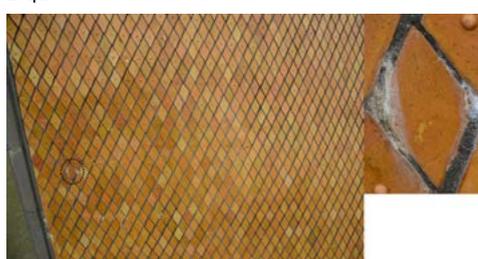
2. 43 Tile efflorescence

IV. Tile efflorescence (Fig. 2.43~2.44)
 The efflorescent condition clearly scatters in several areas (Fig. 2.44). These are also the areas where apparent and acute deteriorations locate (Fig. 2.43).

be replacing tiles in critical deterioration condition, such as efflorescence, with the same batch of tiles stored in the school's warehouse.

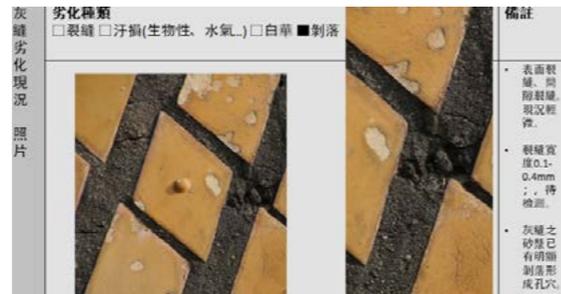
2.52 Mortar cavity and lacuna

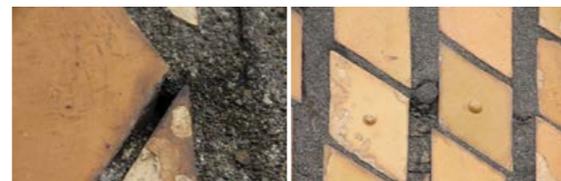
2.53 Mortar cavity and lacuna

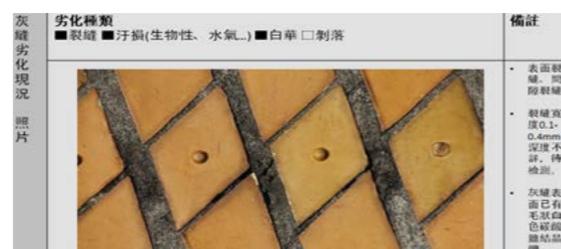
2.55 Mortar efflorescence

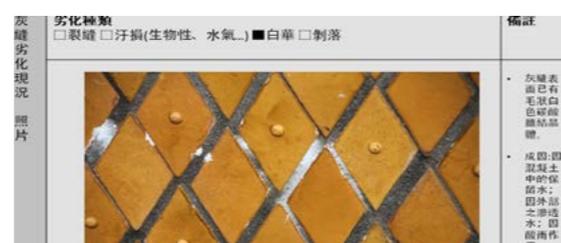
2.56 Mortar efflorescence

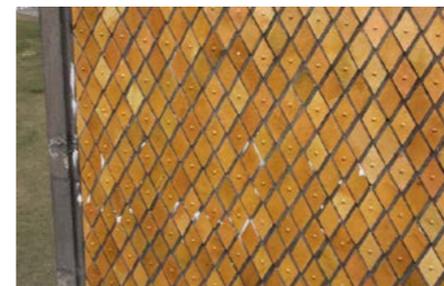
2.57 Mortar efflorescence

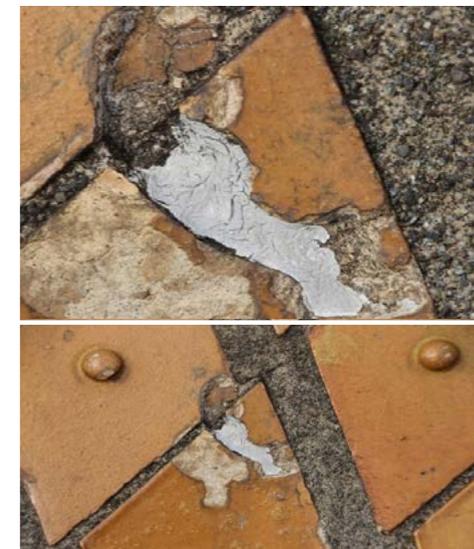
2.59 Inappropriate treatment

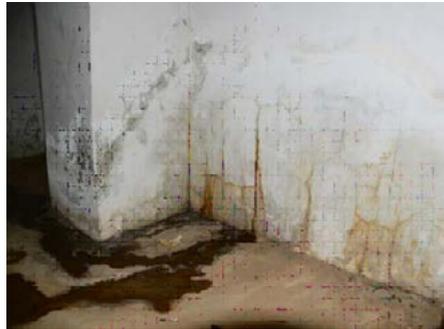
Structurally, Henry Luce Memorial Chapel is composed of four conoid (saddle-shaped) shell walls with one floor, together creating a contour consists of two linear and two curve lines. This gives the chapel a unique upward pitch. The five plates stand individually, disconnecting from one another. The floor caves in at the edges where the groundwork lays contiguous to the four walls, resulting an illusion of discontinuity between the floor and walls. Occasionally, water leaks into the groundwork and eventually hardens into efflorescence, a white powdery residue (Fig. 2. 61~2. 62).

2.61 Leakage and efflorescence condition at the caved in groundwork of Henry Luce Memorial Chapel, Taiwan.

Due to the immense campus lawn and the sprinkling irrigation system situating outside the chapel, both the site itself and the soil surrounding of Henry Luce Memorial Chapel are under high humidity. Water leakage at the caved in groundwork results from cracks and other structural discontinuities. Moreover, the wicking in tiny cracks and pores absorbs water from all directions- even upward porous building materials, such as masonry blocks and concrete also cause efflorescence and water leakage (Fig. 2.63).

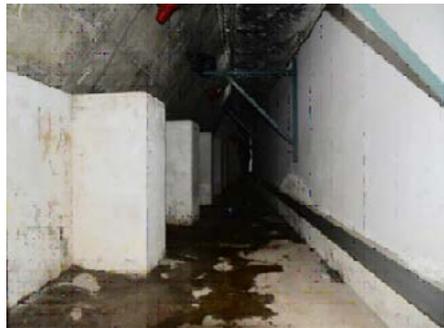
2.62 Leakage and efflorescence condition at the caved in groundwork of Henry Luce Memorial Chapel, Taiwan.

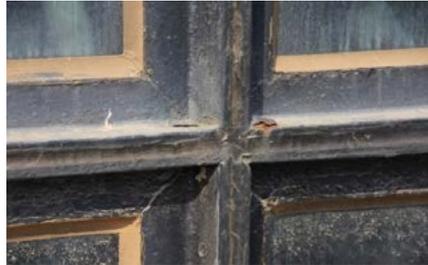
2.69 The corroded frame of the east opening and silicone filled in the recessed structure.

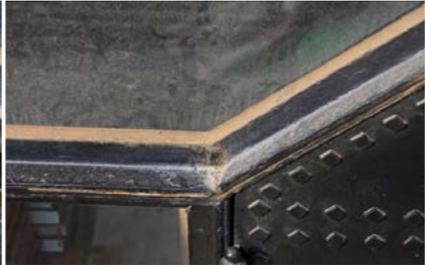
2.70 Corroded upper rims of the frame in the façade of the chapel.

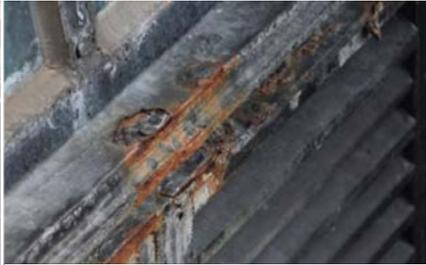
2.71 The chemicals added in the cooling towers aside the west windows caused critical corrosion on the bottom frames of the west openings.

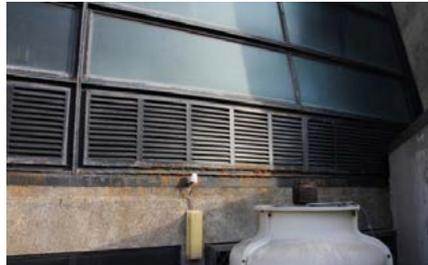
2.72 The west windows and the cooling tower.

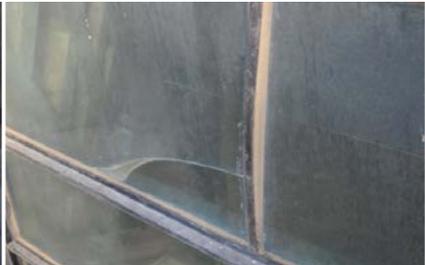
2.73 The distorted frame and broken glass at the west openings.

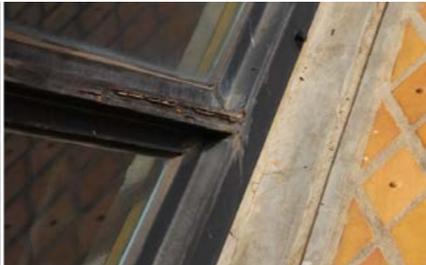
2.74 The frame of the south openings was corroded and the tiny gap between the frame itself and the structure was refilled with cement.

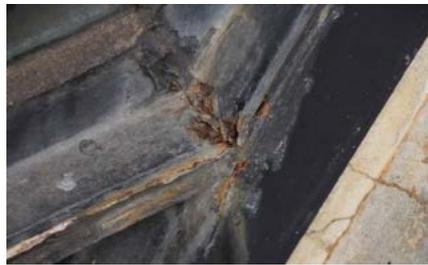
2.75 Corroded upper rims of the south window frame.

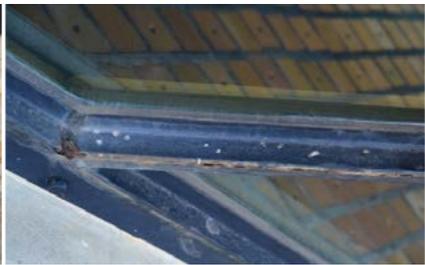
2.76 Corroded upper rims of the north window frame.

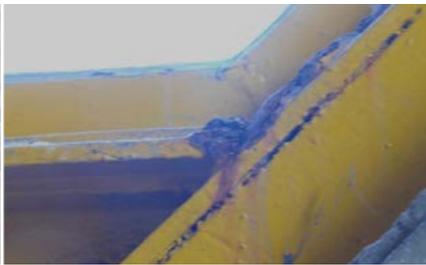
2.77 The welding points on the internal north openings were corroded and the interface between the steel plates and the steel channel was separate.

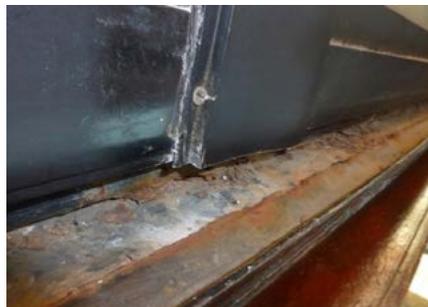
2.78 The internal louver boards of the west façade were corroded.

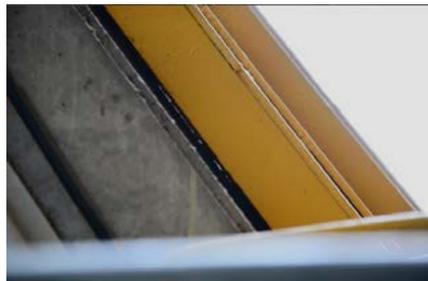
2.79 A close observation on the gaps between the frame and structure at the south openings.

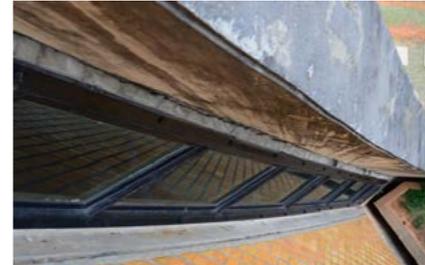
2.80 The splits between the north window frame, walls and interfaces are filled with cement to solve the leaking problem.

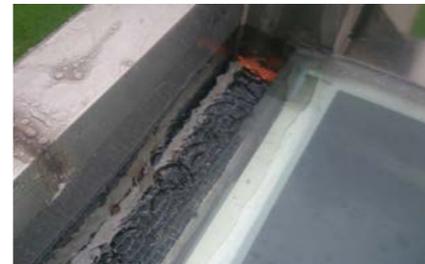
2.81 Water leaking through the interspace of a slight widow due to insufficient drainage function of the gutter.

Two iron drainage pipes with a diameter of 2" width were buried inside the structure during the chapel's construction period. However, only one is still in function at present time. Therefore the gutter is often full of water, and water eventually leaks into the chapel through crevices of the skylight window. Besides, waterproof function of the opening has degraded as the rubber mats inside the steel channels age or slacken.

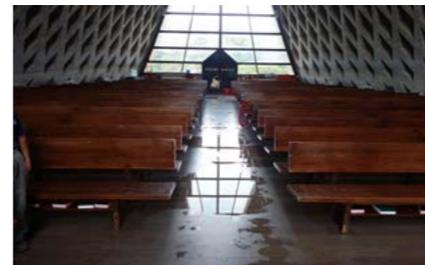
2.82 Rainwater leaking into the chapel from the skylight window.

The skylight leakage is mainly caused by clogged pipes. This leads to poor drainage efficiency. Keeping the performance level of the pipes at a sustainable standard is the priority of the following conservation plan. Two iron pipes with 2" in diameter are buried inside the structure; however, only one is still in function. Therefore, the catchment is significantly insufficient (Fig. 3.33). As shown in table 3-1, placing a drainage pipe with a 50mm internal diameter in both of the gutters will be able to solve the problem. Two proposals are recommended as the following:

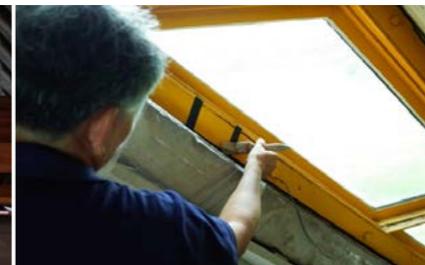
2.83 Coating removal project and paint stripping test on the frame of south openings. After cleaning, the test zone was defined by tapes and peeling paint agent Asur-#1180 was applied.

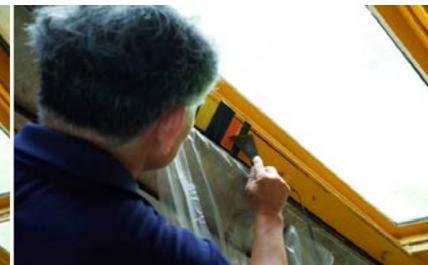
2.84 Scratching off the paints after the chemical reaction of expansion and foaming caused by the peeling paint agent.

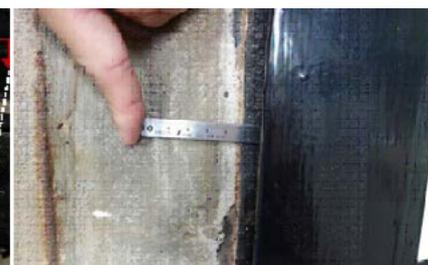
2.87 The inner side of the frames on the west façade was partially dismantled.

For the splits between the frame of the openings and the structure, we dismantled the inner side of the frames on the west façade. By doing the requisite inspection, we could go a step further to confirm the actual combination method and the deteriorating condition. After chiseling the concrete, we found out that the inner steel channels had already corroded. The adding of the screws was to fix the loose channels (Fig. 2.87~2.90).

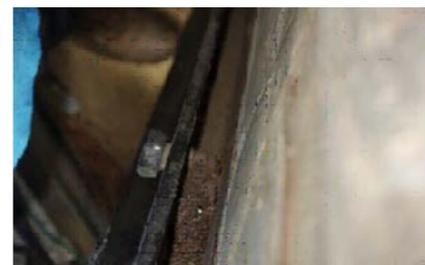
2.88 The screws were applied to fix the loose channels.

The condition of some screws fixed on the steel channels of the opening frames is loose.

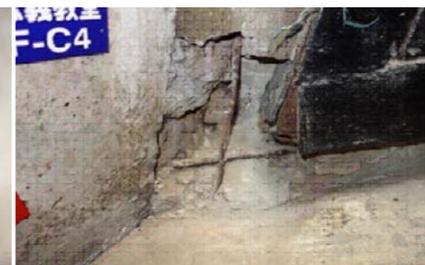
2.89 The inner side of the frames on the west façade was partially dismantled.

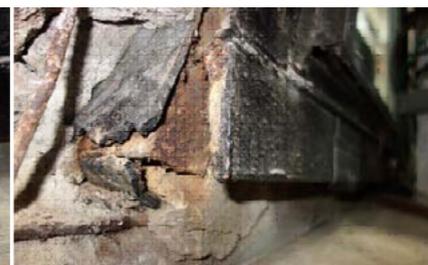
2.90 The inner steel channels were corroded.

Steel corrosion caused by water vapor is the main deterioration at the openings. Places such as the external horizontal frames and the inner louver boards accumulate water easily. Capillary action, the ability of liquid to flow in narrow spaces without the assistance of, and in opposition to, external forces like gravity is another cause of steel corrosion. The welding points suffer serious corrosion from extreme heat. In addition, chemicals added in the cooling towers next to the west windows vaporized in the air and caused critical corrosion at the bottom frames of the west openings.

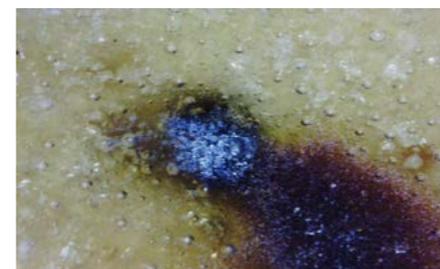
3.8 Black inclusion on tile THU-5b

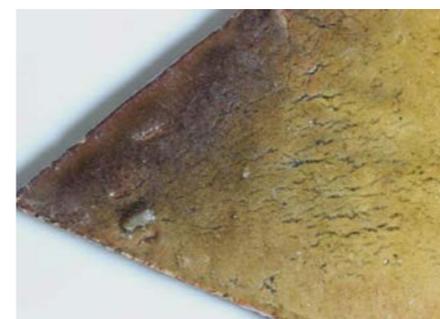
3.9 Dark glaze on tile THU-6

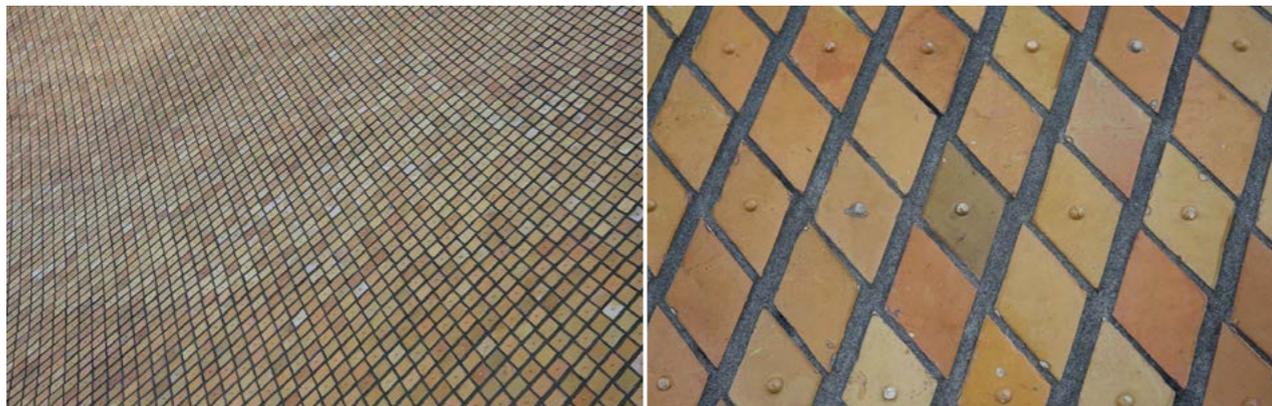
3.14 The golden yellow tinge of Luce Chapel tiles

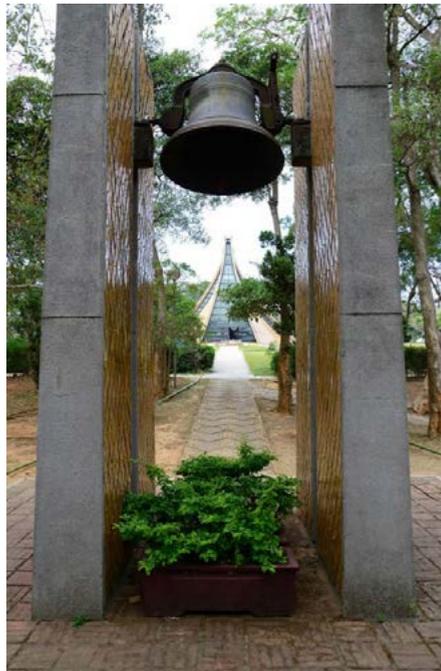
3.16a Bell tower

Being surrounded by trees, ventilation around the bell tower (Fig.3.16a) is not as ideal compared to the chapel. The moisture can thus cause biodeterioration and accelerate the forming of damages such as serious cracks of the tiles (Fig.3-16b,3-17). The same problem was also observed on the chapel walls around areas close to the lawn (Fig.3.18).

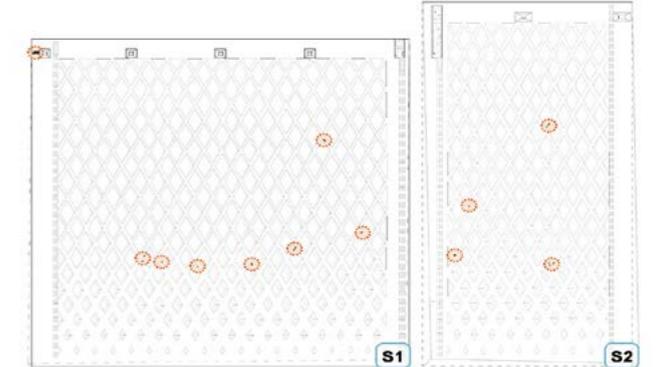
4.53 Concrete deterioration spots on the lattice-beam grids and slabs on the south side of the chapel

(Fig. 3.52) and (Fig. 3.53) demonstrates concrete deterioration spots on the lattice-beam grids. This study discovered that such concrete deterioration was very minor. Most of these deteriorations occurred during the demolding process after the solidification of concrete (Fig. 3.54). Because no plastering or decoration was applied in the interior of the chapel, these concrete deterioration spots can be visually inspected. Moreover, a small portion of these concrete deterioration spots were air voids formed during concrete solidification (Fig. 3.55). In summary, the concrete deterioration of the chapel structural components was minor and unevenly distributed.

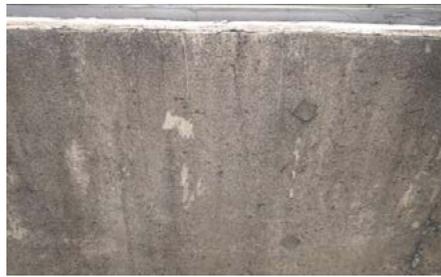
4.58 Vertical cracks at the rooftop parapet walls

(Fig. 4.56) and (Fig. 4.57) display the crack distribution on the outer surfaces of the chapel's shells. As displayed, cracking primarily occurred at the shells' bottom parts, the rooftop parapet walls, and the edge beams next to the rooftop windows. Vertical cracks at the parapet walls (Fig. 4.58) were caused by inadequate protection and years of outdoor exposures (sunlight, wind, and rainfall), which caused RC deterioration. Theoretically, when the reinforcing steel corrodes, the resulting rust occupies a greater volume than the steel, creating tensile stresses in the concrete and thus causes cracking. Because of this reason, cracking took place at the edge beams beside the rooftop windows (Fig. 4.59). Additionally, oblique cracks were also detected at the similar position of the two shell slabs, Slabs N2 and S2 (Fig. 4.60), which are on the chapel's northern and southern sides, respectively. These oblique cracks are the gaps of construction joints. Furthermore, insignificant horizontal cracks were observed at the bottom of the edge columns (Fig. 4.61), and these cracks occurred when the bottom parts of the edge columns were under negative bending moment, which reach a maximal value at the columns' footing.

Most cracks of the Luce Chapel were earthquake-induced micro-cracks and cracks caused by inadequate concrete protection layers and reinforcing steel corrosion. The distribution of these cracks is elaborated in Section 3.2.2. This study recommended

applying epoxy injection to repair this type of cracks (Fig.4.107). Epoxy injection forces resin-based sealer into concrete cracks to repair and restore the load-bearing capacity of the concrete.

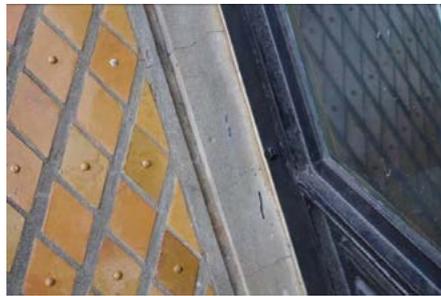
4.59 Cracks at the edge beams around the rooftop windows

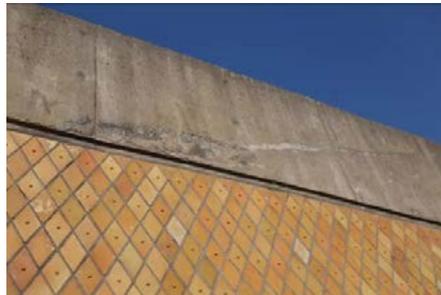
4.60 Oblique cracks at the top of a shell

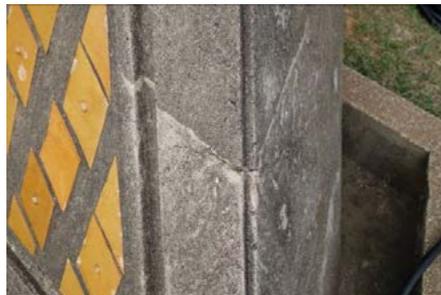
4.61 Cracks at the bottom of a shell

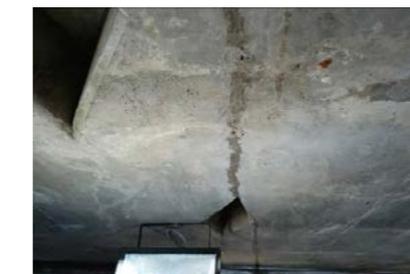
(Fig. 4.62) and (Fig. 4.63) indicate the crack distribution on the lattice-beam grids and slabs inside the chapel. When the overlapping areas of reinforcing bars (i.e., the light blue areas) serve the boundaries for three cracking zones. This study discovered that after the 921 earthquake, a grouting technique was applied to repair earthquake-induced cracks, which concentrated on the lower parts of the lattice-beam grids and slabs (Fig. 4.64). In addition to these repaired cracks, more cracks (width = 0.3–0.6 mm) were observed at the lower parts of the lattice-beam grids and slabs (Fig. 4.65), indicating that substantial tensile forces and earthquake-induced shear forces both occurred at these locations. Furthermore, cracks appear at the reinforcing bar overlapping areas of the lattice beams because the overlapping of reinforcing bars causes unfavorable reinforcing bar gripping, thus leads to the cracking of the lattice beams when under external forces (Fig. 4.66). Cracks also exist at the lattice beam areas above the overlapping areas of the reinforcing bar (Fig. 4.67). Since the lattice beams narrows from the bottom to the top, they are prone to crack when subjected to positive bending incurred by static vertical loads. Cracks in these areas are smaller (i.e., 0.25–0.35 mm) than cracks at the lower parts of the lattice beams.

4.64 Crack repaired after the 921 earthquake by using the grouting technique

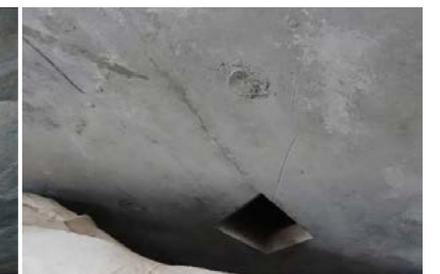
4.65 Lattice-beam cracking at the shell footing

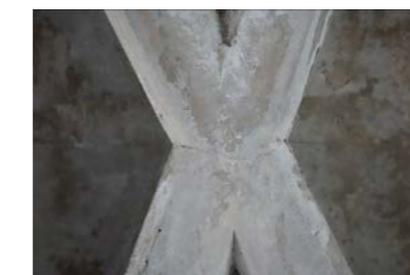
4.66 Cracking at a reinforcing bar overlapping area

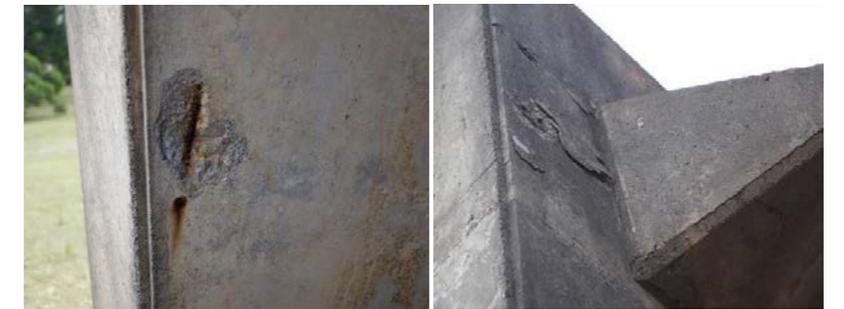
According to the distribution of corroded reinforcing bars and bolts on the chapel's eastern and western sides (Fig. 4.68) and (Fig. 4.69), steel corrosion primarily occurs at the edge columns. The steel corrosions at some locations are associated with concrete spalling and horizontal reinforcing bar exposure (Fig. 4.72). Steel corrosion were also identified at the bottom of the edge columns next to the side windows (Fig. 4.73) and the lower parts of the lattice beams (Fig. 4.70) and (Fig. 4.71). Severe steel corrosion resulted concrete cracking and peripheral damage (Fig. 4.74). Furthermore, the outer side of the rooftop pin joints exhibits similar steel corrosion states as well (Fig. 4.75).

4.74 Corroded reinforcing bars at the bottom of a lattice beam

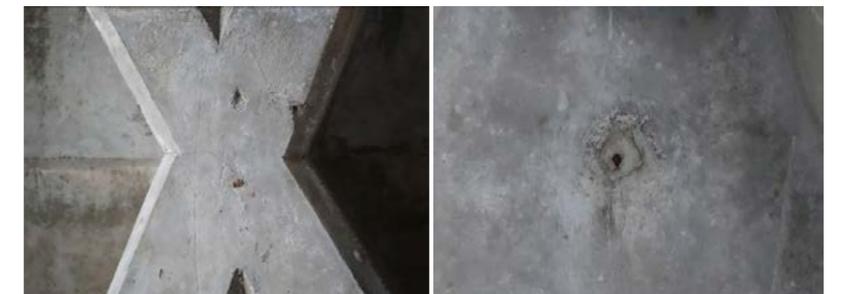
In contrast to the chapel's exterior RC surfaces, the steel corrosion indoor is less severe. The indoor steel corrosions primarily appear on the lattice-beam grids, forming small pits on the beam surface (Fig. 4.76). Exposed screw rods, which were used to affix the formwork during the construction process, also corroded (Fig. 4.77).

4.76 Reinforcing steel corrosion on the lattice beams

4.77 Corrosion of a screw rod inside the chapel beams

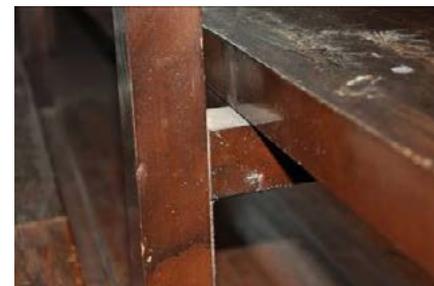
5.14 There's a gap between back of the pew and its frame.

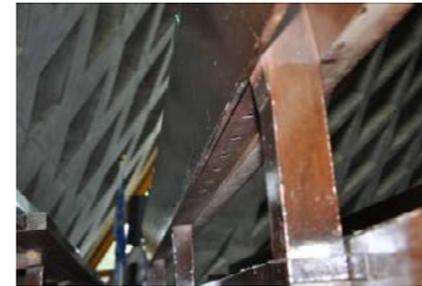
5.17 The frames on the back of the pew were fixed together with nails.

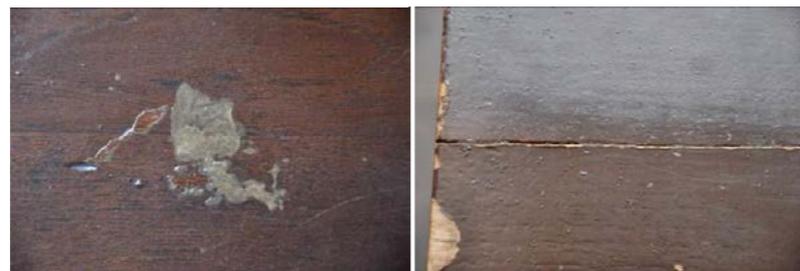
Paint deterioration usually occurs during usage, production process, and thermal expansion and contraction. The most common paint deterioration is peeling (Fig. 5.26), which is caused by various factors. It might be the incompatibility between the paint and the object or the lack of elasticity of the paint, which results hollow (Fig. 5.27), cracks (Fig. 5.28), desquamation (Fig. 5.29), flaking and other conditions. These conditions would result a space between paint layer and the object, allowing water vapor permeation, and create atomization effects. Atomization can also be the result of chemical reaction within the paint, instead of the influence of water vapor. The atomized condition of the paint on the pews; however, is caused by overexposure under the sun (Fig. 5.30).

5.26 Peeling paints

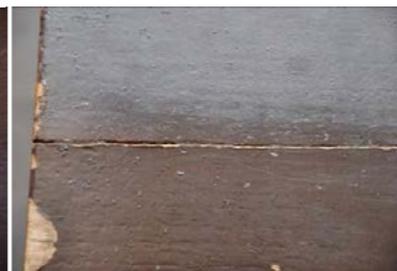
5.27 Hollows under paint layers

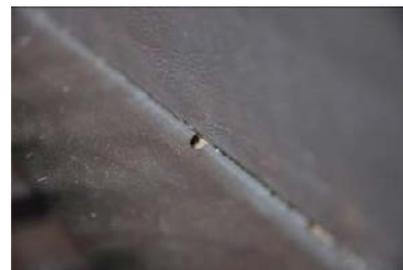
5.28 Cracks

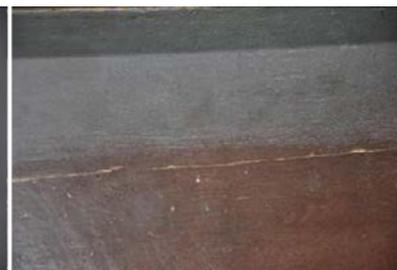
5.29 Desquamation of paint

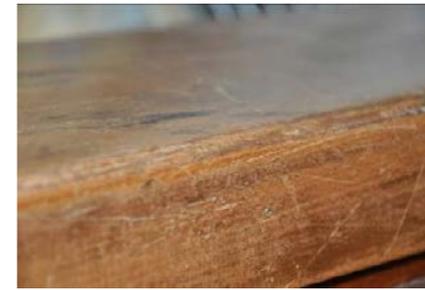
5.30 Atomization

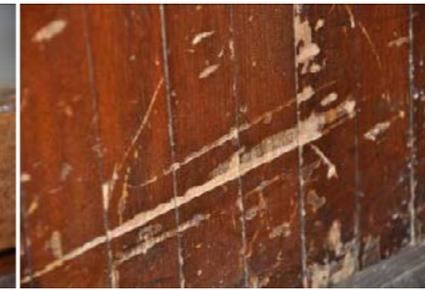
5.31 Tear and wear

The paint deteriorations most likely to result from daily usage is wear and tear (Fig. 5.31), which is commonly found in areas of frequent contact, such as seats and backrests. These parts of the seat are usually left with scratches (Fig. 5.32). In addition to the general deterioration, damages can also be caused from human or animal movements, such as various stain marks, metabolism and tissue residues (Fig. 5.34). Additional causes are adhesives, such as tapes (Fig. 5.35) and blue-tack (Fig. 5.36) used for event decorations. Marks of peeling (Fig. 5.37) and cleansing cotton were left on the pews in the process of adhesive removal (Fig. 5.38). There are even marks of deliberate damages (Fig. 5.39). At the same time, we can also find marks of previous mending, such as touch-up painting (Fig. 5.40) and tape marks (Fig. 5.41).

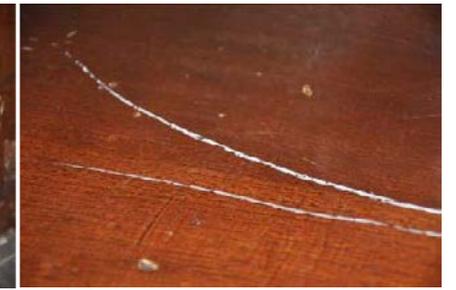
5.32 Scratches

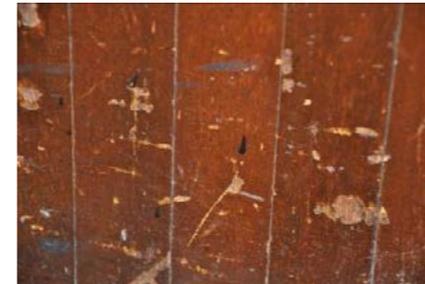
5.33 Stain

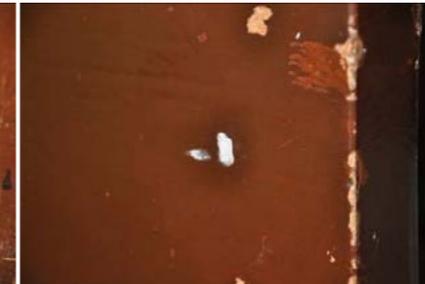
5.34 Biological metabolism and tissue residue

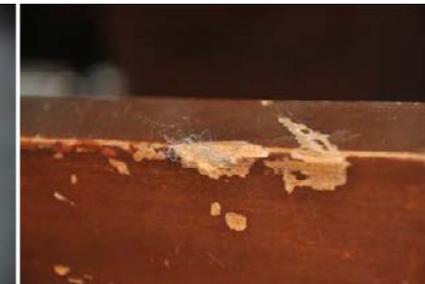
5.37 Marks of peeling

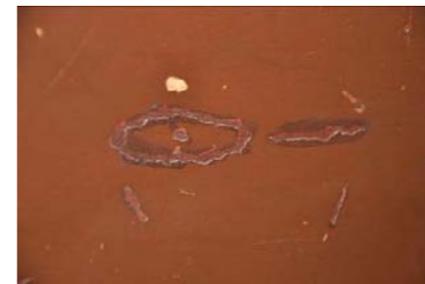
5.39 Deliberate damages

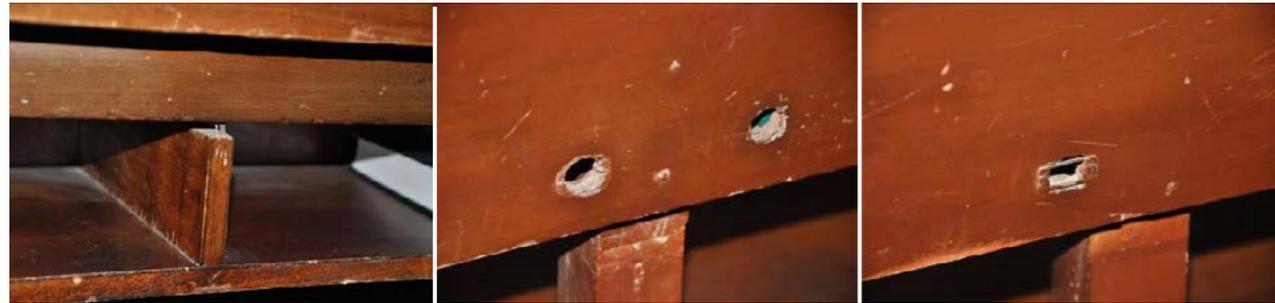
5.57 Slots beneath the seat

5.58 Holes for electric wires

5.59 A hole for electric network

Slots were added to the bottom of the first row pew as Bible holders. (Fig.5.57). There are holes for electric wires on some of the pews to equip interpretation devices, which were added according to the needs of foreign faculty, staff and guests (Fig.5.58 - Fig.5.59). Beside these marks, pinholes from event decorations were also found along the aisle side of the pews (Fig.5.60).

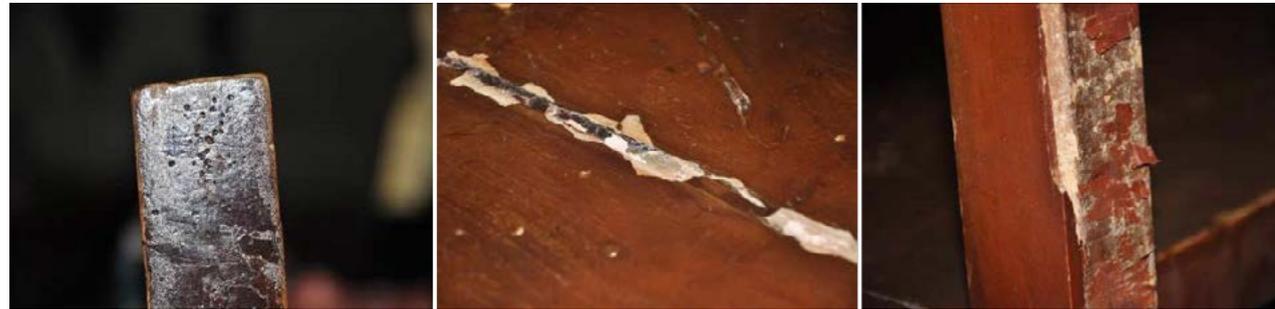
5.60 Pinholes

5.61 Patch marks

5.62 Natural defects

When it comes to wood works, natural defects are usually inevitable. Therefore, minor repairing marks are often found on the front and back of a wood chair (Fig.5.61). Wood fillers are used to patch porous surfaces, and timber for the seams on the backrest. Currently, there are still some natural defects hidden in the inconspicuous corners, places such as pew legs and the bottom of the seats are in need of repair (Fig.5.62). Besides the repairing marks caused during manufacture, subsequent repair for damages caused by normal usage were also discovered. Nails were used to fix loose cup holders (Fig.5.63), and partial sidewall damages (Fig.5.64).

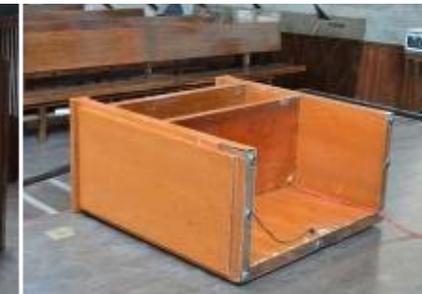
5.78 Current state within the communion table.

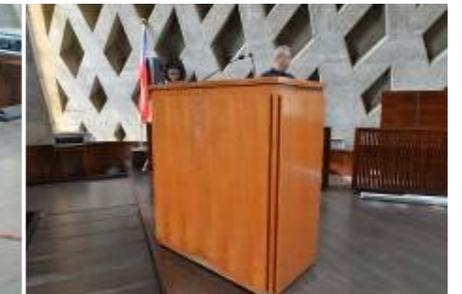
5.79 The pulpit's current inner condition

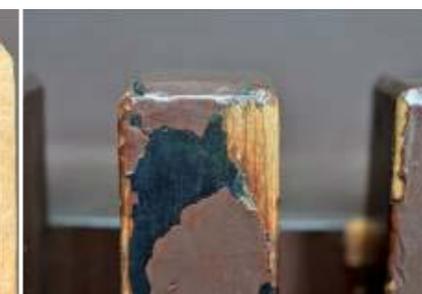
5.88 The Screen made of Taiwan cypress has marks of black and brown paint.

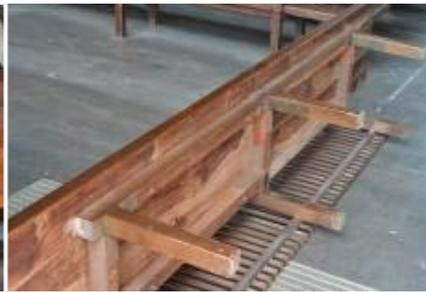
5.91 Current condition of the teak pews

The worn out paint surface indicates the history of the object. The protective paint is to prolong the life span of the objects rather than maintaining the appearance or presenting its historical value. The worn-out paint should be removed before further paint is coated on the objects.

Wooden damages can affect the overall safety of an object. Condition such as: legs fracture should be replaced with the same kind of timber to ensure the stability of the chair. In addition, attachments such as chewing gums, stickers, holes and other natural defects should be removed and repaired to avoid further pest damages on the objects.

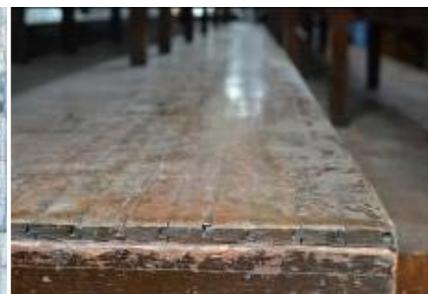
5.99 Apparent wear and tear along with paint deterioration of a lauan wood surface

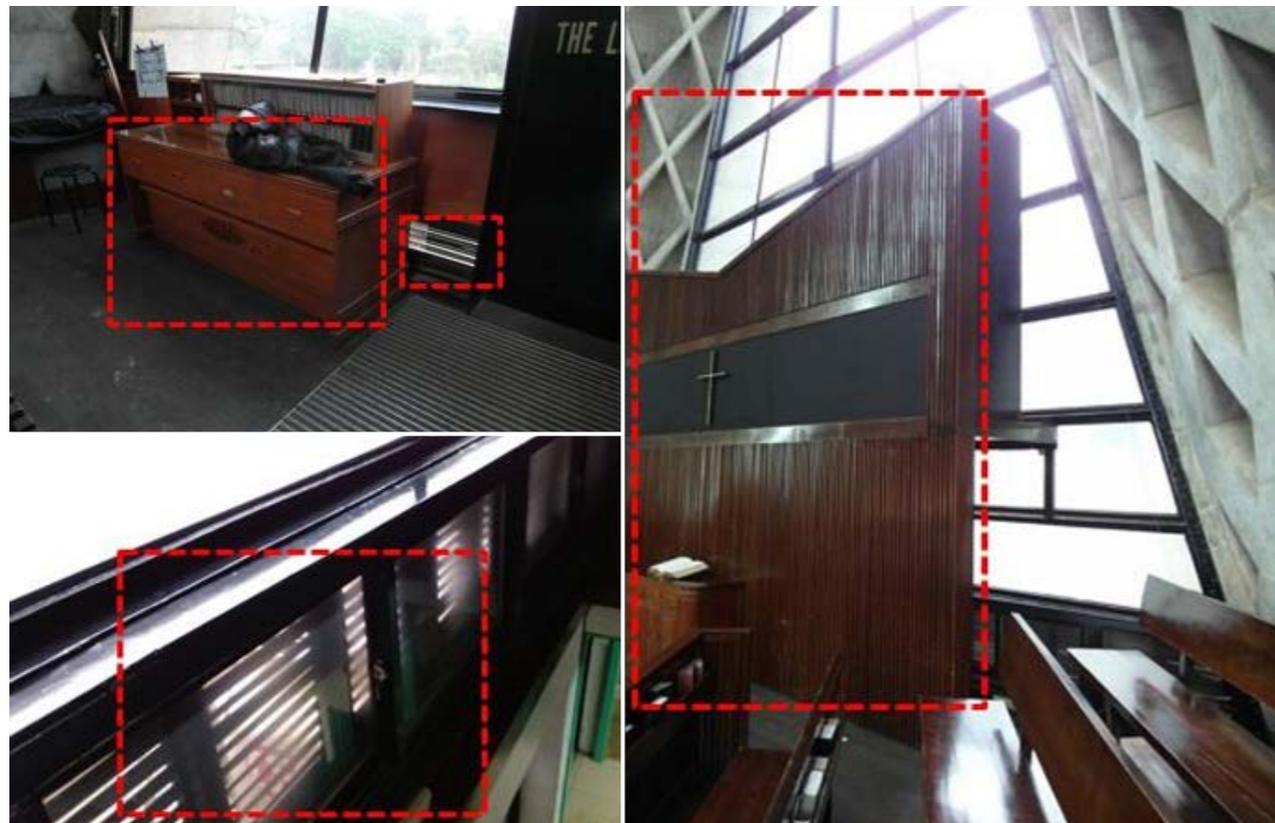
Additional factors obstructing natural ventilation were also found (Fig.6.8):

1. Lower blinds at the west and east sides of the chapel are blocked by inner glass windows, which decrease valid openings and deter ventilation efficiency.
2. Interior objects, such as low shelves and the backrests of the pews block the ventilation route and interfere airflow.

6.8 Factors interfering natural ventilation

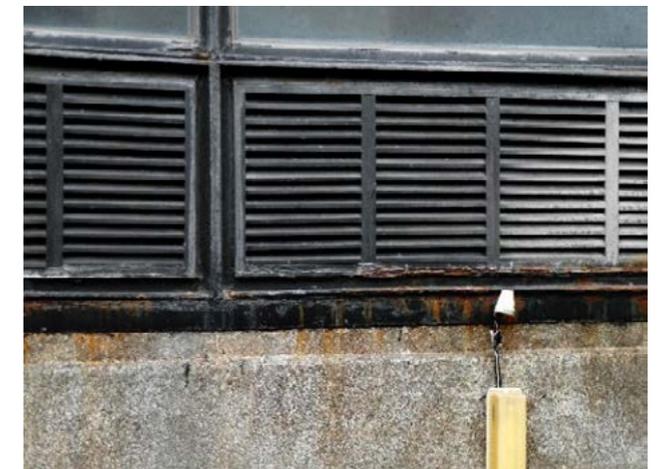
6.11 Rusted blinds caused by the vaped water from the cooling tower

1. Noise from the engines of the air-conditioners in the basement influences people at the pulpit and the front seats. (Fig.6.9)
2. Users indicate that air at the aisle seats is sultry and heated. (Fig.6.10)
3. Water vapor coming from the cooling tower rusted the window frames and the blinds. (Fig.6.11)
4. When the crowd within the chapel gets overloaded, the air quality drops as the lack of outdoor air input sterilizes the indoor ventilation with air lingering inside the chapel for too long.

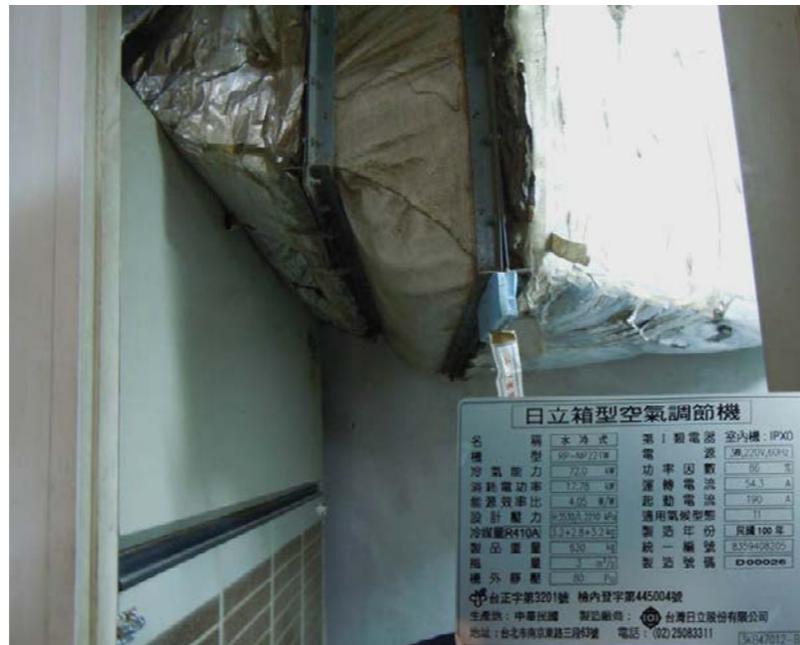
Fig.7.1 Water cooled air handlers at the basement

The existing air conditioning (AC) system of the Luce Chapel was installed at the basement three years ago. Two water cooled air handlers which each carries a capacity of 20 RT/72kw were placed at the corners of the basement (Fig.7.1) with two sets of outdoor water cooling towers providing condenser water to the air conditioners in the basement(Fig.7.2).

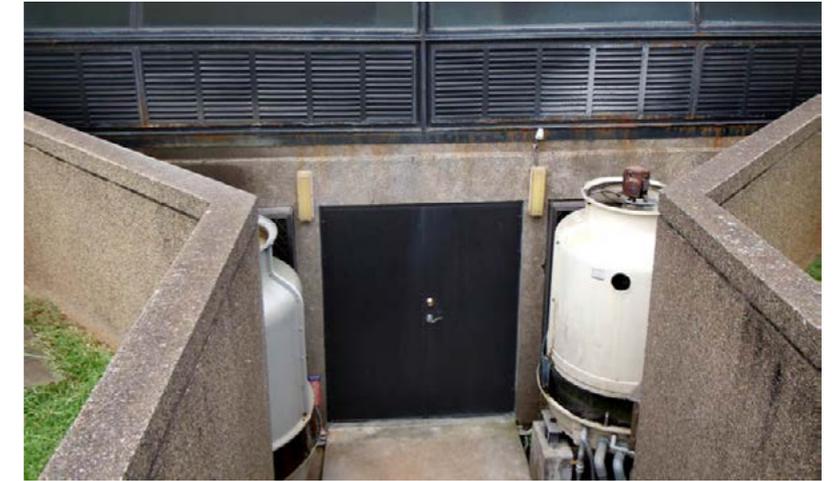
Fig.7.2 Outdoor water cooling towers outside the basement

Another drawback of the existing air-conditioning system is the problems caused by the cooling towers outside the basement. The air intake louvers behind the first floor pulpit have been sealed to prevent polluted air and fan noises from the cooling towers. Furthermore, the splashing water droplets dripping out of the cooling towers has caused significant corrosion on the metal frame of the first floor glass window (Fig.7.4).

First, the proposed AC system does not need cooling towers. The issue of first floor metal window frame corrosion caused by the splashing water droplets from the cooling tower will be eliminated. Second, the 20 small VRF indoor units installed in the indentations at the sides of the nave will be able to be set in a distance, and release some space (compared to the large air ducts of the existing system). The released space can be used for auxiliary lighting installation for the illumination of the nave during night events. This is the additional advantages of this proposed AC system. However, the drawback is that the VRF indoor units need regular cleaning and maintenance (quarterly and annual maintenance). Due to the width restrains of the indentations at both sides of the nave, it requires the maintenance staff to climb over the fence in/out of the indentations for maintaining the VRF indoor units whenever the maintenance or cleaning work is needed. Moreover, this type of VRF air-condition units are imports from Japan and Korea; therefore the cost will be 20 to 30% higher than Solution B.

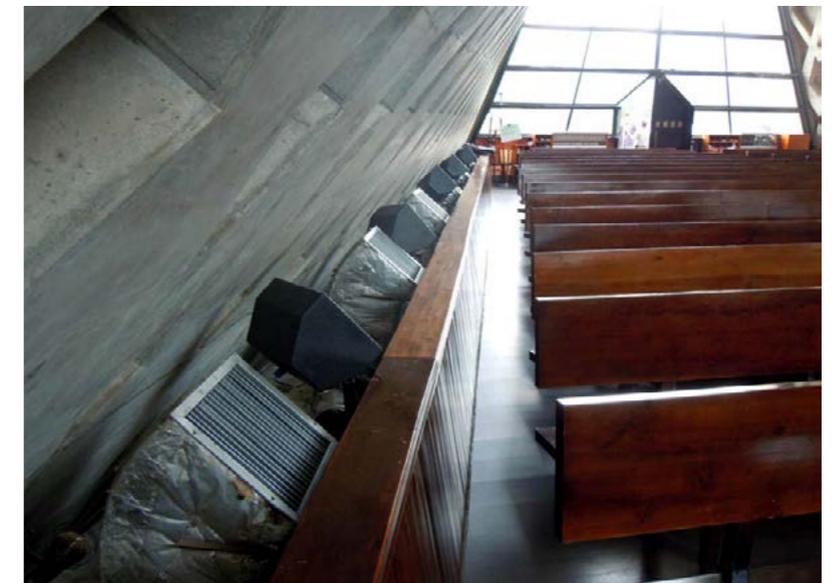
Fig.7.3 The ductwork system besides the seating area

Each packaged air handler is connected with supply air duct (set in the indentations at the sides of the seating area) to deliver conditioned air to the first floor. Each ductwork system has 11 air grilles, set at 60 degree in angle, to supply cold air to the nave and chancel (Fig.7.3). The return air is drawn back to the water cooled air handlers in the basement through the stairways behind the chancel to complete the air conditioning cycle.

By surveying different seating areas located at the first floor, the air was found to have fairly even distribution among the first floor seating area. Temperature variations among each location were also limited. The minor stagnant air zone only appeared at the area around the central aisle. However, the operating noise of package air handlers was around 73 dBA (measured at the basement), which then transmitted via the stairways to the chancel. The rumbling noise was also audible in the first 3 to 4 rows of the seating area. For this reason, many audience had complained about the AC noise for affecting the speech intelligibility of lectures or sermons. Therefore, reducing the operating noise has become a major concern for renovating the chapel's AC system.
