# 山门 状况评估

## Shanmen Condition Assessment

Shanmen, or the gatehouse, is a simple rectangular structure, three bays wide and one bay deep. The gatehouse has surviving painted polychrome decoration on both exterior and interior architectural wooden surfaces.

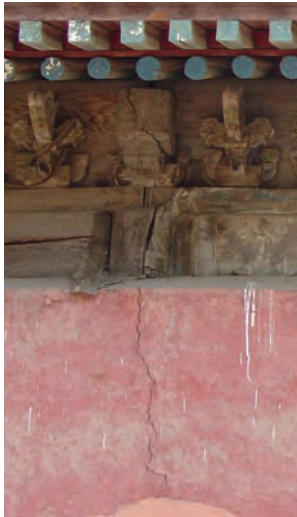
南立面檐柱上的纵向裂缝，从木材直延伸到墙面抹灰，造成该部位画层的脱落。

Vertical crack on column of south facade extends from the wood column down to the wall plaster and contributed to the loss of painting in this area.

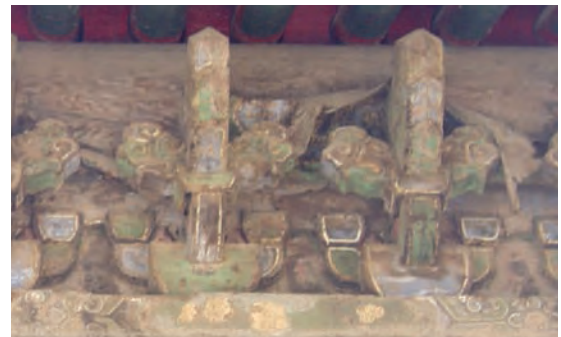
檩上的彩画剥离。

Detachment of painting from purlin.

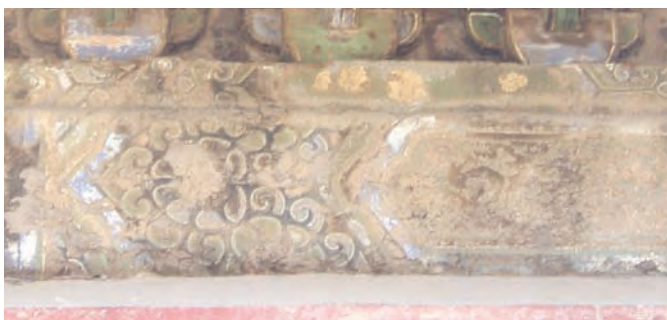
画面污点及变黑。

Staining/darkening of painting.

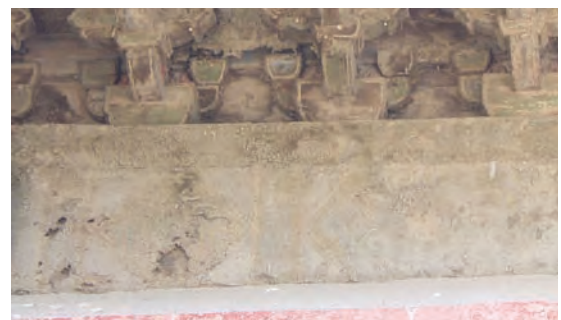
经受风化和磨损的彩画。

Weathered and abraded area of painting.

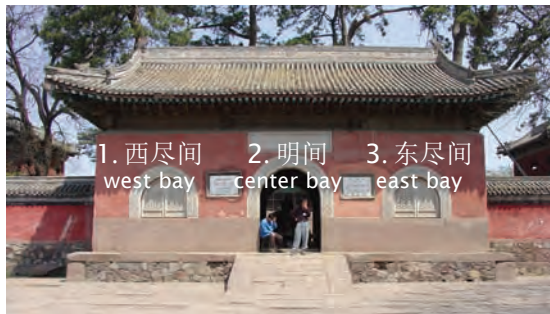
南立面面阔三间，彩画状况最差。西尽间及明间整体彩绘地仗全部脱落，而东尽间尚存的彩画残损严重，表面有污斑、撕破、脱落并呈悬挂状。角科斗拱和檐柱上的彩画通常空鼓或脱落。明间东侧檐柱暴露的木质上存在的垂直裂缝是造成彩画脱落的主要原因。在这一部位只有斗拱上留下了数量相当的彩画。

The south facade is three bays long and the painting is in the poorest condition here. There is almost total loss of the painted plaster on the entire west and center bays. Only very deteriorated painting survives on the east bay, where the painted plaster is very abraded, stained, torn and hanging off in places. Areas of painting on the corner sets and columns is often detached or lost. Vertical cracks are visible on the exposed wood of the column between the center and east bay contributing to the loss of painting in this area. Only the brackets retain a significant amount of paint.

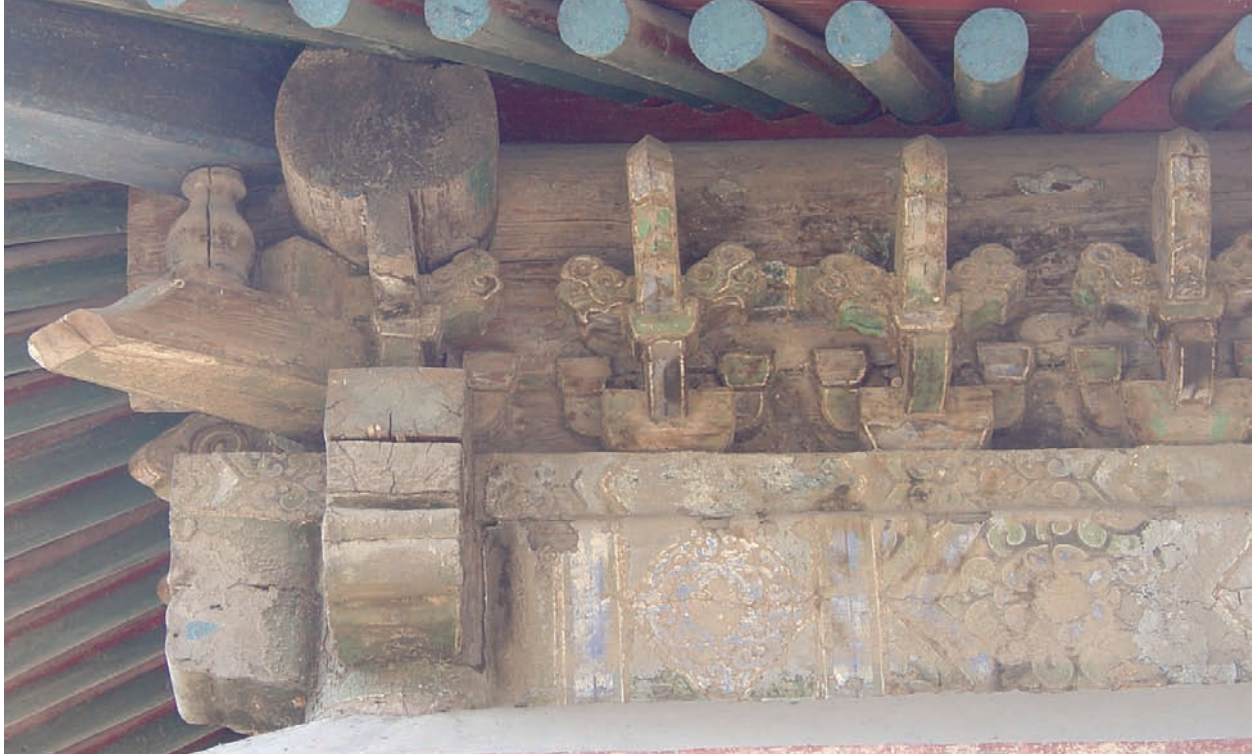
北墙彩画细部。挑檐檩上彩画大部分已经脱落。这里可见一小部分已剥离的彩画，被下面的斗拱挡住。

Details of painting on north facade. Most of the painted plaster on the purlin is lost. Here a small piece is detached and falling, supported in place by the brackets.

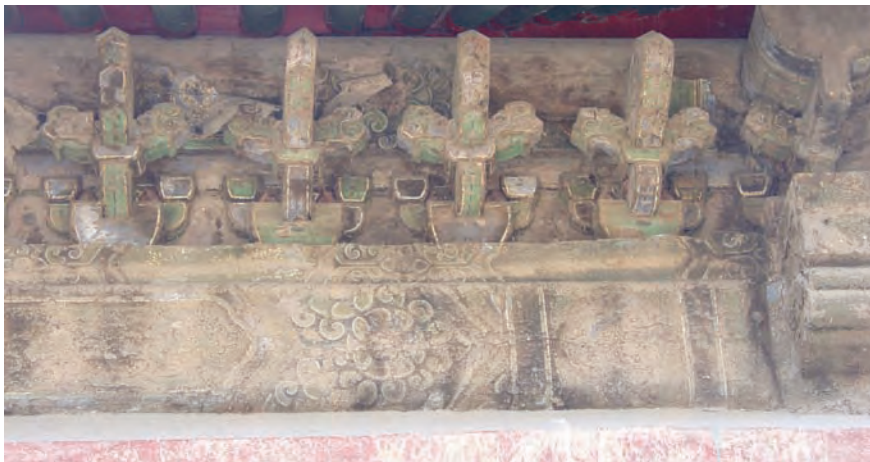
东立面面阔一间。与西立面不同，东立面的彩画几乎全部保存了下来，一些部位的图案仍然可见，尤其是北端。

额枋上的彩画有一条长达额枋2/3的大裂缝。临近裂缝部位的彩画剥离并下垂。檩上尚存彩绘，但位于其最上缘的已缺失。平间斗拱上彩画保存良好，但角科斗拱的彩绘已经脱落了。

A large horizontal crack runs across two thirds of the main architrave painting. The painting in the area around this large crack is detached and sagging. The painting on the brackets is well preserved and the purlins retain paint, though there is some loss along the very top edge. The painting on the corner sets has been lost.

The paint layer exhibits staining, fine cracking, surface paint loss and surface dirt (with noticeably more dirt on the southern end).

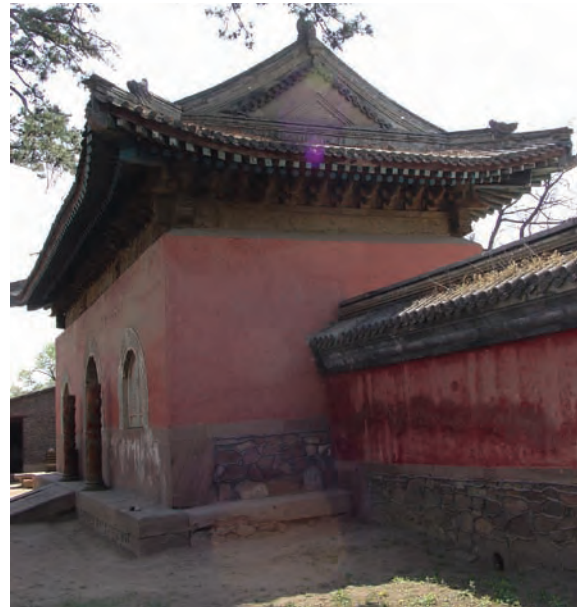
山门西立面彩画几乎完整保存。

Nearly all of the painting survives on the west facade of the gatehouse.

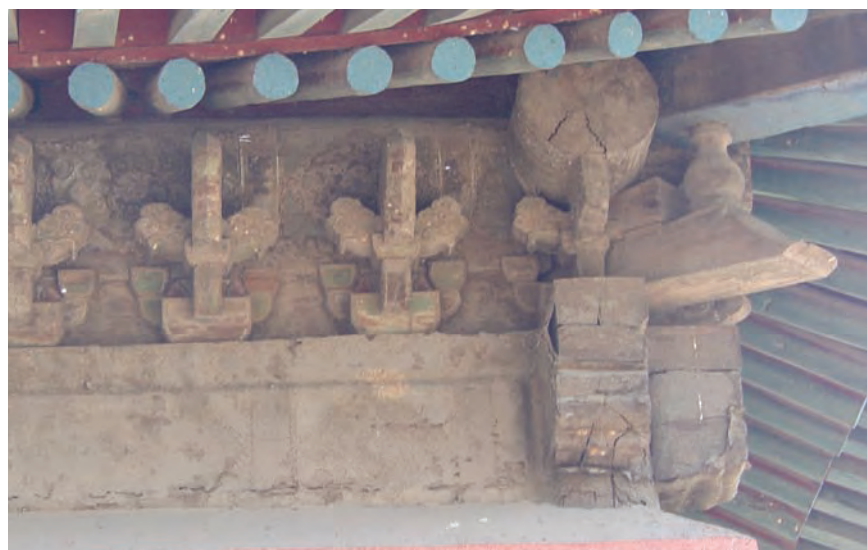
虽然额枋上所有地仗尚存，但其表面相当污浊且风化严重。小面积缺失分布于整个表面。装饰图案难于辨认。

Though all of the plaster survives on the main architrave, the surface is extremely dirty and weathered. Small losses can be seen across the surface and the decorative pattern is difficult to decipher.

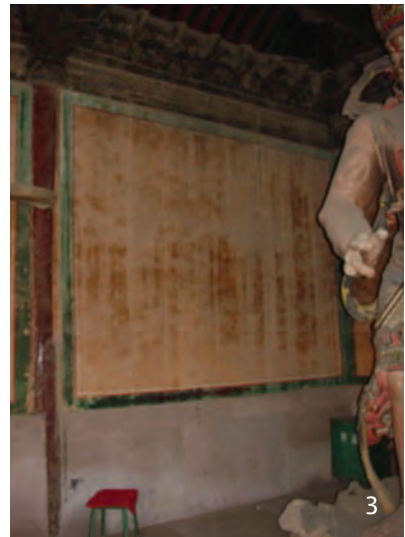
明间彩画细节，请注意檐檩上彩画的缺失  
Detail of center bay showing loss of painting on the purlin.

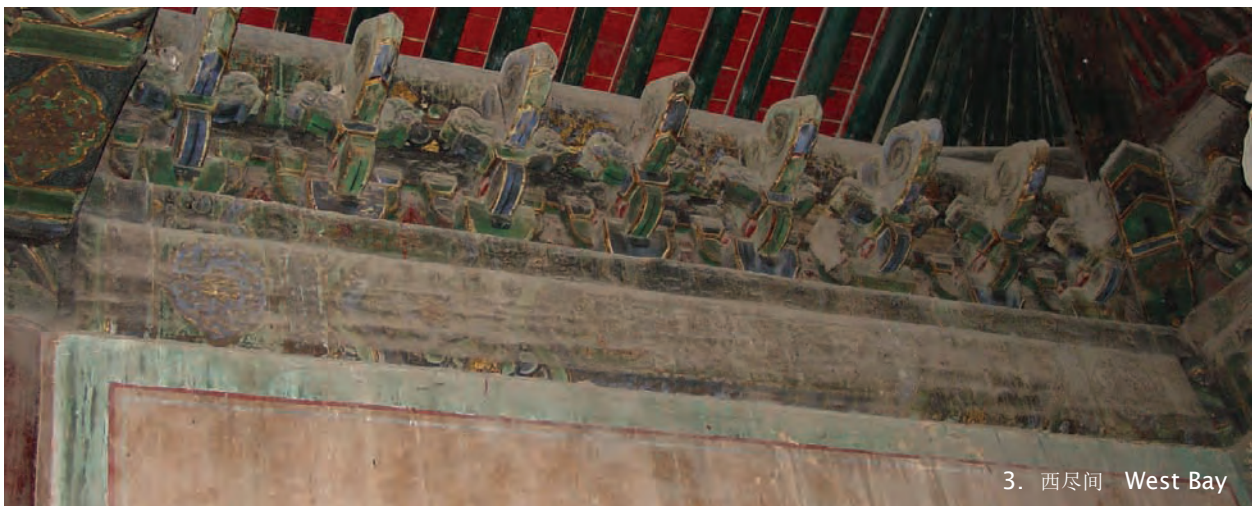
3. 西尽间 West Bay

西尽间：西尽间彩画表面积灰较多，但保存状况较好。

West Bay: the west bay painting, though dusty, survives in good condition.

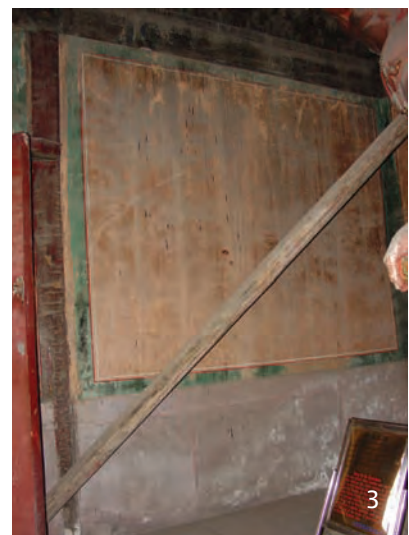
沿西尽间额枋上一水平裂缝出现的彩画缺失和剥离，局部彩画外翻下垂。

Area of loss and detached area of painting along a horizontal crack on the west bay with pieces hanging down.

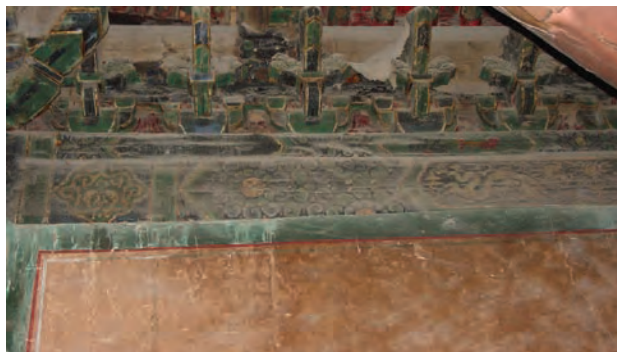
檐檩彩画剥离部位及下垂的片断。

Area of detached pieces of painting on purlin.

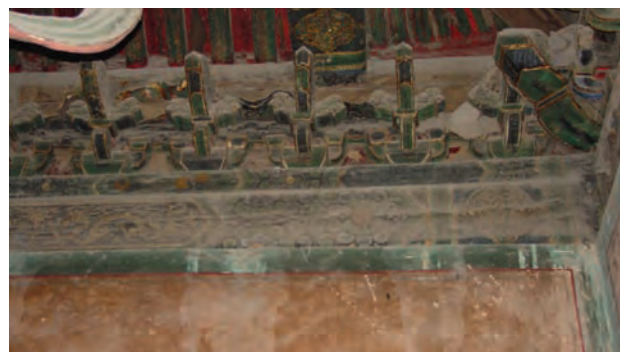
檐檩彩画缺失的部位。

Area of loss of painting on purlin.

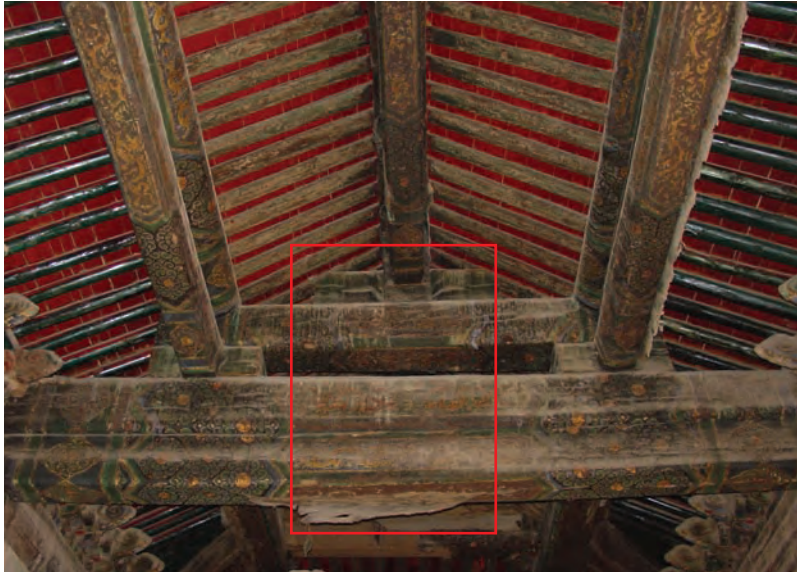
梁细部表现出积灰、水流痕迹及彩画上的污点。

View of east end of ceiling.

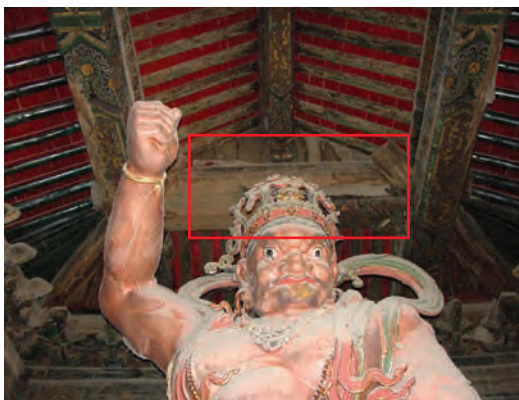
东尽头屋顶区域，可见踩步金上的彩画缺失。

Far eastern area of the ceiling showing loss of the painting on one of the beams.

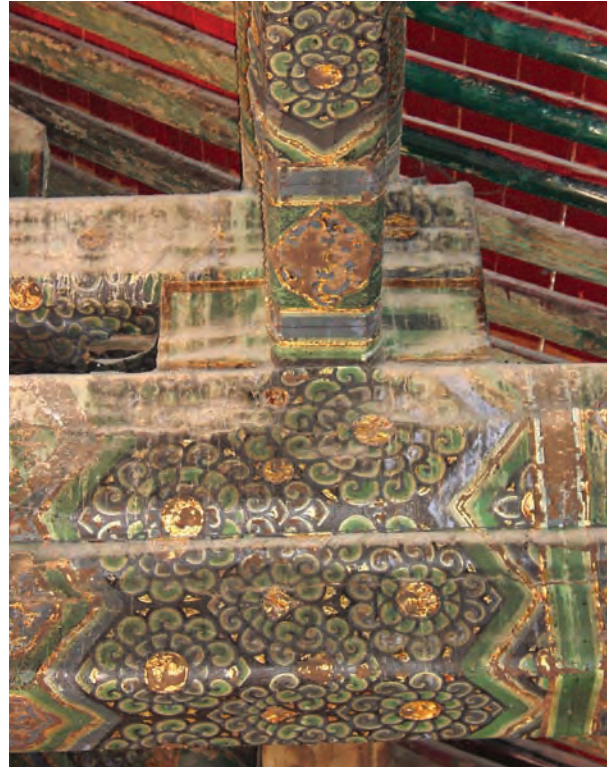
西段屋顶可见大面积地仗层缺失和剥离。请注意暴露的木梁表面的水迹。

Large areas of plaster loss and detachment are visible on the west end ceiling. Note the moisture staining on the exposed wooden beam.

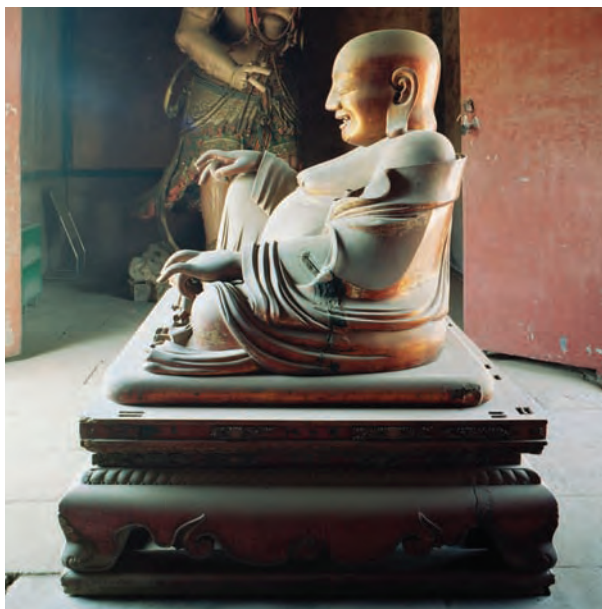
现今的弥勒像和座椅所留存下来的部分。

Maitreya today showing what remains of the throne.

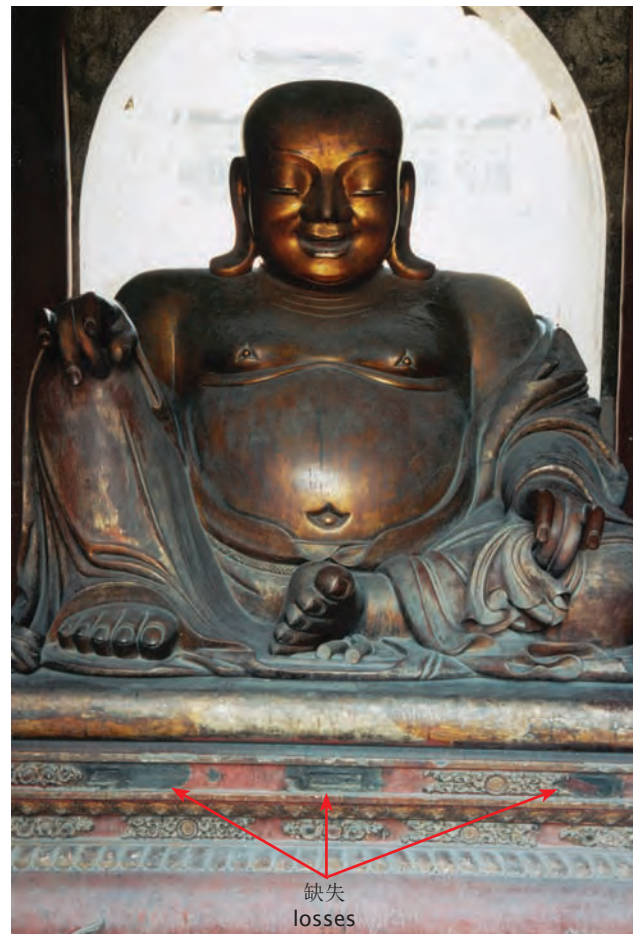
请注意塑像底座的小面积缺失。

Note small losses in the sculpture base.

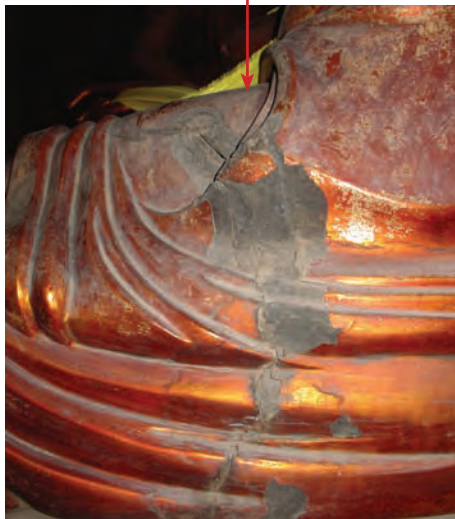
弥勒佛像左臂大面积的缺失。  
Large loss on left arm of Maitreya.

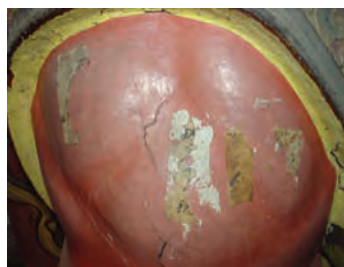
可能的干预遗迹左膝及槌上的标签。

Remains of modern inventory labels on left knee and on scepter.

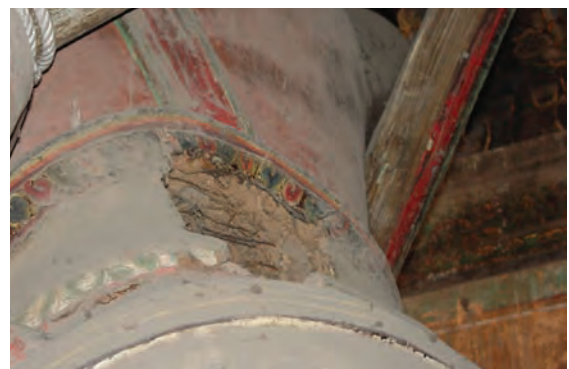
Hole in back of *Heng* which perhaps served as a means to originally anchor and support the statue.

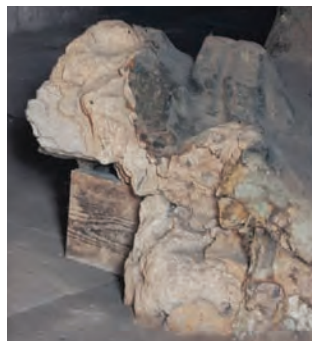
塑像基座的部份缺失。

Losses on sculpture base.

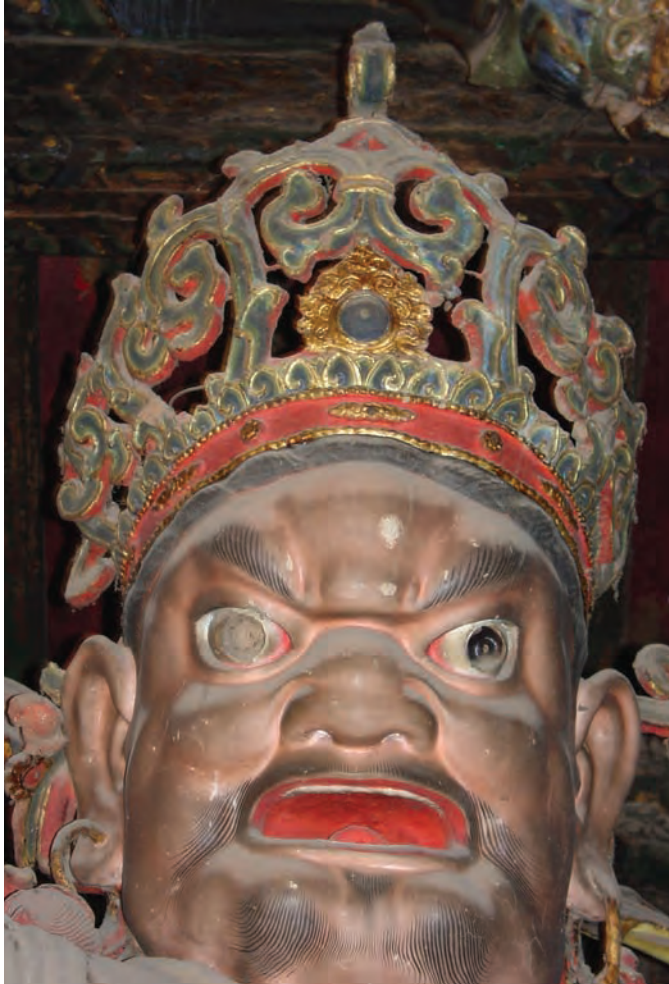
“哈”头部细节。

Detail of head of Temple Guardian *Ha*.

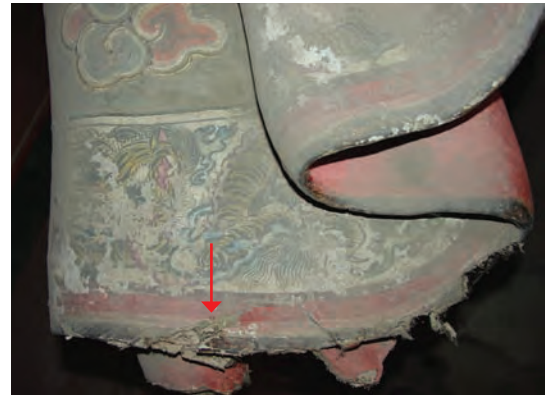
厚灰尘层覆盖油饰表面，且可见小面积缺失。

Thick layer of dust covers the paint surface and small areas of loss are visible.

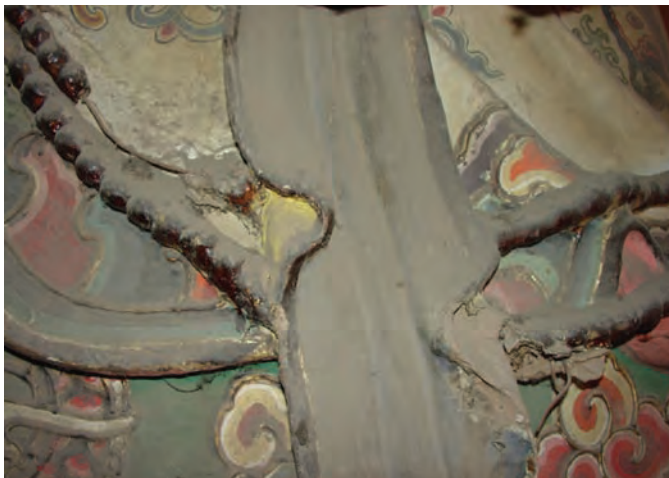
位于突出及精致装饰部分的小面积缺失，例如飘带以及在铁丝骨架上构造的球形装饰。

Small losses to protruding and delicate areas of ornamentation such as ribbons and ball decoration which are built up in plaster on a wire armature.

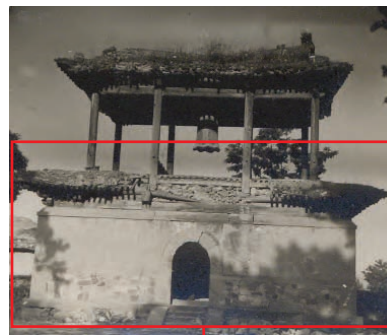
1959年钟楼历史照片；彩画尚存的局部细节。

Historical photograph of the Bell Tower from 1959. Detail of areas with surviving painting.

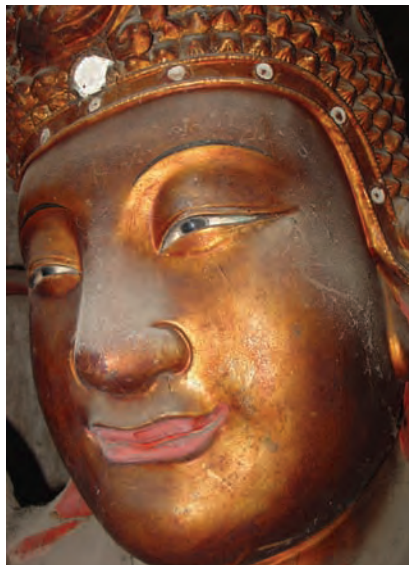
魏陀脸部细部。注意脸部周围装饰的缺失。

Detail of face of *Weituo*. Note losses of decoration around face.
